**Flood Control Project Maintenance
Levee Inspections**

Maintenance Issue Types Only, Levee Inspection Report By Mile - Spring 2020

Butte County Department of Public Works

Waterway	Bank	Unit Miles	Inspection Start/End	Inspector
Unit No. 01 Mud Creek	Right	6.80	04/06/2020 04/06/2020	Makar Sokol

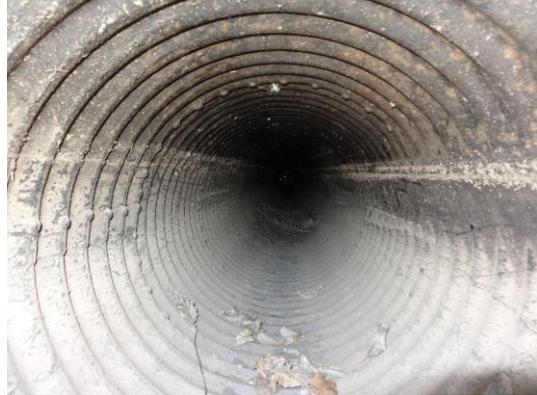
Photo 3 of 3 : UCIP_SP_2020_29705_54922.jpg

LS view: inside view of CMP on levee slope. Looks clean and clear.

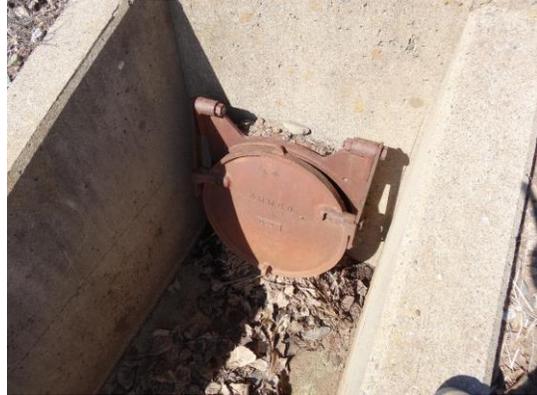
Photo 2 of 3 : UCIP_SP_2020_32044_58542.jpg

Comment Code					
Inspector Comment					
DS_ID:19211 FS_ID:32044 EP_NO: N/A Repair Type: Non-Urgent Crossing Status: Found UCIP Comments: Vegetation debris on waterside. Needs clearing and cleaning. FIELD_STRUCT_DESC: 24-inch corrugated metal gravity drainage pipe through the levee, 12 feet below the crown. Flap gate on the waterside (WS) end. Concrete U-shaped headwall on each end. Grouted riprap apron on the landside (LS) end. Grouted riprap spillway on the WS end. [Additional Reference(s): DWR Levee Log, 1992. USACE Sacramento O&M Manual 504, May 1965, (HLM 1.03)]. FS Date: 2/20/2014

WS view: vegetation debris blocking outlet.

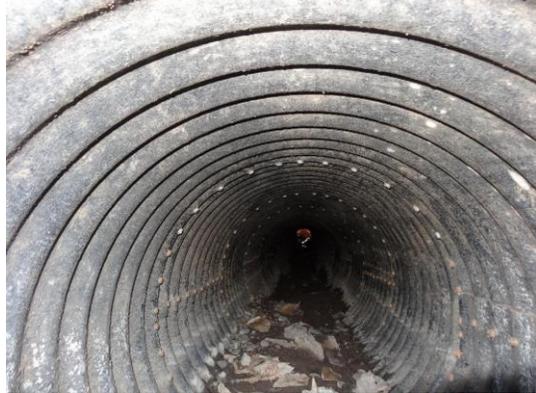
Photo 3 of 3 : UCIP_SP_2020_50142_55884.jpg

LS view: inside view of CMP on levee slope. Needs cleaning and clearing.

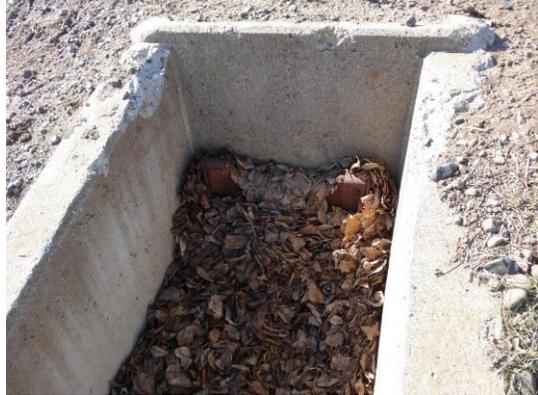
Photo 1 of 2 : UCIP_SP_2020_30295_55706.jpg

WS view: U type concrete headwall, flapgate on levee slope. Vegetation debris blocking the outlet.

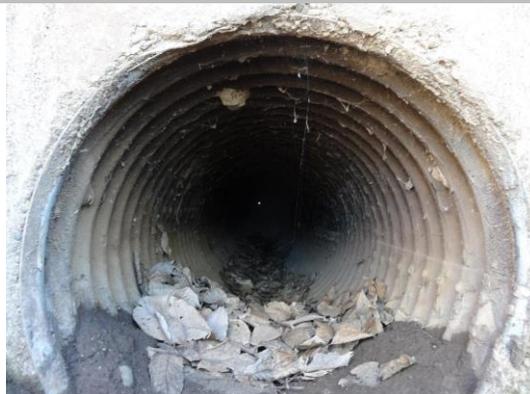
Photo 3 of 3 : UCIP_SP_2020_30310_55739.jpg

LS view: inside view of CMP on levee slope. Needs cleaning and clearing.

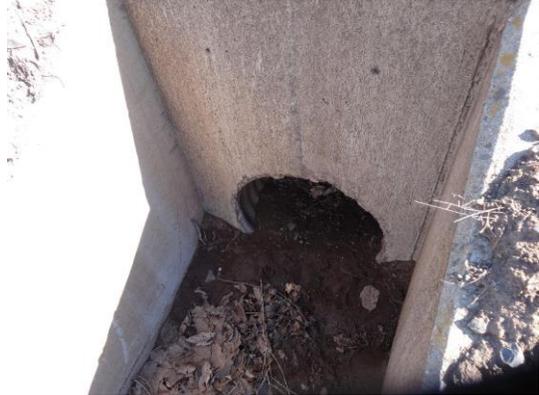
Photo 2 of 2 : UCIP_SP_2020_30311_55742.jpg

Comment Code					
Inspector Comment					
DS_ID:19219 FS_ID:30311 EP_NO: N/A Repair Type: Non-Urgent Crossing Status: Found UCIP Comments: Needs cleaning and clearing of debris in both ends of the pipe. FIELD_STRUCT_DESC: 24-inch corrugated metal gravity drainage pipe through the levee, 9 feet below the crown. Flap gate on the waterside (WS) end. Concrete U-shaped headwall on each end. Grouted riprap apron on the landside (LS) end. Grouted riprap spillway on the WS end. [Additional Reference(s): DWR Levee Log, 1992. USACE Sacramento O&M Manual 504, May 1965, (HLM 4.08)]. FS Date: 2/20/2014

LS view: U type concrete headwall and CMP on levee slope.

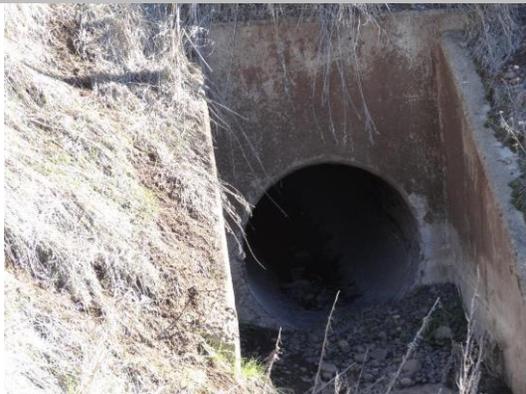
Photo 3 of 3 : UCIP_SP_2020_30327_55766.jpg

LS view: U type concrete headwall and CMP on levee slope.

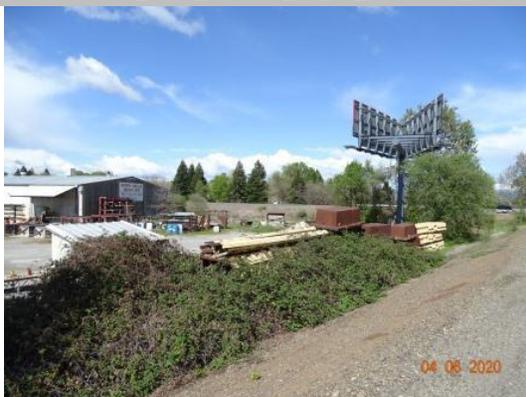
Photo 1 of 1 : SP_2020_NA0003_64_55_20200413_00050.jpg

LM Start	5.20	Rating **	M	Issue No.	55
LM End	5.20	Issue Type +	Ma	Location *	LS
Category	Earthen Levee			GPS Latitude/Longitude	
				Start	End
Item	Vegetation			39.784234 °	39.784234 °
				-121.886589 °	-121.886589 °
DWR ID	DWR_NA0003_01_f_2016_55				
Comment Code					
V2 : Remove the wild growth other than native grasses from the levee slopes.					
Inspector Comment

View of the blackberry bushes along the landside toe. Spring 2020.

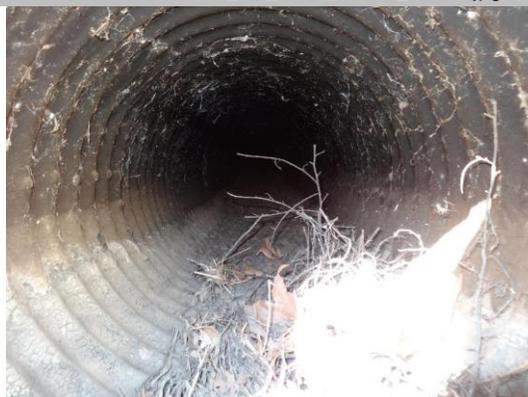
Photo 3 of 3 : UCIP_SP_2020_30403_55920.jpg

LS view: inside view of CMP on levee slope. Needs cleaning and clearing.

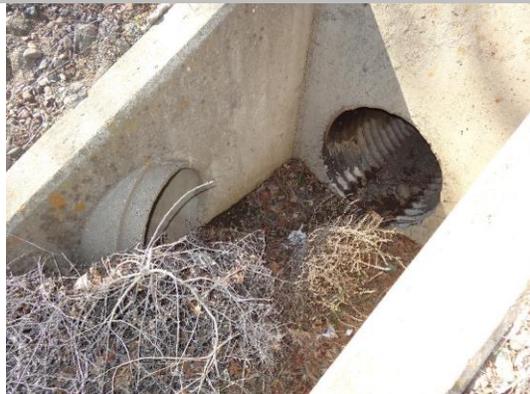
Photo 2 of 2 : UCIP_SP_2020_30743_56640.jpg

Comment Code					
Inspector Comment					
DS_ID:19237 FS_ID:30743 EP_NO: N/A Repair Type: Non-Urgent Crossing Status: Found UCIP Comments: Needs cleaning and clearing of debris. FIELD_STRUCT_DESC: 24-inch corrugated metal gravity drainage pipe through the levee, 11 feet below the crown. Flap gate on the waterside (WS) end. Concrete U-shaped headwall on each end. Grouted riprap apron on the landside (LS) end. Grouted riprap spillway on the WS end. [Additional Reference(s): DWR Levee Log, 1992. USACE Sacramento O&M Manual 504, May 1965, (HLM 1.55)]. FS Date: 2/24/2014

LS view: U type concrete headwall and CMP on levee slope. Vegetation debris and soil in inlet area.

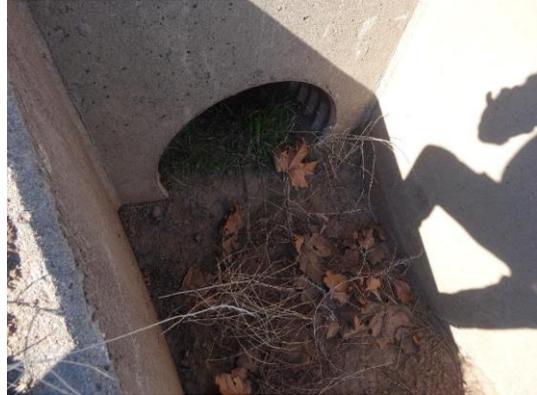
Photo 2 of 3 : UCIP_SP_2020_30763_56661.jpg

LS view: U type concrete headwall and CMP on levee slope.

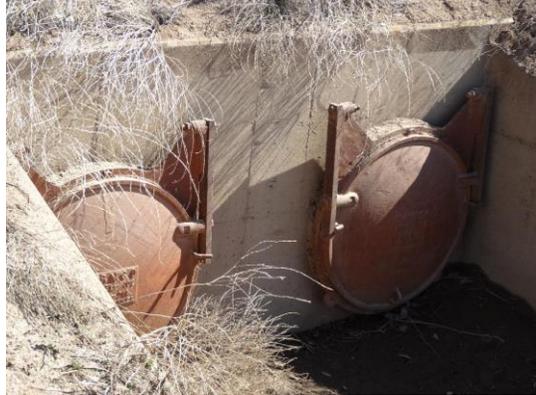
Photo 2 of 3 : UCIP_SP_2020_41376_56919.jpg

WS view: U type concrete headwall, pipes, and flapgates on levee slope. Vegetation debris on outlet box.

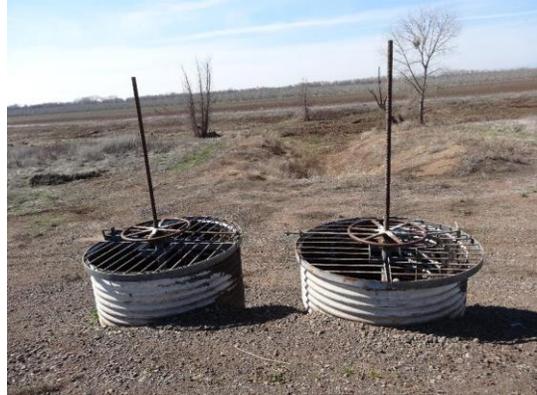
Photo 1 of 3 : UCIP_SP_2020_41377_56923.jpg

Comment Code					
Inspector Comment					
DS_ID:19259 FS_ID:41377 EP_NO: N/A Repair Type: Non-Urgent Crossing Status: Found UCIP Comments: Needs cleaning and clearing of debris. FIELD_STRUCT_DESC: [Channel Slough Drainage Structure] 2 of 2: 42-inch corrugated metal gravity drainage pipe through the levee, 16 feet below the crown. Flap gate on the waterside (WS) end. Slide gate in a corrugated metal pipe (CMP) riser on the WS slope. Concrete U-shaped headwall on each end. Grouted riprap apron and rock revetment on the landside (LS) end. [Additional Reference(s): DWR Levee Log, 1992. USACE Sacramento O&M Manual 504, May 1965, (HLM 6.30)]. FS Date: 2/25/2014

WS view: slide gates in CMP risers on levee slope.

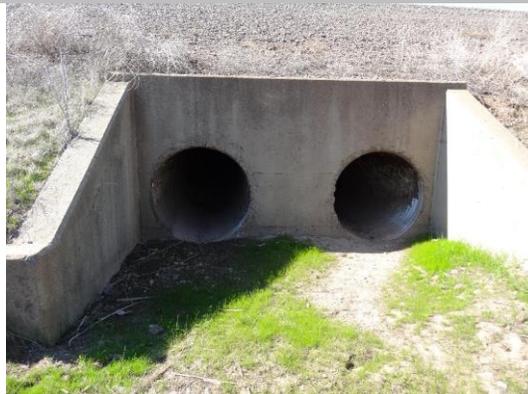
Photo 3 of 3 : UCIP_SP_2020_41377_56921.jpg

LS view: U type concrete headwall and CMPs on levee slope. Soil/mud on inlet box.

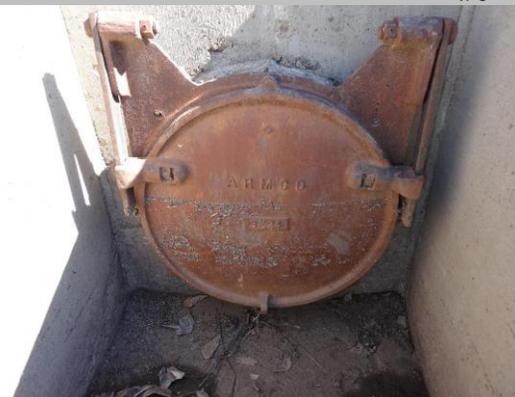
Photo 1 of 3 : UCIP_SP_2020_31034_56926.jpg

WS view: U type concrete headwall, pipe, and flapgate on levee slope.

Comment Code					
Inspector Comment					
DS_ID:19249 FS_ID:31034 EP_NO: N/A Repair Type: Non-Urgent Crossing Status: Found UCIP Comments: Needs cleaning and clearing of debris. FIELD_STRUCT_DESC: 24-inch corrugated metal gravity drainage pipe through the levee, 12 feet below the crown. Flap gate on the waterside (WS) end. Concrete U-shaped headwall on each end. Grouted riprap apron on the landside (LS) end. Grouted riprap spillway on the WS end. [Additional Reference(s): DWR Levee Log, 1992. USACE Sacramento O&M Manual 504, May 1965, (HLM 6.35)]. FS Date: 2/25/2014

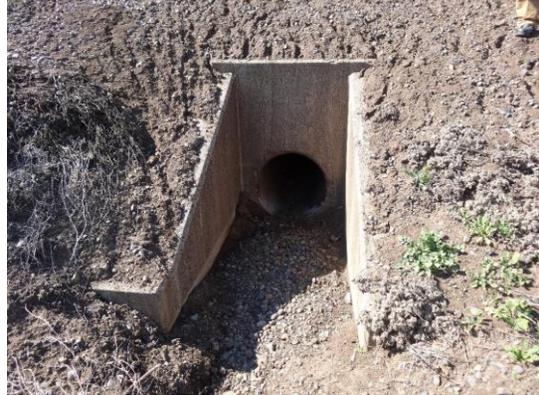
Photo 2 of 3 : UCIP_SP_2020_31034_56925.jpg

LS view: U type concrete headwall and CMP on levee slope.

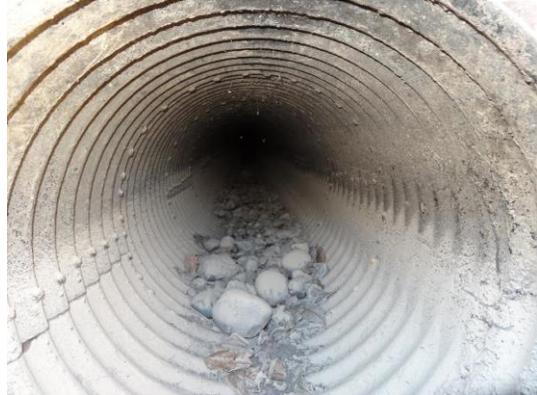
Photo 3 of 3 : UCIP_SP_2020_31085_56986.jpg

LS view: inside view of CMP on levee slope. Needs cleaning and clearing.

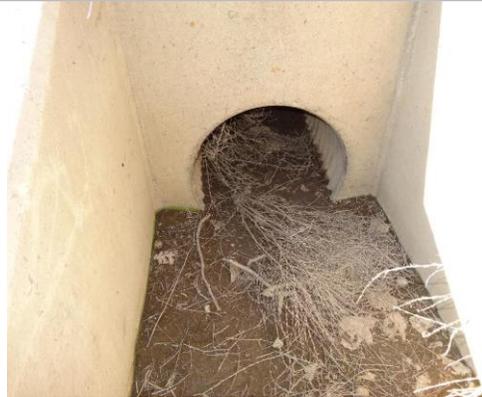
Photo 2 of 3 : UCIP_SP_2020_31103_57001.jpg

LS view: U type concrete headwall and CMP on levee slope. Soil/mud on inlet box.

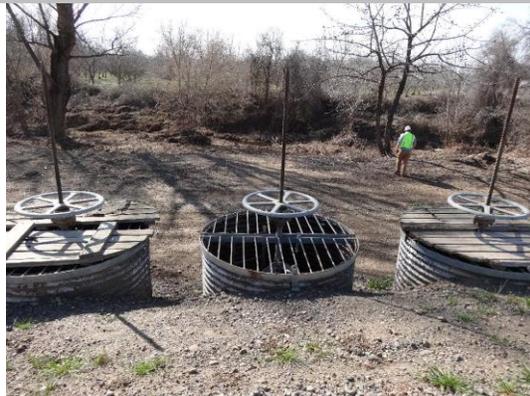
Photo 1 of 3 : UCIP_SP_2020_32085_58585.jpg

Comment Code					
Inspector Comment					
DS_ID:19253 FS_ID:32085 EP_NO: N/A Repair Type: Non-Urgent Crossing Status: Found UCIP Comments: Slide gates in CMP risers on waterside shoulder. Needs cleaning and clearing of debris. FIELD_STRUCT_DESC: 1 of 3: 48-inch corrugated metal gravity drainage pipe through the levee, 18 feet below the crown. Flap gate on the waterside (WS) end. Slide gate in a corrugated metal pipe (CMP) riser on the WS shoulder. Concrete U-shaped headwall on each end. Grouted riprap apron on the landside (LS) end. Grouted riprap spillway on the WS end. [Additional Reference(s): DWR Levee Log, 1992. USACE Sacramento O&M Manual 504, May 1965, (HLM 7.46)]. FS Date: 2/25/2014

WS view: slide gates in CMP risers on waterside shoulder.

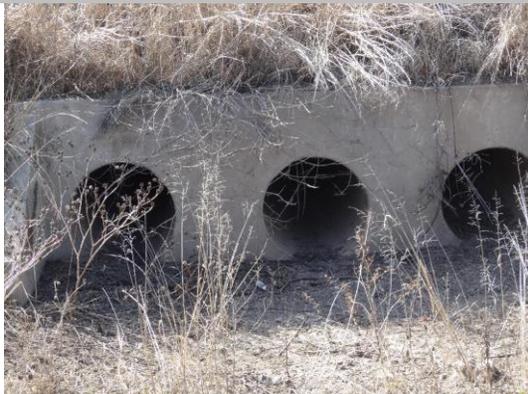
Photo 3 of 3 : UCIP_SP_2020_32085_58586.jpg

LS view: U type concrete headwall and CMPs on levee slope. Soil/mud on inlet box.

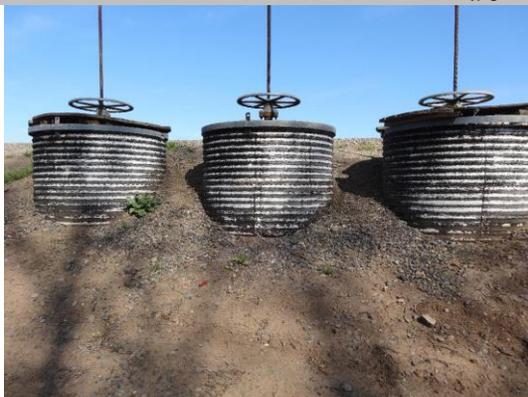
Photo 1 of 3 : UCIP_SP_2020_32087_58592.jpg

WS view: slide gates in CMP risers on waterside shoulder.

Comment Code					
Inspector Comment					
DS_ID:19261 FS_ID:32087 EP_NO: N/A Repair Type: Non-Urgent Crossing Status: Found UCIP Comments: Slide gates in CMP risers on waterside shoulder. Needs cleaning and clearing on both pipe ends. FIELD_STRUCT_DESC: 3 of 3: 48-inch corrugated metal gravity drainage pipe through the levee, 18 feet below the crown. Flap gate on the waterside (WS) end. Slide gate in a corrugated metal pipe (CMP) riser on the WS shoulder. Concrete U-shaped headwall on each end. Grouted riprap apron on the landside (LS) end. Grouted riprap spillway on the WS end. [Additional Reference(s): DWR Levee Log, 1992. USACE Sacramento O&M Manual 504, May 1965, (HLM 7.46)]. FS Date: 2/25/2014

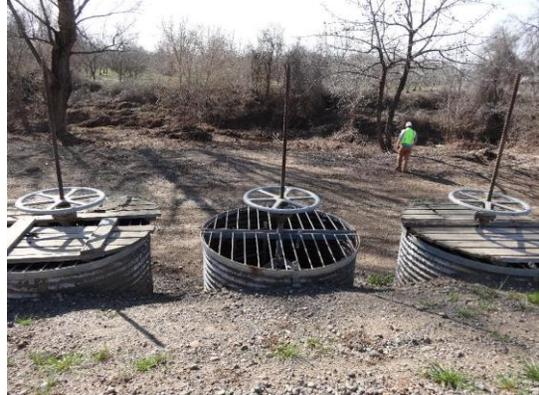
Photo 1 of 3 : UCIP_SP_2020_32086_58589.jpg

Comment Code					
Inspector Comment					
DS_ID:19260 FS_ID:32086 EP_NO: N/A Repair Type: Non-Urgent Crossing Status: Found UCIP Comments: Slide gates in CMP risers on waterside shoulder. Needs cleaning and clearing of debris. FIELD_STRUCT_DESC: 2 of 3: 48-inch corrugated metal gravity drainage pipe through the levee, 18 feet below the crown. Flap gate on the waterside (WS) end. Slide gate in a corrugated metal pipe (CMP) riser on the WS shoulder. Concrete U-shaped headwall on each end. Grouted riprap apron on the landside (LS) end. Grouted riprap spillway on the WS end. [Additional Reference(s): DWR Levee Log, 1992. USACE Sacramento O&M Manual 504, May 1965, (HLM 7.46)]. FS Date: 2/25/2014

WS view: slide gates in CMP risers on waterside shoulder.

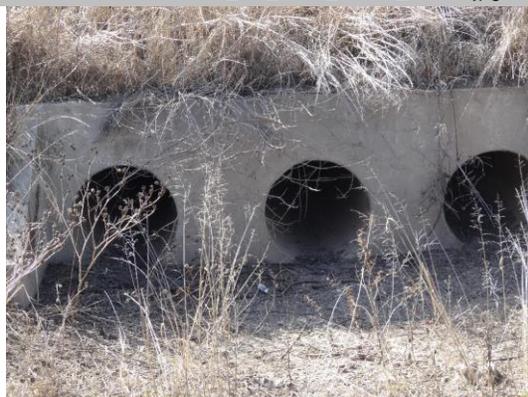
Photo 3 of 3 : UCIP_SP_2020_32086_58587.jpg

LS view: U type concrete headwall and CMPs on levee slope. Soil/mud on inlet box.

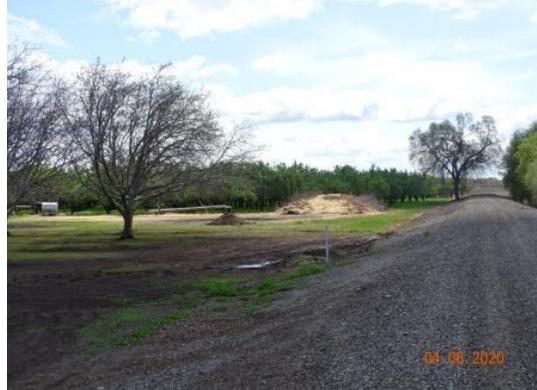
Photo 1 of 1 : SP_2020_NA0003_66_3_20200413_00002.jpg

LM Start	0.21	Rating **	A	Issue No.	3
LM End	0.21	Issue Type +	Ma	Location *	LS
Category	Earthen Levee		GPS Latitude/Longitude		
			Start	End	
Item	Vegetation		39.735707 °	39.735707 °	
			-121.928811 °	-121.928811 °	
DWR ID	DWR_NA0003_02A_s_2020_3				
Comment Code					
V1 : Control annual grass and weeds on the levee slopes and easements.					
Inspector Comment					
Good vegetation control on both landside and waterside slopes.

View of landside slope with good vegetation control. Spring 2020.

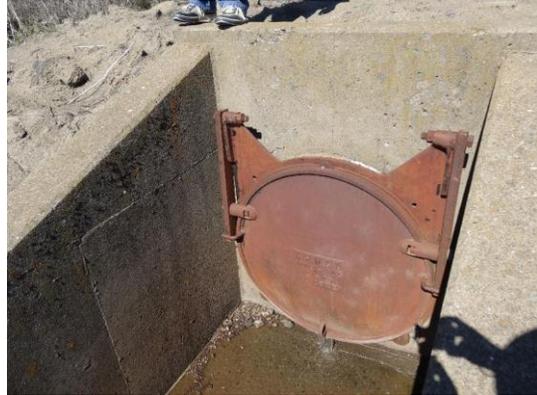
Photo 1 of 3 : UCIP_SP_2020_51844_58602.jpg

Comment Code					
Inspector Comment					
DS_ID:19262 FS_ID:51844 EP_NO: N/A Repair Type: No Action Needed Crossing Status: Found UCIP Comments: 05/16/2017 Crossing has been downgraded from Non-Urgent to No Action Needed. The flap gate appears to be in good working order based on the photos, and the small pile of debris not enough to warrant Non-Urgent rating. (K. Fazel - UCIP)03/11/2014:Slide gate in CMP riser on waterside.The culvert was working during field inspection. (P. Amatya - DWR) FIELD_STRUCT_DESC: 42-inch corrugated metal gravity drainage pipe through the levee, 14 feet below the crown. Flap gate on the waterside (WS) end. Slide gate in a corrugated metal pipe (CMP) riser on the WS slope. Concrete U-shaped headwall on each end. Grouted riprap apron on the landside (LS) end. Grouted riprap spillway on the WS end. [Additional Reference(s): DWR Levee Log, 1992. USACE Sacramento O&M Manual 504, May 1965, (HLM 0.09)]. FS Date: 3/11/2014

WS view: U type concrete headwall, pipe, and flapgate on levee slope.

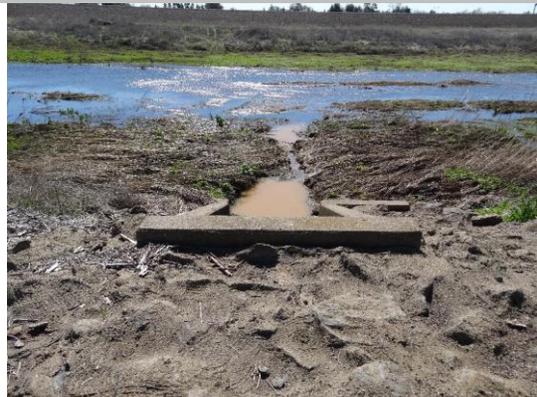
Photo 2 of 3 : UCIP_SP_2020_51844_58601.jpg

WS view: U type concrete headwall of CMP culvert on levee slope. Grouted riprap levee slope and spillway.

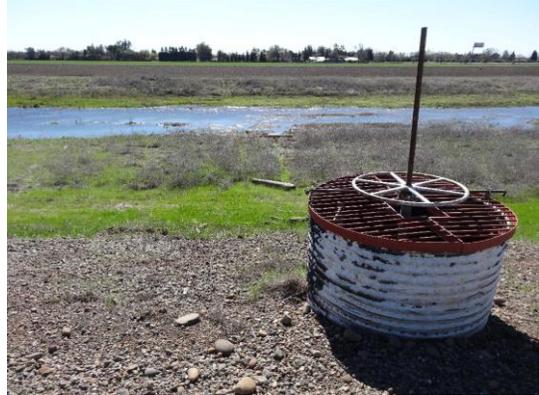
Photo 3 of 3 : UCIP_SP_2020_51844_58600.jpg

WS view: slide gate in CMP riser on waterside shoulder.

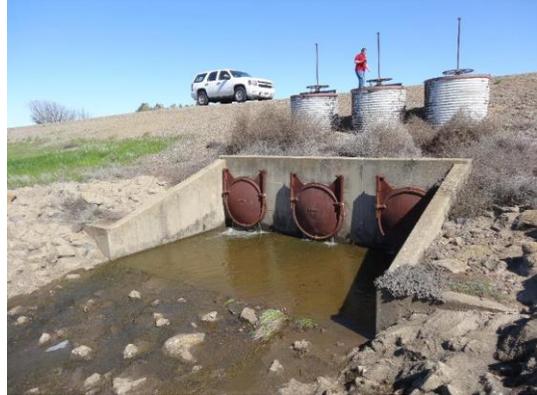
Photo 1 of 2 : UCIP_SP_2020_32104_58606.jpg

LM Start	0.39	Rating **	A/W	Issue No.	30
LM End	0.39	Issue Type +	Ma	Location *	
Category	Supplemental		GPS Latitude/Longitude		
			Start	End	
Item	DWR UCIP LMA Responsibility		39.785262 °	39.785262 °	
			-121.876622 °	-121.876622 °	
DWR ID	19278				
Comment Code					
Inspector Comment					
DS_ID:19278 FS_ID:32104 EP_NO: N/A Repair Type: No Action Needed Crossing Status: Found UCIP Comments: Slide gate in CMP riser on waterside. The culvert was working during the field visit. FIELD_STRUCT_DESC: 1 of 3: 48-inch corrugated metal gravity drainage pipe through the levee, 11.7 feet below the crown. Slide gate in a riser well on the waterside (WS) slope. Concrete U-shaped headwall on each end. Flap gate on the WS end. Grouted riprap outlet channel on the WS. [Additional Reference(s): DWR Levee Log, 1992. USACE Sacramento O&M Manual 504, May 1965, (HLM 0.39)]. FS Date: 3/11/2014

WS view: U type concrete headwall and three CMPs with slide gates on levee slope. Grouted riprap spillway.

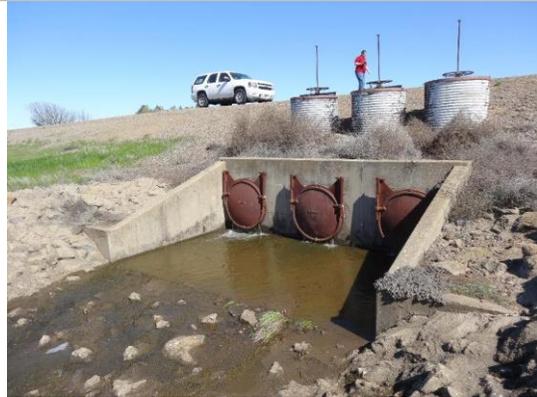
Photo 1 of 2 : UCIP_SP_2020_32106_58610.jpg

LM Start	0.39	Rating **	A/W	Issue No.	32
LM End	0.39	Issue Type +	Ma	Location *	
Category	Supplemental		GPS Latitude/Longitude		
			Start	End	
Item	DWR UCIP LMA Responsibility		39.785230 °	39.785230 °	
			-121.876592 °	-121.876592 °	
DWR ID	19263				
Comment Code					
Inspector Comment					
DS_ID:19263 FS_ID:32106 EP_NO: N/A Repair Type: No Action Needed Crossing Status: Found UCIP Comments: Slide gate in CMP riser on waterside. The culvert was working during the field visit. FIELD_STRUCT_DESC: 3 of 3: 48-inch corrugated metal gravity drainage pipe through the levee, 11.7 feet below the crown. Slide gate in a riser well on the waterside (WS) slope. Concrete U-shaped headwall on each end. Flap gate on the WS end. Grouted riprap outlet channel on the WS. [Additional Reference(s): DWR Levee Log, 1992. USACE Sacramento O&M Manual 504, May 1965, (HLM 0.39)]. FS Date: 3/11/2014

WS view: U type concrete headwall and three CMPs with slide gates on levee slope. Grouted riprap spillway.

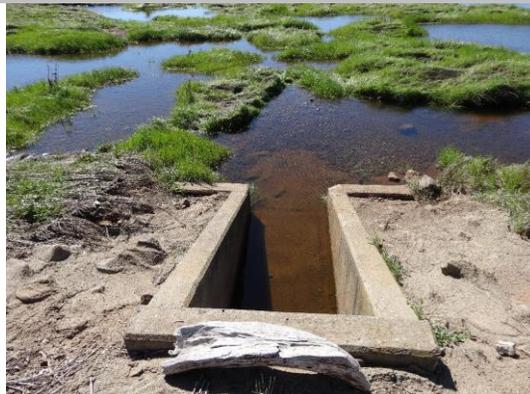
Photo 1 of 3 : UCIP_SP_2020_32107_58613.jpg

LM Start	1.25	Rating **	A/W	Issue No.	33
LM End	1.25	Issue Type +	Ma	Location *	
Category	Supplemental			GPS Latitude/Longitude	
				Start	End
Item	DWR UCIP LMA Responsibility			39.779678 °	39.779678 °
				-121.862632 °	-121.862632 °
DWR ID	19264				
Comment Code					
Inspector Comment					
DS_ID:19264 FS_ID:32107 EP_NO: N/A Repair Type: No Action Needed Crossing Status: Found UCIP Comments: The culvert was working during the field visit. FIELD_STRUCT_DESC: 24-inch corrugated metal gravity drainage pipe through the levee, 11.7 feet below the crown. Flap gate on the waterside (WS) end. Concrete U-shaped headwall on each end. [Additional Reference(s): DWR Levee Log, 1992. USACE Sacramento O&M Manual 504, May 1965, (HLM 1.28)]. FS Date: 3/11/2014

WS view: U type concrete headwall and grouted riprap on levee slope.

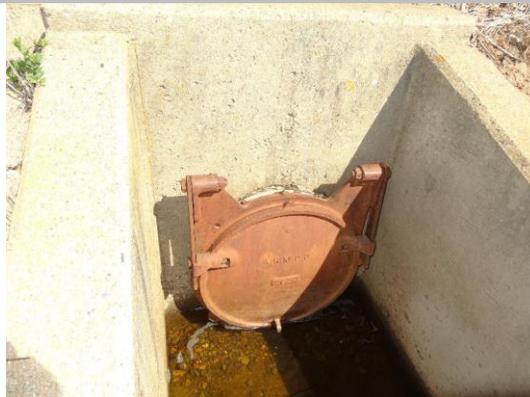
Photo 2 of 3 : UCIP_SP_2020_32107_58612.jpg

WS view: U type concrete headwall, flapgate, and CMP on levee slope.

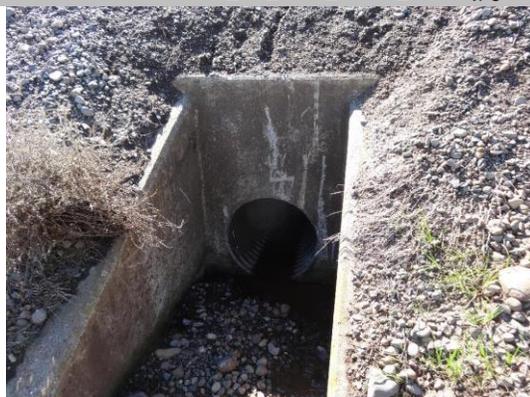
Photo 3 of 3 : UCIP_SP_2020_32107_58611.jpg

LS view: U type concrete headwall and CMP on levee slope.

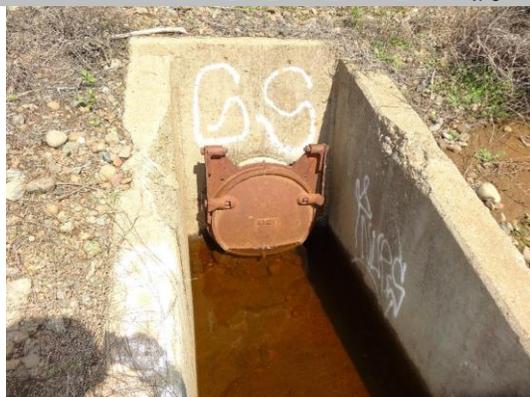
Photo 1 of 2 : UCIP_SP_2020_31899_58187.jpg

WS view: U type concrete headwall, flapgate, and CMP on levee slope. Looks clean and clear.

Comment Code					
Inspector Comment					
DS_ID:19265 FS_ID:31899 EP_NO: N/A Repair Type: No Action Needed Crossing Status: Found UCIP Comments: Working during the field visit. FIELD_STRUCT_DESC: 24-inch corrugated metal gravity drainage pipe through the levee, 11 feet below the crown. Flap gate on the waterside (WS) end. Concrete U-shaped headwall on each end. Grouted riprap apron on each end. [Additional Reference(s): DWR Levee Log, 1992. USACE Sacramento O&M Manual 504, May 1965, (HLM 1.53)]. FS Date: 3/11/2014

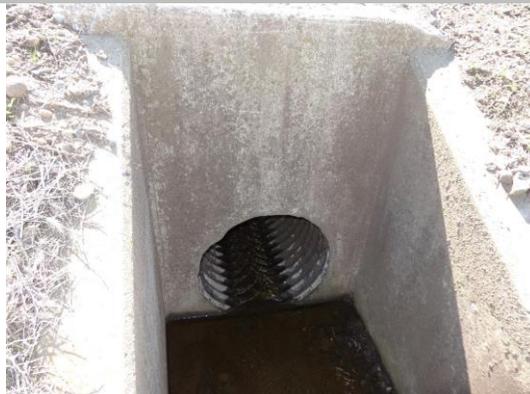
Photo 2 of 2 : UCIP_SP_2020_31899_58186.jpg

LS view: U type concrete headwall and CMP on levee slope. Looks clean and clear.

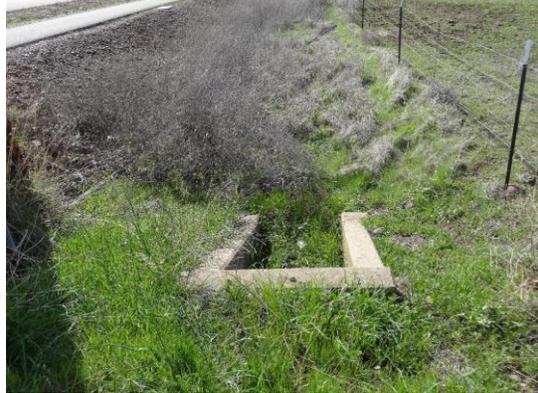
Photo 2 of 3 : UCIP_SP_2020_32124_58624.jpg

Comment Code					
Inspector Comment					
DS_ID:19267 FS_ID:32124 EP_NO: N/A Repair Type: Non-Urgent Crossing Status: Found UCIP Comments: Pipe is about 4 feet below the crown. Needs cleaning and clearing the culvert. FIELD_STRUCT_DESC: 24-inch corrugated metal gravity drainage pipe through the levee, 6 feet below the crown. Flap gate on the waterside (WS) end. Concrete U-shaped headwall on each end. [Additional Reference(s): DWR Levee Log, 1992. USACE Sacramento O&M Manual 504, May 1965, (HLM 2.23)]. FS Date: 3/7/2014

LS view: U type concrete headwall of CMP culvert on levee slope. Vegetation on inlet box.

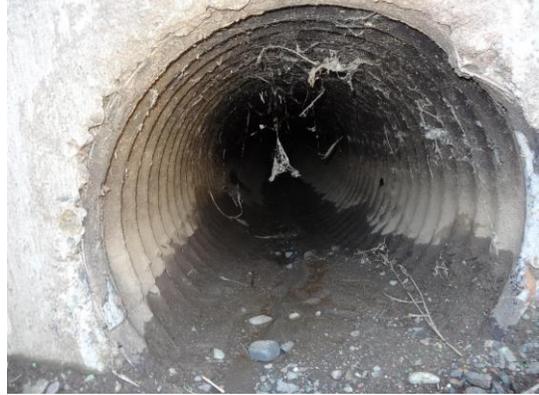
Photo 3 of 3 : UCIP_SP_2020_31901_58195.jpg

LS view: inside view of CMP on levee slope. Needs cleaning and clearing.

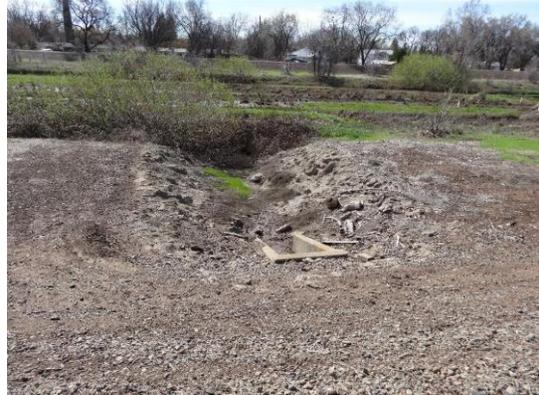
Photo 1 of 3 : UCIP_SP_2020_31902_58201.jpg

LM Start	3.19	Rating **	A/W	Issue No.	39
LM End	3.19	Issue Type +	Ma	Location *	
Category	Supplemental		GPS Latitude/Longitude		
			Start	End	
Item	DWR UCIP LMA Responsibility		39.777463 °	39.777463 °	
			-121.852512 °	-121.852512 °	
DWR ID	19270				
Comment Code					
Inspector Comment					
DS_ID:19270 FS_ID:31902 EP_NO: N/A Repair Type: No Action Needed Crossing Status: Found UCIP Comments: FIELD_STRUCT_DESC: 24-inch corrugated metal gravity drainage pipe through the levee, 11 feet below the crown. Flap gate on the waterside (WS) end. Concrete U-shaped headwall on each end. Grouted riprap apron on the landside (LS) end. Grouted riprap spillway on the WS end. [Additional Reference(s): DWR Levee Log, 1992. USACE Sacramento O&M Manual 504, May 1965, (HLM 3.28)]. FS Date: 3/7/2014

WS view: U type concrete headwall and grouted riprap spillway on levee slope.

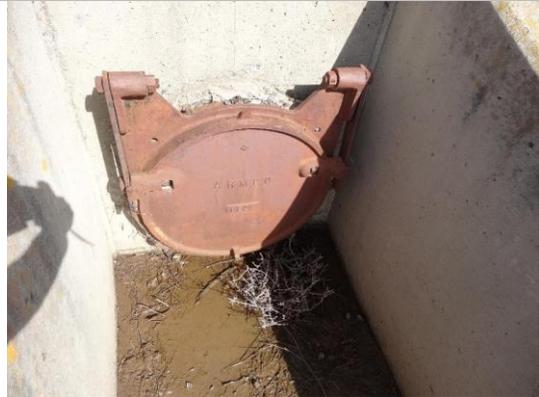
Photo 2 of 3 : UCIP_SP_2020_31902_58200.jpg

WS view: U type concrete headwall and CMP on levee slope.

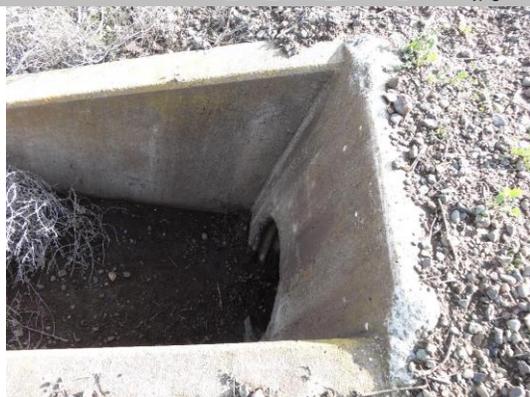
Photo 3 of 3 : UCIP_SP_2020_31902_58199.jpg

LS view: U type concrete headwall and CMP on levee slope. Soil/mud on inlet box.

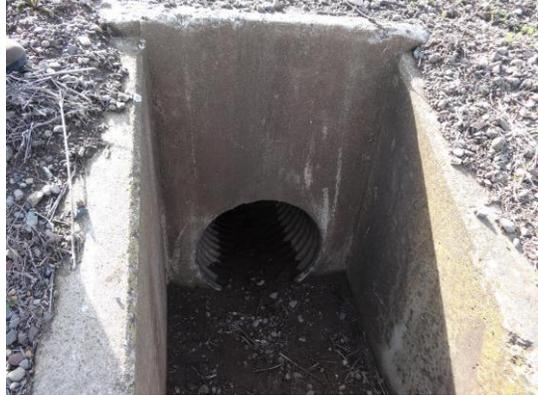
Photo 2 of 3 : UCIP_SP_2020_31864_58068.jpg

Comment Code					
Inspector Comment					
DS_ID:19271 FS_ID:31864 EP_NO: N/A Repair Type: Non-Urgent Crossing Status: Found UCIP Comments: Needs cleaning and clearing the culvert. FIELD_STRUCT_DESC: 24-inch corrugated metal gravity drainage pipe through the levee, 10.5 feet below the crown. Flap gate on the waterside (WS) end. Concrete U-shaped headwall on each end. Grouted riprap apron on the landside (LS) end. Grouted riprap spillway on the WS end. [Additional Reference(s): DWR Levee Log, 1992. USACE Sacramento O&M Manual 504, May 1965, (HLM 3.43)]. FS Date: 3/7/2014

LS view: U type concrete headwall and CMP on levee slope. Soil/mud on inlet box.

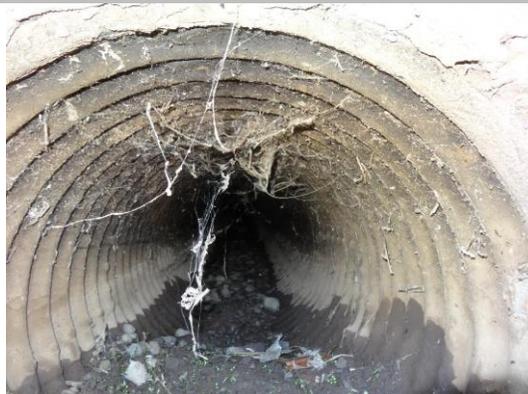
Photo 3 of 3 : UCIP_SP_2020_31856_58051.jpg

LS view: inside view of CMP on levee slope. Needs cleaning and clearing.

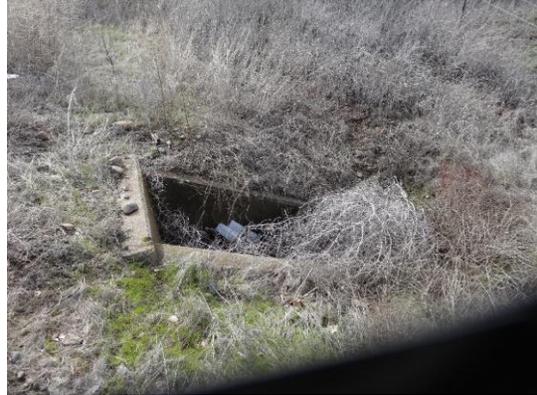
Photo 2 of 2 : UCIP_SP_2020_32125_58628.jpg

Comment Code					
Inspector Comment					
DS_ID:19275 FS_ID:32125 EP_NO: N/A Repair Type: Non-Urgent Crossing Status: Found UCIP Comments: The culvert was working during the field visit.Needs cleaning and clearing on both ends of the pipe. FIELD_STRUCT_DESC: 24-inch corrugated metal gravity drainage pipe through the levee, 7.5 feet below the crown. Flap gate on the waterside (WS) end. Concrete U-shaped headwall on each end. Grouted riprap apron on the landside (LS) end. Grouted riprap spillway on the WS end. [Additional Reference(s): DWR Levee Log, 1992. USACE Sacramento O&M Manual 504, May 1965, (HLM 3.76)]. FS Date: 3/4/2014

LS view: U type concrete headwall and pipe on levee slope. Soil/mud on inlet box. Vegetation debris blocking inlet box.

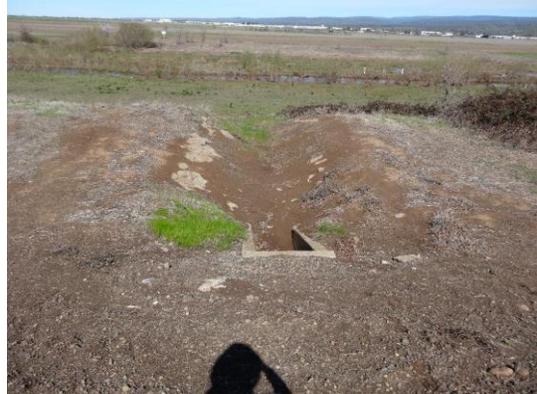
Photo 1 of 3 : UCIP_SP_2020_32026_58520.jpg

LM Start	0.27	Rating **	M	Issue No.	42
LM End	0.27	Issue Type +	Ma	Location *	
Category	Supplemental		GPS Latitude/Longitude		
			Start	End	
Item	DWR UCIP LMA Responsibility		39.776554 °	39.776554 °	
			-121.850730 °	-121.850730 °	
DWR ID	19279				
Comment Code					
Inspector Comment					
DS_ID:19279 FS_ID:32026 EP_NO: N/A Repair Type: Non-Urgent Crossing Status: Found UCIP Comments: Needs cleaning and clearing the culvert. FIELD_STRUCT_DESC: 24-inch corrugated metal gravity drainage pipe through the levee, 10 feet below the crown. Flap gate on the waterside (WS) end. Concrete U-shaped headwall on each end. Grouted riprap apron on the landside (LS) end. Grouted riprap spillway on the WS end. [Additional Reference(s): DWR Levee Log, 1992. USACE Sacramento O&M Manual 504, May 1965, (HLM 0.28)]. FS Date: 3/7/2014

WS view: concrete headwall and grouted riprap spillway on levee slope.

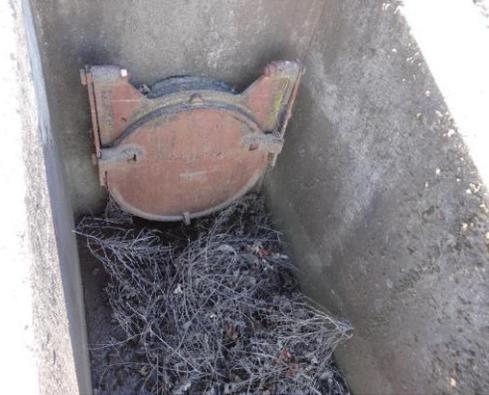
Photo 2 of 3 : UCIP_SP_2020_32026_58519.jpg

WS view: U type concrete headwall and CMP on levee slope. Mud and vegetation debris on outlet box.

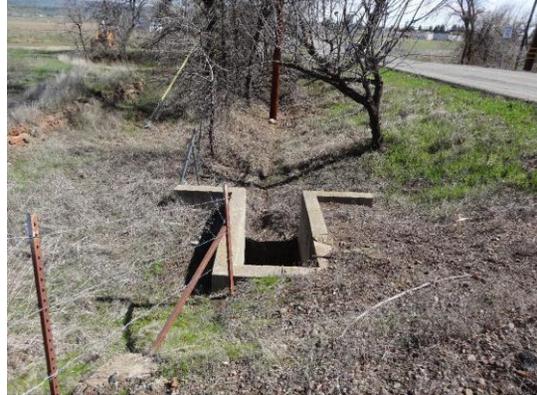
Photo 3 of 3 : UCIP_SP_2020_32025_58510.jpg

LS view: U type concrete headwall and CMP on levee slope. Vegetation debris and mud on inlet box.

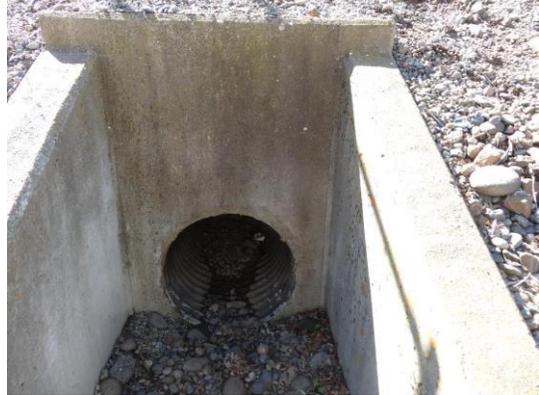
Photo 2 of 3 : UCIP_SP_2020_32023_58504.jpg

Comment Code					
Inspector Comment					
DS_ID:19281 FS_ID:32023 EP_NO: N/A Repair Type: Non-Urgent Crossing Status: Found UCIP Comments: Needs cleaning and clearing the culvert. FIELD_STRUCT_DESC: 24-inch corrugated metal gravity drainage pipe through the levee, 8 feet below the crown. Flap gate on the waterside (WS) end. Concrete U-shaped headwall on each end. Grouted riprap apron on the landside (LS) end. Grouted riprap spillway on the WS end. [Additional Reference(s): DWR Levee Log, 1992. USACE Sacramento O&M Manual 504, May 1965, (HLM 0.36)]. FS Date: 3/7/2014

LM Start	0.35	Rating **	M	Issue No.	44 (cont)
LM End	0.35	Issue Type +	Ma	Location *	
Category	Supplemental			GPS Latitude/Longitude	
				Start	End
Item	DWR UCIP LMA Responsibility			39.775682 °	39.775682 °
				-121.850375 °	-121.850375 °
DWR ID	19281

LS view: U type concrete headwall and CMP on levee slope. Pebbles and mud on inlet box.

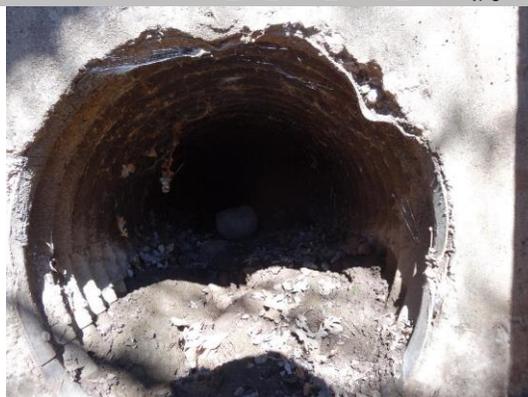
Photo 3 of 3 : UCIP_SP_2020_31963_58385.jpg

LM Start	1.11	Rating **	M	Issue No.	48 (cont)
LM End	1.11	Issue Type +	Ma	Location *	
Category	Supplemental			GPS Latitude/Longitude	
				Start	End
Item	DWR UCIP LMA Responsibility			39.776709 °	39.776709 °
				-121.853932 °	-121.853932 °
DWR ID	19289

LS view: inside view of CMP on levee slope. Needs cleaning and clearing.

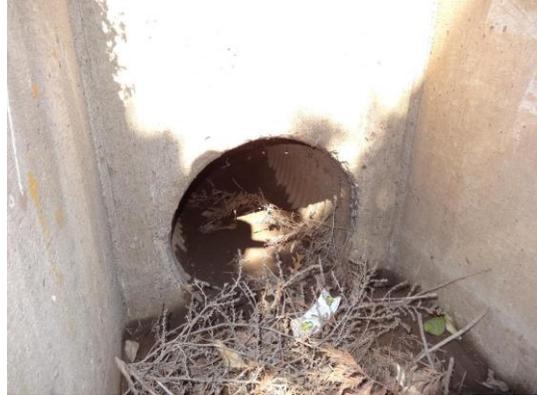
Photo 2 of 2 : UCIP_SP_2020_31964_58388.jpg

Comment Code					
Inspector Comment					
DS_ID:19290 FS_ID:31964 EP_NO: N/A Repair Type: Non-Urgent Crossing Status: Found UCIP Comments: Needs cleaning and clearing the culvert. FIELD_STRUCT_DESC: 24-inch corrugated metal gravity drainage pipe through the levee, 13 feet below the crown. Flap gate on the waterside (WS) end. Concrete U-shaped headwall on each end. Grouted riprap apron on the landside (LS) end. Grouted riprap spillway on the WS end. [Additional Reference(s): DWR Levee Log, 1992. USACE Sacramento O&M Manual 504, May 1965, (HLM 1.41)]. FS Date: 3/7/2014

LM Start	1.35	Rating **	M	Issue No.	49 (cont)
LM End	1.35	Issue Type +	Ma	Location *	
Category	Supplemental			GPS Latitude/Longitude	
				Start	End
Item	DWR UCIP LMA Responsibility			39.778370 °	39.778370 °
				-121.857904 °	-121.857904 °
DWR ID	19290

LS view: U type concrete headwall and CMP on levee slope. Vegetation debris and mud in inlet box.

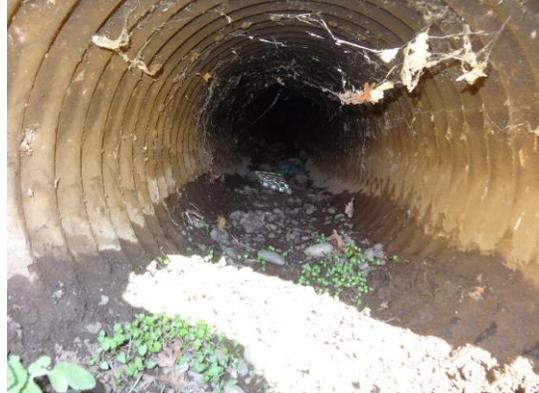
Photo 3 of 3 : UCIP_SP_2020_31965_58393.jpg

LM Start	2.15	Rating **	M	Issue No.	50
LM End	2.15	Issue Type +	Ma	Location *	
Category	Supplemental			GPS Latitude/Longitude	
				Start	End
Item	DWR UCIP LMA Responsibility			39.782777 °	39.782777 °
				-121.871179 °	-121.871179 °
DWR ID	19291				
Comment Code					
Inspector Comment					
DS_ID:19291 FS_ID:31965 EP_NO: N/A Repair Type: Non-Urgent Crossing Status: Found UCIP Comments: Needs cleaning and clearing the culvert. FIELD_STRUCT_DESC: 24-inch corrugated metal gravity drainage pipe through the levee, 11 feet below the crown. Flap gate on the waterside (WS) end. Concrete U-shaped headwall on each end. Grouted riprap apron on the landside (LS) end. Grouted riprap spillway on the WS end. [Additional Reference(s): DWR Levee Log, 1992. USACE Sacramento O&M Manual 504, May 1965, (HLM 2.22)]. FS Date: 3/7/2014

LM Start	2.15	Rating **	M	Issue No.	50 (cont)
LM End	2.15	Issue Type +	Ma	Location *	
Category	Supplemental			GPS Latitude/Longitude	
				Start	End
Item	DWR UCIP LMA Responsibility			39.782777 °	39.782777 °
				-121.871179 °	-121.871179 °
DWR ID	19291

LS view: inside view of CMP on levee slope. Needs cleaning and clearing.

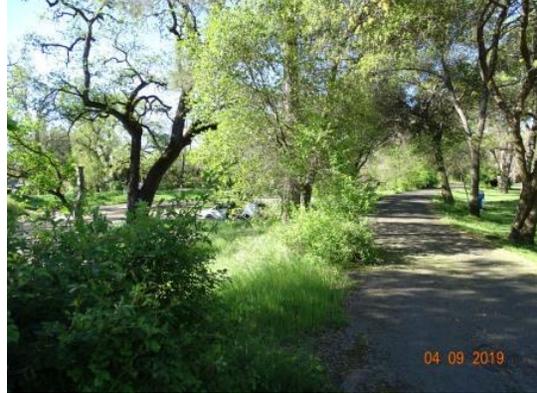
Photo 1 of 1 : SP_2020_NA0003_69_1_20200226_00001.jpg

LM Start	0.03	Rating **	M	Issue No.	1
LM End	0.20	Issue Type +	Ma	Location *	LS
Category	Earthen Levee			GPS Latitude/Longitude	
				Start	End
Item	Vegetation			39.763164 °	39.761860 °
				-121.790335 °	-121.792635 °
DWR ID	DWR_NA0003_05_s_2012_1				
Comment Code					
V2 : Remove the wild growth other than native grasses from the levee slopes.					
Inspector Comment

View of the wild growth on the landside slope. Spring 2019.
