**Flood Control Project Maintenance  
Levee Inspections**

**Fall 2019 Levee Maintenance Deficiency Summary Report**

**Fall 2019 Levee Inspection Results**

**Marysville Levee Commission**

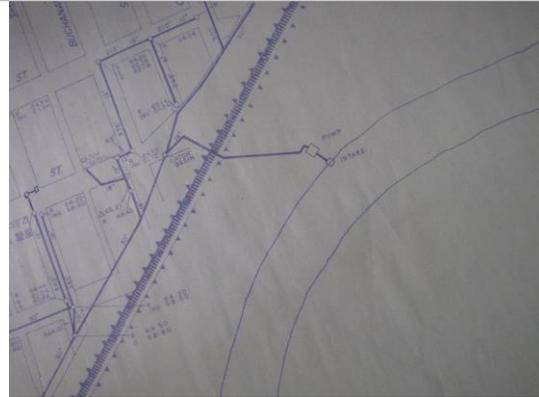
Photo 1 of 1 : UCIP\_FA\_2019\_52822\_17200.jpg

Item	DRAFT DWR UCIP Field Study			39.149063°	39.149063°
				-121.577190°	-121.577190°
DWR ID	19142				
Comment Code					
Inspector Comment					
DS_ID:19142 FS_ID:52822 EP_NO: 7066 Repair Type: Non-Urgent Crossing Status: Indicator Found UCIP Comments: 03/14/2013 Unable to take coordinates due to limited access to waterward side, used desk study coordinates. (DWR UCIP - O. Magana) FIELD_STRUCT_DESC: 14-inch drainage pipe through levee, 6 feet below levee crown. Discharges into Ellis Lake. Slant pump mounted on metal pump stand located approximately 150 feet from waterside toe. (14-inch pipe authorized under Permit No. 7066B, 7066A, 7066, 1970-City of Marysville). [Additional Reference(s): DWR Levee Logs, 1993 and 2005] FS Date: 3/14/2013

As-built dwg provided by Marysville Water Waste Treatment Plant.

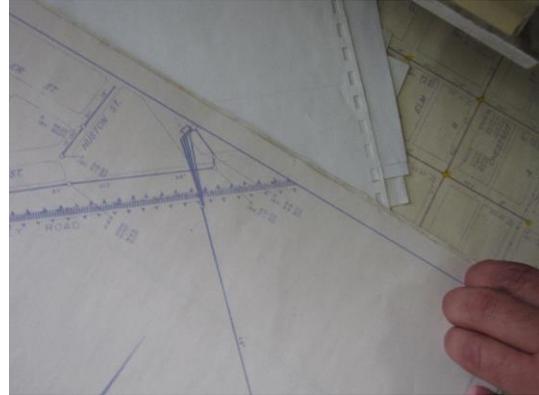
Photo 1 of 3 : UCIP\_FA\_2019\_52825\_69835.jpg

Item	DRAFT DWR UCIP Field Study			39.154741 °	39.154741 °
				-121.569413 °	-121.569413 °
DWR ID	19160				
Comment Code					
Inspector Comment					
DS_ID:19160 FS_ID:52825 EP_NO: 2149 Repair Type: Non-Urgent Crossing Status: Indicator Found UCIP Comments: 03/14/2013 Depression observed on waterward toe filled with concrete rubble and riprap. Need to coordinate with City to determine records and extent of modifications if any. (DWR UCIP - O. Magana) FIELD_STRUCT_DESC: [17th & Howell Pump Station] 2 of 4: 10-inch steel drainage pipe, buried 15-feet below the crown. Runs parallel to other drainpipes, encased in concrete approximately 1-foot spacing. Pipe extends from storm water pump house to manhole (259 feet) north of landside (LS) toe. Flap gates and vent pipes at waterside (WS) toe. Discharges into concrete distribution box (3-foot by 4-foot). (three 30-inch and one 10-inch pipes and a 48-inch outfall pipe across the berm along the right bank of the Yuba River authorized under Permit No. 2149, 1956-City of Marysville). [Additional Reference(s): DWR Levee Logs, 1993 and 2005] FS Date: 3/14/2013

As-builts provided by Marysville Water Treatment.
