**Flood Control Project Maintenance
Levee Inspections**
LMA District Cover Sheet
Spring 2020 Levee Inspection Results

Knights Landing Ridge Drainage District

Spring 2020 Levee Inspection Results

Waterway	Bank	Unit Miles
Unit No. 01 Knights Landing Ridge Cut	Right	6.36

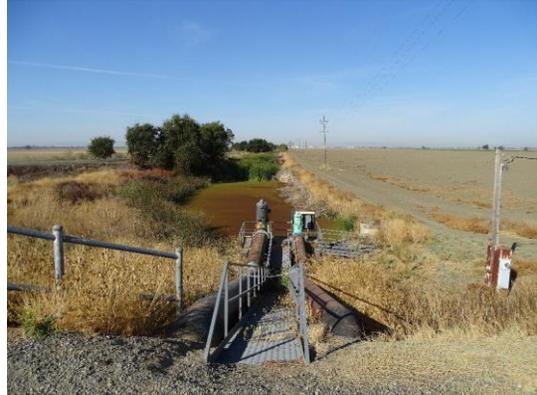
Photo 3 of 3 : UCIP_SP_2020_55721_82555.jpg

LM Start	2.70	Rating **	M	Issue No.	43 (cont)
LM End	2.70	Issue Type +	En	Location *	
Category	Supplemental			GPS Latitude/Longitude	
				Start	End
Item	DWR UCIP Field Study			38.748909 °	38.748909 °
				-121.694811 °	-121.694811 °
DWR ID	19394

View of LS looking from levee crown

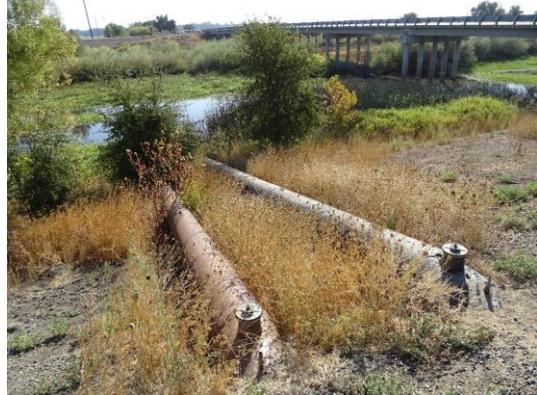
Photo 2 of 3 : UCIP_SP_2020_55722_82563.jpg

LM Start	2.71	Rating **	M	Issue No.	44 (cont)
LM End	2.71	Issue Type +	En	Location *	
Category	Supplemental			GPS Latitude/Longitude	
				Start	End
Item	DWR UCIP Field Study			38.748929 °	38.748929 °
				-121.694749 °	-121.694749 °
DWR ID	19395

View of WS looking from levee crown

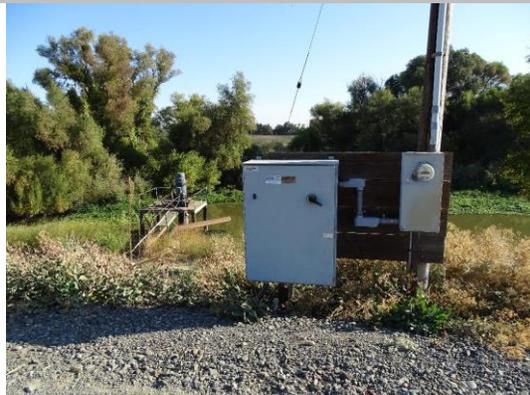
Photo 1 of 3 : UCIP_SP_2020_55745_82656.jpg

Comment Code					
Inspector Comment					
DS_ID:19397 FS_ID:55745 EP_NO: 5276 Repair Type: Non-Urgent Crossing Status: Found UCIP Comments: 10/08/2019 Record remains Non-Urgent, pipe has been abandoned. Pipe is capped under pumping platform. (O.Yakimov - DWR UCIP) 04/05/2013 Pipe appears abandoned at this time. (W.Wylie - DWR UCIP) FIELD_STRUCT_DESC: 2 of 2: 20-inch steel irrigation pipe through the levee, 4.9 feet below the crown. Vertical pump unit on pile structure in stream. Siphon breaker on the landside (LS) shoulder in a 16-inch steel riser. Flap gate on the LS end. Pipe discharges into an irrigation ditch on the LS. Steel plate welded over end of pipe at pump structure. (Replacement of an existing 18-inch pipe at this location authorized under Permit No. 5276, 1966 - Reclamation District No. 730). [Additional Reference(s): DWR Levee Log, 1990]. FS Date: 10/8/2019 9:26:13 AM

View of WS looking from levee crown

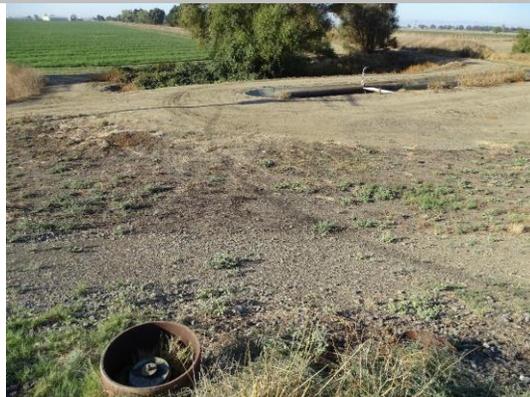
Photo 2 of 3 : UCIP_SP_2020_55745_82659.jpg

View of LS looking from levee crown

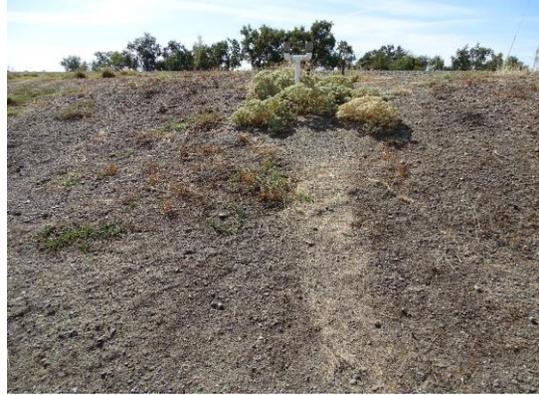
Photo 3 of 3 : UCIP_SP_2020_55754_82700.jpg

LM Start	0.81	Rating **	M	Issue No.	33 (cont)
LM End	0.81	Issue Type +	En	Location *	
Category	Supplemental			GPS Latitude/Longitude	
				Start	End
Item	DWR UCIP Field Study			38.731263 °	38.731263 °
				-121.677177 °	-121.677177 °
DWR ID	19369

View of LS slope at crossing

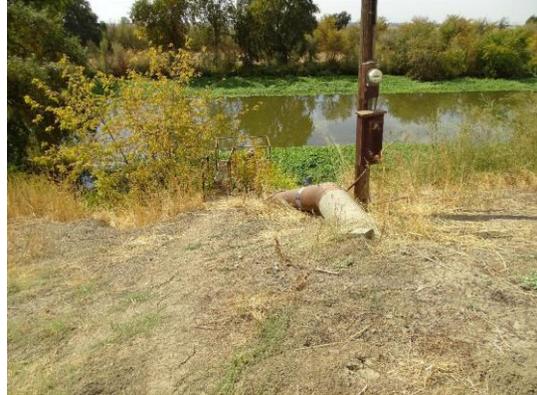
Photo 3 of 3 : UCIP_SP_2020_55757_82723.jpg

LM Start	0.99	Rating **	M	Issue No.	34 (cont)
LM End	0.99	Issue Type +	En	Location *	
Category	Supplemental			GPS Latitude/Longitude	
				Start	End
Item	DWR UCIP Field Study			38.733120 °	38.733120 °
				-121.679383 °	-121.679383 °
DWR ID	19370

View of WS looking from levee crown

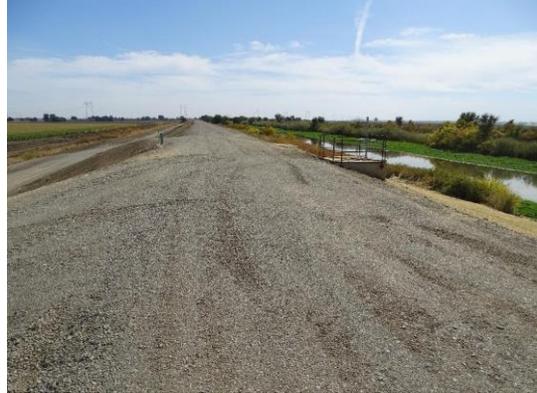
Photo 1 of 3 : UCIP_SP_2020_55761_82744.jpg

Comment Code					
Inspector Comment					
DS_ID:19399 FS_ID:55761 EP_NO: 9320 Repair Type: Non-Urgent Crossing Status: Found UCIP Comments: 10/08/2019 Record updated from No Action Needed to Non-Urgent. Pipe though levee has been replaced as part of the Knights Landing 2015 Levee Repair Project. A concrete box with slide gate was constructed on WS shoulder, a concrete pad with electrical wiring installed at LS toe, pipe inlet on LS is modified and revetted. New flap gate at WS end. Need to have CVFPB review ABO and determine current owner. Encroachment permit is missing. No details provided from Levee Improvement Project. (O.Yakimov - DWR UCIP) FIELD_STRUCT_DESC: *REMOVED & REPLACED with DSID 25597* 24-inch steel drainage pipe through the levee, 21 feet below the crown. Slide gate on the waterside (WS) end. Open on the landside (LS) end. LS toe cobble revetted. Service pole on the LS slope. (24-inch pipe [HLM 1.9] authorized under Automatic Board Order (ABO) issued as Permit No. 9320, 1974 - Ralph W. Pollock). [Additional Reference(s): DWR Levee Log, 1990. USACE Sacramento O&M Manual 127, June 1953, (Station 103+21.8)]. FS Date: 10/8/2019 2:13:30 PM

View of levee crown at the crossing

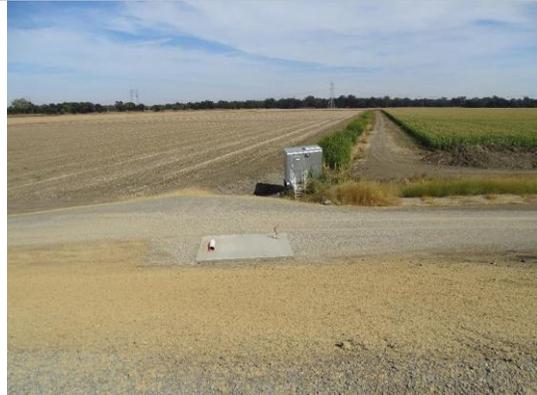
Photo 2 of 3 : UCIP_SP_2020_55761_82749.jpg

View of LS looking from levee crown

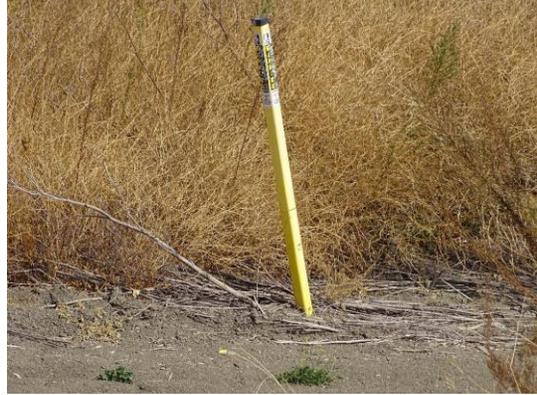
Photo 2 of 2 : UCIP_SP_2020_55763_82752.jpg

LM Start	2.26	Rating **	M	Issue No.	37 (cont)
LM End	2.26	Issue Type +	En	Location *	
Category	Supplemental		GPS Latitude/Longitude		
			Start	End	
Item	DWR UCIP Field Study		38.748282 °	38.748282 °	
			-121.692652 °	-121.692652 °	
DWR ID	19388

Gas line marker

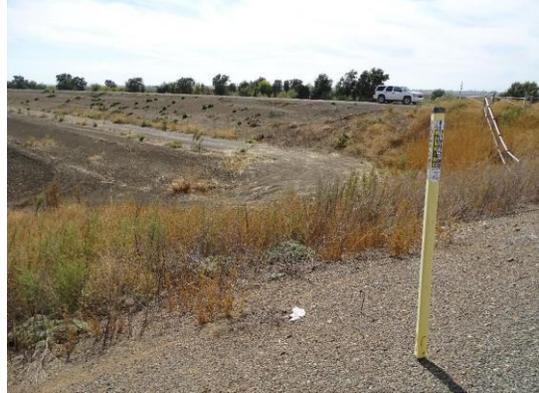
Photo 2 of 2 : UCIP_SP_2020_55764_82754.jpg

Comment Code					
Inspector Comment					
DS_ID:19386 FS_ID:55764 EP_NO: 13164 Repair Type: Non-Urgent Crossing Status: Indicator Found UCIP Comments: 10/08/2019 Record remains Non-Urgent. No inspection records were available to determine status of line through the levee. (O.Yakimov - DWR UCIP) 09/16/2018 Crossing marker on levee Unit 02 is missing. Having a marker on County Road 16 shoulder is not enough to find exact crossing location on levee. Crossing has been downgraded to "Non-Urgent" due to reclassification of gas lines. (O.Yakimov - DWR UCIP)09/01/2016 - Markers present on the edges of Road 16. Alignment indicated by markers shows parallel alignment to the levee. Permit indicates pipe crosses levee and therefore should have markers indicating where it crosses the levee. (T. Hatch/UCIP)04/08/2013 - Need to have pipe located and marked properly if still in use. (W. Wylie/UCIP) FIELD_STRUCT_DESC: 4-inch steel natural gas collection pipe through the levee, 3.2 feet below the crown. Permit indicates that the pipe was installed on the northern shoulder of Road 16 and crosses the Knights Landing Ridge Cut on the northern side of the Road 16 bridge. (4-inch gas line authorized under Permit No. 13164, 1981 - Shell Oil Company). FS Date: 10/8/2019 2:37:40 PM

LM Start	2.28	Rating **	M	Issue No.	38 (cont)
LM End	2.28	Issue Type +	En	Location *	
Category	Supplemental			GPS Latitude/Longitude	
				Start	End
Item	DWR UCIP Field Study			38.748505 °	38.748505 °
				-121.692697 °	-121.692697 °
DWR ID	19386

Gas line marker

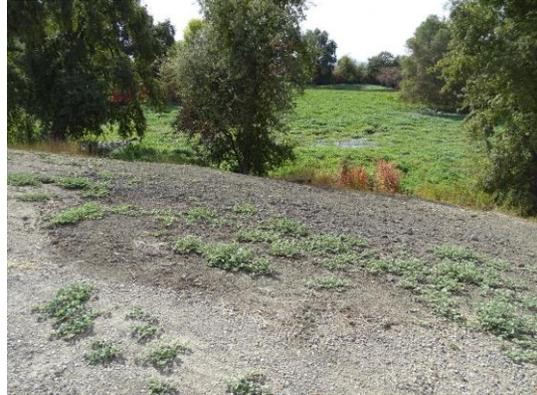
Photo 2 of 3 : UCIP_SP_2020_55774_82796.jpg

Comment Code					
Inspector Comment					
DS_ID:19373 FS_ID:55774 EP_NO: N/A Repair Type: Non-Urgent Crossing Status: Not Found UCIP Comments: 10/08/2019 Record updated from No Action Needed to Non-Urgent. Crossing not found, pipe appurtenances have been removed. Unauthorized encroachment recorded in Levee Log prior to 2011. Unable to locate a permit and confirm proper pipe abandonment. (O.Yakimov - DWR UCIP) 04/09/2013 14-inch pipe debris on the WS slope. (W.Wylie - DWR UCIP) FIELD_STRUCT_DESC: 18-inch reinforced concrete drainage pipe through the levee, 6.5 feet below the crown. No gates or valves. 5-foot by 5-foot concrete distribution box on the waterside (WS) slope (Russell). [Additional Reference(s): DWR Levee Log, 1966]. FS Date: 10/8/2019 3:37:43 PM

LM Start	3.68	Rating **	M	Issue No.	39 (cont)
LM End	3.68	Issue Type +	En	Location *	
Category	Supplemental		GPS Latitude/Longitude		
			Start	End	
Item	DWR UCIP Field Study		38.766573 °	38.766573 °	
			-121.700885 °	-121.700885 °	
DWR ID	19373

View of WS looking from levee crown

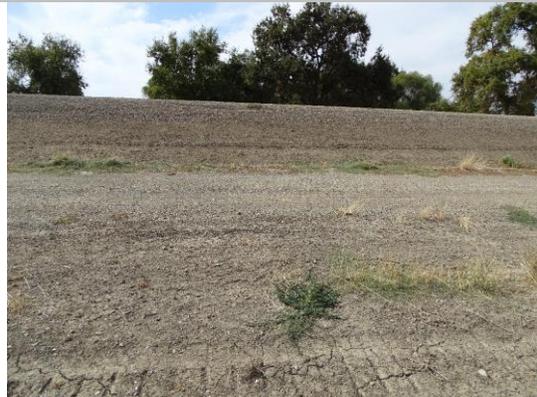
Photo 3 of 3 : UCIP_SP_2020_55774_82797.jpg

View of LS slope looking towards levee

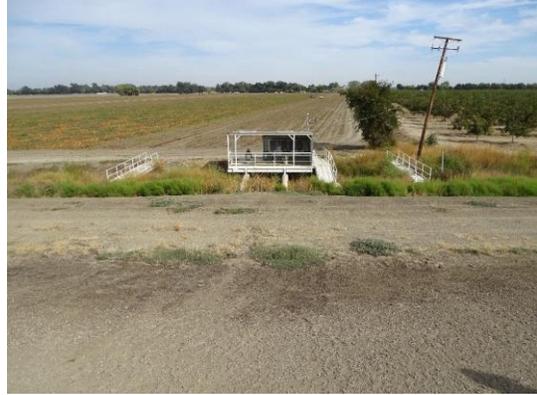
Photo 3 of 3 : UCIP_SP_2020_55749_82672.jpg

LM Start	3.93	Rating **	A/W	Issue No.	40 (cont)
LM End	3.93	Issue Type +	Ma	Location *	
Category	Supplemental			GPS Latitude/Longitude	
				Start	End
Item	DWR UCIP LMA Responsibility			38.770308 °	38.770308 °
				-121.701236 °	-121.701236 °
DWR ID	25571

View of LS looking from levee crown

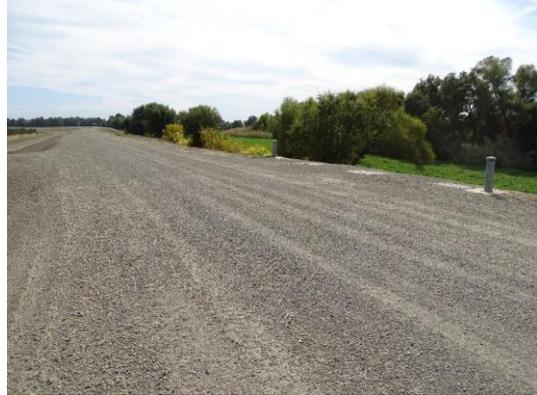
Photo 1 of 3 : UCIP_SP_2020_54351_82677.jpg

LM Start	3.93	Rating **	A/W	Issue No.	41
LM End	3.93	Issue Type +	Ma	Location *	
Category	Supplemental			GPS Latitude/Longitude	
				Start	End
Item	DWR UCIP LMA Responsibility			38.770327 °	38.770327 °
				-121.701245 °	-121.701245 °
DWR ID	25572

View of levee crown at the crossing

Comment Code					
Inspector Comment					
DS_ID:25572 FS_ID:54351 EP_NO: N/A Repair Type: No Action Needed Crossing Status: Found UCIP Comments: 10/08/2019 No issues recorded during inspection (O.Yakimov - DWR UCIP) FIELD_STRUCT_DESC: 24-inch steel discharge pipe through the levee, 6.5-feet below the crown. Pump house on pile structure in drainage ditch on the landward side. Siphon breaker and positive closure device butterfly valve with handwheel operator on the pipe on the waterward side. Pipe replaces a section of pipe through the levee butt welded to the original pipe approximately 37-feet from levee centerline on both levee slopes. Service pole on pump house. (Permit No. 9317-1, applicant - RD730, issued 07/10/2014 gives authorization of emergency removal and replacement of the pipe in September 2012.) FS Date: 10/8/2019

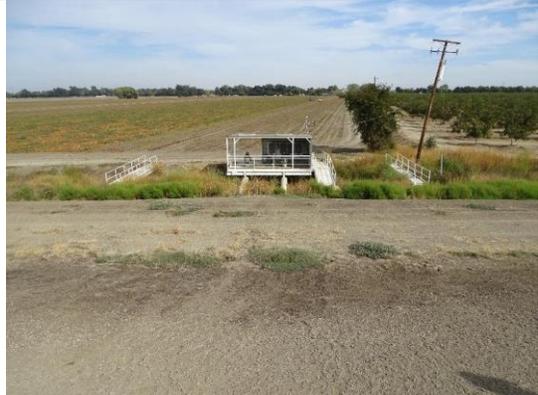
Photo 3 of 3 : UCIP_SP_2020_54351_82679.jpg

View of LS looking from levee crown

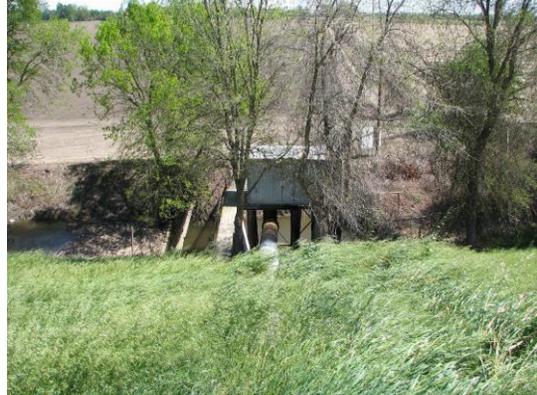
Photo 1 of 3 : UCIP_SP_2020_11293_18675.jpg

Comment Code					
Inspector Comment					
DS_ID:19374 FS_ID:11293 EP_NO: 9317 Repair Type: No Action Needed Crossing Status: Found UCIP Comments: 01/14/2019 Pipe has been replaved with a 16-inch pipe under permit 9317-1; new DS-ID 25571. (O.Yakimov - DWR UCIP) FIELD_STRUCT_DESC: *REMOVED* 1 of 2: 16-inch steel discharge pipe through the levee, 3 feet below the crown. Pump house on pile structure in drainage ditch on the landside (LS). Siphon breaker on the pipe on the waterside (WS). Service pole at the pump house. (16-inch pipe [HLM 3.97] authorized under Automatic Board Order (ABO) issued as Permit No. 9317, 1974 - Reclamation District No. 819). [Additional Reference(s): DWR Levee Log, 1990. USACE Sacramento O&M Manual 127, June 1953, (Station 211+05) (15-inch pipe listed)]. FS Date: 4/9/2013

Pump on LS toe.

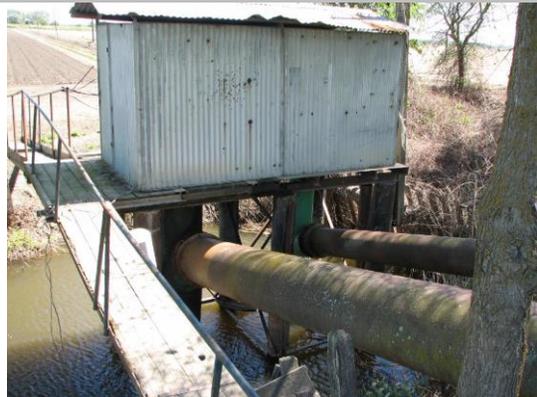
Photo 2 of 3 : UCIP_SP_2020_11293_18674.jpg

Pump and pipes on LS toe.

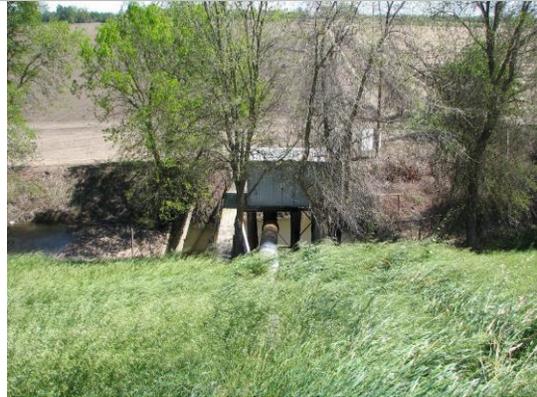
Photo 1 of 3 : UCIP_SP_2020_11291_18669.jpg

LM Start	3.94	Rating **	A/W	Issue No.	43
LM End	3.94	Issue Type +	Ma	Location *	
Category	Supplemental			GPS Latitude/Longitude	
				Start	End
Item	DWR UCIP LMA Responsibility			38.770335 °	38.770335 °
				-121.701286 °	-121.701286 °
DWR ID	19401

Pumphouse at LS toe.

Comment Code					
Inspector Comment					
DS_ID:19401 FS_ID:11291 EP_NO: 9317 Repair Type: No Action Needed Crossing Status: Found UCIP Comments: 01/14/2019 Pipe was removed replaced with a new 24-inch pipe through the levee. Permit 9317-1 issues authorization of emergency removal and replacement of the pipe in September 2012. New DS-ID 25572. (O.Yakimov - DWR UCIP) FIELD_STRUCT_DESC: *REMOVED* 2 of 2: 24-inch steel discharge pipe through the levee, 9 feet below the crown. Pump house on pile structure in drainage ditch on the landside (LS). Siphon breaker on the pipe on the waterside (WS) with a butterfly shutoff valve. Service pole at the pump house. (Permit No. 9317, 1974 - Reclamation District No. 819). Pipe replaced in 2012. [Additional Reference(s): DWR Levee Log, 1990. USACE Sacramento O&M Manual 127, June 1953, (Station 210+99)]. FS Date: 4/9/2013

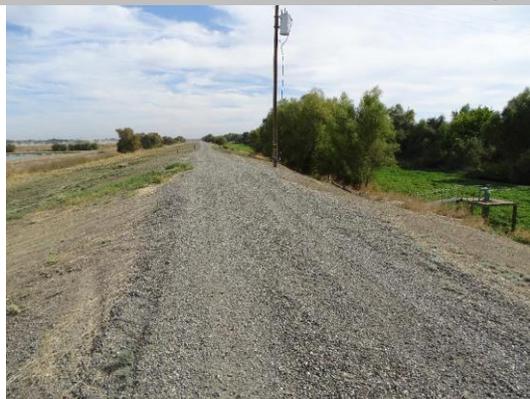
Photo 1 of 3 : UCIP_SP_2020_55777_82798.jpg

Comment Code					
Inspector Comment					
DS_ID:19375 FS_ID:55777 EP_NO: 3671 Repair Type: Urgent Crossing Status: Found UCIP Comments: 10/08/2019 Record has been updated from Non-Urgent to Urgent, heavily corroder pipe at outlet was noted in 2013. Crossing looks abandoned. (O.Yakimov - DWR UCIP)04/09/2013 Electrical panal missing parts. Siphon breaker missing from pipe on LS. Pipe heavily corroded at outlet with holes present. Appears abandoned-should be abandoned properly. (W. Wylie - DWR UCIP) FIELD_STRUCT_DESC: 20-inch coated steel irrigation pipe through the levee, 5.5 feet below the crown. Siphon breaker in a steel pipe riser on the landside (LS) slope. Metal cutoff wall. Service pole on the waterside (WS) slope. (Replaced 20-inch pipe at same location in 1961 under Permit No. 3671, 1961 - Mary Anna Richardson). [Additional Reference(s): DWR Levee Log, 1990]. FS Date: 10/8/2019

View of levee crown at the crossing
