**Flood Control Project Maintenance
Levee Inspections**

Maintenance Issue Types Only, Levee Inspection Report By Mile - Spring 2020

Knights Landing Ridge Drainage District

Waterway	Bank	Unit Miles	Inspection Start/End	Inspector
Unit No. 01 Knights Landing Ridge Cut	Right	6.36	03/25/2020 03/25/2020	Zach Jojola

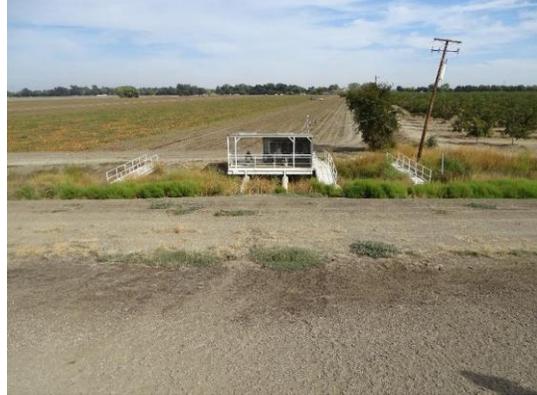
Photo 3 of 3 : UCIP_SP_2020_55749_82672.jpg

LM Start	3.93	Rating **	A/W	Issue No.	40 (cont)
LM End	3.93	Issue Type +	Ma	Location *	
Category	Supplemental			GPS Latitude/Longitude	
				Start	End
Item	DWR UCIP LMA Responsibility			38.770308 °	38.770308 °
				-121.701236 °	-121.701236 °
DWR ID	25571

View of LS looking from levee crown

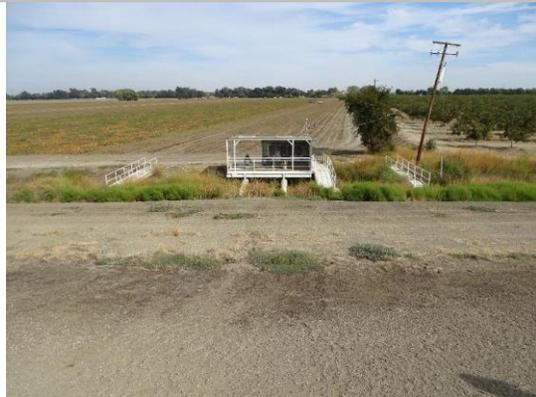
Photo 3 of 3 : UCIP_SP_2020_54351_82679.jpg

Comment Code					
Inspector Comment					
DS_ID:25572 FS_ID:54351 EP_NO: N/A Repair Type: No Action Needed Crossing Status: Found UCIP Comments: 10/08/2019 No issues recorded during inspection (O.Yakimov - DWR UCIP) FIELD_STRUCT_DESC: 24-inch steel discharge pipe through the levee, 6.5-feet below the crown. Pump house on pile structure in drainage ditch on the landward side. Siphon breaker and positive closure device butterfly valve with handwheel operator on the pipe on the waterward side. Pipe replaces a section of pipe through the levee butt welded to the original pipe approximately 37-feet from levee centerline on both levee slopes. Service pole on pump house. (Permit No. 9317-1, applicant - RD730, issued 07/10/2014 gives authorization of emergency removal and replacement of the pipe in September 2012.) FS Date: 10/8/2019

View of LS looking from levee crown
