**Flood Control Project Maintenance
Levee Inspections**

Maintenance Issue Types Only, Levee Inspection Report By Mile - Fall 2019

Lake County Watershed Protection District

Waterway	Bank	Unit Miles	Inspection Start/End	Inspector
Unit No. 01 Middle Creek	Left	3.35	10/16/2019 10/16/2019	Luz Dial

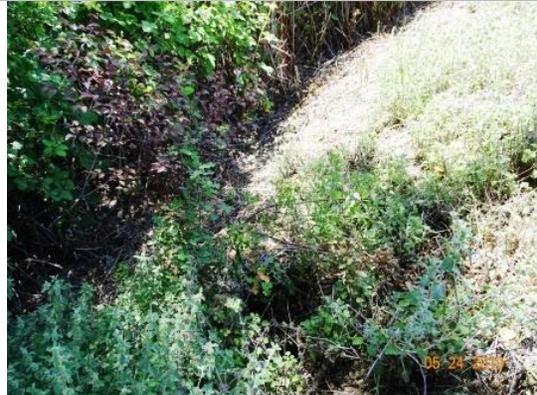
Photo 1 of 1 : FA_2019_NA0009_3_48_20190904_00020.jpg

LM Start	2.49	Rating **	M	Issue No.	48
LM End	2.49	Issue Type +	Ma	Location *	LS
Category	Earthen Levee		GPS Latitude/Longitude		
			Start	End	
Item	Animal Control		39.161472°	39.161472°	
			-122.911822°	-122.911822°	
DWR ID	DWR_NA0009_01_s_2019_48				
Comment Code					
A3 : No rodents visible, but rodent burrows visible; need to backfill and compact or grout burrows.					
Inspector Comment					
Backfill animal holes on both sides of the levee.

View looking downstream at animal holes on the landside slope. Spring 2019

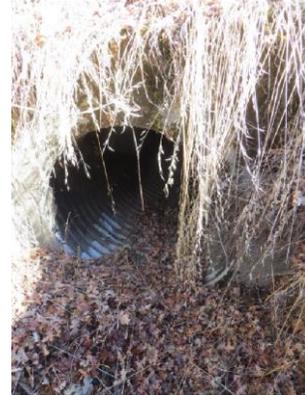
Photo 2 of 3 : UCIP_FA_2019_55713_50048.jpg

Comment Code					
Inspector Comment					
DS_ID:21201 FS_ID:55713 EP_NO: 11485 Repair Type: Non-Urgent Crossing Status: Found UCIP Comments: 10/23/2019 Record has been updated from No Action Needed to Non-Urgent; need to audit record to confirm owner. Crossing has been internally inspected under the DWR DMP Phase 1 project. Inspection report is still not available. The UCIP inspection was completed with DWR Inspector, L. Dial, and LMA representative, S. Webb. (O. Magana - DWR UCIP) FIELD_STRUCT_DESC: 42-inch corrugated metal drainage pipe through the levee, 8.5 feet below the crown. Flap gate on the waterside (WS). Concrete headwalls on both ends. (42-inch pipe [HLM 0.13] retained under Automatic Board Order (ABO) issued as Permit No. 11485, 1975 - John and Vivian Strickfaden). [Additional Reference(s): DWR Levee Log, 2005. USACE Sacramento O&M Manual 506.2, August 1961, (HLM 0.13), Station M315+75, 42-inch pipe, dwg no. CC-4-4-29, Index Sheet 6: page 6, 40 of 64]. FS Date: 10/23/2019 1:44:00 PM

Pipe and headwall visible at LS toe in drainage swale.

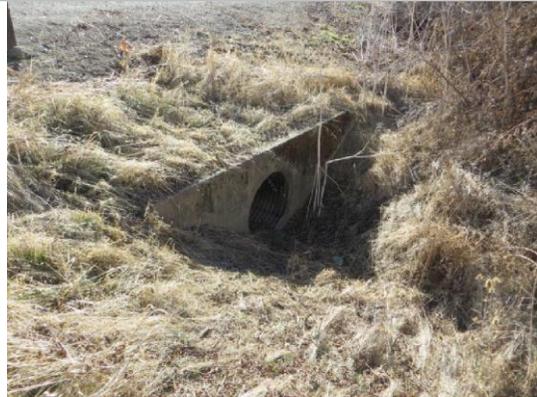
Photo 1 of 3 : UCIP_FA_2019_55717_50322.jpg

Comment Code					
Inspector Comment					
DS_ID:21204 FS_ID:55717 EP_NO: 11484 Repair Type: Non-Urgent Crossing Status: Found UCIP Comments: 10/23/2019 Record has been updated from No Action Needed to Non-Urgent; need to audit record to confirm owner. Crossing has been internally inspected under the DWR DMP Phase 1 project. Inspection report is still not available. The UCIP inspection was completed with DWR Inspector, L. Dial, and LMA representative, S. Webb. (O. Magana - DWR UCIP) FIELD_STRUCT_DESC: 36-inch corrugated metal drainage pipe through the levee, 6 feet below the crown. Flap gate on the waterside (WS) end. Concrete headwalls on both ends. (36-inch pipe [HLM 0.23] retained under Automatic Board Order (ABO) issued as Permit No. 11484, 1975 - Rodney Snow). [Additional Reference(s): DWR Levee Log, 2005. USACE Sacramento O&M Manual 506.2, August 1961, (HLM 0.23), Station M311+10, 36-inch pipe, dwg no. CC-4-4-29, Index Sheet 6: page 6, 40 of 64]. FS Date: 10/23/2019 1:46:00 PM

Concrete headwall and pipe on LS toe.

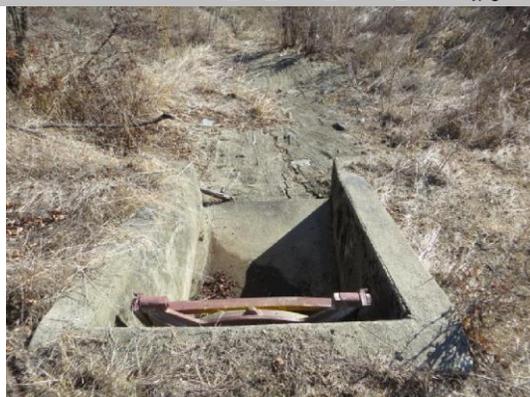
Photo 3 of 3 : UCIP_FA_2019_55717_50320.jpg

Comment Code					
Inspector Comment					
<p>DS_ID:21204 FS_ID:55717 EP_NO: 11484 Repair Type: Non-Urgent Crossing Status: Found UCIP Comments: 10/23/2019 Record has been updated from No Action Needed to Non-Urgent; need to audit record to confirm owner. Crossing has been internally inspected under the DWR DMP Phase 1 project. Inspection report is still not available. The UCIP inspection was completed with DWR Inspector, L. Dial, and LMA representative, S. Webb. (O. Magana - DWR UCIP) FIELD_STRUCTURE_DESC: 36-inch corrugated metal drainage pipe through the levee, 6 feet below the crown. Flap gate on the waterside (WS) end. Concrete headwalls on both ends. (36-inch pipe [HLM 0.23] retained under Automatic Board Order (ABO) issued as Permit No. 11484, 1975 - Rodney Snow). [Additional Reference(s): DWR Levee Log, 2005. USACE Sacramento O&M Manual 506.2, August 1961, (HLM 0.23), Station M311+10, 36-inch pipe, dwg no. CC-4-4-29, Index Sheet 6: page 6, 40 of 64]. FS Date: 10/23/2019 1:46:00 PM</p>

Flapgate and concrete headwall on WS toe.

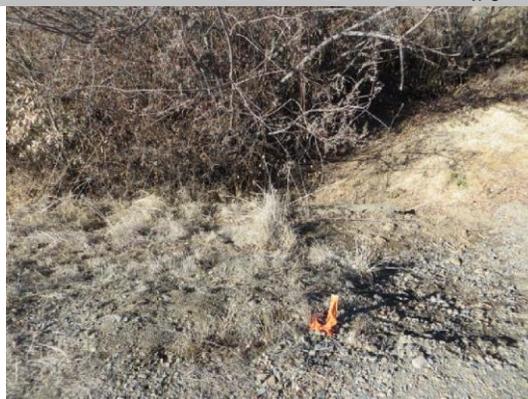
Photo 1 of 3 : UCIP_FA_2019_55718_50326.jpg

Comment Code					
Inspector Comment					
DS_ID:21206 FS_ID:55718 EP_NO: 11478 Repair Type: Non-Urgent Crossing Status: Found UCIP Comments: 10/23/2019 Record has been updated from No Action Needed to Non-Urgent; need to audit record to confirm owner. Crossing has been internally inspected under the DWR DMP Phase 1 project. Inspection report is still not available. The UCIP inspection was completed with DWR Inspector, L. Dial, and LMA representative, S. Webb. (O. Magana - DWR UCIP) FIELD_STRUCT_DESC: 42-inch corrugated metal drainage pipe through the levee, 7.7 feet below the crown. Flap gate on the waterside (WS) end. Concrete headwalls on both ends. Grouted spillway over revetment on bank. (42-inch pipe [HLM 0.38] retained under Automatic Board Order (ABO) issued as Permit No. 11478, 1975 - William D. and Dorothy L. Allison). [Additional Reference(s): DWR Levee Log, 2005. USACE Sacramento O&M Manual 506.2, August 1961, (HLM 0.38), Station M302+80, 42-inch pipe, dwg no. CC-4-4-29, Index Sheet 6: page 6, 40 of 64]. FS Date: 10/23/2019 1:47:00 PM

Pipe and concrete headwall at LS toe.

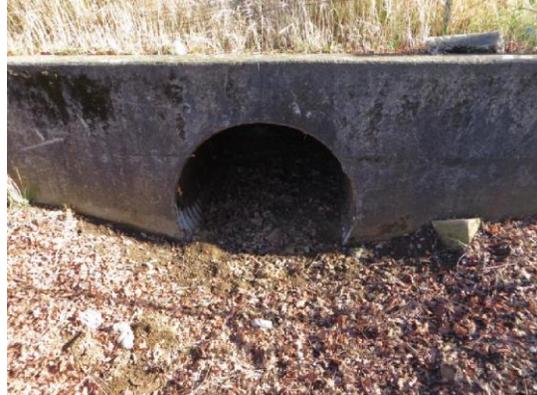
Photo 1 of 3 : UCIP_FA_2019_55723_50389.jpg

Comment Code					
Inspector Comment					
DS_ID:21208 FS_ID:55723 EP_NO: 11480 Repair Type: Non-Urgent Crossing Status: Found UCIP Comments: 10/23/2019 Record has been updated from No Action Needed to Non-Urgent; need to audit record to confirm owner. Also recommend conducting maintenance at the outlet to repair seepage issue. The seepage issue is about 60 feet from WS toe and poses no threat to the levee. The UCIP inspection was completed with DWR Inspector, L. Dial, and LMA representative, S. Webb. (O. Magana - DWR UCIP) FIELD_STRUCT_DESC: 42-inch corrugated metal drainage pipe through the levee, 7 feet below the crown. Flap gate on the waterside (WS) end. Concrete headwalls on both ends. (42-inch pipe [HLM 0.47] retained under Automatic Board Order (ABO) issued as Permit No. 11480, 1975 - Jose G. and Dora Moto). [Additional Reference(s): DWR Levee Log, 2005. USACE Sacramento O&M Manual 506.2, August 1961, (HLM 0.47), Station M299+30, 42-inch pipe, dwg no. CC-4-4-29, Index Sheet 6: page 6, 40 of 64]. FS Date: 10/23/2019 1:48:00 PM

Concrete headwall on LS toe.

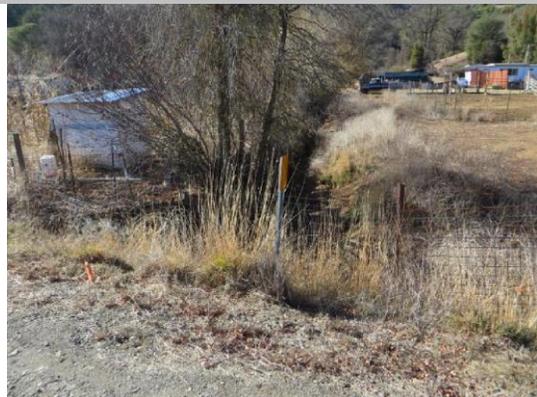
Photo 2 of 3 : UCIP_FA_2019_55723_50388.jpg

Pipe and concrete headwall on LS toe.

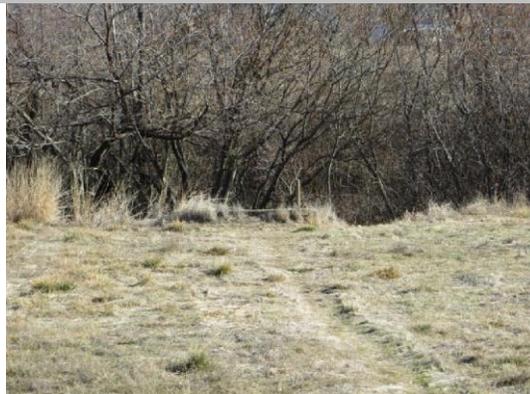
Photo 3 of 3 : UCIP_FA_2019_55723_50387.jpg

Comment Code					
Inspector Comment					
<p>DS_ID:21208 FS_ID:55723 EP_NO: 11480 Repair Type: Non-Urgent Crossing Status: Found UCIP Comments: 10/23/2019 Record has been updated from No Action Needed to Non-Urgent; need to audit record to confirm owner. Also recommend conducting maintenance at the outlet to repair seepage issue. The seepage issue is about 60 feet from WS toe and poses no threat to the levee. The UCIP inspection was completed with DWR Inspector, L. Dial, and LMA representative, S. Webb. (O. Magana - DWR UCIP) FIELD_STRUCT_DESC: 42-inch corrugated metal drainage pipe through the levee, 7 feet below the crown. Flap gate on the waterside (WS) end. Concrete headwalls on both ends. (42-inch pipe [HLM 0.47] retained under Automatic Board Order (ABO) issued as Permit No. 11480, 1975 - Jose G. and Dora Moto). [Additional Reference(s): DWR Levee Log, 2005. USACE Sacramento O&M Manual 506.2, August 1961, (HLM 0.47), Station M299+30, 42-inch pipe, dwg no. CC-4-4-29, Index Sheet 6: page 6, 40 of 64]. FS Date: 10/23/2019 1:48:00 PM</p>

Concrete headwall and flapgate visible on waterside berm

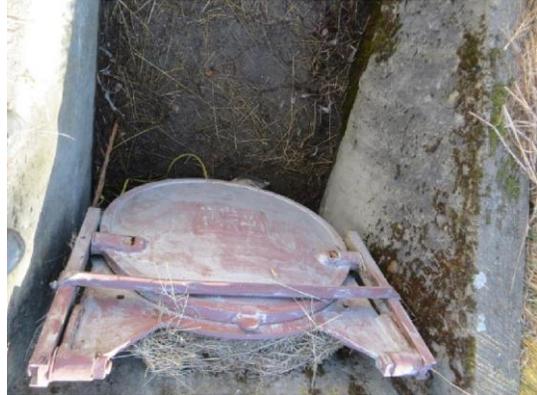
Photo 3 of 3 : UCIP_FA_2019_55730_50409.jpg

Comment Code					
Inspector Comment					
<p>DS_ID:21210 FS_ID:55730 EP_NO: 11482 Repair Type: Non-Urgent Crossing Status: Found UCIP Comments: 10/23/2019 Record remains Non-Urgent; need to audit record to confirm owner. Property owner will also need to address access issue due to fence installed on the LS slope. Crossing has been internally inspected under the DWR DMP Phase 1 project. Inspection report is still not available. The UCIP inspection was completed with DWR Inspector, L. Dial, and LMA representative, S. Webb. (O. Magana - DWR UCIP)01/14/2014 Fence on LS slope creates access issue. (W. Wylie - DWR UCIP) FIELD_STRUCT_DESC: 36-inch corrugated metal drainage pipe through the levee, 9 feet below the crown. Flap gate on the waterside (WS) end. Concrete headwalls on both ends. (36-inch pipe [HLM 0.54] retained under ABO No. 11482, 1975 - George R. and Gladys Schneider). [Additional Reference(s): DWR Levee Log, 2005. USACE Sacramento O&M Manual 506.2, August 1961, (HLM 0.54), Station M294+00, 36-inch pipe, dwg no. CC-4-4-29, Index Sheet 6: page 6, 40 of 64]. FS Date: 10/23/2019 1:50:00 PM</p>

Flapgate and concrete headwall on WS berm.

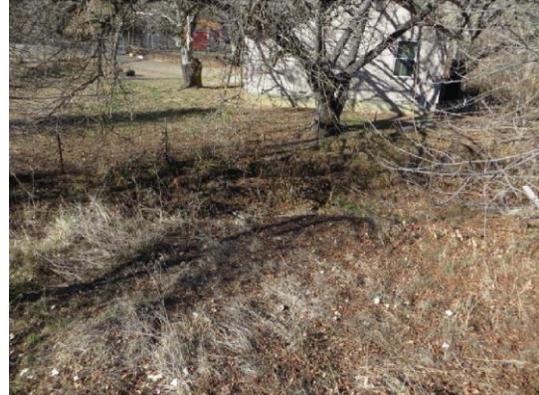
Photo 3 of 3 : UCIP_FA_2019_55740_51200.jpg

Comment Code						
Inspector Comment						
DS_ID:21211 FS_ID:55740 EP_NO: 11486 Repair Type: Non-Urgent Crossing Status: Found UCIP Comments: 10/23/2019 Record has been updated from No Action Needed to Non-Urgent; need to audit record to confirm owner. Crossing has been internally inspected under the DWR DMP Phase 1 project. Inspection report is still not available. The UCIP inspection was completed with DWR Inspector, L. Dial, and LMA representative, S. Webb. (O. Magana - DWR UCIP) FIELD_STRUCT_DESC: 36-inch corrugated metal drainage pipe through the levee, 7.3 feet below the crown. Flap gate on the waterside (WS) end. Concrete headwalls on both ends. Splash apron broken off on the WS end. (36-inch pipe [HLM 1.08] retained under Automatic Board Order (ABO) issued as Permit No. 11486, 1975 - Mary Truesdell). [Additional Reference(s): DWR Levee Log, 2005. USACE Sacramento O&M Manual 506.2, August 1961, (HLM 1.08), Station M269+00, 36-inch pipe, dwg no. CC-4-4-29, Index Sheet 5: page 5, 39 of 64]. FS Date: 10/23/2019 1:16:00 PM

Pipe visible on LS toe.

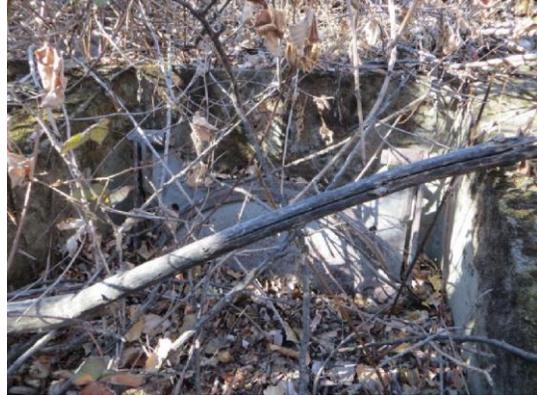
Photo 3 of 3 : UCIP_FA_2019_55741_51215.jpg

Comment Code					
Inspector Comment					
DS_ID:21212 FS_ID:55741 EP_NO: 11483 Repair Type: Non-Urgent Crossing Status: Found UCIP Comments: 10/23/2019 Record remains Non-Urgent, crossing appears abandoned; need to audit record to confirm owner. Crossing has been internally inspected under the DWR DMP Phase 1 project. Inspection report is still not available. The UCIP inspection was completed with DWR Inspector, L. Dial, and LMA representative, S. Webb. (O. Magana - DWR UCIP)01/22/2014 Pipe appears abandoned and if so, should be done so properly. Debris blocking flap gate at outlet. (W. Wylie - DWR UCIP) FIELD_STRUCT_DESC: *ABANDONED* 30-inch corrugated metal drainage pipe through the levee, 17.8 feet below the crown. Slide gate in 44-inch corrugated metal riser unit on the waterside (WS) slope. Flap gate on the WS end at concrete headwall. 6-foot by 8-foot concrete sump at the landside (LS) toe. (30-inch pipe [HLM 1.22] retained under Automatic Board Order (ABO) issued as Permit No. 11483, 1975 - Edward M. and Mildred E. Seely). [Additional Reference(s): DWR Levee Log, 2005. USACE Sacramento O&M Manual 506.2, August 1961, (HLM 1.22)]. FS Date: 10/23/2019 1:16:00 PM

Flapgate and concrete headwall visible off WS berm.

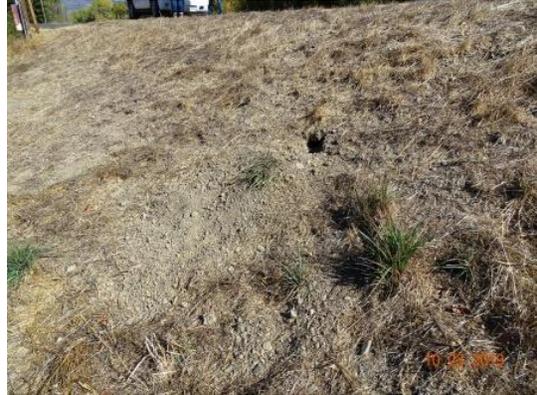
Photo 1 of 2 : FA_2019_NA0009_4_30_20191024_00053.jpg

LM Start	2.01	Rating **	M	Issue No.	30
LM End	2.01	Issue Type +	Ma	Location *	LS
Category	Earthen Levee			GPS Latitude/Longitude	
				Start	End
Item	Animal Control			39.162658°	39.162658°
				-122.916875°	-122.916875°
DWR ID	DWR_NA0009_02_f_2019_30				
Comment Code					
A3 : No rodents visible, but rodent burrows visible; need to backfill and compact or grout burrows.					
Inspector Comment					
Backfill the rodent holes.

View looking upstream at animal holes on the landside slope. Fall 2019

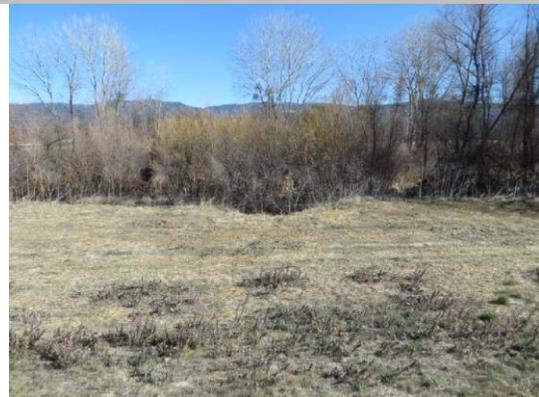
Photo 2 of 3 : UCIP_FA_2019_55756_51282.jpg

Comment Code					
Inspector Comment					
DS_ID:21215 FS_ID:55756 EP_NO: 11481 Repair Type: Non-Urgent Crossing Status: Found UCIP Comments: 10/23/2019 Record remains Non-Urgent; need to audit record to confirm owner. Crossing has been internally inspected under the DWR DMP Phase 1 project. Inspection report is still not available. The UCIP inspection was completed with DWR Inspector, L. Dial, and LMA representative, S. Webb. (O. Magana - DWR UCIP)01/22/2014 Soil partially blocking inlet and outlet. (W. Wylie - DWR UCIP) FIELD_STRUCT_DESC: 24-inch corrugated metal drainage pipe through the levee, 12 feet below the crown. Flap gate on the waterside (WS) end. Concrete headwalls on both ends. (24-inch pipe [HLM 2.93] retained under Automatic Board Order (ABO) issued as Permit No. 11481, 1975 - Dennis P. McCarthy). [Additional Reference(s): DWR Levee Log, 2005. USACE Sacramento O&M Manual 506.2, August 1961, (HLM 2.93), Station M173+00, 24-inch pipe, dwg no. CC-4-4-29, Index Sheet 4: page 4, 38 of 64]. FS Date: 10/23/2019 1:22:00 PM

Concrete headwall and flapgate visible at WS berm.

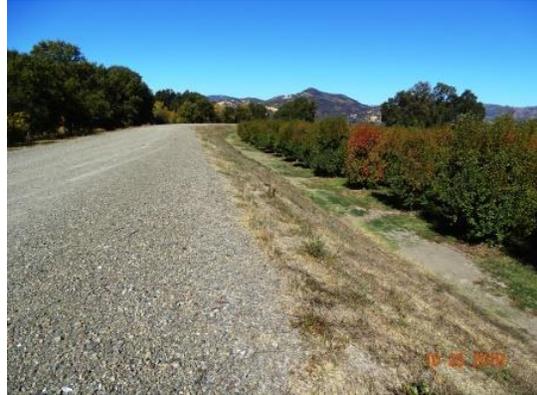
Photo 1 of 1 : FA_2019_NA0009_5_19_20191025_00042.jpg

LM Start	0.23	Rating **	A	Issue No.	19
LM End	0.92	Issue Type +	Ma	Location *	LS
Category	Earthen Levee		GPS Latitude/Longitude		
			Start	End	
Item	Vegetation		39.150733 °	39.159723 °	
			-122.916267 °	-122.920993 °	
DWR ID	DWR_NA0009_03_f_2019_19				
Comment Code					
V1 : Control annual grass and weeds on the levee slopes and easements.					
Inspector Comment

View of well-maintained landside vegetation. Fall 2019

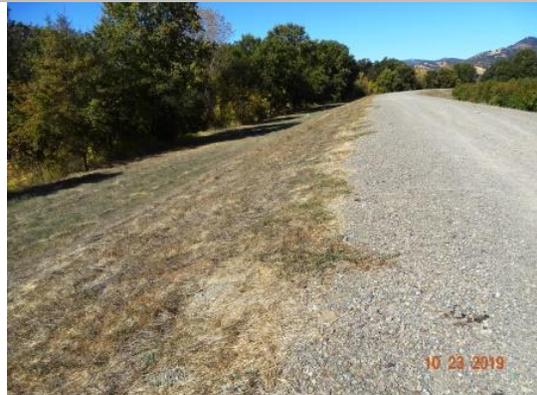
Photo 1 of 1 : FA_2019_NA0009_5_20_20191025_00043.jpg

LM Start	0.23	Rating **	A	Issue No.	20
LM End	0.93	Issue Type +	Ma	Location *	WS
Category	Earthen Levee		GPS Latitude/Longitude		
			Start	End	
Item	Vegetation		39.150733 °	39.159762 °	
			-122.916267 °	-122.921122 °	
DWR ID	DWR_NA0009_03_f_2019_20				
Comment Code					
V1 : Control annual grass and weeds on the levee slopes and easements.					
Inspector Comment

View of well-maintained waterside vegetation. Fall 2019

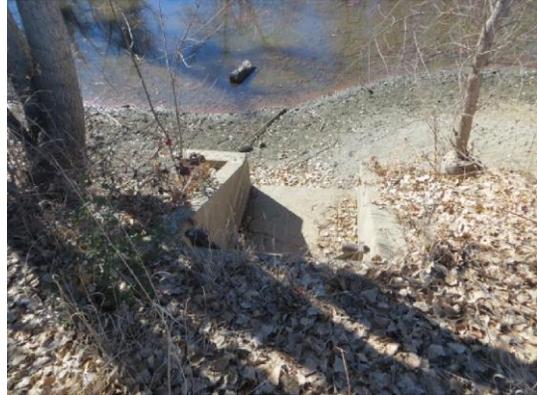
Photo 2 of 3 : UCIP_FA_2019_55769_51541.jpg

Comment Code					
Inspector Comment					
DS_ID:21217 FS_ID:55769 EP_NO: 11492 Repair Type: Non-Urgent Crossing Status: Found UCIP Comments: 10/24/2019 Record remains Non-Urgent; need to audit record to confirm owner. Crossing has been internally inspected under the DWR DMP Phase 1 project. Inspection report is still not available. (O. Magana - DWR UCIP)01/22/2014 Vegetation at inlet and wooden box failing at LS toe. (W. Wylie - DWR UCIP) FIELD_STRUCT_DESC: 42-inch corrugated metal drainage pipe through the levee, 12 feet below the crown. Flap gate on the waterside (WS) end. Concrete headwalls on both ends with a wooden retaining wall drop inlet at the landside (LS) toe. (42-inch pipe [HLM 0.55] retained under Automatic Board Order (ABO) issued as Permit No. 11492, 1975 - Dennis P. McCarthy). [Additional Reference(s): DWR Levee Log, 2005. USACE Sacramento O&M Manual 506.2, August 1961, (HLM 0.55), Station S32+50, 42-inch pipe, dwg no. CC-4-4-29, Index Sheet 4: page 4, 38 of 64]. FS Date: 10/24/2019 12:25:00 PM

Concrete headwall and flapgate visible at WS berm.

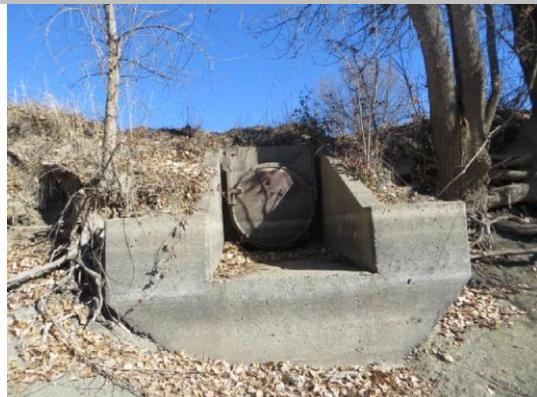
Photo 3 of 3 : UCIP_FA_2019_55769_51540.jpg

Concrete headwall and flapgate visible at WS berm.

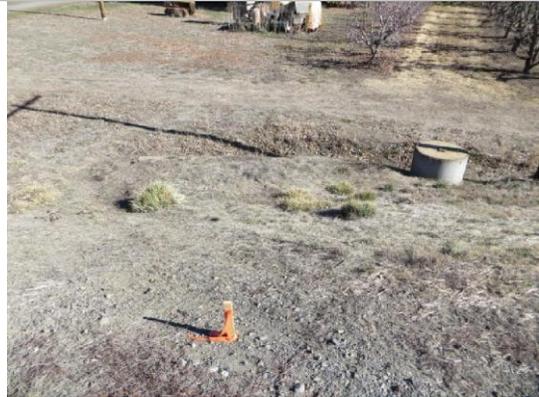
Photo 1 of 3 : UCIP_FA_2019_55778_51591.jpg

Comment Code					
Inspector Comment					
DS_ID:21220 FS_ID:55778 EP_NO: 11492 Repair Type: Non-Urgent Crossing Status: Found UCIP Comments: 10/24/2019 Record remains Non-Urgent; need to audit record to confirm owner. Crossing has been internally inspected under the DWR DMP Phase 1 project. Inspection report is still not available. Also need to determine the purpose of concrete riser located on the LS toe just d/s of the 24-inch pipe. Unable to determine purpose for deep riser located on the LS toe or if it crosses levee. Recommend further exploration of this riser and determine who owns it. (O. Magana - DWR UCIP)01/22/2014 Some sediment buildup at inlet. (W. Wylie - DWR UCIP) FIELD_STRUCT_DESC: 24-inch corrugated metal drainage pipe through the levee, 10 feet below the crown. Flap gate on the waterside (WS) end. Concrete headwalls on both ends. Concrete spillway on the WS slope to bottom of channel. (24-inch pipe [HLM 0.79] retained under Automatic Board Order (ABO) issued as Permit No. 11492, 1975 - Dennis P. McCarthy). [Additional Reference(s): DWR Levee Log, 2005. USACE Sacramento O&M Manual 506.2, August 1961, (HLM 0.79), Station S46+40.56, 24-inch pipe, dwg no. CC-4-4-29, Index Sheet 4: page 4, 38 of 64]. FS Date: 10/24/2019 12:27:00 PM

Concrete headwall visible next to concrete standpipe on LS toe.

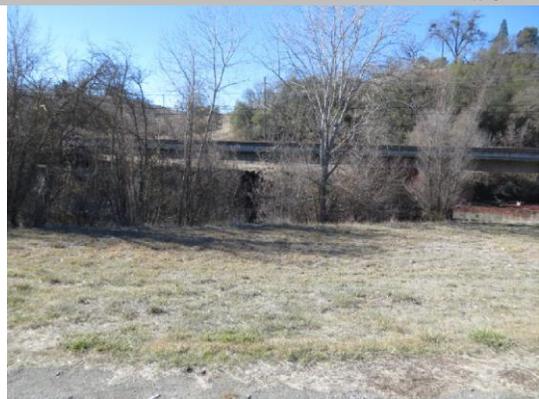
Photo 2 of 3 : UCIP_FA_2019_55778_51590.jpg

Concrete outfall visible off WS berm.

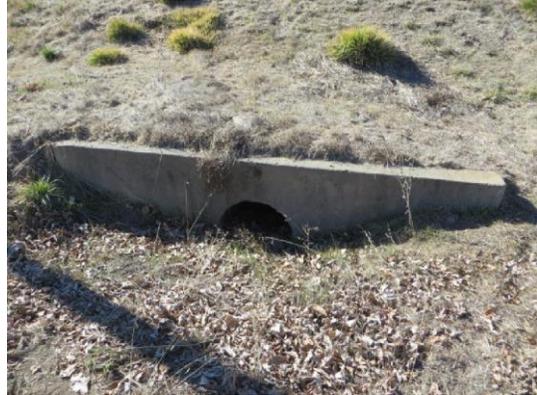
Photo 3 of 3 : UCIP_FA_2019_55778_51589.jpg

Comment Code					
Inspector Comment					
<p>DS_ID:21220 FS_ID:55778 EP_NO: 11492 Repair Type: Non-Urgent Crossing Status: Found UCIP Comments: 10/24/2019 Record remains Non-Urgent; need to audit record to confirm owner. Crossing has been internally inspected under the DWR DMP Phase 1 project. Inspection report is still not available. Also need to determine the purpose of concrete riser located on the LS toe just d/s of the 24-inch pipe. Unable to determine purpose for deep riser located on the LS toe or if it crosses levee. Recommend further exploration of this riser and determine who owns it. (O. Magana - DWR UCIP)01/22/2014 Some sediment buildup at inlet. (W. Wylie - DWR UCIP) FIELD_STRUCT_DESC: 24-inch corrugated metal drainage pipe through the levee, 10 feet below the crown. Flap gate on the waterside (WS) end. Concrete headwalls on both ends. Concrete spillway on the WS slope to bottom of channel. (24-inch pipe [HLM 0.79] retained under Automatic Board Order (ABO) issued as Permit No. 11492, 1975 - Dennis P. McCarthy). [Additional Reference(s): DWR Levee Log, 2005. USACE Sacramento O&M Manual 506.2, August 1961, (HLM 0.79), Station S46+40.56, 24-inch pipe, dwg no. CC-4-4-29, Index Sheet 4: page 4, 38 of 64]. FS Date: 10/24/2019 12:27:00 PM</p>

Concrete headwall visible at LS toe.

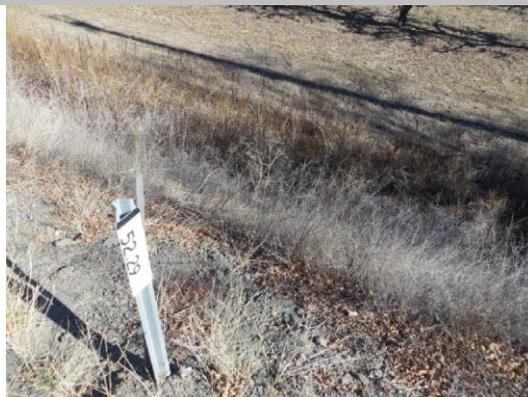
Photo 2 of 3 : UCIP_FA_2019_55781_51594.jpg

Comment Code					
Inspector Comment					
DS_ID:21247 FS_ID:55781 EP_NO: N/A Repair Type: Non-Urgent Crossing Status: Found UCIP Comments: 10/24/2019 Record has been updated from No Action Needed to Non-Urgent, need to audit record to determine current owner. No other issues were recorded at this location. Pipe crossing appears to have been abandoned back in 1961. USACE O&M manual and drawings indicate pipe has been plugged with concrete. Coordinates has been updated from 39.159628, 122.920853 to 39.159278, -122.920783 to reflect actual location of pipe crossing. Pipe crosses State Route 29. (O. Magana - DWR UCIP) FIELD_STRUCT_DESC: *ABANDONED* 36-inch corrugated metal drainage pipe through the levee, 10 feet below the crown. Plugged with concrete. [Additional Reference(s): USACE Sacramento O&M Manual 506.2, August 1961, (HLM 0.90), Station S50+85, 36-inch pipe plugged with concrete, dwg no. CC-4-4-29, Index Sheet 4: page 4, 38 of 64]. FS Date: 10/24/2019 12:28:00 PM

Roadway marker 52.29 on LS and WS shoulder mark pipe location on crown.

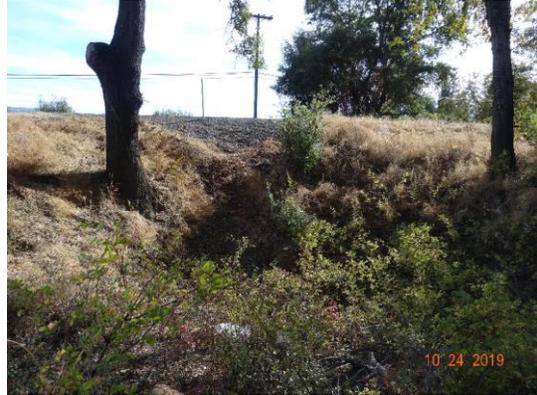
Photo 3 of 3 : UCIP_FA_2019_55781_82821.jpg

Comment Code						
Inspector Comment						
DS_ID:21247 FS_ID:55781 EP_NO: N/A Repair Type: Non-Urgent Crossing Status: Found UCIP Comments: 10/24/2019 Record has been updated from No Action Needed to Non-Urgent, need to audit record to determine current owner. No other issues were recorded at this location. Pipe crossing appears to have been abandoned back in 1961. USACE O&M manual and drawings indicate pipe has been plugged with concrete. Coordinates has been updated from 39.159628, 122.920853 to 39.159278, -122.920783 to reflect actual location of pipe crossing. Pipe crosses State Route 29. (O. Magana - DWR UCIP) FIELD_STRUCT_DESC: *ABANDONED* 36-inch corrugated metal drainage pipe through the levee, 10 feet below the crown. Plugged with concrete. [Additional Reference(s): USACE Sacramento O&M Manual 506.2, August 1961, (HLM 0.90), Station S50+85, 36-inch pipe plugged with concrete, dwg no. CC-4-4-29, Index Sheet 4: page 4, 38 of 64]. FS Date: 10/24/2019 12:28:00 PM

WS view: overview of WS looking towards levee/State Route 29.

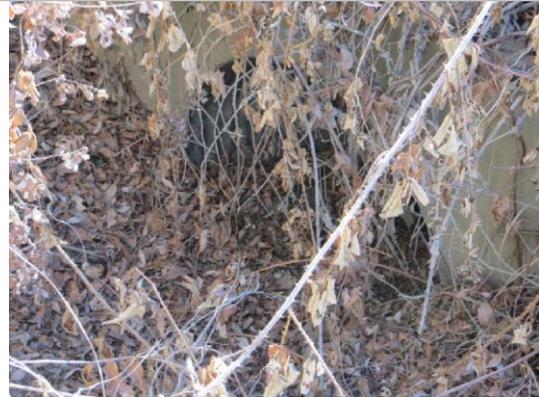
Photo 3 of 3 : UCIP_FA_2019_55782_51597.jpg

Comment Code					
Inspector Comment					
<p>DS_ID:21221 FS_ID:55782 EP_NO: 11488 Repair Type: Non-Urgent Crossing Status: Found UCIP Comments: 10/24/2019 Record remains Non-Urgent due to 2-foot scour under headwall noted in 2014; need to audit record to confirm owner. Crossing has been internally inspected under the DWR DMP Phase 1 project. Inspection report is still not available. (O. Magana - DWR UCIP)01/22/2014 Concrete headwall on WS berm is being undermined. 2-foot of scour under headwall. (W. Wylie - DWR UCIP) FIELD_STRUCT_DESC: 42-inch corrugated metal drainage pipe through the levee, 16.5 feet below the crown. Flap gate on the waterside (WS) end. Concrete headwalls on both ends. (42-inch pipe [HLM 0.94] retained under Automatic Board Order (ABO) issued as Permit No. 11488, 1975 - Robert F. and Mary E. Wheeler). [Additional Reference(s): DWR Levee Log, 2005. USACE Sacramento O&M Manual 506.2, August 1961, (HLM 0.94), Station S53+84, 42-inch pipe, dwg no. CC-4-4-29, Index Sheet 4: page 4, 38 of 64]. FS Date: 10/24/2019 12:28:00 PM</p>

Concrete headwall on LS toe.

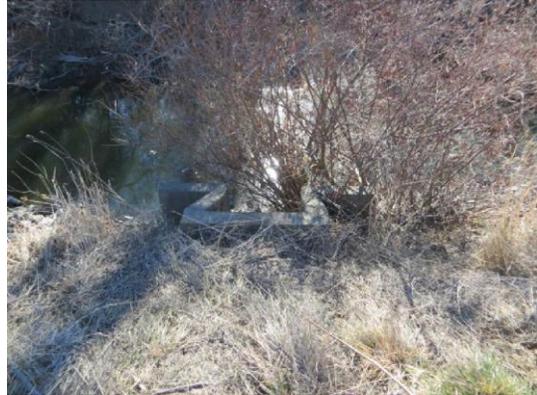
Photo 1 of 3 : UCIP_FA_2019_55784_51642.jpg

Comment Code					
Inspector Comment					
DS_ID:21222 FS_ID:55784 EP_NO: 11488 Repair Type: Non-Urgent Crossing Status: Found UCIP Comments: 10/24/2019 Record remains Non-Urgent due to scour developing behind d/s wingwall; need to audit record to confirm owner. Crossing has been internally inspected under the DWR DMP Phase 1 project. Inspection report is still not available. (O. Magana - DWR UCIP)01/22/2014 Some vegetation buildup at inlet and outlet. (W. Wylie - DWR UCIP) FIELD_STRUCT_DESC: 24-inch corrugated metal drainage pipe through the levee, 14 feet below the crown. Flap gate on the waterside (WS) end. Concrete headwalls on both ends. (24-inch pipe [HLM 1.01] retained under Automatic Board Order (ABO) issued as Permit No. 11488, 1975 - Robert F. and Mary E. Wheeler). [Additional Reference(s): DWR Levee Log, 2005. USACE Sacramento O&M Manual 506.2, August 1961, (HLM 1.01), Station S57+06, 24-inch pipe, dwg no. CC-4-4-29, Index Sheet 4: page 4, 38 of 64]. FS Date: 10/24/2019 12:29:00 PM

Concrete Headwall on WS berm.

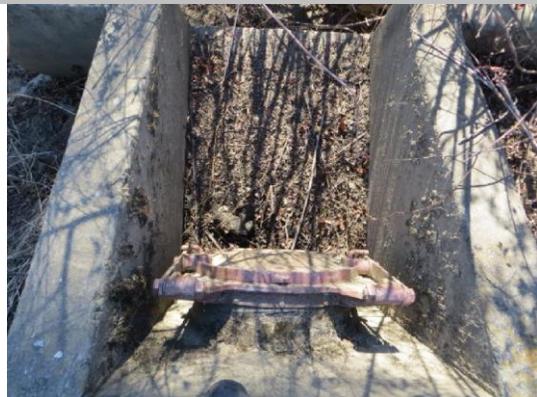
Photo 2 of 3 : UCIP_FA_2019_55784_51641.jpg

Headwall and flapgate on WS berm.

Comment Code					
Inspector Comment					
DS_ID:21222 FS_ID:55784 EP_NO: 11488 Repair Type: Non-Urgent Crossing Status: Found UCIP Comments: 10/24/2019 Record remains Non-Urgent due to scour developing behind d/s wingwall; need to audit record to confirm owner. Crossing has been internally inspected under the DWR DMP Phase 1 project. Inspection report is still not available. (O. Magana - DWR UCIP)01/22/2014 Some vegetation buildup at inlet and outlet. (W. Wylie - DWR UCIP) FIELD_STRUCT_DESC: 24-inch corrugated metal drainage pipe through the levee, 14 feet below the crown. Flap gate on the waterside (WS) end. Concrete headwalls on both ends. (24-inch pipe [HLM 1.01] retained under Automatic Board Order (ABO) issued as Permit No. 11488, 1975 - Robert F. and Mary E. Wheeler). [Additional Reference(s): DWR Levee Log, 2005. USACE Sacramento O&M Manual 506.2, August 1961, (HLM 1.01), Station S57+06, 24-inch pipe, dwg no. CC-4-4-29, Index Sheet 4: page 4, 38 of 64]. FS Date: 10/24/2019 12:29:00 PM

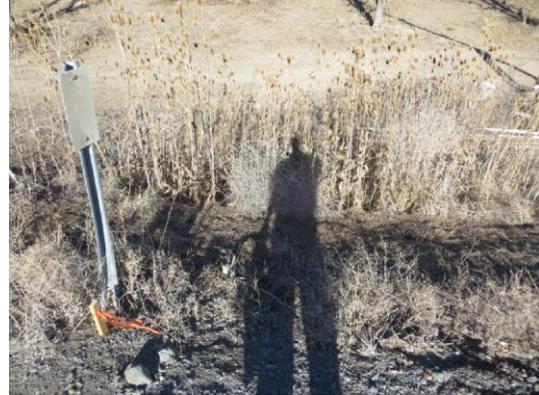
Photo 3 of 3 : UCIP_FA_2019_55784_51640.jpg

Pipe location marked on crown by flasher.

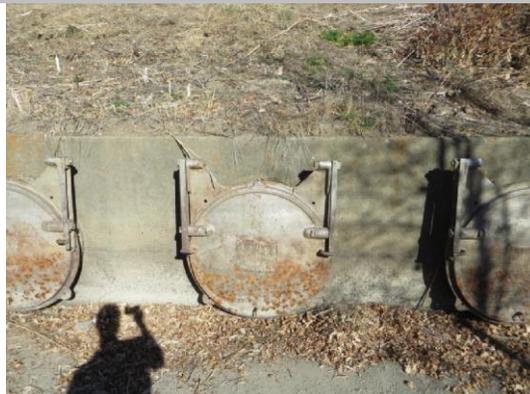
Photo 3 of 3 : UCIP_FA_2019_55787_51663.jpg

Comment Code					
Inspector Comment					
DS_ID:21237 FS_ID:55787 EP_NO: 11489 Repair Type: Non-Urgent Crossing Status: Found UCIP Comments: 10/24/2019 Record has been updated from No Action needed to Non-Urgent; need to audit record to confirm owner. Crossing has been internally inspected under the DWR DMP Phase 1 project. Inspection report is still not available. (O. Magana - DWR UCIP) FIELD_STRUCT_DESC: 2 of 4: 36-inch corrugated metal drainage pipe through the levee, 15.2 feet below the crown. Flap gate on the waterside (WS) end. Concrete headwalls on both ends. (four 36-inch pipes [HLM 1.25] retained under Automatic Board Order (ABO) issued as Permit No. 11489, 1975 - Bank of Upper Lake). [Additional Reference(s): DWR Levee Log, 2005. USACE Sacramento O&M Manual 506.2, August 1961, (HLM 1.25), Station SA10+00, four 36-inch pipes, dwg no. CC-4-4-29, Index Sheet 4: page 4, 38 of 64 and Sheet 35.1 page 64 of 64]. FS Date: 10/24/2019 12:30:00 PM

Flapgate and headwall on WS toe.

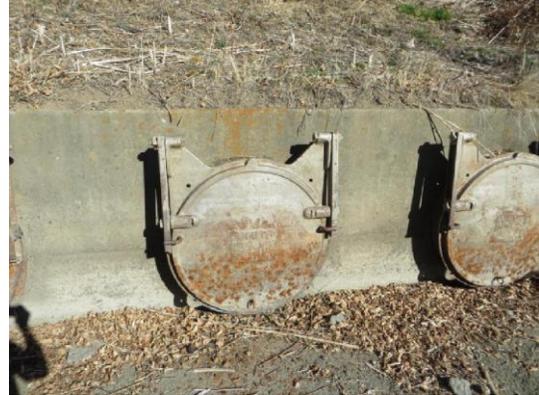
Photo 3 of 3 : UCIP_FA_2019_55788_51666.jpg

Comment Code					
Inspector Comment					
DS_ID:21238 FS_ID:55788 EP_NO: 11489 Repair Type: Non-Urgent Crossing Status: Found UCIP Comments: 10/24/2019 Record has been updated from No Action needed to Non-Urgent; need to audit record to confirm owner. Crossing has been internally inspected under the DWR DMP Phase 1 project. Inspection report is still not available. (O. Magana - DWR UCIP) FIELD_STRUCT_DESC: 3 of 4: 36-inch corrugated metal drainage pipe through the levee, 15.2 feet below the crown. Flap gate on the waterside (WS) end. Concrete headwalls on both ends. (four 36-inch pipes [HLM 1.25] retained under Automatic Board Order (ABO) issued as Permit No. 11489, 1975 - Bank of Upper Lake). [Additional Reference(s): DWR Levee Log, 2005. USACE Sacramento O&M Manual 506.2, August 1961, (HLM 1.25), Station SA10+00, four 36-inch pipes, dwg no. CC-4-4-29, Index Sheet 4: page 4, 38 of 64 and Sheet 35.1 page 64 of 64]. FS Date: 10/24/2019 12:30:00 PM

Flapgates on headwall at WS toe.

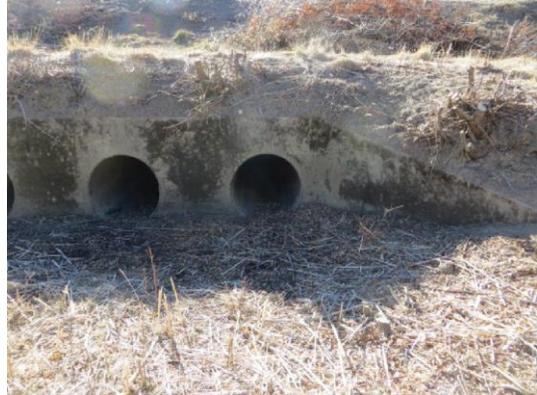
Photo 1 of 3 : UCIP_FA_2019_55789_51671.jpg

Comment Code					
Inspector Comment					
DS_ID:21239 FS_ID:55789 EP_NO: 11489 Repair Type: Non-Urgent Crossing Status: Found UCIP Comments: 10/24/2019 Record has been updated from No Action needed to Non-Urgent; need to audit record to confirm owner. Crossing has been internally inspected under the DWR DMP Phase 1 project. Inspection report is still not available.(O. Magana - DWR UCIP) FIELD_STRUCT_DESC: 4 of 4: 36-inch corrugated metal drainage pipe through the levee, 15.2 feet below the crown. Flap gate on the waterside (WS) end. Concrete headwalls on both ends. (four 36-inch pipes [HLM 1.25] retained under Automatic Board Order (ABO) issued as Permit No. 11489, 1975 - Bank of Upper Lake). [Additional Reference(s): DWR Levee Log, 2005. USACE Sacramento O&M Manual 506.2, August 1961, (HLM 1.25), Station SA10+00, four 36-inch pipes, dwg no. CC-4-4-29, Index Sheet 4: page 4, 38 of 64 and Sheet 35.1 page 64 of 64]. FS Date: 10/24/2019 12:30:00 PM

Pipe and concrete headwall on LS toe.

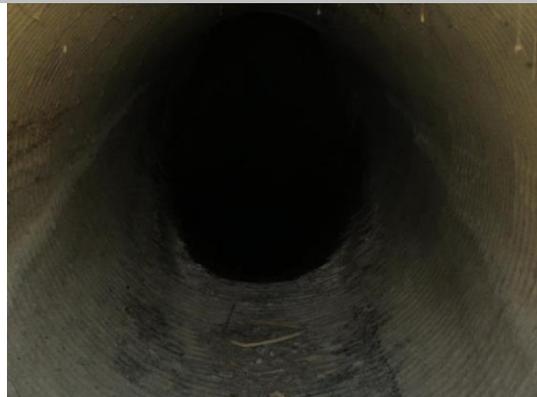
Photo 2 of 3 : UCIP_FA_2019_55789_51670.jpg

Pipe from LS toe.

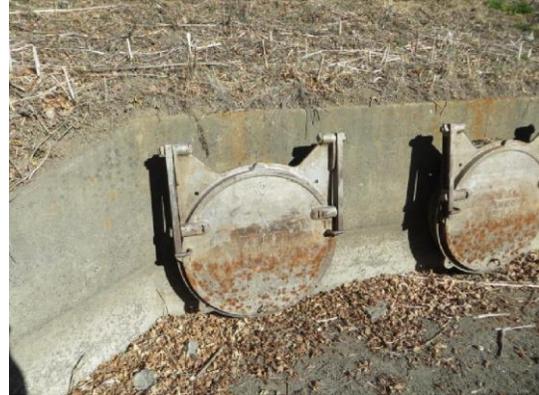
Photo 3 of 3 : UCIP_FA_2019_55789_51669.jpg

Comment Code					
Inspector Comment					
DS_ID:21239 FS_ID:55789 EP_NO: 11489 Repair Type: Non-Urgent Crossing Status: Found UCIP Comments: 10/24/2019 Record has been updated from No Action needed to Non-Urgent; need to audit record to confirm owner. Crossing has been internally inspected under the DWR DMP Phase 1 project. Inspection report is still not available.(O. Magana - DWR UCIP) FIELD_STRUCT_DESC: 4 of 4: 36-inch corrugated metal drainage pipe through the levee, 15.2 feet below the crown. Flap gate on the waterside (WS) end. Concrete headwalls on both ends. (four 36-inch pipes [HLM 1.25] retained under Automatic Board Order (ABO) issued as Permit No. 11489, 1975 - Bank of Upper Lake). [Additional Reference(s): DWR Levee Log, 2005. USACE Sacramento O&M Manual 506.2, August 1961, (HLM 1.25), Station SA10+00, four 36-inch pipes, dwg no. CC-4-4-29, Index Sheet 4: page 4, 38 of 64 and Sheet 35.1 page 64 of 64]. FS Date: 10/24/2019 12:30:00 PM

Flapgate on concrete headwall on WS toe.

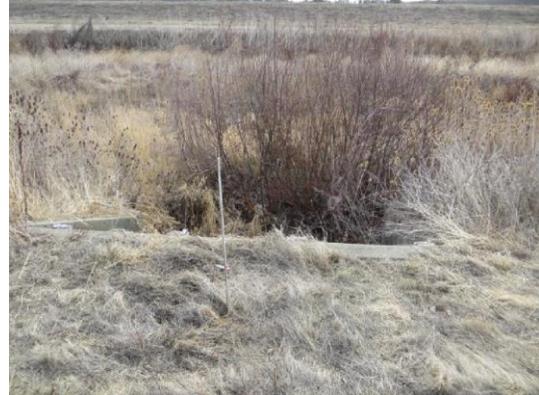
Photo 3 of 3 : UCIP_FA_2019_55812_49791.jpg

Comment Code						
Inspector Comment						
DS_ID:21236 FS_ID:55812 EP_NO: 11499 Repair Type: Non-Urgent Crossing Status: Found UCIP Comments: 10/16/2019 Record was updated from No Action Needed to Non-Urgent; need to audit record to confirm owner. Crossing has been internally inspected under the DWR DMP Phase 1 project. Inspection report is still not available. The UCIP inspection was completed with DWR Inspector, L. Dial, and LMA representative, S. Webb. (O. Magana - DWR UCIP) FIELD_STRUCT_DESC: 1 of 2: 42-inch corrugated metal drainage pipe through the levee, 12 feet below the crown. Flap gate on the waterside (WS) end. Concrete headwalls on both ends. (two 42-inch pipes [HLM 0.14] retained under Automatic Board Order (ABO) issued as Permit No. 11499, 1975 - Howard D. and Eunice A. Norton). [Additional Reference(s): DWR Levee Log, 2005. USACE Sacramento O&M Manual 506.2, August 1961, (HLM 0.14), Station DR8+60, two 42-inch pipes, dwg no. CC-4-4-29, Index Sheet 5: page 5, 39 of 64]. FS Date: 10/16/2019 4:01:00 PM

Concrete headwall visible on WS berm.

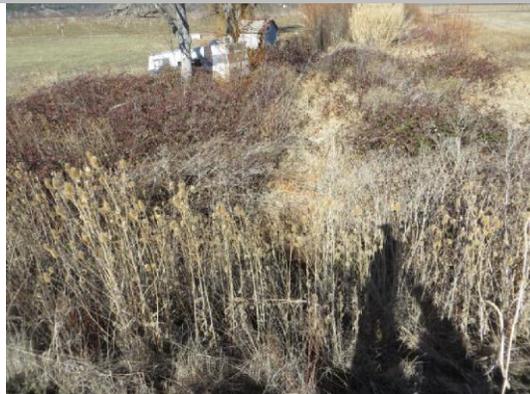
Photo 1 of 3 : UCIP_FA_2019_55811_49754.jpg

Comment Code					
Inspector Comment					
DS_ID:21227 FS_ID:55811 EP_NO: 11501 Repair Type: Urgent Crossing Status: Found UCIP Comments: 10/16/2019 Record remains Urgent due to evidence of pipe integrity issues on WS pipe collar. Need to audit record to confirm owner. Crossing has been internally inspected under the DWR DMP Phase 1 project. Inspection report is still not available. The UCIP inspection was completed with DWR Inspector, L. Dial, and LMA representative, S. Webb. (O. Magana - DWR UCIP)09/06/2018 Same as last inspection; crossing remains Urgent because of pipe integrity (D. Sanoski - DWR UCIP).11/30/2016 Clover Creek has significant sediment build up that blocks the outlet. Crossing is still in use to drain water from LS to WS according to LMA representative, Scott Webb. (O. Magana - DWR UCIP)01/09/2014 Pipe rusted through at connection to flap gate. Good indication pipe may need replacement. Video inspection recommended. (W. Wylie - DWR UCIP) FIELD_STRUCT_DESC: 24-inch corrugated metal (CM) drainage pipe through the levee, 13.8 feet below the crown. Flap gate is located on the waterside (WS) end. Concrete headwalls located on both the WS and landside (LS) ends. (24-inch pipe [HLM 0.77] was retained under Automatic Board Order (ABO) issued as Permit No. 11501, 1975 - Sisevich). [Additional Reference(s): DWR Levee Log, 2005. USACE Sacramento O&M Manual Unit 506.2, August 1961, (HLM 0.77), Station DR41+70, 24-inch pipe, dwg no. CC-4-4-29, Index Sheet 7: page 7, 41 of 64]. FS Date: 10/16/2019 4:01:00 PM

Drainage canal at inlet on LS toe.

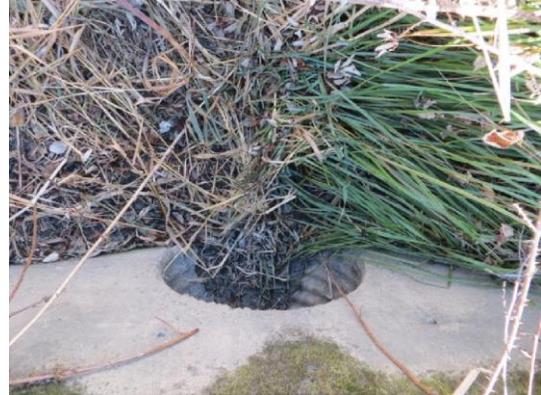
Photo 2 of 3 : UCIP_FA_2019_55811_49753.jpg

Comment Code					
Inspector Comment					
<p>DS_ID:21227 FS_ID:55811 EP_NO: 11501 Repair Type: Urgent Crossing Status: Found UCIP Comments: 10/16/2019 Record remains Urgent due to evidence of pipe integrity issues on WS pipe collar. Need to audit record to confirm owner. Crossing has been internally inspected under the DWR DMP Phase 1 project. Inspection report is still not available. The UCIP inspection was completed with DWR Inspector, L. Dial, and LMA representative, S. Webb. (O. Magana - DWR UCIP)09/06/2018 Same as last inspection; crossing remains Urgent because of pipe integrity (D. Sanoski - DWR UCIP).11/30/2016 Clover Creek has significant sediment build up that blocks the outlet. Crossing is still in use to drain water from LS to WS according to LMA representative, Scott Webb. (O. Magana - DWR UCIP)01/09/2014 Pipe rusted through at connection to flap gate. Good indication pipe may need replacement. Video inspection recommended. (W. Wylie - DWR UCIP) FIELD_STRUCT_DESC: 24-inch corrugated metal (CM) drainage pipe through the levee, 13.8 feet below the crown. Flap gate is located on the waterside (WS) end. Concrete headwalls located on both the WS and landside (LS) ends. (24-inch pipe [HLM 0.77] was retained under Automatic Board Order (ABO) issued as Permit No. 11501, 1975 - Sisevich). [Additional Reference(s): DWR Levee Log, 2005. USACE Sacramento O&M Manual Unit 506.2, August 1961, (HLM 0.77), Station DR41+70, 24-inch pipe, dwg no. CC-4-4-29, Index Sheet 7: page 7, 41 of 64]. FS Date: 10/16/2019 4:01:00 PM</p>

Pipe and concrete headwall visible in drainage channel on LS toe.

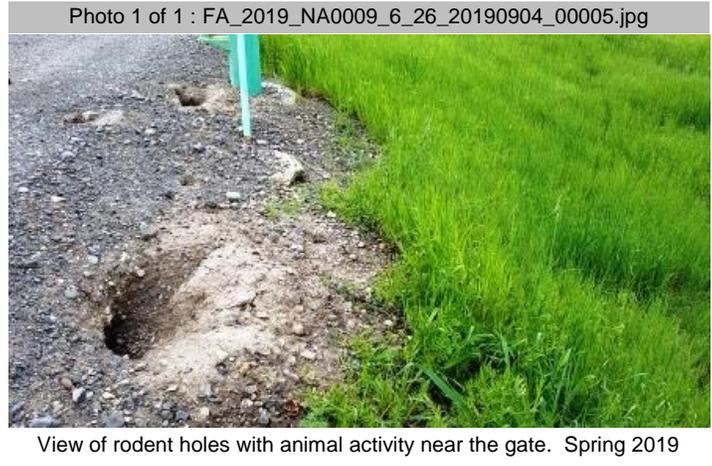
LM Start	1.04	Rating **	M	Issue No.	26
LM End	1.04	Issue Type +	Ma	Location *	LS
Category	Earthen Levee		GPS Latitude/Longitude		
			Start	End	
Item	Animal Control		39.180440°	39.180440°	
			-122.896638°	-122.896638°	
DWR ID	DWR_NA0009_04_s_2019_26				
Comment Code					
A1 : Exterminate rodents and backfill and compact or grout burrows.					
Inspector Comment

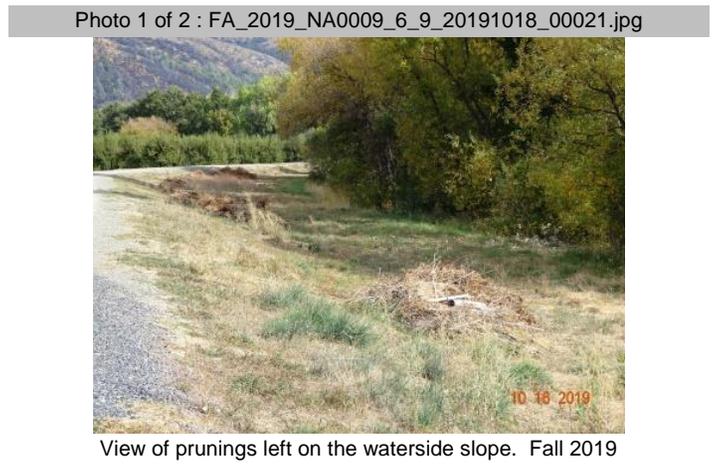
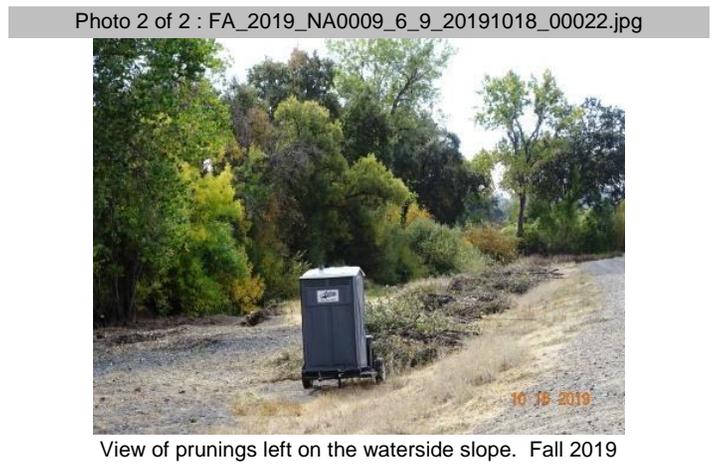
LM Start	1.13	Rating **	M	Issue No.	9
LM End	1.47	Issue Type +	Ma	Location *	WS
Category	Earthen Levee		GPS Latitude/Longitude		
			Start	End	
Item	Encroachments		39.181415°	39.185743°	
			-122.895588°	-122.893320°	
DWR ID	DWR_NA0009_04_f_2019_9				
Comment Code					
PR : Prunings					
Inspector Comment

LM Start	1.13	Rating **	M	Issue No.	9 (cont)
LM End	1.47	Issue Type +	Ma	Location *	WS

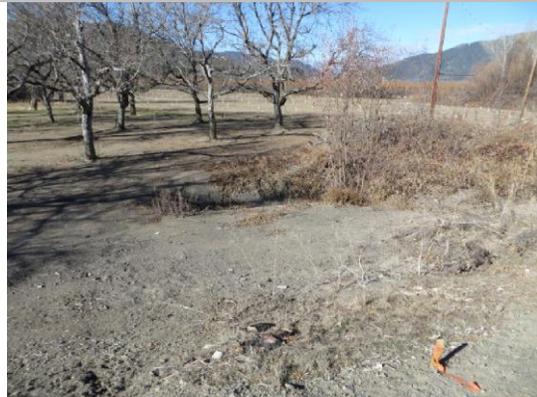
Photo 1 of 3 : UCIP_FA_2019_55816_49762.jpg

Comment Code					
Inspector Comment					
DS_ID:21228 FS_ID:55816 EP_NO: 11496 Repair Type: Urgent Crossing Status: Found UCIP Comments: 10/16/2019 Record was updated from No Action Needed to Urgent due to flap gate failure; flap gate does not seal properly which contributes to uncontrolled flow from WS to LS. Need to audit record to confirm owner. Also need to clear head of ditch to re-establish flow of ditch. Crossing has been internally inspected under the DWR DMP Phase 1 project. Inspection report is still not available. The UCIP inspection was completed with DWR Inspector, L. Dial, and LMA representative, S. Webb. (O. Magana - DWR UCIP) FIELD_STRUCT_DESC: 42-inch corrugated metal drainage pipe through the levee, 8 feet below the crown. Flap gate on the waterside (WS) end. Concrete headwalls on both ends. (24-inch pipes [HLM 1.21] retained under Automatic Board Order (ABO) issued as Permit No. 11496, 1975 - Earl Foutch). [Additional Reference(s): DWR Levee Log, 2005. USACE Sacramento O&M Manual 506.2, August 1961, (HLM 1.21), Station A15+50, 24-inch pipe referenced but 42-inch pipe constructed, dwg no. CC-4-4-29, Index Sheet 7: page 7, 41 of 64]. FS Date: 10/16/2019 4:03:00 PM

Drainpipe visible at LS toe.

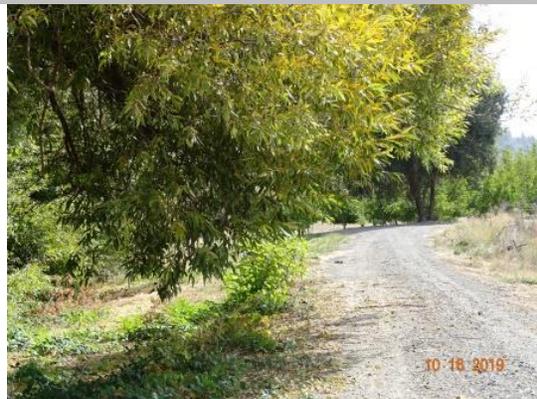
Photo 1 of 1 : FA_2019_NA0009_7_11_20191021_00030.jpg

LM Start	0.04	Rating **	M	Issue No.	11
LM End	0.04	Issue Type +	Ma	Location *	WS
Category	Earthen Levee		GPS Latitude/Longitude		
			Start	End	
Item	Trim / Thin Trees		39.177086°	39.177086°	
			-122.894018°	-122.894018°	
DWR ID	DWR_NA0009_05_s_2019_11				
Comment Code					
T1 : Trim trees to at least five feet above ground level.					
Inspector Comment

View of low tree branches hanging over the crown and slope. Fall 2019

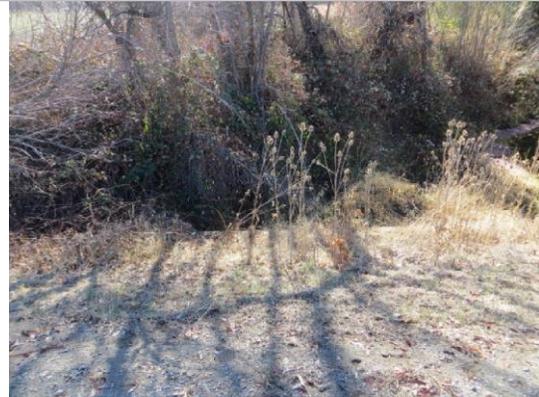
Photo 2 of 3 : UCIP_FA_2019_55848_49711.jpg

Comment Code					
Inspector Comment					
<p>DS_ID:21235 FS_ID:55848 EP_NO: 11507 Repair Type: Non-Urgent Crossing Status: Found UCIP Comments: 11/20/2019 Received update from LMA representative, S. Webb, regarding the removal of the gravel bar at the Clover Creek Diversion Structure completed in late October-2019. Photos of the clearing have been uploaded. Record remains Non-Urgent; need to clarify owner for this structure. (O. Magana - DWR UCIP) 10/16/2019 Crossing remains Non-Urgent due to a non-functional structure. As noted in the DWR Levee Annual Inspection report dated June 2019, significant gravel bar is impeding the flow of the channel. The new channel u/s created from the gravel reroutes low flows past the structure. According to LMA representative, S. Webb, this structure might be over designed. Mr. Webb would like to explore potential modifications to the Clover Creek Diversion Structure [six 36-inch pipes]. The proposed modification would include adding a slide gate to the most d/s pipe (designated as pipe 6) and use that one to control summer flows in conjunction the concrete weir. The pipes designated as 3, 4, and 5 (u/s to d/s, middle pipes) would not be necessary and would require proper abandonment. Pipes designated as 1 and 2 with slide gates would remain in use and would be used to allow the clear lake hitch fish to migrate u/s of the tributary. Currently, four of the six pipes without slide gates have metal sheet covering the inlet which prevent flows (flooding) from WS to LS. The structure has been designated for internal video inspection and has been scheduled for December 2019. Recommend having the CVFPB audit ABO to clarify owner. The UCIP inspection was completed with DWR Inspector, L. Dial, and DWR Sutter Yard Supervisor, S. Webb. (O. Magana - DWR UCIP)10/27/2017 This structure is inspected annually under the Structure and Channel Summer Inspection (part of the Levee Inspection Program) conducted by the DWR Flood Project Integrity and Inspection Branch (FPIIB). (DWR UCIP - O. Magana) 01/09/2014 Some sediment buildup at LS toe. (W. Wylie - DWR UCIP) FIELD_STRUCT_DESC: [Clover Creek Diversion Structure] 1 of 6: 36-inch corrugated metal drainage pipe through the levee, 12 feet below the crown. Slide gate on the waterside (WS) end. Steel walkway on the WS slope to slide gate. Concrete headwall on both ends. (six 36-inch pipes and structure [HLM 0.3] retained under Automatic Board Order (ABO) issued as Permit No. 11507, 1975 - Lake County Flood Control and Water Conservation District). [Additional Reference(s): DWR Levee Log, 2005. USACE Sacramento O&M Manual 506, Part 2, August 1961, (HLM 0.31), Station DR40+19 to DR41+10, six 36-inch pipes referenced as Clover Creek Outlet Works, dwg no. CC-4-4-29, Index Sheet 7: page 7, 41 of 64 and Sheet 29/20-21, page 53, 54 of 64]. FS Date: 10/16/2019 4:03:00 PM</p>

Outlet visible at concrete headwall on LS toe.

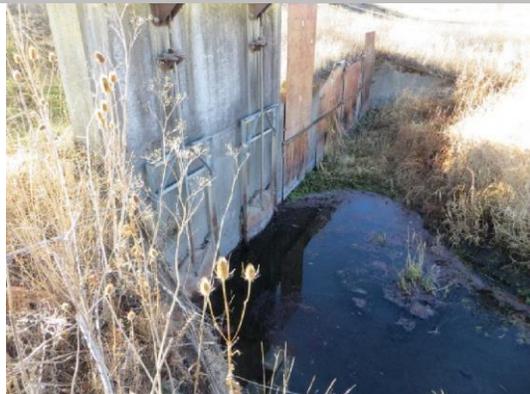
Photo 3 of 3 : UCIP_FA_2019_55848_49710.jpg

LM Start	0.31	Rating **	M	Issue No.	27 (cont)
LM End	0.31	Issue Type +	Ma	Location *	
Category	Supplemental			GPS Latitude/Longitude	
				Start	End
Item	DRAFT DWR UCIP LMA Responsibility			39.177076°	39.177076°
				-122.898879°	-122.898879°
DWR ID	21235

Slide gate at concrete headwall on WS toe.

DS_ID:21235
 FS_ID:55848
 EP_NO: 11507
 Repair Type: Non-Urgent
 Crossing Status: Found
 UCIP Comments: 11/20/2019 Received update from LMA representative, S. Webb, regarding the removal of the gravel bar at the Clover Creek Diversion Structure completed in late October-2019. Photos of the clearing have been uploaded. Record remains Non-Urgent; need to clarify owner for this structure. (O. Magana - DWR UCIP) 10/16/2019 Crossing remains Non-Urgent due to a non-functional structure. As noted in the DWR Levee Annual Inspection report dated June 2019, significant gravel bar is impeding the flow of the channel. The new channel u/s created from the gravel reroutes low flows past the structure. According to LMA representative, S. Webb, this structure might be over designed. Mr. Webb would like to explore potential modifications to the Clover Creek Diversion Structure [six 36-inch pipes]. The proposed modification would include adding a slide gate to the most d/s pipe (designated as pipe 6) and use that one to control summer flows in conjunction the concrete weir. The pipes designated as 3, 4, and 5 (u/s to d/s, middle pipes) would not be necessary and would require proper abandonment. Pipes designated as 1 and 2 with slide gates would remain in use and would be used to allow the clear lake hitch fish to migrate u/s of the tributary. Currently, four of the six pipes without slide gates have metal sheet covering the inlet which prevent flows (flooding) from WS to LS. The structure has been designated for internal video inspection and has been scheduled for December 2019. Recommend having the CVFPB audit ABO to clarify owner. The UCIP inspection was completed with DWR Inspector, L. Dial, and DWR Sutter Yard Supervisor, S. Webb. (O. Magana - DWR UCIP)10/27/2017 This structure is inspected annually under the Structure and Channel Summer Inspection (part of the Levee Inspection Program) conducted by the DWR Flood Project Integrity and Inspection Branch (FPIIB). (DWR UCIP - O. Magana) 01/09/2014 Some sediment buildup at LS toe. (W. Wylie - DWR UCIP) FIELD_STRUCT_DESC: [Clover Creek Diversion Structure] 1 of 6: 36-inch corrugated metal drainage pipe through the levee, 12 feet below the crown. Slide gate on the waterside (WS) end. Steel walkway on the WS slope to slide gate. Concrete headwall on both ends. (six 36-inch pipes and structure [HLM 0.3] retained under Automatic Board Order (ABO) issued as Permit No. 11507, 1975 - Lake County Flood Control and Water Conservation District). [Additional Reference(s): DWR Levee Log, 2005. USACE Sacramento O&M Manual 506, Part 2, August 1961, (HLM 0.31), Station DR40+19 to DR41+10, six 36-inch pipes referenced as Clover Creek Outlet Works, dwg no. CC-4-4-29, Index Sheet 7: page 7, 41 of 64 and Sheet 29/20-21, page 53, 54 of 64].

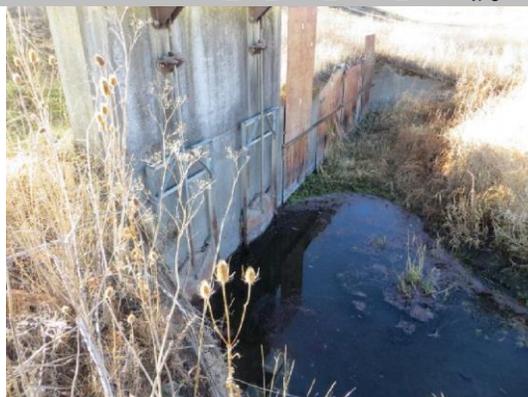
Photo 3 of 3 : UCIP_FA_2019_55849_49680.jpg

LM Start	0.31	Rating **	M	Issue No.	28 (cont)
LM End	0.31	Issue Type +	Ma	Location *	
Category	Supplemental			GPS Latitude/Longitude	
				Start	End
Item	DRAFT DWR UCIP LMA Responsibility			39.177074 °	39.177074 °
				-122.898902 °	-122.898902 °
DWR ID	21234

Slide gate visible at concrete headwall on WS toe.

DS_ID:21234
 FS_ID:55849
 EP_NO: 11507
 Repair Type: Non-Urgent
 Crossing Status: Found
 UCIP Comments: 11/20/2019 Received update from LMA representative, S. Webb, regarding the removal of the gravel bar at the Clover Creek Diversion Structure completed in late October-2019. Photos of the clearing have been uploaded. Record remains Non-Urgent; need to clarify owner for this structure. (O. Magana - DWR UCIP)10/16/2019 Crossing remains Non-Urgent due to a non-functional structure. As noted in the DWR Levee Annual Inspection report dated June 2019, significant gravel bar is impeding the flow of the channel. The new channel u/s created from the gravel reroutes low flows past the structure. According to LMA representative, S. Webb, this structure might be over designed. Mr. Webb would like to explore potential modifications to the Clover Creek Diversion Structure [six 36-inch pipes]. The proposed modification would include adding a slide gate to the most d/s pipe (designated as pipe 6) and use that one to control summer flows in conjunction the concrete weir. The pipes designated as 3, 4, and 5 (u/s to d/s, middle pipes) would not be necessary and would require proper abandonment. Pipes designated as 1 and 2 with slide gates would remain in use and would be used to allow the clear lake hitch fish to migrate u/s of the tributary. Currently, four of the six pipes without slide gates have metal sheet covering the inlet which prevent flows (flooding) from WS to LS. The structure has been designated for internal video inspection and has been scheduled for December 2019. Recommend having the CVFPB audit ABO to clarify owner. The UCIP inspection was completed with DWR Inspector, L. Dial, and DWR Sutter Yard Supervisor, S. Webb. (O. Magana - DWR UCIP)10/27/2017 This structure is inspected annually under the Structure and Channel Summer Inspection (part of the Levee Inspection Program) conducted by the DWR Flood Project Integrity and Inspection Branch (FPIIB). (DWR UCIP - O. Magana) 01/09/2014 Some sediment buildup on LS toe. (W. Wylie - DWR UCIP) FIELD_STRUCT_DESC: [Clover Creek Diversion Structure] 2 of 6: 36-inch corrugated metal drainage pipe through the levee, 12 feet below the crown. Slide gate on the waterside (WS) end. Steel walkway on the WS slope to slide gate. Concrete headwalls on both ends. (six 36-inch pipes and structure [HLM 0.3] retained under Automatic Board Order (ABO) issued as Permit No. 11507, 1975 - Lake County Flood Control and Water Conservation District). [Additional Reference(s): DWR Levee Log, 2005. USACE Sacramento O&M Manual 506, Part 2, August 1961, (HLM 0.31)].
