**Flood Control Project Maintenance
Levee Inspections**

Maintenance Issue Types Only, Levee Inspection Report By Mile - Fall 2019

Lake County Watershed Protection District

Waterway	Bank	Unit Miles	Inspection Start/End	Inspector
Unit No. 01 Middle Creek	Left	3.35	10/16/2019 10/16/2019	Luz Dial

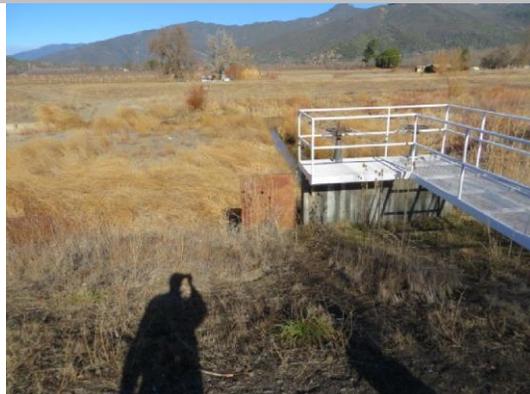
Photo 1 of 3 : UCIP_FA_2019_55853_49666.jpg

DS_ID:21233
 FS_ID:55853
 EP_NO: 11507
 Repair Type: Non-Urgent
 Crossing Status: Found
 UCIP Comments: 11/20/2019 Received update from LMA representative, S. Webb, regarding the removal of the gravel bar at the Clover Creek Diversion Structure completed in late October-2019. Photos of the clearing have been uploaded. Record remains Non-Urgent; need to clarify owner for this structure. (O. Magana - DWR UCIP)10/16/2019 Crossing remains Non-Urgent due to a non-functional structure. As noted in the DWR Levee Annual Inspection report dated June 2019, significant gravel bar is impeding the flow of the channel. The new channel u/s created from the gravel reroutes low flows past the structure. According to LMA representative, S. Webb, this structure might be over designed. Mr. Webb would like to explore potential modifications to the Clover Creek Diversion Structure [six 36-inch pipes]. The proposed modification would include adding a slide gate to the most d/s pipe (designated as pipe 6) and use that one to control summer flows in conjunction the concrete weir. The pipes designated as 3, 4, and 5 (u/s to d/s, middle pipes) would not be necessary and would require proper abandonment. Pipes designated as 1 and 2 with slide gates would remain in use and would be used to allow the clear lake hitch fish to migrate u/s of the tributary. Currently, four of the six pipes without slide gates have metal sheet covering the inlet which prevent flows (flooding) from WS to LS. The structure has been designated for internal video inspection and has been scheduled for December 2019. Recommend having the CVFPB audit ABO to clarify owner. The UCIP inspection was completed with DWR Inspector, L. Dial, and DWR Sutter Yard Supervisor, S. Webb. (O. Magana - DWR UCIP)10/27/2017 This structure is inspected annually under the Structure and Channel Summer Inspection (part of the Levee Inspection Program) conducted by the DWR Flood Project Integrity and Inspection Branch (FPIIB). (DWR UCIP - O. Magana) 01/09/2014 Some sediment buildup at outlet on LS toe. (W. Wylie - DWR UCIP)

FIELD_STRUCT_DESC: [Clover Creek Diversion Structure] 3 of 6: 36-inch corrugated metal drainage pipe through the levee, 12 feet below the crown. Concrete headwall on both ends. Steel slide gate plate blocks inlet on the waterside (WS) toe. (six 36-inch pipes and structure [HLM 0.3] retained under Automatic Board Order (ABO) issued as Permit No. 11507, 1975 - Lake County Flood Control and Water Conservation District). [Additional Reference(s): DWR Levee Log, 2005. USACE Sacramento O&M Manual 506, Part 2, August 1961, (HLM 0.31)].
 FS Date: 10/16/2019 4:04:00 PM

Steel slide gate visible at concrete headwall on WS toe.

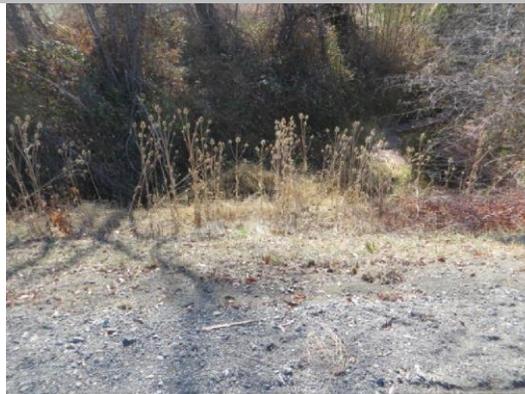
Photo 2 of 3 : UCIP_FA_2019_55853_49665.jpg

LM Start	0.32	Rating **	M	Issue No.	29 (cont)
LM End	0.32	Issue Type +	Ma	Location *	
Category	Supplemental			GPS Latitude/Longitude	
				Start	End
Item	DRAFT DWR UCIP LMA Responsibility			39.177078°	39.177078°
				-122.898926°	-122.898926°
DWR ID	21233

Outlet visible at concrete headwall on LS toe.

DS_ID:21233
 FS_ID:55853
 EP_NO: 11507
 Repair Type: Non-Urgent
 Crossing Status: Found
 UCIP Comments: 11/20/2019 Received update from LMA representative, S. Webb, regarding the removal of the gravel bar at the Clover Creek Diversion Structure completed in late October-2019. Photos of the clearing have been uploaded. Record remains Non-Urgent; need to clarify owner for this structure. (O. Magana - DWR UCIP)10/16/2019 Crossing remains Non-Urgent due to a non-functional structure. As noted in the DWR Levee Annual Inspection report dated June 2019, significant gravel bar is impeding the flow of the channel. The new channel u/s created from the gravel reroutes low flows past the structure. According to LMA representative, S. Webb, this structure might be over designed. Mr. Webb would like to explore potential modifications to the Clover Creek Diversion Structure [six 36-inch pipes]. The proposed modification would include adding a slide gate to the most d/s pipe (designated as pipe 6) and use that one to control summer flows in conjunction the concrete weir. The pipes designated as 3, 4, and 5 (u/s to d/s, middle pipes) would not be necessary and would require proper abandonment. Pipes designated as 1 and 2 with slide gates would remain in use and would be used to allow the clear lake hitch fish to migrate u/s of the tributary. Currently, four of the six pipes without slide gates have metal sheet covering the inlet which prevent flows (flooding) from WS to LS. The structure has been designated for internal video inspection and has been scheduled for December 2019. Recommend having the CVFPB audit ABO to clarify owner. The UCIP inspection was completed with DWR Inspector, L. Dial, and DWR Sutter Yard Supervisor, S. Webb. (O. Magana - DWR UCIP)10/27/2017 This structure is inspected annually under the Structure and Channel Summer Inspection (part of the Levee Inspection Program) conducted by the DWR Flood Project Integrity and Inspection Branch (FPIIB). (DWR UCIP - O. Magana) 01/09/2014 Some sediment buildup at outlet on LS toe. (W. Wylie - DWR UCIP)

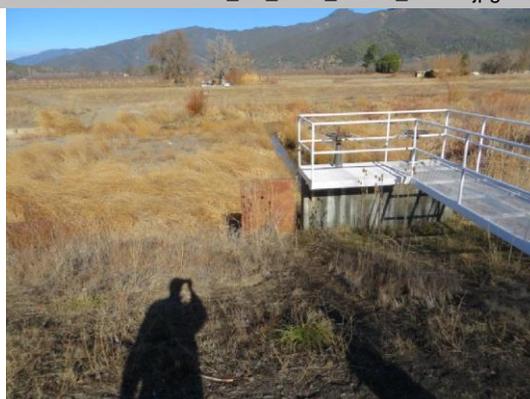
Photo 1 of 3 : UCIP_FA_2019_55851_49634.jpg

DS_ID:21232
 FS_ID:55851
 EP_NO: 11507
 Repair Type: Non-Urgent
 Crossing Status: Found
 UCIP Comments: 11/20/2019 Received update from LMA representative, S. Webb, regarding the removal of the gravel bar at the Clover Creek Diversion Structure completed in late October-2019. Photos of the clearing have been uploaded. Record remains Non-Urgent; need to clarify owner for this structure. (O. Magana - DWR UCIP)10/16/2019 Crossing remains Non-Urgent due to a non-functional structure. As noted in the DWR Levee Annual Inspection report dated June 2019, significant gravel bar is impeding the flow of the channel. The new channel u/s created from the gravel reroutes low flows past the structure. According to LMA representative, S. Webb, this structure might be over designed. Mr. Webb would like to explore potential modifications to the Clover Creek Diversion Structure [six 36-inch pipes]. The proposed modification would include adding a slide gate to the most d/s pipe (designated as pipe 6) and use that one to control summer flows in conjunction the concrete weir. The pipes designated as 3, 4, and 5 (u/s to d/s, middle pipes) would not be necessary and would require proper abandonment. Pipes designated as 1 and 2 with slide gates would remain in use and would be used to allow the clear lake hitch fish to migrate u/s of the tributary. Currently, four of the six pipes without slide gates have metal sheet covering the inlet which prevent flows (flooding) from WS to LS. The structure has been designated for internal video inspection and has been scheduled for December 2019. Recommend having the CVFPB audit ABO to clarify owner. The UCIP inspection was completed with DWR Inspector, L. Dial, and DWR Sutter Yard Supervisor, S. Webb. (O. Magana - DWR UCIP)10/27/2017 This structure is inspected annually under the Structure and Channel Summer Inspection (part of the Levee Inspection Program) conducted by the DWR Flood Project Integrity and Inspection Branch (FPIIB). (DWR UCIP - O. Magana) 01/09/2014 Some sediment buildup at outlet on LS toe. (W. Wylie - DWR UCIP)

FIELD_STRUCT_DESC: [Clover Creek Diversion Structure] 4 of 6: 36-inch corrugated metal drainage pipe through the levee, 12 feet below the crown. Concrete headwall on both ends. (six 36-inch pipes and structure [HLM 0.3] retained under Automatic Board Order (ABO) issued as Permit No. 11507, 1975 - Lake County Flood Control and Water Conservation District). [Additional Reference(s): DWR Levee Log, 2005. USACE Sacramento O&M Manual 506, Part 2, August 1961, (HLM 0.31)].
 FS Date: 10/16/2019 4:06:00 PM

Steel plate slide gate visible at headwall on WS toe.

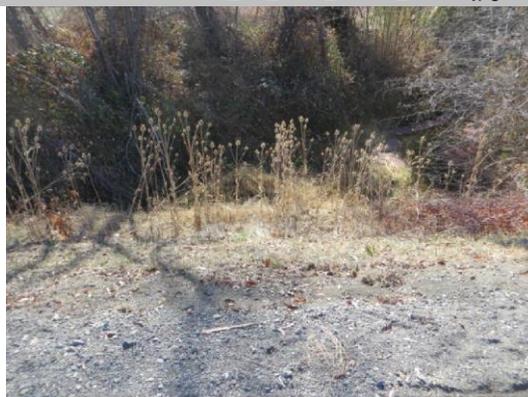
Photo 2 of 3 : UCIP_FA_2019_55851_49633.jpg

LM Start	0.32	Rating **	M	Issue No.	30 (cont)
LM End	0.32	Issue Type +	Ma	Location *	
Category	Supplemental			GPS Latitude/Longitude	
				Start	End
Item	DRAFT DWR UCIP LMA Responsibility			39.177074°	39.177074°
				-122.898949°	-122.898949°
DWR ID	21232

Outlet visible at concrete headwall on LS toe.

DS_ID:21232
 FS_ID:55851
 EP_NO: 11507
 Repair Type: Non-Urgent
 Crossing Status: Found
 UCIP Comments: 11/20/2019 Received update from LMA representative, S. Webb, regarding the removal of the gravel bar at the Clover Creek Diversion Structure completed in late October-2019. Photos of the clearing have been uploaded. Record remains Non-Urgent; need to clarify owner for this structure. (O. Magana - DWR UCIP)10/16/2019 Crossing remains Non-Urgent due to a non-functional structure. As noted in the DWR Levee Annual Inspection report dated June 2019, significant gravel bar is impeding the flow of the channel. The new channel u/s created from the gravel reroutes low flows past the structure. According to LMA representative, S. Webb, this structure might be over designed. Mr. Webb would like to explore potential modifications to the Clover Creek Diversion Structure [six 36-inch pipes]. The proposed modification would include adding a slide gate to the most d/s pipe (designated as pipe 6) and use that one to control summer flows in conjunction the concrete weir. The pipes designated as 3, 4, and 5 (u/s to d/s, middle pipes) would not be necessary and would require proper abandonment. Pipes designated as 1 and 2 with slide gates would remain in use and would be used to allow the clear lake hitch fish to migrate u/s of the tributary. Currently, four of the six pipes without slide gates have metal sheet covering the inlet which prevent flows (flooding) from WS to LS. The structure has been designated for internal video inspection and has been scheduled for December 2019. Recommend having the CVFPB audit ABO to clarify owner. The UCIP inspection was completed with DWR Inspector, L. Dial, and DWR Sutter Yard Supervisor, S. Webb. (O. Magana - DWR UCIP)10/27/2017 This structure is inspected annually under the Structure and Channel Summer Inspection (part of the Levee Inspection Program) conducted by the DWR Flood Project Integrity and Inspection Branch (FPIIB). (DWR UCIP - O. Magana) 01/09/2014 Some sediment buildup at outlet on LS toe. (W. Wylie - DWR UCIP)

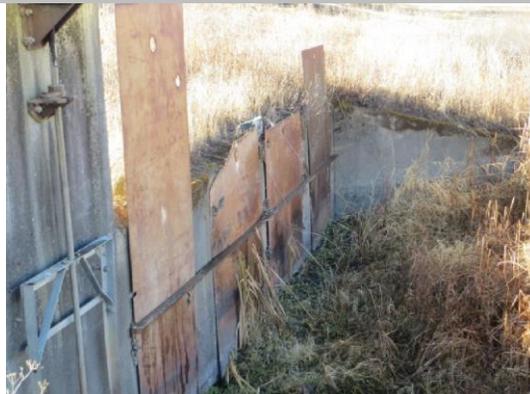
Photo 3 of 3 : UCIP_FA_2019_55851_49632.jpg

LM Start	0.32	Rating **	M	Issue No.	30 (cont)
LM End	0.32	Issue Type +	Ma	Location *	
Category	Supplemental			GPS Latitude/Longitude	
				Start	End
Item	DRAFT DWR UCIP LMA Responsibility			39.177074 °	39.177074 °
				-122.898949 °	-122.898949 °
DWR ID	21232

Steel plate slide gate visible at headwall on WS toe.

DS_ID:21232
 FS_ID:55851
 EP_NO: 11507
 Repair Type: Non-Urgent
 Crossing Status: Found
 UCIP Comments: 11/20/2019 Received update from LMA representative, S. Webb, regarding the removal of the gravel bar at the Clover Creek Diversion Structure completed in late October-2019. Photos of the clearing have been uploaded. Record remains Non-Urgent; need to clarify owner for this structure. (O. Magana - DWR UCIP)10/16/2019 Crossing remains Non-Urgent due to a non-functional structure. As noted in the DWR Levee Annual Inspection report dated June 2019, significant gravel bar is impeding the flow of the channel. The new channel u/s created from the gravel reroutes low flows past the structure. According to LMA representative, S. Webb, this structure might be over designed. Mr. Webb would like to explore potential modifications to the Clover Creek Diversion Structure [six 36-inch pipes]. The proposed modification would include adding a slide gate to the most d/s pipe (designated as pipe 6) and use that one to control summer flows in conjunction the concrete weir. The pipes designated as 3, 4, and 5 (u/s to d/s, middle pipes) would not be necessary and would require proper abandonment. Pipes designated as 1 and 2 with slide gates would remain in use and would be used to allow the clear lake hitch fish to migrate u/s of the tributary. Currently, four of the six pipes without slide gates have metal sheet covering the inlet which prevent flows (flooding) from WS to LS. The structure has been designated for internal video inspection and has been scheduled for December 2019. Recommend having the CVFPB audit ABO to clarify owner. The UCIP inspection was completed with DWR Inspector, L. Dial, and DWR Sutter Yard Supervisor, S. Webb. (O. Magana - DWR UCIP)10/27/2017 This structure is inspected annually under the Structure and Channel Summer Inspection (part of the Levee Inspection Program) conducted by the DWR Flood Project Integrity and Inspection Branch (FPIIB). (DWR UCIP - O. Magana) 01/09/2014 Some sediment buildup at outlet on LS toe. (W. Wylie - DWR UCIP)

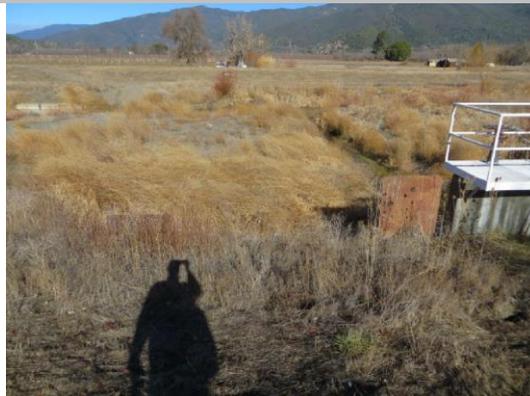
Photo 1 of 3 : UCIP_FA_2019_55854_49622.jpg

DS_ID:21231
 FS_ID:55854
 EP_NO: 11507
 Repair Type: Non-Urgent
 Crossing Status: Found
 UCIP Comments: 11/20/2019 Received update from LMA representative, S. Webb, regarding the removal of the gravel bar at the Clover Creek Diversion Structure completed in late October-2019. Photos of the clearing have been uploaded. Record remains Non-Urgent; need to clarify owner for this structure. (O. Magana - DWR UCIP)10/16/2019 Crossing remains Non-Urgent due to a non-functional structure. As noted in the DWR Levee Annual Inspection report dated June 2019, significant gravel bar is impeding the flow of the channel. The new channel u/s created from the gravel reroutes low flows past the structure. According to LMA representative, S. Webb, this structure might be over designed. Mr. Webb would like to explore potential modifications to the Clover Creek Diversion Structure [six 36-inch pipes]. The proposed modification would include adding a slide gate to the most d/s pipe (designated as pipe 6) and use that one to control summer flows in conjunction the concrete weir. The pipes designated as 3, 4, and 5 (u/s to d/s, middle pipes) would not be necessary and would require proper abandonment. Pipes designated as 1 and 2 with slide gates would remain in use and would be used to allow the clear lake hitch fish to migrate u/s of the tributary. Currently, four of the six pipes without slide gates have metal sheet covering the inlet which prevent flows (flooding) from WS to LS. The structure has been designated for internal video inspection and has been scheduled for December 2019. Recommend having the CVFPB audit ABO to clarify owner. The UCIP inspection was completed with DWR Inspector, L. Dial, and DWR Sutter Yard Supervisor, S. Webb. (O. Magana - DWR UCIP)10/27/2017 This structure is inspected annually under the Structure and Channel Summer Inspection (part of the Levee Inspection Program) conducted by the DWR Flood Project Integrity and Inspection Branch (FPIIB). (DWR UCIP - O. Magana) 01/09/2014 Some sediment buildup on LS toe. (W. Wylie - DWR UCIP) FIELD_STRUCT_DESC: [Clover Creek Diversion Structure] 5 of 6: 36-inch corrugated metal drainage pipe through the levee, 12 feet below the crown. Concrete headwall on both ends. Steel slide gate blocks inlet on the waterside (WS) toe. (six 36-inch pipes and structure [HLM 0.3] retained under Automatic Board Order (ABO) issued as Permit No. 11507, 1975 - Lake County Flood Control and Water Conservation District). [Additional Reference(s): DWR Levee Log, 2005. USACE Sacramento O&M Manual 506, Part 2, August 1961, (HLM 0.31)].

Metal slide gate visible at concrete headwall on WS toe.

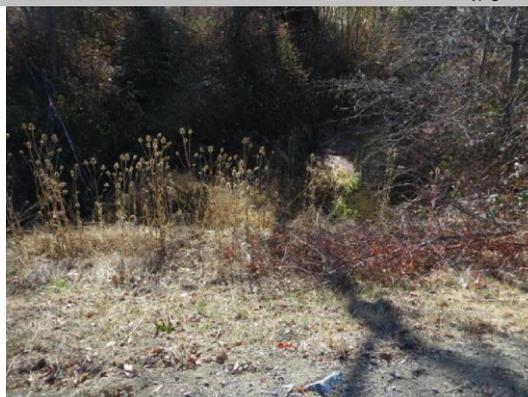
Photo 2 of 3 : UCIP_FA_2019_55854_49621.jpg

LM Start	0.32	Rating **	M	Issue No.	31 (cont)
LM End	0.32	Issue Type +	Ma	Location *	
Category	Supplemental			GPS Latitude/Longitude	
				Start	End
Item	DRAFT DWR UCIP LMA Responsibility			39.177070°	39.177070°
				-122.898967°	-122.898967°
DWR ID	21231

Pipe visible at concrete headwall on LS toe.

DS_ID:21231
 FS_ID:55854
 EP_NO: 11507
 Repair Type: Non-Urgent
 Crossing Status: Found
 UCIP Comments: 11/20/2019 Received update from LMA representative, S. Webb, regarding the removal of the gravel bar at the Clover Creek Diversion Structure completed in late October-2019. Photos of the clearing have been uploaded. Record remains Non-Urgent; need to clarify owner for this structure. (O. Magana - DWR UCIP)10/16/2019 Crossing remains Non-Urgent due to a non-functional structure. As noted in the DWR Levee Annual Inspection report dated June 2019, significant gravel bar is impeding the flow of the channel. The new channel u/s created from the gravel reroutes low flows past the structure. According to LMA representative, S. Webb, this structure might be over designed. Mr. Webb would like to explore potential modifications to the Clover Creek Diversion Structure [six 36-inch pipes]. The proposed modification would include adding a slide gate to the most d/s pipe (designated as pipe 6) and use that one to control summer flows in conjunction the concrete weir. The pipes designated as 3, 4, and 5 (u/s to d/s, middle pipes) would not be necessary and would require proper abandonment. Pipes designated as 1 and 2 with slide gates would remain in use and would be used to allow the clear lake hitch fish to migrate u/s of the tributary. Currently, four of the six pipes without slide gates have metal sheet covering the inlet which prevent flows (flooding) from WS to LS. The structure has been designated for internal video inspection and has been scheduled for December 2019. Recommend having the CVFPB audit ABO to clarify owner. The UCIP inspection was completed with DWR Inspector, L. Dial, and DWR Sutter Yard Supervisor, S. Webb. (O. Magana - DWR UCIP)10/27/2017 This structure is inspected annually under the Structure and Channel Summer Inspection (part of the Levee Inspection Program) conducted by the DWR Flood Project Integrity and Inspection Branch (FPIIB). (DWR UCIP - O. Magana) 01/09/2014 Some sediment buildup on LS toe. (W. Wylie - DWR UCIP) FIELD_STRUCT_DESC: [Clover Creek Diversion Structure] 5 of 6: 36-inch corrugated metal drainage pipe through the levee, 12 feet below the crown. Concrete headwall on both ends. Steel slide gate blocks inlet on the waterside (WS) toe. (six 36-inch pipes and structure [HLM 0.3] retained under Automatic Board Order (ABO) issued as Permit No. 11507, 1975 - Lake County Flood Control and Water Conservation District). [Additional Reference(s): DWR Levee Log, 2005. USACE Sacramento O&M Manual 506, Part 2, August 1961, (HLM 0.31)]. FS Date: 10/16/2019 4:06:00 PM

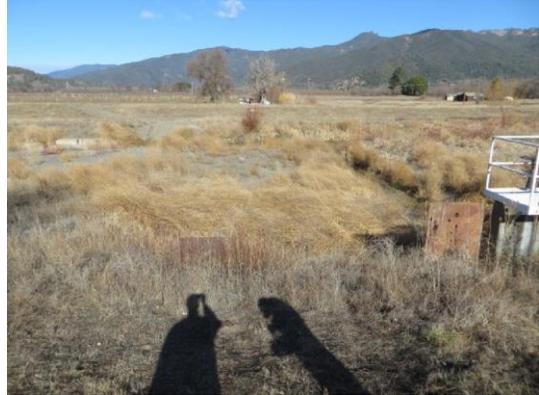
Photo 1 of 3 : UCIP_FA_2019_55341_49610.jpg

Comment Code					
Inspector Comment					
DS_ID:21229 FS_ID:55341 EP_NO: 11507 Repair Type: Non-Urgent Crossing Status: Found UCIP Comments: 10/16/2019 (O. Magana - DWR UCIP)10/27/2017 This structure is inspected annually under the Structure and Channel Summer Inspection (part of the Levee Inspection Program) conducted by the DWR Flood Project Integrity and Inspection Branch (FPIIB). (DWR UCIP - O. Magana) 01/09/2014 Some sediment buildup at outlet on LS toe. (W. Wylie - DWR UCIP) FIELD_STRUCT_DESC: [Clover Creek Diversion Structure] 6 of 6: 36-inch corrugated metal drainage pipe through the levee, 12 feet below the crown. Concrete headwall on both ends. Steel slide gate covers waterside (WS) inlet. (six 36-inch pipes and structure [HLM 0.3] retained under Automatic Board Order (ABO) issued as Permit No. 11507, 1975 - Lake County Flood Control and Water Conservation District). [Additional Reference(s): DWR Levee Log, 2005. USACE Sacramento O&M Manual 506, Part 2, August 1961, (HLM 0.31)]. FS Date: 10/16/2019 4:06:57 PM

Steel slide gate visible at headwall on WS toe.

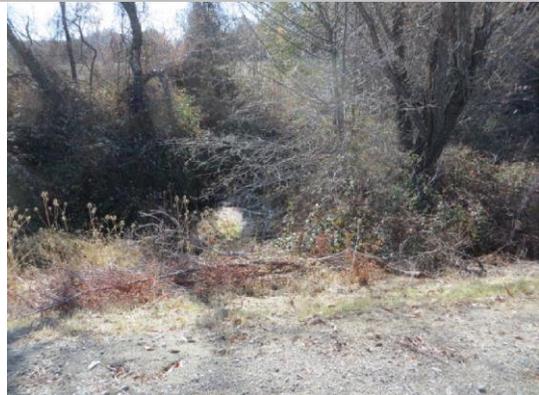
Photo 2 of 3 : UCIP_FA_2019_55341_49609.jpg

LM Start	0.32	Rating **	M	Issue No.	32 (cont)
LM End	0.32	Issue Type +	Ma	Location *

Concrete headwall on LS toe.

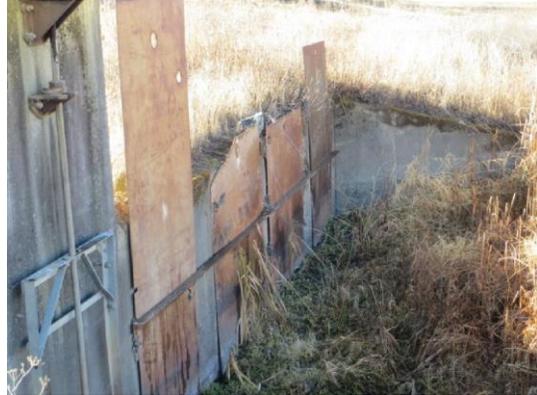
Photo 3 of 3 : UCIP_FA_2019_55341_49608.jpg

Comment Code					
Inspector Comment					
DS_ID:21229 FS_ID:55341 EP_NO: 11507 Repair Type: Non-Urgent Crossing Status: Found UCIP Comments: 10/16/2019 (O. Magana - DWR UCIP)10/27/2017 This structure is inspected annually under the Structure and Channel Summer Inspection (part of the Levee Inspection Program) conducted by the DWR Flood Project Integrity and Inspection Branch (FPIIB). (DWR UCIP - O. Magana) 01/09/2014 Some sediment buildup at outlet on LS toe. (W. Wylie - DWR UCIP) FIELD_STRUCT_DESC: [Clover Creek Diversion Structure] 6 of 6: 36-inch corrugated metal drainage pipe through the levee, 12 feet below the crown. Concrete headwall on both ends. Steel slide gate covers waterside (WS) inlet. (six 36-inch pipes and structure [HLM 0.3] retained under Automatic Board Order (ABO) issued as Permit No. 11507, 1975 - Lake County Flood Control and Water Conservation District). [Additional Reference(s): DWR Levee Log, 2005. USACE Sacramento O&M Manual 506, Part 2, August 1961, (HLM 0.31)]. FS Date: 10/16/2019 4:06:57 PM

Steel slide gate visible at headwall on WS toe.

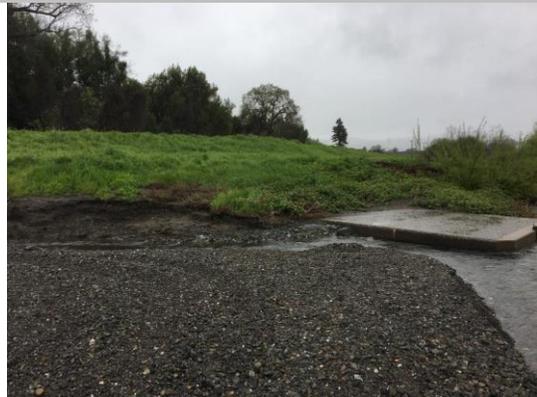
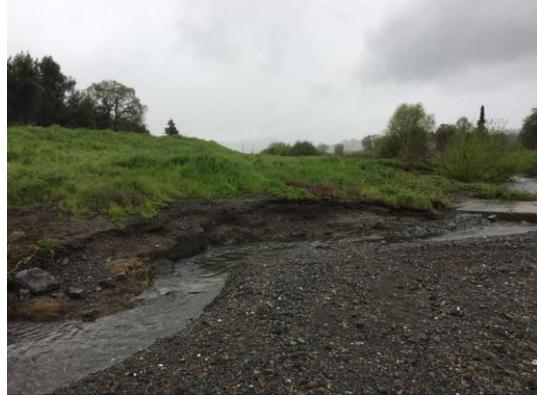
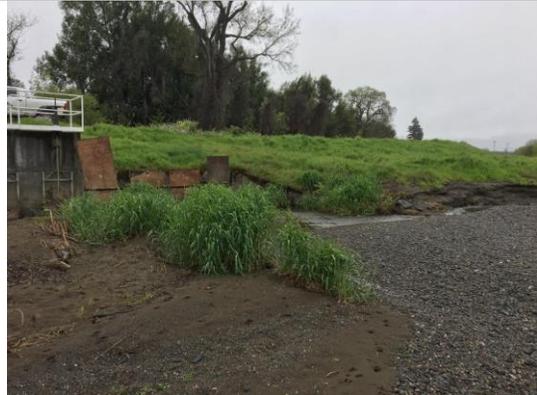
LM Start	0.32	Rating **	A/W	Issue No.	13
LM End	0.32	Issue Type +	Ma	Location *	LS
Category	Supplemental		GPS Latitude/Longitude		
			Start	End	
Item	2017 Storm Damage		39.177150°	39.177150°	
			-122.899111°	-122.899111°	
DWR ID	LCWPD-01				
Comment Code					
Inspector Comment					
Levee Evaluation Comments Description: Site ID No:19 Site Designation:LCWPD-01 Repair Type: Erosion Rating: Area of Concern Field Date:6/5/2017 Notes: Erosion exists between a small weir and diversion pipes. Spring 2019 DWR Inspection: Headwall and pipes appear to be intact.

LM Start	0.32	Rating **	A/W	Issue No.	13 (cont)
LM End	0.32	Issue Type +	Ma	Location *	LS
Category	Supplemental			GPS Latitude/Longitude	
				Start	End
Item	2017 Storm Damage			39.177150°	39.177150°
				-122.899111°	-122.899111°
DWR ID	LCWPD-01				
Comment Code					
Inspector Comment					
Levee Evaluation Comments					
Description:					
Site ID No:19					
Site Designation:LCWPD-01					
Repair Type: Erosion					
Rating: Area of Concern					
Field Date:6/5/2017					
Notes: Erosion exists between a small weir and diversion pipes. Spring 2019 DWR Inspection: Headwall and pipes appear to be intact.

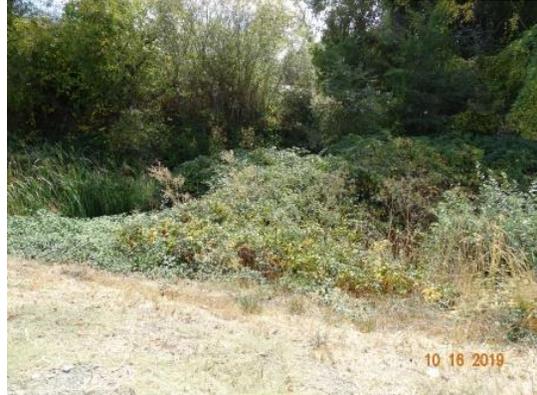
Photo 1 of 1 : FA_2019_NA0009_7_16_20191021_00031.jpg

LM Start	0.32	Rating **	M	Issue No.	16
LM End	0.32	Issue Type +	Ma	Location *	LS
Category	Earthen Levee		GPS Latitude/Longitude		
			Start	End	
Item	Vegetation		39.177010°	39.177010°	
			-122.899110°	-122.899110°	
DWR ID	DWR_NA0009_05_f_2019_16				
Comment Code					
V2 : Remove the wild growth other than native grasses from the levee slopes.					
Inspector Comment					
Remove wild growth near the outlet at the levee toe.

View of wild growth at the landside toe near the diversion outlet. Fall 2019
