**Flood Control Project Maintenance
Levee Inspections**

Maintenance Issue Types Only, Levee Inspection Report By Mile - Spring 2020

Lake County Watershed Protection District

Waterway	Bank	Unit Miles	Inspection Start/End	Inspector
Unit No. 01 Middle Creek	Left	3.35	04/01/2020 04/02/2020	Luz Dial

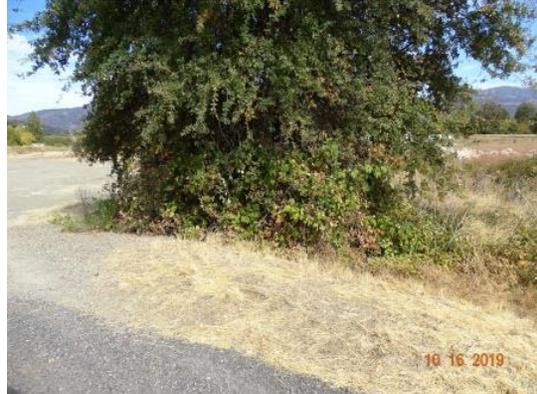
Photo 1 of 1 : SP_2020_NA0009_3_46_20200302_00018.jpg

LM Start	2.36	Rating **	M	Issue No.	46
LM End	2.40	Issue Type +	Ma	Location *	LS
Category	Earthen Levee			GPS Latitude/Longitude	
				Start	End
Item	Vegetation			39.161160 °	39.161655 °
				-122.912752 °	-122.912262 °
DWR ID	DWR_NA0009_01_s_2019_46				
Comment Code					
V2 : Remove the wild growth other than native grasses from the levee slopes.					
Inspector Comment

View of wild growth on the landside slope. Fall 2019

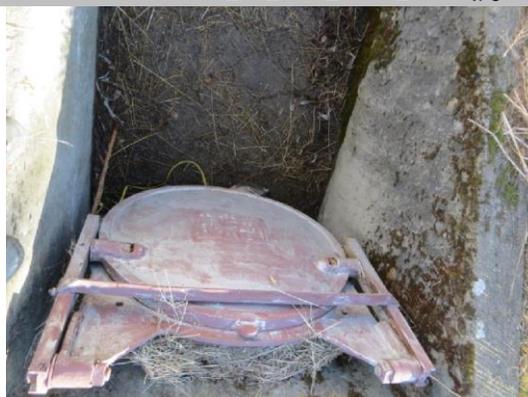
Photo 3 of 3 : UCIP_SP_2020_55730_50409.jpg

Comment Code					
Inspector Comment					
DS_ID:21210 FS_ID:55730 EP_NO: 11482 Repair Type: Non-Urgent Crossing Status: Found UCIP Comments: 10/23/2019 Record remains Non-Urgent; need to audit record to confirm owner. Property owner will also need to address access issue due to fence installed on the LS slope. Crossing has been internally inspected under the DWR DMP Phase 1 project. Inspection report is still not available. The UCIP inspection was completed with DWR Inspector, L. Dial, and LMA representative, S. Webb. (O. Magana - DWR UCIP)01/14/2014 Fence on LS slope creates access issue. (W. Wylie - DWR UCIP) FIELD_STRUCT_DESC: 36-inch corrugated metal drainage pipe through the levee, 9 feet below the crown. Flap gate on the waterside (WS) end. Concrete headwalls on both ends. (36-inch pipe [HLM 0.54] retained under ABO No. 11482, 1975 - George R. and Gladys Schneider). [Additional Reference(s): DWR Levee Log, 2005. USACE Sacramento O&M Manual 506.2, August 1961, (HLM 0.54), Station M294+00, 36-inch pipe, dwg no. CC-4-4-29, Index Sheet 6: page 6, 40 of 64]. FS Date: 10/23/2019 1:50:00 PM

LM Start	0.55	Rating **	M	Issue No.	64 (cont)
LM End	0.55	Issue Type +	Ma	Location *	
Category	Supplemental			GPS Latitude/Longitude	
				Start	End
Item	DWR UCIP LMA Responsibility			39.183130 °	39.183130 °
				-122.912198 °	-122.912198 °
DWR ID	21210

Flapgate and concrete headwall on WS berm.

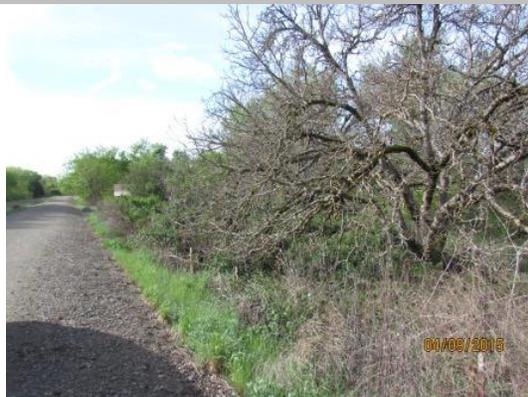
Photo 1 of 1 : SP_2020_NA0009_4_7_20200302_00003.jpg

LM Start	0.97	Rating **	M	Issue No.	7
LM End	0.98	Issue Type +	Ma	Location *	LS
Category	Earthen Levee			GPS Latitude/Longitude	
				Start	End
Item	Vegetation			39.177218 °	39.176992 °
				-122.913673 °	-122.913642 °
DWR ID	DWR_NA0009_02_s_2012_7

View of the vegetation at the landside toe.

Comment Code					
V2 : Remove the wild growth other than native grasses from the levee slopes.					
Inspector Comment

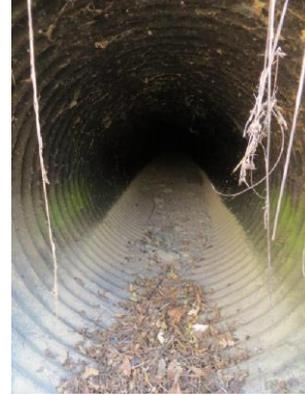
Photo 2 of 3 : UCIP_SP_2020_55740_51201.jpg

Comment Code					
Inspector Comment					
DS_ID:21211 FS_ID:55740 EP_NO: 11486 Repair Type: Non-Urgent Crossing Status: Found UCIP Comments: 10/23/2019 Record has been updated from No Action Needed to Non-Urgent; need to audit record to confirm owner. Crossing has been internally inspected under the DWR DMP Phase 1 project. Inspection report is still not available. The UCIP inspection was completed with DWR Inspector, L. Dial, and LMA representative, S. Webb. (O. Magana - DWR UCIP) FIELD_STRUCT_DESC: 36-inch corrugated metal drainage pipe through the levee, 7.3 feet below the crown. Flap gate on the waterside (WS) end. Concrete headwalls on both ends. Splash apron broken off on the WS end. (36-inch pipe [HLM 1.08] retained under Automatic Board Order (ABO) issued as Permit No. 11486, 1975 - Mary Truesdell). [Additional Reference(s): DWR Levee Log, 2005. USACE Sacramento O&M Manual 506.2, August 1961, (HLM 1.08), Station M269+00, 36-inch pipe, dwg no. CC-4-4-29, Index Sheet 5: page 5, 39 of 64]. FS Date: 10/23/2019 1:16:00 PM

LM Start	1.03	Rating **	M	Issue No.	65 (cont)
LM End	1.03	Issue Type +	Ma	Location *	
Category	Supplemental			GPS Latitude/Longitude	
				Start	End
Item	DWR UCIP LMA Responsibility			39.176366 °	39.176366 °
				-122.913509 °	-122.913509 °
DWR ID	21211

Pipe as visible from LS toe.

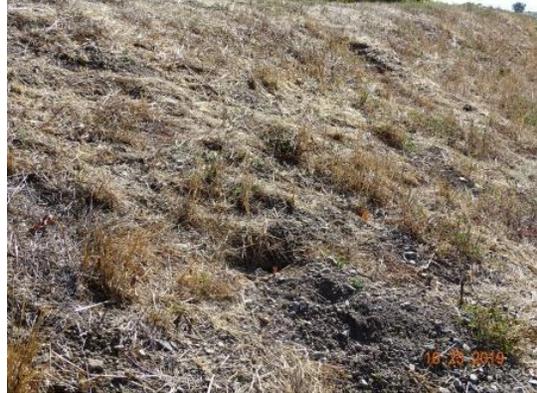
Photo 2 of 2 : SP_2020_NA0009_4_30_20200302_00010.jpg

LM Start	2.01	Rating **	M	Issue No.	30 (cont)
LM End	2.01	Issue Type +	Ma	Location *	LS
Category	Earthen Levee			GPS Latitude/Longitude	
				Start	End
Item	Animal Control			39.162658 °	39.162658 °
				-122.916875 °	-122.916875 °
DWR ID	DWR_NA0009_02_f_2019_30

View looking downstream at animal holes on the landside slope with recent activity. Fall 2019

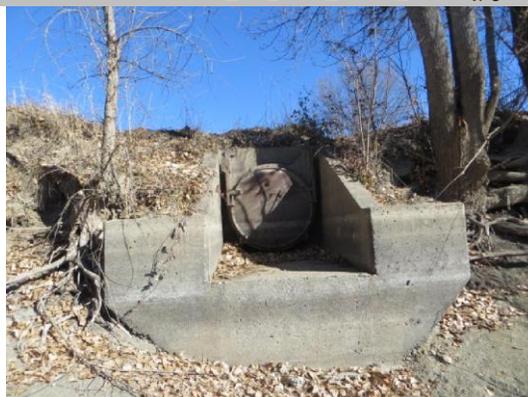
Photo 3 of 3 : UCIP_SP_2020_55769_51540.jpg

LM Start	0.54	Rating **	M	Issue No.	32 (cont)
LM End	0.54	Issue Type +	Ma	Location *	
Category	Supplemental			GPS Latitude/Longitude	
				Start	End
Item	DWR UCIP LMA Responsibility			39.154786 °	39.154786 °
				-122.918703 °	-122.918703 °
DWR ID	21217

Concrete headwall and flapgat visible at WS berm.

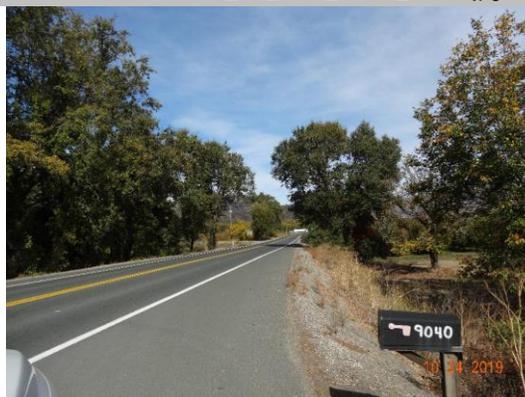
Photo 3 of 3 : UCIP_SP_2020_55781_82825.jpg

LM Start	0.90	Rating **	M	Issue No.	38 (cont)
LM End	0.90	Issue Type +	Ma	Location *	
Category	Supplemental			GPS Latitude/Longitude	
				Start	End
Item	DWR UCIP LMA Responsibility			39.159278 °	39.159278 °
				-122.920783 °	-122.920783 °
DWR ID	21247

Overview of levee/State Route 29 looking u/s towards pipe crossing.

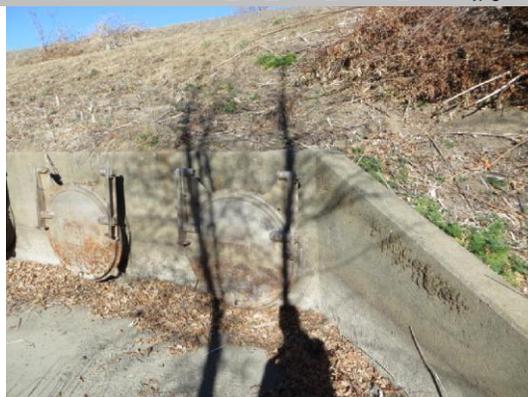
Photo 3 of 3 : UCIP_SP_2020_55786_51660.jpg

LM Start	1.23	Rating **	M	Issue No.	43 (cont)
LM End	1.23	Issue Type +	Ma	Location *	
Category	Supplemental			GPS Latitude/Longitude	
				Start	End
Item	DWR UCIP LMA Responsibility			39.160359 °	39.160359 °
				-122.926188 °	-122.926188 °
DWR ID	21224

Flapgate on headwall at WS toe.

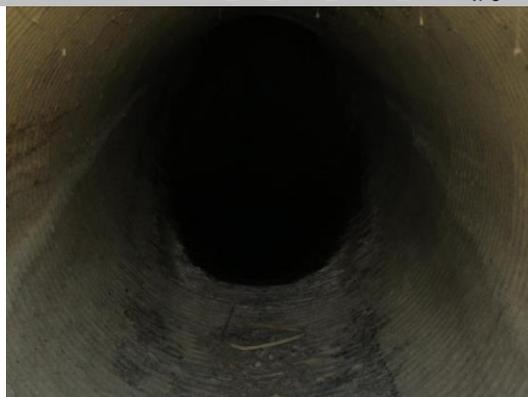
Photo 2 of 3 : UCIP_SP_2020_55789_51670.jpg

LM Start	1.24	Rating **	M	Issue No.	46 (cont)
LM End	1.24	Issue Type +	Ma	Location *	
Category	Supplemental			GPS Latitude/Longitude	
				Start	End
Item	DWR UCIP LMA Responsibility			39.160386 °	39.160386 °
				-122.926239 °	-122.926239 °
DWR ID	21239

Pipe from LS toe.

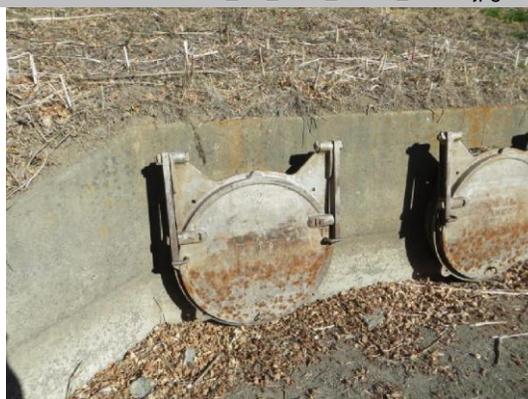
Photo 3 of 3 : UCIP_SP_2020_55789_51669.jpg

Flapgate on concrete headwall on WS toe.

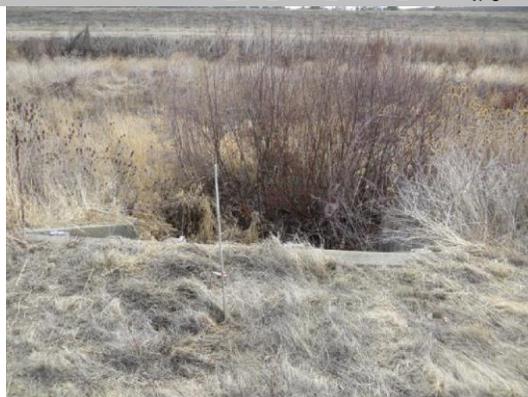
Photo 3 of 3 : UCIP_SP_2020_55813_49795.jpg

LM Start	0.14	Rating **	M	Issue No.	28 (cont)
LM End	0.14	Issue Type +	Ma	Location *	
Category	Supplemental			GPS Latitude/Longitude	
				Start	End
Item	DWR UCIP LMA Responsibility			39.176419 °	39.176419 °
				-122.909954 °	-122.909954 °
DWR ID	21225

Concrete headwall visible on toe of WS berm.

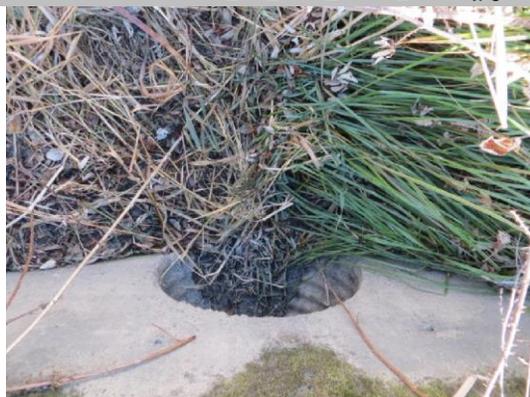
Photo 2 of 3 : UCIP_SP_2020_55811_49753.jpg

LM Start	0.75	Rating **	U	Issue No.	30 (cont)
LM End	0.75	Issue Type +	Ma	Location *	
Category	Supplemental			GPS Latitude/Longitude	
				Start	End
Item	DWR UCIP LMA Responsibility			39.177676 °	39.177676 °
				-122.898917 °	-122.898917 °
DWR ID	21227

Pipe and concrete headwall visible in drainage channel on LS toe.

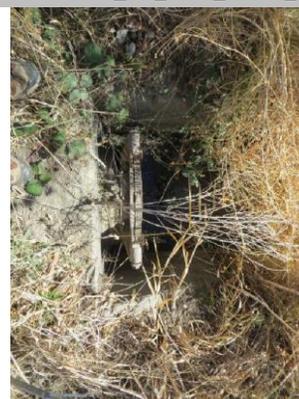
Photo 3 of 3 : UCIP_SP_2020_55811_49752.jpg

Flapgate at concrete headwall on WS toe.

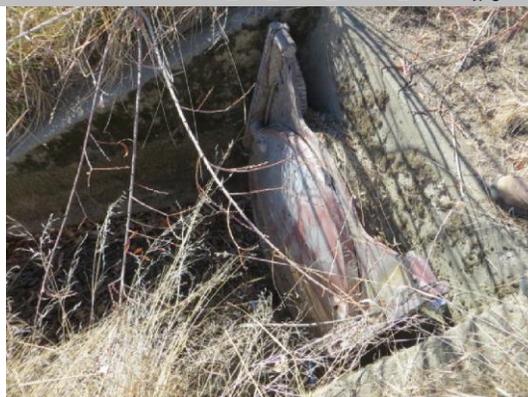
Photo 3 of 3 : UCIP_SP_2020_55816_49760.jpg

LM Start	1.19	Rating **	U	Issue No.	31 (cont)
LM End	1.19	Issue Type +	Ma	Location *	
Category	Supplemental			GPS Latitude/Longitude	
				Start	End
Item	DWR UCIP LMA Responsibility			39.182079 °	39.182079 °
				-122.895038 °	-122.895038 °
DWR ID	21228

Concrete headwall visible off WS berm.

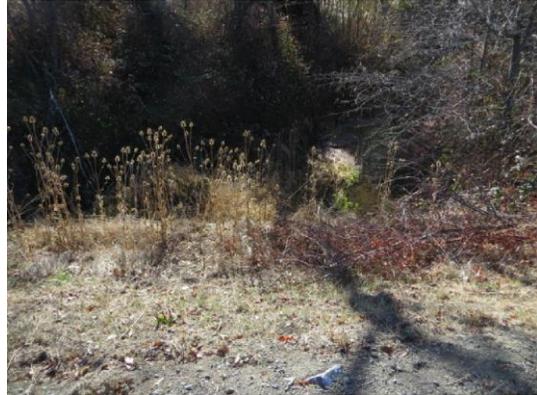
Photo 2 of 3 : UCIP_SP_2020_55854_49621.jpg

LM Start	0.32	Rating **	M	Issue No.	28 (cont)
LM End	0.32	Issue Type +	Ma	Location *	
Category	Supplemental			GPS Latitude/Longitude	
				Start	End
Item	DWR UCIP LMA Responsibility			39.177070 °	39.177070 °
				-122.898967 °	-122.898967 °
DWR ID	21231

Pipe visible at concrete headwall on LS toe.
