**Flood Control Project Maintenance  
Levee Inspections**

**2020 Channel Summary Report**

**Merced Streams Group**

**Levee Inspection Report By Mile - Channel 2020**

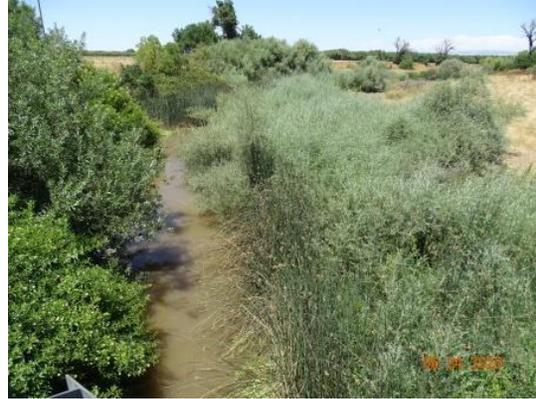
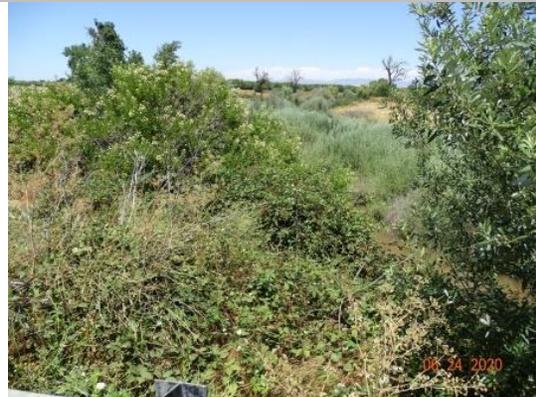
Photo 1 of 2 : CH\_2020\_NA0013\_32\_1\_20200703\_00087.jpg

Check Point / View				
<b>Bonner Rd / Up</b>				
Rating **	U	Issue No.	1	GPS Lat/Long
Issue Type +	Ma	Location *		37.336900 °
Category	Rivers, Channels & Designated Flood			-120.311100 °
Item	Vegetation & Obstructions			
DWR ID	DWR_NA0013_32_c_2016_1			
Action/Comments				
Inspector Comments: Vegetation in channel upstream of bridge crossing needs to be trimmed, as flow may be impeded.

View of vegetation upstream of Bonner Road crossing. Summer 2020

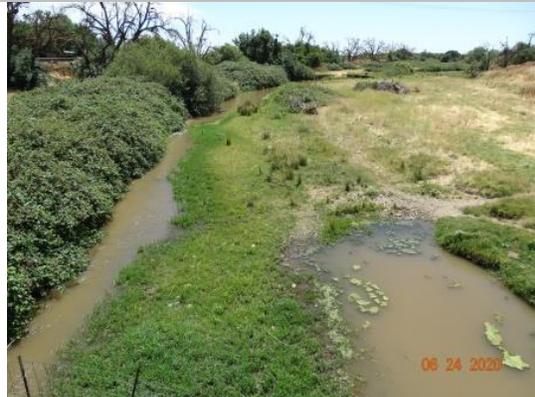
Photo 1 of 1 : CH\_2020\_NA0013\_32\_6\_20200703\_00089.jpg

Check Point / View				
<b>Bonner Rd / Down</b>				
Rating **	A	Issue No.	<b>6</b>	GPS Lat/Long
Issue Type +	Ma	Location *		37.336900 °
Category	Rivers, Channels & Designated Flood			-120.311100 °
Item	Vegetation & Obstructions			
DWR ID	DWR_NA0013_32_c_2016_6			
Action/Comments				
Inspector Comments: There is vegetation present downstream of bridge crossing, left bank; remove wild growth of berries.

View of vegetation downstream of Bonner Road crossing. Summer 2020

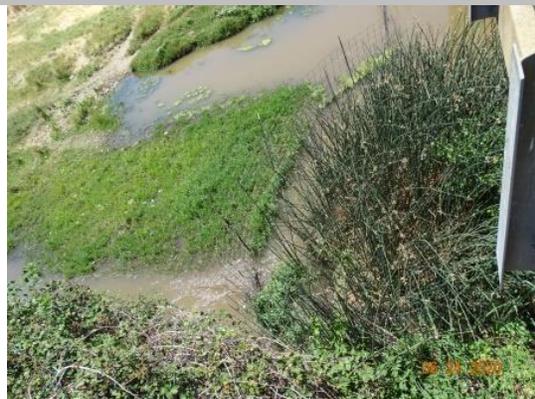
Photo 1 of 2 : CH\_2020\_NA0013\_32\_10\_20200703\_00090.jpg

Rating **	M	Issue No. <b>10</b>	GPS Lat/Long
Issue Type +	En	Location *	37.336900 °
Category	Rivers, Channels & Designated Flood		-120.311100 °
Item	Encroachments		
DWR ID	DWR_NA0013_32_c_2016_10		
Action/Comments			
Inspector Comments: The wire fence across the channel does not appear to have a permit and needs to be removed.

View of wire fence across the channel. Summer 2020

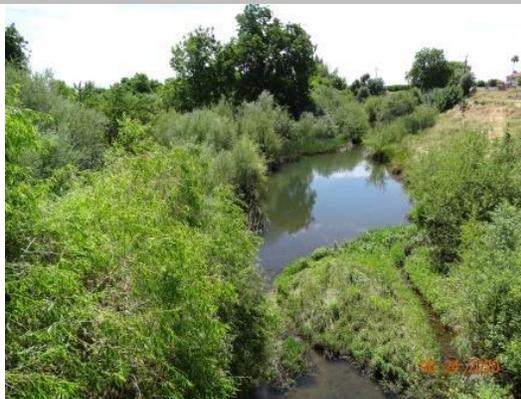
Photo 1 of 1 : CH\_2020\_NA0013\_32\_21\_20200703\_00083.jpg

Inspector Comments: There is growth in the channel and vegetation on both banks upstream of the crossing, which should be cleared at least 100 ft. upstream from the bridge.

View of vegetation upstream of Arboleda Road. Summer 2020

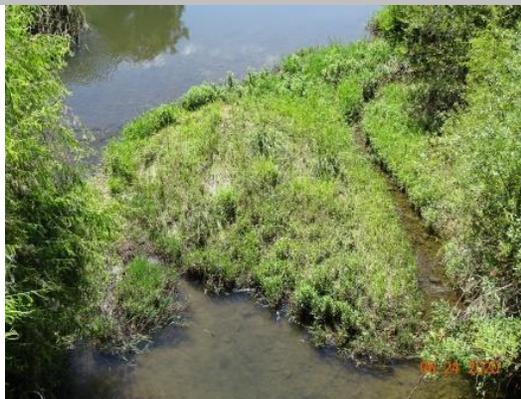
Photo 1 of 1 : CH\_2020\_NA0013\_32\_22\_20200703\_00084.jpg

Inspector Comments: There is shoaling with vegetation present in the channel.

View of shoaling with vegetation upstream of Arboleda Road. Summer 2020

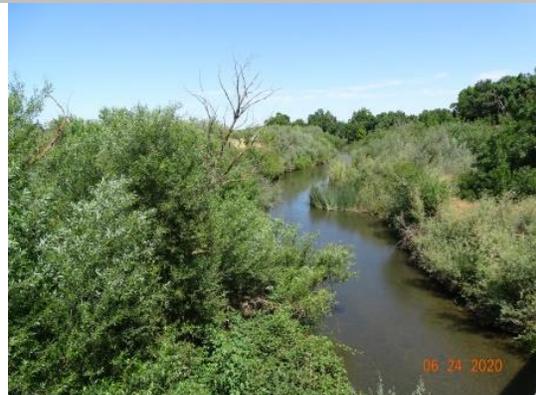
Photo 1 of 1 : CH\_2020\_NA0013\_32\_26\_20200703\_00085.jpg

Check Point / View			
<b>Arboleda Dr / Down</b>			
Rating **	M	Issue No. <b>26</b>	GPS Lat/Long
Issue Type +	Ma	Location *	37.310805 °
Category	Rivers, Channels & Designated Flood		-120.378733 °
Item	Vegetation & Obstructions		
DWR ID	DWR_NA0013_32_c_2016_26		
Action/Comments			
Inspector Comments: There is vegetation present on both banks, which should be cleared at least 100 ft. downstream from the bridge.

View of vegetation downstream of Arboleda Road. Summer 2020

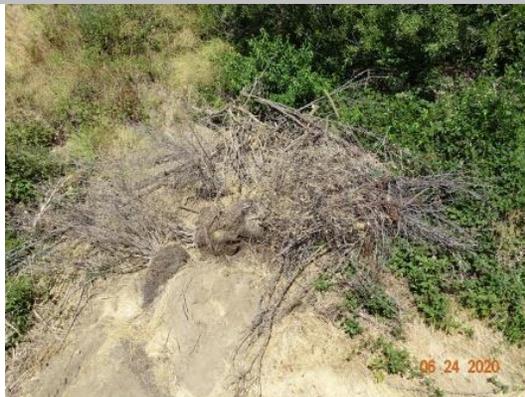
Photo 1 of 1 : CH\_2020\_NA0013\_32\_30\_20200703\_00086.jpg

Check Point / View				
<b>Arboleda Dr / Down (cont)</b>				
Rating **	M	Issue No.	<b>30</b>	GPS Lat/Long
Issue Type +	Ma	Location *		37.310805 °
Category	Rivers, Channels & Designated Flood			-120.378733 °
Item	Encroachments			
DWR ID	DWR_NA0013_32_c_2016_30			
Action/Comments				
Inspector Comments: Remove tree debris from the left bank downstream of the bridge.

View of tree debris on the left bank. Summer 2020

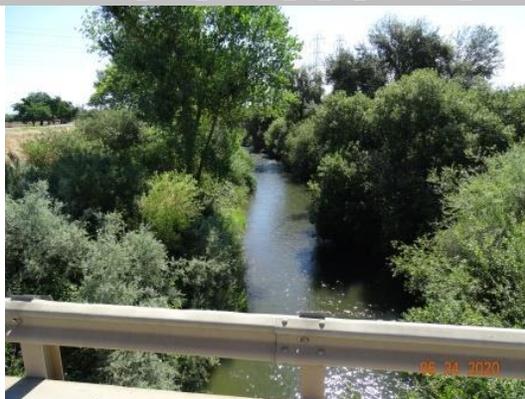
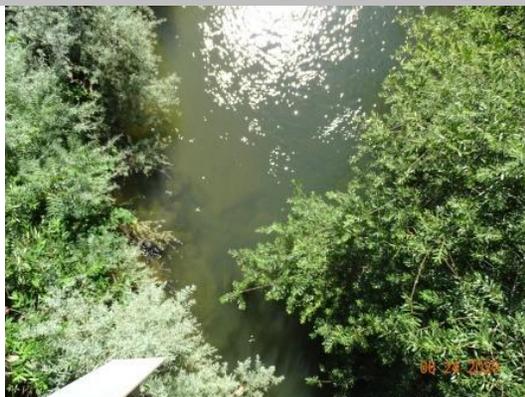
Photo 1 of 2 : CH\_2020\_NA0013\_32\_31\_20200703\_00077.jpg

View of vegetation upstream of Kibby Road. Summer 2020

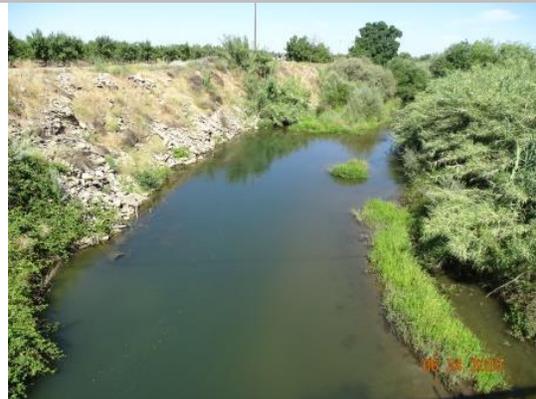
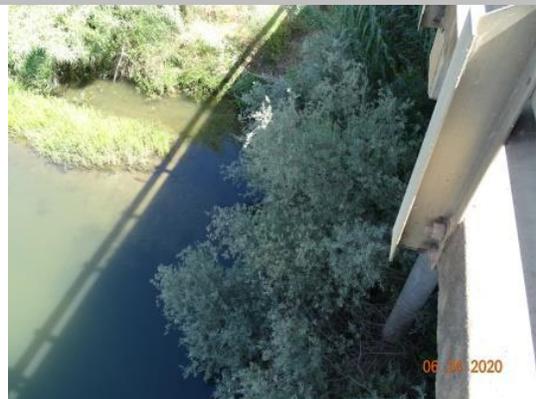
Photo 1 of 2 : CH\_2020\_NA0013\_32\_36\_20200703\_00079.jpg

Check Point / View				
<b>Kibby Rd / Down</b>				
Rating **	A	Issue No.	<b>36</b>	GPS Lat/Long
Issue Type +	Ma	Location *		37.312195 °
Category	Rivers, Channels & Designated Flood			-120.414967 °
Item	Vegetation & Obstructions			
DWR ID	DWR_NA0013_32_c_2016_36			
Action/Comments				
Inspector Comments: Remove Arundo growth underneath the bridge.

View of vegetation downstream of Kibby Road. Summer 2020

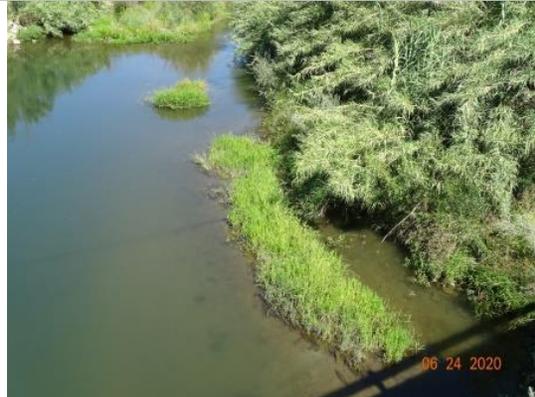
Photo 1 of 1 : CH\_2020\_NA0013\_32\_37\_20200703\_00081.jpg

Rating **	M	Issue No.	<b>37</b>	GPS Lat/Long
Issue Type +	Ma	Location *		37.312195 °
Category	Rivers, Channels & Designated Flood			-120.414967 °
Item	Shoaling / Sedimentation			
DWR ID	DWR_NA0013_32_c_2016_37			
Action/Comments				
Inspector Comments: There is shoaling downstream from the bridge crossing with grasses and brush growing on it.

View of shoaling with vegetation downstream of Kibby Road. Summer 2020

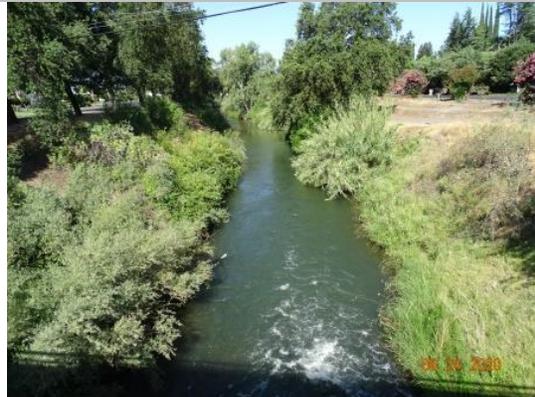
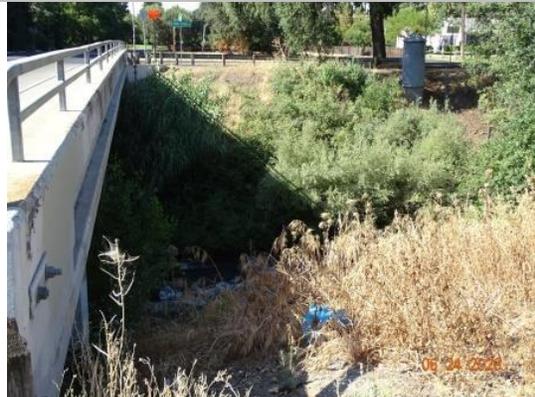
Photo 1 of 2 : CH\_2020\_NA0013\_32\_46\_20200701\_00076.jpg

Check Point / View				
<b>McKee Rd / Down</b>				
Rating **	M	Issue No.	<b>46</b>	GPS Lat/Long
Issue Type +	Ma	Location *		37.309600 °
Category	Rivers, Channels & Designated Flood			-120.444500 °
Item	Vegetation & Obstructions			
DWR ID	DWR_NA0013_32_c_2016_46			
Action/Comments				
Inspector Comments: Remove woody vegetation underneath the bridge of McKee Road.

View of vegetation on Bear Creek downstream of McKee Road. Summer 2020

View of vegetation on Bear Creek underneath McKee Road. Summer 2020

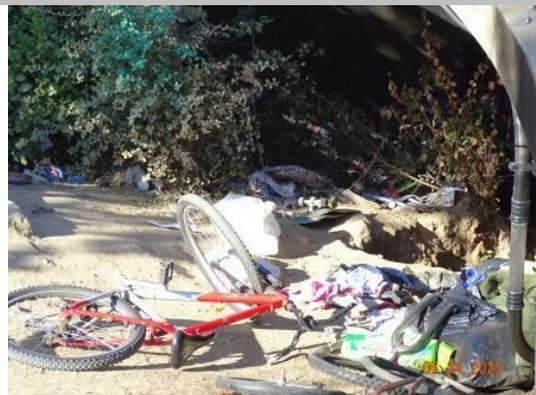
Photo 1 of 1 : CH\_2020\_NA0013\_32\_53\_20200701\_00071.jpg

Rating **	U	Issue No.	53	GPS Lat/Long
Issue Type +	Ma	Location *		37.313400 °
Category	Rivers, Channels & Designated Flood			-120.487500 °
Item	Erosion / Bank Caving			
DWR ID	DWR_NA0013_32_c_2016_53			
Action/Comments				
Inspector Comments: Campers dug into the right bank beneath the bridge crossing.

View of excavation on the right bank by campers underneath the bridge. Summer 2020

Check Point / View				
<b>R St / Down (cont)</b>				
Rating **	M	Issue No.	<b>60</b>	GPS Lat/Long
Issue Type +	Ma	Location *		37.313400 °
Category	Rivers, Channels & Designated Flood			-120.487500 °
Item	Encroachments			
DWR ID	DWR_NA0013_32_c_2016_60			
Action/Comments				
Inspector Comments: Remove camper debris on the right bank underneath the bridge, and repair excavation.

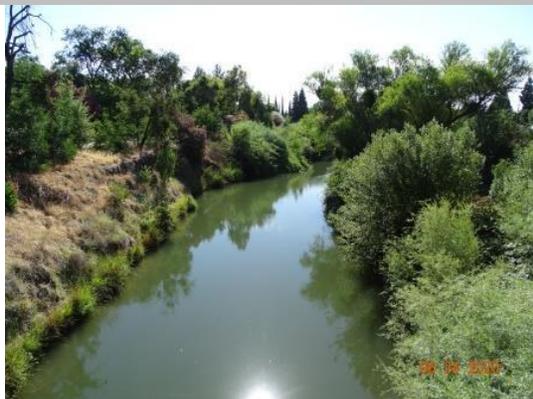
Photo 1 of 1 : CH\_2020\_NA0013\_32\_56\_20200701\_00072.jpg

Check Point / View			
<b>R St / Down</b>			
Rating **	A	Issue No.	56
Issue Type +	Ma	Location *	37.313400 °
Category	Rivers, Channels & Designated Flood		-120.487500 °
Item	Vegetation & Obstructions		
DWR ID	DWR_NA0013_32_c_2016_56		
Action/Comments			
Inspector Comments: The arundo on the right bank needs to be removed.

View of vegetation downstream of the R Street crossing. Summer 2020

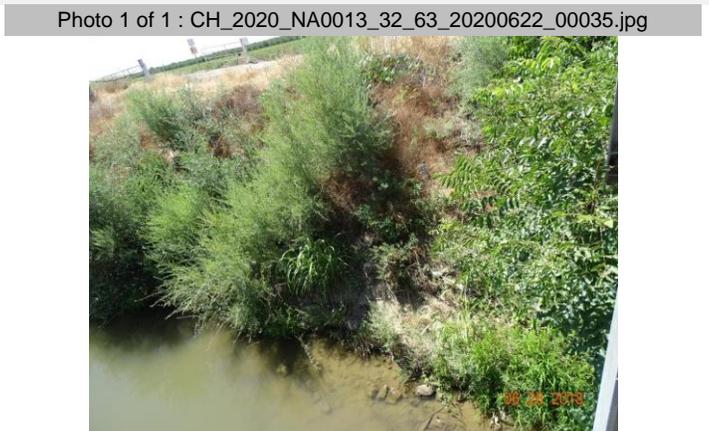
View of minor erosion upstream of Franklin Rd crossing, but it does not appear to endanger the channel capacity. Summer 2018

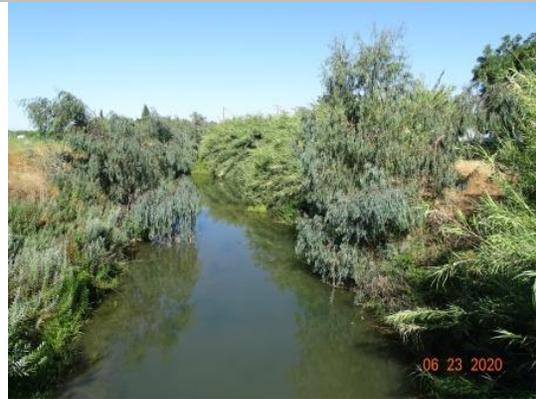
Photo 1 of 1 : CH\_2020\_NA0013\_32\_66\_20200701\_00056.jpg

Check Point / View			
<b>Franklin Rd / Down</b>			
Rating **	A	Issue No. <b>66</b>	GPS Lat/Long
Issue Type +	Ma	Location *	37.311486 °
Category	Rivers, Channels & Designated Flood		-120.541088 °
Item	Vegetation & Obstructions		
DWR ID	DWR_NA0013_32_c_2016_66		
Action/Comments			
Inspector Comments: Remove Arundo on right bank.

View of vegetation downstream. Summer 2020

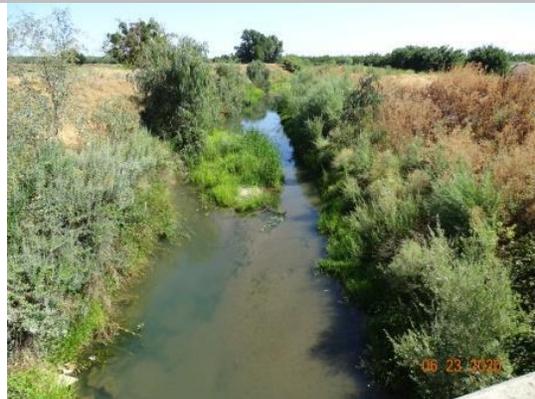
Photo 1 of 1 : CH\_2020\_NA0013\_32\_71\_20200701\_00057.jpg

Check Point / View			
<b>Hwy 140 / Up</b>			
Rating **	A	Issue No.	71
Issue Type +	Ma	Location *	GPS Lat/Long
Category	Rivers, Channels & Designated Flood		37.302576 °
Item	Vegetation & Obstructions		-120.551477 °
DWR ID	DWR_NA0013_32_c_2016_71		
Action/Comments			
Inspector Comments: Vegetation is present in the channel.

View looking upstream from Hwy 140 bridge crossing. Summer 2020

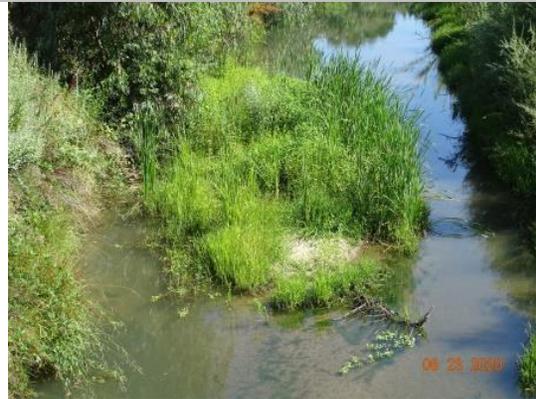
Photo 1 of 1 : CH\_2020\_NA0013\_32\_72\_20200701\_00058.jpg

Check Point / View			
<b>Hwy 140 / Up (cont)</b>			
Rating **	M	Issue No. <b>72</b>	GPS Lat/Long
Issue Type +	Ma	Location *	37.302576 °
Category	Rivers, Channels & Designated Flood		-120.551477 °
Item	Shoaling / Sedimentation		
DWR ID	DWR_NA0013_32_c_2016_72		
Action/Comments			
Inspector Comments: Shoaling is present in channel at this location with vegetation growth established.

View of shoaling in the channel upstream. Summer 2020

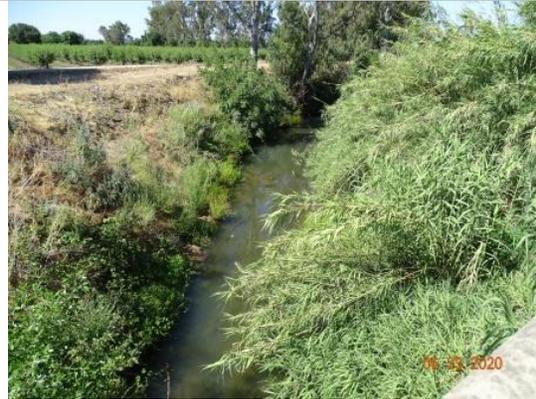
Photo 1 of 1 : CH\_2020\_NA0013\_32\_76\_20200701\_00059.jpg

Check Point / View			
<b>Hwy 140 / Down</b>			
Rating **	M	Issue No.	<b>76</b>
Issue Type +	Ma	Location *	37.302576 °
Category	Rivers, Channels & Designated Flood		-120.551477 °
Item	Vegetation & Obstructions		
DWR ID	DWR_NA0013_32_c_2018_76		
Action/Comments			
Inspector Comments: Wild growth in the channel downstream of and underneath bridge should be controlled. Remove Arundo.

View looking downstream from the Hwy 140 bridge crossing. Summer 2020

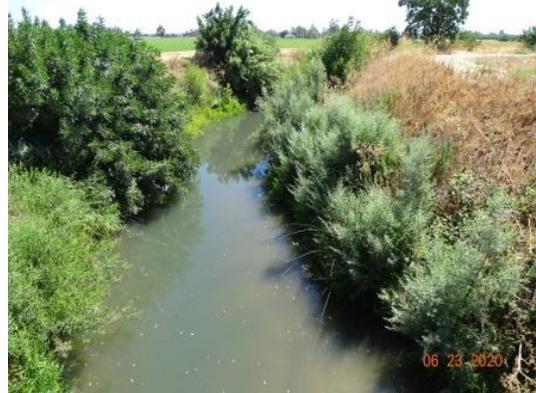
Photo 1 of 2 : CH\_2020\_NA0013\_32\_81\_20200701\_00060.jpg

Check Point / View				
<b>Buhach Rd / Up</b>				
Rating **	A	Issue No.	<b>81</b>	GPS Lat/Long
Issue Type +	Ma	Location *		37.291282 °
Category	Rivers, Channels & Designated Flood			-120.577961 °
Item	Vegetation & Obstructions			
DWR ID	DWR_NA0013_32_c_2016_81			
Action/Comments				
Inspector Comments: Remove Arundo on the left bank.

View of Bear Creek looking upstream from the Buhach Road crossing. Summer 2020

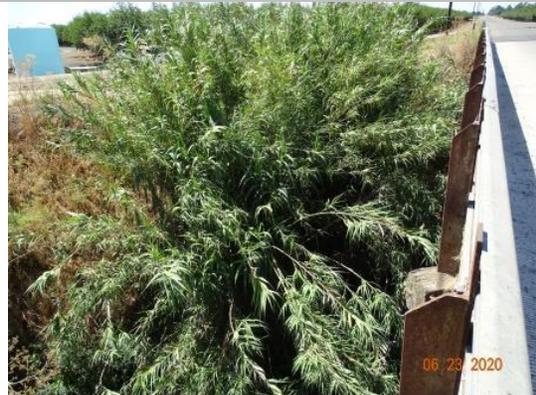
Photo 2 of 2 : CH\_2020\_NA0013\_32\_81\_20200701\_00061.jpg

View of Arundo upstream of the Buhach Road crossing. Summer 2020

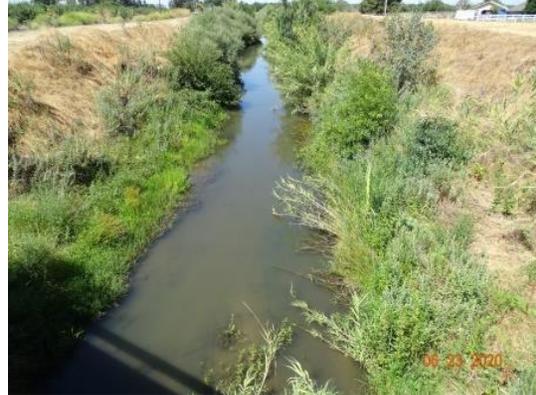
Photo 1 of 1 : CH\_2020\_NA0013\_32\_86\_20200701\_00062.jpg

Check Point / View				
<b>Buhach Rd / Down</b>				
Rating **	M	Issue No.	<b>86</b>	GPS Lat/Long
Issue Type +	Ma	Location *		37.291282 °
Category	Rivers, Channels & Designated Flood			-120.577961 °
Item	Vegetation & Obstructions			
DWR ID	DWR_NA0013_32_c_2016_86			
Action/Comments				
Inspector Comments: Remove Arundo underneath the bridge.

View of Bear Creek looking downstream from Buhach Road crossing. Summer 2020

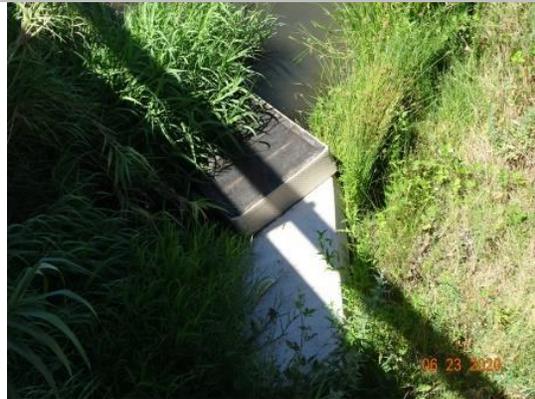
Photo 1 of 1 : CH\_2020\_NA0013\_32\_90\_20200701\_00063.jpg

Check Point / View			
Rating **	M	Issue No.	90
Issue Type +	Ma	Location *	37.291282 °
Category	Rivers, Channels & Designated Flood		-120.577961 °
Item	Encroachments		
DWR ID	DWR_NA0013_32_c_2016_90		
Action/Comments			
Inspector Comments: Remove mattress debris from the channel.

View of mattresses on the right bank. Summer 2020

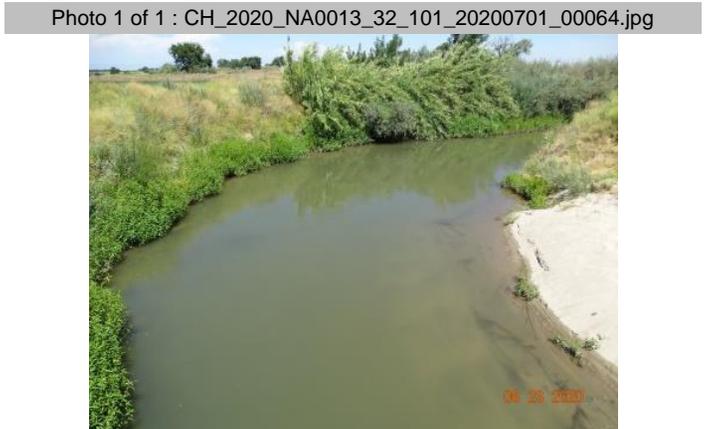
Check Point / View			
<b>Bert Crane Rd / Up</b>			
Rating **	A	Issue No.	<b>101</b>
Issue Type +	Ma	Location *	GPS Lat/Long
Category	Rivers, Channels & Designated Flood		37.256440 °
Item	Vegetation & Obstructions		-120.651870 °
DWR ID	DWR_NA0013_32_c_2016_101		
Action/Comments			
Inspector Comments: Remove Arundo on right bank.

View of Bear Creek looking upstream from Bert Crane Rd. crossing. Summer 2020

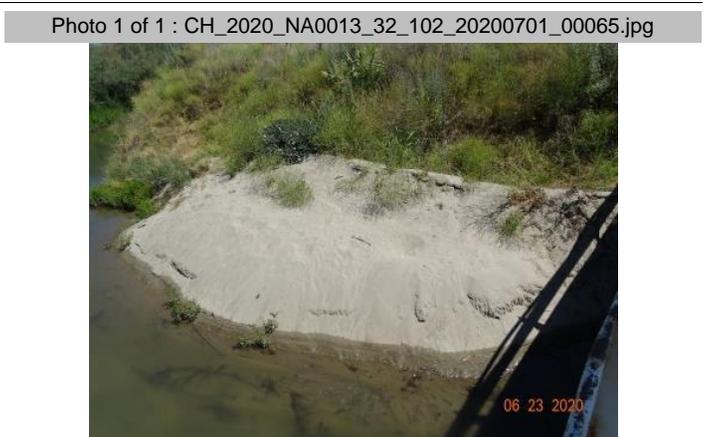
Rating **	M	Issue No.	<b>102</b>
Issue Type +	Ma	Location *	GPS Lat/Long
Category	Rivers, Channels & Designated Flood		37.256440 °
Item	Shoaling / Sedimentation		-120.651870 °
DWR ID	DWR_NA0013_32_c_2016_102		
Action/Comments			
Inspector Comments: There is sedimentation on the left bank, but channel flow does not appear to be impeded.

View of sedimentation along the left bank. Summer 2020

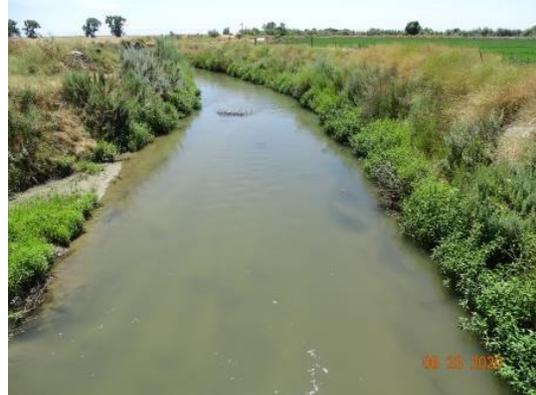
Photo 1 of 1 : CH\_2020\_NA0013\_32\_106\_20200701\_00067.jpg

View of Bear Creek downstream from Bert Crane Road crossing. Summer 2020

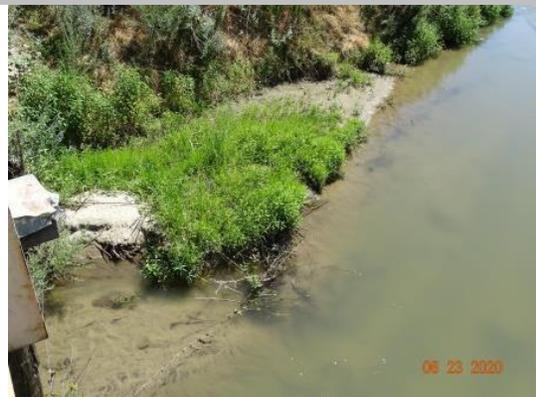
Photo 1 of 1 : CH\_2020\_NA0013\_32\_107\_20200701\_00068.jpg

Rating **	M	Issue No.	<b>107</b>	GPS Lat/Long
Issue Type +	Ma	Location *		37.256440 °
Category	Rivers, Channels & Designated Flood			-120.651870 °
Item	Shoaling / Sedimentation			
DWR ID	DWR_NA0013_32_c_2016_107			
Action/Comments				
Inspector Comments: Some sedimentation is accumulating downstream of the bridge, but channel flow does not appear to be impeded.

View of shoaling on the left bank. Summer 2020

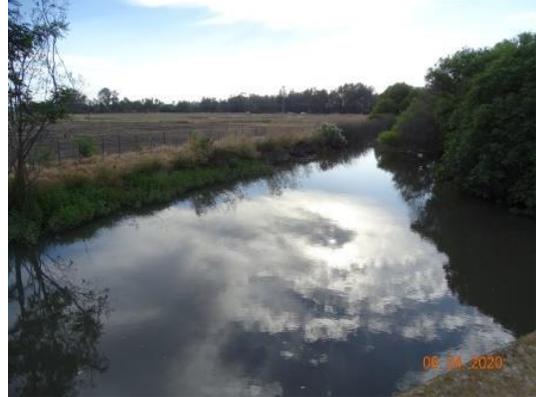
Photo 1 of 1 : CH\_2020\_NA0013\_33\_1\_20200701\_00046.jpg

View of vegetation looking upstream. Summer 2020

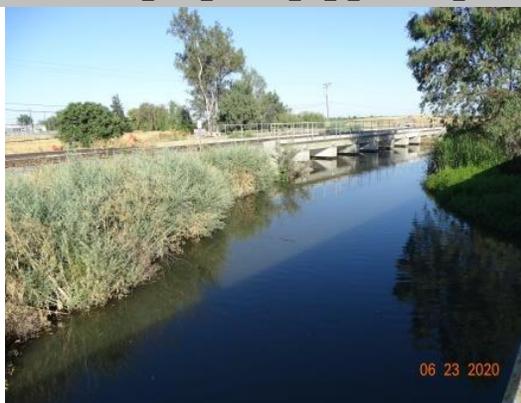
Photo 1 of 1 : CH\_2020\_NA0013\_33\_6\_20200701\_00047.jpg

Check Point / View			
<b>Santa Fe Dr / Down</b>			
Rating **	A	Issue No. <b>6</b>	GPS Lat/Long
Issue Type +	Ma	Location *	37.320720 °
Category	Rivers, Channels & Designated Flood		-120.508760 °
Item	Vegetation & Obstructions		
DWR ID	DWR_NA0013_33_c_2016_6		
Action/Comments			
Inspector Comments: There is vegetation in the channel, but it does not appear to impede the capacity of the channel at this time.

View of vegetation looking downstream. Summer 2020

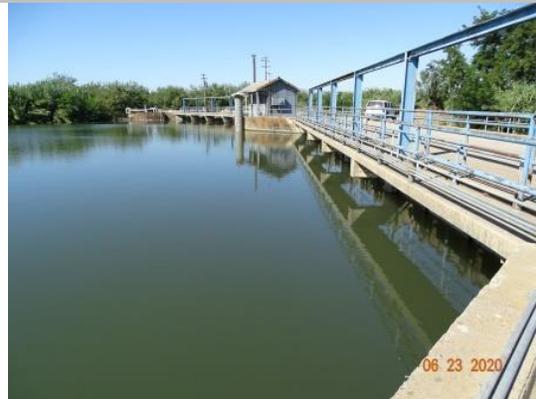
Photo 1 of 1 : CH\_2020\_NA0013\_33\_11\_20200701\_00052.jpg

View of vegetation upstream. Summer 2020

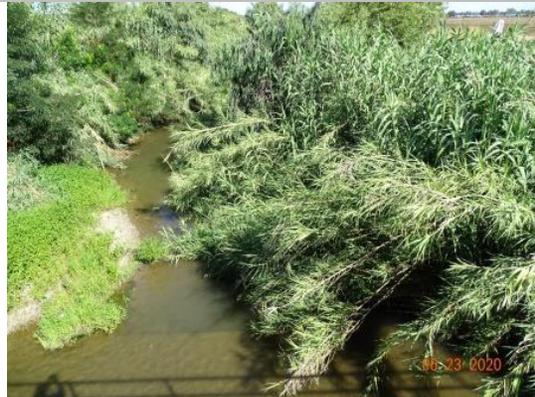
Photo 1 of 1 : CH\_2020\_NA0013\_33\_16\_20200701\_00053.jpg

Check Point / View			
<b>Crocker Dam / Down</b>			
Rating **	U	Issue No.	16
Issue Type +	Ma	Location *	37.312458 °
Category	Rivers, Channels & Designated Flood		-120.532708 °
Item	Vegetation & Obstructions		
DWR ID	DWR_NA0013_33_c_2016_16		
Action/Comments			
Inspector Comments: Remove Arundo wild growth from both banks.

View of vegetation and Arundo on both banks. Summer 2020

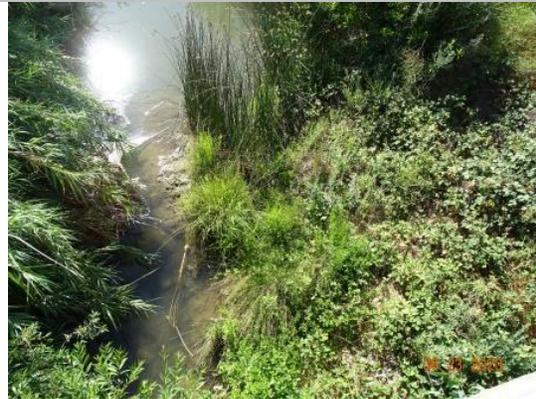
Photo 1 of 1 : CH\_2020\_NA0013\_33\_22\_20200701\_00049.jpg

Check Point / View			
<b>Franklin Rd / Up (cont)</b>			
Rating **	M	Issue No. <b>22</b>	GPS Lat/Long
Issue Type +	Ma	Location *	37.314050 °
Category	Rivers, Channels & Designated Flood		-120.541078 °
Item	Shoaling / Sedimentation		
DWR ID	DWR_NA0013_33_c_2016_22		
Action/Comments			
Inspector Comments: There is shoaling with brush underneath the crossing, but flow does not appear to be impeded.

View of shoaling upstream of Franklin Road. Summer 2020

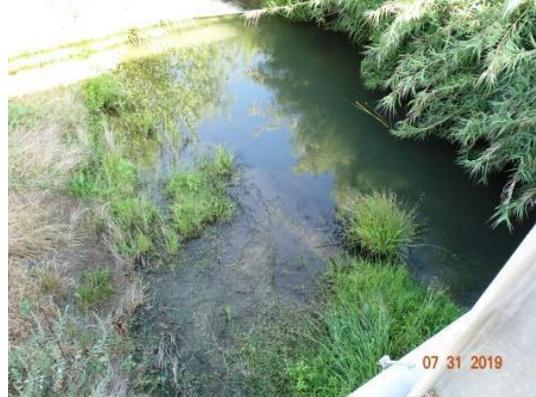
Photo 1 of 1 : CH\_2020\_NA0013\_33\_27\_20200622\_00016.jpg

Check Point / View			
<b>Franklin Rd / Down (cont)</b>			
Rating **	M	Issue No.	<b>27</b>
Issue Type +	Ma	Location *	37.314050 °
Category	Rivers, Channels & Designated Flood		-120.541078 °
Item	Shoaling / Sedimentation		
DWR ID	DWR_NA0013_33_c_2016_27		
Action/Comments			
Inspector Comments: Shoaling with brush exists, but flow does not appear to be impeded.

View of shoaling downstream of the bridge. Summer 2019

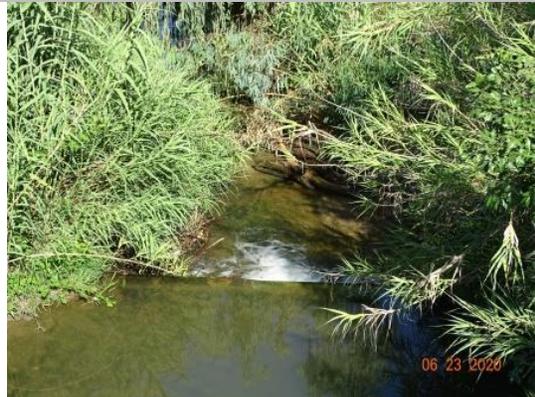
Photo 1 of 1 : CH\_2020\_NA0013\_33\_30\_20200701\_00051.jpg

View of weir or check dam across the channel. Summer 2020

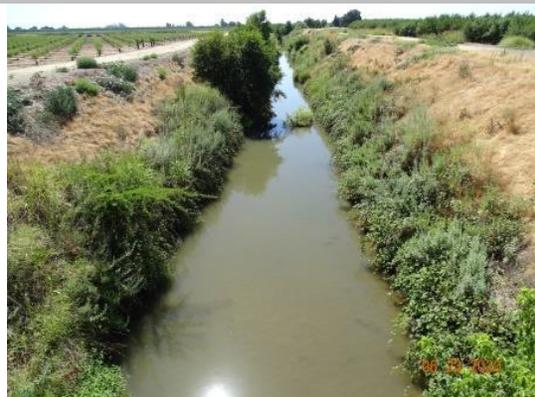
Photo 1 of 1 : CH\_2020\_NA0013\_33\_31\_20200701\_00055.jpg

Check Point / View				
<b>Gurr Rd / Up</b>				
Rating **	A	Issue No.	<b>31</b>	GPS Lat/Long
Issue Type +	Ma	Location *		37.313110 °
Category	Rivers, Channels & Designated Flood			-120.559070 °
Item	Vegetation & Obstructions			
DWR ID	DWR_NA0013_33_c_2016_31			
Action/Comments				
Inspector Comments: Brush underneath the crossing needs to be controlled, but vegetation does not appear to impede flow.

View of vegetation upstream of Gurr Road. Summer 2020

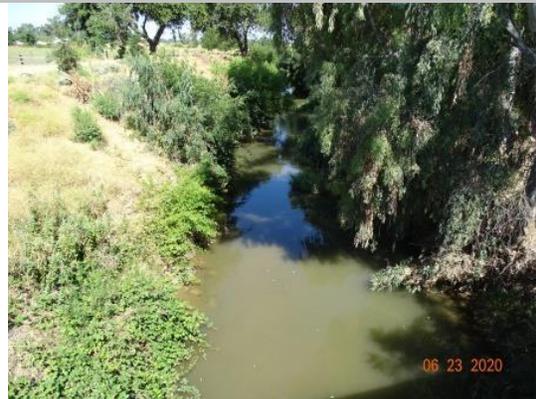
Photo 1 of 1 : CH\_2020\_NA0013\_33\_36\_20200701\_00056.jpg

Check Point / View				
<b>Gurr Rd / Down</b>				
Rating **	U	Issue No.	36	GPS Lat/Long
Issue Type +	Ma	Location *		37.313110 °
Category	Rivers, Channels & Designated Flood			-120.559070 °
Item	Vegetation & Obstructions			
DWR ID	DWR_NA0013_33_c_2016_36			
Action/Comments				
Inspector Comments: The wild growth on the right bank needs to be removed as its extending into the channel making it hard to inspect.

View looking downstream from Gurr Road crossing. Summer 2020

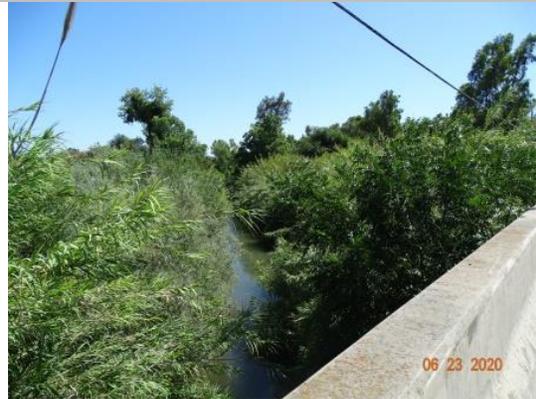
Photo 1 of 1 : CH\_2020\_NA0013\_33\_41\_20200701\_00058.jpg

Check Point / View			
<b>Hwy 140 / Up</b>			
Rating **	U	Issue No. <b>41</b>	GPS Lat/Long
Issue Type +	Ma	Location *	37.302329 °
Category	Rivers, Channels & Designated Flood		-120.575613 °
Item	Vegetation & Obstructions		
DWR ID	DWR_NA0013_33_c_2016_41		
Action/Comments			
Inspector Comments: Arundo is taking over the channel and growing over the bridge crossing.

View of vegetation upstream of Hwy 140. Summer 2020

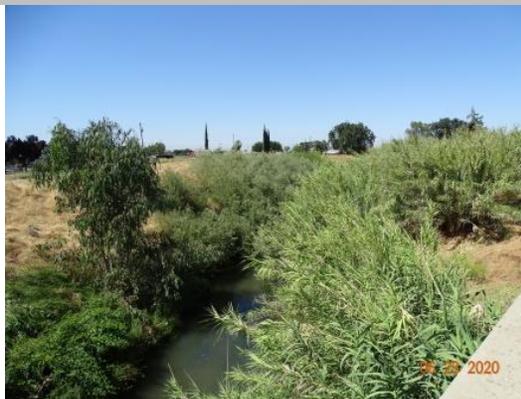
Photo 1 of 1 : CH\_2020\_NA0013\_33\_46\_20200701\_00059.jpg

Check Point / View			
<b>Hwy 140 / Down</b>			
Rating **	M	Issue No. <b>46</b>	GPS Lat/Long
Issue Type +	Ma	Location *	37.302329 °
Category	Rivers, Channels & Designated Flood		-120.575613 °
Item	Vegetation & Obstructions		
DWR ID	DWR_NA0013_33_c_2016_46		
Action/Comments			
Inspector Comments: Remove wild Arundo growth.

View of vegetation downstream of Hwy 140. Summer 2020

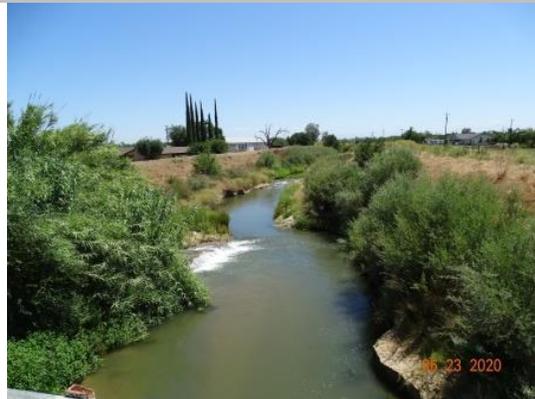
Photo 1 of 1 : CH\_2020\_NA0013\_33\_51\_20200701\_00062.jpg

Check Point / View			
<b>Quinley Rd / Up</b>			
Rating **	A	Issue No. <b>51</b>	GPS Lat/Long
Issue Type +	Ma	Location *	37.293797 °
Category	Rivers, Channels & Designated Flood		-120.596922 °
Item	Vegetation & Obstructions		
DWR ID	DWR_NA0013_33_c_2016_51		
Action/Comments			
Inspector Comments: Remove Arundo on the right bank.

View of Black Rascal Creek upstream of Quinley Road crossing. Summer 2020

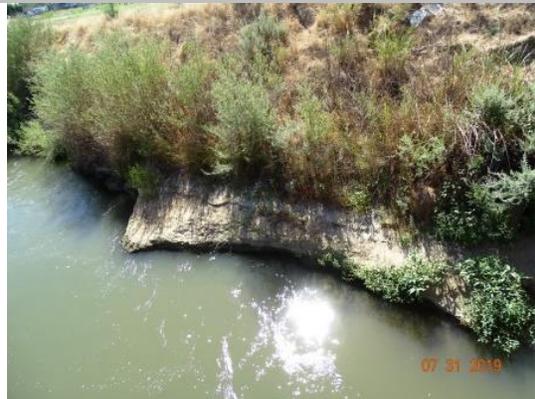
Photo 2 of 2 : CH\_2020\_NA0013\_33\_53\_20200622\_00026.jpg

Rating **	M	Issue No.	<b>53</b>	GPS Lat/Long
Issue Type +	Ma	Location *		37.293797 °
Category	Rivers, Channels & Designated Flood			-120.596922 °
Item	Erosion / Bank Caving			
DWR ID	DWR_NA0013_33_c_2016_53			
Action/Comments				
Inspector Comments: Repair erosion on left bank.

Rating **	M	Issue No.	<b>53 (cont)</b>	GPS Lat/Long
Issue Type +	Ma	Location *		37.293797 °
Category	Rivers, Channels & Designated Flood			-120.596922 °
Item	Erosion / Bank Caving			
DWR ID	DWR_NA0013_33_c_2016_53

View of erosion on left bank. Summer 2019

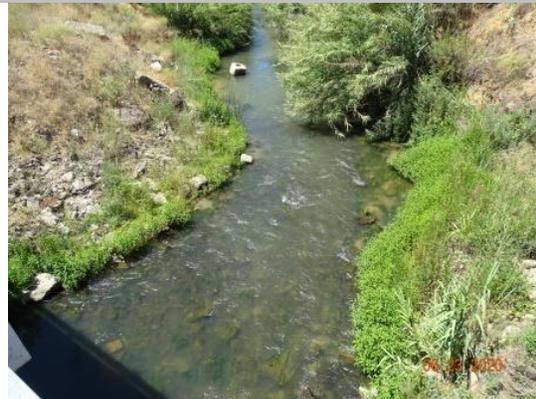
Photo 1 of 1 : CH\_2020\_NA0013\_33\_56\_20200701\_00063.jpg

Check Point / View			
<b>Quinley Rd / Down</b>			
Rating **	M	Issue No.	56
Issue Type +	Ma	Location *	37.293797 °
Category	Rivers, Channels & Designated Flood		-120.596922 °
Item	Vegetation & Obstructions		
DWR ID	DWR_NA0013_33_c_2016_56		
Action/Comments			
Inspector Comments: Remove Arundo from both banks.

View of vegetation downstream of Quinley Road crossing. Summer 2020

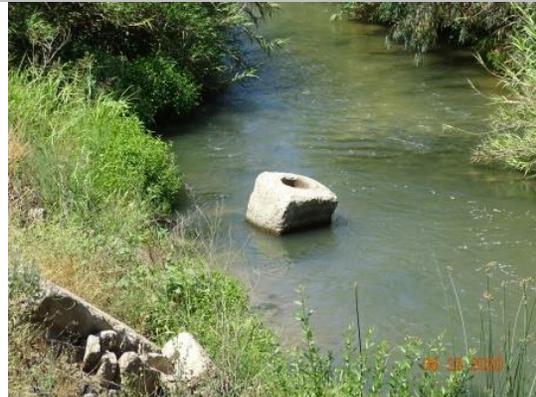
Photo 1 of 1 : CH\_2020\_NA0013\_33\_60\_20200701\_00066.jpg

Check Point / View			
<b>Quinley Rd / Down (cont)</b>			
Rating **	M	Issue No.	<b>60</b>
Issue Type +	Ma	Location *	GPS Lat/Long
Category	Rivers, Channels & Designated Flood		-120.596922 °
Item	Encroachments		
DWR ID	DWR_NA0013_33_c_2016_60		
Action/Comments			
Inspector Comments: Remove the concrete block from the low flow of the channel. The earth dam was removed.

View of a concrete block in the channel. Summer 2020

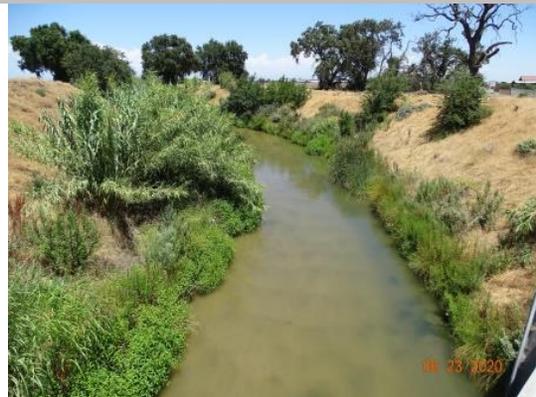
Photo 1 of 1 : CH\_2020\_NA0013\_33\_61\_20200701\_00068.jpg

Check Point / View			
<b>Oak Ave / Up</b>			
Rating **	A	Issue No.	<b>61</b>
Issue Type +	Ma	Location *	GPS Lat/Long
Category	Rivers, Channels & Designated Flood		-120.609400 °
Item	Vegetation & Obstructions		
DWR ID	DWR_NA0013_33_c_2020_61		
Action/Comments			
Inspector Comments: Remove Arundo growth from both banks.

View of Black Rascal Creek upstream of Oak Avenue crossing. Summer 2020

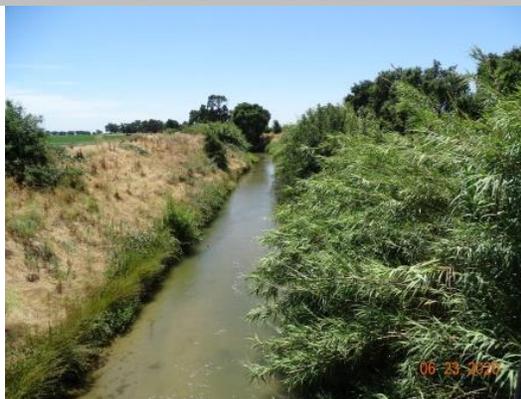
Photo 1 of 1 : CH\_2020\_NA0013\_33\_66\_20200701\_00069.jpg

Check Point / View				
<b>Oak Ave / Down</b>				
Rating **	M	Issue No.	66	GPS Lat/Long
Issue Type +	Ma	Location *		37.280330 °
Category	Rivers, Channels & Designated Flood			-120.609400 °
Item	Vegetation & Obstructions			
DWR ID	DWR_NA0013_33_c_2018_66			
Action/Comments				
Inspector Comments: Arundo underneath crossing and on the right bank should be removed.

View of Black Rascal Creek downstream of Oak Avenue crossing. Summer 2020

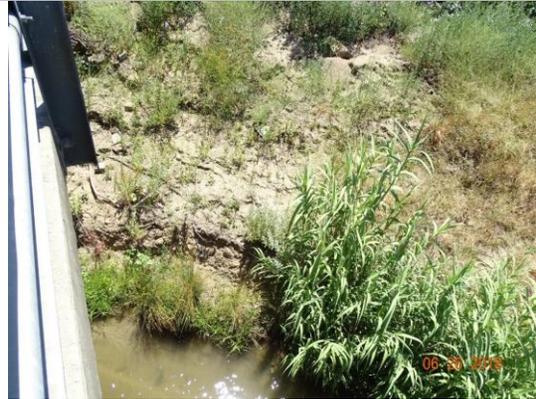
Photo 1 of 1 : CH\_2020\_NA0013\_33\_68\_20200622\_00039.jpg

Rating **	A	Issue No.	<b>68</b>	GPS Lat/Long
Issue Type +	Ma	Location *		37.280330 °
Category	Rivers, Channels & Designated Flood			-120.609400 °
Item	Erosion / Bank Caving			
DWR ID	DWR_NA0013_33_c_2016_68			
Action/Comments				
Inspector Comments: There is minor erosion on the left bank.

Some erosion on left bank downstream of Oak Ave. crossing. Summer 2018

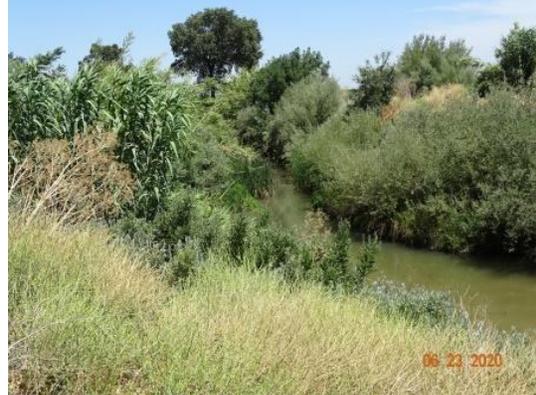
Photo 1 of 1 : CH\_2020\_NA0013\_33\_71\_20200701\_00071.jpg

Check Point / View				
<b>Bear Creek Confluence / Up</b>				
Rating **	U	Issue No.	71	GPS Lat/Long
Issue Type +	Ma	Location *		37.268311 °
Category	Rivers, Channels & Designated Flood			-120.624111 °
Item	Vegetation & Obstructions			
DWR ID	DWR_NA0013_33_c_2016_71			
Action/Comments				
Inspector Comments: Remove Arundo from both banks that obstruct view of channel.

View of Black Rascal Creek upstream of the Confluence with Bear Creek. Summer 2020

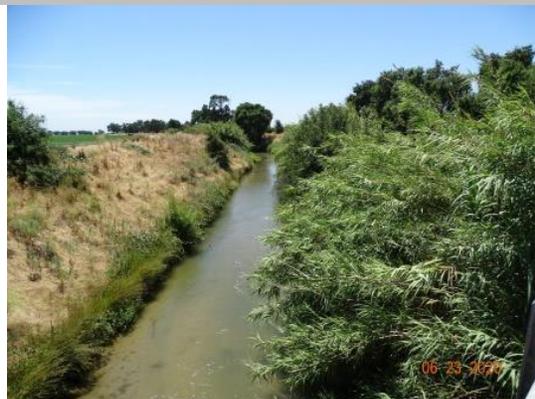
Photo 1 of 1 : CH\_2020\_NA0013\_33\_76\_20200701\_00073.jpg

Check Point / View			
<b>Bear Creek Confluence / Down</b>			
Rating **	A	Issue No. <b>76</b>	GPS Lat/Long
Issue Type +	Ma	Location *	37.268311 °
Category	Rivers, Channels & Designated Flood		-120.624111 °
Item	Vegetation & Obstructions		
DWR ID	DWR_NA0013_33_c_2016_76		
Action/Comments

View looking downstream of the Bear Creek Confluence. Summer 2020

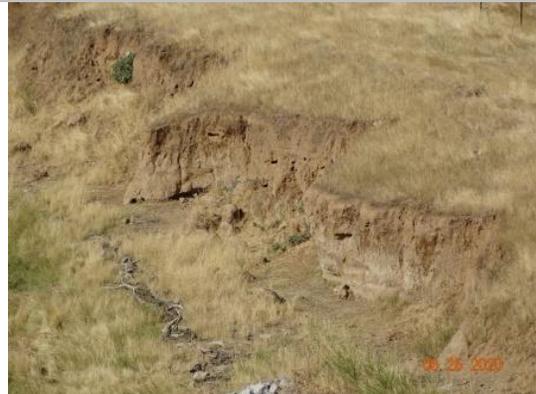
Photo 1 of 2 : CH\_2020\_NA0013\_34\_8\_20200703\_00034.jpg

Rating **	A	Issue No.	8
Issue Type +	Ma	Location *	37.377220 °
Category	Rivers, Channels & Designated Flood		-120.276360 °
Item	Erosion / Bank Caving		
DWR ID	DWR_NA0013_34_c_2016_8		
Action/Comments			
Inspector Comments: Historic Erosion exists on left and right banks but it does not appear to be active.

View of historic erosion on the right bank at the Burns Creek Dam outlet. This erosion does not appear to be active. Summer 2020

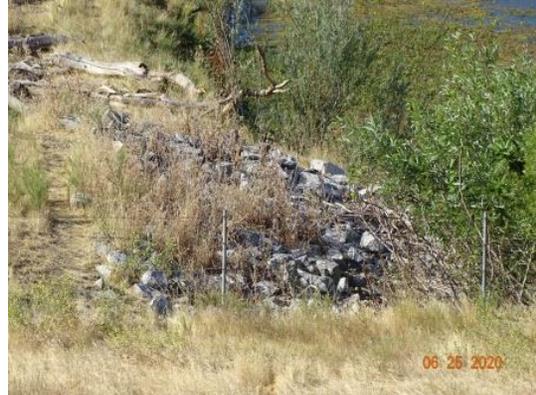
Photo 2 of 2 : CH\_2020\_NA0013\_34\_9\_20200703\_00036.jpg

Check Point / View			
<b>Burns Creek Dam / Down (cont)</b>			
Rating **	M	Issue No.	<b>9 (cont)</b>
Issue Type +	Ma	Location *	GPS Lat/Long
Category	Rivers, Channels & Designated Flood		37.377220 °
Item	Revetments		-120.276360 °
DWR ID	DWR_NA0013_34_c_2016_9		
Action/Comments			
Inspector Comments: The vegetation on the left bank growing within the riprap should be removed.

View of revetment on the left bank of the Burns Creek Dam outlet. Summer 2020

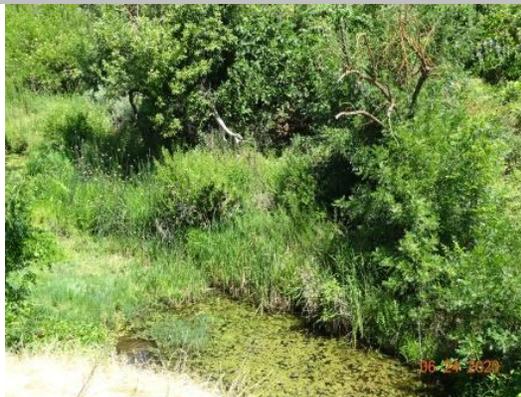
Photo 1 of 1 : CH\_2020\_NA0013\_34\_21\_20200703\_00025.jpg

Check Point / View				
<b>Confluence / Up</b>				
Rating **	U	Issue No.	<b>21</b>	GPS Lat/Long
Issue Type +	Ma	Location *		37.333581 °
Category	Rivers, Channels & Designated Flood			-120.320642 °
Item	Vegetation & Obstructions			
DWR ID	DWR_NA0013_34_c_2016_21			
Action/Comments				
Inspector Comments: Access to this location via the right bank requires notification of the property owner. Vegetation on Burns and Bear Creeks was never maintained and needs to be controlled or removed.

View of vegetation upstream of the confluence with Bear Creek. Summer 2020

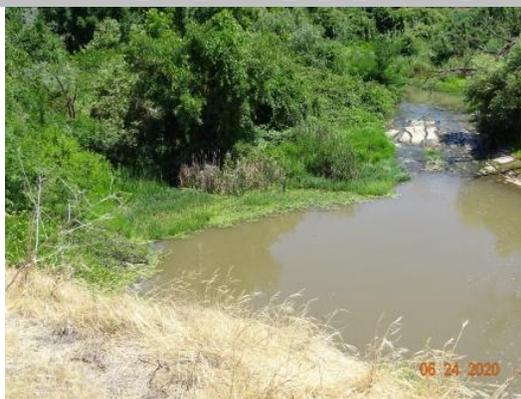
Photo 1 of 1 : CH\_2020\_NA0013\_34\_22\_20200703\_00028.jpg

Rating **	U	Issue No.	<b>22</b>	GPS Lat/Long
Issue Type +	Ma	Location *		37.333581 °
Category	Rivers, Channels & Designated Flood			-120.320642 °
Item	Shoaling / Sedimentation			
DWR ID	DWR_NA0013_34_c_2016_22			
Action/Comments				
Inspector Comments: The shoal with vegetation crossing Burns Creek impedes flow and needs to be removed.

View of shoaling connecting the banks of Burns Creek. Summer 2020

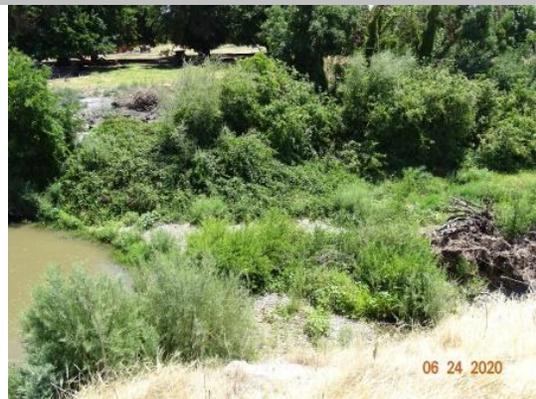
Photo 1 of 1 : CH\_2020\_NA0013\_34\_26\_20200703\_00026.jpg

Check Point / View			
<b>Confluence / Down</b>			
Rating **	U	Issue No. <b>26</b>	GPS Lat/Long
Issue Type +	Ma	Location *	37.333581 °
Category	Rivers, Channels & Designated Flood		-120.320642 °
Item	Vegetation & Obstructions		
DWR ID	DWR_NA0013_34_c_2016_26		
Action/Comments			
Inspector Comments: This vantage point is on private property looking across the channel. The channel is not maintained, and overgrown brush along banks needs to be controlled or removed.

View of vegetation downstream of the confluence with Bear Creek. Summer 2020

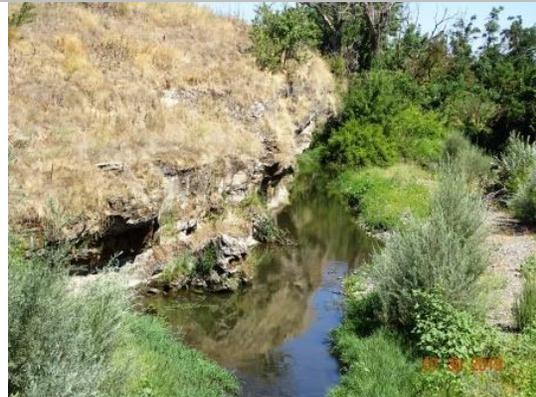
Photo 1 of 1 : CH\_2020\_NA0013\_34\_28\_20200622\_00017.jpg

Rating **	A	Issue No.	28	GPS Lat/Long
Issue Type +	Ma	Location *		37.333581 °
Category	Rivers, Channels & Designated Flood			-120.320642 °
Item	Erosion / Bank Caving			
DWR ID	DWR_NA0013_34_c_2016_28			
Action/Comments				
Inspector Comments: Rocky vertical bluff shows signs of historic erosion, but it does not appear to be active.

View looking at rocky vertical bluff on the right bank downstream of the Confluence. Summer 2019

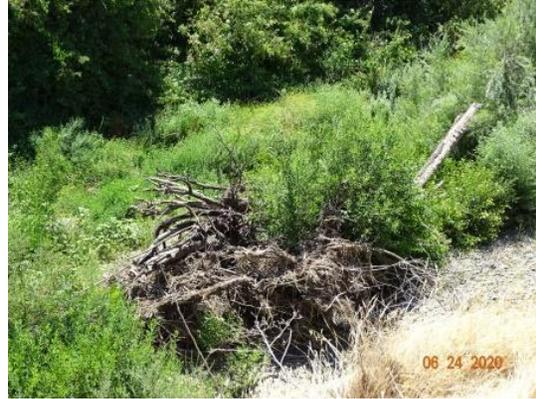
Photo 1 of 1 : CH\_2020\_NA0013\_34\_30\_20200703\_00027.jpg

Check Point / View				
<b>Confluence / Down (cont)</b>				
Rating **	M	Issue No.	<b>30</b>	GPS Lat/Long
Issue Type +	Ma	Location *		37.333581 °
Category	Rivers, Channels & Designated Flood			-120.320642 °
Item	Encroachments			
DWR ID	DWR_NA0013_34_c_2016_30			
Action/Comments				
Inspector Comments: Remove large tree debris on the right bank.

View of large tree debris in the channel downstream of the confluence.  
Summer 2020

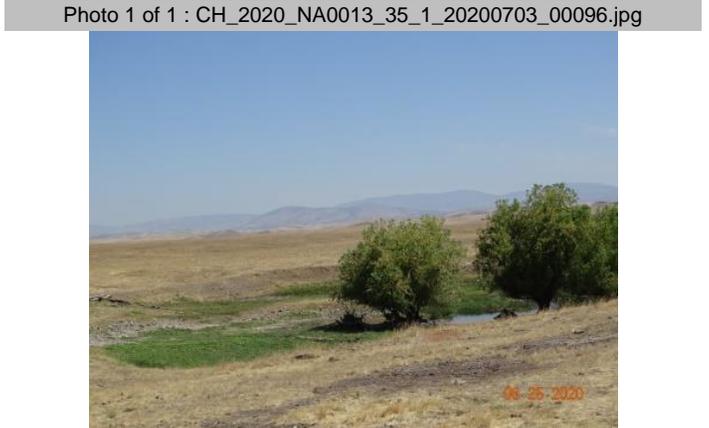
Check Point / View			
<b>White Rock Rd / Up</b>			
Rating **	A	Issue No. <b>1</b>	GPS Lat/Long
Issue Type +	Ma	Location *	37.261425 °
Category	Rivers, Channels & Designated Flood		-120.198078 °
Item	Vegetation & Obstructions		
DWR ID	DWR_NA0013_35_c_2016_1		
Action/Comments

View of vegetation upstream of White Rock Road. Summer 2020

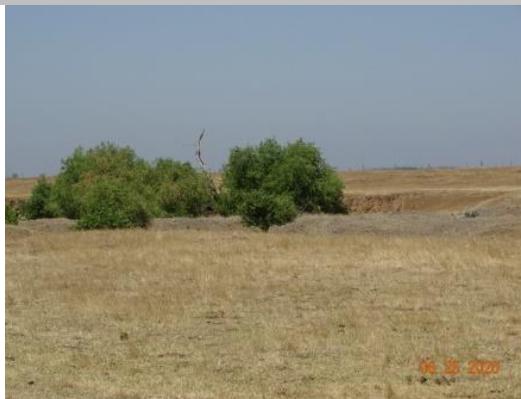
Photo 1 of 1 : CH\_2020\_NA0013\_35\_6\_20200703\_00098.jpg

Check Point / View			
<b>White Rock Rd / Down</b>			
Rating **	A	Issue No. <b>6</b>	GPS Lat/Long
Issue Type +	Ma	Location *	37.261425 °
Category	Rivers, Channels & Designated Flood		-120.198078 °
Item	Vegetation & Obstructions		
DWR ID	DWR_NA0013_35_c_2018_6		
Action/Comments

View of vegetation downstream of White Rock Road. Summer 2020

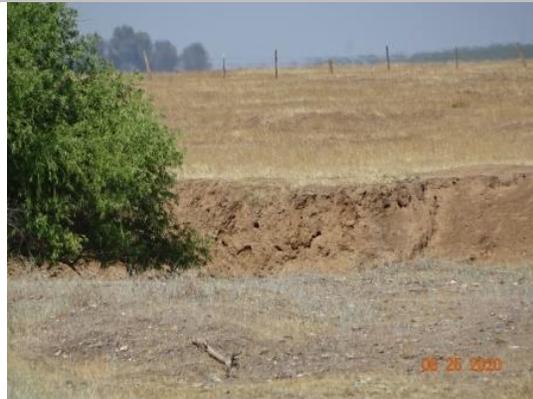
Photo 1 of 2 : CH\_2020\_NA0013\_35\_8\_20200703\_00101.jpg

Rating **	A	Issue No.	8	GPS Lat/Long
Issue Type +	Ma	Location *		37.261425 °
Category	Rivers, Channels & Designated Flood			-120.198078 °
Item	Erosion / Bank Caving			
DWR ID	DWR_NA0013_35_c_2016_8			
Action/Comments				
Inspector Comments: There is minor erosion of the right bank.

View of historic erosion on the right bank downstream of White Rock Road, but erosion does not appear to be active. Summer 2020

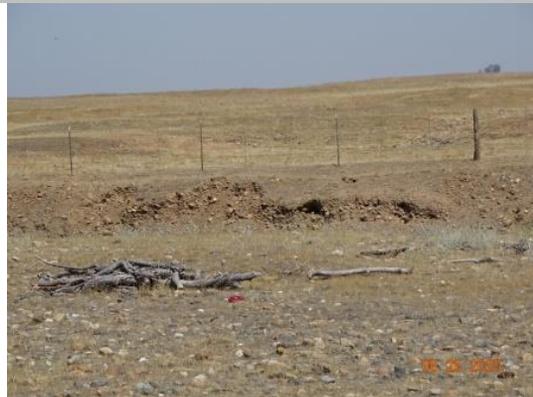
Photo 2 of 2 : CH\_2020\_NA0013\_35\_8\_20200703\_00102.jpg

Rating **	A	Issue No.	8 (cont)	GPS Lat/Long
Issue Type +	Ma	Location *		37.261425 °
Category	Rivers, Channels & Designated Flood			-120.198078 °
Item	Erosion / Bank Caving			
DWR ID	DWR_NA0013_35_c_2016_8

View of historic erosion on the right bank downstream of White Rock Road, but erosion does not appear to be active. Summer 2020

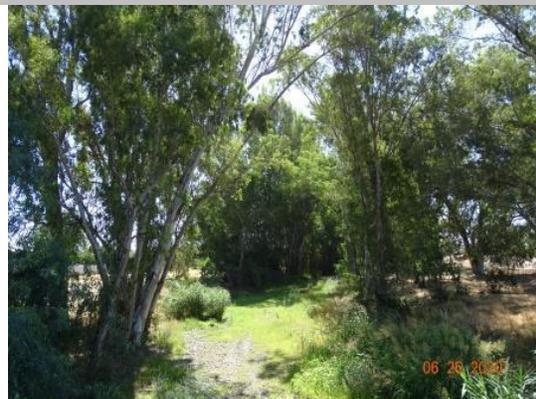
Photo 1 of 2 : CH\_2020\_NA0013\_35\_11\_20200703\_00091.jpg

View of vegetation upstream of Fresno Road crossing. Summer 2020

Check Point / View			
<b>Fresno Rd / Up</b>			
Rating **	A	Issue No.	11
Issue Type +	Ma	Location *	GPS Lat/Long
Category	Rivers, Channels & Designated Flood		37.237998 °
Item	Vegetation & Obstructions		-120.243649 °
DWR ID	DWR_NA0013_35_c_2016_11		
Action/Comments			
Inspector Comments: Although flows do not appear to be impeded, Arundo on the left bank needs to be removed.

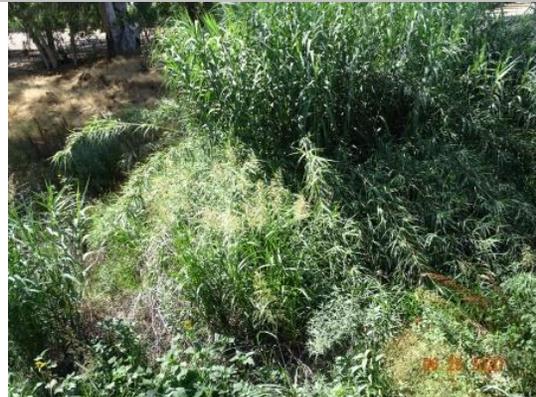
Photo 2 of 2 : CH\_2020\_NA0013\_35\_11\_20200703\_00092.jpg

View of Arundo on the left bank upstream of Fresno Road crossing. Summer 2020

Check Point / View				
<b>Fresno Rd / Up (cont)</b>				
Rating **	A	Issue No.	<b>11 (cont)</b>	GPS Lat/Long
Issue Type +	Ma	Location *		37.237998 °
Category	Rivers, Channels & Designated Flood			-120.243649 °
Item	Vegetation & Obstructions			
DWR ID	DWR_NA0013_35_c_2016_11			
Action/Comments				
Inspector Comments: Although flows do not appear to be impeded, Arundo on the left bank needs to be removed.

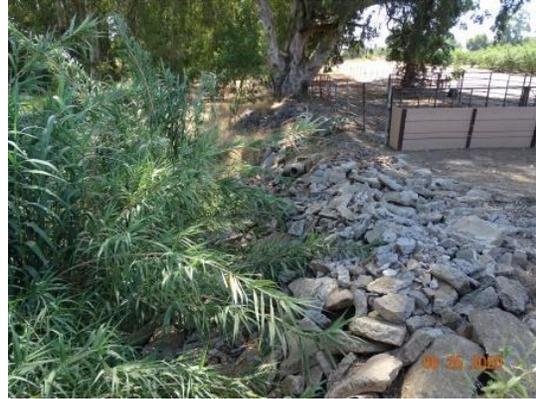
Photo 1 of 1 : CH\_2020\_NA0013\_35\_14\_20200703\_00093.jpg

Check Point / View				
<b>Fresno Rd / Up (cont)</b>				
Rating **	A	Issue No.	14	GPS Lat/Long
Issue Type +	Ma	Location *		37.237998 °
Category	Rivers, Channels & Designated Flood			-120.243649 °
Item	Revetments			
DWR ID	DWR_NA0013_35_c_2016_14			
Action/Comments				
Inspector Comments: Broken concrete riprap on the left bank is clearly visible.

View of the revetment on the left bank upstream of Fresno Road crossing. Summer 2020

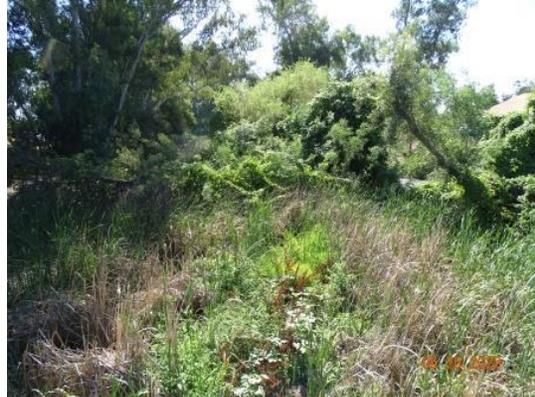
Photo 1 of 2 : CH\_2020\_NA0013\_35\_21\_20200703\_00087.jpg

View of vegetation upstream of Cunningham Road crossing. Summer 2020

Check Point / View			
<b>Cunningham Rd / Up</b>			
Rating **	U	Issue No.	<b>21</b>
Issue Type +	Ma	Location *	GPS Lat/Long
Category	Rivers, Channels & Designated Flood		37.238920 °
Item	Vegetation & Obstructions		-120.252701 °
DWR ID	DWR_NA0013_35_c_2016_21		
Action/Comments			
Inspector Comments: Remove wild growth and fallen trees with ivy that impede flows.

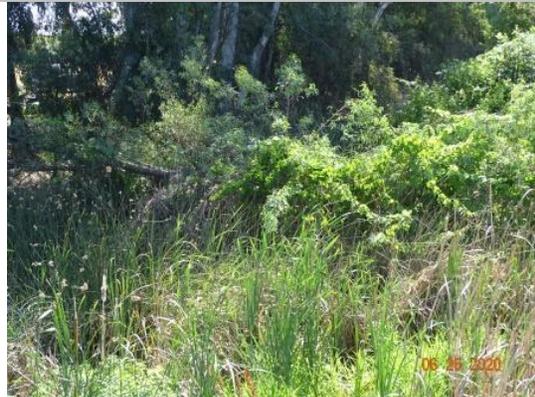
Photo 2 of 2 : CH\_2020\_NA0013\_35\_21\_20200703\_00088.jpg

View of fallen tree in the channel upstream of Cunningham Road crossing. Summer 2020

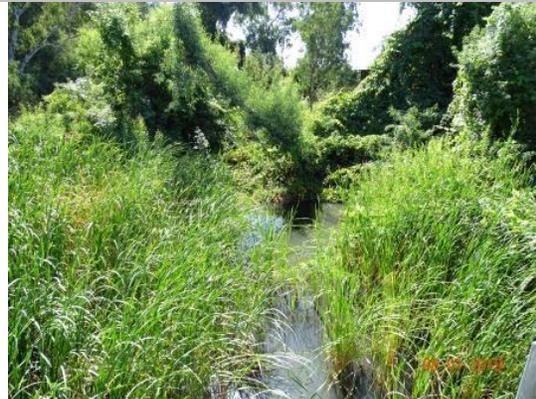
Photo 1 of 1 : CH\_2020\_NA0013\_35\_22\_20200622\_00018.jpg

View of shoaling with vegetation in the channel. Summer 2019

Check Point / View			
<b>Cunningham Rd / Up (cont)</b>			
Rating **	M	Issue No. <b>22</b>	GPS Lat/Long
Issue Type +	Ma	Location *	37.238920 °
Category	Rivers, Channels & Designated Flood		-120.252701 °
Item	Shoaling / Sedimentation		
DWR ID	DWR_NA0013_35_c_2016_22		
Action/Comments			
Inspector Comments: Shoaling with vegetation may impede flow and should be controlled.
