**Flood Control Project Maintenance  
Levee Inspections**

**2020 Channel Summary Report**

**Merced Streams Group**

**Levee Inspection Report By Mile - Channel 2020**

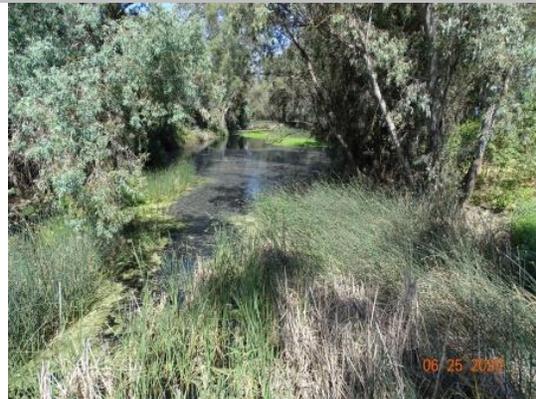
Photo 1 of 1 : CH\_2020\_NA0013\_35\_26\_20200703\_00089.jpg

Check Point / View				
<b>Cunningham Rd / Down</b>				
Rating **	A	Issue No.	26	GPS Lat/Long
Issue Type +	Ma	Location *		37.238920 °
Category	Rivers, Channels & Designated Flood			-120.252701 °
Item	Vegetation & Obstructions			
DWR ID	DWR_NA0013_35_c_2016_26			
Action/Comments

View of vegetation downstream of Cunningham Road crossing. Summer 2020

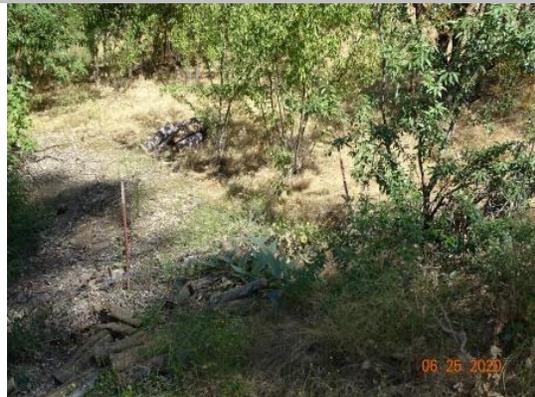
Photo 1 of 1 : CH\_2020\_NA0013\_35\_30\_20200703\_00090.jpg

Rating **	M	Issue No.	30	GPS Lat/Long
Issue Type +	En	Location *		37.238920 °
Category	Rivers, Channels & Designated Flood			-120.252701 °
Item	Encroachments			
DWR ID	DWR_NA0013_35_c_2016_30			
Action/Comments				
Inspector Comments: A wire fence on the right bank appears to be unauthorized.

View of wire fencing on the right bank downstream of Cunningham Road crossing. Summer 2020

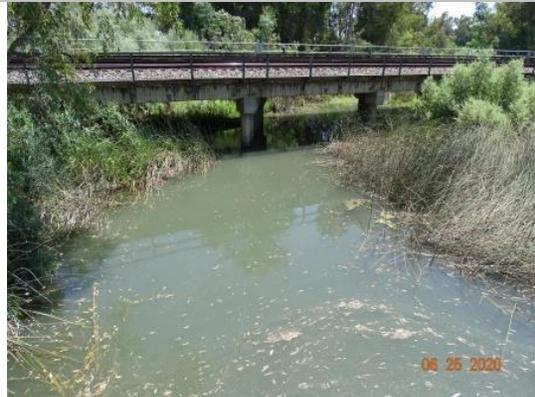
Photo 1 of 1 : CH\_2020\_NA0013\_35\_31\_20200703\_00103.jpg

View of vegetation upstream of Santa Fe Drive crossing. Summer 2020

Check Point / View			
<b>RR Bridge near Santa Fe Dr / Up</b>			
Rating **	M	Issue No. <b>31</b>	GPS Lat/Long
Issue Type +	Ma	Location *	37.239326 °
Category	Rivers, Channels & Designated Flood		-120.259357 °
Item	Vegetation & Obstructions		
DWR ID	DWR_NA0013_35_c_2016_31		
Action/Comments			
Inspector Comments: Vegetation in the channel is growing and should be controlled. Remove Arundo from the left bank.

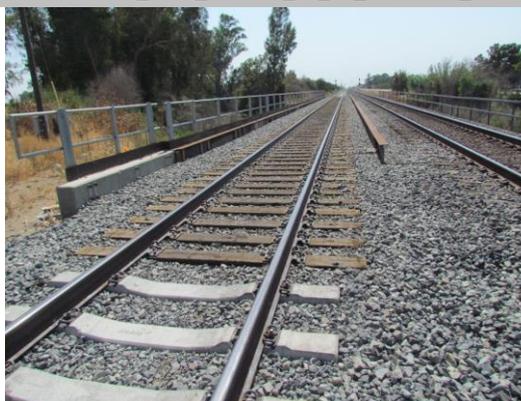
Photo 1 of 2 : CH\_2020\_NA0013\_35\_35\_20200622\_00024.jpg

New RR Bridge line crossing the Mariposa Creek without Authorization from CVFP Board.

Rating **	U	Issue No. <b>35</b>	GPS Lat/Long
Issue Type +	En	Location *	37.239326 °
Category	Rivers, Channels & Designated Flood		-120.259357 °
Item	Encroachments		
DWR ID	DWR_NA0013_35_c_2016_35		
Action/Comments			
Inspector Comments: The new RR bridge crossing was not authorized by CVFPB, and BNSF needs to secure a permit.

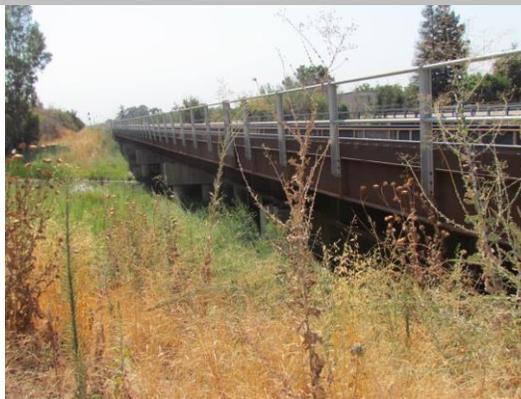
Photo 2 of 2 : CH\_2020\_NA0013\_35\_35\_20200622\_00025.jpg

View of the New RR Bridge line from upstream right bank.

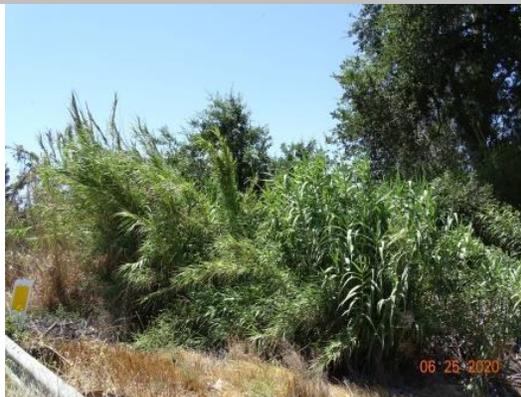
Photo 1 of 2 : CH\_2020\_NA0013\_35\_36\_20200703\_00105.jpg

View of Arundo on the right bank downstream of Santa Fe Drive crossing. Summer 2020

Check Point / View				
<b>RR Bridge near Santa Fe Dr / Down</b>				
Rating **	M	Issue No.	<b>36</b>	GPS Lat/Long
Issue Type +	Ma	Location *		37.239326 °
Category	Rivers, Channels & Designated Flood			-120.259357 °
Item	Vegetation & Obstructions			
DWR ID	DWR_NA0013_35_c_2016_36			
Action/Comments				
Inspector Comments: The vegetation in the channel should be managed. Remove Arundo from the right bank.

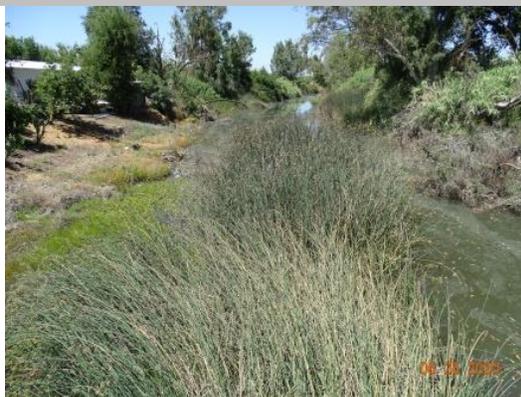
Photo 2 of 2 : CH\_2020\_NA0013\_35\_36\_20200703\_00104.jpg

View of vegetation downstream of Santa Fe Drive crossing. Summer 2020

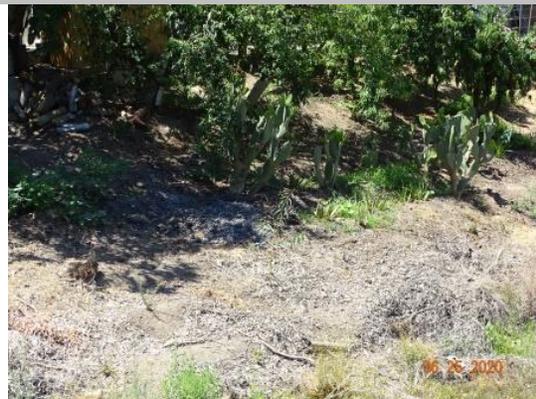
Photo 1 of 1 : CH\_2020\_NA0013\_35\_40\_20200703\_00106.jpg

View of cactus planted on the left bank. Summer 2020

Rating **	M	Issue No.	<b>40</b>
Issue Type +	En	Location *	GPS Lat/Long
Category	Rivers, Channels & Designated Flood		37.239326 °
Item	Encroachments		-120.259357 °
DWR ID	DWR_NA0013_35_c_2016_40		
Action/Comments			
Inspector Comments: The property owner needs to remove cactus and garden from the left bank.

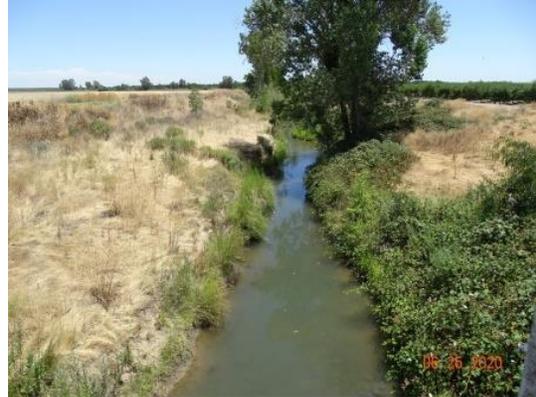
Photo 1 of 1 : CH\_2020\_NA0013\_35\_41\_20200703\_00107.jpg

View of vegetation upstream of Burchell Road. Summer 2020

Check Point / View				
<b>Burchell Rd / Up</b>				
Rating **	M	Issue No.	<b>41</b>	GPS Lat/Long
Issue Type +	Ma	Location *		37.257235 °
Category	Rivers, Channels & Designated Flood			-120.288731 °
Item	Vegetation & Obstructions			
DWR ID	DWR_NA0013_35_c_2016_41			
Action/Comments				
Inspector Comments: Remove wild berry bushes from the left bank.

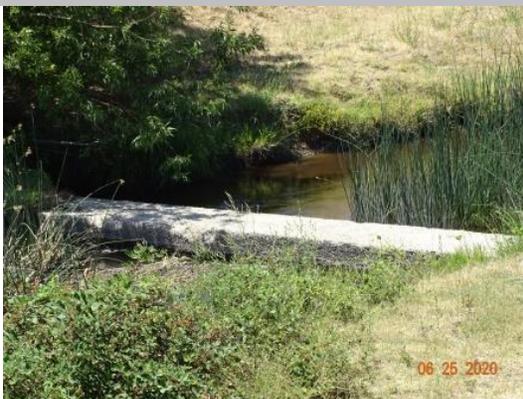
Photo 1 of 3 : CH\_2020\_NA0013\_35\_50\_20200703\_00111.jpg

Check Point / View			
<b>Burchell Rd / Down (cont)</b>			
Rating **	U	Issue No.	<b>50</b>
Issue Type +	En	Location *	37.257235 °
Category	Rivers, Channels & Designated Flood		-120.288731 °
Item	Encroachments		
DWR ID	DWR_NA0013_35_c_2016_50		
Action/Comments			
Inspector Comments: A property line wire fence and a concrete weir or dam structure exist across the channel without permits.

View of a concrete dam across the channel downstream of Burchell Road. Summer 2020

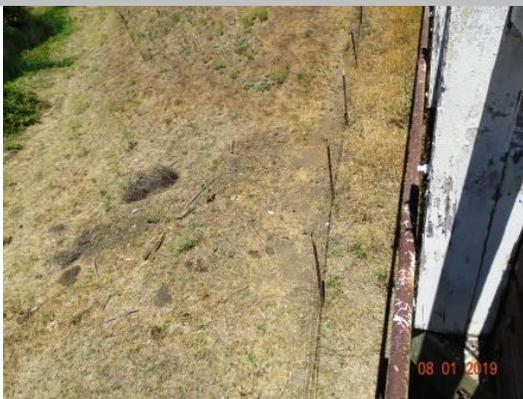
Photo 2 of 3 : CH\_2020\_NA0013\_35\_50\_20200622\_00032.jpg

View of wire fencing across the right bank. Summer 2019

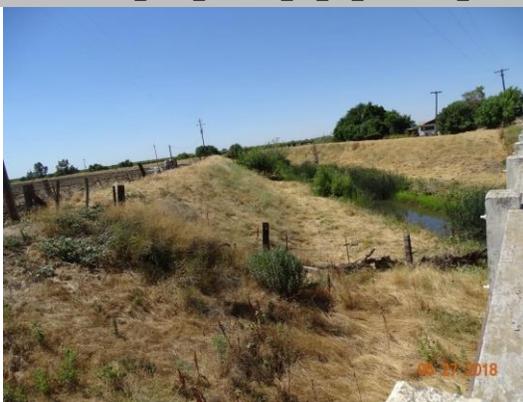
Photo 3 of 3 : CH\_2020\_NA0013\_35\_50\_20200622\_00033.jpg

View of wire fencing across the left bank. Summer 2018

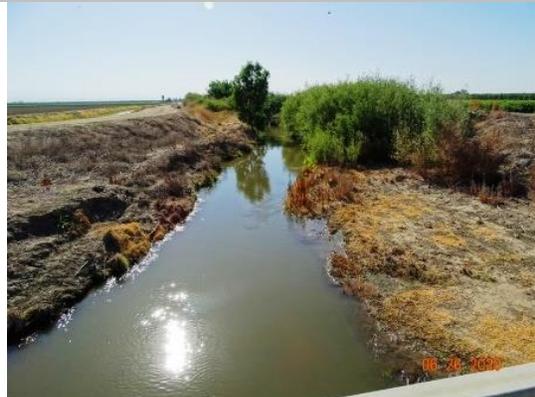
Photo 1 of 1 : CH\_2020\_NA0013\_35\_51\_20200716\_00112.jpg

Check Point / View				
<b>Plainsburg Rd / Up</b>				
Rating **	A	Issue No.	<b>51</b>	GPS Lat/Long
Issue Type +	Ma	Location *		37.258430 °
Category	Rivers, Channels & Designated Flood			-120.325070 °
Item	Vegetation & Obstructions			
DWR ID	DWR_NA0013_35_c_2016_51			
Action/Comments

View of vegetation upstream of Plainsburg Road crossing. Summer 2020

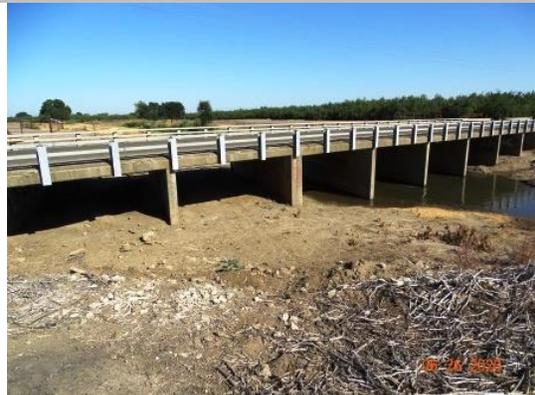
Photo 1 of 2 : CH\_2020\_NA0013\_35\_52\_20200716\_00113.jpg

View of sedimentation in two south bays. Summer 2020

Rating **	M	Issue No.	<b>52</b>	GPS Lat/Long
Issue Type +	Ma	Location *		37.258430 °
Category	Rivers, Channels & Designated Flood			-120.325070 °
Item	Shoaling / Sedimentation			
DWR ID	DWR_NA0013_35_c_2016_52			
Action/Comments				
Inspector Comments: Remove sedimentation underneath the bridge.

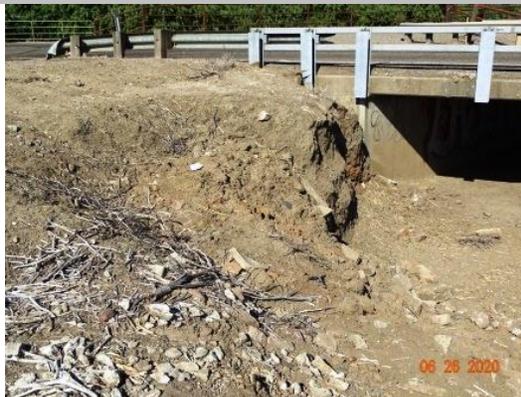
Photo 1 of 2 : CH\_2020\_NA0013\_35\_53\_20200716\_00116.jpg

Check Point / View				
<b>Plainsburg Rd / Up (cont)</b>				
Rating **	M	Issue No.	<b>53</b>	GPS Lat/Long
Issue Type +	Ma	Location *		37.258430 °
Category	Rivers, Channels & Designated Flood			-120.325070 °
Item	Erosion / Bank Caving			
DWR ID	DWR_NA0013_35_c_2016_53			
Action/Comments				
Inspector Comments: There is some erosion on the left bank that appears to be partially addressed by some fill.

View of erosion on the left bank. Summer 2020

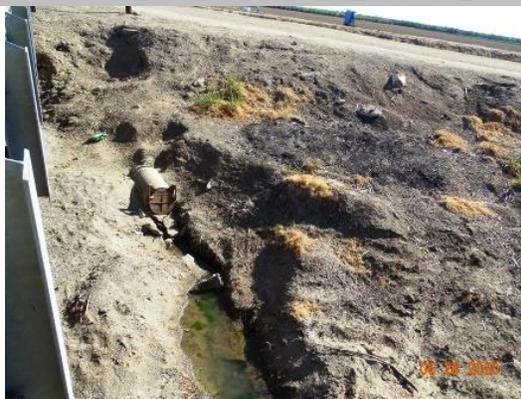
Photo 2 of 2 : CH\_2020\_NA0013\_35\_53\_20200716\_00118.jpg

View of erosion on the right bank. Summer 2020

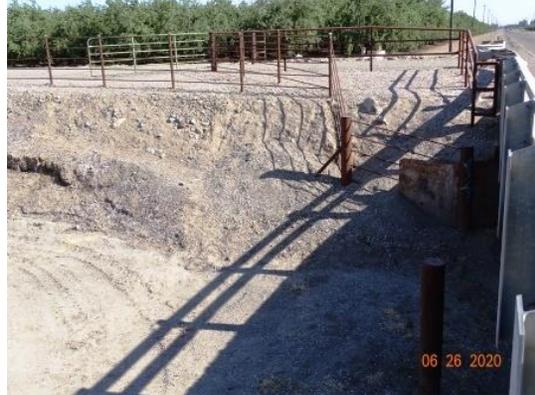
Photo 1 of 3 : CH\_2020\_NA0013\_35\_60\_20200716\_00122.jpg

Rating **	M	Issue No.	60	GPS Lat/Long
Issue Type +	En	Location *		37.258430 °
Category	Rivers, Channels & Designated Flood			-120.325070 °
Item	Encroachments			
DWR ID	DWR_NA0013_35_c_2016_60			
Action/Comments				
Inspector Comments: There is no permit on file for these metal pipes crossing the Mariposa Creek and the gates on the banks.

View of the metal gate extended onto the right bank. Summer 2020

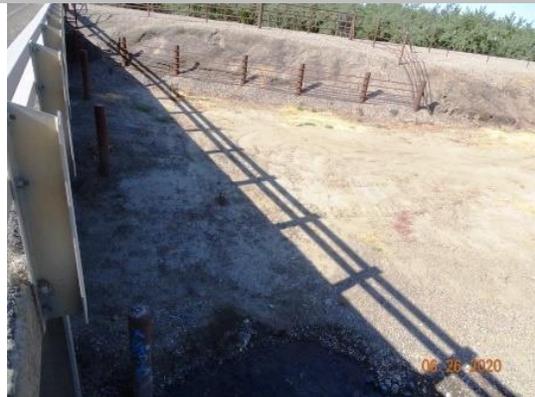
Photo 2 of 3 : CH\_2020\_NA0013\_35\_60\_20200716\_00121.jpg

View of the metal gate extended onto the left bank. Summer 2020

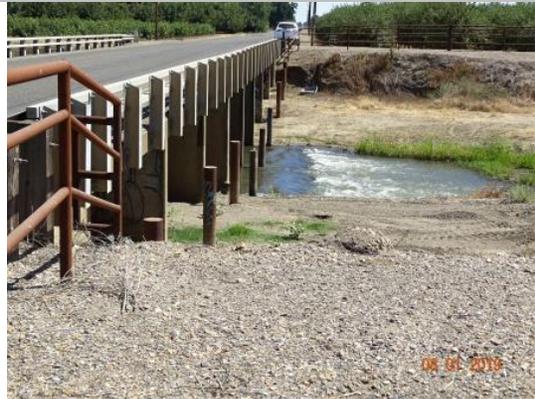
Photo 3 of 3 : CH\_2020\_NA0013\_35\_60\_20200622\_00045.jpg

Check Point / View				
<b>Plainsburg Rd / Down (cont)</b>				
Rating **	M	Issue No.	<b>60 (cont)</b>	GPS Lat/Long
Issue Type +	En	Location *		37.258430 °
Category	Rivers, Channels & Designated Flood			-120.325070 °
Item	Encroachments			
DWR ID	DWR_NA0013_35_c_2016_60			
Action/Comments				
Inspector Comments: There is no permit on file for these metal pipes crossing the Mariposa Creek and the gates on the banks.

View of metal railing and posts installed across channel. Summer 2019

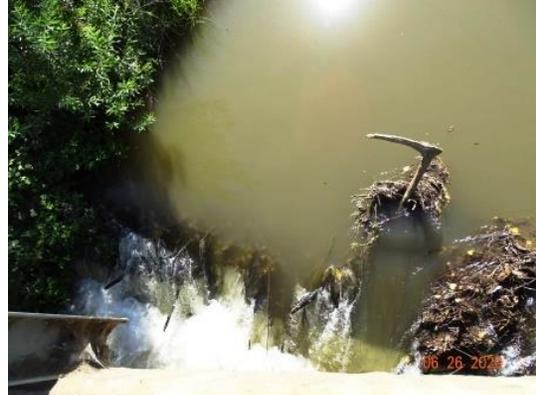
Photo 2 of 2 : CH\_2020\_NA0013\_35\_61\_20200716\_00124.jpg

Check Point / View				
<b>Whealan Rd / Up (cont)</b>				
Rating **	M	Issue No.	<b>61 (cont)</b>	GPS Lat/Long
Issue Type +	Ma	Location *		37.261540 °
Category	Rivers, Channels & Designated Flood			-120.343200 °
Item	Vegetation & Obstructions			
DWR ID	DWR_NA0013_35_c_2016_61			
Action/Comments				
Inspector Comments: Vegetation and obstructions underneath crossing impede flow.

View of vegetation and obstructions upstream of Whealan Road. Summer 2020

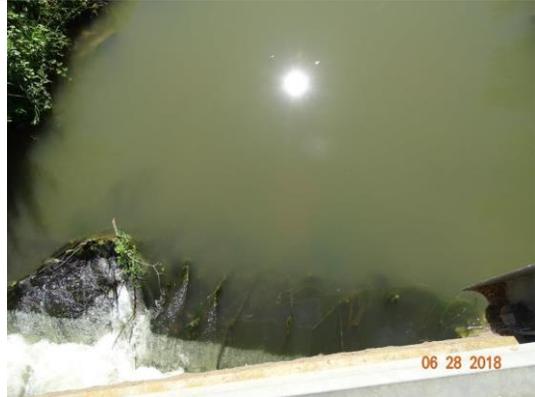
Photo 1 of 1 : CH\_2020\_NA0013\_35\_65\_20200622\_00049.jpg

Rating **	M	Issue No. <b>65</b>	GPS Lat/Long
Issue Type +	En	Location *	37.261540 °
Category	Rivers, Channels & Designated Flood		-120.343200 °
Item	Encroachments		
DWR ID	DWR_NA0013_35_c_2016_65		
Action/Comments			
Inspector Comments: This concrete weir or dam structure does not appear to have a permit.

View of a concrete weir or dam underneath the crossing. Summer 2018

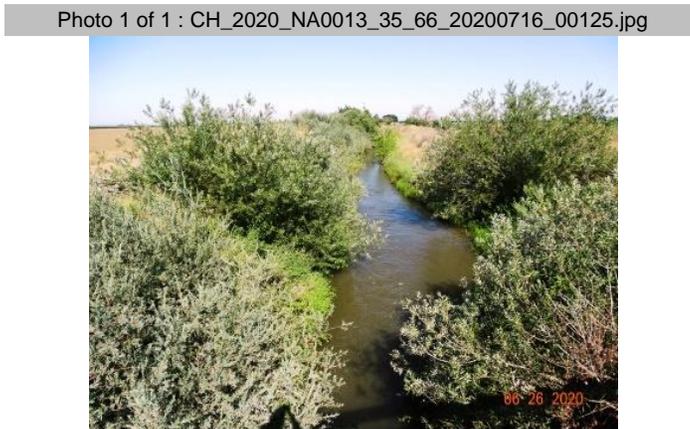
Check Point / View				
<b>Whealan Rd / Down</b>				
Rating **	M	Issue No.	<b>66</b>	GPS Lat/Long
Issue Type +	Ma	Location *		37.261540 °
Category	Rivers, Channels & Designated Flood			-120.343200 °
Item	Vegetation & Obstructions			
DWR ID	DWR_NA0013_35_c_2016_66			
Action/Comments				
Inspector Comments: Remove woody vegetation in the channel.

View of vegetation downstream of Whealan Road. Summer 2020

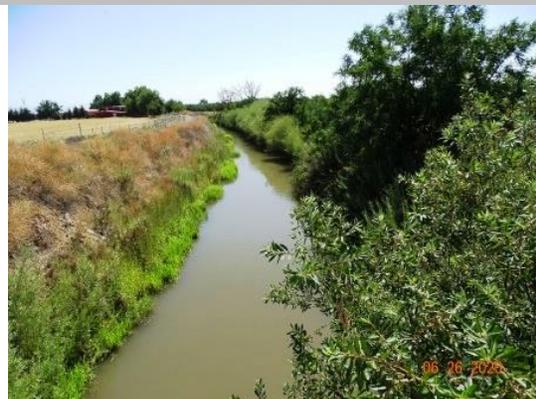
Photo 1 of 1 : CH\_2020\_NA0013\_35\_71\_20200716\_00126.jpg

Check Point / View			
<b>Arboleda Rd / Up</b>			
Rating **	M	Issue No.	71
Issue Type +	Ma	Location *	GPS Lat/Long
Category	Rivers, Channels & Designated Flood		37.257036 °
Item	Vegetation & Obstructions		-120.379219 °
DWR ID	DWR_NA0013_35_c_2016_71		
Action/Comments			
Inspector Comments: Control the vegetation growth on the left bank.

View of vegetation upstream of Arboleda Road crossing. Summer 2020

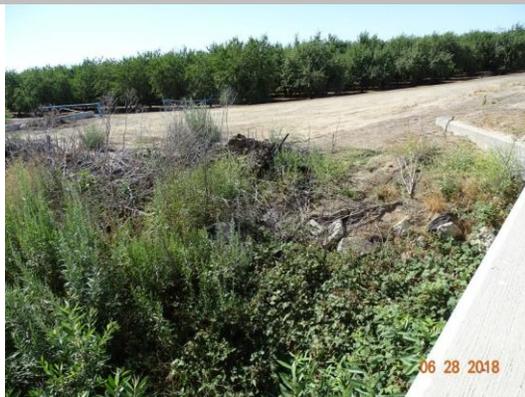
Photo 1 of 2 : CH\_2020\_NA0013\_35\_74\_20200622\_00054.jpg

Rating **	A	Issue No. <b>74</b>	GPS Lat/Long
Issue Type +	Ma	Location *	37.257036 °
Category	Rivers, Channels & Designated Flood		-120.379219 °
Item	Revetments		
DWR ID	DWR_NA0013_35_c_2016_74		
Action/Comments			
Inspector Comments: Revetment consists of broken concrete and is visible on both banks.

View of left bank riprap. Summer 2018

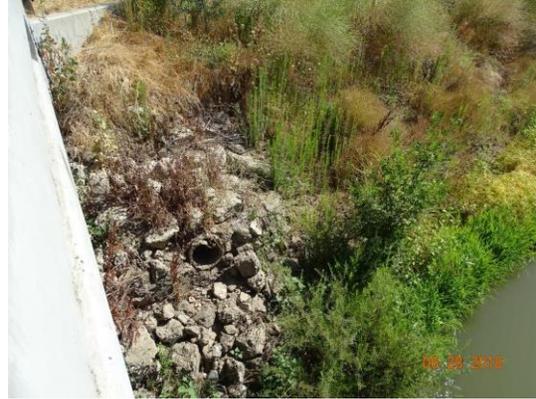
Photo 2 of 2 : CH\_2020\_NA0013\_35\_74\_20200622\_00055.jpg

Check Point / View			
<b>Arboleda Rd / Up (cont)</b>			
Rating **	A	Issue No.	<b>74 (cont)</b>
Issue Type +	Ma	Location *	GPS Lat/Long
Category	Rivers, Channels & Designated Flood		-120.379219 °
Item	Revetments		
DWR ID	DWR_NA0013_35_c_2016_74		
Action/Comments			
Inspector Comments: Revetment consists of broken concrete and is visible on both banks.

View of right bank riprap. Summer 2018

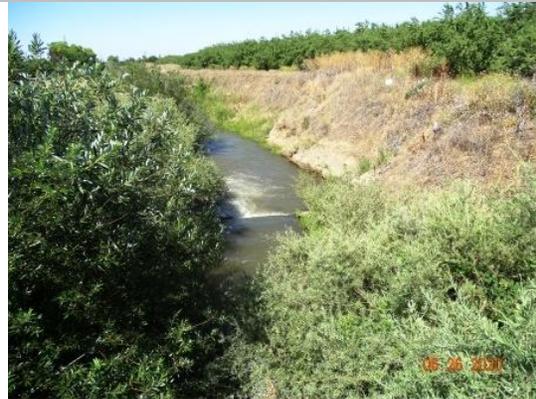
Photo 1 of 1 : CH\_2020\_NA0013\_35\_76\_20200716\_00127.jpg

Check Point / View				
<b>Arboleda Rd / Down</b>				
Rating **	M	Issue No.	<b>76</b>	GPS Lat/Long
Issue Type +	Ma	Location *		37.257036 °
Category	Rivers, Channels & Designated Flood			-120.379219 °
Item	Vegetation & Obstructions			
DWR ID	DWR_NA0013_35_c_2016_76			
Action/Comments				
Inspector Comments: Remove woody vegetation from the channel.

View of vegetation downstream of Arboleda Road crossing. Summer 2020

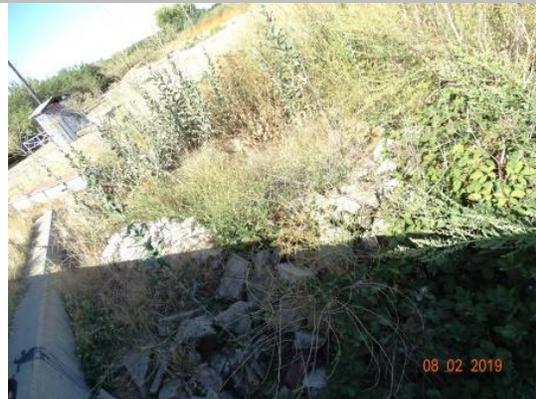
Photo 1 of 2 : CH\_2020\_NA0013\_35\_79\_20200622\_00062.jpg

View of riprap on the left bank. Summer 2019

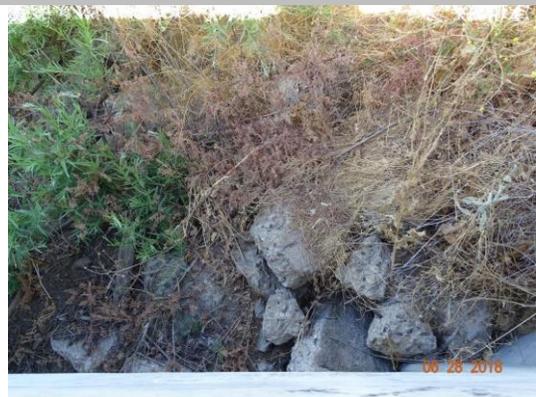
Photo 2 of 2 : CH\_2020\_NA0013\_35\_79\_20200622\_00063.jpg

View of riprap on right bank. Summer 2018

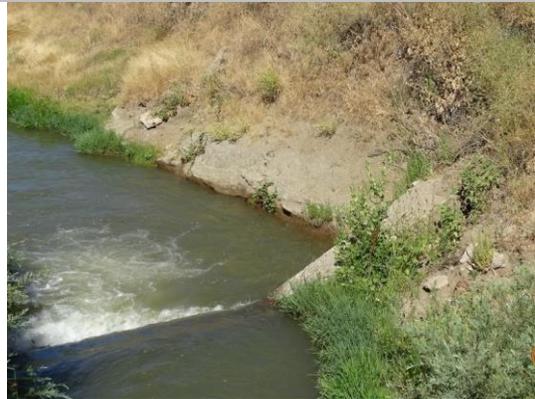
Photo 1 of 1 : CH\_2020\_NA0013\_35\_80\_20200622\_00064.jpg

Check Point / View				
<b>Arboleda Rd / Down (cont)</b>				
Rating **	U	Issue No.	<b>80</b>	GPS Lat/Long
Issue Type +	En	Location *		37.257036 °
Category	Rivers, Channels & Designated Flood			-120.379219 °
Item	Encroachments			
DWR ID	DWR_NA0013_35_c_2016_80			
Action/Comments				
Inspector Comments: A longstanding concrete weir or dam structure exists across the channel without an apparent permit.

View of a longstanding concrete weir or dam structure across the channel. Summer 2018

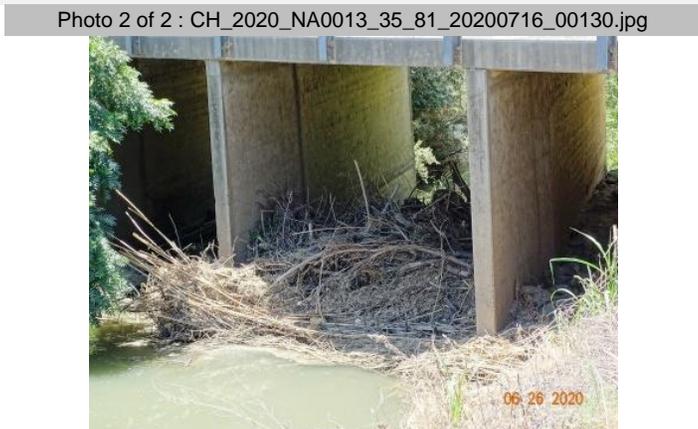
Check Point / View				
<b>Healy Rd / Up (cont)</b>				
Rating **	M	Issue No.	<b>81 (cont)</b>	GPS Lat/Long
Issue Type +	Ma	Location *		37.246003 °
Category	Rivers, Channels & Designated Flood			-120.434235 °
Item	Vegetation & Obstructions			
DWR ID	DWR_NA0013_35_c_2016_81			
Action/Comments				
Inspector Comments: Control the wild growth on the left bank, and remove debris from underneath the crossing.

View of vegetation upstream of Healy Road crossing. Summer 2020

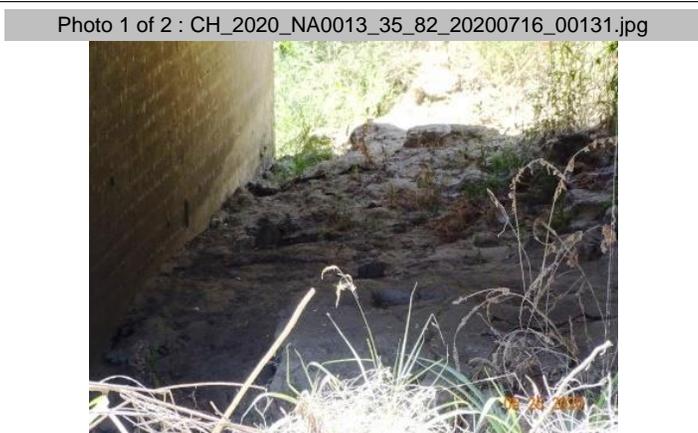
Rating **	M	Issue No.	<b>82</b>	GPS Lat/Long
Issue Type +	Ma	Location *		37.246003 °
Category	Rivers, Channels & Designated Flood			-120.434235 °
Item	Shoaling / Sedimentation			
DWR ID	DWR_NA0013_35_c_2016_82			
Action/Comments				
Inspector Comments: Sedimentation in the northernmost bay of the bridge is diverting flows to the south bays.

View of sedimentation underneath Healy Road crossing. Summer 2020

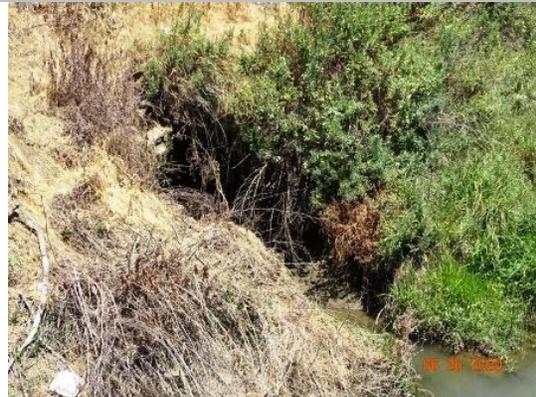
Photo 2 of 3 : CH\_2020\_NA0013\_35\_83\_20200716\_00132.jpg

Check Point / View				
<b>Healy Rd / Up (cont)</b>				
Rating **	U	Issue No.	<b>83</b>	GPS Lat/Long
Issue Type +	Ma	Location *		37.246003 °
Category	Rivers, Channels & Designated Flood			-120.434235 °
Item	Erosion / Bank Caving			
DWR ID	DWR_NA0013_35_c_2016_83			
Action/Comments				
Inspector Comments: Repair erosion around the drainage outlets on both banks.

View of erosion at the drainage outlet on the right bank. Summer 2020

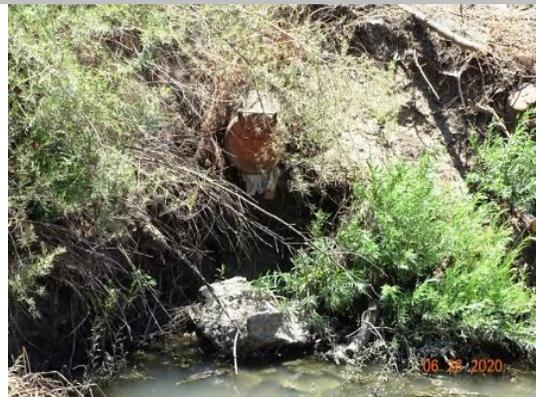
Photo 3 of 3 : CH\_2020\_NA0013\_35\_83\_20200716\_00134.jpg

View of erosion at the drainage outlet on the left bank. Summer 2020

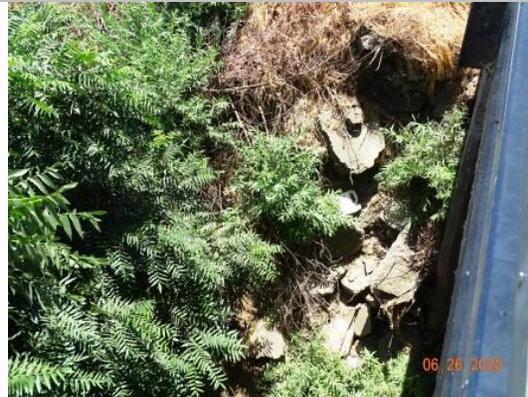
Photo 1 of 1 : CH\_2020\_NA0013\_35\_84\_20200716\_00135.jpg

Check Point / View			
<b>Healy Rd / Up (cont)</b>			
Rating **	M	Issue No. <b>84</b>	GPS Lat/Long
Issue Type +	Ma	Location *	37.246003 °
Category	Rivers, Channels & Designated Flood		-120.434235 °
Item	Revetments		
DWR ID	DWR_NA0013_35_c_2016_84		
Action/Comments			
Inspector Comments: The vegetation over riprap must be cleared.

View of revetment covered by vegetation on the left bank. Summer 2020

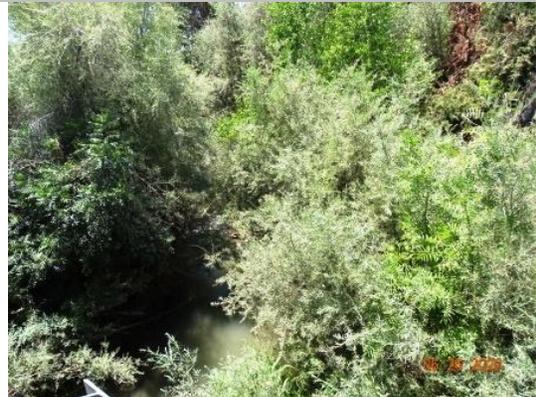
Photo 1 of 2 : CH\_2020\_NA0013\_35\_86\_20200716\_00136.jpg

Check Point / View				
<b>Healy Rd / Down</b>				
Rating **	U	Issue No.	<b>86</b>	GPS Lat/Long
Issue Type +	Ma	Location *		37.246003 °
Category	Rivers, Channels & Designated Flood			-120.434235 °
Item	Vegetation & Obstructions			
DWR ID	DWR_NA0013_35_c_2016_86			
Action/Comments				
Inspector Comments: Control the wild vegetation growth on both banks of the channel, which is impeding flows.

View of vegetation in the channel and along the banks. Summer 2020

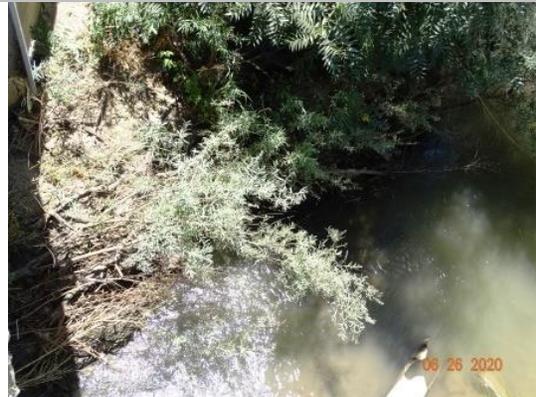
Photo 2 of 2 : CH\_2020\_NA0013\_35\_86\_20200716\_00137.jpg

View of vegetation on the left bank . Summer 2020

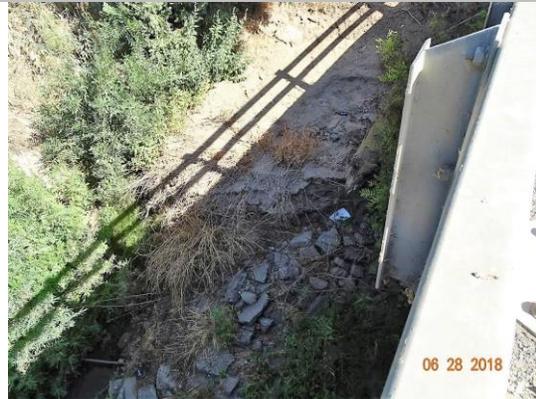
Photo 1 of 2 : CH\_2020\_NA0013\_35\_88\_20200622\_00072.jpg

Check Point / View			
<b>Healy Rd / Down (cont)</b>			
Rating **	M	Issue No.	<b>88</b>
Issue Type +	Ma	Location *	37.246003 °
Category	Rivers, Channels & Designated Flood		-120.434235 °
Item	Erosion / Bank Caving		
DWR ID	DWR_NA0013_35_c_2016_88		
Action/Comments			
Inspector Comments: Erosion near the crossing on both banks may affect infrastructure in the future.

View of erosion on the right bank. Summer 2018

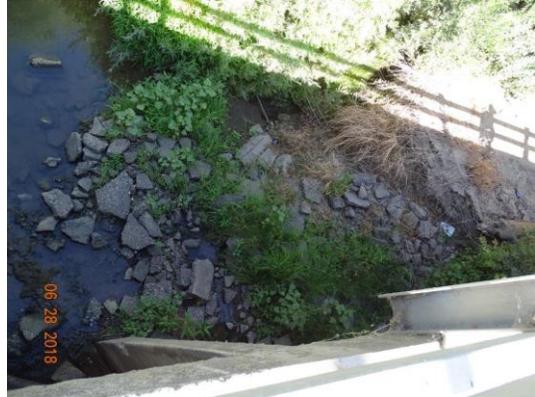
Photo 2 of 2 : CH\_2020\_NA0013\_35\_89\_20200622\_00075.jpg

Check Point / View			
<b>Healy Rd / Down (cont)</b>			
Rating **	M	Issue No. <b>89 (cont)</b>	GPS Lat/Long
Issue Type +	Ma	Location *	37.246003 °
Category	Rivers, Channels & Designated Flood		-120.434235 °
Item	Revetments		
DWR ID	DWR_NA0013_35_c_2016_89		
Action/Comments			
Inspector Comments: Vegetation covering riprap needs to be cleared, and some broken concrete shifted to the channel.

View of revetment partially covered by vegetation. Summer 2018

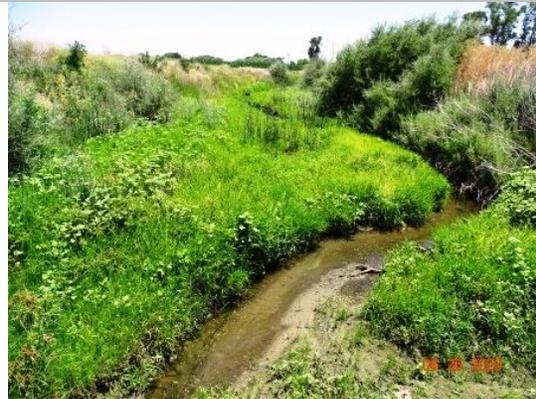
Photo 1 of 1 : CH\_2020\_NA0013\_35\_91\_20200716\_00139.jpg

Check Point / View				
<b>Hwy 59 / Up</b>				
Rating **	M	Issue No.	<b>91</b>	GPS Lat/Long
Issue Type +	Ma	Location *		37.233949 °
Category	Rivers, Channels & Designated Flood			-120.488009 °
Item	Vegetation & Obstructions			
DWR ID	DWR_NA0013_35_c_2016_91			
Action/Comments				
Inspector Comments: Remove woody vegetation from the channel.

View of vegetation in the channel upstream of Hwy 59 crossing. Summer 2020

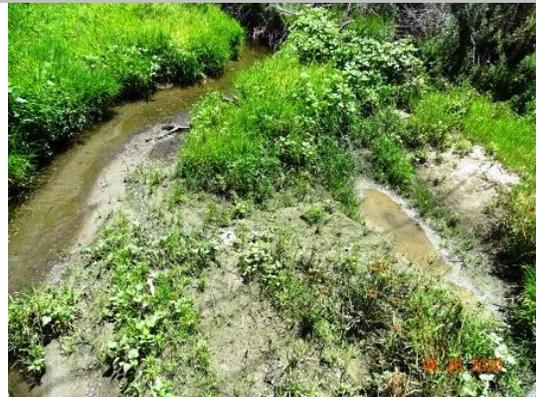
Photo 1 of 2 : CH\_2020\_NA0013\_35\_92\_20200716\_00140.jpg

Rating **	M	Issue No.	<b>92</b>	GPS Lat/Long
Issue Type +	Ma	Location *		37.233949 °
Category	Rivers, Channels & Designated Flood			-120.488009 °
Item	Shoaling / Sedimentation			
DWR ID	DWR_NA0013_35_c_2016_92			
Action/Comments				
Inspector Comments: Non-aquatic grasses are present on shoal but do not appear to impede flow at this time.

View of shoaling with vegetation in the channel. Summer 2020

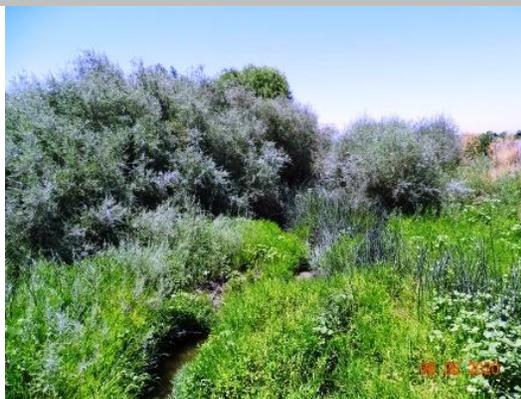
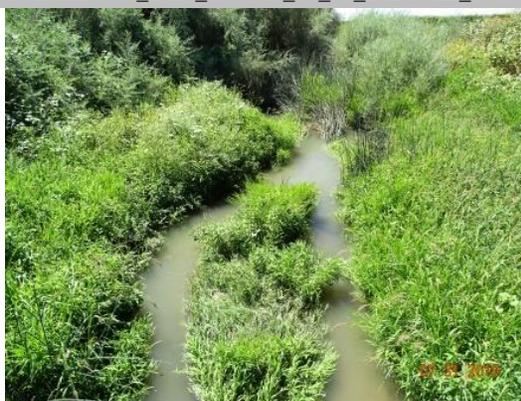
Check Point / View				
<b>Hwy 59 / Down</b>				
Rating **	U	Issue No.	<b>96</b>	GPS Lat/Long
Issue Type +	Ma	Location *		37.233949 °
Category	Rivers, Channels & Designated Flood			-120.488009 °
Item	Vegetation & Obstructions			
DWR ID	DWR_NA0013_35_c_2016_96			
Action/Comments				
Inspector Comments: The wild growth on both banks will likely impede flow and needs to be controlled.

View of vegetation downstream of the Hwy 59 crossing. Summer 2020

View of vegetation downstream of the Hwy 59 crossing. Summer 2019

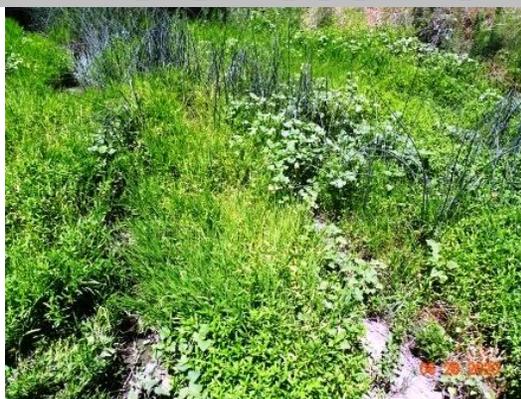
Photo 1 of 1 : CH\_2020\_NA0013\_35\_97\_20200716\_00142.jpg

Rating **	M	Issue No.	<b>97</b>	GPS Lat/Long
Issue Type +	Ma	Location *		37.233949 °
Category	Rivers, Channels & Designated Flood			-120.488009 °
Item	Shoaling / Sedimentation			
DWR ID	DWR_NA0013_35_c_2016_97			
Action/Comments				
Inspector Comments: Non-aquatic grasses are present on the shoal.

View of the shoal downstream of Hwy 59 crossing. Summer 2020

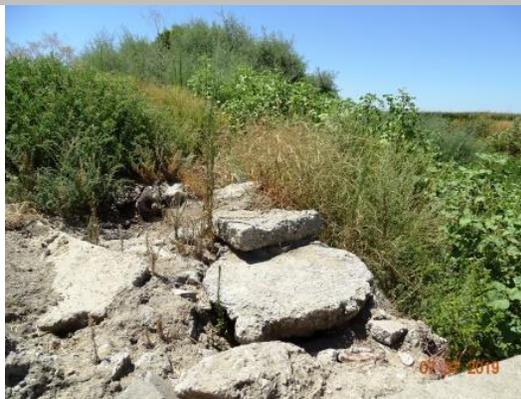
Photo 1 of 1 : CH\_2020\_NA0013\_35\_99\_20200622\_00085.jpg

Rating **	A	Issue No.	<b>99</b>	GPS Lat/Long
Issue Type +	Ma	Location *		37.233949 °
Category	Rivers, Channels & Designated Flood			-120.488009 °
Item	Revetments			
DWR ID	DWR_NA0013_35_c_2016_99			
Action/Comments				
Inspector Comments: Some concrete riprap exists on the left bank.

View of broken concrete riprap on left bank. Summer 2019

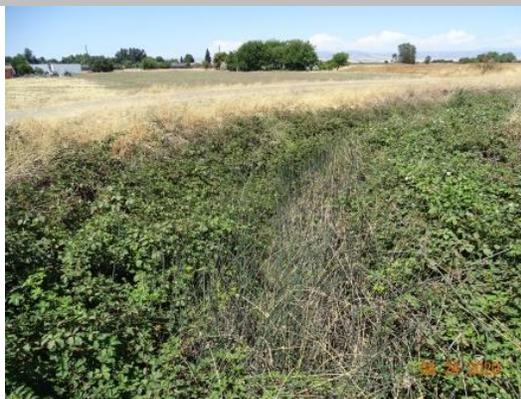
Photo 1 of 1 : CH\_2020\_NA0013\_36\_1\_20200703\_00070.jpg

Rating **	U	Issue No.	1	GPS Lat/Long
Issue Type +	Ma	Location *		37.287900 °
Category	Rivers, Channels & Designated Flood			-120.309480 °
Item	Vegetation & Obstructions			
DWR ID	DWR_NA0013_36_c_2012_1			
Action/Comments				
Inspector Comments: Remove bushes that impede flows.

View of vegetation upstream of Childs Avenue crossing. Summer 2020

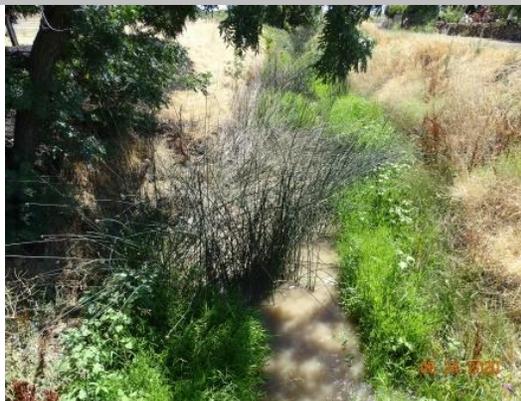
Photo 1 of 1 : CH\_2020\_NA0013\_36\_6\_20200703\_00071.jpg

View of vegetation downstream of Childs Avenue crossing. Summer 2020

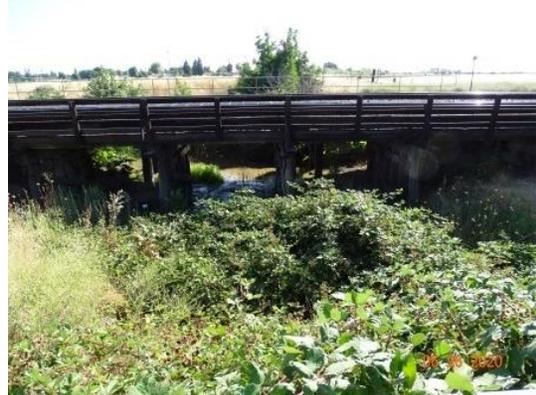
Photo 1 of 2 : CH\_2020\_NA0013\_36\_11\_20200703\_00072.jpg

Check Point / View				
<b>Santa Fe Dr / Up</b>				
Rating **	M	Issue No.	11	GPS Lat/Long
Issue Type +	Ma	Location *		37.284356 °
Category	Rivers, Channels & Designated Flood			-120.315478 °
Item	Vegetation & Obstructions			
DWR ID	DWR_NA0013_36_c_2012_11			
Action/Comments				
Inspector Comments: Blackberry bushes and a few trees are growing near the bridge which may impede flow; vegetation and driftwood need to be cleared.

View of vegetation upstream of Santa Fe Avenue crossing. Summer 2020

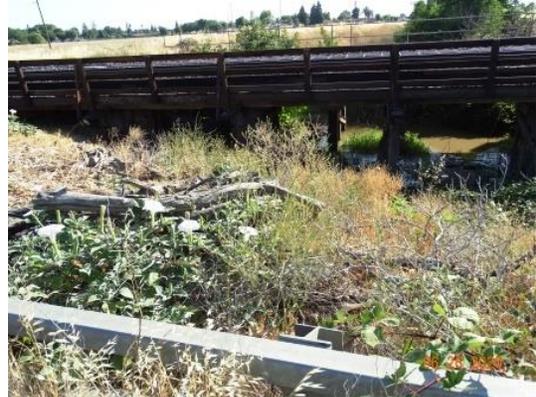
Photo 2 of 2 : CH\_2020\_NA0013\_36\_11\_20200703\_00073.jpg

Check Point / View				
<b>Santa Fe Dr / Up (cont)</b>				
Rating **	M	Issue No.	<b>11 (cont)</b>	GPS Lat/Long
Issue Type +	Ma	Location *		37.284356 °
Category	Rivers, Channels & Designated Flood			-120.315478 °
Item	Vegetation & Obstructions			
DWR ID	DWR_NA0013_36_c_2012_11			
Action/Comments				
Inspector Comments: Blackberry bushes and a few trees are growing near the bridge which may impede flow; vegetation and driftwood need to be cleared.

View of log jams on the right bank upstream of Santa Fe Avenue crossing. Summer 2020

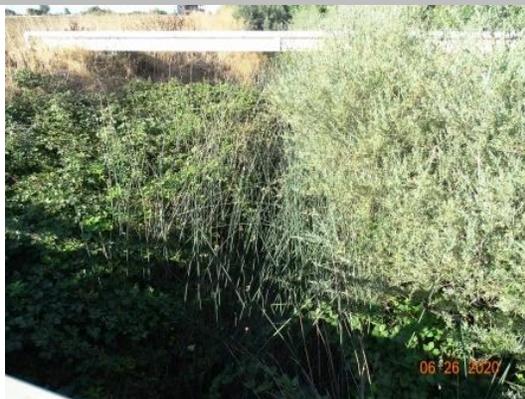
Photo 1 of 2 : CH\_2020\_NA0013\_36\_16\_20200703\_00074.jpg

Check Point / View			
<b>Santa Fe Dr / Down</b>			
Rating **	U	Issue No.	16
Issue Type +	Ma	Location *	37.284356 °
Category	Rivers, Channels & Designated Flood		-120.315478 °
Item	Vegetation & Obstructions		
DWR ID	DWR_NA0013_36_c_2012_16		
Action/Comments			
Inspector Comments: Woody vegetation and wild berry bushes impede flow and should be cleared at least 100 feet downstream.

View of vegetation downstream of the Santa Fe Avenue crossing. Summer 2020

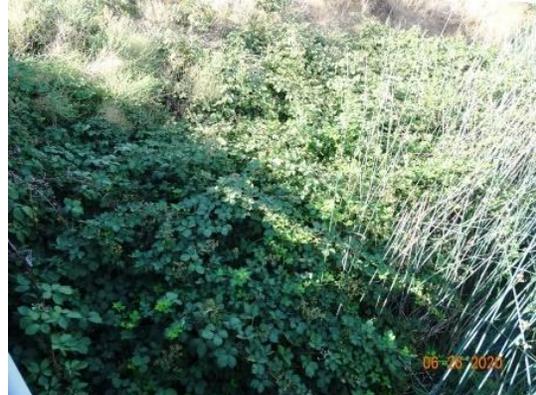
Photo 2 of 2 : CH\_2020\_NA0013\_36\_16\_20200703\_00075.jpg

Check Point / View				
<b>Santa Fe Dr / Down (cont)</b>				
Rating **	U	Issue No.	<b>16 (cont)</b>	GPS Lat/Long
Issue Type +	Ma	Location *		37.284356 °
Category	Rivers, Channels & Designated Flood			-120.315478 °
Item	Vegetation & Obstructions			
DWR ID	DWR_NA0013_36_c_2012_16			
Action/Comments				
Inspector Comments: Woody vegetation and wild berry bushes impede flow and should be cleared at least 100 feet downstream.

View of berry bushes downstream of the Santa Fe Avenue crossing. Summer 2020

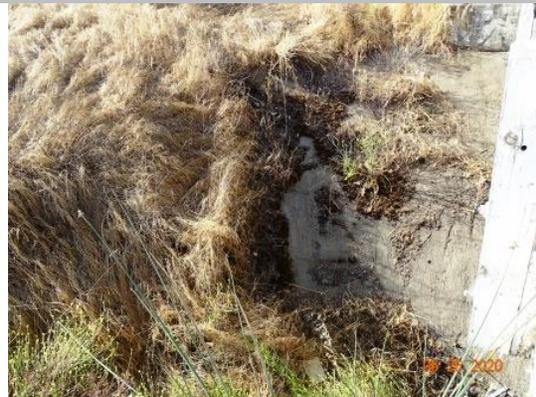
Photo 1 of 1 : CH\_2020\_NA0013\_36\_24\_20200703\_00077.jpg

Rating **	N	Issue No.	24	GPS Lat/Long
Issue Type +	Ma	Location *		37.282285 °
Category	Rivers, Channels & Designated Flood			-120.324890 °
Item	Revetments			
DWR ID	DWR_NA0013_36_c_2012_24			
Action/Comments				
Inspector Comments: The channel is concrete-lined at the bridge.

View of concrete-lined channel section under the bridge. Summer 2020

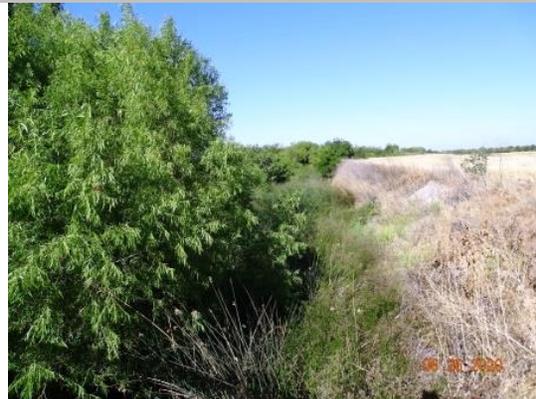
Photo 1 of 1 : CH\_2020\_NA0013\_36\_26\_20200703\_00078.jpg

Check Point / View				
<b>Plainsburg Rd / Down</b>				
Rating **	M	Issue No.	26	GPS Lat/Long
Issue Type +	Ma	Location *		37.282060 °
Category	Rivers, Channels & Designated Flood			-120.324870 °
Item	Vegetation & Obstructions			
DWR ID	DWR_NA0013_36_c_2012_26			
Action/Comments				
Inspector Comments: Woody vegetation in the channel should be maintained to prevent a reduction in channel capacity.

View of vegetation downstream of Plainsburg Road crossing. Summer 2020

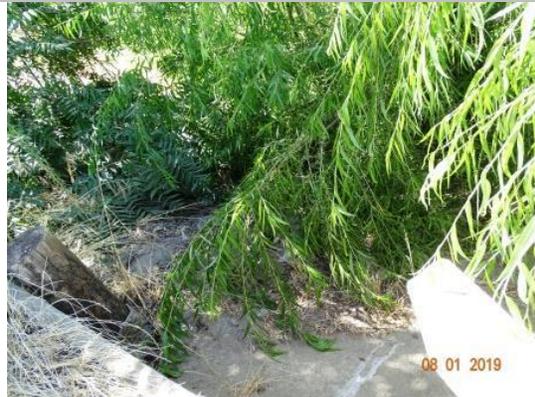
Photo 1 of 1 : CH\_2020\_NA0013\_36\_29\_20200622\_00014.jpg

Rating **	N	Issue No.	<b>29</b>	GPS Lat/Long
Issue Type +	Ma	Location *		37.282060 °
Category	Rivers, Channels & Designated Flood			-120.324870 °
Item	Revetments			
DWR ID	DWR_NA0013_36_c_2012_29			
Action/Comments				
Inspector Comments: The channel is concrete-lined at the bridge.

View of the concrete-lined channel section underneath the bridge.  
Summer 2019

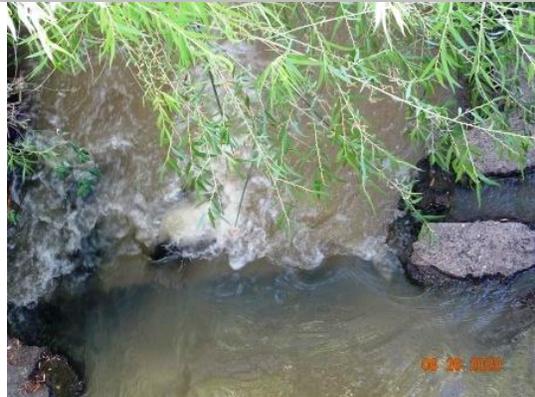
Photo 1 of 1 : CH\_2020\_NA0013\_36\_30\_20200703\_00079.jpg

Check Point / View				
<b>Plainsburg Rd / Down (cont)</b>				
Rating **	M	Issue No.	<b>30</b>	GPS Lat/Long
Issue Type +	En	Location *		37.282285 °
Category	Rivers, Channels & Designated Flood			-120.324890 °
Item	Encroachments			
DWR ID	DWR_NA0013_36_c_2012_30			
Action/Comments				
Inspector Comments: There is a concrete weir or dam structure across the creek that does not appear to have a permit.

View of concrete dam or weir structure downstream of Plainsburg Road crossing. Summer 2020

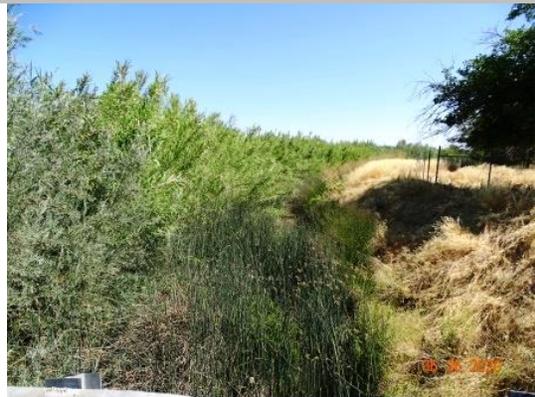
Photo 1 of 1 : CH\_2020\_NA0013\_36\_31\_20200716\_00080.jpg

Check Point / View				
<b>Gerard Ave / Up</b>				
Rating **	M	Issue No.	<b>31</b>	GPS Lat/Long
Issue Type +	Ma	Location *		37.280720 °
Category	Rivers, Channels & Designated Flood			-120.331200 °
Item	Vegetation & Obstructions			
DWR ID	DWR_NA0013_36_c_2012_31			
Action/Comments				
Inspector Comments: Arundo in the channel should be cleared.

View of vegetation upstream of Gerard Avenue crossing. Summer 2020

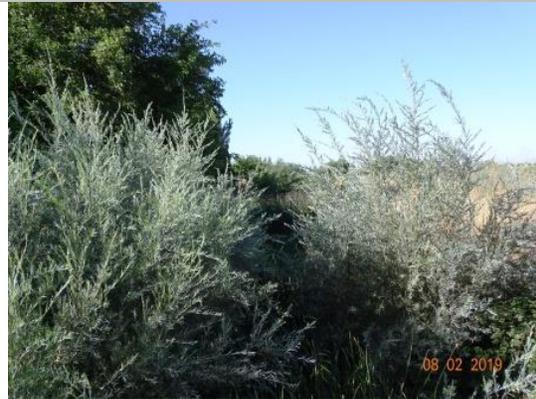
Photo 2 of 2 : CH\_2020\_NA0013\_36\_36\_20200622\_00019.jpg

Check Point / View			
<b>Gerard Ave / Down (cont)</b>			
Rating **	M	Issue No. <b>36 (cont)</b>	GPS Lat/Long
Issue Type +	Ma	Location *	37.280720 °
Category	Rivers, Channels & Designated Flood		-120.331200 °
Item	Vegetation & Obstructions		
DWR ID	DWR_NA0013_36_c_2012_36		
Action/Comments			
Inspector Comments: Vegetation may impede flow and needs to be cleared.

View of vegetation in the channel. Summer 2019

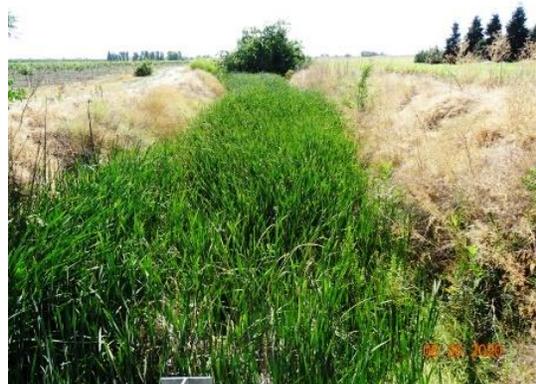
Photo 1 of 1 : CH\_2020\_NA0013\_36\_41\_20200716\_00082.jpg

Check Point / View			
<b>Whealan Rd / Up</b>			
Rating **	M	Issue No.	41
Issue Type +	Ma	Location *	37.278630 °
Category	Rivers, Channels & Designated Flood		-120.343030 °
Item	Vegetation & Obstructions		
DWR ID	DWR_NA0013_36_c_2012_41		
Action/Comments			
Inspector Comments: Vegetation in the channel may impede flow and should be cleared.

View of vegetation upstream of the Whealan Road crossing. Summer 2020

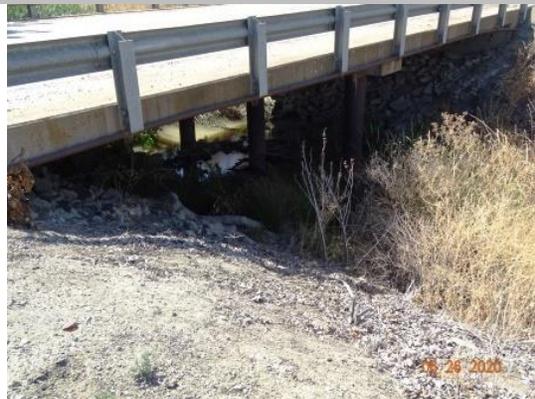
Photo 1 of 1 : CH\_2020\_NA0013\_36\_44\_20200716\_00084.jpg

Rating **	A	Issue No.	44	GPS Lat/Long
Issue Type +	Ma	Location *		37.278696 °
Category	Rivers, Channels & Designated Flood			-120.343030 °
Item	Revetments			
DWR ID	DWR_NA0013_36_c_2012_44			
Action/Comments

View of revetment underneath the bridge. Summer 2020

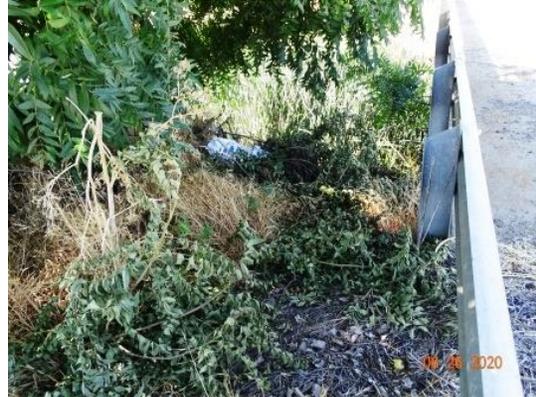
Photo 1 of 1 : CH\_2020\_NA0013\_36\_45\_20200716\_00085.jpg

Check Point / View			
<b>Whealan Rd / Up (cont)</b>			
Rating **	A	Issue No.	45
Issue Type +	Ma	Location *	37.278696 °
Category	Rivers, Channels & Designated Flood		-120.343030 °
Item	Encroachments		
DWR ID	DWR_NA0013_36_c_2012_45		
Action/Comments			
Inspector Comments: Remove prunings from the right bank.

View of prunings on the right bank Summer 2020

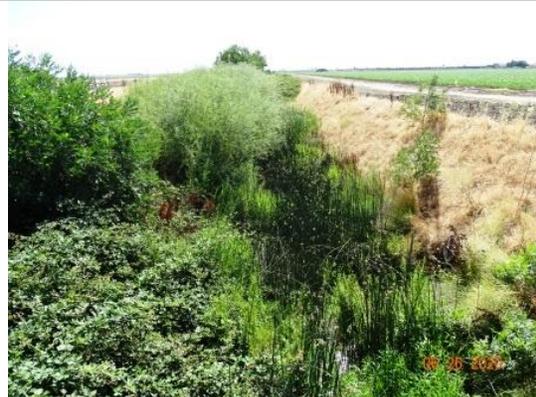
Photo 1 of 2 : CH\_2020\_NA0013\_36\_51\_20200716\_00087.jpg

Check Point / View				
<b>Arboleda Dr / Up</b>				
Rating **	M	Issue No.	51	GPS Lat/Long
Issue Type +	Ma	Location *		37.272980 °
Category	Rivers, Channels & Designated Flood			-120.379090 °
Item	Vegetation & Obstructions			
DWR ID	DWR_NA0013_36_c_2012_51			
Action/Comments				
Inspector Comments: Vegetation in the channel and berry bushes on the right bank need to be cleared.

View of vegetation upstream of Arboleda Drive crossing. Summer 2020

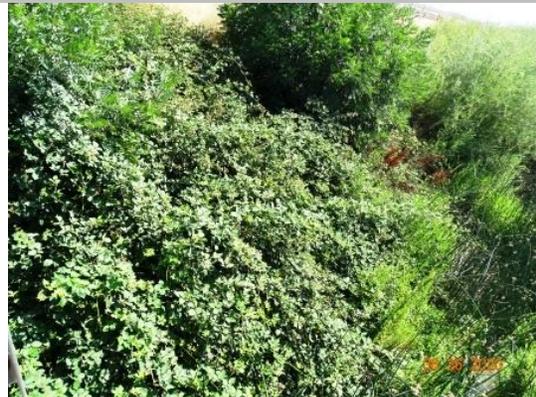
Photo 2 of 2 : CH\_2020\_NA0013\_36\_51\_20200716\_00088.jpg

View of wild berry bushes on the right bank. Summer 2020

Rating **	M	Issue No.	51 (cont)	GPS Lat/Long
Issue Type +	Ma	Location *		37.272980 °
Category	Rivers, Channels & Designated Flood			-120.379090 °
Item	Vegetation & Obstructions			
DWR ID	DWR_NA0013_36_c_2012_51

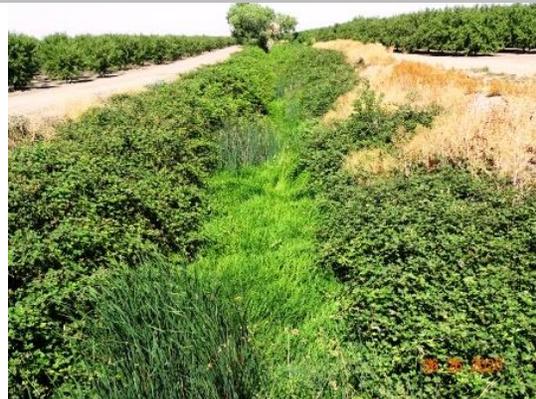
Photo 1 of 1 : CH\_2020\_NA0013\_36\_56\_20200716\_00089.jpg

Check Point / View			
<b>Arboleda Dr / Down</b>			
Rating **	M	Issue No.	56
Issue Type +	Ma	Location *	37.272980 °
Category	Rivers, Channels & Designated Flood		-120.379090 °
Item	Vegetation & Obstructions		
DWR ID	DWR_NA0013_36_c_2012_56		
Action/Comments			
Inspector Comments: Clear vines that may reduce channel capacity.

View of vegetation downstream of Arboleda Drive crossing. Summer 2020

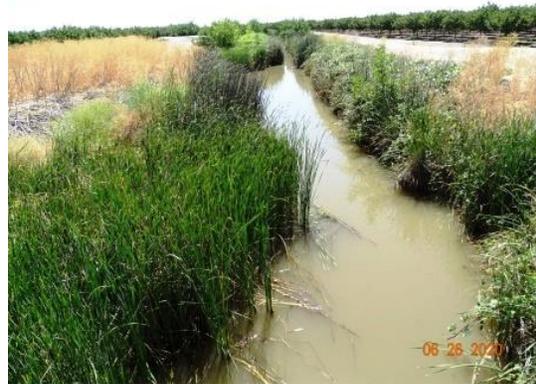
Photo 1 of 1 : CH\_2020\_NA0013\_36\_61\_20200716\_00090.jpg

Check Point / View				
<b>Orchard Rd / Up</b>				
Rating **	M	Issue No.	<b>61</b>	GPS Lat/Long
Issue Type +	Ma	Location *		37.269380 °
Category	Rivers, Channels & Designated Flood			-120.397470 °
Item	Vegetation & Obstructions			
DWR ID	DWR_NA0013_36_c_2014_61			
Action/Comments				
Inspector Comments: Cat tail growth needs to be removed from the channel.

View of vegetation upstream of Orchard Road crossing. Summer 2020

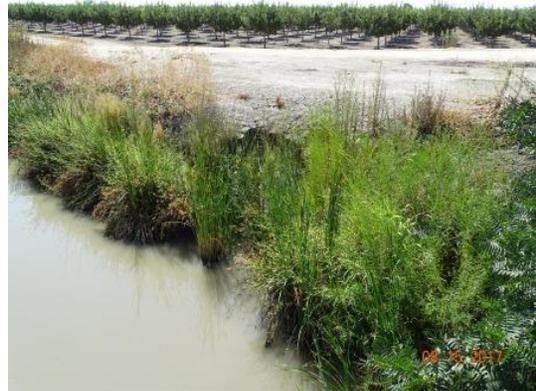
Photo 2 of 2 : CH\_2020\_NA0013\_36\_63\_20200622\_00035.jpg

Check Point / View			
<b>Orchard Rd / Up (cont)</b>			
Rating **	M	Issue No. <b>63 (cont)</b>	GPS Lat/Long
Issue Type +	Ma	Location *	37.269380 °
Category	Rivers, Channels & Designated Flood		-120.397470 °
Item	Erosion / Bank Caving		
DWR ID	DWR_NA0013_36_c_2012_63		
Action/Comments			
Inspector Comments: Erosion on the left bank is covered with vegetation.

View of the erosion in the channel. Summer 2017

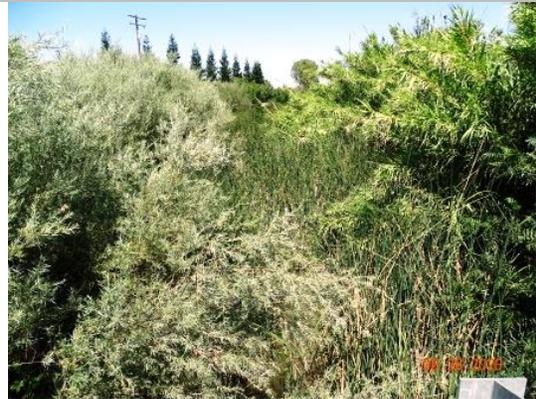
Photo 1 of 2 : CH\_2020\_NA0013\_36\_66\_20200716\_00092.jpg

Check Point / View				
<b>Orchard Rd / Down</b>				
Rating **	U	Issue No.	<b>66</b>	GPS Lat/Long
Issue Type +	Ma	Location *		37.269380 °
Category	Rivers, Channels & Designated Flood			-120.397470 °
Item	Vegetation & Obstructions			
DWR ID	DWR_NA0013_36_c_2012_66			
Action/Comments				
Inspector Comments: Excessive vegetation and Arundo impede flow and should be cleared at least 100 feet downstream.

View of vegetation downstream of Orchard Road crossing and Arundo on the right bank. Summer 2020

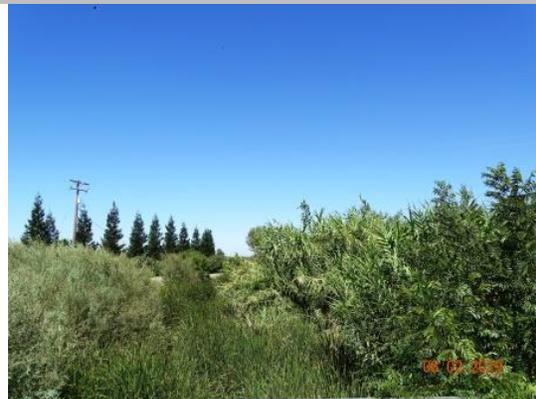
Photo 2 of 2 : CH\_2020\_NA0013\_36\_66\_20200622\_00036.jpg

Rating **	U	Issue No.	<b>66 (cont)</b>	GPS Lat/Long
Issue Type +	Ma	Location *		37.269380 °
Category	Rivers, Channels & Designated Flood			-120.397470 °
Item	Vegetation & Obstructions			
DWR ID	DWR_NA0013_36_c_2012_66

View of vegetation in the channel and Arundo on the right bank. Summer 2019

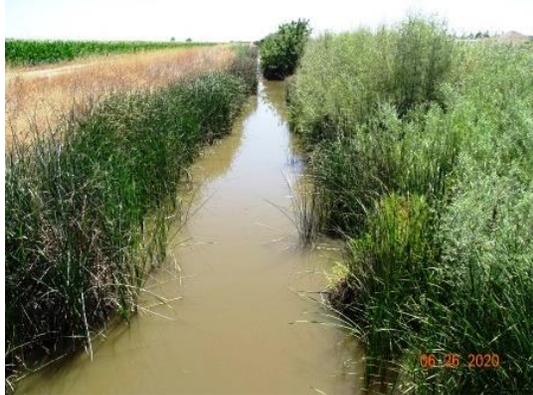
Photo 1 of 1 : CH\_2020\_NA0013\_36\_111\_20200716\_00093.jpg

Check Point / View				
<b>Miles Rd / Up</b>				
Rating **	M	Issue No.	111	GPS Lat/Long
Issue Type +	Ma	Location *		37.267185 °
Category	Rivers, Channels & Designated Flood			-120.415332 °
Item	Vegetation & Obstructions			
DWR ID	DWR_NA0013_36_c_2013_111			
Action/Comments				
Inspector Comments: Remove berry bushes from the left bank.

View of vegetation upstream of Miles Road crossing. Summer 2020

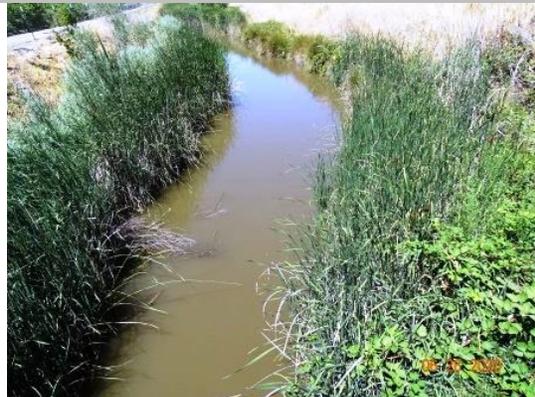
Photo 1 of 2 : CH\_2020\_NA0013\_36\_116\_20200716\_00094.jpg

Check Point / View			
<b>Miles Rd / Down</b>			
Rating **	M	Issue No. <b>116</b>	GPS Lat/Long
Issue Type +	Ma	Location *	37.267185 °
Category	Rivers, Channels & Designated Flood		-120.415332 °
Item	Vegetation & Obstructions		
DWR ID	DWR_NA0013_36_c_2013_116		
Action/Comments			
Inspector Comments: Remove wild berry bushes from the right bank.

View of vegetation downstream of Miles Road crossing. Summer 2020
