**Flood Control Project Maintenance  
Levee Inspections**

**2020 Channel Summary Report**

**Merced Streams Group**

**Levee Inspection Report By Mile - Channel 2020**

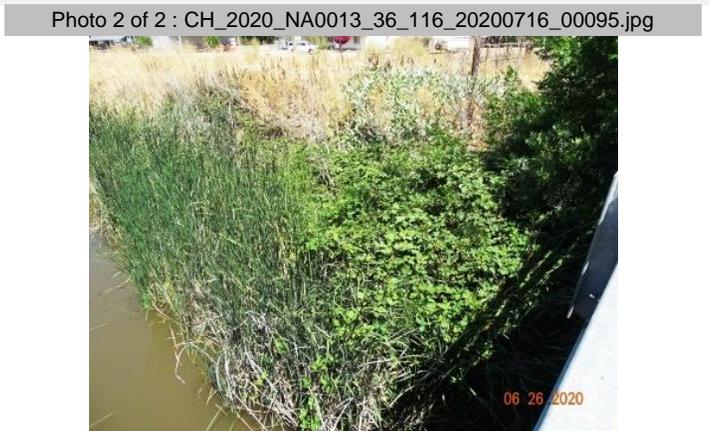
Check Point / View			
<b>Miles Rd / Down (cont)</b>			
Rating **	M	Issue No. <b>116 (cont)</b>	GPS Lat/Long
Issue Type +	Ma	Location *	37.267185 °
Category	Rivers, Channels & Designated Flood		-120.415332 °
Item	Vegetation & Obstructions		
DWR ID	DWR_NA0013_36_c_2013_116		
Action/Comments			
Inspector Comments: Remove wild berry bushes from the right bank.

View of berry bushes on the right bank. Summer 2020

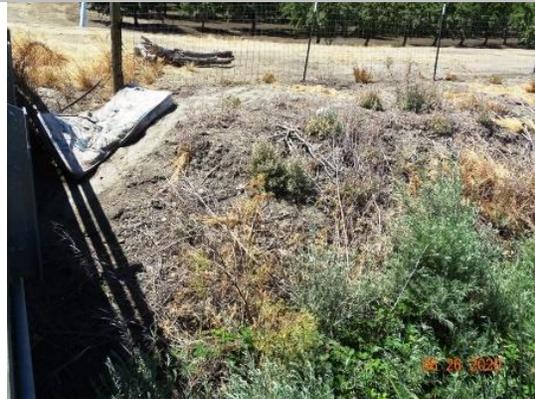
Photo 1 of 1 : CH\_2020\_NA0013\_36\_120\_20200716\_00096.jpg

Rating **	A	Issue No. <b>120</b>	GPS Lat/Long
Issue Type +	Ma	Location *	37.267270 °
Category	Rivers, Channels & Designated Flood		-120.415340 °
Item	Encroachments		
DWR ID	DWR_NA0013_36_c_2013_120		
Action/Comments			
Inspector Comments: Remove mattress from the left bank.

View of mattress on left bank. Summer 2020

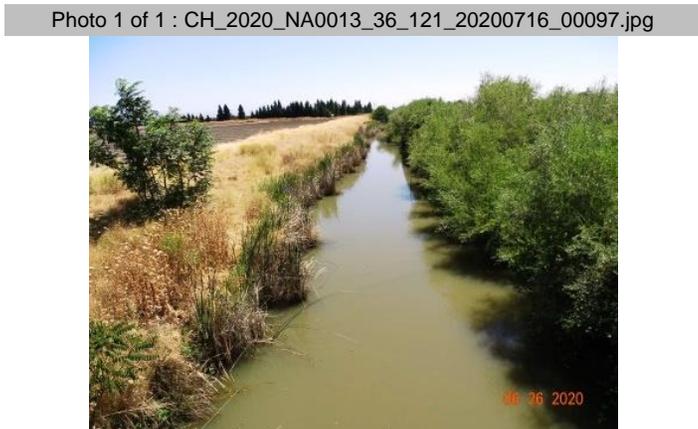
Check Point / View				
<b>Coffee St / Up</b>				
Rating **	M	Issue No.	121	GPS Lat/Long
Issue Type +	Ma	Location *		37.265040 °
Category	Rivers, Channels & Designated Flood			-120.427405 °
Item	Vegetation & Obstructions			
DWR ID	DWR_NA0013_36_c_2013_121			
Action/Comments				
Inspector Comments: Woody vegetation may impede flow.

View of vegetation upstream of Coffee Street crossing. Summer 2020

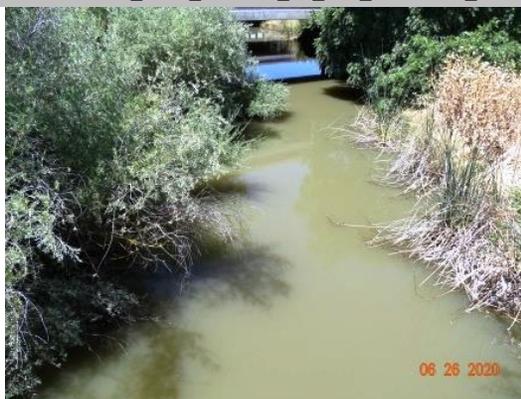
Photo 1 of 1 : CH\_2020\_NA0013\_36\_126\_20200716\_00098.jpg

Check Point / View			
<b>Coffee St / Down</b>			
Rating **	M	Issue No.	126
Issue Type +	Ma	Location *	37.265040 °
Category	Rivers, Channels & Designated Flood		-120.427410 °
Item	Vegetation & Obstructions		
DWR ID	DWR_NA0013_36_c_2013_126		
Action/Comments			
Inspector Comments: Woody vegetation on the left bank may impede flow and should be controlled.

View of vegetation downstream of Coffee Street crossing. Summer 2020

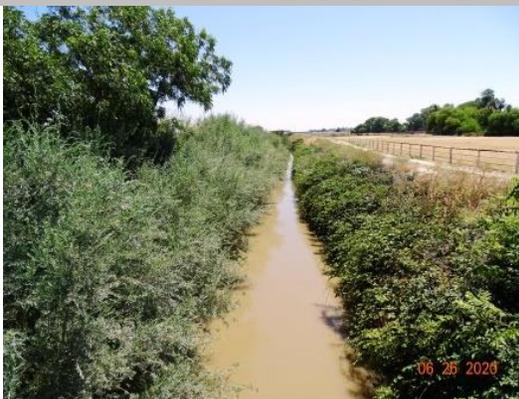
Photo 1 of 1 : CH\_2020\_NA0013\_36\_71\_20200716\_00099.jpg

Check Point / View			
<b>Healy Rd / Up</b>			
Rating **	M	Issue No.	71
Issue Type +	Ma	Location *	37.263590 °
Category	Rivers, Channels & Designated Flood		-120.434500 °
Item	Vegetation & Obstructions		
DWR ID	DWR_NA0013_36_c_2012_71		
Action/Comments			
Inspector Comments: Woody vegetation in the channel may impede flow and should be cleared at least 100 feet upstream.

View of vegetation upstream of Healy Road crossing. Summer 2020

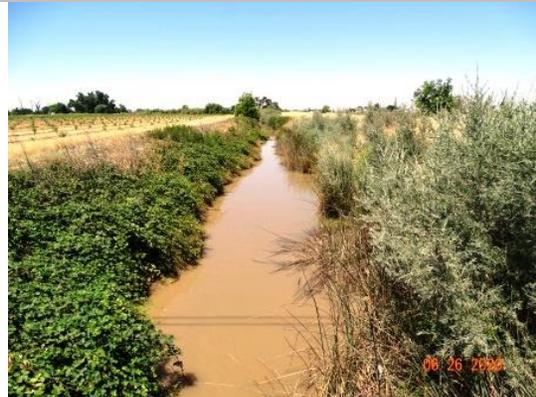
Photo 1 of 2 : CH\_2020\_NA0013\_36\_76\_20200716\_00100.jpg

Check Point / View				
<b>Healy Rd / Down</b>				
Rating **	M	Issue No.	<b>76</b>	GPS Lat/Long
Issue Type +	Ma	Location *		37.263590 °
Category	Rivers, Channels & Designated Flood			-120.434500 °
Item	Vegetation & Obstructions			
DWR ID	DWR_NA0013_36_c_2012_76			
Action/Comments				
Inspector Comments: Clear wild berry bushes on the left bank.

View of vegetation downstream of Healy Road crossing. Summer 2020

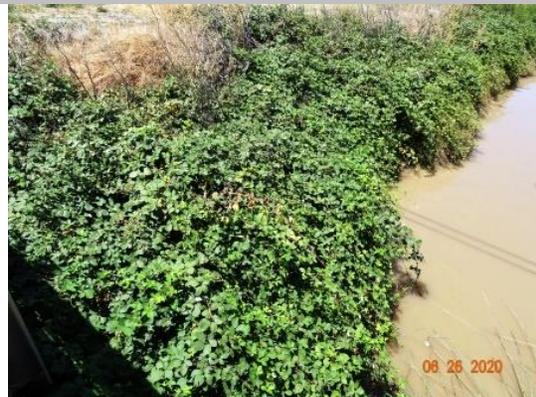
Photo 2 of 2 : CH\_2020\_NA0013\_36\_76\_20200716\_00101.jpg

View of wild berry bushes on the left bank. Summer 2020

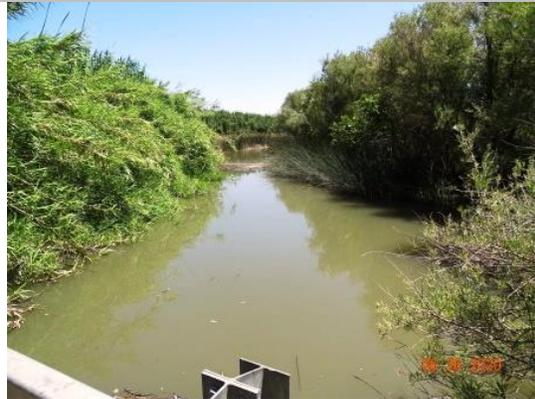
Photo 1 of 2 : CH\_2020\_NA0013\_36\_81\_20200716\_00102.jpg

Check Point / View				
<b>Tyler Rd / Up</b>				
Rating **	M	Issue No.	<b>81</b>	GPS Lat/Long
Issue Type +	Ma	Location *		37.263560 °
Category	Rivers, Channels & Designated Flood			-120.469660 °
Item	Vegetation & Obstructions			
DWR ID	DWR_NA0013_36_c_2012_81			
Action/Comments				
Inspector Comments: Woody vegetation at bridge and Arundo need to be removed. There is possible evidence of Nutria upstream.

View of vegetation upstream of Tyler Road crossing. Summer 2020

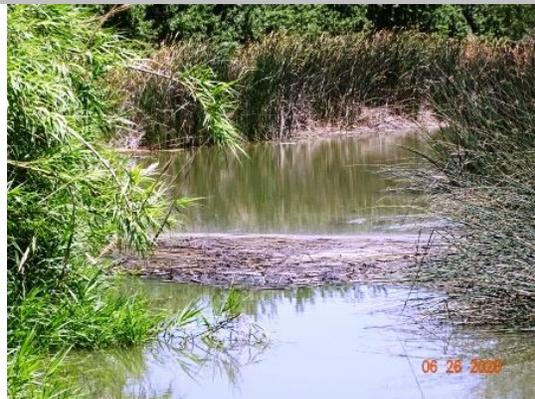
Photo 2 of 2 : CH\_2020\_NA0013\_36\_81\_20200716\_00103.jpg

View of a possible indicator of Nutria. Summer 2020

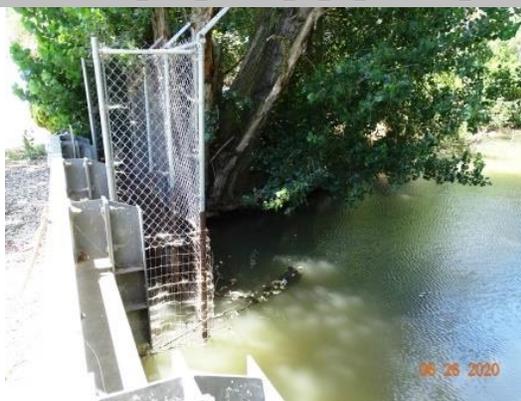
Photo 1 of 2 : CH\_2020\_NA0013\_36\_90\_20200716\_00106.jpg

Rating **	U	Issue No.	90	GPS Lat/Long
Issue Type +	En	Location *	37.263560 °	
Category	Rivers, Channels & Designated Flood		-120.469660 °	
Item	Encroachments			
DWR ID	DWR_NA0013_36_c_2012_90			
Action/Comments				
Inspector Comments: A wire fence extends across the channel by 11 feet on both sides. It may accumulate debris and restrict flow. Consider removing the lower part of the fence just below the bridge superstructure.

View of wire fencing on left bank. Summer 2020

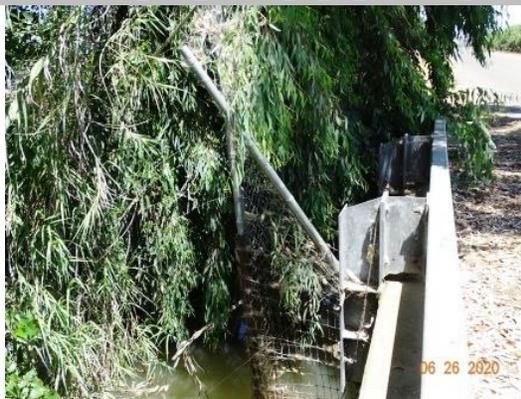
Photo 2 of 2 : CH\_2020\_NA0013\_36\_90\_20200716\_00107.jpg

Rating **	U	Issue No.	90 (cont)	GPS Lat/Long
Issue Type +	En	Location *	37.263560 °	
Category	Rivers, Channels & Designated Flood		-120.469660 °	
Item	Encroachments			
DWR ID	DWR_NA0013_36_c_2012_90

View of wire fencing on right bank. Summer 2020

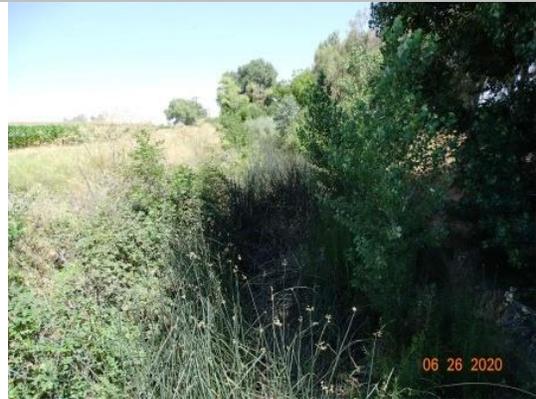
Photo 1 of 1 : CH\_2020\_NA0013\_36\_91\_20200716\_00108.jpg

Check Point / View			
<b>Reilly Rd / Up</b>			
Rating **	M	Issue No. <b>91</b>	GPS Lat/Long
Issue Type +	Ma	Location *	37.258252 °
Category	Rivers, Channels & Designated Flood		-120.475232 °
Item	Vegetation & Obstructions		
DWR ID	DWR_NA0013_36_c_2012_91		
Action/Comments			
Inspector Comments: Remove woody vegetation in the channel.

View of vegetation upstream of Reilly Road crossing. Summer 2020

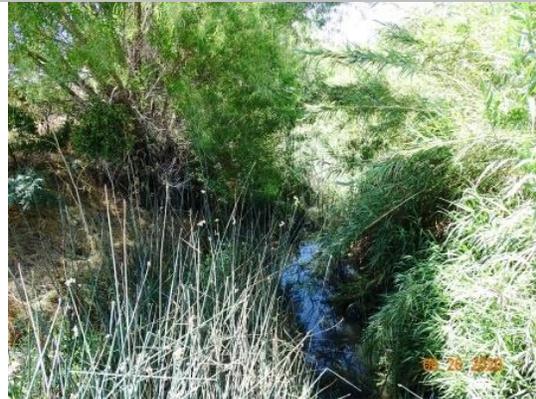
Photo 1 of 1 : CH\_2020\_NA0013\_36\_96\_20200716\_00109.jpg

Check Point / View			
<b>Reilly Rd / Down</b>			
Rating **	U	Issue No. <b>96</b>	GPS Lat/Long
Issue Type +	Ma	Location *	37.257780 °
Category	Rivers, Channels & Designated Flood		-120.475090 °
Item	Vegetation & Obstructions		
DWR ID	DWR_NA0013_36_c_2012_96		
Action/Comments			
Inspector Comments: Remove Arundo and woody vegetation from the channel that impede flows.

View of vegetation downstream of Reilly Road crossing. Summer 2020

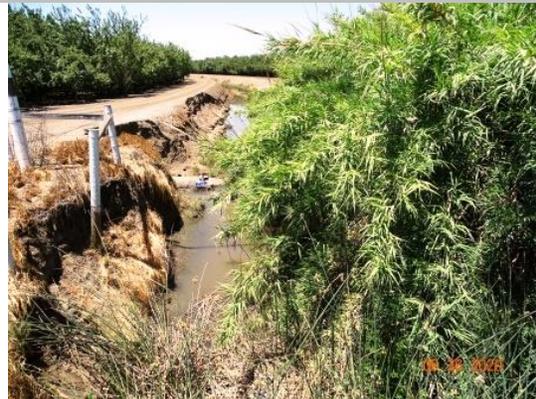
Photo 1 of 1 : CH\_2020\_NA0013\_36\_106\_20200716\_00112.jpg

Check Point / View			
<b>Hwy 59 / Down</b>			
Rating **	U	Issue No.	<b>106</b>
Issue Type +	Ma	Location *	GPS Lat/Long
Category	Rivers, Channels & Designated Flood		37.255920 °
Item	Vegetation & Obstructions		-120.487940 °
DWR ID	DWR_NA0013_36_c_2012_106		
Action/Comments			
Inspector Comments: Arundo and woody vegetation impede flows and needs to be controlled or removed.

View of vegetation downstream of the Hwy 59 crossing. Summer 2020

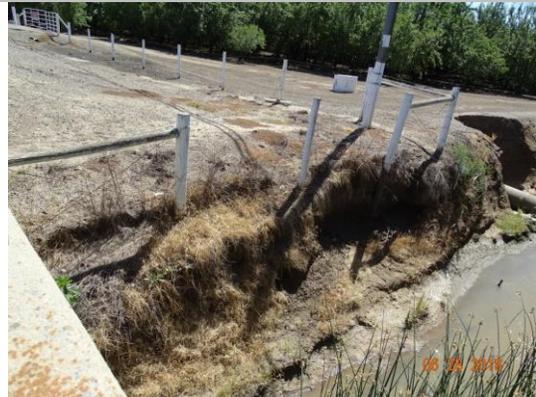
Photo 2 of 2 : CH\_2020\_NA0013\_36\_108\_20200622\_00060.jpg

Check Point / View			
<b>Hwy 59 / Down (cont)</b>			
Rating **	U	Issue No.	<b>108</b>
Issue Type +	Ma	Location *	GPS Lat/Long
Category	Rivers, Channels & Designated Flood		37.255886 °
Item	Erosion / Bank Caving		-120.487970 °
DWR ID	DWR_NA0013_36_c_2012_108		
Action/Comments			
Inspector Comments: Erosion on the left bank may be due to the pipe crossing and the overgrown woody vegetation on the right bank. The bank should be repaired, and the woody vegetation should be cleared.

View of erosion on the left bank. Summer 2018

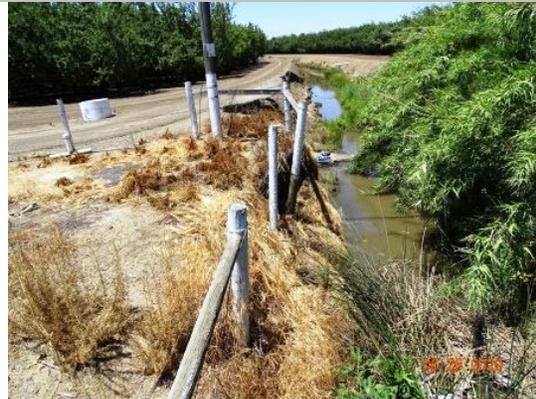
Photo 1 of 3 : CH\_2020\_NA0013\_36\_110\_20200716\_00115.jpg

Check Point / View				
<b>Hwy 59 / Down (cont)</b>				
Rating **	U	Issue No.	<b>110</b>	GPS Lat/Long
Issue Type +	En	Location *		37.255920 °
Category	Rivers, Channels & Designated Flood			-120.487940 °
Item	Encroachments			
DWR ID	DWR_NA0013_36_c_2012_110			
Action/Comments				
Inspector Comments: The fencing and pipe crossing do not appear to be authorized.

View of fencing on the left bank. Summer 2020

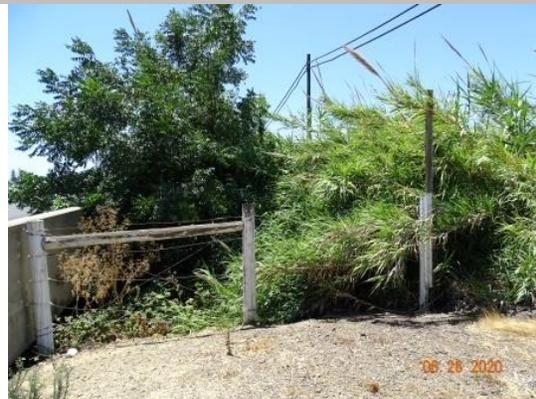
Photo 2 of 3 : CH\_2020\_NA0013\_36\_110\_20200716\_00114.jpg

View of fencing on the right bank. Summer 2020

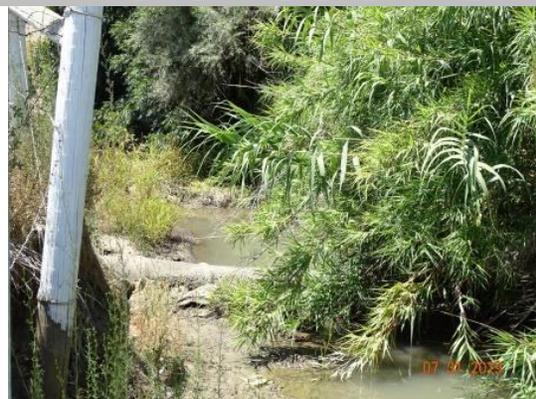
Photo 3 of 3 : CH\_2020\_NA0013\_36\_110\_20200622\_00061.jpg

View of pipe crossing downstream of Hwy 59 bridge. Summer 2019

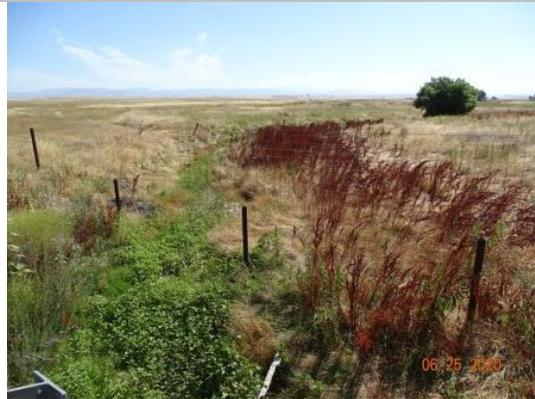
Photo 1 of 1 : CH\_2020\_NA0013\_37\_1\_20200703\_00028.jpg

View of vegetation upstream of Cunningham Road. Summer 2020

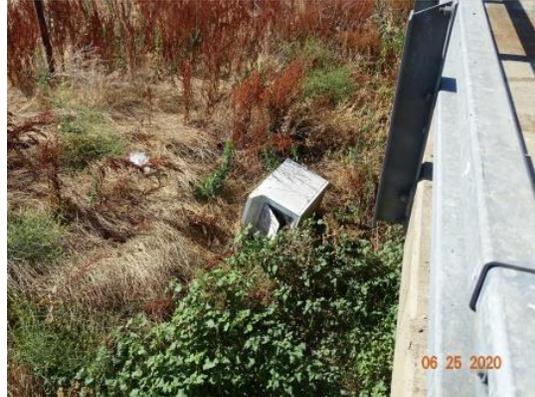
Photo 1 of 2 : CH\_2020\_NA0013\_37\_5\_20200703\_00029.jpg

Rating **	M	Issue No.	5	GPS Lat/Long
Issue Type +	Ma	Location *		37.290387 °
Category	Rivers, Channels & Designated Flood			-120.251840 °
Item	Encroachments			
DWR ID	DWR_NA0013_37_c_2012_5			
Action/Comments				
Inspector Comments: There is a wire fence with a pulley system to raise it during flood season. Remove washer and other debris from the channel.

View of washer upstream of Cunningham Road. Summer 2020

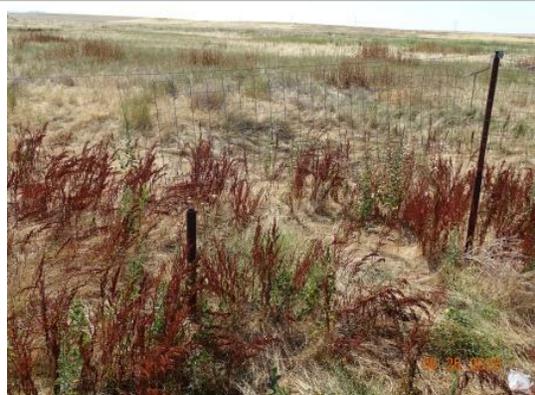
Photo 2 of 2 : CH\_2020\_NA0013\_37\_5\_20200703\_00030.jpg

View of retractable wire fence across the channel and old wire fence on the right bank. Summer 2020

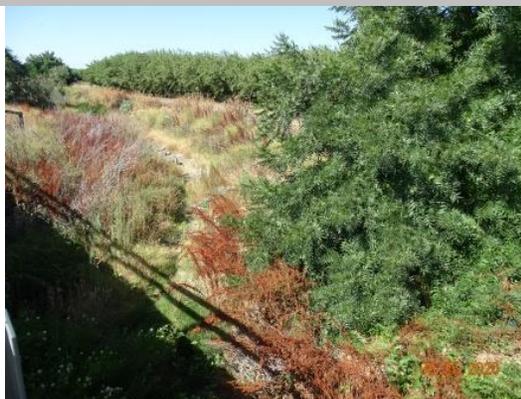
Photo 1 of 2 : CH\_2020\_NA0013\_37\_6\_20200703\_00031.jpg

Check Point / View			
<b>Cunningham Rd / Down</b>			
Rating **	M	Issue No.	<b>6</b>
Issue Type +	Ma	Location *	37.289408 °
Category	Rivers, Channels & Designated Flood		-120.251939 °
Item	Vegetation & Obstructions		
DWR ID	DWR_NA0013_37_c_2012_6		
Action/Comments			
Inspector Comments: Vegetation in the channel, especially underneath the bridge, should be maintained.

View of vegetation downstream of Cunningham Road crossing. Summer 2020

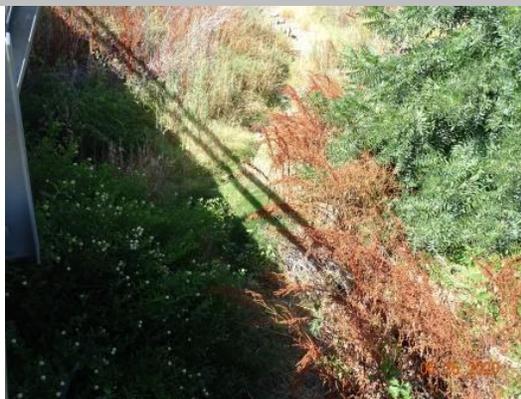
Photo 2 of 2 : CH\_2020\_NA0013\_37\_6\_20200703\_00032.jpg

View of vegetation downstream of Cunningham Road crossing. Summer 2020

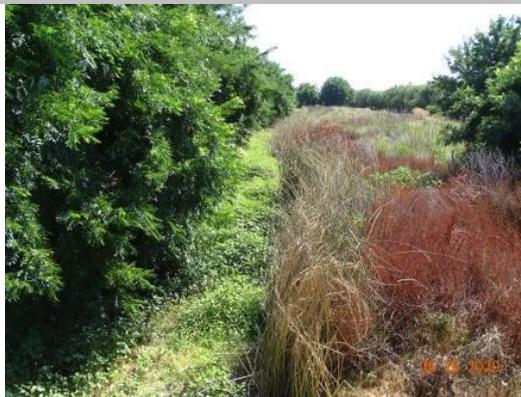
Photo 1 of 2 : CH\_2020\_NA0013\_37\_11\_20200703\_00033.jpg

Check Point / View				
<b>Childs Ave / Up</b>				
Rating **	A	Issue No.	11	GPS Lat/Long
Issue Type +	Ma	Location *		37.287269 °
Category	Rivers, Channels & Designated Flood			-120.254914 °
Item	Vegetation & Obstructions			
DWR ID	DWR_NA0013_37_c_2012_11			
Action/Comments				
Inspector Comments: Although flows do not appear to be impeded, the fig tree growing underneath the bridge needs to be removed.

View of vegetation upstream of Childs Avenue crossing. Summer 2020

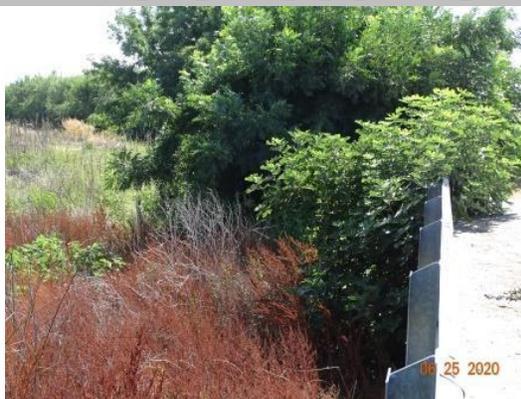
Photo 2 of 2 : CH\_2020\_NA0013\_37\_11\_20200703\_00034.jpg

View of vegetation upstream of Childs Avenue crossing. Summer 2020

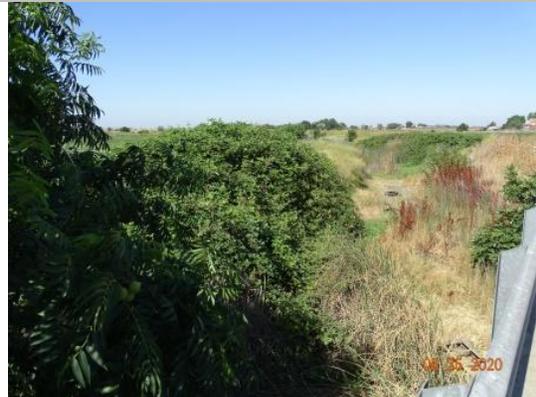
Photo 1 of 1 : CH\_2020\_NA0013\_37\_16\_20200703\_00036.jpg

Check Point / View				
<b>Childs Ave / Down</b>				
Rating **	M	Issue No.	<b>16</b>	GPS Lat/Long
Issue Type +	Ma	Location *		37.287303 °
Category	Rivers, Channels & Designated Flood			-120.254863 °
Item	Vegetation & Obstructions			
DWR ID	DWR_NA0013_37_c_2012_16			
Action/Comments				
Inspector Comments: The vegetation in the channel may impede flows and needs to be controlled or removed.

View of vegetation downstream of Childs Avenue crossing. Summer 2020

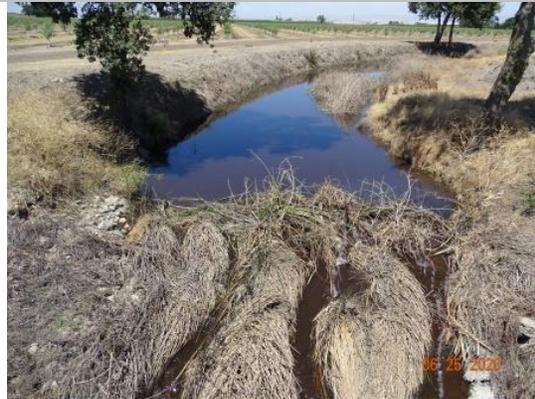
Photo 1 of 1 : CH\_2020\_NA0013\_37\_21\_20200703\_00038.jpg

View of vegetation upstream of Mission Avenue crossing. Summer 2020

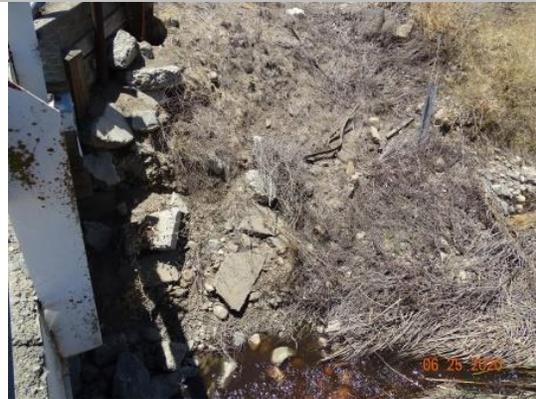
Photo 1 of 2 : CH\_2020\_NA0013\_37\_24\_20200703\_00039.jpg

View of riprap on the right bank. Summer 2020

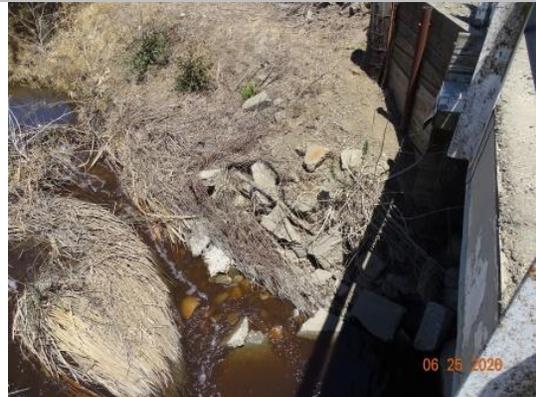
Photo 2 of 2 : CH\_2020\_NA0013\_37\_24\_20200703\_00040.jpg

View of riprap on the left bank. Summer 2020

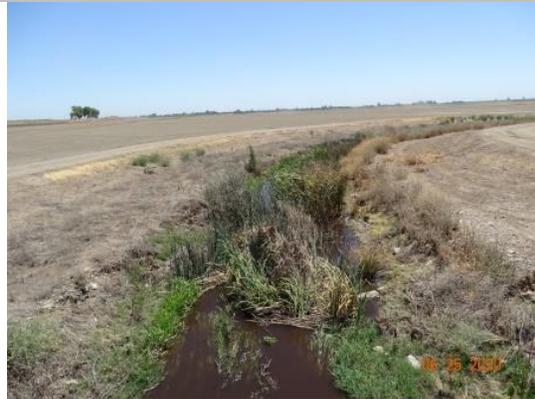
Photo 1 of 1 : CH\_2020\_NA0013\_37\_26\_20200703\_00041.jpg

View of the vegetation downstream of Mission Avenue crossing. Summer 2020

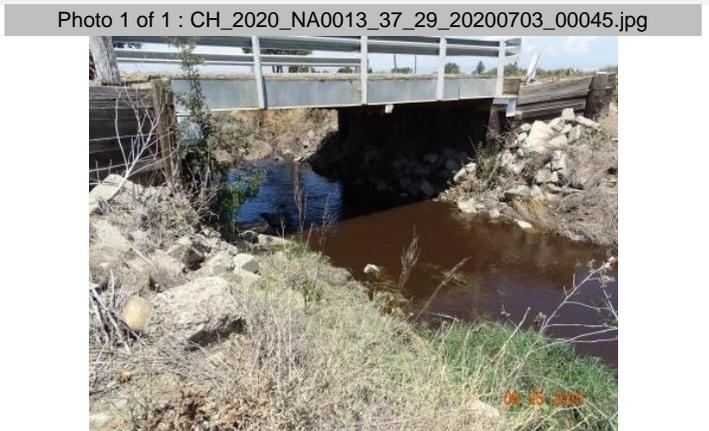
View of riprap on both banks underneath and downstream of Mission Avenue crossing. Summer 2020

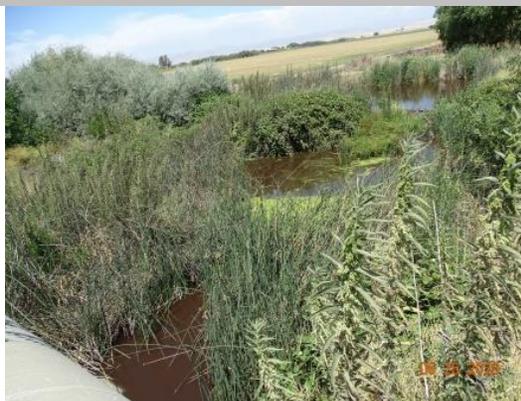
Photo 1 of 1 : CH\_2020\_NA0013\_37\_31\_20200703\_00046.jpg

Inspector Comments: Although flows do not appear to be impeded, Arundo on the left bank needs to be removed.

View of vegetation upstream of the Le Grand Canal. Summer 2020

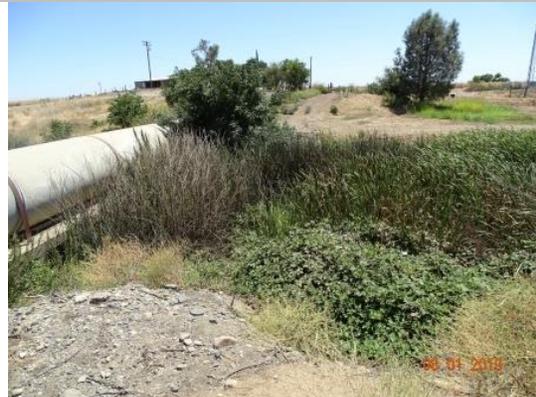
Photo 1 of 1 : CH\_2020\_NA0013\_37\_36\_20200622\_00027.jpg

Check Point / View				
<b>Diversion at Le Grand Canal, D/S Limit / Down</b>				
Rating **	M	Issue No.	<b>36</b>	GPS Lat/Long
Issue Type +	Ma	Location *		37.273619 °
Category	Rivers, Channels & Designated Flood			-120.277469 °
Item	Vegetation & Obstructions			
DWR ID	DWR_NA0013_37_c_2012_36			
Action/Comments				
Inspector Comments: Clear channel vegetation and wild berry bushes on the left bank that may impede flows.

View of vegetation in the channel downstream of the diversion. Summer 2019
