**Flood Control Project Maintenance  
Levee Inspections  
2020 Channel Summary Report  
Overall Unit and Item Ratings**

**San Joaquin County Flood Control and Water Conservation District**

**Levee Inspection Report By Mile - Channel 2020**

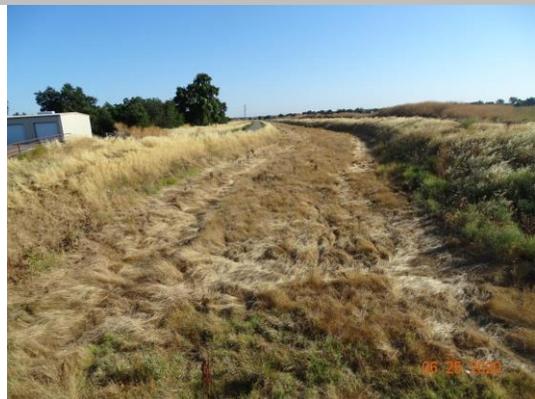
Photo 1 of 1 : CH\_2020\_NA0017\_43\_11\_20200701\_00020.jpg

Check Point / View			
<b>Farmington Rd/ Hwy 4 / Up</b>			
Rating **	A	Issue No. <b>11</b>	GPS Lat/Long
Issue Type +	Ma	Location *	37.930250 °
Category	Rivers, Channels & Designated Flood		-120.991220 °
Item	Vegetation & Obstructions		
DWR ID	DWR_NA0017_43_c_2012_11		
Action/Comments			
Inspector Comments: Flow is not impeded by the minimal vegetation within the channel.

View of vegetation within the channel looking upstream. Summer 2020

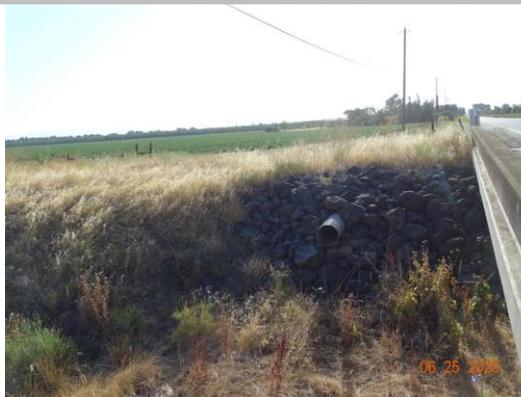
Photo 1 of 2 : CH\_2020\_NA0017\_43\_14\_20200701\_00021.jpg

Rating **	A	Issue No.	14
Issue Type +	Ma	Location *	GPS Lat/Long
Category	Rivers, Channels & Designated Flood		37.930250 °
Item	Revetments		
DWR ID	DWR_NA0017_43_c_2012_14		
Action/Comments			
Inspector Comments: Riprap is in place and well maintained.

View of upstream revetments on the left bank of channel. Summer 2020

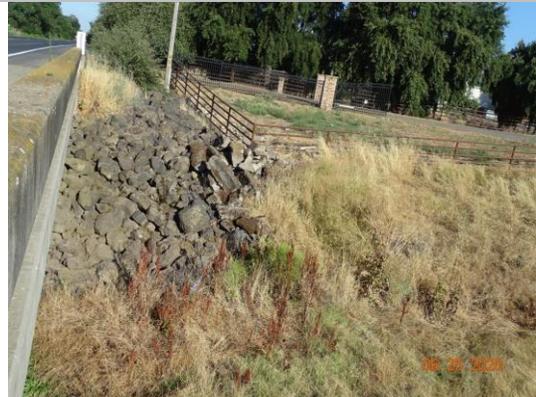
Photo 2 of 2 : CH\_2020\_NA0017\_43\_14\_20200701\_00023.jpg

Check Point / View			
<b>Farmington Rd/ Hwy 4 / Up (cont)</b>			
Rating **	A	Issue No.	<b>14 (cont)</b>
Issue Type +	Ma	Location *	GPS Lat/Long
Category	Rivers, Channels & Designated Flood		37.930250 °
Item	Revetments		-120.991220 °
DWR ID	DWR_NA0017_43_c_2012_14		
Action/Comments			
Inspector Comments: Riprap is in place and well maintained.

View of upstream revetments on the right bank of channel. Summer

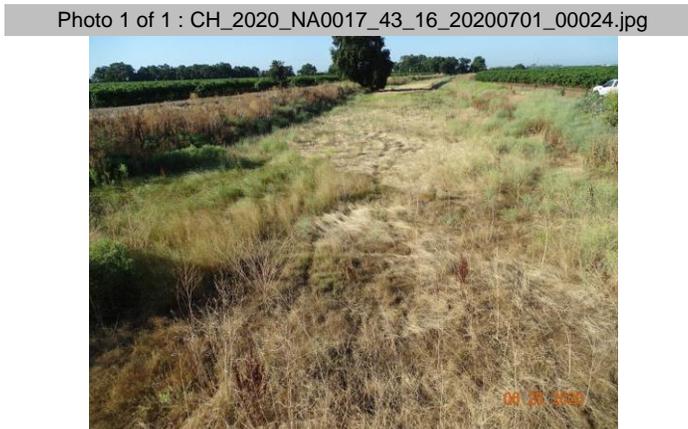
Check Point / View				
<b>Farmington Rd/ Hwy 4 / Down</b>				
Rating **	A	Issue No.	<b>16</b>	GPS Lat/Long
Issue Type +	Ma	Location *		37.930250 °
Category	Rivers, Channels & Designated Flood			-120.991220 °
Item	Vegetation & Obstructions			
DWR ID	DWR_NA0017_43_c_2012_16			
Action/Comments				
Inspector Comments: Flow is not impeded by the minimal vegetation within the channel.

View of vegetation within the channel looking downstream. Summer 2020

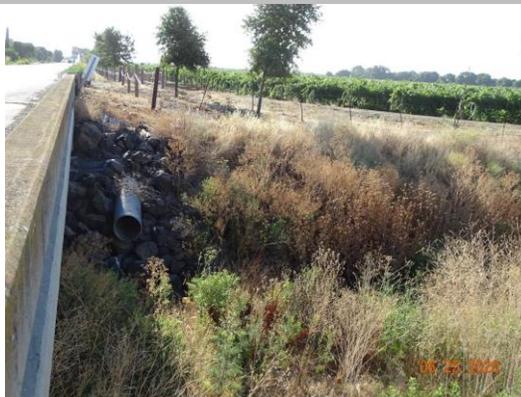
Photo 1 of 2 : CH\_2020\_NA0017\_43\_19\_20200701\_00025.jpg

Check Point / View			
<b>Farmington Rd/ Hwy 4 / Down (cont)</b>			
Rating **	A	Issue No.	<b>19</b>
Issue Type +	Ma	Location *	GPS Lat/Long
Category	Rivers, Channels & Designated Flood		37.930250 °
Item	Revetments		-120.991220 °
DWR ID	DWR_NA0017_43_c_2012_19		
Action/Comments			
Inspector Comments: Riprap is in place and well maintained.

View of riprap on the left bank of channel looking downstream. Summer 2020

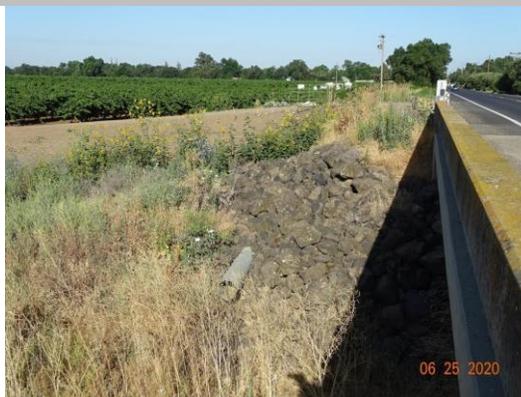
Photo 2 of 2 : CH\_2020\_NA0017\_43\_19\_20200709\_00029.jpg

View of riprap on the right bank of channel looking downstream. Summer 2020

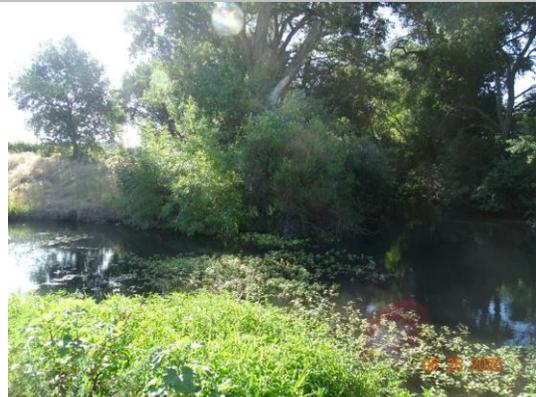
Photo 1 of 1 : CH\_2020\_NA0017\_43\_21\_20200701\_00027.jpg

Check Point / View			
<b>Confluence with South Littlejohn Creek / Up</b>			
Rating **	A	Issue No. <b>21</b>	GPS Lat/Long
Issue Type +	Ma	Location *	37.925730 °
Category	Rivers, Channels & Designated Flood		-120.992290 °
Item	Vegetation & Obstructions		
DWR ID	DWR_NA0017_43_c_2012_21		
Action/Comments			
Inspector Comments: Flow is not impeded by the minimal vegetation within the channel.

View of the vegetation within the channel confluence. Summer 2020

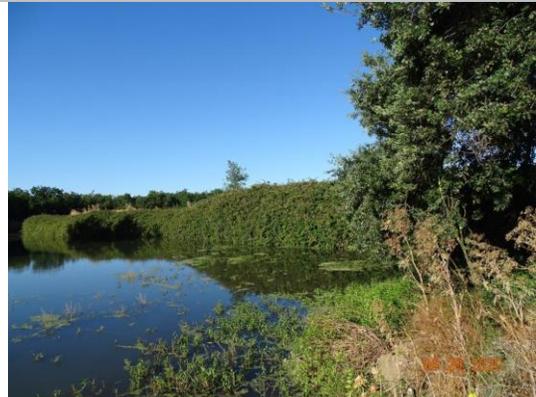
Photo 1 of 2 : CH\_2020\_NA0017\_42\_6\_20200706\_00045.jpg

Check Point / View				
<b>Upstream Limit / Up</b>				
Rating **	A	Issue No.	<b>6</b>	GPS Lat/Long
Issue Type +	Ma	Location *		37.919430 °
Category	Rivers, Channels & Designated Flood			-121.034800 °
Item	Vegetation & Obstructions			
DWR ID	DWR_NA0017_42_c_2012_6			
Action/Comments				
Inspector Comments: Flow is not impeded by the minimal vegetation within the channel.

View of vegetation within the channel at upstream confluence. Summer 2020

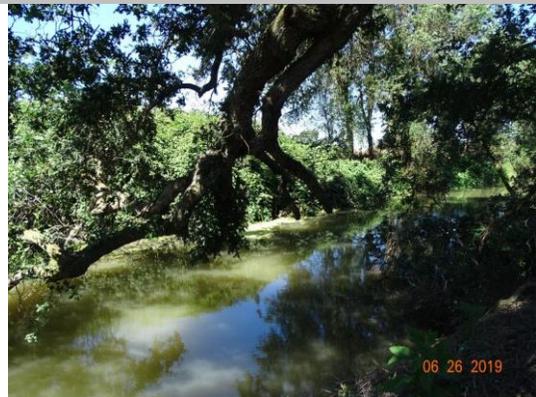
Photo 2 of 2 : CH\_2020\_NA0017\_42\_6\_20200617\_00001.jpg

View of vegetation looking downstream. Summer 2019

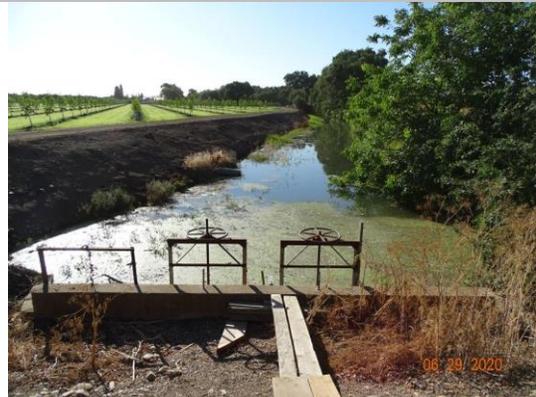
Photo 1 of 1 : CH\_2020\_NA0017\_42\_11\_20200706\_00046.jpg

Check Point / View				
<b>Hewit Lane / Up</b>				
Rating **	A	Issue No.	11	GPS Lat/Long
Issue Type +	Ma	Location *		37.920600 °
Category	Rivers, Channels & Designated Flood			-121.037920 °
Item	Vegetation & Obstructions			
DWR ID	DWR_NA0017_42_c_2012_11			
Action/Comments				
Inspector Comments: Flow is not impeded by the minimal vegetation within the channel.

View of vegetation within the channel looking upstream. Summer 2020

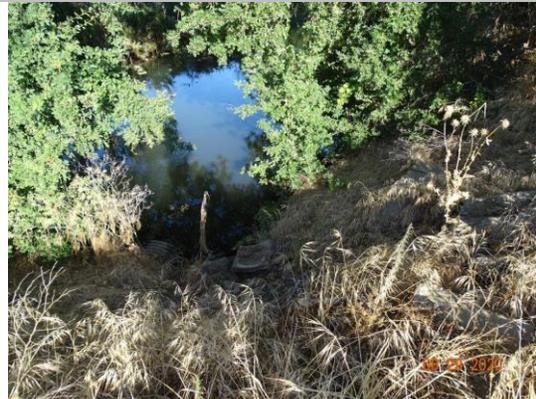
Photo 1 of 1 : CH\_2020\_NA0017\_42\_16\_20200706\_00049.jpg

Check Point / View				
<b>Hewit Lane / Down</b>				
Rating **	A	Issue No.	<b>16</b>	GPS Lat/Long
Issue Type +	Ma	Location *		37.920584 °
Category	Rivers, Channels & Designated Flood			-121.037914 °
Item	Vegetation & Obstructions			
DWR ID	DWR_NA0017_42_c_2012_16			
Action/Comments				
Inspector Comments: Flow is not impeded by the minimal vegetation within the channel.

View of vegetation within the channel looking downstream. Summer 2020

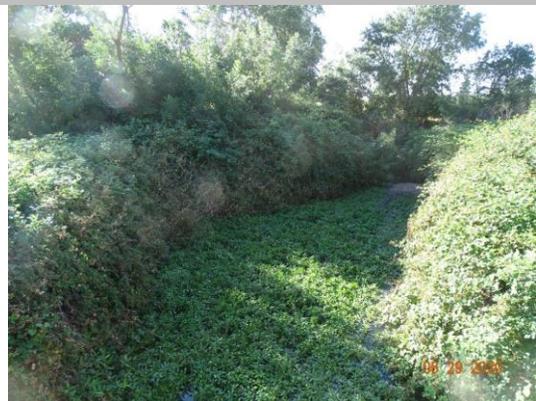
Photo 1 of 1 : CH\_2020\_NA0017\_42\_21\_20200706\_00050.jpg

Check Point / View			
<b>Van Allen Rd / Up</b>			
Rating **	A	Issue No.	21
Issue Type +	Ma	Location *	37.918960 °
Category	Rivers, Channels & Designated Flood		-121.056260 °
Item	Vegetation & Obstructions		
DWR ID	DWR_NA0017_42_c_2012_21		
Action/Comments			
Inspector Comments: View of vegetation looking upstream. Summer 2019

View of vegetation looking upstream. Summer 2020

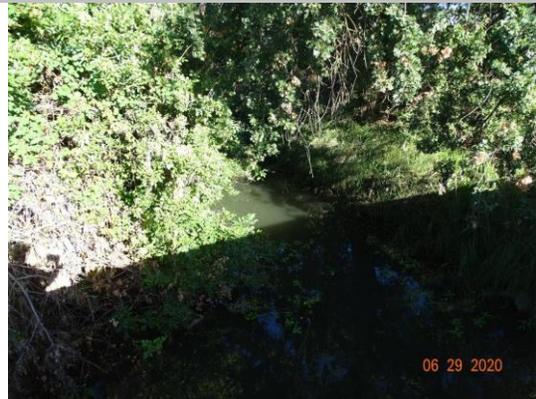
Photo 1 of 1 : CH\_2020\_NA0017\_42\_26\_20200706\_00051.jpg

Check Point / View			
<b>Van Allen Rd / Down</b>			
Rating **	A	Issue No.	26
Issue Type +	Ma	Location *	GPS Lat/Long
Category	Rivers, Channels & Designated Flood		37.918960 °
Item	Vegetation & Obstructions		-121.056260 °
DWR ID	DWR_NA0017_42_c_2012_26		
Action/Comments			
Inspector Comments: Vegetation on channel slopes is dense, but channel flow is not impeded.

View of vegetation looking downstream of channel. Summer 2020

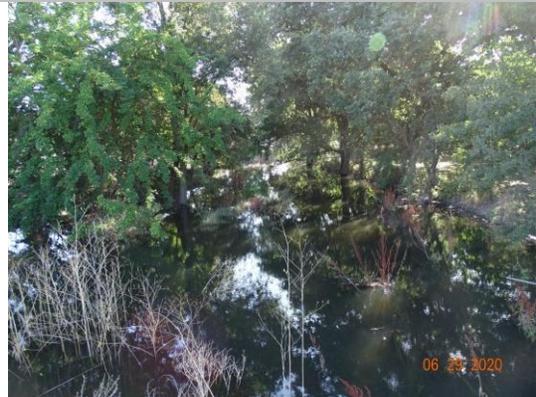
Photo 1 of 1 : CH\_2020\_NA0017\_42\_31\_20200706\_00053.jpg

Check Point / View			
<b>Jack Tone Rd / Up</b>			
Rating **	A	Issue No. <b>31</b>	GPS Lat/Long
Issue Type +	Ma	Location *	37.921460 °
Category	Rivers, Channels & Designated Flood		-121.147570 °
Item	Vegetation & Obstructions		
DWR ID	DWR_NA0017_42_c_2012_31		
Action/Comments			
Inspector Comments: Flow is not impeded by the minimal vegetation within the channel.

View of vegetation within the channel looking upstream. Summer 2020

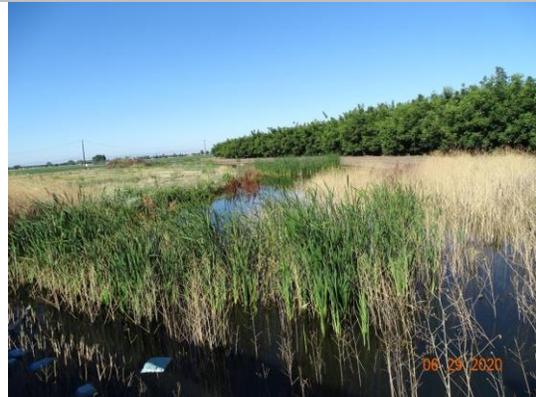
Photo 1 of 1 : CH\_2020\_NA0017\_42\_36\_20200706\_00055.jpg

Check Point / View			
<b>Jack Tone Rd / Down</b>			
Rating **	A	Issue No.	<b>36</b>
Issue Type +	Ma	Location *	GPS Lat/Long
Category	Rivers, Channels & Designated Flood		37.921460 °
Item	Vegetation & Obstructions		-121.147570 °
DWR ID	DWR_NA0017_42_c_2012_36		
Action/Comments			
Inspector Comments: There is minimal vegetation within the channel, flow is not likely to be impeded.

View of vegetation within the channel looking downstream. Summer 2020

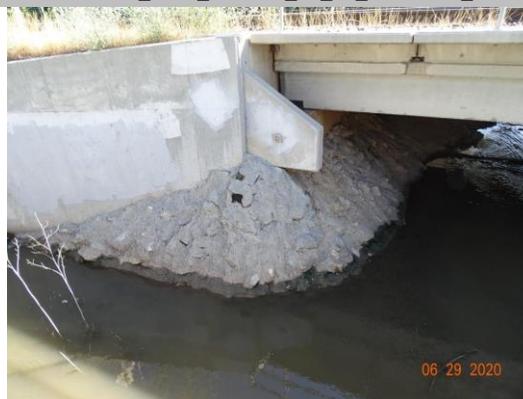
Photo 1 of 2 : CH\_2020\_NA0017\_42\_41\_20200706\_00056.jpg

Check Point / View			
<b>Mariposa Rd / Up</b>			
Rating **	A	Issue No. <b>41</b>	GPS Lat/Long
Issue Type +	Ma	Location *	37.915879 °
Category	Rivers, Channels & Designated Flood		-121.189095 °
Item	Vegetation & Obstructions		
DWR ID	DWR_NA0017_42_c_2012_41		
Action/Comments			
Inspector Comments: There is no vegetation within the channel.

View of right bank upstream channel crossing. Summer 2020

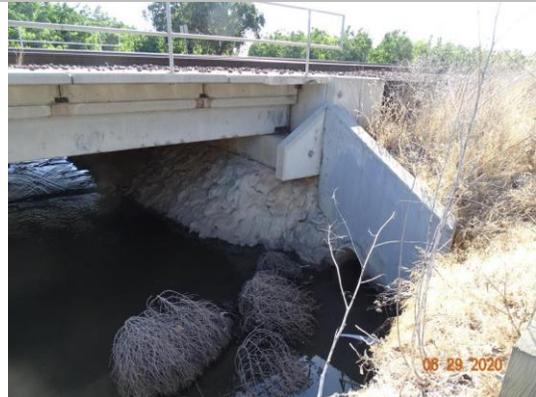
Photo 2 of 2 : CH\_2020\_NA0017\_42\_41\_20200706\_00058.jpg

Check Point / View			
<b>Mariposa Rd / Up (cont)</b>			
Rating **	A	Issue No.	<b>41 (cont)</b>
Issue Type +	Ma	Location *	GPS Lat/Long
Category	Rivers, Channels & Designated Flood		37.915879 °
Item	Vegetation & Obstructions		-121.189095 °
DWR ID	DWR_NA0017_42_c_2012_41		
Action/Comments			
Inspector Comments: There is no vegetation within the channel.

View of left bank upstream channel crossing. Summer 2020

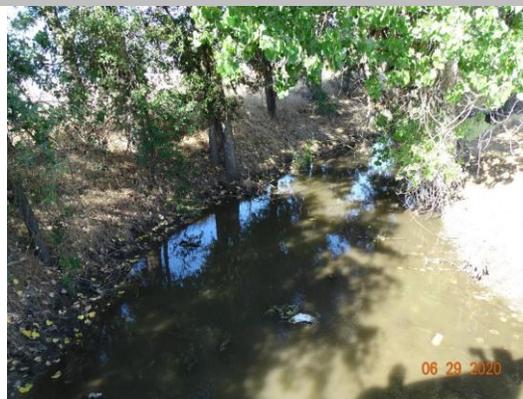
Photo 1 of 1 : CH\_2020\_NA0017\_42\_46\_20200706\_00060.jpg

Check Point / View			
<b>Mariposa Rd / Down</b>			
Rating **	A	Issue No.	<b>46</b>
			GPS Lat/Long
Issue Type +	Ma	Location *	37.915879 °
Category	Rivers, Channels & Designated Flood		-121.189095 °
Item	Vegetation & Obstructions		
DWR ID	DWR_NA0017_42_c_2012_46		
Action/Comments			
Inspector Comments: Flow is not impeded by the minimal vegetation within the channel.

View of vegetation within the channel looking downstream. Summer 2020

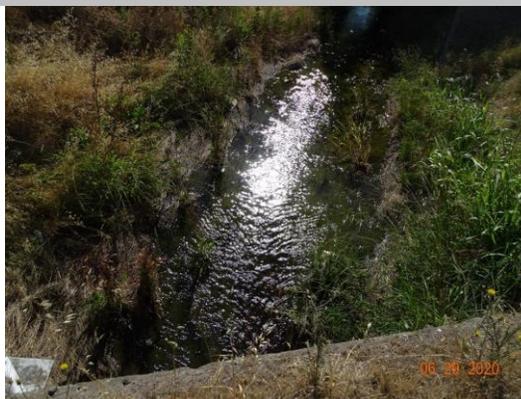
Photo 1 of 1 : CH\_2020\_NA0017\_42\_51\_20200706\_00062.jpg

Check Point / View			
<b>Highway 99 / Up</b>			
Rating **	A	Issue No. <b>51</b>	GPS Lat/Long
Issue Type +	Ma	Location *	37.913239 °
Category	Rivers, Channels & Designated Flood		-121.225915 °
Item	Vegetation & Obstructions		
DWR ID	DWR_NA0017_42_c_2012_51		
Action/Comments			
Inspector Comments: Flow is not impeded by the minimal vegetation within the channel.

View of vegetation within the channel looking upstream. Summer 2020

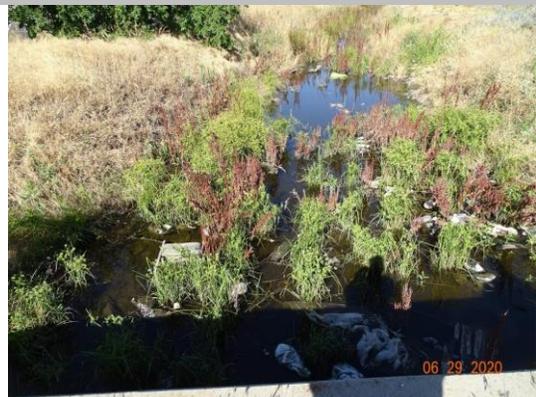
Photo 1 of 1 : CH\_2020\_NA0017\_42\_56\_20200706\_00063.jpg

Check Point / View			
<b>Highway 99 / Down</b>			
Rating **	A	Issue No. <b>56</b>	GPS Lat/Long
Issue Type +	Ma	Location *	37.913239 °
Category	Rivers, Channels & Designated Flood		-121.225915 °
Item	Vegetation & Obstructions		
DWR ID	DWR_NA0017_42_c_2012_56		
Action/Comments			
Inspector Comments: Flow is not impeded by the minimal vegetation within the channel.

View of vegetation within the channel looking downstream. Summer 2020

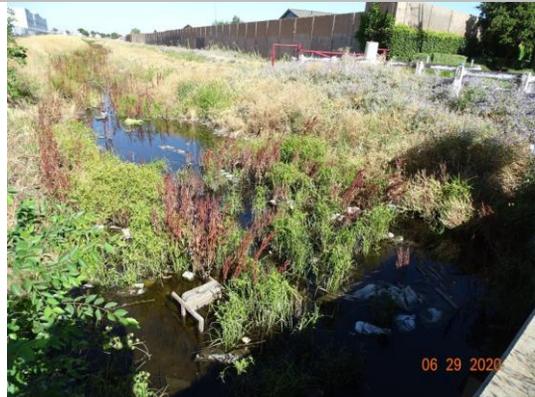
Photo 1 of 1 : CH\_2020\_NA0017\_42\_60\_20200706\_00064.jpg

Check Point / View				
<b>Highway 99 / Down (cont)</b>				
Rating **	A	Issue No.	<b>60</b>	GPS Lat/Long
Issue Type +	Ma	Location *		37.913239 °
Category	Rivers, Channels & Designated Flood			-121.225915 °
Item	Encroachments			
DWR ID	DWR_NA0017_42_c_2012_60			
Action/Comments				
Inspector Comments: There is minimal amounts of trash and debris with the channel. LMA has been advised to remove. Flow is not likely to be impeded.

View of minimal trash and debris within the channel looking downstream. Summer 2020

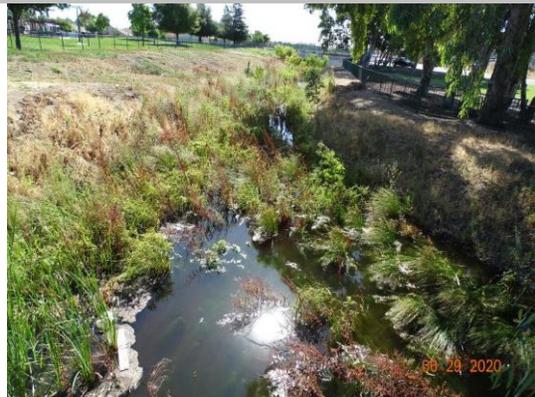
Photo 1 of 1 : CH\_2020\_NA0017\_42\_61\_20200706\_00065.jpg

Check Point / View				
<b>Pock Lane / Up</b>				
Rating **	A	Issue No.	<b>61</b>	GPS Lat/Long
Issue Type +	Ma	Location *		37.914290 °
Category	Rivers, Channels & Designated Flood			-121.238800 °
Item	Vegetation & Obstructions			
DWR ID	DWR_NA0017_42_c_2012_61			
Action/Comments				
Inspector Comments: Flow is not impeded by the minimal vegetation within the channel.

View of vegetation within the channel looking upstream. Summer 2020

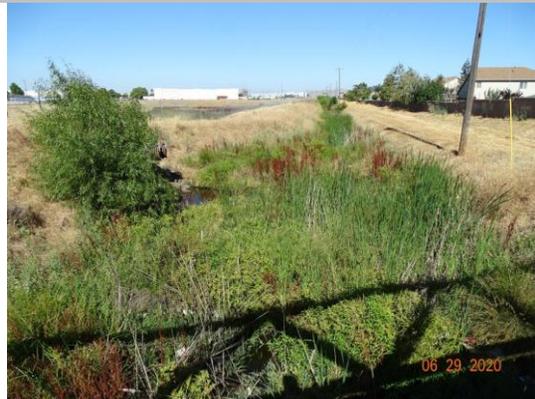
Photo 1 of 1 : CH\_2020\_NA0017\_42\_66\_20200706\_00066.jpg

Check Point / View				
<b>Pock Lane / Down</b>				
Rating **	A	Issue No.	66	GPS Lat/Long
Issue Type +	Ma	Location *		37.914290 °
Category	Rivers, Channels & Designated Flood			-121.238800 °
Item	Vegetation & Obstructions			
DWR ID	DWR_NA0017_42_c_2012_66			
Action/Comments				
Inspector Comments: Flow is not impeded by the minimal vegetation within the channel.

View of vegetation within the channel looking downstream. Summer 2020

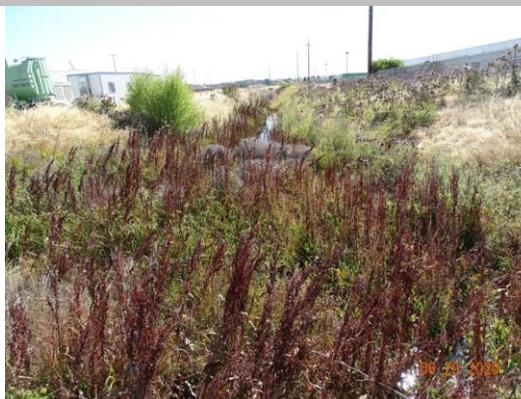
Photo 1 of 1 : CH\_2020\_NA0017\_42\_71\_20200706\_00067.jpg

Check Point / View				
<b>South B Street / Up</b>				
Rating **	A	Issue No.	<b>71</b>	GPS Lat/Long
Issue Type +	Ma	Location *		37.913716 °
Category	Rivers, Channels & Designated Flood			-121.247761 °
Item	Vegetation & Obstructions			
DWR ID	DWR_NA0017_42_c_2012_71			
Action/Comments				
Inspector Comments: Flow is not impeded by the minimal vegetation within the channel.

View of vegetation within the channel looking upstream. Summer 2020

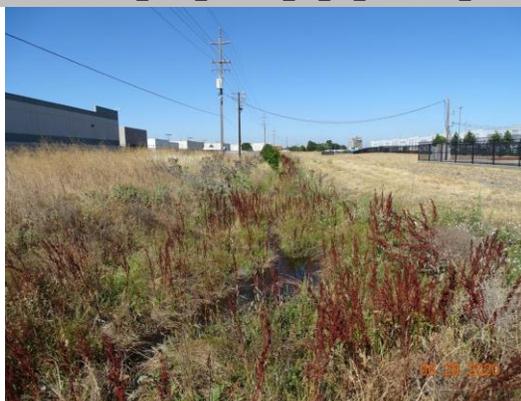
Photo 1 of 1 : CH\_2020\_NA0017\_42\_76\_20200706\_00068.jpg

Check Point / View			
<b>South B Street / Down</b>			
Rating **	A	Issue No. <b>76</b>	GPS Lat/Long
Issue Type +	Ma	Location *	37.913716 °
Category	Rivers, Channels & Designated Flood		-121.247761 °
Item	Vegetation & Obstructions		
DWR ID	DWR_NA0017_42_c_2012_76		
Action/Comments			
Inspector Comments: Flow is not impeded by the minimal vegetation within the channel.

View of vegetation within the channel looking downstream. Summer 2020

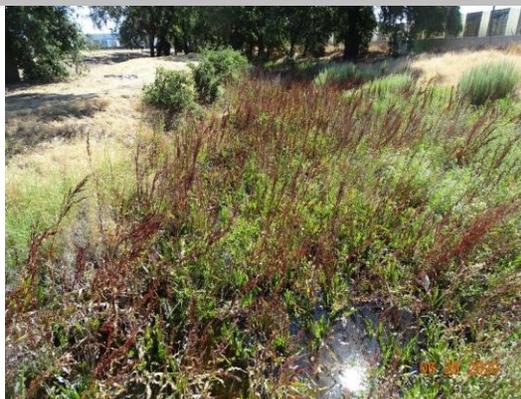
Photo 1 of 1 : CH\_2020\_NA0017\_42\_81\_20200706\_00069.jpg

Check Point / View				
<b>Airport Way / Up</b>				
Rating **	A	Issue No.	81	GPS Lat/Long
Issue Type +	Ma	Location *		37.912070 °
Category	Rivers, Channels & Designated Flood			-121.258811 °
Item	Vegetation & Obstructions			
DWR ID	DWR_NA0017_42_c_2012_81			
Action/Comments				
Inspector Comments: Flow is not impeded by the minimal vegetation within the channel.

View of the vegetation within the channel looking upstream. Summer 2020

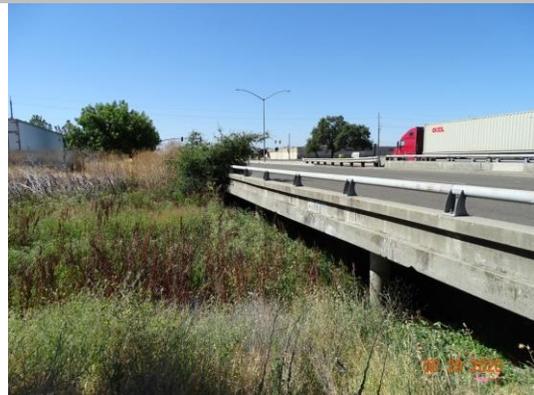
Photo 1 of 1 : CH\_2020\_NA0017\_42\_85\_20200706\_00070.jpg

Rating **	A	Issue No.	<b>85</b>	GPS Lat/Long
Issue Type +	Ma	Location *		37.912070 °
Category	Rivers, Channels & Designated Flood			-121.258811 °
Item	Encroachments			
DWR ID	DWR_NA0017_42_c_2012_85			
Action/Comments				
Inspector Comments: No trash or debris was observed within the channel.

View of upstream bridge crossing. Summer 2020

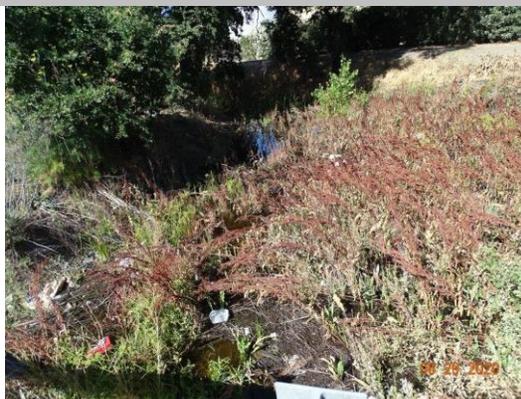
Photo 1 of 1 : CH\_2020\_NA0017\_42\_86\_20200706\_00071.jpg

Check Point / View				
<b>Airport Way / Down</b>				
Rating **	A	Issue No.	<b>86</b>	GPS Lat/Long
Issue Type +	Ma	Location *		37.912070 °
Category	Rivers, Channels & Designated Flood			-121.258811 °
Item	Vegetation & Obstructions			
DWR ID	DWR_NA0017_42_c_2012_86			
Action/Comments				
Inspector Comments: Flow is not impeded by the minimal vegetation within the channel.

View of vegetation within the channel looking downstream. Summer 2020

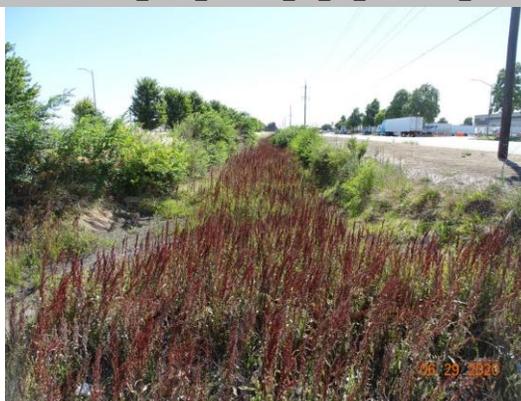
Photo 1 of 1 : CH\_2020\_NA0017\_42\_91\_20200706\_00072.jpg

Check Point / View			
<b>Producers Drive / Up</b>			
Rating **	A	Issue No. <b>91</b>	GPS Lat/Long
Issue Type +	Ma	Location *	37.908433 °
Category	Rivers, Channels & Designated Flood		-121.269214 °
Item	Vegetation & Obstructions		
DWR ID	DWR_NA0017_42_c_2012_91		
Action/Comments			
Inspector Comments: Flow is not impeded by the minimal vegetation within the channel.

View of vegetation within the channel looking upstream. Summer 2020

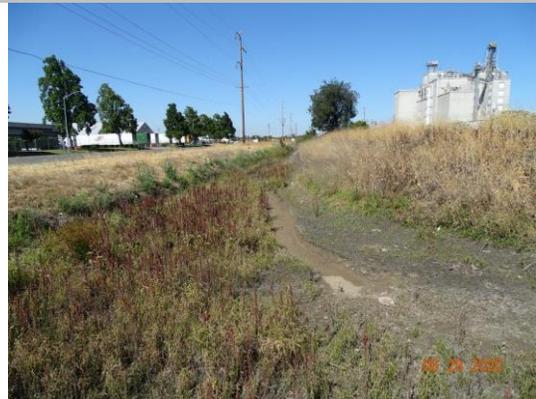
Photo 1 of 1 : CH\_2020\_NA0017\_42\_96\_20200706\_00073.jpg

Check Point / View				
<b>Producers Drive / Down</b>				
Rating **	A	Issue No.	96	GPS Lat/Long
Issue Type +	Ma	Location *		37.908433 °
Category	Rivers, Channels & Designated Flood			-121.269214 °
Item	Vegetation & Obstructions			
DWR ID	DWR_NA0017_42_c_2012_96			
Action/Comments				
Inspector Comments: Flow is not impeded by the minimal vegetation within the channel.

View of vegetation within the channel looking downstream. Summer 2020

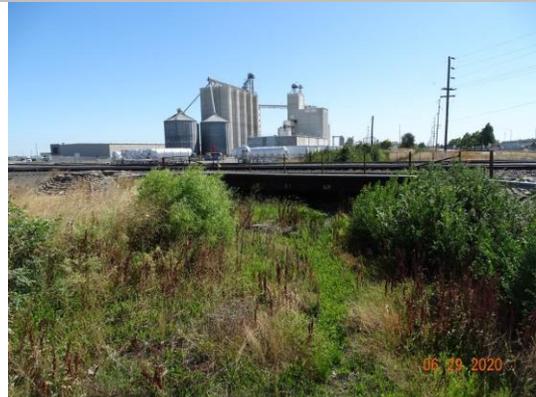
Photo 1 of 1 : CH\_2020\_NA0017\_42\_101\_20200706\_00074.jpg

Check Point / View			
<b>McKinley Avenue / Up</b>			
Rating **	M	Issue No. <b>101</b>	GPS Lat/Long
Issue Type +	Ma	Location *	37.907158 °
Category	Rivers, Channels & Designated Flood		-121.273935 °
Item	Vegetation & Obstructions		
DWR ID	DWR_NA0017_42_c_2012_101		
Action/Comments			
Inspector Comments: Flow may be impeded by the vegetation within the channel.

View of vegetation within the channel looking upstream. Summer 2020

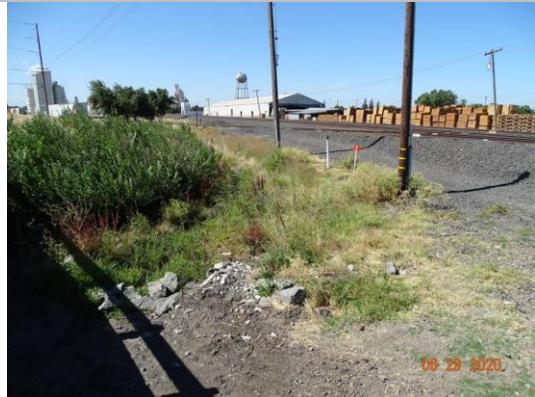
Photo 1 of 1 : CH\_2020\_NA0017\_42\_106\_20200706\_00076.jpg

Check Point / View				
<b>McKinley Avenue / Down</b>				
Rating **	A	Issue No.	<b>106</b>	GPS Lat/Long
Issue Type +	Ma	Location *		37.907158 °
Category	Rivers, Channels & Designated Flood			-121.273935 °
Item	Vegetation & Obstructions			
DWR ID	DWR_NA0017_42_c_2012_106			
Action/Comments				
Inspector Comments: Flow is not impeded by the minimal vegetation within the channel.

View of vegetation within the channel looking downstream. Summer 2020

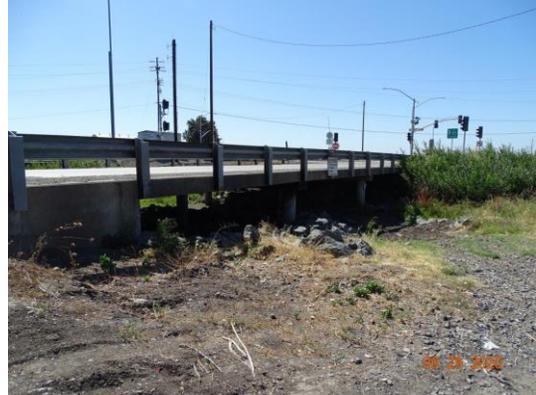
Photo 1 of 1 : CH\_2020\_NA0017\_42\_109\_20200706\_00077.jpg

Check Point / View				
<b>McKinley Avenue / Down (cont)</b>				
Rating **	A	Issue No.	<b>109</b>	GPS Lat/Long
Issue Type +	Ma	Location *		37.907158 °
Category	Rivers, Channels & Designated Flood			-121.273935 °
Item	Revetments			
DWR ID	DWR_NA0017_42_c_2012_109			
Action/Comments				
Inspector Comments: Riprap under the channel crossing is in place and well maintained.

View of riprap under the channel crossing on the downstream side. Summer 2020

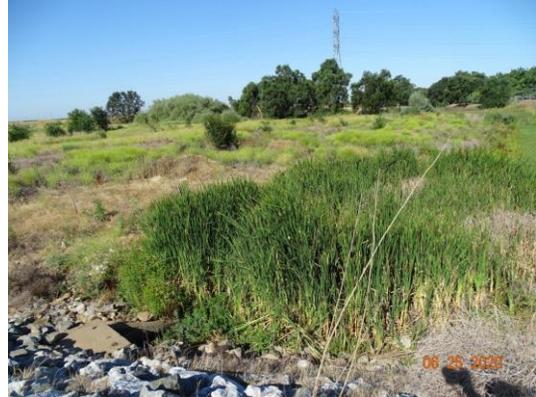
Photo 1 of 1 : CH\_2020\_NA0017\_44\_6\_20200701\_00072.jpg

Check Point / View			
<b>Farmington Dam / Down</b>			
Rating **	A	Issue No. <b>6</b>	GPS Lat/Long
Issue Type +	Ma	Location *	37.914340 °
Category	Rivers, Channels & Designated Flood		-120.937860 °
Item	Vegetation & Obstructions		
DWR ID	DWR_NA0017_44_c_2012_6		
Action/Comments			
Inspector Comments: Flow is not impeded by the minimal vegetation within the channel.

View of vegetation with the channel downstream of outlet. Summer 2020

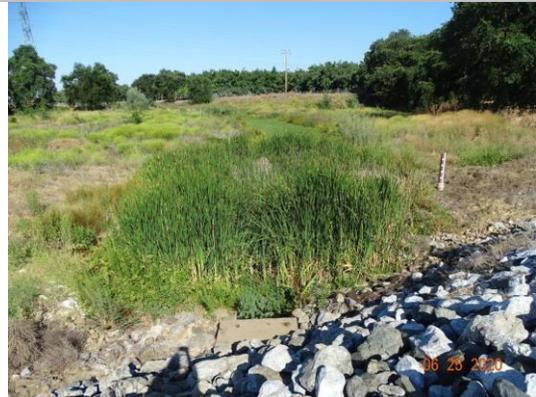
Photo 1 of 2 : CH\_2020\_NA0017\_44\_9\_20200701\_00073.jpg

Check Point / View				
<b>Farmington Dam / Down (cont)</b>				
Rating **	A	Issue No.	<b>9</b>	GPS Lat/Long
Issue Type +	Ma	Location *		37.900822 °
Category	Rivers, Channels & Designated Flood			-120.932889 °
Item	Revetments			
DWR ID	DWR_NA0017_44_c_2012_9			
Action/Comments				
Inspector Comments: Riprap is in place and well maintained.

View of well placed and maintained riprap at the Farmington Dam outlet. Summer 2020

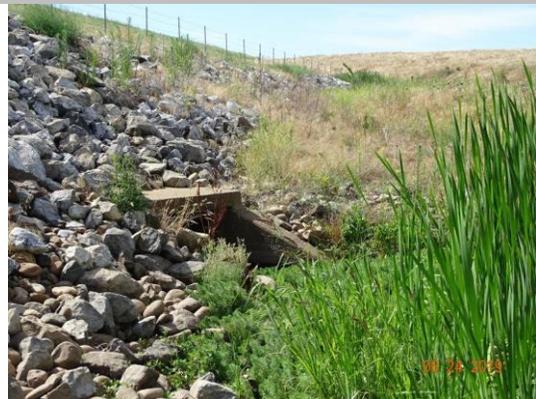
Photo 2 of 2 : CH\_2020\_NA0017\_44\_9\_20200617\_00002.jpg

Rating **	A	Issue No.	<b>9 (cont)</b>	GPS Lat/Long
Issue Type +	Ma	Location *		37.900822 °
Category	Rivers, Channels & Designated Flood			-120.932889 °
Item	Revetments			
DWR ID	DWR_NA0017_44_c_2012_9

View of riprap at outlet. Summer 2019

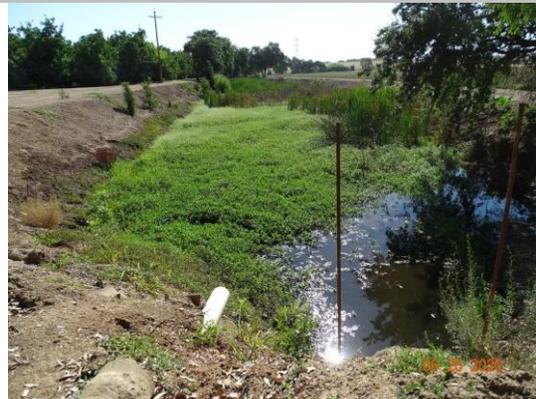
Photo 1 of 1 : CH\_2020\_NA0017\_44\_99\_20200707\_00074.jpg

Check Point / View			
<b>Wedding Chappel Crossing / Up</b>			
Rating **	A	Issue No.	99
Issue Type +	Ma	Location *	GPS Lat/Long
Category	Rivers, Channels & Designated Flood		37.900040 °
Item	Vegetation & Obstructions		-120.938949 °
DWR ID	DWR_NA0017_42_c_2013_99		
Action/Comments			
Inspector Comments: Flow is not impeded by the minimal vegetation within the channel.

View of vegetation within the channel looking downstream. Summer 2020

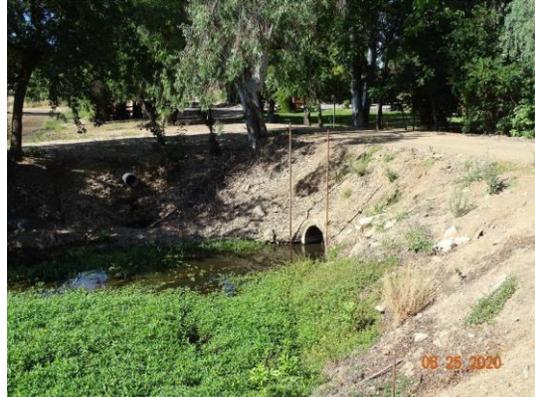
Photo 1 of 1 : CH\_2020\_NA0017\_44\_108\_20200707\_00075.jpg

Check Point / View			
<b>Wedding Chappel Crossing / Up (cont)</b>			
Rating **	A	Issue No.	<b>108</b>
Issue Type +	Ma	Location *	GPS Lat/Long
Category	Rivers, Channels & Designated Flood		-120.938949 °
Item	Gates		
DWR ID	DWR_NA0017_44_c_2013_108		
Action/Comments			
Inspector Comments: Inlet pipe appears to be well maintained and debris free.

View of inlet pipe on upstream side. Summer 2020

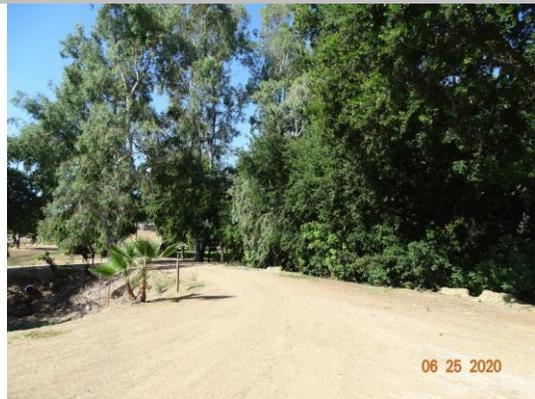
Photo 1 of 2 : CH\_2020\_NA0017\_44\_104\_20200707\_00076.jpg

Check Point / View			
<b>Wedding Chappel Crossing / Down</b>			
Rating **	M	Issue No.	<b>104</b>
Issue Type +	Ma	Location *	GPS Lat/Long
Category	Rivers, Channels & Designated Flood		-120.938949 °
Item	Vegetation & Obstructions		
DWR ID	DWR_NA0017_44_c_2013_104		
Action/Comments			
Inspector Comments: Vegetation within the channel and on the channel slopes may impede flows and channel capacity.

View of dense vegetation looking downstream. Summer 2020

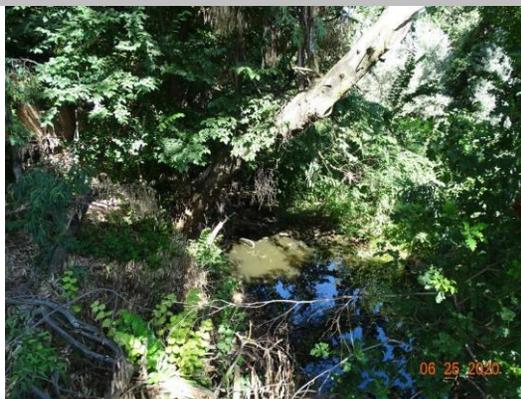
Photo 2 of 2 : CH\_2020\_NA0017\_44\_104\_20200707\_00077.jpg

Check Point / View			
<b>Wedding Chappel Crossing / Down (cont)</b>			
Rating **	M	Issue No.	<b>104 (cont)</b>
Issue Type +	Ma	Location *	GPS Lat/Long
Category	Rivers, Channels & Designated Flood		-120.938949 °
Item	Vegetation & Obstructions		
DWR ID	DWR_NA0017_44_c_2013_104		
Action/Comments			
Inspector Comments: Vegetation within the channel and on the channel slopes may impede flows and channel capacity.

View of dense vegetation looking downstream. Summer 2020

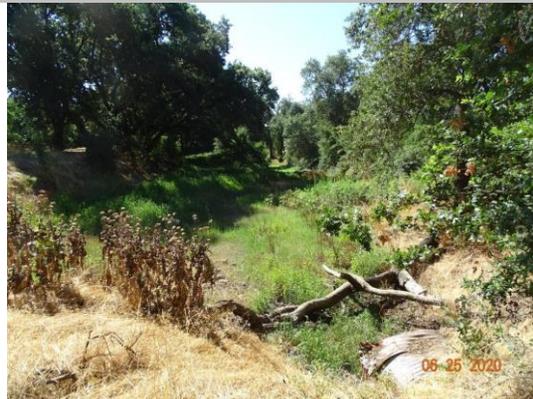
Photo 1 of 1 : CH\_2020\_NA0017\_44\_141\_20200707\_00078.jpg

Check Point / View			
<b>Henry Road / Up</b>			
Rating **	M	Issue No.	141
Issue Type +	Ma	Location *	GPS Lat/Long
Category	Rivers, Channels & Designated Flood		37.903161 °
Item	Vegetation & Obstructions		-120.945289 °
DWR ID	DWR_NA0017_44_c_2015_141		
Action/Comments			
Inspector Comments: There are trees and log jams within the channel which will impact flows and capacity.

View of fallen trees within the channel on the upstream side. Summer 2020

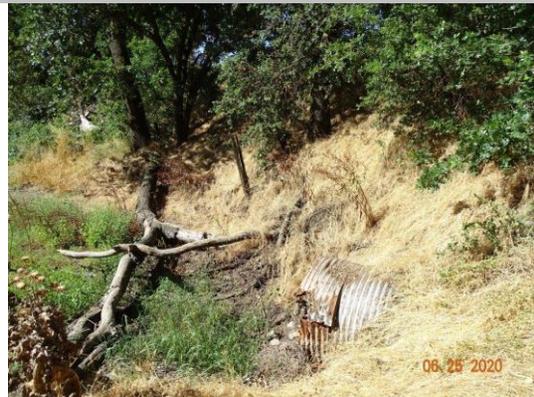
Photo 1 of 1 : CH\_2020\_NA0017\_44\_150\_20200707\_00079.jpg

Rating **	M	Issue No.	150	GPS Lat/Long
Issue Type +	Ma	Location *		37.903161 °
Category	Rivers, Channels & Designated Flood			-120.945289 °
Item	Gates			
DWR ID	DWR_NA0017_44_c_2015_150			
Action/Comments				
Inspector Comments: The inlet pipe appears to be in need of maintenace and/or repair.

View of inlet pipe on the upstream side. Summer 2020

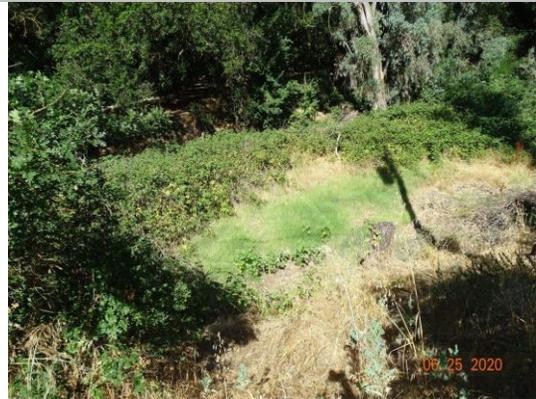
Photo 1 of 1 : CH\_2020\_NA0017\_44\_146\_20200707\_00080.jpg

Check Point / View			
<b>Henry Road / Down</b>			
Rating **	M	Issue No. <b>146</b>	GPS Lat/Long
Issue Type +	Ma	Location *	37.903161 °
Category	Rivers, Channels & Designated Flood		-120.945289 °
Item	Vegetation & Obstructions		
DWR ID	DWR_NA0017_44_c_2015_146		
Action/Comments			
Inspector Comments: Vegetation within the channel may impede the flow and capacity.

View of vegetation looking downstream of channel. Summer 2020

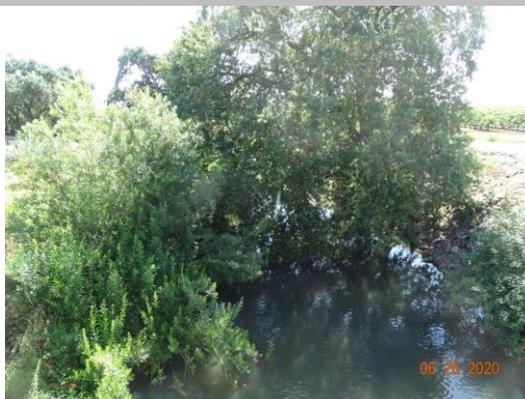
Photo 1 of 2 : CH\_2020\_NA0017\_44\_21\_20200707\_00081.jpg

Check Point / View			
<b>Escalon Bellota Rd / Up</b>			
Rating **	A	Issue No.	21
Issue Type +	Ma	Location *	37.925330 °
Category	Rivers, Channels & Designated Flood		-121.000120 °
Item	Vegetation & Obstructions		
DWR ID	DWR_NA0017_44_c_2012_21		
Action/Comments			
Inspector Comments: Flow is not impeded by the minimal vegetation within the channel.

View of the channel looking upstream. Summer 2020

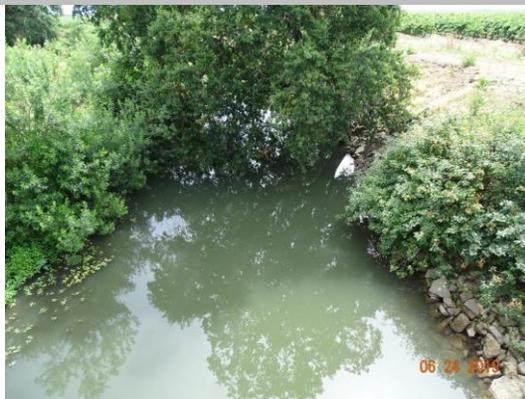
Photo 2 of 2 : CH\_2020\_NA0017\_44\_21\_20200617\_00004.jpg

View of the channel looking upstream. Summer 2019

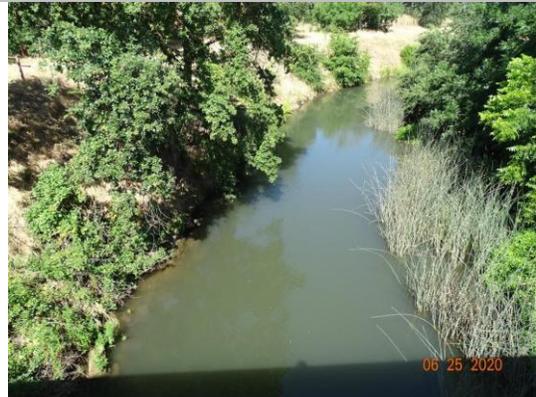
Photo 1 of 1 : CH\_2020\_NA0017\_44\_26\_20200707\_00084.jpg

Check Point / View			
<b>Escalon Bellota Rd / Down</b>			
Rating **	A	Issue No. <b>26</b>	GPS Lat/Long
Issue Type +	Ma	Location *	37.925330 °
Category	Rivers, Channels & Designated Flood		-121.000120 °
Item	Vegetation & Obstructions		
DWR ID	DWR_NA0017_44_c_2012_26		
Action/Comments			
Inspector Comments: Flow is not impeded by the minimal vegetation within the channel.

View of vegetation within the channel looking downstream. Summer 2020

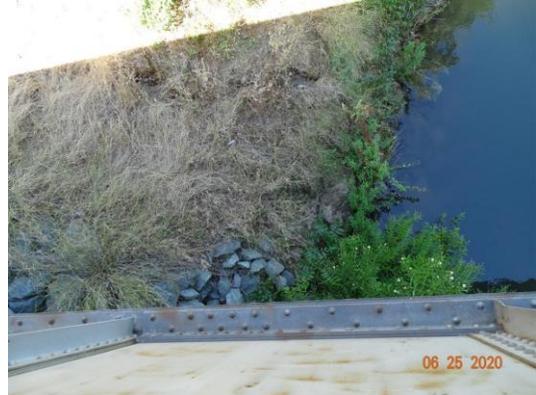
Photo 1 of 1 : CH\_2020\_NA0017\_44\_24\_20200707\_00083.jpg

Check Point / View				
<b>Escalon Bellota Rd / Down (cont)</b>				
Rating **	A	Issue No.	<b>24</b>	GPS Lat/Long
Issue Type +	Ma	Location *		37.925330 °
Category	Rivers, Channels & Designated Flood			-121.000120 °
Item	Revetments			
DWR ID	DWR_NA0017_44_c_2012_24			
Action/Comments				
Inspector Comments: Upstream: Riprap is limited to bridge crossing, protecting bridge abutments.

View of revetment on left bank of upstream channel. Summer 2020

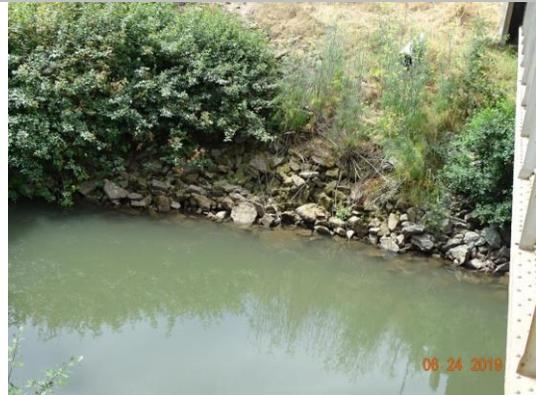
Photo 2 of 1 : CH\_2020\_NA0017\_44\_29\_20200617\_00008.jpg

View of revetments on right bank looking downstream. Summer 2019

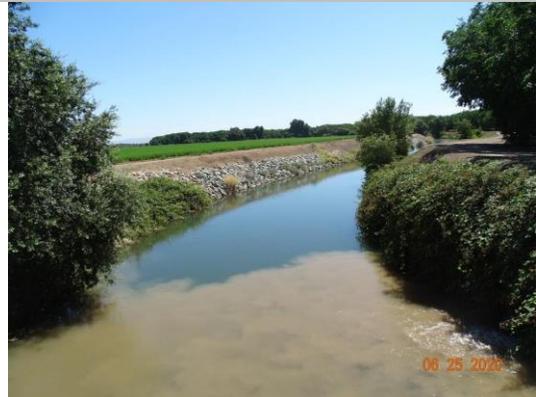
Photo 1 of 1 : CH\_2020\_NA0017\_44\_31\_20200707\_00085.jpg

Check Point / View			
<b>Stanley Rd / Up</b>			
Rating **	A	Issue No.	<b>31</b>
Issue Type +	Ma	Location *	GPS Lat/Long
Category	Rivers, Channels & Designated Flood		37.920060 °
Item	Vegetation & Obstructions		-121.027790 °
DWR ID	DWR_NA0017_44_c_2012_31		
Action/Comments			
Inspector Comments: Flow is not impeded by the minimal vegetation within the channel.

View of vegetation within the channel looking upstream. Summer 2020

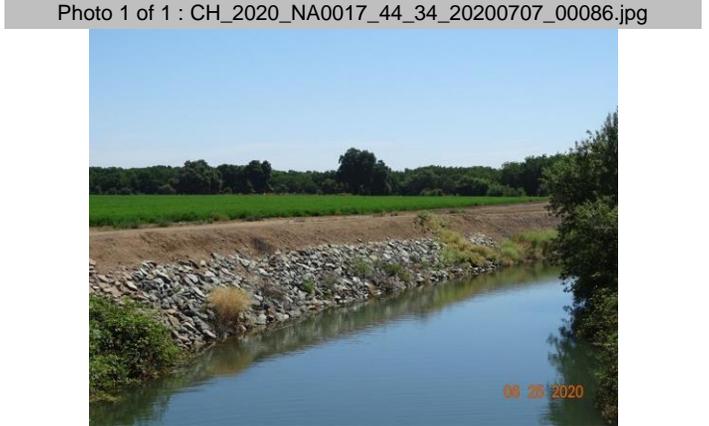
Check Point / View			
<b>Stanley Rd / Up (cont)</b>			
Rating **	A	Issue No.	<b>34</b>
Issue Type +	Ma	Location *	GPS Lat/Long
Category	Rivers, Channels & Designated Flood		37.920060 °
Item	Revetments		-121.027790 °
DWR ID	DWR_NA0017_44_c_2012_34		
Action/Comments			
Inspector Comments: Riprap is in place and well maintained.

View of revetments on right bank of upstream channel. Summer 2020

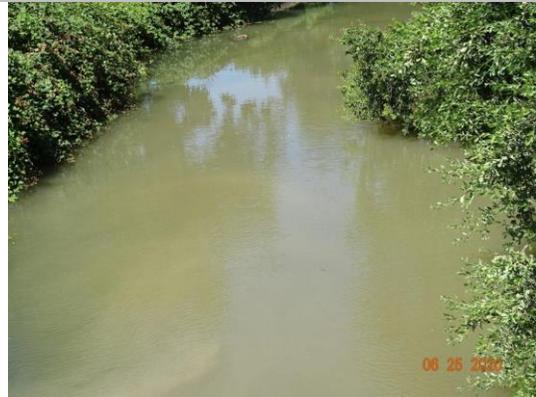
Photo 1 of 1 : CH\_2020\_NA0017\_44\_36\_20200707\_00087.jpg

Check Point / View				
<b>Stanley Rd / Down</b>				
Rating **	A	Issue No.	<b>36</b>	GPS Lat/Long
Issue Type +	Ma	Location *		37.920060 °
Category	Rivers, Channels & Designated Flood			-121.027790 °
Item	Vegetation & Obstructions			
DWR ID	DWR_NA0017_44_c_2012_36			
Action/Comments				
Inspector Comments: : Flow is not impeded by the minimal vegetation within the channel.

View of vegetation within the channel looking downstream. Summer 2020

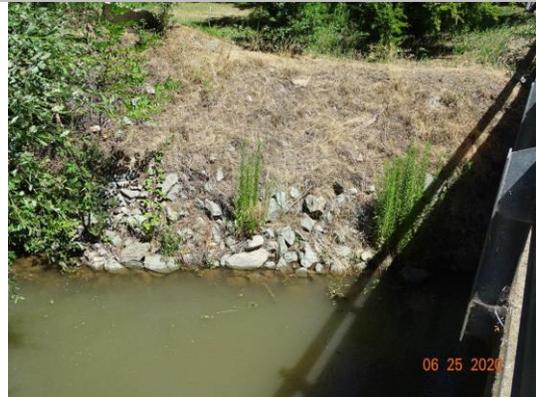
Photo 1 of 1 : CH\_2020\_NA0017\_44\_39\_20200707\_00088.jpg

Check Point / View			
<b>Stanley Rd / Down (cont)</b>			
Rating **	A	Issue No.	39
Issue Type +	Ma	Location *	GPS Lat/Long
Category	Rivers, Channels & Designated Flood		37.920060 °
Item	Revetments		-121.027790 °
DWR ID	DWR_NA0017_44_c_2012_39		
Action/Comments			
Inspector Comments: Riprap is in place and well maintained.

View of the revetments on the right bank of the channel looking downstream. Summer 2020

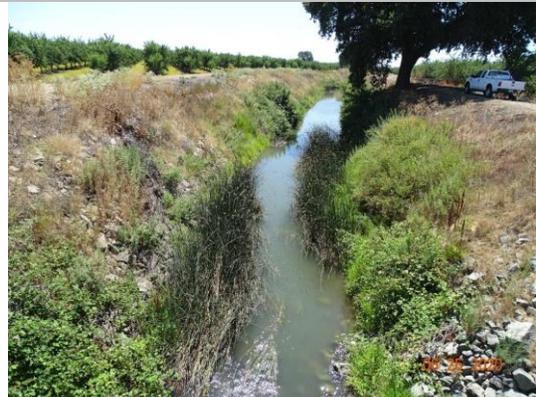
Photo 1 of 1 : CH\_2020\_NA0017\_44\_41\_20200707\_00089.jpg

Check Point / View			
<b>Van Allen Rd / Up</b>			
Rating **	A	Issue No. <b>41</b>	GPS Lat/Long
Issue Type +	Ma	Location *	37.913060 °
Category	Rivers, Channels & Designated Flood		-121.056230 °
Item	Vegetation & Obstructions		
DWR ID	DWR_NA0017_44_c_2012_41		
Action/Comments			
Inspector Comments: Flow is not impeded by the minimal vegetation within the channel.

View of vegetation within the channel looking upstream. Summer 2020

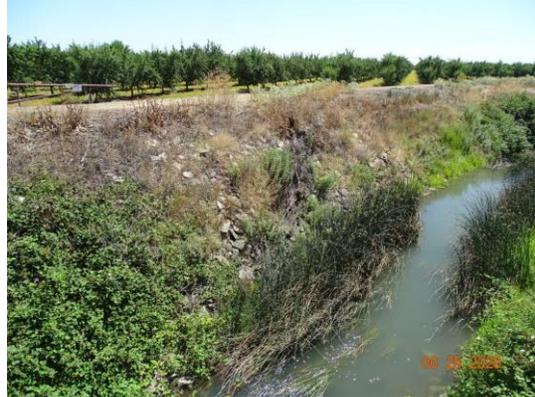
Photo 1 of 2 : CH\_2020\_NA0017\_44\_44\_20200707\_00090.jpg

Check Point / View			
<b>Van Allen Rd / Up (cont)</b>			
Rating **	A	Issue No.	<b>44</b>
Issue Type +	Ma	Location *	37.913060 °
Category	Rivers, Channels & Designated Flood		-121.056230 °
Item	Revetments		
DWR ID	DWR_NA0017_44_c_2012_44		
Action/Comments			
Inspector Comments: Riprap is in place and well maintained.

View of revetments looking upstream. Summer 2020

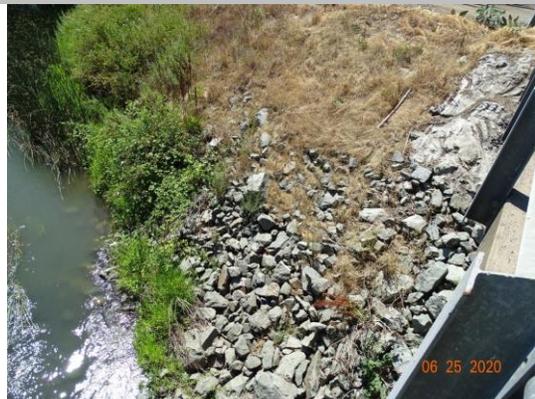
Photo 2 of 2 : CH\_2020\_NA0017\_44\_44\_20200707\_00092.jpg

View of revetments looking upstream. Summer 2020

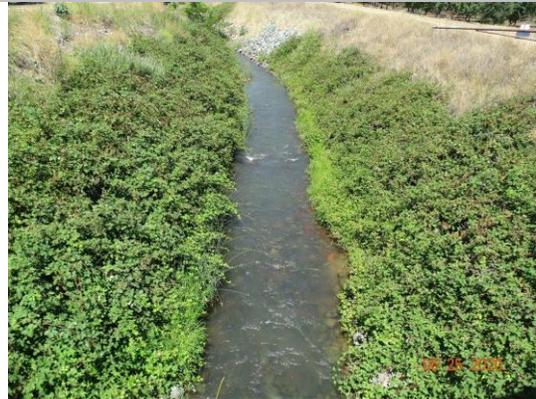
Photo 1 of 1 : CH\_2020\_NA0017\_44\_46\_20200707\_00093.jpg

Check Point / View				
<b>Van Allen Rd / Down</b>				
Rating **	A	Issue No.	<b>46</b>	GPS Lat/Long
Issue Type +	Ma	Location *		37.913060 °
Category	Rivers, Channels & Designated Flood			-121.056230 °
Item	Vegetation & Obstructions			
DWR ID	DWR_NA0017_44_c_2012_46			
Action/Comments				
Inspector Comments: Flow is not impeded by the minimal vegetation within the channel.

View of vegetation within the channel looking downstream. Summer 2020

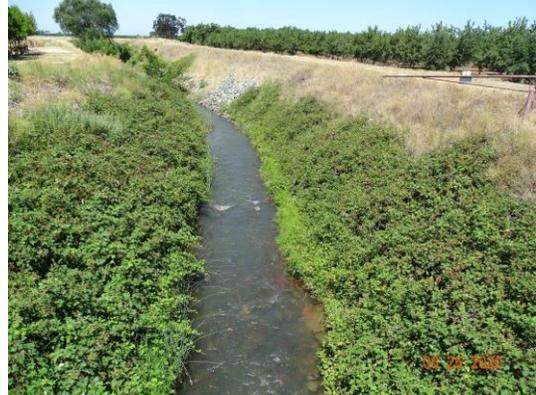
Photo 1 of 2 : CH\_2020\_NA0017\_44\_49\_20200707\_00094.jpg

Check Point / View				
<b>Van Allen Rd / Down (cont)</b>				
Rating **	A	Issue No.	<b>49</b>	GPS Lat/Long
Issue Type +	Ma	Location *		37.913060 °
Category	Rivers, Channels & Designated Flood			-121.056230 °
Item	Revetments			
DWR ID	DWR_NA0017_44_c_2012_49			
Action/Comments				
Inspector Comments: Riprap is visible and appears to be undamaged.

View of existing revetment looking downstream. Summer 2020

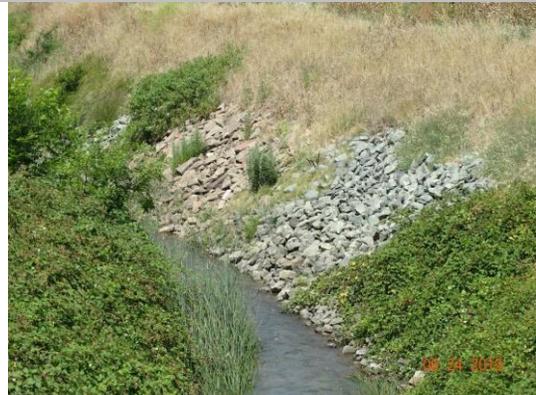
Photo 2 of 2 : CH\_2020\_NA0017\_44\_49\_20200617\_00022.jpg

View of existing revetment looking downstream. Summer 2019

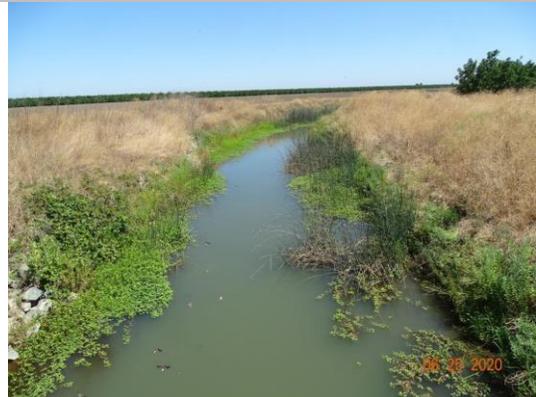
Photo 1 of 1 : CH\_2020\_NA0017\_44\_51\_20200707\_00095.jpg

Check Point / View			
<b>Mariposa Rd / Up</b>			
Rating **	A	Issue No.	51
Issue Type +	Ma	Location *	GPS Lat/Long
Category	Rivers, Channels & Designated Flood		37.895050 °
Item	Vegetation & Obstructions		-121.118200 °
DWR ID	DWR_NA0017_44_c_2012_51		
Action/Comments			
Inspector Comments: Flow is not impeded by the minimal vegetation within the channel.

View of vegetation within the channel looking upstream. Summer 2020

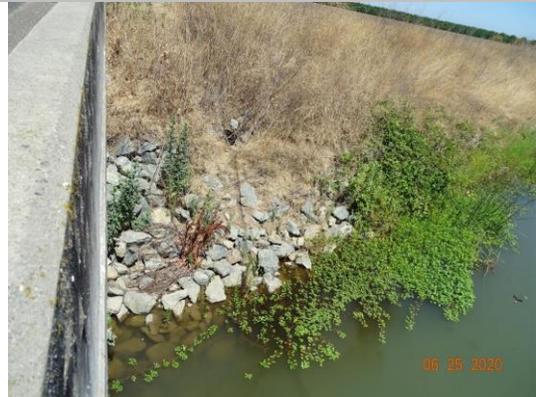
Photo 1 of 1 : CH\_2020\_NA0017\_44\_151\_20200707\_00096.jpg

Check Point / View			
<b>Mariposa Rd / Up (cont)</b>			
Rating **	A	Issue No.	151
Issue Type +	Ma	Location *	GPS Lat/Long
Category	Rivers, Channels & Designated Flood		37.895050 °
Item	Revetments		-121.118200 °
DWR ID	DWR_NA0017_44_c_2016_151		
Action/Comments			
Inspector Comments: Riprap is in place and well maintained.

View of riprap that is in place and well maintained on the downstream side. Summer 2020

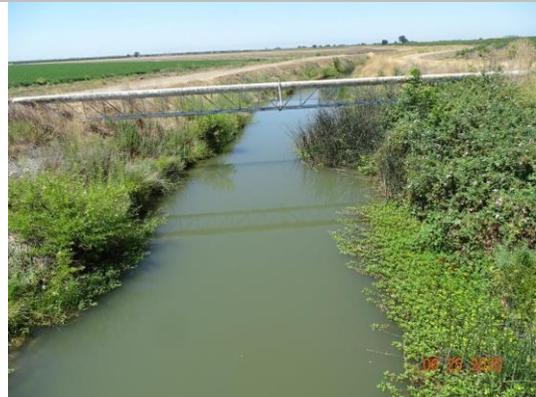
Photo 1 of 1 : CH\_2020\_NA0017\_44\_56\_20200707\_00097.jpg

Check Point / View				
<b>Mariposa Rd / Down</b>				
Rating **	A	Issue No.	<b>56</b>	GPS Lat/Long
Issue Type +	Ma	Location *		37.895050 °
Category	Rivers, Channels & Designated Flood			-121.118200 °
Item	Vegetation & Obstructions			
DWR ID	DWR_NA0017_44_c_2012_56			
Action/Comments				
Inspector Comments: Flow is not impeded by the minimal vegetation within the channel.

View of vegetation within the channel looking downstream. Summer 2020

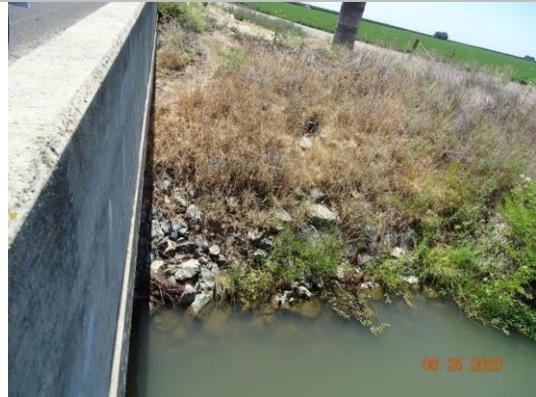
Photo 1 of 1 : CH\_2020\_NA0017\_44\_59\_20200707\_00098.jpg

Check Point / View			
<b>Mariposa Rd / Down (cont)</b>			
Rating **	A	Issue No.	59
Issue Type +	Ma	Location *	GPS Lat/Long
Category	Rivers, Channels & Designated Flood		37.895050 °
Item	Revetments		-121.118200 °
DWR ID	DWR_NA0017_44_c_2012_59		
Action/Comments			
Inspector Comments: Riprap is in place and well maintained..

View of riprap that is in place and well maintained on the downstream side. Summer 2020

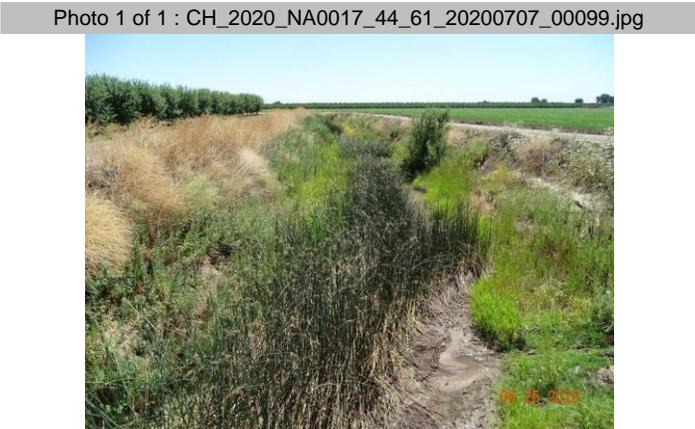
Check Point / View			
<b>Jack Tone Rd / Up</b>			
Rating **	A	Issue No. <b>61</b>	GPS Lat/Long
Issue Type +	Ma	Location *	37.880726 °
Category	Rivers, Channels & Designated Flood		-121.146929 °
Item	Vegetation & Obstructions		
DWR ID	DWR_NA0017_44_c_2012_61		
Action/Comments			
Inspector Comments: Flow is not impeded by the minimal vegetation within the channel.

View of vegetation within the channel looking upstream. Summer 2020

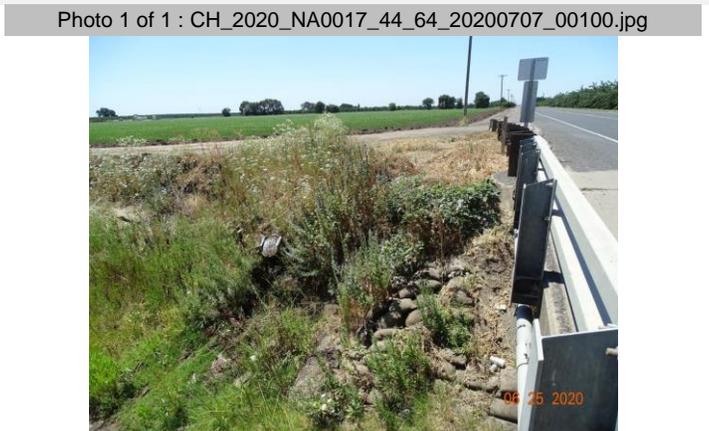
Check Point / View			
<b>Jack Tone Rd / Up (cont)</b>			
Rating **	A	Issue No. <b>64</b>	GPS Lat/Long
Issue Type +	Ma	Location *	37.880726 °
Category	Rivers, Channels & Designated Flood		-121.146929 °
Item	Revetments		
DWR ID	DWR_NA0017_44_c_2012_64		
Action/Comments			
Inspector Comments: Riprap is in place and well maintained.

View of riprap that is in place and well maintained on the downstream side. Summer 2020

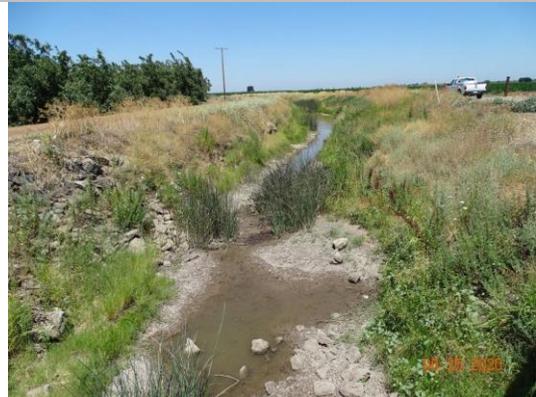
Photo 1 of 1 : CH\_2020\_NA0017\_44\_66\_20200707\_00101.jpg

Check Point / View				
<b>Jack Tone Rd / Down</b>				
Rating **	A	Issue No.	<b>66</b>	GPS Lat/Long
Issue Type +	Ma	Location *		37.880726 °
Category	Rivers, Channels & Designated Flood			-121.146929 °
Item	Vegetation & Obstructions			
DWR ID	DWR_NA0017_44_c_2012_66			
Action/Comments				
Inspector Comments: Flow is not impeded by the minimal vegetation within the channel.

View of vegetation within the channel looking downstream. Summer 2020
