**Flood Control Project Maintenance  
Levee Inspections  
2020 Channel Summary Report  
Overall Unit and Item Ratings**

**San Joaquin County Flood Control and Water Conservation District**

**Levee Inspection Report By Mile - Channel 2020**

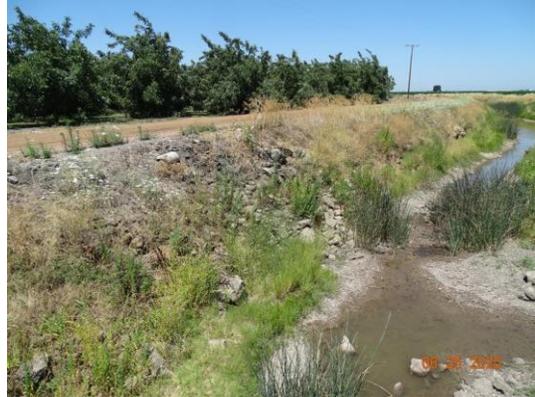
Photo 1 of 1 : CH\_2020\_NA0017\_44\_69\_20200707\_00102.jpg

Check Point / View			
<b>Jack Tone Rd / Down (cont)</b>			
Rating **	A	Issue No.	69
Issue Type +	Ma	Location *	37.880726 °
Category	Rivers, Channels & Designated Flood		-121.146929 °
Item	Revetments		
DWR ID	DWR_NA0017_44_c_2012_69		
Action/Comments			
Inspector Comments: Riprap is in place and well maintained.

View of riprap that is in place on the downstream side. Summer 2020

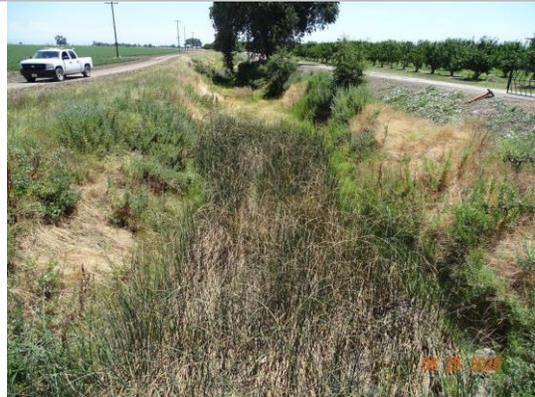
Photo 1 of 1 : CH\_2020\_NA0017\_44\_71\_20200707\_00103.jpg

Check Point / View			
<b>Austin Rd / Up</b>			
Rating **	M	Issue No.	71
Issue Type +	Ma	Location *	37.872720 °
Category	Rivers, Channels & Designated Flood		-121.183100 °
Item	Vegetation & Obstructions		
DWR ID	DWR_NA0017_44_c_2012_71		
Action/Comments			
Inspector Comments: Flow maybe impeded by the vegetation within the channel.

View of vegetation within the channel looking upstream. Summer 2020

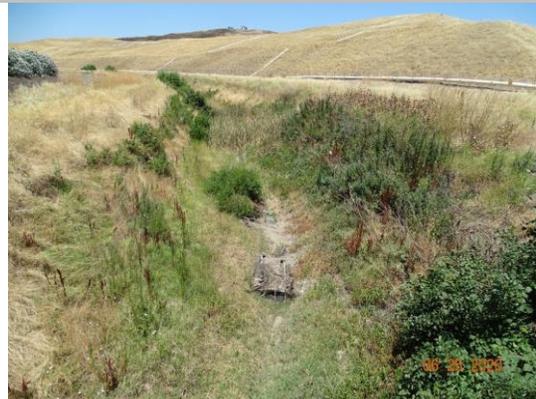
Photo 1 of 1 : CH\_2020\_NA0017\_44\_76\_20200707\_00104.jpg

Check Point / View				
<b>Austin Rd / Down</b>				
Rating **	M	Issue No.	76	GPS Lat/Long
Issue Type +	Ma	Location *		37.872720 °
Category	Rivers, Channels & Designated Flood			-121.183100 °
Item	Vegetation & Obstructions			
DWR ID	DWR_NA0017_44_c_2012_76			
Action/Comments				
Inspector Comments: Flow may be impeded by the vegetation within the channel.

View of vegetation within the channel looking downstream. Summer 2020

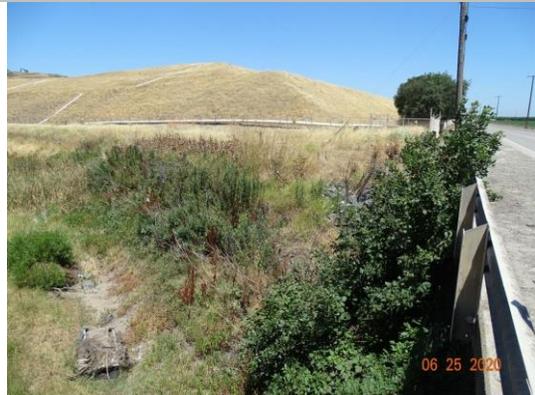
Photo 1 of 1 : CH\_2020\_NA0017\_44\_79\_20200707\_00105.jpg

Rating **	A	Issue No.	<b>79</b>	GPS Lat/Long
Issue Type +	Ma	Location *		37.872720 °
Category	Rivers, Channels & Designated Flood			-121.183100 °
Item	Revetments			
DWR ID	DWR_NA0017_44_c_2012_79			
Action/Comments				
Inspector Comments: Riprap is in place and well maintained.

View of riprap that is in place on the downstream side. Summer 2020

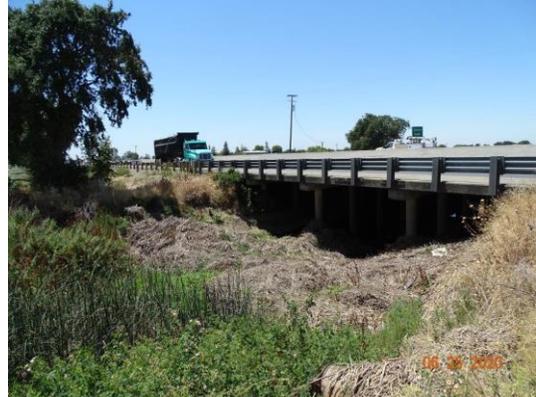
Photo 1 of 1 : CH\_2020\_NA0017\_44\_81\_20200707\_00106.jpg

Check Point / View				
<b>Highway 99 / Up</b>				
Rating **	M	Issue No.	<b>81</b>	GPS Lat/Long
Issue Type +	Ma	Location *		37.872077 °
Category	Rivers, Channels & Designated Flood			-121.219318 °
Item	Vegetation & Obstructions			
DWR ID	DWR_NA0017_44_c_2012_81			
Action/Comments				
Inspector Comments: Flow may be impeded by the vegetation within the channel.

View of vegetation within the upstream channel. Summer 2020

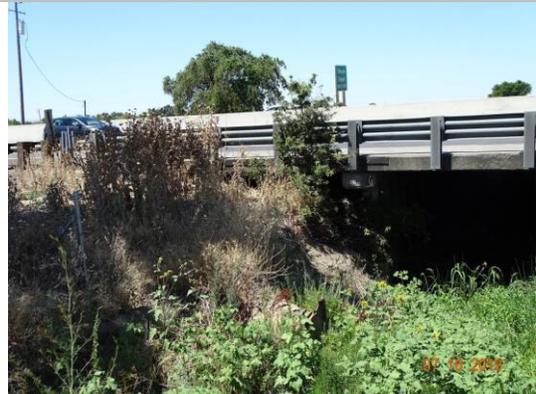
Photo 1 of 1 : CH\_2020\_NA0017\_44\_83\_20200617\_00044.jpg

Rating **	M	Issue No.	<b>83</b>	GPS Lat/Long
Issue Type +	Ma	Location *		37.872077 °
Category	Rivers, Channels & Designated Flood			-121.219318 °
Item	Erosion / Bank Caving			
DWR ID	DWR_NA0017_44_c_2012_83			
Action/Comments				
Inspector Comments: Erosion near pipe outlet on left bank.

View of pipe outlet on left bank, upstream of Hwy 99. Summer 2019

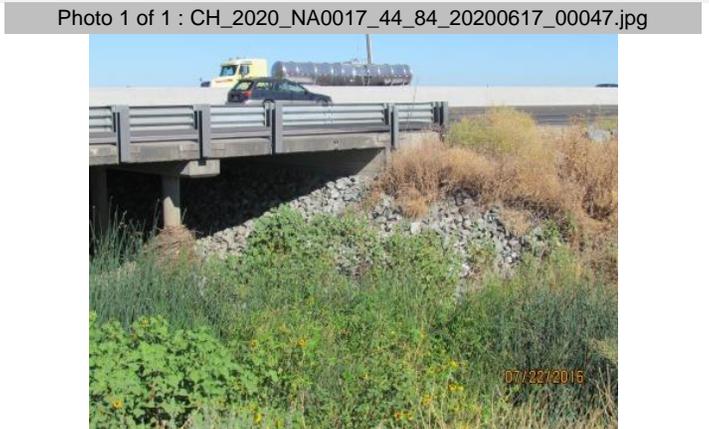
Check Point / View			
<b>Highway 99 / Up (cont)</b>			
Rating **	A	Issue No.	<b>84</b>
Issue Type +	Ma	Location *	GPS Lat/Long
Category	Rivers, Channels & Designated Flood		37.872077 °
Item	Revetments		-121.219318 °
DWR ID	DWR_NA0017_44_c_2012_84		
Action/Comments			
Inspector Comments: Riprap is in place and well maintained.

View of the existing revetments on the upstream end of the channel.

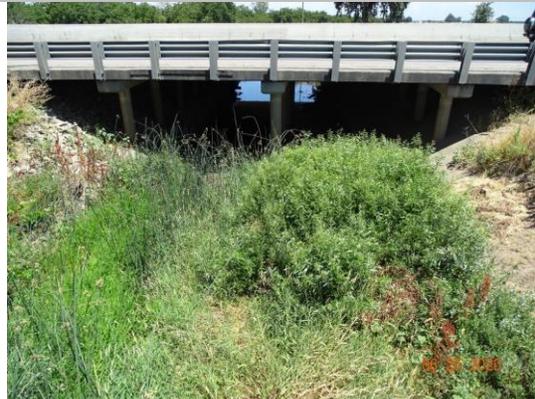
Photo 1 of 1 : CH\_2020\_NA0017\_44\_86\_20200707\_00107.jpg

Check Point / View				
<b>Highway 99 / Down</b>				
Rating **	M	Issue No.	<b>86</b>	GPS Lat/Long
Issue Type +	Ma	Location *		37.872077 °
Category	Rivers, Channels & Designated Flood			-121.219318 °
Item	Vegetation & Obstructions			
DWR ID	DWR_NA0017_44_c_2012_86			
Action/Comments				
Inspector Comments: Flow may be impeded by the vegetation within the channel.

View of vegetation within the channel looking downstream. Summer 2020

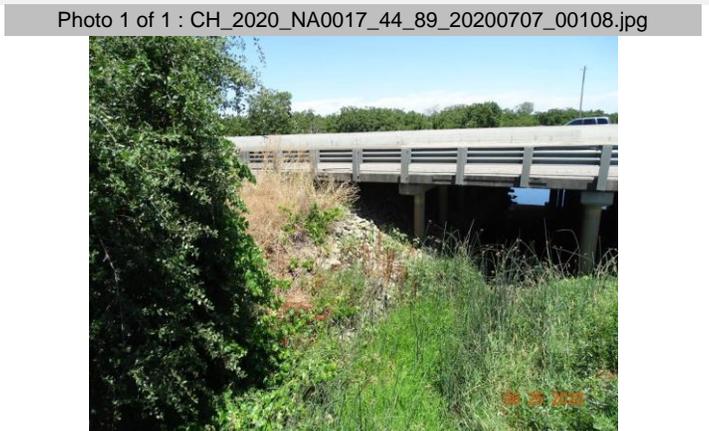
Check Point / View			
<b>Highway 99 / Down (cont)</b>			
Rating **	A	Issue No.	89
Issue Type +	Ma	Location *	GPS Lat/Long
Category	Rivers, Channels & Designated Flood		37.872077 °
Item	Revetments		-121.219318 °
DWR ID	DWR_NA0017_44_c_2012_89		
Action/Comments			
Inspector Comments: Riprap is in place and well maintained.

View of riprap that is in place and well maintained on the downstream side. Summer 2020

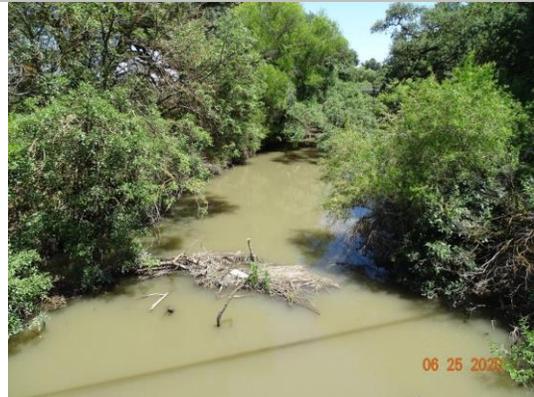
Photo 1 of 1 : CH\_2020\_NA0017\_44\_120\_20200707\_00109.jpg

Check Point / View				
<a href="#">El Dorado Rd. / Up</a>				
Rating **	A	Issue No.	<b>120</b>	GPS Lat/Long
Issue Type +	Ma	Location *		37.894480 °
Category	Rivers, Channels & Designated Flood			-121.275977 °
Item	Vegetation & Obstructions			
DWR ID	DWR_NA0017_44_c_2014_120			
Action/Comments				
Inspector Comments: Flow is not impeded by the minimal vegetation within the channel.

View of vegetation within the channel looking upstream. Summer 2020

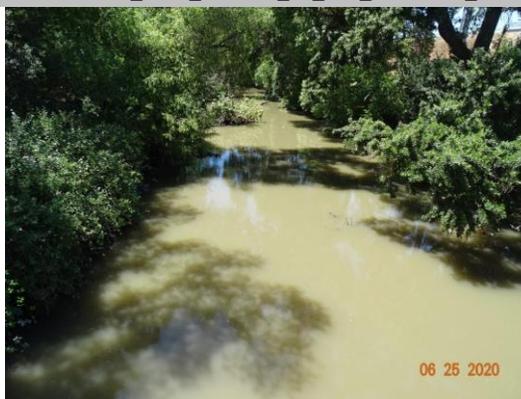
Photo 1 of 1 : CH\_2020\_NA0017\_44\_125\_20200707\_00110.jpg

Check Point / View			
<b>El Dorado Rd. / Down</b>			
Rating **	A	Issue No. <b>125</b>	GPS Lat/Long
Issue Type +	Ma	Location *	37.894480 °
Category	Rivers, Channels & Designated Flood		-121.275977 °
Item	Vegetation & Obstructions		
DWR ID	DWR_NA0017_44_c_2014_125		
Action/Comments			
Inspector Comments: Flow is not impeded by the minimal vegetation within the channel.

View of vegetation within the channel looking downstream. Summer 2020

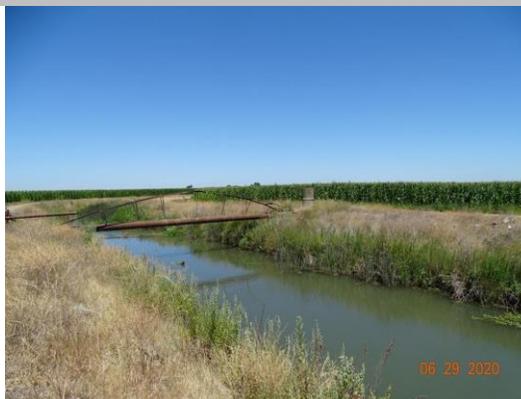
Photo 1 of 1 : CH\_2020\_NA0017\_45\_6\_20200707\_00022.jpg

Inspector Comments: Flow is not impeded by the minimal vegetation within the channel.

View of vegetation within the channel looking upstream. Summer 2020

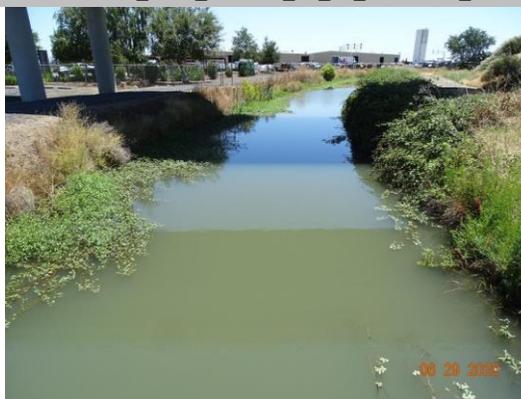
Photo 1 of 1 : CH\_2020\_NA0017\_45\_11\_20200707\_00023.jpg

Check Point / View			
<b>Jack Tone Rd / Up</b>			
Rating **	A	Issue No. <b>11</b>	GPS Lat/Long
Issue Type +	Ma	Location *	37.889520 °
Category	Rivers, Channels & Designated Flood		-121.146980 °
Item	Vegetation & Obstructions		
DWR ID	DWR_NA0017_45_c_2012_11		
Action/Comments			
Inspector Comments: Flow is not impeded by the minimal vegetation within the channel.

View of vegetation within the channel looking upstream. Summer 2020

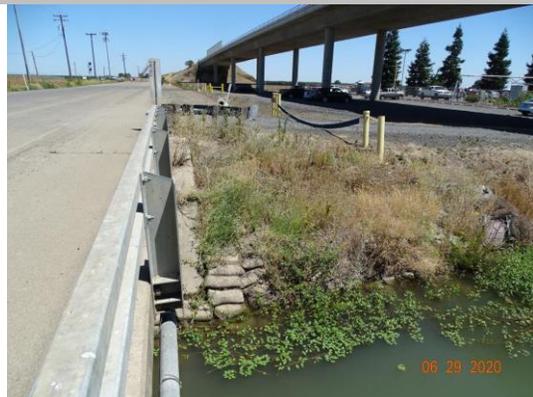
Photo 1 of 1 : CH\_2020\_NA0017\_45\_14\_20200707\_00024.jpg

Rating **	A	Issue No. <b>14</b>	GPS Lat/Long
Issue Type +	Ma	Location *	37.889520 °
Category	Rivers, Channels & Designated Flood		-121.146980 °
Item	Revetments		
DWR ID	DWR_NA0017_45_c_2012_14		
Action/Comments			
Inspector Comments: Riprap is in place and well maintained.

View of riprap that is in place and well maintained on theupstream side. Summer 2020

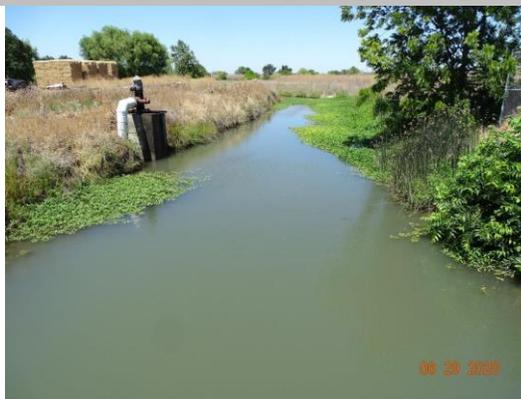
Photo 1 of 1 : CH\_2020\_NA0017\_45\_16\_20200707\_00025.jpg

Check Point / View			
<b>Jack Tone Rd / Down</b>			
Rating **	A	Issue No. <b>16</b>	GPS Lat/Long
Issue Type +	Ma	Location *	37.889520 °
Category	Rivers, Channels & Designated Flood		-121.146980 °
Item	Vegetation & Obstructions		
DWR ID	DWR_NA0017_45_c_2012_16		
Action/Comments			
Inspector Comments: Flow is not impeded by the minimal vegetation within the channel.

View of vegetation within the channel looking downstream. Summer 2020

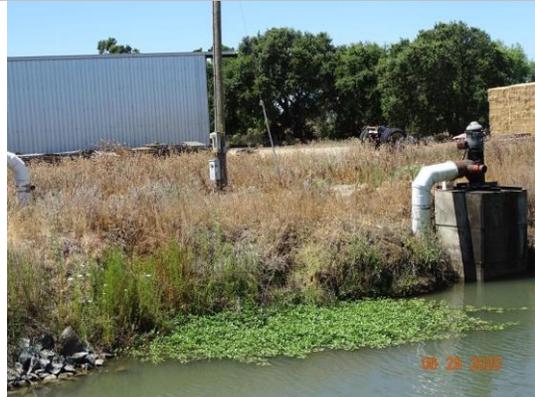
Photo 1 of 3 : CH\_2020\_NA0017\_45\_18\_20200707\_00026.jpg

Rating **	M	Issue No.	<b>18</b>	GPS Lat/Long
Issue Type +	Ma	Location *		37.889520 °
Category	Rivers, Channels & Designated Flood			-121.146980 °
Item	Erosion / Bank Caving			
DWR ID	DWR_NA0017_45_c_2012_18			
Action/Comments				
Inspector Comments: Minor erosion on the left bank is present.

View of left bank erosion on the downstream of channel. Summer 2020

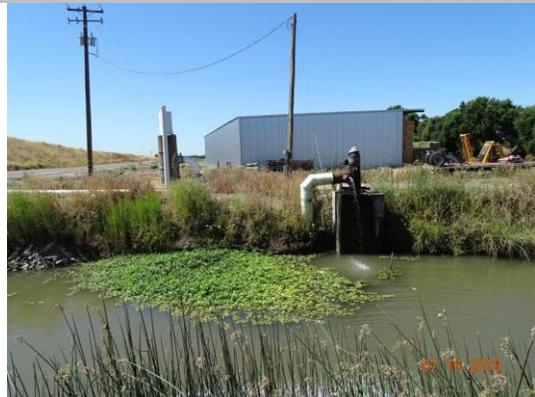
Photo 2 of 3 : CH\_2020\_NA0017\_45\_18\_20200617\_00005.jpg

View looking downstream of minor left bank erosion. Summer 2019

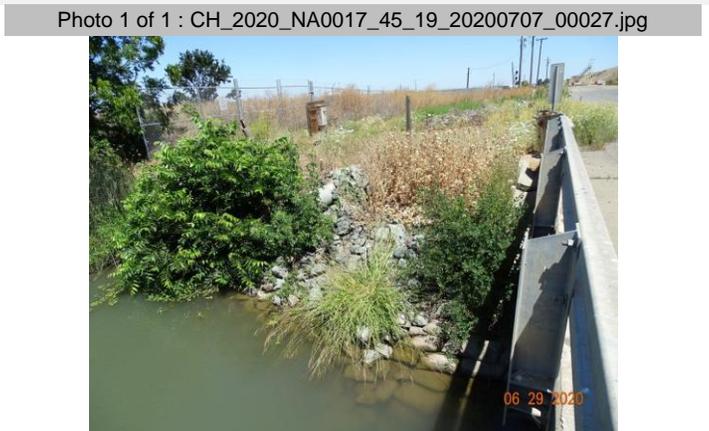
Check Point / View			
<b>Jack Tone Rd / Down (cont)</b>			
Rating **	A	Issue No.	19
Issue Type +	Ma	Location *	GPS Lat/Long
Category	Rivers, Channels & Designated Flood		37.889520 °
Item	Revetments		-121.146980 °
DWR ID	DWR_NA0017_45_c_2012_19		
Action/Comments			
Inspector Comments: Riprap is in place and well maintained.

View of riprap that is in place and well maintained on the downstream side. Summer 2020

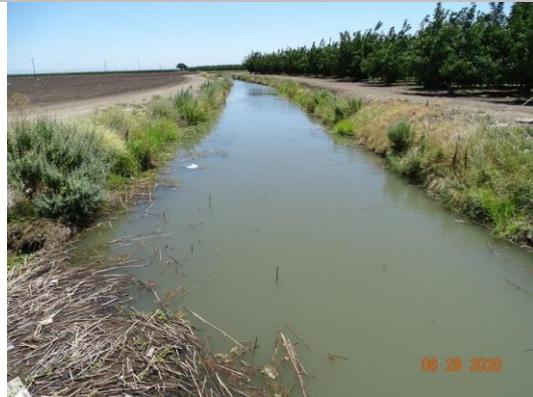
Photo 1 of 1 : CH\_2020\_NA0017\_45\_21\_20200707\_00028.jpg

Check Point / View			
<b>Austin Rd / Up</b>			
Rating **	A	Issue No. <b>21</b>	GPS Lat/Long
Issue Type +	Ma	Location *	37.886056 °
Category	Rivers, Channels & Designated Flood		-121.183664 °
Item	Vegetation & Obstructions		
DWR ID	DWR_NA0017_45_c_2012_21		
Action/Comments			
Inspector Comments: Flow is not impeded by the minimal vegetation within the channel.

View of vegetation within the channel looking upstream. Summer 2020

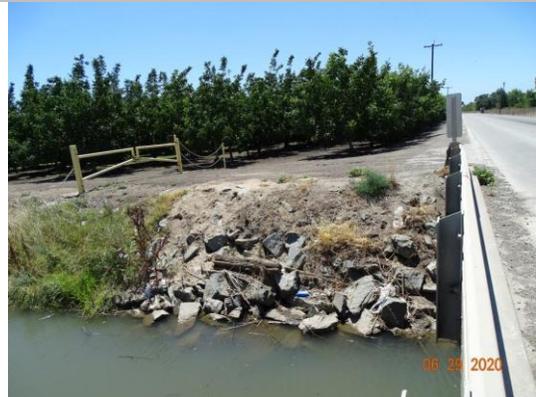
Photo 1 of 1 : CH\_2020\_NA0017\_45\_24\_20200707\_00029.jpg

Check Point / View				
<b>Austin Rd / Up (cont)</b>				
Rating **	A	Issue No.	<b>24</b>	GPS Lat/Long
Issue Type +	Ma	Location *		37.886056 °
Category	Rivers, Channels & Designated Flood			-121.183664 °
Item	Revetments			
DWR ID	DWR_NA0017_45_c_2012_24			
Action/Comments				
Inspector Comments: Riprap is in place and well maintained.

View of riprap that is in place and well maintained on the upstream side. Summer 2020

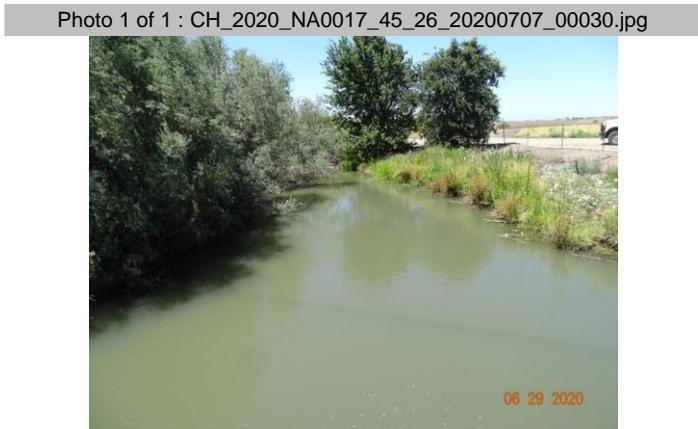
Check Point / View				
<b>Austin Rd / Down</b>				
Rating **	A	Issue No.	<b>26</b>	GPS Lat/Long
Issue Type +	Ma	Location *		37.886056 °
Category	Rivers, Channels & Designated Flood			-121.183664 °
Item	Vegetation & Obstructions			
DWR ID	DWR_NA0017_45_c_2012_26			
Action/Comments				
Inspector Comments: Flow is not impeded by the minimal vegetation within the channel.

View of vegetation within the channel looking upstream. Summer 2020

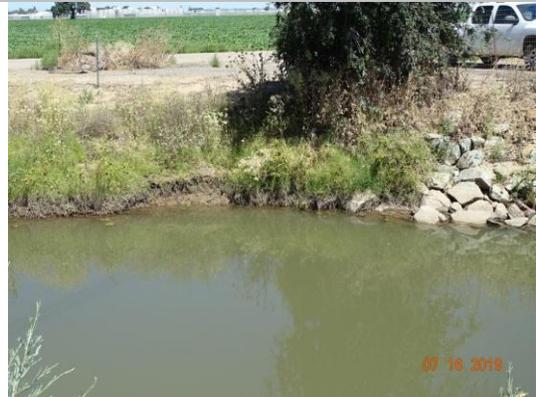
Photo 2 of 3 : CH\_2020\_NA0017\_45\_28\_20200617\_00010.jpg

Check Point / View				
<b>Austin Rd / Down (cont)</b>				
Rating **	M	Issue No.	<b>28 (cont)</b>	GPS Lat/Long
Issue Type +	Ma	Location *		37.886056 °
Category	Rivers, Channels & Designated Flood			-121.183664 °
Item	Erosion / Bank Caving			
DWR ID	DWR_NA0017_45_c_2012_28			
Action/Comments				
Inspector Comments: There is erosion on the right bank of the channel.

View of erosion on right bank of channel. Summer 2019

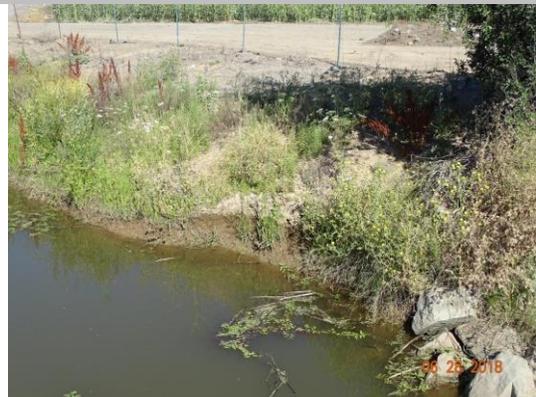
Photo 3 of 3 : CH\_2020\_NA0017\_45\_28\_20200617\_00011.jpg

View of the erosion on the right bank of the channel. Summer 2018

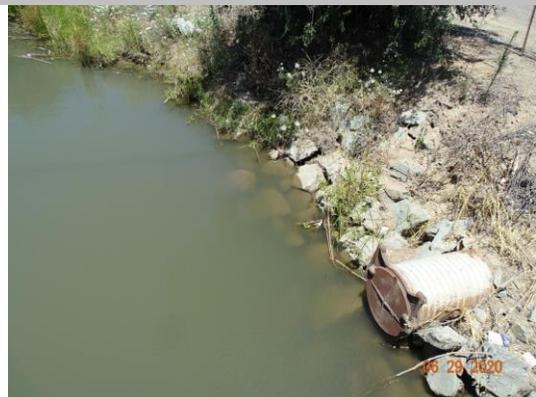
Photo 1 of 2 : CH\_2020\_NA0017\_45\_29\_20200707\_00032.jpg

Rating **	A	Issue No.	<b>29</b>	GPS Lat/Long
Issue Type +	Ma	Location *		37.886056 °
Category	Rivers, Channels & Designated Flood			-121.183664 °
Item	Revetments			
DWR ID	DWR_NA0017_45_c_2012_29			
Action/Comments				
Inspector Comments: Riprap is visible and appears to be undamaged.

View of riprap that is in place on the downstream side. Summer 2020

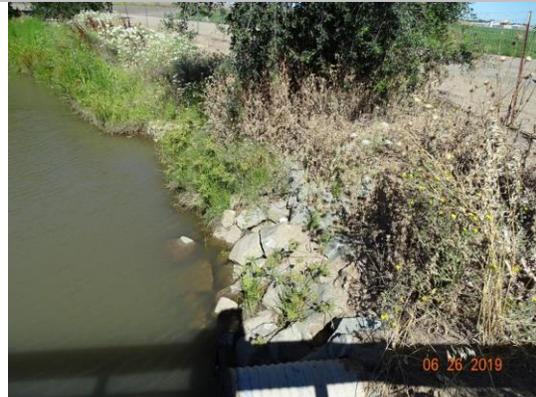
Photo 2 of 2 : CH\_2020\_NA0017\_45\_29\_20200617\_00012.jpg

Check Point / View			
<b>Austin Rd / Down (cont)</b>			
Rating **	A	Issue No.	<b>29 (cont)</b>
Issue Type +	Ma	Location *	GPS Lat/Long
Category	Rivers, Channels & Designated Flood		37.886056 °
Item	Revetments		-121.183664 °
DWR ID	DWR_NA0017_45_c_2012_29		
Action/Comments			
Inspector Comments: Riprap is visible and appears to be undamaged.

View looking downstream of revetment on right bank. Summer 2019

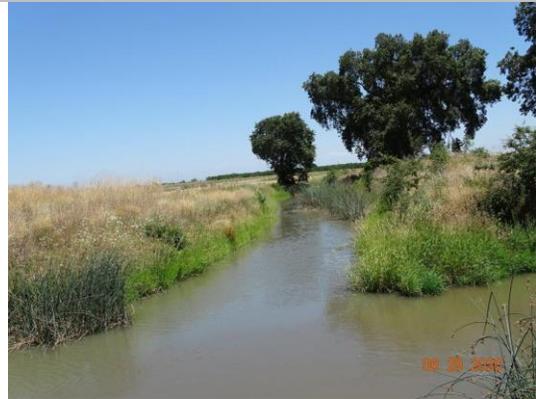
Photo 1 of 1 : CH\_2020\_NA0017\_45\_31\_20200707\_00039.jpg

Check Point / View				
<b>Confluence at Airport Way / Up</b>				
Rating **	A	Issue No.	31	GPS Lat/Long
Issue Type +	Ma	Location *		37.876513 °
Category	Rivers, Channels & Designated Flood			-121.236231 °
Item	Vegetation & Obstructions			
DWR ID	DWR_NA0017_45_c_2012_31			
Action/Comments				
Inspector Comments: Flow is not impeded by the minimal vegetation within the channel.

View of confluence looking upstream. Summer 2020

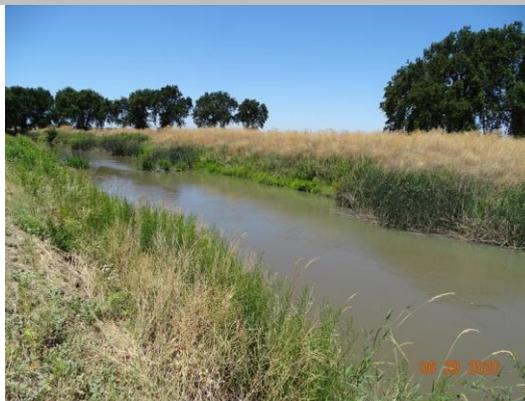
Photo 1 of 1 : CH\_2020\_NA0017\_45\_36\_20200707\_00040.jpg

Check Point / View			
<b>Confluence at Airport Way / Down</b>			
Rating **	A	Issue No. <b>36</b>	GPS Lat/Long
Issue Type +	Ma	Location *	37.876513 °
Category	Rivers, Channels & Designated Flood		-121.236231 °
Item	Vegetation & Obstructions		
DWR ID	DWR_NA0017_45_c_2012_36		
Action/Comments			
Inspector Comments: Flow is not impeded by the minimal vegetation within the channel.

View of channel looking downstream. Summer 2020

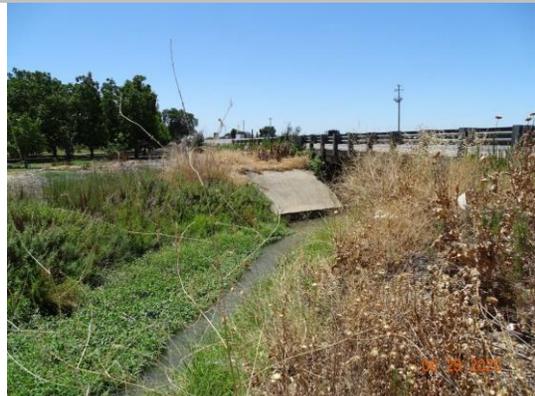
Photo 1 of 2 : CH\_2020\_NA0017\_45\_41\_20200707\_00033.jpg

Check Point / View			
<b>Highway 99 / Up</b>			
Rating **	M	Issue No.	41
Issue Type +	Ma	Location *	37.875127 °
Category	Rivers, Channels & Designated Flood		-121.219201 °
Item	Vegetation & Obstructions		
DWR ID	DWR_NA0017_45_c_2013_41		
Action/Comments			
Inspector Comments: Flow may be impeded by the vegetation within the channel.

View of vegetation upstream from Hwy 99. Summer 2020

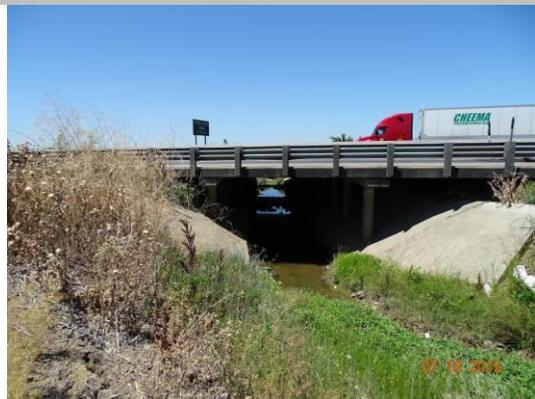
Photo 2 of 2 : CH\_2020\_NA0017\_45\_41\_20200617\_00015.jpg

View of vegetation upstream from Hwy 99. Summer 2019

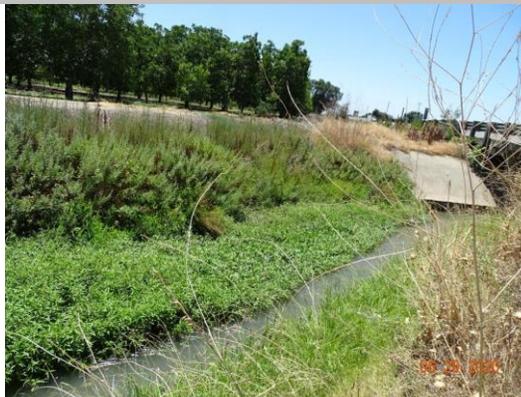
Photo 1 of 2 : CH\_2020\_NA0017\_45\_43\_20200707\_00034.jpg

Rating **	A	Issue No.	<b>43</b>	GPS Lat/Long
Issue Type +	Ma	Location *		37.875127 °
Category	Rivers, Channels & Designated Flood			-121.219201 °
Item	Revetments			
DWR ID	DWR_NA0017_45_c_2013_43			
Action/Comments				
Inspector Comments: Riprap is in place and well maintained.

View of revetments on right bank upstream of Hwy 99. Summer 2020

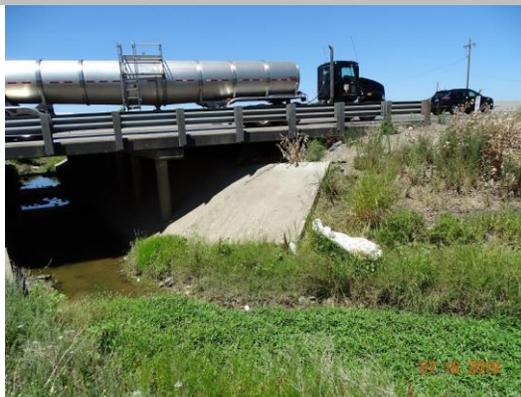
Photo 2 of 2 : CH\_2020\_NA0017\_45\_43\_20200617\_00017.jpg

View of revetments on right bank upstream of Hwy 99. Summer 2019

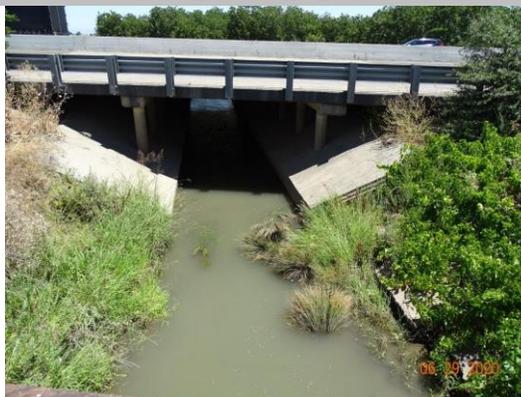
Photo 1 of 1 : CH\_2020\_NA0017\_45\_45\_20200707\_00035.jpg

Check Point / View			
<b>Highway 99 / Down</b>			
Rating **	A	Issue No.	<b>45</b>
Issue Type +	Ma	Location *	GPS Lat/Long
Category	Rivers, Channels & Designated Flood		37.875127 °
Item	Vegetation & Obstructions		-121.219201 °
DWR ID	DWR_NA0017_45_c_2013_45		
Action/Comments			
Inspector Comments: Flow is not impeded by the minimal vegetation within the channel.

View of vegetation downstream of Hwy 99. Summer 2020

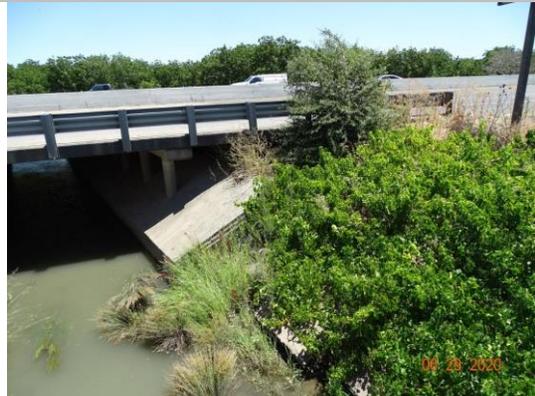
Photo 1 of 2 : CH\_2020\_NA0017\_45\_48\_20200707\_00036.jpg

Rating **	A	Issue No.	<b>48</b>
Issue Type +	Ma	Location *	37.875127 °
Category	Rivers, Channels & Designated Flood		-121.219201 °
Item	Revetments		
DWR ID	DWR_NA0017_45_c_2013_48		
Action/Comments			
Inspector Comments: Riprap is visible and appears to be undamaged.

View of revetments downstream of Hwy 99. Summer 2020

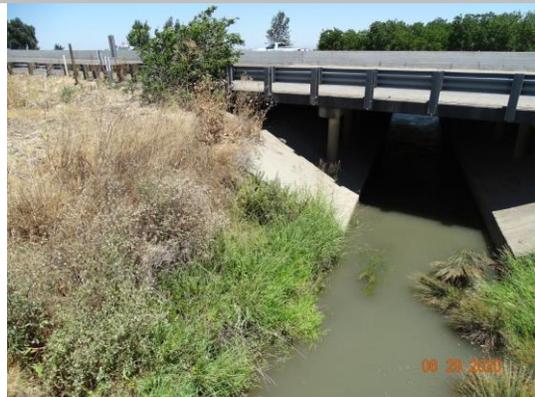
Photo 2 of 2 : CH\_2020\_NA0017\_45\_48\_20200707\_00038.jpg

View of revetments downstream of Hwy 99. Summer 2020
