Flood Control Project Maintenance

2020 Structure Inspection Results

San Joaquin County Flood Control and Water Conservation District

Structure	
Duck Creek Diversion Weir And Control Structure

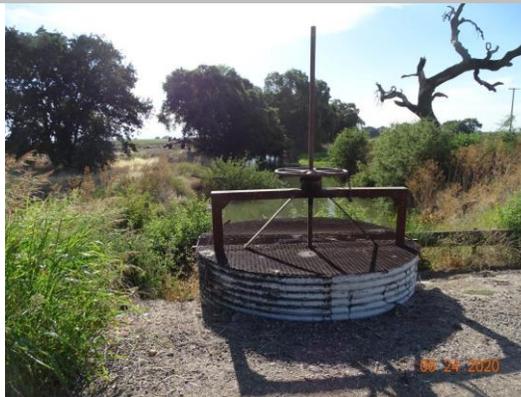
Photo 1 of 1 : ST_2020_NA0017_5_12_20200708_00031.jpg

LM Start	0.00	Rating **	A	Issue No.	12
LM End	0.00	Issue Type +	Ma	Location *	
Category	Structures & Concrete Lined Channels		GPS Latitude/Longitude		
			Start	End	
Item	Sluice/Slide Gates		37.938383 °	37.938383 °	
			-120.990133 °	-120.990133 °	
DWR ID	DWR_NA0017_5_t_2012_12				
Action/Comments					
Inspector Comments: The slide gate was tested and is well maintained.

View of the slide gate. Summer 2020

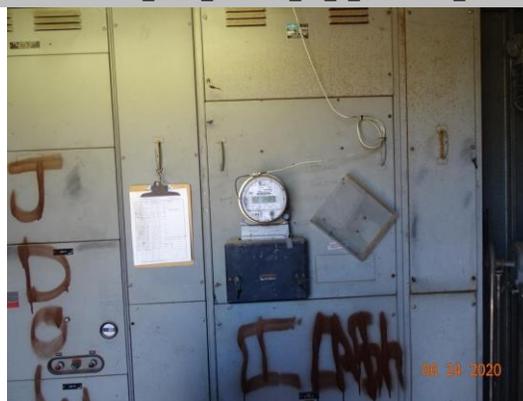
Photo 1 of 1 : ST_2020_NA0017_18_1_20200708_00018.jpg

LM Start	0.00	Rating **	A	Issue No.	1
LM End	0.00	Issue Type +	Ma	Location *	
Category	Pump Stations		GPS Latitude/Longitude		
			Start	End	
Item	Operating Log		37.989633 °	37.989633 °	
			-121.266933 °	-121.266933 °	
DWR ID	DWR_NA0017_18_t_2012_1				
Action/Comments					
Inspector Comments: Operating log is maintained and is kept at the pumping plant.

View of the operation log. Summer 2020

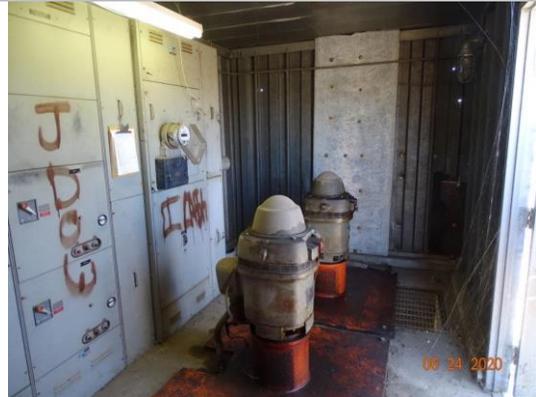
Photo 1 of 2 : ST_2020_NA0017_18_7_20200708_00021.jpg

LM Start	0.00	Rating **	A	Issue No.	7
LM End	0.00	Issue Type +	Ma	Location *	
Category	Pump Stations		GPS Latitude/Longitude		
			Start	End	
Item	Pumps		37.989633 °	37.989633 °	
			-121.266933 °	-121.266933 °	
DWR ID	DWR_NA0017_18_t_2012_7				
Action/Comments					
Inspector Comments: Pumps are routinely inspected and are operational.

View of pumps inside plant. Summer 2020

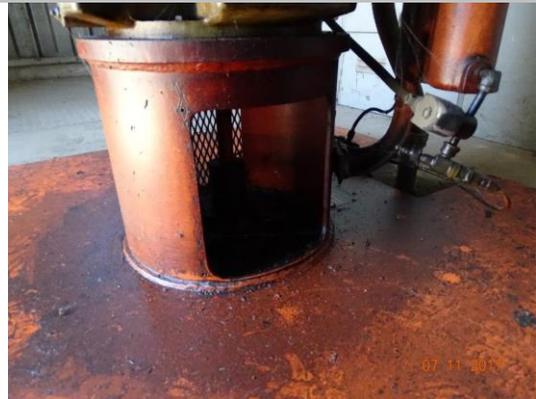
Photo 2 of 2 : ST_2020_NA0017_18_7_20200617_00005.jpg

View of the shaft under a pump.

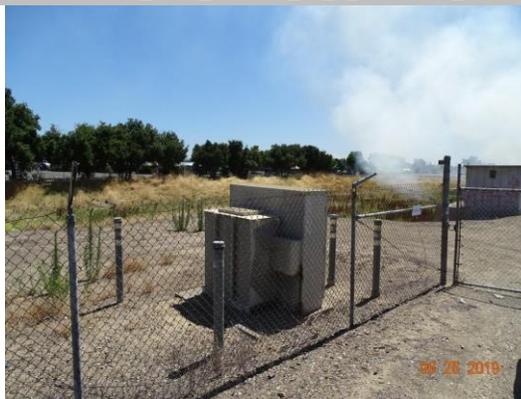
Photo 1 of 2 : ST_2020_NA0017_18_8_20200617_00006.jpg

LM Start	0.00	Rating **	A	Issue No.	8
LM End	0.00	Issue Type +	Ma	Location *	
Category	Pump Stations			GPS Latitude/Longitude	
				Start	End
Item	Power			37.989633 °	37.989633 °
				-121.266933 °	-121.266933 °
DWR ID	DWR_NA0017_18_t_2012_8				
Action/Comments					
Inspector Comments: The power source and its appurtenances are well maintained..

View of power source next to pumping plant. Summer 2019

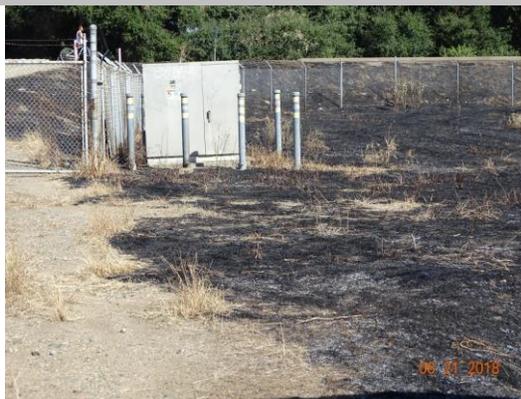
Photo 2 of 2 : ST_2020_NA0017_18_8_20200617_00007.jpg

View of the power source next to the pumping plant.

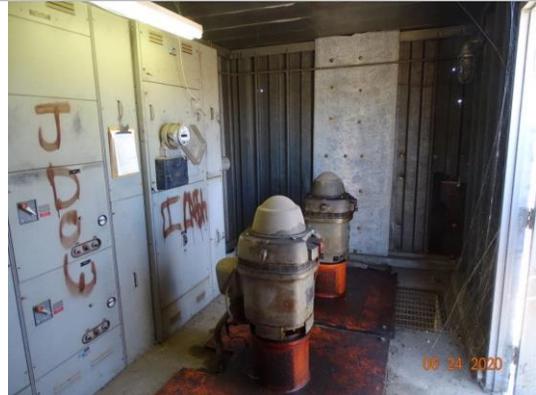
Photo 1 of 2 : ST_2020_NA0017_18_11_20200708_00026.jpg

LM Start	0.00	Rating **	A	Issue No.	11
LM End	0.00	Issue Type +	Ma	Location *	
Category	Pump Stations		GPS Latitude/Longitude		
			Start	End	
Item	Pump Control Systems		37.989633 °	37.989633 °	
			-121.266933 °	-121.266933 °	
DWR ID	DWR_NA0017_18_t_2012_11				
Action/Comments					
Inspector Comments: The pump control systems/panel have graffiti but are routinely monitored and are operational.

View of pump control sytem panels. Summer 2020

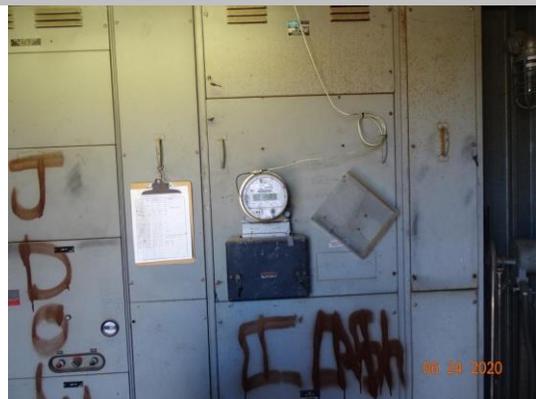
Photo 2 of 2 : ST_2020_NA0017_18_11_20200708_00027.jpg

View of pump control sytem panels. Summer 2020

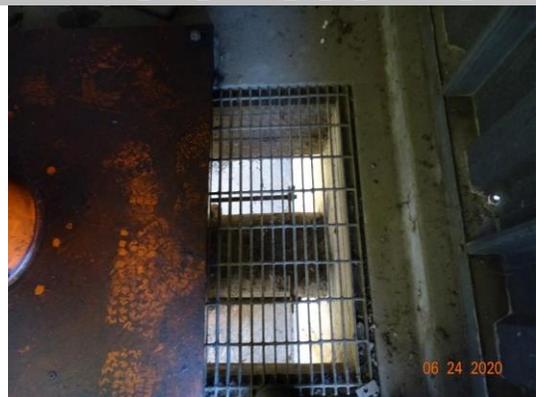
Photo 1 of 1 : ST_2020_NA0017_18_12_20200708_00028.jpg

LM Start	0.00	Rating **	A	Issue No.	12
LM End	0.00	Issue Type +	Ma	Location *	
Category	Pump Stations		GPS Latitude/Longitude		
			Start	End	
Item	Sumps/Wet Well		37.989633 °	37.989633 °	
			-121.266933 °	-121.266933 °	
DWR ID	DWR_NA0017_18_t_2012_12				
Action/Comments					
Inspector Comments: Wet wells were dry and had minimal debris.

View of wet well. Summer 2020

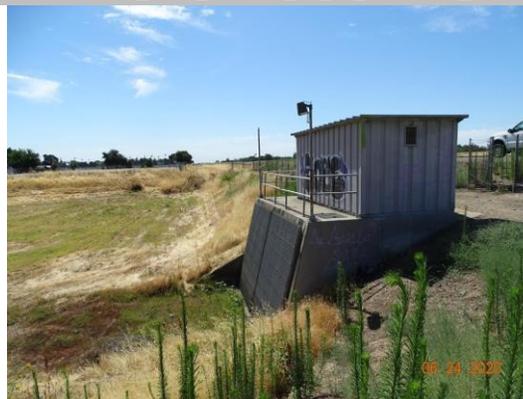
Photo 1 of 1 : ST_2020_NA0017_18_13_20200708_00029.jpg

LM Start	0.00	Rating **	A	Issue No.	13
LM End	0.00	Issue Type +	Ma	Location *	
Category	Pump Stations		GPS Latitude/Longitude		
			Start	End	
Item	Trash Racks		37.989633 °	37.989633 °	
			-121.266933 °	-121.266933 °	
DWR ID	DWR_NA0017_18_t_2012_13				
Action/Comments					
Inspector Comments: Trash racks are properly maintained and clear of debris.

View of trash racks. Summer 2020

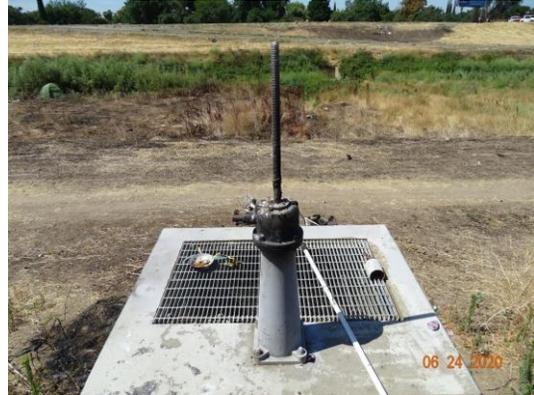
Photo 1 of 1 : ST_2020_NA0017_18_17_20200708_00030.jpg

LM Start	0.00	Rating **	A	Issue No.	17
LM End	0.00	Issue Type +	Ma	Location *	
Category	Pump Stations		GPS Latitude/Longitude		
			Start	End	
Item	Manual Gate Operators		37.989633 °	37.989633 °	
			-121.266933 °	-121.266933 °	
DWR ID	DWR_NA0017_18_t_2012_17				
Action/Comments					
Inspector Comments: Manual gate operator is operational and well maintained. Gate wheel has been removed in order to prevent unauthorized use and theft.

View of slide gate manual housing unit. Summer 2020

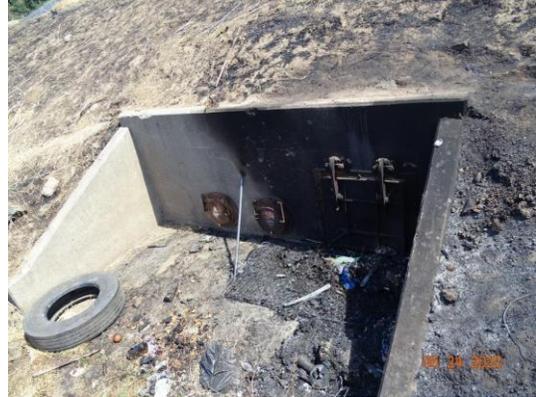
Photo 1 of 1 : ST_2020_NA0017_18_19_20200708_00031.jpg

LM Start	0.00	Rating **	A	Issue No.	19
LM End	0.00	Issue Type +	Ma	Location *	
Category	Pump Stations		GPS Latitude/Longitude		
			Start	End	
Item	Flap Gates		37.989633 °	37.989633 °	
			-121.266933 °	-121.266933 °	
DWR ID	DWR_NA0017_18_t_2012_19				
Action/Comments					
Inspector Comments: Flap gates are routinely inspected and are operational.

View of flap gates. Summer 2020

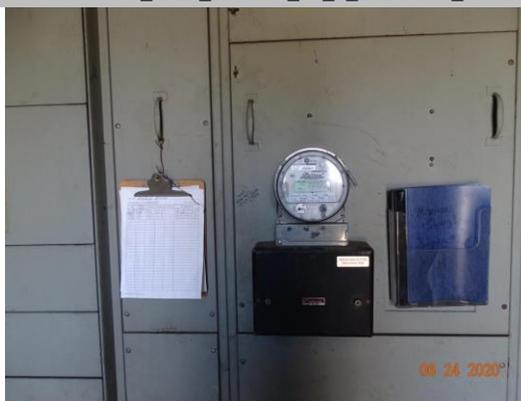
Photo 1 of 1 : ST_2020_NA0017_19_1_20200708_00016.jpg

LM Start	0.00	Rating **	A	Issue No.	1
LM End	0.00	Issue Type +	Ma	Location *	
Category	Pump Stations		GPS Latitude/Longitude		
			Start	End	
Item	Operating Log		37.982317 °	37.982317 °	
			-121.249433 °	-121.249433 °	
DWR ID	DWR_NA0017_19_t_2012_1				
Action/Comments					
Inspector Comments: Operating log is maintained and is kept at the pumping plant.

View of the operation log inside the pumping plant. Summer 2020

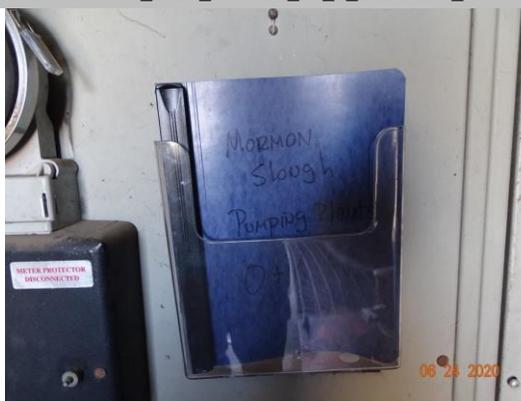
Photo 1 of 1 : ST_2020_NA0017_19_2_20200708_00017.jpg

LM Start	0.00	Rating **	A	Issue No.	2
LM End	0.00	Issue Type +	Ma	Location *	
Category	Pump Stations		GPS Latitude/Longitude		
			Start	End	
Item	Operation & Maintenance Manual		37.982317 °	37.982317 °	
			-121.249433 °	-121.249433 °	
DWR ID	DWR_NA0017_19_t_2012_2				
Action/Comments					
Inspector Comments: The O&M Manual is posted and kept in the pumping plant.

View of O&M manual inside the plant. Summer 2020

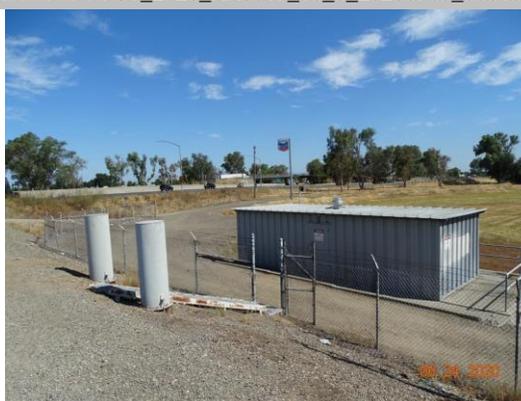
Photo 1 of 1 : ST_2020_NA0017_19_3_20200708_00018.jpg

LM Start	0.00	Rating **	A	Issue No.	3
LM End	0.00	Issue Type +	Ma	Location *	
Category	Pump Stations		GPS Latitude/Longitude		
			Start	End	
Item	Plant Building		37.982317 °	37.982317 °	
			-121.249433 °	-121.249433 °	
DWR ID	DWR_NA0017_19_t_2012_3				
Action/Comments					
Inspector Comments: The plant building is routinely inspected and repaired as necessary.

View of the pumping plant. Summer 2020

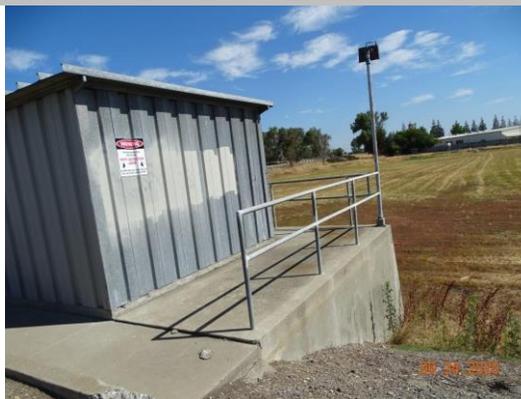
Photo 1 of 1 : ST_2020_NA0017_19_5_20200708_00019.jpg

LM Start	0.00	Rating **	A	Issue No.	5
LM End	0.00	Issue Type +	Ma	Location *	
Category	Pump Stations		GPS Latitude/Longitude		
			Start	End	
Item	Safety		37.982317 °	37.982317 °	
			-121.249433 °	-121.249433 °	
DWR ID	DWR_NA0017_19_t_2012_5				
Action/Comments					
Inspector Comments: The guard rails around the plant are well maintained and in good condition.

View of hand rails around the pumping plant. Summer 2020

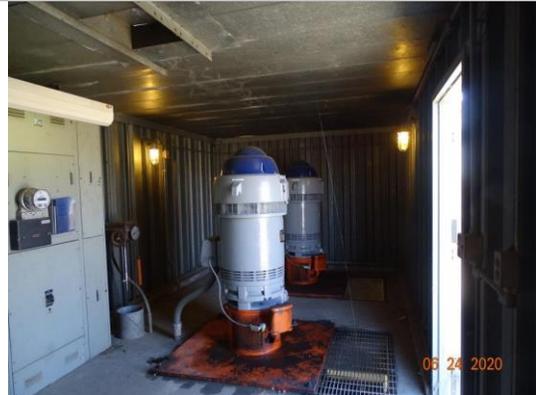
Photo 1 of 2 : ST_2020_NA0017_19_7_20200708_00020.jpg

LM Start	0.00	Rating **	A	Issue No.	7
LM End	0.00	Issue Type +	Ma	Location *	
Category	Pump Stations		GPS Latitude/Longitude		
			Start	End	
Item	Pumps		37.982317 °	37.982317 °	
			-121.249433 °	-121.249433 °	
DWR ID	DWR_NA0017_19_t_2012_7				
Action/Comments					
Inspector Comments: Pumps are routinely inspected and are operational.

View of pumps inside the pumping plant. Summer 2020

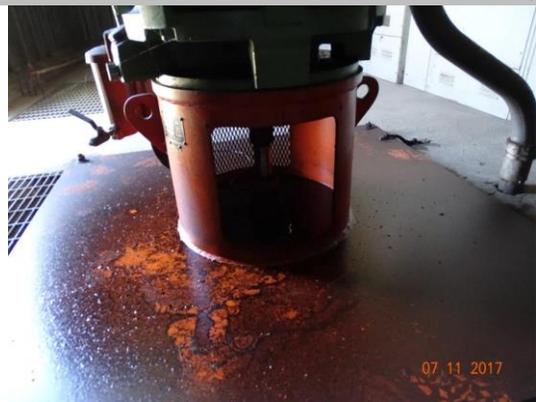
Photo 2 of 2 : ST_2020_NA0017_19_7_20200617_00006.jpg

View of the shaft under a pump.

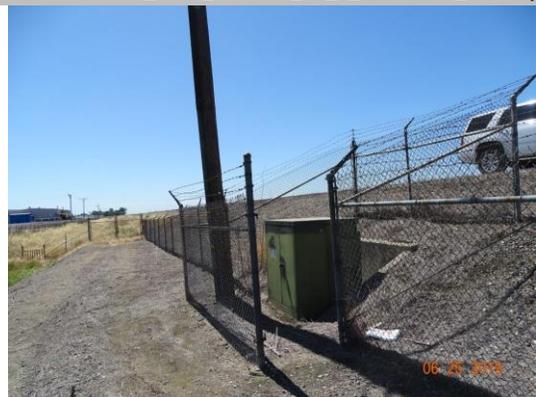
Photo 1 of 1 : ST_2020_NA0017_19_8_20200617_00007.jpg

LM Start	0.00	Rating **	A	Issue No.	8
LM End	0.00	Issue Type +	Ma	Location *	
Category	Pump Stations		GPS Latitude/Longitude		
			Start	End	
Item	Power		37.982317 °	37.982317 °	
			-121.249433 °	-121.249433 °	
DWR ID	DWR_NA0017_19_t_2012_8				
Action/Comments					
Inspector Comments: The power source and its appurtenances are well maintained.

View of the power source for the pumping plant. Summer 2019

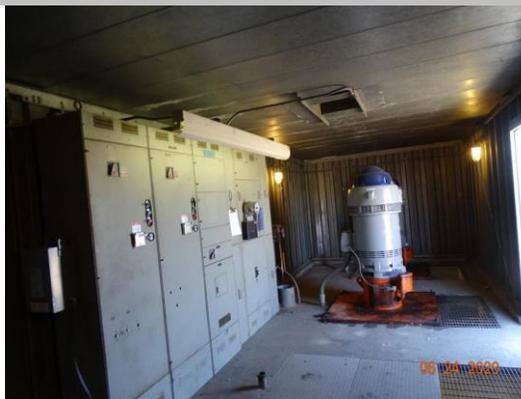
Photo 1 of 1 : ST_2020_NA0017_19_11_20200708_00021.jpg

LM Start	0.00	Rating **	A	Issue No.	11
LM End	0.00	Issue Type +	Ma	Location *	
Category	Pump Stations		GPS Latitude/Longitude		
			Start	End	
Item	Pump Control Systems		37.982317 °	37.982317 °	
			-121.249433 °	-121.249433 °	
DWR ID	DWR_NA0017_19_t_2012_11				
Action/Comments					
Inspector Comments: The pump control systems/panel are routinely monitored and are operational.

View of the power control system. Summer 2020

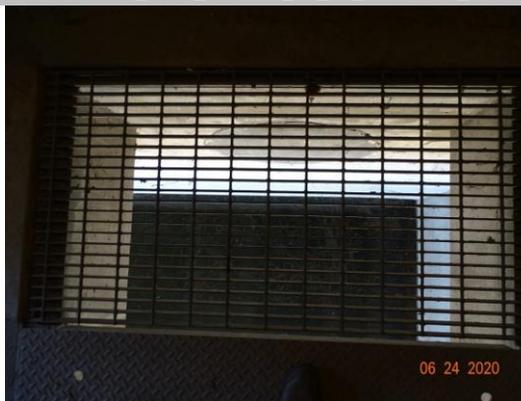
Photo 1 of 1 : ST_2020_NA0017_19_12_20200708_00022.jpg

LM Start	0.00	Rating **	A	Issue No.	12
LM End	0.00	Issue Type +	Ma	Location *	
Category	Pump Stations		GPS Latitude/Longitude		
			Start	End	
Item	Sumps/Wet Well		37.982317 °	37.982317 °	
			-121.249433 °	-121.249433 °	
DWR ID	DWR_NA0017_19_t_2012_12				
Action/Comments					
Inspector Comments: Wet wells were dry and had minimal debris.

View of the wet well. Summer 2020

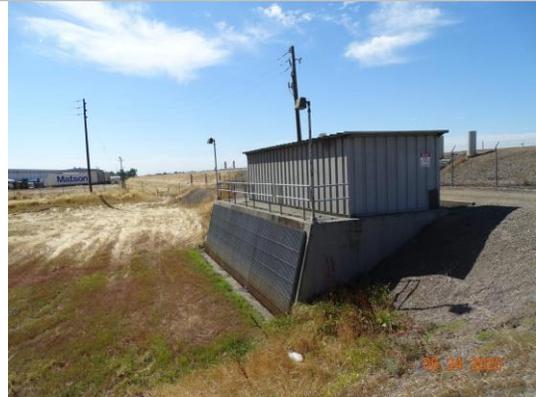
Photo 1 of 1 : ST_2020_NA0017_19_13_20200708_00023.jpg

LM Start	0.00	Rating **	A	Issue No.	13
LM End	0.00	Issue Type +	Ma	Location *	
Category	Pump Stations		GPS Latitude/Longitude		
			Start	End	
Item	Trash Racks		37.982317 °	37.982317 °	
			-121.249433 °	-121.249433 °	
DWR ID	DWR_NA0017_19_t_2012_13				
Action/Comments					
Inspector Comments: Trash racks are properly maintained and clear of debris.

View of the trash racks. Summer 2020

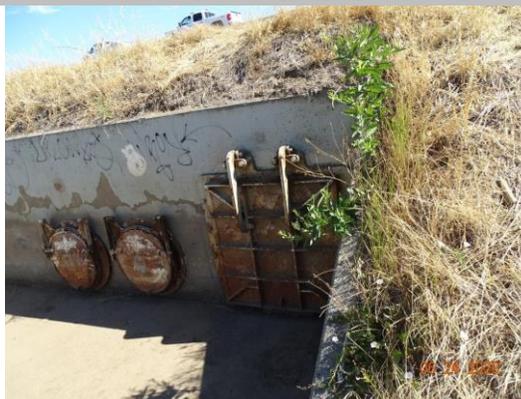
Photo 1 of 1 : ST_2020_NA0017_19_19_20200708_00026.jpg

LM Start	0.00	Rating **	A	Issue No.	19
LM End	0.00	Issue Type +	Ma	Location *	
Category	Pump Stations		GPS Latitude/Longitude		
			Start	End	
Item	Flap Gates		37.982317 °	37.982317 °	
			-121.249433 °	-121.249433 °	
DWR ID	DWR_NA0017_19_t_2012_19				
Action/Comments					
Inspector Comments: Flap gates are routinely inspected and are operational.

View of the flap gates for the pumping plant. Summer 2020

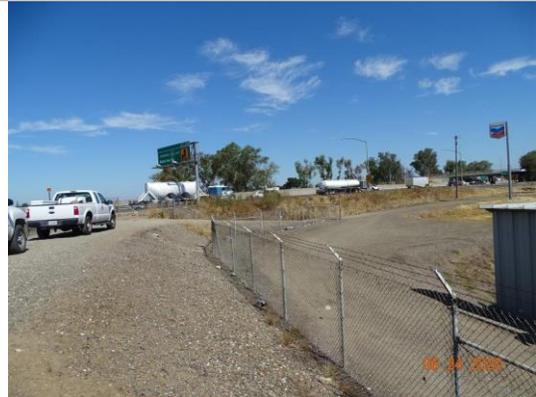
Photo 1 of 2 : ST_2020_NA0017_19_21_20200708_00028.jpg

LM Start	0.00	Rating **	A	Issue No.	21
LM End	0.00	Issue Type +	Ma	Location *	
Category	Pump Stations			GPS Latitude/Longitude	
				Start	End
Item	Security Fencing			37.982317 °	37.982317 °
				-121.249433 °	-121.249433 °
DWR ID	DWR_NA0017_19_t_2012_21				
Action/Comments					
Inspector Comments: Security fence is routinely inspected and repaired as necessary.

View of the security fencing. Summer 2020

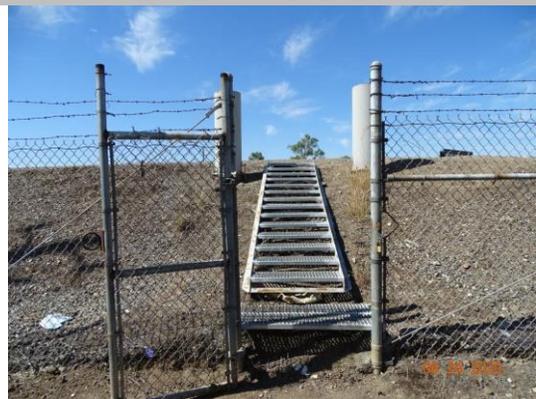
Photo 2 of 2 : ST_2020_NA0017_19_21_20200708_00029.jpg

View of the security fencing and stairs. Summer 2020

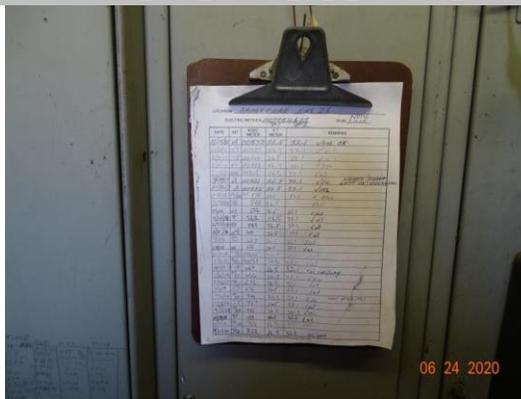
Photo 1 of 1 : ST_2020_NA0017_20_1_20200708_00014.jpg

LM Start	0.00	Rating **	A	Issue No.	1
LM End	0.00	Issue Type +	Ma	Location *	
Category	Pump Stations		GPS Latitude/Longitude		
			Start	End	
Item	Operating Log		37.973983 °	37.973983 °	
			-121.229967 °	-121.229967 °	
DWR ID	DWR_NA0017_20_t_2012_1				
Action/Comments					
Inspector Comments: Operating log is maintained and is kept at the pumping plant.

View of the operating log inside the plant. Summer 2020

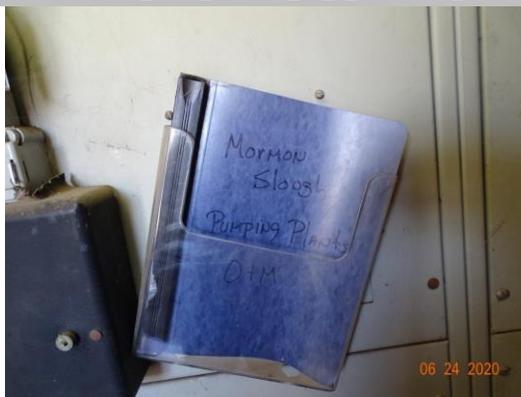
Photo 1 of 1 : ST_2020_NA0017_20_2_20200708_00015.jpg

LM Start	0.00	Rating **	A	Issue No.	2
LM End	0.00	Issue Type +	Ma	Location *	
Category	Pump Stations		GPS Latitude/Longitude		
			Start	End	
Item	Operation & Maintenance Manual		37.973983 °	37.973983 °	
			-121.229967 °	-121.229967 °	
DWR ID	DWR_NA0017_20_t_2012_2				
Action/Comments					
Inspector Comments: The O&M Manual is posted and kept in the pumping plant.

View of O&M manual inside the pumping plant. Summer 2020

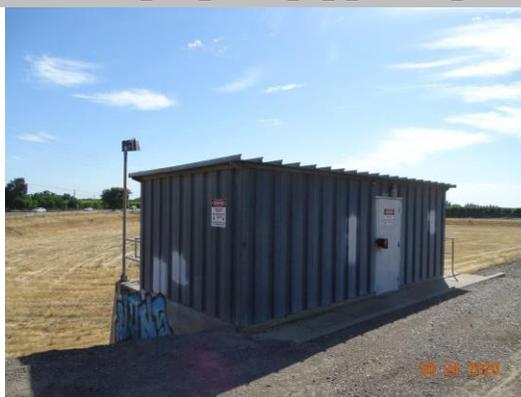
Photo 1 of 1 : ST_2020_NA0017_20_3_20200708_00016.jpg

LM Start	0.00	Rating **	A	Issue No.	3
LM End	0.00	Issue Type +	Ma	Location *	
Category	Pump Stations		GPS Latitude/Longitude		
			Start	End	
Item	Plant Building		37.973983 °	37.973983 °	
			-121.229967 °	-121.229967 °	
DWR ID	DWR_NA0017_20_t_2012_3				
Action/Comments					
Inspector Comments: The plant building is routinely inspected and repaired as necessary.

View of pumping plant. Summer 2020

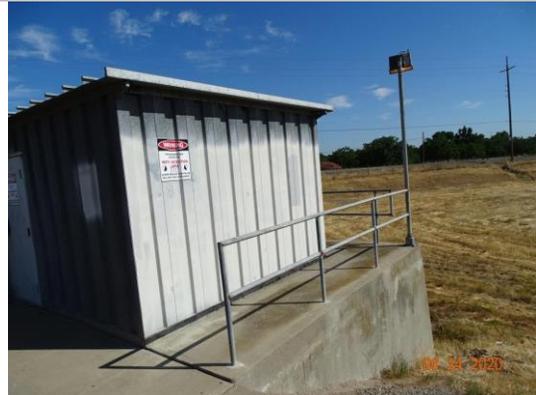
Photo 1 of 1 : ST_2020_NA0017_20_5_20200708_00017.jpg

LM Start	0.00	Rating **	A	Issue No.	5
LM End	0.00	Issue Type +	Ma	Location *	
Category	Pump Stations		GPS Latitude/Longitude		
			Start	End	
Item	Safety		37.973983 °	37.973983 °	
			-121.229967 °	-121.229967 °	
DWR ID	DWR_NA0017_20_t_2012_5				
Action/Comments					
Inspector Comments: The guard rails around the structure are well maintained and in good condition.

View of guard rails around the pumping plant. Summer 2020

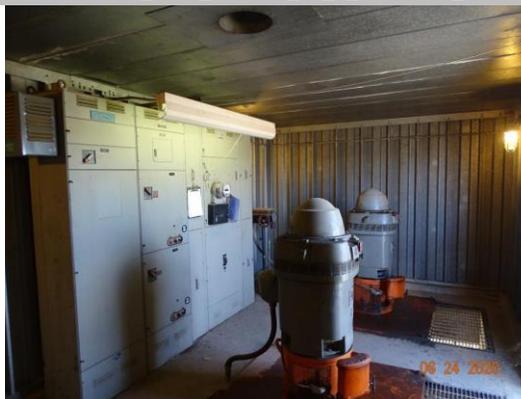
Photo 1 of 2 : ST_2020_NA0017_20_7_20200708_00019.jpg

LM Start	0.00	Rating **	A	Issue No.	7
LM End	0.00	Issue Type +	Ma	Location *	
Category	Pump Stations		GPS Latitude/Longitude		
			Start	End	
Item	Pumps		37.973983 °	37.973983 °	
			-121.229967 °	-121.229967 °	
DWR ID	DWR_NA0017_20_t_2012_7				
Action/Comments					
Inspector Comments: Pumps are routinely inspected and are operational.

View of the pumps inside the pumping plant. Summer 2020

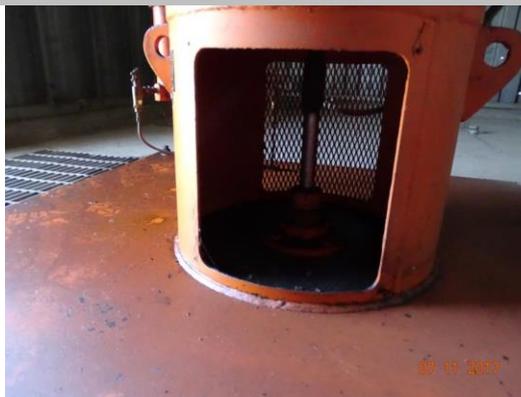
Photo 2 of 2 : ST_2020_NA0017_20_7_20200617_00006.jpg

View of bottom shaft of one of the pumps inside the plant.

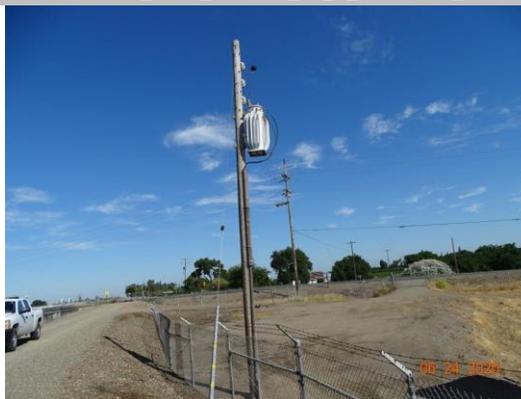
Photo 1 of 2 : ST_2020_NA0017_20_8_20200708_00021.jpg

LM Start	0.00	Rating **	A	Issue No.	8
LM End	0.00	Issue Type +	Ma	Location *	
Category	Pump Stations		GPS Latitude/Longitude		
			Start	End	
Item	Power		37.973983 °	37.973983 °	
			-121.229967 °	-121.229967 °	
DWR ID	DWR_NA0017_20_t_2012_8				
Action/Comments					
Inspector Comments: The power source and its appurtenances are well maintained.

View of the power source for the pumping plant. Summer 2020

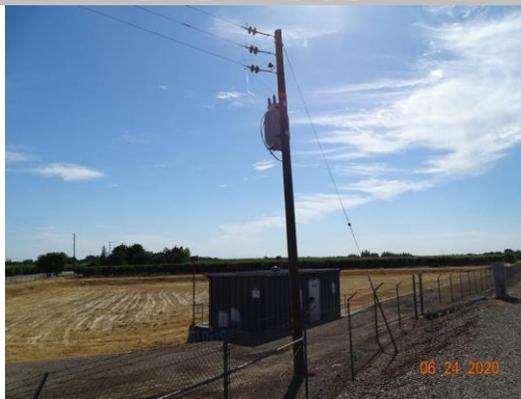
Photo 2 of 2 : ST_2020_NA0017_20_8_20200708_00022.jpg

LM Start	0.00	Rating **	A	Issue No.	8 (cont)
LM End	0.00	Issue Type +	Ma	Location *	
Category	Pump Stations			GPS Latitude/Longitude	
				Start	End
Item	Power			37.973983 °	37.973983 °
				-121.229967 °	-121.229967 °
DWR ID	DWR_NA0017_20_t_2012_8				
Action/Comments					
Inspector Comments: The power source and its appurtenances are well maintained.

View of the power source for the pumping plant. Summer 2020

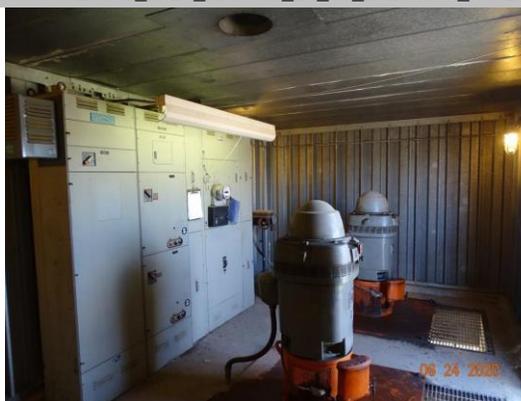
Photo 1 of 2 : ST_2020_NA0017_20_11_20200708_00023.jpg

LM Start	0.00	Rating **	A	Issue No.	11
LM End	0.00	Issue Type +	Ma	Location *	
Category	Pump Stations			GPS Latitude/Longitude	
				Start	End
Item	Pump Control Systems			37.973983 °	37.973983 °
				-121.229967 °	-121.229967 °
DWR ID	DWR_NA0017_20_t_2012_11				
Action/Comments					
Inspector Comments: The pump control systems/panel are routinely monitored and are operational.

View of pump control panel/system control unit. Summer 2020

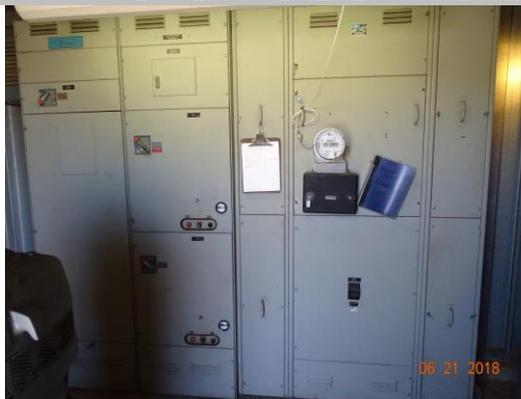
Photo 2 of 2 : ST_2020_NA0017_20_11_20200617_00008.jpg

LM Start	0.00	Rating **	A	Issue No.	11 (cont)
LM End	0.00	Issue Type +	Ma	Location *	
Category	Pump Stations		GPS Latitude/Longitude		
			Start	End	
Item	Pump Control Systems		37.973983 °	37.973983 °	
			-121.229967 °	-121.229967 °	
DWR ID	DWR_NA0017_20_t_2012_11				
Action/Comments					
Inspector Comments: The pump control systems/panel are routinely monitored and are operational.

View of the power control systems inside the plant.

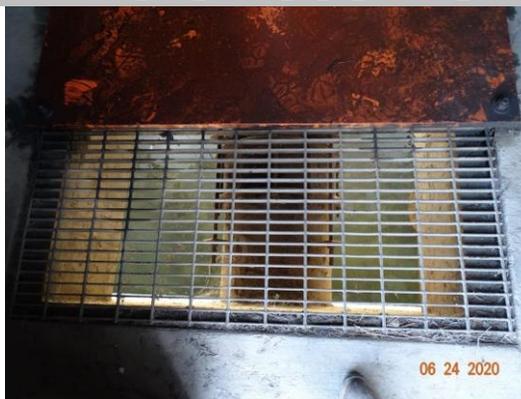
Photo 1 of 1 : ST_2020_NA0017_20_12_20200708_00025.jpg

LM Start	0.00	Rating **	A	Issue No.	12
LM End	0.00	Issue Type +	Ma	Location *	
Category	Pump Stations		GPS Latitude/Longitude		
			Start	End	
Item	Sumps/Wet Well		37.973983 °	37.973983 °	
			-121.229967 °	-121.229967 °	
DWR ID	DWR_NA0017_20_t_2012_12				
Action/Comments					
Inspector Comments: Wet wells were dry and had minimal debris.

View of wet well inside the pumping plant. Summer 2020

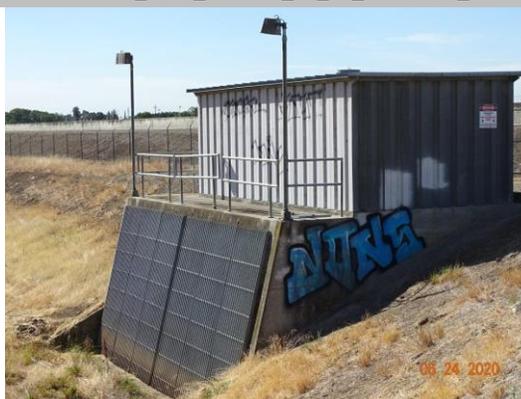
Photo 1 of 1 : ST_2020_NA0017_20_13_20200708_00026.jpg

LM Start	0.00	Rating **	A	Issue No.	13
LM End	0.00	Issue Type +	Ma	Location *	
Category	Pump Stations		GPS Latitude/Longitude		
			Start	End	
Item	Trash Racks		37.973983 °	37.973983 °	
			-121.229967 °	-121.229967 °	
DWR ID	DWR_NA0017_20_t_2012_13				
Action/Comments					
Inspector Comments: Trash racks are properly maintained and clear of debris.

View of the trash racks. Summer 2020

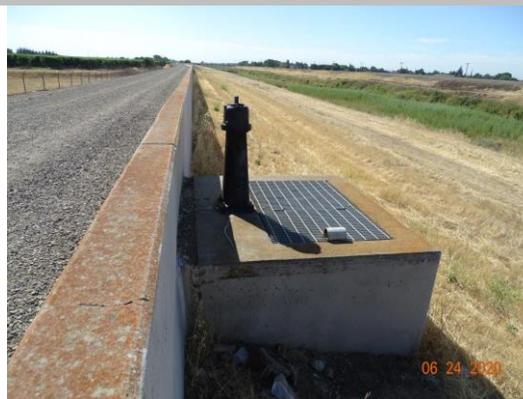
Photo 1 of 1 : ST_2020_NA0017_20_15_20200708_00027.jpg

LM Start	0.00	Rating **	A	Issue No.	15
LM End	0.00	Issue Type +	Ma	Location *	
Category	Pump Stations		GPS Latitude/Longitude		
			Start	End	
Item	Sluice / Slide Gates		37.973983 °	37.973983 °	
			-121.229967 °	-121.229967 °	
DWR ID	DWR_NA0017_20_t_2012_15				
Action/Comments					
Inspector Comments: The slide gate is operational and in good condition.

View of the slide gate housing unit. Summer 2020

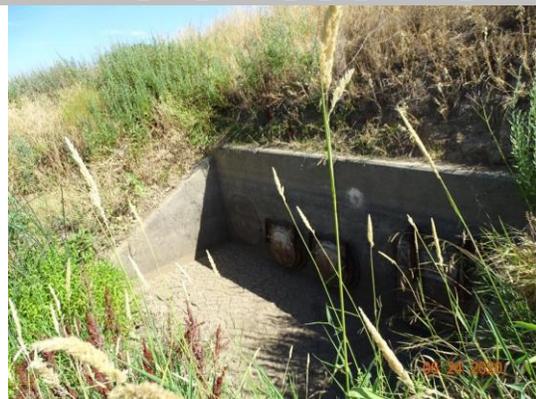
Photo 1 of 1 : ST_2020_NA0017_20_19_20200708_00029.jpg

LM Start	0.00	Rating **	A	Issue No.	19
LM End	0.00	Issue Type +	Ma	Location *	
Category	Pump Stations		GPS Latitude/Longitude		
			Start	End	
Item	Flap Gates		37.973983 °	37.973983 °	
			-121.229967 °	-121.229967 °	
DWR ID	DWR_NA0017_20_t_2012_19				
Action/Comments					
Inspector Comments: Flap gates are routinely inspected and are operational.

View of flap gates. Summer 2020

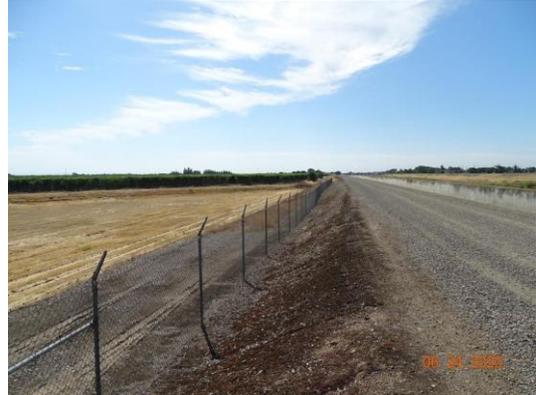
Photo 1 of 2 : ST_2020_NA0017_20_21_20200708_00031.jpg

LM Start	0.00	Rating **	A	Issue No.	21
LM End	0.00	Issue Type +	Ma	Location *	
Category	Pump Stations		GPS Latitude/Longitude		
			Start	End	
Item	Security Fencing		37.973983 °	37.973983 °	
			-121.229967 °	-121.229967 °	
DWR ID	DWR_NA0017_20_t_2012_21				
Action/Comments					
Inspector Comments: Security fence is routinely inspected and repaired as necessary.

View of the security fencing. Summer 2020

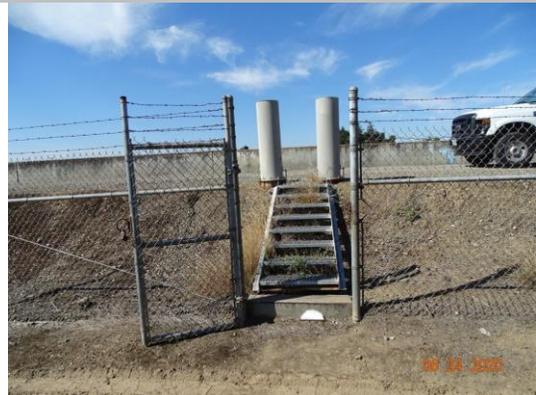
Photo 2 of 2 : ST_2020_NA0017_20_21_20200708_00032.jpg

View of the security fencing and stairs. Summer 2020
