**Flood Control Project Maintenance
Levee Inspections**

Fall 2019 Levee Maintenance Deficiency Summary Report

**Flood Control Project Maintenance
Levee Inspections
LMA District Cover Sheet
Fall 2019 Levee Inspection Results**

Tehama County Flood Control and Water Conservation District

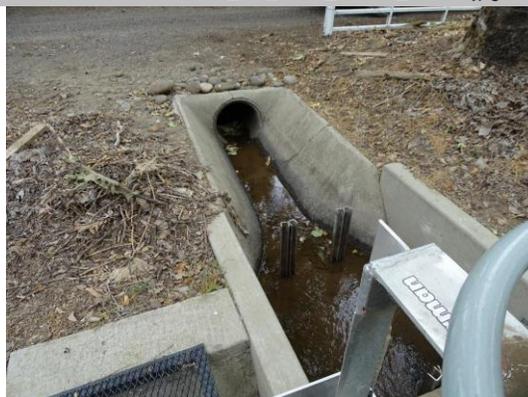
Photo 3 of 3 : UCIP_FA_2019_54000_79259.jpg

LM Start	0.49	Rating **	M	Issue No.	281 (cont)
LM End	0.49	Issue Type +	En	Location *	
Category	Supplemental			GPS Latitude/Longitude	
				Start	End
Item	DRAFT DWR UCIP Field Study			39.972280°	39.972280°
				-121.989227°	-121.989227°
DWR ID	24686				
Comment Code					
Inspector Comment					
DS_ID:24686 FS_ID:54000 EP_NO: N/A Repair Type: Non-Urgent Crossing Status: Found UCIP Comments: 05/14/2019 Pipe is designed to drain excess of water from irrigation canal to Deer Creek. Backflow prevention device is absent on this crossing. (O.Yakimov - DWR UCIP)No permit identified for crossing. FIELD_STRUCT_DESC: 20-inch reinforced concrete irrigation pipe through the levee, 2 feet below the crown. Concrete canal and distribution structure with slat boards on the landside (LS) shoulder. FS Date: 5/14/2019 3:11:32 PM

View of headwall from irrigation canal

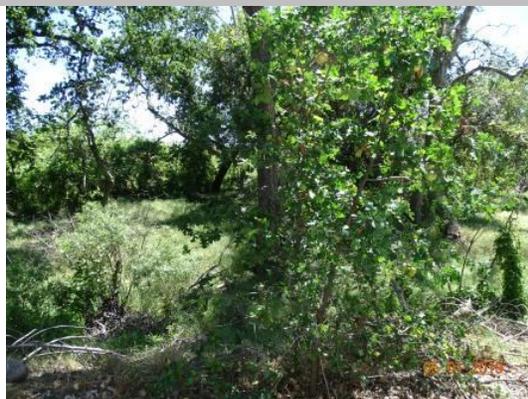
Photo 1 of 1 : FA_2019_NA0019_78_30_20190822_00010.jpg

LM Start	0.89	Rating **	M	Issue No.	30
LM End	0.89	Issue Type +	Ma	Location *	LS
Category	Earthen Levee			GPS Latitude/Longitude	
				Start	End
Item	Trim / Thin Trees			39.971005°	39.971005°
				-121.996351°	-121.996351°
DWR ID	DWR_NA0019_01_s_2019_30				
Comment Code					
T2 : Thin trees to allow visibility of the ground and room to flood fight.					
Inspector Comment					
Trees four inches in diameter or less at chest height should be removed from the landside slope.

View of a small tree on the landside toe. Spring 2019.

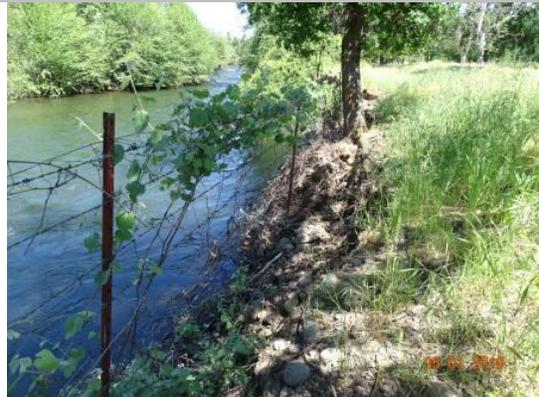
Photo 2 of 3 : FA_2019_NA0019_78_42_20190822_00015.jpg

LM Start	1.55	Rating **	A/W	Issue No.	42
LM End	1.58	Issue Type +	Ma	Location *	WS
Category	Earthen Levee		GPS Latitude/Longitude		
			Start	End	
Item	Erosion / Bank Caving		39.969193°	39.969052°	
			-122.008458°	-122.008920°	
DWR ID	DWR_NA0019_01_s_2017_42				
Comment Code					
E2 : Schedule repair of erosion site prior to the next inspection.					
Inspector Comment

View of the erosion along the waterside toe. Spring 2019.

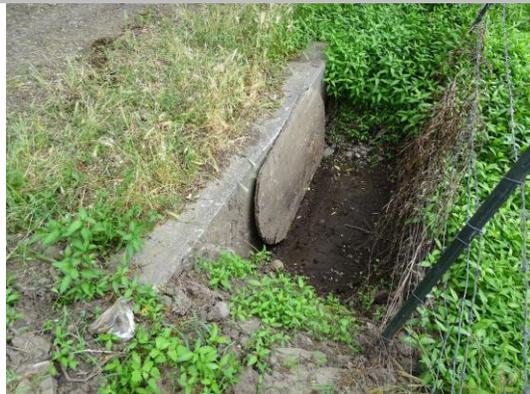
Photo 1 of 3 : UCIP_FA_2019_54006_79261.jpg

Comment Code					
Inspector Comment					
DS_ID:20770 FS_ID:54006 EP_NO: N/A Repair Type: Non-Urgent Crossing Status: Found UCIP Comments: 05/14/2019 Pipe end on WS has been cleared from sediment buildup to let flap gate close properly, but the rest of pipe is still silted inside. Flap gate was fixed and operable now. (O.Yakimov - DWR UCIP)10/15/2018 Flap gate on WS end stuck open. Lower part of pipe is silted that makes impossible flap gate to fully close. Needs sediment cleanup around pipe outlet on WS. (O.Yakimov - DWR)12/05/2016 Sediment buildup inside pipe (see photo) and sediment buildup on WS blocking flap gate. Crossing has been downgraded from Urgent to Non-Urgent crossing was closed on both WS and LS. (O. Magana - DWR UCIP)10/02/2013 Flapgate blocked by soil buildup. (W. Wylie - DWR UCIP) FIELD_STRUCT_DESC: 24-inch steel drainage pipe through the levee, 1.5 feet below the crown. Flap gate on the waterside (WS) toe. [Additional Reference(s): DWR Levee Log, 1992. USACE Sacramento O&M Manual Unit 509, March 1957, As-built drawings available 50-4-2394 (Station 185+40)]. FS Date: 5/14/2019 3:33:54 PM

LS view of concrete headwall with wood panel blocking opening

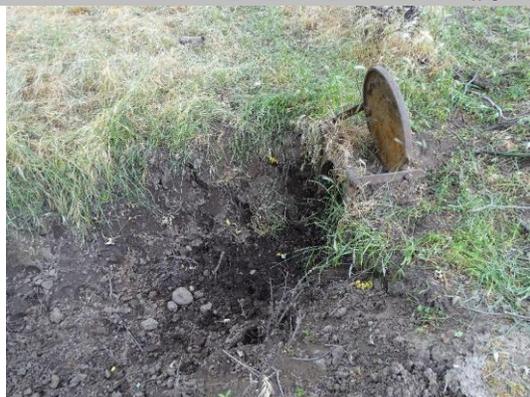
Photo 2 of 3 : UCIP_FA_2019_54006_79262.jpg

Flap gate at WS toe

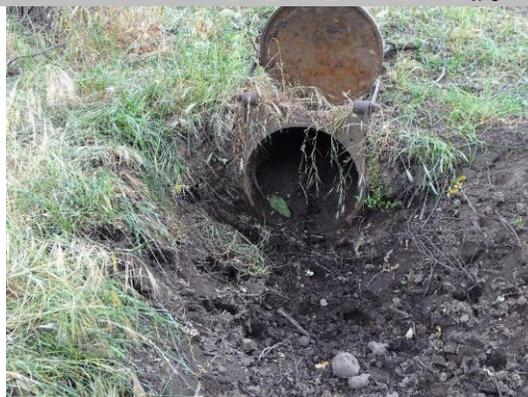
Photo 3 of 3 : UCIP_FA_2019_54006_79263.jpg

Comment Code					
Inspector Comment					
DS_ID:20770 FS_ID:54006 EP_NO: N/A Repair Type: Non-Urgent Crossing Status: Found UCIP Comments: 05/14/2019 Pipe end on WS has been cleared from sediment buildup to let flap gate close properly, but the rest of pipe is still silted inside. Flap gate was fixed and operable now. (O.Yakimov - DWR UCIP)10/15/2018 Flap gate on WS end stuck open. Lower part of pipe is silted that makes impossible flap gate to fully close. Needs sediment cleanup around pipe outlet on WS. (O.Yakimov - DWR)12/05/2016 Sediment buildup inside pipe (see photo) and sediment buildup on WS blocking flap gate. Crossing has been downgraded from Urgent to Non-Urgent crossing was closed on both WS and LS. (O. Magana - DWR UCIP)10/02/2013 Flapgate blocked by soil buildup. (W. Wylie - DWR UCIP) FIELD_STRUCT_DESC: 24-inch steel drainage pipe through the levee, 1.5 feet below the crown. Flap gate on the waterside (WS) toe. [Additional Reference(s): DWR Levee Log, 1992. USACE Sacramento O&M Manual Unit 509, March 1957, As-built drawings available 50-4-2394 (Station 185+40)]. FS Date: 5/14/2019 3:33:54 PM

Sediment was cleared around flap gate

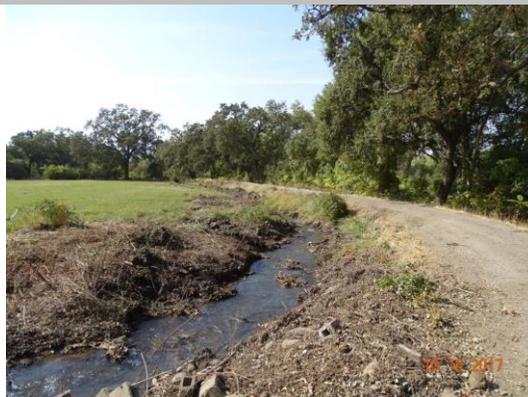
Photo 1 of 2 : FA_2019_NA0019_78_2_20190822_00001.jpg

LM Start	1.79	Rating **	U	Issue No.	2
LM End	2.22	Issue Type +	En	Location *	LS
Category	Earthen Levee			GPS Latitude/Longitude	
				Start	End
Item	Encroachments			39.969443 °	39.966921 °
				-122.012261 °	-122.019469 °
DWR ID	DWR_NA0019_01_s_2012_2				
Comment Code					
DT : Ditch					
Inspector Comment					
Repair the cleaned out irrigation ditch along the landside toe.

View of the irrigation ditch along the landside toe.

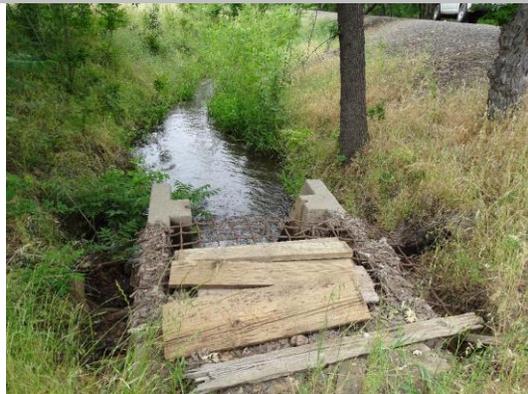
Photo 3 of 3 : UCIP_FA_2019_54008_79268.jpg

Comment Code					
Inspector Comment					
DS_ID:20769 FS_ID:54008 EP_NO: N/A Repair Type: Urgent Crossing Status: Found UCIP Comments: 05/14/20198 Same as last inspection. Flapgate on WS is missing, pipe partially blocked with sedimen. (O.Yakimov - DWR UCIP)10/15/2018 Flapgate on WS is missing, pipe partially blocked with sediment. (O.Yakimov - DWR)12/05/2016 same as last inspection. Crossing remains "Urgent" WS opened during flood season due to damaged flap gate. (O. Magana - DWR UCIP)10/02/2013 Flapgate missing or burried on WS toe. Pipe partially blocked by soil on WS toe. (W. Wylie - DWR UCIP) FIELD_STRUCT_DESC: 24-inch corrugated metal drainage pipe through the levee, 7 feet below the crown. Flap gate located on the waterside (WS) end. A 5-foot by 5-foot concrete control structure located on the landside (LS) toe. [Additional Reference(s): DWR Levee Log, 1992. USACE Sacramento O&M Manual Unit 509, March 1957, As-built drawing no. 50-4-2394 (Station 176+10)]. FS Date: 5/14/2019 4:05:54 PM

Concrete outfall structure at LS toe and irrigation canal

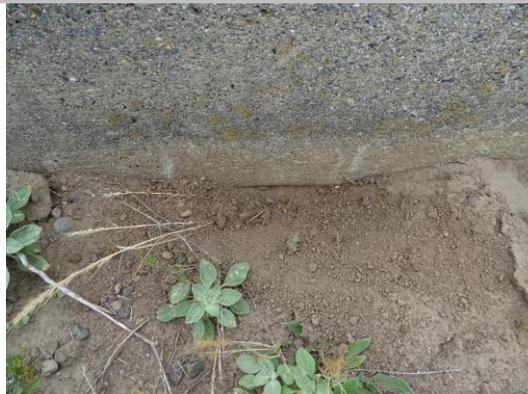
Photo 2 of 3 : UCIP_FA_2019_54011_79273.jpg

Comment Code					
Inspector Comment					
DS_ID:20877 FS_ID:54011 EP_NO: N/A Repair Type: Non-Urgent Crossing Status: Found UCIP Comments: 05/14/2019 Pipe outlet and headwall were excavated to evaluate pipe condition. Pipe is completely filled with soil that makes impossible to clear it for DMP internal video inspection. Pipe may be rehabilitated under DMP Phase II or removed. Excavated soil was backfilled. (O.Yakimov - DWR UCIP)Headwall covered with soil. Needs to be cleared at both ends. FIELD_STRUCT_DESC: 24-inch corrugated metal pipe through the levee 5-feet below the crown. Calco automatic drainage gate. Originally included in O+M manual (1957). As-built drawings available 50-4-2394. FS Date: 5/14/2019 8:37:31 AM

Concrete headwall on LS toe: top of pipe visible

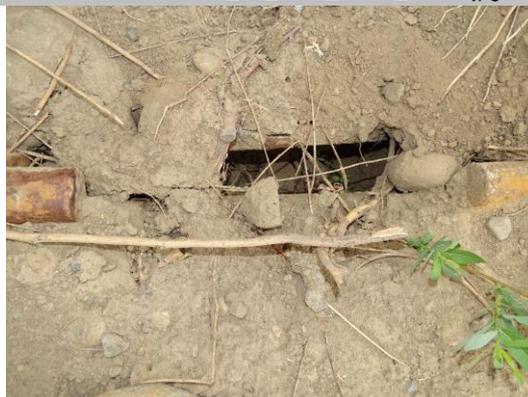
Photo 3 of 3 : UCIP_FA_2019_54011_79274.jpg

Pipe outlet discovered at WS toe. Visible gap between flap gate and pipe

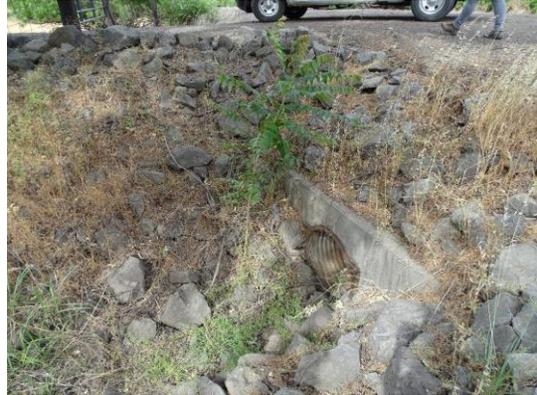
Photo 1 of 3 : UCIP_FA_2019_54018_79286.jpg

Comment Code					
Inspector Comment					
DS_ID:24689 FS_ID:54018 EP_NO: N/A Repair Type: Urgent Crossing Status: Found UCIP Comments: 05/14/2019 Flap gate needs to be restored to working condition and debris cleared at pipe outlet. (O. Yakimov - DWR UCIP)10/15/2018 Per conversation with district manager Ryan Teubert one of the hinges of flap gate at WS end was bent that makes impossible to close gate completely. Brush at outlet. (O. Yakimov - DWR)12/05/2016 same as last inspection. Crossing has been downgraded from Urgent to Non-Urgent WS flap gate is closed. Recommend clearing dense vegetation on WS and completing an internal inspection to determine condition of the pipe through the levee. (O. Magana - DWR UCIP)10/03/2013 Flapgate does not fully close. Needs brush cleared away from outlet. (W. Wylie - DWR UCIP) FIELD_STRUCT_DESC: 36-inch corrugated metal drainage pipe through the levee, 7 feet below the crown. Flap gate located on the waterside (WS) end. Concrete headwall located on the landside (LS) toe. FS Date: 5/14/2019 10:21:52 AM

View of pipe inlet at LS toe

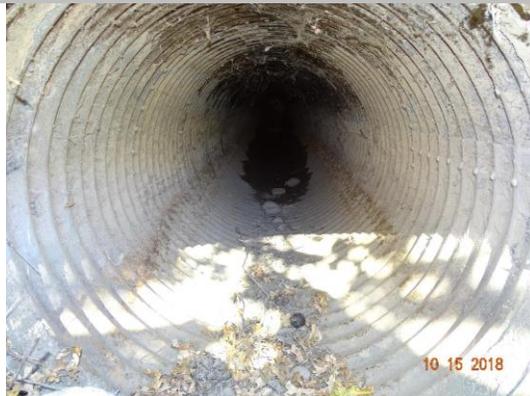
Photo 3 of 3 : UCIP_FA_2019_54018_78196.jpg

Comment Code					
Inspector Comment					
DS_ID:24689 FS_ID:54018 EP_NO: N/A Repair Type: Urgent Crossing Status: Found UCIP Comments: 05/14/2019 Flap gate needs to be restored to working condition and debris cleared at pipe outlet. (O.Yakimov - DWR UCIP)10/15/2018 Per conversation with district manager Ryan Teubert one of the hinges of flap gate at WS end was bent that makes impossible to close gate completely. Brush at outlet. (O.Yakimov - DWR)12/05/2016 same as last inspection. Crossing has been downgraded from Urgent to Non-Urgent WS flap gate is closed. Recommend clearing dense vegetation on WS and completing an internal inspection to determine condition of the pipe through the levee. (O. Magana - DWR UCIP)10/03/2013 Flapgate does not fully close. Needs brush cleared away from outlet. (W. Wylie - DWR UCIP) FIELD_STRUCT_DESC: 36-inch corrugated metal drainage pipe through the levee, 7 feet below the crown. Flap gate located on the waterside (WS) end. Concrete headwall located on the landside (LS) toe. FS Date: 5/14/2019 10:21:52 AM

Inside view of the pipe looking from LS

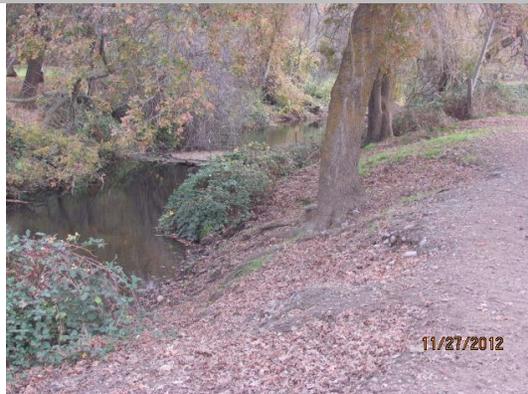
Photo 1 of 1 : FA_2019_NA0019_78_15_20190822_00003.jpg

LM Start	3.68	Rating **	M	Issue No.	15
LM End	3.68	Issue Type +	Ma	Location *	LS
Category	Earthen Levee		GPS Latitude/Longitude		
			Start	End	
Item	Slope Stability		39.945045°	39.945045°	
			-122.053469°	-122.053469°	
DWR ID	DWR_NA0019_01_f_2012_15				
Comment Code					
S1 : Repair slope instability.					
Inspector Comment

View of the instability caused by livestock along the landside slope.

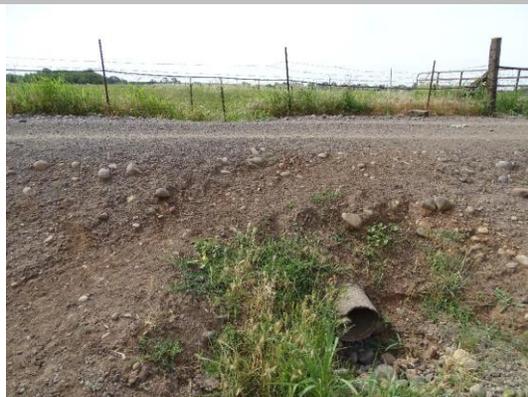
Photo 1 of 3 : UCIP_FA_2019_54021_79289.jpg

LM Start	3.75	Rating **	M	Issue No.	300
LM End	3.75	Issue Type +	En	Location *	
Category	Supplemental		GPS Latitude/Longitude		
			Start	End	
Item	DRAFT DWR UCIP Field Study		39.944460°	39.944460°	
			-122.053930°	-122.053930°	
DWR ID	20763				
Comment Code					
Inspector Comment					
DS_ID:20763 FS_ID:54021 EP_NO: N/A Repair Type: Non-Urgent Crossing Status: Found UCIP Comments: 05/14/2019 Backflow prevention device is not needed because LS elevation is higher then WS. (O.Yakimov - DWR UCIP) FIELD_STRUCT_DESC: 12-inch concrete drainage pipe, through the levee, 2-feet below the crown. FS Date: 5/14/2019 10:34:40 AM

View of pipe outlet at WS toe

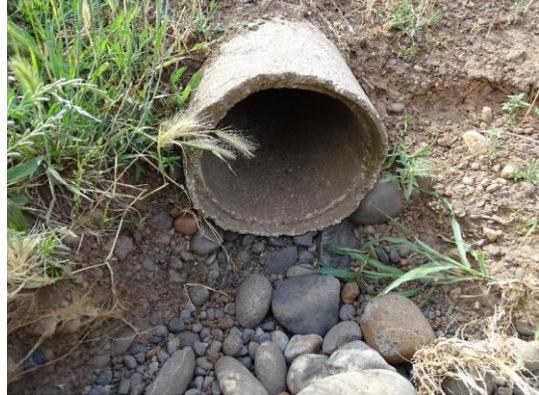
Photo 2 of 3 : UCIP_FA_2019_54021_79290.jpg

LM Start	3.75	Rating **	M	Issue No.	300 (cont)
LM End	3.75	Issue Type +	En	Location *	
Category	Supplemental			GPS Latitude/Longitude	
				Start	End
Item	DRAFT DWR UCIP Field Study			39.944460°	39.944460°
				-122.053930°	-122.053930°
DWR ID	20763				
Comment Code					
Inspector Comment					
DS_ID:20763 FS_ID:54021 EP_NO: N/A Repair Type: Non-Urgent Crossing Status: Found UCIP Comments: 05/14/2019 Backflow prevention device is not needed because LS elevation is higher then WS. (O.Yakimov - DWR UCIP) FIELD_STRUCT_DESC: 12-inch concrete drainage pipe, through the levee, 2-feet below the crown. FS Date: 5/14/2019 10:34:40 AM

Concrete pipe outlet

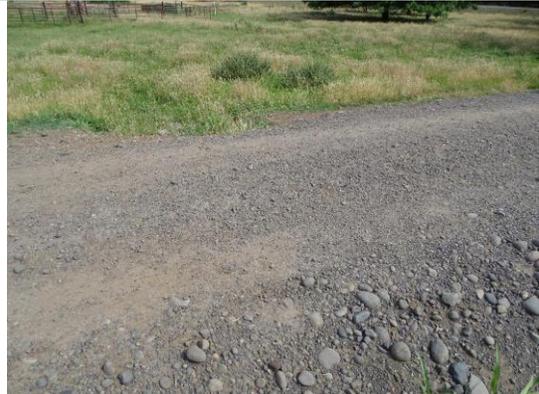
Photo 3 of 3 : UCIP_FA_2019_54021_79292.jpg

View of levee crown at the crossing

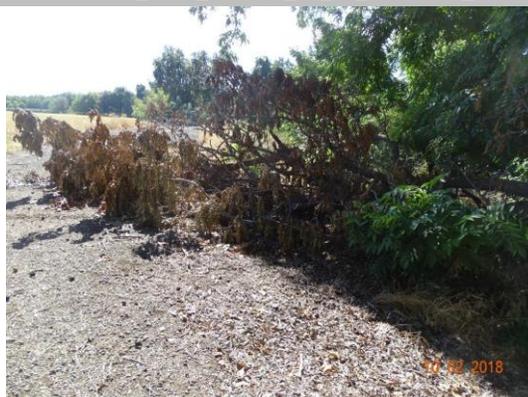
Photo 1 of 1 : FA_2019_NA0019_78_44_20190822_00017.jpg

LM Start	3.99	Rating **	M	Issue No.	44
LM End	3.99	Issue Type +	Ma	Location *	WS
Category	Earthen Levee			GPS Latitude/Longitude	
				Start	End
Item	Encroachments			39.941990°	39.941990°
				-122.057140°	-122.057140°
DWR ID	DWR_NA0019_01_f_2018_44				
Comment Code					
TR : Tree or limb					
Inspector Comment					
The tree should be removed from the waterside slope.

View of the tree limb along the waterside slope.

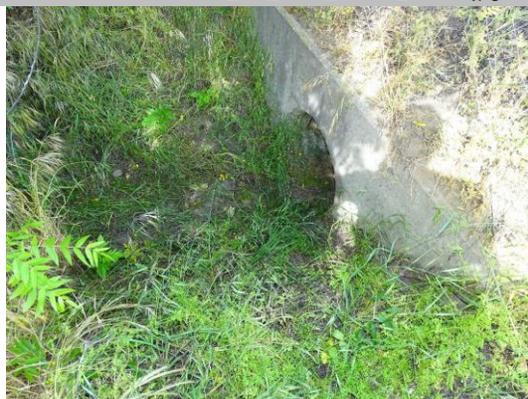
Photo 1 of 3 : UCIP_FA_2019_54023_79298.jpg

LM Start	4.03	Rating **	M	Issue No.	302
LM End	4.03	Issue Type +	Ma	Location *	
Category	Supplemental			GPS Latitude/Longitude	
				Start	End
Item	DRAFT DWR UCIP LMA Responsibility			39.941574°	39.941574°
				-122.057597°	-122.057597°
DWR ID	20760				
Comment Code					
Inspector Comment					
DS_ID:20760 FS_ID:54023 EP_NO: N/A Repair Type: Non-Urgent Crossing Status: Found UCIP Comments: 05/14/2019 No issues recorded during inspection. (O.Yakimov - DWR UCIP) FIELD_STRUCT_DESC: 24-inch corrugated metal drainage pipe through the levee, 5 feet below the crown. Flap gate on the waterside (WS) end. Headwalls on both sides of levee. [Additional Reference(s): DWR Levee Log, 1992. USACE Sacramento O&M Manual 509, March 1957, (Assumed Station 5+00) Drawing No. 50-4-2394]. FS Date: 5/14/2019 10:53:58 AM

Headwall and pipe inlet at LS toe

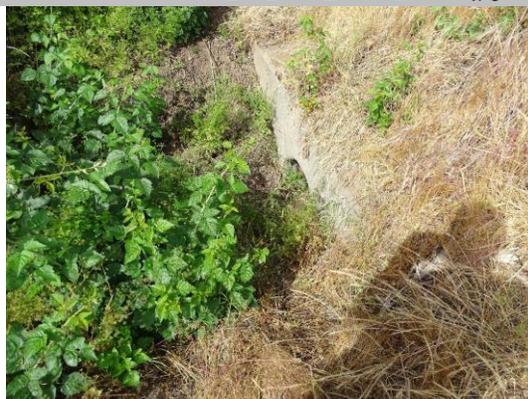
Photo 1 of 3 : UCIP_FA_2019_54024_79304.jpg

Comment Code					
Inspector Comment					
DS_ID:20762 FS_ID:54024 EP_NO: N/A Repair Type: Urgent Crossing Status: Found UCIP Comments: 05/14/2019 Missing flap gate, pipe outlet is silted. (O.Yakimov - DWR UCIP)10/15/2018 Missing flap gate at WS end of the pipe. Pipe is partially blocked with silt. Updated coordinates and CLM. (O.Yakimov - DWR)12/05/2016 unable to complete inspection -- unable to locate. (O. Magana - DWR UCIP)10/03/2013 Gate missing from WS toe. (W. Wylie - DWR UCIP) FIELD_STRUCT_DESC: 24-inch corrugated metal drainage pipe through the levee, 5.5 feet below the crown. Flap gate located on the waterside (WS) end. Concrete headwall located on the landside (LS) toe. [Additional Reference(s): DWR Levee Log, 1992. USACE Sacramento O&M Manual Unit 509, March 1957, As-built drawing no. 50-4-2394 (Station 0+65)]. FS Date: 5/14/2019 11:01:16 AM

Headwall and inlet at LS toe

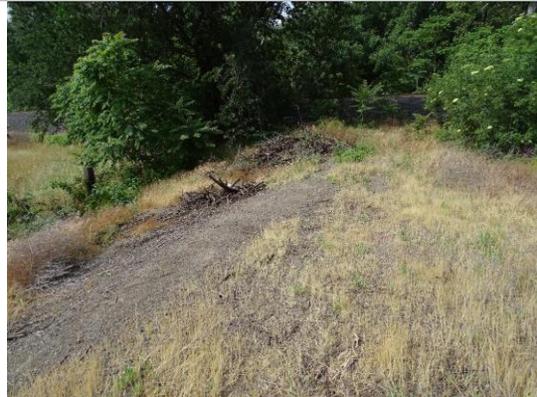
Photo 3 of 3 : UCIP_FA_2019_54024_79303.jpg

View of levee crown at the crossing

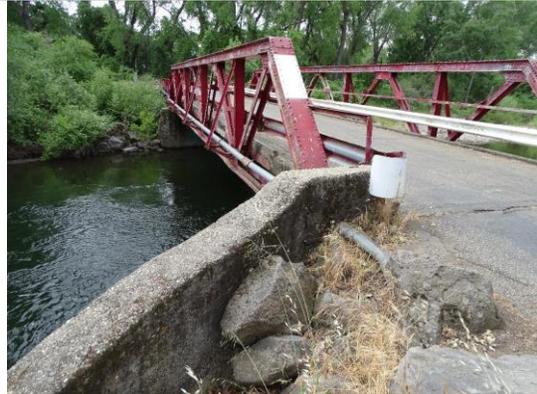
Photo 2 of 3 : UCIP_FA_2019_53996_79236.jpg

Conduit on upstream side on Leninger Rd bridge

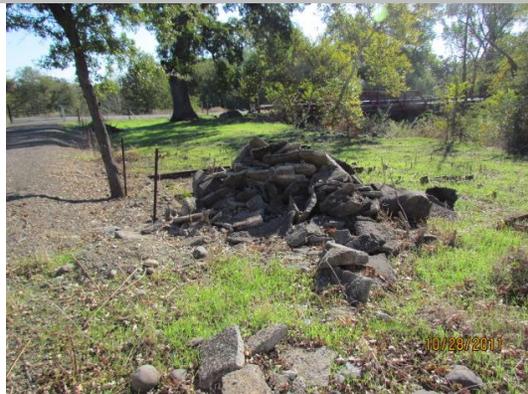
Photo 1 of 1 : FA_2019_NA0019_79_4_20190822_00002.jpg

LM Start	0.34	Rating **	M	Issue No.	4
LM End	0.34	Issue Type +	En	Location *	WS
Category	Earthen Levee		GPS Latitude/Longitude		
			Start	End	
Item	Encroachments		39.970210°	39.970210°	
			-122.015198°	-122.015198°	
DWR ID	DWR_NA0019_02_s_2012_4				
Comment Code					
DE : Debris					
Inspector Comment

View of the concrete pile along the waterside toe.

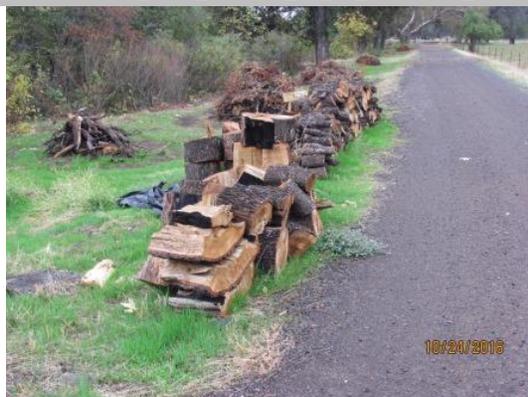
Photo 1 of 1 : FA_2019_NA0019_79_14_20190822_00008.jpg

LM Start	0.35	Rating **	M	Issue No.	14
LM End	0.35	Issue Type +	En	Location *	WS
Category	Earthen Levee		GPS Latitude/Longitude		
			Start	End	
Item	Encroachments		39.970153°	39.970153°	
			-122.015194°	-122.015194°	
DWR ID	DWR_NA0019_02_f_2016_14				
Comment Code					
FW : Firewood					
Inspector Comment

View of the firewood along the waterside slope.

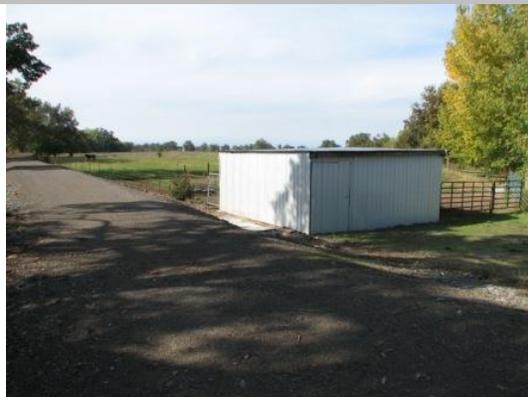
Photo 1 of 1 : FA_2019_NA0019_79_7_20190822_00003.jpg

LM Start	0.35	Rating **	M	Issue No.	7
LM End	0.35	Issue Type +	En	Location *	LS
Category	Earthen Levee		GPS Latitude/Longitude		
			Start	End	
Item	Encroachments		39.970117°	39.970117°	
			-122.015365°	-122.015365°	
DWR ID	DWR_NA0019_02_s_2012_7				
Comment Code					
BU : Building					
Inspector Comment

View of a building along the levee toe.

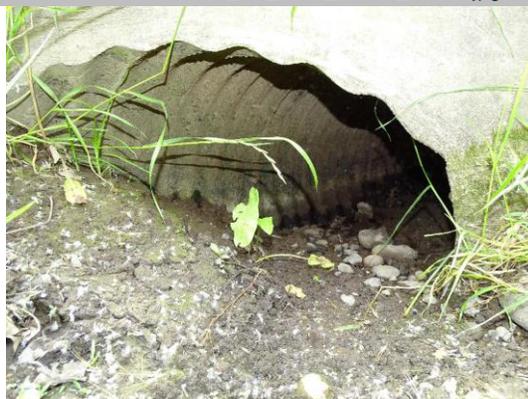
Photo 1 of 3 : UCIP_FA_2019_53997_79240.jpg

Comment Code					
Inspector Comment					
<p>DS_ID:20771 FS_ID:53997 EP_NO: N/A Repair Type: Non-Urgent Crossing Status: Found UCIP Comments: 05/14/2019 Pipe is 50% silted throughout its entire length. Flap gate on WS is partially buried in mud that affects proper operation, visible gap between flap gate and pipe. Pipe crosses levee at an angle. (O.Yakimov - DWR UCIP)12/05/2016 Crossing has been downgraded from Urgent to Non-Urgent some debris blocking proper function of flapgate on WS. Recommend clearing debris from WS for flapgate to function properly. (O. Magana - DWR UCIP)10/01/2013 Debris blocking proper function of flapgate on WS toe. (W. Wylie - DWR UCIP) FIELD_STRUCT_DESC: 24-inch steel drainage pipe through the levee, 8.3 feet below the crown. Flap gate located on the waterside (WS) end. Concrete headwall located on the landside (LS). [Additional Reference(s): DWR Levee Log, 1992. USACE Sacramento O&M Manual Unit 509, March 1957, Unit 510, April 1963, Unit 511, May 1973, Unit 512, March 1964, Unit 513, December 1970, As-builts drawing 50-4-2394 (Station 155+40)]. FS Date: 5/14/2019 1:15:18 PM</p>

View of pipe from LS

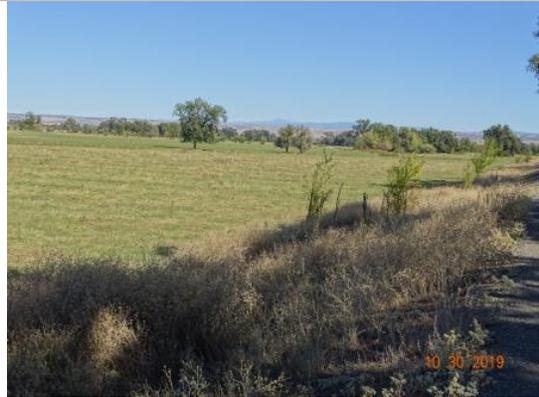
Photo 1 of 1 : FA_2019_NA0019_79_10_20191101_00016.jpg

LM Start	1.17	Rating **	M	Issue No.	10
LM End	1.17	Issue Type +	Ma	Location *	LS
Category	Earthen Levee			GPS Latitude/Longitude	
				Start	End
Item	Vegetation			39.965721 °	39.965721 °
				-122.028993 °	-122.028993 °
DWR ID	DWR_NA0019_02_f_2019_10				
Comment Code					
V1 : Control annual grass and weeds on the levee slopes and easements.					
Inspector Comment

View of the vegetation along the landside slope. Fall 2019.

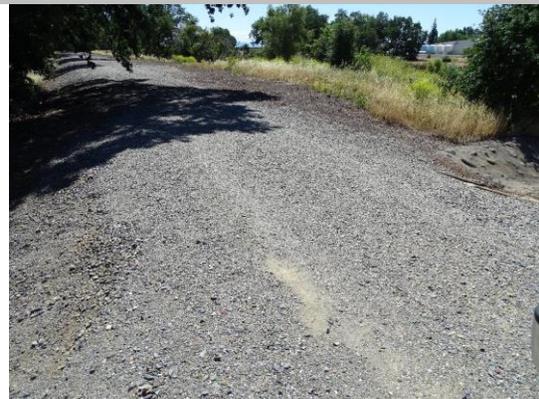
Photo 1 of 3 : UCIP_FA_2019_54114_79538.jpg

LM Start	0.25	Rating **	M	Issue No.	917
LM End	0.25	Issue Type +	Ma	Location *	
Category	Supplemental			GPS Latitude/Longitude	
				Start	End
Item	DRAFT DWR UCIP LMA Responsibility			40.051604°	40.051604°
				-122.184431°	-122.184431°
DWR ID	20775				
Comment Code					
Inspector Comment					
DS_ID:20775 FS_ID:54114 EP_NO: N/A Repair Type: Non-Urgent Crossing Status: Found UCIP Comments: 05/28/2019 Debris at the outlet needs to be cleared for proper flap gate operation. (O.Yakimov - DWR UCIP) FIELD_STRUCT_DESC: 24-inch corrugated metal drainage pipe through the levee, 4 feet below the crown. Flap gate and concrete U-shaped headwall on the waterside (WS) end. Concrete U-shaped headwall on the landside (LS) end. [Additional Reference(s): DWR Levee Log, 1992. USACE Sacramento O&M Manual 510, April 1963, (HLM 0.26) Drawing No. 50-4-3622]. FS Date: 5/28/2019 7:19:25 AM

Top of Levee

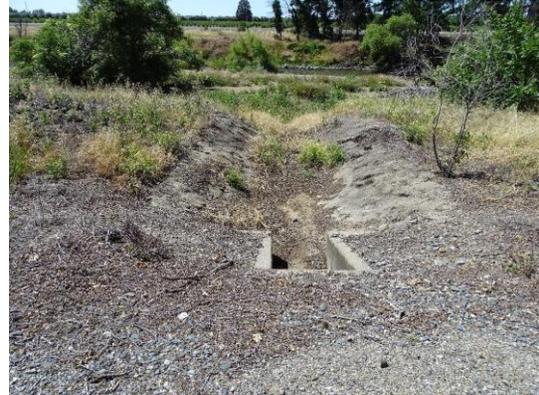
Photo 3 of 3 : UCIP_FA_2019_54116_79554.jpg

LM Start	0.51	Rating **	M	Issue No.	919 (cont)
LM End	0.51	Issue Type +	Ma	Location *	
Category	Supplemental			GPS Latitude/Longitude	
				Start	End
Item	DRAFT DWR UCIP LMA Responsibility			40.051211 °	40.051211 °
				-122.179663 °	-122.179663 °
DWR ID	20777				
Comment Code					
Inspector Comment					
DS_ID:20777 FS_ID:54116 EP_NO: N/A Repair Type: Non-Urgent Crossing Status: Found UCIP Comments: 05/28/2019 Debris at the outlet needs to be cleared for proper flap gate operation. (O.Yakimov - DWR UCIP) FIELD_STRUCT_DESC: 24-inch corrugated metal drainage pipe through the levee, 5 feet below the crown. Flap gate and concrete U-shaped headwall on the waterside (WS) end. Concrete U-shaped headwall on the landside (LS) end. [Additional Reference(s): DWR Levee Log, 1992. USACE Sacramento O&M Manual 510, April 1963, (HLM 0.52) Drawing No. 50-4-3622]. FS Date: 5/28/2019 9:54:39 AM

Water-Side

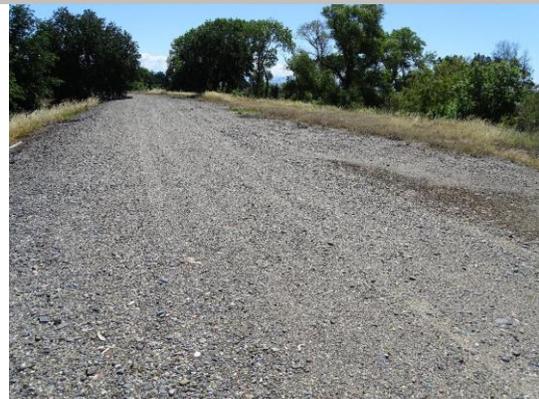
Photo 1 of 3 : UCIP_FA_2019_54117_79557.jpg

LM Start	0.64	Rating **	M	Issue No.	920
LM End	0.64	Issue Type +	Ma	Location *	
Category	Supplemental			GPS Latitude/Longitude	
				Start	End
Item	DRAFT DWR UCIP LMA Responsibility			40.051699°	40.051699°
				-122.177320°	-122.177320°
DWR ID	20778				
Comment Code					
Inspector Comment					
DS_ID:20778 FS_ID:54117 EP_NO: N/A Repair Type: Non-Urgent Crossing Status: Found UCIP Comments: 05/28/2019 No issues recorded during inspection (O.Yakimov - DWR UCIP) FIELD_STRUCT_DESC: 1 of 2: 36-inch corrugated metal drainage pipe through the levee, 8.6 feet below the crown. Flap gate and concrete U-shaped headwall on the waterside (WS) end. Concrete U-shaped headwall on the landside (LS) end. [Additional Reference(s): DWR Levee Log, 1992. USACE Sacramento O&M Manual 510, April 1963, (HLM 0.65) Drawing No. 50-4-3622]. FS Date: 5/28/2019 10:22:34 AM

View of levee crown at crossing

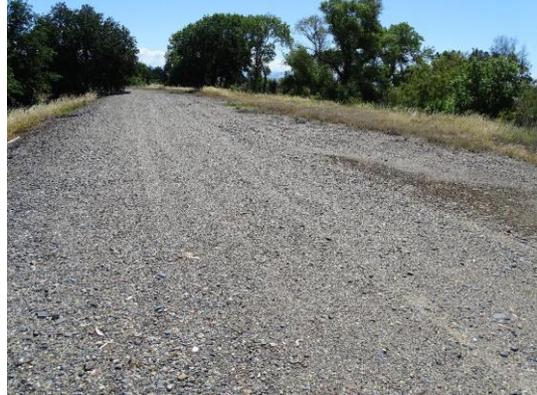
Photo 1 of 3 : UCIP_FA_2019_54118_79564.jpg

Comment Code					
Inspector Comment					
DS_ID:20880 FS_ID:54118 EP_NO: N/A Repair Type: Non-Urgent Crossing Status: Found UCIP Comments: 05/28/2019 No issues recorded during inspection (O.Yakimov - DWR UCIP)12/05/2016 Crossing has been downgraded from Urgent to Non-Urgent vegetation found on WS but does not appear to prevent proper function of flap gate. Recommend clearing dry vegetation on WS above concrete headwall.(O. Magana - DWR UCIP)10/03/2013 Flapgate operation hindered by soil and vegetation on WS toe. (W. Wylie - DWR UCIP) FIELD_STRUCT_DESC: 2 of 2: 36-inch corrugated metal drainage pipe through levee, 8.6 feet below crown. Flap gate and concrete "U" headwall located on the waterside (WS) end. Concrete "U" headwall located on the landside (LS) end. [Additional Reference(s): DWR Levee Log, 1992. USACE Sacramento O&M Manual, Unit 510, April 1963, As-built drawing No. 50-4-3622 (HLM 0.65)] FS Date: 5/28/2019 10:27:16 AM

View of levee crown at crossing

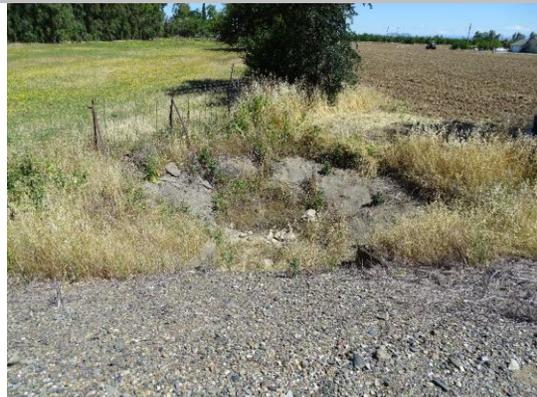
Photo 2 of 3 : UCIP_FA_2019_54118_79565.jpg

View of LS

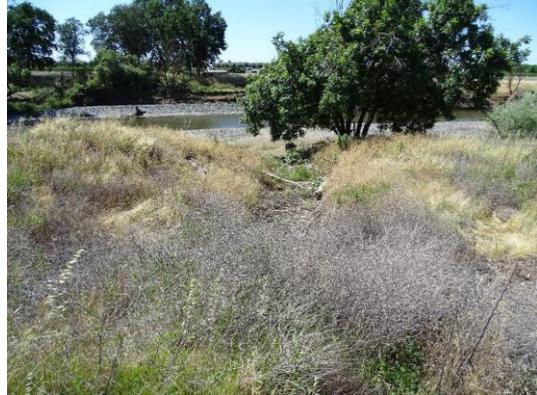
Photo 3 of 3 : UCIP_FA_2019_54118_79566.jpg

Comment Code					
Inspector Comment					
DS_ID:20880 FS_ID:54118 EP_NO: N/A Repair Type: Non-Urgent Crossing Status: Found UCIP Comments: 05/28/2019 No issues recorded during inspection (O.Yakimov - DWR UCIP)12/05/2016 Crossing has been downgraded from Urgent to Non-Urgent vegetation found on WS but does not appear to prevent proper function of flap gate. Recommend clearing dry vegetation on WS above concrete headwall.(O. Magana - DWR UCIP)10/03/2013 Flapgate operation hindered by soil and vegetation on WS toe. (W. Wylie - DWR UCIP) FIELD_STRUCT_DESC: 2 of 2: 36-inch corrugated metal drainage pipe through levee, 8.6 feet below crown. Flap gate and concrete "U" headwall located on the waterside (WS) end. Concrete "U" headwall located on the landside (LS) end. [Additional Reference(s): DWR Levee Log, 1992. USACE Sacramento O&M Manual, Unit 510, April 1963, As-built drawing No. 50-4-3622 (HLM 0.65)] FS Date: 5/28/2019 10:27:16 AM

View of WS

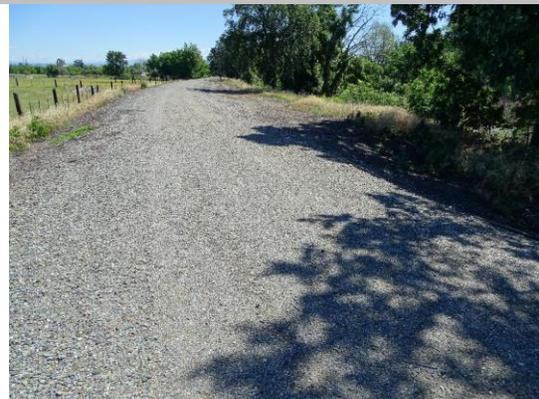
Photo 1 of 3 : UCIP_FA_2019_54119_79571.jpg

LM Start	0.75	Rating **	M	Issue No.	922
LM End	0.75	Issue Type +	Ma	Location *	
Category	Supplemental			GPS Latitude/Longitude	
				Start	End
Item	DRAFT DWR UCIP LMA Responsibility			40.052194°	40.052194°
				-122.175390°	-122.175390°
DWR ID	20779				
Comment Code					
Inspector Comment					
DS_ID:20779 FS_ID:54119 EP_NO: N/A Repair Type: Non-Urgent Crossing Status: Found UCIP Comments: 05/28/2019 Pipe is partially filled with silt and debris. (O.Yakimov - DWR UCIP) FIELD_STRUCT_DESC: 24-inch corrugated metal drainage pipe through the levee, 5.8 feet below the crown. Flap gate and concrete U-shaped headwall on the waterside (WS) end. Concrete U-shaped headwall on the landside (LS) end. [Additional Reference(s): DWR Levee Log, 1992. USACE Sacramento O&M Manual 510, April 1963, (HLM 0.76) Drawing No. 50-4-3622]. FS Date: 5/28/2019 10:30:54 AM

Top of Levee

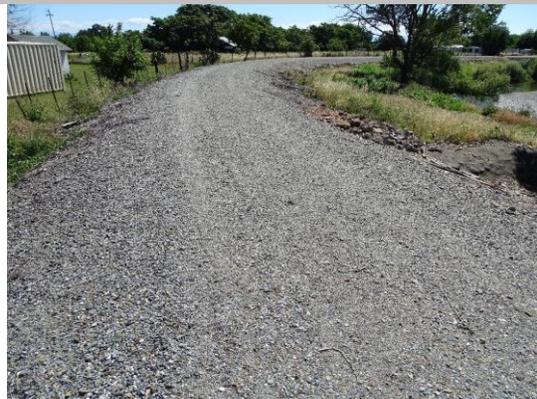
Photo 1 of 3 : UCIP_FA_2019_54120_79577.jpg

LM Start	0.91	Rating **	M	Issue No.	923
LM End	0.91	Issue Type +	Ma	Location *	
Category	Supplemental			GPS Latitude/Longitude	
				Start	End
Item	DRAFT DWR UCIP LMA Responsibility			40.053401 °	40.053401 °
				-122.172848 °	-122.172848 °
DWR ID	20780				
Comment Code					
Inspector Comment					
DS_ID:20780 FS_ID:54120 EP_NO: N/A Repair Type: Non-Urgent Crossing Status: Found UCIP Comments: 05/28/2019 Pipe is slightly filled with silt and debris. (O.Yakimov - DWR UCIP) FIELD_STRUCT_DESC: 24-inch corrugated metal drainage pipe through the levee, 4.5 feet below the crown. Flap gate and concrete U-shaped headwall on the waterside (WS) end. Concrete U-shaped headwall on the landside (LS) end. [Additional Reference(s): DWR Levee Log, 1992. USACE Sacramento O&M Manual 510, April 1963, (HLM 0.93) Drawing No. 50-4-3622]. FS Date: 5/28/2019 11:11:41 AM

View of levee crown at the crossing

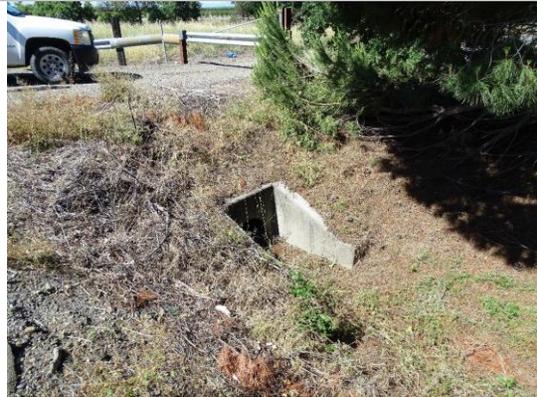
Photo 3 of 3 : UCIP_FA_2019_54121_79584.jpg

LM Start	1.07	Rating **	M	Issue No.	924 (cont)
LM End	1.07	Issue Type +	Ma	Location *	
Category	Supplemental			GPS Latitude/Longitude	
				Start	End
Item	DRAFT DWR UCIP LMA Responsibility			40.052400°	40.052400°
				-122.170279°	-122.170279°
DWR ID	20790				
Comment Code					
Inspector Comment					
DS_ID:20790 FS_ID:54121 EP_NO: N/A Repair Type: Non-Urgent Crossing Status: Found UCIP Comments: 05/28/2019 No issues recorded during inspection (O.Yakimov - DWR UCIP) FIELD_STRUCT_DESC: 24-inch corrugated metal drainage pipe through the levee, 5 feet below the crown. Flap gate and concrete U-shaped headwall on the waterside (WS) end. Concrete U-shaped headwall on the landside (LS) end. [Additional Reference(s): DWR Levee Log, 1992. USACE Sacramento O&M Manual 510, April 1963, (HLM 1.10) Drawing No. 50-4-3622]. FS Date: 5/28/2019 11:19:17 AM

LS levee slope

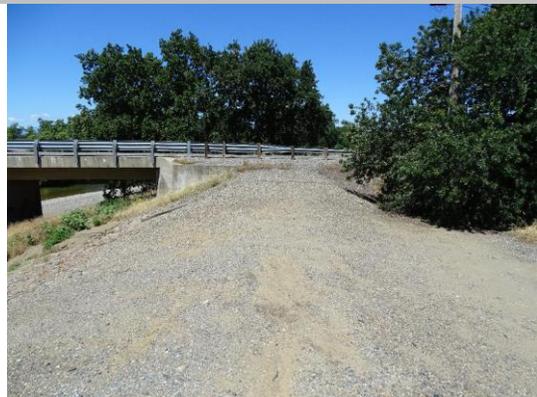
Photo 1 of 3 : UCIP_FA_2019_54123_79589.jpg

LM Start	1.11	Rating **	M	Issue No.	925
LM End	1.11	Issue Type +	Ma	Location *	
Category	Supplemental			GPS Latitude/Longitude	
				Start	End
Item	DRAFT DWR UCIP LMA Responsibility			40.051958°	40.051958°
				-122.170031°	-122.170031°
DWR ID	20773				
Comment Code					
Inspector Comment					
DS_ID:20773 FS_ID:54123 EP_NO: N/A Repair Type: Non-Urgent Crossing Status: Found UCIP Comments: 05/28/2019 No issues recorded during inspection (O.Yakimov - DWR UCIP) FIELD_STRUCT_DESC: 24-inch corrugated metal drainage pipe through the levee, 5.1 feet below the crown. Flap gate and concrete U-shaped headwall on the waterside (WS) end. Concrete U-shaped headwall on the landside (LS) end. [Additional Reference(s): DWR Levee Log, 1992. USACE Sacramento O&M Manual 510, April 1963, (HLM 1.12) Drawing No. 50-4-3622]. FS Date: 5/28/2019 11:34:16 AM

View of levee crown at the crossing

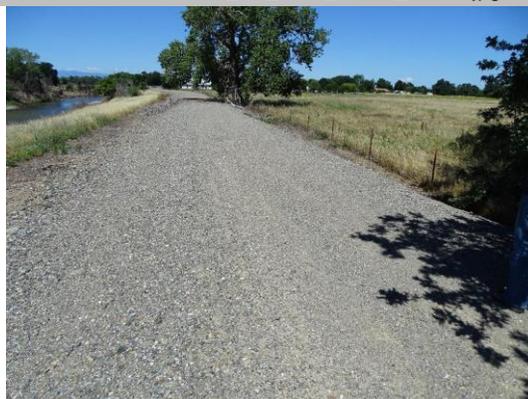
Photo 1 of 3 : UCIP_FA_2019_54124_79596.jpg

LM Start	1.30	Rating **	M	Issue No.	926
LM End	1.30	Issue Type +	Ma	Location *	
Category	Supplemental			GPS Latitude/Longitude	
				Start	End
Item	DRAFT DWR UCIP LMA Responsibility			40.051563 °	40.051563 °
				-122.166630 °	-122.166630 °
DWR ID	20782				
Comment Code					
Inspector Comment					
DS_ID:20782 FS_ID:54124 EP_NO: N/A Repair Type: Non-Urgent Crossing Status: Found UCIP Comments: 05/28/2019 No issues recorded during inspection (O.Yakimov - DWR UCIP) FIELD_STRUCT_DESC: 24-inch corrugated metal drainage pipe through the levee, 4.5 feet below the crown. Flap gate and concrete U-shaped headwall on the waterside (WS) end. Concrete U-shaped headwall on the landside (LS) end. [Additional Reference(s): DWR Levee Log, 1992. USACE Sacramento O&M Manual 510, April 1963, (HLM 1.30) Drawing No. 50-4-3622]. FS Date: 5/28/2019 12:41:38 PM

View of levee crown at the crossing

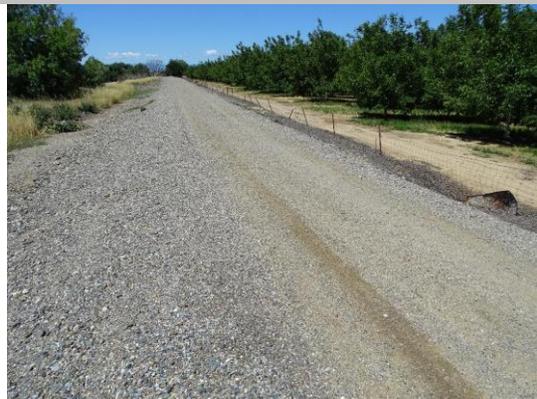
Photo 1 of 3 : UCIP_FA_2019_54125_79602.jpg

LM Start	1.56	Rating **	M	Issue No.	927
LM End	1.56	Issue Type +	Ma	Location *	
Category	Supplemental			GPS Latitude/Longitude	
				Start	End
Item	DRAFT DWR UCIP LMA Responsibility			40.052495°	40.052495°
				-122.161921°	-122.161921°
DWR ID	20783				
Comment Code					
Inspector Comment					
DS_ID:20783 FS_ID:54125 EP_NO: N/A Repair Type: Non-Urgent Crossing Status: Found UCIP Comments: 05/28/2019 Pipe is partially filled with silt and debris. (O.Yakimov - DWR UCIP) FIELD_STRUCT_DESC: 24-inch corrugated metal drainage pipe through the levee, 5.8 feet below the crown. Flap gate and concrete U-shaped headwall on the waterside (WS) end. Concrete U-shaped headwall on the landside (LS) end. [Additional Reference(s): DWR Levee Log, 1992. USACE Sacramento O&M Manual 510, April 1963, (HLM 1.57) Drawing No. 50-4-3622]. FS Date: 5/28/2019 12:53:39 PM

View of levee crown at the crossing

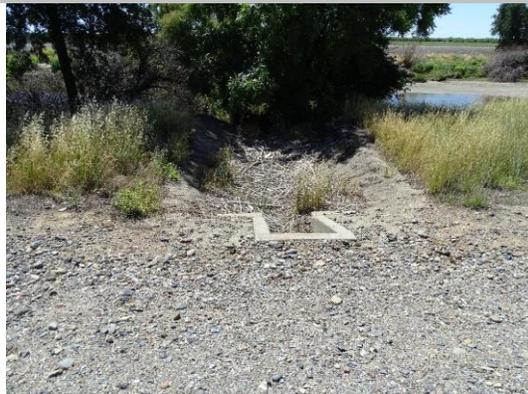
Photo 2 of 3 : UCIP_FA_2019_54125_79603.jpg

LM Start	1.56	Rating **	M	Issue No.	927 (cont)
LM End	1.56	Issue Type +	Ma	Location *	
Category	Supplemental		GPS Latitude/Longitude		
			Start	End	
Item	DRAFT DWR UCIP LMA Responsibility		40.052495°	40.052495°	
			-122.161921°	-122.161921°	
DWR ID	20783				
Comment Code					
Inspector Comment					
DS_ID:20783 FS_ID:54125 EP_NO: N/A Repair Type: Non-Urgent Crossing Status: Found UCIP Comments: 05/28/2019 Pipe is partially filled with silt and debris. (O.Yakimov - DWR UCIP) FIELD_STRUCT_DESC: 24-inch corrugated metal drainage pipe through the levee, 5.8 feet below the crown. Flap gate and concrete U-shaped headwall on the waterside (WS) end. Concrete U-shaped headwall on the landside (LS) end. [Additional Reference(s): DWR Levee Log, 1992. USACE Sacramento O&M Manual 510, April 1963, (HLM 1.57) Drawing No. 50-4-3622]. FS Date: 5/28/2019 12:53:39 PM

Water-Side

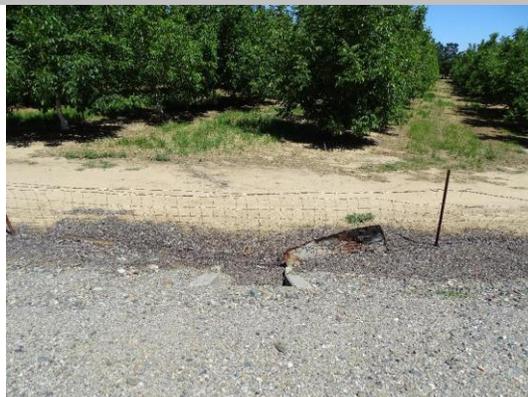
Photo 3 of 3 : UCIP_FA_2019_54125_79604.jpg

Land-Side

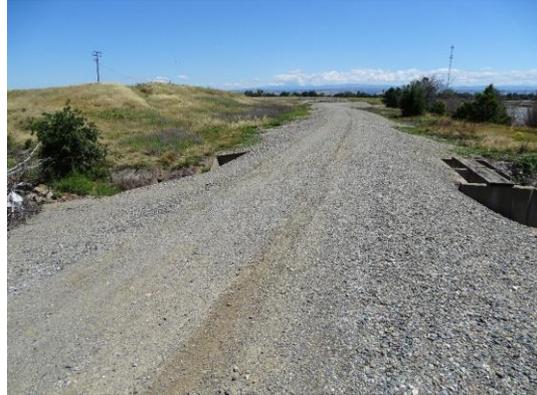
Photo 1 of 3 : UCIP_FA_2019_54126_79608.jpg

LM Start	1.58	Rating **	M	Issue No.	928
LM End	1.58	Issue Type +	En	Location *	
Category	Supplemental		GPS Latitude/Longitude		
			Start	End	
Item	DRAFT DWR UCIP Field Study		40.052598°	40.052598°	
			-122.161655°	-122.161655°	
DWR ID	20784				
Comment Code					
Inspector Comment					
DS_ID:20784 FS_ID:54126 EP_NO: N/A Repair Type: Non-Urgent Crossing Status: Found UCIP Comments: 05/28/2019 Debris at the outlet needs to be cleared for proper flap gate operation. (O.Yakimov - DWR UCIP) FIELD_STRUCT_DESC: 1 of 3: 36-inch reinforced concrete drainage pipe through the levee, 10.4 feet below the crown. Flap gate on the waterside (WS) end. [Additional Reference(s): DWR Levee Log, 1992]. FS Date: 5/28/2019 1:10:12 PM

View of levee crown at the crossing

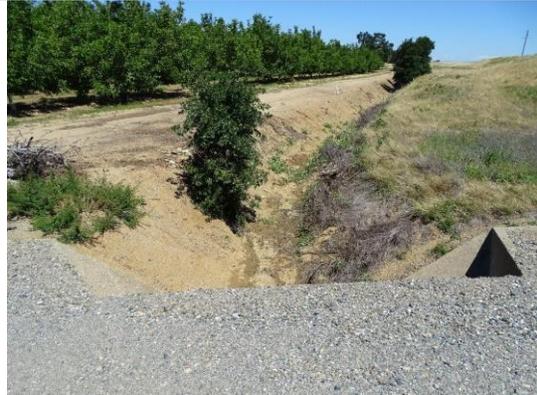
Photo 2 of 3 : UCIP_FA_2019_54126_79610.jpg

View of LS

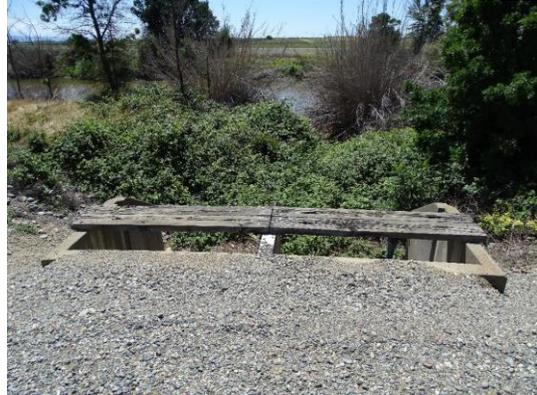
Photo 3 of 3 : UCIP_FA_2019_54126_79611.jpg

LM Start	1.58	Rating **	M	Issue No.	928 (cont)
LM End	1.58	Issue Type +	En	Location *	
Category	Supplemental			GPS Latitude/Longitude	
				Start	End
Item	DRAFT DWR UCIP Field Study			40.052598 °	40.052598 °
				-122.161655 °	-122.161655 °
DWR ID	20784				
Comment Code					
Inspector Comment					
DS_ID:20784 FS_ID:54126 EP_NO: N/A Repair Type: Non-Urgent Crossing Status: Found UCIP Comments: 05/28/2019 Debris at the outlet needs to be cleared for proper flap gate operation. (O.Yakimov - DWR UCIP) FIELD_STRUCT_DESC: 1 of 3: 36-inch reinforced concrete drainage pipe through the levee, 10.4 feet below the crown. Flap gate on the waterside (WS) end. [Additional Reference(s): DWR Levee Log, 1992]. FS Date: 5/28/2019 1:10:12 PM

View of WS

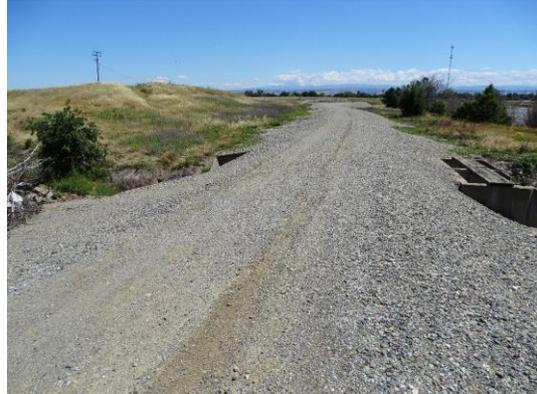
Photo 1 of 3 : UCIP_FA_2019_54127_79618.jpg

LM Start	1.58	Rating **	M	Issue No.	929
LM End	1.58	Issue Type +	En	Location *	
Category	Supplemental			GPS Latitude/Longitude	
				Start	End
Item	DRAFT DWR UCIP Field Study			40.052603 °	40.052603 °
				-122.161640 °	-122.161640 °
DWR ID	20881				
Comment Code					
Inspector Comment					
DS_ID:20881 FS_ID:54127 EP_NO: N/A Repair Type: Non-Urgent Crossing Status: Found UCIP Comments: 05/28/2019 Debris at the outlet needs to be cleared for proper flap gate operation. (O.Yakimov - DWR UCIP) FIELD_STRUCT_DESC: 2 of 3: 36-inch reinforced concrete drainage pipe through the levee, 10.4 feet below the crown. Flap gate on the waterside (WS) end. [Additional Reference(s): DWR Levee Log, 1992]. FS Date: 5/28/2019 1:11:26 PM

View of levee crown at the crossing

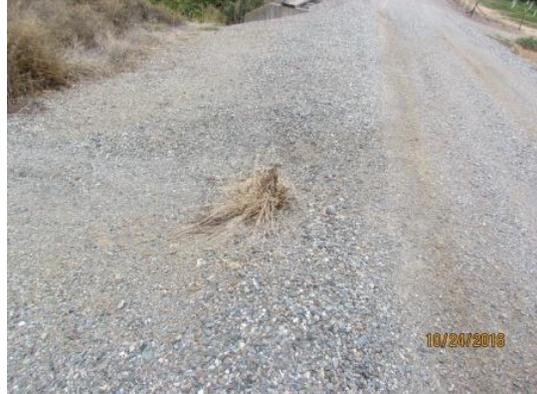
Photo 1 of 2 : FA_2019_NA0019_81_3_20190822_00003.jpg

LM Start	1.59	Rating **	A/W	Issue No.	3
LM End	1.59	Issue Type +	Ma	Location *	WS
Category	Earthen Levee			GPS Latitude/Longitude	
				Start	End
Item	Slope Stability			40.052607 °	40.052705 °
				-122.161418 °	-122.161442 °
DWR ID	DWR_NA0019_04_f_2018_3				
Comment Code					
S3 : Repair the levee slope damaged by vehicle traffic and prevent access where possible.					
Inspector Comment					
Tehama Co. repaired the slope that was damaged by vehicle traffic, but the damage has returned. On 4/26/16, vehicle erosion area was repaired again, but should be monitored.

View of a dip along the levee slope.

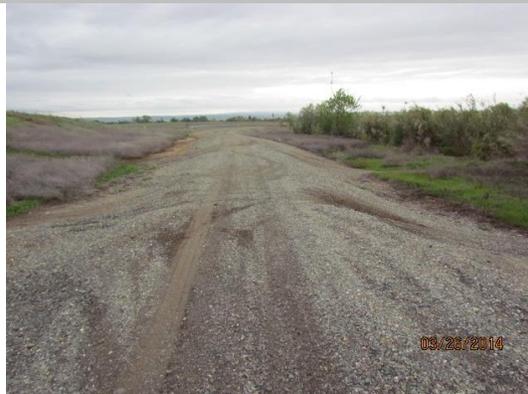
Photo 2 of 2 : FA_2019_NA0019_81_3_20190822_00004.jpg

LM Start	1.59	Rating **	A/W	Issue No.	3 (cont)
LM End	1.59	Issue Type +	Ma	Location *	WS
Category	Earthen Levee			GPS Latitude/Longitude	
				Start	End
Item	Slope Stability			40.052607°	40.052705°
				-122.161418°	-122.161442°
DWR ID	DWR_NA0019_04_f_2018_3				
Comment Code					
S3 : Repair the levee slope damaged by vehicle traffic and prevent access where possible.					
Inspector Comment					
Tehama Co. repaired the slope that was damaged by vehicle traffic, but the damage has returned. On 4/26/16, vehicle erosion area was repaired again, but should be monitored.

View of the levee slope damaged by vehicle traffic.

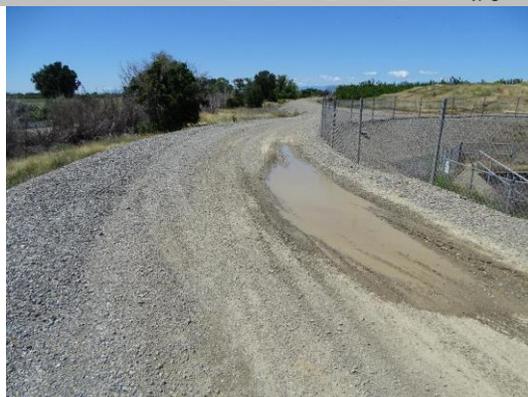
Photo 1 of 3 : UCIP_FA_2019_54129_79630.jpg

LM Start	1.65	Rating **	M	Issue No.	931
LM End	1.65	Issue Type +	En	Location *	
Category	Supplemental			GPS Latitude/Longitude	
				Start	End
Item	DRAFT DWR UCIP Field Study			40.053149°	40.053149°
				-122.160463°	-122.160463°
DWR ID	20785				
Comment Code					
Inspector Comment					
DS_ID:20785 FS_ID:54129 EP_NO: N/A Repair Type: Non-Urgent Crossing Status: Found UCIP Comments: 05/28/2019 Water level in canal is too high to see siphon pipe. (O.Yakimov - DWR UCIP) FIELD_STRUCT_DESC: [Tehama-Colusa Canal] 18-foot reinforced concrete irrigation siphon pipe through the levee, 30 feet below the crown. [Additional Reference(s): DWR Levee Log, 1992]. FS Date: 5/28/2019 2:01:09 PM

View of levee crown at the crossing

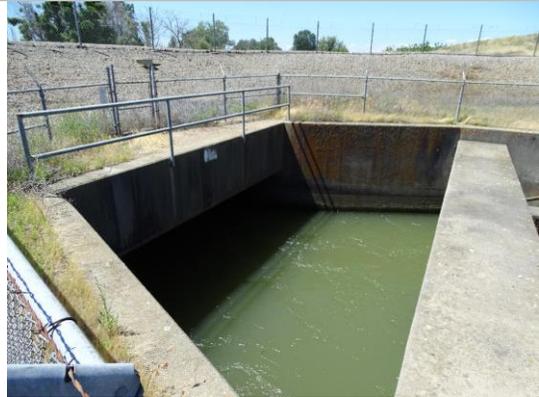
Photo 2 of 3 : UCIP_FA_2019_54129_79631.jpg

LM Start	1.65	Rating **	M	Issue No.	931 (cont)
LM End	1.65	Issue Type +	En	Location *	
Category	Supplemental			GPS Latitude/Longitude	
				Start	End
Item	DRAFT DWR UCIP Field Study			40.053149°	40.053149°
				-122.160463°	-122.160463°
DWR ID	20785				
Comment Code					
Inspector Comment					
DS_ID:20785 FS_ID:54129 EP_NO: N/A Repair Type: Non-Urgent Crossing Status: Found UCIP Comments: 05/28/2019 Water level in canal is too high to see siphon pipe. (O.Yakimov - DWR UCIP) FIELD_STRUCT_DESC: [Tehama-Colusa Canal] 18-foot reinforced concrete irrigation siphon pipe through the levee, 30 feet below the crown. [Additional Reference(s): DWR Levee Log, 1992]. FS Date: 5/28/2019 2:01:09 PM

View of LS slope

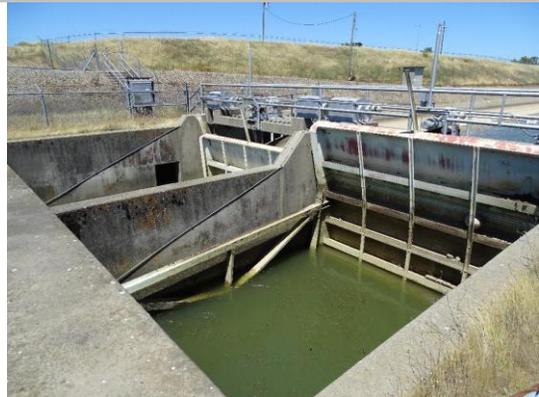
Photo 3 of 3 : UCIP_FA_2019_54129_79632.jpg

Canal flow regulating gates

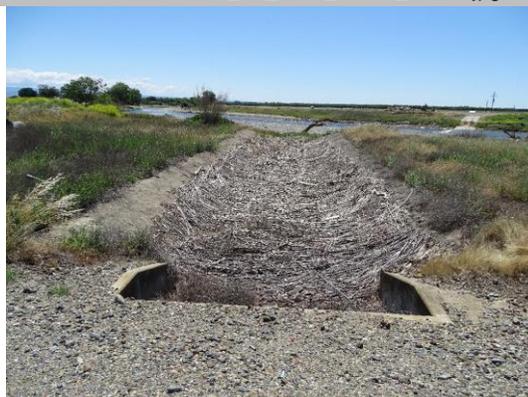
Photo 3 of 3 : UCIP_FA_2019_54130_79637.jpg

LM Start	1.69	Rating **	M	Issue No.	932 (cont)
LM End	1.69	Issue Type +	Ma	Location *	
Category	Supplemental			GPS Latitude/Longitude	
				Start	End
Item	DRAFT DWR UCIP LMA Responsibility			40.053590 °	40.053590 °
				-122.159982 °	-122.159982 °
DWR ID	20786				
Comment Code					
Inspector Comment					
DS_ID:20786 FS_ID:54130 EP_NO: N/A Repair Type: Non-Urgent Crossing Status: Found UCIP Comments: 05/28/2019 Brush at pipe outlet, but doesn't seem to affect flap gate operation. (O.Yakimov - DWR UCIP) FIELD_STRUCT_DESC: 1 of 3: 36-inch corrugated metal drainage pipe through the levee, 7.3 feet below the crown. Flap gate and concrete U-shaped headwall on the waterside (WS) end. Concrete U-shaped headwall on the landside (LS) end. [Additional Reference(s): DWR Levee Log, 1992. USACE Sacramento O&M Manual 510, April 1963, (HLM 1.70) Drawing No. 50-4-3622]. FS Date: 5/28/2019 2:18:51 PM

View of WS

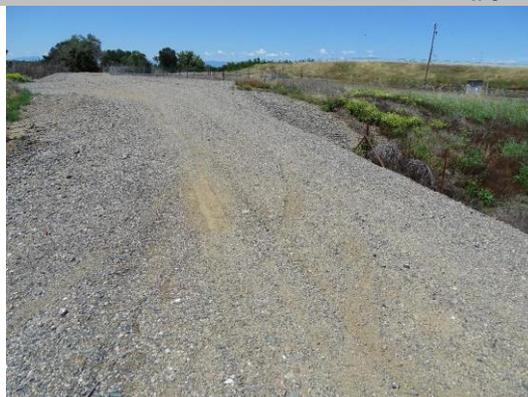
Photo 1 of 3 : UCIP_FA_2019_54131_79641.jpg

LM Start	1.69	Rating **	M	Issue No.	933
LM End	1.69	Issue Type +	Ma	Location *	
Category	Supplemental			GPS Latitude/Longitude	
				Start	End
Item	DRAFT DWR UCIP LMA Responsibility			40.053601 °	40.053601 °
				-122.159966 °	-122.159966 °
DWR ID	20883				
Comment Code					
Inspector Comment					
DS_ID:20883 FS_ID:54131 EP_NO: N/A Repair Type: Non-Urgent Crossing Status: Found UCIP Comments: 05/28/2019 Brush at pipe outlet, but doesn't seem to affect flap gate operation. (O.Yakimov - DWR UCIP) FIELD_STRUCT_DESC: 2 of 3: 36-inch corrugated metal drainage pipe through the levee, 7.3 feet below the crown. Flap gate and concrete U-shaped headwall on the waterside (WS) end. Concrete U-shaped headwall on the landside (LS) end. [Additional Reference(s): DWR Levee Log, 1992. USACE Sacramento O&M Manual 510, April 1963, (HLM 1.70) Drawing No. 50-4-3622]. FS Date: 5/28/2019 2:24:53 PM

View of levee crown at the crossing

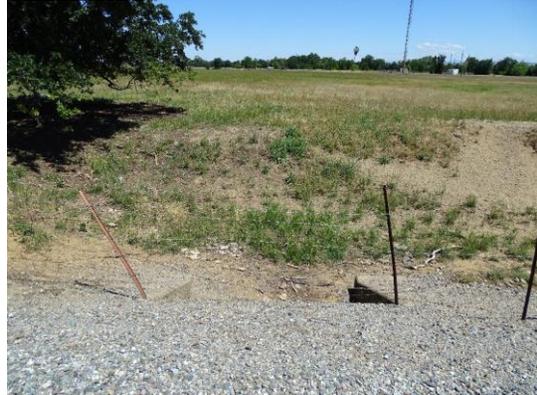
Photo 3 of 3 : UCIP_FA_2019_54133_79656.jpg

LM Start	1.99	Rating **	M	Issue No.	935 (cont)
LM End	1.99	Issue Type +	Ma	Location *	
Category	Supplemental			GPS Latitude/Longitude	
				Start	End
Item	DRAFT DWR UCIP LMA Responsibility			40.052731 °	40.052731 °
				-122.154695 °	-122.154695 °
DWR ID	20787				
Comment Code					
Inspector Comment					
DS_ID:20787 FS_ID:54133 EP_NO: N/A Repair Type: Non-Urgent Crossing Status: Found UCIP Comments: 05/28/2019 No issues recorded during inspection (O.Yakimov - DWR UCIP) FIELD_STRUCT_DESC: 1 of 2: 36-inch corrugated metal drainage pipe through the levee, 7.6 feet below the crown. Flap gate and concrete U-shaped headwall on the waterside (WS) end. Concrete U-shaped headwall on the landside (LS) end. [Additional Reference(s): DWR Levee Log, 1992. USACE Sacramento O&M Manual 510, April 1963, (HLM 2.01) Drawing No. 50-4-3622]. FS Date: 5/28/2019 2:33:09 PM

View of LS

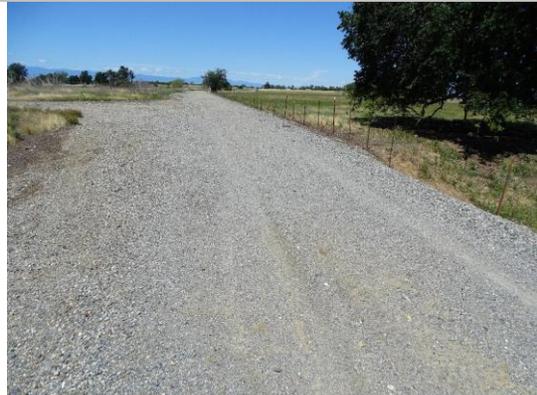
Photo 1 of 3 : UCIP_FA_2019_54134_79660.jpg

LM Start	1.99	Rating **	M	Issue No.	936
LM End	1.99	Issue Type +	Ma	Location *	
Category	Supplemental			GPS Latitude/Longitude	
				Start	End
Item	DRAFT DWR UCIP LMA Responsibility			40.052729 °	40.052729 °
				-122.154673 °	-122.154673 °
DWR ID	20885				
Comment Code					
Inspector Comment					
DS_ID:20885 FS_ID:54134 EP_NO: N/A Repair Type: Non-Urgent Crossing Status: Found UCIP Comments: 05/28/2019 No issues recorded during inspection (O.Yakimov - DWR UCIP) FIELD_STRUCT_DESC: 2 of 2: 36-inch corrugated metal drainage pipe through the levee, 7.6 feet below the crown. Flap gate and concrete U-shaped headwall on the waterside (WS) end. Concrete U-shaped headwall on the landside (LS) end. [Additional Reference(s): DWR Levee Log, 1992. USACE Sacramento O&M Manual 510, April 1963, (HLM 2.01) Drawing No. 50-4-3622]. FS Date: 5/28/2019 2:38:32 PM

View of levee crown at the crossing

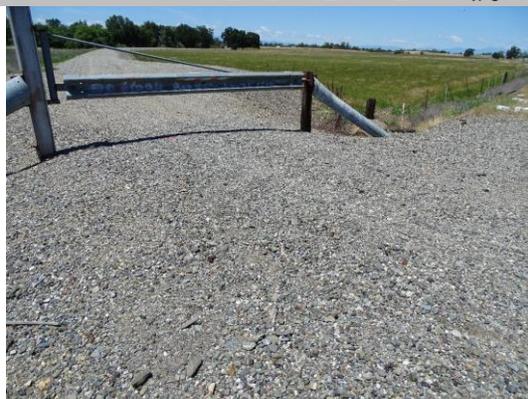
Photo 1 of 3 : UCIP_FA_2019_54135_79666.jpg

LM Start	2.21	Rating **	M	Issue No.	937
LM End	2.21	Issue Type +	Ma	Location *	
Category	Supplemental			GPS Latitude/Longitude	
				Start	End
Item	DRAFT DWR UCIP LMA Responsibility			40.051985 °	40.051985 °
				-122.150737 °	-122.150737 °
DWR ID	20788				
Comment Code					
Inspector Comment					
DS_ID:20788 FS_ID:54135 EP_NO: N/A Repair Type: Non-Urgent Crossing Status: Found UCIP Comments: 05/28/2019 No issues recorded during inspection (O.Yakimov - DWR UCIP) FIELD_STRUCT_DESC: 24-inch corrugated metal drainage pipe through the levee, 5.9 feet below the crown. Flap gate and concrete U-shaped headwall on the waterside (WS) end. Concrete U-shaped headwall on the landside (LS) end. [Additional Reference(s): DWR Levee Log, 1992. USACE Sacramento O&M Manual 510, April 1963, (HLM 2.24) Drawing No. 50-4-3622]. FS Date: 5/28/2019 2:44:10 PM

View of levee crown at the crossing
