**Flood Control Project Maintenance
Levee Inspections**

Fall 2019 Levee Maintenance Deficiency Summary Report

**Flood Control Project Maintenance
Levee Inspections
LMA District Cover Sheet
Fall 2019 Levee Inspection Results**

Tehama County Flood Control and Water Conservation District

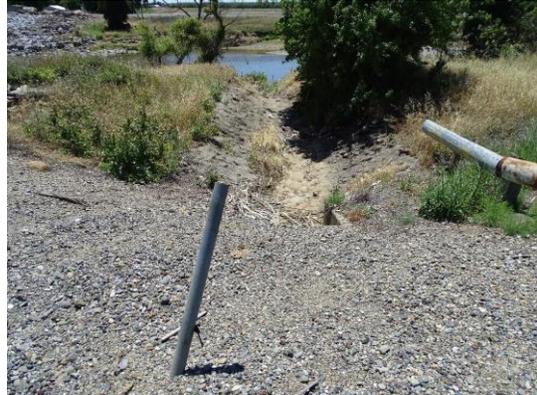
Photo 2 of 3 : UCIP_FA_2019_54135_79667.jpg

LM Start	2.21	Rating **	M	Issue No.	937 (cont)
LM End	2.21	Issue Type +	Ma	Location *	
Category	Supplemental			GPS Latitude/Longitude	
				Start	End
Item	DRAFT DWR UCIP LMA Responsibility			40.051985°	40.051985°
				-122.150737°	-122.150737°
DWR ID	20788				
Comment Code					
Inspector Comment					
DS_ID:20788 FS_ID:54135 EP_NO: N/A Repair Type: Non-Urgent Crossing Status: Found UCIP Comments: 05/28/2019 No issues recorded during inspection (O.Yakimov - DWR UCIP) FIELD_STRUCT_DESC: 24-inch corrugated metal drainage pipe through the levee, 5.9 feet below the crown. Flap gate and concrete U-shaped headwall on the waterside (WS) end. Concrete U-shaped headwall on the landside (LS) end. [Additional Reference(s): DWR Levee Log, 1992. USACE Sacramento O&M Manual 510, April 1963, (HLM 2.24) Drawing No. 50-4-3622]. FS Date: 5/28/2019 2:44:10 PM

View of WS

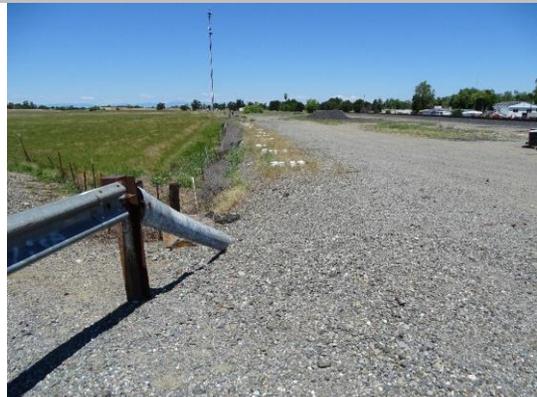
Photo 3 of 3 : UCIP_FA_2019_54135_79669.jpg

View of LS

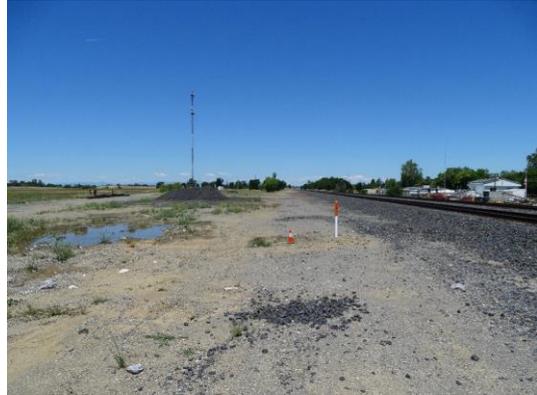
Photo 1 of 3 : UCIP_FA_2019_54136_79673.jpg

LM Start	2.23	Rating **	M	Issue No.	938
LM End	2.23	Issue Type +	En	Location *	
Category	Supplemental			GPS Latitude/Longitude	
				Start	End
Item	DRAFT DWR UCIP Field Study			40.052063 °	40.052063 °
				-122.150450 °	-122.150450 °
DWR ID	24695				
Comment Code					
Inspector Comment					
DS_ID:24695 FS_ID:54136 EP_NO: N/A Repair Type: Non-Urgent Crossing Status: Indicator Found UCIP Comments: 05/28/2019 Found indications of the crossing. Reclassified crossing status to Indicator Found. (O.Yakimov - DWR UCIP)No permit identified for this crossing. FIELD_STRUCT_DESC: oyakimovFiber optics conduit of an unknown size or material through the levee, at an unknown depth. Signage on the landside (LS) visible. FS Date: 5/28/2019 2:55:24 PM

View of LS with fiber optic line markers

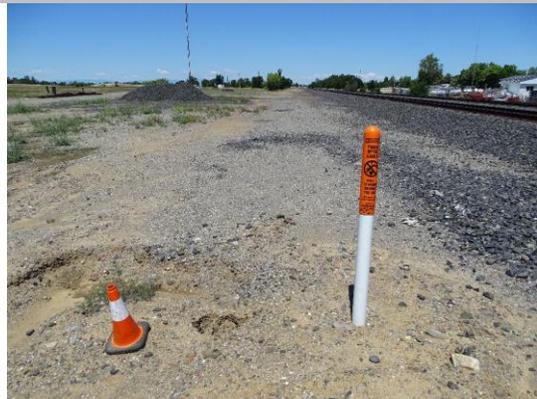
Photo 2 of 3 : UCIP_FA_2019_54136_79672.jpg

Fiber optic line markers on LS

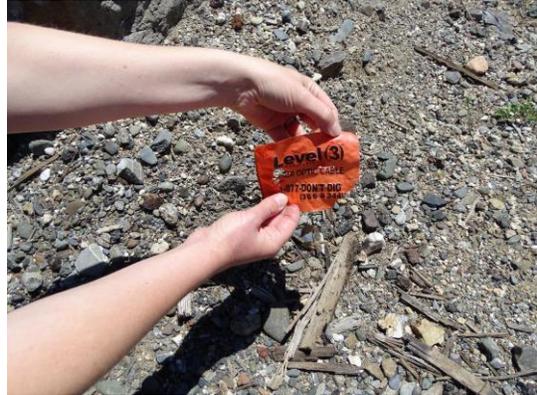
Photo 3 of 3 : UCIP_FA_2019_54136_79674.jpg

LM Start	2.23	Rating **	M	Issue No.	938 (cont)
LM End	2.23	Issue Type +	En	Location *	
Category	Supplemental			GPS Latitude/Longitude	
				Start	End
Item	DRAFT DWR UCIP Field Study			40.052063°	40.052063°
				-122.150450°	-122.150450°
DWR ID	24695				
Comment Code					
Inspector Comment					
DS_ID:24695 FS_ID:54136 EP_NO: N/A Repair Type: Non-Urgent Crossing Status: Indicator Found UCIP Comments: 05/28/2019 Found indications of the crossing. Reclassified crossing status to Indicator Found. (O.Yakimov - DWR UCIP)No permit identified for this crossing. FIELD_STRUCT_DESC: oyakimovFiber optics conduit of an unknown size or material through the levee, at an unknown depth. Signage on the landside (LS) visible. FS Date: 5/28/2019 2:55:24 PM

An indicator of crossing on WS shoulder

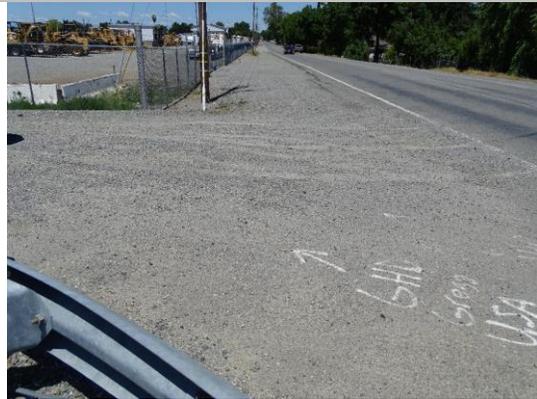
Photo 1 of 3 : UCIP_FA_2019_54137_79677.jpg

LM Start	2.28	Rating **	M	Issue No.	939
LM End	2.28	Issue Type +	En	Location *	
Category	Supplemental			GPS Latitude/Longitude	
				Start	End
Item	DRAFT DWR UCIP Field Study			40.052379°	40.052379°
				-122.149534°	-122.149534°
DWR ID	24694				
Comment Code					
Inspector Comment					
DS_ID:24694 FS_ID:54137 EP_NO: N/A Repair Type: Non-Urgent Crossing Status: Found UCIP Comments: No permit identified for this crossing. FIELD_STRUCT_DESC: 4-inch coated steel gas pipeline through the levee, 3.5 feet below the crown. Pipe visible on upstream side of bridge. FS Date: 5/28/2019 3:08:00 PM

Levee crown at crossing

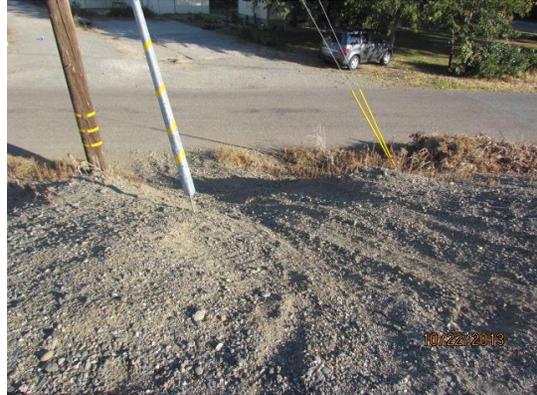
Photo 1 of 1 : FA_2019_NA0019_81_12_20190822_00007.jpg

LM Start	2.32	Rating **	M	Issue No.	12
LM End	2.32	Issue Type +	Ma	Location *	LS
Category	Earthen Levee			GPS Latitude/Longitude	
				Start	End
Item	Slope Stability			40.052443°	40.052443°
				-122.148863°	-122.148863°
DWR ID	DWR_NA0019_04_f_2013_12				
Comment Code					
S3 : Repair the levee slope damaged by vehicle traffic and prevent access where possible.					
Inspector Comment

View of the slope instability caused by vehicles along the landside slope.

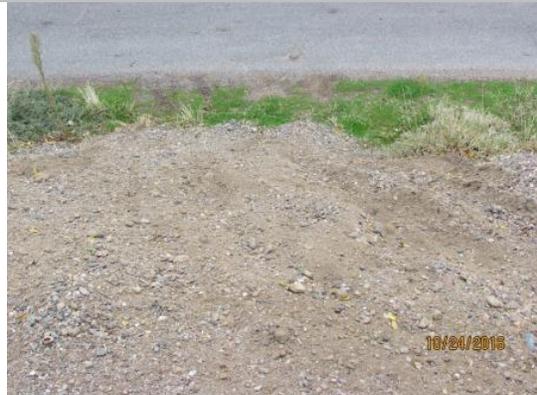
Photo 1 of 1 : FA_2019_NA0019_81_30_20190822_00017.jpg

LM Start	2.35	Rating **	M	Issue No.	30
LM End	2.35	Issue Type +	Ma	Location *	LS
Category	Earthen Levee			GPS Latitude/Longitude	
				Start	End
Item	Slope Stability			40.052450°	40.052450°
				-122.148352°	-122.148352°
DWR ID	DWR_NA0019_04_f_2016_30				
Comment Code					
S3 : Repair the levee slope damaged by vehicle traffic and prevent access where possible.					
Inspector Comment

View of the slope instability caused by vehicles along the landside slope.

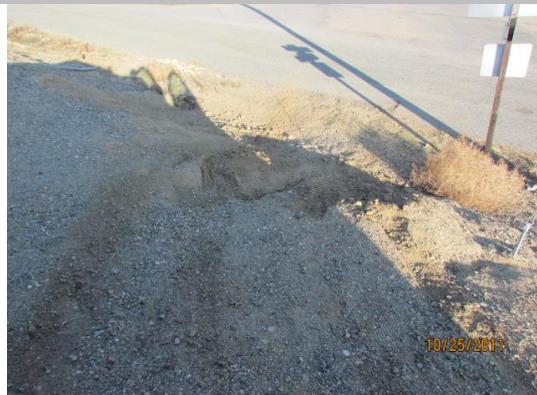
Photo 1 of 1 : FA_2019_NA0019_81_20_20190822_00012.jpg

LM Start	2.43	Rating **	M	Issue No.	20
LM End	2.43	Issue Type +	Ma	Location *	LS
Category	Earthen Levee			GPS Latitude/Longitude	
				Start	End
Item	Slope Stability			40.052417°	40.052417°
				-122.146747°	-122.146747°
DWR ID	DWR_NA0019_04_s_2012_20				
Comment Code					
S3 : Repair the levee slope damaged by vehicle traffic and prevent access where possible.					
Inspector Comment

View of the slope instability caused by vehicles along the landside slope.

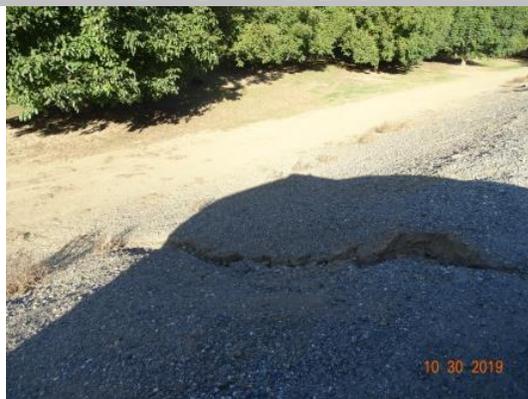
Photo 1 of 1 : FA_2019_NA0019_81_71_20191101_00095.jpg

LM Start	2.83	Rating **	M	Issue No.	71
LM End	2.83	Issue Type +	Ma	Location *	LS
Category	Earthen Levee			GPS Latitude/Longitude	
				Start	End
Item	Erosion / Bank Caving			40.055528°	40.055528°
				-122.141319°	-122.141319°
DWR ID	DWR_NA0019_04_f_2019_71				
Comment Code					
E2 : Schedule repair of erosion site prior to the next inspection.					
Inspector Comment					
Runoff is causing erosion rills in this area. The rills should be repaired.

View of a large rill on the landside slope. Fall 2019.

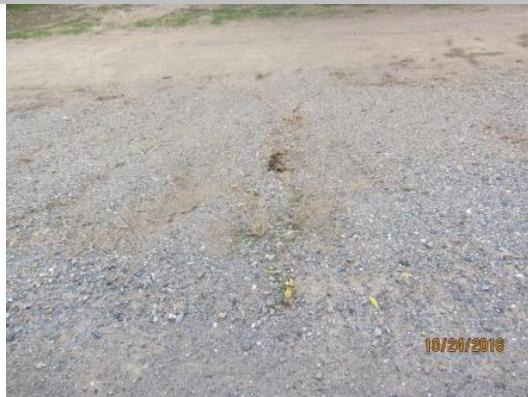
Photo 1 of 1 : FA_2019_NA0019_81_916_20190822_00025.jpg

LM Start	2.83	Rating **	A/W	Issue No.	916
LM End	2.86	Issue Type +	Ma	Location *	WS
Category	Earthen Levee			GPS Latitude/Longitude	
				Start	End
Item	Slope Stability			40.055596°	40.055985°
				-122.141322°	-122.141385°
DWR ID	DWR_NA0019_04_s_2012_916				
Comment Code					
S3 : Repair the levee slope damaged by vehicle traffic and prevent access where possible.					
Inspector Comment

View of the slope instability caused by vehicles along the waterside slope.

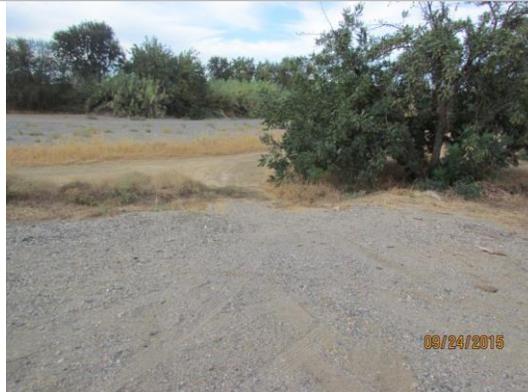
Photo 1 of 1 : FA_2019_NA0019_81_10_20190822_00006.jpg

LM Start	3.01	Rating **	M	Issue No.	10
LM End	3.01	Issue Type +	Ma	Location *	WS
Category	Earthen Levee			GPS Latitude/Longitude	
				Start	End
Item	Slope Stability			40.056388°	40.056388°
				-122.139168°	-122.139168°
DWR ID	DWR_NA0019_04_s_2012_10				
Comment Code					
S3 : Repair the levee slope damaged by vehicle traffic and prevent access where possible.					
Inspector Comment

View of the slope instability caused by vehicles along the waterside slope.

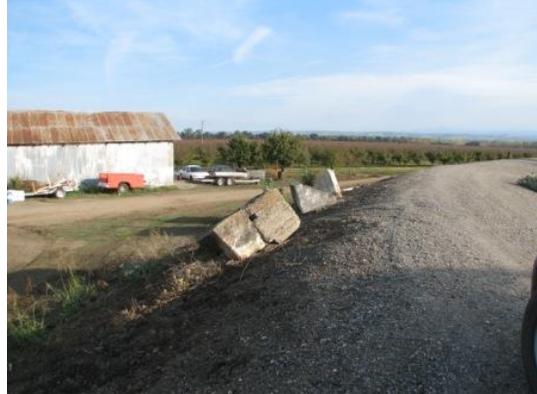
Photo 1 of 1 : FA_2019_NA0019_81_1_20190822_00001.jpg

LM Start	3.11	Rating **	M	Issue No.	1
LM End	3.13	Issue Type +	En	Location *	LS
Category	Earthen Levee			GPS Latitude/Longitude	
				Start	End
Item	Encroachments			40.057083°	40.057291°
				-122.137935°	-122.137743°
DWR ID	DWR_NA0019_04_s_2012_1				
Comment Code					
DE : Debris					
Inspector Comment					
Remove concrete blocks, concrete pipes, and concrete stairs from the landside slope.

View of the concrete stairways on the slope.

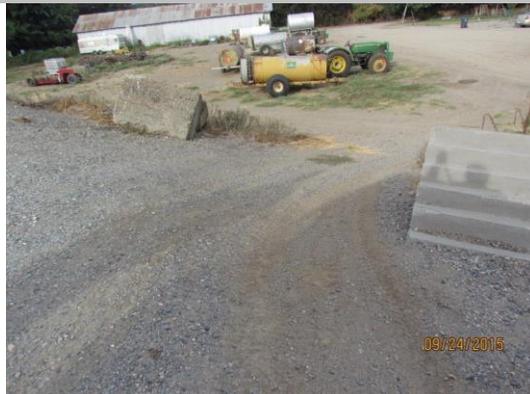
Photo 1 of 1 : FA_2019_NA0019_81_25_20190822_00014.jpg

LM Start	3.13	Rating **	M	Issue No.	25
LM End	3.13	Issue Type +	Ma	Location *	LS
Category	Earthen Levee			GPS Latitude/Longitude	
				Start	End
Item	Slope Stability			40.057350°	40.057350°
				-122.137667°	-122.137667°
DWR ID	DWR_NA0019_04_f_2015_25				
Comment Code					
S3 : Repair the levee slope damaged by vehicle traffic and prevent access where possible.					
Inspector Comment

View of the slope instability caused by vehicles along the landside slope.

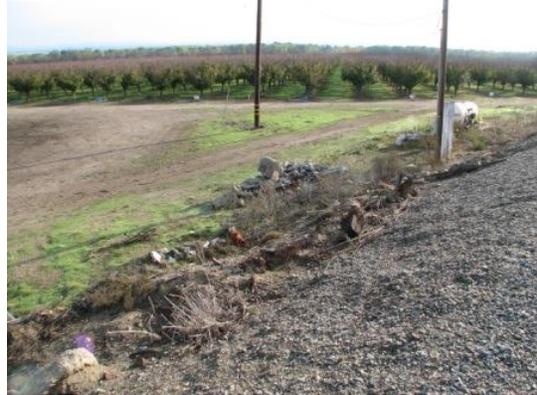
Photo 1 of 1 : FA_2019_NA0019_81_6_20190822_00005.jpg

LM Start	3.31	Rating **	M	Issue No.	6
LM End	3.31	Issue Type +	En	Location *	LS
Category	Earthen Levee			GPS Latitude/Longitude	
				Start	End
Item	Encroachments			40.057558°	40.057558°
				-122.134417°	-122.134417°
DWR ID	DWR_NA0019_04_s_2012_6				
Comment Code					
GA : Garbage					
Inspector Comment

View of the garbage and metal along the landside slope and toe of the levee.

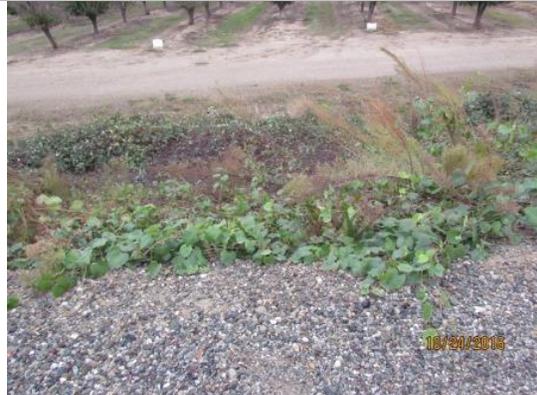
Photo 1 of 1 : FA_2019_NA0019_81_39_20190822_00019.jpg

LM Start	3.40	Rating **	M	Issue No.	39
LM End	3.44	Issue Type +	Ma	Location *	LS
Category	Earthen Levee			GPS Latitude/Longitude	
				Start	End
Item	Vegetation			40.056546°	40.055906°
				-122.133530°	-122.133294°
DWR ID	DWR_NA0019_04_f_2016_39				
Comment Code					
V2 : Remove the wild growth other than native grasses from the levee slopes.					
Inspector Comment

View of the blackberries along the landside slope blocking visibility and access.

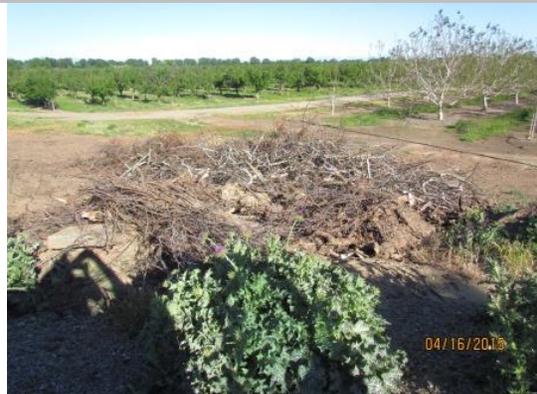
Photo 1 of 1 : FA_2019_NA0019_81_21_20190822_00013.jpg

LM Start	3.66	Rating **	M	Issue No.	21
LM End	3.66	Issue Type +	En	Location *	LS
Category	Earthen Levee			GPS Latitude/Longitude	
				Start	End
Item	Encroachments			40.055735°	40.055735°
				-122.129445°	-122.129445°
DWR ID	DWR_NA0019_04_s_2015_21				
Comment Code					
PR : Prunings					
Inspector Comment					
Remove the prunings from the landside toe.

View of the prunings along landside toe.

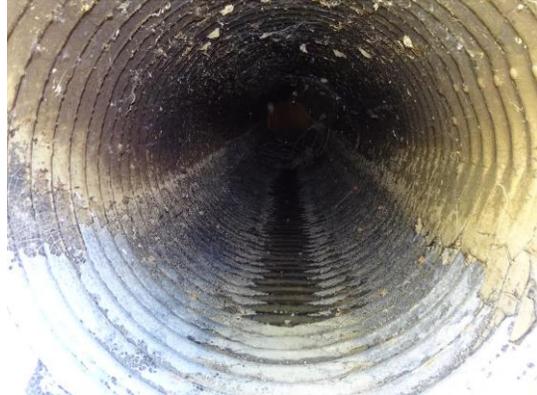
Photo 3 of 3 : UCIP_FA_2019_54066_79379.jpg

LM Start	0.11	Rating **	M	Issue No.	20 (cont)
LM End	0.11	Issue Type +	Ma	Location *	
Category	Supplemental			GPS Latitude/Longitude	
				Start	End
Item	DRAFT DWR UCIP LMA Responsibility			40.051702°	40.051702°
				-122.189922°	-122.189922°
DWR ID	20799				
Comment Code					
Inspector Comment					
DS_ID:20799 FS_ID:54066 EP_NO: N/A Repair Type: Non-Urgent Crossing Status: Found UCIP Comments: 05/28/2019 Debris at the outlet needs to be cleared for proper flap gate operation. (O.Yakimov - DWR UCIP) FIELD_STRUCT_DESC: 24-inch corrugated metal drainage pipe through the levee, 5.4 feet below the crown. Flap gate on the waterside (WS) end. Concrete U-shaped headwalls on the WS and landside (LS) ends. [Additional Reference(s): DWR Levee Log, 1992. USACE Sacramento O&M Manual 510, April 1963, (HLM 0.11) Drawing No. 50-4-3622]. FS Date: 5/28/2019 1:31:26 PM

Inside of pipe looking from LS inlet

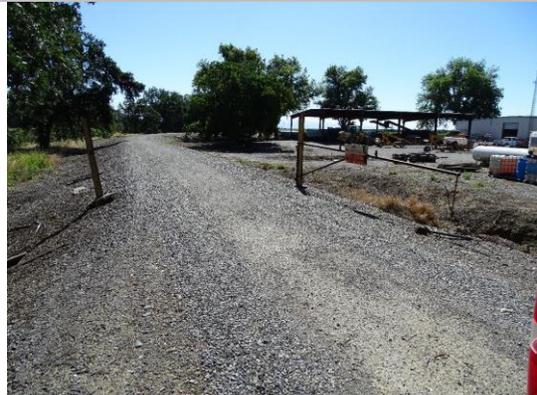
Photo 1 of 3 : UCIP_FA_2019_54069_79394.jpg

LM Start	0.50	Rating **	M	Issue No.	21
LM End	0.50	Issue Type +	Ma	Location *	
Category	Supplemental			GPS Latitude/Longitude	
				Start	End
Item	DRAFT DWR UCIP LMA Responsibility			40.050585°	40.050585°
				-122.182972°	-122.182972°
DWR ID	20801

Comment Code					
Inspector Comment					
DS_ID:20801 FS_ID:54069 EP_NO: N/A Repair Type: Non-Urgent Crossing Status: Found UCIP Comments: 05/28/2019 No issues recorded during inspection. (O.Yakimov - DWR UCIP)Debris inside pipe at WS toe needs to be removed as it may prevent proper operation of the flapgate. FIELD_STRUCT_DESC: 24-inch corrugated metal drainage pipe through the levee, 5.2 feet below the crown. Flap gate on the waterside (WS) end. Concrete U-shaped headwalls on the WS and landside (LS) ends. [Additional Reference(s): DWR Levee Log, 1992. USACE Sacramento O&M Manual 510, April 1963, (HLM 0.51) Drawing No. 50-4-3622]. FS Date: 5/28/2019

View of levee crown at the crossing

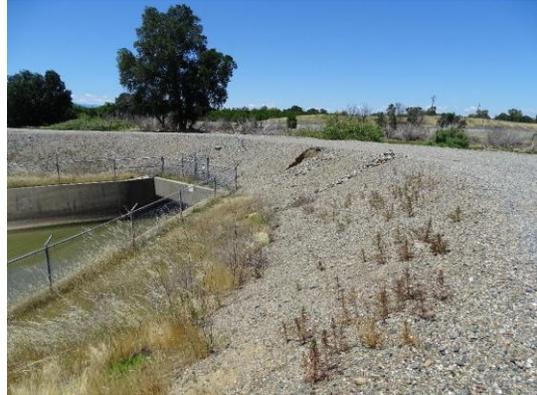
Photo 1 of 3 : UCIP_FA_2019_54060_79348.jpg

LM Start	1.83	Rating **	U	Issue No.	22
LM End	1.83	Issue Type +	En	Location *	
Category	Supplemental			GPS Latitude/Longitude	
				Start	End
Item	DRAFT DWR UCIP Field Study			40.052313°	40.052313°
				-122.160085°	-122.160085°
DWR ID	20795				
Comment Code					
Inspector Comment					
DS_ID:20795 FS_ID:54060 EP_NO: N/A Repair Type: Urgent Crossing Status: Found UCIP Comments: 5/28/2019 Subsidence on LS slope near pipe alignment more than a foot in depth. (O.Yakimov - DWR UCIP) FIELD_STRUCT_DESC: [Tehama and Colusa Canal] 18.5-foot reinforced concrete irrigation siphon pipe through the levee, 30 feet below the crown. 1.5-foot by 2-foot electrical conduit box on the landside (LS) slope. [Additional Reference(s): DWR Levee Log, 1992]. FS Date: 5/28/2019 7:24:30 AM

Subsidence on LS slope just downstream of pipe alignment

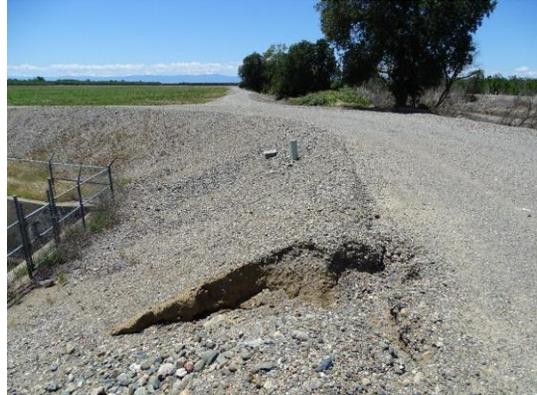
Photo 3 of 3 : UCIP_FA_2019_54060_79350.jpg

LM Start	1.83	Rating **	U	Issue No.	22 (cont)
LM End	1.83	Issue Type +	En	Location *	
Category	Supplemental			GPS Latitude/Longitude	
				Start	End
Item	DRAFT DWR UCIP Field Study			40.052313 °	40.052313 °
				-122.160085 °	-122.160085 °
DWR ID	20795				
Comment Code					
Inspector Comment					
DS_ID:20795 FS_ID:54060 EP_NO: N/A Repair Type: Urgent Crossing Status: Found UCIP Comments: 5/28/2019 Subsidence on LS slope near pipe alignment more than a foot in depth. (O.Yakimov - DWR UCIP) FIELD_STRUCT_DESC: [Tehama and Colusa Canal] 18.5-foot reinforced concrete irrigation siphon pipe through the levee, 30 feet below the crown. 1.5-foot by 2-foot electrical conduit box on the landside (LS) slope. [Additional Reference(s): DWR Levee Log, 1992]. FS Date: 5/28/2019 7:24:30 AM

View of LS slope at the crossing

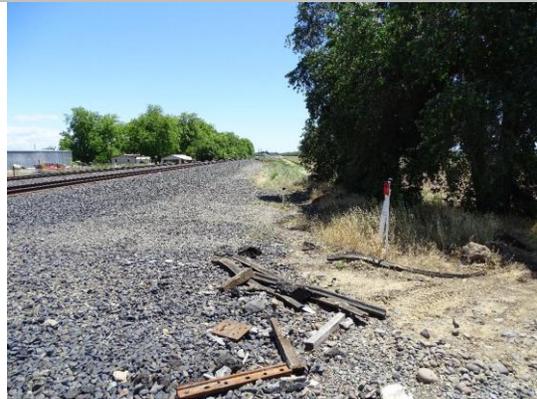
Photo 1 of 3 : UCIP_FA_2019_54079_79412.jpg

LM Start	2.41	Rating **	M	Issue No.	23
LM End	2.41	Issue Type +	En	Location *	
Category	Supplemental			GPS Latitude/Longitude	
				Start	End
Item	DRAFT DWR UCIP Field Study			40.051336 °	40.051336 °
				-122.149991 °	-122.149991 °
DWR ID	24692				
Comment Code					
Inspector Comment					
DS_ID:24692 FS_ID:54079 EP_NO: N/A Repair Type: Non-Urgent Crossing Status: Found UCIP Comments: 05/28/2019 No issues recorded during inspection. (O.Yakimov - DWR UCIP)No permit identified for this crossing. FIELD_STRUCT_DESC: Steel fiber optics conduit of an unknown size through the levee, at an unknown depth. Sign markers on the landside (LS) shoulder. FS Date: 5/28/2019 2:53:47 PM

Landside view with markers installed

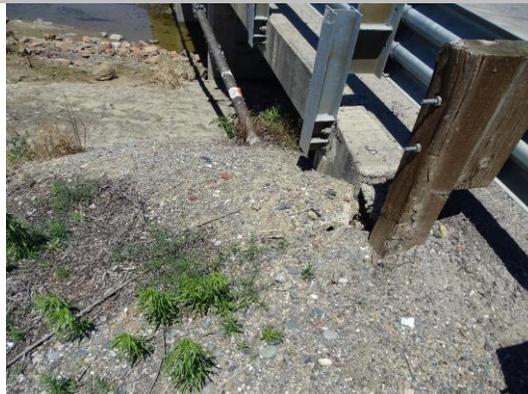
Photo 3 of 3 : UCIP_FA_2019_54083_79417.jpg

LM Start	2.47	Rating **	M	Issue No.	24 (cont)
LM End	2.47	Issue Type +	En	Location *	
Category	Supplemental			GPS Latitude/Longitude	
				Start	End
Item	DRAFT DWR UCIP Field Study			40.051667°	40.051667°
				-122.149033°	-122.149033°
DWR ID	24693				
Comment Code					
Inspector Comment					
DS_ID:24693 FS_ID:54083 EP_NO: N/A Repair Type: Non-Urgent Crossing Status: Found UCIP Comments: 05/28/2019 Minor runoff erision between the bridge and WS slope at the place where crossing daylight. (O.Yakimov - DWR UCIP)No permit identified for this crossing. FIELD_STRUCT_DESC: 4-inch steel gas pipeline through the levee, 2.5 feet below the crown. Pipe visible on upstream side of bridge. FS Date: 5/28/2019 3:02:30 PM

Minor runoff erosion at the bridge and WS slope

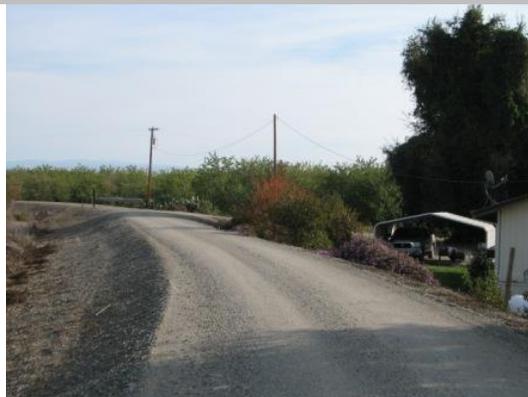
Photo 1 of 1 : FA_2019_NA0019_82_2_20190822_00001.jpg

LM Start	2.65	Rating **	M	Issue No.	2
LM End	2.70	Issue Type +	En	Location *	LS
Category	Earthen Levee			GPS Latitude/Longitude	
				Start	End
Item	Vegetation			40.051778°	40.052243°
				-122.145745°	-122.144825°
DWR ID	DWR_NA0019_05_s_2012_2				
Comment Code					
V6 : Landscaping					
Inspector Comment

View of the landscaping along the slope.

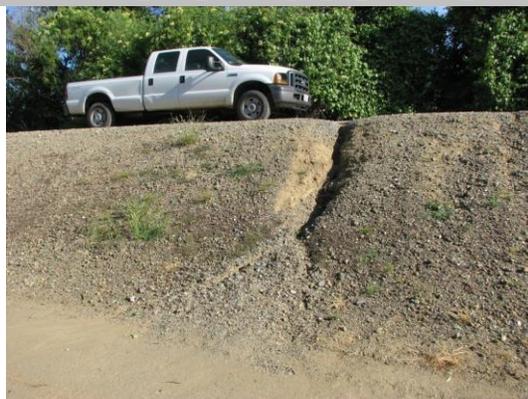
Photo 1 of 1 : FA_2019_NA0019_82_10_20190822_00005.jpg

LM Start	3.35	Rating **	U	Issue No.	10
LM End	3.35	Issue Type +	Ma	Location *	LS
Category	Earthen Levee		GPS Latitude/Longitude		
			Start	End	
Item	Erosion / Bank Caving		40.056875 °	40.056875 °	
			-122.135349 °	-122.135349 °	
DWR ID	DWR_NA0019_05_s_2016_10				
Comment Code					
E2 : Schedule repair of erosion site prior to the next inspection.					
Inspector Comment					
Erosion rut runs down the landside slope from crown to toe.

View of the erosion along the landside slope.

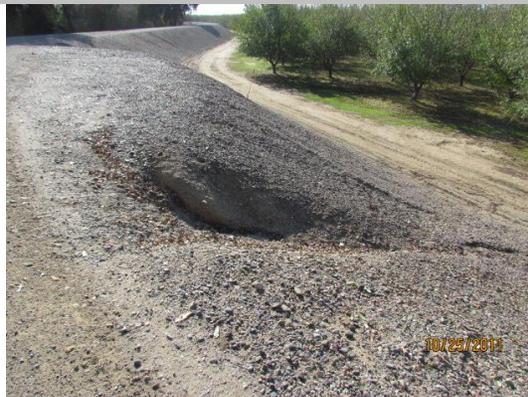
Photo 1 of 1 : FA_2019_NA0019_82_7_20190822_00003.jpg

LM Start	3.38	Rating **	U	Issue No.	7
LM End	3.38	Issue Type +	Ma	Location *	LS
Category	Earthen Levee		GPS Latitude/Longitude		
			Start	End	
Item	Erosion / Bank Caving		40.056727 °	40.056727 °	
			-122.134888 °	-122.134888 °	
DWR ID	DWR_NA0019_05_s_2016_7				
Comment Code					
E2 : Schedule repair of erosion site prior to the next inspection.					
Inspector Comment

View of the erosion along the landside slope.

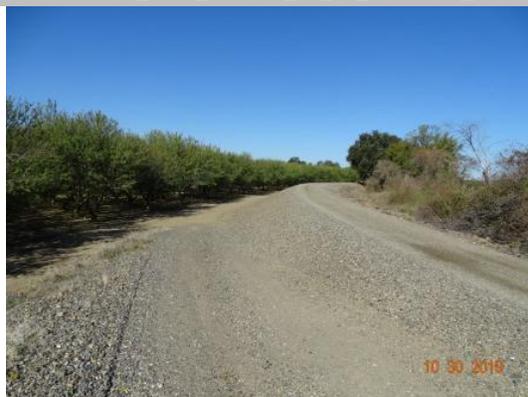
Photo 1 of 1 : FA_2019_NA0019_82_16_20191101_00023.jpg

LM Start	3.52	Rating **	A	Issue No.	16
LM End	3.52	Issue Type +	Ma	Location *	LS
Category	Earthen Levee			GPS Latitude/Longitude	
				Start	End
Item	Vegetation			40.054979°	40.054979°
				-122.133702°	-122.133702°
DWR ID	DWR_NA0019_05_f_2019_16				
Comment Code					
V1 : Control annual grass and weeds on the levee slopes and easements.					
Inspector Comment					
Landside slope is well maintained and free of vegetation.

View of well maintained landside slope. Fall 2019.

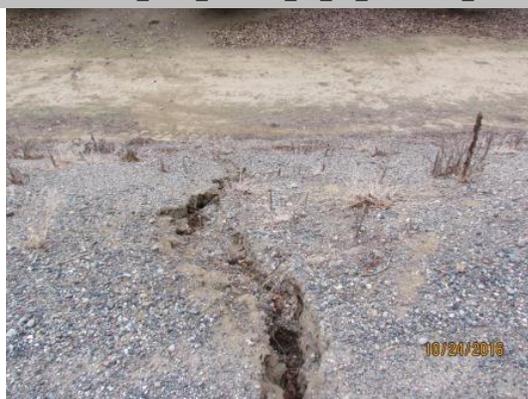
Photo 1 of 1 : FA_2019_NA0019_82_19_20190822_00007.jpg

LM Start	3.69	Rating **	M	Issue No.	19
LM End	3.69	Issue Type +	Ma	Location *	LS
Category	Earthen Levee			GPS Latitude/Longitude	
				Start	End
Item	Erosion / Bank Caving			40.054604°	40.054604°
				-122.130490°	-122.130490°
DWR ID	DWR_NA0019_05_f_2016_19				
Comment Code					
E2 : Schedule repair of erosion site prior to the next inspection.					
Inspector Comment

View of the erosion along the landside slope.

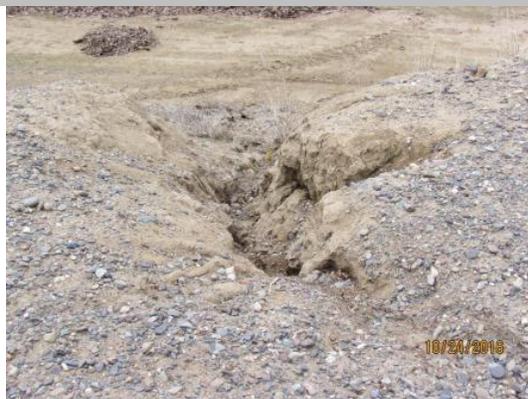
Photo 1 of 1 : FA_2019_NA0019_82_18_20190822_00006.jpg

LM Start	3.76	Rating **	U	Issue No.	18
LM End	3.76	Issue Type +	Ma	Location *	LS
Category	Earthen Levee			GPS Latitude/Longitude	
				Start	End
Item	Erosion / Bank Caving			40.054829°	40.054829°
				-122.129329°	-122.129329°
DWR ID	DWR_NA0019_05_f_2016_18				
Comment Code					
E2 : Schedule repair of erosion site prior to the next inspection.					
Inspector Comment

View of the erosion along the landside slope.
