**Flood Control Project Maintenance
Levee Inspections**
2020 Channel Summary Report
Overall Unit and Item Ratings

DWR Sutter Maintenance Yard

Levee Inspection Report By Mile - Channel 2020

Channel	Channel Length	Inspection Start/End	Inspector
Big Chico Creek	13.00	07/29/2020 07/29/2020	Brooks Weisser

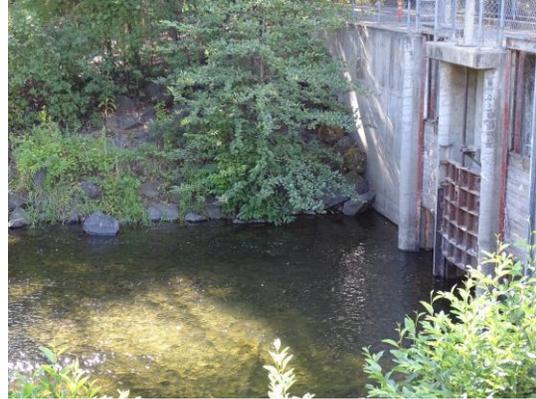
Photo 1 of 1 : CH_2020_NA0060_5_4_20200804_00032.jpg

Check Point / View			
Big Chico Creek Control Structure / Up (cont)			
Rating **	A	Issue No.	4
Issue Type +	Ma	Location *	39.761840 °
Category	Rivers, Channels & Designated Flood		-121.792590 °
Item	Revetments		
DWR ID	DWR_NA0060_5_c_2012_4		
Action/Comments			
Inspector Comments: Some of the riprap is covered with vegetation. Trees and other vegetation growth should be managed/removed from riprap.

View of typical revetment on the upstream side of the structure, 2020.

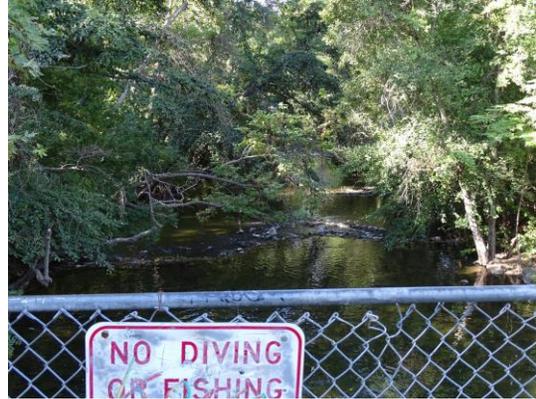
Photo 1 of 1 : CH_2020_NA0060_5_6_20200804_00029.jpg

Check Point / View			
Big Chico Creek Control Structure / Down			
Rating **	A	Issue No. 6	GPS Lat/Long
Issue Type +	Ma	Location *	39.761840 °
Category	Rivers, Channels & Designated Flood		-121.792590 °
Item	Vegetation & Obstructions		
DWR ID	DWR_NA0060_5_c_2012_6		
Action/Comments			
Inspector Comments: Minimal, scattered obstructions and vegetation. The flow is not impeded.

View of the downstream side of the channel from the structure, 2020

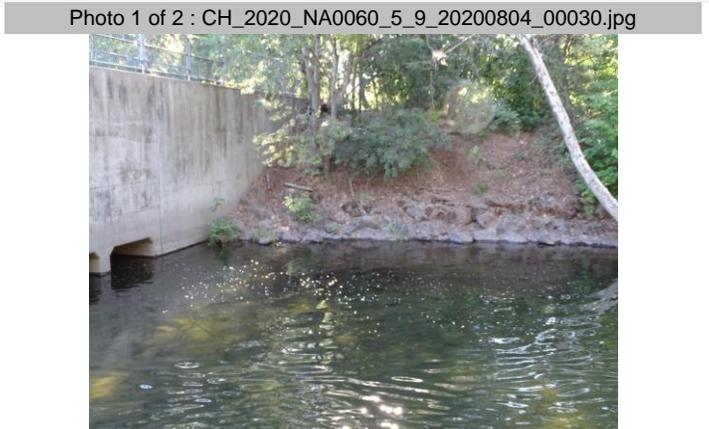
Check Point / View			
Big Chico Creek Control Structure / Down (cont)			
Rating **	A	Issue No.	9
Issue Type +	Ma	Location *	GPS Lat/Long
Category	Rivers, Channels & Designated Flood		39.761840 °
Item	Revetments		-121.792590 °
DWR ID	DWR_NA0060_5_c_2012_9		
Action/Comments			
Inspector Comments: Riprap is visible and appears properly maintained.

View of the revetment downstream left bank of the channel from the structure, 2020.

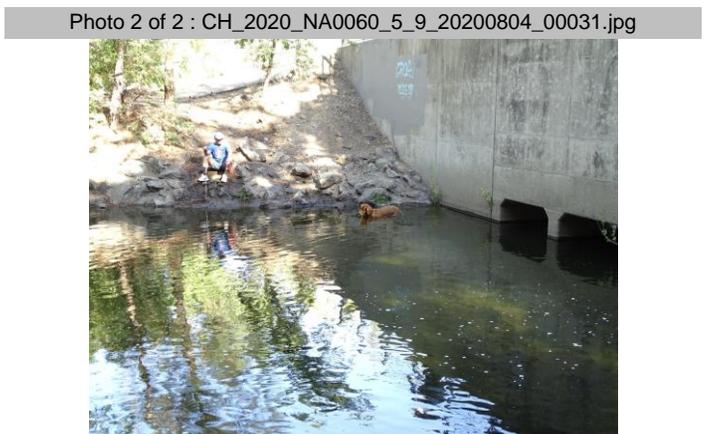
Rating **	A	Issue No.	9 (cont)
Issue Type +	Ma	Location *	GPS Lat/Long
Category	Rivers, Channels & Designated Flood		39.761840 °
Item	Revetments		-121.792590 °
DWR ID	DWR_NA0060_5_c_2012_9

View of the revetment downstream right bank of the channel from the structure, 2020.

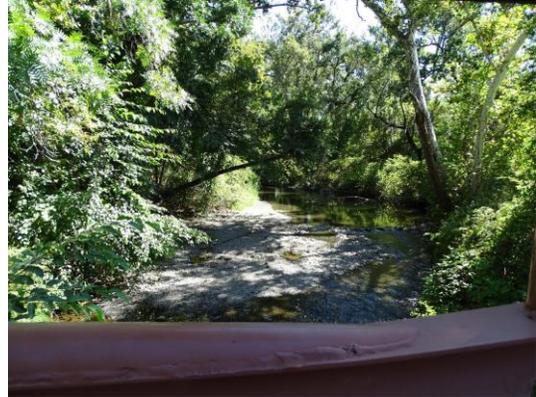
Photo 1 of 1 : CH_2020_NA0060_5_11_20200804_00035.jpg

Check Point / View				
Manzanita Ave. / Up				
Rating **	A	Issue No.	11	GPS Lat/Long
Issue Type +	Ma	Location *		39.758224 °
Category	Rivers, Channels & Designated Flood			-121.795853 °
Item	Vegetation & Obstructions			
DWR ID	DWR_NA0060_5_c_2012_11			
Action/Comments				
Inspector Comments: Minimal, scattered obstructions and vegetation. The flow is not impeded.

This photo is looking upstream from under Manzanita Avenue Bridge, 2020.

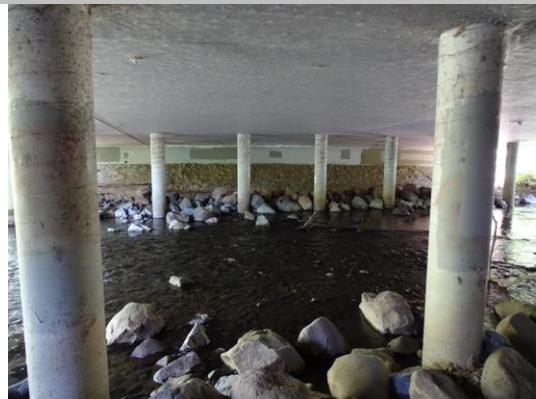
Photo 1 of 2 : CH_2020_NA0060_5_14_20200804_00034.jpg

Rating **	A	Issue No.	14	GPS Lat/Long
Issue Type +	Ma	Location *		39.758224 °
Category	Rivers, Channels & Designated Flood			-121.795853 °
Item	Revetments			
DWR ID	DWR_NA0060_5_c_2012_14			
Action/Comments				
Inspector Comments: Riprap is visible and appears properly maintained.

View looking upstream at the right bank of typical revetment around the abutment and bike path, 2020.

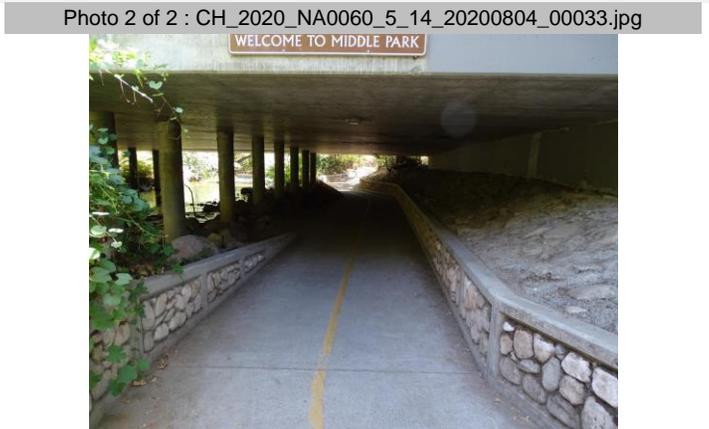
Check Point / View				
Manzanita Ave. / Up (cont)				
Rating **	A	Issue No.	14 (cont)	GPS Lat/Long
Issue Type +	Ma	Location *		39.758224 °
Category	Rivers, Channels & Designated Flood			-121.795853 °
Item	Revetments			
DWR ID	DWR_NA0060_5_c_2012_14			
Action/Comments				
Inspector Comments: Riprap is visible and appears properly maintained.

View looking upstream at the left bank of typical revetment around the abutment and bike path, 2020.

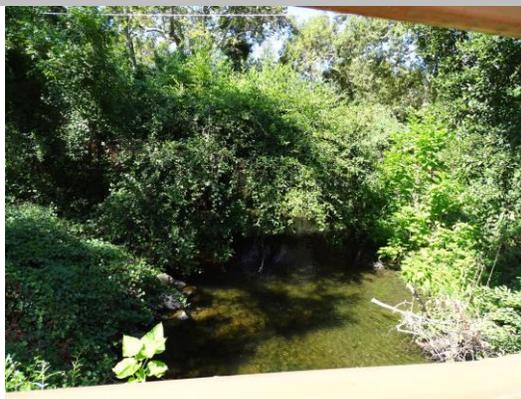
Photo 1 of 1 : CH_2020_NA0060_5_16_20200804_00036.jpg

Check Point / View			
Manzanita Ave. / Down			
Rating **	A	Issue No.	16
Issue Type +	Ma	Location *	39.758224 °
Category	Rivers, Channels & Designated Flood		-121.795853 °
Item	Vegetation & Obstructions		
DWR ID	DWR_NA0060_5_c_2012_16		
Action/Comments			
Inspector Comments: Minimal, scattered obstructions and vegetation. The flow is not impeded.

This photo is looking downstream from Manzanita Avenue Bridge, 2020.

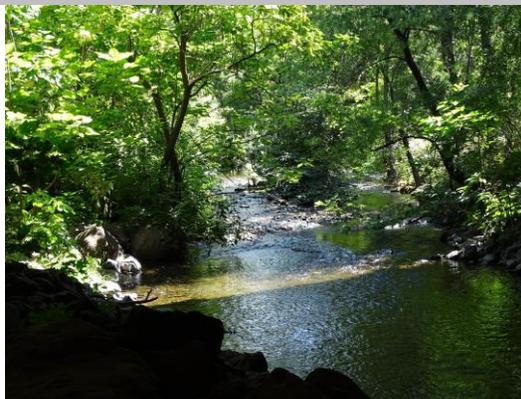
Photo 1 of 1 : CH_2020_NA0060_5_21_20200804_00037.jpg

Check Point / View			
Hwy 99 Bridge / Up			
Rating **	A	Issue No.	21
Issue Type +	Ma	Location *	39.738490 °
Category	Rivers, Channels & Designated Flood		-121.822810 °
Item	Vegetation & Obstructions		
DWR ID	DWR_NA0060_5_c_2012_21		
Action/Comments			
Inspector Comments: Minimal scattered obstructions or vegetation. The flow is not impeded.

View of the channel up from Highway 99 facing upstream, 2020.

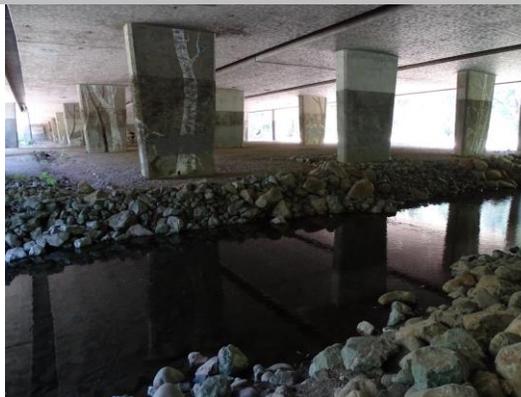
Photo 1 of 2 : CH_2020_NA0060_5_24_20200804_00038.jpg

Rating **	A	Issue No. 24	GPS Lat/Long
Issue Type +	Ma	Location *	39.738490 °
Category	Rivers, Channels & Designated Flood		-121.822810 °
Item	Revetments		
DWR ID	DWR_NA0060_5_c_2012_24		
Action/Comments			
Inspector Comments: Existing riprap protection is properly maintained and is undamaged. Riprap is clearly visible on both sides.

View of revetment along the channel right bank, looking upstream, 2020.

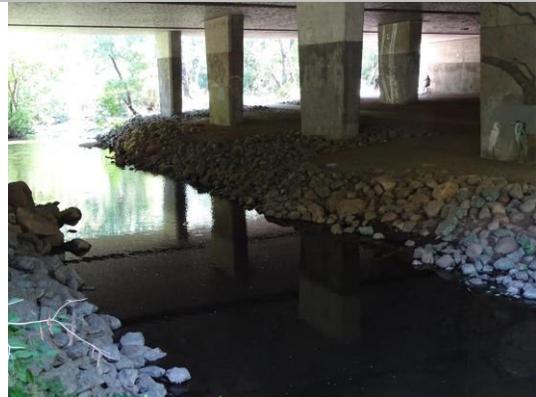
Photo 2 of 2 : CH_2020_NA0060_5_24_20200804_00042.jpg

Check Point / View			
Hwy 99 Bridge / Up (cont)			
Rating **	A	Issue No.	24 (cont)
Issue Type +	Ma	Location *	39.738490 °
Category	Rivers, Channels & Designated Flood		-121.822810 °
Item	Revetments		
DWR ID	DWR_NA0060_5_c_2012_24		
Action/Comments			
Inspector Comments: Existing riprap protection is properly maintained and is undamaged. Riprap is clearly visible on both sides.

View of revetment along the channel left bank, looking upstream, 2020.

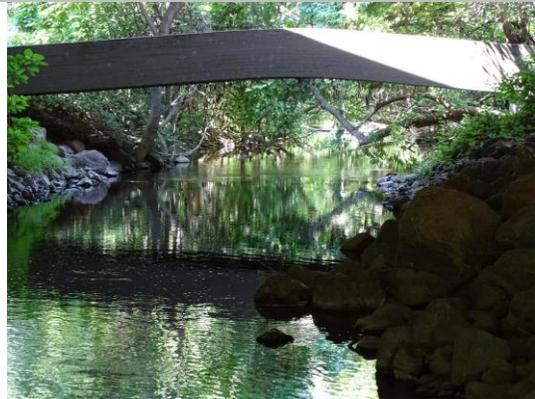
Photo 1 of 1 : CH_2020_NA0060_5_26_20200804_00043.jpg

Check Point / View			
Hwy 99 Bridge / Down			
Rating **	M	Issue No. 26	GPS Lat/Long
Issue Type +	Ma	Location *	39.738490 °
Category	Rivers, Channels & Designated Flood		-121.822810 °
Item	Vegetation & Obstructions		
DWR ID	DWR_NA0060_5_c_2012_26		
Action/Comments			
Inspector Comments: Scattered obstructions and vegetation, the flow is not impeded.

View of the channel under Highway 99 facing downstream, 2020.

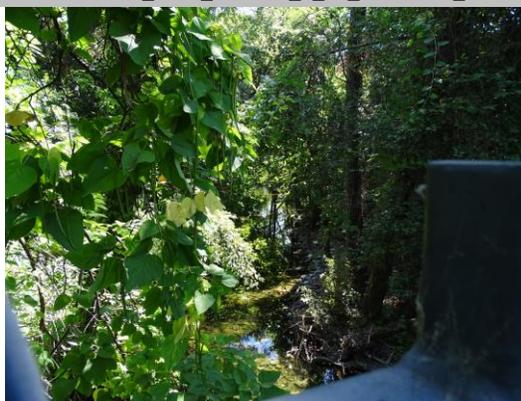
Photo 1 of 1 : CH_2020_NA0060_5_36_20200804_00044.jpg

Check Point / View			
Esplanade / Up			
Rating **	A	Issue No.	36
Issue Type +	Ma	Location *	GPS Lat/Long
Category	Rivers, Channels & Designated Flood		39.731810 °
Item	Vegetation & Obstructions		-121.841870 °
DWR ID	DWR_NA0060_5_c_2012_36		
Action/Comments			
Inspector Comments: Scattered obstructions and vegetation. The flow is not impeded.

View of the channel facing upstream, 2020.

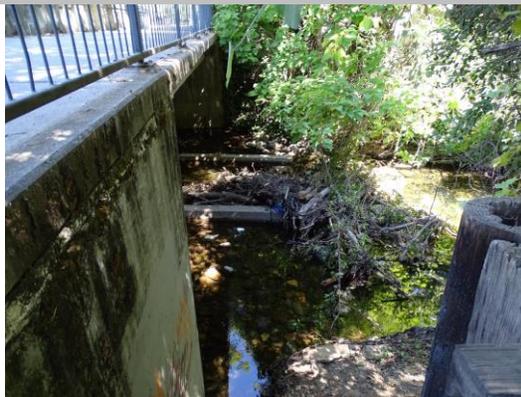
Photo 1 of 2 : CH_2020_NA0060_5_34_20200804_00045.jpg

Rating **	N	Issue No.	34
			GPS Lat/Long
Issue Type +	Ma	Location *	39.731810 °
Category	Rivers, Channels & Designated Flood		-121.841870 °
Item	Revetments		
DWR ID	DWR_NA0060_5_c_2012_34		
Action/Comments			
Inspector Comments: No revetments present.

No visible revetment left bank, 2020

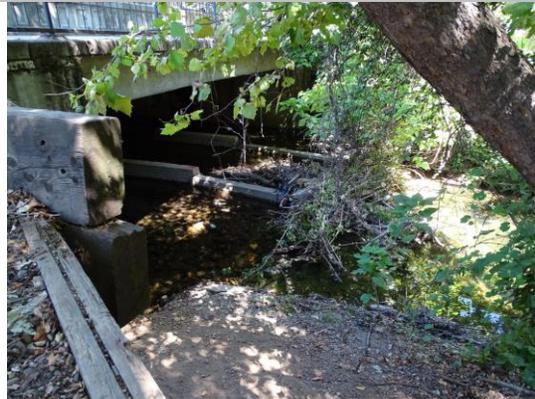
Photo 2 of 2 : CH_2020_NA0060_5_34_20200804_00046.jpg

Check Point / View			
Esplanade / Up (cont)			
Rating **	N	Issue No. 34 (cont)	GPS Lat/Long
Issue Type +	Ma	Location *	39.731810 °
Category	Rivers, Channels & Designated Flood		-121.841870 °
Item	Revetments		
DWR ID	DWR_NA0060_5_c_2012_34		
Action/Comments			
Inspector Comments: No revetments present.

No visible revetment right bank, 2020.

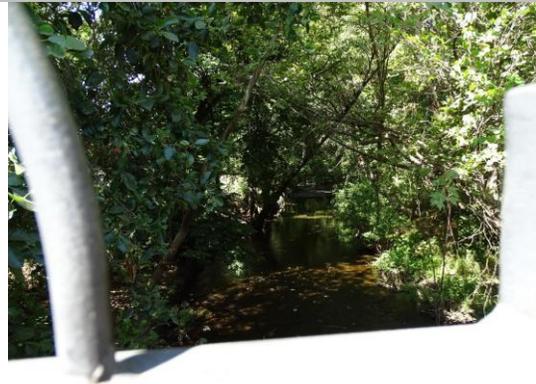
Photo 1 of 1 : CH_2020_NA0060_5_31_20200804_00047.jpg

Check Point / View			
Esplanade / Down			
Rating **	A	Issue No. 31	GPS Lat/Long
Issue Type +	Ma	Location *	39.731810 °
Category	Rivers, Channels & Designated Flood		-121.841870 °
Item	Vegetation & Obstructions		
DWR ID	DWR_NA0060_5_c_2012_31		
Action/Comments			
Inspector Comments: Scattered obstructions and vegetation is minimal. The flow is not impeded.

View of the channel facing downstream, 2020.

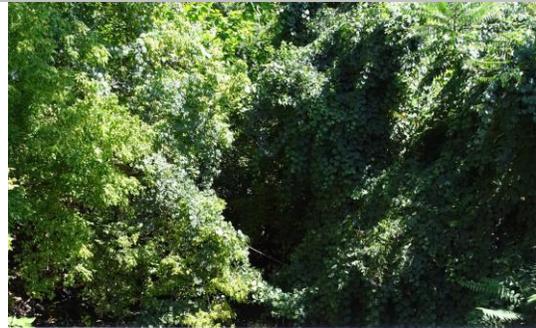
Photo 1 of 1 : CH_2020_NA0060_5_41_20200804_00049.jpg

Check Point / View			
Hwy 32 / Up			
Rating **	A	Issue No. 41	GPS Lat/Long
Issue Type +	Ma	Location *	39.725776 °
Category	Rivers, Channels & Designated Flood		-121.851207 °
Item	Vegetation & Obstructions		
DWR ID	DWR_NA0060_5_c_2012_41		
Action/Comments			
Inspector Comments: Scattered obstructions and vegetation. The flow is not impeded.

View of the channel facing upstream, 2020.

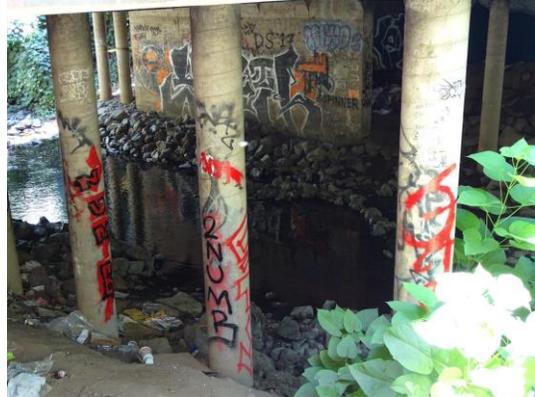
Photo 1 of 1 : CH_2020_NA0060_5_44_20200804_00050.jpg

Check Point / View				
Hwy 32 / Up (cont)				
Rating **	A	Issue No.	44	GPS Lat/Long
Issue Type +	Ma	Location *		39.725776 °
Category	Rivers, Channels & Designated Flood			-121.851207 °
Item	Revetments			
DWR ID	DWR_NA0060_5_c_2012_44			
Action/Comments				
Inspector Comments: Revetments present both sides of channel.

View of revetment around piers both right bank and left bank, 2020.

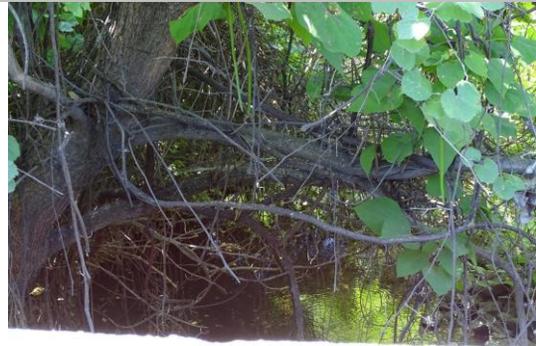
Photo 1 of 1 : CH_2020_NA0060_5_46_20200804_00052.jpg

Check Point / View			
Hwy 32 / Down			
Rating **	M	Issue No. 46	GPS Lat/Long
Issue Type +	Ma	Location *	39.725776 °
Category	Rivers, Channels & Designated Flood		-121.851207 °
Item	Vegetation & Obstructions		
DWR ID	DWR_NA0060_5_c_2012_46		
Action/Comments			
Inspector Comments: Moderate vegetation on banks. The flow may be impeded.

View of the channel facing downstream, 2020.

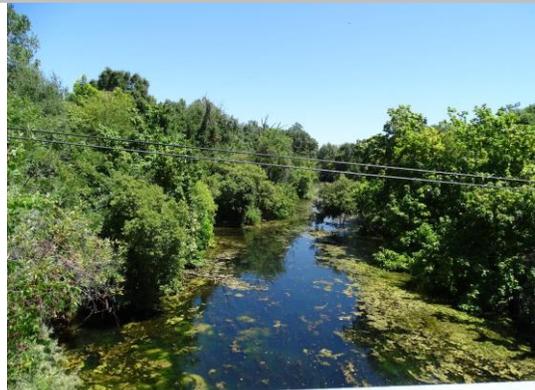
Photo 1 of 1 : CH_2020_NA0060_5_51_20200804_00053.jpg

Check Point / View			
Mud Creek at River Rd / Up			
Rating **	A	Issue No.	51
Issue Type +	Ma	Location *	GPS Lat/Long
Category	Rivers, Channels & Designated Flood		39.704580 °
Item	Vegetation & Obstructions		-121.939320 °
DWR ID	DWR_NA0060_5_c_2012_51		
Action/Comments			
Inspector Comments: Minimal scattered obstructions and vegetation. The flow is not impeded.

View of Mud Creek at River Road facing upstream, 2020.

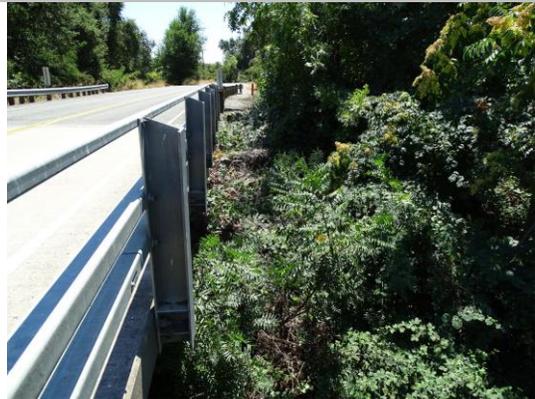
Photo 1 of 2 : CH_2020_NA0060_5_54_20200804_00054.jpg

Rating **	A	Issue No. 54	GPS Lat/Long
Issue Type +	Ma	Location *	39.704580 °
Category	Rivers, Channels & Designated Flood		-121.939320 °
Item	Revetments		
DWR ID	DWR_NA0060_5_c_2012_54		
Action/Comments			
Inspector Comments: Riprap is covered with vegetation. Trees and other vegetation growth should be managed/removed from riprap.

View of the revetment left bank that is over grown with vegetation, 2020.

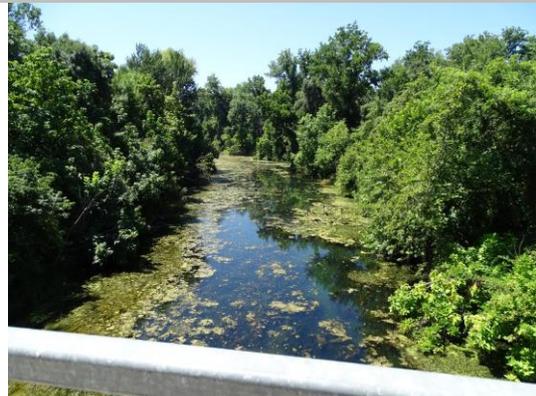
Photo 1 of 1 : CH_2020_NA0060_5_56_20200804_00056.jpg

Check Point / View			
Mud Creek at River Rd / Down			
Rating **	A	Issue No.	56
Issue Type +	Ma	Location *	39.704580 °
Category	Rivers, Channels & Designated Flood		-121.939320 °
Item	Vegetation & Obstructions		
DWR ID	DWR_NA0060_5_c_2012_56		
Action/Comments			
Inspector Comments: No obstructions observed, the flow is not impeded.

View looking downstream from the bridge, 2020.

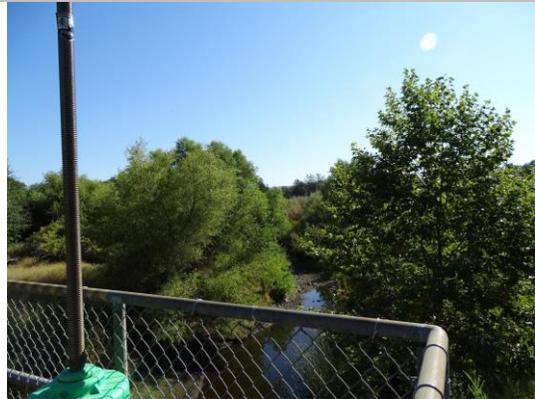
Photo 1 of 1 : CH_2020_NA0060_6_1_20200805_00057.jpg

Check Point / View			
Diversion Structure / Up			
Rating **	A	Issue No.	1
Issue Type +	Ma	Location *	GPS Lat/Long
Category	Rivers, Channels & Designated Flood		39.761590 °
Item	Vegetation & Obstructions		-121.797320 °
DWR ID	DWR_NA0060_6_c_2012_1		
Action/Comments			
Inspector Comments: Minimal, scattered obstructions and small trees exists however the flow is not impeded.

View of the channel facing upstream, 2020.

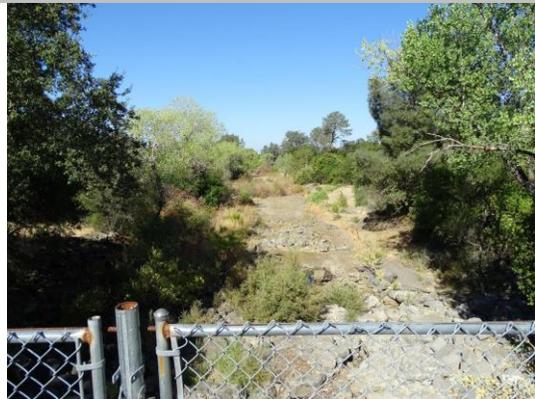
Photo 1 of 1 : CH_2020_NA0060_6_6_20200805_00058.jpg

Check Point / View			
Diversion Structure / Down			
Rating **	A	Issue No. 6	GPS Lat/Long
Issue Type +	Ma	Location *	39.761590 °
Category	Rivers, Channels & Designated Flood		-121.797320 °
Item	Vegetation & Obstructions		
DWR ID	DWR_NA0060_6_c_2012_6		
Action/Comments			
Inspector Comments: Minimal, scattered obstructions or vegetation exists however the flow is not impeded.

View of the channel facing downstream, 2020.

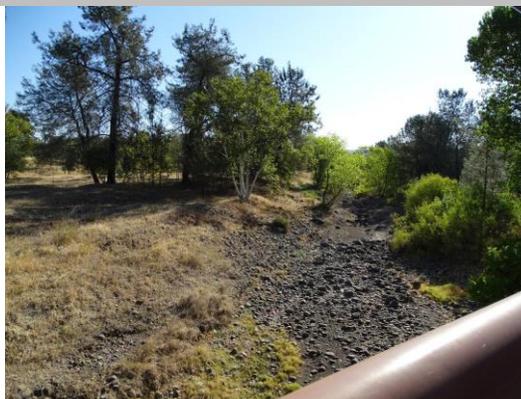
Photo 1 of 1 : CH_2020_NA0060_6_11_20200805_00061.jpg

Check Point / View				
Manzanita Ave / Up				
Rating **	A	Issue No.	11	GPS Lat/Long
Issue Type +	Ma	Location *		39.760390 °
Category	Rivers, Channels & Designated Flood			-121.801621 °
Item	Vegetation & Obstructions			
DWR ID	DWR_NA0060_6_c_2012_11			
Action/Comments				
Inspector Comments: Minimal, scattered obstructions or vegetation exists however the flow is not impeded.

View of the channel facing upstream, 2020.

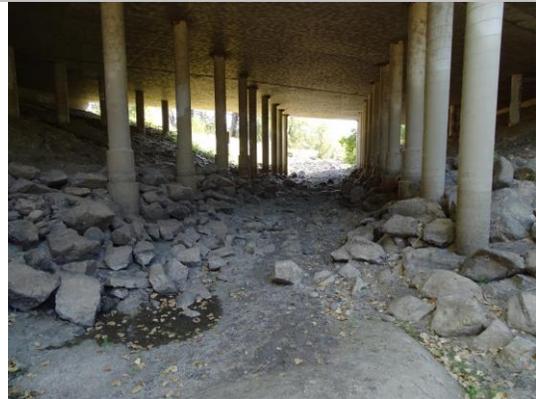
Photo 1 of 1 : CH_2020_NA0060_6_14_20200805_00064.jpg

Check Point / View			
Manzanita Ave / Up (cont)			
Rating **	A	Issue No.	14
Issue Type +	Ma	Location *	39.760390 °
Category	Rivers, Channels & Designated Flood		-121.801621 °
Item	Revetments		
DWR ID	DWR_NA0060_6_c_2012_14		
Action/Comments			
Inspector Comments: Revetment under bridge, both right and left abutments.

View of revetment on both banks of bridge abutment, 2020.

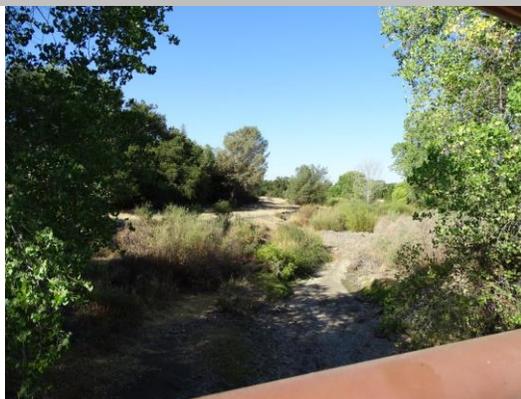
Photo 1 of 1 : CH_2020_NA0060_6_16_20200805_00063.jpg

Check Point / View			
Manzanita Ave / Down			
Rating **	M	Issue No. 16	GPS Lat/Long
Issue Type +	Ma	Location *	39.760390 °
Category	Rivers, Channels & Designated Flood		-121.801621 °
Item	Vegetation & Obstructions		
DWR ID	DWR_NA0060_6_c_2012_16		
Action/Comments			
Inspector Comments: Minimal, scattered obstructions or vegetation exists and the flow could be impeded.

View of the channel facing downstream, 2020.

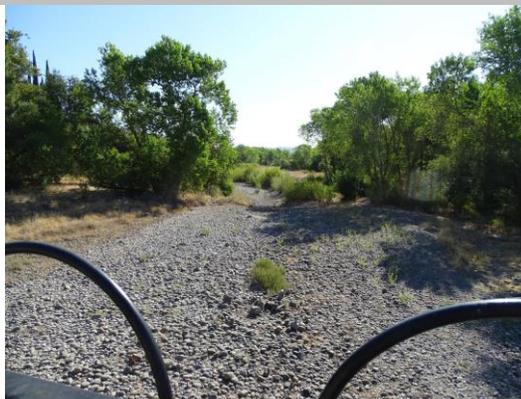
Photo 1 of 1 : CH_2020_NA0060_6_21_20200805_00065.jpg

Check Point / View			
Bike Path Bridge at Madrone Ave / Up			
Rating **	A	Issue No. 21	GPS Lat/Long
Issue Type +	Ma	Location *	39.755400 °
Category	Rivers, Channels & Designated Flood		-121.814580 °
Item	Vegetation & Obstructions		
DWR ID	DWR_NA0060_6_c_2012_21		
Action/Comments			
Inspector Comments: Minimal, scattered obstructions or vegetation exists however the flow is not impeded.

View of the channel facing upstream from the bridge, 2020.

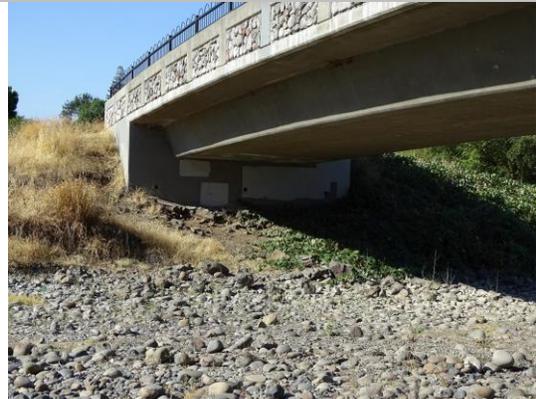
Photo 2 of 2 : CH_2020_NA0060_6_24_20200805_00067.jpg

Check Point / View				
Bike Path Bridge at Madrone Ave / Up (cont)				
Rating **	M	Issue No.	24 (cont)	GPS Lat/Long
Issue Type +	Ma	Location *		39.755400 °
Category	Rivers, Channels & Designated Flood			-121.814580 °
Item	Revetments			
DWR ID	DWR_NA0060_6_c_2012_24			
Action/Comments				
Inspector Comments: Riprap at the foot of the bridge seems to have slid down towards the channel in previous high water events, but the capacity of the channel is not affected.

View looking at the left bank abutment very little revetment remaining, 2020.

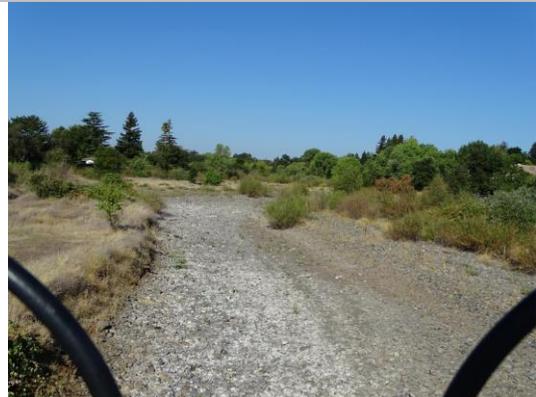
Photo 1 of 1 : CH_2020_NA0060_6_26_20200805_00068.jpg

Check Point / View			
Bike Path Bridge at Madrone Ave / Down			
Rating **	A	Issue No.	26
			GPS Lat/Long
Issue Type +	Ma	Location *	39.755400 °
Category	Rivers, Channels & Designated Flood		-121.814580 °
Item	Vegetation & Obstructions		
DWR ID	DWR_NA0060_6_c_2012_26		
Action/Comments			
Inspector Comments: Minimal, scattered obstructions or vegetation exists however the flow is not impeded.

View of the channel facing downstream from the bridge, 2020.

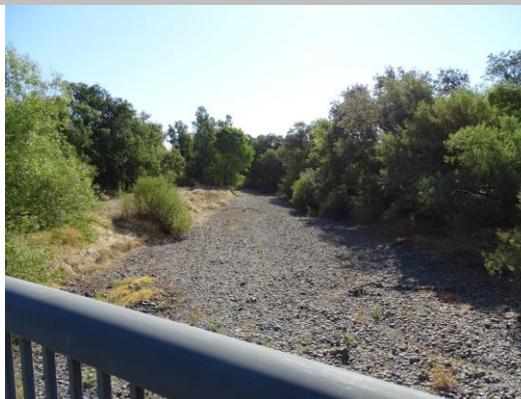
Photo 1 of 1 : CH_2020_NA0060_6_31_20200805_00069.jpg

Check Point / View			
Mariposa Ave / Up			
Rating **	A	Issue No.	31
			GPS Lat/Long
Issue Type +	Ma	Location *	39.752730 °
Category	Rivers, Channels & Designated Flood		-121.824560 °
Item	Vegetation & Obstructions		
DWR ID	DWR_NA0060_6_c_2012_31		
Action/Comments			
Inspector Comments: Minimal, scattered log obstructions exists however the flow is not impeded.

View of the channel facing upstream from the bridge, 2020.

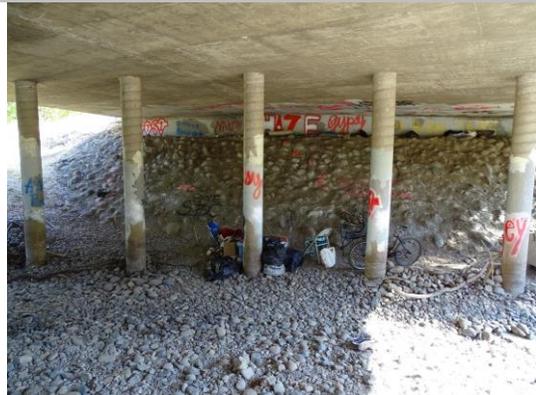
Photo 1 of 2 : CH_2020_NA0060_6_34_20200805_00070.jpg

Rating **	A	Issue No. 34	GPS Lat/Long
Issue Type +	Ma	Location *	39.752730 °
Category	Rivers, Channels & Designated Flood		-121.824560 °
Item	Revetments		
DWR ID	DWR_NA0060_6_c_2012_34		
Action/Comments			
Inspector Comments: Revetment on slope up to the bridge abutment, both sides.

View of right bank, revetment on slope up to the bridge abutment, 2020.

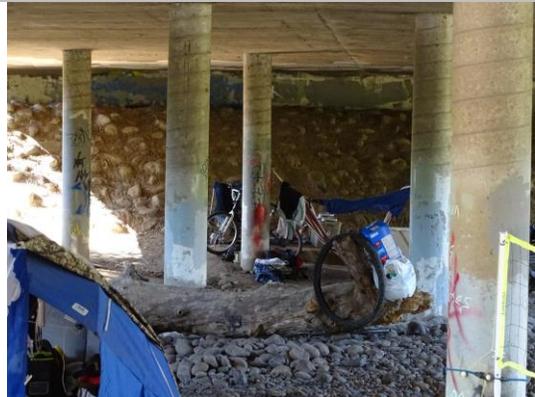
Photo 2 of 2 : CH_2020_NA0060_6_34_20200805_00071.jpg

Check Point / View			
Mariposa Ave / Up (cont)			
Rating **	A	Issue No. 34 (cont)	GPS Lat/Long
Issue Type +	Ma	Location *	39.752730 °
Category	Rivers, Channels & Designated Flood		-121.824560 °
Item	Revetments		
DWR ID	DWR_NA0060_6_c_2012_34		
Action/Comments			
Inspector Comments: Revetment on slope up to the bridge abutment, both sides.

View of left bank, revetment on slope up to the bridge abutment, 2020.

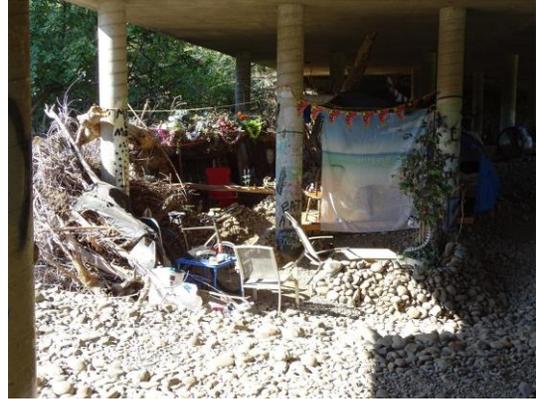
Photo 2 of 5 : CH_2020_NA0060_6_35_20200805_00074.jpg

Check Point / View			
Mariposa Ave / Up (cont)			
Rating **	M	Issue No.	35 (cont)
Issue Type +	Ma	Location *	GPS Lat/Long
Category	Rivers, Channels & Designated Flood		39.752730 °
Item	Encroachments		-121.824560 °
DWR ID	DWR_NA0060_6_c_2012_35		
Action/Comments			
Inspector Comments: Debris and trash from campers within the project easement area needs to be removed, 2020.

Debris and trash from campers within the project easement area needs to be removed, 2020.

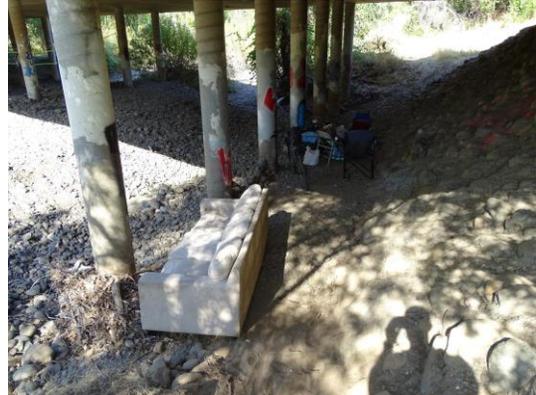
Photo 4 of 5 : CH_2020_NA0060_6_35_20200805_00073.jpg

Check Point / View			
Mariposa Ave / Up (cont)			
Rating **	M	Issue No.	35 (cont)
Issue Type +	Ma	Location *	GPS Lat/Long
Category	Rivers, Channels & Designated Flood		39.752730 °
Item	Encroachments		-121.824560 °
DWR ID	DWR_NA0060_6_c_2012_35		
Action/Comments			
Inspector Comments: Debris and trash from campers within the project easement area needs to be removed, 2020.

Debris and trash from campers within the project easement area needs to be removed, 2020.

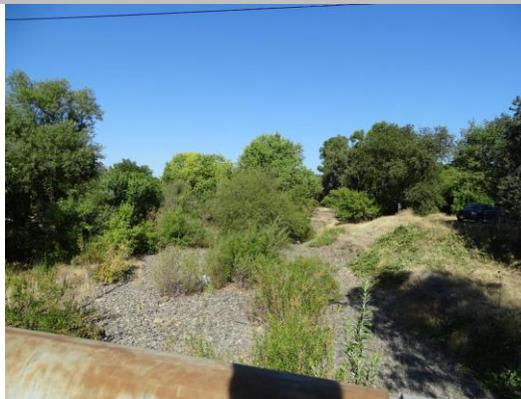
Photo 1 of 1 : CH_2020_NA0060_6_36_20200805_00077.jpg

Rating **	A	Issue No.	36	GPS Lat/Long
Issue Type +	Ma	Location *		39.752730 °
Category	Rivers, Channels & Designated Flood			-121.824560 °
Item	Vegetation & Obstructions			
DWR ID	DWR_NA0060_6_c_2012_36			
Action/Comments				
Inspector Comments: Minimal, scattered obstructions or vegetation exists however the flow is not impeded.

View of the channel facing downstream from the bridge, 2020.

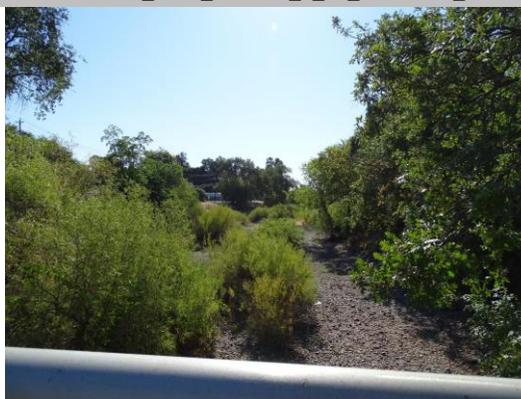
Photo 1 of 1 : CH_2020_NA0060_6_41_20200805_00078.jpg

Check Point / View			
5th Ave / Up			
Rating **	A	Issue No. 41	GPS Lat/Long
Issue Type +	Ma	Location *	39.753307 °
Category	Rivers, Channels & Designated Flood		-121.829234 °
Item	Vegetation & Obstructions		
DWR ID	DWR_NA0060_6_c_2012_41		
Action/Comments			
Inspector Comments: Minimal, scattered obstructions or vegetation exists however the flow is not impeded.

View of the channel facing upstream from the bridge, 2020.

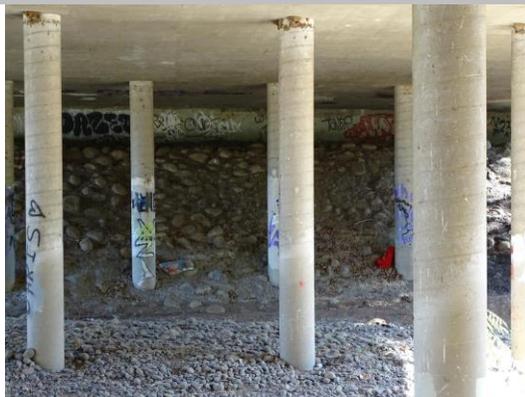
Photo 1 of 2 : CH_2020_NA0060_6_44_20200805_00079.jpg

Rating **	A	Issue No. 44	GPS Lat/Long
Issue Type +	Ma	Location *	39.753307 °
Category	Rivers, Channels & Designated Flood		-121.829234 °
Item	Revetments		
DWR ID	DWR_NA0060_6_c_2012_44		
Action/Comments			
Inspector Comments: Existing riprap protecting is properly maintained and is undamaged. There is erosion at the toe on left bank abutment.

View of right bank, revetment on slope up to the bridge abutment, 2020.

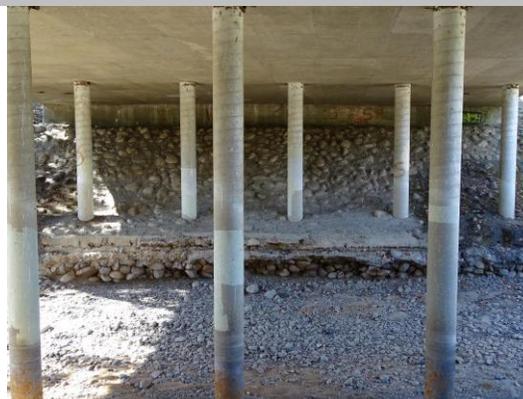
Photo 2 of 2 : CH_2020_NA0060_6_44_20200805_00080.jpg

Check Point / View			
5th Ave / Up (cont)			
Rating **	A	Issue No.	44 (cont)
Issue Type +	Ma	Location *	
Category	Rivers, Channels & Designated Flood		GPS Lat/Long
Item	Revetments		
DWR ID	DWR_NA0060_6_c_2012_44		
Action/Comments			
Inspector Comments: Existing riprap protecting is properly maintained and is undamaged. There is erosion at the toe on left bank abutment.

View of left bank, revetment on slope up to the bridge abutment, 2020.

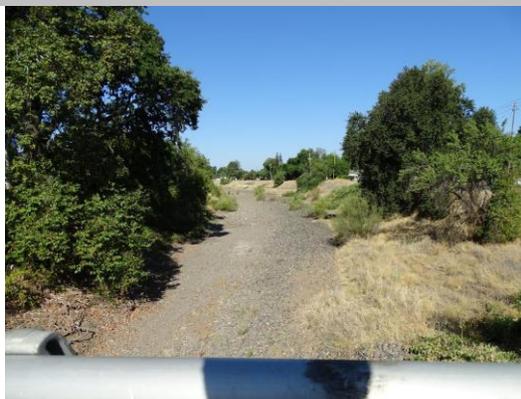
Photo 1 of 1 : CH_2020_NA0060_6_46_20200805_00081.jpg

Check Point / View			
5th Ave / Down			
Rating **	A	Issue No.	46
Issue Type +	Ma	Location *	39.753307 °
Category	Rivers, Channels & Designated Flood		-121.829234 °
Item	Vegetation & Obstructions		
DWR ID	DWR_NA0060_6_c_2012_46		
Action/Comments			
Inspector Comments: Minimal, scattered obstructions or vegetation exists however the flow is not impeded.

View of channel facing downstream from the bridge, 2020.

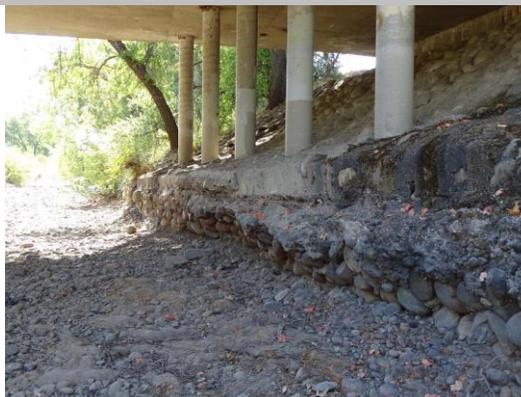
Photo 1 of 1 : CH_2020_NA0060_6_48_20200805_00082.jpg

Rating **	M	Issue No.	48
Issue Type +	Ma	Location *	39.753307 °
Category	Rivers, Channels & Designated Flood		-121.829234 °
Item	Erosion / Bank Caving		
DWR ID	DWR_NA0060_6_c_2012_48		
Action/Comments			
Inspector Comments: There is erosion around bridge footing and south bank of channel.

View of the erosion found under the bridge south end left bank, 2020.

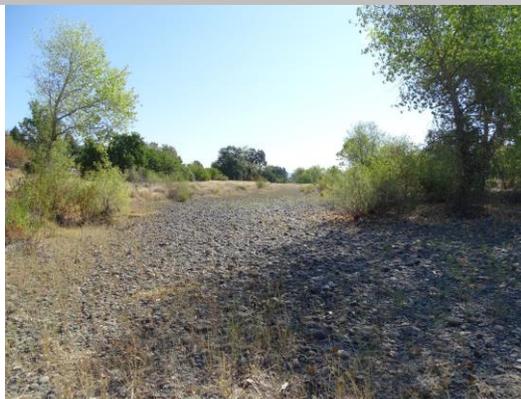
Photo 1 of 1 : CH_2020_NA0060_6_91_20200805_00083.jpg

Check Point / View			
Highway 99 / Up			
Rating **	A	Issue No.	91
Issue Type +	Ma	Location *	
Category	Rivers, Channels & Designated Flood		GPS Lat/Long
Item	Vegetation & Obstructions		
DWR ID	DWR_NA0060_6_c_2015_91		
Action/Comments			
Inspector Comments: Minimal, scattered obstructions or vegetation exists however the flow is not impeded.

View of the channel facing upstream from the channel, 2020.

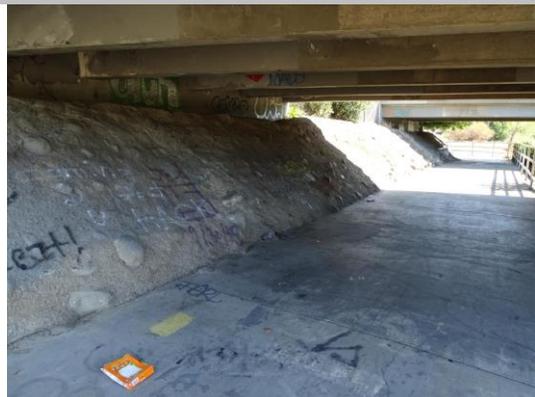
Photo 1 of 1 : CH_2020_NA0060_6_99_20200805_00085.jpg

Rating **	A	Issue No.	99
Issue Type +	Ma	Location *	39.751220 °
Category	Rivers, Channels & Designated Flood		-121.840042 °
Item	Revetments		
DWR ID	DWR_NA0060_6_c_2015_99		
Action/Comments			
Inspector Comments: Existing riprap protection is properly maintained and is undamaged. Riprap clearly visible both sides.

View of right bank revetment looking upstream on slope up to the bridge abutment, 2020.

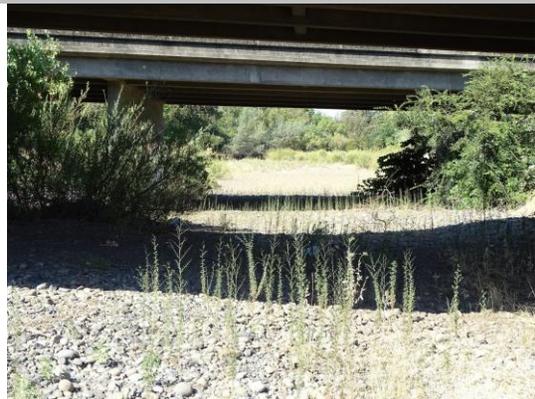
Photo 1 of 1 : CH_2020_NA0060_6_96_20200805_00087.jpg

Check Point / View			
Highway 99 / Down			
Rating **	A	Issue No. 96	GPS Lat/Long
Issue Type +	Ma	Location *	39.751220 °
Category	Rivers, Channels & Designated Flood		-121.840042 °
Item	Vegetation & Obstructions		
DWR ID	DWR_NA0060_6_c_2015_96		
Action/Comments			
Inspector Comments: Minimal, scattered obstructions or vegetation exists however the flow is not impeded.

View of the channel facing downstream from under the north bound lanes of Highway 99, 2020.

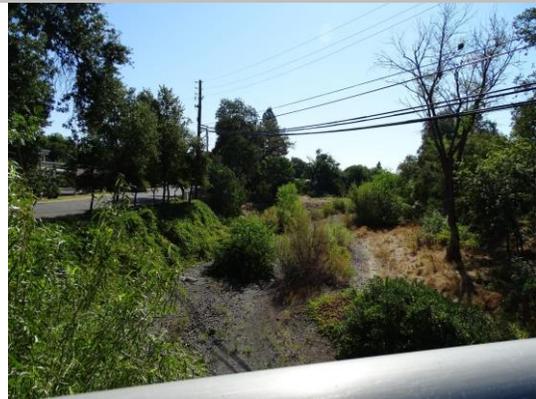
Photo 1 of 1 : CH_2020_NA0060_6_111_20200805_00088.jpg

Check Point / View			
Mangrove Avenue / Up			
Rating **	A	Issue No.	111
Issue Type +	Ma	Location *	GPS Lat/Long
Category	Rivers, Channels & Designated Flood		39.750979 °
Item	Vegetation & Obstructions		-121.844711 °
DWR ID	DWR_NA0060_6_c_2015_111		
Action/Comments			
Inspector Comments: Minimal, scattered obstructions or vegetation exists however the flow is not impeded.

View of the channel looking upstream, 2020.

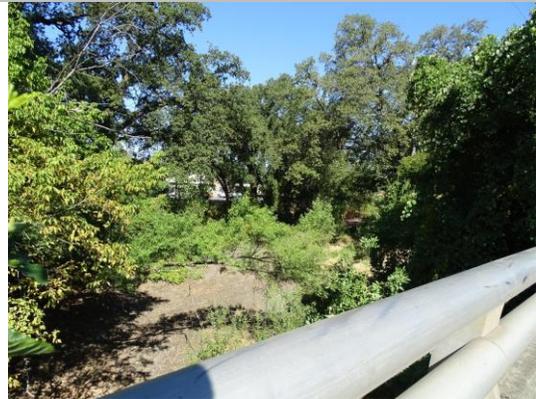
Photo 1 of 1 : CH_2020_NA0060_6_116_20200805_00092.jpg

Check Point / View			
Mangrove Avenue / Down			
Rating **	M	Issue No.	116
			GPS Lat/Long
Issue Type +	Ma	Location *	39.750979 °
Category	Rivers, Channels & Designated Flood		-121.844711 °
Item	Vegetation & Obstructions		
DWR ID	DWR_NA0060_6_c_2015_116		
Action/Comments			
Inspector Comments: Minimal, scattered obstructions and vegetation exists which may impede the flow of the channel.

View of the channel facing downstream, 2020.

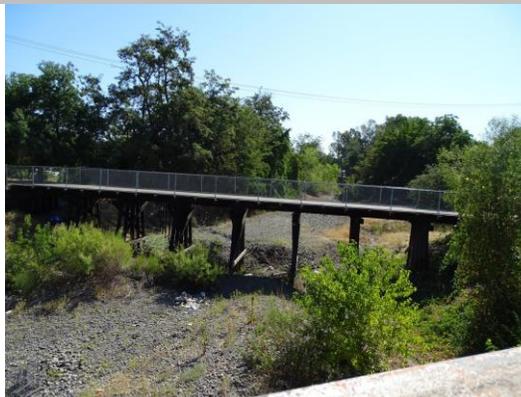
Photo 1 of 1 : CH_2020_NA0060_6_51_20200805_00093.jpg

Check Point / View			
Esplanade / Up			
Rating **	M	Issue No. 51	GPS Lat/Long
Issue Type +	Ma	Location *	39.749458 °
Category	Rivers, Channels & Designated Flood		-121.854296 °
Item	Vegetation & Obstructions		
DWR ID	DWR_NA0060_6_c_2012_51		
Action/Comments			
Inspector Comments: Minimal, scattered obstructions or vegetation exists and the flow could be impeded.

View of the channel facing upstream, 2020.

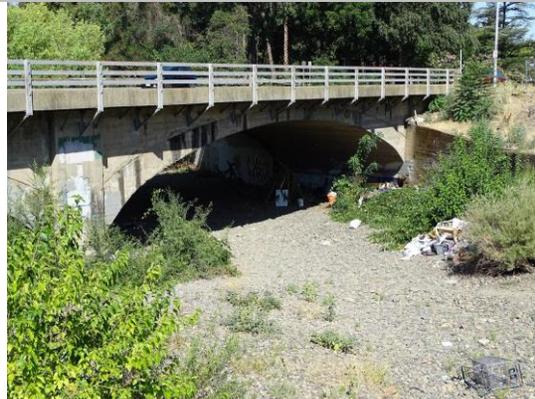
Photo 1 of 1 : CH_2020_NA0060_6_54_20200805_00094.jpg

Check Point / View			
Esplanade / Up (cont)			
Rating **	N	Issue No. 54	GPS Lat/Long
Issue Type +	Ma	Location *	39.749458 °
Category	Rivers, Channels & Designated Flood		-121.854296 °
Item	Revetments		
DWR ID	DWR_NA0060_6_c_2012_54		
Action/Comments			
Inspector Comments: There is no revetment at the bridge abutments and is not needed.

View of both abutments, no revetment exist, 2020

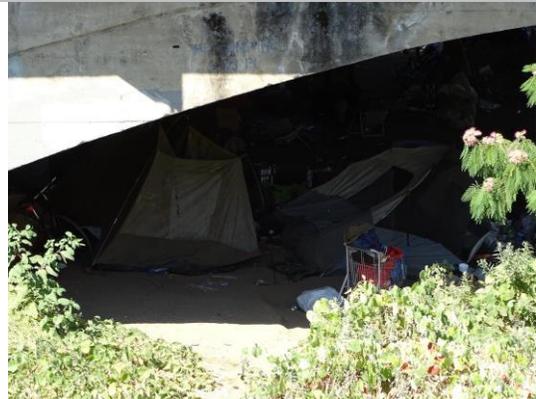
Photo 2 of 2 : CH_2020_NA0060_6_55_20200805_00096.jpg

Check Point / View				
Esplanade / Up (cont)				
Rating **	M	Issue No.	55 (cont)	GPS Lat/Long
Issue Type +	Ma	Location *		39.749458 °
Category	Rivers, Channels & Designated Flood			-121.854296 °
Item	Encroachments			
DWR ID	DWR_NA0060_6_c_2012_55			
Action/Comments				
Inspector Comments: Debris is caught on the foot bridge piles and needs to be removed, 2019.

View of the left bank facing upstream. Large debris and trash piles from campers, 2020.

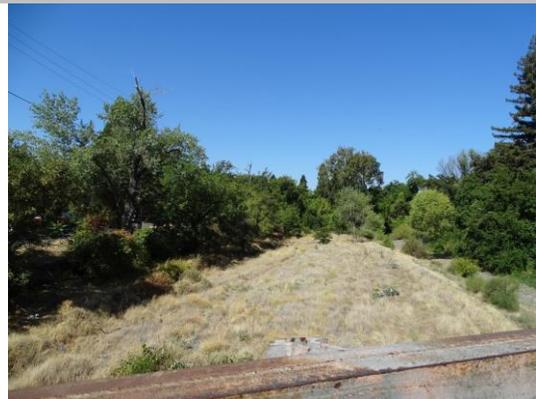
Photo 1 of 1 : CH_2020_NA0060_6_56_20200805_00097.jpg

Check Point / View				
Esplanade / Down				
Rating **	M	Issue No.	56	GPS Lat/Long
Issue Type +	Ma	Location *		39.749458 °
Category	Rivers, Channels & Designated Flood			-121.854296 °
Item	Vegetation & Obstructions			
DWR ID	DWR_NA0060_6_c_2012_56			
Action/Comments				
Inspector Comments: Vegetation and scattered obstructions exists and the flow may be impeded.

View of the channel facing downstream, 2020.

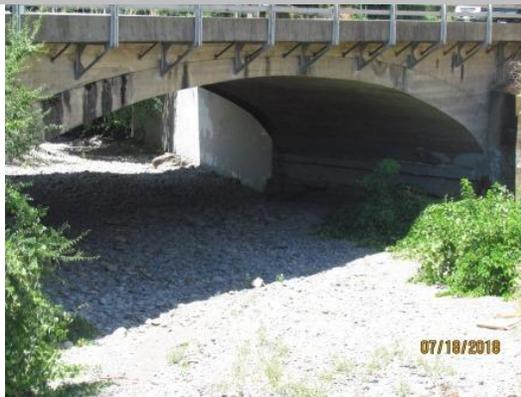
Photo 1 of 1 : CH_2020_NA0060_6_59_20200730_00030.jpg

Rating **	N	Issue No.	59
			GPS Lat/Long
Issue Type +	Ma	Location *	39.749458 °
Category	Rivers, Channels & Designated Flood		-121.854296 °
Item	Revetments		
DWR ID	DWR_NA0060_6_c_2012_59		
Action/Comments			
Inspector Comments: There is no revetment in the channel at the abutments.

View of the right bank looking downstream, there is no revetment in the channel at the abutment, 2018.

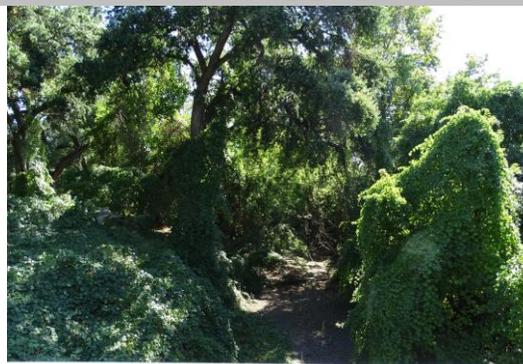
Photo 1 of 1 : CH_2020_NA0060_6_101_20200805_00098.jpg

Check Point / View			
Holly Avenue / Up			
Rating **	A	Issue No.	101
Issue Type +	Ma	Location *	39.749209 °
Category	Rivers, Channels & Designated Flood		-121.865682 °
Item	Vegetation & Obstructions		
DWR ID	DWR_NA0060_12_c_2015_101		
Action/Comments			
Inspector Comments: Minimal, scattered obstructions and vegetation exists however the flow does not look to be impeded.

View of the channel looking upstream, 2020.

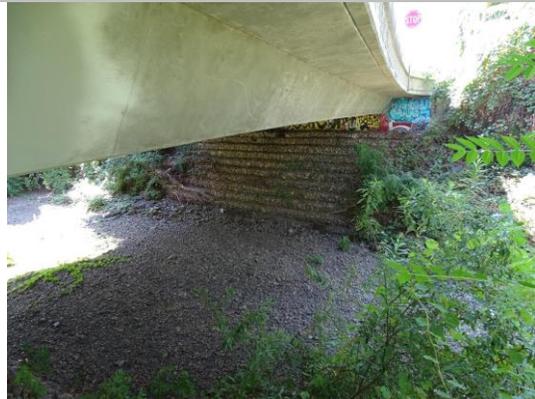
Photo 1 of 2 : CH_2020_NA0060_6_104_20200805_00100.jpg

Rating **	A	Issue No.	104
Issue Type +	Ma	Location *	39.749209 °
Category	Rivers, Channels & Designated Flood		-121.865682 °
Item	Revetments		
DWR ID	DWR_NA0060_6_c_2015_104		
Action/Comments			
Inspector Comments: Gabion wall revetment at bridge abutment, right and left bank.

View of gabion wall revetment at bridge abutment, left bank, 2020.

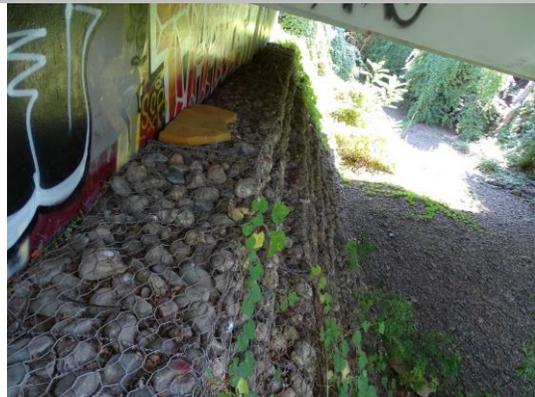
Photo 2 of 2 : CH_2020_NA0060_6_104_20200805_00101.jpg

View of gabion wall revetment at bridge abutment, right bank, 2020.

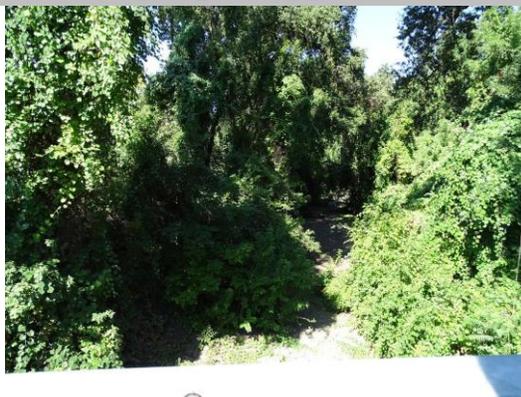
Photo 1 of 1 : CH_2020_NA0060_6_106_20200805_00099.jpg

Check Point / View			
Holly Avenue / Down			
Rating **	A	Issue No.	106
Issue Type +	Ma	Location *	39.749209 °
Category	Rivers, Channels & Designated Flood		-121.865682 °
Item	Vegetation & Obstructions		
DWR ID	DWR_NA0060_6_c_2015_106		
Action/Comments			
Inspector Comments: Minimal, scattered obstructions or vegetation exists however the flow does not seem to be impeded.

View of the channel looking downstream, 2020.

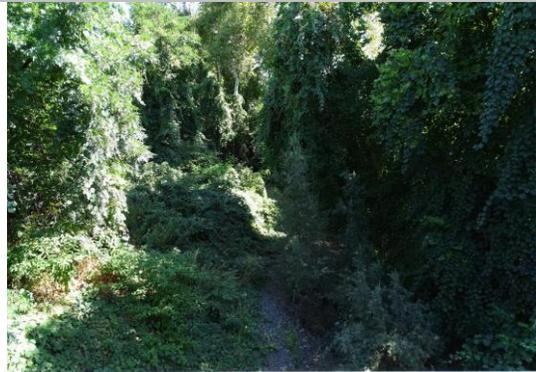
Photo 1 of 1 : CH_2020_NA0060_6_61_20200805_00102.jpg

Check Point / View			
Hwy 32 / Up			
Rating **	M	Issue No. 61	GPS Lat/Long
Issue Type +	Ma	Location *	39.741277 °
Category	Rivers, Channels & Designated Flood		-121.881402 °
Item	Vegetation & Obstructions		
DWR ID	DWR_NA0060_6_c_2012_61		
Action/Comments			
Inspector Comments: Vegetation exists and may impede the flow.

View of the channel looking upstream, 2020.

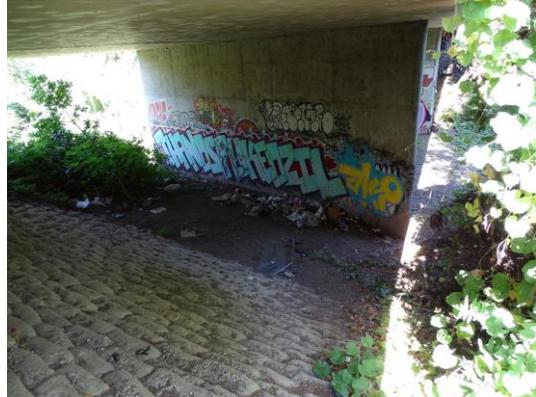
Photo 1 of 1 : CH_2020_NA0060_6_64_20200805_00104.jpg

Check Point / View				
Hwy 32 / Up (cont)				
Rating **	A	Issue No.	64	GPS Lat/Long
Issue Type +	Ma	Location *		39.741277 °
Category	Rivers, Channels & Designated Flood			-121.881402 °
Item	Revetments			
DWR ID	DWR_NA0060_6_c_2012_64			
Action/Comments				
Inspector Comments: Revetment is present and in good condition, but maintain vegetation to keep revetment visible.

View of left bank concrete filled sandbag revetment, typical for both sides, 2020.

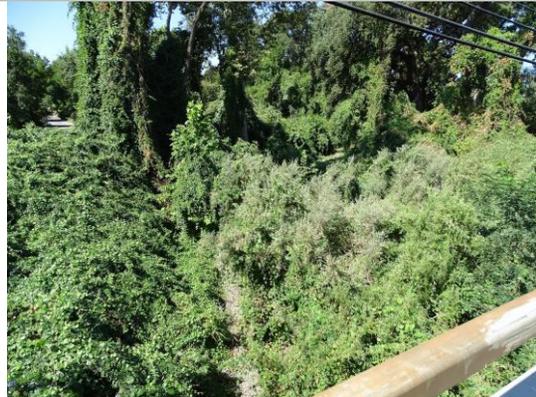
Photo 1 of 1 : CH_2020_NA0060_6_66_20200805_00103.jpg

Check Point / View				
Hwy 32 / Down				
Rating **	M	Issue No.	66	GPS Lat/Long
Issue Type +	Ma	Location *		39.741277 °
Category	Rivers, Channels & Designated Flood			-121.881402 °
Item	Vegetation & Obstructions			
DWR ID	DWR_NA0060_6_c_2012_66			
Action/Comments				
Inspector Comments: Vegetation exists and may impede the flow.

View of the channel looking downstream, 2020.

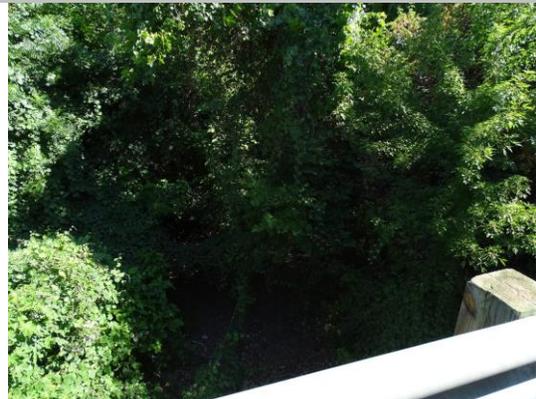
Photo 1 of 1 : CH_2020_NA0060_6_121_20200805_00105.jpg

Check Point / View			
Oak Ave. / Up			
Rating **	M	Issue No.	121
Issue Type +	Ma	Location *	GPS Lat/Long
Category	Rivers, Channels & Designated Flood		39.735560 °
Item	Vegetation & Obstructions		-121.890970 °
DWR ID	DWR_NA0060_6_c_2017_121		
Action/Comments			
Inspector Comments: Various scattered obstructions or vegetation exists which may impede flows.

View of the vegetation looking upstream from the bridge, 2019.

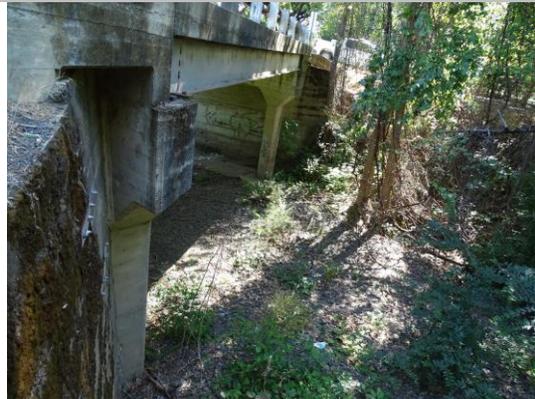
Photo 1 of 2 : CH_2020_NA0060_6_74_20200805_00107.jpg

Rating **	N	Issue No.	74	GPS Lat/Long
Issue Type +	Ma	Location *		39.735560 °
Category	Rivers, Channels & Designated Flood			-121.890970 °
Item	Revetments			
DWR ID	DWR_NA0060_6_c_2012_74			
Action/Comments				
Inspector Comments: No revetments present.

View of left abutment with no revetment, 2020.

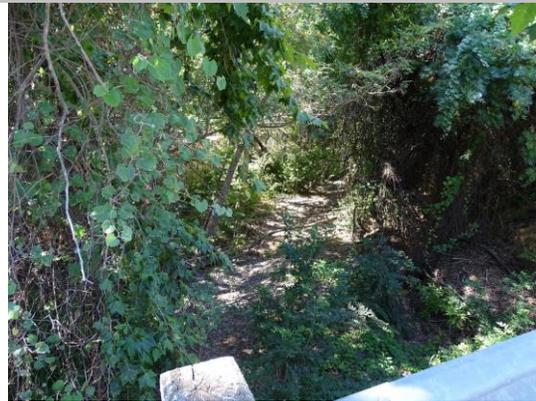
Photo 1 of 1 : CH_2020_NA0060_6_71_20200805_00106.jpg

Check Point / View				
Oak Ave. / Down				
Rating **	M	Issue No.	71	GPS Lat/Long
Issue Type +	Ma	Location *		39.735560 °
Category	Rivers, Channels & Designated Flood			-121.890970 °
Item	Vegetation & Obstructions			
DWR ID	DWR_NA0060_6_c_2012_71			
Action/Comments				
Inspector Comments: Scattered obstructions and vegetation exists which may impede the flow of the channel.

View of the channel facing downstream, 2020.

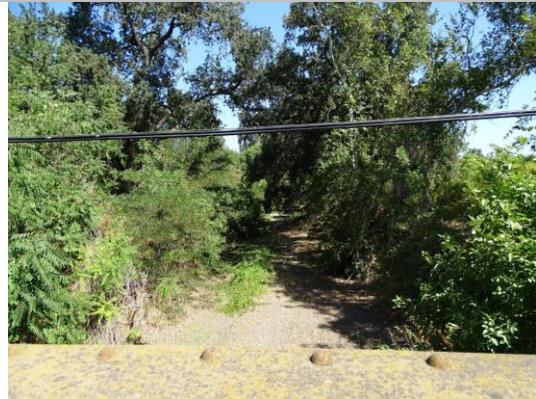
Photo 1 of 1 : CH_2020_NA0060_6_81_20200805_00109.jpg

Check Point / View			
Grape Way / Up			
Rating **	A	Issue No.	81
Issue Type +	Ma	Location *	GPS Lat/Long
Category	Rivers, Channels & Designated Flood		39.722724 °
Item	Vegetation & Obstructions		-121.912363 °
DWR ID	DWR_NA0060_6_c_2012_81		
Action/Comments			
Inspector Comments: Minimal, scattered obstructions or vegetation. The flow is not impeded.

View of the channel facing upstream, 2020.

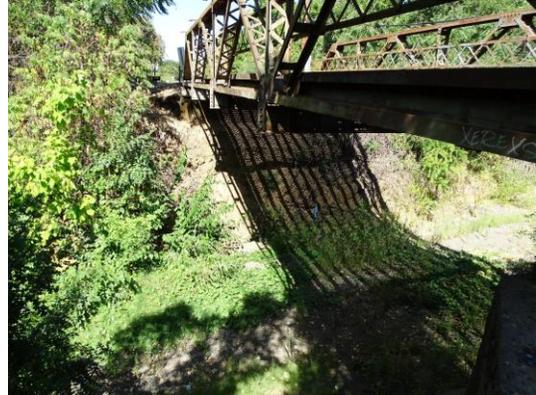
Photo 1 of 2 : CH_2020_NA0060_6_84_20200805_00111.jpg

Check Point / View				
Grape Way / Up (cont)				
Rating **	A	Issue No.	84	GPS Lat/Long
Issue Type +	Ma	Location *		39.722724 °
Category	Rivers, Channels & Designated Flood			-121.912363 °
Item	Revetments			
DWR ID	DWR_NA0060_6_c_2012_84			
Action/Comments				
Inspector Comments: Revetments are in place and maintained properly. Concrete sandbag revetment at bridge abutments, both sides.

View of concrete sandbag revetment at bridge abutments, right bank, 2020.

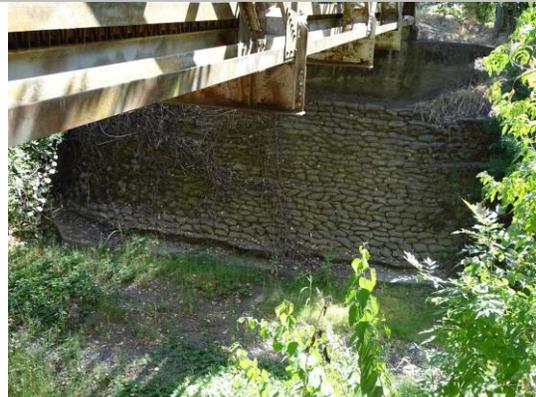
Photo 2 of 2 : CH_2020_NA0060_6_84_20200805_00112.jpg

View of concrete sandbag revetment at bridge abutments, left bank, 2020

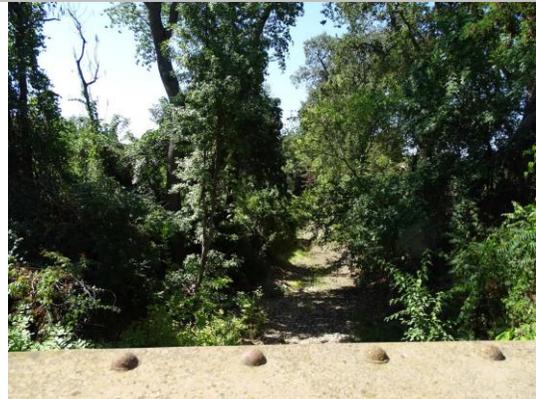
Photo 1 of 1 : CH_2020_NA0060_6_86_20200805_00110.jpg

Check Point / View				
Grape Way / Down				
Rating **	A	Issue No.	86	GPS Lat/Long
Issue Type +	Ma	Location *		39.722724 °
Category	Rivers, Channels & Designated Flood			-121.912363 °
Item	Vegetation & Obstructions			
DWR ID	DWR_NA0060_6_c_2012_86			
Action/Comments				
Inspector Comments: Minimal, scattered obstructions or vegetation. The flow is not impeded.

View of the channel facing downstream, 2020.
