**Flood Control Project Maintenance
Levee Inspections**
2020 Channel Summary Report
Overall Unit and Item Ratings

DWR Sutter Maintenance Yard

Levee Inspection Report By Mile - Channel 2020

Channel	Channel Length	Inspection Start/End	Inspector
Big Chico Creek	13.00	07/29/2020 07/29/2020	Brooks Weisser

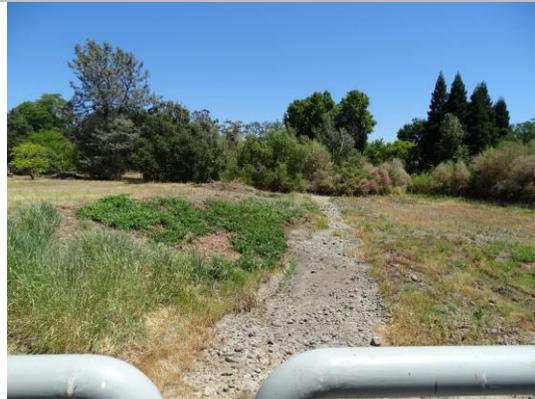
Photo 1 of 1 : CH_2020_NA0060_12_1_20200805_00044.jpg

Check Point / View			
Little Chico Ck Control Structure / Up			
Rating **	A	Issue No.	1
Issue Type +	Ma	Location *	39.733681 °
Category	Rivers, Channels & Designated Flood		-121.771865 °
Item	Vegetation & Obstructions		
DWR ID	DWR_NA0060_12_c_2012_1		
Action/Comments			
Inspector Comments: Minimal, scattered obstructions and vegetation. The flow is not impeded.

This is the upstream view from the Little Chico Control Structure, 2020.

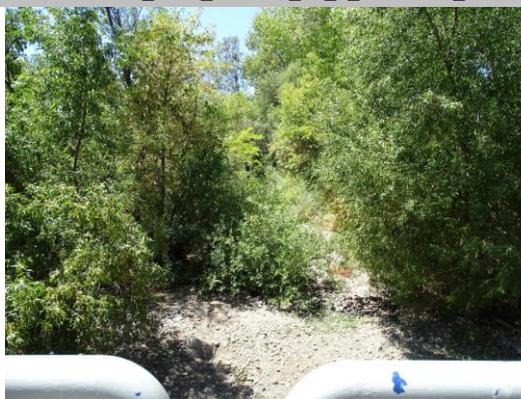
Photo 1 of 1 : CH_2020_NA0060_12_6_20200805_00045.jpg

Check Point / View			
Little Chico Ck Control Structure / Down			
Rating **	M	Issue No.	6
Issue Type +	Ma	Location *	39.733681 °
Category	Rivers, Channels & Designated Flood		-121.771865 °
Item	Vegetation & Obstructions		
DWR ID	DWR_NA0060_12_c_2012_6		
Action/Comments			
Inspector Comments: Scattered obstructions and vegetation. The flow may be impeded. Willow trees should be removed.

This is the downstream view from the Little Chico Control Structure, 2020.

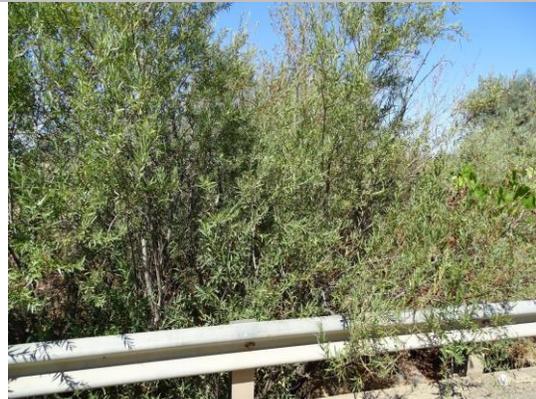
Photo 1 of 1 : CH_2020_NA0060_12_11_20200805_00050.jpg

Check Point / View				
Bruce Rd / Down				
Rating **	U	Issue No.	11	GPS Lat/Long
Issue Type +	Ma	Location *		39.733316 °
Category	Rivers, Channels & Designated Flood			-121.787540 °
Item	Vegetation & Obstructions			
DWR ID	DWR_NA0060_12_c_2012_11			
Action/Comments				
Inspector Comments: The vegetation obstructed the view of the channel. Its likely flow will be impeded in a high water event.

View of the channel facing downstream, 2020.

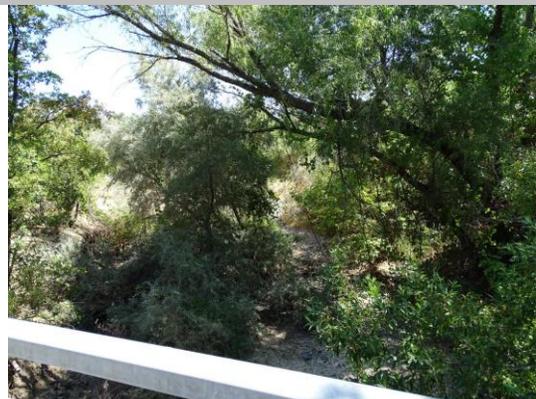
Photo 1 of 1 : CH_2020_NA0060_12_115_20200805_00053.jpg

Check Point / View			
Forest Ave / Up			
Rating **	A	Issue No. 115	GPS Lat/Long
Issue Type +	Ma	Location *	39.737400 °
Category	Rivers, Channels & Designated Flood		-121.804530 °
Item	Vegetation & Obstructions		
DWR ID	DWR_NA0060_12_c_2019_115		
Action/Comments			
Inspector Comments: Minimal, scattered obstructions or vegetation. The flow is not impeded.

View looking upstream at the channel from the bridge, 2020.

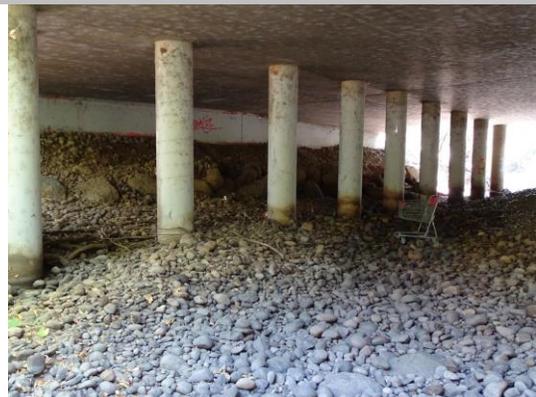
Photo 1 of 2 : CH_2020_NA0060_12_24_20200805_00055.jpg

Rating **	A	Issue No.	24
			GPS Lat/Long
Issue Type +	Ma	Location *	39.737400 °
Category	Rivers, Channels & Designated Flood		-121.804530 °
Item	Revetments		
DWR ID	DWR_NA0060_12_c_2012_24		
Action/Comments			
Inspector Comments: Revetments present.

View of revetment on right bank, 2020.

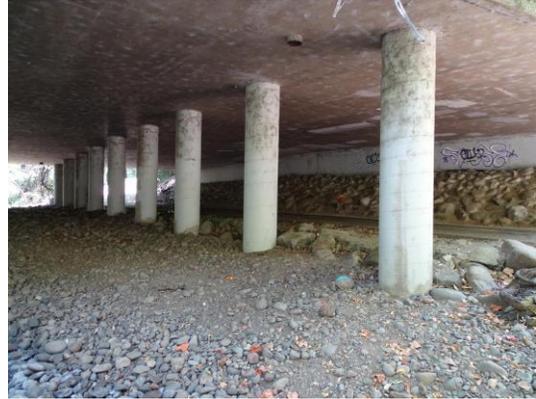
Photo 2 of 2 : CH_2020_NA0060_12_24_20200805_00054.jpg

Check Point / View				
Forest Ave / Up (cont)				
Rating **	A	Issue No.	24 (cont)	GPS Lat/Long
Issue Type +	Ma	Location *		39.737400 °
Category	Rivers, Channels & Designated Flood			-121.804530 °
Item	Revetments			
DWR ID	DWR_NA0060_12_c_2012_24			
Action/Comments				
Inspector Comments: Revetments present.

View of revetment on left bank, 2020.

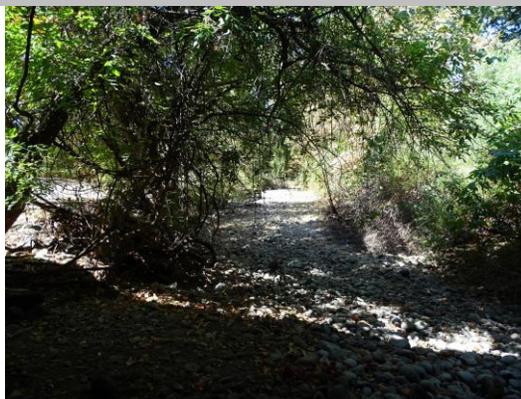
Photo 1 of 1 : CH_2020_NA0060_12_21_20200805_00056.jpg

Check Point / View			
Forest Ave / Down			
Rating **	M	Issue No. 21	GPS Lat/Long
Issue Type +	Ma	Location *	39.737400 °
Category	Rivers, Channels & Designated Flood		-121.804530 °
Item	Vegetation & Obstructions		
DWR ID	DWR_NA0060_12_c_2012_21		
Action/Comments			
Inspector Comments: Scattered bushes and vegetation may impede the flow of the channel.

View of the channel from the bridge facing downstream, 2020.

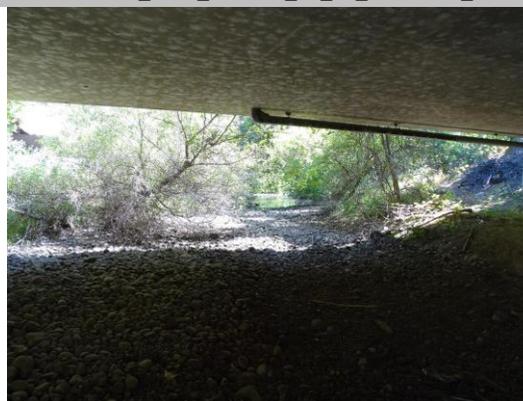
Photo 1 of 1 : CH_2020_NA0060_12_31_20200805_00047.jpg

Check Point / View			
Repair site upstream of Hwy 99 / Up			
Rating **	A	Issue No.	31
Issue Type +	Ma	Location *	39.735670 °
Category	Rivers, Channels & Designated Flood		-121.814510 °
Item	Vegetation & Obstructions		
DWR ID	DWR_NA0060_12_c_2012_31		
Action/Comments			
Inspector Comments: Scattered vegetation. The flow does not appear impeded.

View looking upstream from Hwy 99 bridge, 2020.

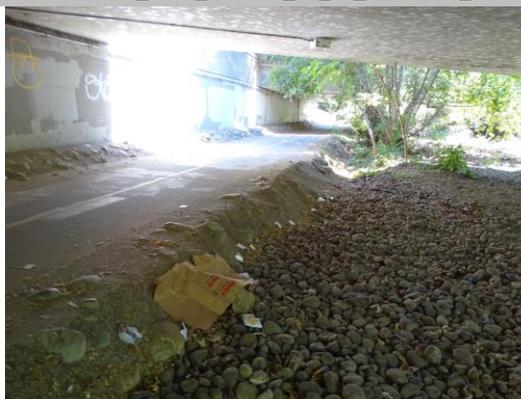
Photo 1 of 3 : CH_2020_NA0060_12_34_20200805_00060.jpg

Rating **	A	Issue No.	34
Issue Type +	Ma	Location *	39.735670 °
Category	Rivers, Channels & Designated Flood		-121.814510 °
Item	Revetments		
DWR ID	DWR_NA0060_12_c_2012_34		
Action/Comments			
Inspector Comments: The gabion wall repair is still intact and has no signs of damage. Riprap is visible and appears properly maintained under the bridge.

View of the revetment along the abutment of the bridge on the right bank looking upstream, 2020.

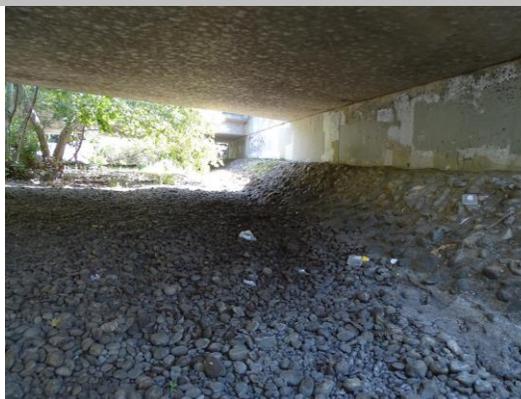
Photo 2 of 3 : CH_2020_NA0060_12_34_20200805_00058.jpg

Check Point / View				
Repair site upstream of Hwy 99 / Up (cont)				
Rating **	A	Issue No.	34 (cont)	GPS Lat/Long
Issue Type +	Ma	Location *		39.735670 °
Category	Rivers, Channels & Designated Flood			-121.814510 °
Item	Revetments			
DWR ID	DWR_NA0060_12_c_2012_34			
Action/Comments				
Inspector Comments: The gabion wall repair is still intact and has no signs of damage. Riprap is visible and appears properly maintained under the bridge.

View looking upstream of revetment at bridge abutment left bank, 2020.

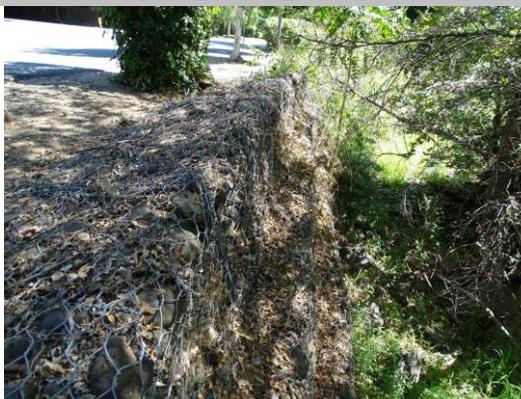
Photo 3 of 3 : CH_2020_NA0060_12_34_20200805_00059.jpg

View of the gabion wall repair 300 yards upstream of the bridge at Highway 99, 2020.

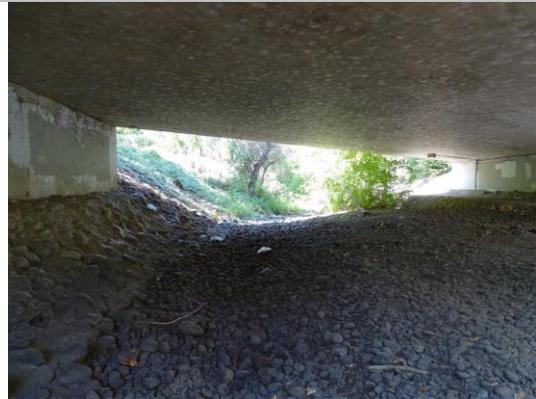
Photo 1 of 1 : CH_2020_NA0060_12_36_20200805_00061.jpg

Check Point / View			
Repair site upstream of Hwy 99 / Down			
Rating **	A	Issue No. 36	GPS Lat/Long
Issue Type +	Ma	Location *	39.735670 °
Category	Rivers, Channels & Designated Flood		-121.814510 °
Item	Vegetation & Obstructions		
DWR ID	DWR_NA0060_12_c_2012_36		
Action/Comments			
Inspector Comments: There is vegetation over the channel, the flow does not look to be impeded during high water.

View looking downstream from under the bridge, 2020.

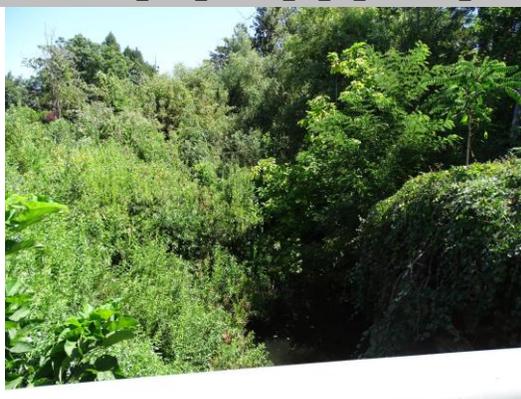
Photo 1 of 1 : CH_2020_NA0060_12_82_20200805_00048.jpg

Check Point / View			
Bruce Street / Up			
Rating **	M	Issue No.	82
Issue Type +	Ma	Location *	39.733204 °
Category	Rivers, Channels & Designated Flood		-121.819610 °
Item	Vegetation & Obstructions		
DWR ID	DWR_NA0060_12_c_2015_82		
Action/Comments			
Inspector Comments: There is vegetation in the channel and it appears to potentially impede the flow.

View of the channel from the bridge facing upstream, 2020.

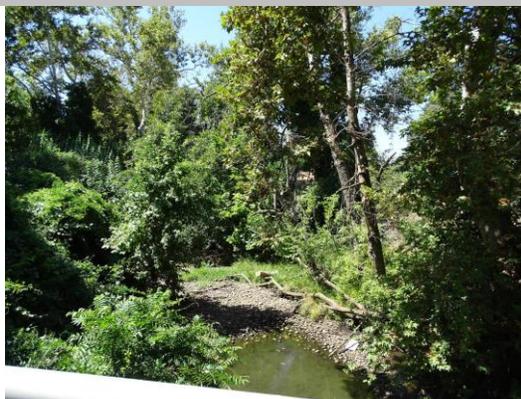
Photo 1 of 1 : CH_2020_NA0060_12_89_20200805_00064.jpg

Inspector Comments: There is some vegetation on the banks, but the channel is clear and the flow does not appear to be impeded.

View of the channel from the bridge facing downstream, 2020.

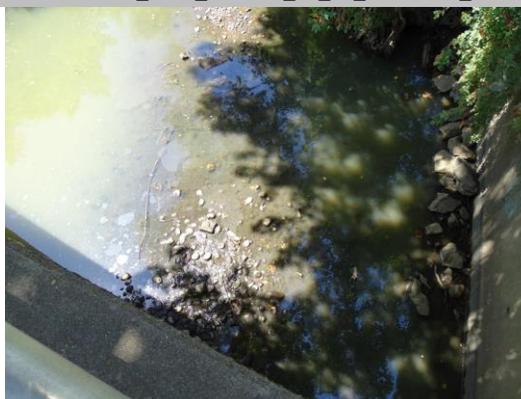
Photo 1 of 1 : CH_2020_NA0060_12_90_20200805_00063.jpg

Rating **	M	Issue No.	90	GPS Lat/Long
Issue Type +	Ma	Location *		39.733204 °
Category	Rivers, Channels & Designated Flood			-121.819610 °
Item	Shoaling / Sedimentation			
DWR ID	DWR_NA0060_12_c_2015_90

Inspector Comments: Sedimentation observed on the right bank downstream of the bridge should be removed, 2020.

View of sedimentation on the downstream right bank, 2020.

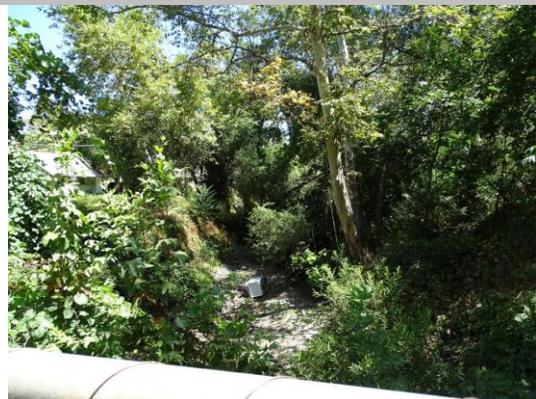
Photo 1 of 1 : CH_2020_NA0060_12_41_20200805_00065.jpg

Check Point / View			
Boucher St / Up			
Rating **	M	Issue No.	41
Issue Type +	Ma	Location *	39.730240 °
Category	Rivers, Channels & Designated Flood		-121.823800 °
Item	Vegetation & Obstructions		
DWR ID	DWR_NA0060_12_c_2012_41		
Action/Comments			
Inspector Comments: There is vegetation in the channel and overhanging the channel, the flow could be impeded.

View of the channel from the bridge facing upstream, 2020.

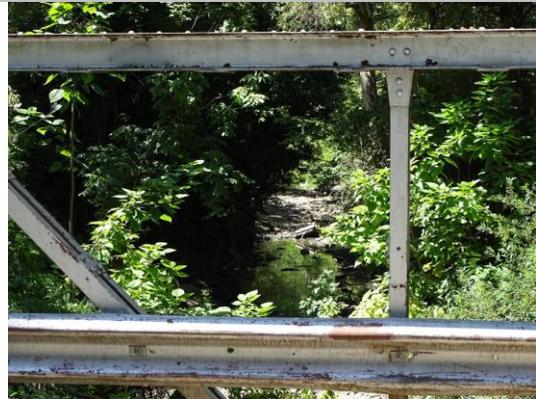
Photo 1 of 1 : CH_2020_NA0060_12_46_20200805_00066.jpg

Check Point / View				
Boucher St / Down				
Rating **	M	Issue No.	46	GPS Lat/Long
Issue Type +	Ma	Location *		39.730240 °
Category	Rivers, Channels & Designated Flood			-121.823800 °
Item	Vegetation & Obstructions			
DWR ID	DWR_NA0060_12_c_2012_46			
Action/Comments				
Inspector Comments: There is vegetation in the channel, overhanging the channel, and arundo. The flow does appear slightly impeded.

View of the channel from the bridge facing downstream, 2020.

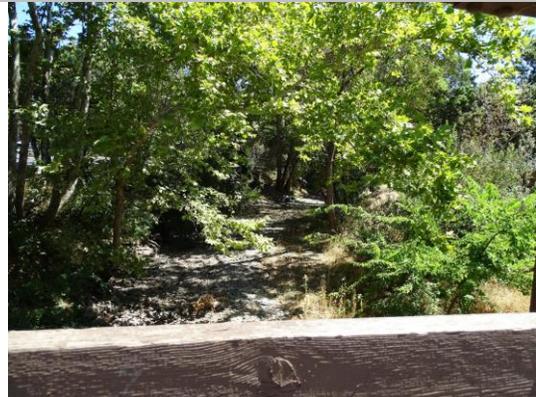
Photo 1 of 1 : CH_2020_NA0060_12_51_20200805_00070.jpg

Check Point / View			
Olive St / Up			
Rating **	A	Issue No.	51
Issue Type +	Ma	Location *	GPS Lat/Long
Category	Rivers, Channels & Designated Flood		39.726792 °
Item	Vegetation & Obstructions		-121.829713 °
DWR ID	DWR_NA0060_12_c_2012_51		
Action/Comments			
Inspector Comments: There is vegetation over the channel, it does not appear to impede the flow.

View of the channel from the bridge facing upstream, 2020.

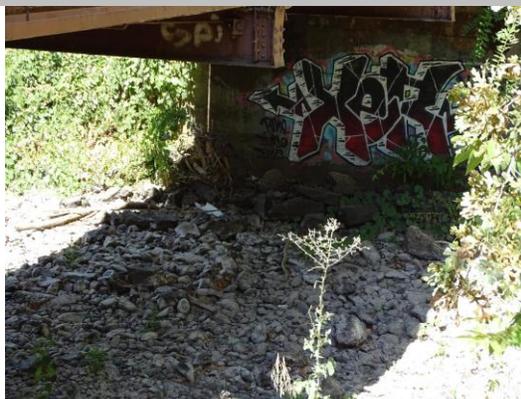
Photo 1 of 2 : CH_2020_NA0060_12_54_20200805_00074.jpg

Check Point / View				
Olive St / Up (cont)				
Rating **	N	Issue No.	54	GPS Lat/Long
Issue Type +	Ma	Location *		39.726792 °
Category	Rivers, Channels & Designated Flood			-121.829713 °
Item	Revetments			
DWR ID	DWR_NA0060_12_c_2012_54			
Action/Comments				
Inspector Comments: No riprap observed at this site.

View of the right abutment, no revetment present, 2020.

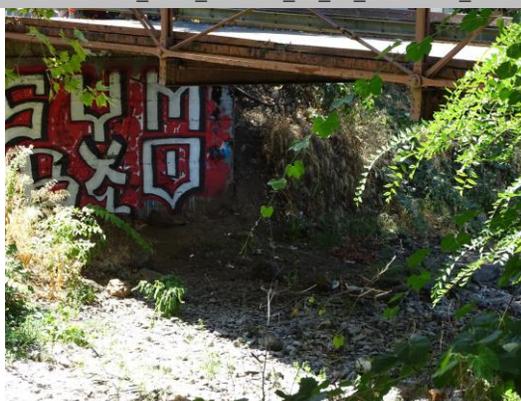
Photo 2 of 2 : CH_2020_NA0060_12_54_20200805_00075.jpg

View of the left abutment, no revetment present, 2020.

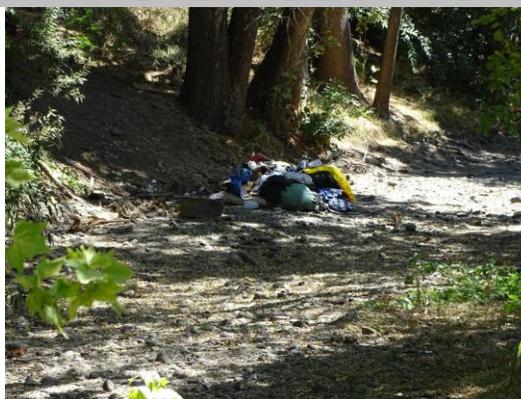
Photo 1 of 1 : CH_2020_NA0060_12_55_20200805_00073.jpg

Rating **	A	Issue No.	55	GPS Lat/Long
Issue Type +	Ma	Location *		39.726792 °
Category	Rivers, Channels & Designated Flood			-121.829713 °
Item	Encroachments			
DWR ID	DWR_NA0060_12_c_2012_55			
Action/Comments				
Inspector Comments: Trash and debris observed upstream of the bridge should be removed but will not impede the flow, 2020.

View of trash and debris left by campers upstream of the bridge, 2020.

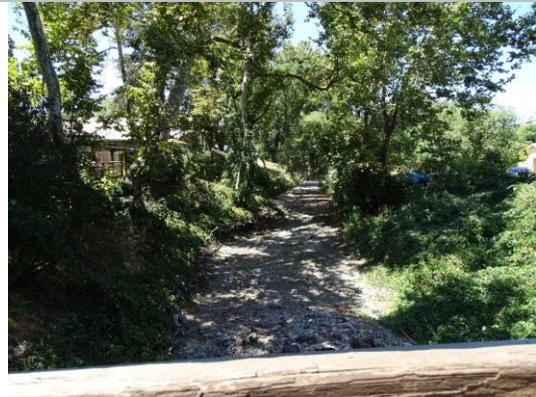
Photo 1 of 1 : CH_2020_NA0060_12_56_20200805_00071.jpg

Check Point / View			
Olive St / Down			
Rating **	A	Issue No.	56
Issue Type +	Ma	Location *	
Category	Rivers, Channels & Designated Flood		GPS Lat/Long
Item	Vegetation & Obstructions		
DWR ID	DWR_NA0060_12_c_2012_56		
Action/Comments			
Inspector Comments: There is vegetation over the channel, the flow does not appear impeded.

View of the channel from the bridge facing downstream, 2020.

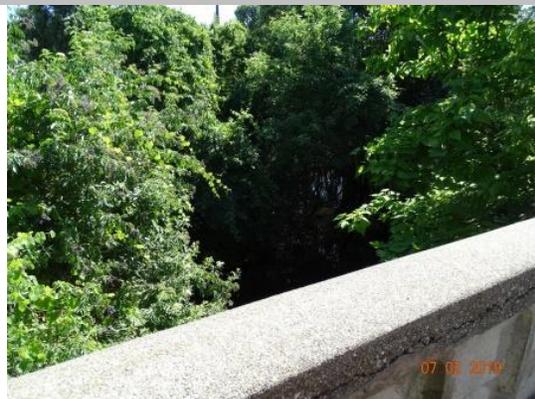
Photo 1 of 1 : CH_2020_NA0060_12_61_20200730_00020.jpg

Check Point / View			
Broadway St / Up			
Rating **	M	Issue No.	61
Issue Type +	Ma	Location *	39.724328 °
Category	Rivers, Channels & Designated Flood		-121.835233 °
Item	Vegetation & Obstructions		
DWR ID	DWR_NA0060_12_c_2012_61		
Action/Comments			
Inspector Comments: There are scattered obstructions and vegetation which may impede the flow of the channel.

View of the channel from the bridge facing upstream, 2019.

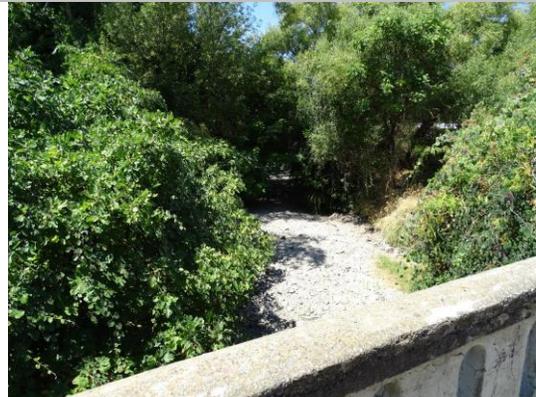
Photo 1 of 1 : CH_2020_NA0060_12_66_20200805_00051.jpg

Check Point / View				
Broadway St / Down				
Rating **	A	Issue No.	66	GPS Lat/Long
Issue Type +	Ma	Location *		39.724328 °
Category	Rivers, Channels & Designated Flood			-121.835233 °
Item	Vegetation & Obstructions			
DWR ID	DWR_NA0060_12_c_2012_66			
Action/Comments				
Inspector Comments: There is vegetation over the channel, the flow does not appear impeded.

View of the channel from the bridge facing downstream, 2020.

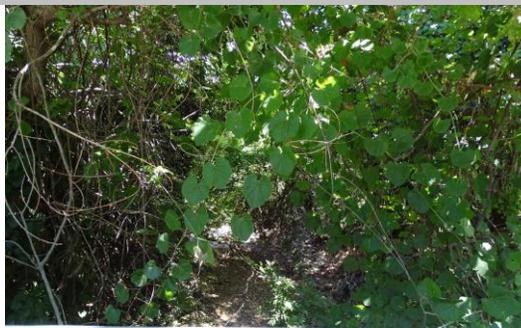
Photo 1 of 1 : CH_2020_NA0060_12_94_20200805_00079.jpg

Check Point / View			
Ivy Street / Up			
Rating **	A	Issue No. 94	GPS Lat/Long
Issue Type +	Ma	Location *	39.720476 °
Category	Rivers, Channels & Designated Flood		-121.838990 °
Item	Vegetation & Obstructions		
DWR ID	DWR_NA0060_5_c_2015_94		
Action/Comments			
Inspector Comments: Scattered obstructions and vegetation over channel should not impede the flow of the channel.

View of the channel from the bridge facing upstream, 2020.

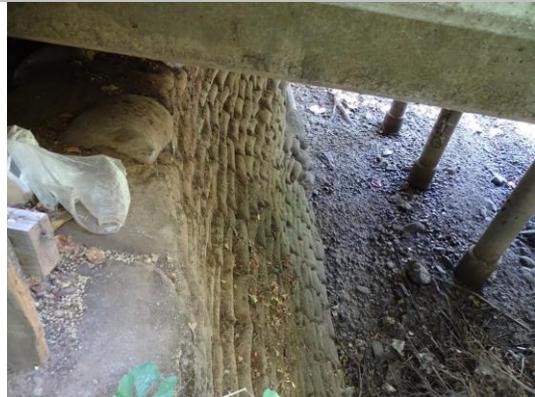
Photo 2 of 2 : CH_2020_NA0060_12_97_20200805_00082.jpg

Check Point / View			
Ivy Street / Up (cont)			
Rating **	A	Issue No.	97 (cont)
Issue Type +	Ma	Location *	GPS Lat/Long
Category	Rivers, Channels & Designated Flood		39.720476 °
Item	Revetments		-121.838990 °
DWR ID	DWR_NA0060_12_c_2015_97		
Action/Comments			
Inspector Comments: Sandbag revetment on left bank of abutment, no revetment on right bank and none needed.

View of left bank of abutment with sandbag revetment, 2020.

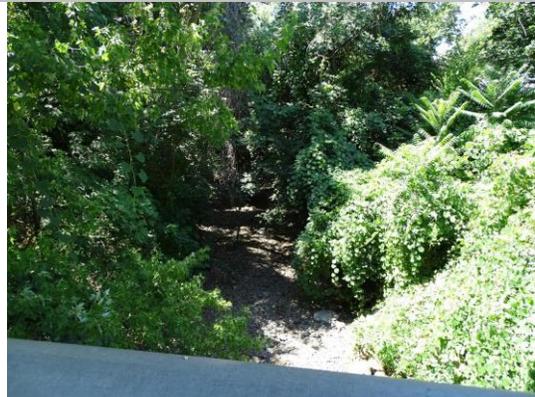
Photo 1 of 1 : CH_2020_NA0060_12_99_20200805_00084.jpg

Check Point / View				
Ivy Street / Down				
Rating **	M	Issue No.	99	GPS Lat/Long
Issue Type +	Ma	Location *		39.720476 °
Category	Rivers, Channels & Designated Flood			-121.838990 °
Item	Vegetation & Obstructions			
DWR ID	DWR_NA0060_12_c_2015_99			
Action/Comments				
Inspector Comments: Scattered obstructions and vegetation, may impede the flow of the channel.

View of the channel from the bridge facing downstream, 2020.

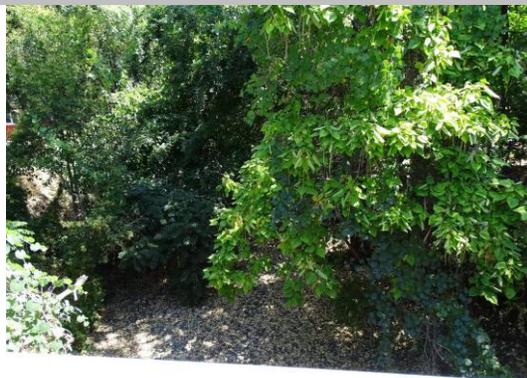
Photo 1 of 1 : CH_2020_NA0060_12_104_20200805_00085.jpg

Check Point / View			
Walnut Street / Up			
Rating **	A	Issue No.	104
Issue Type +	Ma	Location *	GPS Lat/Long
Category	Rivers, Channels & Designated Flood		39.718434 °
Item	Vegetation & Obstructions		-121.843512 °
DWR ID	DWR_NA0060_12_c_2015_104		
Action/Comments			
Inspector Comments: The channel appeared to be free of any vegetation that would impede the flow.

View of the channel from the bridge facing upstream, 2020.

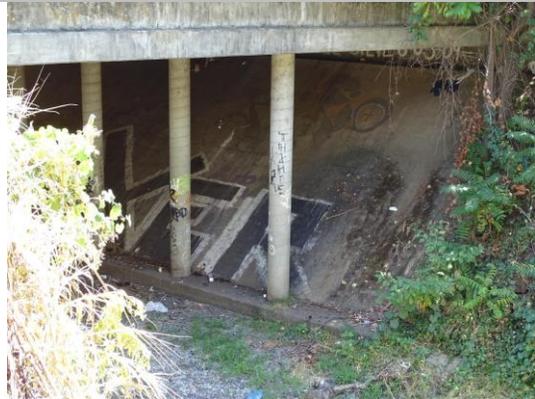
Photo 2 of 2 : CH_2020_NA0060_12_107_20200805_00087.jpg

Check Point / View			
Walnut Street / Up (cont)			
Rating **	M	Issue No.	107 (cont)
Issue Type +	Ma	Location *	GPS Lat/Long
Category	Rivers, Channels & Designated Flood		39.718434 °
Item	Revetments		-121.843512 °
DWR ID	DWR_NA0060_12_c_2015_107		
Action/Comments			
Inspector Comments: Revetment on right bank is overgrown with vegetation. Vegetation should be removed, 2020.

View of the left bank abutment, no revetment present, 2020.

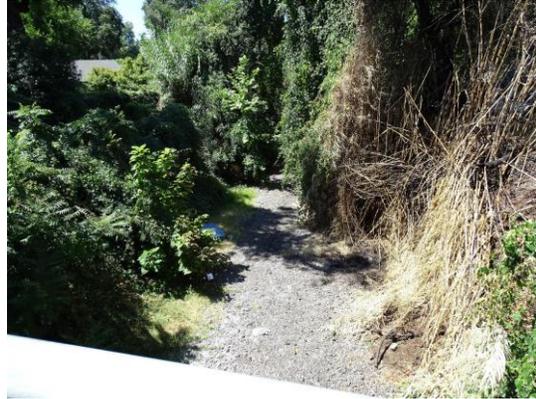
Photo 1 of 1 : CH_2020_NA0060_12_109_20200805_00088.jpg

Check Point / View			
Walnut Street / Down			
Rating **	A	Issue No.	109
Issue Type +	Ma	Location *	GPS Lat/Long
Category	Rivers, Channels & Designated Flood		39.718434 °
Item	Vegetation & Obstructions		-121.843512 °
DWR ID	DWR_NA0060_12_c_2015_109		
Action/Comments			
Inspector Comments: The channel appeared free of any vegetation that would impede the flow. Although the Arundo should be removed before it chokes down the channel.

View of the channel from the bridge facing upstream, 2020.

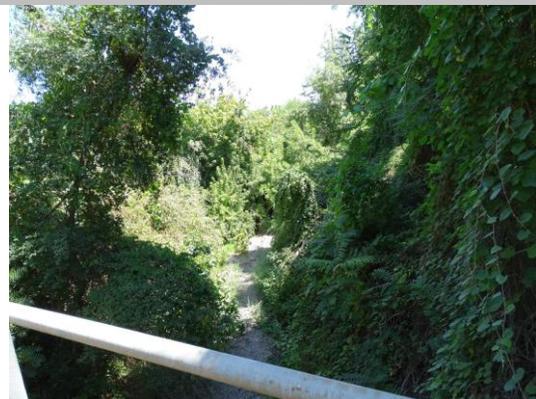
Photo 1 of 1 : CH_2020_NA0060_12_71_20200805_00089.jpg

Check Point / View			
Lone Pine Avenue / Up			
Rating **	M	Issue No. 71	GPS Lat/Long
Issue Type +	Ma	Location *	39.703260 °
Category	Rivers, Channels & Designated Flood		-121.868470 °
Item	Vegetation & Obstructions		
DWR ID	DWR_NA0060_12_c_2012_71		
Action/Comments			
Inspector Comments: Scattered obstructions and vegetation may impede the flow of the channel.

View of the channel from the bridge facing upstream, 2020.

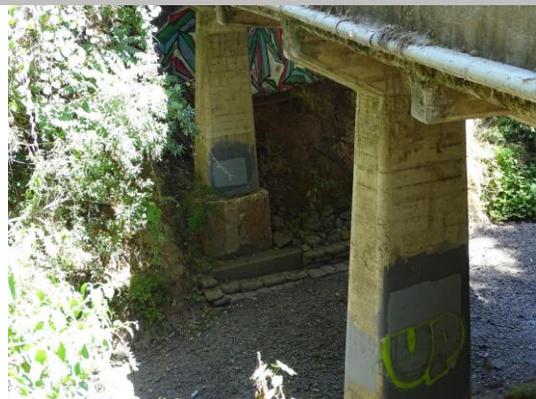
Photo 1 of 2 : CH_2020_NA0060_12_74_20200805_00090.jpg

Rating **	A	Issue No.	74	GPS Lat/Long
Issue Type +	Ma	Location *		39.703260 °
Category	Rivers, Channels & Designated Flood			-121.868470 °
Item	Revetments			
DWR ID	DWR_NA0060_12_c_2012_74			
Action/Comments				
Inspector Comments: Concrete filled sandbags used for riprap at bridge abutments on both sides.

View of concrete sandbag revetment on the channels edge left bank, 2020.

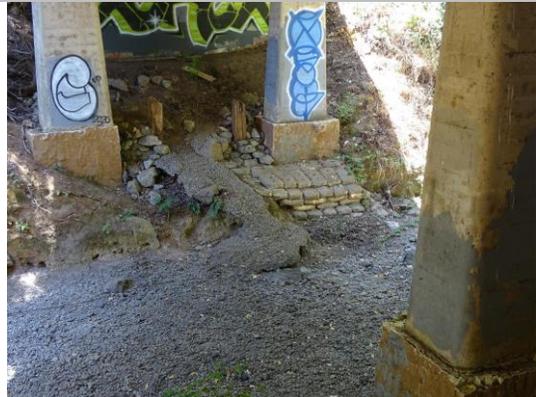
Photo 2 of 2 : CH_2020_NA0060_12_74_20200805_00091.jpg

Check Point / View				
Lone Pine Avenue / Up (cont)				
Rating **	A	Issue No.	74 (cont)	GPS Lat/Long
Issue Type +	Ma	Location *		39.703260 °
Category	Rivers, Channels & Designated Flood			-121.868470 °
Item	Revetments			
DWR ID	DWR_NA0060_12_c_2012_74			
Action/Comments				
Inspector Comments: Concrete filled sandbags used for riprap at bridge abutments on both sides.

View of concrete sandbag revetment on the channels edge right bank, 2020.

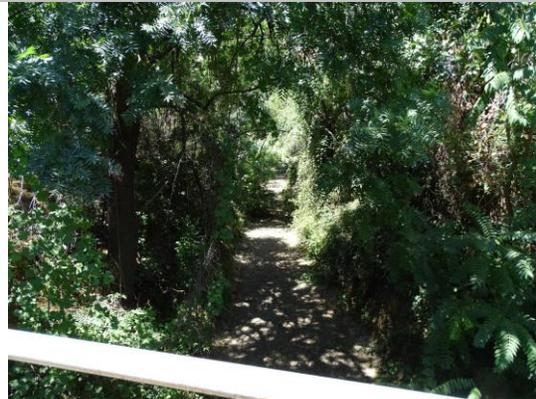
Photo 1 of 1 : CH_2020_NA0060_12_76_20200805_00052.jpg

Check Point / View			
Lone Pine Avenue / Down			
Rating **	A	Issue No.	76
Issue Type +	Ma	Location *	39.703260 °
Category	Rivers, Channels & Designated Flood		-121.868470 °
Item	Vegetation & Obstructions		
DWR ID	DWR_NA0060_12_c_2012_76		
Action/Comments			
Inspector Comments: There is vegetation in the channel, the flow does not appear impeded.

View of the channel facing downstream from bridge, 2020.
