**Flood Control Project Maintenance**  
**2020 Structure Summary Report**  
**Overall Unit and Item Ratings**

**DWR Sutter Maintenance Yard**

**Butte Slough Drainage Structure**

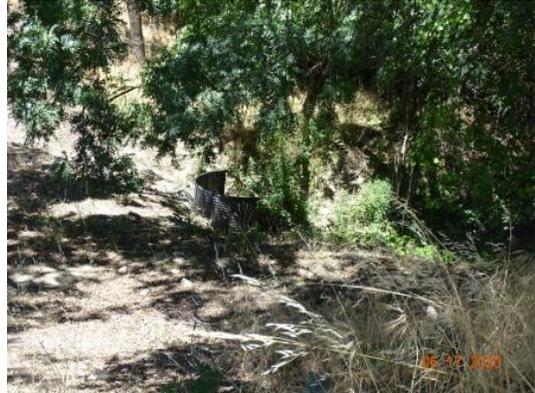
Photo 1 of 6 : ST\_2020\_NA0060\_38\_1\_20200618\_00009.jpg

View of the Butte Slough Drainage Structure on the landside.

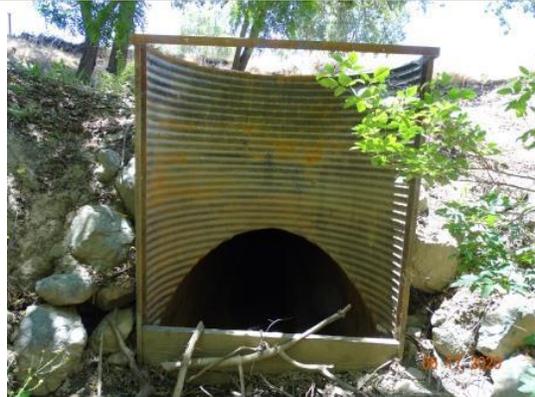
Photo 2 of 6 : ST\_2020\_NA0060\_38\_1\_20200618\_00010.jpg

Up-close view of the Butte Slough Drainage Structure on the landside.

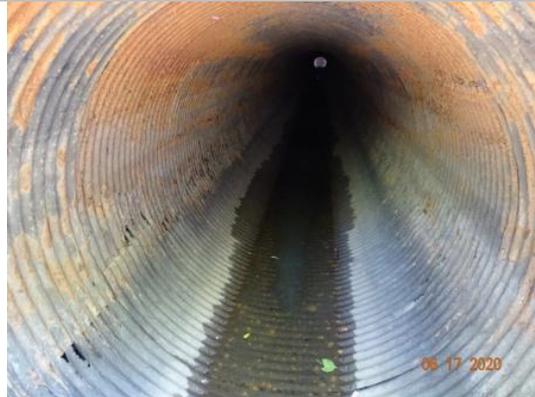
Photo 3 of 6 : ST\_2020\_NA0060\_38\_1\_20200618\_00011.jpg

View of the pipe from the landside.

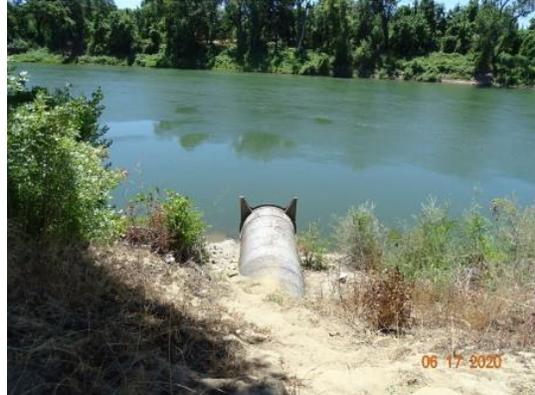
Photo 4 of 6 : ST\_2020\_NA0060\_38\_1\_20200618\_00012.jpg

View of the Butte Slough Drainage Structure on the waterside.

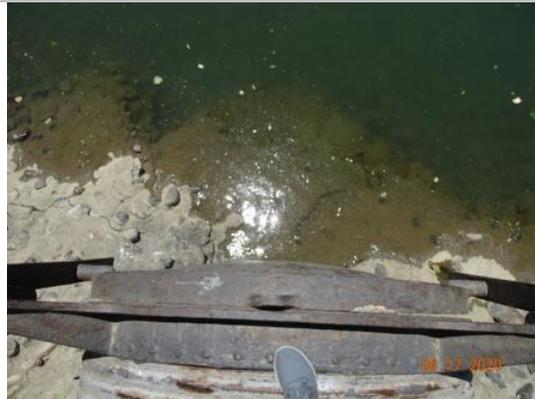
Photo 5 of 6 : ST\_2020\_NA0060\_38\_1\_20200618\_00013.jpg

Top view of the outfall flap gate.

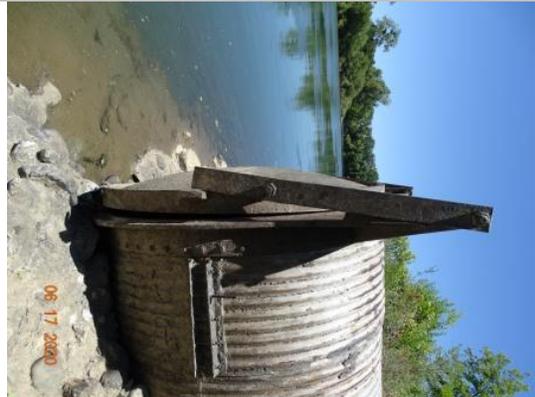
Photo 6 of 6 : ST\_2020\_NA0060\_38\_1\_20200618\_00014.jpg

Side view of the outfall flap gate.

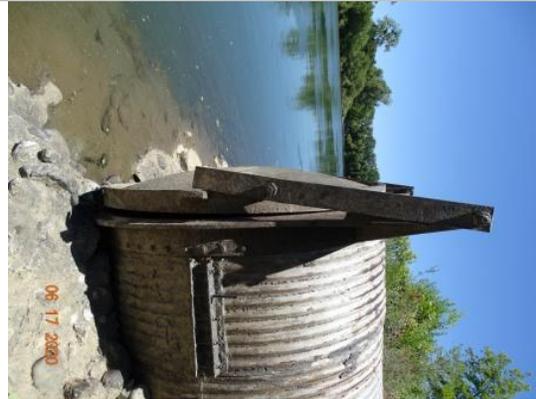
Photo 1 of 1 : ST\_2020\_NA0060\_38\_11\_20200618\_00015.jpg

LM Start	<b>0.00</b>	Rating **	A	Issue No.	<b>11</b>
LM End	<b>0.00</b>	Issue Type +	Ma	Location *	
Category	Structures & Concrete Lined Channels		GPS Latitude/Longitude		
			Start	End	
Item	Flap Gates		39.197288 °	39.197288 °	
			-121.943847 °	-121.943847 °	
DWR ID	DWR_NA0060_38_t_2012_11				
Action/Comments

View of the flap gate.

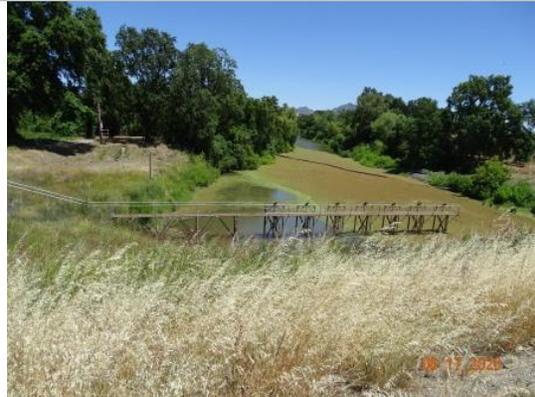
Photo 1 of 8 : ST\_2020\_NA0060\_42\_1\_20200618\_00012.jpg

View of the Butte Slough Outfall Structure from the landside levee crown.

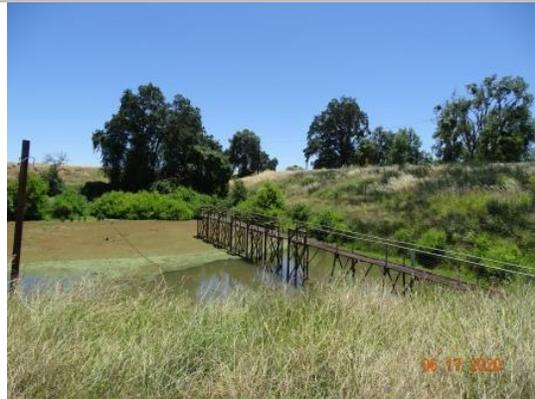
Photo 2 of 8 : ST\_2020\_NA0060\_42\_1\_20200618\_00013.jpg

Another view of the Butte Slough Outfall Structure.

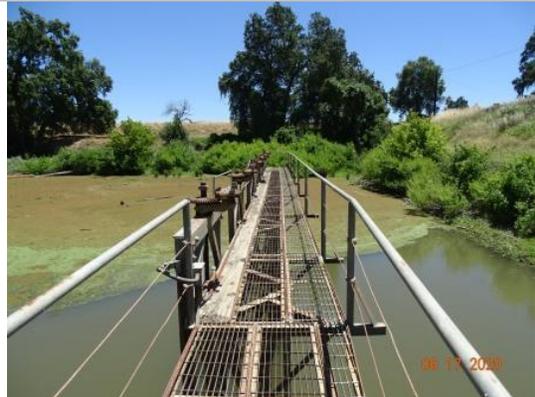
Photo 3 of 8 : ST\_2020\_NA0060\_42\_1\_20200618\_00014.jpg

View of the platform and mechanical gate operation mechanism.

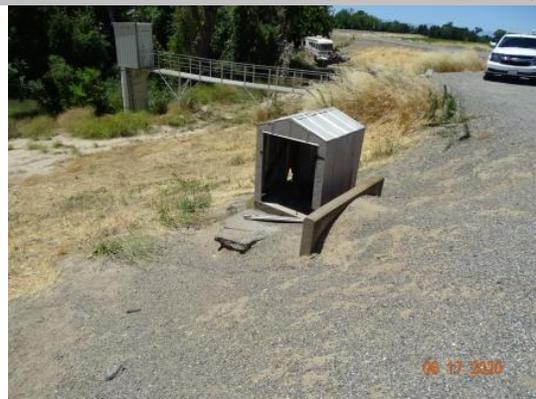
Photo 5 of 8 : ST\_2020\_NA0060\_42\_1\_20200618\_00016.jpg

View of the abandoned in-place hoist system.

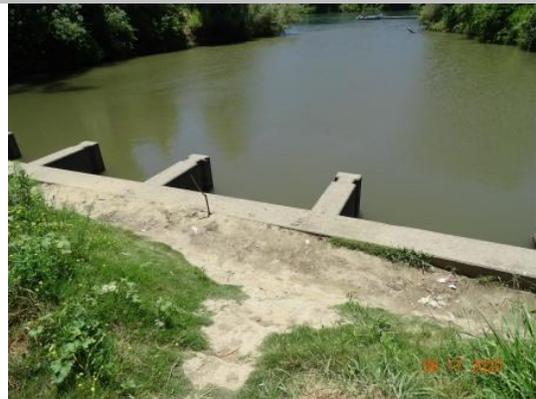
Photo 6 of 8 : ST\_2020\_NA0060\_42\_1\_20200618\_00017.jpg

View of the Butte Slough Outfall Structure headwall on the waterside of the levee.

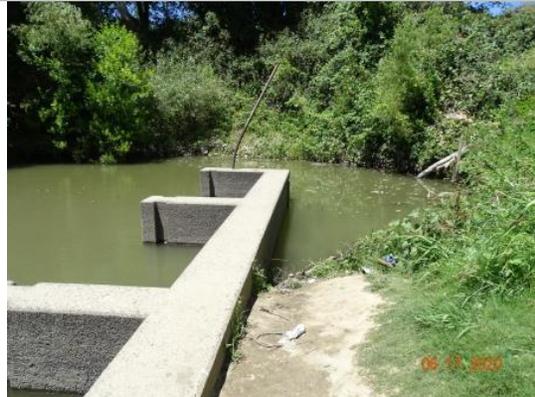
Photo 7 of 8 : ST\_2020\_NA0060\_42\_1\_20200618\_00018.jpg

View of the right side of the structure's headwall.

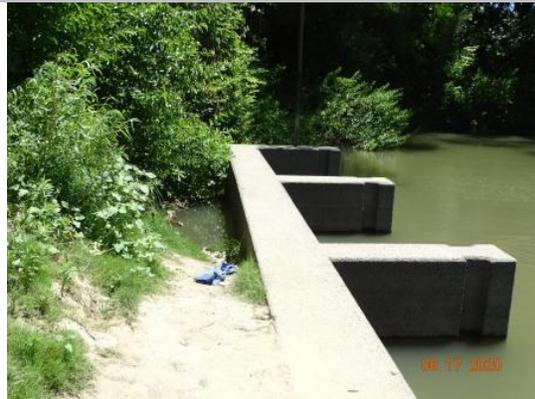
Photo 8 of 8 : ST\_2020\_NA0060\_42\_1\_20200618\_00019.jpg

View of the left side of the structure's headwall.

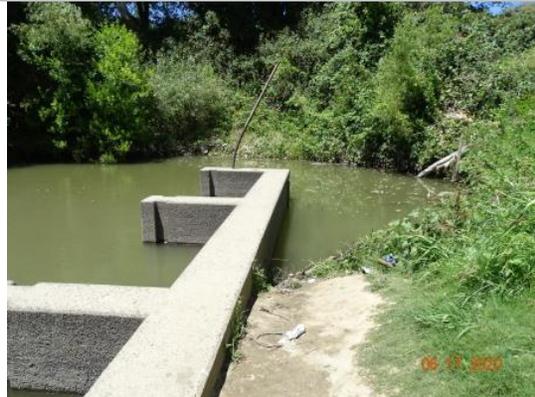
Photo 1 of 2 : ST\_2020\_NA0060\_42\_4\_20200618\_00020.jpg

LM Start	<b>0.00</b>	Rating **	M	Issue No.	<b>4</b>
LM End	<b>0.00</b>	Issue Type +	Ma	Location *	
Category	Structures & Concrete Lined Channels		GPS Latitude/Longitude		
			Start	End	
Item	Erosion / Bank Caving		39.194972 °	39.194972 °	
			-121.936088 °	-121.936088 °	
DWR ID	DWR_NA0060_42_t_2012_4				
Action/Comments					
Inspector Comments: The active erosion at the outlet's headwall is progressing from year to year. The erosion needs to be addressed.

View of the active erosion around the rightside of the headwall.

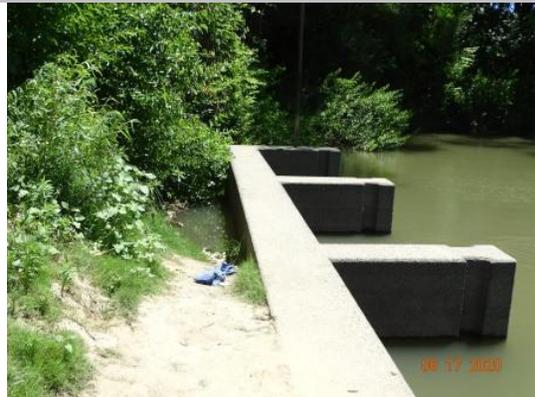
Photo 2 of 2 : ST\_2020\_NA0060\_42\_4\_20200618\_00021.jpg

View of the active erosion around the leftside of the headwall.

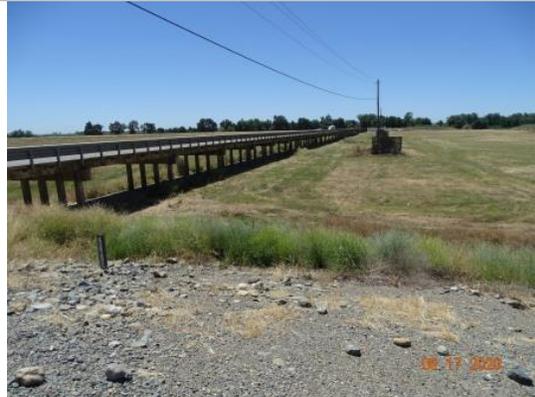
Photo 1 of 8 : ST\_2020\_NA0060\_55\_1\_20200618\_00014.jpg

View of the weir from the left bank looking downstream.

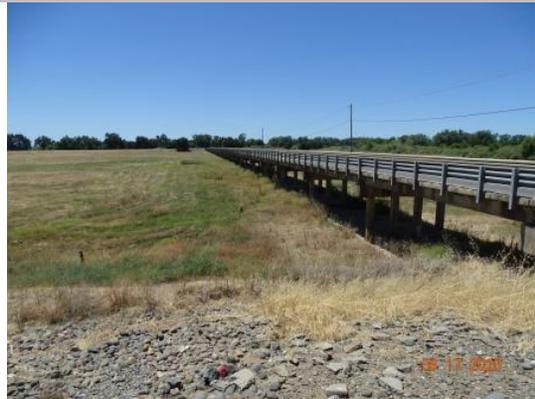
Photo 2 of 8 : ST\_2020\_NA0060\_55\_1\_20200618\_00015.jpg

View of the weir from the left bank looking upstream.

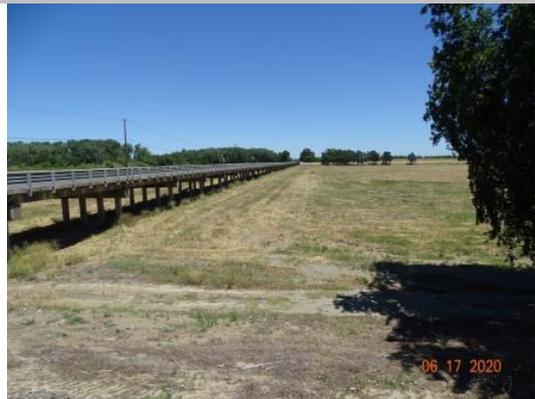
Photo 3 of 8 : ST\_2020\_NA0060\_55\_1\_20200618\_00016.jpg

View of the weir from the right bank looking upstream.

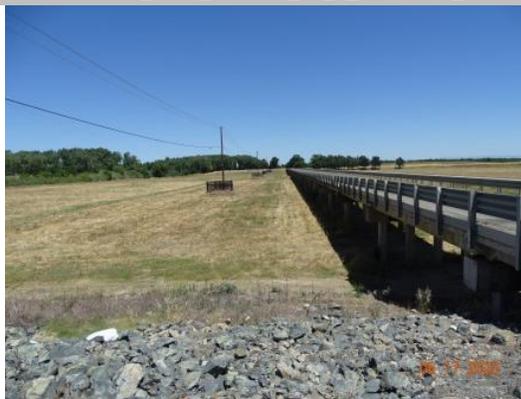
Photo 4 of 8 : ST\_2020\_NA0060\_55\_1\_20200618\_00017.jpg

View of the weir from the right bank looking downstream.

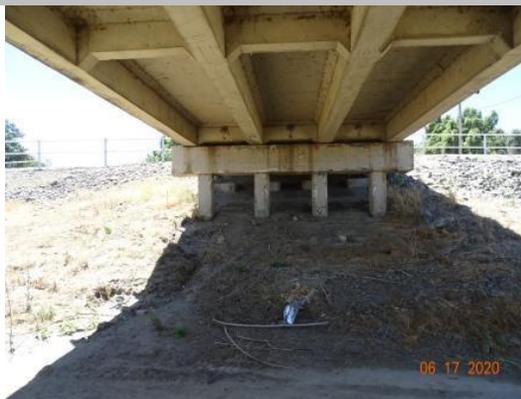
Photo 5 of 8 : ST\_2020\_NA0060\_55\_1\_20200618\_00018.jpg

View of the weir's right bank abutment.

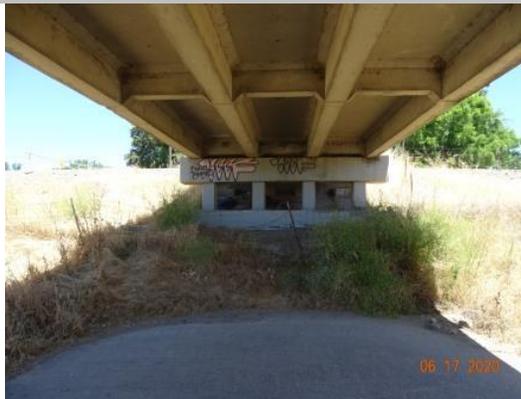
Photo 6 of 8 : ST\_2020\_NA0060\_55\_1\_20200618\_00021.jpg

View of the weir's left bank abutment.

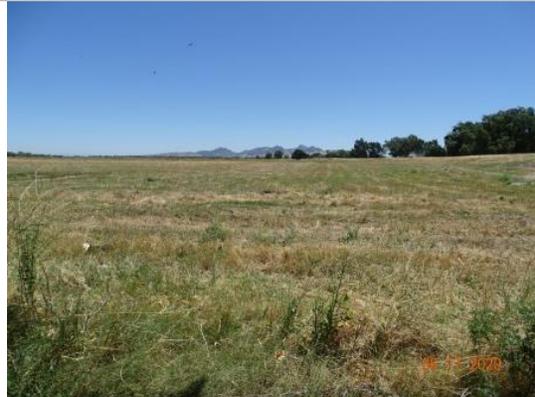
Photo 7 of 8 : ST\_2020\_NA0060\_55\_1\_20200618\_00019.jpg

Typical downstream view from the weir.

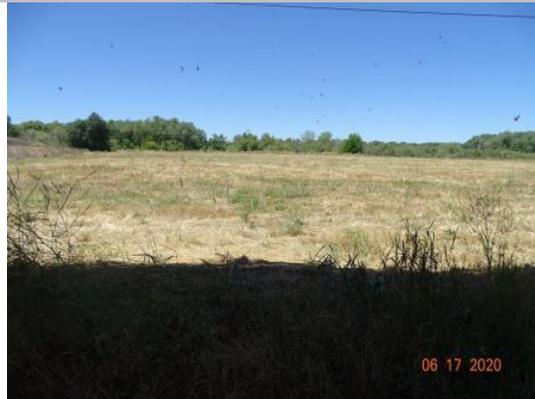
Photo 8 of 8 : ST\_2020\_NA0060\_55\_1\_20200618\_00020.jpg

Typical upstream view from the weir.

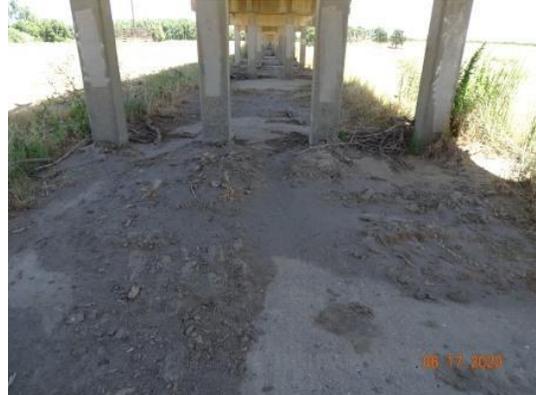
Photo 1 of 1 : ST\_2020\_NA0060\_55\_3\_20200618\_00024.jpg

LM Start	<b>0.00</b>	Rating **	M	Issue No.	<b>3</b>
LM End	<b>0.00</b>	Issue Type +	Ma	Location *	
Category	Structures & Concrete Lined Channels		GPS Latitude/Longitude		
			Start	End	
Item	Shoaling / Sedimentation		39.232135 °	39.232135 °	
			-121.996253 °	-121.996253 °	
DWR ID	DWR_NA0060_55_t_2012_3				
Action/Comments					
Inspector Comments: Sedimentation is present. Most of the sedimentation buildup is within the right half of the weir.

View of the sediment buildup.

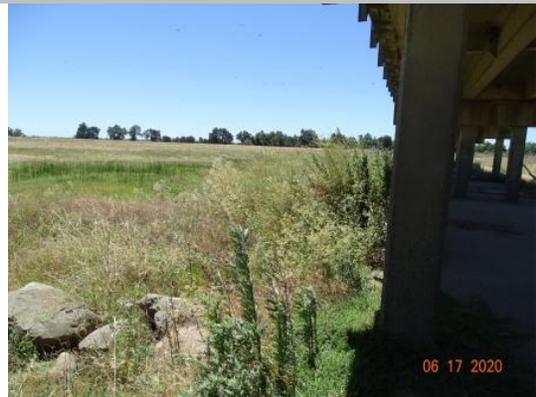
Photo 1 of 1 : ST\_2020\_NA0060\_55\_5\_20200618\_00025.jpg

LM Start	<b>0.00</b>	Rating **	M	Issue No.	<b>5</b>
LM End	<b>0.00</b>	Issue Type +	Ma	Location *	
Category	Structures & Concrete Lined Channels		GPS Latitude/Longitude		
			Start	End	
Item	Revetments		39.232135 °	39.232135 °	
			-121.996253 °	-121.996253 °	
DWR ID	DWR_NA0060_55_t_2012_5				
Action/Comments					
Inspector Comments: The riprap is present. Vegetation within the riprapped area should be cleared.

View of the riprap on the downstream side of the weir.

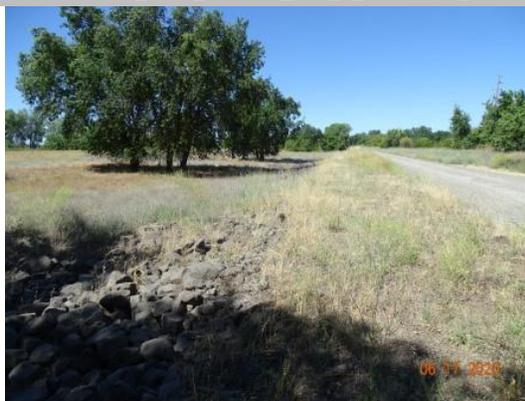
Photo 2 of 2 : ST\_2020\_NA0060\_225\_1\_20200618\_00007.jpg

Typical view of the structure.

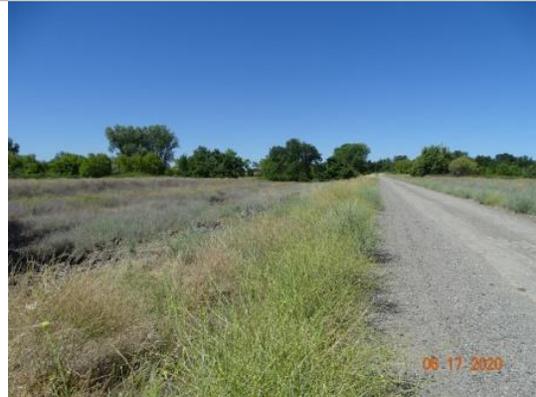
Photo 2 of 2 : ST\_2020\_NA0060\_225\_2\_20200618\_00010.jpg

LM Start	<b>0.00</b>	Rating **	M	Issue No.	<b>2 (cont)</b>
LM End	<b>0.00</b>	Issue Type +	Ma	Location *	LS
Category	Structures & Concrete Lined Channels		GPS Latitude/Longitude		
			Start	End	
Item	Vegetation & Obstructions		39.569247 °	39.569247 °	
			-121.982569 °	-121.982569 °	
DWR ID	DWR_NA0060_225_t_2013_2				
Action/Comments					
Inspector Comments: Spray the vegetation for approximately 20 feet on both sides of the weir.

View of the vegetation on the downstream of the weir.

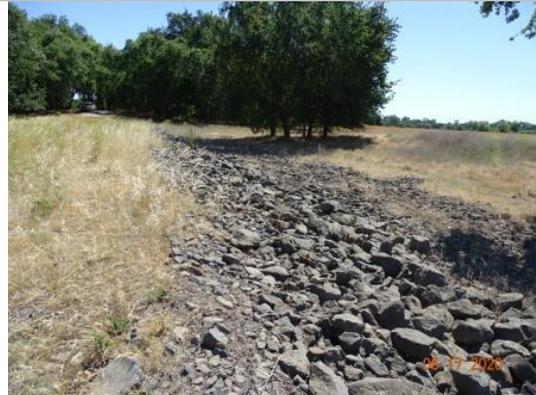
Photo 1 of 1 : ST\_2020\_NA0060\_225\_5\_20200618\_00011.jpg

LM Start	<b>0.00</b>	Rating **	A	Issue No.	<b>5</b>
LM End	<b>0.00</b>	Issue Type +	Ma	Location *	LS
Category	Structures & Concrete Lined Channels		GPS Latitude/Longitude		
			Start	End	
Item	Revetments		39.569248 °	39.569248 °	
			-121.982569 °	-121.982569 °	
DWR ID	DWR_NA0060_225_t_2013_5				
Action/Comments

View of the revetment on the downstream of the weir.

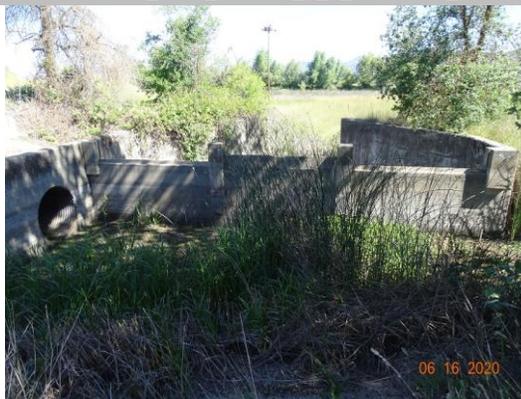
Photo 1 of 1 : ST\_2020\_NA0060\_7\_1\_20200617\_00008.jpg

LM Start	<b>0.00</b>	Rating **	N	Issue No.	<b>1</b>
LM End	<b>0.00</b>	Issue Type +	Ma	Location *	
Category	Structures & Concrete Lined Channels		GPS Latitude/Longitude		
			Start	End	
Item	Photo Documentation		39.126317 °	39.126317 °	
			-122.882733 °	-122.882733 °	
DWR ID	DWR_NA0009_7_t_2012_1				
Action/Comments					
Inspector Comments: Highland Canal Diversion Weir works as a control point that diverts water through a culvert during high water season.

View of the weir. Summer 2020.

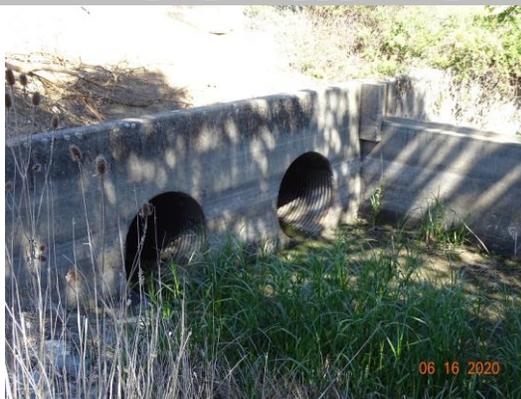
Photo 1 of 2 : ST\_2020\_NA0060\_7\_7\_20200617\_00010.jpg

LM Start	<b>0.00</b>	Rating **	A	Issue No.	<b>7</b>
LM End	<b>0.00</b>	Issue Type +	Ma	Location *	
Category	Structures & Concrete Lined Channels		GPS Latitude/Longitude		
			Start	End	
Item	Culverts: Inlets / Outlets		39.126317 °	39.126317 °	
			-122.882733 °	-122.882733 °	
DWR ID	DWR_NA0009_7_t_2012_7				
Action/Comments					
Inspector Comments: Minimal debris within the culvert.

View of the inlets. Summer 2020.

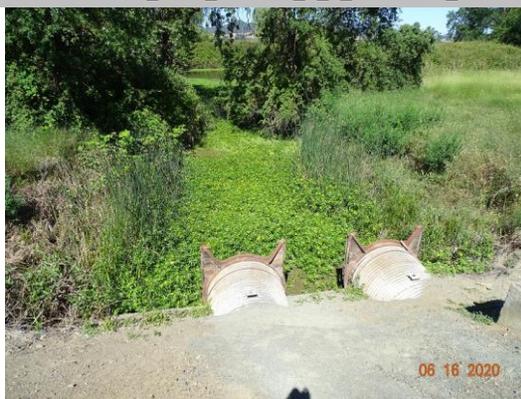
Photo 2 of 2 : ST\_2020\_NA0060\_7\_7\_20200617\_00011.jpg

View of the outlets. Summer 2020.

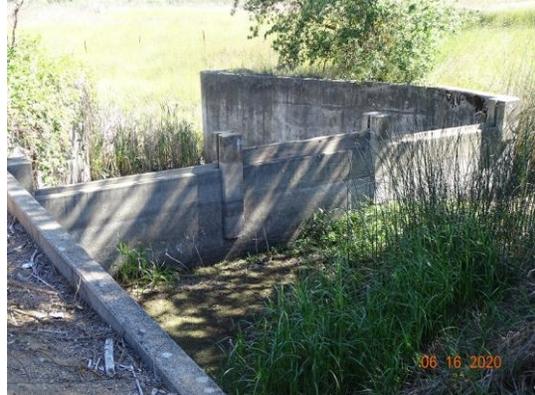
Photo 1 of 2 : ST\_2020\_NA0060\_7\_15\_20200617\_00012.jpg

LM Start	<b>0.00</b>	Rating **	A	Issue No.	<b>15</b>
LM End	<b>0.00</b>	Issue Type +	Ma	Location *	
Category	Structures & Concrete Lined Channels		GPS Latitude/Longitude		
			Start	End	
Item	Concrete Surfaces		39.126317 °	39.126317 °	
			-122.882733 °	-122.882733 °	
DWR ID	DWR_NA0009_7_t_2012_15				
Action/Comments					
Inspector Comments: Minor cracking and scaling on the concrete structure, but does not appear to threaten its structural integrity.

View of the weir inlet. Summer 2020.

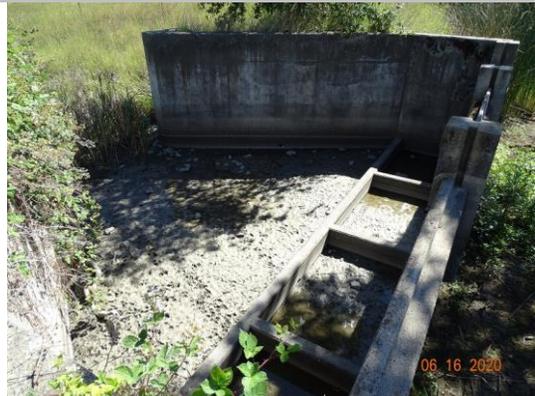
Photo 2 of 2 : ST\_2020\_NA0060\_7\_15\_20200617\_00013.jpg

View of the weir stilling basin at the outlet. Summer 2020.

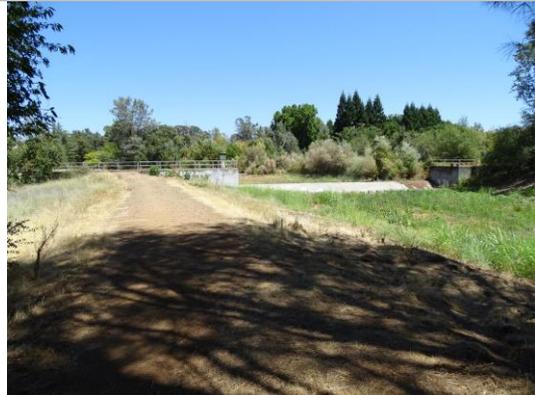
Photo 1 of 5 : ST\_2020\_NA0060\_9\_1\_20200805\_00019.jpg

View of the Little Chico Structure looking upstream, 2020.

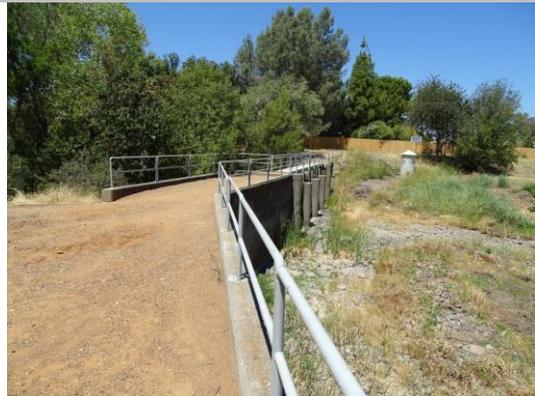
Photo 2 of 5 : ST\_2020\_NA0060\_9\_1\_20200805\_00020.jpg

View of the Little Chico Structure looking north, 2020.

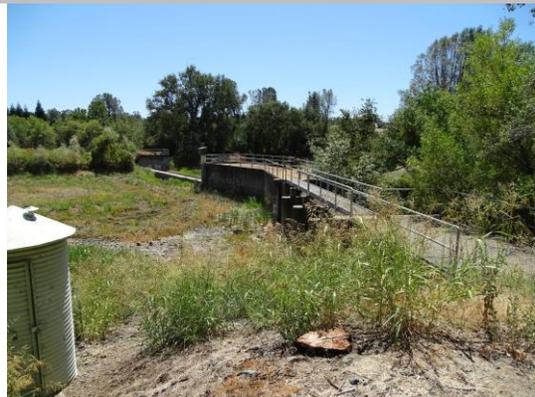
Photo 3 of 5 : ST\_2020\_NA0060\_9\_1\_20200805\_00021.jpg

View of the control structure and weir looking downstream, 2020.

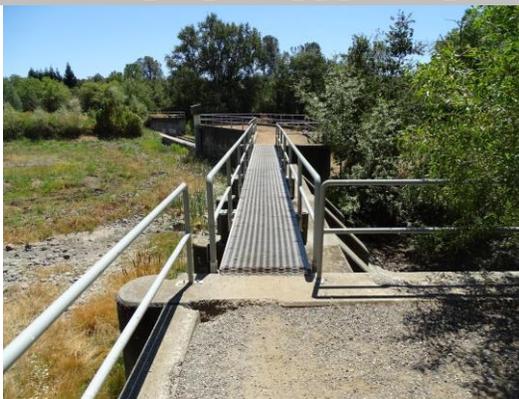
Photo 4 of 5 : ST\_2020\_NA0060\_9\_1\_20200805\_00022.jpg

View of the Little Chico Structure looking south, 2020.

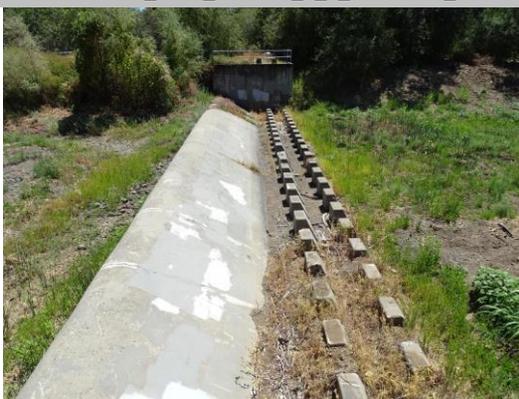
Photo 5 of 5 : ST\_2020\_NA0060\_9\_1\_20200805\_00023.jpg

View of the Little Chico Weir Structure looking south, 2020.

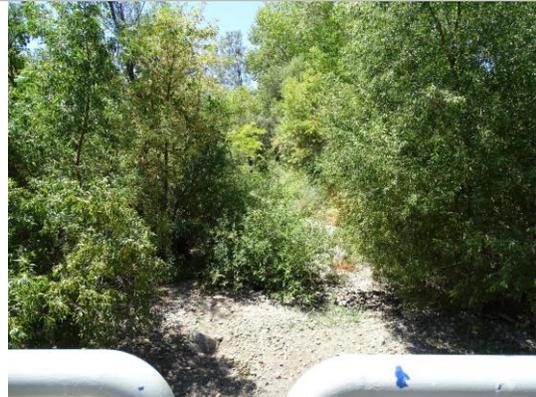
Photo 2 of 3 : ST\_2020\_NA0060\_9\_2\_20200805\_00028.jpg

LM Start	<b>0.00</b>	Rating **	A	Issue No.	<b>2 (cont)</b>
LM End	<b>0.00</b>	Issue Type +	Ma	Location *	
Category	Structures & Concrete Lined Channels			GPS Latitude/Longitude	
				Start	End
Item	Vegetation & Obstructions			39.733555 °	39.733555 °
				-121.771772 °	-121.771772 °
DWR ID	DWR_NA0060_9_t_2012_2				
Action/Comments					
Inspector Comments: Any unwanted vegetation should be removed before winter but currently will not impede flow, 2020.

This is a view looking downstream from the control structure at the vegetation, 2020.

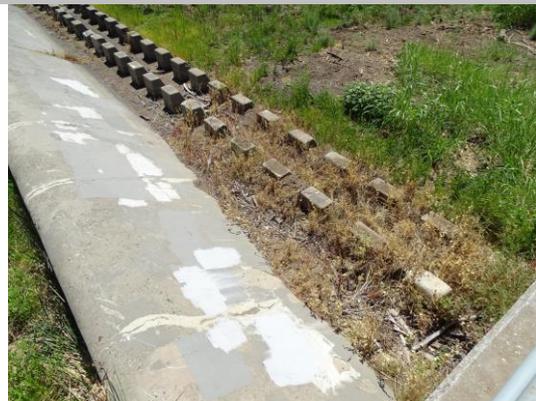
Photo 3 of 3 : ST\_2020\_NA0060\_9\_2\_20200805\_00029.jpg

This is a view looking downstream from the weir at the vegetation, 2020.

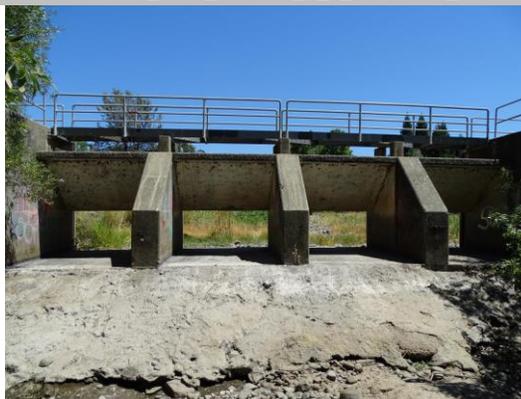
Photo 1 of 1 : ST\_2020\_NA0060\_9\_7\_20200805\_00031.jpg

LM Start	<b>0.00</b>	Rating **	A	Issue No.	<b>7</b>
LM End	<b>0.00</b>	Issue Type +	Ma	Location *	
Category	Structures & Concrete Lined Channels		GPS Latitude/Longitude		
			Start	End	
Item	Culverts: Inlets / Outlets		39.733555 °	39.733555 °	
			-121.771772 °	-121.771772 °	
DWR ID	DWR_NA0060_9_t_2012_7				
Action/Comments					
Inspector Comments: Inlets and outlets are clear of obstructions, 2020.

View of culverts clear of obstructions, 2020.

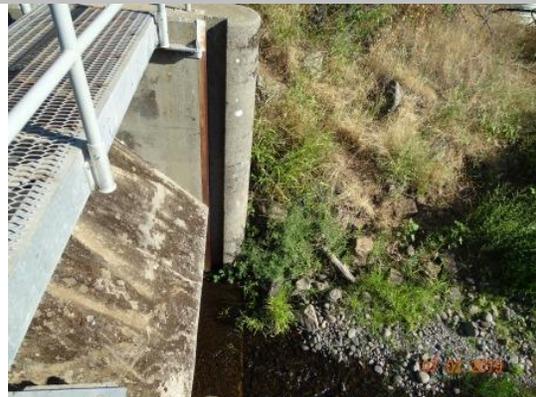
Photo 1 of 2 : ST\_2020\_NA0060\_9\_12\_20200727\_00014.jpg

LM Start	<b>0.00</b>	Rating **	A	Issue No.	<b>12</b>
LM End	<b>0.00</b>	Issue Type +	Ma	Location *	
Category	Structures & Concrete Lined Channels		GPS Latitude/Longitude		
			Start	End	
Item	Sluice/Slide Gates		39.733555 °	39.733555 °	
			-121.771772 °	-121.771772 °	
DWR ID	DWR_NA0060_9_t_2012_12				
Action/Comments					
Inspector Comments: The two sluice gates on either end of the control structure are in good condition, 2020.

View of the two sluice gates on either end of the control structure, 2019.

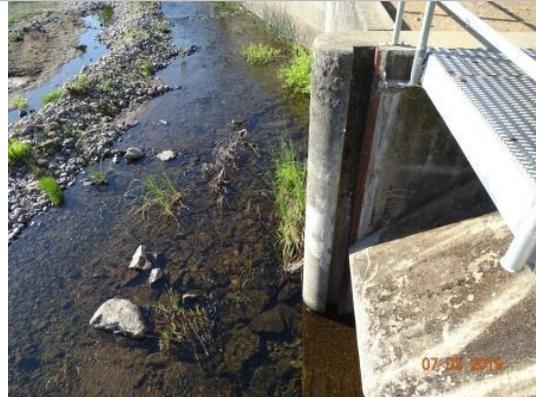
Photo 2 of 2 : ST\_2020\_NA0060\_9\_12\_20200727\_00015.jpg

LM Start	<b>0.00</b>	Rating **	A	Issue No.	<b>12 (cont)</b>
LM End	<b>0.00</b>	Issue Type +	Ma	Location *	
Category	Structures & Concrete Lined Channels		GPS Latitude/Longitude		
			Start	End	
Item	Sluice/Slide Gates		39.733555 °	39.733555 °	
			-121.771772 °	-121.771772 °	
DWR ID	DWR_NA0060_9_t_2012_12				
Action/Comments					
Inspector Comments: The two sluice gates on either end of the control structure are in good condition, 2020.

View of the two sluice gates on either end of the control structure, 2019.

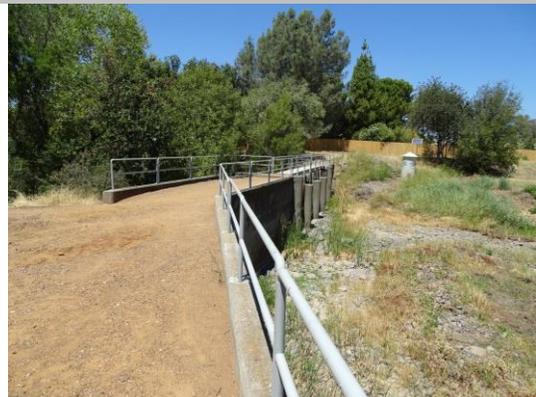
Photo 1 of 2 : ST\_2020\_NA0060\_9\_23\_20200805\_00033.jpg

LM Start	<b>0.00</b>	Rating **	A	Issue No.	<b>23</b>
LM End	<b>0.00</b>	Issue Type +	Ma	Location *	
Category	Structures & Concrete Lined Channels		GPS Latitude/Longitude		
			Start	End	
Item	Safety		39.733555 °	39.733555 °	
			-121.771772 °	-121.771772 °	
DWR ID	DWR_NA0060_9_t_2012_23				
Action/Comments					
Inspector Comments: Hand rails are installed and are in good condition, 2020.

Hand rails are installed and are in good condition, 2020.

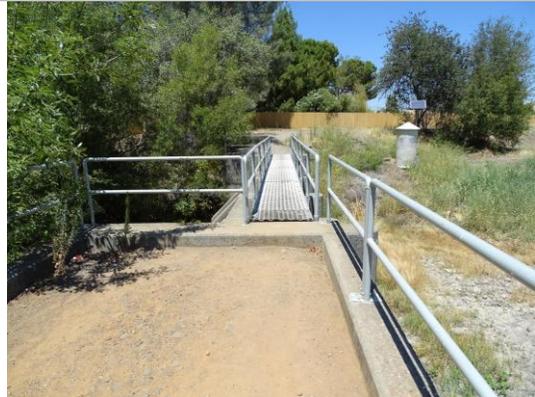
Photo 2 of 2 : ST\_2020\_NA0060\_9\_23\_20200805\_00034.jpg

LM Start	<b>0.00</b>	Rating **	A	Issue No.	<b>23 (cont)</b>
LM End	<b>0.00</b>	Issue Type +	Ma	Location *	
Category	Structures & Concrete Lined Channels		GPS Latitude/Longitude		
			Start	End	
Item	Safety		39.733555 °	39.733555 °	
			-121.771772 °	-121.771772 °	
DWR ID	DWR_NA0060_9_t_2012_23				
Action/Comments					
Inspector Comments: Hand rails are installed and are in good condition, 2020.

Hand rails are installed and are in good condition, 2020.

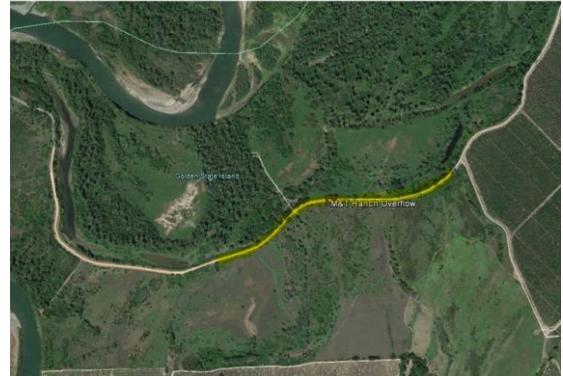
Photo 1 of 3 : ST\_2020\_NA0060\_228\_1\_20200616\_00001.jpg

LM Start	<b>0.00</b>	Rating **	N	Issue No.	<b>1</b>
LM End	<b>0.00</b>	Issue Type +	Ma	Location *	WS
Category	Structures & Concrete Lined Channels		GPS Latitude/Longitude		
			Start	End	
Item	Photo Documentation		39.671973 °	39.671973 °	
			-121.953475 °	-121.953475 °	
DWR ID	DWR_NA0014_228_t_2013_1				
Action/Comments					
Inspector Comments: Per Sutter Yard, the temporary berm on the upstream side of the structure was placed to divert the flow for the restoration project. The berm requires no maintenance and will erode naturally.

The structure location is highlighted and is shown in relation to the Sacramento River.

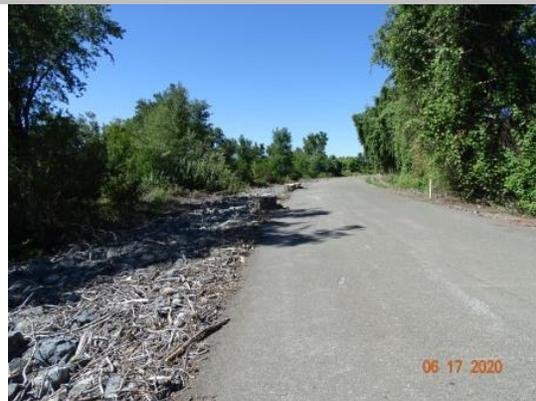
Photo 2 of 3 : ST\_2020\_NA0060\_228\_1\_20200618\_00008.jpg

Typical view of the structure.

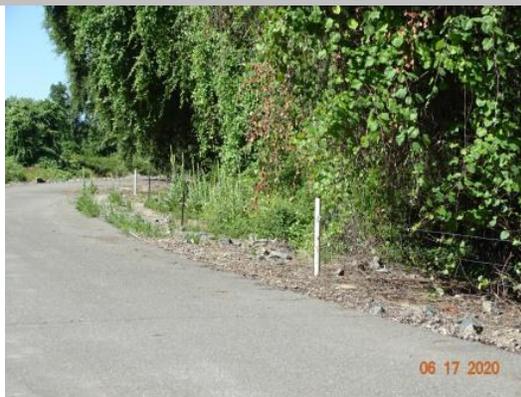
Photo 1 of 1 : ST\_2020\_NA0060\_228\_6\_20200618\_00011.jpg

LM Start	<b>0.00</b>	Rating **	M	Issue No.	<b>6</b>
LM End	<b>0.00</b>	Issue Type +	En	Location *	WS
Category	Structures & Concrete Lined Channels		GPS Latitude/Longitude		
			Start	End	
Item	Encroachments		39.671973 °	39.671973 °	
			-121.953475 °	-121.953475 °	
DWR ID	DWR_NA0014_228_t_2013_6				
Action/Comments

View of the electrical wire fence encroachment on the upstream side of the structure.

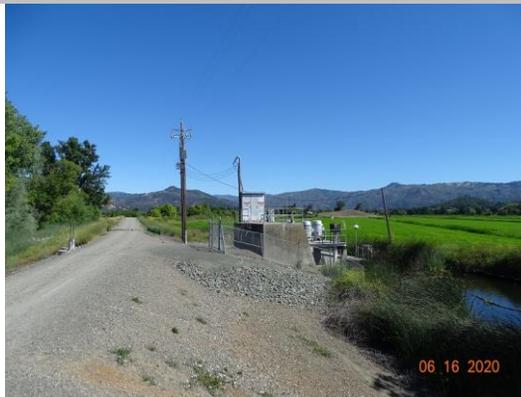
Photo 1 of 2 : ST\_2020\_NA0060\_17\_3\_20200617\_00012.jpg

LM Start	<b>0.00</b>	Rating **	M	Issue No.	<b>3</b>
LM End	<b>0.00</b>	Issue Type +	Ma	Location *	
Category	Pump Stations		GPS Latitude/Longitude		
			Start	End	
Item	Plant Building		39.142300 °	39.142300 °	
			-122.902350 °	-122.902350 °	
DWR ID	DWR_NA0060_17_t_2012_3				
Action/Comments					
Inspector Comments: The plant building was in good structural condition with no major cracks that could threaten the integrity of the building. The adjacent structure has some differential settlement that has been stable for the last few years.

View of the pumping plant. Summer 2020.

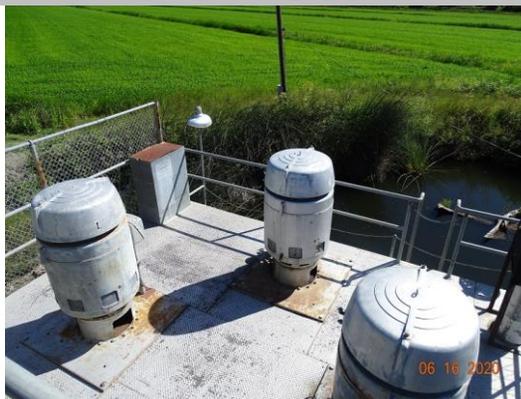
Photo 1 of 1 : ST\_2020\_NA0060\_17\_7\_20200617\_00014.jpg

LM Start	<b>0.00</b>	Rating **	A	Issue No.	<b>7</b>
LM End	<b>0.00</b>	Issue Type +	Ma	Location *	
Category	Pump Stations		GPS Latitude/Longitude		
			Start	End	
Item	Pumps		39.142300 °	39.142300 °	
			-122.902350 °	-122.902350 °	
DWR ID	DWR_NA0060_17_t_2012_7				
Action/Comments					
Inspector Comments: The pumps appeared to be in good working condition and properly maintained including proper lubrication level.

View of the pumps. Summer 2020.

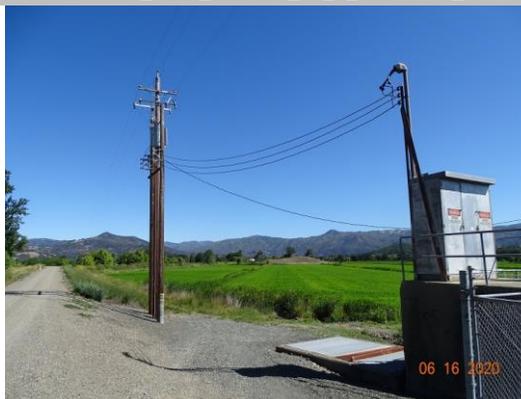
Photo 1 of 1 : ST\_2020\_NA0060\_17\_8\_20200617\_00015.jpg

LM Start	<b>0.00</b>	Rating **	A	Issue No.	<b>8</b>
LM End	<b>0.00</b>	Issue Type +	Ma	Location *	
Category	Pump Stations		GPS Latitude/Longitude		
			Start	End	
Item	Power		39.142300 °	39.142300 °	
			-122.902350 °	-122.902350 °	
DWR ID	DWR_NA0060_17_t_2012_8				
Action/Comments					
Inspector Comments: The power source appears to be reliable and safe.

View of the powerlines that supply power to the plant. Summer 2020.

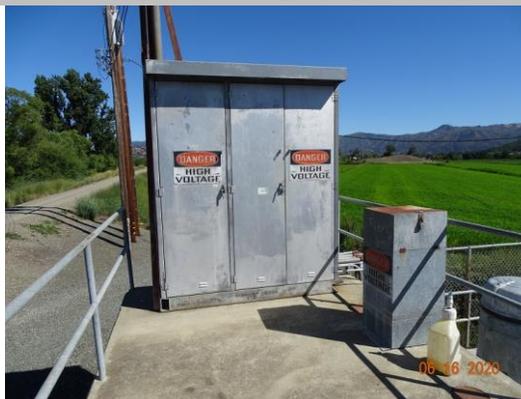
Photo 1 of 1 : ST\_2020\_NA0060\_17\_11\_20200617\_00016.jpg

LM Start	<b>0.00</b>	Rating **	A	Issue No.	<b>11</b>
LM End	<b>0.00</b>	Issue Type +	Ma	Location *	
Category	Pump Stations		GPS Latitude/Longitude		
			Start	End	
Item	Pump Control Systems		39.142300 °	39.142300 °	
			-122.902350 °	-122.902350 °	
DWR ID	DWR_NA0060_17_t_2020_11				
Action/Comments					
Inspector Comments: The pump control systems appeared to be operational and free of damage.

View of the pump control housing. Summer 2020.

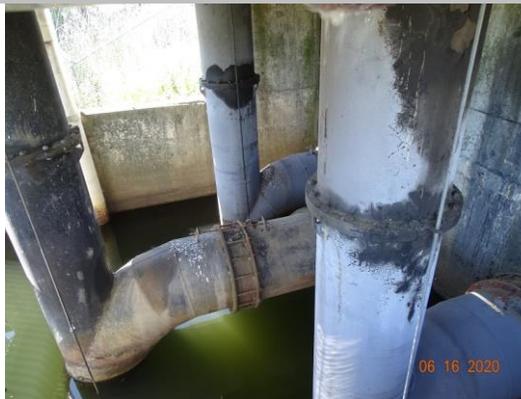
Photo 1 of 1 : ST\_2020\_NA0060\_17\_12\_20200617\_00018.jpg

LM Start	<b>0.00</b>	Rating **	A	Issue No.	<b>12</b>
LM End	<b>0.00</b>	Issue Type +	Ma	Location *	
Category	Pump Stations		GPS Latitude/Longitude		
			Start	End	
Item	Sumps/Wet Well		39.142300 °	39.142300 °	
			-122.902350 °	-122.902350 °	
DWR ID	DWR_NA0060_17_t_2013_12				
Action/Comments					
Inspector Comments: Wet wells were clear of debris.

View of the wet well and intake pumps. Summer 2020.

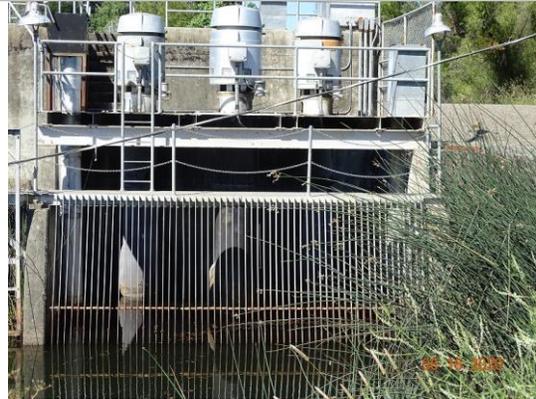
Photo 1 of 1 : ST\_2020\_NA0060\_17\_13\_20200617\_00019.jpg

LM Start	<b>0.00</b>	Rating **	A	Issue No.	<b>13</b>
LM End	<b>0.00</b>	Issue Type +	Ma	Location *	
Category	Pump Stations		GPS Latitude/Longitude		
			Start	End	
Item	Trash Racks		39.142300 °	39.142300 °	
			-122.902350 °	-122.902350 °	
DWR ID	DWR_NA0060_17_t_2012_13				
Action/Comments					
Inspector Comments: Trash racks appeared to be in good condition and free of debris.

View of the trash racks. Summer 2020.

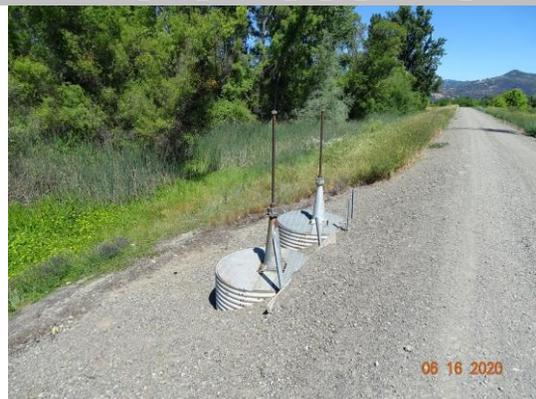
Photo 1 of 1 : ST\_2020\_NA0060\_17\_15\_20200617\_00020.jpg

LM Start	<b>0.00</b>	Rating **	A	Issue No.	<b>15</b>
LM End	<b>0.00</b>	Issue Type +	Ma	Location *	
Category	Pump Stations		GPS Latitude/Longitude		
			Start	End	
Item	Sluice / Slide Gates		39.142300 °	39.142300 °	
			-122.902350 °	-122.902350 °	
DWR ID	DWR_NA0060_17_t_2013_15				
Action/Comments					
Inspector Comments: The slide gates are in good working condition.

View of the slide gates. Summer 2020.

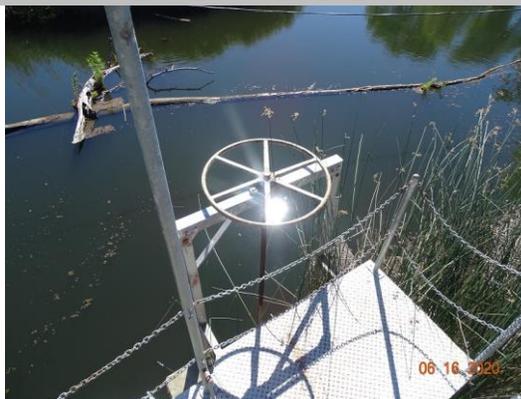
Photo 1 of 2 : ST\_2020\_NA0060\_17\_17\_20200617\_00022.jpg

LM Start	<b>0.00</b>	Rating **	A	Issue No.	<b>17</b>
LM End	<b>0.00</b>	Issue Type +	Ma	Location *	
Category	Pump Stations		GPS Latitude/Longitude		
			Start	End	
Item	Manual Gate Operators		39.142300 °	39.142300 °	
			-122.902350 °	-122.902350 °	
DWR ID	DWR_NA0060_17_t_2012_17				
Action/Comments					
Inspector Comments: The manual gate operators are in good working condition.

View of a manual gate operator. Summer 2020.

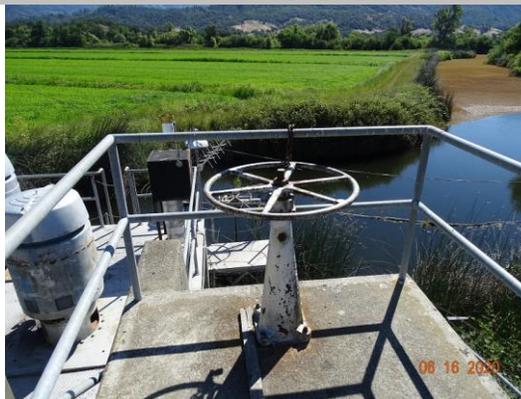
Photo 2 of 2 : ST\_2020\_NA0060\_17\_17\_20200617\_00023.jpg

View of the second manual gate operator. Summer 2020.

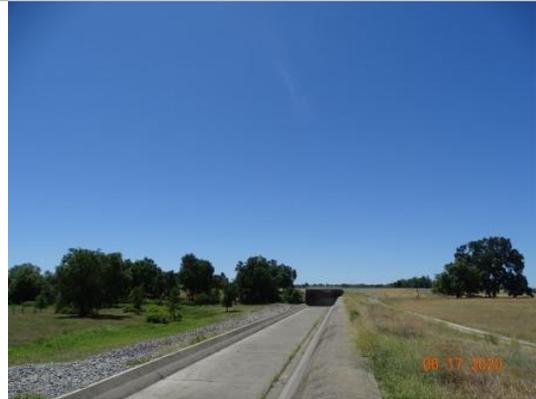
Photo 1 of 6 : ST\_2020\_NA0060\_4\_1\_20200618\_00017.jpg

View of the weir from the left bank abutment.

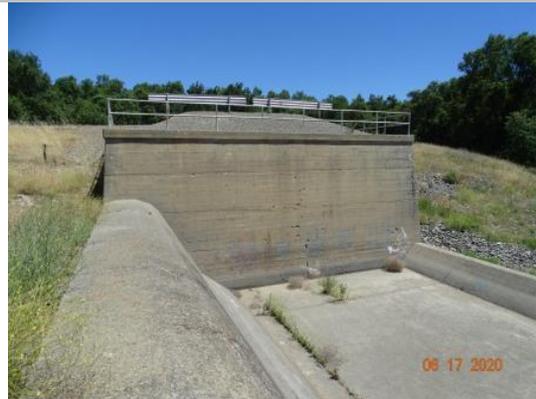
Photo 2 of 6 : ST\_2020\_NA0060\_4\_1\_20200618\_00021.jpg

View of the left bank abutment.

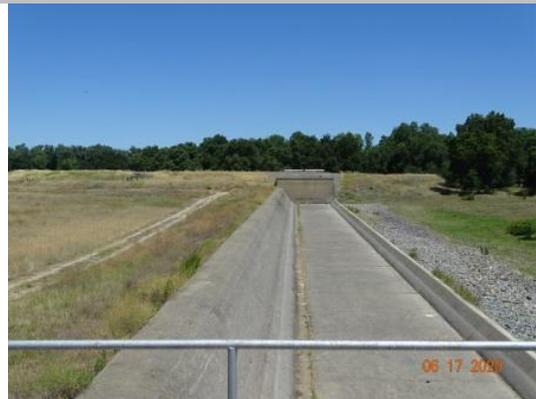
Photo 3 of 6 : ST\_2020\_NA0060\_4\_1\_20200618\_00018.jpg

View of the weir from the right bank abutment.

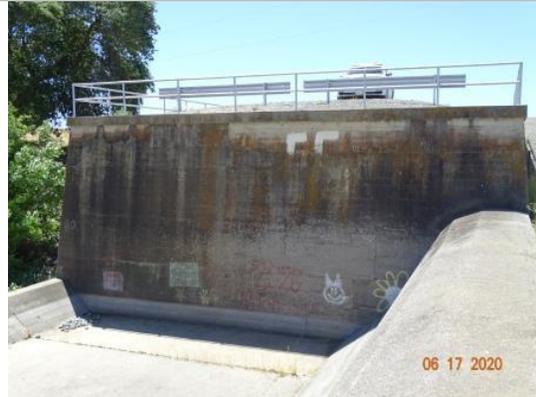
Photo 4 of 6 : ST\_2020\_NA0060\_4\_1\_20200618\_00022.jpg

View of the right bank abutment.

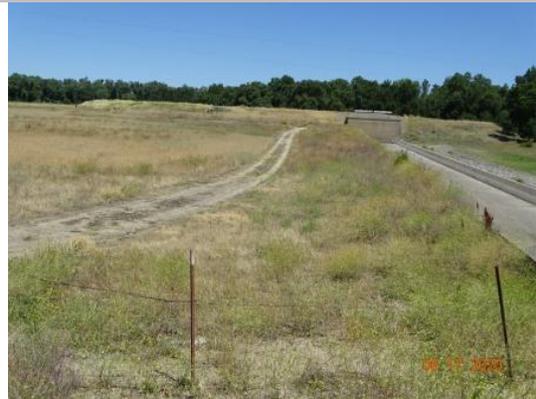
Photo 5 of 6 : ST\_2020\_NA0060\_4\_1\_20200618\_00019.jpg

View of the upstream of the weir from the right bank.

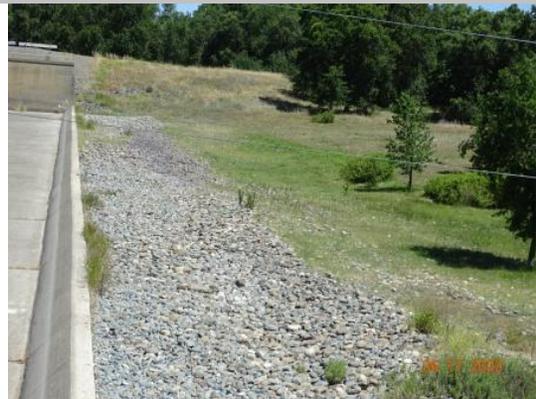
Photo 6 of 6 : ST\_2020\_NA0060\_4\_1\_20200618\_00020.jpg

View of the downstream of the weir from the right bank.

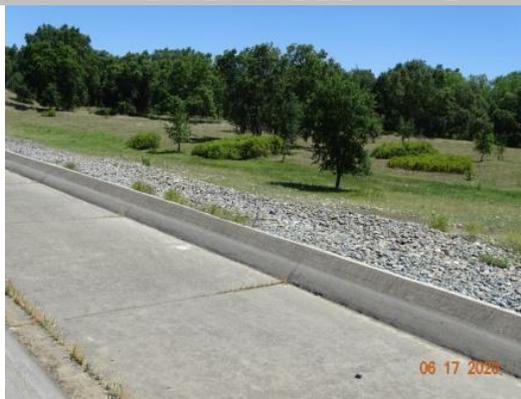
Photo 1 of 1 : ST\_2020\_NA0060\_4\_5\_20200618\_00023.jpg

LM Start	<b>0.00</b>	Rating **	A	Issue No.	<b>5</b>
LM End	<b>0.00</b>	Issue Type +	Ma	Location *	
Category	Structures & Concrete Lined Channels		GPS Latitude/Longitude		
			Start	End	
Item	Revetments		39.338242 °	39.338242 °	
			-122.022073 °	-122.022073 °	
DWR ID	DWR_NA0060_4_t_2012_5				
Action/Comments					
Inspector Comments: Existing riprap protection is properly maintained and is undamaged. Riprap clearly visible.

View of the revetment along the downstream side of the weir.

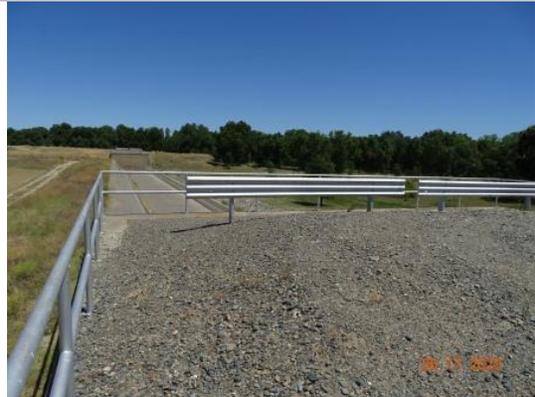
Photo 1 of 1 : ST\_2020\_NA0060\_4\_23\_20200618\_00026.jpg

LM Start	<b>0.00</b>	Rating **	A	Issue No.	<b>23</b>
LM End	<b>0.00</b>	Issue Type +	Ma	Location *	
Category	Structures & Concrete Lined Channels		GPS Latitude/Longitude		
			Start	End	
Item	Safety		39.338242 °	39.338242 °	
			-122.022073 °	-122.022073 °	
DWR ID	DWR_NA0060_4_t_2012_23				
Action/Comments					
Inspector Comments: Adequate protection for fall hazards exist. No hazardous conditions that might affect the operation of the structure exist.

View of the safety and guard railing around the right bank abutment.

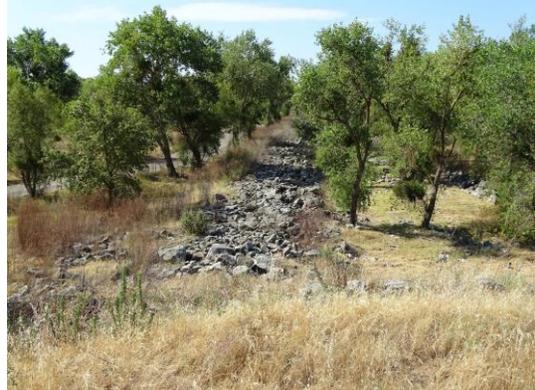
Photo 1 of 2 : ST\_2020\_NA0060\_54\_1\_20200727\_00001.jpg

View looking south of Nelson Bend Rock Quarry Weir, 2020.

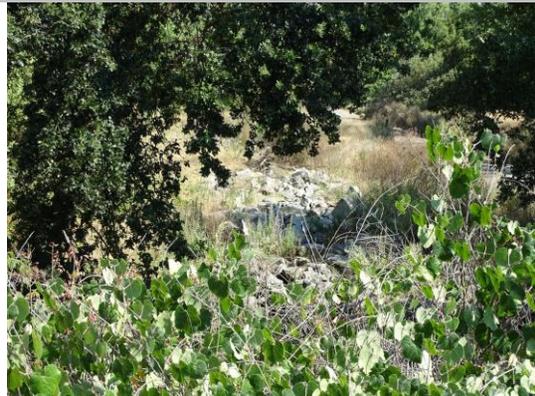
Photo 2 of 2 : ST\_2020\_NA0060\_54\_1\_20200727\_00002.jpg

View looking north of Nelson Bend Rock Quarry Weir, 2020.

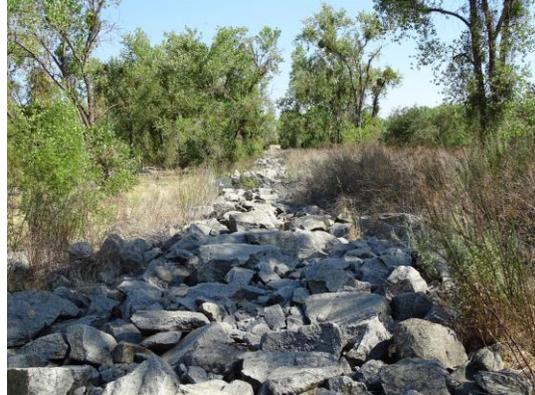
Photo 2 of 3 : ST\_2020\_NA0060\_54\_2\_20200727\_00004.jpg

LM Start	<b>0.00</b>	Rating **	U	Issue No.	<b>2 (cont)</b>
LM End	<b>0.00</b>	Issue Type +	Ma	Location *	
Category	Structures & Concrete Lined Channels		GPS Latitude/Longitude		
			Start	End	
Item	Vegetation & Obstructions		38.895500 °	38.887450 °	
			-121.616950 °	-121.615330 °	
DWR ID	DWR_NA0060_54_t_2012_2				
Action/Comments					
Inspector Comments: There is scattered obstructions or vegetation. The vegetation should be cleared and trees trimmed up. Flows will be Impeded in a high water event.

View of the vegetation that is overgrowing the rock weir looking north, 2020.

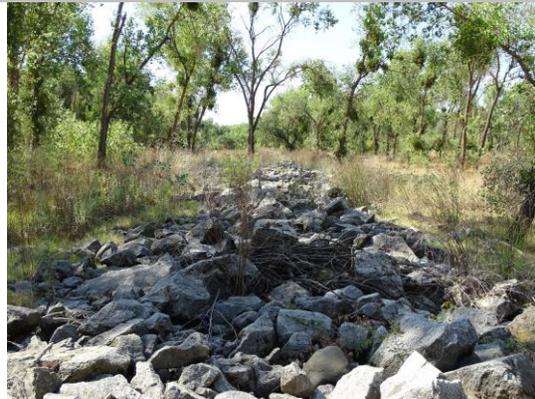
Photo 3 of 3 : ST\_2020\_NA0060\_54\_2\_20200727\_00005.jpg

LM Start	<b>0.00</b>	Rating **	U	Issue No.	<b>2 (cont)</b>
LM End	<b>0.00</b>	Issue Type +	Ma	Location *

View of the vegetation around the rock weir looking downstream, 2020.

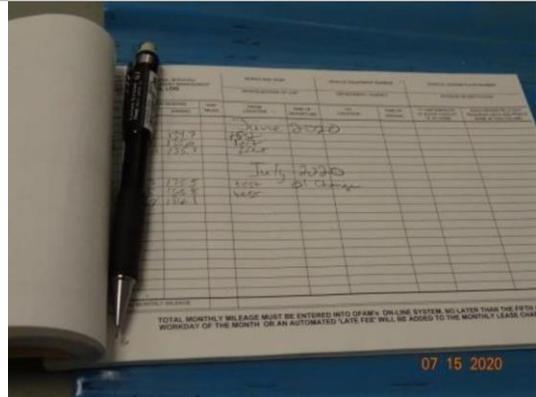
Photo 1 of 2 : ST\_2020\_NA0060\_21\_1\_20200716\_00030.jpg

LM Start	<b>0.00</b>	Rating **	A	Issue No.	<b>1</b>
LM End	<b>0.00</b>	Issue Type +	Ma	Location *	
Category	Pump Stations		GPS Latitude/Longitude		
			Start	End	
Item	Operating Log		38.931815 °	38.931815 °	
			-121.634331 °	-121.634331 °	
DWR ID	DWR_NA0060_21_t_2012_1				
Action/Comments					
Inspector Comments: The operating log is kept on site.

Operating log (Summer 2020).

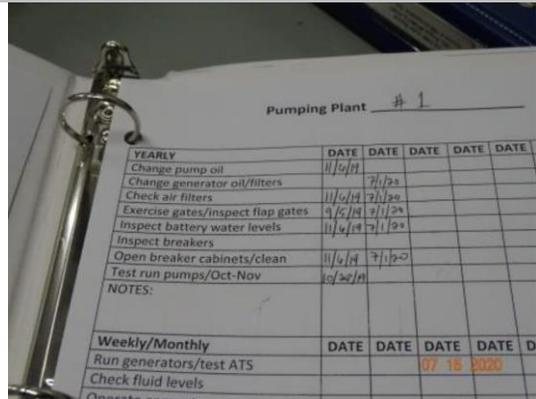
Photo 2 of 2 : ST\_2020\_NA0060\_21\_1\_20200716\_00031.jpg

Maintenance log (Summer 2020).

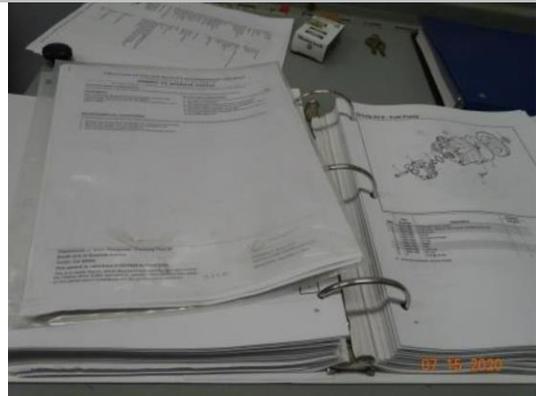
Photo 1 of 1 : ST\_2020\_NA0060\_21\_2\_20200716\_00032.jpg

LM Start	<b>0.00</b>	Rating **	A	Issue No.	<b>2</b>
LM End	<b>0.00</b>	Issue Type +	Ma	Location *	
Category	Pump Stations		GPS Latitude/Longitude		
			Start	End	
Item	Operation & Maintenance Manual		38.931815 °	38.931815 °	
			-121.634331 °	-121.634331 °	
DWR ID	DWR_NA0060_21_t_2012_2				
Action/Comments					
Inspector Comments: The O&M manual is available at the site.

O&M Manual (Summer 2020).

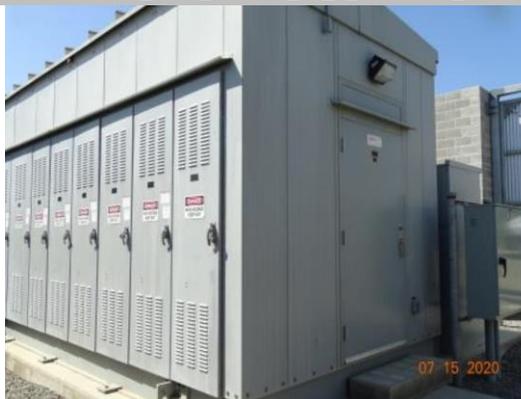
Photo 1 of 1 : ST\_2020\_NA0060\_21\_3\_20200716\_00034.jpg

LM Start	<b>0.00</b>	Rating **	A	Issue No.	<b>3</b>
LM End	<b>0.00</b>	Issue Type +	Ma	Location *	
Category	Pump Stations		GPS Latitude/Longitude		
			Start	End	
Item	Plant Building		38.931815 °	38.931815 °	
			-121.634331 °	-121.634331 °	
DWR ID	DWR_NA0060_21_t_2012_3				
Action/Comments					
Inspector Comments: Plant building appears to be in good working order.

View of control room (Summer 2020).

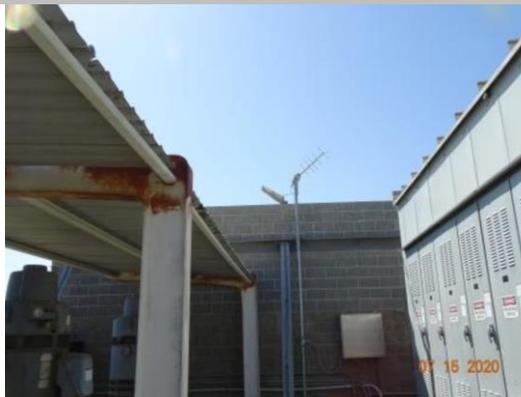
Photo 1 of 2 : ST\_2020\_NA0060\_21\_4\_20200716\_00035.jpg

LM Start	<b>0.00</b>	Rating **	A	Issue No.	<b>4</b>
LM End	<b>0.00</b>	Issue Type +	Ma	Location *	
Category	Pump Stations		GPS Latitude/Longitude		
			Start	End	
Item	Communications		38.931815 °	38.931815 °	
			-121.634331 °	-121.634331 °	
DWR ID	DWR_NA0060_21_t_2012_4				
Action/Comments					
Inspector Comments: Cell phones and two-way radios are available to pump station operators. The remote control operating system (SCADA) appears to be operational. Satellite dish and antenna communicate real-time plant data.

View of data broadcasting antennae (Summer 2020).

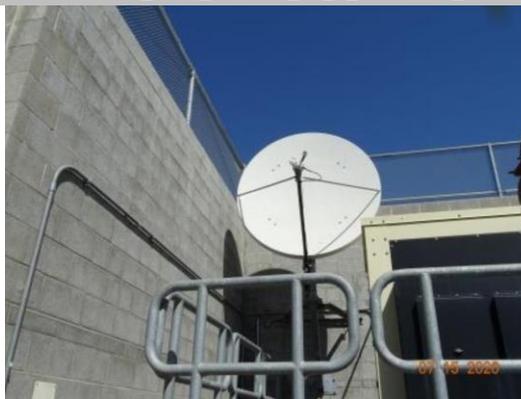
Photo 2 of 2 : ST\_2020\_NA0060\_21\_4\_20200716\_00036.jpg

View of data broadcasting satellite dish (Summer 2020).

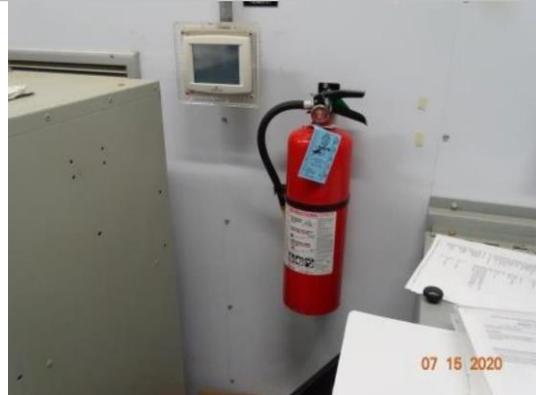
Photo 1 of 5 : ST\_2020\_NA0060\_21\_5\_20200716\_00025.jpg

LM Start	<b>0.00</b>	Rating **	A	Issue No.	<b>5</b>
LM End	<b>0.00</b>	Issue Type +	Ma	Location *	
Category	Pump Stations			GPS Latitude/Longitude	
				Start	End
Item	Safety			38.931815 °	38.931815 °
				-121.634331 °	-121.634331 °
DWR ID	DWR_NA0060_21_t_2012_5				
Action/Comments					
Inspector Comments: All safety gear is in place and in working order.

View of fire extinguisher inside the operating room (Summer 2020).
