**Flood Control Project Maintenance**  
**2020 Structure Summary Report**  
**Overall Unit and Item Ratings**

**DWR Sutter Maintenance Yard**

**Butte Slough Drainage Structure**

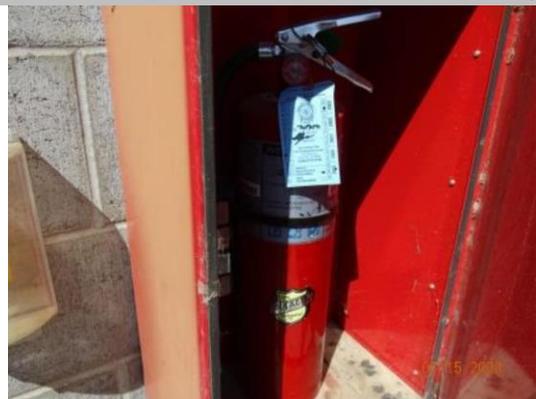
Photo 2 of 5 : ST\_2020\_NA0060\_21\_5\_20200716\_00026.jpg

View of fire extinguisher next to facility entrance (Summer 2020).

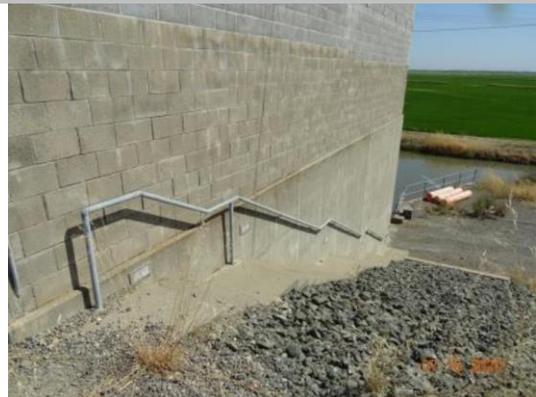
Photo 3 of 5 : ST\_2020\_NA0060\_21\_5\_20200716\_00027.jpg

View of stairway railing along side of facility (Summer 2020).

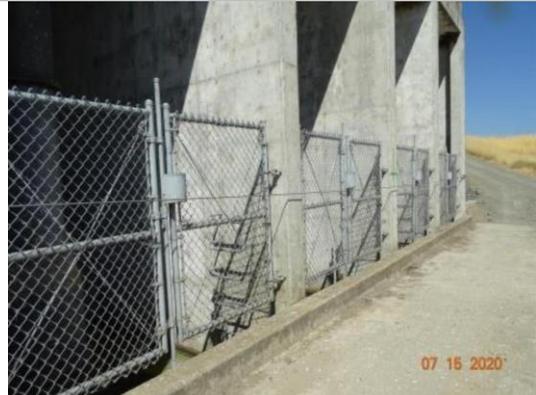
Photo 4 of 5 : ST\_2020\_NA0060\_21\_5\_20200716\_00028.jpg

LM Start	<b>0.00</b>	Rating **	A	Issue No.	<b>5 (cont)</b>
LM End	<b>0.00</b>	Issue Type +	Ma	Location *	
Category	Pump Stations		GPS Latitude/Longitude		
			Start	End	
Item	Safety		38.931815 °	38.931815 °	
			-121.634331 °	-121.634331 °	
DWR ID	DWR_NA0060_21_t_2012_5				
Action/Comments					
Inspector Comments: All safety gear is in place and in working order.

View of fall protection cable hook-in next to wet wells (Summer 2020).

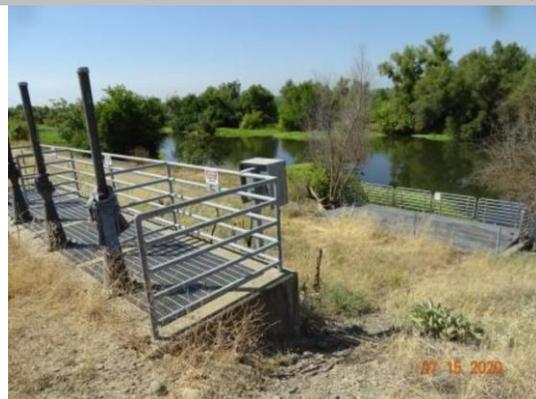
Photo 5 of 5 : ST\_2020\_NA0060\_21\_5\_20200716\_00029.jpg

View of railings next to flap gate grate and manual gate operators (Summer 2020).

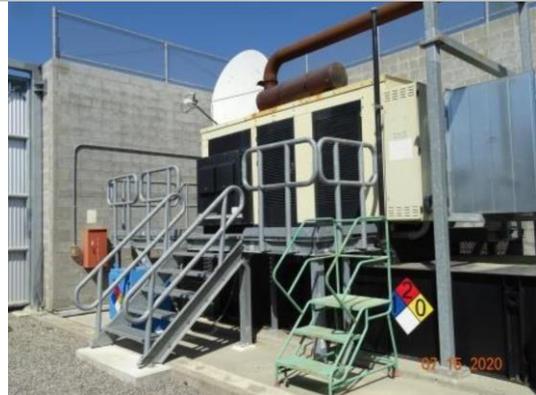
Photo 1 of 1 : ST\_2020\_NA0060\_21\_8\_20200716\_00037.jpg

LM Start	<b>0.00</b>	Rating **	A	Issue No.	<b>8</b>
LM End	<b>0.00</b>	Issue Type +	Ma	Location *	
Category	Pump Stations		GPS Latitude/Longitude		
			Start	End	
Item	Power		38.931815 °	38.931815 °	
			-121.634331 °	-121.634331 °	
DWR ID	DWR_NA0060_21_t_2012_8				
Action/Comments					
Inspector Comments: The structure is on the grid with emergency backup generator.

View of backup generator inside the facility (Summer 2020).

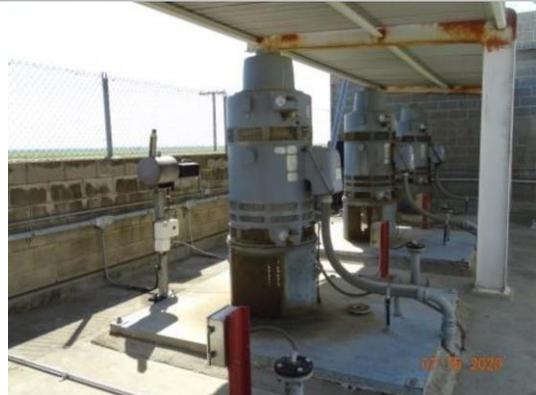
Photo 1 of 2 : ST\_2020\_NA0060\_21\_10\_20200716\_00038.jpg

LM Start	<b>0.00</b>	Rating **	A	Issue No.	<b>10</b>
LM End	<b>0.00</b>	Issue Type +	Ma	Location *	
Category	Pump Stations		GPS Latitude/Longitude		
			Start	End	
Item	Motors, Engines, Fans & Gear Reducers		38.931815 °	38.931815 °	
			-121.634331 °	-121.634331 °	
DWR ID	DWR_NA0060_21_t_2012_10				
Action/Comments					
Inspector Comments: These items appear to be maintained and in operating condition.

View of pump motors (Summer 2020).

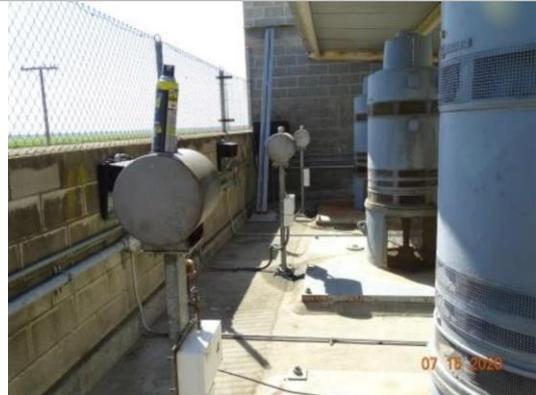
Photo 2 of 2 : ST\_2020\_NA0060\_21\_10\_20200716\_00039.jpg

LM Start	<b>0.00</b>	Rating **	A	Issue No.	<b>10 (cont)</b>
LM End	<b>0.00</b>	Issue Type +	Ma	Location *	
Category	Pump Stations		GPS Latitude/Longitude		
			Start	End	
Item	Motors, Engines, Fans & Gear Reducers		38.931815 °	38.931815 °	
			-121.634331 °	-121.634331 °	
DWR ID	DWR_NA0060_21_t_2012_10				
Action/Comments					
Inspector Comments: These items appear to be maintained and in operating condition.

View of pump oil well (Summer 2020).

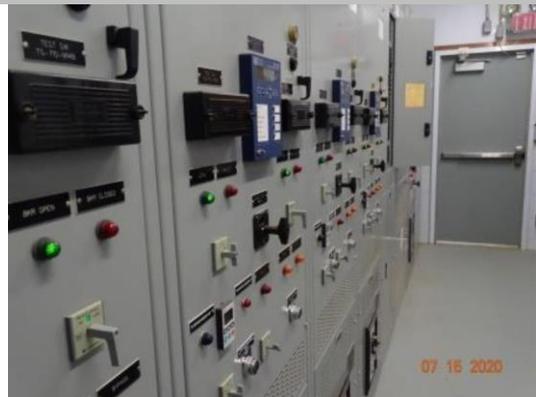
Photo 1 of 1 : ST\_2020\_NA0060\_21\_11\_20200716\_00033.jpg

LM Start	<b>0.00</b>	Rating **	A	Issue No.	<b>11</b>
LM End	<b>0.00</b>	Issue Type +	Ma	Location *	
Category	Pump Stations		GPS Latitude/Longitude		
			Start	End	
Item	Pump Control Systems		38.931815 °	38.931815 °	
			-121.634331 °	-121.634331 °	
DWR ID	DWR_NA0060_21_t_2012_11				
Action/Comments					
Inspector Comments: Pump control systems on site are new and appear to be in working order.

View of pump control panels inside operating room (Summer 2020).

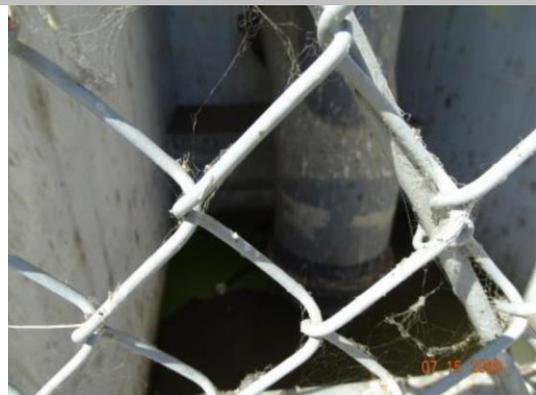
Photo 1 of 1 : ST\_2020\_NA0060\_21\_12\_20200716\_00040.jpg

LM Start	<b>0.00</b>	Rating **	A	Issue No.	<b>12</b>
LM End	<b>0.00</b>	Issue Type +	Ma	Location *	
Category	Pump Stations		GPS Latitude/Longitude		
			Start	End	
Item	Sumps/Wet Well		38.931815 °	38.931815 °	
			-121.634331 °	-121.634331 °	
DWR ID	DWR_NA0060_21_t_2012_12				
Action/Comments					
Inspector Comments: Sumps are clear and free of debris.

View of one of the wet wells. All four wet wells looked like this (Summer 2020).

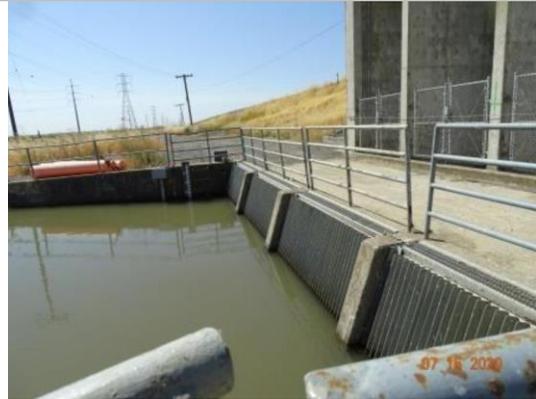
Photo 1 of 1 : ST\_2020\_NA0060\_21\_13\_20200716\_00041.jpg

LM Start	<b>0.00</b>	Rating **	A	Issue No.	<b>13</b>
LM End	<b>0.00</b>	Issue Type +	Ma	Location *	
Category	Pump Stations		GPS Latitude/Longitude		
			Start	End	
Item	Trash Racks		38.931815 °	38.931815 °	
			-121.634331 °	-121.634331 °	
DWR ID	DWR_NA0060_21_t_2012_13				
Action/Comments					
Inspector Comments: No debris present on trash racks, they appear to be in good condition.

View of trash racks (Summer 2020).

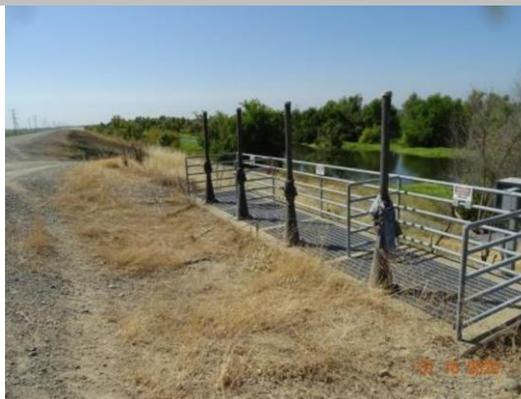
Photo 1 of 1 : ST\_2020\_NA0060\_21\_17\_20200716\_00042.jpg

LM Start	<b>0.00</b>	Rating **	A	Issue No.	<b>17</b>
LM End	<b>0.00</b>	Issue Type +	Ma	Location *	
Category	Pump Stations		GPS Latitude/Longitude		
			Start	End	
Item	Manual Gate Operators		38.931815 °	38.931815 °	
			-121.634331 °	-121.634331 °	
DWR ID	DWR_NA0060_21_t_2012_17				
Action/Comments					
Inspector Comments: Manual gate operators appear to be in good condition.

View of manual gate operators (Summer 2020).

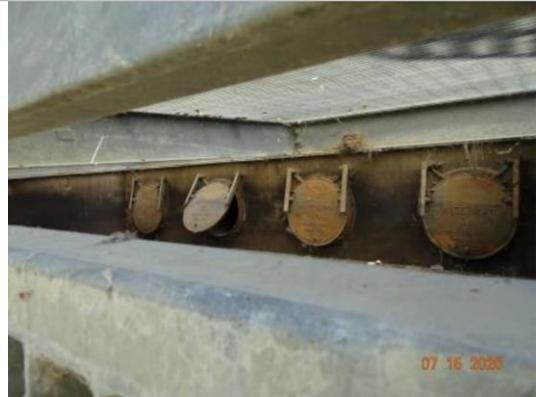
Photo 1 of 1 : ST\_2020\_NA0060\_21\_19\_20200716\_00043.jpg

LM Start	<b>0.00</b>	Rating **	A	Issue No.	<b>19</b>
LM End	<b>0.00</b>	Issue Type +	Ma	Location *	
Category	Pump Stations		GPS Latitude/Longitude		
			Start	End	
Item	Flap Gates		38.931815 °	38.931815 °	
			-121.634331 °	-121.634331 °	
DWR ID	DWR_NA0060_21_t_2012_19				
Action/Comments					
Inspector Comments: Flap gates appear to be in working condition. There are no apparent signs of significant corrosion or damage. All are closed.

View of flap gates (Summer 2020).

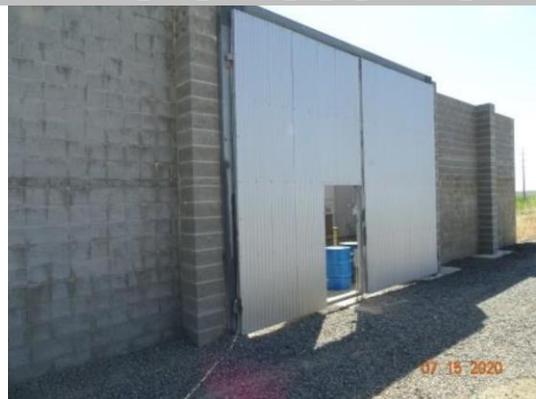
Photo 1 of 1 : ST\_2020\_NA0060\_21\_21\_20200716\_00044.jpg

LM Start	<b>0.00</b>	Rating **	A	Issue No.	<b>21</b>
LM End	<b>0.00</b>	Issue Type +	Ma	Location *	
Category	Pump Stations		GPS Latitude/Longitude		
			Start	End	
Item	Security Fencing		38.931815 °	38.931815 °	
			-121.634331 °	-121.634331 °	
DWR ID	DWR_NA0060_21_t_2012_21				
Action/Comments					
Inspector Comments: Site is secured by a masonry brick wall and steel gate.

View of concrete security fence with additional chainlink fence, and steel security door (Summer 2020).

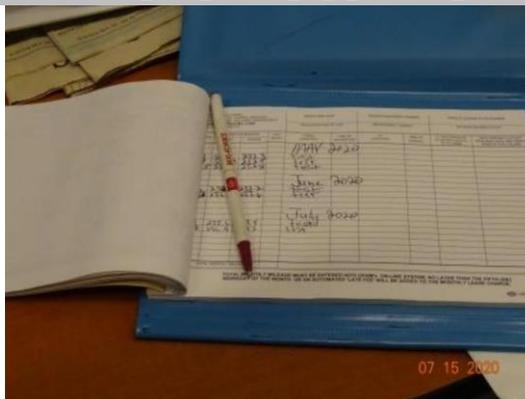
Photo 1 of 2 : ST\_2020\_NA0060\_22\_1\_20200716\_00022.jpg

LM Start	<b>0.00</b>	Rating **	A	Issue No.	<b>1</b>
LM End	<b>0.00</b>	Issue Type +	Ma	Location *	
Category	Pump Stations		GPS Latitude/Longitude		
			Start	End	
Item	Operating Log		39.026449 °	39.026449 °	
			-121.726937 °	-121.726937 °	
DWR ID	DWR_NA0060_22_t_2012_1				
Action/Comments					
Inspector Comments: Operation log and maintenance log located in the control building.

View of operating log (Summer 2020).

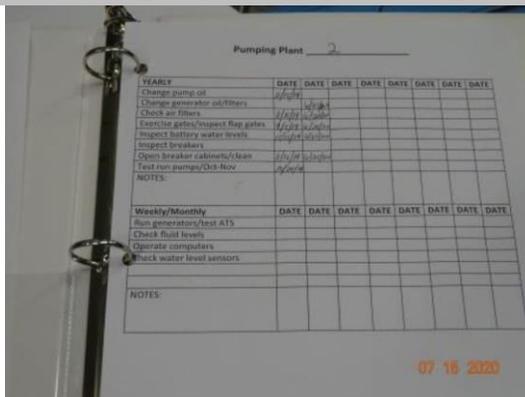
Photo 2 of 2 : ST\_2020\_NA0060\_22\_1\_20200716\_00023.jpg

View of maintenance log (Summer 2020).

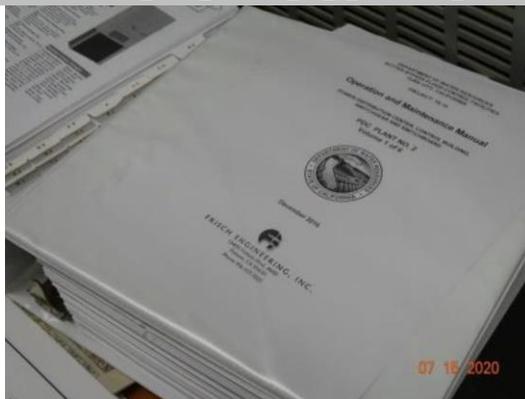
Photo 1 of 1 : ST\_2020\_NA0060\_22\_2\_20200716\_00024.jpg

LM Start	<b>0.00</b>	Rating **	A	Issue No.	<b>2</b>
LM End	<b>0.00</b>	Issue Type +	Ma	Location *	
Category	Pump Stations		GPS Latitude/Longitude		
			Start	End	
Item	Operation & Maintenance Manual		39.026449 °	39.026449 °	
			-121.726937 °	-121.726937 °	
DWR ID	DWR_NA0060_22_t_2012_2				
Action/Comments					
Inspector Comments: O&M Manual is present in the control building.

View of O&M Manual (Summer 2020).

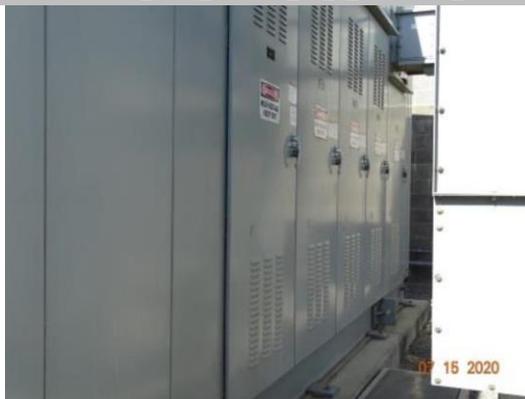
Photo 1 of 1 : ST\_2020\_NA0060\_22\_3\_20200716\_00025.jpg

LM Start	<b>0.00</b>	Rating **	A	Issue No.	<b>3</b>
LM End	<b>0.00</b>	Issue Type +	Ma	Location *	
Category	Pump Stations		GPS Latitude/Longitude		
			Start	End	
Item	Plant Building		39.026449 °	39.026449 °	
			-121.726937 °	-121.726937 °	
DWR ID	DWR_NA0060_22_t_2012_3				
Action/Comments					
Inspector Comments: Plant building appears to be in working order.

View of outside of pump operating building (Summer 2020).

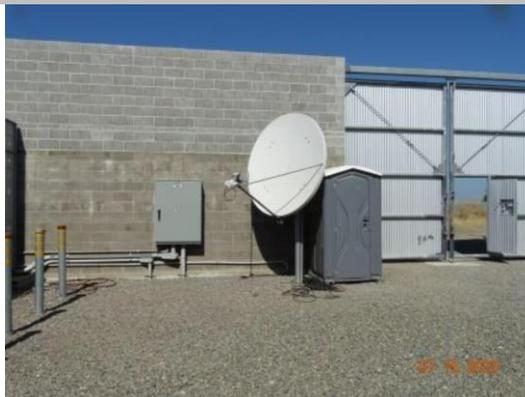
Photo 1 of 2 : ST\_2020\_NA0060\_22\_4\_20200716\_00026.jpg

LM Start	<b>0.00</b>	Rating **	A	Issue No.	<b>4</b>
LM End	<b>0.00</b>	Issue Type +	Ma	Location *	
Category	Pump Stations		GPS Latitude/Longitude		
			Start	End	
Item	Communications		39.026449 °	39.026449 °	
			-121.726937 °	-121.726937 °	
DWR ID	DWR_NA0060_22_t_2012_4				
Action/Comments					
Inspector Comments: Operator has two-way radio and cellular phone available to them. The remote control operating system (SCADA) appears to be operational. Satellite dish and antenna communicate real-time plant data.

View of data broadcasting satellite dish (Summer 2020).

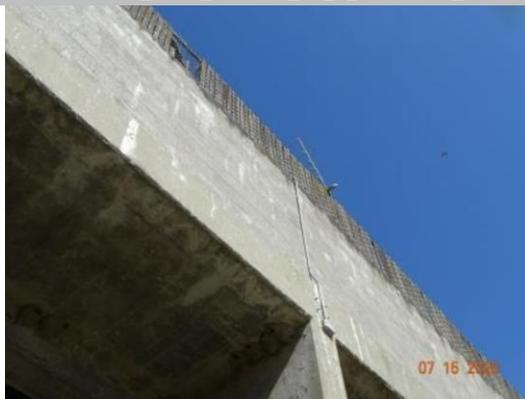
Photo 2 of 2 : ST\_2020\_NA0060\_22\_4\_20200716\_00027.jpg

View of data broadcasting antennae (Summer 2020).

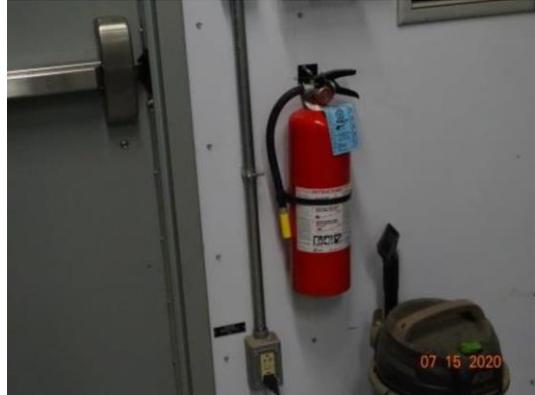
Photo 1 of 6 : ST\_2020\_NA0060\_22\_5\_20200716\_00028.jpg

LM Start	<b>0.00</b>	Rating **	A	Issue No.	<b>5</b>
LM End	<b>0.00</b>	Issue Type +	Ma	Location *	
Category	Pump Stations		GPS Latitude/Longitude		
			Start	End	
Item	Safety		39.026449 °	39.026449 °	
			-121.726937 °	-121.726937 °	
DWR ID	DWR_NA0060_22_t_2019_5				
Action/Comments					
Inspector Comments: The site has fire extinguishers on site and fall protection rails. Gates have been installed to limit access to pump inlet. Railings above trash racks are in the process of installation.

View of fire extinguisher inside operating building (Summer 2020).

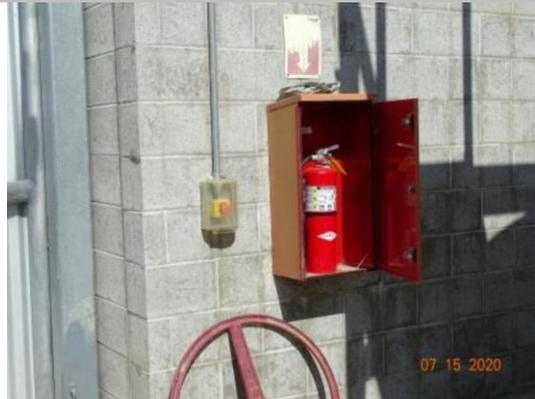
Photo 2 of 6 : ST\_2020\_NA0060\_22\_5\_20200716\_00029.jpg

View of fire extinguisher next to facility entrance (Summer 2020).

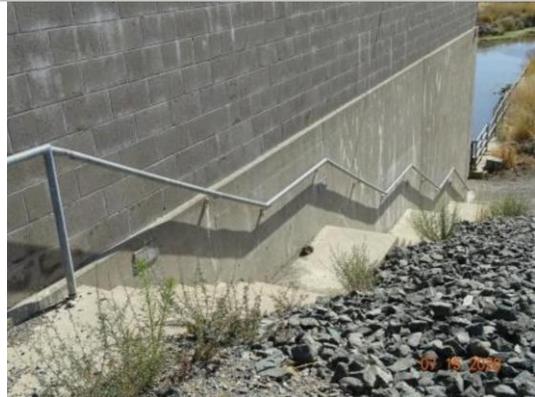
Photo 3 of 6 : ST\_2020\_NA0060\_22\_5\_20200716\_00030.jpg

View of stair railing down to pump inlet (Summer 2020).

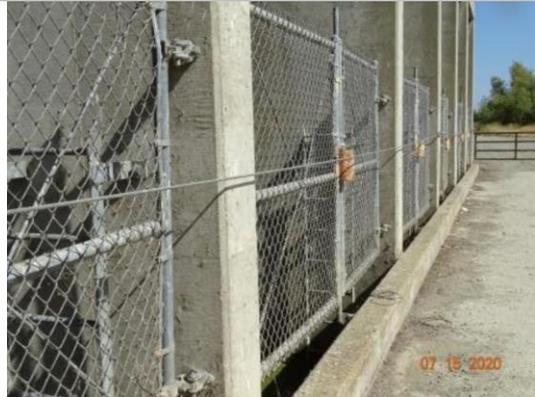
Photo 4 of 6 : ST\_2020\_NA0060\_22\_5\_20200716\_00031.jpg

LM Start	<b>0.00</b>	Rating **	A	Issue No.	<b>5 (cont)</b>
LM End	<b>0.00</b>	Issue Type +	Ma	Location *	
Category	Pump Stations			GPS Latitude/Longitude	
				Start	End
Item	Safety			39.026449 °	39.026449 °
				-121.726937 °	-121.726937 °
DWR ID	DWR_NA0060_22_t_2019_5				
Action/Comments					
Inspector Comments: The site has fire extinguishers on site and fall protection rails. Gates have been installed to limit access to pump inlet. Railings above trash racks are in the process of installation.

View of fall protection cable next to wet wells (Summer 2020).

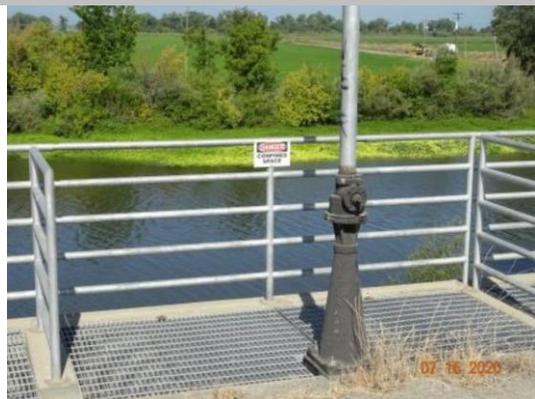
Photo 5 of 6 : ST\_2020\_NA0060\_22\_5\_20200716\_00032.jpg

View of railing and signage next to manual gate operators (Summer 2020).

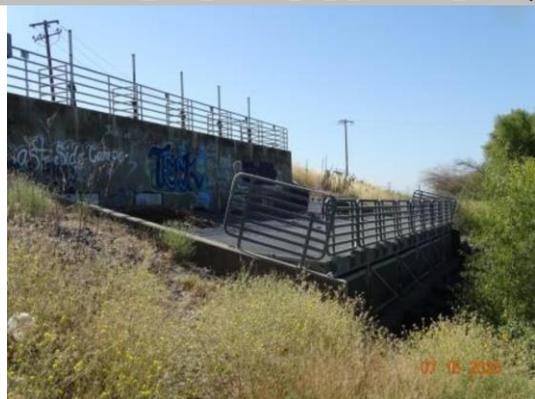
Photo 6 of 6 : ST\_2020\_NA0060\_22\_5\_20200716\_00033.jpg

View of railings above the outlets (Summer 2020).

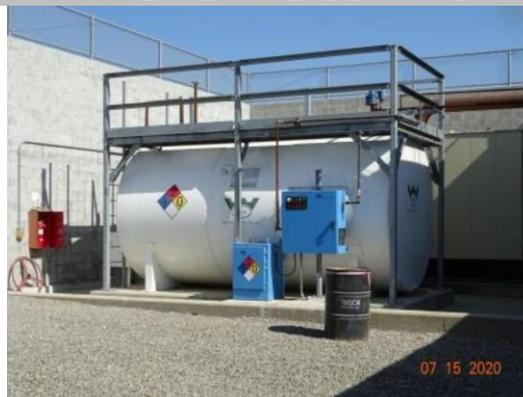
Photo 1 of 2 : ST\_2020\_NA0060\_22\_8\_20200716\_00034.jpg

LM Start	<b>0.00</b>	Rating **	A	Issue No.	<b>8</b>
LM End	<b>0.00</b>	Issue Type +	Ma	Location *	
Category	Pump Stations		GPS Latitude/Longitude		
			Start	End	
Item	Power		39.026449 °	39.026449 °	
			-121.726937 °	-121.726937 °	
DWR ID	DWR_NA0060_22_t_2012_8				
Action/Comments					
Inspector Comments: The structure is on the grid with emergency backup generator.

View of fuel tank for emergency generator (Summer 2020).

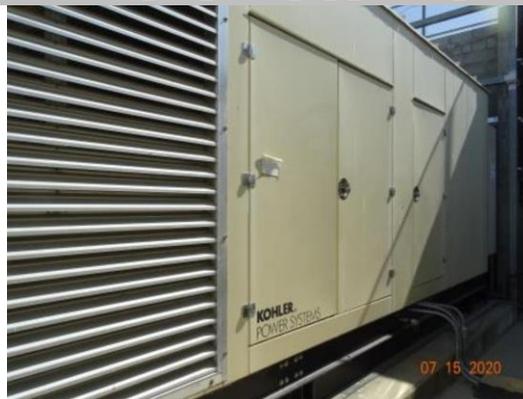
Photo 2 of 2 : ST\_2020\_NA0060\_22\_8\_20200716\_00035.jpg

LM Start	<b>0.00</b>	Rating **	A	Issue No.	<b>8 (cont)</b>
LM End	<b>0.00</b>	Issue Type +	Ma	Location *	
Category	Pump Stations			GPS Latitude/Longitude	
				Start	End
Item	Power			39.026449 °	39.026449 °
				-121.726937 °	-121.726937 °
DWR ID	DWR_NA0060_22_t_2012_8				
Action/Comments					
Inspector Comments: The structure is on the grid with emergency backup generator.

View of emergency generator (Summer 2020).

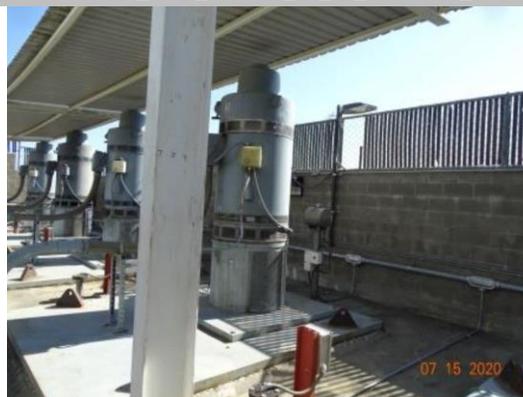
Photo 1 of 2 : ST\_2020\_NA0060\_22\_10\_20200716\_00036.jpg

LM Start	<b>0.00</b>	Rating **	A	Issue No.	<b>10</b>
LM End	<b>0.00</b>	Issue Type +	Ma	Location *	
Category	Pump Stations			GPS Latitude/Longitude	
				Start	End
Item	Motors, Engines, Fans & Gear Reducers			39.026449 °	39.026449 °
				-121.726937 °	-121.726937 °
DWR ID	DWR_NA0060_22_t_2012_10				
Action/Comments					
Inspector Comments: These items appear to be maintained and in operational condition.

View of pump motors (Summer 2020).

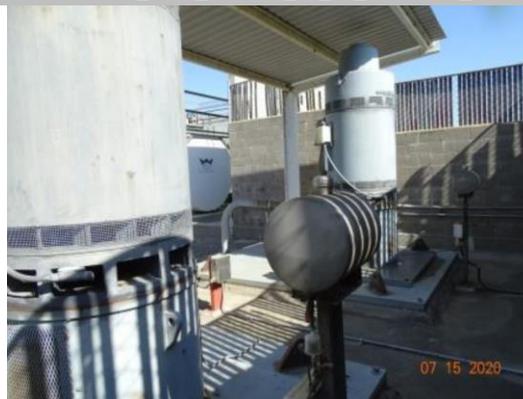
Photo 2 of 2 : ST\_2020\_NA0060\_22\_10\_20200716\_00037.jpg

View of pump oil wells (Summer 2020).

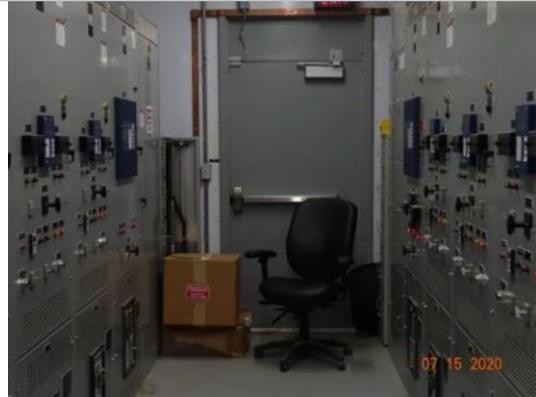
Photo 1 of 1 : ST\_2020\_NA0060\_22\_11\_20200716\_00038.jpg

LM Start	<b>0.00</b>	Rating **	A	Issue No.	<b>11</b>
LM End	<b>0.00</b>	Issue Type +	Ma	Location *	
Category	Pump Stations		GPS Latitude/Longitude		
			Start	End	
Item	Pump Control Systems		39.026449 °	39.026449 °	
			-121.726937 °	-121.726937 °	
DWR ID	DWR_NA0060_22_t_2012_11				
Action/Comments					
Inspector Comments: Pump control systems on site are new and appear to be in working order.

View of pump control panels in the pump operating room (Summer 2020).

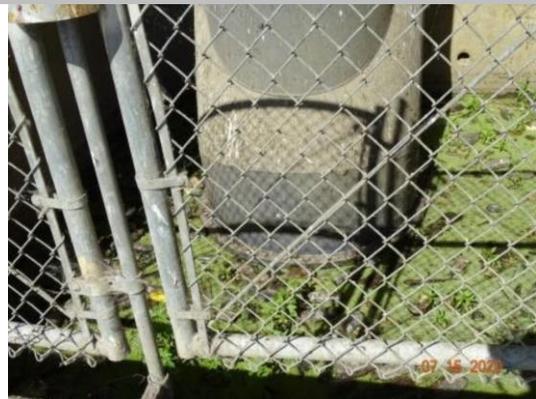
Photo 1 of 1 : ST\_2020\_NA0060\_22\_12\_20200716\_00039.jpg

LM Start	<b>0.00</b>	Rating **	M	Issue No.	<b>12</b>
LM End	<b>0.00</b>	Issue Type +	Ma	Location *	
Category	Pump Stations		GPS Latitude/Longitude		
			Start	End	
Item	Sumps/Wet Well		39.026449 °	39.026449 °	
			-121.726937 °	-121.726937 °	
DWR ID	DWR_NA0060_22_t_2012_12				
Action/Comments					
Inspector Comments: Trash and plant debris buildup in sump number 4 should be removed.

View of debris in sump 4 (Summer 2020).

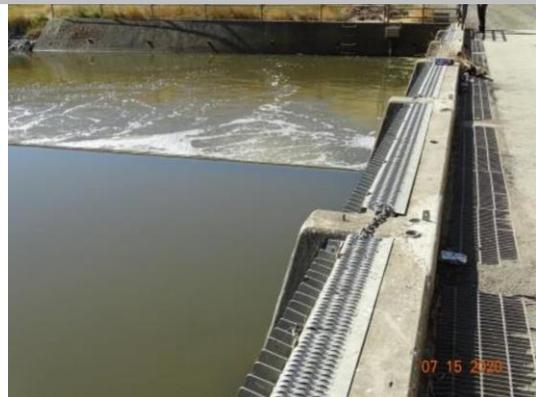
Photo 1 of 1 : ST\_2020\_NA0060\_22\_13\_20200716\_00040.jpg

LM Start	<b>0.00</b>	Rating **	A	Issue No.	<b>13</b>
LM End	<b>0.00</b>	Issue Type +	Ma	Location *	
Category	Pump Stations		GPS Latitude/Longitude		
			Start	End	
Item	Trash Racks		39.026449 °	39.026449 °	
			-121.726937 °	-121.726937 °	
DWR ID	DWR_NA0060_22_t_2012_13				
Action/Comments					
Inspector Comments: Trash rack is secure and free of debris.

View of trash racks (Summer 2020).

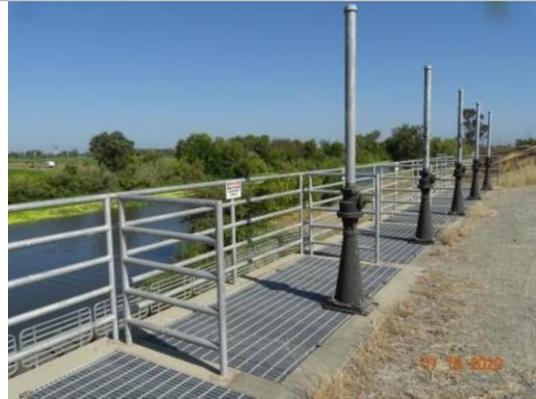
Photo 1 of 1 : ST\_2020\_NA0060\_22\_17\_20200716\_00041.jpg

LM Start	<b>0.00</b>	Rating **	A	Issue No.	<b>17</b>
LM End	<b>0.00</b>	Issue Type +	Ma	Location *	
Category	Pump Stations		GPS Latitude/Longitude		
			Start	End	
Item	Manual Gate Operators		39.026449 °	39.026449 °	
			-121.726937 °	-121.726937 °	
DWR ID	DWR_NA0060_22_t_2012_17				
Action/Comments					
Inspector Comments: Manual gate operators appear to be in good working condition.

View of manual gate operators (Summer 2020).

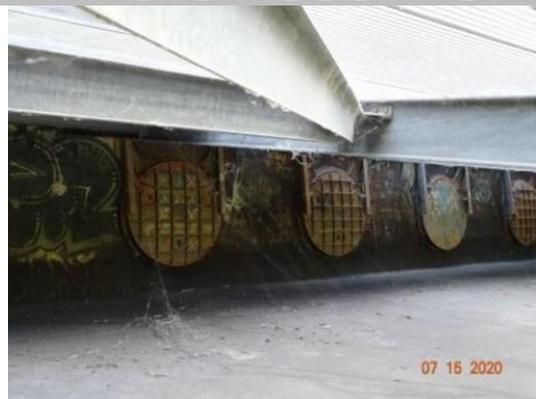
Photo 1 of 1 : ST\_2020\_NA0060\_22\_19\_20200716\_00042.jpg

LM Start	<b>0.00</b>	Rating **	A	Issue No.	<b>19</b>
LM End	<b>0.00</b>	Issue Type +	Ma	Location *	
Category	Pump Stations		GPS Latitude/Longitude		
			Start	End	
Item	Flap Gates		39.026449 °	39.026449 °	
			-121.726937 °	-121.726937 °	
DWR ID	DWR_NA0060_22_t_2019_19				
Action/Comments					
Inspector Comments: Flap gates appear to be in working condition. There are no apparent signs of significant corrosion or damage. All are closed.

View of closed flap gates (Summer 2020).

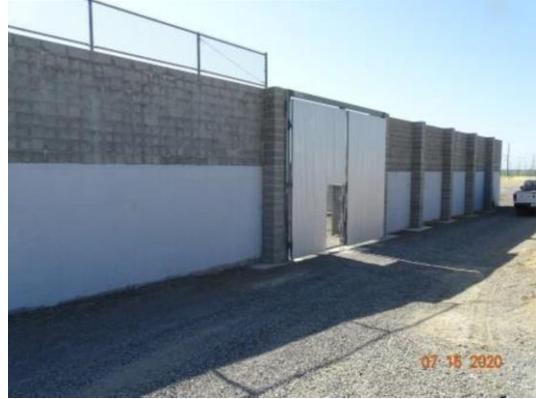
Photo 1 of 1 : ST\_2020\_NA0060\_22\_21\_20200716\_00043.jpg

LM Start	<b>0.00</b>	Rating **	A	Issue No.	<b>21</b>
LM End	<b>0.00</b>	Issue Type +	Ma	Location *	
Category	Pump Stations		GPS Latitude/Longitude		
			Start	End	
Item	Security Fencing		39.026449 °	39.026449 °	
			-121.726937 °	-121.726937 °	
DWR ID	DWR_NA0060_22_t_2012_21				
Action/Comments					
Inspector Comments: Site is secured with masonry and concrete wall and steel entrance door.

View of steel security door and concrete security wall around facility (Summer 2020).

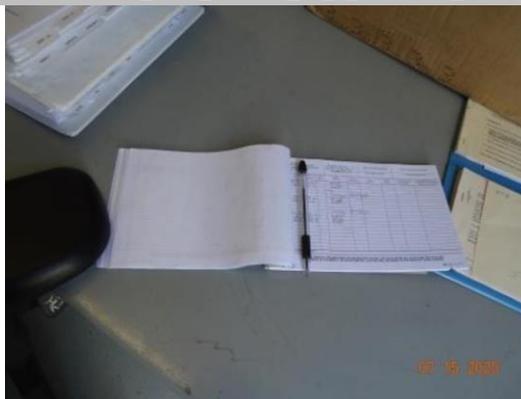
Photo 1 of 2 : ST\_2020\_NA0060\_23\_1\_20200716\_00019.jpg

LM Start	<b>0.00</b>	Rating **	A	Issue No.	<b>1</b>
LM End	<b>0.00</b>	Issue Type +	Ma	Location *	
Category	Pump Stations		GPS Latitude/Longitude		
			Start	End	
Item	Operating Log		39.120096 °	39.120096 °	
			-121.779234 °	-121.779234 °	
DWR ID	DWR_NA0060_23_t_2012_1				
Action/Comments					
Inspector Comments: Operation log and maintenance log are in the operating building.

View of operating log (Summer 2020).

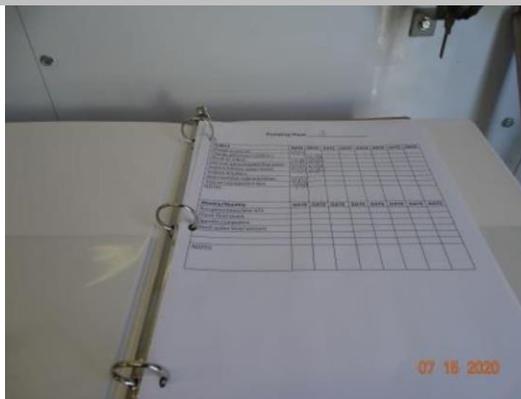
Photo 2 of 2 : ST\_2020\_NA0060\_23\_1\_20200716\_00020.jpg

View of maintenance log (Summer 2020).

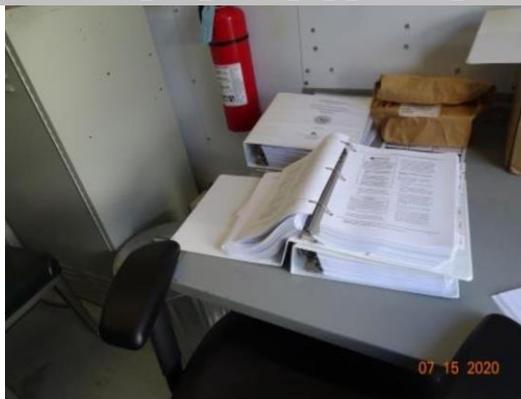
Photo 1 of 1 : ST\_2020\_NA0060\_23\_2\_20200716\_00021.jpg

LM Start	<b>0.00</b>	Rating **	A	Issue No.	<b>2</b>
LM End	<b>0.00</b>	Issue Type +	Ma	Location *	
Category	Pump Stations		GPS Latitude/Longitude		
			Start	End	
Item	Operation & Maintenance Manual		39.120096 °	39.120096 °	
			-121.779230 °	-121.779230 °	
DWR ID	DWR_NA0060_23_t_2012_2				
Action/Comments					
Inspector Comments: O&M Manual is present at the site. Sutter Maintenance Yard will provide documentation of maintenance going forward.

View of O&M Manual (Summer 2020).

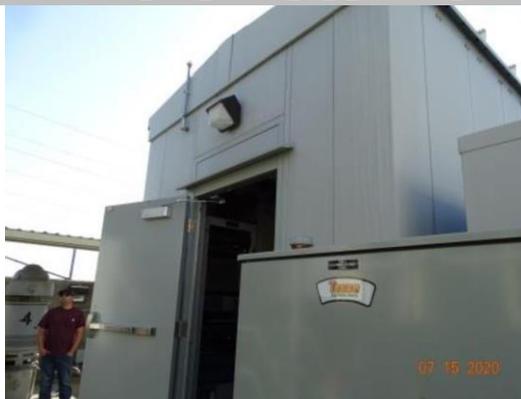
Photo 1 of 1 : ST\_2020\_NA0060\_23\_3\_20200716\_00022.jpg

LM Start	<b>0.00</b>	Rating **	A	Issue No.	<b>3</b>
LM End	<b>0.00</b>	Issue Type +	Ma	Location *	
Category	Pump Stations		GPS Latitude/Longitude		
			Start	End	
Item	Plant Building		39.120096 °	39.120096 °	
			-121.779230 °	-121.779230 °	
DWR ID	DWR_NA0060_23_t_2012_3				
Action/Comments					
Inspector Comments: Plant building appears to be in working condition.

View of plant operating building (Summer 2020).

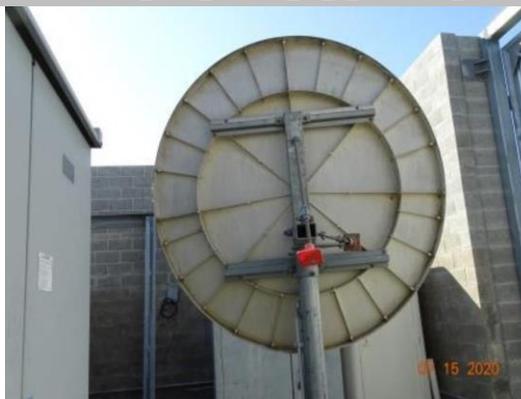
Photo 1 of 2 : ST\_2020\_NA0060\_23\_4\_20200716\_00036.jpg

LM Start	<b>0.00</b>	Rating **	A	Issue No.	<b>4</b>
LM End	<b>0.00</b>	Issue Type +	Ma	Location *	
Category	Pump Stations		GPS Latitude/Longitude		
			Start	End	
Item	Communications		39.120096 °	39.120096 °	
			-121.779230 °	-121.779230 °	
DWR ID	DWR_NA0060_23_t_2012_4				
Action/Comments					
Inspector Comments: Operator has two-way radio and cellular phone available to them. The remote control operating system (SCADA) appears to be operational. Satellite dish and antenna communicate realtime plant data.

View of data broadcasting satellite dish (Summer 2020).

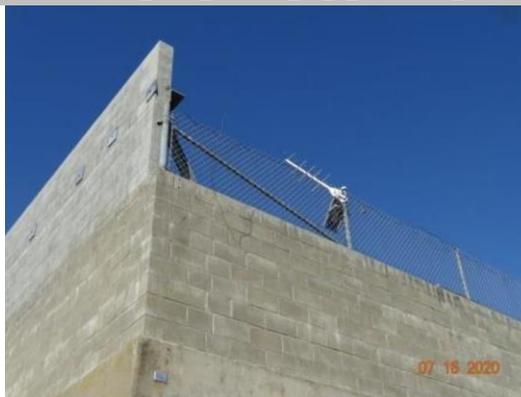
Photo 2 of 2 : ST\_2020\_NA0060\_23\_4\_20200716\_00037.jpg

View of data broadcasting antennae (Summer 2020).

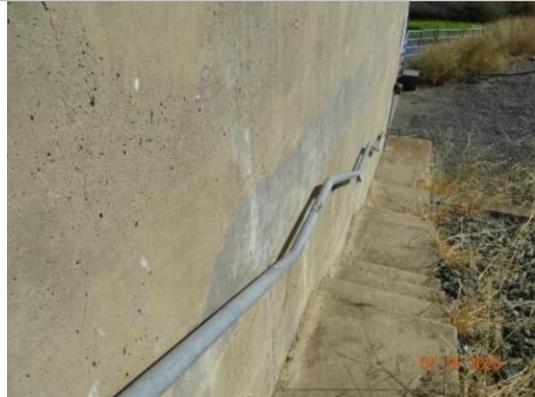
Photo 1 of 5 : ST\_2020\_NA0060\_23\_5\_20200716\_00027.jpg

LM Start	<b>0.00</b>	Rating **	A	Issue No.	<b>5</b>
LM End	<b>0.00</b>	Issue Type +	Ma	Location *	
Category	Pump Stations		GPS Latitude/Longitude		
			Start	End	
Item	Safety		39.120096 °	39.120096 °	
			-121.779230 °	-121.779230 °	
DWR ID	DWR_NA0060_23_t_2012_5				
Action/Comments					
Inspector Comments: The site has fire extinguishers on site and fall protection rails.

View of railing for stairway down to pump inlet (Summer 2020).

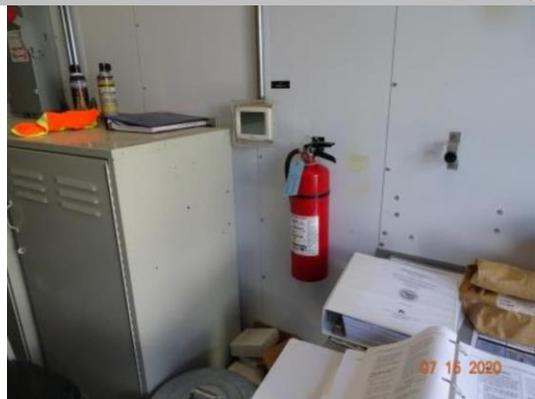
Photo 2 of 5 : ST\_2020\_NA0060\_23\_5\_20200716\_00023.jpg

View of fire extinguisher inside operating building (Summer 2020).

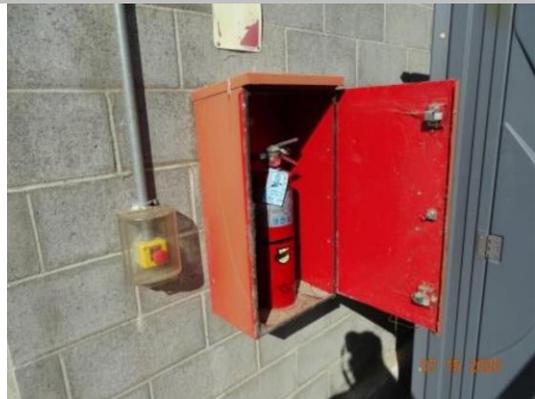
Photo 3 of 5 : ST\_2020\_NA0060\_23\_5\_20200716\_00024.jpg

View of fire extinguisher adjacent to facility entrance (Summer 2020).

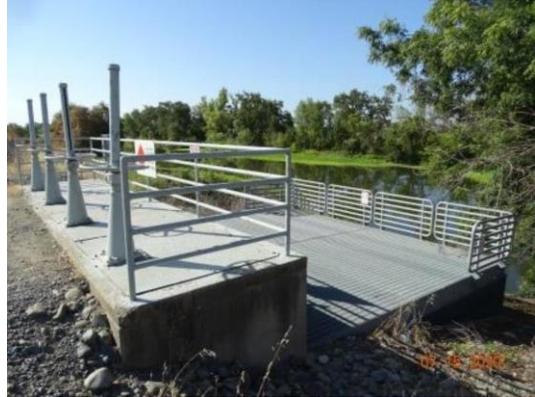
Photo 4 of 5 : ST\_2020\_NA0060\_23\_5\_20200716\_00025.jpg

LM Start	<b>0.00</b>	Rating **	A	Issue No.	<b>5 (cont)</b>
LM End	<b>0.00</b>	Issue Type +	Ma	Location *	
Category	Pump Stations		GPS Latitude/Longitude		
			Start	End	
Item	Safety		39.120096 °	39.120096 °	
			-121.779230 °	-121.779230 °	
DWR ID	DWR_NA0060_23_t_2012_5				
Action/Comments					
Inspector Comments: The site has fire extinguishers on site and fall protection rails.

View of safety railing and signage above flap gates and manual gate operators (Summer 2020).

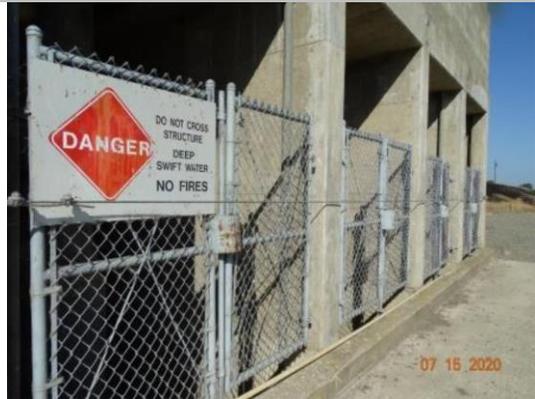
Photo 5 of 5 : ST\_2020\_NA0060\_23\_5\_20200716\_00026.jpg

View of fall protection cable and signage next to wet wells (Summer 2020).

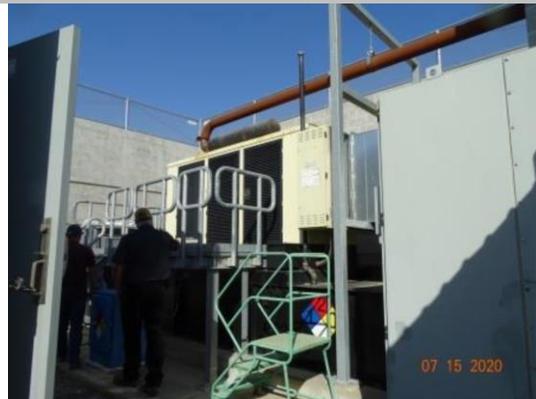
Photo 1 of 1 : ST\_2020\_NA0060\_23\_8\_20200716\_00028.jpg

LM Start	<b>0.00</b>	Rating **	A	Issue No.	<b>8</b>
LM End	<b>0.00</b>	Issue Type +	Ma	Location *	
Category	Pump Stations		GPS Latitude/Longitude		
			Start	End	
Item	Power		39.120096 °	39.120096 °	
			-121.779230 °	-121.779230 °	
DWR ID	DWR_NA0060_23_t_2012_8				
Action/Comments					
Inspector Comments: The structure is on the grid with emergency generator backup.

View of emergency backup generator (Summer 2020).

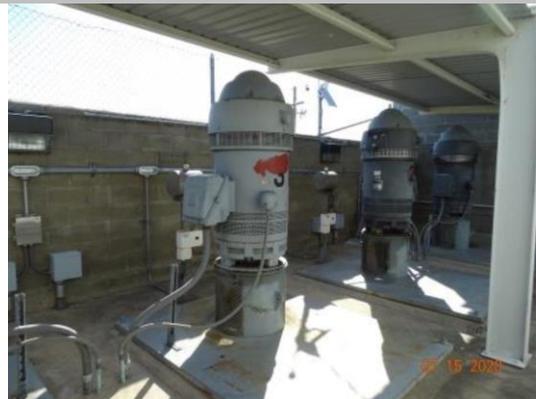
Photo 1 of 2 : ST\_2020\_NA0060\_23\_10\_20200716\_00029.jpg

LM Start	<b>0.00</b>	Rating **	A	Issue No.	<b>10</b>
LM End	<b>0.00</b>	Issue Type +	Ma	Location *	
Category	Pump Stations		GPS Latitude/Longitude		
			Start	End	
Item	Motors, Engines, Fans & Gear Reducers		39.120096 °	39.120096 °	
			-121.779230 °	-121.779230 °	
DWR ID	DWR_NA0060_23_t_2012_10				
Action/Comments					
Inspector Comments: These items appear to be maintained and in operating condition.

View of pump motors (Summer 2020).

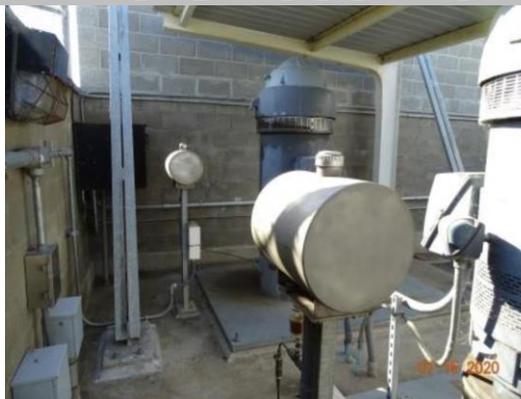
Photo 2 of 2 : ST\_2020\_NA0060\_23\_10\_20200716\_00030.jpg

LM Start	<b>0.00</b>	Rating **	A	Issue No.	<b>10 (cont)</b>
LM End	<b>0.00</b>	Issue Type +	Ma	Location *	
Category	Pump Stations			GPS Latitude/Longitude	
				Start	End
Item	Motors, Engines, Fans & Gear Reducers			39.120096 °	39.120096 °
				-121.779230 °	-121.779230 °
DWR ID	DWR_NA0060_23_t_2012_10				
Action/Comments					
Inspector Comments: These items appear to be maintained and in operating condition.

View of pump oil well (Summer 2020).

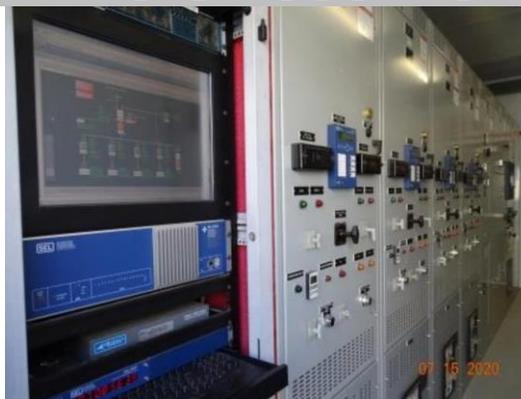
Photo 1 of 1 : ST\_2020\_NA0060\_23\_11\_20200716\_00031.jpg

LM Start	<b>0.00</b>	Rating **	A	Issue No.	<b>11</b>
LM End	<b>0.00</b>	Issue Type +	Ma	Location *	
Category	Pump Stations			GPS Latitude/Longitude	
				Start	End
Item	Pump Control Systems			39.120096 °	39.120096 °
				-121.779230 °	-121.779230 °
DWR ID	DWR_NA0060_23_t_2012_11				
Action/Comments					
Inspector Comments: Pump control systems on site are new and appear to be in working order.

View of pump control panels in operating building (Summer 2020).

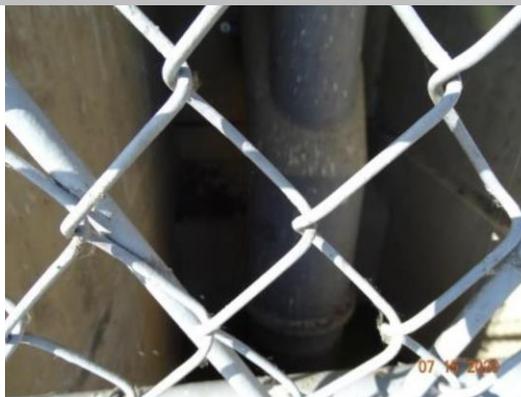
Photo 1 of 1 : ST\_2020\_NA0060\_23\_12\_20200716\_00032.jpg

LM Start	<b>0.00</b>	Rating **	A	Issue No.	<b>12</b>
LM End	<b>0.00</b>	Issue Type +	Ma	Location *	
Category	Pump Stations			GPS Latitude/Longitude	
				Start	End
Item	Sumps/Wet Well			39.120096 °	39.120096 °
				-121.779230 °	-121.779230 °
DWR ID	DWR_NA0060_23_t_2012_12				
Action/Comments					
Inspector Comments: Sumps are clear and free of debris.

View of one wet well that represents appearance of all wet wells (Summer 2020).

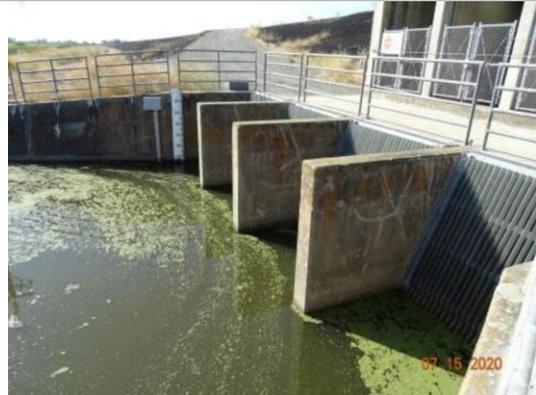
Photo 1 of 1 : ST\_2020\_NA0060\_23\_13\_20200716\_00033.jpg

LM Start	<b>0.00</b>	Rating **	A	Issue No.	<b>13</b>
LM End	<b>0.00</b>	Issue Type +	Ma	Location *	
Category	Pump Stations		GPS Latitude/Longitude		
			Start	End	
Item	Trash Racks		39.120096 °	39.120096 °	
			-121.779230 °	-121.779230 °	
DWR ID	DWR_NA0060_23_t_2012_13				
Action/Comments					
Inspector Comments: No debris present on trash racks, they appear to be in good condition.

View of trash racks (Summer 2020).

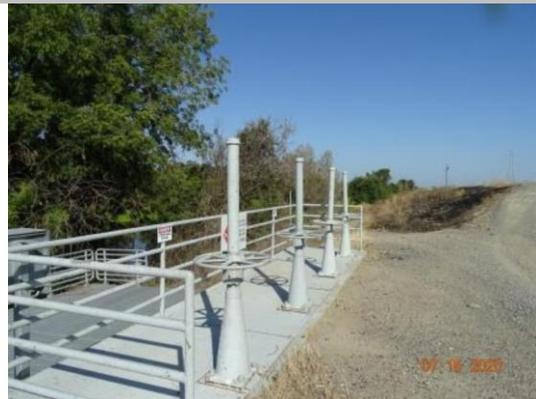
Photo 1 of 1 : ST\_2020\_NA0060\_23\_17\_20200716\_00034.jpg

LM Start	<b>0.00</b>	Rating **	A	Issue No.	<b>17</b>
LM End	<b>0.00</b>	Issue Type +	Ma	Location *	
Category	Pump Stations		GPS Latitude/Longitude		
			Start	End	
Item	Manual Gate Operators		39.120096 °	39.120096 °	
			-121.779230 °	-121.779230 °	
DWR ID	DWR_NA0060_23_t_2012_17				
Action/Comments					
Inspector Comments: Manual gate operators appear to be in working order.

View of manual gate operators (Summer 2020).

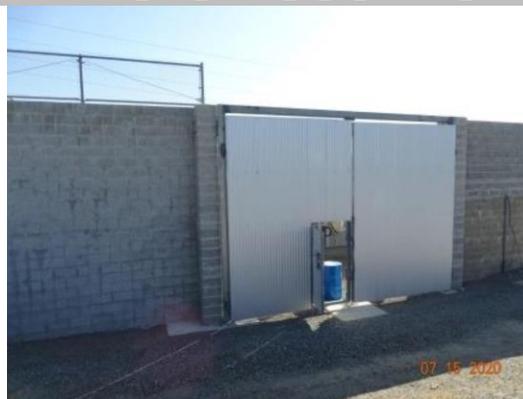
Photo 1 of 1 : ST\_2020\_NA0060\_23\_21\_20200716\_00035.jpg

LM Start	<b>0.00</b>	Rating **	A	Issue No.	<b>21</b>
LM End	<b>0.00</b>	Issue Type +	Ma	Location *	
Category	Pump Stations		GPS Latitude/Longitude		
			Start	End	
Item	Security Fencing		39.120096 °	39.120096 °	
			-121.779230 °	-121.779230 °	
DWR ID	DWR_NA0060_23_t_2012_21				
Action/Comments					
Inspector Comments: Site is currently secured by a concrete wall and steel entrance door.

View of concrete security fencing and steel entrance door (Summer 2020).

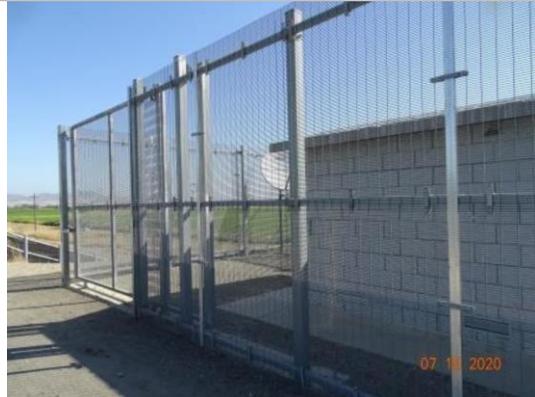
Photo 1 of 3 : ST\_2020\_NA0060\_10\_1\_20200716\_00022.jpg

View of outside of compressor facility (Summer 2020).

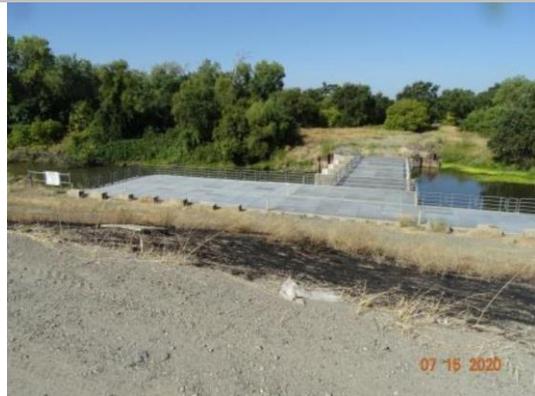
Photo 2 of 3 : ST\_2020\_NA0060\_10\_1\_20200716\_00023.jpg

View looking downslope of levee at entire weir and fish ladder (Summer 2020).

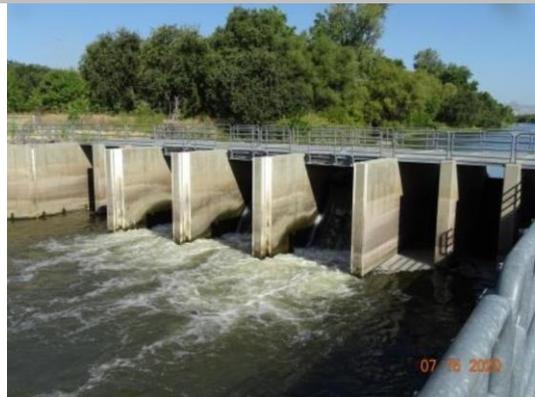
Photo 3 of 3 : ST\_2020\_NA0060\_10\_1\_20200716\_00025.jpg

View looking upstream at weir (Summer 2020).

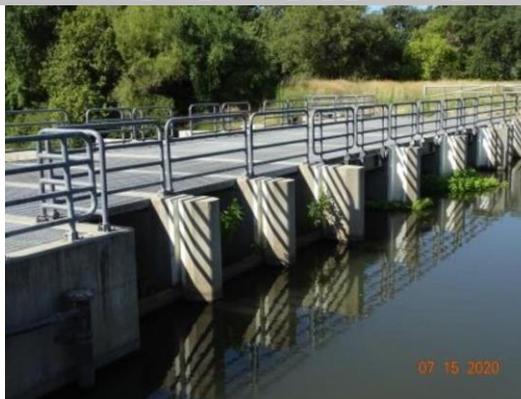
Photo 1 of 2 : ST\_2020\_NA0060\_10\_2\_20200716\_00013.jpg

LM Start	<b>0.00</b>	Rating **	M	Issue No.	<b>2</b>
LM End	<b>0.00</b>	Issue Type +	Ma	Location *	
Category	Structures & Concrete Lined Channels		GPS Latitude/Longitude		
			Start	End	
Item	Vegetation & Obstructions		39.102526 °	39.102526 °	
			-121.758682 °	-121.758682 °	
DWR ID	DWR_NA0060_10_t_2012_2				
Action/Comments					
Inspector Comments: Some vegetation starting to establish on sluice gates and in front of fish ladder.

View of vegetation starting to establish in front of sluice gates (Summer 2020).

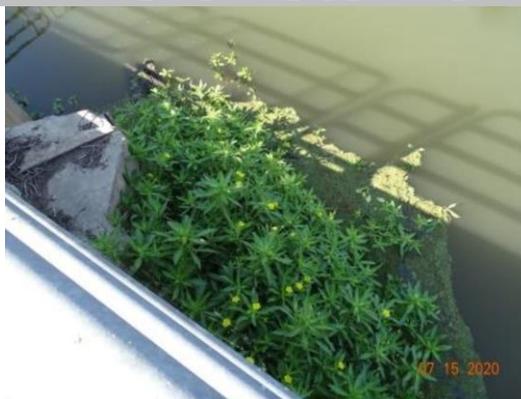
Photo 2 of 2 : ST\_2020\_NA0060\_10\_2\_20200716\_00014.jpg

View of vegetation starting to establish in front of fish ladder (Summer 2020).

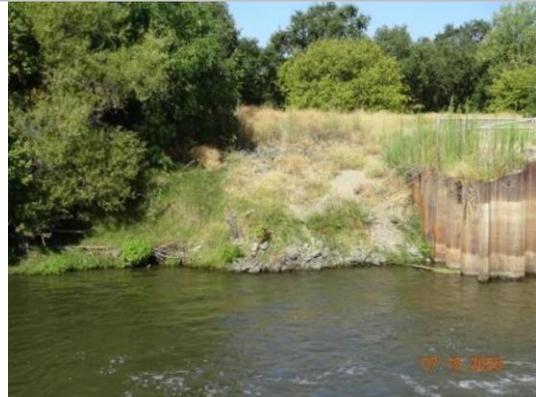
Photo 1 of 2 : ST\_2020\_NA0060\_10\_5\_20200716\_00015.jpg

LM Start	<b>0.00</b>	Rating **	A	Issue No.	<b>5</b>
LM End	<b>0.00</b>	Issue Type +	Ma	Location *	
Category	Structures & Concrete Lined Channels		GPS Latitude/Longitude		
			Start	End	
Item	Revetments		39.102526 °	39.102526 °	
			-121.758682 °	-121.758682 °	
DWR ID	DWR_NA0060_10_t_2012_5				
Action/Comments					
Inspector Comments: Existing riprap protection is properly maintained and is undamaged. Riprap clearly visible.

View of rip rap on the right bank downstream of the weir (Summer 2020).

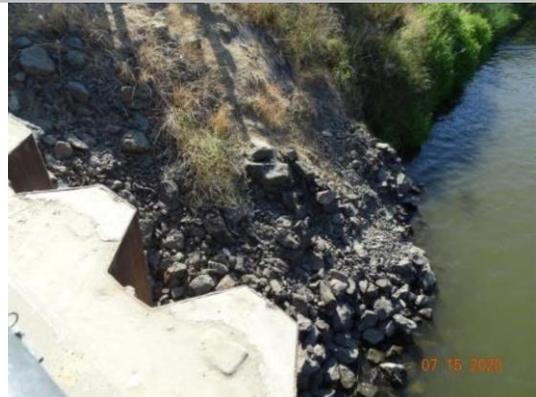
Photo 2 of 2 : ST\_2020\_NA0060\_10\_5\_20200716\_00016.jpg

View of rip rap on the left bank downstream of the weir (Summer 2020).

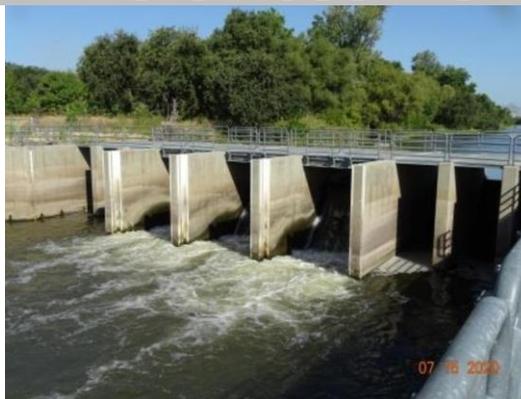
Photo 1 of 1 : ST\_2020\_NA0060\_10\_12\_20200716\_00017.jpg

LM Start	<b>0.00</b>	Rating **	A	Issue No.	<b>12</b>
LM End	<b>0.00</b>	Issue Type +	Ma	Location *	
Category	Structures & Concrete Lined Channels		GPS Latitude/Longitude		
			Start	End	
Item	Sluice/Slide Gates		39.102526 °	39.102526 °	
			-121.758682 °	-121.758682 °	
DWR ID	DWR_NA0060_10_t_2012_12				
Action/Comments					
Inspector Comments: Gates open and close freely with minor leakage. Sill is free of sediment and other obstructions. Gates and lifters have been maintained.

View of slide gates looking upstream (Summer 2020).

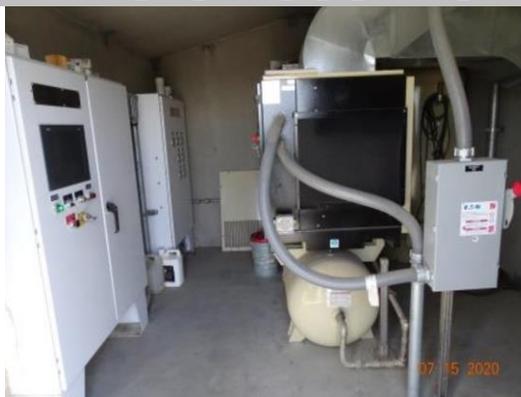
Photo 1 of 1 : ST\_2020\_NA0060\_10\_13\_20200716\_00018.jpg

LM Start	<b>0.00</b>	Rating **	A	Issue No.	<b>13</b>
LM End	<b>0.00</b>	Issue Type +	Ma	Location *	
Category	Structures & Concrete Lined Channels		GPS Latitude/Longitude		
			Start	End	
Item	Electric Gate Operators		39.102526 °	39.102526 °	
			-121.758682 °	-121.758682 °	
DWR ID	DWR_NA0060_10_t_2012_13				
Action/Comments					
Inspector Comments: The sluice gates are opened and closed by the inflation/deflation of a bladder. The compressors' are located in the building on the left bank of the levee crown and are functioning properly.

View of control panel, air compressor, and generator (Summer 2020).

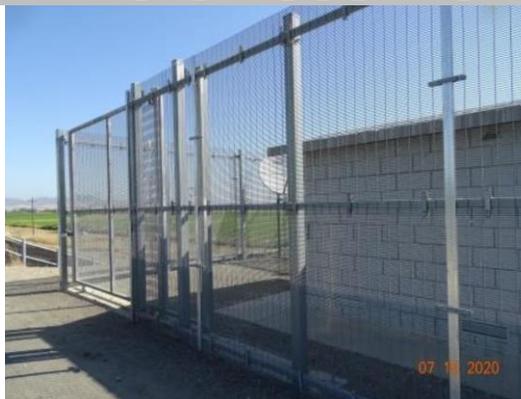
Photo 1 of 1 : ST\_2020\_NA0060\_10\_18\_20200716\_00019.jpg

LM Start	<b>0.00</b>	Rating **	A	Issue No.	<b>18</b>
LM End	<b>0.00</b>	Issue Type +	Ma	Location *	
Category	Structures & Concrete Lined Channels		GPS Latitude/Longitude		
			Start	End	
Item	Security Fencing		39.102526 °	39.102526 °	
			-121.758682 °	-121.758682 °	
DWR ID	DWR_NA0060_10_t_2012_18				
Action/Comments					
Inspector Comments: Safety / security fencing is in good condition and provides protection against falling or unauthorized access. Gates open and close freely, locks are in place, and there is little corrosion on metal parts. The fence is very close to the hinge point of the slope and does not allow access around the out side of the fence in this location.

View of security fencing around the compressor building (Summer 2020).

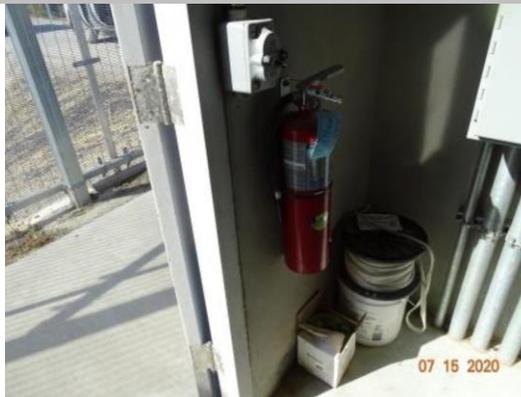
Photo 1 of 2 : ST\_2020\_NA0060\_10\_23\_20200716\_00020.jpg

LM Start	<b>0.00</b>	Rating **	A	Issue No.	<b>23</b>
LM End	<b>0.00</b>	Issue Type +	Ma	Location *	
Category	Structures & Concrete Lined Channels		GPS Latitude/Longitude		
			Start	End	
Item	Safety		39.102526 °	39.102526 °	
			-121.758682 °	-121.758682 °	
DWR ID	DWR_NA0060_10_t_2012_23				
Action/Comments					
Inspector Comments: Safety hardware installed. Adequate protection for fall hazards exist. No hazardous conditions that might affect the operation of the structure. Fire extinguisher is located in the compressor building and is current.

View of fire extinguisher in compressor building (Summer 2020).

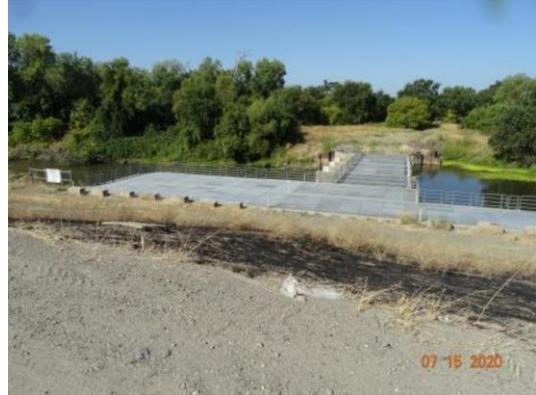
Photo 2 of 2 : ST\_2020\_NA0060\_10\_23\_20200716\_00021.jpg

LM Start	<b>0.00</b>	Rating **	A	Issue No.	<b>23 (cont)</b>
LM End	<b>0.00</b>	Issue Type +	Ma	Location *	
Category	Structures & Concrete Lined Channels		GPS Latitude/Longitude		
			Start	End	
Item	Safety		39.102526 °	39.102526 °	
			-121.758682 °	-121.758682 °	
DWR ID	DWR_NA0060_10_t_2012_23				
<b>Action/Comments</b>					
Inspector Comments: Safety hardware installed. Adequate protection for fall hazards exist. No hazardous conditions that might affect the operation of the structure. Fire extinguisher is located in the compressor building and is current.

View of fall protection railing surrounding weir (Summer 2020).

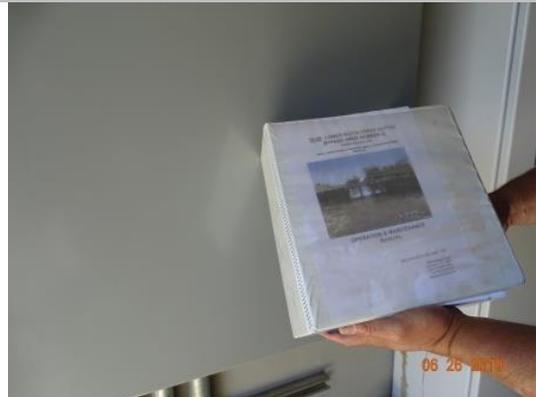
Photo 1 of 1 : ST\_2020\_NA0060\_10\_24\_20200714\_00012.jpg

LM Start	<b>0.00</b>	Rating **	A	Issue No.	<b>24</b>
LM End	<b>0.00</b>	Issue Type +	Ma	Location *	
Category	Structures & Concrete Lined Channels		GPS Latitude/Longitude		
			Start	End	
Item	Operation & Maintenance Manual		39.102526 °	39.102526 °	
			-121.758682 °	-121.758682 °	
DWR ID	DWR_NA0060_10_t_2013_24				
<b>Action/Comments</b>					
Inspector Comments: Sutter Maintenance Yard has a copy of the O&M at the site.

View of O&M manual (Summer 2019).

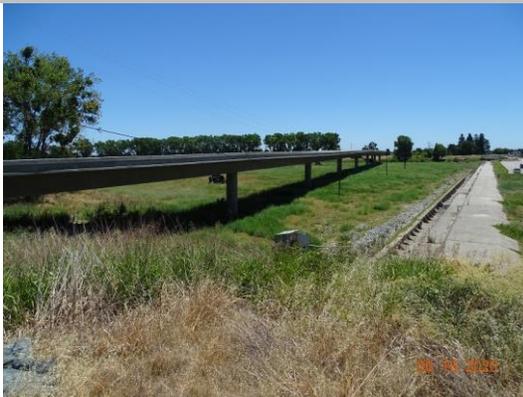
Photo 1 of 4 : ST\_2020\_NA0060\_3\_1\_20200617\_00017.jpg

View of the weir from the north abutment. Summer 2020.

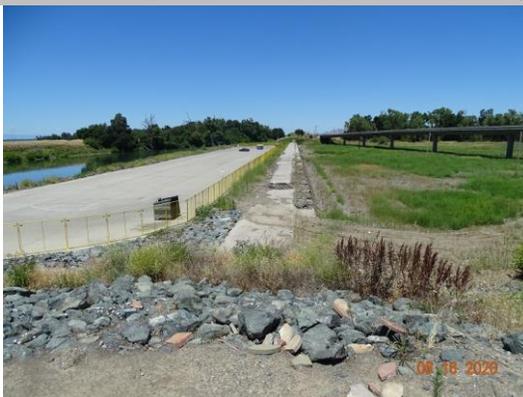
Photo 2 of 4 : ST\_2020\_NA0060\_3\_1\_20200617\_00018.jpg

View of the weir from the south abutment. Summer 2020.
