**Flood Control Project Maintenance**  
**2020 Structure Summary Report**  
**Overall Unit and Item Ratings**

**DWR Sutter Maintenance Yard**

**Butte Slough Drainage Structure**

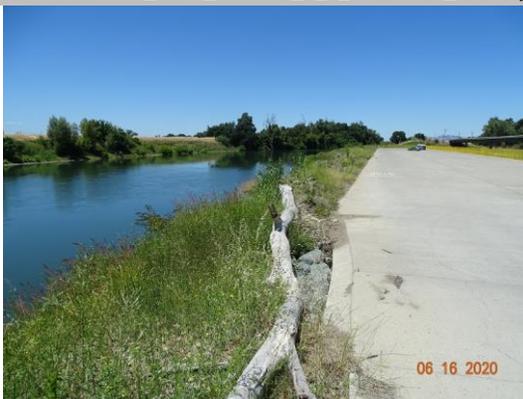
Photo 3 of 4 : ST\_2020\_NA0060\_3\_1\_20200617\_00019.jpg

View of the weir inlet. Summer 2020.

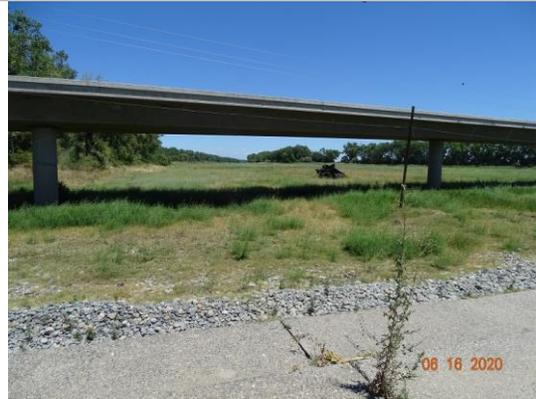
Photo 4 of 4 : ST\_2020\_NA0060\_3\_1\_20200617\_00020.jpg

Downstream view of the weir. Summer 2020.

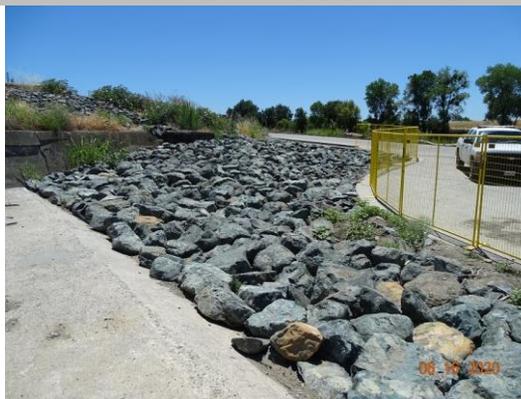
Photo 1 of 1 : ST\_2020\_NA0060\_3\_5\_20200617\_00021.jpg

LM Start	<b>0.00</b>	Rating **	A	Issue No.	<b>5</b>
LM End	<b>0.00</b>	Issue Type +	Ma	Location *	
Category	Structures & Concrete Lined Channels		GPS Latitude/Longitude		
			Start	End	
Item	Revetments		39.026713 °	39.026713 °	
			-121.821995 °	-121.821995 °	
DWR ID	DWR_NA0060_3_t_2012_5				
Action/Comments					
Inspector Comments: Existing riprap is undamaged.

View of the riprap on the south end. Summer 2020.

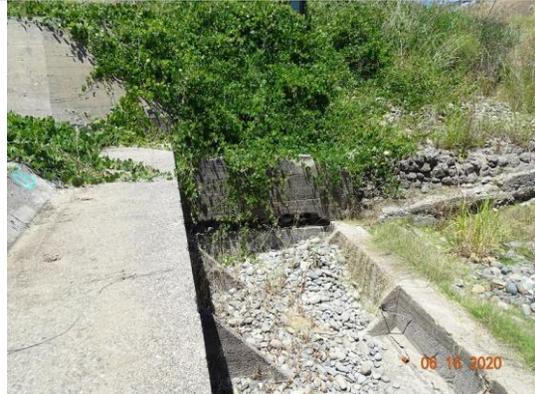
Photo 3 of 3 : ST\_2020\_NA0060\_3\_15\_20200617\_00024.jpg

LM Start	<b>0.00</b>	Rating **	U	Issue No.	<b>15 (cont)</b>
LM End	<b>0.00</b>	Issue Type +	Ma	Location *	
Category	Structures & Concrete Lined Channels			GPS Latitude/Longitude	
				Start	End
Item	Concrete Surfaces			39.026713 °	39.026713 °
				-121.821995 °	-121.821995 °
DWR ID	DWR_NA0060_3_t_2012_15				
Action/Comments					
Inspector Comments: Spalling, scaling, cracking, exposed rebar throughout the structure.

View of exposed rebar on north abutment. Summer 2020.

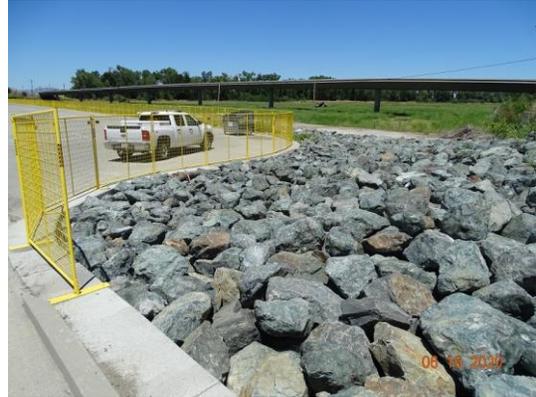
Photo 1 of 1 : ST\_2020\_NA0060\_3\_23\_20200617\_00025.jpg

LM Start	<b>0.00</b>	Rating **	A	Issue No.	<b>23</b>
LM End	<b>0.00</b>	Issue Type +	Ma	Location *	
Category	Structures & Concrete Lined Channels		GPS Latitude/Longitude		
			Start	End	
Item	Safety		39.026713 °	39.026713 °	
			-121.821995 °	-121.821995 °	
DWR ID	DWR_NA0060_3_t_2012_23				
Action/Comments					
Inspector Comments: No safety hazards present.

View of safety fence. Summer 2020.

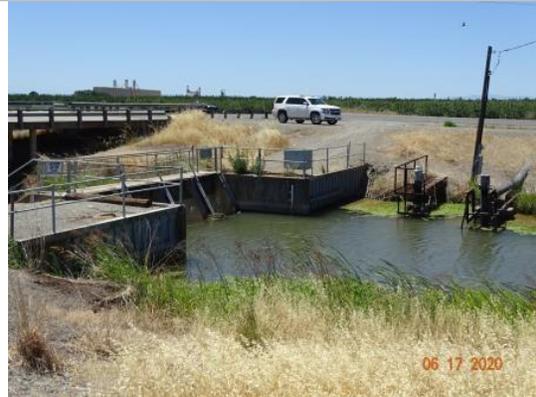
Photo 1 of 3 : ST\_2020\_NA0060\_11\_23\_20200618\_00007.jpg

View of the upstream side of the Wadsworth Canal Weir No. 4.

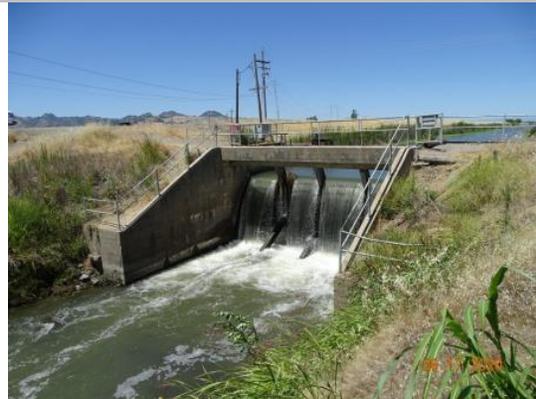
Photo 2 of 3 : ST\_2020\_NA0060\_11\_23\_20200618\_00008.jpg

View of the downstream side of the Wadsworth Canal Weir No. 4.

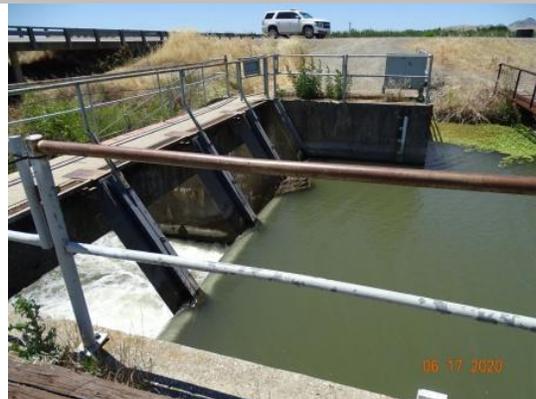
Photo 3 of 3 : ST\_2020\_NA0060\_11\_23\_20200618\_00006.jpg

Upclose view of the upstream side of the Wadsworth Canal Weir No. 4.

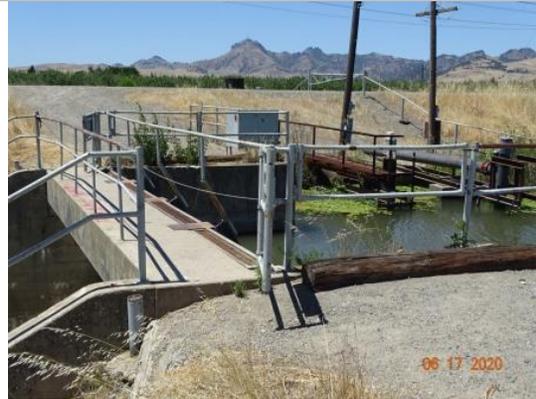
Photo 1 of 1 : ST\_2020\_NA0060\_11\_22\_20200618\_00009.jpg

LM Start	<b>0.00</b>	Rating **	A	Issue No.	<b>22</b>
LM End	<b>0.00</b>	Issue Type +	Ma	Location *	
Category	Structures & Concrete Lined Channels		GPS Latitude/Longitude		
			Start	End	
Item	Safety		39.153325 °	39.153325 °	
			-121.734122 °	-121.734122 °	
DWR ID	DWR_NA0060_11_t_2012_22				
Action/Comments					
Inspector Comments: There is a safety rail around the structure.

View of the safety railings around the structure.
