**Flood Control Project Maintenance
Levee Inspections**

Fall 2019 Levee Maintenance Deficiency Summary Report

Sacramento River Basin

Reclamation District No. 0010 Honcut

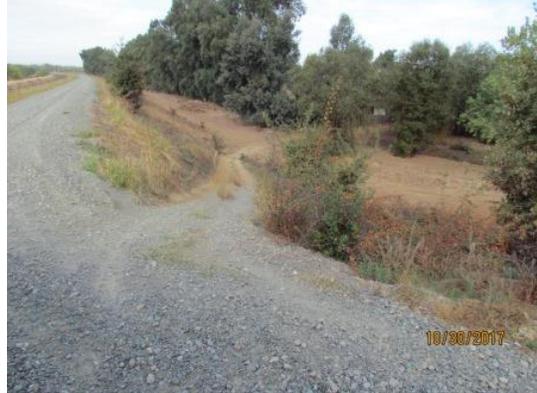
Photo 1 of 1 : FA_2019_RD0010_163_48_20190904_00009.jpg

LM Start	0.72	Rating **	A/W	Issue No.	48
LM End	0.72	Issue Type +	Ma	Location *	LS
Category	Earthen Levee			GPS Latitude/Longitude	
				Start	End
Item	Slope Stability			39.161198°	39.161198°
				-121.597102°	-121.597102°
DWR ID	DWR_RD0010_01_f_2013_48				
Comment Code					
S3 : Repair the levee slope damaged by vehicle traffic and prevent access where possible.					
Inspector Comment					
Ramp is caused by constant ATV foot traffic use on levee slope, there is no sign of separation, cracking, or caving, Fall 2019.

View of the slope stability caused by foot traffic on the landward side of the levee looking downstream.

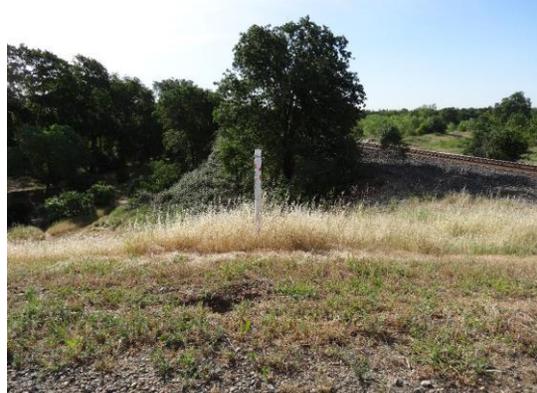
Photo 1 of 2 : UCIP_FA_2019_27715_51371.jpg

LM Start	0.72	Rating **	M	Issue No.	70
LM End	0.72	Issue Type +	En	Location *	
Category	Supplemental			GPS Latitude/Longitude	
				Start	End
Item	DRAFT DWR UCIP Field Study			39.161229°	39.161229°
				-121.597072°	-121.597072°
DWR ID	24656				
Comment Code					
Inspector Comment					
DS_ID:24656 FS_ID:27715 EP_NO: N/A Repair Type: Non-Urgent Crossing Status: Indicator Found UCIP Comments: 04/29/2013 Need to contact owner--unable to determine if crossing is authorized (no permit found) also need to determine if crossing goes through levee. (DWR UCIP - O. Magana) FIELD_STRUCT_DESC: Fiber optics line markers on levee slope. Unable to determine if line goes through the levee. This line was field discovered. FS Date: 4/29/2013

View of marker located on waterward side.

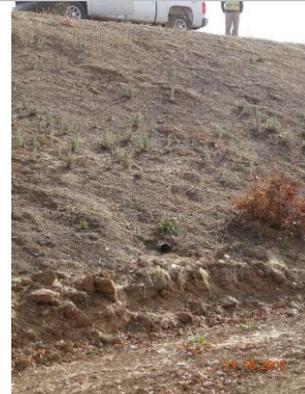
Photo 1 of 1 : UCIP_FA_2019_40545_51418.jpg

Comment Code					
Inspector Comment					
DS_ID:21260 FS_ID:40545 EP_NO: 4555 Repair Type: Non-Urgent Crossing Status: Indicator Found UCIP Comments: 04/29/2013 Pipe is approximately 4-6 inches in diameter located near the toe of levee. Crossing is approximately 50 feet downstream of 24-inch pipe. Need to contact owner to determine status of this crossing and to verify the purpose of crossing. If crossing is no longer in use owner will need to contact the CVFPB to comply with Title 23. (DWR UCIP - O. Magana) FIELD_STRUCT_DESC: *ABANDONED* 6-inch steel drainage discharge pipe through the levee, 1 foot below the crown. Siphon breaker on the waterside (WS) shoulder. Pump at the landside (LS) toe. Revetment around the discharge end of the pipe. Pipe drains into a ditch at the WS toe. Pipe is not buried in berms. Gravel pad over pipe across levee crown for vehicular access. (Plans for installing a drainage pipe across the levee authorized under Permit No. 4555, 1964 - Ledbetter, Carbah, and Huddle). [Additional Reference(s): DWR Levee Log, 2005]. FS Date: 4/29/2013

Pipe through levee near waterward toe.

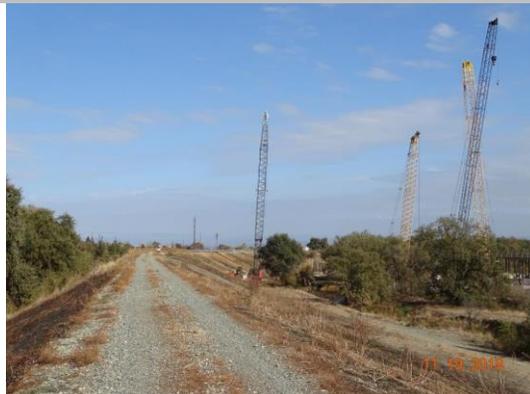
Photo 2 of 2 : FA_2019_RD0010_163_28_20191119_00083.jpg

LM Start	1.28	Rating **	A	Issue No.	28 (cont)
LM End	1.42	Issue Type +	Ma	Location *	CR
Category	Earthen Levee			GPS Latitude/Longitude	
				Start	End
Item	Crown Surface / Depressions / Rutting			39.168075°	39.169123°
				-121.591579°	-121.589389°
DWR ID	DWR_RD0010_01_f_2019_28				
Comment Code					
Inspector Comment					
Construction of the new Highway 70 Bridge, this section is not inspected this fall, Fall 2019.

View looking upstream of the construction of the new Highway 70 Bridge, Fall 2019.

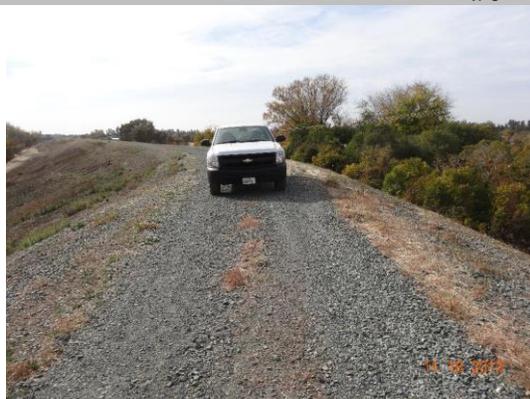
Photo 1 of 3 : UCIP_FA_2019_27725_51386.jpg

Comment Code					
Inspector Comment					
DS_ID:21262 FS_ID:27725 EP_NO: N/A Repair Type: Non-Urgent Crossing Status: Found UCIP Comments: 04/29/2013 Crossing appears not to be in use--need to contact owner. Need to coordinate with owner to determine status of crossing. If crossing is no longer in use owner will need to contact the CVFPB to comply with Title 23. This crossing is referenced in the USACE Periodic Inspection as item USACE_CESPK_HON1_2013_p_0012. (DWR UCIP - O. Magana) FIELD_STRUCT_DESC: 10-inch steel irrigation discharge pipe through the levee, 7.3 feet below the crown. Siphon breaker in a corrugated metal pipe (CMP) riser on the waterside (WS) slope. Pump on the WS berm. Pump not present. Switch house on the WS slope. No switch house present. 24-inch concrete standpipe at the landside (LS) toe. Concrete pad is still present on the WS. [Additional Reference(s): DWR Levee Log, 2005. USACE Sacramento O&M Manual 151, May 1953, (Station 14+82)]. FS Date: 4/29/2013

View of levee crown looking upstream.

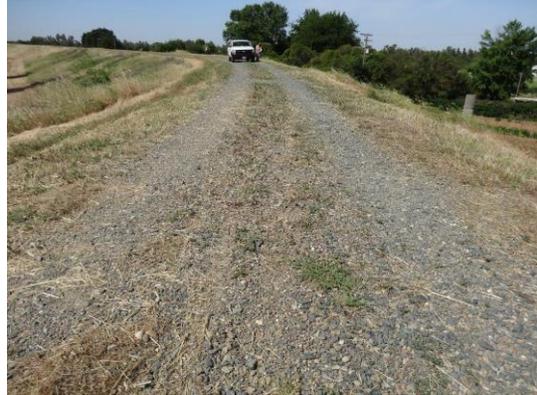
Photo 1 of 3 : UCIP_FA_2019_24811_44582.jpg

Comment Code					
Inspector Comment					
DS_ID:21264 FS_ID:24811 EP_NO: N/A Repair Type: No Action Needed Crossing Status: Found UCIP Comments: 04/29/2013 This crossing is referenced in the USACE Periodic Inspection as item USACE_CESPK_HON1_2013_p_0004. (DWR UCIP - O. Magana) FIELD_STRUCT_DESC: [Reclamation District No. 10 (RD0010) Drainage Plant] 16-inch steel drainage discharge pipe through the levee, 7 feet below the crown. Steel cutoff plate around the pipe at the center of the levee. Siphon breaker on the landside (LS) slope. Flap gate on the waterside (WS) end. Pump in a pit at the LS toe with steps along the LS slope. Saddle and 8-foot splash apron at the discharge end of the pipe. Concrete headwall at the LS toe. Metal shed on the LS slope. [Additional Reference(s): DWR Levee Log, 2005. USACE Sacramento O&M Manual 151, May 1953, (Station 13+88)]. FS Date: 4/29/2013

View of levee crown looking upstream of crossing.

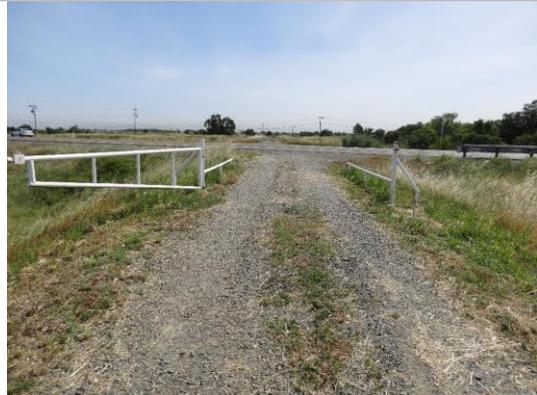
Photo 2 of 3 : UCIP_FA_2019_24811_44581.jpg

View of levee crown looking downstream--access gate near HWY 70.

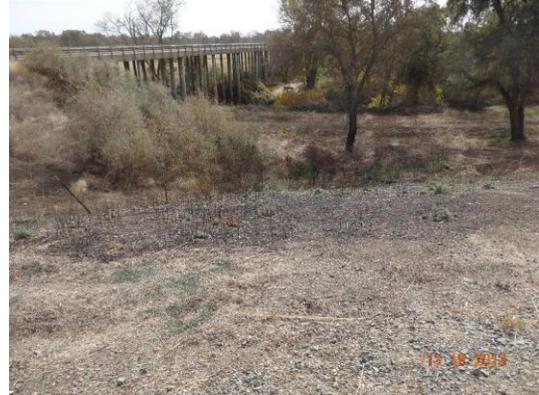
Photo 3 of 3 : UCIP_FA_2019_24811_44585.jpg

Comment Code					
Inspector Comment					
DS_ID:21264 FS_ID:24811 EP_NO: N/A Repair Type: No Action Needed Crossing Status: Found UCIP Comments: 04/29/2013 This crossing is referenced in the USACE Periodic Inspection as item USACE_CESPK_HON1_2013_p_0004. (DWR UCIP - O. Magana) FIELD_STRUCT_DESC: [Reclamation District No. 10 (RD0010) Drainage Plant] 16-inch steel drainage discharge pipe through the levee, 7 feet below the crown. Steel cutoff plate around the pipe at the center of the levee. Siphon breaker on the landside (LS) slope. Flap gate on the waterside (WS) end. Pump in a pit at the LS toe with steps along the LS slope. Saddle and 8-foot splash apron at the discharge end of the pipe. Concrete headwall at the LS toe. Metal shed on the LS slope. [Additional Reference(s): DWR Levee Log, 2005. USACE Sacramento O&M Manual 151, May 1953, (Station 13+88)]. FS Date: 4/29/2013

View of waterward side.

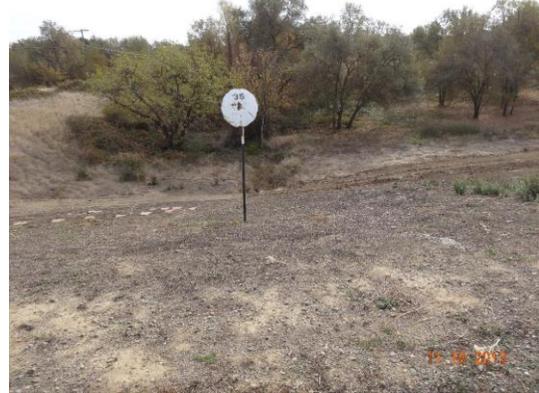
Photo 1 of 3 : UCIP_FA_2019_53136_44588.jpg

Comment Code					
Inspector Comment					
<p>DS_ID:21318 FS_ID:53136 EP_NO: N/A Repair Type: Urgent Crossing Status: Found UCIP Comments: 10/18/2018 No change since the last inspection. Pipe remains Urgent due to deteriorated wall (visible holes present inside) near WS flap gate. This pipe is part of DWR's Deferred Maintenance Project (DMP). According to LMA representative, the video inspection of DMP pipes is expected to be completed next year. Levee height is about 25-30 feet. (O. Magana - DWR UCIP)7/01/2016 Pipe wall in poor condition--deteriorated pipe wall indicated by holes at the inlet and outlet pipe collar. Recommend internal integrity inspection of the pipe through the levee to determine extent of damage. (DWR UCIP - omagana)4/29/2013 Holes present on pipe wall. Need to contact owner to notify of issue with pipe. Also need to contact DWR Inspector and CVFPB to determine how to address issue. This crossing is referenced in the USACE Periodic Inspection as item USACE_CESPK_HON1_2013_p_0140. Pipe should be 30-inch instead of 36-inch mentioned Periodic Inspection. (DWR UCIP - omagana) FIELD_STRUCT_DESC: 30-inch corrugated metal gravity drainage pipe through the levee, approximately 30 feet below the crown. Two corrugated metal cutoff walls around the pipe on each side. Saddle and splash apron at the waterside (WS) discharge point. Concrete headwall and sluice gate on the landside (LS). [Additional Reference(s): DWR Levee Log, 2005. USACE Sacramento O&M Manual 151, May 1953, (Station 10+38)]. FS Date: 10/18/2018</p>

View of WS--marker present on WS shoulder.

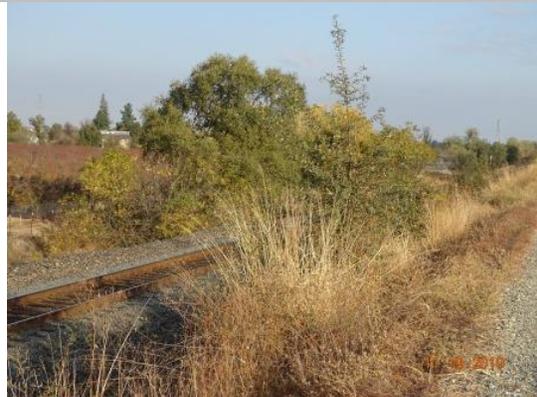
Photo 1 of 1 : FA_2019_RD0010_163_34_20191119_00084.jpg

LM Start	1.65	Rating **	M	Issue No.	34
LM End	1.79	Issue Type +	Ma	Location *	LS
Category	Earthen Levee			GPS Latitude/Longitude	
				Start	End
Item	Trim / Thin Trees			39.169788°	39.171858°
				-121.585746°	-121.585500°
DWR ID	DWR_RD0010_01_f_2019_34				
Comment Code					
T2 : Thin trees to allow visibility of the ground and room to flood fight.					
Inspector Comment					
Remove small starter trees from levee slope, Fall 2019.

View looking upstream landside of small starter trees that need to be removed, Fall 2019.

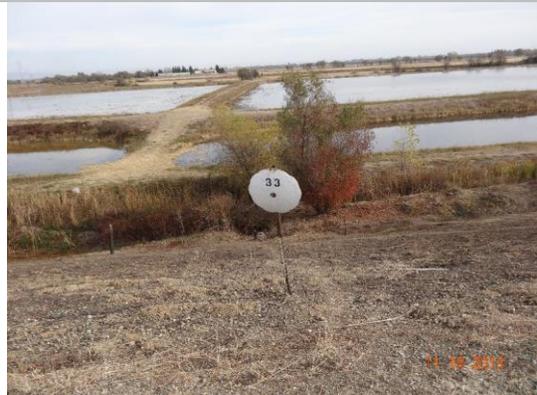
Photo 1 of 3 : UCIP_FA_2019_27745_51429.jpg

Comment Code					
Inspector Comment					
DS_ID:21271 FS_ID:27745 EP_NO: N/A Repair Type: Non-Urgent Crossing Status: Found UCIP Comments: 04/29/2013 Unable to determine if crossing is still present on landward side--need to confirm. Need to contact owner to determine status of crossing. This crossing is referenced in the USACE Periodic Inspection as item USACE_CESPK_HON1_2013_p_0185. (DWR UCIP - O. Magana) FIELD_STRUCT_DESC: 24-inch gravity drainage pipe of an unknown material through the levee, 30 feet below the crown. Flap gate on the waterside (WS) end. Concrete headwall at each toe. [Additional Reference(s): DWR Levee Log, 2005]. FS Date: 4/29/2013

View of waterward side--marker indicating crossing visible on waterward shoulder.

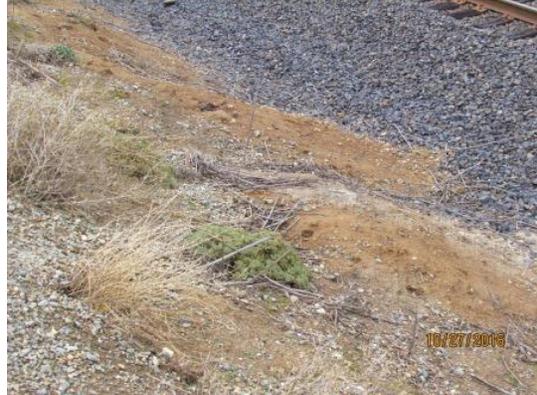
Photo 1 of 1 : FA_2019_RD0010_163_61_20190904_00018.jpg

LM Start	2.16	Rating **	M	Issue No.	61
LM End	2.38	Issue Type +	Ma	Location *	LS
Category	Earthen Levee			GPS Latitude/Longitude	
				Start	End
Item	Animal Control			39.177129°	39.180309°
				-121.584841°	-121.584451°
DWR ID	DWR_RD0010_01_s_2016_61				
Comment Code					
A3 : No rodents visible, but rodent burrows visible; need to backfill and compact or grout burrows.					
Inspector Comment					
Squirrel holes still are visible but there is no sign of activity, Fall 2019.

View of squirrel holes on the landside slope and toe, no rodent activity was observed.

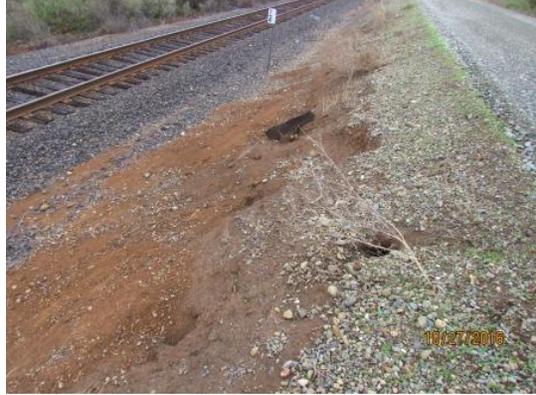
Photo 1 of 1 : FA_2019_RD0010_163_57_20190904_00014.jpg

LM Start	2.76	Rating **	M	Issue No.	57
LM End	2.76	Issue Type +	Ma	Location *	LS
Category	Earthen Levee		GPS Latitude/Longitude		
			Start	End	
Item	Animal Control		39.185845°	39.185845°	
			-121.583760°	-121.583760°	
DWR ID	DWR_RD0010_01_s_2016_57				
Comment Code					
A3 : No rodents visible, but rodent burrows visible; need to backfill and compact or grout burrows.					
Inspector Comment					
Squirrel holes still are visible but there is no sign of activity, Fall 2019.

View of squirrel holes on the landside slope and toe, no rodent activity was observed.

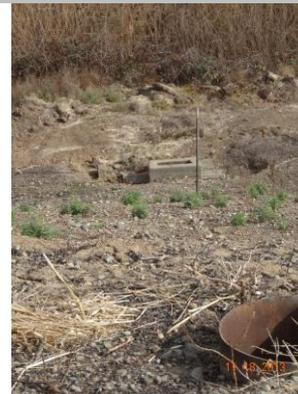
Photo 1 of 3 : UCIP_FA_2019_53137_44608.jpg

DS_ID:21272
 FS_ID:53137
 EP_NO: 14020
 Repair Type: Urgent
 Crossing Status: Indicator Found
 UCIP Comments: 10/30/2018 Erosion around the concrete box is still present. Erosion does not appear to have progressed since 2013. Unable to determine reason for subsidence around the concrete box located on the WS toe. Recommend internal inspection to determine the condition of the pipe through the levee. Permit recordation indicates that the 10-inch pipe was sleeved through a 16-inch pipe where the annular space between the pipes was grouted, adding some protection to the levee. Photo of the inside of the 10-inch pipe shows that the tar coating is coming off. Continue to monitor site for any changes at the WS toe and the WS slope. Crossing remains Urgent until an internal inspection can be completed to determine the integrity of the pipe through the levee. (O. Magana - DWR UCIP)7/01/2016 Dense vegetation--unable to determine if the sink hole/slope depression noted back in Jan 2013 in the USACE's PI Report is still present. Need to revisit the site once vegetation from the slopes has been cleared. (DWR UCIP - omagana)4/29/2013 Unable to determine status of crossing--sink hole was observed as part of the USACE Periodic Inspection Report dated May 2013. Need to coordinate with owner to determine status of crossing. If crossing is no longer in use owner will need to contact the CVFPB to comply with Title 23. Need to confirm with Finney to determine if pump and controls belong to pipe crossing located on landward side. This crossing is referenced in the USACE Periodic Inspection as item USACE_CESPK_HON1_2013_p_0192. (DWR UCIP - omagana)

View of WS--concrete box located located at WS toe.

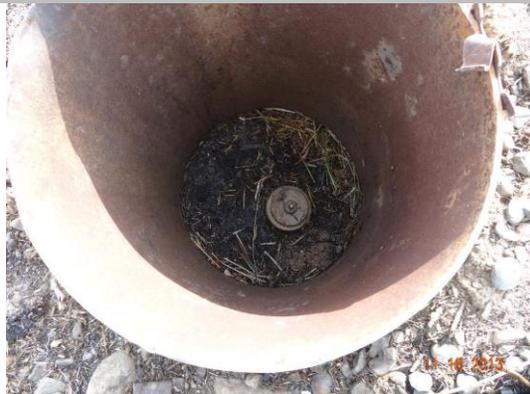
Photo 3 of 3 : UCIP_FA_2019_53137_44606.jpg

DS_ID:21272
 FS_ID:53137
 EP_NO: 14020
 Repair Type: Urgent
 Crossing Status: Indicator Found
 UCIP Comments: 10/30/2018 Erosion around the concrete box is still present. Erosion does not appear to have progressed since 2013. Unable to determine reason for subsidence around the concrete box located on the WS toe. Recommend internal inspection to determine the condition of the pipe through the levee. Permit recordation indicates that the 10-inch pipe was sleeved through a 16-inch pipe where the annular space between the pipes was grouted, adding some protection to the levee. Photo of the inside of the 10-inch pipe shows that the tar coating is coming off. Continue to monitor site for any changes at the WS toe and the WS slope. Crossing remains Urgent until an internal inspection can be completed to determine the integrity of the pipe through the levee. (O. Magana - DWR UCIP)7/01/2016 Dense vegetation--unable to determine if the sink hole/slope depression noted back in Jan 2013 in the USACE's PI Report is still present. Need to revisit the site once vegetation from the slopes has been cleared. (DWR UCIP - omagana)4/29/2013 Unable to determine status of crossing--sink hole was observed as part of the USACE Periodic Inspection Report dated May 2013. Need to coordinate with owner to determine status of crossing. If crossing is no longer in use owner will need to contact the CVFPB to comply with Title 23. Need to confirm with Finney to determine if pump and controls belong to pipe crossing located on landward side. This crossing is referenced in the USACE Periodic Inspection as item USACE_CESPK_HON1_2013_p_0192. (DWR UCIP - omagana)

View of siphon breaker located inside steel riser.

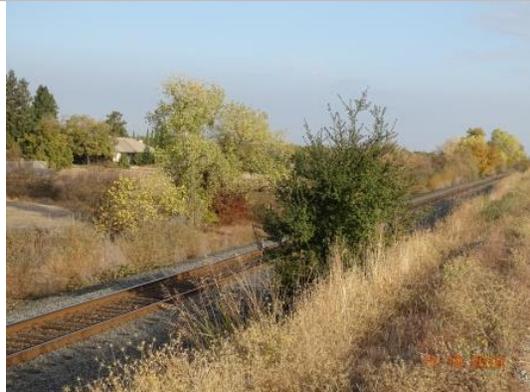
Photo 1 of 1 : FA_2019_RD0010_163_36_20191119_00085.jpg

LM Start	2.79	Rating **	M	Issue No.	36
LM End	2.79	Issue Type +	Ma	Location *	LS
Category	Earthen Levee		GPS Latitude/Longitude		
			Start	End	
Item	Trim / Thin Trees		39.186285°	39.186285°	
			-121.583707°	-121.583707°	
DWR ID	DWR_RD0010_01_f_2019_36				
Comment Code					
T2 : Thin trees to allow visibility of the ground and room to flood fight.					
Inspector Comment					
Small starter trees on levee slope need to be removed, Fall 2019.

View looking upstream landside at small starter trees that need to be removed, Fall 2019.

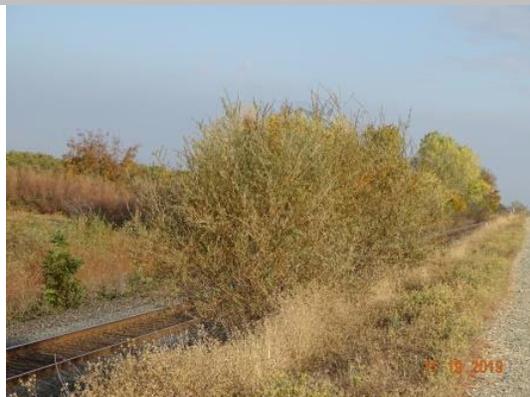
Photo 1 of 1 : FA_2019_RD0010_163_38_20191119_00086.jpg

LM Start	2.92	Rating **	M	Issue No.	38
LM End	2.92	Issue Type +	Ma	Location *	LS
Category	Earthen Levee		GPS Latitude/Longitude		
			Start	End	
Item	Trim / Thin Trees		39.188073°	39.188073°	
			-121.583483°	-121.583483°	
DWR ID	DWR_RD0010_01_f_2019_38				
Comment Code					
T2 : Thin trees to allow visibility of the ground and room to flood fight.					
Inspector Comment					
Small starter trees on levee slope need to be removed, Fall 2019.

View looking upstream landside at small starter trees that need to be removed, Fall 2019.

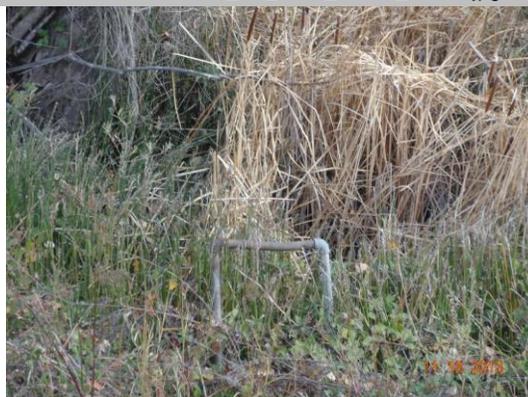
Photo 3 of 3 : UCIP_FA_2019_24816_44612.jpg

Comment Code					
Inspector Comment					
DS_ID:21317 FS_ID:24816 EP_NO: N/A Repair Type: Non-Urgent Crossing Status: Indicator Found UCIP Comments: 04/29/2013 Indicator marker visible on WS; Dense vegetation on waterward toe and landward side access limits the inspector's visibility to identify signs of pipe failure (leaks) along the slope. Recommend removing vegetation along pipe alignment to conduct proper inspection of structure and appurtenances. Access to landward side will need to be coordinated with railroad. Need to coordinate with owner to determine status of crossing. If crossing is no longer in use owner will need to contact the CVFPB to comply with Title 23. This crossing is referenced in the USACE Periodic Inspection as item USACE_CESPK_HON1_2013_p_0204. (DWR UCIP - O. Magana) FIELD_STRUCT_DESC: 24-inch corrugated metal gravity drainage pipe through the levee, 23 feet below the crown. Flap gate on the waterside (WS) end. Concrete headwall at each toe. Siphon breaker on the WS shoulder, unable to find. Concrete saddle and apron on the WS. [Additional Reference(s): DWR Levee Log, 2005. USACE Sacramento O&M Manual 151, May 1953, (Station 299+56)]. FS Date: 4/29/2013

Unable to confirm crossing--only visible sign is U shaped pipe through vegetation.

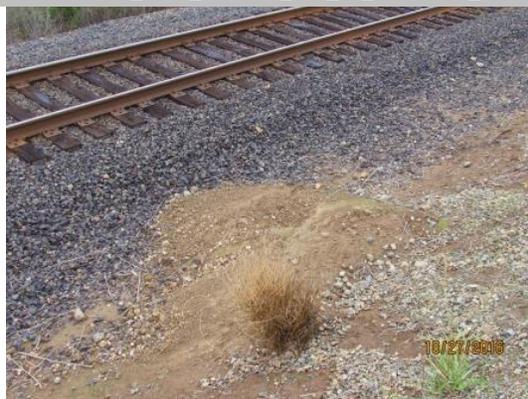
Photo 1 of 1 : FA_2019_RD0010_163_52_20190904_00013.jpg

LM Start	3.69	Rating **	M	Issue No.	52
LM End	3.69	Issue Type +	Ma	Location *	LS
Category	Earthen Levee			GPS Latitude/Longitude	
				Start	End
Item	Animal Control			39.199095 °	39.199095 °
				-121.582118 °	-121.582118 °
DWR ID	DWR_RD0010_01_s_2016_52				
Comment Code					
A3 : No rodents visible, but rodent burrows visible; need to backfill and compact or grout burrows.					
Inspector Comment					
Squirrel holes still are visible but there is no sign of activity, Fall 2019.

View of squirrel holes on the landside slope and toe, no rodent activity was observed. Fall 2016.

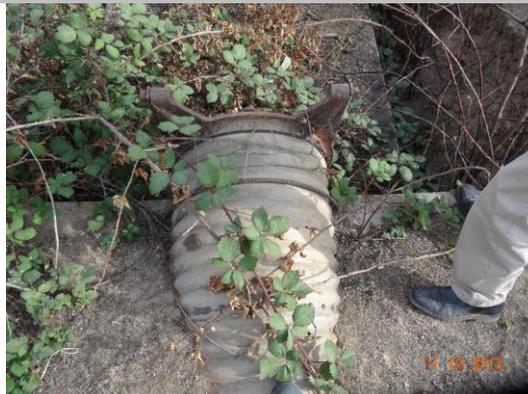
Photo 3 of 3 : UCIP_FA_2019_27746_51439.jpg

LM Start	3.70	Rating **	A/W	Issue No.	83 (cont)
LM End	3.70	Issue Type +	Ma	Location *	
Category	Supplemental			GPS Latitude/Longitude	
				Start	End
Item	DRAFT DWR UCIP LMA Responsibility			39.199281°	39.199281°
				-121.582091°	-121.582091°
DWR ID	21273				
Comment Code					
Inspector Comment					
DS_ID:21273 FS_ID:27746 EP_NO: N/A Repair Type: No Action Needed Crossing Status: Found UCIP Comments: 04/29/2013 This crossing is referenced in the USACE Periodic Inspection as item USACE_CESPK_HON1_2013_p_0217. (DWR UCIP - O. Magana) FIELD_STRUCT_DESC: 24-inch reinforced concrete gravity drainage pipe through the levee, 19.5 feet below the crown. Flap gate on the waterside (WS) end. Concrete headwall at each toe. Concrete saddle and apron on the WS. [Additional Reference(s): DWR Levee Log, 2005. USACE Sacramento O&M Manual 151, May 1953, (Station 317+80)]. FS Date: 4/29/2013

View of pipe, headwall, and concrete apron on waterward toe.

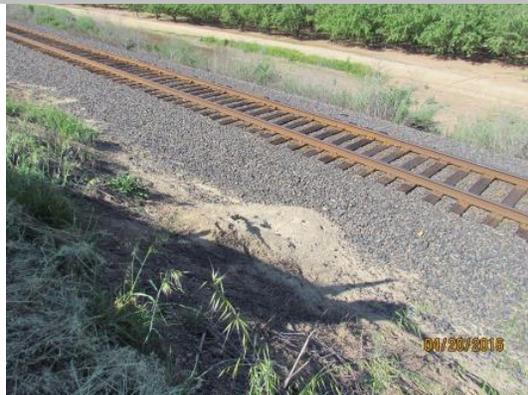
Photo 1 of 1 : FA_2019_RD0010_163_51_20190904_00012.jpg

LM Start	3.75	Rating **	U	Issue No.	51
LM End	3.75	Issue Type +	Ma	Location *	LS
Category	Earthen Levee			GPS Latitude/Longitude	
				Start	End
Item	Animal Control			39.200003°	39.200003°
				-121.582002°	-121.582002°
DWR ID	DWR_RD0010_01_s_2016_51				
Comment Code					
A3 : No rodents visible, but rodent burrows visible; need to backfill and compact or grout burrows.					
Inspector Comment					
There is a large rodent hole the exceeds 2 cubic feet of dirt and needs to be properly backfilled, Fall 2019.

View of large burrow on landside.

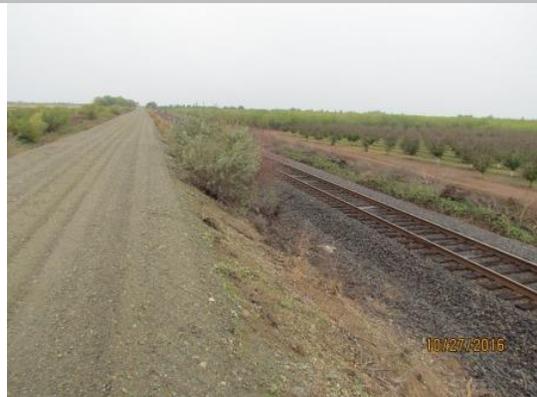
Photo 1 of 1 : FA_2019_RD0010_163_47_20190904_00008.jpg

LM Start	3.93	Rating **	M	Issue No.	47
LM End	3.93	Issue Type +	Ma	Location *	LS
Category	Earthen Levee		GPS Latitude/Longitude		
			Start	End	
Item	Trim / Thin Trees		39.202569°	39.202569°	
			-121.581681°	-121.581681°	
DWR ID	DWR_RD0010_01_s_2016_47				
Comment Code					
T2 : Thin trees to allow visibility of the ground and room to flood fight.					
Inspector Comment					
Remove small willow tree from the levee slope. Fall 2019.

View of a small willow tree that should be removed on the landside looking downstream.

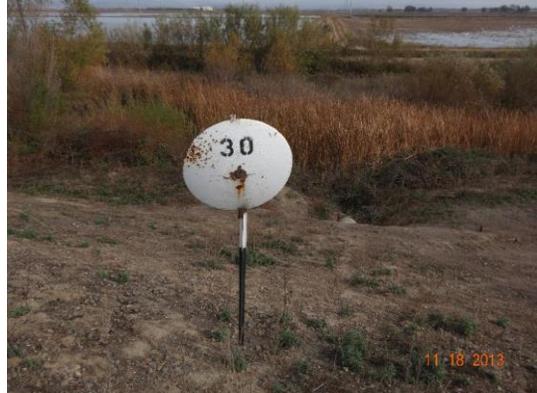
Photo 1 of 3 : UCIP_FA_2019_27747_51441.jpg

Comment Code					
Inspector Comment					
DS_ID:21274 FS_ID:27747 EP_NO: N/A Repair Type: Non-Urgent Crossing Status: Indicator Found UCIP Comments: 04/29/2013 sign marker on WS 30; Unable to confirm landward side. This crossing is referenced in the USACE Periodic Inspection as item USACE_CESPK_HON1_2013_p_0232. (DWR UCIP - O. Magana) FIELD_STRUCT_DESC: 24-inch corrugated metal gravity drainage pipe through the levee, 18 feet below the crown. Corrugated metal cutoff wall around the pipe at the center of the levee. Flap gate and 6-foot by 6-foot splash apron on the waterside (WS) end. [Additional Reference(s): DWR Levee Log, 2005. USACE Sacramento O&M Manual 151, May 1953, (Station 339+55.10)]. FS Date: 4/29/2013

View of waterwar side--marker indicating crossing located on waterward shoulder.

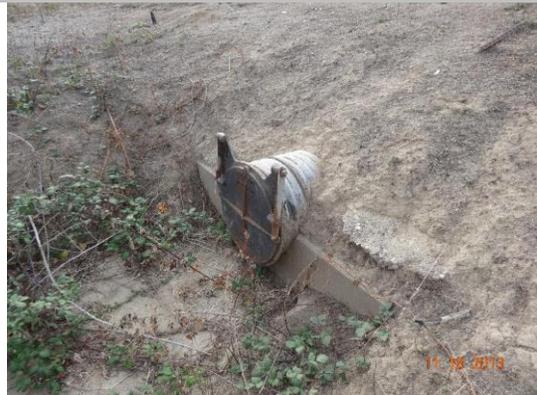
Photo 2 of 3 : UCIP_FA_2019_27747_51445.jpg

View of pipe, flap gate, and headwall located on waterward toe.

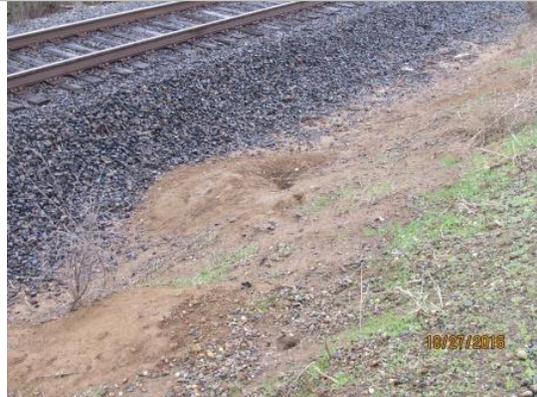
Photo 1 of 1 : FA_2019_RD0010_163_42_20190904_00006.jpg

LM Start	5.04	Rating **	M	Issue No.	42
LM End	5.04	Issue Type +	Ma	Location *	LS
Category	Earthen Levee		GPS Latitude/Longitude		
			Start	End	
Item	Animal Control		39.218564 °	39.218564 °	
			-121.579682 °	-121.579682 °	
DWR ID	DWR_RD0010_01_s_2016_42				
Comment Code					
A3 : No rodents visible, but rodent burrows visible; need to backfill and compact or grout burrows.					
Inspector Comment					
Squirrel holes still are visible but there is no sign of activity, Fall 2019.

View of squirrel holes on landside toe, no sign of activity.

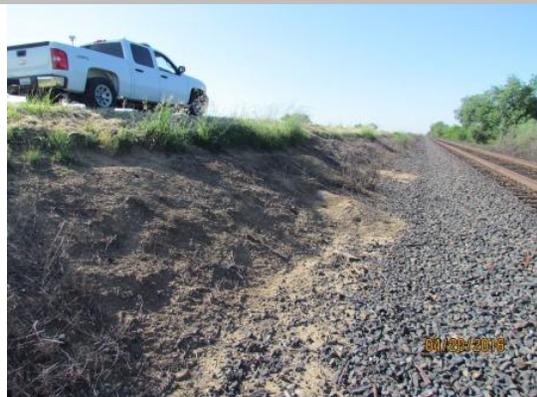
Photo 1 of 1 : FA_2019_RD0010_163_41_20190904_00005.jpg

LM Start	5.45	Rating **	M	Issue No.	41
LM End	5.45	Issue Type +	Ma	Location *	LS
Category	Earthen Levee		GPS Latitude/Longitude		
			Start	End	
Item	Animal Control		39.224485 °	39.224485 °	
			-121.578944 °	-121.578944 °	
DWR ID	DWR_RD0010_01_s_2016_41				
Comment Code					
A3 : No rodents visible, but rodent burrows visible; need to backfill and compact or grout burrows.					
Inspector Comment					
Squirrel holes still are visible but there is no sign of activity, Fall 2019.

View of multiple ground squirrel holes on landside slope looking downstream. There is no evidence of active squirrels.

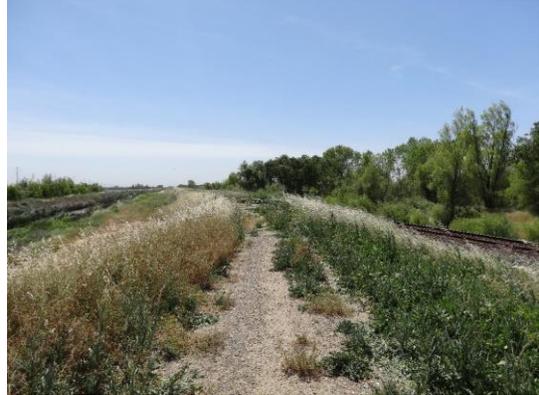
Photo 3 of 3 : UCIP_FA_2019_27531_51122.jpg

Comment Code					
Inspector Comment					
DS_ID:21277 FS_ID:27531 EP_NO: 6127 Repair Type: Non-Urgent Crossing Status: Indicator Found UCIP Comments: 04/29/2013 Recommend removing vegetation along pipe alignment to conduct proper inspection of structure and appurtances. (DWR UCIP - O. Magana) FIELD_STRUCT_DESC: Two 1-inch aluminum electrical conduits through the levee, 3 feet below the crown. Cutoff wall around the conduits at the center of the levee. (Plans to construct a low levee along the bank of the canal authorized under Permit No. 6127, 1968 - Morgan C. Chambers and Edgar Meyer). [Additional Reference(s): DWR Levee Log, 2005]. FS Date: 4/29/2013

View of levee crown.

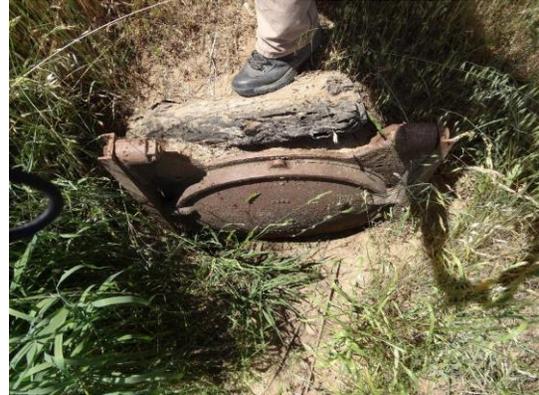
Photo 3 of 3 : UCIP_FA_2019_24438_43501.jpg

Comment Code					
Inspector Comment					
DS_ID:21278 FS_ID:24438 EP_NO: N/A Repair Type: Non-Urgent Crossing Status: Found UCIP Comments: 04/29/2013 Dense vegetation limits the inspector's visibility to identify signs of pipe failure (leaks) along the slope. Recommend removing vegetation along pipe alignment to conduct proper inspection of structure and appurtances. This crossing is referenced in the USACE Periodic Inspection as item USACE_CESPK_HON1_2013_p_0290. (DWR UCIP - O. Magana) FIELD_STRUCT_DESC: 30-inch corrugated metal gravity drainage pipe through the levee, 12.5 feet below the crown. Corrugated metal cutoff wall around the pipe at each shoulder. Flap gate on the waterside (WS) end. Concrete headwall, saddle, and apron on the WS end. [Additional Reference(s): DWR Levee Log, 2005. USACE Sacramento O&M Manual 151, May 1953, (Station 455+00)]. FS Date: 4/29/2013

Pipe and flap gate confirmed on waterward side.

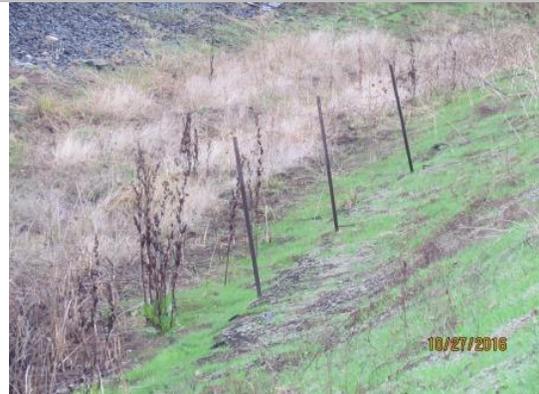
Photo 1 of 1 : FA_2019_RD0010_163_33_20190904_00001.jpg

LM Start	6.48	Rating **	M	Issue No.	33
LM End	7.13	Issue Type +	En	Location *	LS
Category	Earthen Levee			GPS Latitude/Longitude	
				Start	End
Item	Encroachments			39.239303°	39.248725°
				-121.576970°	-121.575824°
DWR ID	DWR_RD0010_01_s_2016_33				
Comment Code					
FE : Fence					
Inspector Comment					
Fence t-post at levee toe should be removed.

View of fence post that run along the landside levee toe, looking upstream.

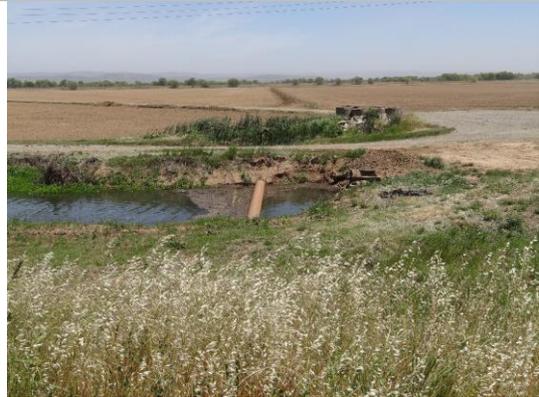
Photo 3 of 3 : UCIP_FA_2019_27532_51130.jpg

Comment Code						
Inspector Comment						
DS_ID:21279 FS_ID:27532 EP_NO: N/A Repair Type: Non-Urgent Crossing Status: Found UCIP Comments: 04/29/2013 Need to clear sediment near gate. Need to coordinate with owner to determine status of crossing. If crossing is no longer in use owner will need to contact the CVFPB to comply with Title 23. This crossing is referenced in the USACE Periodic Inspection as item USACE_CESPK_HON1_2013_p_0291-294. (DWR UCIP - O. Magana) FIELD_STRUCT_DESC: 16-inch steel drainage pipe through the levee, 10.3 feet below the crown. Cutoff wall around the pipe at the center of the levee. Slide gate on the waterside (WS) end. Pipe exposed across irrigation canal on the landside (LS). [Additional Reference(s): DWR Levee Log, 2005. USACE Sacramento O&M Manual 151, May 1953, (Station 473+58)]. FS Date: 4/29/2013

View of waterward side--pipe goes through Simmerly Slough.

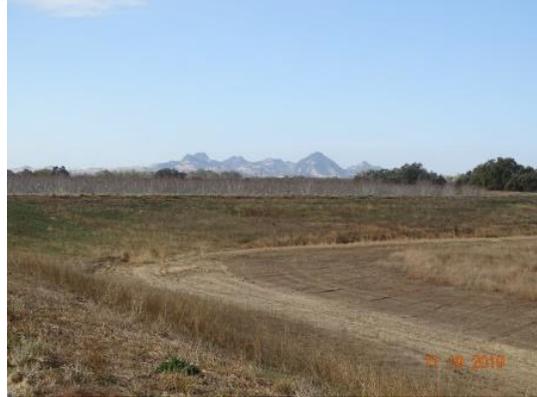
Photo 1 of 1 : FA_2019_RD0010_164_46_20191120_00099.jpg

LM Start	0.03	Rating **	A	Issue No.	46
LM End	11.36	Issue Type +	Ma	Location *	WS
Category	Earthen Levee		GPS Latitude/Longitude		
			Start	End	
Item	Vegetation		39.164109°	39.310024°	
			-121.610069°	-121.616347°	
DWR ID	DWR_RD0010_02_f_2019_46				
Comment Code					
V1 : Control annual grass and weeds on the levee slopes and easements.					
Inspector Comment					
The annual vegetation in this section is well maintained, Fall 2019

View looking downstream waterside at the well maintained annual vegetation, Fall 2019.

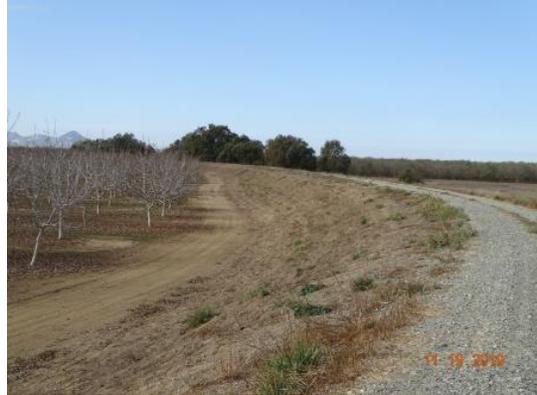
Photo 1 of 1 : FA_2019_RD0010_164_43_20191120_00101.jpg

LM Start	0.03	Rating **	A	Issue No.	43
LM End	11.36	Issue Type +	Ma	Location *	LS
Category	Earthen Levee			GPS Latitude/Longitude	
				Start	End
Item	Vegetation			39.164109°	39.310024°
				-121.610070°	-121.616346°
DWR ID	DWR_RD0010_02_f_2019_43				
Comment Code					
V1 : Control annual grass and weeds on the levee slopes and easements.					
Inspector Comment					
The annual vegetation in this section is well maintained, Fall 2019

View looking downstream landside at the well maintained annual vegetation, Fall 2019.

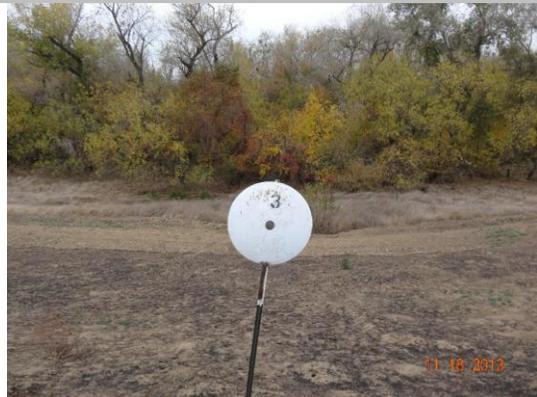
Photo 1 of 3 : UCIP_FA_2019_27533_51135.jpg

Comment Code					
Inspector Comment					
DS_ID:21280 FS_ID:27533 EP_NO: N/A Repair Type: Non-Urgent Crossing Status: Found UCIP Comments: 04/30/2013 Recommend removing vegetation and debris along pipe alignment (debris blocking gate on waterward side and vegetation blocking access to screw gate on landward side). Need to coordinate with owner to determine status of crossing. If crossing is no longer in use owner will need to contact the CVFPB to comply with Title 23. This crossing is referenced in the USACE Periodic Inspection as item USACE_CESPK_HON2_2013_p_0027. (DWR UCIP - O. Magana) FIELD_STRUCT_DESC: 24-inch corrugated metal gravity drainage pipe through the levee, 25.6 feet below the crown. Corrugated metal cutoff wall around the pipe at each shoulder. Flap gate on the waterside (WS) end. Concrete headwall, saddle, and apron on the WS end. [Additional Reference(s): DWR Levee Log, 2005. USACE Sacramento O&M Manual 151, May 1953, (Station 106+00)]. FS Date: 4/30/2013

View of waterward side.

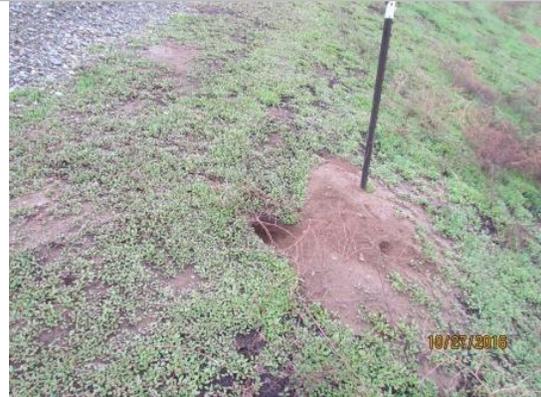
Photo 1 of 1 : FA_2019_RD0010_164_28_20190904_00003.jpg

LM Start	0.38	Rating **	M	Issue No.	28
LM End	0.38	Issue Type +	Ma	Location *	WS
Category	Earthen Levee			GPS Latitude/Longitude	
				Start	End
Item	Animal Control			39.169231 °	39.169231 °
				-121.610711 °	-121.610711 °
DWR ID	DWR_RD0010_02_f_2015_28				
Comment Code					
A3 : No rodents visible, but rodent burrows visible; need to backfill and compact or grout burrows.					
Inspector Comment					
No rodent activity but squirrel hole needs to be backfilled, Fall 2019.

View of squirrel hole on the waterside looking downstream.

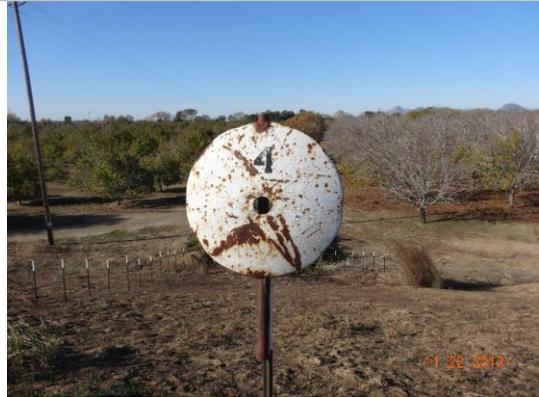
Photo 1 of 3 : UCIP_FA_2019_24821_44640.jpg

Comment Code					
Inspector Comment					
DS_ID:21281 FS_ID:24821 EP_NO: N/A Repair Type: Non-Urgent Crossing Status: Found UCIP Comments: 04/30/2013 Screw gate on landward side is blocked by sediment. Recommend removing sediment in front of gate. This crossing is referenced in the USACE Periodic Inspection as item USACE_CESPK_HON2_2013_p_0082. (DWR UCIP - O. Magana) FIELD_STRUCT_DESC: 24-inch corrugated metal gravity drainage pipe through the levee, 26 feet below the crown. Corrugated metal cutoff wall around the pipe at each shoulder. Flap gate on the waterside (WS) end. Slide gate on the landside (LS) end. Concrete headwall, saddle, and apron on the WS end. [Additional Reference(s): DWR Levee Log, 2005. USACE Sacramento O&M Manual 151, May 1953, (Station 149+88)]. FS Date: 4/30/2013

Marker visible on waterward side--No. 4.

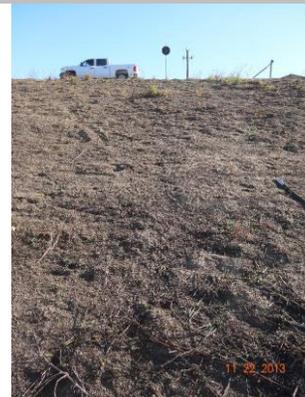
Photo 2 of 3 : UCIP_FA_2019_24821_44639.jpg

View of waterward slope side.

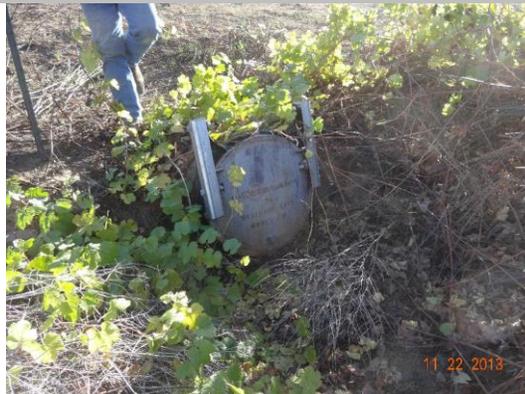
Photo 3 of 3 : UCIP_FA_2019_24821_44638.jpg

Comment Code					
Inspector Comment					
DS_ID:21281 FS_ID:24821 EP_NO: N/A Repair Type: Non-Urgent Crossing Status: Found UCIP Comments: 04/30/2013 Screw gate on landward side is blocked by sediment. Recommend removing sediment in front of gate. This crossing is referenced in the USACE Periodic Inspection as item USACE_CESPK_HON2_2013_p_0082. (DWR UCIP - O. Magana) FIELD_STRUCT_DESC: 24-inch corrugated metal gravity drainage pipe through the levee, 26 feet below the crown. Corrugated metal cutoff wall around the pipe at each shoulder. Flap gate on the waterside (WS) end. Slide gate on the landside (LS) end. Concrete headwall, saddle, and apron on the WS end. [Additional Reference(s): DWR Levee Log, 2005. USACE Sacramento O&M Manual 151, May 1953, (Station 149+88)]. FS Date: 4/30/2013

View of flap gate located on waterward side.

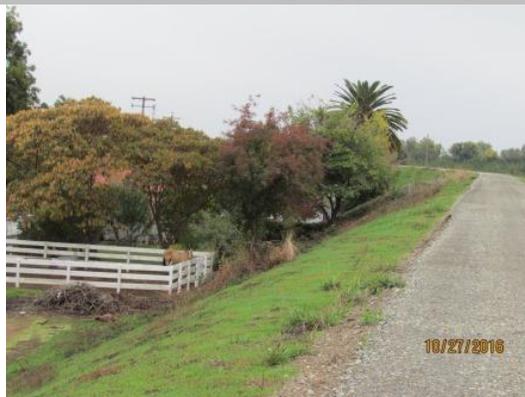
Photo 1 of 1 : FA_2019_RD0010_164_9_20190904_00002.jpg

LM Start	1.34	Rating **	M	Issue No.	9
LM End	1.34	Issue Type +	En	Location *	LS
Category	Earthen Levee			GPS Latitude/Longitude	
				Start	End
Item	Vegetation			39.182957°	39.182957°
				-121.609800°	-121.609800°
DWR ID	DWR_RD0010_02_s_2012_9				
Comment Code					
V6 : Landscaping					
Inspector Comment					
Landscaping and fence should be removed from the levee toe and slope.

View of homeowners landscaping and fence that encroaches on the landside levee slope, looking downstream.

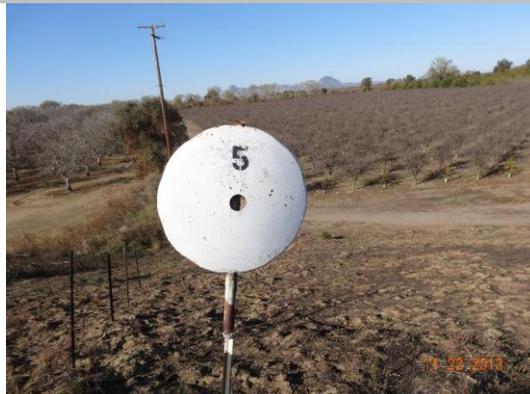
Photo 1 of 3 : UCIP_FA_2019_24822_44647.jpg

Marker visible on waterward side--No. 5.

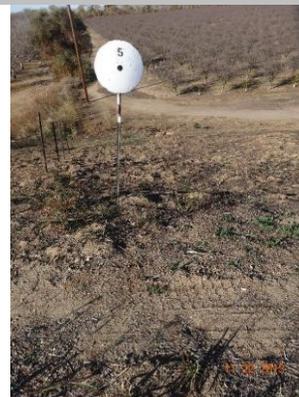
Photo 2 of 3 : UCIP_FA_2019_24822_44648.jpg

Overview of waterward slope--dense burrow activity on slope.

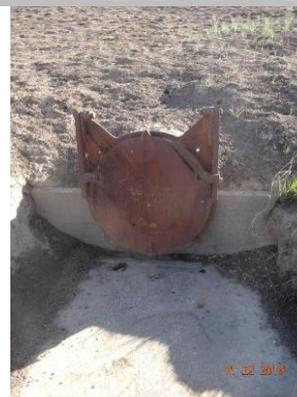
Photo 3 of 3 : UCIP_FA_2019_24822_44645.jpg

View of flap gate on waterward side.

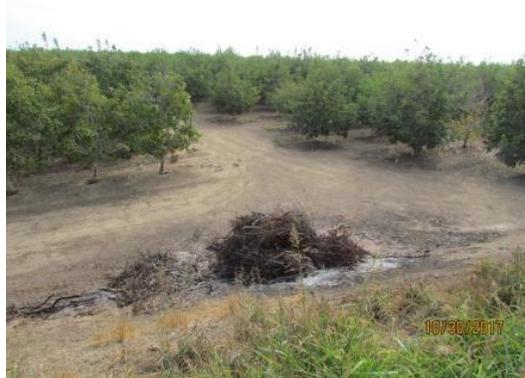
Photo 1 of 1 : FA_2019_RD0010_164_39_20190904_00013.jpg

LM Start	1.80	Rating **	M	Issue No.	39
LM End	1.80	Issue Type +	En	Location *	LS
Category	Earthen Levee			GPS Latitude/Longitude	
				Start	End
Item	Encroachments			39.189467°	39.189467°
				-121.607991°	-121.607991°
DWR ID	DWR_RD0010_02_s_2016_39				
Comment Code					
PR : Prunings					
Inspector Comment					
Remove prunings from toe of slope, Fall 2019.

View of prunings at landside levee toe.

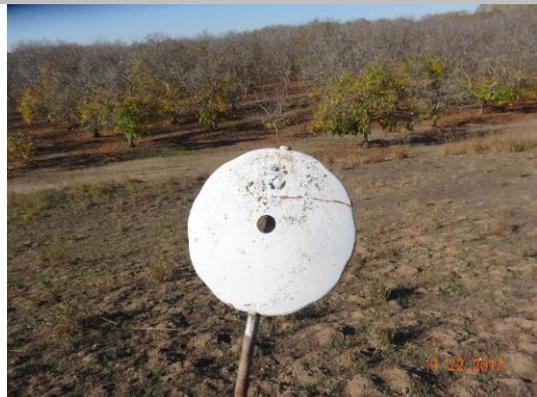
Photo 1 of 3 : UCIP_FA_2019_27773_51461.jpg

LM Start	3.10	Rating **	M	Issue No.	71
LM End	3.10	Issue Type +	En	Location *	
Category	Supplemental			GPS Latitude/Longitude	
				Start	End
Item	DRAFT DWR UCIP Field Study			39.208193 °	39.208193 °
				-121.609909 °	-121.609909 °
DWR ID	21283				
Comment Code					
Inspector Comment					
DS_ID:21283 FS_ID:27773 EP_NO: N/A Repair Type: Non-Urgent Crossing Status: Found UCIP Comments: 04/30/2013 High rodent activity along pipe alignment--animal control would be beneficial. This crossing is referenced in the USACE Periodic Inspection as item USACE_CESPK_HON2_2013_p_0150. (DWR UCIP - O. Magana) FIELD_STRUCT_DESC: 30-inch corrugated metal gravity drainage pipe through the levee, 22.5 feet below the crown. Flap gate on the waterside (WS) end. Metal marker on the WS shoulder. [Additional Reference(s): DWR Levee Log, 2005]. FS Date: 4/30/2013

Marker visible on waterward side.

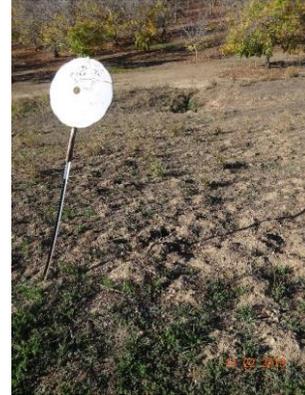
Photo 2 of 3 : UCIP_FA_2019_27773_51460.jpg

View of waterward side--burrow activity present on slope.

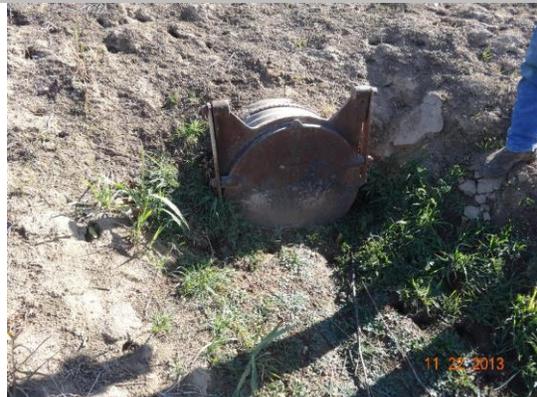
Photo 3 of 3 : UCIP_FA_2019_27773_51464.jpg

View of gate on waterward side.

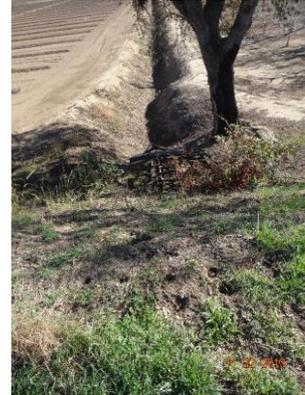
Photo 3 of 3 : UCIP_FA_2019_52889_44656.jpg

Comment Code					
Inspector Comment					
DS_ID:21284 FS_ID:52889 EP_NO: N/A Repair Type: Non-Urgent Crossing Status: Found UCIP Comments: 04/30/2013 Remove concrete piece preventing complete closure of screw gate on landward side. This crossing is referenced in the USACE Periodic Inspection as item USACE_CESPK_HON2_2013_p_0152. (DWR UCIP - O. Magana) FIELD_STRUCT_DESC: 36-inch corrugated metal gravity drainage pipe through the levee, 24 feet below the crown. Corrugated metal cutoff wall around the pipe at each shoulder. Flap gate on the waterside (WS) end. Slide gate on the landside (LS) end. Concrete headwall at each end. [Additional Reference(s): DWR Levee Log, 2005. USACE Sacramento O&M Manual 151, May 1953, (Station 259+76)]. FS Date: 4/30/2013

View of landward side--barrier used to discourage damage to crossing near toe.

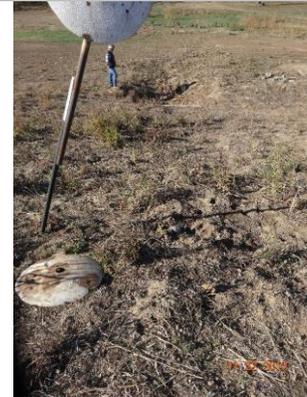
Photo 2 of 3 : UCIP_FA_2019_24825_44663.jpg

View of waterward slope--burrow activity present.

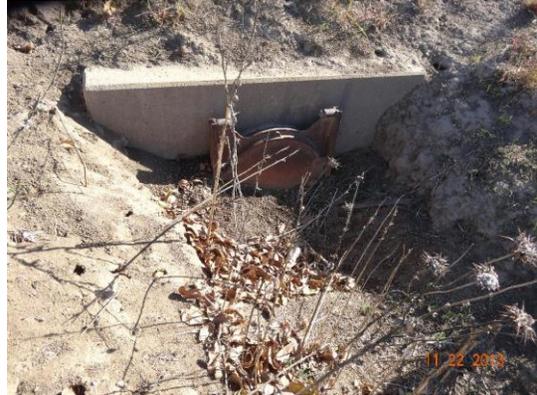
Photo 3 of 3 : UCIP_FA_2019_24825_44662.jpg

Comment Code					
Inspector Comment					
DS_ID:21285 FS_ID:24825 EP_NO: N/A Repair Type: Non-Urgent Crossing Status: Found UCIP Comments: 04/30/2013 Sediment blocking flap gate and screw gate--recommend removing material. Dense burrow activity present along levee slopes (large holes visible on landward side)--recommend addressing issue. This crossing is referenced in the USACE Periodic Inspection as item USACE_CESPK_HON2_2013_p_0169. (DWR UCIP - O. Magana) FIELD_STRUCT_DESC: 30-inch corrugated metal gravity drainage pipe through the levee, 19.5 feet below the crown. Corrugated metal cutoff wall around the pipe at each shoulder. Flap gate on the waterside (WS) end. Slide gate on the landside (LS) end. Concrete headwall at each end. [Additional Reference(s): DWR Levee Log, 2005. USACE Sacramento O&M Manual 151, May 1953, (Station 277+00)]. FS Date: 4/30/2013

Flap gate located on waterward side--debris blocking gate.

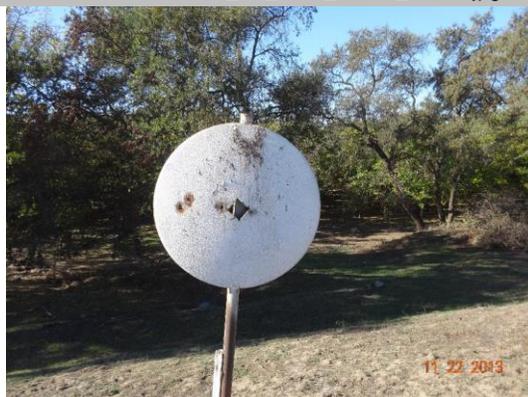
Photo 1 of 3 : UCIP_FA_2019_24826_44669.jpg

Comment Code					
Inspector Comment					
DS_ID:21286 FS_ID:24826 EP_NO: N/A Repair Type: Non-Urgent Crossing Status: Found UCIP Comments: 04/30/2013 Deformation observed on the top wall of pipe at the entrance of landward side--need to contact owner to address issue. This crossing is referenced in the USACE Periodic Inspection as item USACE_CESPK_HON2_2013_p_0180. (DWR UCIP - O. Magana) FIELD_STRUCT_DESC: 30-inch corrugated metal gravity drainage pipe through the levee, 21.5 feet below the crown. Corrugated metal cutoff walls around the pipe at each shoulder. Flap gate on the waterside (WS) end. Slide gate on the landside (LS) end. Concrete headwall at each end. [Additional Reference(s): DWR Levee Log, 2005. USACE Sacramento O&M Manual 151, May 1953, (Station 294+84)]. FS Date: 4/30/2013

View of marker located on waterward shoulder, no reference number is visible.

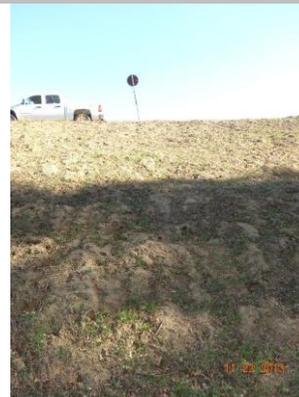
Photo 2 of 3 : UCIP_FA_2019_24826_44668.jpg

View of waterward slope.

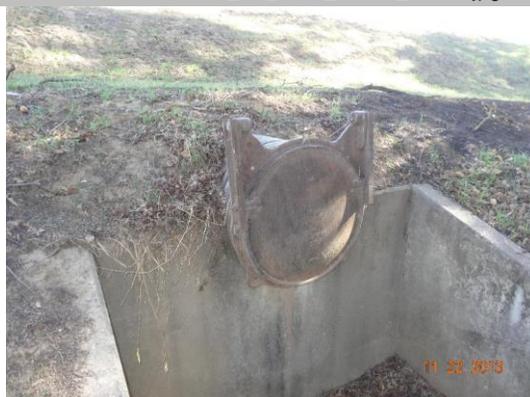
Photo 3 of 3 : UCIP_FA_2019_24826_44673.jpg

Comment Code					
Inspector Comment					
DS_ID:21286 FS_ID:24826 EP_NO: N/A Repair Type: Non-Urgent Crossing Status: Found UCIP Comments: 04/30/2013 Deformation observed on the top wall of pipe at the entrance of landward side--need to contact owner to address issue. This crossing is referenced in the USACE Periodic Inspection as item USACE_CESPK_HON2_2013_p_0180. (DWR UCIP - O. Magana) FIELD_STRUCT_DESC: 30-inch corrugated metal gravity drainage pipe through the levee, 21.5 feet below the crown. Corrugated metal cutoff walls around the pipe at each shoulder. Flap gate on the waterside (WS) end. Slide gate on the landside (LS) end. Concrete headwall at each end. [Additional Reference(s): DWR Levee Log, 2005. USACE Sacramento O&M Manual 151, May 1953, (Station 294+84)]. FS Date: 4/30/2013

View of flapgate on concrete head wall on waterward side.

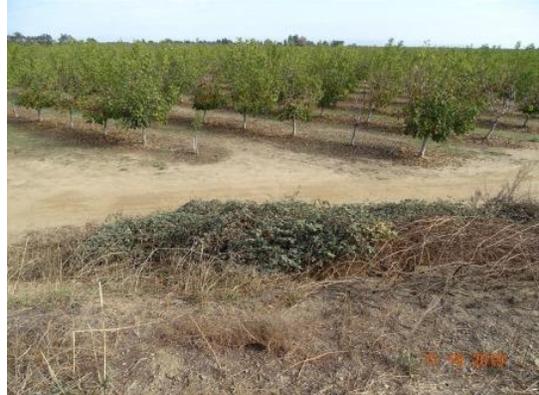
Photo 1 of 1 : FA_2019_RD0010_164_58_20191120_00102.jpg

LM Start	4.17	Rating **	M	Issue No.	58
LM End	4.17	Issue Type +	Ma	Location *	LS
Category	Earthen Levee		GPS Latitude/Longitude		
			Start	End	
Item	Vegetation		39.223276°	39.223276°	
			-121.612510°	-121.612510°	
DWR ID	DWR_RD0010_02_f_2019_58				
Comment Code					
V2 : Remove the wild growth other than native grasses from the levee slopes.					
Inspector Comment					
Remove blackberry bushes from levee slope, Fall 2019.

View looking at blackberry bushes on the landside levee slope that need to be removed, Fall 2019.

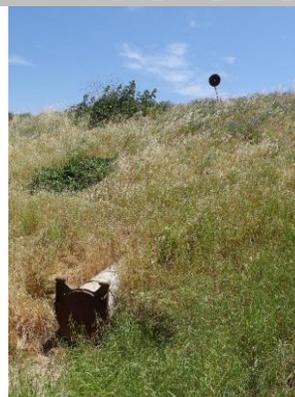
Photo 1 of 3 : UCIP_FA_2019_24751_44375.jpg

Comment Code					
Inspector Comment					
DS_ID:21288 FS_ID:24751 EP_NO: N/A Repair Type: Non-Urgent Crossing Status: Found UCIP Comments: 04/30/2013 Need to updated photos showing cleared slopes. This crossing is referenced in the USACE Periodic Inspection as item USACE_CESPK_HON2_2013_p_0193. (DWR UCIP - O. Magana) FIELD_STRUCT_DESC: 24-inch corrugated metal gravity drainage pipe through the levee, 19 feet below the crown. Corrugated metal cutoff wall around the pipe at each shoulder. Flap gate on the waterside (WS) end. Slide gate on the landside (LS). Concrete headwall, saddle, and apron on the WS end. [Additional Reference(s): DWR Levee Log, 2005. USACE Sacramento O&M Manual 151, May 1953, (Station 322+25)]. FS Date: 4/30/2013

View of waterward side--dense vegetation on slope.

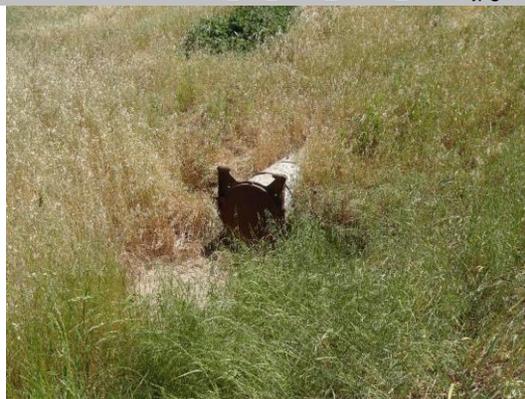
Photo 2 of 3 : UCIP_FA_2019_24751_44376.jpg

View of flap gate on waterward side.

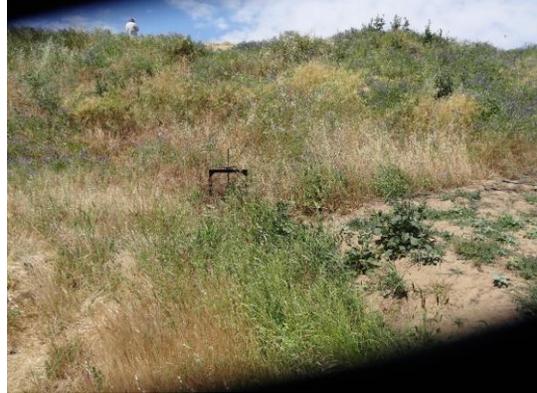
Photo 3 of 3 : UCIP_FA_2019_24751_44373.jpg

Comment Code					
Inspector Comment					
DS_ID:21288 FS_ID:24751 EP_NO: N/A Repair Type: Non-Urgent Crossing Status: Found UCIP Comments: 04/30/2013 Need to updated photos showing cleared slopes. This crossing is referenced in the USACE Periodic Inspection as item USACE_CESPK_HON2_2013_p_0193. (DWR UCIP - O. Magana) FIELD_STRUCT_DESC: 24-inch corrugated metal gravity drainage pipe through the levee, 19 feet below the crown. Corrugated metal cutoff wall around the pipe at each shoulder. Flap gate on the waterside (WS) end. Slide gate on the landside (LS). Concrete headwall, saddle, and apron on the WS end. [Additional Reference(s): DWR Levee Log, 2005. USACE Sacramento O&M Manual 151, May 1953, (Station 322+25)]. FS Date: 4/30/2013

View of landward side--dense vegetation.

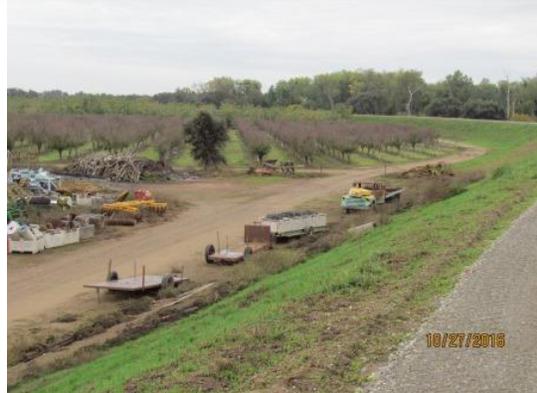
Photo 1 of 1 : FA_2019_RD0010_164_31_20190904_00006.jpg

LM Start	4.44	Rating **	M	Issue No.	31
LM End	4.48	Issue Type +	En	Location *	LS
Category	Earthen Levee			GPS Latitude/Longitude	
				Start	End
Item	Encroachments			39.226946°	39.227445°
				-121.613048°	-121.612718°
DWR ID	DWR_RD0010_02_f_2015_31				
Comment Code					
EQ : Equipment					
Inspector Comment					
Remove existing equipment from the levee toe.

View of the equipment at the toe of the levee on the landward side of the levee looking downstream.

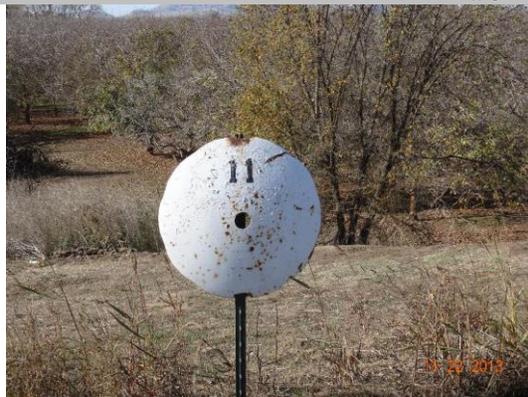
Photo 1 of 3 : UCIP_FA_2019_27774_51467.jpg

LM Start	4.78	Rating **	M	Issue No.	77
LM End	4.78	Issue Type +	En	Location *	
Category	Supplemental			GPS Latitude/Longitude	
				Start	End
Item	DRAFT DWR UCIP Field Study			39.231251°	39.231251°
				-121.614494°	-121.614494°
DWR ID	21289				
Comment Code					
Inspector Comment					
DS_ID:21289 FS_ID:27774 EP_NO: N/A Repair Type: Non-Urgent Crossing Status: Indicator Found UCIP Comments: 04/30/2013 Sediment build-up inside and at the opening pipe. This crossing is referenced in the USACE Periodic Inspection as item USACE_CESPK_HON2_2013_p_0206. (DWR UCIP - O. Magana) FIELD_STRUCT_DESC: 30-inch gravity drainage pipe of an unknown material through the levee, 20 feet below the crown. Flap gate on the waterside (WS) end. Slide gate on the landside (LS) end. [Additional Reference(s): DWR Levee Log, 2005]. FS Date: 4/30/2013

Marker visible on waterward shoulder, Reference ID No. 11 for crossing.
