**Flood Control Project Maintenance
Levee Inspections**

Fall 2019 Levee Maintenance Deficiency Summary Report

Sacramento River Basin

Reclamation District No. 0010 Honcut

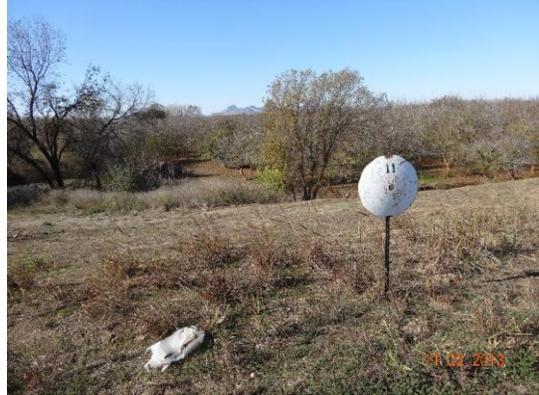
Photo 2 of 3 : UCIP_FA_2019_27774_51470.jpg

View of waterward side.

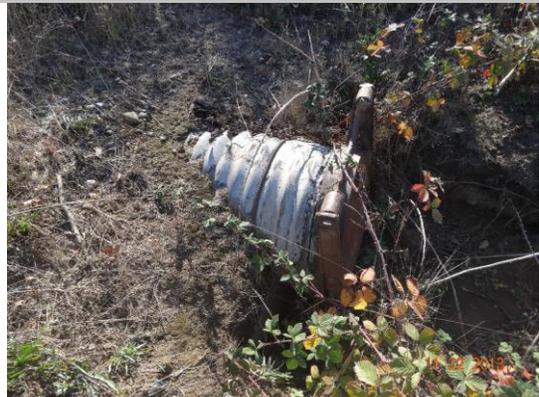
Photo 3 of 3 : UCIP_FA_2019_27774_51469.jpg

View of flap gate located on waterward side.

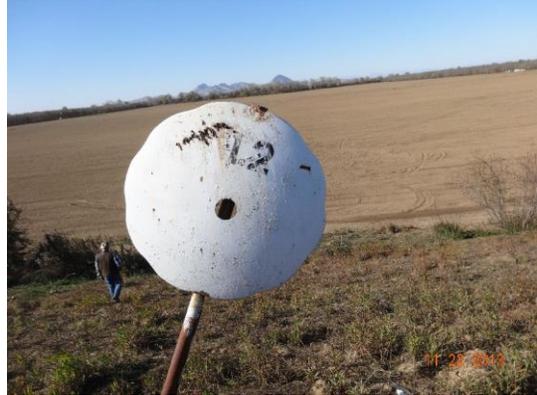
Photo 1 of 3 : UCIP_FA_2019_24828_44680.jpg

Comment Code					
Inspector Comment					
DS_ID:21290 FS_ID:24828 EP_NO: N/A Repair Type: No Action Needed Crossing Status: Found UCIP Comments: 04/30/2013 This crossing is referenced in the USACE Periodic Inspection as item USACE_CESPK_HON2_2013_p_0212. (DWR UCIP - O. Magana) FIELD_STRUCT_DESC: 30-inch corrugated metal gravity drainage pipe through the levee, 20 feet below the crown. Corrugated metal cutoff wall around the pipe at each shoulder. Flap gate on the waterside (WS) end. Slide gate on the landside (LS). Concrete headwall, saddle, and apron on the WS end. Pipe discharges into a 5-foot by 5-foot concrete distribution box at the WS toe. [Additional Reference(s): DWR Levee Log, 2005. USACE Sacramento O&M Manual 151, May 1953, (Station 354+96)]. FS Date: 4/30/2013

View of marker located on waterward shoulder--crossing referenced as No. 12.

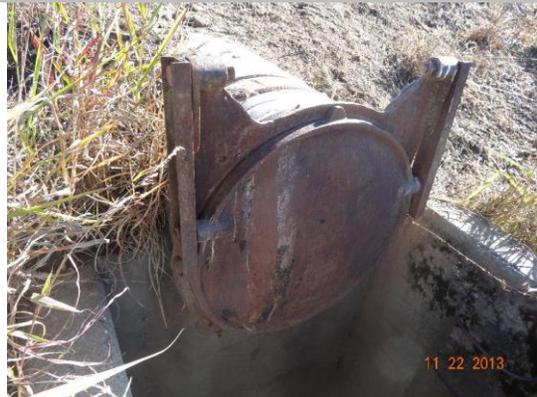
Photo 2 of 3 : UCIP_FA_2019_24828_44684.jpg

View of flap gate located on waterward side.

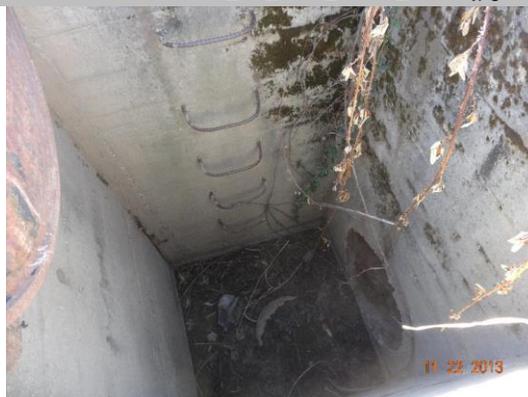
Photo 3 of 3 : UCIP_FA_2019_24828_44683.jpg

Inside view of concrete distribution box.

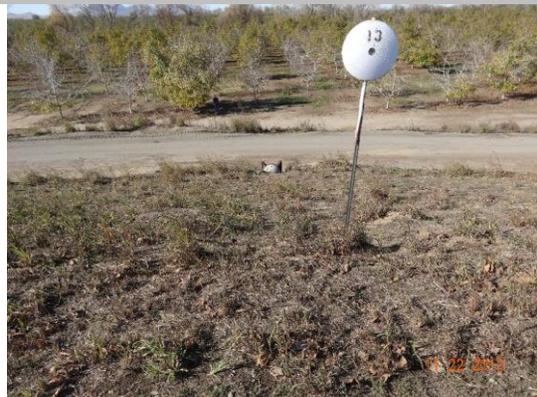
Photo 1 of 3 : UCIP_FA_2019_27793_51514.jpg

Comment Code					
Inspector Comment					
DS_ID:21291 FS_ID:27793 EP_NO: N/A Repair Type: Non-Urgent Crossing Status: Found UCIP Comments: 04/30/2013 Need to contact owner to remove debris inside concrete distribution box and on slope. This crossing is referenced in the USACE Periodic Inspection as item USACE_CESPK_HON2_2013_p_0244. (DWR UCIP - O. Magana) FIELD_STRUCT_DESC: 30-inch corrugated metal gravity drainage pipe through the levee, 17.3 feet below the crown. Corrugated metal cutoff wall around the pipe at each shoulder. Flap gate on the waterside (WS) end. Slide gate on the landside (LS) end. Concrete headwall at each end. [Additional Reference(s): DWR Levee Log, 2005. USACE Sacramento O&M Manual 151, May 1953, (Station 413+81)]. FS Date: 4/30/2013

View of marker located on waterward shoulder, pipe is reference as No. 13.

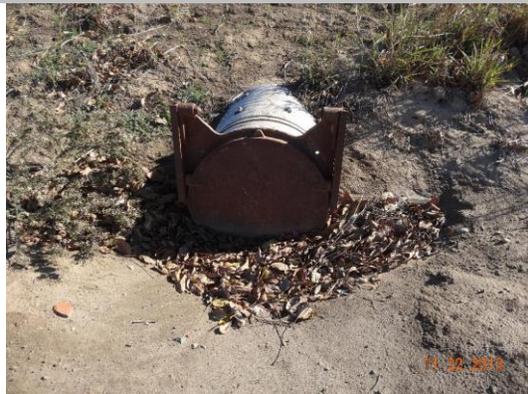
Photo 2 of 3 : UCIP_FA_2019_27793_51517.jpg

View of flap gate located on waterward side.

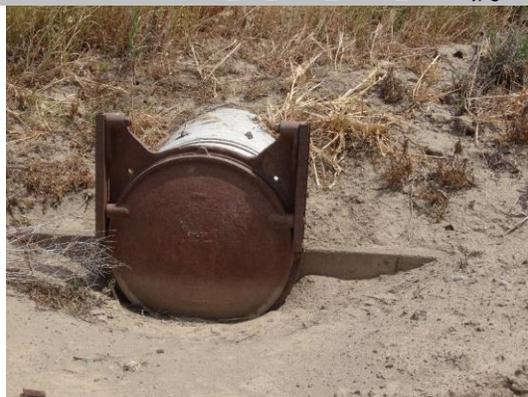
Photo 3 of 3 : UCIP_FA_2019_27793_51513.jpg

Flap gate and concrete headwall visible on waterward side.

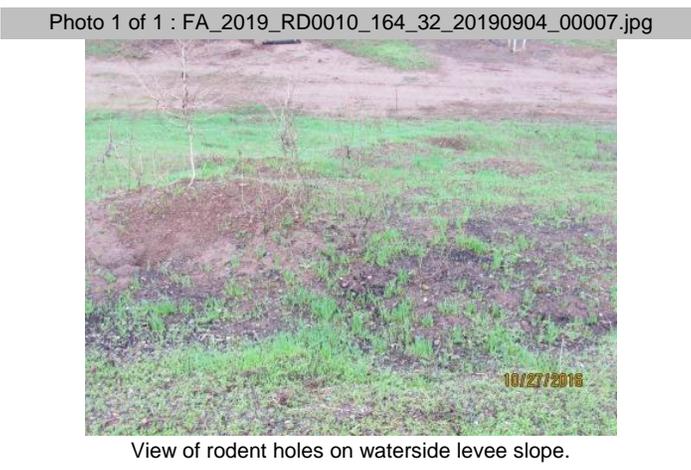
LM Start	6.72	Rating **	M	Issue No.	32
LM End	6.72	Issue Type +	Ma	Location *	WS
Category	Earthen Levee			GPS Latitude/Longitude	
				Start	End
Item	Animal Control			39.257859 °	39.257859 °
				-121.617667 °	-121.617667 °
DWR ID	DWR_RD0010_02_f_2015_32				
Comment Code					
A3 : No rodents visible, but rodent burrows visible; need to backfill and compact or grout burrows.					
Inspector Comment					
No rodent activity but holes need to be properly backfilled, Fall 2019.

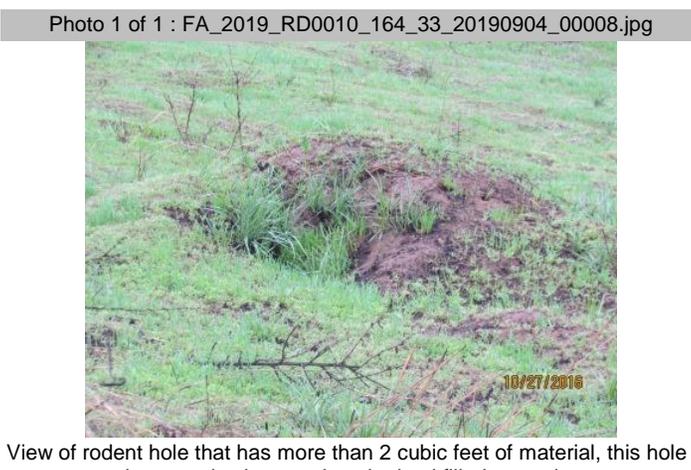
LM Start	6.88	Rating **	U	Issue No.	33
LM End	6.88	Issue Type +	Ma	Location *	WS
Category	Earthen Levee			GPS Latitude/Longitude	
				Start	End
Item	Animal Control			39.259843 °	39.259843 °
				-121.616013 °	-121.616013 °
DWR ID	DWR_RD0010_02_f_2015_33				
Comment Code					
A3 : No rodents visible, but rodent burrows visible; need to backfill and compact or grout burrows.					
Inspector Comment					
Rodent hole that has more than 2 cubic feet of material, this hole is not active but needs to be backfilled properly, Fall 2019.

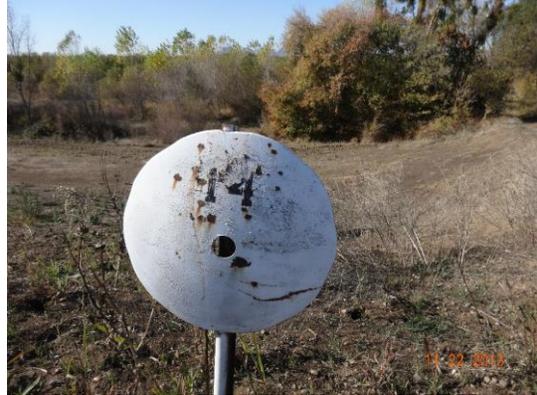
Photo 1 of 3 : UCIP_FA_2019_50059_44693.jpg

Comment Code					
Inspector Comment					
DS_ID:21293 FS_ID:50059 EP_NO: N/A Repair Type: Non-Urgent Crossing Status: Indicator Found UCIP Comments: 7/01/2016 Crossing is blocked by sediment and debris on both WS and LS. Screw gate is missing on LS. (DWR UCIP - omagana)4/30/2013 Both openings of crossing are blocked by sediment--screw gate is damage. Recommend notifying owner to repair screw gate and remove sediment build-up blocking openings. This crossing is referenced in the USACE Periodic Inspection as item USACE_CESPK_HON2_2013_p_0295. (DWR UCIP - omagana) FIELD_STRUCT_DESC: 24-inch corrugated metal gravity drainage pipe through the levee, 13 feet below the crown. Corrugated metal cutoff wall around the pipe at each shoulder. Flap gate on the waterside (WS) end. Slide gate on the landside (LS). Concrete headwall, saddle, and apron on the WS end. [Additional Reference(s): DWR Levee Log, 2005. USACE Sacramento O&M Manual 151, May 1953, (Station 471+21)]. FS Date: 7/1/2016

Marker visible on WS shoulder, crossing referenced as No. 14.

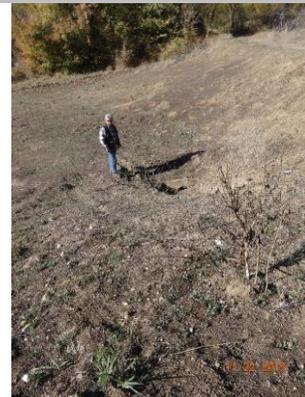
Photo 2 of 3 : UCIP_FA_2019_50059_44692.jpg

View of WS slope.

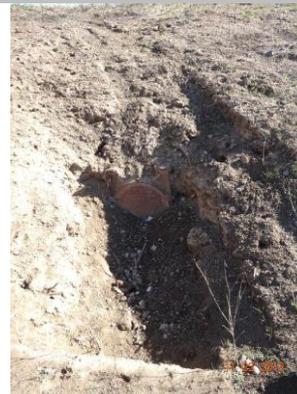
Photo 3 of 3 : UCIP_FA_2019_50059_44697.jpg

Comment Code					
Inspector Comment					
DS_ID:21293 FS_ID:50059 EP_NO: N/A Repair Type: Non-Urgent Crossing Status: Indicator Found UCIP Comments: 7/01/2016 Crossing is blocked by sediment and debris on both WS and LS. Screw gate is missing on LS. (DWR UCIP - omagana)4/30/2013 Both openings of crossing are blocked by sediment--screw gate is damage. Recommend notifying owner to repair screw gate and remove sediment build-up blocking openings. This crossing is referenced in the USACE Periodic Inspection as item USACE_CESPK_HON2_2013_p_0295. (DWR UCIP - omagana) FIELD_STRUCT_DESC: 24-inch corrugated metal gravity drainage pipe through the levee, 13 feet below the crown. Corrugated metal cutoff wall around the pipe at each shoulder. Flap gate on the waterside (WS) end. Slide gate on the landside (LS). Concrete headwall, saddle, and apron on the WS end. [Additional Reference(s): DWR Levee Log, 2005. USACE Sacramento O&M Manual 151, May 1953, (Station 471+21)]. FS Date: 7/1/2016

View of flap gate and concrete distribution box on WS.

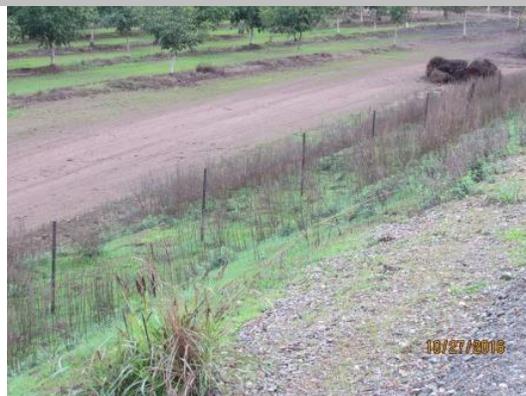
Photo 1 of 1 : FA_2019_RD0010_164_55_20190904_00022.jpg

LM Start	7.31	Rating **	M	Issue No.	55
LM End	11.34	Issue Type +	En	Location *	LS
Category	Earthen Levee			GPS Latitude/Longitude	
				Start	End
Item	Encroachments			39.265726 °	39.309707 °
				-121.613676 °	-121.616552 °
DWR ID	DWR_RD0010_02_s_2016_55				
Comment Code					
FE : Fence					
Inspector Comment					
Fence runs along the landside levee toe.

View of fence at landside levee toe looking downstream.

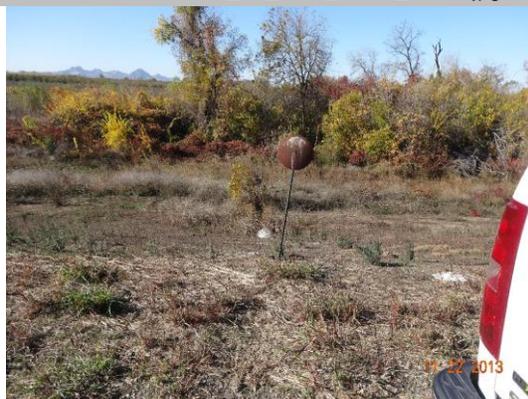
Photo 1 of 3 : UCIP_FA_2019_24831_44700.jpg

Comment Code					
Inspector Comment					
DS_ID:21294 FS_ID:24831 EP_NO: N/A Repair Type: No Action Needed Crossing Status: Found UCIP Comments: 04/30/2013 This crossing is referenced in the USACE Periodic Inspection as item USACE_CESPK_HON2_2013_p_0312. (DWR UCIP - O. Magana) FIELD_STRUCT_DESC: 24-inch corrugated metal gravity drainage pipe through the levee, 13 feet below the crown. Corrugated metal cutoff wall around the pipe at each shoulder. Flap gate on the waterside (WS) end. Slide gate on the landside (LS) end. Concrete headwall at each end. Metal marker on the LS shoulder. [Additional Reference(s): DWR Levee Log, 2005. USACE Sacramento O&M Manual 151, May 1953, (Station 493+50)]. FS Date: 4/30/2013

Visible marker located on waterward shoulder--no id number noted.

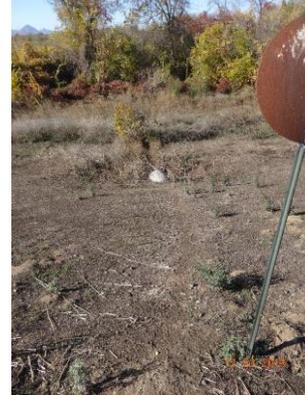
Photo 2 of 3 : UCIP_FA_2019_24831_44699.jpg

View of waterward slope.

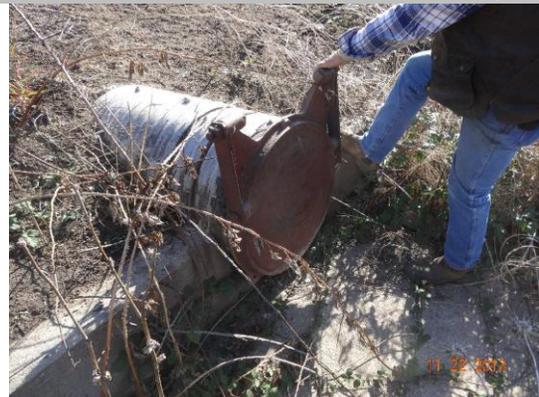
Photo 3 of 3 : UCIP_FA_2019_24831_44698.jpg

Flap gate visible on waterward side.

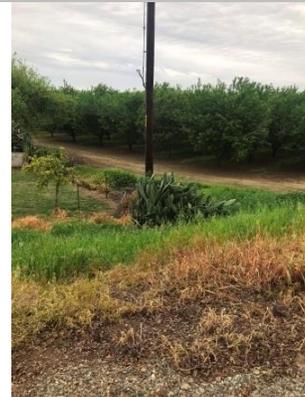
Photo 1 of 1 : FA_2019_RD0010_164_41_20190904_00015.jpg

LM Start	8.02	Rating **	M	Issue No.	41
LM End	8.02	Issue Type +	En	Location *	LS
Category	Earthen Levee			GPS Latitude/Longitude	
				Start	End
Item	Vegetation			39.274334 °	39.274334 °
				-121.611986 °	-121.611986 °
DWR ID	DWR_RD0010_02_s_2018_41				
Comment Code					
V6 : Landscaping					
Inspector Comment					
Remove landscape from the levee toe.

View looking downstream landside of a landscape bush at the levee toe.

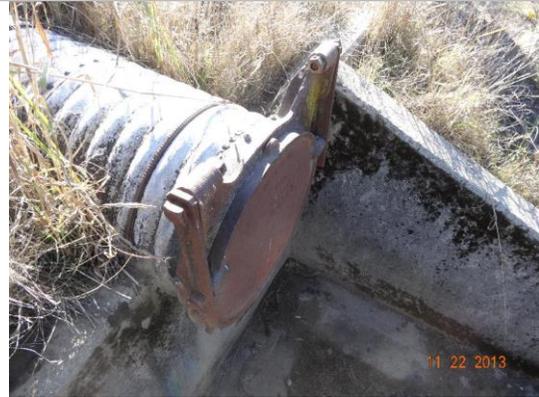
Photo 3 of 3 : UCIP_FA_2019_24832_44703.jpg

Comment Code					
Inspector Comment					
DS_ID:21295 FS_ID:24832 EP_NO: N/A Repair Type: No Action Needed Crossing Status: Found UCIP Comments: 04/30/2013 This crossing is referenced in the USACE Periodic Inspection as item USACE_CESPK_HON2_2013_p_0329. (DWR UCIP - O. Magana) FIELD_STRUCT_DESC: 24-inch corrugated metal gravity drainage pipe through the levee, 12.5 feet below the crown. Corrugated metal cutoff wall around the pipe at each shoulder. Flap gate on the waterside (WS) end. Slide gate on the landside (LS) end. Concrete headwall at each end. [Additional Reference(s): DWR Levee Log, 2005. USACE Sacramento O&M Manual 151, May 1953, (Station 515+52)]. FS Date: 4/30/2013

View of flap gate located on waterward side.

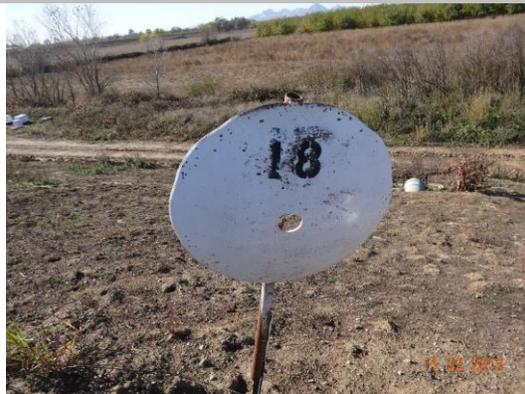
Photo 1 of 3 : UCIP_FA_2019_24834_44715.jpg

Comment Code					
Inspector Comment					
DS_ID:21297 FS_ID:24834 EP_NO: N/A Repair Type: Non-Urgent Crossing Status: Found UCIP Comments: 04/30/2013 Slide gate missing on landward side. Need to contact owner to determine status of crossing. This crossing is referenced in the USACE Periodic Inspection as item USACE_CESPK_HON2_2013_p_0367. (DWR UCIP - O. Magana) FIELD_STRUCT_DESC: 24-inch corrugated metal gravity drainage pipe through the levee, 14 feet below the crown. Corrugated metal cutoff wall around the pipe at each shoulder. Flap gate on the waterside (WS) end. Slide gate on the landside (LS), slide gate missing. Concrete headwall, saddle, and apron on the WS end. 6-foot by 6-foot concrete splash apron at the WS toe. [Additional Reference(s): DWR Levee Log, 2005. USACE Sacramento O&M Manual 151, May 1953, (Station 565+74)]. FS Date: 4/30/2013

Marker visible on waterward shoulder, crossing is referenced as No. 18.

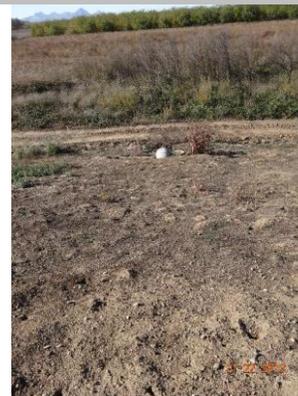
Photo 2 of 3 : UCIP_FA_2019_24834_44714.jpg

View of waterward side.

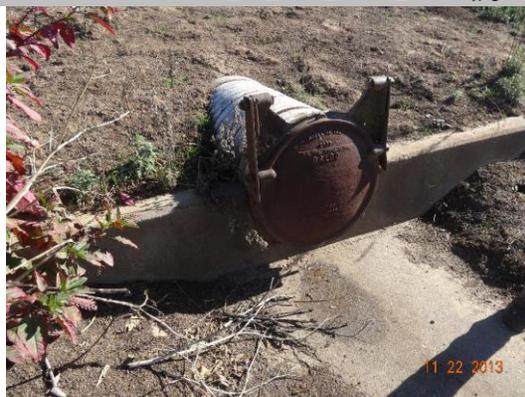
Photo 3 of 3 : UCIP_FA_2019_24834_44716.jpg

Comment Code					
Inspector Comment					
DS_ID:21297 FS_ID:24834 EP_NO: N/A Repair Type: Non-Urgent Crossing Status: Found UCIP Comments: 04/30/2013 Slide gate missing on landward side. Need to contact owner to determine status of crossing. This crossing is referenced in the USACE Periodic Inspection as item USACE_CESPK_HON2_2013_p_0367. (DWR UCIP - O. Magana) FIELD_STRUCT_DESC: 24-inch corrugated metal gravity drainage pipe through the levee, 14 feet below the crown. Corrugated metal cutoff wall around the pipe at each shoulder. Flap gate on the waterside (WS) end. Slide gate on the landside (LS), slide gate missing. Concrete headwall, saddle, and apron on the WS end. 6-foot by 6-foot concrete splash apron at the WS toe. [Additional Reference(s): DWR Levee Log, 2005. USACE Sacramento O&M Manual 151, May 1953, (Station 565+74)]. FS Date: 4/30/2013

View of flap gate visible on waterward side.

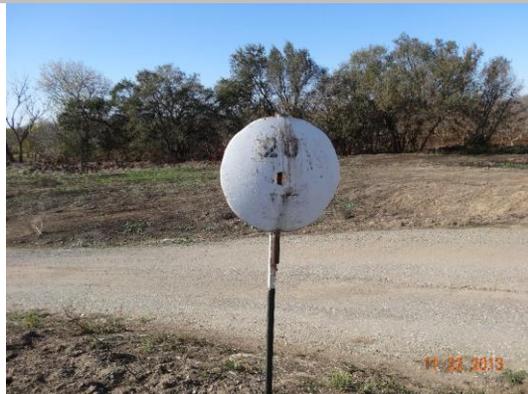
Photo 1 of 3 : UCIP_FA_2019_24769_44454.jpg

Comment Code					
Inspector Comment					
DS_ID:21299 FS_ID:24769 EP_NO: N/A Repair Type: Non-Urgent Crossing Status: Found UCIP Comments: 04/30/2013 Need to contact owner. Need to clear debris from concrete distribution box on waterward and remove debris blocking landward side. This crossing is referenced in the USACE Periodic Inspection as item USACE_CESPK_HON2_2013_p_0383. (DWR UCIP - O. Magana) FIELD_STRUCT_DESC: 24-inch corrugated metal gravity drainage pipe through the levee, 12 feet below the crown. Corrugated metal cutoff wall around the pipe at each shoulder. Flap gate on the waterside (WS) end. Slide gate on the landside (LS). Concrete headwall, saddle, and apron on the WS end. Metal marker on the WS shoulder. [Additional Reference(s): DWR Levee Log, 2005. USACE Sacramento O&M Manual 151, May 1953, (Station 582+72)]. FS Date: 4/30/2013

Marker visible on waterward side shoulder, crossing is referenced as No. 20.

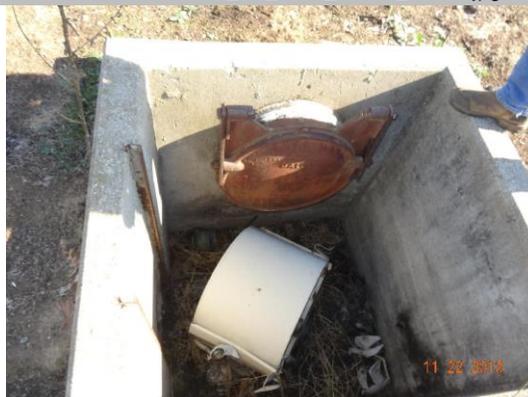
Photo 2 of 3 : UCIP_FA_2019_24769_44453.jpg

View of flap gate located inside concrete distribution box. Debris scattered inside box.

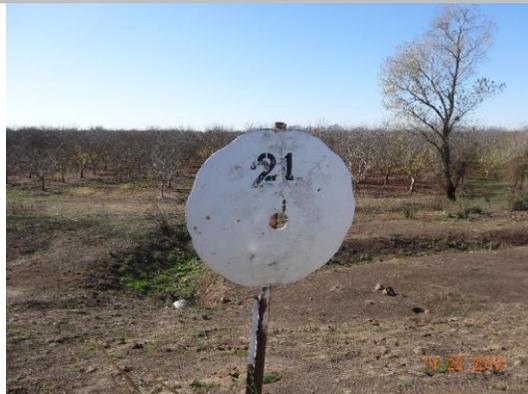
Photo 1 of 3 : UCIP_FA_2019_24835_44721.jpg

Marker visible on waterward shoulder, crossing referenced as No. 21.

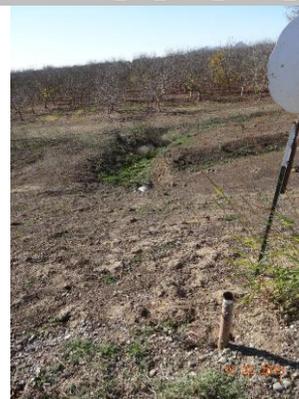
Photo 2 of 3 : UCIP_FA_2019_24835_44720.jpg

View of waterward side.

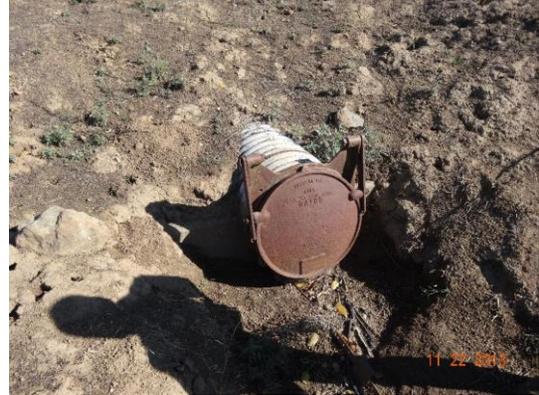
Photo 3 of 3 : UCIP_FA_2019_24835_44725.jpg

View of flap gate located on waterward side.

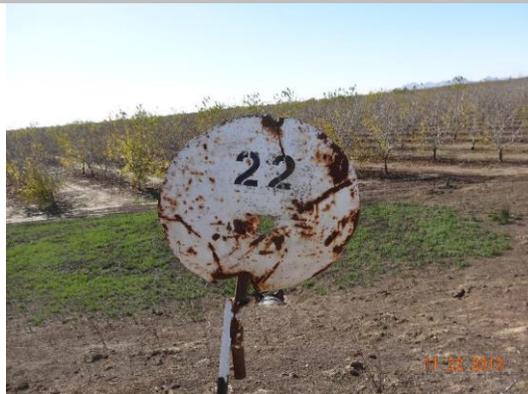
Photo 1 of 3 : UCIP_FA_2019_27776_51478.jpg

LM Start	9.71	Rating **	M	Issue No.	88
LM End	9.71	Issue Type +	En	Location *	
Category	Supplemental			GPS Latitude/Longitude	
				Start	End
Item	DRAFT DWR UCIP Field Study			39.291474°	39.291474°
				-121.603677°	-121.603677°
DWR ID	21301				
Comment Code					
Inspector Comment					
DS_ID:21301 FS_ID:27776 EP_NO: N/A Repair Type: Non-Urgent Crossing Status: Found UCIP Comments: 04/30/2013 Recommend removing debris blocking slide gate on landward side. This crossing is referenced in the USACE Periodic Inspection as item USACE_CESPK_HON2_2013_p_0402. (DWR UCIP - O. Magana) FIELD_STRUCT_DESC: 24-inch gravity drainage pipe of an unknown material through the levee, 13 feet below the crown. Flap gate on the waterside (WS) end. Slide gate on the landside (LS) end. Concrete headwall at the LS toe. [Additional Reference(s): DWR Levee Log, 2005]. FS Date: 4/30/2013

Marker visible on waterward shoulder, crossing referenced as No. 22.

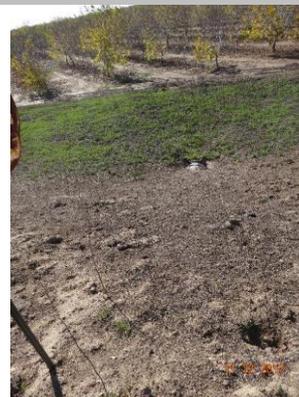
Photo 2 of 3 : UCIP_FA_2019_27776_51482.jpg

View of waterward side.

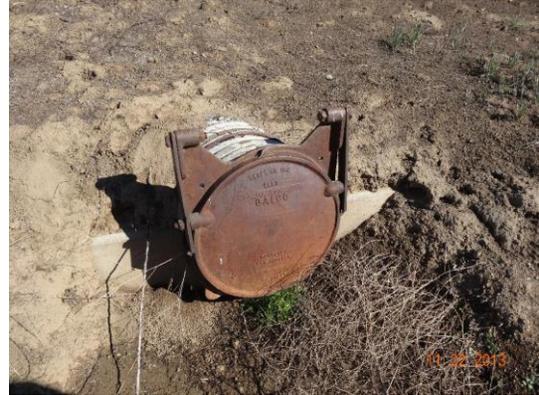
Photo 3 of 3 : UCIP_FA_2019_27776_51481.jpg

View of flap gate located on waterward toe.

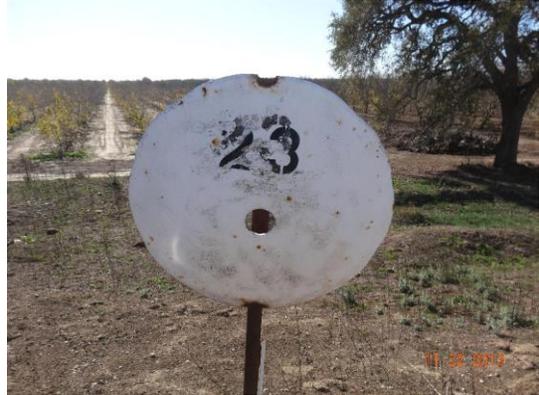
Photo 1 of 3 : UCIP_FA_2019_24837_44731.jpg

Marker visible on waterward shoulder, crossing is referenced as No. 23.

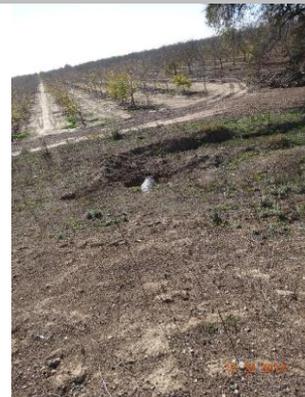
Photo 2 of 3 : UCIP_FA_2019_24837_44735.jpg

Overview of waterward side.

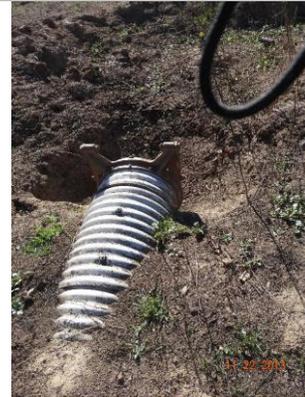
Photo 3 of 3 : UCIP_FA_2019_24837_44734.jpg

Pipe through waterside side.

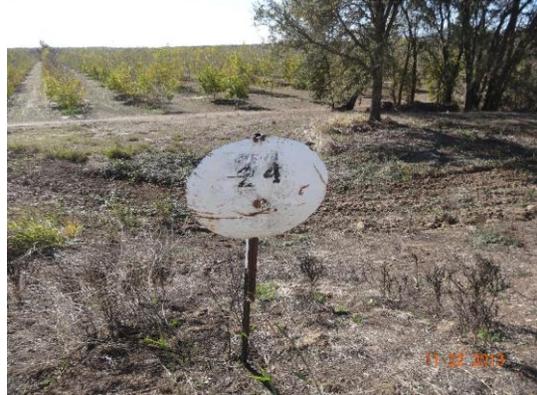
Photo 1 of 3 : UCIP_FA_2019_24838_44737.jpg

Comment Code					
Inspector Comment					
DS_ID:21303 FS_ID:24838 EP_NO: 1069 Repair Type: Non-Urgent Crossing Status: Found UCIP Comments: 04/30/2013 Unable to find the crossing on landward side--indicators found of crossing. Need to coordinate with owner to determine status of crossing. If crossing is no longer in use owner will need to contact the CVFPB to comply with Title 23. This crossing is referenced in the USACE Periodic Inspection as item USACE_CESPK_HON2_2013_p_0442. (DWR UCIP - O. Magana) FIELD_STRUCT_DESC: 24-inch steel gravity irrigation pipe through the levee, 13 feet below the crown. Concrete cutoff wall around the pipe at each shoulder. Flap gate and concrete headwall on the waterside (WS) end. Slide gate, concrete saddle, and apron on the landside (LS) end. (Plans for installation of a 24-inch corrugated iron pipe through the levee authorized under Permit No. 1069, 1946 - Pacific Ranch, care of Chas. J. Mathews). [Additional Reference(s): DWR Levee Log, 2005. USACE Sacramento O&M Manual 151, May 1953, (Station 638+00)]. FS Date: 4/30/2013

Marker visible on waterward shoulder, this crossing is reference as No. 24.

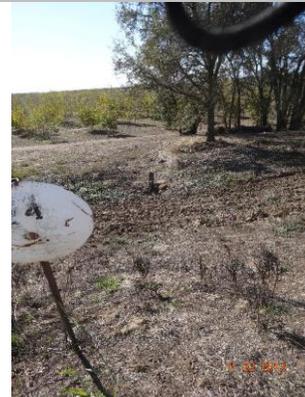
Photo 2 of 3 : UCIP_FA_2019_24838_44741.jpg

View of waterward side.

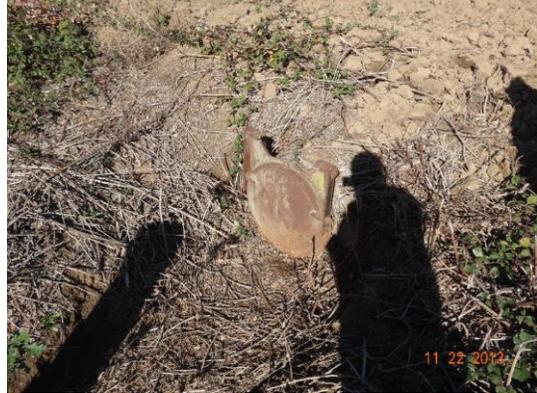
Photo 3 of 3 : UCIP_FA_2019_24838_44740.jpg

Comment Code					
Inspector Comment					
DS_ID:21303 FS_ID:24838 EP_NO: 1069 Repair Type: Non-Urgent Crossing Status: Found UCIP Comments: 04/30/2013 Unable to find the crossing on landward side--indicators found of crossing. Need to coordinate with owner to determine status of crossing. If crossing is no longer in use owner will need to contact the CVFPB to comply with Title 23. This crossing is referenced in the USACE Periodic Inspection as item USACE_CESPK_HON2_2013_p_0442. (DWR UCIP - O. Magana) FIELD_STRUCT_DESC: 24-inch steel gravity irrigation pipe through the levee, 13 feet below the crown. Concrete cutoff wall around the pipe at each shoulder. Flap gate and concrete headwall on the waterside (WS) end. Slide gate, concrete saddle, and apron on the landside (LS) end. (Plans for installation of a 24-inch corrugated iron pipe through the levee authorized under Permit No. 1069, 1946 - Pacific Ranch, care of Chas. J. Mathews). [Additional Reference(s): DWR Levee Log, 2005. USACE Sacramento O&M Manual 151, May 1953, (Station 638+00)]. FS Date: 4/30/2013

View of flap gate located on waterward side.

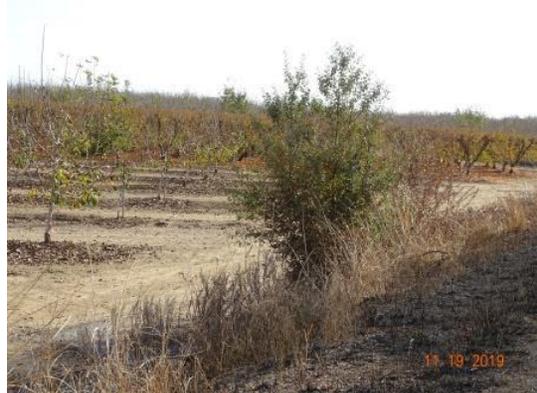
Photo 1 of 1 : FA_2019_RD0010_164_56_20191120_00106.jpg

LM Start	10.53	Rating **	M	Issue No.	56
LM End	10.53	Issue Type +	Ma	Location *	LS
Category	Earthen Levee			GPS Latitude/Longitude	
				Start	End
Item	Trim / Thin Trees			39.299244°	39.299244°
				-121.615166°	-121.615166°
DWR ID	DWR_RD0010_02_f_2019_56				
Comment Code					
T2 : Thin trees to allow visibility of the ground and room to flood fight.					
Inspector Comment					
Remove small starter tree from levee slope, Fall 2019.

View looking downstream landside at a small starter tree that needs to be removed, Fall 2019.

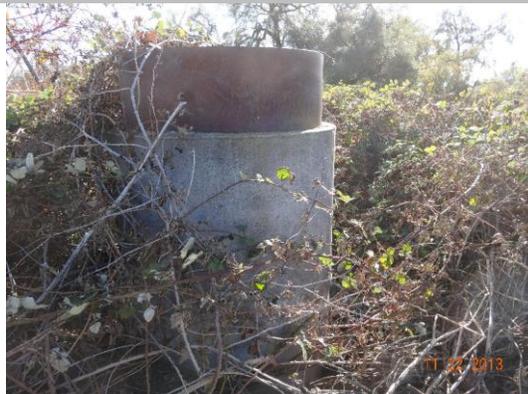
Photo 3 of 3 : UCIP_FA_2019_24839_44748.jpg

Comment Code					
Inspector Comment					
DS_ID:21304 FS_ID:24839 EP_NO: N/A Repair Type: Non-Urgent Crossing Status: Found UCIP Comments: 04/30/2013 Rip rap was used to stabilize the waterward slope during high water as a means of emergency repair-- unable to determine storm event when repair was performed. Recommend obtaining records of the repair and to determine if crossing is still being used. Need to determine owner. Dense vegetation limits the inspector's visibility to identify signs of pipe failure (leaks) along the slope. Recommend removing vegetation along pipe alignment to conduct proper inspection of structure and appurtenances. This crossing is referenced in the USACE Periodic Inspection as item USACE_CESPK_HON2_2013_p_0458 and 460. (DWR UCIP - O. Magana) FIELD_STRUCT_DESC: 24-inch steel irrigation discharge pipe through the levee, 5 feet below the crown. Slide gate in a 36-inch concrete riser on the landside (LS) shoulder. Gate valve in a pump house on the waterside (WS) slope. Concrete headwall, saddle, and apron on the WS end. [Additional Reference(s): DWR Levee Log, 2005. USACE Sacramento O&M Manual 151, May 1953, (Station 655+65)]. FS Date: 4/30/2013

View of standpipe located on waterward side.

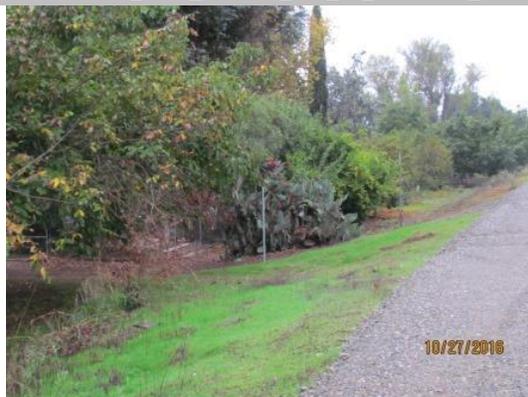
Photo 1 of 1 : FA_2019_RD0010_164_37_20190904_00012.jpg

LM Start	10.94	Rating **	M	Issue No.	37
LM End	10.94	Issue Type +	En	Location *	LS
Category	Earthen Levee			GPS Latitude/Longitude	
				Start	End
Item	Vegetation			39.304087 °	39.304087 °
				-121.618086 °	-121.618086 °
DWR ID	DWR_RD0010_02_f_2015_37				
Comment Code					
V6 : Landscaping					
Inspector Comment					
Landscaping on the levee toe should be removed.

View of the cactus on the landward side of the levee looking downstream.

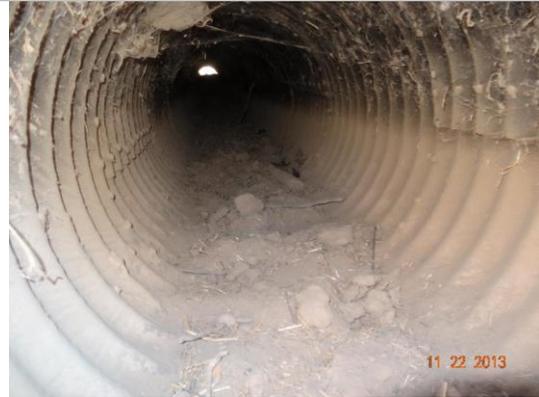
Photo 3 of 3 : UCIP_FA_2019_24840_44751.jpg

Comment Code					
Inspector Comment					
DS_ID:21305 FS_ID:24840 EP_NO: N/A Repair Type: Non-Urgent Crossing Status: Found UCIP Comments: 04/30/2013 Burrow activity--large holes found on landward side. Crossing on landward side is blocked. Recommend clearing headwall and crossing. Need to coordinate with owner to determine status of crossing. If crossing is no longer in use owner will need to contact the CVFPB to comply with Title 23. This crossing is referenced in the USACE Periodic Inspection as item USACE_CESPK_HON2_2013_p_0476. (DWR UCIP - O. Magana) FIELD_STRUCT_DESC: 24-inch corrugated metal gravity drainage pipe through the levee, 7.5 feet below the crown. Corrugated metal cutoff wall around the pipe at each shoulder. Flap gate on the waterside (WS) end. Concrete headwall at each toe. Saddle and apron on the WS. [Additional Reference(s): DWR Levee Log, 2005. USACE Sacramento O&M Manual 151, May 1953, (Station 674+73)]. FS Date: 4/30/2013

Internal view of pipe wall from waterward side.

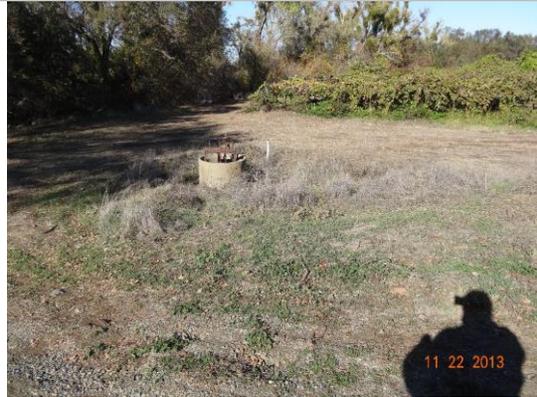
Photo 1 of 3 : UCIP_FA_2019_24841_44759.jpg

LM Start	0.01	Rating **	M	Issue No.	11
LM End	0.01	Issue Type +	En	Location *	
Category	Supplemental			GPS Latitude/Longitude	
				Start	End
Item	DRAFT DWR UCIP Field Study			39.310096°	39.310096°
				-121.616250°	-121.616250°
DWR ID	21306				
Comment Code					
Inspector Comment					
DS_ID:21306 FS_ID:24841 EP_NO: N/A Repair Type: Non-Urgent Crossing Status: Found UCIP Comments: 05/01/2013 Debris found inside crossing-- recommend removing it. (DWR UCIP - O. Magana) FIELD_STRUCT_DESC: 24-inch corrugated metal gravity drainage pipe through the levee, 6 feet below the crown. Slide gate in a concrete standpipe on the waterside (WS) end. [Additional Reference(s): DWR Levee Log, 2005]. FS Date: 5/1/2013

View of waterward side.

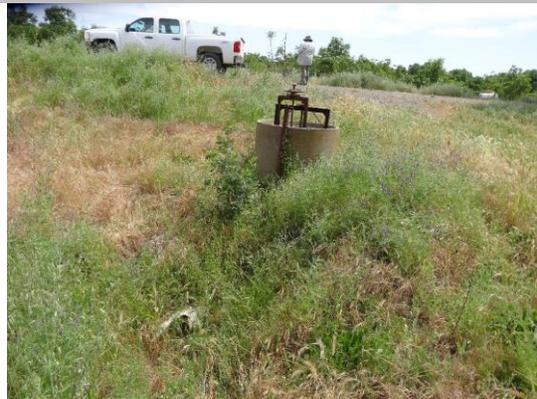
Photo 2 of 3 : UCIP_FA_2019_24841_44757.jpg

View of concrete standpipe and plastic pipe extension visible on waterward side.

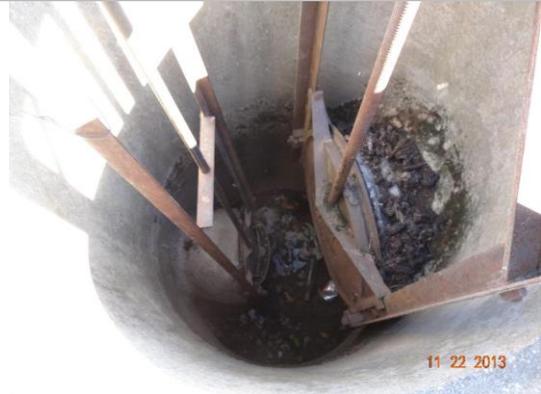
Photo 3 of 3 : UCIP_FA_2019_24841_44758.jpg

LM Start	0.01	Rating **	M	Issue No.	11 (cont)
LM End	0.01	Issue Type +	En	Location *	
Category	Supplemental			GPS Latitude/Longitude	
				Start	End
Item	DRAFT DWR UCIP Field Study			39.310096°	39.310096°
				-121.616250°	-121.616250°
DWR ID	21306				
Comment Code					
Inspector Comment					
DS_ID:21306 FS_ID:24841 EP_NO: N/A Repair Type: Non-Urgent Crossing Status: Found UCIP Comments: 05/01/2013 Debris found inside crossing-- recommend removing it. (DWR UCIP - O. Magana) FIELD_STRUCT_DESC: 24-inch corrugated metal gravity drainage pipe through the levee, 6 feet below the crown. Slide gate in a concrete standpipe on the waterside (WS) end. [Additional Reference(s): DWR Levee Log, 2005]. FS Date: 5/1/2013

Inside view of concrete standpipe with 2 screw gates inside.

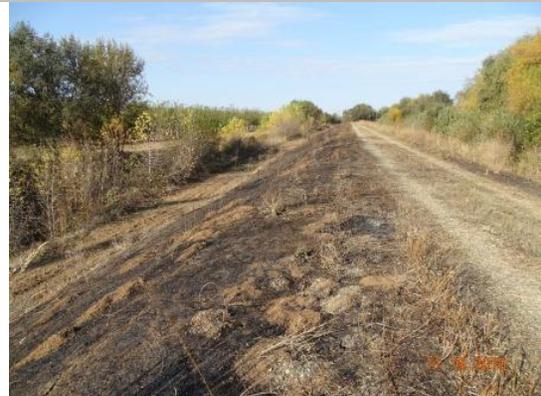
Photo 1 of 1 : FA_2019_RD0010_165_4_20191120_00013.jpg

LM Start	0.50	Rating **	A	Issue No.	4
LM End	2.78	Issue Type +	Ma	Location *	LS
Category	Earthen Levee			GPS Latitude/Longitude	
				Start	End
Item	Vegetation			39.310233°	39.298646°
				-121.607111°	-121.570284°
DWR ID	DWR_RD0010_03_f_2019_4				
Comment Code					
V1 : Control annual grass and weeds on the levee slopes and easements.					
Inspector Comment					
The annual vegetation is well maintained, Fall 2019.

View looking downstream landside at the well maintained annual vegetation, Fall 2019.

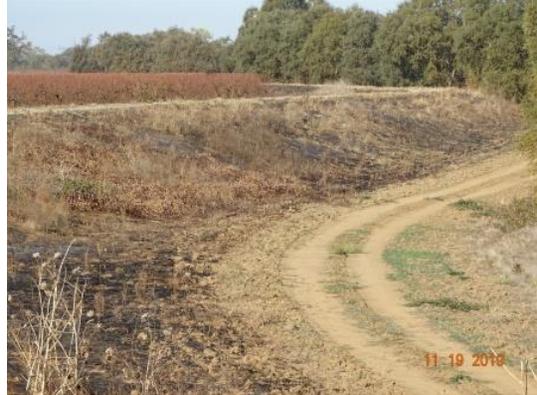
Photo 1 of 1 : FA_2019_RD0010_165_5_20191120_00015.jpg

LM Start	0.50	Rating **	A	Issue No.	5
LM End	2.78	Issue Type +	Ma	Location *	WS
Category	Earthen Levee		GPS Latitude/Longitude		
			Start	End	
Item	Vegetation		39.310233°	39.298646°	
			-121.607111°	-121.570284°	
DWR ID	DWR_RD0010_03_f_2019_5				
Comment Code					
V1 : Control annual grass and weeds on the levee slopes and easements.					
Inspector Comment					
The annual vegetation is well maintained, Fall 2019.

View looking downstream waterside at the well maintained annual vegetation, Fall 2019.

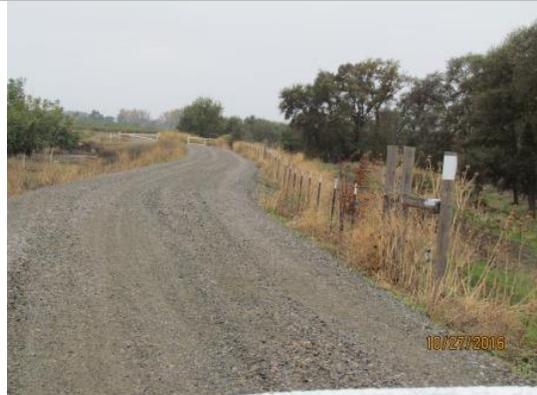
Photo 1 of 1 : FA_2019_RD0010_165_8_20190904_00002.jpg

LM Start	1.08	Rating **	M	Issue No.	8
LM End	1.21	Issue Type +	En	Location *	WS
Category	Earthen Levee		GPS Latitude/Longitude		
			Start	End	
Item	Encroachments		39.307106°	39.306422°	
			-121.597439°	-121.595205°	
DWR ID	DWR_RD0010_03_s_2016_8				
Comment Code					
FE : Fence					
Inspector Comment					
Unpermitted fence on waterside levee hinge point.

View of an unpermitted fence on waterside levee hinge point.

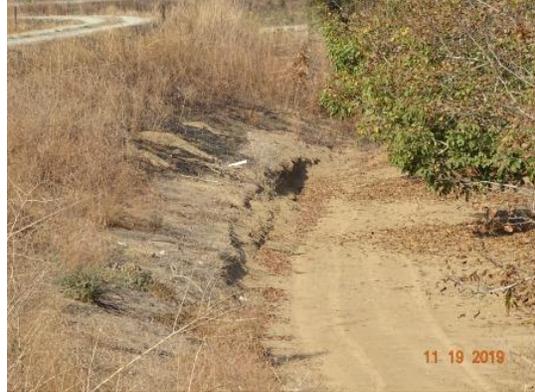
Photo 1 of 1 : FA_2019_RD0010_165_7_20191120_00016.jpg

LM Start	1.56	Rating **	U	Issue No.	7
LM End	1.60	Issue Type +	En	Location *	WS
Category	Earthen Levee			GPS Latitude/Longitude	
				Start	End
Item	Encroachments			39.303316°	39.302962°
				-121.590452°	-121.589812°
DWR ID	DWR_RD0010_03_f_2019_7				
Comment Code					
AT : Agricultural tilling					
Inspector Comment					
2 foot vertical cut in levee toe by the farmer, Fall 2019.

View looking downstream waterside at a 2 foot vertical cut in the levee toe, Fall 2019.

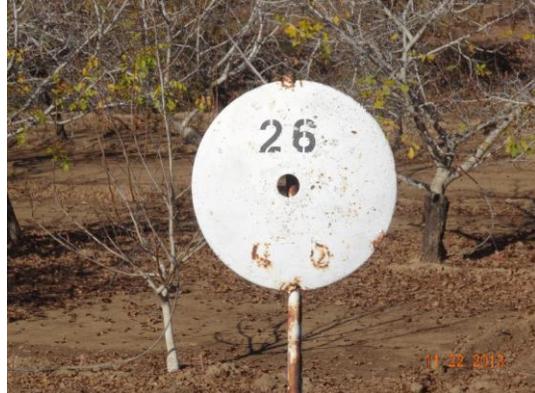
Photo 1 of 3 : UCIP_FA_2019_24842_44764.jpg

Comment Code					
Inspector Comment					
DS_ID:21307 FS_ID:24842 EP_NO: N/A Repair Type: Non-Urgent Crossing Status: Found UCIP Comments: 05/01/2013 Sediment deposit inside pipe--Need to coordinate with owner to determine status of crossing. If crossing is no longer in use owner will need to contact the CVFPB to comply with Title 23. (DWR UCIP - O. Magana) FIELD_STRUCT_DESC: 24-inch corrugated metal gravity drainage pipe through the levee, 15 feet below the crown. Corrugated metal cutoff wall around the pipe at each shoulder. Flap gate on the waterside (WS) end. Slide gate on the landside (LS) end. Concrete headwall at each toe. [Additional Reference(s): DWR Levee Log, 2005. USACE Sacramento O&M Manual 151, May 1953, (Station 134+06)]. FS Date: 5/1/2013

Marker visible on waterward side--No. 26.

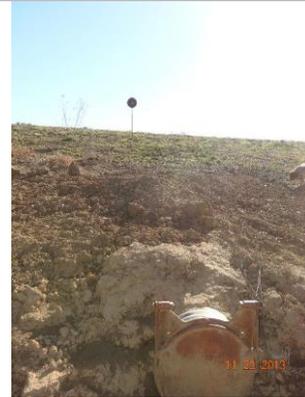
Photo 2 of 3 : UCIP_FA_2019_24842_44762.jpg

Comment Code					
Inspector Comment					
DS_ID:21307 FS_ID:24842 EP_NO: N/A Repair Type: Non-Urgent Crossing Status: Found UCIP Comments: 05/01/2013 Sediment deposit inside pipe--Need to coordinate with owner to determine status of crossing. If crossing is no longer in use owner will need to contact the CVFPB to comply with Title 23. (DWR UCIP - O. Magana) FIELD_STRUCT_DESC: 24-inch corrugated metal gravity drainage pipe through the levee, 15 feet below the crown. Corrugated metal cutoff wall around the pipe at each shoulder. Flap gate on the waterside (WS) end. Slide gate on the landside (LS) end. Concrete headwall at each toe. [Additional Reference(s): DWR Levee Log, 2005. USACE Sacramento O&M Manual 151, May 1953, (Station 134+06)]. FS Date: 5/1/2013

View of waterward slope.

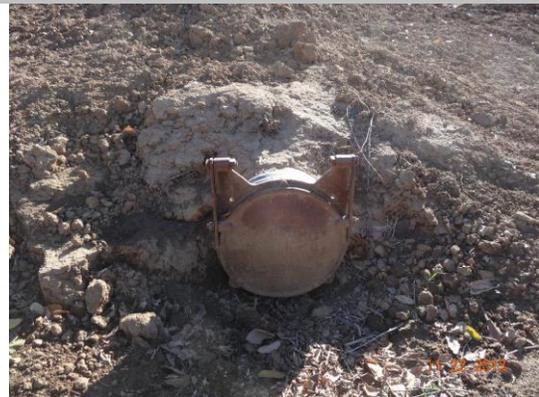
Photo 3 of 3 : UCIP_FA_2019_24842_44763.jpg

View of flap gate located on waterward side.
