**Flood Control Project Maintenance
Levee Inspections**

Maintenance Issue Types Only, Levee Inspection Report By Mile - Spring 2020

Reclamation District No. 0010 Honcut

Waterway	Bank	Unit Miles	Inspection Start/End	Inspector
Unit No. 01 Simmerly Slough	Right	7.65	04/28/2020 04/28/2020	Sterling York

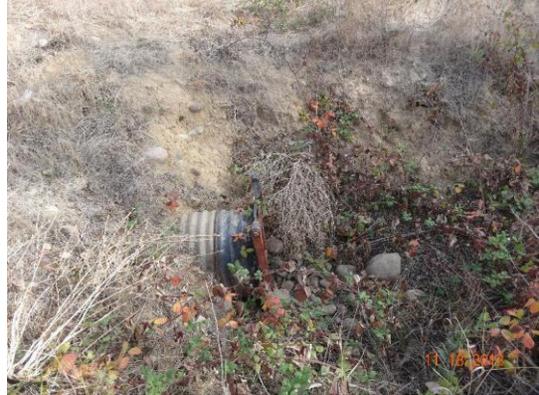
Photo 3 of 3 : UCIP_SP_2020_27791_51504.jpg

View of pipe and flap gate located on waterward side.

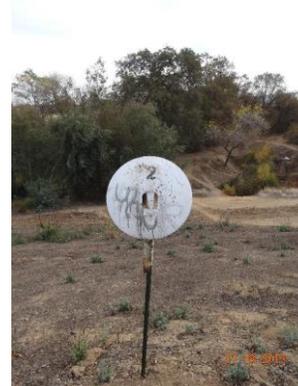
Photo 1 of 3 : UCIP_SP_2020_50058_51415.jpg

Comment Code					
Inspector Comment					
DS_ID:21258 FS_ID:50058 EP_NO: N/A Repair Type: Non-Urgent Crossing Status: Found UCIP Comments: 7/01/2016 Gate has been repaired--WS gate is functional. LS gate still needs new stem for the gate to properly function--stem is bent. USACE's PI issue references permit number 13710 this is incorrect permit is associated with DS_ID 21259 (CLM 0.767). (DWR UCIP - omagana)4/29/2013 Damaged flap gate on waterward side and damaged stem on screw gate on landward side. Need to contact owner to determine if crossing is still active. If crossing is still in use owner will need to address damage on flap gate and screw gate. If crossing is no longer in use owner will need to contact the CVFPB to comply with Title 23. This crossing is referenced in the USACE Periodic Inspection as item USACE_CESPK_HON1_2013_p_0053 and 0057. (DWR UCIP - omagana) FIELD_STRUCT_DESC: 24-inch corrugated metal gravity drainage pipe through the levee, 31 feet below the crown. Two corrugated metal cutoff walls around pipe. Concrete headwall at each end. Flap gate on the waterside (WS) end. Slide gate on the landside (LS) end. Pipe discharges into 6-foot concrete splash apron on the WS. [Additional Reference(s): DWR Levee Log, 2005. USACE Sacramento O&M Manual 151, May 1953, (Station 46+60)]. FS Date: 7/1/2016

View of WS--Marker indicates crossing is labelled as 2.

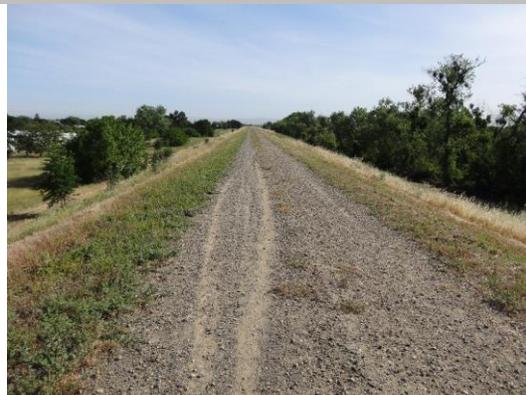
Photo 2 of 3 : UCIP_SP_2020_50058_51410.jpg

View of levee crown looking downstream.

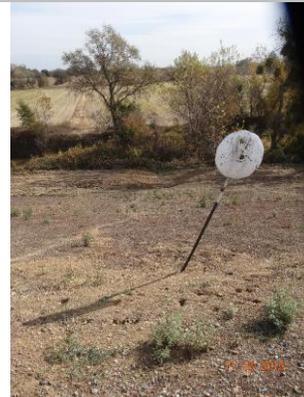
Photo 1 of 3 : UCIP_SP_2020_27748_51453.jpg

View of waterward side--slope and marker for pipe crossing.

Comment Code					
Inspector Comment					
DS_ID:21261 FS_ID:27748 EP_NO: N/A Repair Type: No Action Needed Crossing Status: Found UCIP Comments: 04/29/2013 No signs of damage to levee present during inspection. This crossing is referenced in the USACE Periodic Inspection as item USACE_CESPK_HON1_2013_p_0037 and 0040. (DWR UCIP - O. Magana) FIELD_STRUCT_DESC: 24-inch corrugated metal gravity drainage pipe through the levee, 29.5 feet below the crown. Two corrugated metal cutoff walls around the pipe on each end. Slide gate on the landside (LS) end. Flap gate on the waterside (WS) end. Concrete headwall at the LS toe. [Additional Reference(s): DWR Levee Log, 2005. USACE Sacramento O&M Manual 151, May 1953, (Station 37+66)]. FS Date: 4/29/2013

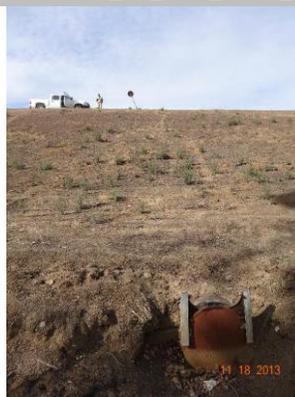
Photo 2 of 3 : UCIP_SP_2020_27748_51450.jpg

View of slope located on waterward side.

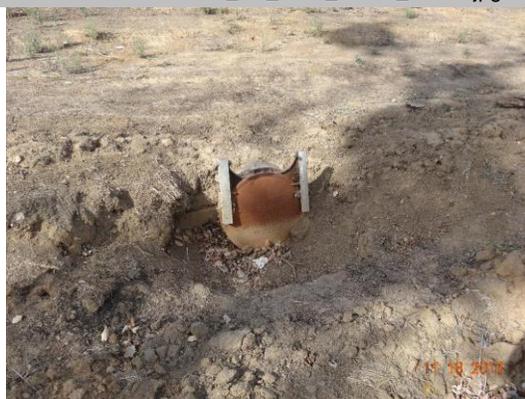
Photo 3 of 3 : UCIP_SP_2020_27748_51451.jpg

View of flap gate located on waterward side.

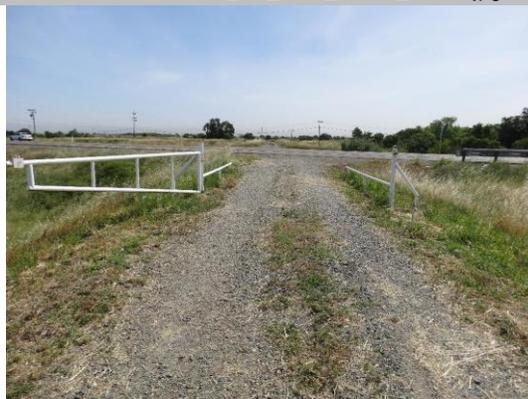
Photo 2 of 3 : UCIP_SP_2020_24811_44581.jpg

View of levee crown looking downstream--access gate near HWY 70.

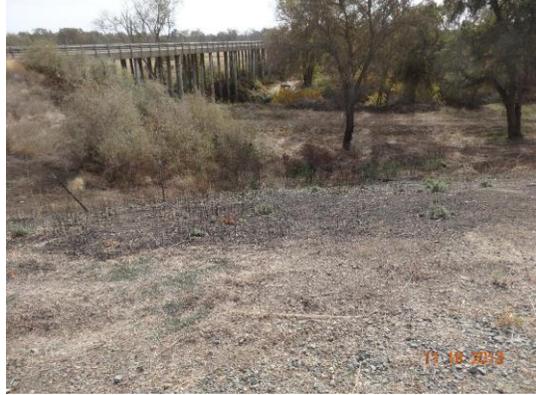
Photo 3 of 3 : UCIP_SP_2020_24811_44585.jpg

View of waterward side.

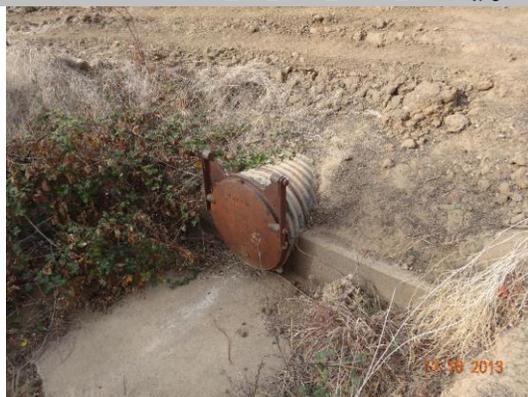
Photo 2 of 3 : UCIP_SP_2020_53136_44587.jpg

View of headwall, pipe, and flap gate located on WS.

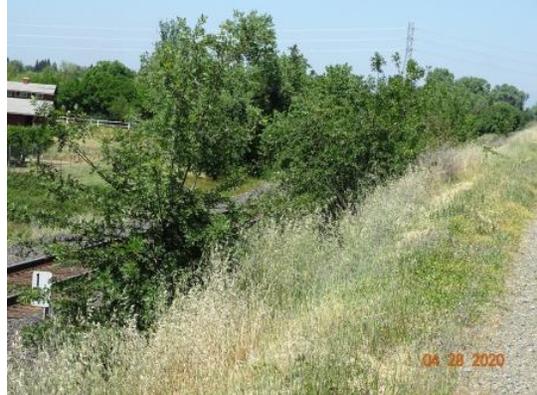
Photo 1 of 1 : SP_2020_RD0010_163_68_20200430_00089.jpg

LM Start	1.76	Rating **	M	Issue No.	68
LM End	1.79	Issue Type +	Ma	Location *	LS
Category	Earthen Levee		GPS Latitude/Longitude		
			Start	End	
Item	Trim / Thin Trees		39.171328 °	39.171855 °	
			-121.585561 °	-121.585503 °	
DWR ID	DWR_RD0010_01_s_2020_68				
Comment Code					
T3 : Trim and thin trees to allow visibility of the ground and room to flood fight.					
Inspector Comment					
Trees with less than 4" diameter at chest height should be removed, Spring 2020.

View looking upstream landside at small starter trees on levee slope, Spring 2020.

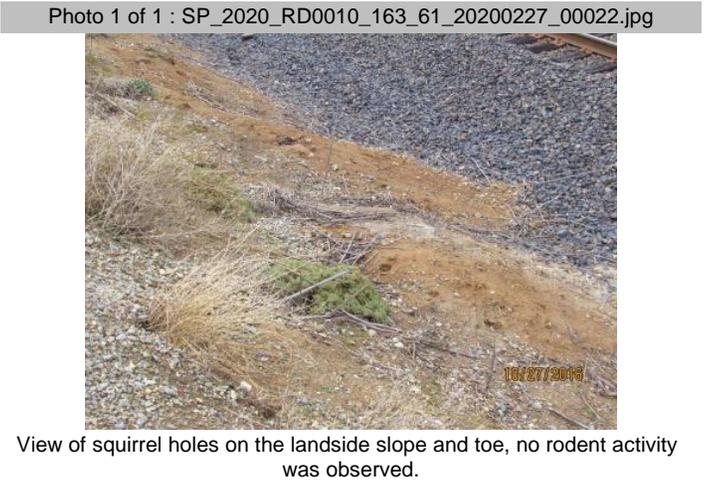
LM Start	2.16	Rating **	M	Issue No.	61
LM End	2.38	Issue Type +	Ma	Location *	LS
Category	Earthen Levee		GPS Latitude/Longitude		
			Start	End	
Item	Animal Control		39.177129 °	39.180309 °	
			-121.584841 °	-121.584451 °	
DWR ID	DWR_RD0010_01_s_2016_61				
Comment Code					
A3 : No rodents visible, but rodent burrows visible; need to backfill and compact or grout burrows.					
Inspector Comment					
Squirrel holes still are visible but there is no sign of activity.

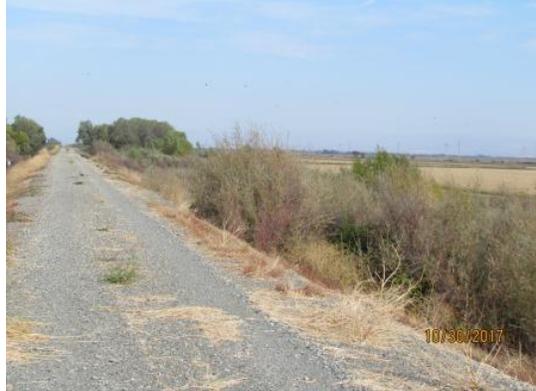
Photo 1 of 1 : SP_2020_RD0010_163_35_20200227_00003.jpg

LM Start	2.70	Rating **	M	Issue No.	35
LM End	2.70	Issue Type +	Ma	Location *	WS
Category	Earthen Levee		GPS Latitude/Longitude		
			Start	End	
Item	Trim / Thin Trees		39.184974 °	39.184974 °	
			-121.583836 °	-121.583836 °	
DWR ID	DWR_RD0010_01_f_2017_35				
Comment Code					
T3 : Trim and thin trees to allow visibility of the ground and room to flood fight.					
Inspector Comment					
Trees with less than 4" diameter at chest height should be removed, Spring 2020.

View looking upstream waterside at Willow Trees that need to be removed.

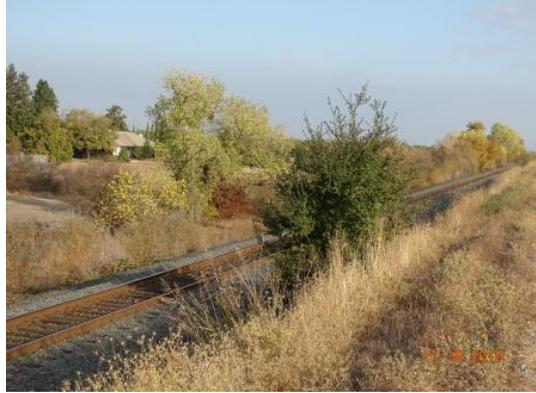
Photo 1 of 1 : SP_2020_RD0010_163_36_20200227_00004.jpg

LM Start	2.79	Rating **	M	Issue No.	36
LM End	2.79	Issue Type +	Ma	Location *	LS
Category	Earthen Levee		GPS Latitude/Longitude		
			Start	End	
Item	Trim / Thin Trees		39.186285 °	39.186285 °	
			-121.583707 °	-121.583707 °	
DWR ID	DWR_RD0010_01_f_2019_36				
Comment Code					
T3 : Trim and thin trees to allow visibility of the ground and room to flood fight.					
Inspector Comment					
Trees with less than 4" diameter at chest height should be removed, Spring 2020.

View looking upstream landside at small starter trees that need to be removed, Fall 2019.

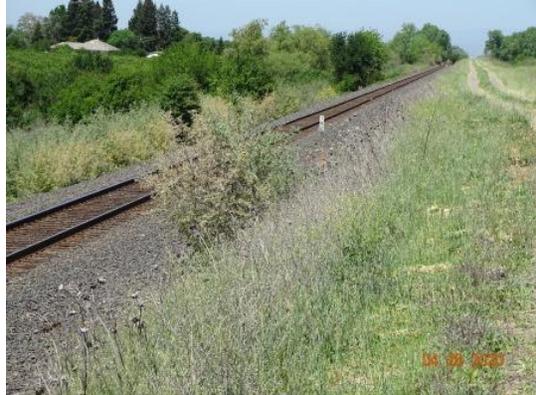
Photo 1 of 1 : SP_2020_RD0010_163_70_20200430_00090.jpg

LM Start	3.60	Rating **	M	Issue No.	70
LM End	3.60	Issue Type +	Ma	Location *	WS
Category	Earthen Levee			GPS Latitude/Longitude	
				Start	End
Item	Trim / Thin Trees			39.197886 °	39.197886 °
				-121.582069 °	-121.582069 °
DWR ID	DWR_RD0010_01_s_2020_70				
Comment Code					
T3 : Trim and thin trees to allow visibility of the ground and room to flood fight.					
Inspector Comment					
Trees with less than 4" diameter at chest height should be removed, Spring 2020.

View looking upstream landside at small starter tree on levee slope, Spring 2020.

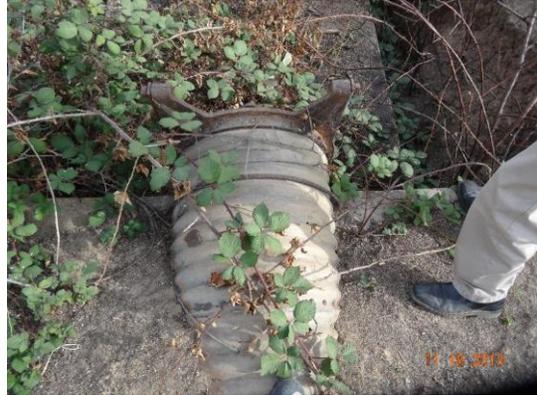
Photo 3 of 3 : UCIP_SP_2020_27746_51439.jpg

View of pipe, headwall, and concrete apron on waterward toe.

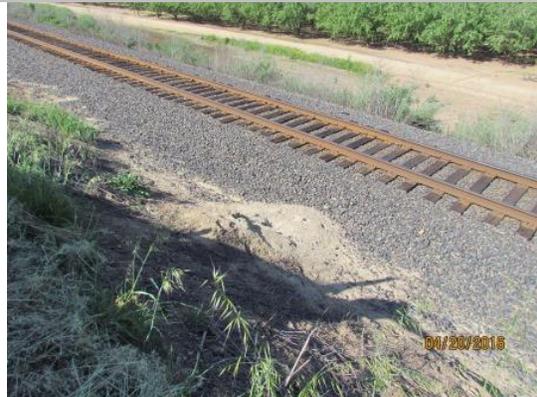
Photo 1 of 1 : SP_2020_RD0010_163_51_20200227_00016.jpg

LM Start	3.75	Rating **	U	Issue No.	51
LM End	3.75	Issue Type +	Ma	Location *	LS
Category	Earthen Levee			GPS Latitude/Longitude	
				Start	End
Item	Animal Control			39.200003 °	39.200003 °
				-121.582002 °	-121.582002 °
DWR ID	DWR_RD0010_01_s_2016_51

View of large burrow on landside.

Comment Code
A3 : No rodents visible, but rodent burrows visible; need to backfill and compact or grout burrows.

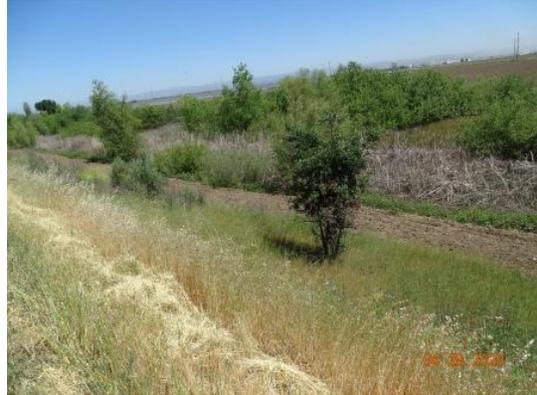
Photo 1 of 1 : SP_2020_RD0010_163_49_20200430_00091.jpg

LM Start	3.91	Rating **	M	Issue No.	49
LM End	3.91	Issue Type +	Ma	Location *	WS
Category	Earthen Levee		GPS Latitude/Longitude		
			Start	End	
Item	Trim / Thin Trees		39.202358 °	39.202358 °	
			-121.581714 °	-121.581714 °	
DWR ID	DWR_RD0010_01_s_2016_49				
Comment Code					
T3 : Trim and thin trees to allow visibility of the ground and room to flood fight.					
Inspector Comment					
Trees with less than 4" diameter at chest height should be removed, Spring 2020.

View looking upstream waterside at small starter trees on levee slope, Spring 2020.

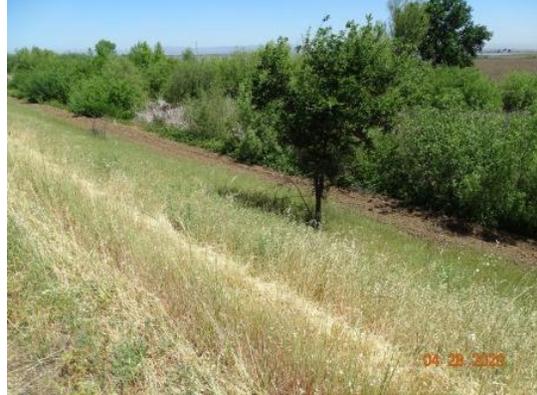
Photo 1 of 1 : SP_2020_RD0010_163_30_20200430_00092.jpg

LM Start	4.04	Rating **	M	Issue No.	30
LM End	4.04	Issue Type +	Ma	Location *	WS
Category	Earthen Levee		GPS Latitude/Longitude		
			Start	End	
Item	Trim / Thin Trees		39.204192 °	39.204192 °	
			-121.581490 °	-121.581490 °	
DWR ID	DWR_RD0010_01_s_2020_30				
Comment Code					
T3 : Trim and thin trees to allow visibility of the ground and room to flood fight.					
Inspector Comment					
Trees with less than 4" diameter at chest height should be removed, Spring 2020.

View looking upstream waterside at small starter tree on levee slope, Spring 2020.

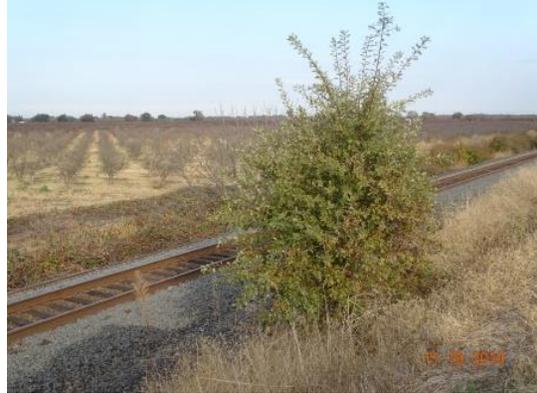
Photo 1 of 1 : SP_2020_RD0010_163_39_20200227_00007.jpg

LM Start	4.63	Rating **	M	Issue No.	39
LM End	4.63	Issue Type +	Ma	Location *	LS
Category	Earthen Levee		GPS Latitude/Longitude		
			Start	End	
Item	Trim / Thin Trees		39.212749 °	39.212749 °	
			-121.580406 °	-121.580406 °	
DWR ID	DWR_RD0010_01_f_2019_39				
Comment Code					
T3 : Trim and thin trees to allow visibility of the ground and room to flood fight.					
Inspector Comment					
Trees with less than 4" diameter at chest height should be removed, Spring 2020.

View looking upstream landside at small starter trees that need to be removed, Fall 2019.

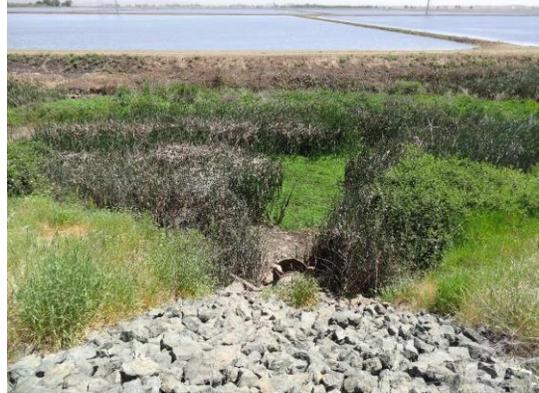
Photo 2 of 3 : UCIP_SP_2020_53138_44809.jpg

LM Start	4.90	Rating **	U	Issue No.	91 (cont)
LM End	4.90	Issue Type +	Ma	Location *	
Category	Supplemental			GPS Latitude/Longitude	
				Start	End
Item	DWR UCIP LMA Responsibility			39.216591 °	39.216591 °
				-121.579919 °	-121.579919 °
DWR ID	21275

View of WS during April.

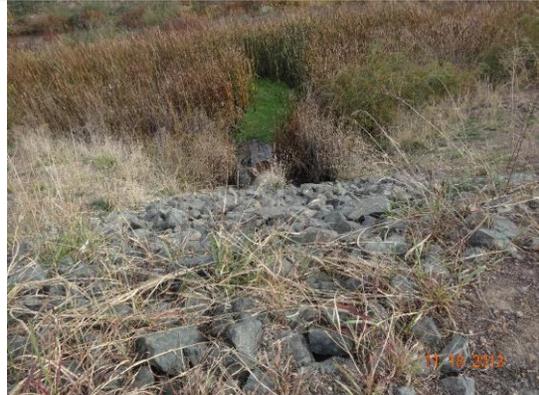
Photo 3 of 3 : UCIP_SP_2020_53138_44810.jpg

View of WS slope covered with rip rap along pipe alignment.

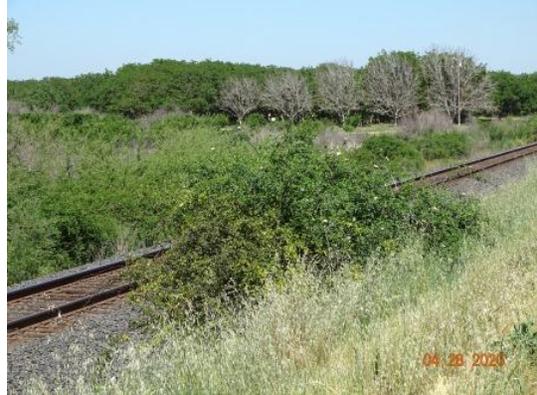
Photo 1 of 1 : SP_2020_RD0010_163_55_20200430_00096.jpg

LM Start	4.94	Rating **	M	Issue No.	55
LM End	4.94	Issue Type +	Ma	Location *	LS
Category	Earthen Levee		GPS Latitude/Longitude		
			Start	End	
Item	Trim / Thin Trees		39.217206 °	39.217206 °	
			-121.579855 °	-121.579855 °	
DWR ID	DWR_RD0010_01_s_2020_55				
Comment Code					
T2 : Thin trees to allow visibility of the ground and room to flood fight.					
Inspector Comment					
Remove wild rose bush, Spring 2020.

View looking upstream landside at wild rose bush on levee slope, Spring 2020.

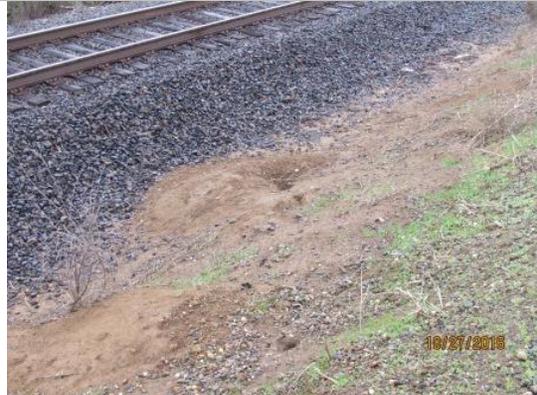
Photo 1 of 1 : SP_2020_RD0010_163_42_20200227_00010.jpg

LM Start	5.04	Rating **	M	Issue No.	42
LM End	5.04	Issue Type +	Ma	Location *	LS
Category	Earthen Levee		GPS Latitude/Longitude		
			Start	End	
Item	Animal Control		39.218564 °	39.218564 °	
			-121.579682 °	-121.579682 °	
DWR ID	DWR_RD0010_01_s_2016_42				
Comment Code					
A3 : No rodents visible, but rodent burrows visible; need to backfill and compact or grout burrows.					
Inspector Comment					
Squirrel holes still are visible but there is no sign of activity.

View of squirrel holes on landside toe, no sign of activity.

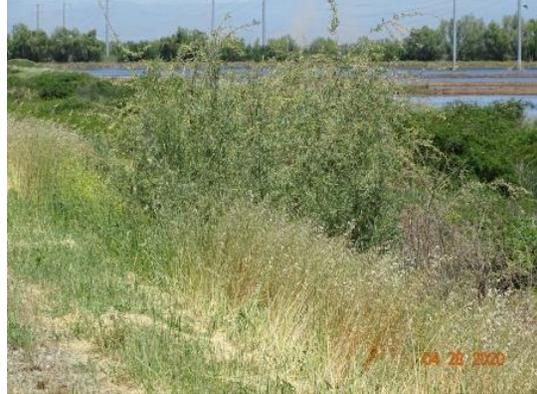
Photo 1 of 1 : SP_2020_RD0010_163_62_20200430_00098.jpg

LM Start	5.42	Rating **	M	Issue No.	62
LM End	5.42	Issue Type +	Ma	Location *	WS
Category	Earthen Levee		GPS Latitude/Longitude		
			Start	End	
Item	Trim / Thin Trees		39.224041 °	39.224041 °	
			-121.579008 °	-121.579008 °	
DWR ID	DWR_RD0010_01_s_2020_62				
Comment Code					
T3 : Trim and thin trees to allow visibility of the ground and room to flood fight.					
Inspector Comment					
Trees with less than 4" diameter at chest height should be removed, Spring 2020.

View looking upstream waterside at small starter tree on levee slope, Spring 2020.

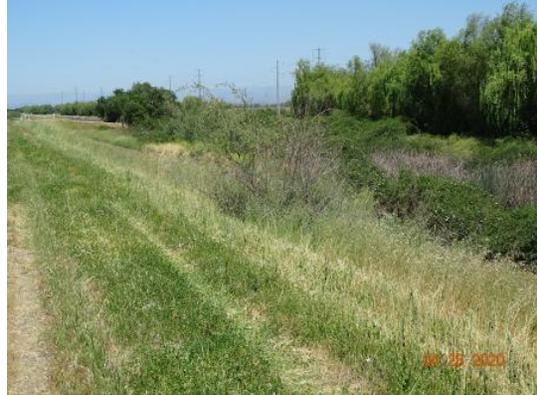
Photo 1 of 1 : SP_2020_RD0010_163_65_20200430_00099.jpg

LM Start	5.46	Rating **	M	Issue No.	65
LM End	5.52	Issue Type +	Ma	Location *	WS
Category	Earthen Levee		GPS Latitude/Longitude		
			Start	End	
Item	Trim / Thin Trees		39.224652 °	39.225433 °	
			-121.578929 °	-121.578832 °	
DWR ID	DWR_RD0010_01_s_2020_65				
Comment Code					
T3 : Trim and thin trees to allow visibility of the ground and room to flood fight.					
Inspector Comment					
Trees with less than 4" diameter at chest height should be removed, Spring 2020.

View looking upstream waterside at small starter tree on levee slope, Spring 2020.

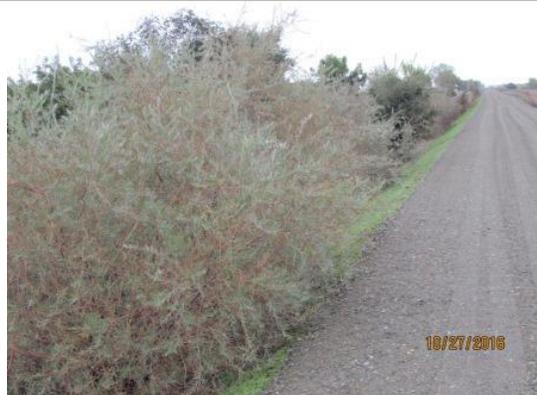
Photo 1 of 1 : SP_2020_RD0010_163_40_20200227_00008.jpg

LM Start	5.60	Rating **	M	Issue No.	40
LM End	5.60	Issue Type +	Ma	Location *	LS
Category	Earthen Levee		GPS Latitude/Longitude		
			Start	End	
Item	Trim / Thin Trees		39.226679 °	39.226679 °	
			-121.578670 °	-121.578670 °	
DWR ID	DWR_RD0010_01_s_2016_40				
Comment Code					
T3 : Trim and thin trees to allow visibility of the ground and room to flood fight.					
Inspector Comment					
Trees with less than 4" diameter at chest height should be removed, Spring 2020.

View of willow trees on the landside slope looking upstream.

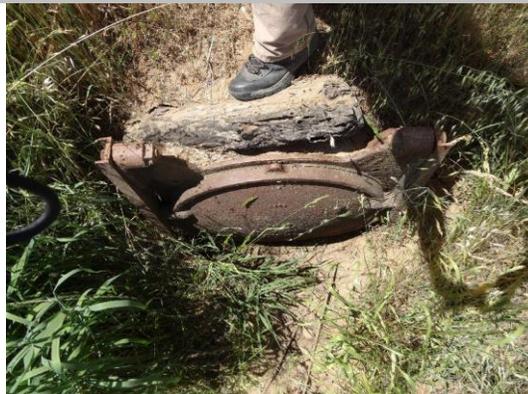
Photo 3 of 3 : UCIP_SP_2020_24438_43501.jpg

LM Start	6.31	Rating **	M	Issue No.	93 (cont)
LM End	6.31	Issue Type +	Ma	Location *	
Category	Supplemental			GPS Latitude/Longitude	
				Start	End
Item	DWR UCIP LMA Responsibility			39.236827 °	39.236827 °
				-121.577262 °	-121.577262 °
DWR ID	21278

Pipe and flap gate confirmed on waterward side.

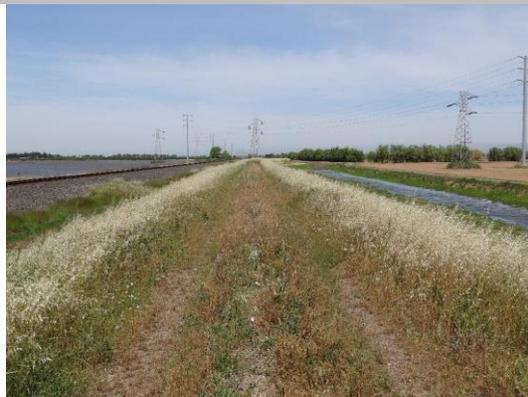
Photo 1 of 3 : UCIP_SP_2020_27532_51129.jpg

LM Start	6.65	Rating **	M	Issue No.	94
LM End	6.65	Issue Type +	Ma	Location *	
Category	Supplemental			GPS Latitude/Longitude	
				Start	End
Item	DWR UCIP LMA Responsibility			39.241726 °	39.241726 °
				-121.576488 °	-121.576488 °
DWR ID	21279

View of levee looking upstream.

Comment Code					
Inspector Comment					
DS_ID:21279 FS_ID:27532 EP_NO: N/A Repair Type: Non-Urgent Crossing Status: Found UCIP Comments: 04/29/2013 Need to clear sediment near gate. Need to coordinate with owner to determine status of crossing. If crossing is no longer in use owner will need to contact the CVFPB to comply with Title 23. This crossing is referenced in the USACE Periodic Inspection as item USACE_CESPK_HON1_2013_p_0291-294. (DWR UCIP - O. Magana) FIELD_STRUCT_DESC: 16-inch steel drainage pipe through the levee, 10.3 feet below the crown. Cutoff wall around the pipe at the center of the levee. Slide gate on the waterside (WS) end. Pipe exposed across irrigation canal on the landside (LS). [Additional Reference(s): DWR Levee Log, 2005. USACE Sacramento O&M Manual 151, May 1953, (Station 473+58)]. FS Date: 4/29/2013

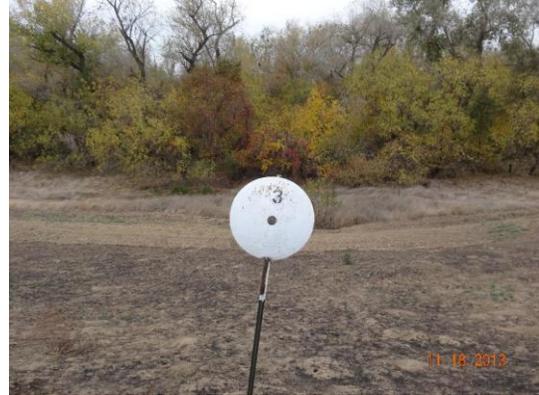
Photo 1 of 3 : UCIP_SP_2020_27533_51135.jpg

Comment Code					
Inspector Comment					
DS_ID:21280 FS_ID:27533 EP_NO: N/A Repair Type: Non-Urgent Crossing Status: Found UCIP Comments: 04/30/2013 Recommend removing vegetation and debris along pipe alignment (debris blocking gate on waterward side and vegetation blocking access to screw gate on landward side). Need to coordinate with owner to determine status of crossing. If crossing is no longer in use owner will need to contact the CVFPB to comply with Title 23. This crossing is referenced in the USACE Periodic Inspection as item USACE_CESPK_HON2_2013_p_0027. (DWR UCIP - O. Magana) FIELD_STRUCT_DESC: 24-inch corrugated metal gravity drainage pipe through the levee, 25.6 feet below the crown. Corrugated metal cutoff wall around the pipe at each shoulder. Flap gate on the waterside (WS) end. Concrete headwall, saddle, and apron on the WS end. [Additional Reference(s): DWR Levee Log, 2005. USACE Sacramento O&M Manual 151, May 1953, (Station 106+00)]. FS Date: 4/30/2013

View of waterward side.

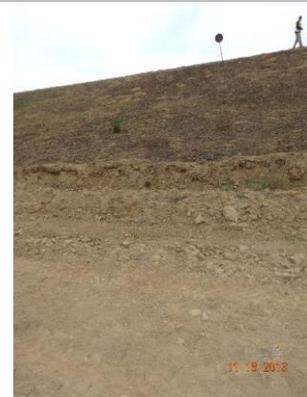
Photo 2 of 3 : UCIP_SP_2020_27533_51137.jpg

View of waterward slope.

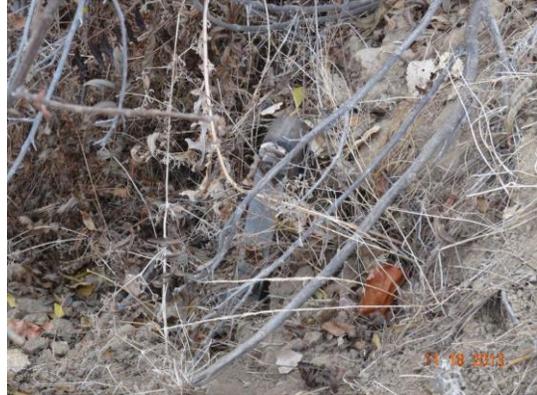
Photo 3 of 3 : UCIP_SP_2020_27533_51138.jpg

LM Start	0.38	Rating **	M	Issue No.	72 (cont)
LM End	0.38	Issue Type +	Ma	Location *	
Category	Supplemental			GPS Latitude/Longitude	
				Start	End
Item	DWR UCIP LMA Responsibility			39.169174 °	39.169174 °
				-121.610698 °	-121.610698 °
DWR ID	21280

Buried flap gate on waterward side.

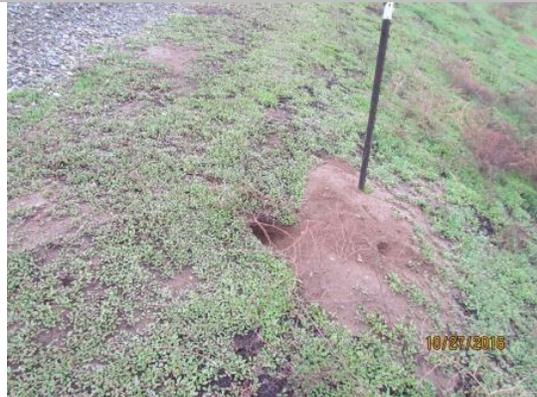
Photo 1 of 1 : SP_2020_RD0010_164_28_20200227_00002.jpg

LM Start	0.38	Rating **	M	Issue No.	28
LM End	0.38	Issue Type +	Ma	Location *	WS
Category	Earthen Levee			GPS Latitude/Longitude	
				Start	End
Item	Animal Control			39.169231 °	39.169231 °
				-121.610711 °	-121.610711 °
DWR ID	DWR_RD0010_02_f_2015_28				
Comment Code					
A3 : No rodents visible, but rodent burrows visible; need to backfill and compact or grout burrows.					
Inspector Comment					
No rodent activity but squirrel hole needs to be backfilled.

View of squirrel hole on the waterside looking downstream.

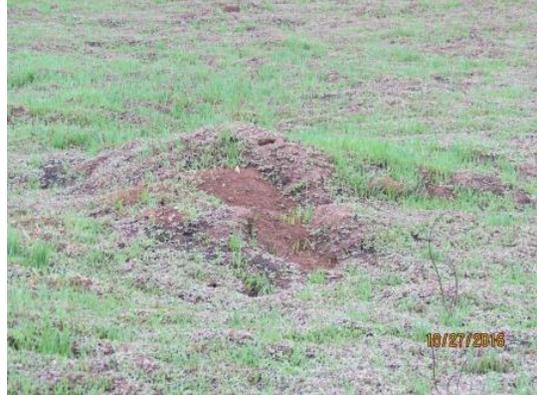
Photo 1 of 1 : SP_2020_RD0010_164_29_20200227_00003.jpg

LM Start	0.94	Rating **	U	Issue No.	29
LM End	0.94	Issue Type +	Ma	Location *	WS
Category	Earthen Levee		GPS Latitude/Longitude		
			Start	End	
Item	Animal Control		39.177289 °	39.177289 °	
			-121.609860 °	-121.609860 °	
DWR ID	DWR_RD0010_02_f_2015_29				
Comment Code					
A3 : No rodents visible, but rodent burrows visible; need to backfill and compact or grout burrows.					
Inspector Comment					
No rodent activity but squirrel hole needs to be backfilled.

View of rodent hole that has more than 2 cubic feet of material on the waterside.

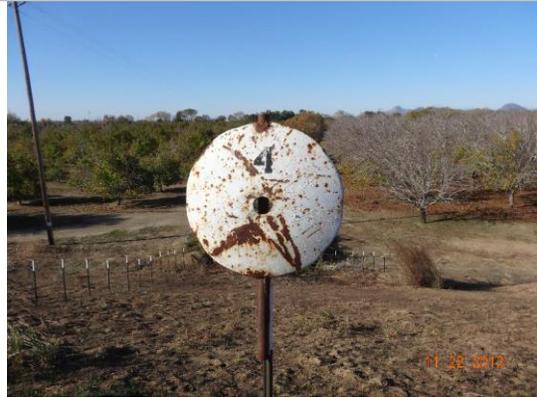
Photo 1 of 3 : UCIP_SP_2020_24821_44640.jpg

Comment Code					
Inspector Comment					
DS_ID:21281 FS_ID:24821 EP_NO: N/A Repair Type: Non-Urgent Crossing Status: Found UCIP Comments: 04/30/2013 Screw gate on landward side is blocked by sediment. Recommend removing sediment in front of gate. This crossing is referenced in the USACE Periodic Inspection as item USACE_CESPK_HON2_2013_p_0082. (DWR UCIP - O. Magana) FIELD_STRUCT_DESC: 24-inch corrugated metal gravity drainage pipe through the levee, 26 feet below the crown. Corrugated metal cutoff wall around the pipe at each shoulder. Flap gate on the waterside (WS) end. Slide gate on the landside (LS) end. Concrete headwall, saddle, and apron on the WS end. [Additional Reference(s): DWR Levee Log, 2005. USACE Sacramento O&M Manual 151, May 1953, (Station 149+88)]. FS Date: 4/30/2013

Marker visible on waterward side--No. 4.

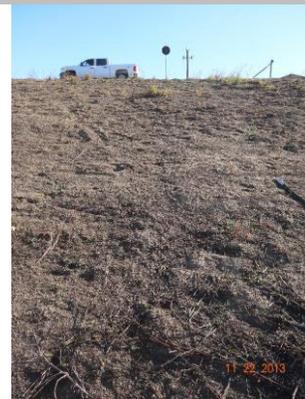
Photo 2 of 3 : UCIP_SP_2020_24821_44639.jpg

View of waterward slope side.

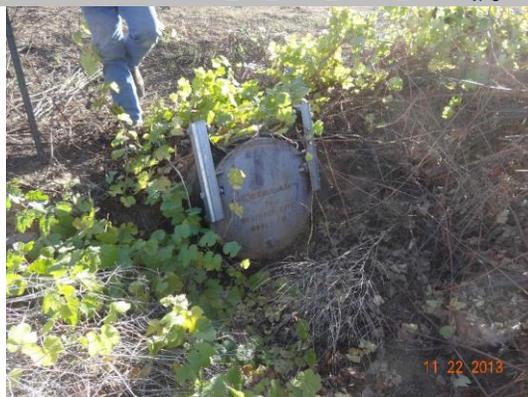
Photo 3 of 3 : UCIP_SP_2020_24821_44638.jpg

LM Start	1.19	Rating **	M	Issue No.	73 (cont)
LM End	1.19	Issue Type +	Ma	Location *	
Category	Supplemental			GPS Latitude/Longitude	
				Start	End
Item	DWR UCIP LMA Responsibility			39.180875 °	39.180875 °
				-121.610053 °	-121.610053 °
DWR ID	21281

View of flap gate located on waterward side.

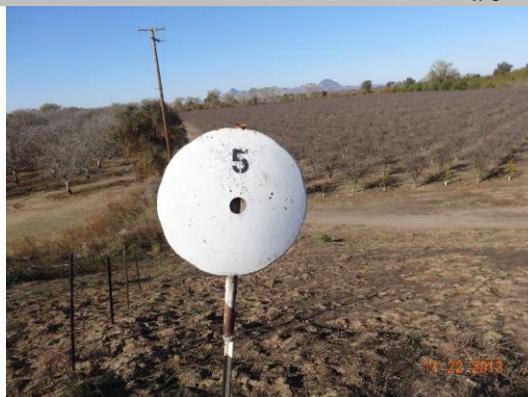
Photo 1 of 3 : UCIP_SP_2020_24822_44647.jpg

LM Start	1.49	Rating **	A/W	Issue No.	74
LM End	1.49	Issue Type +	Ma	Location *	
Category	Supplemental			GPS Latitude/Longitude	
				Start	End
Item	DWR UCIP LMA Responsibility			39.185141 °	39.185141 °
				-121.609091 °	-121.609091 °
DWR ID	21282

Marker visible on waterward side--No. 5.

Comment Code					
Inspector Comment					
DS_ID:21282 FS_ID:24822 EP_NO: N/A Repair Type: No Action Needed Crossing Status: Found UCIP Comments: 04/29/2013 This crossing is referenced in the USACE Periodic Inspection as item USACE_CESPK_HON2_2013_p_0109. (DWR UCIP - O. Magana) FIELD_STRUCT_DESC: 36-inch corrugated metal gravity drainage pipe through the levee, 25 feet below the crown. Corrugated metal cutoff wall around the pipe at each shoulder. Flap gate on the waterside (WS) end. Slide gate on the landside (LS) end. Concrete headwall, saddle, and apron on the WS end. [Additional Reference(s): DWR Levee Log, 2005. USACE Sacramento O&M Manual 151, May 1953, (Station 164+65)]. FS Date: 4/30/2013

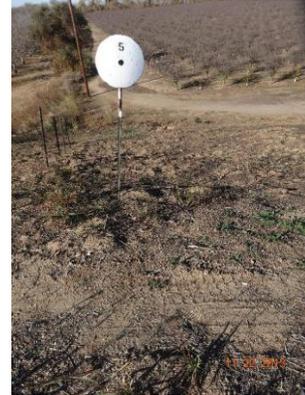
Photo 2 of 3 : UCIP_SP_2020_24822_44648.jpg

LM Start	1.49	Rating **	A/W	Issue No.	74 (cont)
LM End	1.49	Issue Type +	Ma	Location *	
Category	Supplemental			GPS Latitude/Longitude	
				Start	End
Item	DWR UCIP LMA Responsibility			39.185141 °	39.185141 °
				-121.609091 °	-121.609091 °
DWR ID	21282

Overview of waterward slope--dense burrow activity on slope.

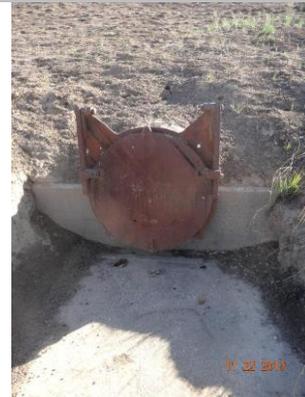
Photo 3 of 3 : UCIP_SP_2020_24822_44645.jpg

LM Start	1.49	Rating **	A/W	Issue No.	74 (cont)
LM End	1.49	Issue Type +	Ma	Location *

View of flap gate on waterward side.

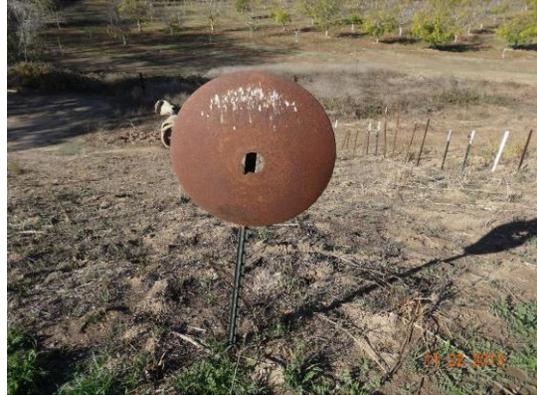
Photo 1 of 3 : UCIP_SP_2020_52889_44658.jpg

Comment Code					
Inspector Comment					
DS_ID:21284 FS_ID:52889 EP_NO: N/A Repair Type: Non-Urgent Crossing Status: Found UCIP Comments: 04/30/2013 Remove concrete piece preventing complete closure of screw gate on landward side. This crossing is referenced in the USACE Periodic Inspection as item USACE_CESPK_HON2_2013_p_0152. (DWR UCIP - O. Magana) FIELD_STRUCT_DESC: 36-inch corrugated metal gravity drainage pipe through the levee, 24 feet below the crown. Corrugated metal cutoff wall around the pipe at each shoulder. Flap gate on the waterside (WS) end. Slide gate on the landside (LS) end. Concrete headwall at each end. [Additional Reference(s): DWR Levee Log, 2005. USACE Sacramento O&M Manual 151, May 1953, (Station 259+76)]. FS Date: 4/30/2013

Marker visible on waterward side.

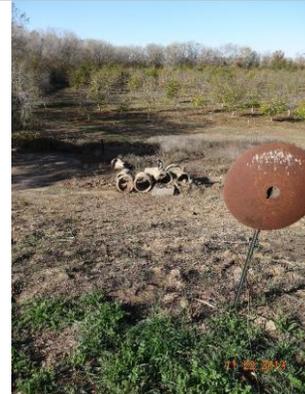
Photo 2 of 3 : UCIP_SP_2020_52889_44657.jpg

Overview of waterward slope--barrier placed at toe to discourage damage to crossing.

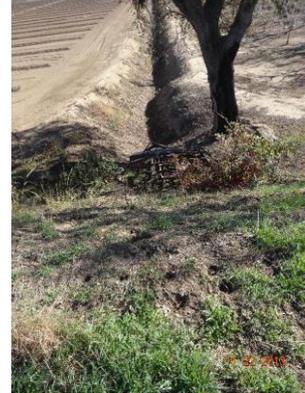
Photo 3 of 3 : UCIP_SP_2020_52889_44656.jpg

View of landward side--barrier used to discourage damage to crossing near toe.

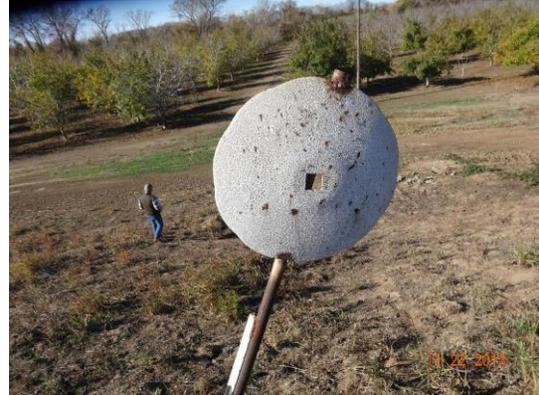
Photo 1 of 3 : UCIP_SP_2020_24825_44664.jpg

Comment Code					
Inspector Comment					
DS_ID:21285 FS_ID:24825 EP_NO: N/A Repair Type: Non-Urgent Crossing Status: Found UCIP Comments: 04/30/2013 Sediment blocking flap gate and screw gate--recommend removing material. Dense burrow activity present along levee slopes (large holes visible on landward side)--recommend addressing issue. This crossing is referenced in the USACE Periodic Inspection as item USACE_CESPK_HON2_2013_p_0169. (DWR UCIP - O. Magana) FIELD_STRUCT_DESC: 30-inch corrugated metal gravity drainage pipe through the levee, 19.5 feet below the crown. Corrugated metal cutoff wall around the pipe at each shoulder. Flap gate on the waterside (WS) end. Slide gate on the landside (LS) end. Concrete headwall at each end. [Additional Reference(s): DWR Levee Log, 2005. USACE Sacramento O&M Manual 151, May 1953, (Station 277+00)]. FS Date: 4/30/2013

Marker visible on waterward side.

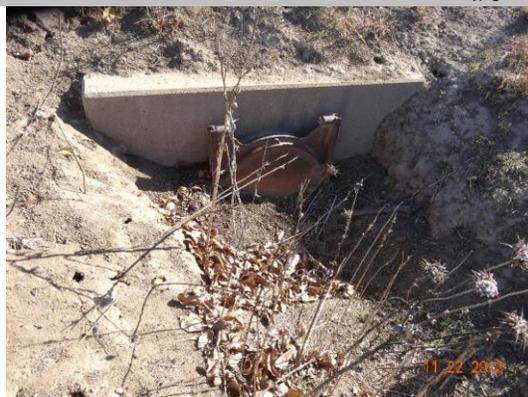
Photo 3 of 3 : UCIP_SP_2020_24825_44662.jpg

Flap gate located on waterward side--debris blocking gate.

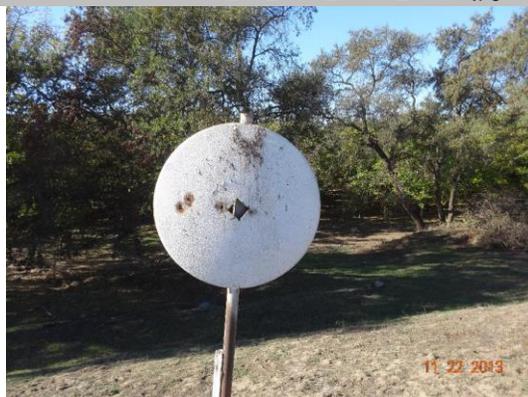
Photo 1 of 3 : UCIP_SP_2020_24826_44669.jpg

View of marker located on waterward shoulder, no reference number is visible.

Comment Code					
Inspector Comment					
DS_ID:21286 FS_ID:24826 EP_NO: N/A Repair Type: Non-Urgent Crossing Status: Found UCIP Comments: 04/30/2013 Deformation observed on the top wall of pipe at the entrance of landward side--need to contact owner to address issue. This crossing is referenced in the USACE Periodic Inspection as item USACE_CESPK_HON2_2013_p_0180. (DWR UCIP - O. Magana) FIELD_STRUCT_DESC: 30-inch corrugated metal gravity drainage pipe through the levee, 21.5 feet below the crown. Corrugated metal cutoff walls around the pipe at each shoulder. Flap gate on the waterside (WS) end. Slide gate on the landside (LS) end. Concrete headwall at each end. [Additional Reference(s): DWR Levee Log, 2005. USACE Sacramento O&M Manual 151, May 1953, (Station 294+84)]. FS Date: 4/30/2013

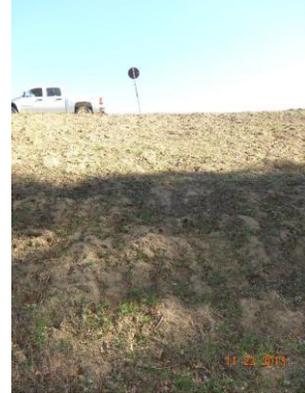
Photo 2 of 3 : UCIP_SP_2020_24826_44668.jpg

View of waterward slope.

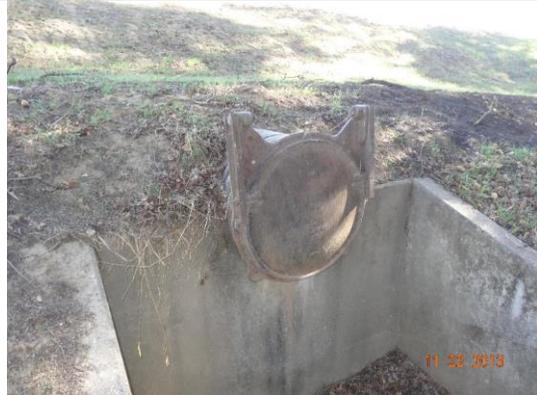
Photo 3 of 3 : UCIP_SP_2020_24826_44673.jpg

View of flapgate on concrete head wall on waterward side.

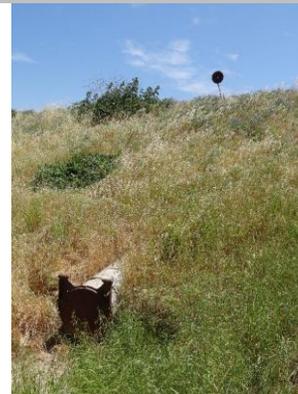
Photo 1 of 3 : UCIP_SP_2020_24751_44375.jpg

Comment Code					
Inspector Comment					
DS_ID:21288 FS_ID:24751 EP_NO: N/A Repair Type: Non-Urgent Crossing Status: Found UCIP Comments: 04/30/2013 Need to updated photos showing cleared slopes. This crossing is referenced in the USACE Periodic Inspection as item USACE_CESPK_HON2_2013_p_0193. (DWR UCIP - O. Magana) FIELD_STRUCT_DESC: 24-inch corrugated metal gravity drainage pipe through the levee, 19 feet below the crown. Corrugated metal cutoff wall around the pipe at each shoulder. Flap gate on the waterside (WS) end. Slide gate on the landside (LS). Concrete headwall, saddle, and apron on the WS end. [Additional Reference(s): DWR Levee Log, 2005. USACE Sacramento O&M Manual 151, May 1953, (Station 322+25)]. FS Date: 4/30/2013

View of waterward side--dense vegetation on slope.

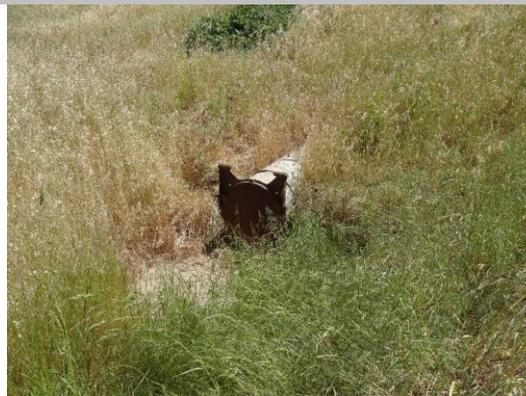
Photo 2 of 3 : UCIP_SP_2020_24751_44376.jpg

View of flap gate on waterward side.

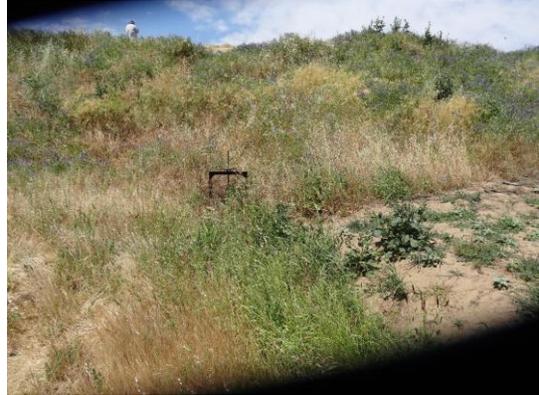
Photo 3 of 3 : UCIP_SP_2020_24751_44373.jpg

View of landward side--dense vegetation.

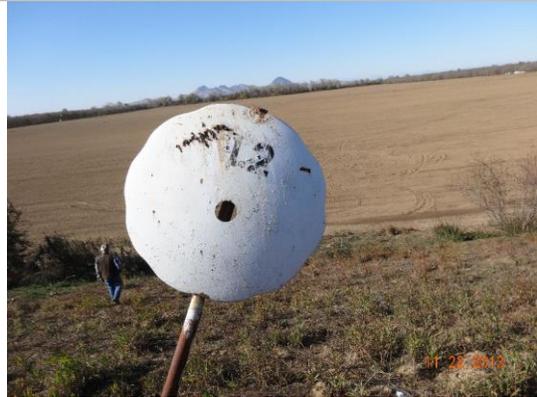
Photo 1 of 3 : UCIP_SP_2020_24828_44680.jpg

View of marker located on waterward shoulder--crossing referenced as No. 12.

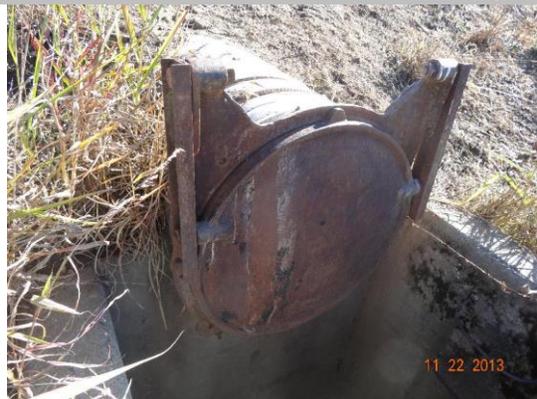
Photo 2 of 3 : UCIP_SP_2020_24828_44684.jpg

View of flap gate located on waterward side.

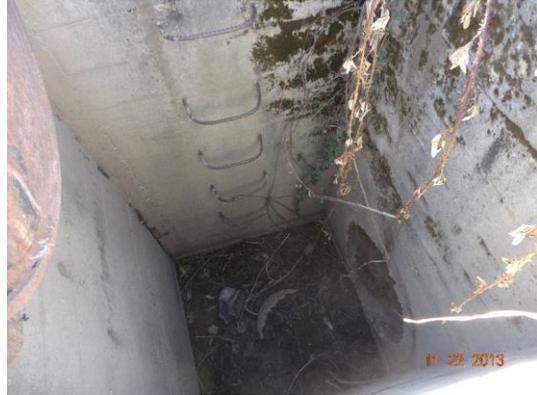
Photo 3 of 3 : UCIP_SP_2020_24828_44683.jpg

Inside view of concrete distribution box.

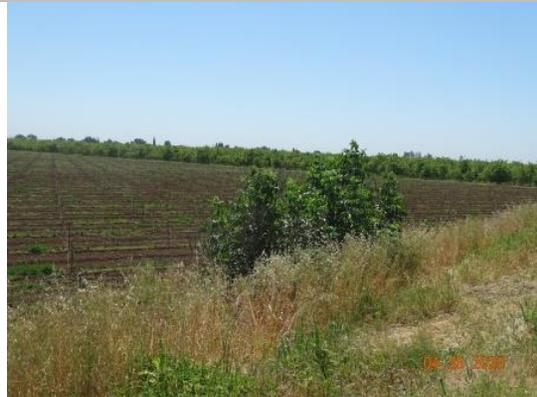
Photo 1 of 1 : SP_2020_RD0010_164_62_20200429_00103.jpg

LM Start	5.18	Rating **	M	Issue No.	62
LM End	5.18	Issue Type +	Ma	Location *	LS
Category	Earthen Levee			GPS Latitude/Longitude	
				Start	End
Item	Trim / Thin Trees			39.237106 °	39.237106 °
				-121.615358 °	-121.615358 °
DWR ID	DWR_RD0010_02_s_2020_62				
Comment Code					
T3 : Trim and thin trees to allow visibility of the ground and room to flood fight.					
Inspector Comment					
Trees with less than 4" diameter at chest height should be removed, Spring 2020.

View looking downstream landside at small starter tree on levee slope, Spring 2020.

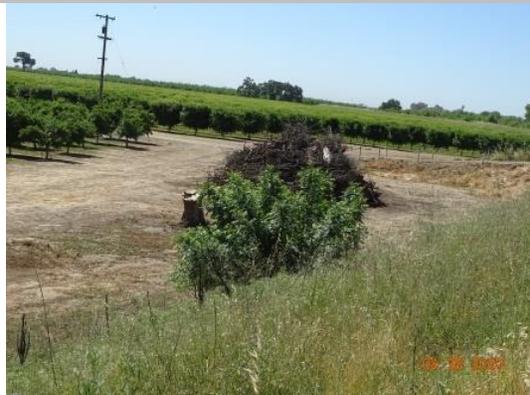
Photo 1 of 1 : SP_2020_RD0010_164_60_20200429_00101.jpg

LM Start	6.15	Rating **	M	Issue No.	60
LM End	6.15	Issue Type +	Ma	Location *	LS
Category	Earthen Levee			GPS Latitude/Longitude	
				Start	End
Item	Trim / Thin Trees			39.250463 °	39.250463 °
				-121.619194 °	-121.619194 °
DWR ID	DWR_RD0010_02_s_2020_60				
Comment Code					
T3 : Trim and thin trees to allow visibility of the ground and room to flood fight.					
Inspector Comment					
Trees with less than 4" diameter at chest height should be removed, Spring 2020.

View looking downstream landside at small starter tree on levee slope, Spring 2020.

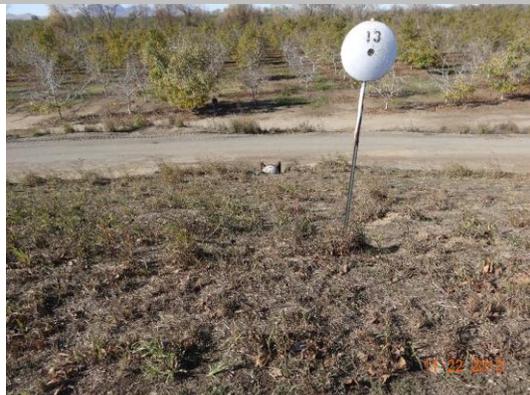
Photo 1 of 3 : UCIP_SP_2020_27793_51514.jpg

Comment Code					
Inspector Comment					
DS_ID:21291 FS_ID:27793 EP_NO: N/A Repair Type: Non-Urgent Crossing Status: Found UCIP Comments: 04/30/2013 Need to contact owner to remove debris inside concrete distribution box and on slope. This crossing is referenced in the USACE Periodic Inspection as item USACE_CESPK_HON2_2013_p_0244. (DWR UCIP - O. Magana) FIELD_STRUCT_DESC: 30-inch corrugated metal gravity drainage pipe through the levee, 17.3 feet below the crown. Corrugated metal cutoff wall around the pipe at each shoulder. Flap gate on the waterside (WS) end. Slide gate on the landside (LS) end. Concrete headwall at each end. [Additional Reference(s): DWR Levee Log, 2005. USACE Sacramento O&M Manual 151, May 1953, (Station 413+81)]. FS Date: 4/30/2013

View of marker located on waterward shoulder, pipe is reference as No. 13.

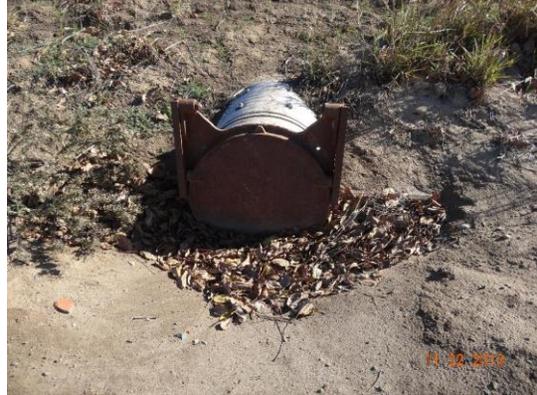
Photo 2 of 3 : UCIP_SP_2020_27793_51517.jpg

View of flap gate located on waterward side.

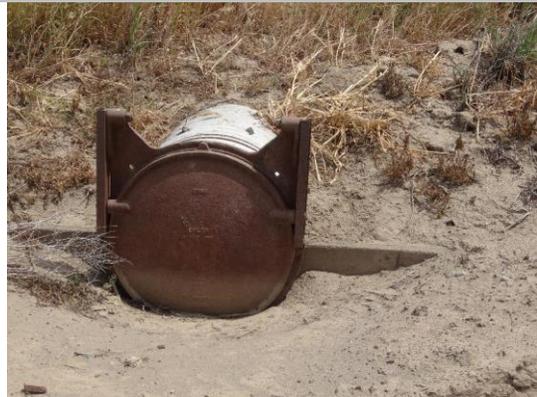
Photo 3 of 3 : UCIP_SP_2020_27793_51513.jpg

Flap gate and concrete headwall visible on waterward side.

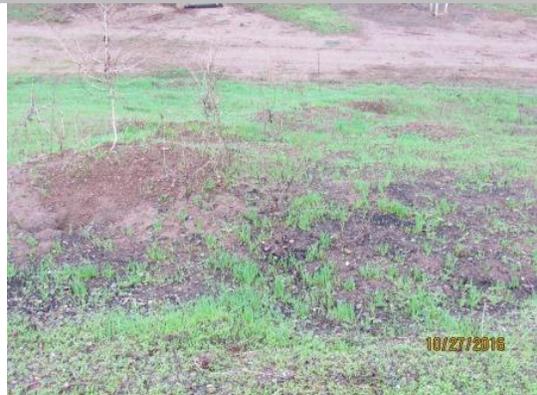
Photo 1 of 1 : SP_2020_RD0010_164_32_20200227_00005.jpg

View of rodent holes on waterside levee slope.

Comment Code					
A3 : No rodents visible, but rodent burrows visible; need to backfill and compact or grout burrows.					
Inspector Comment					
No rodent activity but holes need to be properly backfilled.

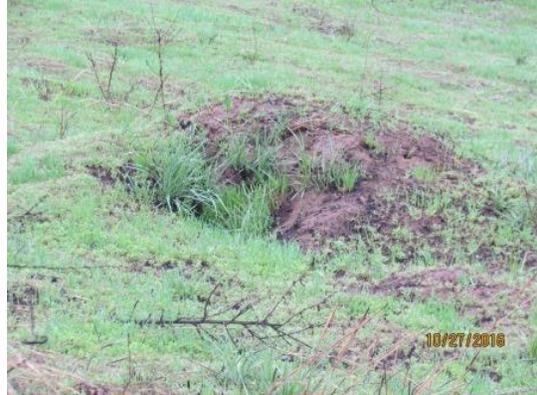
Photo 1 of 1 : SP_2020_RD0010_164_33_20200227_00006.jpg

LM Start	6.88	Rating **	U	Issue No.	33
LM End	6.88	Issue Type +	Ma	Location *	WS
Category	Earthen Levee			GPS Latitude/Longitude	
				Start	End
Item	Animal Control			39.259843 °	39.259843 °
				-121.616013 °	-121.616013 °
DWR ID	DWR_RD0010_02_f_2015_33				
Comment Code					
A3 : No rodents visible, but rodent burrows visible; need to backfill and compact or grout burrows.					
Inspector Comment					
Rodent hole that has more than 2 cubic feet of material, this hole is not active but needs to be backfilled properly.

View of rodent hole that has more than 2 cubic feet of material, this hole is not active but needs to be backfilled properly.

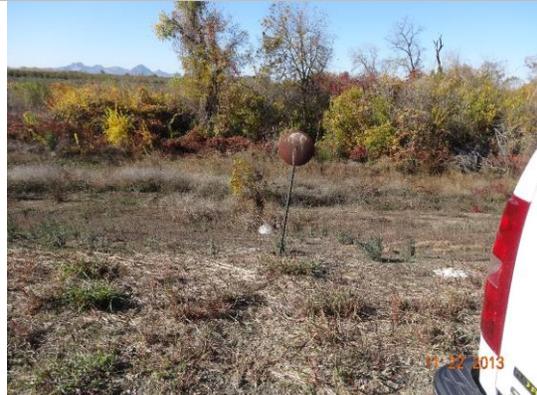
Photo 1 of 3 : UCIP_SP_2020_24831_44700.jpg

Visible marker located on waterward shoulder--no id number noted.

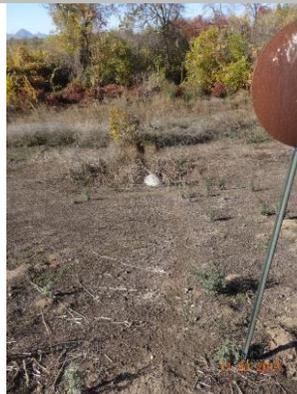
Photo 2 of 3 : UCIP_SP_2020_24831_44699.jpg

View of waterward slope.

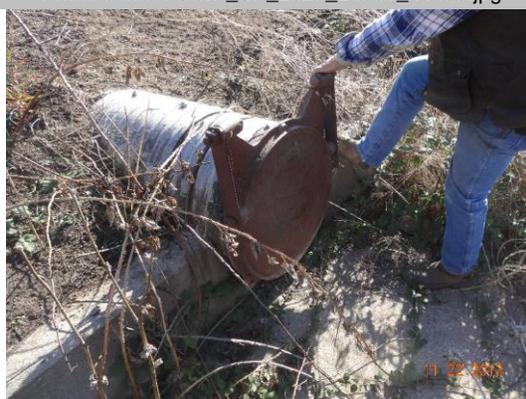
Photo 3 of 3 : UCIP_SP_2020_24831_44698.jpg

Flap gate visible on waterward side.

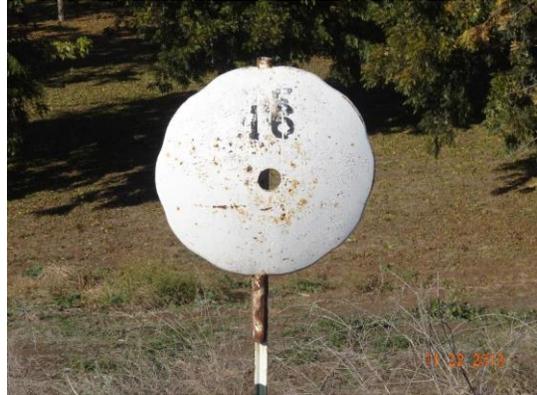
Photo 1 of 3 : UCIP_SP_2020_24832_44705.jpg

Comment Code					
Inspector Comment					
DS_ID:21295 FS_ID:24832 EP_NO: N/A Repair Type: No Action Needed Crossing Status: Found UCIP Comments: 04/30/2013 This crossing is referenced in the USACE Periodic Inspection as item USACE_CESPK_HON2_2013_p_0329. (DWR UCIP - O. Magana) FIELD_STRUCT_DESC: 24-inch corrugated metal gravity drainage pipe through the levee, 12.5 feet below the crown. Corrugated metal cutoff wall around the pipe at each shoulder. Flap gate on the waterside (WS) end. Slide gate on the landside (LS) end. Concrete headwall at each end. [Additional Reference(s): DWR Levee Log, 2005. USACE Sacramento O&M Manual 151, May 1953, (Station 515+52)]. FS Date: 4/30/2013

Marker visible on waterward shoulder, crossing is referenced as No. 16.

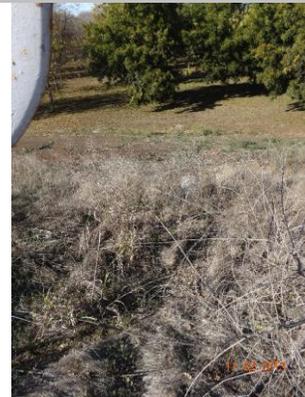
Photo 2 of 3 : UCIP_SP_2020_24832_44704.jpg

View of waterward side.

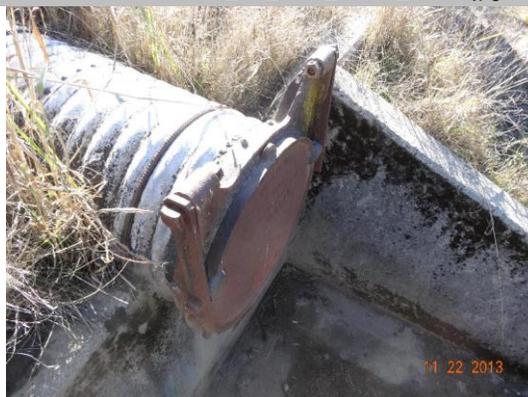
Photo 3 of 3 : UCIP_SP_2020_24832_44703.jpg

View of flap gate located on waterward side.

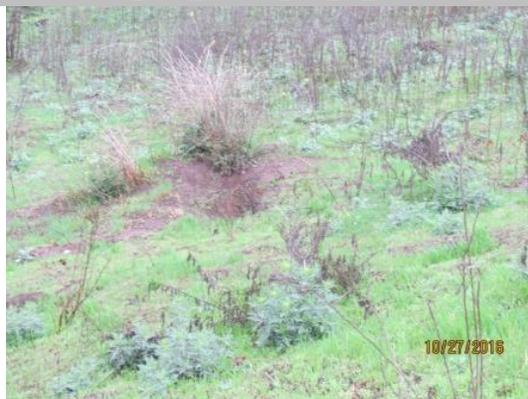
Photo 1 of 1 : SP_2020_RD0010_164_35_20200227_00007.jpg

No rodent activity but holes need to be backfilled.

View of rodent hole on waterside.

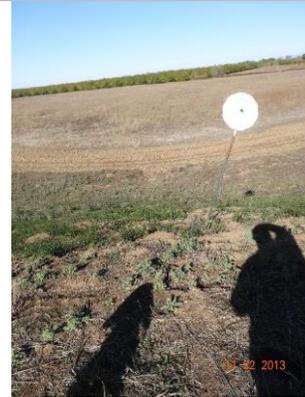
Photo 1 of 3 : UCIP_SP_2020_27775_51473.jpg

Comment Code					
Inspector Comment					
DS_ID:21296 FS_ID:27775 EP_NO: N/A Repair Type: Non-Urgent Crossing Status: Found UCIP Comments: 04/30/2013 Sediment build-up at the inlet-- recommend clearing sediment. This crossing is referenced in the USACE Periodic Inspection as item USACE_CESPK_HON2_2013_p_0348. (DWR UCIP - O. Magana) FIELD_STRUCT_DESC: 30-inch corrugated metal gravity drainage pipe through the levee, 23 feet below the crown. Corrugated metal cutoff wall around the pipe at each shoulder. Flap gate on the waterside (WS) end. Slide gate on the landside (LS) end. Concrete headwall at each end. Metal marker on the WS shoulder. [Additional Reference(s): DWR Levee Log, 2005. USACE Sacramento O&M Manual 151, May 1953, (Station 551+96)]. FS Date: 4/30/2013

View of waterward side.

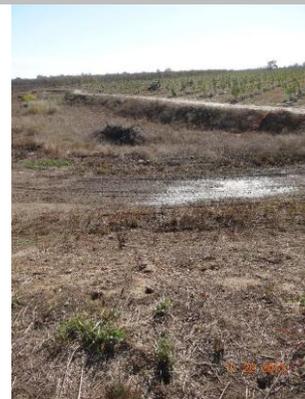
Photo 2 of 3 : UCIP_SP_2020_27775_51472.jpg

View of landward side.

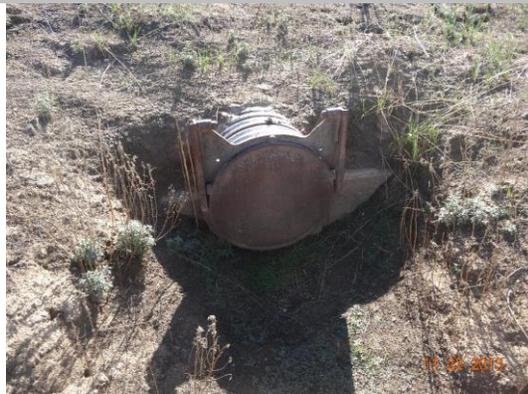
Photo 3 of 3 : UCIP_SP_2020_27775_51477.jpg

View of flap gate visible on waterward side.

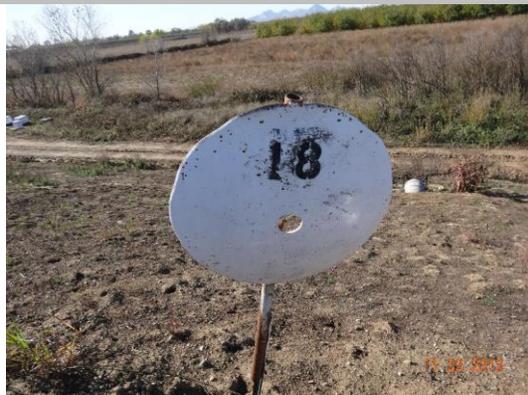
Photo 1 of 3 : UCIP_SP_2020_24834_44715.jpg

Marker visible on waterward shoulder, crossing is referenced as No. 18.

Comment Code					
Inspector Comment					
DS_ID:21297 FS_ID:24834 EP_NO: N/A Repair Type: Non-Urgent Crossing Status: Found UCIP Comments: 04/30/2013 Slide gate missing on landward side. Need to contact owner to determine status of crossing. This crossing is referenced in the USACE Periodic Inspection as item USACE_CESPK_HON2_2013_p_0367. (DWR UCIP - O. Magana) FIELD_STRUCT_DESC: 24-inch corrugated metal gravity drainage pipe through the levee, 14 feet below the crown. Corrugated metal cutoff wall around the pipe at each shoulder. Flap gate on the waterside (WS) end. Slide gate on the landside (LS), slide gate missing. Concrete headwall, saddle, and apron on the WS end. 6-foot by 6-foot concrete splash apron at the WS toe. [Additional Reference(s): DWR Levee Log, 2005. USACE Sacramento O&M Manual 151, May 1953, (Station 565+74)]. FS Date: 4/30/2013

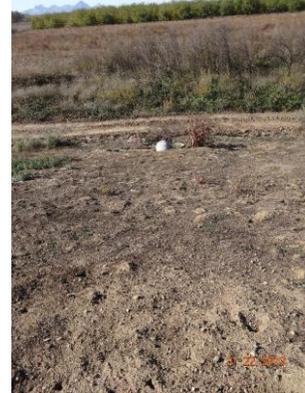
Photo 2 of 3 : UCIP_SP_2020_24834_44714.jpg

View of waterward side.
