**Flood Control Project Maintenance
Levee Inspections**

Maintenance Issue Types Only, Levee Inspection Report By Mile - Spring 2020

Reclamation District No. 0010 Honcut

Waterway	Bank	Unit Miles	Inspection Start/End	Inspector
Unit No. 01 Simmerly Slough	Right	7.65	04/28/2020 04/28/2020	Sterling York

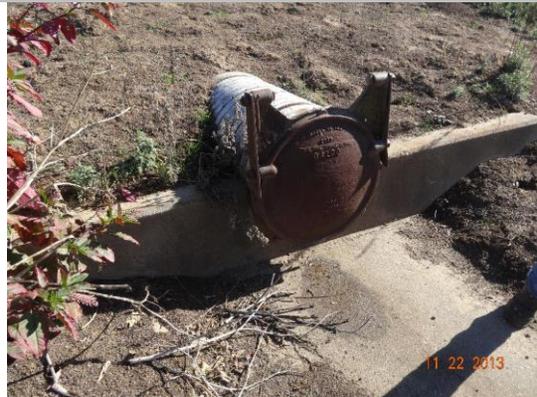
Photo 3 of 3 : UCIP_SP_2020_24834_44716.jpg

View of flap gate visible on waterward side.

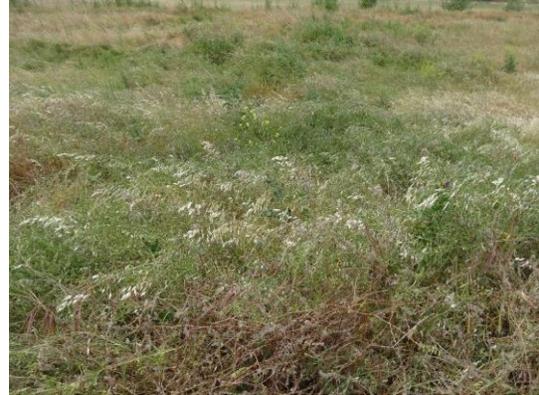
Photo 1 of 3 : UCIP_SP_2020_24768_44450.jpg

Comment Code					
Inspector Comment					
DS_ID:21298 FS_ID:24768 EP_NO: N/A Repair Type: Non-Urgent Crossing Status: Found UCIP Comments: 04/30/2013 Crossing is buried--found indicators of concrete headwall. Need to contact owner to determine status of crossing. This crossing is referenced in the USACE Periodic Inspection as item USACE_CESPK_HON2_2013_p_0378. (DWR UCIP - O. Magana) FIELD_STRUCT_DESC: 24-inch corrugated metal gravity drainage pipe through the levee, 13 feet below the crown. Corrugated metal cutoff wall around the pipe at each shoulder. Flap gate on the waterside (WS) end. Slide gate on the landside (LS) end. Concrete headwall at each end. Metal marker on the WS slope. [Additional Reference(s): DWR Levee Log, 2005. USACE Sacramento O&M Manual 151, May 1953, (Station 576+75)]. FS Date: 4/30/2013

View of waterward slope.

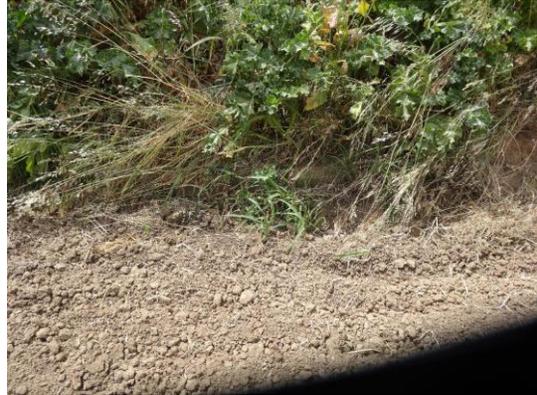
Photo 3 of 3 : UCIP_SP_2020_24768_44449.jpg

View of concrete headwall visible through dense vegetation.

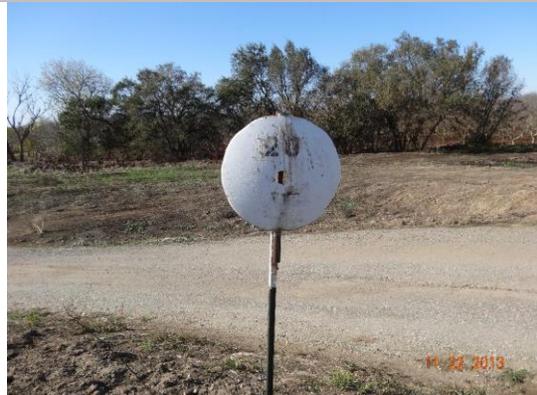
Photo 1 of 3 : UCIP_SP_2020_24769_44454.jpg

Marker visible on waterward side shoulder, crossing is referenced as No. 20.

Comment Code					
Inspector Comment					
DS_ID:21299 FS_ID:24769 EP_NO: N/A Repair Type: Non-Urgent Crossing Status: Found UCIP Comments: 04/30/2013 Need to contact owner. Need to clear debris from concrete distribution box on waterward and remove debris blocking landward side. This crossing is referenced in the USACE Periodic Inspection as item USACE_CESPK_HON2_2013_p_0383. (DWR UCIP - O. Magana) FIELD_STRUCT_DESC: 24-inch corrugated metal gravity drainage pipe through the levee, 12 feet below the crown. Corrugated metal cutoff wall around the pipe at each shoulder. Flap gate on the waterside (WS) end. Slide gate on the landside (LS). Concrete headwall, saddle, and apron on the WS end. Metal marker on the WS shoulder. [Additional Reference(s): DWR Levee Log, 2005. USACE Sacramento O&M Manual 151, May 1953, (Station 582+72)]. FS Date: 4/30/2013

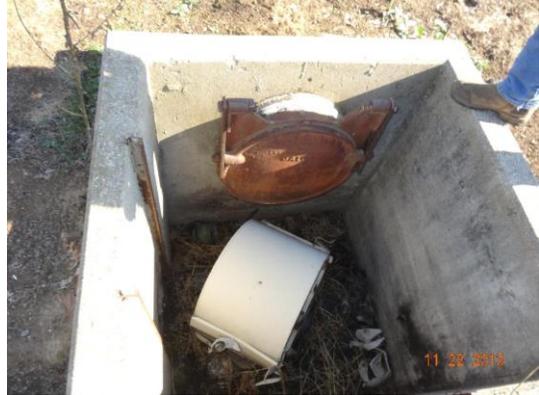
Photo 2 of 3 : UCIP_SP_2020_24769_44453.jpg

View of flap gate located inside concrete distribution box. Debris scattered inside box.

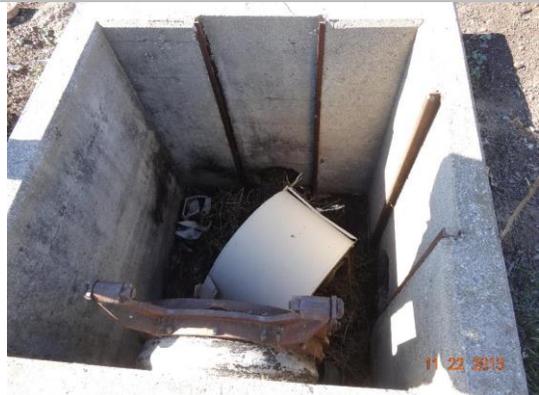
Photo 3 of 3 : UCIP_SP_2020_24769_44452.jpg

View of concrete distribution box located on waterward side.

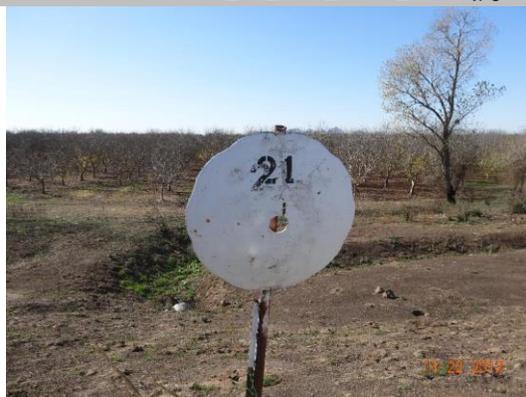
Photo 1 of 3 : UCIP_SP_2020_24835_44721.jpg

Comment Code					
Inspector Comment					
DS_ID:21300 FS_ID:24835 EP_NO: N/A Repair Type: No Action Needed Crossing Status: Found UCIP Comments: 04/30/2013 This crossing is referenced in the USACE Periodic Inspection as item USACE_CESPK_HON2_2013_p_0388. (DWR UCIP - O. Magana) FIELD_STRUCT_DESC: 24-inch corrugated metal gravity drainage pipe through the levee, 14 feet below the crown. Corrugated metal cutoff wall around the pipe at each shoulder. Flap gate on the waterside (WS) end. Slide gate on the landside (LS). Concrete headwall, saddle, and apron on the WS end. Metal marker on the WS shoulder. [Additional Reference(s): DWR Levee Log, 2005. USACE Sacramento O&M Manual 151, May 1953, (Station 591+77)]. FS Date: 4/30/2013

Marker visible on waterward shoulder, crossing referenced as No. 21.

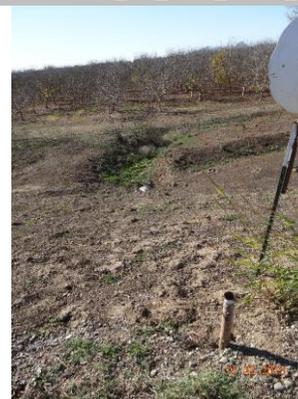
Photo 2 of 3 : UCIP_SP_2020_24835_44720.jpg

View of waterward side.

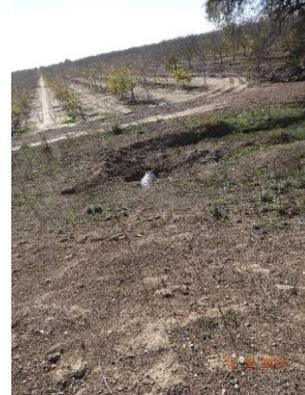
Photo 2 of 3 : UCIP_SP_2020_24837_44735.jpg

Overview of waterward side.

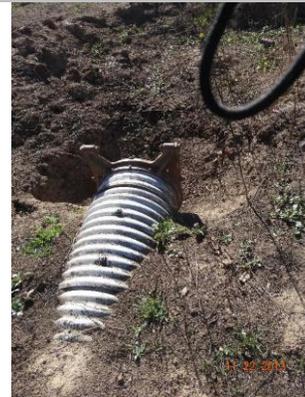
Photo 3 of 3 : UCIP_SP_2020_24837_44734.jpg

Pipe through waterward side.

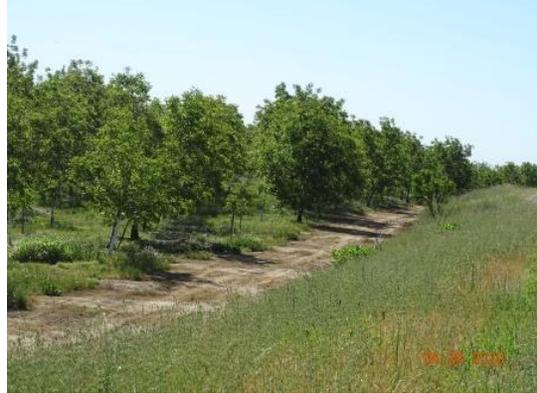
Photo 1 of 1 : SP_2020_RD0010_164_46_20200429_00095.jpg

LM Start	10.36	Rating **	M	Issue No.	46
LM End	10.36	Issue Type +	Ma	Location *	LS
Category	Earthen Levee		GPS Latitude/Longitude		
			Start	End	
Item	Trim / Thin Trees		39.297507 °	39.297507 °	
			-121.612875 °	-121.612875 °	
DWR ID	DWR_RD0010_02_s_2020_46				
Comment Code					
T3 : Trim and thin trees to allow visibility of the ground and room to flood fight.					
Inspector Comment					
Trees with less than 4" diameter at chest height should be removed, Spring 2020.

View looking downstream landside at small starter tree on levee slope, Spring 2020.

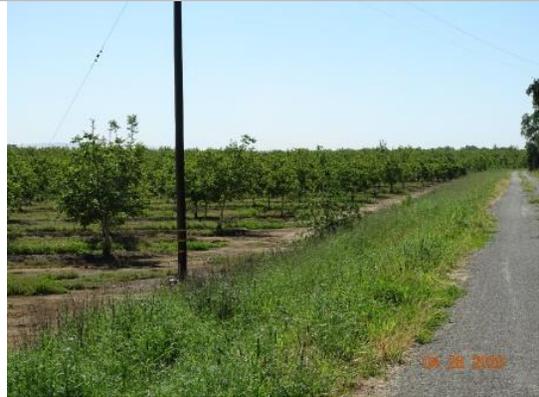
Photo 1 of 1 : SP_2020_RD0010_164_44_20200429_00094.jpg

LM Start	10.65	Rating **	M	Issue No.	44
LM End	10.65	Issue Type +	Ma	Location *	LS
Category	Earthen Levee		GPS Latitude/Longitude		
			Start	End	
Item	Trim / Thin Trees		39.300273 °	39.300273 °	
			-121.616903 °	-121.616903 °	
DWR ID	DWR_RD0010_02_s_2020_44				
Comment Code					
T3 : Trim and thin trees to allow visibility of the ground and room to flood fight.					
Inspector Comment					
Trees with less than 4" diameter at chest height should be removed, Spring 2020.

View looking downstream landside at small starter tree on levee slope, Spring 2020.

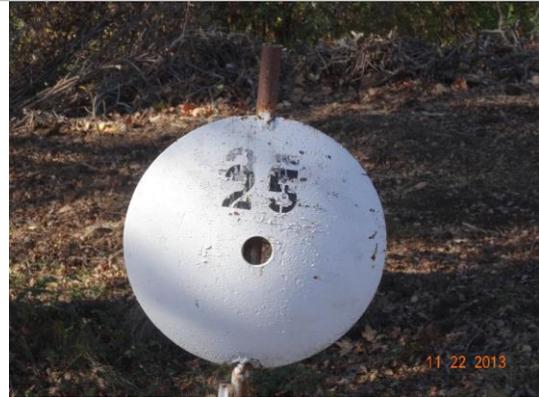
Photo 1 of 3 : UCIP_SP_2020_24840_44753.jpg

Comment Code					
Inspector Comment					
DS_ID:21305 FS_ID:24840 EP_NO: N/A Repair Type: Non-Urgent Crossing Status: Found UCIP Comments: 04/30/2013 Burrow activity--large holes found on landward side. Crossing on landward side is blocked. Recommend clearing headwall and crossing. Need to coordinate with owner to determine status of crossing. If crossing is no longer in use owner will need to contact the CVFPB to comply with Title 23. This crossing is referenced in the USACE Periodic Inspection as item USACE_CESPK_HON2_2013_p_0476. (DWR UCIP - O. Magana) FIELD_STRUCT_DESC: 24-inch corrugated metal gravity drainage pipe through the levee, 7.5 feet below the crown. Corrugated metal cutoff wall around the pipe at each shoulder. Flap gate on the waterside (WS) end. Concrete headwall at each toe. Saddle and apron on the WS. [Additional Reference(s): DWR Levee Log, 2005. USACE Sacramento O&M Manual 151, May 1953, (Station 674+73)]. FS Date: 4/30/2013

Marker visible on waterward side, crossing is referenced as No. 25.

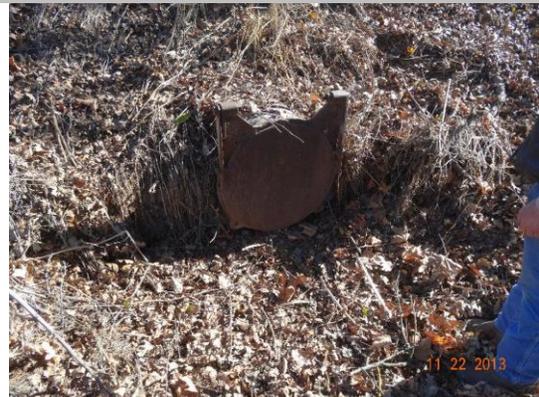
Photo 2 of 3 : UCIP_SP_2020_24840_44752.jpg

View of flap gate located on waterward side.

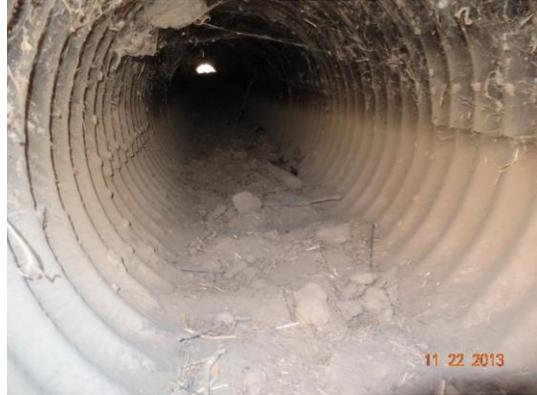
Photo 3 of 3 : UCIP_SP_2020_24840_44751.jpg

Internal view of pipe wall from waterward side.

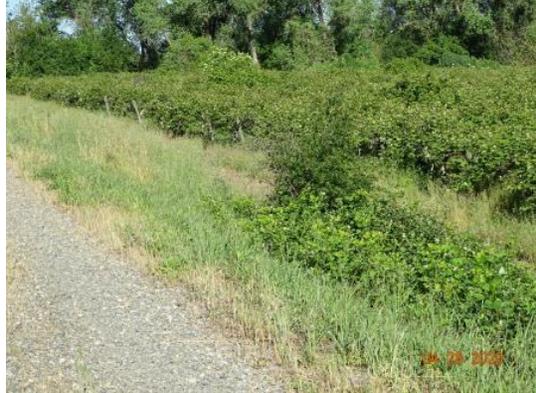
Photo 1 of 1 : SP_2020_RD0010_165_22_20200429_00027.jpg

LM Start	0.09	Rating **	M	Issue No.	22
LM End	0.09	Issue Type +	Ma	Location *	WS
Category	Earthen Levee		GPS Latitude/Longitude		
			Start	End	
Item	Trim / Thin Trees		39.310229 °	39.310229 °	
			-121.614697 °	-121.614697 °	
DWR ID	DWR_RD0010_03_s_2020_22				
Comment Code					
T3 : Trim and thin trees to allow visibility of the ground and room to flood fight.					
Inspector Comment					
Trees with less than 4" diameter at chest height should be removed, Spring 2020.

View looking downstream waterside at a small starter tree and wild growth that needs to be removed, Spring 2020.

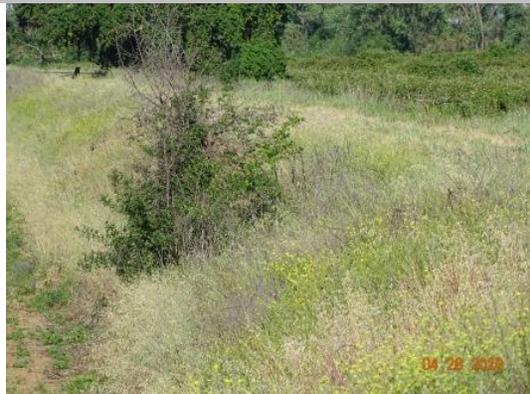
Photo 1 of 1 : SP_2020_RD0010_165_20_20200429_00025.jpg

LM Start	0.56	Rating **	M	Issue No.	20
LM End	0.56	Issue Type +	Ma	Location *	LS
Category	Earthen Levee		GPS Latitude/Longitude		
			Start	End	
Item	Trim / Thin Trees		39.310227 °	39.310227 °	
			-121.606027 °	-121.606027 °	
DWR ID	DWR_RD0010_03_s_2020_20				
Comment Code					
T3 : Trim and thin trees to allow visibility of the ground and room to flood fight.					
Inspector Comment					
Trees with less than 4" diameter at chest height should be removed, Spring 2020.

View looking downstream landside at a small starter tree that needs to be removed, Spring 2020.

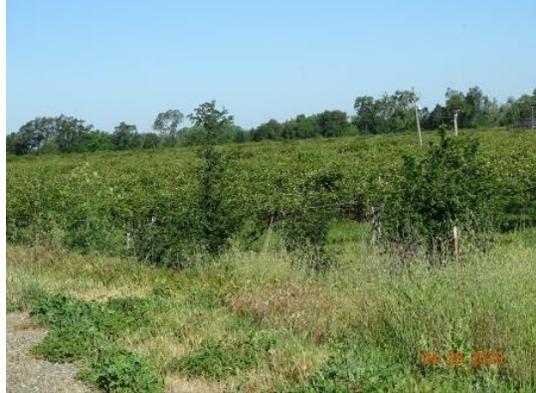
Photo 1 of 1 : SP_2020_RD0010_165_18_20200429_00023.jpg

LM Start	0.59	Rating **	M	Issue No.	18
LM End	0.59	Issue Type +	Ma	Location *	WS
Category	Earthen Levee		GPS Latitude/Longitude		
			Start	End	
Item	Trim / Thin Trees		39.310209 °	39.310209 °	
			-121.605456 °	-121.605456 °	
DWR ID	DWR_RD0010_03_s_2020_18				
Comment Code					
T3 : Trim and thin trees to allow visibility of the ground and room to flood fight.					
Inspector Comment					
Trees with less than 4" diameter at chest height should be removed, Spring 2020.

View looking downstream waterside at a small starter trees that needs to be removed, Spring 2020.

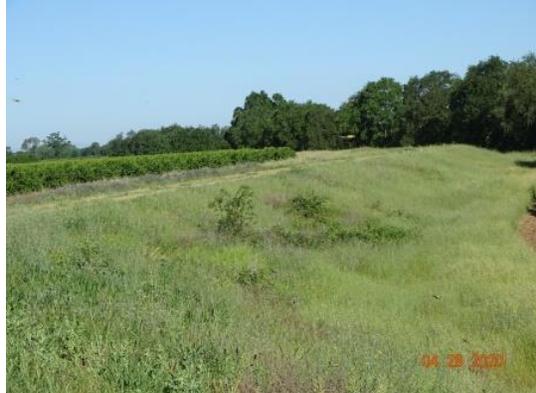
Photo 1 of 1 : SP_2020_RD0010_165_15_20200429_00020.jpg

LM Start	0.95	Rating **	M	Issue No.	15
LM End	0.95	Issue Type +	Ma	Location *	WS
Category	Earthen Levee		GPS Latitude/Longitude		
			Start	End	
Item	Trim / Thin Trees		39.307583 °	39.307583 °	
			-121.599640 °	-121.599640 °	
DWR ID	DWR_RD0010_03_s_2020_15				
Comment Code					
T3 : Trim and thin trees to allow visibility of the ground and room to flood fight.					
Inspector Comment					
Trees with less than 4" diameter at chest height should be removed, Spring 2020.

View looking downstream waterside at a small starter trees that needs to be removed, Spring 2020.

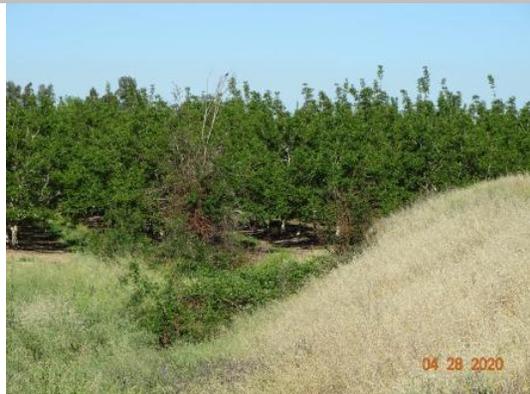
Photo 1 of 1 : SP_2020_RD0010_165_13_20200429_00018.jpg

LM Start	1.47	Rating **	M	Issue No.	13
LM End	1.47	Issue Type +	Ma	Location *	LS
Category	Earthen Levee		GPS Latitude/Longitude		
			Start	End	
Item	Trim / Thin Trees		39.303777 °	39.303777 °	
			-121.591853 °	-121.591853 °	
DWR ID	DWR_RD0010_03_s_2020_13				
Comment Code					
T3 : Trim and thin trees to allow visibility of the ground and room to flood fight.					
Inspector Comment					
Trees with less than 4" diameter at chest height should be removed, Spring 2020.

View looking downstream landside at small starter trees that need to be removed, Spring 2020.

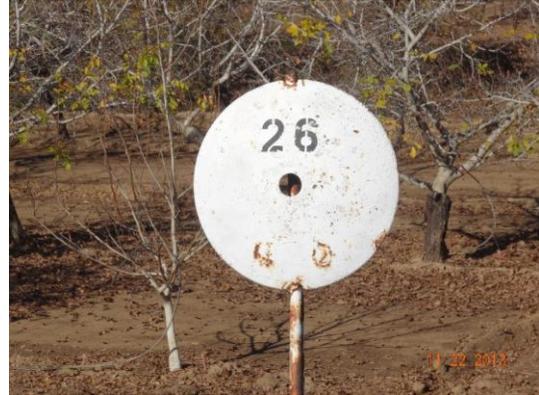
Photo 1 of 3 : UCIP_SP_2020_24842_44764.jpg

Comment Code					
Inspector Comment					
DS_ID:21307 FS_ID:24842 EP_NO: N/A Repair Type: Non-Urgent Crossing Status: Found UCIP Comments: 05/01/2013 Sediment deposit inside pipe--Need to coordinate with owner to determine status of crossing. If crossing is no longer in use owner will need to contact the CVFPB to comply with Title 23. (DWR UCIP - O. Magana) FIELD_STRUCT_DESC: 24-inch corrugated metal gravity drainage pipe through the levee, 15 feet below the crown. Corrugated metal cutoff wall around the pipe at each shoulder. Flap gate on the waterside (WS) end. Slide gate on the landside (LS) end. Concrete headwall at each toe. [Additional Reference(s): DWR Levee Log, 2005. USACE Sacramento O&M Manual 151, May 1953, (Station 134+06)]. FS Date: 5/1/2013

Marker visible on waterward side--No. 26.

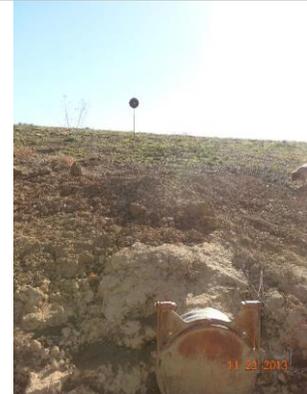
Photo 2 of 3 : UCIP_SP_2020_24842_44762.jpg

View of waterward slope.

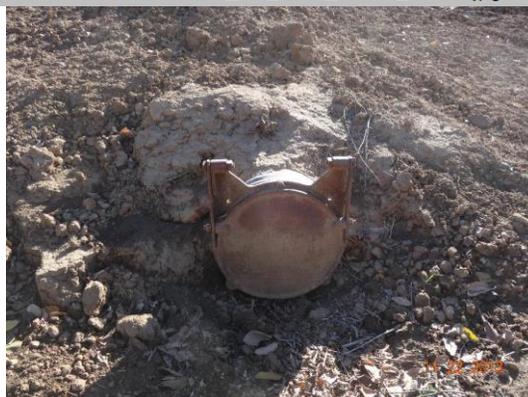
Photo 3 of 3 : UCIP_SP_2020_24842_44763.jpg

View of flap gate located on waterward side.

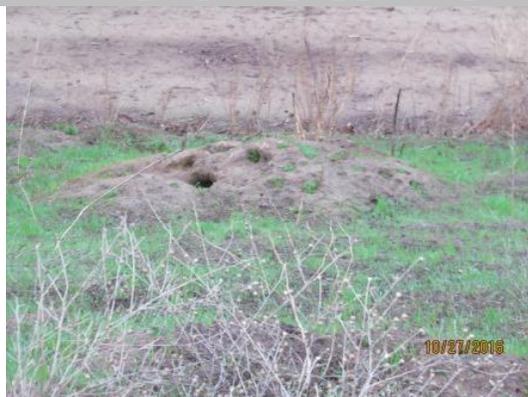
Photo 1 of 1 : SP_2020_RD0010_165_6_20200227_00001.jpg

No squirrel activity seen, but rodent holes need to be back filled properly.

View of waterside slope, no squirrel activity seen, but rodent holes need to be back filled properly.

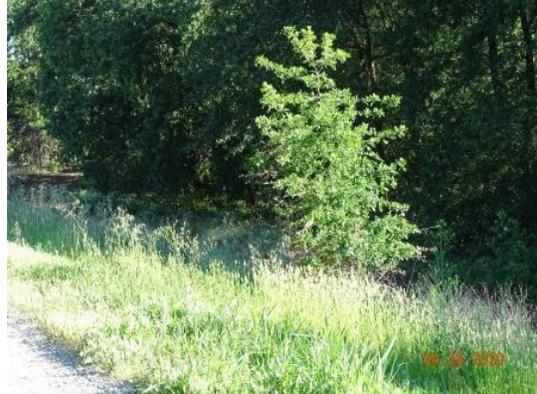
Photo 1 of 1 : SP_2020_RD0010_165_9_20200429_00015.jpg

LM Start	2.51	Rating **	M	Issue No.	9
LM End	2.51	Issue Type +	Ma	Location *	WS
Category	Earthen Levee			GPS Latitude/Longitude	
				Start	End
Item	Trim / Thin Trees			39.300973 °	39.300973 °
				-121.574087 °	-121.574087 °
DWR ID	DWR_RD0010_03_s_2020_9				
Comment Code					
T3 : Trim and thin trees to allow visibility of the ground and room to flood fight.					
Inspector Comment					
Trees with less than 4" diameter at chest height should be removed, Spring 2020.

View looking downstream waterside at a small starter tree that needs to be removed, Spring 2020.

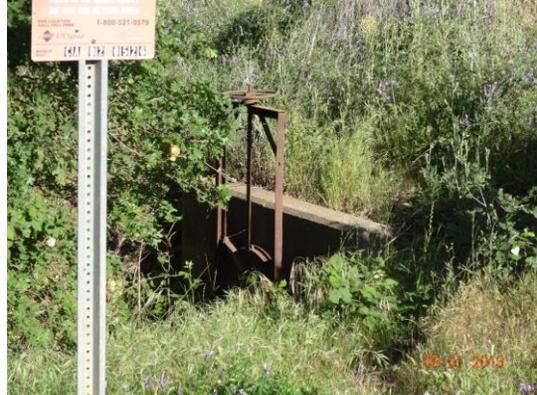
Photo 1 of 2 : UCIP_SP_2020_24883_44820.jpg

Comment Code					
Inspector Comment					
DS_ID:21308 FS_ID:24883 EP_NO: N/A Repair Type: Non-Urgent Crossing Status: Found UCIP Comments: 05/01/2013 Dense vegetation limits the inspector's visibility to identify signs of pipe failure (leaks) along the slope. Recommend removing vegetation along pipe alignment to conduct proper inspection of structure and appurtances. (DWR UCIP - O. Magana) FIELD_STRUCT_DESC: 24-inch corrugated metal gravity drainage pipe through the levee, 12 feet below the crown. Corrugated metal cutoff wall around the pipe at each shoulder. Flap gate on the waterside (WS) end. Slide gate on the landside (LS) end. Concrete headwall at the LS toe. [Additional Reference(s): DWR Levee Log, 2005. USACE Sacramento O&M Manual 151, May 1953, (Station 192+33)]. FS Date: 5/1/2013

View of slide gate and concrete headwall located on landward side.
