**Flood Control Project Maintenance
Levee Inspections**

Fall 2019 Levee Maintenance Deficiency Summary Report

San Joaquin River Basin

Reclamation District No. 0017 Mossdale

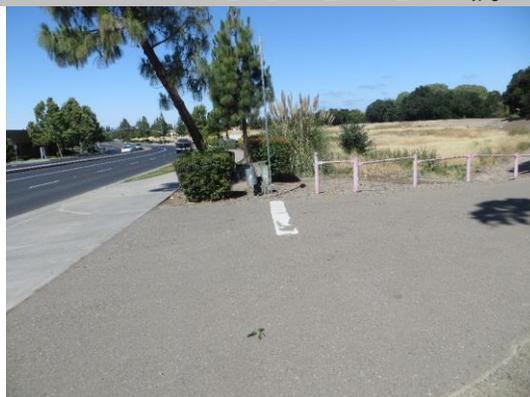
Photo 3 of 3 : UCIP_FA_2019_49990_74220.jpg

Comment Code					
Inspector Comment					
DS_ID:72 FS_ID:49990 EP_NO: 15185 Repair Type: Non-Urgent Crossing Status: Indicator Found UCIP Comments: 04/06/2018 Received supporting information from T. Marlow with KSN pertaining to line. PG&E has installed gas line distribution markers on both shoulder of the levee. Crossing is an active line. PG&E performs a leak survey at least twice a year according to Mr. R. Muok, Supervisor, Gas Pipeline Operations and Maintenance Stockton. Mr. Muok can be reached at 209-406-7926. Crossing has been downgraded from Urgent to Non-Urgent--pipe is inspected by owner. UCIP will need to coordinate with PG&E to obtain confirmation of inspections, obtain emergency contact information, and maintenance contact information. (DWR UCIP - O. Magana) 07/12/2016 No markers (no photos taken in 2016). Need to contact owner to determine status of crossing. If crossing is active, owner will need to coordinate with CVFPB to install markers to comply with Title 23. (DWR UCIP - omagana)5/19/2015 Need to install gasline markers. (DWR UCIP - omagana) FIELD_STRUCT_DESC: 8-inch soil proofed steel gas main through the left bank levee and under the channel of French Camp Slough. The pipeline has a minimum cover of 20 to 25 feet within the overflow areas and under the channel. (8-inch line authorized under Permit No. 15185, 1989 - Pacific Gas & Electric Company [PG&E]) FS Date: 7/12/2016

LS crown. No gasline markers.

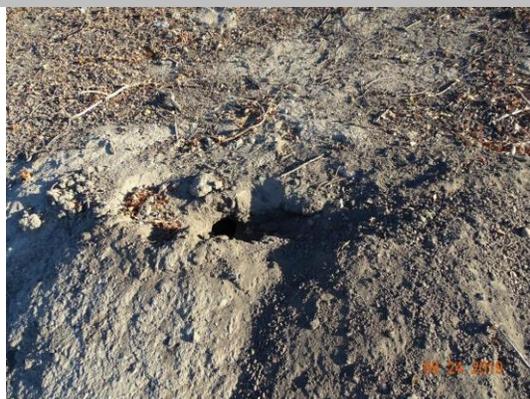
Photo 1 of 1 : FA_2019_RD0017_303_9_20191001_00016.jpg

LM Start	0.23	Rating **	M	Issue No.	9
LM End	0.23	Issue Type +	Ma	Location *	LS
Category	Earthen Levee			GPS Latitude/Longitude	
				Start	End
Item	Animal Control			37.913438 °	37.913438 °
				-121.294178 °	-121.294178 °
DWR ID	DWR_RD0017_01_f_2019_9				
Comment Code					
A3 : No rodents visible, but rodent burrows visible; need to backfill and compact or grout burrows.					
Inspector Comment

View of rodent hole greater than 6 inches on landside slope. Fall 2019

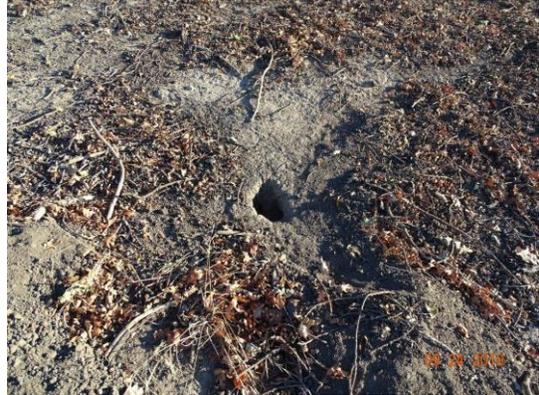
Photo 1 of 1 : FA_2019_RD0017_303_10_20191001_00017.jpg

LM Start	0.28	Rating **	M	Issue No.	10
LM End	0.28	Issue Type +	Ma	Location *	LS
Category	Earthen Levee			GPS Latitude/Longitude	
				Start	End
Item	Animal Control			37.913466°	37.913466°
				-121.295092°	-121.295092°
DWR ID	DWR_RD0017_01_f_2019_10				
Comment Code					
A3 : No rodents visible, but rodent burrows visible; need to backfill and compact or grout burrows.					
Inspector Comment

View of rodent hole greater than 6 inches on landside slope. Fall 2019

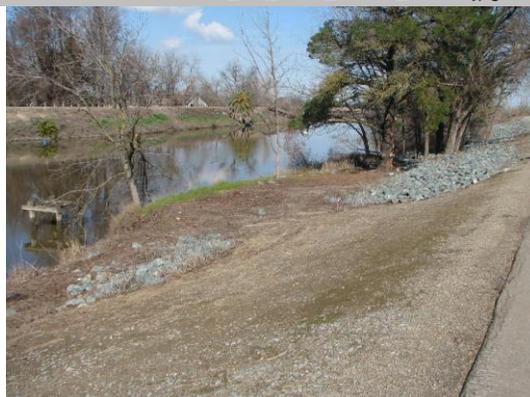
Photo 3 of 3 : UCIP_FA_2019_40628_38514.jpg

Comment Code					
Inspector Comment					
DS_ID:75 FS_ID:40628 EP_NO: 15093 Repair Type: Non-Urgent Crossing Status: Found UCIP Comments: Only appurtenances remaining at this location--4 pillings located on waterward side. According to records the pillings were to be removed under a completion maintenace contract. Need to coordinate with owner. FIELD_STRUCT_DESC: 14-inch-diameter pipeline through levee at unknown depth. Per inspector's notes "this crossing is abandoned almost all materials removed including pipes, conduit, and pump house. The only items left are 4 pillings which are to be removed under a completion maintenance contract. Approximately 200 feet of reinforced concrete pipe lateral removed in R/W south of crossing". FS Date: 2/3/2010

View of waterward side.

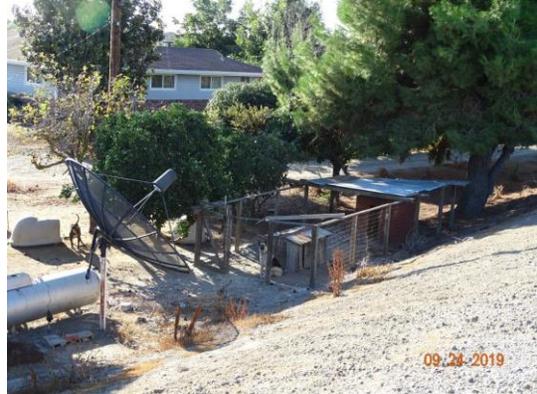
Photo 1 of 1 : FA_2019_RD0017_304_73_20191001_00194.jpg

LM Start	1.13	Rating **	M	Issue No.	73
LM End	1.13	Issue Type +	En	Location *	LS
Category	Earthen Levee			GPS Latitude/Longitude	
				Start	End
Item	Encroachments			37.901693 °	37.901693 °
				-121.325582 °	-121.325582 °
DWR ID	DWR_RD0017_02_s_2017_73				
Comment Code					
BU : Building					
Inspector Comment					
Dog kennels are within flood control right of way.

View of dog kennels within flood control right of way on landside slope. Fall 2019

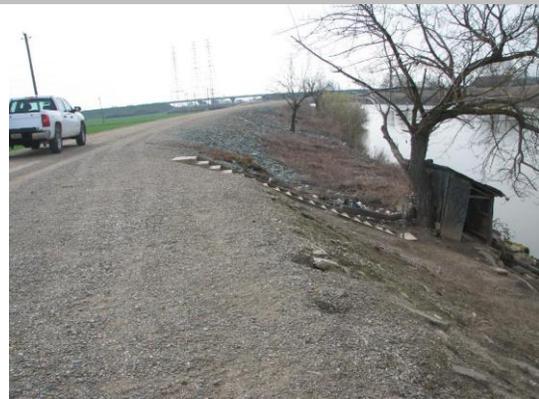
Photo 1 of 3 : UCIP_FA_2019_40646_72010.jpg

Comment Code					
Inspector Comment					
DS_ID:17 FS_ID:40646 EP_NO: 15103 Repair Type: Non-Urgent Crossing Status: Found UCIP Comments: Need to coordinate with owner to determine status of crossing. If crossing is no longer in use owner will need to contact the CVFPB to comply with Title 23. FIELD_STRUCT_DESC: 8-inch steel irrigation pipe through levee. Invert of pipe is 3.47 feet below crown. Siphon breaker on landside (LS) shoulder. Pump house on waterside (WS) slope, standpipe located 10 feet from LS toe. Concrete stairway on WS slope. (new 8-inch authorized under Permit No. 15103, 1990 - C. Young, existing 8-inch pipe removed; new 8-inch pipe was installed during the levee work approved under Permit No. 15014) [Additional Reference(s): DWR Levee Logs, 1981, 2003] FS Date: 2/4/2010

View of waterward side.

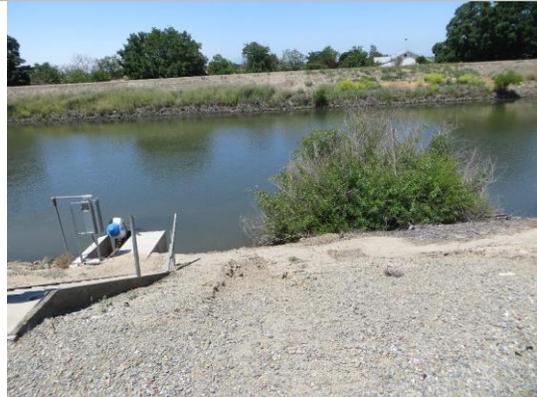
Photo 1 of 3 : UCIP_FA_2019_46009_74439.jpg

Comment Code					
Inspector Comment					
DS_ID:315 FS_ID:46009 EP_NO: N/A Repair Type: Non-Urgent Crossing Status: Found UCIP Comments: 05/19/15 Pipe has been removed. Need to contact KSN, engineering consultants for LMA, to obtain records showing pipe removal and obtain permit authoring work. 02/04/10 Hole present on waterward side pipe--historical records indicate crossing abandoned however unable to confirm. Unable to confirm condition of pipe through levee. Need to coordinate with owner to determine status of crossing. If crossing is no longer in use owner will need to contact the CVFPB to comply with Title 23. FIELD_STRUCT_DESC: *REMOVED* 4-inch irrigation pipe of unknown material through the levee, 2 feet below the crown. Pipe open on both ends, waterside (WS) and landside (LS). Pump on concrete pad and gate valve located on the WS slope. [Additional Reference(s): DWR Levee Logs, 1981, 2003] FS Date: 5/19/2015

(2015) View of waterward slope.

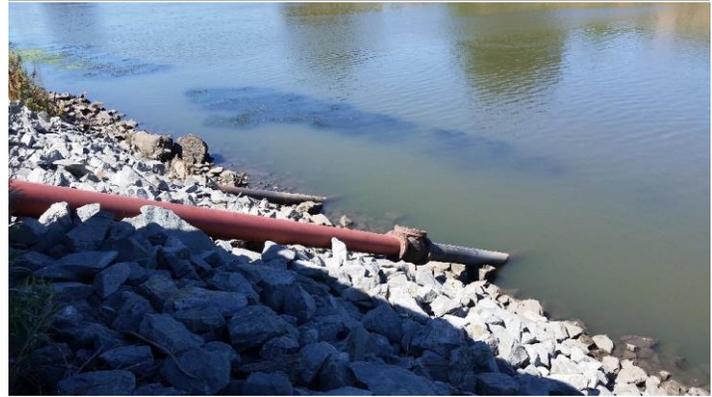
Photo 1 of 3 : UCIP_FA_2019_53329_75736.jpg

View of WS, photo taken downstream looking at upstream pipe. Photo 1 of 2.

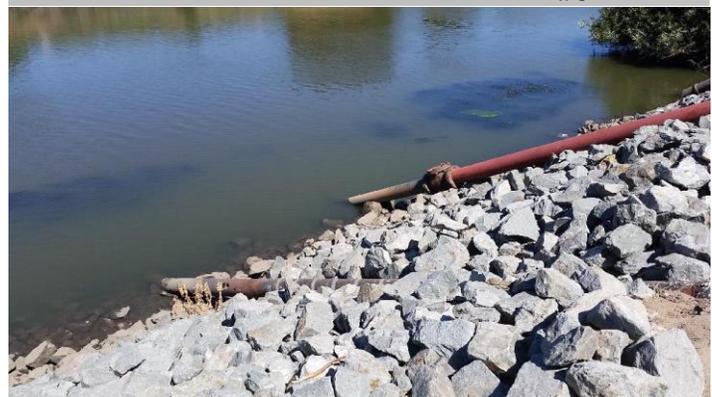
Photo 2 of 3 : UCIP_FA_2019_53329_75733.jpg

View of WS, photo taken upstream looking at first pipe. Photo 1 of 2.

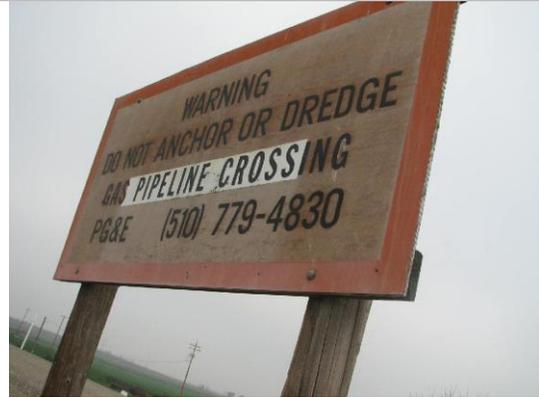
Photo 3 of 3 : UCIP_FA_2019_40658_72110.jpg

Comment Code					
Inspector Comment					
<p>DS_ID:23 FS_ID:40658 EP_NO: 4116 Repair Type: Non-Urgent Crossing Status: Found UCIP Comments: Need to contact owner to determine status of crossing. Need date of last inspection and confirmation that crossing is still in operable condition. FIELD_STRUCT_DESC: 8.625-inch steel high pressure gas main through the levee. Invert of pipe is 3.9 feet below the crown. Location sign for gas pipeline crossing on waterside (WS) slope. PG&E contact information 510-779-4830 for crossing. (8.625-inch gas main authorized under Permit No. 4116, 1962-Pacific Gas and Electric Company [PG&E]) [Additional Reference(s): DWR Levee Logs, 1981, 2003] FS Date: 2/4/2010</p>

Marker visible on waterward side.

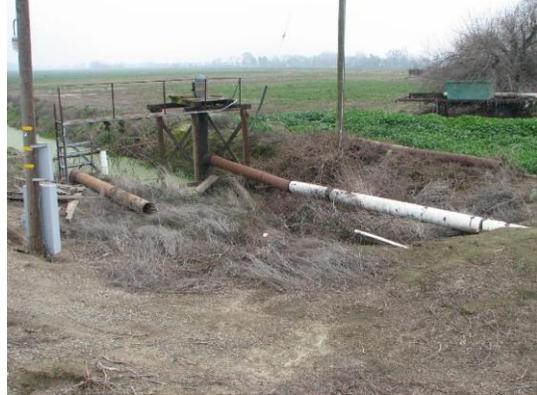
Photo 1 of 3 : UCIP_FA_2019_40659_72116.jpg

LM Start	3.63	Rating **	M	Issue No.	116
LM End	3.63	Issue Type +	En	Location *	
Category	Supplemental			GPS Latitude/Longitude	
				Start	End
Item	DRAFT DWR UCIP Field Study			37.868657°	37.868657°
				-121.327383°	-121.327383°
DWR ID	26				
Comment Code					
Inspector Comment					
DS_ID:26 FS_ID:40659 EP_NO: 15109 Repair Type: Non-Urgent Crossing Status: Found UCIP Comments: Erosion around siphon breaker on landward side recommend investigating potential leak. FIELD_STRUCT_DESC: 12-inch steel drainage pipe through levee, 3 feet below levee crown. Siphon breaker on landside (LS) shoulder. Pump in irrigation ditch is located about 45 feet from LS toe. (12-inch pipe authorized under Permit No. 15109, 1990 - R. Muller) [Additional Reference(s): DWR Levee Logs, 1981, 2003] FS Date: 2/4/2010

View of pipe section and pump station located on landward side.

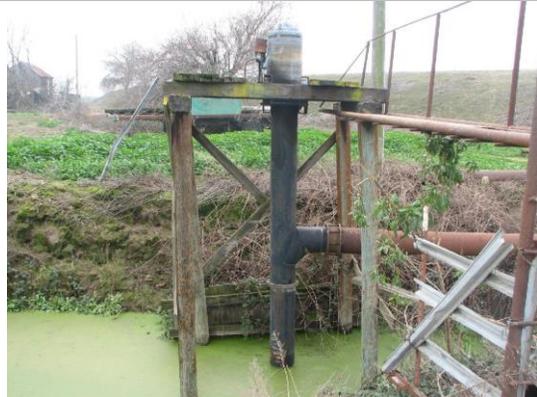
Photo 2 of 3 : UCIP_FA_2019_40659_72115.jpg

Pump station locate on landward side.

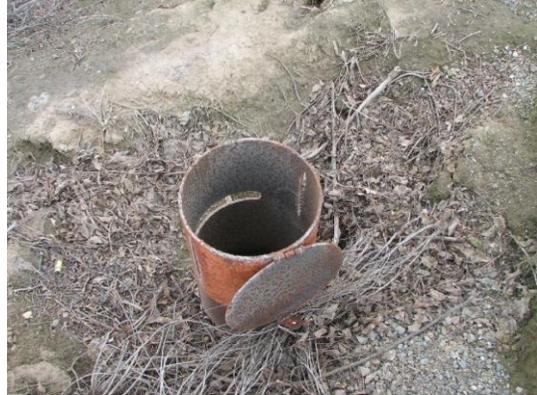
Photo 3 of 3 : UCIP_FA_2019_40659_72114.jpg

LM Start	3.63	Rating **	M	Issue No.	116 (cont)
LM End	3.63	Issue Type +	En	Location *	
Category	Supplemental			GPS Latitude/Longitude	
				Start	End
Item	DRAFT DWR UCIP Field Study			37.868657°	37.868657°
				-121.327383°	-121.327383°
DWR ID	26				
Comment Code					
Inspector Comment					
DS_ID:26 FS_ID:40659 EP_NO: 15109 Repair Type: Non-Urgent Crossing Status: Found UCIP Comments: Erosion around siphon breaker on landward side recommend investigating potential leak. FIELD_STRUCT_DESC: 12-inch steel drainage pipe through levee, 3 feet below levee crown. Siphon breaker on landside (LS) shoulder. Pump in irrigation ditch is located about 45 feet from LS toe. (12-inch pipe authorized under Permit No. 15109, 1990 - R. Muller) [Additional Reference(s): DWR Levee Logs, 1981, 2003] FS Date: 2/4/2010

Siphon breaker located on landward slope.

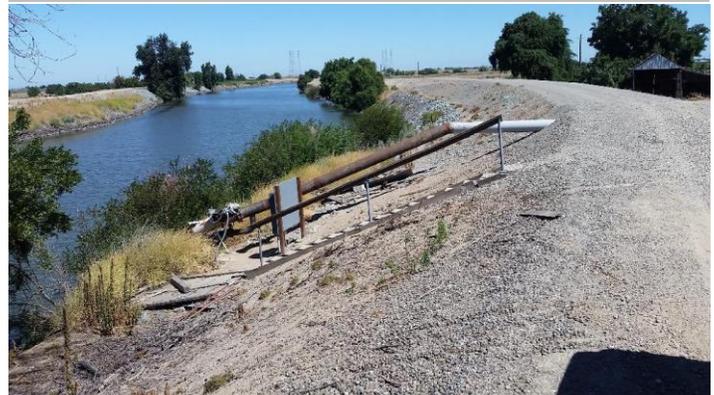
Photo 1 of 3 : UCIP_FA_2019_50005_75863.jpg

Comment Code					
Inspector Comment					
DS_ID:25465 FS_ID:50005 EP_NO: N/A Repair Type: Non-Urgent Crossing Status: Found UCIP Comments: 7/12/2016 Missing permit number and as-built drawings for this crossing. New pipe installed June 2016. According to Rick Toy, KSN-District Engineer, DCC Engineering is working with CVFPB to obtain permit for owner. Pipe replaces DS_ID 27--pipe removed May 2016. (DWR UCIP - omagana) FIELD_STRUCT_DESC: UNK-inch steel irrigation pipe through levee, X.XX feet below the crown. Slant pump is located on waterside (WS) slope, standpipe located 5 feet from LS toe. Concrete stairways with guardrail located on the WS. Two power poles (about 10 feet apart) located on landside (LS) toe. (Permit No. XXXXX, 2016 - XXXXXX) FS Date: 7/12/2016

View of WS, photo taken looking downstream.

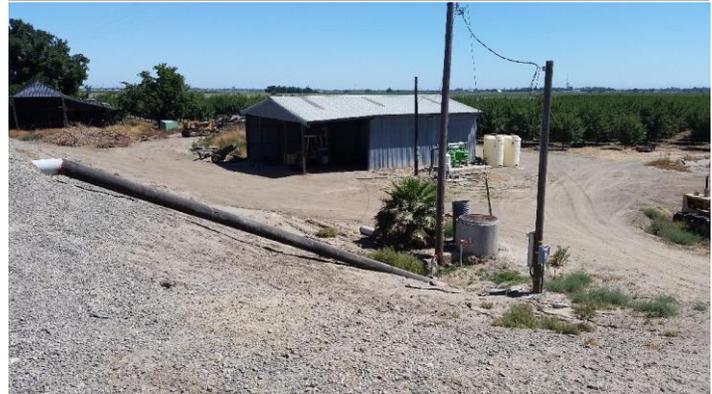
Photo 2 of 3 : UCIP_FA_2019_50005_75864.jpg

Comment Code					
Inspector Comment					
DS_ID:25465 FS_ID:50005 EP_NO: N/A Repair Type: Non-Urgent Crossing Status: Found UCIP Comments: 7/12/2016 Missing permit number and as-built drawings for this crossing. New pipe installed June 2016. According to Rick Toy, KSN-District Engineer, DCC Engineering is working with CVFPB to obtain permit for owner. Pipe replaces DS_ID 27--pipe removed May 2016. (DWR UCIP - omagana) FIELD_STRUCT_DESC: UNK-inch steel irrigation pipe through levee, X.XX feet below the crown. Slant pump is located on waterside (WS) slope, standpipe located 5 feet from LS toe. Concrete stairways with guardrail located on the WS. Two power poles (about 10 feet apart) located on landside (LS) toe. (Permit No. XXXXX, 2016 - XXXXXX) FS Date: 7/12/2016

View of LS, photo taken looking downstream.

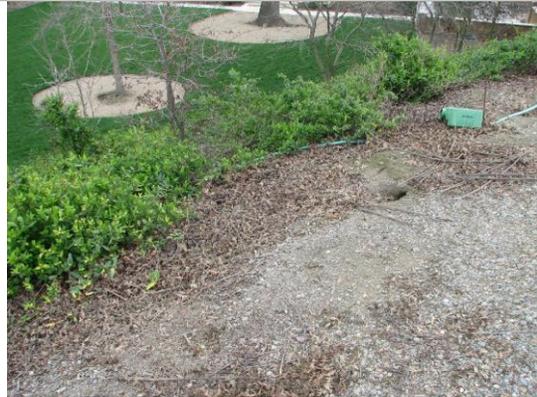
Photo 2 of 3 : UCIP_FA_2019_43264_72124.jpg

Comment Code					
Inspector Comment					
DS_ID:28 FS_ID:43264 EP_NO: 15111 Repair Type: Non-Urgent Crossing Status: Found UCIP Comments: 2/4/15--Olivia 2010 Records from KSN show this crossing was removed based on the RD17 As-Built Pipe Crossing Stating Reference, however when field verification was completed in this area a 2-inch pipe was found. This could be a different 2-inch pipe in nearby area. Need to coordinate with owner to determine permit issued for this crossing. 2/4/10 Pipe is not continuous. Need to coordinate with owner to determine status of crossing. If crossing is no longer in use owner will need to contact the CVFPB to comply with Title 23. FIELD_STRUCT_DESC: *REMOVED* 2-inch pipeline through levee, 3.92 feet (invert depth) below levee crown. Siphon breaker on landside (LS) shoulder. Pump on waterside (WS) slope. Pipe extends beyond 10 feet of the LS toe. (existing 2-inch removed under Permit No. 15111, 1990 - R. Jocopetti; 2-inch pipe was removed during the levee work approved under Permit No. 15014, 1989 - Reclamation District 17 [RD0017]) [Additional Reference(s): DWR Levee Logs, 1981, 2003] FS Date: 2/4/2010

View of landward side.

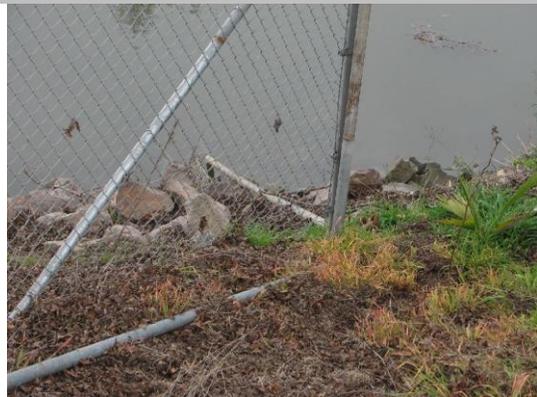
Photo 3 of 3 : UCIP_FA_2019_43264_72123.jpg

View of crossing on waterward side.

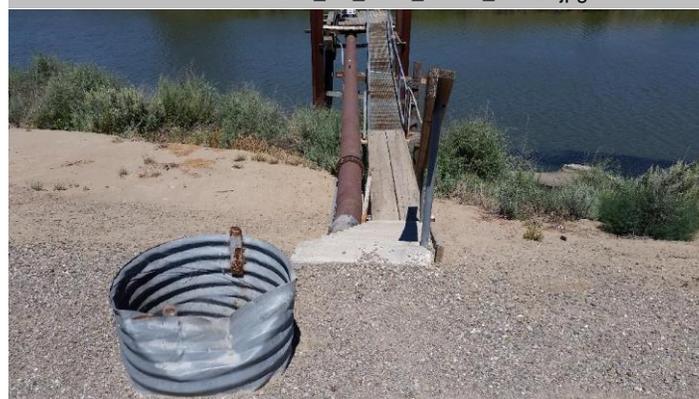
Photo 1 of 3 : UCIP_FA_2019_53539_75723.jpg

FIELD_STRUCT_DESC: 14-inch steel irrigation pipe through levee, 3.66-feet below the levee crown. Siphon breaker is located on the waterside (WS) shoulder. Also visible on the WS is the pump, the platform supported by steel piles in channel, a wooden walkway which extends from pump platform to WS slope, a concrete stairway which extends from walkway to WS shoulder. A double side approach ramp is located on the landside (LS) slope. (14-inch installed and existing 12-inch pipe removed under Permit No. 15116, 1990 - Rio Blanco Ranch, Inc.; 14-inch pipe was installed as part of the re-shaping of RD17 project levees in 1989. The re-shaping of the levees was to increase levee elevations and provide freeboard above 100-year stages in both the San Joaquin River and French Camp Slough; work was authorized and documented under Permit No. 15014, 1989 - Reclamation District [RD0017]) [Additional Reference(s): DWR Levee Log, 1981 and 2003]

View of WS.

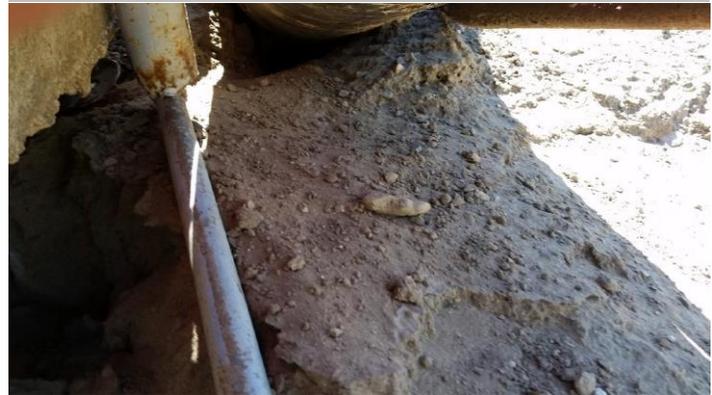
Photo 2 of 3 : UCIP_FA_2019_53539_75724.jpg

Internal erosion still visible on WS.

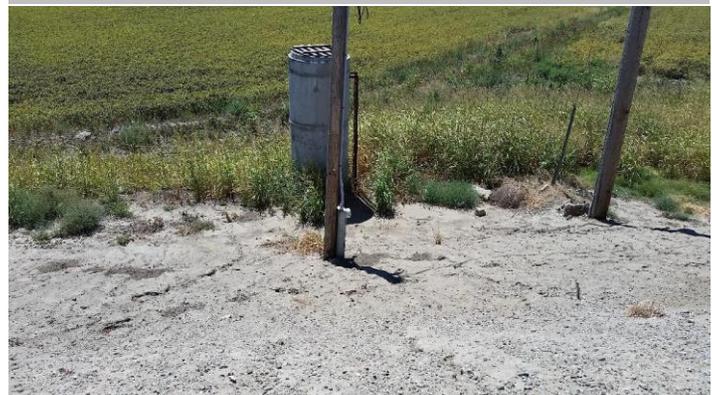
Photo 3 of 3 : UCIP_FA_2019_53539_75720.jpg

View of LS.

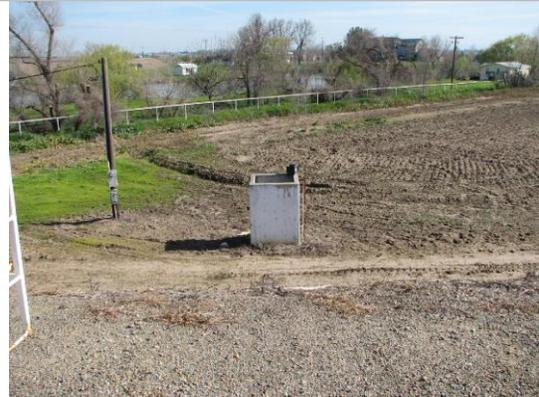
Photo 3 of 3 : UCIP_FA_2019_40669_72237.jpg

Comment Code					
Inspector Comment					
DS_ID:36 FS_ID:40669 EP_NO: 15119 Repair Type: Non-Urgent Crossing Status: Found UCIP Comments: Need to contact owner to determine status. FIELD_STRUCT_DESC: 16-inch steel irrigation pipe through levee, 1.33 feet below levee crown. Slant pump on riverbank, standpipe located 30 feet from the landside (LS) toe. Ramp on waterside (WS) slope. (16-inch pipe authorized under Permit No. 15119, 1990 - J. J. Lawrence, et al; 16-inch pipe was part of the levee work approved under Permit No. 15014, 1990 - Reclamation District 17 [RD0017]) [Additional Reference(s): DWR Levee Logs, 1981 and 2003] FS Date: 2/4/2010

Distribution box located on landward side.

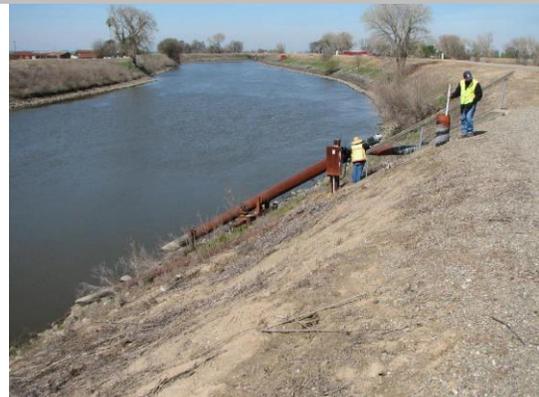
Photo 1 of 3 : UCIP_FA_2019_40672_72270.jpg

Comment Code					
Inspector Comment					
DS_ID:38 FS_ID:40672 EP_NO: 15121 Repair Type: Non-Urgent Crossing Status: Found UCIP Comments: Pipe section at waterward toe is missing wall. Need to coordinate with owner to determine integrity of pipe section through levee. This crossing is a good candidate for video inspection to determine internal condition of pipe. FIELD_STRUCT_DESC: 10-inch steel drainage through the levee, 4 feet below crown. (10-inch pipe authorized under Permit No. 15121, 1989 - R. Muller, additional work also includes removal of 12-inch and two 9-inch pipes at different locations and installation of a 12-inch pipe; 10-inch pipe was installed during the levee work approved under Permit No. 15014, 1989-Reclamation District [RD0017]) [Additional Reference(s): DWR Levee Logs, 1981 and 2003] FS Date: 2/4/2010

View of pipe section on waterward side.

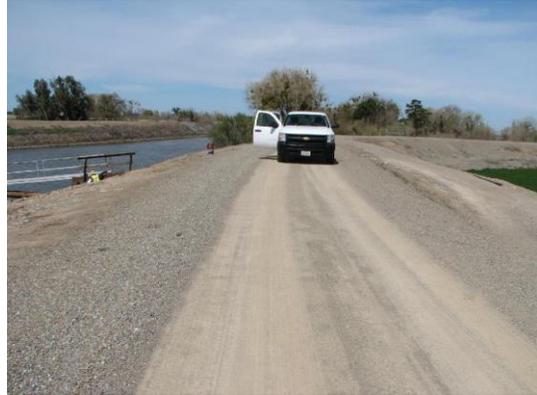
Photo 1 of 3 : UCIP_FA_2019_40677_72289.jpg

Comment Code					
Inspector Comment					
DS_ID:40 FS_ID:40677 EP_NO: 15123 Repair Type: Non-Urgent Crossing Status: Found UCIP Comments: Landowner mentioned power line was stolen crossing was non-functional during inspection. Potential erosion underneath walkway--need to confirm lose soil. Need to contact owner to determine status of crossing. If crossing is no longer used need to coordinate with CVFPB for proper abandonment. FIELD_STRUCT_DESC: 16-inch steel irrigation pipe through levee, 2.70 feet below the levee crown. Siphon breaker on waterside (WS) shoulder. Ramp on platform in channel, walkway from pump platform to WS slope, standpipe located at landside (LS) berm toe. (16-inch pipe installed and authorized under Permit No. 15123-1989, also includes removal of two existing pipes, 8-inch and 10-inch) [Additional Reference(s): DWR Levee Logs, 1981 and 2003] FS Date: 2/4/2010

View of levee crown at crossing.

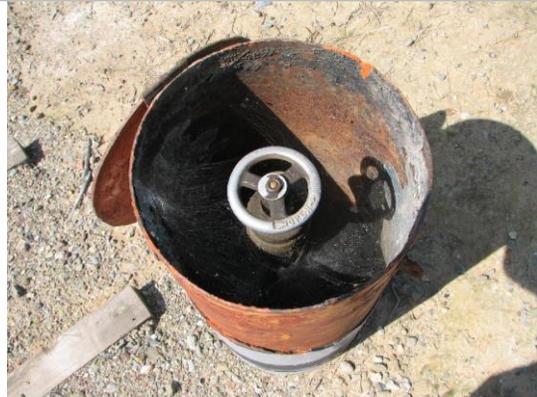
Photo 2 of 3 : UCIP_FA_2019_40677_72294.jpg

Siphon breaker located on waterward side.

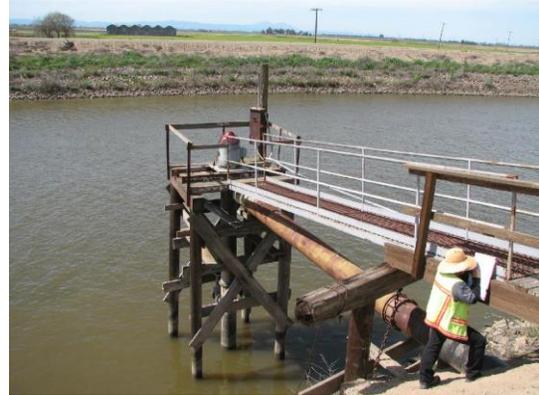
Photo 3 of 3 : UCIP_FA_2019_40677_72292.jpg

Comment Code					
Inspector Comment					
DS_ID:40 FS_ID:40677 EP_NO: 15123 Repair Type: Non-Urgent Crossing Status: Found UCIP Comments: Landowner mentioned power line was stolen crossing was non-functional during inspection. Potential erosion underneath walkway--need to confirm lose soil. Need to contact owner to determine status of crossing. If crossing is no longer used need to coordinate with CVFPB for proper abandonment. FIELD_STRUCT_DESC: 16-inch steel irrigation pipe through levee, 2.70 feet below the levee crown. Siphon breaker on waterside (WS) shoulder. Ramp on platform in channel, walkway from pump platform to WS slope, standpipe located at landside (LS) berm toe. (16-inch pipe installed and authorized under Permit No. 15123-1989, also includes removal of two existing pipes, 8-inch and 10-inch) [Additional Reference(s): DWR Levee Logs, 1981 and 2003] FS Date: 2/4/2010

View of waterward side.

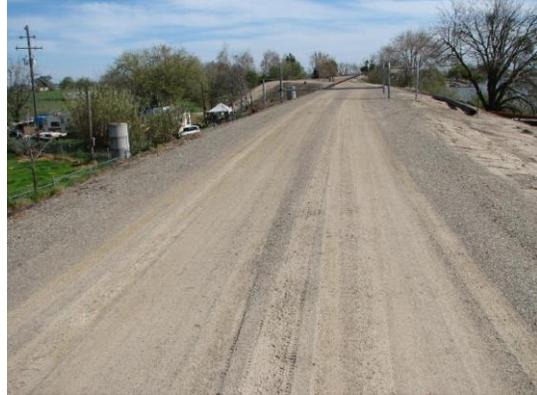
Photo 1 of 3 : UCIP_FA_2019_40679_72307.jpg

Comment Code					
Inspector Comment					
DS_ID:42 FS_ID:40679 EP_NO: 15077 Repair Type: Non-Urgent Crossing Status: Found UCIP Comments: Surface erosion on waterward slope. Abandoned pipe section left on waterward slope. Need to contact owner to obtain additional information about crossing. FIELD_STRUCT_DESC: 12-inch steel irrigation pipe through levee. Invert of pipe 3.67 feet below levee crown. Siphon breaker on landside (LS) shoulder. Pump on platform in channel, walkway from pump platform to waterside (WS) shoulder. Standpipe located 15 feet from the LS toe. (12-inch pipe authorized under Permit No. 15077, 1989 - J. P. Leal, existing 12-inch pipe removed) [Additional Reference(s): DWR Levee Logs, 1981 and 2003, 12-inch pipe] FS Date: 2/4/2010

Overview of levee crown at crossing.

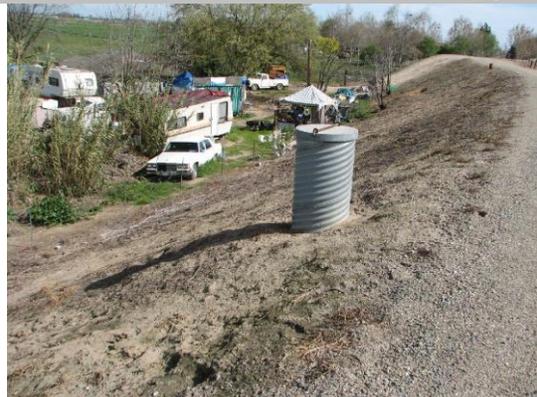
Photo 2 of 3 : UCIP_FA_2019_40679_72306.jpg

CMP riser located on landward slope.

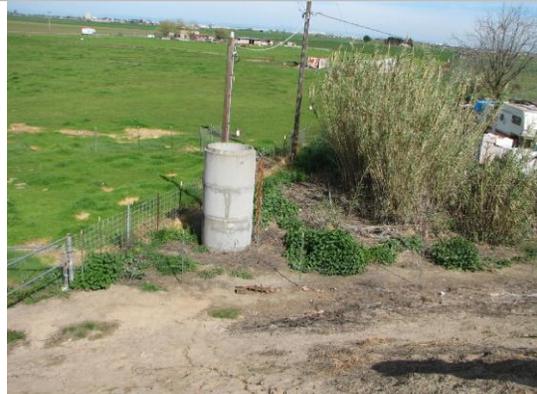
Photo 3 of 3 : UCIP_FA_2019_40679_72305.jpg

Comment Code					
Inspector Comment					
DS_ID:42 FS_ID:40679 EP_NO: 15077 Repair Type: Non-Urgent Crossing Status: Found UCIP Comments: Surface erosion on waterward slope. Abandoned pipe section left on waterward slope. Need to contact owner to obtain additional information about crossing. FIELD_STRUCT_DESC: 12-inch steel irrigation pipe through levee. Invert of pipe 3.67 feet below levee crown. Siphon breaker on landside (LS) shoulder. Pump on platform in channel, walkway from pump platform to waterside (WS) shoulder. Standpipe located 15 feet from the LS toe. (12-inch pipe authorized under Permit No. 15077, 1989 - J. P. Leal, existing 12-inch pipe removed) [Additional Reference(s): DWR Levee Logs, 1981 and 2003, 12-inch pipe] FS Date: 2/4/2010

Standpipe visible on landward toe.

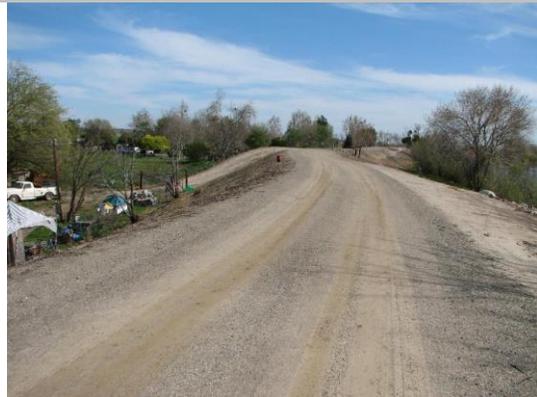
Photo 1 of 3 : UCIP_FA_2019_40680_72314.jpg

Comment Code					
Inspector Comment					
DS_ID:43 FS_ID:40680 EP_NO: 15078 Repair Type: Non-Urgent Crossing Status: Found UCIP Comments: Crossing is non-functional recommend contacting owner to determine status of crossing. If crossing is no longer used need to coordinate with CVFPB for proper abandonment. FIELD_STRUCT_DESC: 4-inch irrigation pipe of unknown material through levee, 2.89 feet below levee crown. Siphon breaker on landside (LS) shoulder. Pump on waterside (WS) berm. (4-inch pipe authorized under Permit No. 15078, 1989 - S. and F. Aurelio, existing 4-inch pipe removed) [Additional Reference(s): DWR Levee Logs, 1981 and 2003] FS Date: 2/4/2010

Overview of levee crown at crossing.

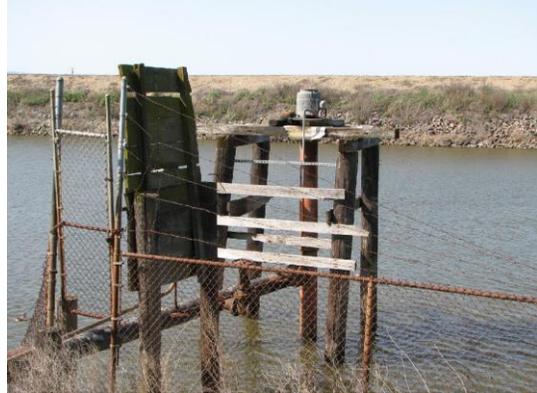
Photo 3 of 3 : UCIP_FA_2019_40681_72330.jpg

Comment Code					
Inspector Comment					
DS_ID:44 FS_ID:40681 EP_NO: 15079 Repair Type: Non-Urgent Crossing Status: Found UCIP Comments: If crossing is no longer in use owner will need to coordinate with DWR inspector and CVFPB to remove according to Title 23 requirements. Unable to determine if crossing is in use. FIELD_STRUCT_DESC: 14-inch steel irrigation pipe through levee, 1.17 feet below levee crown. Siphon breaker on waterside (WS) shoulder. Pump on platform in channel, walkway from pump platform to the top of the riverbank, standpipe located 12 feet from landside (LS) toe. (14-inch pipe installed under Permit No. 15079-1990 - San Joaquin County Parks and Joe P. Aven, authorized work also include installation of 10-inch pipe in general area and the removal of two existing pipes, 10-inch pipe and 6-inch pipe) [Additional Reference(s): DWR Levee Logs, 1981 and 2003] FS Date: 2/4/2010

Pump station fenced off on waterward side.

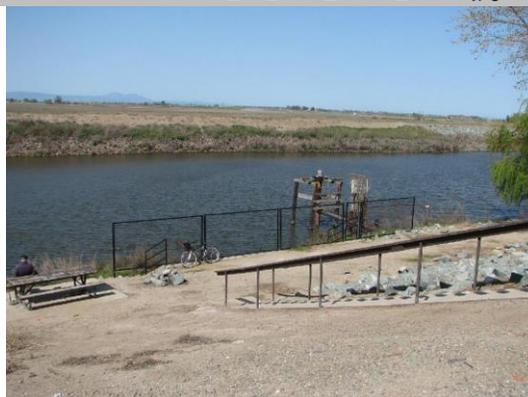
Photo 3 of 3 : UCIP_FA_2019_40682_72320.jpg

Comment Code					
Inspector Comment					
DS_ID:99 FS_ID:40682 EP_NO: 17643 Repair Type: Non-Urgent Crossing Status: Found UCIP Comments: Need to coordinate with owner to determine when the other 3 crossings will become online. FIELD_STRUCT_DESC: [Stonebridge Pump Station/Dos Reis Road Outfall Structure] 30-inch and 36-inch combination cement motar lined and coated steel drainage pipe through the levee, 2-feet below the levee crown. Concrete headwall on waterside (WS) toe and a 36-inch tidal flex valve on outlet of pipe. 36-inch pipe section starts at WS headwall and is reduced with a 30-inch pipe on WS. The 30-inch pipe continues through from WS to LS levee. Structure was designed for 5 crossings however only 1 crossing is active (30-inch pipe and 36-inch combination pipe through the levee authorized under Permit No. 17643, 2005 - City of Lathrop, structure can accommodate five 36-inch pipes discharge pipes - only one 36-inch pipe active). FS Date: 2/4/2010

View of waterward side.

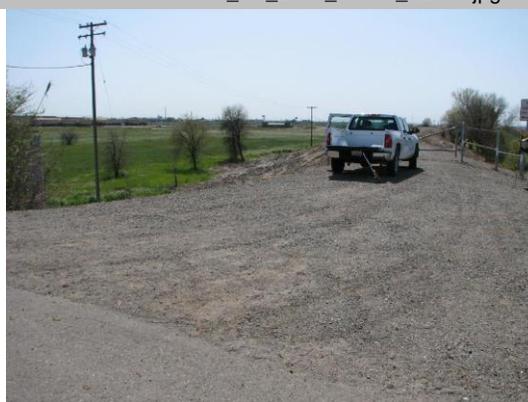
Photo 1 of 3 : UCIP_FA_2019_40683_72333.jpg

LM Start	7.45	Rating **	M	Issue No.	130
LM End	7.45	Issue Type +	En	Location *	
Category	Supplemental			GPS Latitude/Longitude	
				Start	End
Item	DRAFT DWR UCIP Field Study			37.829922°	37.829922°
				-121.310865°	-121.310865°
DWR ID	284				
Comment Code					
Inspector Comment					
DS_ID:284 FS_ID:40683 EP_NO: 15079 Repair Type: Non-Urgent Crossing Status: Found UCIP Comments: Potential leak at standpipe--unable to confirm if crossing is operable. If crossing is no longer in use owner will need to coordinate with DWR inspector and CVFPB to remove according to Title 23 requirements. Unable to determine if crossing is in use. FIELD_STRUCT_DESC: 2 of 2. 10 inch pipe also referenced as 478+22, old 6 inch pipe was removed per encroachment recordation. FS Date: 2/4/2010

Overview of levee crown at crossing.

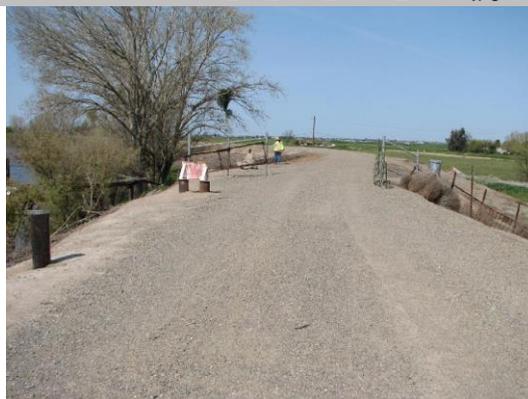
Photo 1 of 3 : UCIP_FA_2019_40685_72351.jpg

LM Start	7.71	Rating **	M	Issue No.	132
LM End	7.71	Issue Type +	En	Location *	
Category	Supplemental			GPS Latitude/Longitude	
				Start	End
Item	DRAFT DWR UCIP Field Study			37.826333°	37.826333°
				-121.309495°	-121.309495°
DWR ID	98				
Comment Code					
Inspector Comment					
DS_ID:98 FS_ID:40685 EP_NO: 15081 Repair Type: Non-Urgent Crossing Status: Found UCIP Comments: Erosion present on waterward toe underneath piles. Need to coordinate with owner to address issue on waterward side and to determine status of crossing. FIELD_STRUCT_DESC: 16-inch asphalt coated and wrapped steel irrigation pipe through the levee, 2.6-feet below the crown. Siphon breaker located on landside (LS). Stand pipe located at LS toe. Pump on Platform at waterside (WS) toe. (16-inch pipe installed under Permit No. 15081, 1989 - I. N. Robinson, Jr., existing 14-inch pipe removed) FS Date: 2/4/2010

Overview of levee crown at pipe crossing.

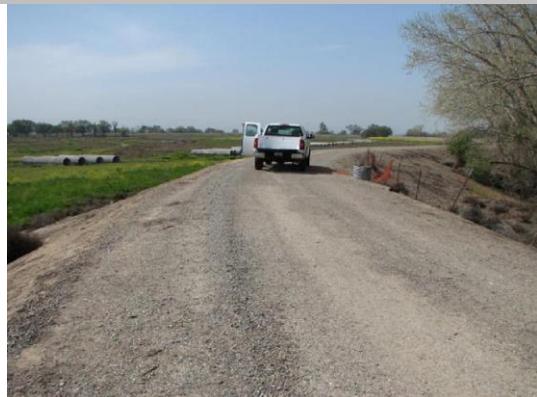
Photo 1 of 3 : UCIP_FA_2019_40689_72367.jpg

LM Start	7.89	Rating **	M	Issue No.	136
LM End	7.89	Issue Type +	En	Location *	
Category	Supplemental			GPS Latitude/Longitude	
				Start	End
Item	DRAFT DWR UCIP Field Study			37.823987 °	37.823987 °
				-121.309841 °	-121.309841 °
DWR ID	805				
Comment Code					
Inspector Comment					
<p>DS_ID:805 FS_ID:40689 EP_NO: N/A Repair Type: Non-Urgent Crossing Status: Indicator Found UCIP Comments: Only siphon breakers were found on landward shoulder no other appurtenances were found. If crossing is no longer in use owner will need to coordinate with DWR inspector and CVFPB to remove according to Title 23 requirements. Unable to determine if crossing is in use. FIELD_STRUCT_DESC: Siphon breaker located on landward shoulder. FS Date: 2/4/2010</p>

View of levee crown at crossing.

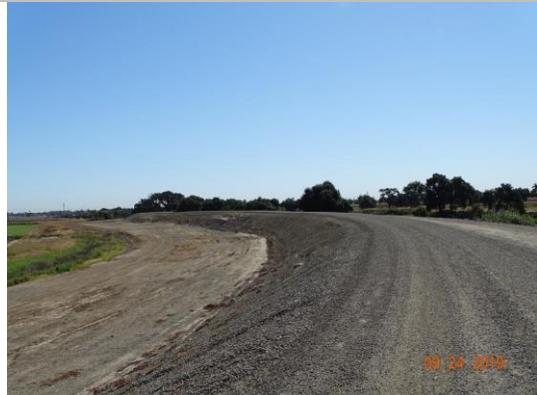
Photo 1 of 1 : FA_2019_RD0017_304_68_20191001_00196.jpg

LM Start	8.66	Rating **	A	Issue No.	68
LM End	8.66	Issue Type +	Ma	Location *	LS
Category	Earthen Levee		GPS Latitude/Longitude		
			Start	End	
Item	Vegetation		37.819715 °	37.819715 °	
			-121.319447 °	-121.319447 °	
DWR ID	DWR_RD0017_02_f_2019_68				
Comment Code					
V1 : Control annual grass and weeds on the levee slopes and easements.					
Inspector Comment					
Landside vegetation is well maintained.

Typical view of landside slope. Fall 2019

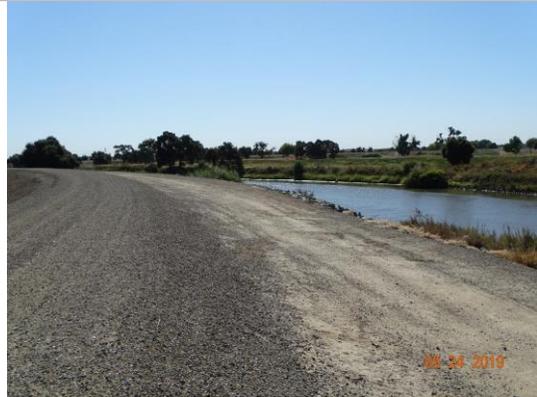
Photo 1 of 1 : FA_2019_RD0017_304_69_20191001_00197.jpg

LM Start	8.66	Rating **	A	Issue No.	69
LM End	8.66	Issue Type +	Ma	Location *	WS
Category	Earthen Levee		GPS Latitude/Longitude		
			Start	End	
Item	Vegetation		37.819715°	37.819715°	
			-121.319447°	-121.319447°	
DWR ID	DWR_RD0017_02_f_2019_69				
Comment Code					
V1 : Control annual grass and weeds on the levee slopes and easements.					
Inspector Comment					
Waterside vegetation is well maintained.

Typical view of waterside slope. Fall 2019

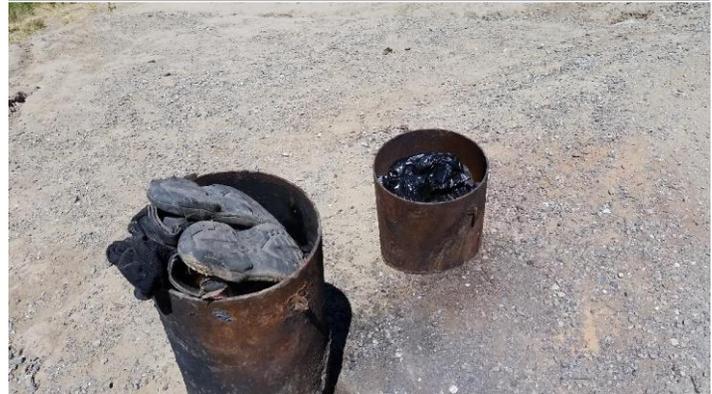
Photo 3 of 3 : UCIP_FA_2019_53331_75738.jpg

Comment Code					
Inspector Comment					
<p>DS_ID:285 FS_ID:53331 EP_NO: 15083 Repair Type: Urgent Crossing Status: Found UCIP Comments: 9/5/2018 Same as last inspection; WS pipe section completely corroded at section end. Crossing remains Urgent (D. Sanoski - DWR UCIP).7/12/2016 Same as last inspection--WS pipe section deteriorated. Per Rick Toy, KSN-District Engineer, this crossing is currently owned by the City of Lathrop. Need to coordinate with the City of Lathrop to submit name change to the CVFPB and for the City to provide future use for this crossing. Recommend internal integrity inspection of section of the pipe through the levee. (DWR UCIP - omagana)5/21/2015 Pipe is still in same condition. Need to contact KSN, LMA engineering firm, to determine update on crossing. (DWR UCIP - omagana)2/04/2010 Pipe wall has corroded through--wall missing from pipe section located on waterward side. Recommend investigating the pipe integrity through levee section. Damage to pipe has eroded the levee slope on waterward side. Recommend LMA superintendent contact owner to stop using crossing and coordinate with CVFPB to address pipe leak. Owner will need to coordinate with DWR inspector and CVFPB. (DWR UCIP - omagana) FIELD_STRUCT_DESC: 12-inch steel irrigation pipe through levee, 2.69 feet below crown. Siphon breaker is located on the waterside (WS) shoulder. Pump is located in the irrigation ditch approximately 50 feet from landside (LS) toe. (12-inch pipe authorized under Permit No. 15083, 1989 - I. N. Robinson, Jr.; 12-inch pipe was installed as part of the re-shaping of RD17 project levees in 1989. The re-shaping of the levees was to increase levee elevations and provide freeboard above 100-year stages in both the San Joaquin River and French Camp Slough; work was authorized and documented under Permit No. 15014, 1989 - Reclamation District 17 [RD0017]) [Additional Reference(s): DWR Levee Log, 1981 and 2003] FS Date: 9/5/2018 10:25:00 AM</p>

WS shoulder--protective housing units for siphon breakers.

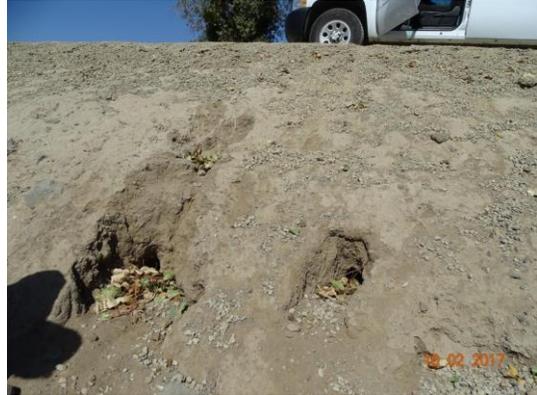
Photo 1 of 1 : FA_2019_RD0017_304_85_20190830_00012.jpg

LM Start	9.24	Rating **	M	Issue No.	85
LM End	9.24	Issue Type +	Ma	Location *	LS
Category	Earthen Levee			GPS Latitude/Longitude	
				Start	End
Item	Animal Control			37.815269 °	37.815269 °
				-121.316805 °	-121.316805 °
DWR ID	DWR_RD0017_02_f_2017_85				
Comment Code					
A3 : No rodents visible, but rodent burrows visible; need to backfill and compact or grout burrows.					
Inspector Comment

Looking north at landside slope.

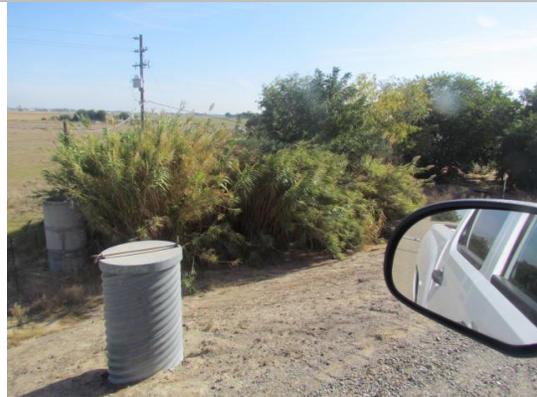
Photo 1 of 1 : FA_2019_RD0017_304_9_20190830_00005.jpg

LM Start	9.29	Rating **	M	Issue No.	9
LM End	9.29	Issue Type +	Ma	Location *	LS
Category	Earthen Levee			GPS Latitude/Longitude	
				Start	End
Item	Vegetation			37.815270 °	37.815270 °
				-121.317692 °	-121.317692 °
DWR ID	DWR_RD0017_02_s_2012_9				
Comment Code					
V4 : Elderberries are blocking visibility and flood fight capability.					
Inspector Comment					
Bamboo & elderberries at landside toe.

Looking east at bamboo and elderberries at landward toe.

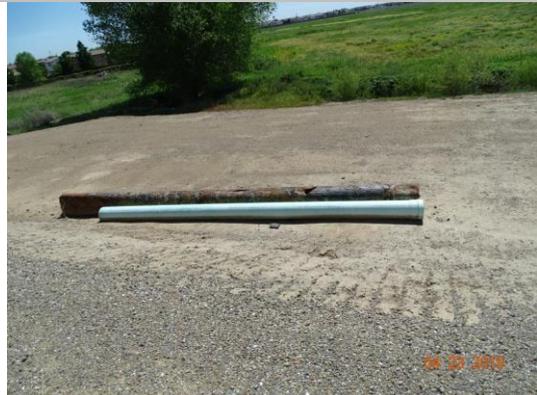
Photo 1 of 1 : FA_2019_RD0017_304_96_20190830_00013.jpg

LM Start	9.67	Rating **	M	Issue No.	96
LM End	9.67	Issue Type +	En	Location *	LS
Category	Earthen Levee			GPS Latitude/Longitude	
				Start	End
Item	Encroachments			37.812380 °	37.812380 °
				-121.316942 °	-121.316942 °
DWR ID	DWR_RD0017_02_s_2019_96				
Comment Code					
DE : Debris					
Inspector Comment					
Farmer is storing drain pipes on landside toe and easement.

View of pipes on landside toe. (Spring 2019)

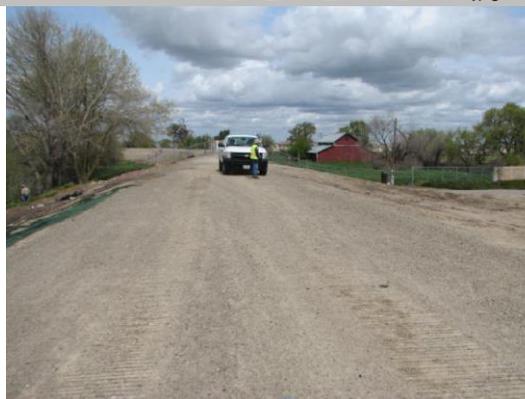
Photo 1 of 3 : UCIP_FA_2019_40695_72420.jpg

Comment Code					
Inspector Comment					
DS_ID:51 FS_ID:40695 EP_NO: 15055 Repair Type: Non-Urgent Crossing Status: Found UCIP Comments: Pipe is not connected on waterward side. Crossing is non-functional recommend contacting owner to determine status of crossing. If crossing is no longer used need to coordinate with CVFPB for proper abandonment. FIELD_STRUCT_DESC: 16-inch steel irrigation pipe through levee, 2.77 feet below levee crown. Siphon breaker on landside (LS) shoulder. Slant pump on waterside (WS) slope, standpipe located 11 feet from the LS toe. (16-inch pipe authorized under Permit No. 15055, 1989 - F. G. and B. J. Terry, existing 14-inch pipe removed) [Additional Reference(s): DWR Levee Logs, 1981 and 2003] FS Date: 2/4/2010

Overview of levee crown at crossing.

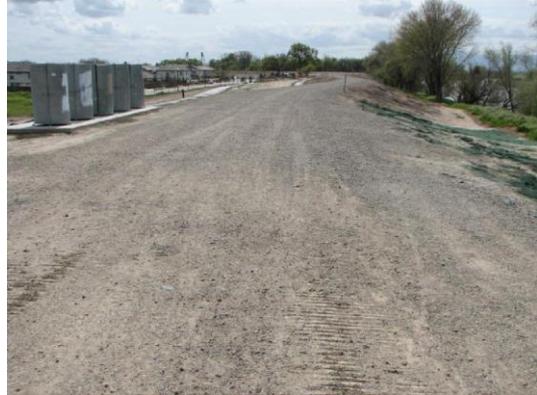
Photo 1 of 3 : UCIP_FA_2019_40696_72440.jpg

Comment Code					
Inspector Comment					
DS_ID:103 FS_ID:40696 EP_NO: 17792 Repair Type: Non-Urgent Crossing Status: Found UCIP Comments: Surface erosion on waterward slope--Need to contact owner. FIELD_STRUCT_DESC: [Mossdale Outfall] 1 of 6. 30-inch steel drainage pipe through levee at unknown depth. Structure is part of Lathrop City Stormwater Pump Station 112. Station consists 6 drainage pipes, pump station, air release valves, and concrete headwall. Air release valves located inside risers are located on landside (LS) shoulder on top of concrete pad. Concrete headwall and gates located on waterside (WS). (six 30-inch pipes authorized under Permit No. 17792, 2005 - City of Lathrop) FS Date: 2/4/2010

Overview of levee crown at crossing.

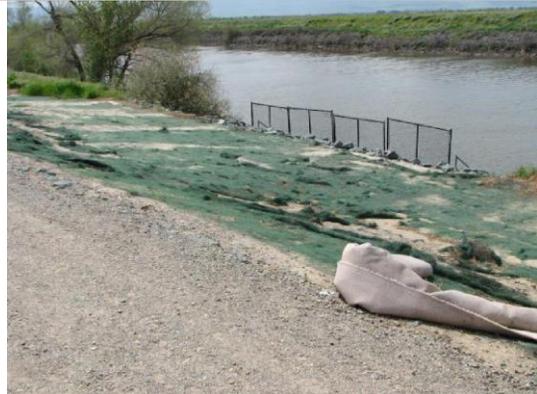
Photo 2 of 3 : UCIP_FA_2019_40696_72448.jpg

View of waterward side geotech fabric damage along slope.

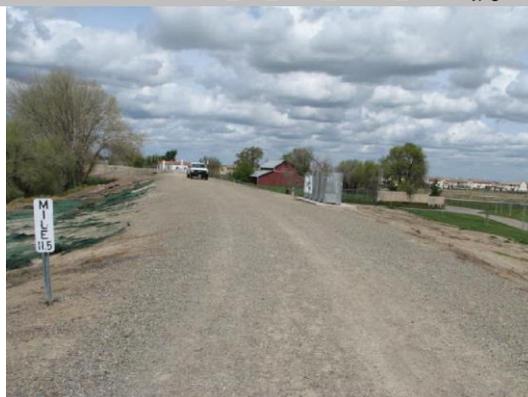
Photo 1 of 3 : UCIP_FA_2019_40700_72462.jpg

Comment Code					
Inspector Comment					
DS_ID:476 FS_ID:40700 EP_NO: 17792 Repair Type: Non-Urgent Crossing Status: Found UCIP Comments: Surface erosion on waterward slope--need to contact owner. FIELD_STRUCT_DESC: [Mossdale Outfall] 5 of 6. 30-inch steel drainage pipe through levee at unknown depth. Structure is part of Lathrop City Stormwater Pump Station 112. Station consists 6 drainage pipes, pump station, air release valves, and concrete headwall. Air release valves located inside risers are located on landside (LS) shoulder on top of concrete pad. Concrete headwall and gates located on waterside (WS). (six 30-inch pipes authorized under Permit No. 17792, 2005 - City of Lathrop) FS Date: 2/4/2010

Overview of levee crown at crossings.

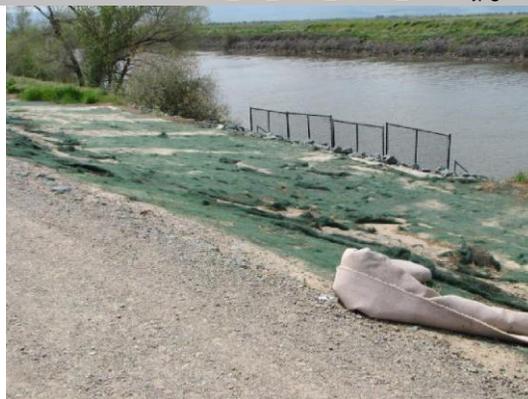
Photo 2 of 3 : UCIP_FA_2019_40700_72467.jpg

View of waterward side.

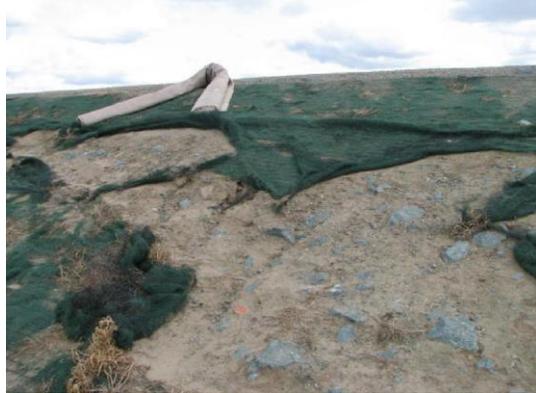
Photo 3 of 3 : UCIP_FA_2019_40700_72465.jpg

Comment Code					
Inspector Comment					
DS_ID:476 FS_ID:40700 EP_NO: 17792 Repair Type: Non-Urgent Crossing Status: Found UCIP Comments: Surface erosion on waterward slope--need to contact owner. FIELD_STRUCT_DESC: [Mossdale Outfall] 5 of 6. 30-inch steel drainage pipe through levee at unknown depth. Structure is part of Lathrop City Stormwater Pump Station 112. Station consists 6 drainage pipes, pump station, air release valves, and concrete headwall. Air release valves located inside risers are located on landside (LS) shoulder on top of concrete pad. Concrete headwall and gates located on waterside (WS). (six 30-inch pipes authorized under Permit No. 17792, 2005 - City of Lathrop) FS Date: 2/4/2010

Surface erosion on waterward side.

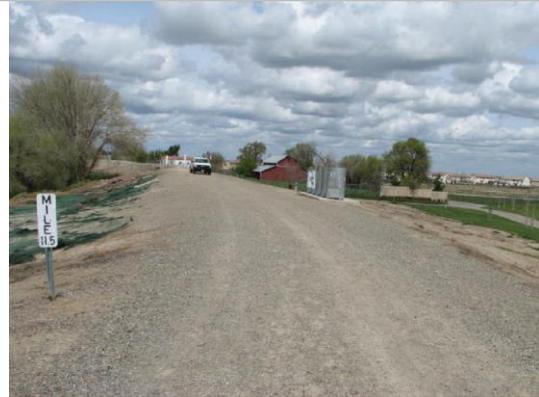
Photo 1 of 3 : UCIP_FA_2019_40701_72470.jpg

Comment Code					
Inspector Comment					
DS_ID:477 FS_ID:40701 EP_NO: 17792 Repair Type: Non-Urgent Crossing Status: Found UCIP Comments: Surface erosion on waterward slope--need to contact owner. FIELD_STRUCT_DESC: [Mossdale Outfall] 6 of 6. 30-inch steel drainage pipe through levee at unknown depth. Structure is part of Lathrop City Stormwater Pump Station 112. Station consists 6 drainage pipes, pump station, air release valves, and concrete headwall. Air release valves located inside risers are located on landside (LS) shoulder on top of concrete pad. Concrete headwall and gates located on waterside (WS). (six 30-inch pipes authorized under Permit No. 17792, 2005 - City of Lathrop) FS Date: 2/4/2010

Overview of levee crown at crossings.

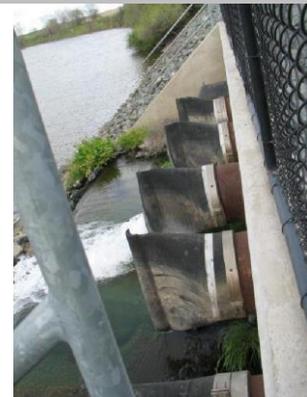
Photo 2 of 3 : UCIP_FA_2019_40701_72469.jpg

Outlet concrete headwall and gates on waterward toe.

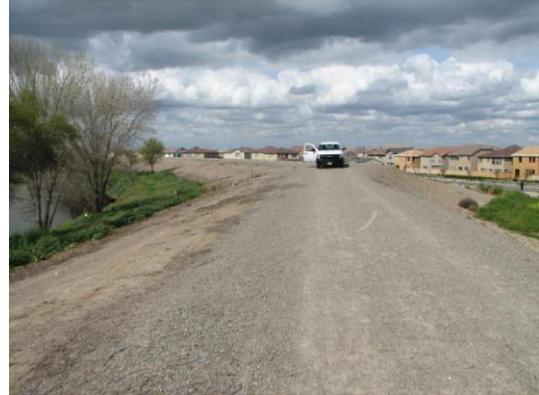
Photo 1 of 3 : UCIP_FA_2019_40702_72481.jpg

Comment Code					
Inspector Comment					
DS_ID:806 FS_ID:40702 EP_NO: N/A Repair Type: Non-Urgent Crossing Status: Found UCIP Comments: No pipe found during site visit only air valve and power meter. Dense vegetation along waterward slope recommend clearing vegetation from slope to conduct proper pipe inspection. If crossing is no longer in use owner will need to coordinate with DWR inspector and CVFPB to remove according to Title 23 requirements. FIELD_STRUCT_DESC: *REMOVED* 20-inch steel drainage pipe through the levee 5-feet below the crown. Siphon breaker in steel riser on waterside (WS) shoulder and a flap gate on the WS toe. (20-inch pipe authorized under Permit No. 3799, 1961 - Libbey-Owens-Ford Glass Company; 24-inch pipe removed under Permit No. 15318, 1989 - Libby-Owens-Ford Glass Co. & Reclamation District 17 [RD0017], 20-inch pipe installed) [Additional Reference(s): DWR Levee Logs, 1981, 2003, 20-inch. USACE San Joaquin O&M Manual Unit No. 2, May 1963, (HLM 12.16), 20-inch pipe] FS Date: 2/4/2010

Overview of levee crown at crossing.

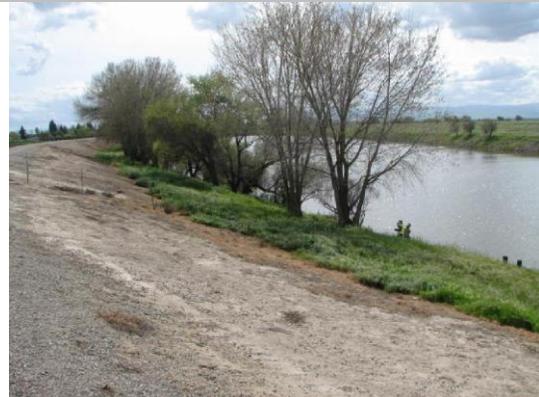
Photo 2 of 3 : UCIP_FA_2019_40702_72480.jpg

View of waterward side.

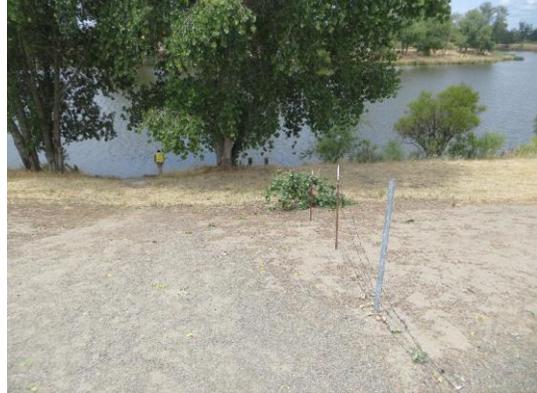
Photo 3 of 3 : UCIP_FA_2019_45464_74123.jpg

Comment Code					
Inspector Comment					
DS_ID:56 FS_ID:45464 EP_NO: 15318 Repair Type: Non-Urgent Crossing Status: Indicator Found UCIP Comments: Crossings appears to be abandoned. Need to contact owner to determine status of crossing. If abandoned, it should be done so properly. FIELD_STRUCT_DESC: 20-inch steel drainage pipe through levee, 3.4-feet below levee crown. Air vent in 12-inch steel riser found on the landside (LS) shoulder. Electric service riser on waterside (WS) berm has been removed. (20-inch pipe authorized under Permit No. 15318, 1989 - Libby-Owens-Ford Glass Co. & Reclamation District 17 [RD0017], 24-inch pipe removed) [Additional Reference(s): DWR Levee Logs, 1981 and 2003] FS Date: 5/21/2015

View of WS at crossing.

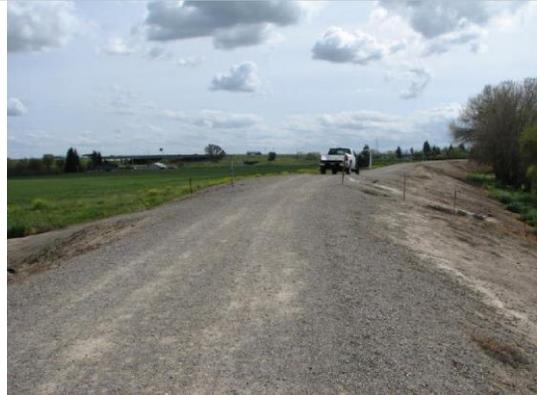
Photo 1 of 3 : UCIP_FA_2019_40703_72487.jpg

Comment Code					
Inspector Comment					
DS_ID:799 FS_ID:40703 EP_NO: N/A Repair Type: Non-Urgent Crossing Status: Found UCIP Comments: Need to contact owner to determine status of crossing and obtain additional information about crossing (permit and install date). FIELD_STRUCT_DESC: 48-inch steel drainage pipe through the levee, 2.5-feet below the crown. Siphon breaker on landside (LS) shoulder. Concrete "U" shaped headwall on waterside (WS) toe with flap gate. 8-4 inch steel coated scheduled 40 pipes located on WS shoulder about 6 inch cover. (48-inch pipe and 12-inch pipe authorized under Permit No. 15845, 1993 - City of Lathrop and Kearny Ventures) FS Date: 2/4/2010

Overview of levee crown at crossings.

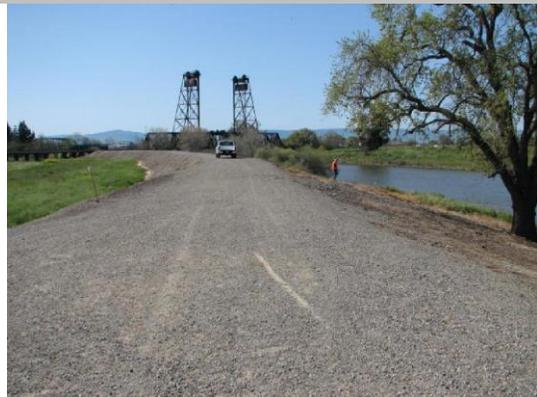
Photo 1 of 3 : UCIP_FA_2019_40706_72509.jpg

Comment Code					
Inspector Comment					
DS_ID:807 FS_ID:40706 EP_NO: N/A Repair Type: Non-Urgent Crossing Status: Found UCIP Comments: Pipe disconnected on waterward side. Need to contact owner to determine status of crossing. If crossing is no longer in use owner will need to coordinate with DWR inspector and CVFPB to remove according to Title 23 requirements. FIELD_STRUCT_DESC: 8-inch irrigation pipe of unknown material through levee, 3.2-feet below the crown. Pump on waterside (WS) toe and a siphon breaker on the landside (LS) shoulder. (6-inch pipe authorized under Permit No. 15049, 1989 - T. and I. Queirolo, existing 6-inch pipe removed) [Additional Reference(s): DWR Levee Logs, 1981 and 2003] FS Date: 2/4/2010

Overview of levee crown at crossing.
