**Flood Control Project Maintenance
Levee Inspections**

Fall 2019 Levee Maintenance Deficiency Summary Report

San Joaquin River Basin

Reclamation District No. 0017 Mossdale

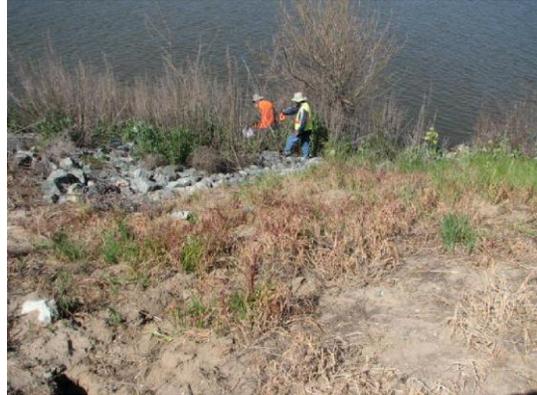
Photo 2 of 3 : UCIP_FA_2019_40706_72511.jpg

Comment Code					
Inspector Comment					
DS_ID:807 FS_ID:40706 EP_NO: N/A Repair Type: Non-Urgent Crossing Status: Found UCIP Comments: Pipe disconnected on waterward side. Need to contact owner to determine status of crossing. If crossing is no longer in use owner will need to coordinate with DWR inspector and CVFPB to remove according to Title 23 requirements. FIELD_STRUCT_DESC: 8-inch irrigation pipe of unknown material through levee, 3.2-feet below the crown. Pump on waterside (WS) toe and a siphon breaker on the landside (LS) shoulder. (6-inch pipe authorized under Permit No. 15049, 1989 - T. and I. Queirolo, existing 6-inch pipe removed) [Additional Reference(s): DWR Levee Logs, 1981 and 2003] FS Date: 2/4/2010

View of waterward toe--rip rap along pipe alignment.

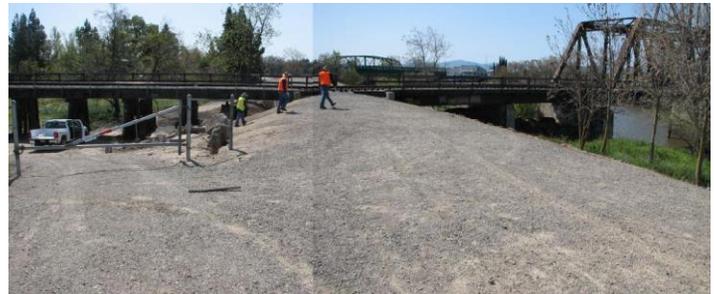
Photo 1 of 3 : UCIP_FA_2019_40707_72515.jpg

LM Start	12.55	Rating **	M	Issue No.	153
LM End	12.55	Issue Type +	En	Location *	
Category	Supplemental			GPS Latitude/Longitude	
				Start	End
Item	DRAFT DWR UCIP Field Study			37.787929°	37.787929°
				-121.307173°	-121.307173°
DWR ID	60				
Comment Code					
Inspector Comment					
DS_ID:60 FS_ID:40707 EP_NO: 14326 Repair Type: Non-Urgent Crossing Status: Indicator Found UCIP Comments: Wires exposed near levee crown unable to determine if these wires are part of the crossing. Need to contact owner to determine status of crossing. FIELD_STRUCT_DESC: 4-inch galvanized iron communication cable through levee. Invert of conduit is 3.0 feet below levee crown. (4-inch fiber optic cable authorized under Permit No. 14326, 1986 - GTE Sprint Communications Corp.) [Additional Reference(s): DWR Levee Logs, 1981 and 2003] FS Date: 2/4/2010

Overview of levee crown at crossing.

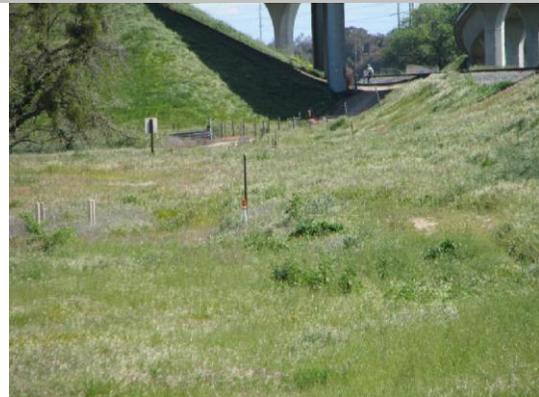
Photo 2 of 3 : UCIP_FA_2019_40707_72514.jpg

Crossing alignment along landward side.

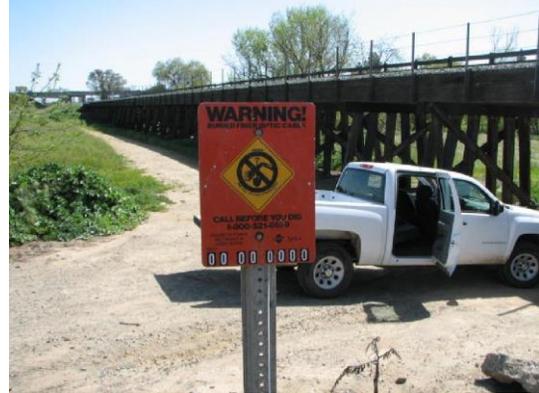
Photo 3 of 3 : UCIP_FA_2019_40707_72513.jpg

LM Start	12.55	Rating **	M	Issue No.	153 (cont)
LM End	12.55	Issue Type +	En	Location *	
Category	Supplemental			GPS Latitude/Longitude	
				Start	End
Item	DRAFT DWR UCIP Field Study			37.787929°	37.787929°
				-121.307173°	-121.307173°
DWR ID	60				
Comment Code					
Inspector Comment					
DS_ID:60 FS_ID:40707 EP_NO: 14326 Repair Type: Non-Urgent Crossing Status: Indicator Found UCIP Comments: Wires exposed near levee crown unable to determine if these wires are part of the crossing. Need to contact owner to determine status of crossing. FIELD_STRUCT_DESC: 4-inch galvanized iron communication cable through levee. Invert of conduit is 3.0 feet below levee crown. (4-inch fiber optic cable authorized under Permit No. 14326, 1986 - GTE Sprint Communications Corp.) [Additional Reference(s): DWR Levee Logs, 1981 and 2003] FS Date: 2/4/2010

Conduit marker on landward side.

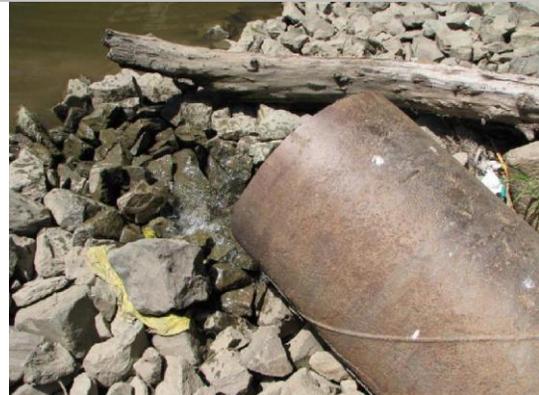
Photo 1 of 3 : UCIP_FA_2019_45466_72523.jpg

Comment Code					
Inspector Comment					
DS_ID:808 FS_ID:45466 EP_NO: 2366 Repair Type: Non-Urgent Crossing Status: Found UCIP Comments: Pipe exposed on WS slope where soil has been removed from around pipe. There does not appear to be any damage or repair at excavation. Pipe should be buried. FIELD_STRUCT_DESC: 22-inch steel drainage pipe through the levee, 10-feet below levee crown. 54-inch square, concrete manhole at the centerline of the levee between Manthey Road and the HWY 120 on ramp to I-5. (22-inch pipe authorized under Permit No. 2366, 1956 - State of California Department of Public Works Division of Highways District X) [Additional Reference(s): DWR Levee Logs, 1981, 2003, 22-inch listed. USACE San Joaquin O&M Manual Unit No. 2, May 1963, (HLM 12.74), 22-inch pipe] FS Date: 5/21/2015

Pipe was running during field inspection.

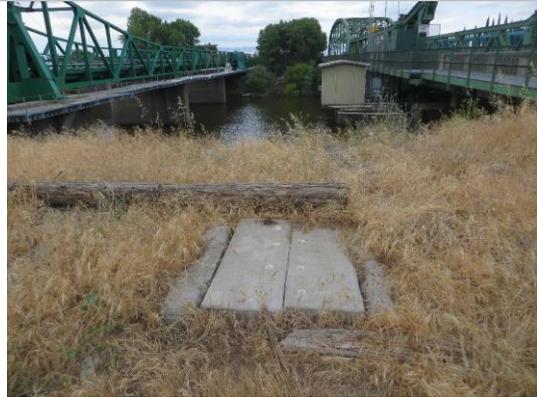
Photo 2 of 3 : UCIP_FA_2019_45466_74131.jpg

Comment Code					
Inspector Comment					
DS_ID:808 FS_ID:45466 EP_NO: 2366 Repair Type: Non-Urgent Crossing Status: Found UCIP Comments: Pipe exposed on WS slope where soil has been removed from around pipe. There does not appear to be any damage or repair at excavation. Pipe should be buried. FIELD_STRUCT_DESC: 22-inch steel drainage pipe through the levee, 10-feet below levee crown. 54-inch square, concrete manhole at the centerline of the levee between Manthey Road and the HWY 120 on ramp to I-5. (22-inch pipe authorized under Permit No. 2366, 1956 - State of California Department of Public Works Division of Highways District X) [Additional Reference(s): DWR Levee Logs, 1981, 2003, 22-inch listed. USACE San Joaquin O&M Manual Unit No. 2, May 1963, (HLM 12.74), 22-inch pipe] FS Date: 5/21/2015

Concrete manhole on WS shoulder.

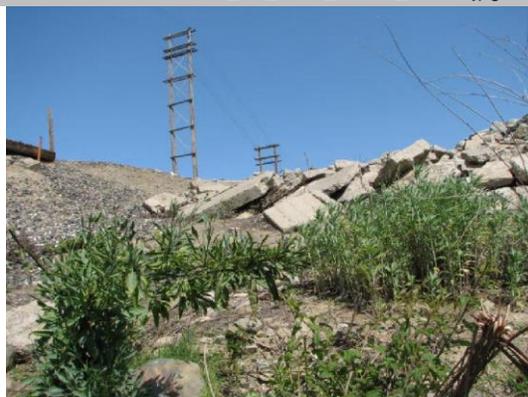
Photo 3 of 3 : UCIP_FA_2019_40712_72530.jpg

LM Start	13.26	Rating **	M	Issue No.	155 (cont)
LM End	13.26	Issue Type +	En	Location *	
Category	Supplemental			GPS Latitude/Longitude	
				Start	End
Item	DRAFT DWR UCIP Field Study			37.779653 °	37.779653 °
				-121.300064 °	-121.300064 °
DWR ID	65				
Comment Code					
Inspector Comment					
DS_ID:65 FS_ID:40712 EP_NO: 14450 Repair Type: Non-Urgent Crossing Status: Found UCIP Comments: Need to contact owner to determine status of crossing. FIELD_STRUCT_DESC: [Oakwood Lake Discharge Lines] 1 of 2. 18-inch steel drainage discharge pipe through levee at unknown depth below the levee crown. (two 18-inch pipes authorized under Permit No. 14450-1985 - R. H. Brown, remove existing 18-inch pipe) [Additional Reference(s): DWR Levee Logs, 1981 and 2003] FS Date: 2/4/2010

View of waterward slope.

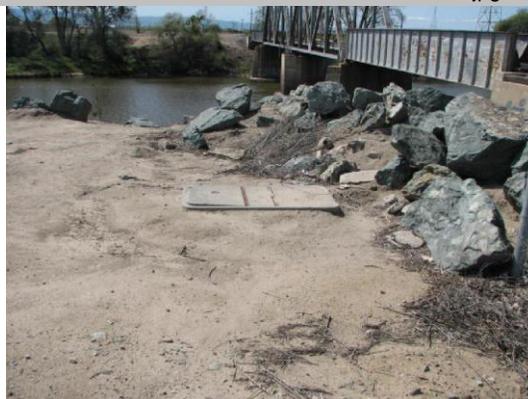
Photo 1 of 3 : UCIP_FA_2019_40713_72534.jpg

LM Start	13.26	Rating **	M	Issue No.	156
LM End	13.26	Issue Type +	En	Location *	
Category	Supplemental			GPS Latitude/Longitude	
				Start	End
Item	DRAFT DWR UCIP Field Study			37.779643 °	37.779643 °
				-121.300057 °	-121.300057 °
DWR ID	287				
Comment Code					
Inspector Comment					
DS_ID:287 FS_ID:40713 EP_NO: 14450 Repair Type: Non-Urgent Crossing Status: Found UCIP Comments: Need to contact owner to determine status of crossing. FIELD_STRUCT_DESC: [Oakwood Lake Discharge Lines] 2 of 2. 18-inch steel drainage discharge pipe through levee at unknown depth below the levee crown. (two 18-inch pipes authorized under Permit No. 14450-1985 - R. H. Brown, remove existing 18-inch pipe) [Additional Reference(s): DWR Levee Logs, 1981 and 2003] FS Date: 2/4/2010

Precast concrete box located on levee shoulder.

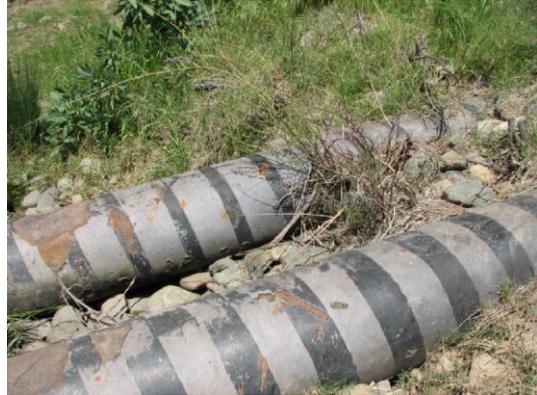
Photo 2 of 3 : UCIP_FA_2019_40713_72533.jpg

LM Start	13.26	Rating **	M	Issue No.	156 (cont)
LM End	13.26	Issue Type +	En	Location *	
Category	Supplemental			GPS Latitude/Longitude	
				Start	End
Item	DRAFT DWR UCIP Field Study			37.779643°	37.779643°
				-121.300057°	-121.300057°
DWR ID	287				
Comment Code					
Inspector Comment					
DS_ID:287 FS_ID:40713 EP_NO: 14450 Repair Type: Non-Urgent Crossing Status: Found UCIP Comments: Need to contact owner to determine status of crossing. FIELD_STRUCT_DESC: [Oakwood Lake Discharge Lines] 2 of 2. 18-inch steel drainage discharge pipe through levee at unknown depth below the levee crown. (two 18-inch pipes authorized under Permit No. 14450-1985 - R. H. Brown, remove existing 18-inch pipe) [Additional Reference(s): DWR Levee Logs, 1981 and 2003] FS Date: 2/4/2010

Pipes visible on waterward side.

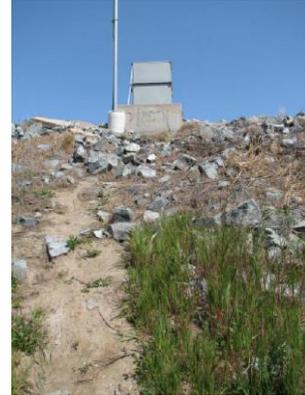
Photo 3 of 3 : UCIP_FA_2019_40714_72542.jpg

Comment Code					
Inspector Comment					
DS_ID:66 FS_ID:40714 EP_NO: 14467 Repair Type: Non-Urgent Crossing Status: Found UCIP Comments: Records show this crossing was suppose to be abandoned however, the drain pipe was operable during site visit. Need to contact owner to clarify if crossing that was abandoned was removed and replaced with current crossing. FIELD_STRUCT_DESC: 36-inch concrete discharge gravity municipal water discharge through levee approximately 23 feet below crown. The reinforced concrete outfall structure with sluice gate will be constructed within the pipeline at the waterside (WS) levee shoulder. (36-inch pipe authorized under Permit No. 14467, 1986 - City of Manteca) [Additional Reference(s): DWR Levee Logs, 1981 and 2003] FS Date: 2/4/2010

View of waterward side.

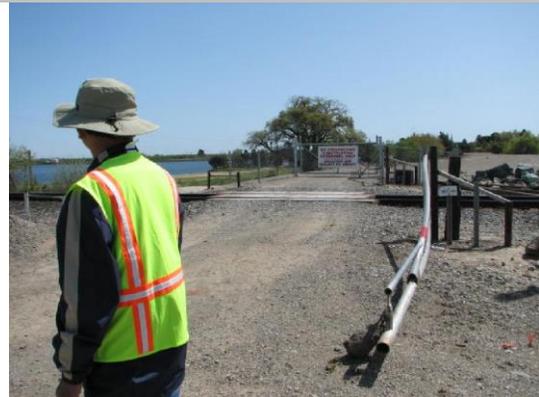
Photo 1 of 2 : UCIP_FA_2019_45995_72526.jpg

LM Start	13.28	Rating **	M	Issue No.	158
LM End	13.28	Issue Type +	En	Location *	
Category	Supplemental			GPS Latitude/Longitude	
				Start	End
Item	DRAFT DWR UCIP Field Study			37.779470°	37.779470°
				-121.299954°	-121.299954°
DWR ID	67				
Comment Code					
Inspector Comment					
DS_ID:67 FS_ID:45995 EP_NO: N/A Repair Type: Non-Urgent Crossing Status: Indicator Found UCIP Comments: Markers visible on landward side only. Recommend contacting owner to confirm alignment and crossing. FIELD_STRUCT_DESC: Submarine power cable through the levee and across the channel. [Additional Reference(s): DWR Levee Logs, 1981 and 2003] FS Date: 2/4/2010

View of levee crown at crossing.

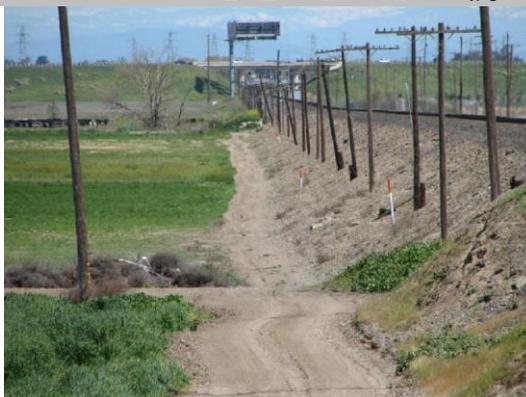
Photo 2 of 2 : UCIP_FA_2019_45995_72525.jpg

LM Start	13.28	Rating **	M	Issue No.	158 (cont)
LM End	13.28	Issue Type +	En	Location *	
Category	Supplemental			GPS Latitude/Longitude	
				Start	End
Item	DRAFT DWR UCIP Field Study			37.779470 °	37.779470 °
				-121.299954 °	-121.299954 °
DWR ID	67				
Comment Code					
Inspector Comment					
DS_ID:67 FS_ID:45995 EP_NO: N/A Repair Type: Non-Urgent Crossing Status: Indicator Found UCIP Comments: Markers visible on landward side only. Recommend contacting owner to confirm alignment and crossing. FIELD_STRUCT_DESC: Submarine power cable through the levee and across the channel. [Additional Reference(s): DWR Levee Logs, 1981 and 2003] FS Date: 2/4/2010

Markers visible along landward side.

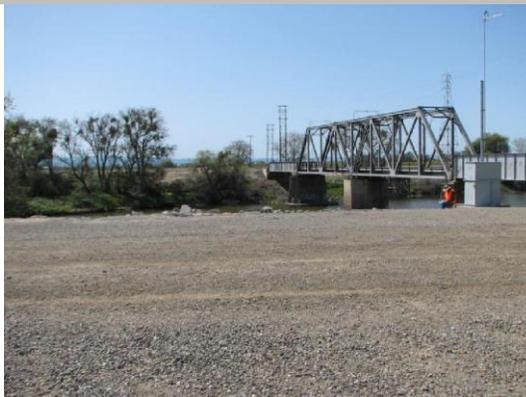
Photo 1 of 3 : UCIP_FA_2019_40715_72548.jpg

Comment Code					
Inspector Comment					
DS_ID:809 FS_ID:40715 EP_NO: N/A Repair Type: Non-Urgent Crossing Status: Found UCIP Comments: No information was obtained from desk study. This crossing was found during field visit. Need to contact owner to obtain additional details about crossing (installation date and permit) and status. FIELD_STRUCT_DESC: *ABANDONED* [Reclamation District No. 17 Drainage Plant] 18-inch drainage pipe of unknown material through the levee, 5.8 feet below the crown. Gate valve and siphon breaker on the waterside (WS) slope. Flap gate on the WS end. One CM cutoff wall. Pump on the landside (LS). (18-inch pipe Installed by USACE in 1961 -- no permit found; existing 18-inch pipe removed under Permit No. 14450, 1988 - R. H. Brown, two 18-inch pipes installed) [Additional Reference(s): DWR Levee Logs, 1981, 2003. USACE San Joaquin O&M Manual Unit No. 2, May 1963, (HLM 13.36)] FS Date: 2/4/2010

View of levee crown at crossing.

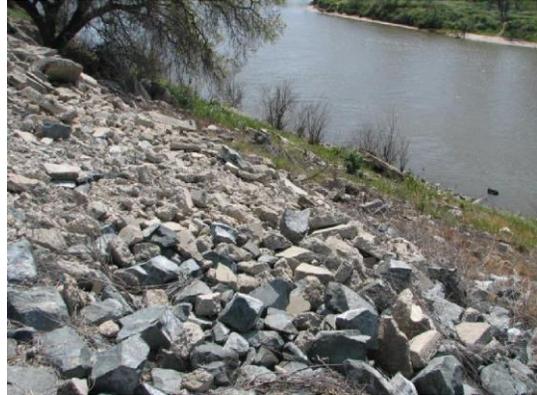
Photo 2 of 3 : UCIP_FA_2019_40715_72551.jpg

Comment Code					
Inspector Comment					
DS_ID:809 FS_ID:40715 EP_NO: N/A Repair Type: Non-Urgent Crossing Status: Found UCIP Comments: No information was obtained from desk study. This crossing was found during field visit. Need to contact owner to obtain additional details about crossing (installation date and permit) and status. FIELD_STRUCT_DESC: *ABANDONED* [Reclamation District No. 17 Drainage Plant] 18-inch drainage pipe of unknown material through the levee, 5.8 feet below the crown. Gate valve and siphon breaker on the waterside (WS) slope. Flap gate on the WS end. One CM cutoff wall. Pump on the landside (LS). (18-inch pipe Installed by USACE in 1961 -- no permit found; existing 18-inch pipe removed under Permit No. 14450, 1988 - R. H. Brown, two 18-inch pipes installed) [Additional Reference(s): DWR Levee Logs, 1981, 2003. USACE San Joaquin O&M Manual Unit No. 2, May 1963, (HLM 13.36)] FS Date: 2/4/2010

View of waterward side, photo 1 of 2.

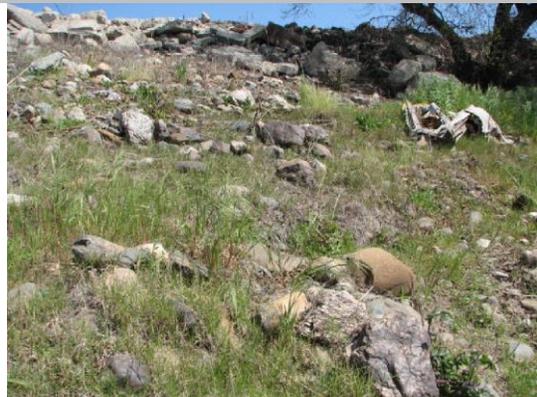
Photo 3 of 3 : UCIP_FA_2019_40715_72549.jpg

View of waterward side, photo 2 of 2.
