**Flood Control Project Maintenance
Levee Inspections**
LMA District Cover Sheet
Spring 2020 Levee Inspection Results

Reclamation District No. 0070 Meridian

Spring 2020 Levee Inspection Results

Waterway		Bank	Unit Miles
Unit No. 01 Sutter Bypass		Right	7.92

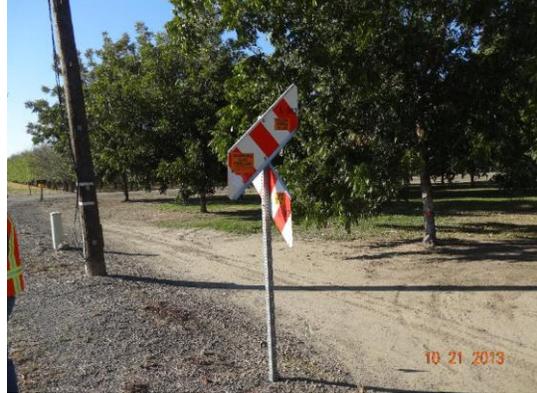
Photo 2 of 3 : UCIP_SP_2020_23384_40247.jpg

View of markers on the west side of S. Tarke Road.

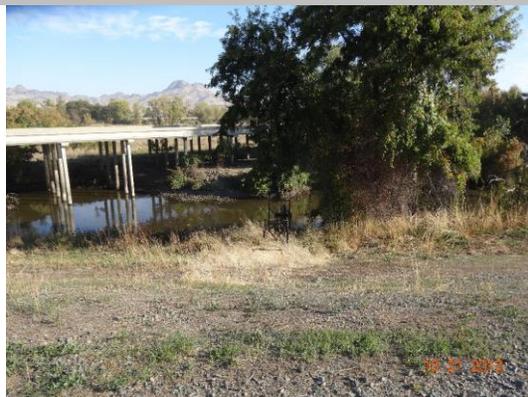
Photo 3 of 3 : UCIP_SP_2020_23503_40785.jpg

View of waterward side--dense vegetation along slope.

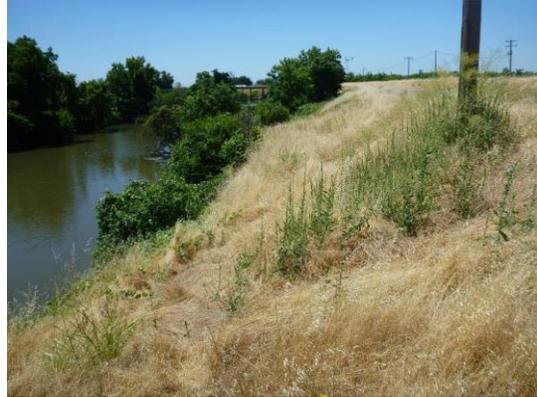
Photo 1 of 3 : LEVAL_SP_2020_154_1686.jpg

LM Start	0.76	Rating **	A/W	Issue No.	36
LM End	0.76	Issue Type +	Ma	Location *	WS
Category	Earthen Levee			GPS Latitude/Longitude	
				Start	End
Item	Erosion / Bank Caving			39.145240 °	39.145240 °
				-121.842650 °	-121.842650 °
DWR ID	RD 70-03				
Comment Code					
E1 : Note and monitor erosion site.					
Inspector Comment					
Known erosion site. LMA should continue to monitor. Site ID No:154 Site Designation:RD 70-03

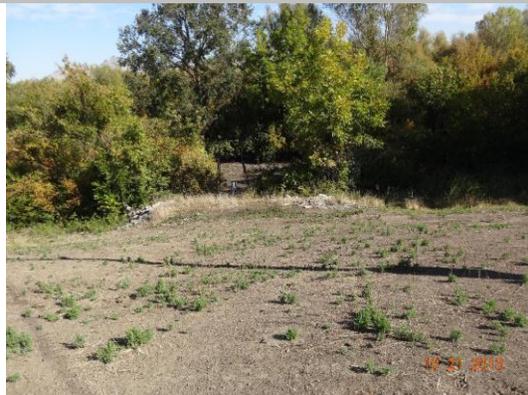
Photo 3 of 3 : UCIP_SP_2020_23508_40820.jpg

View of waterward side.

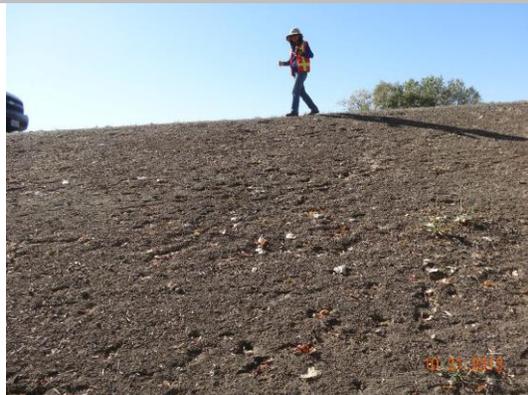
Photo 2 of 3 : UCIP_SP_2020_23530_40972.jpg

Comment Code					
Inspector Comment					
DS_ID:21322 FS_ID:23530 EP_NO: N/A Repair Type: Non-Urgent Crossing Status: Indicator Found UCIP Comments: Unable to determine if crossing exists need to coordinate with LMA to determine if more information is available about crossing. This crossing is referenced in the USACE Periodic Inspection as item USACE_CESPK_MRD1_2012_p_0208 for concrete ditch lined within 15 feet of LS toe, no water present, and no USACE recommendation letter available. FIELD_STRUCT_DESC: 12-inch steel irrigation discharge pipe through the levee, at an unknown depth. Cutoff wall around the pipe at the center of the levee. Slide gate on each end. Pump on the waterside (WS). Concrete distribution box on the landside (LS). [Additional Reference(s): USACE Sacramento O&M Manual 134, June 1953, (Station 142+70)]. FS Date: 10/21/2013

View of waterward slope.

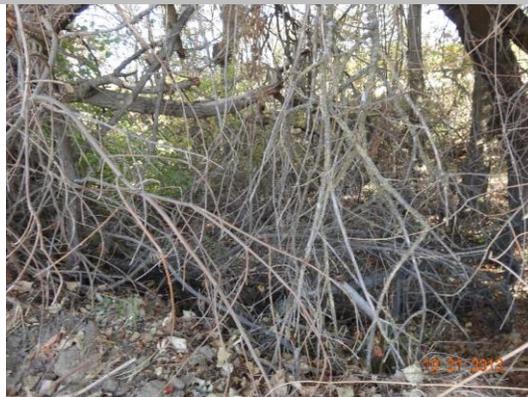
Photo 3 of 3 : UCIP_SP_2020_23530_40971.jpg

Waterward side covered by vegetation.

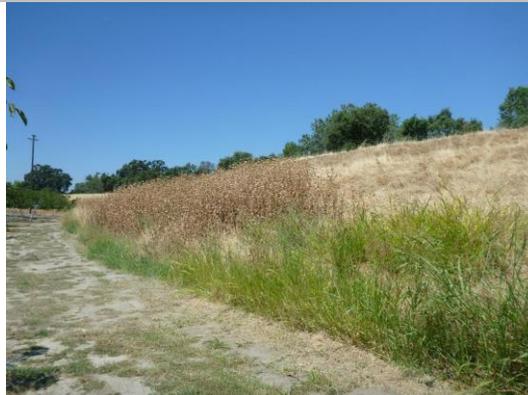
Photo 1 of 3 : LEVAL_SP_2020_153_1702.jpg

LM Start	3.18	Rating **	A/W	Issue No.	37
LM End	3.18	Issue Type +	Ob	Location *	LS
Category	Earthen Levee			GPS Latitude/Longitude	
				Start	End
Item	Seepage / Sandboils			39.157480 °	39.157480 °
				-121.879250 °	-121.879250 °
DWR ID	RD 70-02				
Comment Code					
Inspector Comment					
Known seepage area. Site ID No:153 Site Designation:RD 70-02

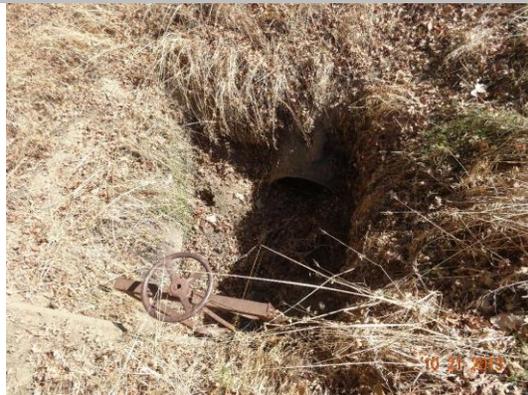
Photo 3 of 3 : UCIP_SP_2020_23515_40869.jpg

View of concrete box located on waterward side, photo 2 of 2.

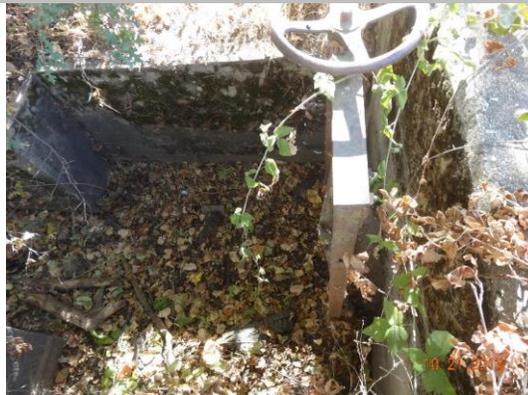
Photo 3 of 3 : UCIP_SP_2020_23517_40882.jpg

View of slide gate on waterward side.

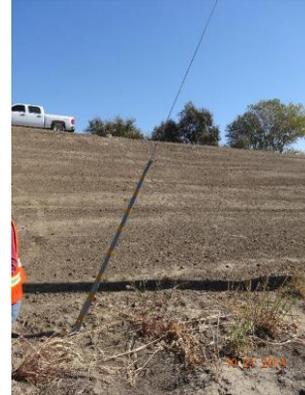
Photo 3 of 3 : UCIP_SP_2020_23519_40897.jpg

Comment Code					
Inspector Comment					
DS_ID:21357 FS_ID:23519 EP_NO: 9957 Repair Type: Non-Urgent Crossing Status: Found UCIP Comments: Burrow activity on slopes -- recommend addressing issue. This crossing is referenced in the USACE Periodic Inspection as item USACE_CESPK_MRD1_2012_p_0110. FIELD_STRUCT_DESC: 12-inch steel irrigation discharge pipe through the levee, 5.5 feet below the crown. Pump on the waterside (WS) slope. Siphon breaker in a corrugated metal pipe (CMP) riser on the landside (LS) slope. Pipe discharges into a concrete box at the LS toe. Service pole at the LS toe. (Plans to retain a 12-inch steel pipe through the levee, 5.5 feet below the crown, a siphon breaker in a CMP riser, a pump, and a concrete box authorized under Automatic Board Order (ABO) issued as Permit No. 9957, 1974 - James E. and Mattie Smith). [Additional Reference(s): DWR Levee Log, 2007]. FS Date: 10/21/2013

View of landward slope.

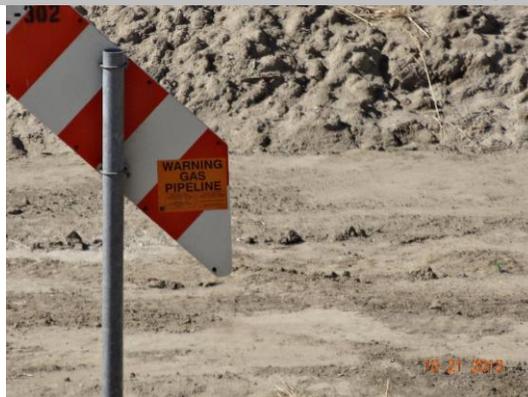
Photo 2 of 3 : UCIP_SP_2020_23479_40723.jpg

DS_ID:21360
 FS_ID:23479
 EP_NO: 4867
 Repair Type: Non-Urgent
 Crossing Status: Found
 UCIP Comments: Utility marker contact information includes Contact prior to Excavation call 1-800-227-2600 or Emergency Contact 1-800-811-4111. Need to contact owner to determine status of crossing. Need date of last inspection and confirmation that crossing is still in operable condition.
 FIELD_STRUCT_DESC: 6.5-inch coated steel natural gas pipeline through the levee, 4 feet below the crown. Concrete cutoff wall around the pipe at the center of the levee. Rock revetment on the waterside (WS) slope. (Plans for installing a gas line through the levee authorized under Permit No. 4867, 1965 - Pacific Gas and Electric Company [PG&E]). [Additional Reference(s): DWR Levee Log, 2007].
 FS Date: 10/21/2013

Pipeline marker on landward side.

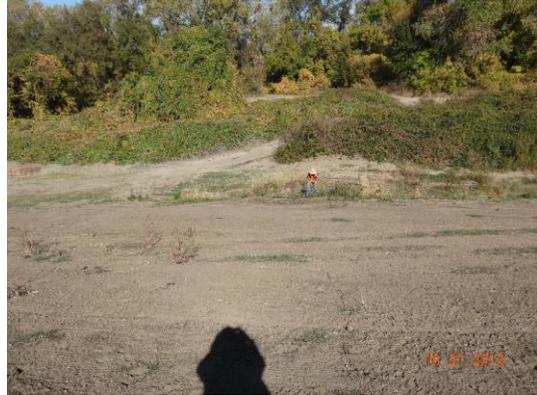
Photo 2 of 3 : UCIP_SP_2020_46422_40914.jpg

View of waterward side.

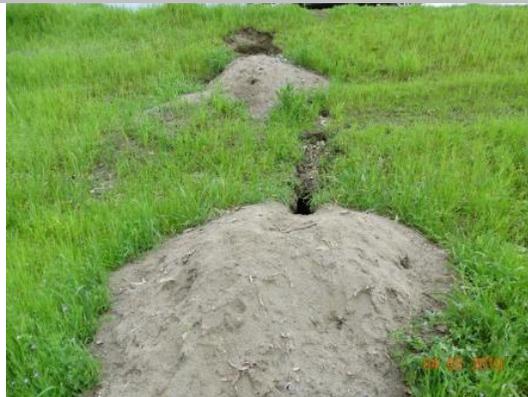
Photo 1 of 1 : SP_2020_RD0070_30_101_20200226_00020.jpg

LM Start	0.85	Rating **	U	Issue No.	101
LM End	0.85	Issue Type +	Ma	Location *	WS
Category	Earthen Levee		GPS Latitude/Longitude		
			Start	End	
Item	Animal Control		39.185567 °	39.185567 °	
			-121.941427 °	-121.941427 °	
DWR ID	DWR_RD0070_02_s_2019_101				
Comment Code					
A3 : No rodents visible, but rodent burrows visible; need to backfill and compact or grout burrows.					
Inspector Comment

View of large rodent holes on the waterside slope. Spring 2019.

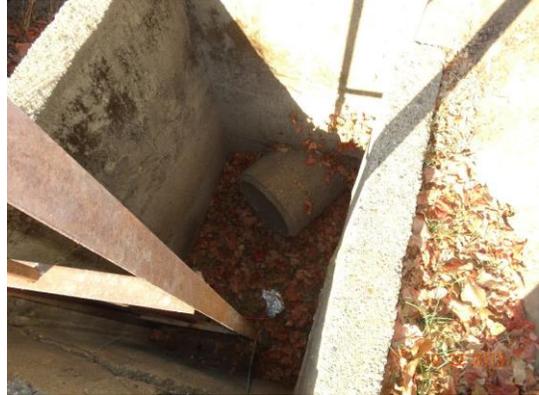
Photo 3 of 3 : UCIP_SP_2020_54252_42042.jpg

Inside view of concrete distribution box located on waterward side.

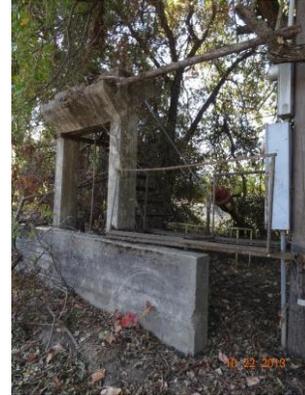
Photo 3 of 3 : UCIP_SP_2020_23885_41815.jpg

Concrete structure located on waterward side with screw gate.

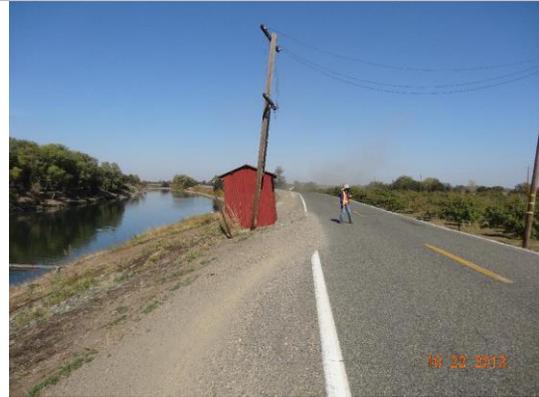
Photo 1 of 3 : UCIP_SP_2020_23888_41819.jpg

View of levee crown and waterward side.

Comment Code					
Inspector Comment					
DS_ID:21366 FS_ID:23888 EP_NO: 9996 Repair Type: Non-Urgent Crossing Status: Found UCIP Comments: Need inside photo of the concrete distribution box located at the landward toe. Debris found on waterward slope (conduit running parallel to levee). This crossing is referenced in the USACE Periodic Inspection as item USACE_CESPK_MRD2_2012_p_0124. FIELD_STRUCT_DESC: 12-inch steel irrigation discharge pipe through the levee, 24 feet below the crown. Gate valve in a concrete U-shaped headwall on the waterside (WS) slope. Pump and switch house on the WS shoulder. Discharge box at the landside (LS) toe. (Retention of a 12-inch steel pipe through the levee, 24 feet below the crown, a pump, a gate valve, a switch house, and a discharge box authorized under Automatic Board Order (ABO) issued as Permit No. 9996, 1974 - Chas. F. and Nora M. Reische, et al.). [Additional Reference(s): DWR Levee Log, 2007]. FS Date: 10/22/2013

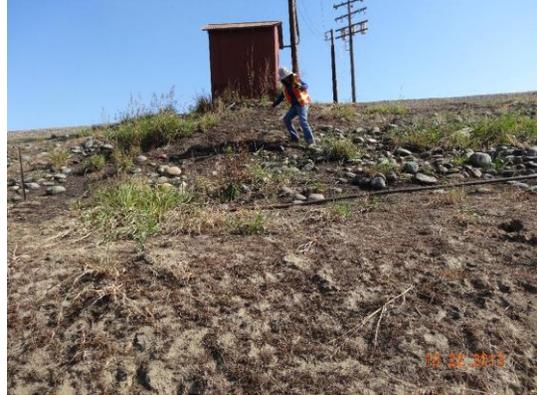
Photo 2 of 3 : UCIP_SP_2020_23888_41822.jpg

View of slope on waterward side.

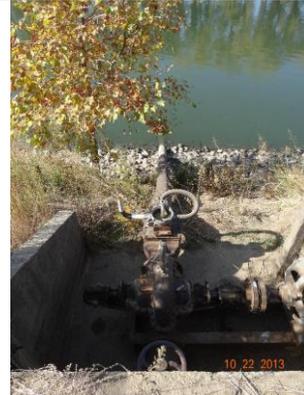
Photo 3 of 3 : UCIP_SP_2020_23888_41821.jpg

View of U-concrete headwall with positive closure device, photo 1 of 2.

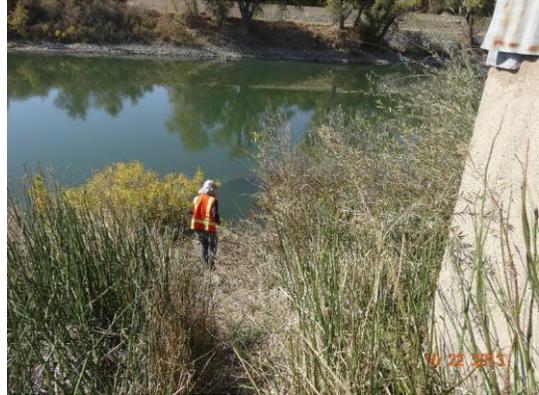
Photo 3 of 3 : UCIP_SP_2020_23891_41837.jpg

Dense vegetation covers pipe intake on waterward side.

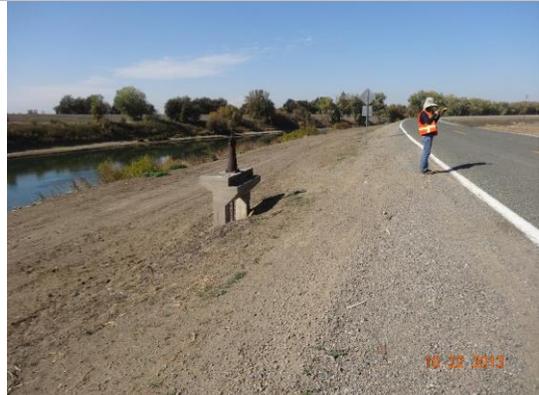
Photo 1 of 3 : UCIP_SP_2020_23892_41839.jpg

View of waterward side.

Comment Code					
Inspector Comment					
DS_ID:21369 FS_ID:23892 EP_NO: N/A Repair Type: Non-Urgent Crossing Status: Found UCIP Comments: If crossing is no longer used by owner, the owner will need to coordinate with DWR Inspector and CVFPB to remove crossing according to Title 23 requirements. Dense vegetation limits the inspector's visibility to identify signs of pipe failure (leaks) along the slope. Recommend removing vegetation along pipe alignment to conduct proper inspection of structure and appurtenances. This crossing is referenced in the USACE Periodic Inspection as item USACE_CESPK_MRD1_2012_p_0167. FIELD_STRUCT_DESC: *ABANDONED* 24-inch corrugated metal drainage pipe through the levee, 21 feet below the crown. Slide gate on the waterside (WS) end. (Cat. IVA). [Additional Reference(s): DWR Levee Log, 2007]. FS Date: 10/22/2013

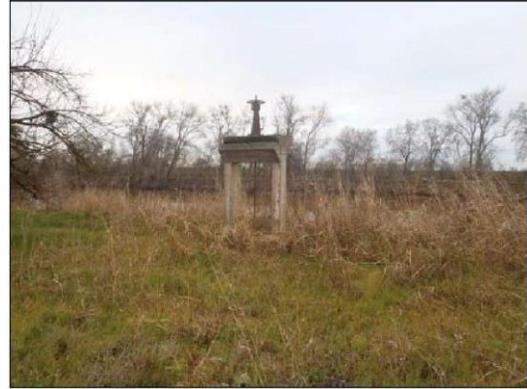
Photo 1 of 2 : UCIP_SP_2020_24115_42495.jpg

Comment Code					
Inspector Comment					
DS_ID:21370 FS_ID:24115 EP_NO: N/A Repair Type: Non-Urgent Crossing Status: Found UCIP Comments: No connection present--need to contact owner to determine if owner plans to use. If crossing is no longer in use owner will need to coordinate with DWR inspector and CVFPB to remove according to Title 23 requirements. This crossing is referenced in the USACE Periodic Inspection as USACE_CESPK_MRD2_2012_p_0197. FIELD_STRUCT_DESC: *ABANDONED* 24-inch drainage pipe of an unknown material through the levee, 18.5 feet below the crown. Slide gate on a concrete gate structure on the berm. [Additional Reference(s): DWR Levee Log, 2007]. FS Date: 10/22/2013

View of waterward side--photo is from USACE PI Report draft final issue USACE_CESPK_MRD2_2012_p_0197.

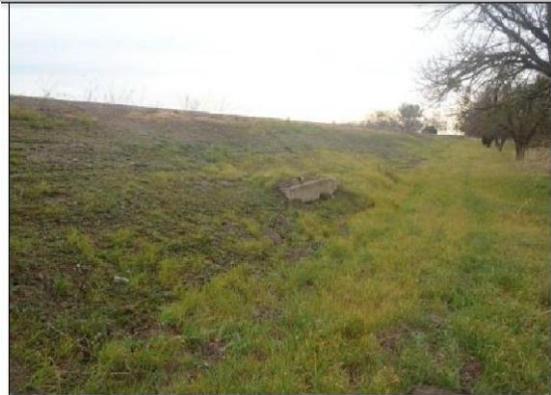
Photo 2 of 2 : UCIP_SP_2020_24115_42496.jpg

View of landward side--photo is from USACE PI Report draft final issue USACE_CESPK_MRD2_2012_p_0197.

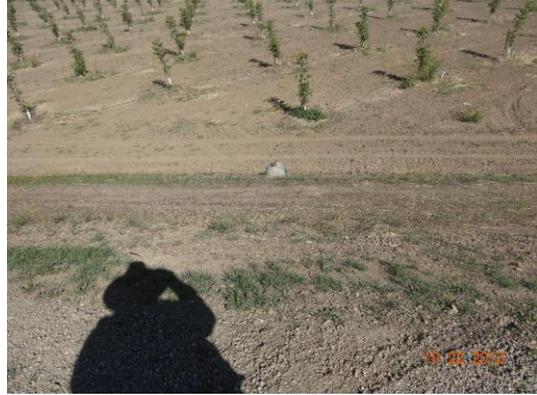
Photo 1 of 2 : UCIP_SP_2020_24117_42502.jpg

Comment Code					
Inspector Comment					
DS_ID:21371 FS_ID:24117 EP_NO: N/A Repair Type: Non-Urgent Crossing Status: Found UCIP Comments: No connection present--need to contact owner to determine if owner plans to use. If crossing is no longer in use owner will need to coordinate with DWR inspector and CVFPB to remove according to Title 23 requirements. This crossing is referenced in the USACE Periodic Inspection as USACE_CESPK_MRD2_2012_p_0197. FIELD_STRUCT_DESC: *ABANDONED* 24-inch drainage pipe of an unknown material through the levee, 18.5 feet below the crown. Slide gate on a concrete gate structure on the berm. [Additional Reference(s): DWR Levee Log, 2007]. FS Date: 10/22/2013

View of pipe on landward side.

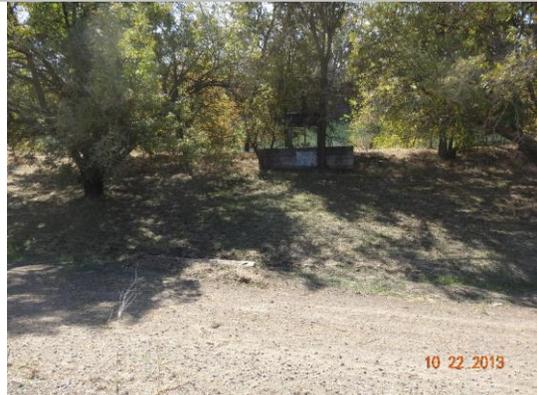
Photo 2 of 2 : UCIP_SP_2020_24117_42501.jpg

LM Start	3.40	Rating **	M	Issue No.	110 (cont)
LM End	3.40	Issue Type +	En	Location *

View of concrete headwall and screw gate on waterward side.

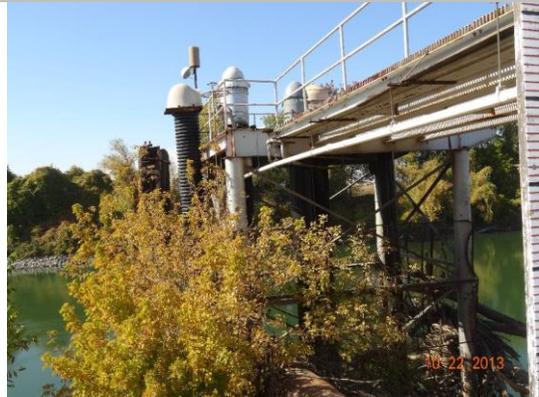
Photo 3 of 3 : UCIP_SP_2020_47030_42569.jpg

LM Start	4.11	Rating **	M	Issue No.	113 (cont)
LM End	4.11	Issue Type +	En	Location *

View of pumps located on waterward side.

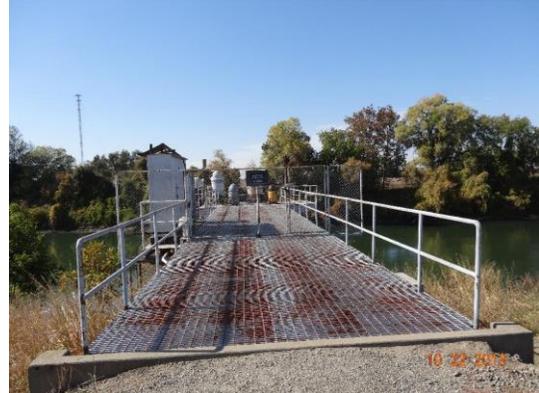
Photo 1 of 3 : UCIP_SP_2020_47032_42076.jpg

Comment Code					
Inspector Comment					
<p>DS_ID:21373 FS_ID:47032 EP_NO: N/A Repair Type: Non-Urgent Crossing Status: Indicator Found UCIP Comments: Unable to confirm 54-inch pipe only found 42-inch pipe. Pump station is to be removed. Need to update record once crossing has been modified. This crossing is referenced in the USACE Periodic Inspection as item USACE_CESPK_MRD2_2012_p_0235. FIELD_STRUCT_DESC: [Meridian Farms Water Company Pumping Plant No. 2] 4 of 4: 54-inch steel irrigation discharge pipe through the levee, 24 feet below the crown. Pipe is concrete encased through the levee. Two concrete cutoff walls, one at each shoulder. Slide gate in a surge box on the waterside (WS). Concrete pump pit on the WS slope. Three pumps on a structure on the WS. Walkway to the pumps. Concrete headwall on the landside (LS). Pipe discharges into a concrete lined irrigation ditch on the LS. Debris deflectors in the river. (Plans for construction of a pumping plant and related facilities to replace an existing plant on the left bank of the Sacramento River authorized under Permit No. 4525, 1964 - Meridian Farms Water Company. Plans for existing pumping plant to be demolished with all pipes removed and replaced with a new Meridian Diversion pumping facility, two retractable fish screens, and a 72-inch gravity feed intake pipe under the levee authorized under Permit No. 18762, 2013 - Meridian Farms Water Company). [Additional Reference(s): DWR Levee Log, 2007]. FS Date: 10/22/2013</p>

View of walkway and pump station on waterward side.

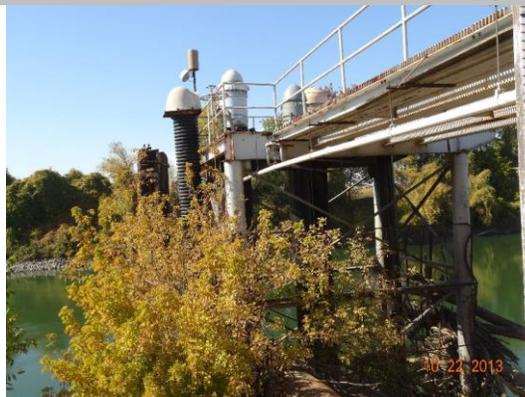
Photo 3 of 3 : UCIP_SP_2020_47032_42082.jpg

LM Start	4.11	Rating **	M	Issue No.	114 (cont)
LM End	4.11	Issue Type +	En	Location *	
Category	Supplemental			GPS Latitude/Longitude	
				Start	End
Item	DWR UCIP Field Study			39.147247 °	39.147247 °
				-121.916691 °	-121.916691 °
DWR ID	21373

View of pumps located on waterward side.

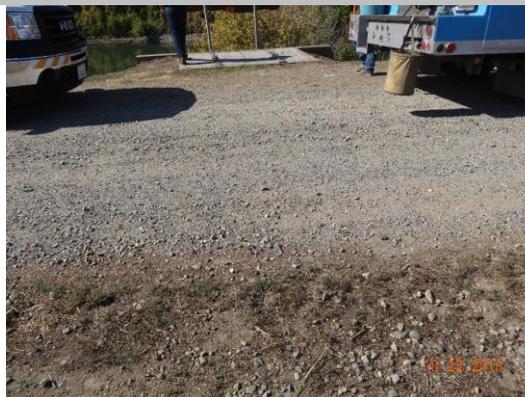
Photo 1 of 3 : UCIP_SP_2020_24165_42573.jpg

LM Start	4.12	Rating **	M	Issue No.	115
LM End	4.12	Issue Type +	En	Location *	
Category	Supplemental			GPS Latitude/Longitude	
				Start	End
Item	DWR UCIP Field Study			39.147072 °	39.147072 °
				-121.916783 °	-121.916783 °
DWR ID	21374

View of levee crown.

Comment Code					
Inspector Comment					
DS_ID:21374 FS_ID:24165 EP_NO: 767 Repair Type: Non-Urgent Crossing Status: Found UCIP Comments: Need to contact owner to determine if crossing is still active and to determine last inspection date. Will need copy of letter showing crossings passed inspection. This crossing is referenced in the USACE Periodic Inspection as item USACE_CESPK_MRD2_2012_p_0237. FIELD_STRUCT_DESC: 3-inch steel natural gas pipeline (not 3.5-inch, as mentioned in the desk study) through the levee, 3 feet below the crown. 8-foot by 10-foot by 1-foot concrete inspection well with a metal cover on the waterside (WS) shoulder. Rock revetment on the WS slope. Painted aluminum marker on the WS. Contact information provided on marker: (916) 742-7344 and for emergencies call (916) 742-3251. (Plans for the construction of a natural gas pipeline across the Sacramento River and the east and west levees thereof authorized under Permit No. 767, 1938 - Pacific Gas and Electric Company [PG&E]). [Additional Reference(s): DWR Levee Log, 2007]. FS Date: 10/22/2013

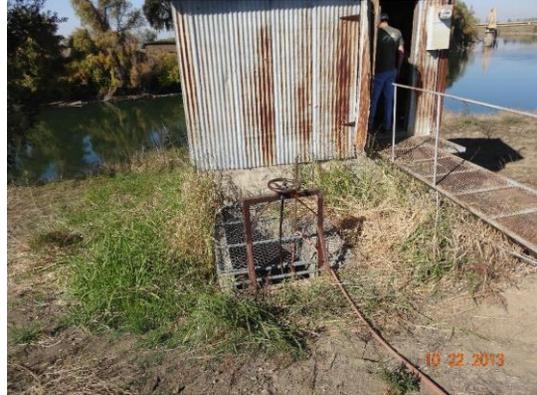
Photo 2 of 3 : UCIP_SP_2020_23962_42104.jpg

LM Start	4.55	Rating **	M	Issue No.	119 (cont)
LM End	4.55	Issue Type +	En	Location *	
Category	Supplemental			GPS Latitude/Longitude	
				Start	End
Item	DWR UCIP Field Study			39.141254 °	39.141254 °
				-121.919221 °	-121.919221 °
DWR ID	21379

Positive closure device located at the waterward side inside concrete distribution box.

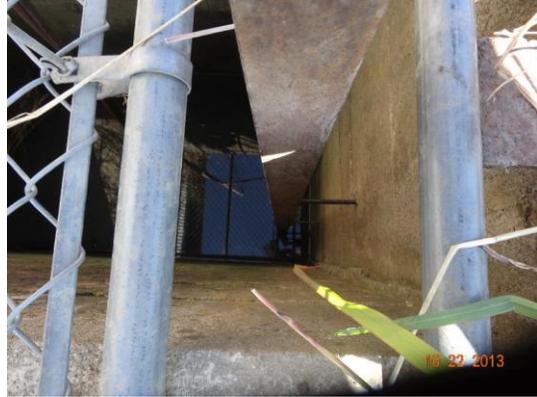
Photo 3 of 3 : UCIP_SP_2020_23962_42101.jpg

LM Start	4.55	Rating **	M	Issue No.	119 (cont)
LM End	4.55	Issue Type +	En	Location *

Photo of the concrete distribution box located on waterward side.

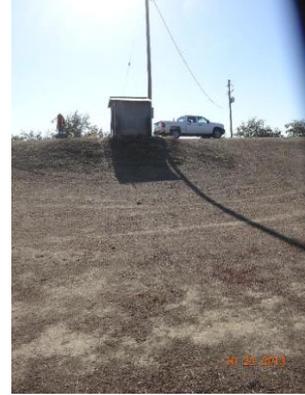
Photo 1 of 3 : UCIP_SP_2020_24166_42581.jpg

Comment Code					
Inspector Comment					
<p>DS_ID:21380 FS_ID:24166 EP_NO: 9970 Repair Type: Non-Urgent Crossing Status: Found UCIP Comments: Need to coordinate with owner to determine status of crossing. No pump is located inside the pump house located on waterward side. If crossing is no longer in use owner will need to contact the CVFPB to comply with Title 23. Dense vegetation limits the inspector's visibility to identify signs of pipe failure (leaks) along the slope. Recommend removing vegetation along pipe alignment to conduct proper inspection of structure and appurtenances. This crossing is referenced in the USACE Periodic Inspection as item USACE_CESPK_MRD2_2012_p_0274. FIELD_STRUCT_DESC: 10-inch steel irrigation discharge pipe through the levee, 4.8 feet below the crown. Corrugated metal cutoff wall around the pipe at the center of the levee. Siphon breaker on the landside (LS) slope, not found. Pump in a pump house on the waterside (WS) shoulder. Shutoff valve on the LS. Concrete discharge box at the LS toe. (Retention of a 10-inch steel pipe through the levee, 4.8 feet below the crown, a pump, a service pole, a siphon breaker, and a concrete discharge box authorized under Automatic Board Order (ABO) issued as Permit No. 9970, 1974 - Arnold Chesini). [Additional Reference(s): DWR Levee Log, 2007. USACE Sacramento O&M Manual 134, June 1953, (Station 526+71)]. FS Date: 10/22/2013</p>

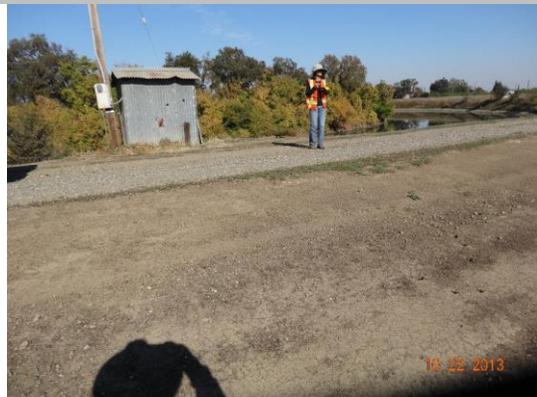
Photo 2 of 3 : UCIP_SP_2020_24166_42580.jpg

LM Start	4.76	Rating **	M	Issue No.	120 (cont)
LM End	4.76	Issue Type +	En	Location *

View of levee crown and pump house photo taken from landward side.

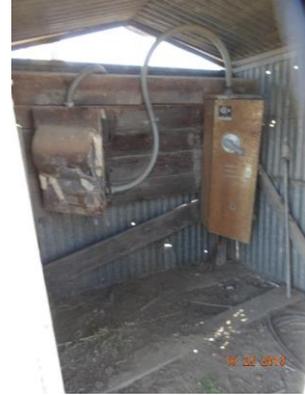
Photo 3 of 3 : UCIP_SP_2020_24166_42583.jpg

LM Start	4.76	Rating **	M	Issue No.	120 (cont)
LM End	4.76	Issue Type +	En	Location *	
Category	Supplemental			GPS Latitude/Longitude	
				Start	End
Item	DWR UCIP Field Study			39.141136 °	39.141136 °
				-121.922785 °	-121.922785 °
DWR ID	21380

View of the inside of pump house--no pump.

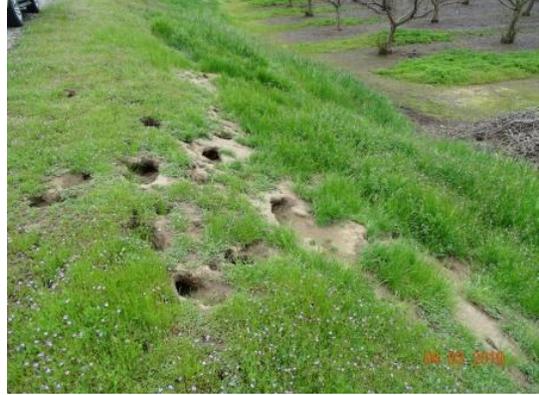
Photo 1 of 3 : SP_2020_RD0070_30_89_20200226_00015.jpg

LM Start	5.03	Rating **	U	Issue No.	89
LM End	5.08	Issue Type +	Ma	Location *	LS
Category	Earthen Levee		GPS Latitude/Longitude		
			Start	End	
Item	Animal Control		39.141997 °	39.141905 °	
			-121.927776 °	-121.928654 °	
DWR ID	DWR_RD0070_02_s_2019_89				
Comment Code					
A3 : No rodents visible, but rodent burrows visible; need to backfill and compact or grout burrows.					
Inspector Comment

View of the rodent burrows on the landside slope. Spring 2019.

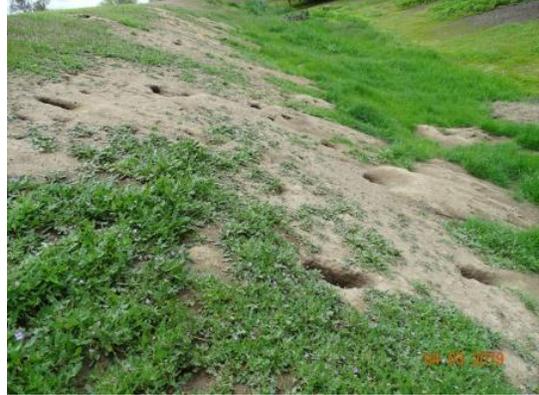
Photo 2 of 3 : SP_2020_RD0070_30_89_20200226_00016.jpg

LM Start	5.03	Rating **	U	Issue No.	89 (cont)
LM End	5.08	Issue Type +	Ma	Location *	LS

Another view of the rodent burrows on the landside slope. Spring 2019.

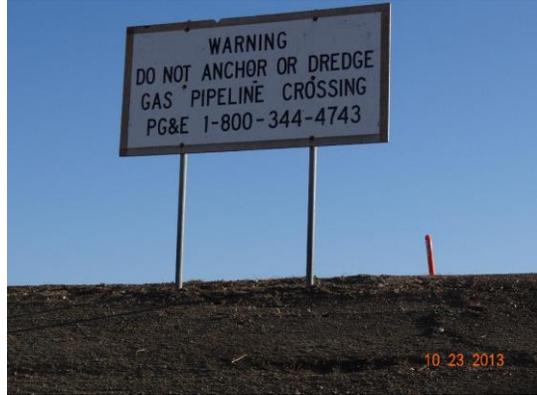
Photo 3 of 3 : UCIP_SP_2020_23965_42122.jpg

LM Start	6.28	Rating **	M	Issue No.	122 (cont)
LM End	6.28	Issue Type +	En	Location *	
Category	Supplemental			GPS Latitude/Longitude	
				Start	End
Item	DWR UCIP Field Study			39.133847 °	39.133847 °
				-121.937689 °	-121.937689 °
DWR ID	21385

Sign visible on waterward side.

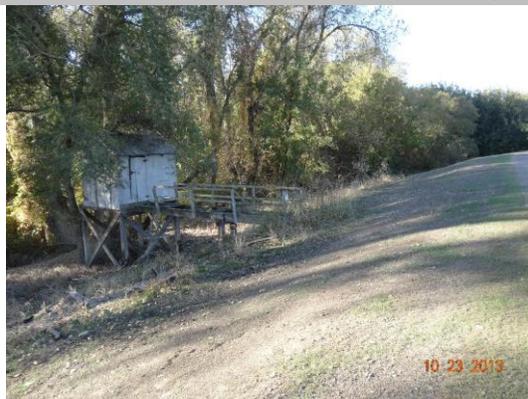
Photo 1 of 3 : UCIP_SP_2020_23966_42128.jpg

Comment Code					
Inspector Comment					
<p>DS_ID:21387 FS_ID:23966 EP_NO: 9966 Repair Type: Non-Urgent Crossing Status: Indicator Found UCIP Comments: Pipe daylight at waterward side blocked. Unable to determine if connection is present--need to contact owner to determine if owner plans to use. If crossing is no longer in use owner will need to coordinate with DWR inspector and CVFPB to remove according to Title 23 requirements. Unable to determine if crossing is in use. This crossing is referenced in the USACE Periodic Inspection as item USACE_CESPK_MRD2_2012_p_0371. FIELD_STRUCT_DESC: 10-inch coated steel irrigation discharge pipe and 1.5-inch electrical conduit of an unknown material through the levee, 12 feet and 8 feet below the crown, respectively. Pipe is concrete encased under the crown, between the shoulders. Concrete cutoff wall under each shoulder. Pump and gate valve on a pile structure in the stream. Walkway to the pump. Concrete standpipe on the landside (LS). (retain 10-inch concrete-encased steel pipe, pump and gate valve, concrete standpipe, and two concrete headwalls authorized under Automatic Board Order (ABO) issued as Permit No. 9966, 1976 - Ray and Janice Anderson). [Additional Reference(s): DWR Levee Log, 2007. USACE Sacramento O&M Manual 134, June 1953, (Station 689+50)]. FS Date: 10/23/2013</p>

Pump house located on waterward side.

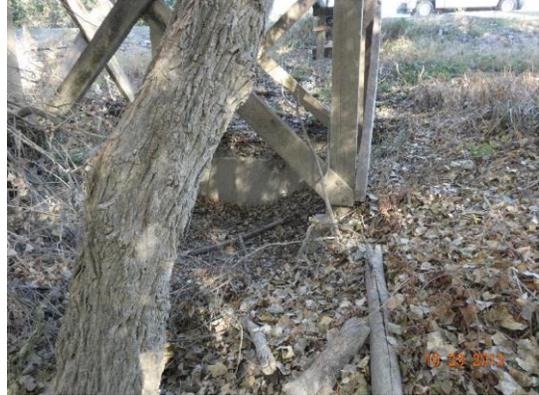
Photo 2 of 3 : UCIP_SP_2020_23966_42126.jpg

LM Start	7.82	Rating **	M	Issue No.	124 (cont)
LM End	7.82	Issue Type +	En	Location *	
Category	Supplemental			GPS Latitude/Longitude	
				Start	End
Item	DWR UCIP Field Study			39.124562 °	39.124562 °
				-121.913758 °	-121.913758 °
DWR ID	21387

Concrete headwall located on waterward side.

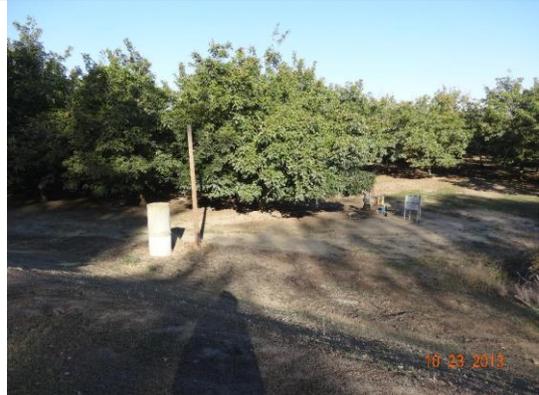
Photo 3 of 3 : UCIP_SP_2020_23966_42127.jpg

LM Start	7.82	Rating **	M	Issue No.	124 (cont)
LM End	7.82	Issue Type +	En	Location *

Stand pipe located on landward side.

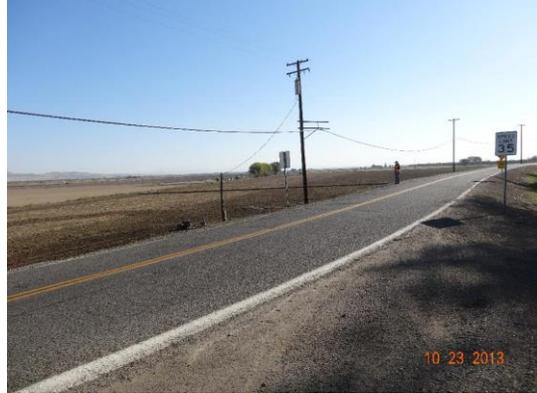
Photo 1 of 3 : UCIP_SP_2020_24191_42677.jpg

Comment Code					
Inspector Comment					
DS_ID:21389 FS_ID:24191 EP_NO: 1264 Repair Type: Non-Urgent Crossing Status: Indicator Found UCIP Comments: Need to coordinate with owner to determine status of crossing. If crossing is no longer in use owner will need to contact the CVFPB to comply with Title 23. This crossing is referenced in the USACE Periodic Inspection as item USACE_CESPK_MRD2_2012_p_0124. FIELD_STRUCT_DESC: *ABANDONED* 10-inch (not 14-inch as specified in the permit) irrigation discharge pipe of an unknown material through the levee, 5 feet below the crown. Pump on the waterside (WS). Double concrete discharge box at the landside (LS) toe. (Plans for installing an irrigation pumping plant and a 14-inch steel discharge pipe through the levee authorized under Permit No. 1264, 1948 - Robert Chesney). [Additional Reference(s): DWR Levee Log, 2007]. FS Date: 10/23/2013

View of levee crown at crossing.

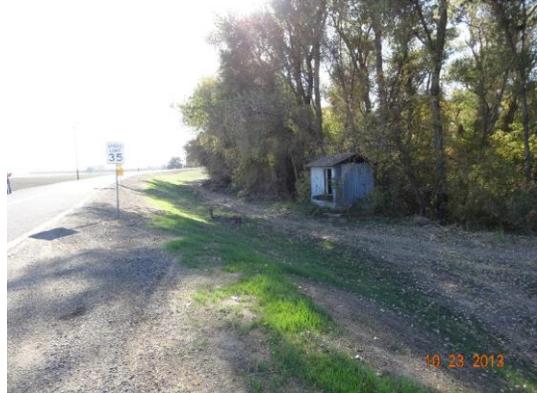
Photo 2 of 3 : UCIP_SP_2020_24191_42678.jpg

LM Start	7.92	Rating **	M	Issue No.	125 (cont)
LM End	7.92	Issue Type +	En	Location *

View of waterward side--only pump house of nearby crossing located downstream from crossing.

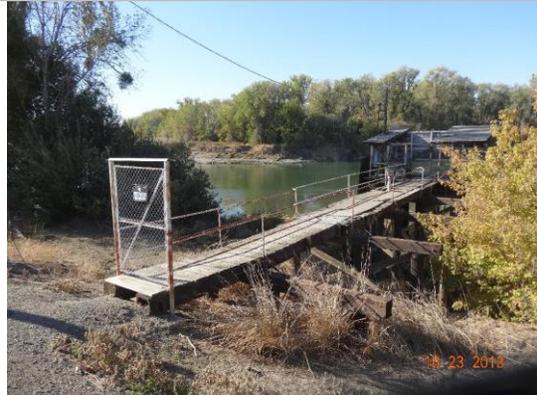
Photo 1 of 3 : UCIP_SP_2020_24108_42463.jpg

Comment Code					
Inspector Comment					
DS_ID:21423 FS_ID:24108 EP_NO: 9971 Repair Type: Non-Urgent Crossing Status: Found UCIP Comments: Will need to contact owner. Need to obtain maintenance records and clarify modifications made to crossing (size). This crossing is referenced in the USACE Periodic Inspection as item USACE_CESPK_MRD2_2012_p_0433. FIELD_STRUCT_DESC: [Meridian Farms Water Company Pumping Plant No. 3] 2 of 3: 16-inch irrigation discharge pipe of an unknown material (not a 30-inch pipe, as mentioned in the desk study) through the levee, 20.5 feet below the crown. Gate valve on the waterside (WS) end. Pump on a pile structure in the stream. Wooden walkway to the pump. Concrete distribution box on the landside (LS). (Retention of a 30-inch steel pipe through the levee, 20.5 feet below the crown, a pump, a gate valve, and a concrete distribution box authorized under Automatic Board Order (ABO) issued as Permit No. 9971, 1974 - Georgia Chesney, Life Estate. Plans to demolish and remove the existing Meridian Diversion Pumping Facility and the existing Drexler Diversion Pumping Facility and to construct a new Meridian Diversion Pumping Facility with two retractable fish screens and a 72-inch gravity feed intake pipe under the levee authorized under Permit No. 18762, 2013 - Meridian Farms Water Company). [Additional Reference(s): DWR Levee Log, 2007]. FS Date: 10/23/2013

View of landward side--pump station and walkway

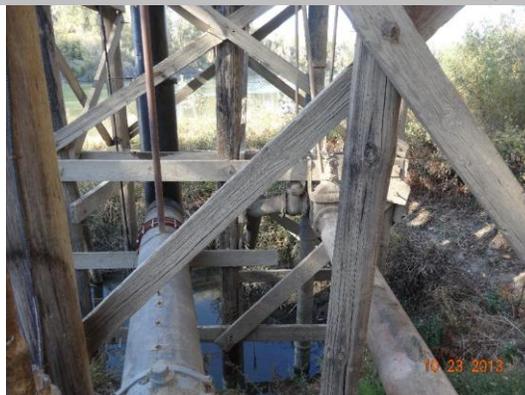
Photo 3 of 3 : UCIP_SP_2020_24108_42464.jpg

LM Start	9.00	Rating **	M	Issue No.	128 (cont)
LM End	9.00	Issue Type +	En	Location *	
Category	Supplemental			GPS Latitude/Longitude	
				Start	End
Item	DWR UCIP Field Study			39.110878 °	39.110878 °
				-121.902775 °	-121.902775 °
DWR ID	21423

View of 16-inch pipe and 24-inch pipe located on waterward side.

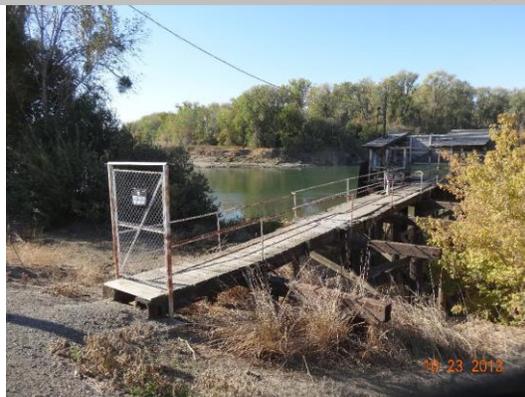
Photo 1 of 3 : UCIP_SP_2020_24107_42457.jpg

DS_ID:21394
 FS_ID:24107
 EP_NO: N/A
 Repair Type: Non-Urgent
 Crossing Status: Found
 UCIP Comments: This pump station is to be demolished. This crossing will need to be updated once the work has been completed. This crossing is referenced in the USACE Periodic Inspection as item USACE_CESPK_MRD2_2012_p_0433.
 FIELD_STRUCT_DESC: [Meridian Farms Water Company Pumping Plant No. 3] 3 of 3: 24-inch irrigation discharge pipe of an unknown material through the levee, 20.5 feet below the crown. Gate valve on the waterside (WS) end. Pump on a pile structure in the stream. Wooden walkway to the pump. Concrete distribution box on the landside (LS). (Plans to demolish and remove the existing Meridian Diversion Pumping Facility and the existing Drexler Diversion Pumping Facility and to construct a new Meridian Diversion Pumping Facility with two retractable fish screens and a 72-inch gravity feed intake pipe under the levee authorized under Permit No. 18762, 2013 - Meridian Farms Water Company). [Additional Reference(s): DWR Levee Log, 2007].

View of waterward side--pump station and walkway.

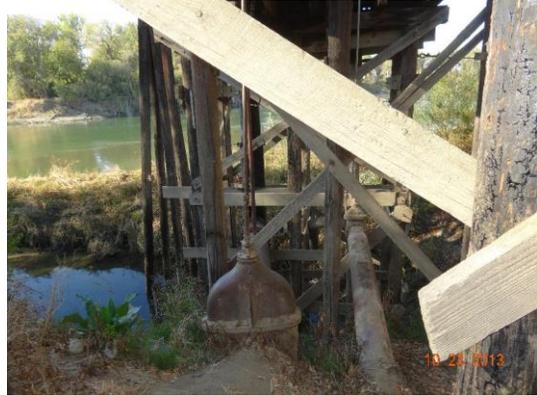
Photo 2 of 3 : UCIP_SP_2020_24107_42458.jpg

LM Start	9.01	Rating **	M	Issue No.	129 (cont)
LM End	9.01	Issue Type +	En	Location *	
Category	Supplemental			GPS Latitude/Longitude	
				Start	End
Item	DWR UCIP Field Study			39.110869 °	39.110869 °
				-121.902771 °	-121.902771 °
DWR ID	21394

View of 16-inch pipe and 24-inch pipe through levee on waterward side.

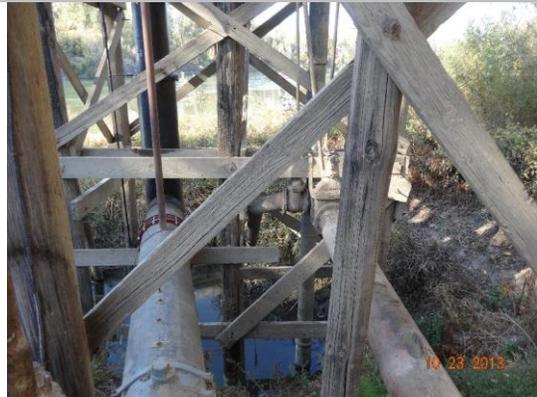
Photo 3 of 3 : UCIP_SP_2020_24107_42461.jpg

LM Start	9.01	Rating **	M	Issue No.	129 (cont)
LM End	9.01	Issue Type +	En	Location *

View of pipes located on waterward side.

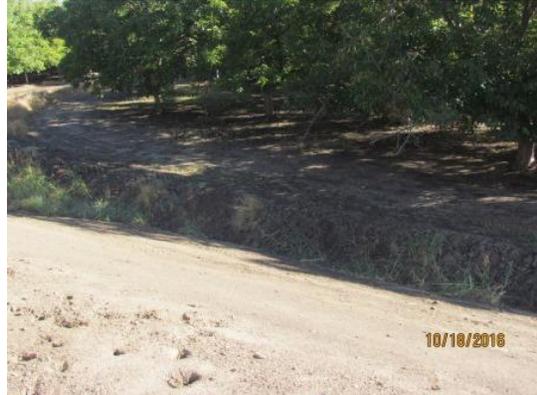
Photo 1 of 1 : SP_2020_RD0070_30_62_20200226_00007.jpg

LM Start	9.57	Rating **	M	Issue No.	62
LM End	9.70	Issue Type +	En	Location *	LS
Category	Earthen Levee		GPS Latitude/Longitude		
			Start	End	
Item	Encroachments		39.103192 °	39.101213 °	
			-121.899606 °	-121.899380 °	
DWR ID	DWR_RD0070_02_f_2016_62				
Comment Code					
DT : Ditch					
Inspector Comment

View of a ditch along the landside toe.

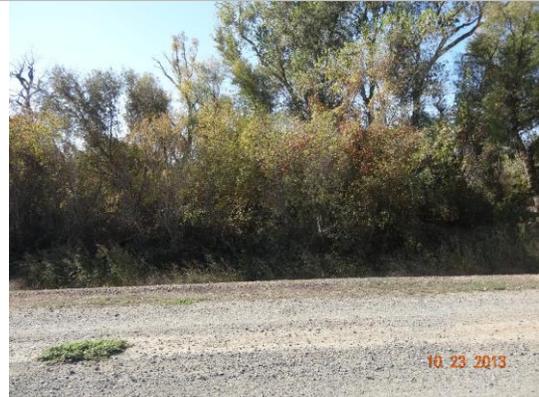
Photo 1 of 3 : UCIP_SP_2020_23967_42129.jpg

Comment Code					
Inspector Comment					
DS_ID:21396 FS_ID:23967 EP_NO: N/A Repair Type: Non-Urgent Crossing Status: Indicator Found UCIP Comments: No evidence of pipe is visible on waterward side. Need to coordinate with owner to determine status of crossing. If crossing is no longer in use owner will need to contact the CVFPB to comply with Title 23. This crossing is referenced in the USACE Periodic Inspection as item USACE_CESPK_MRD2_2012_p_0477. FIELD_STRUCT_DESC: *ABANDONED* 12-inch pipe of an unknown material or purpose through the levee, 3.1 feet below the crown. Siphon breaker in a corrugated metal pipe (CMP) riser on the landside (LS) shoulder. Concrete plug on the LS end. Wooden distribution box on the LS at the discharge end. (Cat. IV-A). [Additional Reference(s): DWR Levee Log, 2007. USACE Sacramento O&M Manual 134, June 1953, (Station 813+00)]. FS Date: 10/23/2013

View of waterward side.

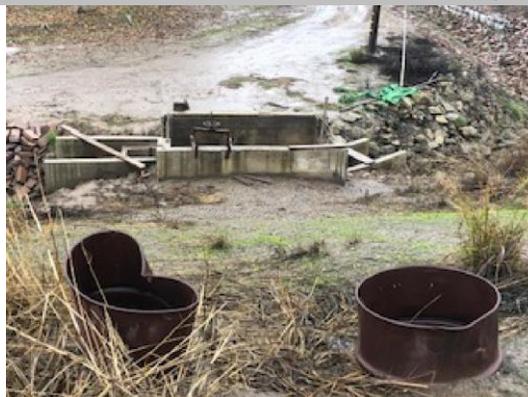
Photo 3 of 3 : UCIP_SP_2020_56122_83368.jpg

LM Start	10.40	Rating **	U	Issue No.	132 (cont)
LM End	10.40	Issue Type +	En	Location *	
Category	Supplemental			GPS Latitude/Longitude	
				Start	End
Item	DWR UCIP Field Study			39.093699 °	39.093699 °
				-121.892553 °	-121.892553 °
DWR ID	21430

View of WS at crossing. Photo courteously provided by CVFPB.

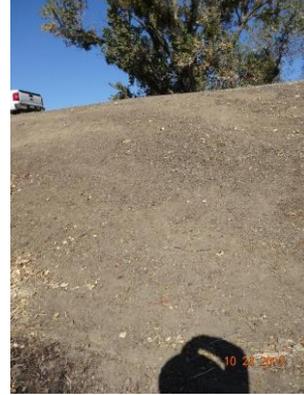
Photo 2 of 3 : UCIP_SP_2020_24197_42698.jpg

LM Start	11.61	Rating **	M	Issue No.	133 (cont)
LM End	11.61	Issue Type +	En	Location *	
Category	Supplemental			GPS Latitude/Longitude	
				Start	End
Item	DWR UCIP Field Study			39.080517 °	39.080517 °
				-121.890574 °	-121.890574 °
DWR ID	21400

View of landward slope.

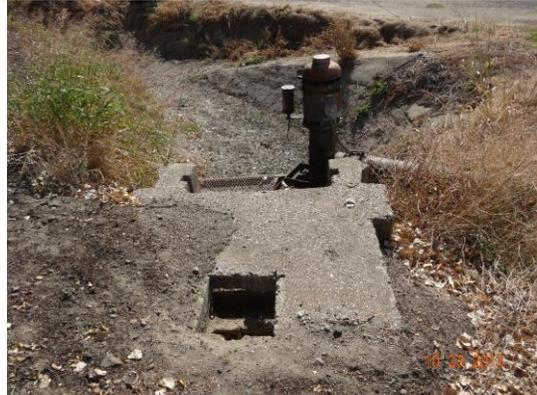
Photo 3 of 3 : UCIP_SP_2020_24197_42697.jpg

View of concrete slab with pump located on landward side.

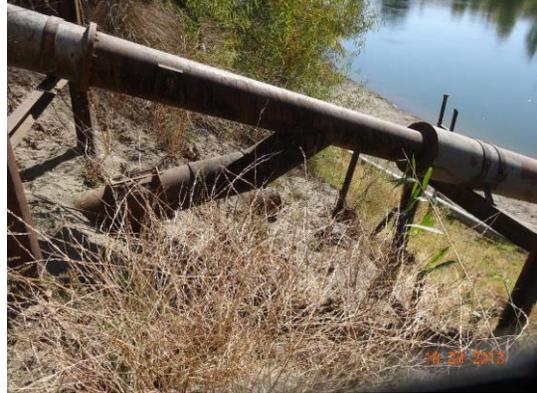
Photo 2 of 3 : UCIP_SP_2020_47033_42139.jpg

Comment Code					
Inspector Comment					
DS_ID:21402 FS_ID:47033 EP_NO: 9997 Repair Type: Non-Urgent Crossing Status: Found UCIP Comments: Debris found on waterward side along berm running parallel to levee. Two crossing found--Need to coordinate with owner to determine permit for second crossing and status of crossing. If crossing is no longer in use owner will need to contact the CVFPB to comply with Title 23. Dense vegetation limits the inspector's visibility to identify signs of pipe failure (leaks) along the waterward slope. Recommend removing vegetation along pipe alignment to conduct proper inspection of structure and appurtenances. This crossing is referenced in the USACE Periodic Inspection as item USACE_CESPK_MRD2_2012_p_0559. FIELD_STRUCT_DESC: 12-inch steel irrigation discharge pipe through the levee, 3.5 feet below the crown. Siphon breaker in a corrugated metal pipe (CMP) riser on the landside (LS) shoulder. Pump and control valve on the waterside (WS). Power pole on the WS shoulder. Discharge box at the LS toe. (Retention of a 12-inch steel pipe through the levee, 3.5 feet below the crown, a pump, a control valve, a siphon breaker, and a discharge box authorized under Automatic Board Order (ABO) issued as Permit No. 9997, 1974 - H. and Anne M. Rohleder). [Additional Reference(s): DWR Levee Log, 2007. USACE Sacramento O&M Manual 134, June 1953, (Station 930+22)]. FS Date: 10/23/2013

LM Start	12.37	Rating **	M	Issue No.	134 (cont)
LM End	12.37	Issue Type +	En	Location *	
Category	Supplemental			GPS Latitude/Longitude	
				Start	End
Item	DWR UCIP Field Study			39.072540 °	39.072540 °
				-121.887807 °	-121.887807 °
DWR ID	21402

Pipe crossing on waterward side. Second pipe comes out approximately 3 feet downstream from this crossing.

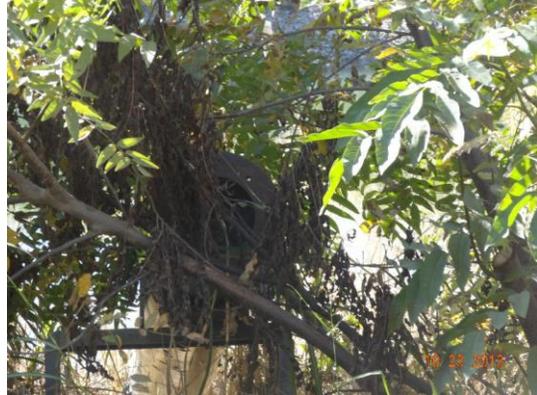
Photo 3 of 3 : UCIP_SP_2020_47033_42143.jpg

Pipe section exposed unable to determine if it is still in use.

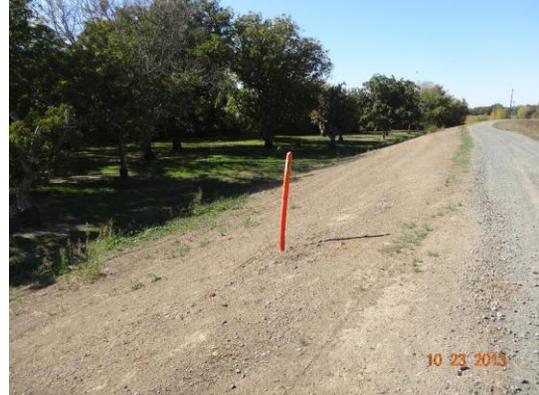
Photo 1 of 3 : UCIP_SP_2020_23984_42172.jpg

Comment Code					
Inspector Comment					
DS_ID:21403 FS_ID:23984 EP_NO: 3800 Repair Type: Non-Urgent Crossing Status: Indicator Found UCIP Comments: Need to contact owner to determine if crossing is still active and to determine last inspection date. Will need copy of letter showing crossings passed inspection. This crossing is referenced in the USACE Periodic Inspection as item USACE_CESPK_MRD2_2012_p_0568. FIELD_STRUCT_DESC: 20-inch coated steel natural gas pipeline through the levee, 3 feet below the crown. Concrete cutoff wall around the pipe at the center of the levee. Marker sign on the waterside (WS) shoulder. Natural gas equipment pad at the landside (LS) toe. (Plans to construct and maintain a 20-inch gas line across the Sacramento River authorized under Permit No. 3800, 1961 - Pacific Gas and Electric Company [PG&E]). [Additional Reference(s): DWR Levee Log, 2007]. FS Date: 10/23/2013

Marker located on waterward side.

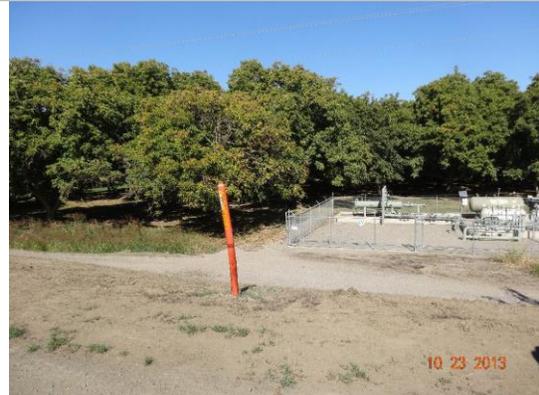
Photo 2 of 3 : UCIP_SP_2020_23984_42171.jpg

Marker on landward side.

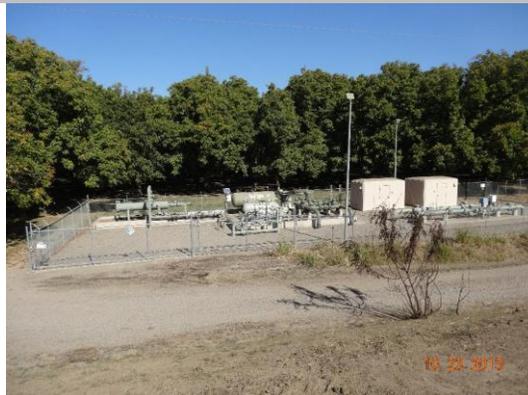
Photo 3 of 3 : UCIP_SP_2020_23984_42170.jpg

LM Start	12.46	Rating **	M	Issue No.	135 (cont)
LM End	12.46	Issue Type +	En	Location *	
Category	Supplemental			GPS Latitude/Longitude	
				Start	End
Item	DWR UCIP Field Study			39.072512 °	39.072512 °
				-121.886000 °	-121.886000 °
DWR ID	21403

Additional appurtenances located on landward side.

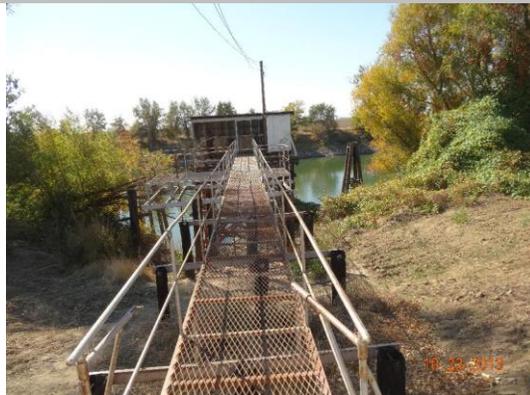
Photo 1 of 3 : UCIP_SP_2020_24229_42848.jpg

Comment Code					
Inspector Comment					
DS_ID:21421 FS_ID:24229 EP_NO: 9990 Repair Type: Non-Urgent Crossing Status: Found UCIP Comments: Need to determine if crossings are still being used. This crossing is referenced in the USACE Periodic Inspection as item USACE_CESPK_MRD2_2012_p_0685. FIELD_STRUCT_DESC: 1 of 2: 24-inch steel irrigation discharge pipe sleeved through a 30-inch coated steel pipe through the levee, 24 feet below the crown. Gate valve on the waterside (WS) end. Concrete headwall with a flap gate on the landside (LS). Pump on a pile structure in the stream. Wooden walkway to the pump. (Retention of two 24-inch steel pipes through the levee, 24 feet below the crown, two pumps, and two gate valves authorized under Automatic Board Order (ABO) issued as Permit No. 9990, 1974 - Newhall Land and Farming Company). [Additional Reference(s): DWR Levee Log, 2007. USACE Sacramento O&M Manual 134, June 1953, (Station 1086+55)]. FS Date: 10/23/2013

Walkway and pump house on waterward side.

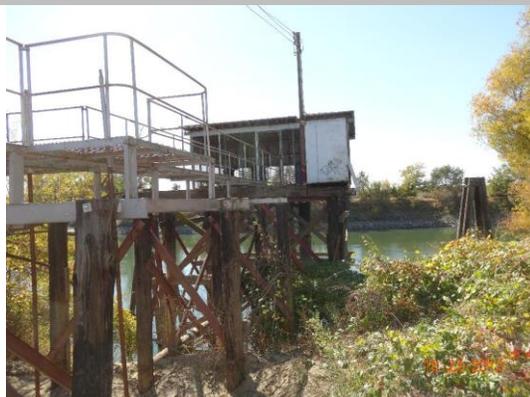
Photo 2 of 3 : UCIP_SP_2020_24229_42849.jpg

Pump house located on waterward side.
