**Flood Control Project Maintenance
Levee Inspections**

Fall 2019 Levee Maintenance Deficiency Summary Report

Reclamation District No. 0150 Merrit Island

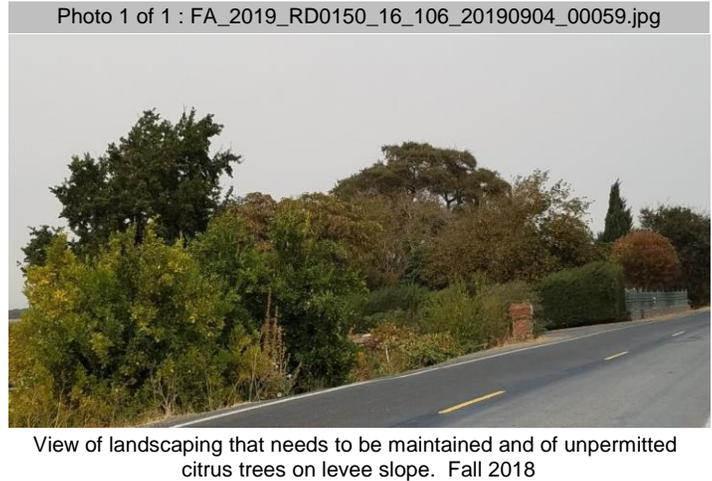
LM Start	0.14	Rating **	U	Issue No.	106
LM End	0.16	Issue Type +	En	Location *	LS
Category	Earthen Levee		GPS Latitude/Longitude		
			Start	End	
Item	Vegetation		38.329782°	38.330058°	
			-121.574820°	-121.574574°	
DWR ID	DWR_RD0150_02_s_2018_106				
Comment Code					
V6 : Landscaping					
Inspector Comment					
Landowner needs to maintain vegetation and remove unpermitted fruit trees on levee slope and cactus.

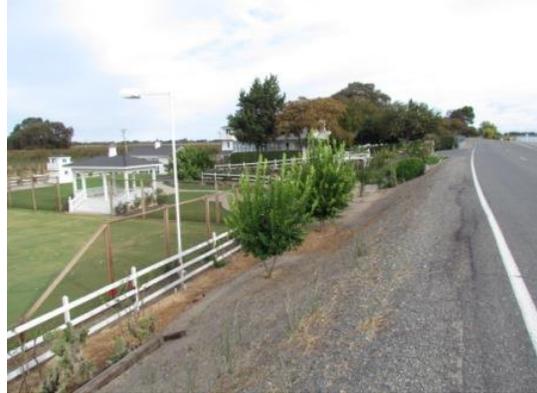
Photo 1 of 1 : FA_2019_RD0150_16_990_20190904_00068.jpg

LM Start	0.17	Rating **	M	Issue No.	990
LM End	0.21	Issue Type +	En	Location *	LS
Category	Earthen Levee			GPS Latitude/Longitude	
				Start	End
Item	Vegetation			38.330173°	38.330576°
				-121.574490°	-121.574093°
DWR ID	DWR_RD0150_02_s_2012_990				
Comment Code					
V6 : Landscaping					
Inspector Comment					
Rose bushes and persimmon tree are planted on the levee slope and easement.

Landscaping was found on the landside of the levee looking upstream.

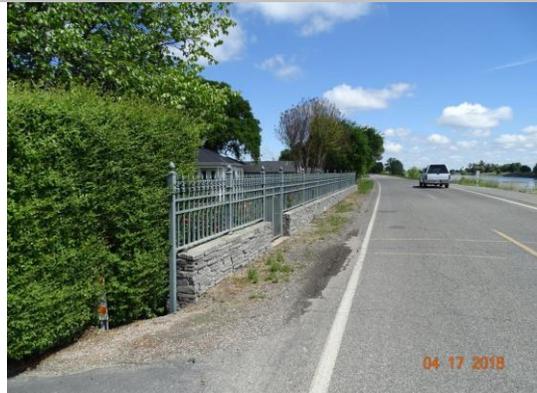
Photo 1 of 1 : FA_2019_RD0150_16_105_20190904_00058.jpg

LM Start	0.18	Rating **	U	Issue No.	105
LM End	0.20	Issue Type +	En	Location *	LS
Category	Earthen Levee			GPS Latitude/Longitude	
				Start	End
Item	Encroachments			38.330339°	38.330500°
				-121.574311°	-121.574138°
DWR ID	DWR_RD0150_02_s_2018_105				
Comment Code					
FE : Fence					
Inspector Comment					
The landowner has installed a fence that is blocking access to the levee.

Iron fence was not included under Permit 17359-A; only retaining wall, terraced slope, and steps were approved on landside. Spring 2018

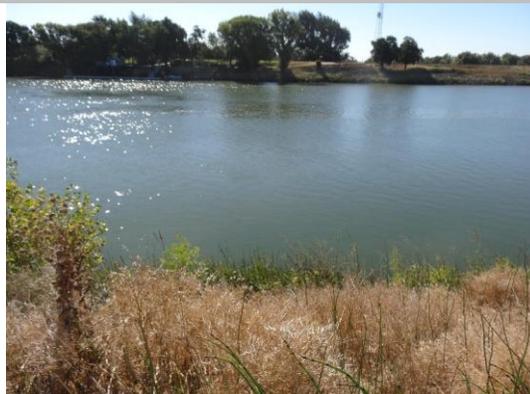
Photo 1 of 3 : UCIP_FA_2019_42700_34247.jpg

WS view: No pipe found on waterside slope. Dense vegetation on waterside.

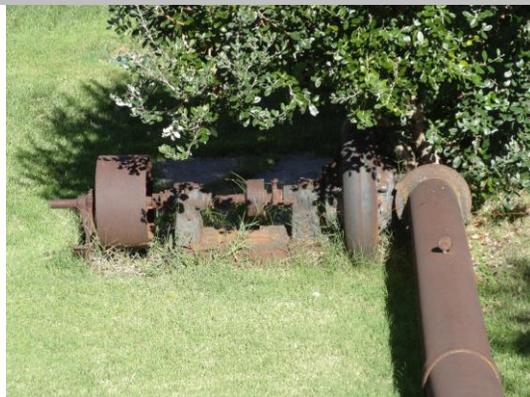
Photo 2 of 3 : UCIP_FA_2019_42700_34246.jpg

LS view: abandoned pipe and pump on landside toe.

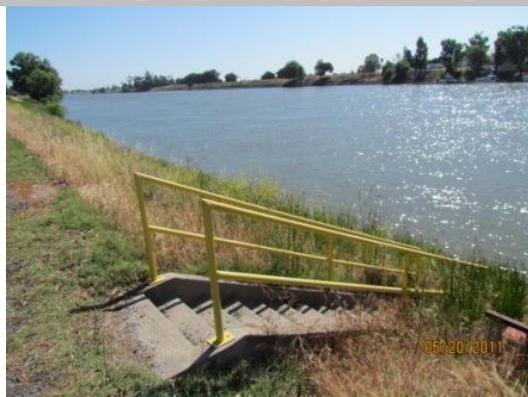
Photo 1 of 1 : FA_2019_RD0150_16_13_20190904_00005.jpg

LM Start	0.38	Rating **	M	Issue No.	13
LM End	0.38	Issue Type +	En	Location *	WS
Category	Earthen Levee			GPS Latitude/Longitude	
				Start	End
Item	Encroachments			38.332647°	38.332647°
				-121.572140°	-121.572140°
DWR ID	DWR_RD0150_02_s_2012_13				
Comment Code					
ST : Stairway					
Inspector Comment

A stairway was found on the waterside of the levee. The picture was taken from the crown looking upstream. Spring 2011

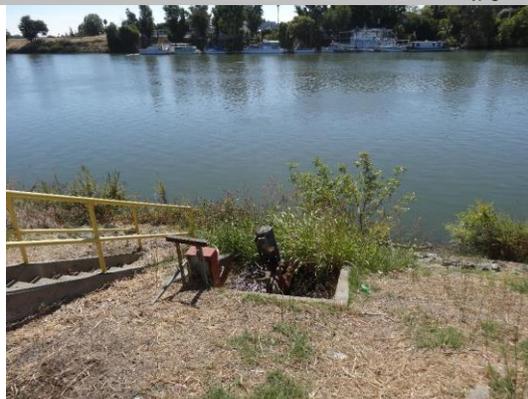
Photo 1 of 3 : UCIP_FA_2019_20268_34244.jpg

Comment Code					
Inspector Comment					
DS_ID:22417 FS_ID:20268 EP_NO: N/A Repair Type: Non-Urgent Crossing Status: Found UCIP Comments: - Water leaks from pressure breaker.- Distribution box at the landward toe not found/visible.- Service pole on LS toe. FIELD_STRUCT_DESC: 4-inch steel irrigation discharge pipe joined to a 6-inch steel irrigation discharge pipe which is in turn joined to a 10-inch steel irrigation discharge pipe through the levee, 5.8 feet below the crown. 1.5-inch electrical conduit through the levee, 3 feet below the crown. Pump and gate valve on the waterside (WS) slope. (Retention of an irrigation pumping plant, centrifugal pump, and gate valve on the WS levee slope with a 10-inch pipe through the levee authorized under Permit No. 9448, 1974 - William N. Runyon). [Additional Reference(s): DWR Levee Log, 2005]. FS Date: 8/27/2013

WS view: walkway/stairs, pump on levee slope.

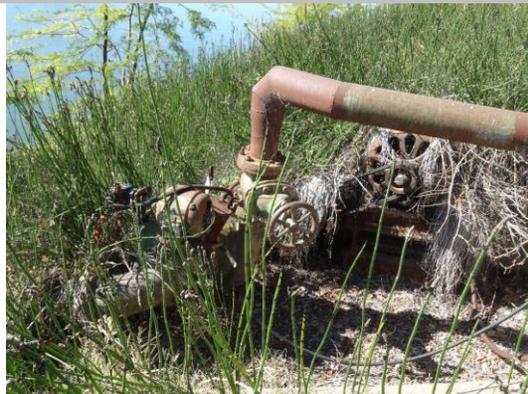
Photo 3 of 3 : UCIP_FA_2019_20267_34237.jpg

Comment Code					
Inspector Comment					
DS_ID:22418 FS_ID:20267 EP_NO: N/A Repair Type: Non-Urgent Crossing Status: Found UCIP Comments: - Abandoned pipe and pump.- Needs proper abandonment. FIELD_STRUCT_DESC: 6-inch steel irrigation discharge pipe and a 1-inch electrical conduit through the levee, invert elevation 3.5 feet below the crown. Pump and gate valve on the waterside (WS) slope. Electrical box on the WS slope. (Retention of an irrigation pumping plant, centrifugal pump, and gate valve on the WS with a 6-inch pipe through the levee authorized under Permit No. 9447, 1974 - Reuben A. Gentner). [Additional Reference(s): DWR Levee Log, 2005. USACE Sacramento O&M Manual 112, March 1957, (RM 34.47)]. FS Date: 8/27/2013

WS view: steel pipe, gate valve, and pump on levee slope. Seems abandoned.

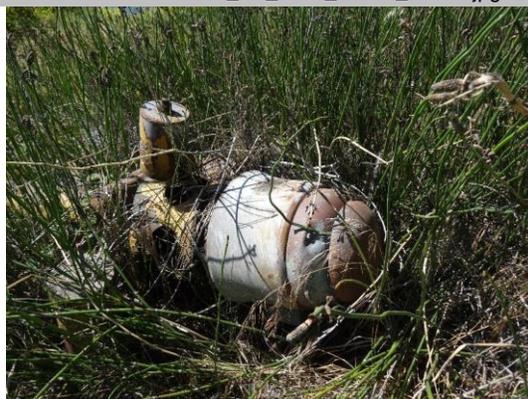
Photo 1 of 2 : UCIP_FA_2019_20284_34265.jpg

WS view: abandoned pump on levee slope. Dense vegetation on waterside.

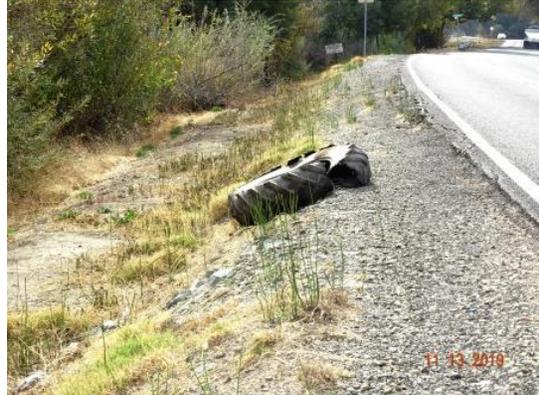
Photo 1 of 1 : FA_2019_RD0150_16_35_20191121_00121.jpg

LM Start	0.65	Rating **	M	Issue No.	35
LM End	0.65	Issue Type +	Ma	Location *	WS
Category	Earthen Levee		GPS Latitude/Longitude		
			Start	End	
Item	Encroachments		38.335490°	38.335490°	
			-121.568917°	-121.568917°	
DWR ID	DWR_RD0150_02_f_2019_35				
Comment Code					
DE : Debris					
Inspector Comment

View of tire on waterside slope. Fall 2019

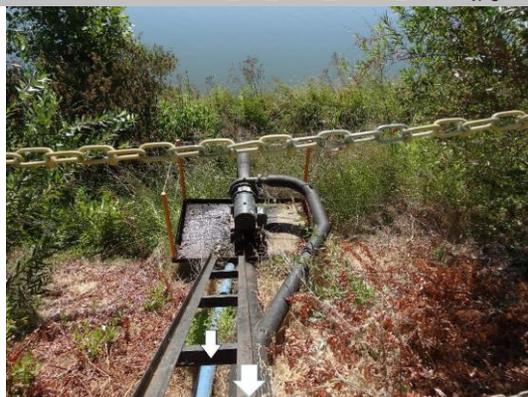
Photo 1 of 3 : UCIP_FA_2019_20303_34287.jpg

Comment Code					
Inspector Comment					
DS_ID:22421 FS_ID:20303 EP_NO: 16109 Repair Type: Non-Urgent Crossing Status: Found UCIP Comments: - 10" steel pipe on both sides of the levee. According to permit and inspectors note- 16" steel pipe through the levee.- concrete standpipe inside water filtration plant on landside toe.- air pressure tank on waterside steel deck. FIELD_STRUCT_DESC: 16-inch wrapped steel irrigation discharge pipe and a 2-inch electrical conduit through the levee, invert elevation 6.2 feet below the crown. Slant pump on a steel platform on the waterside (WS) slope. 4-inch abandoned pipe on the WS slope. Concrete standpipe and power pole at the landside (LS) toe. (Plans to replace an existing irrigation pipe with a 16-inch wrapped steel pipe through the levee, construct a 3-foot-square concrete anchorage block on the WS slope, and install a 2-inch utility pipe through the levee authorized under Permit No. 18258-Revised, 2007 - Wilson Farms, Inc). [Additional Reference(s): DWR Levee Log, 2005, 14-inch pipe referenced. USACE Sacramento O&M Manual 112, March 1957, (RM 34.71), 14-inch pipe referenced]. FS Date: 8/27/2013

WS view: slant pump on steel deck, 4-inch pipe (left) and 10-inch pipe (right) on levee slope.

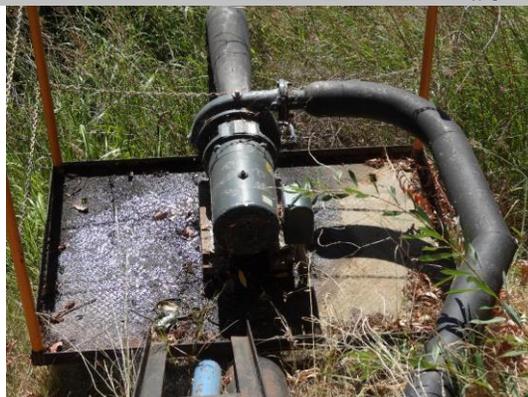
Photo 2 of 3 : UCIP_FA_2019_20303_34286.jpg

WS view: steel pipes and leaky slant pump on steel deck.

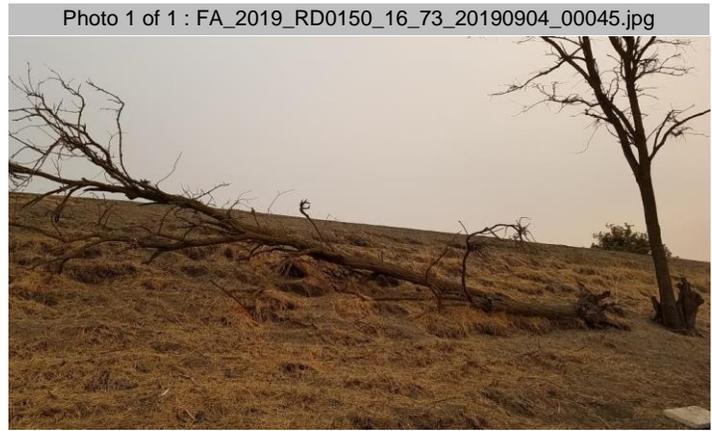
LM Start	0.79	Rating **	M	Issue No.	73
LM End	0.79	Issue Type +	Ma	Location *	LS
Category	Earthen Levee			GPS Latitude/Longitude	
				Start	End
Item	Encroachments			38.337307°	38.337307°
				-121.567698°	-121.567698°
DWR ID	DWR_RD0150_02_f_2017_73				
Comment Code					
TR : Tree or limb					
Inspector Comment					
The dead tree needs to be removed from the levee slope.

View of fallen tree on landside levee slope. Fall 2018

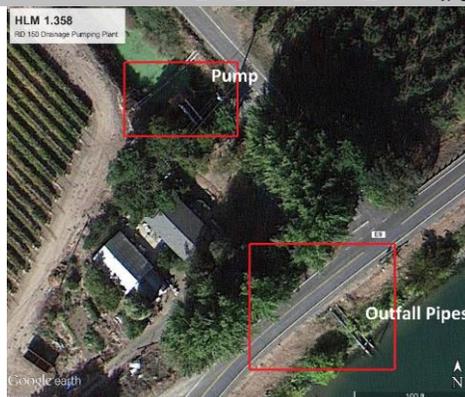
Photo 1 of 3 : UCIP_FA_2019_20727_34889.jpg

Comment Code					
Inspector Comment					
DS_ID:22393 FS_ID:20727 EP_NO: 18221 Repair Type: Non-Urgent Crossing Status: Found UCIP Comments: Pump house and drainage ditch about 250 feet from the levee on landside.Pumps on piling structure with shed in drainage ditch.Siphon breaker cover missing. Needs to fix it. FIELD_STRUCT_DESC: [Reclamation District No. 150 (RD0150) Drainage Plant] 1 of 2: 30-inch steel drainage discharge pipe through the levee, 7 feet below the crown. Flap gate on the waterside (WS) end. Siphon breaker on the WS slope. Pump on a piling structure with a shed in the drainage ditch. (Plans to replace existing 36-inch and 24-inch discharge pipes with 30-inch and 24-inch steel discharge pipes through the levee authorized under Permit No. 18221, 2007 - RD0150). [Additional Reference(s): DWR Levee Log, 2005, 36-inch pipe referenced, 9 feet below the crown. USACE Sacramento O&M Manual 112, March 1957, (RM 35.36), 36-inch pipe referenced, invert elevation 9 feet below the crown]. FS Date: 8/27/2013

Bird's eye view: outfall pipes (bottom) and pump structure in drainage ditch (top)

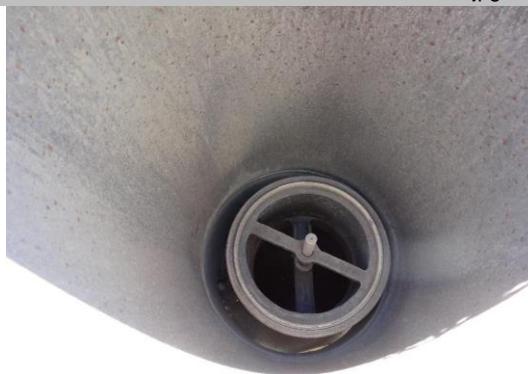
Photo 2 of 3 : UCIP_FA_2019_20727_34888.jpg

WS view: siphon breaker in pipe riser on levee shoulder.

Comment Code					
Inspector Comment					
DS_ID:22393 FS_ID:20727 EP_NO: 18221 Repair Type: Non-Urgent Crossing Status: Found UCIP Comments: Pump house and drainage ditch about 250 feet from the levee on landside.Pumps on piling structure with shed in drainage ditch.Siphon breaker cover missing. Needs to fix it. FIELD_STRUCT_DESC: [Reclamation District No. 150 (RD0150) Drainage Plant] 1 of 2: 30-inch steel drainage discharge pipe through the levee, 7 feet below the crown. Flap gate on the waterside (WS) end. Siphon breaker on the WS slope. Pump on a piling structure with a shed in the drainage ditch. (Plans to replace existing 36-inch and 24-inch discharge pipes with 30-inch and 24-inch steel discharge pipes through the levee authorized under Permit No. 18221, 2007 - RD0150). [Additional Reference(s): DWR Levee Log, 2005, 36-inch pipe referenced, 9 feet below the crown. USACE Sacramento O&M Manual 112, March 1957, (RM 35.36), 36-inch pipe referenced, invert elevation 9 feet below the crown]. FS Date: 8/27/2013

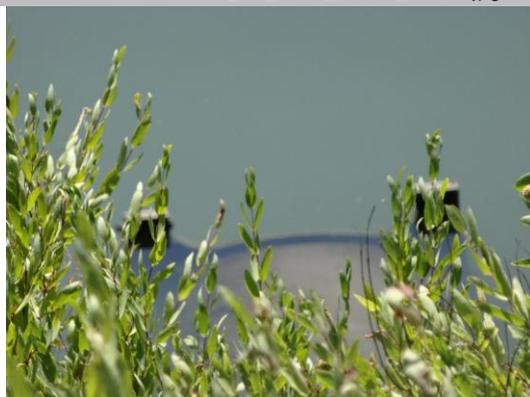
Photo 3 of 3 : UCIP_FA_2019_20727_34887.jpg

WS view: submerged flap gate in the stream.

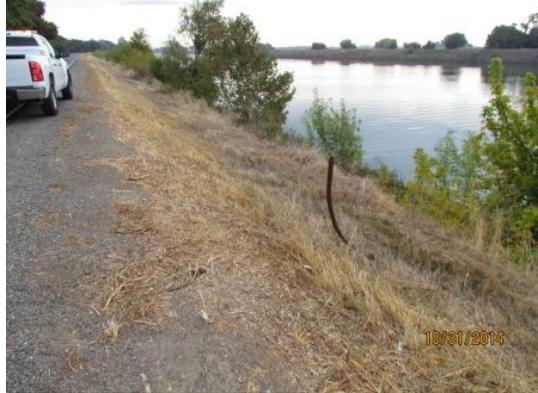
Photo 1 of 1 : FA_2019_RD0150_16_48_20190904_00022.jpg

LM Start	1.73	Rating **	M	Issue No.	48
LM End	1.73	Issue Type +	En	Location *	WS
Category	Earthen Levee		GPS Latitude/Longitude		
			Start	End	
Item	Encroachments		38.345583°	38.345583°	
			-121.554507°	-121.554507°	
DWR ID	DWR_RD0150_02_f_2014_48				
Comment Code					
PO : Pole					
Inspector Comment					
Remove pipe protruding from WS slope as it's a hazard for maintenance equipment and personnel.

A pole/pipe was found on the waterside slope of the levee looking upstream. Fall 2014

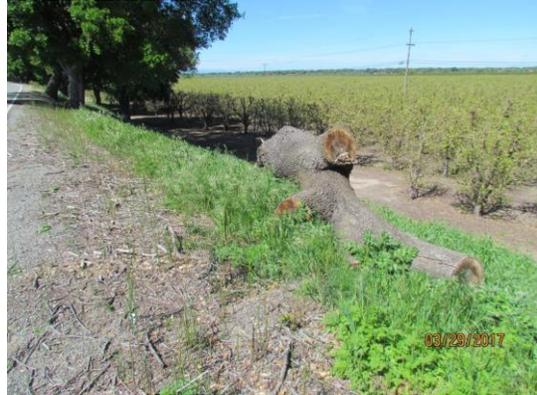
Photo 1 of 1 : FA_2019_RD0150_16_63_20190904_00041.jpg

LM Start	2.10	Rating **	M	Issue No.	63
LM End	2.10	Issue Type +	Ma	Location *	LS
Category	Earthen Levee		GPS Latitude/Longitude		
			Start	End	
Item	Encroachments		38.347002°	38.347002°	
			-121.547803°	-121.547803°	
DWR ID	DWR_RD0150_02_f_2016_63				
Comment Code					
TR : Tree or limb					
Inspector Comment

Remove the log from the landside slope of the levee.

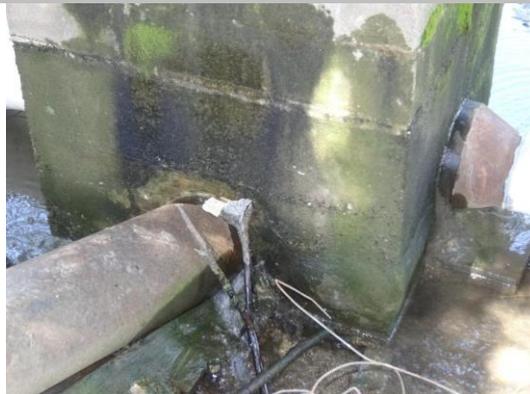
Photo 3 of 3 : UCIP_FA_2019_20731_34903.jpg

LM Start	2.14	Rating **	M	Issue No.	998 (cont)
LM End	2.14	Issue Type +	En	Location *	
Category	Supplemental			GPS Latitude/Longitude	
				Start	End
Item	DRAFT DWR UCIP Field Study			38.347032°	38.347032°
				-121.547159°	-121.547159°
DWR ID	22396				
Comment Code					
Inspector Comment					
DS_ID:22396 FS_ID:20731 EP_NO: N/A Repair Type: Non-Urgent Crossing Status: Found UCIP Comments: - Operating during inspection. Leaky joint at the concrete box.- Power overhead crossing. Power pole at waterside shoulder, and landside toe. FIELD_STRUCT_DESC: 12-inch steel irrigation discharge pipe through the levee, invert elevation 5 feet below the crown. Slant pump on the waterside (WS) slope. Power pole on the WS shoulder. [Additional Reference(s): DWR Levee Log, 2005. USACE Sacramento O&M Manual 112, March 1957, (RM 36.17)]. FS Date: 8/27/2013

LS view: leaky concrete distribution box on levee toe.

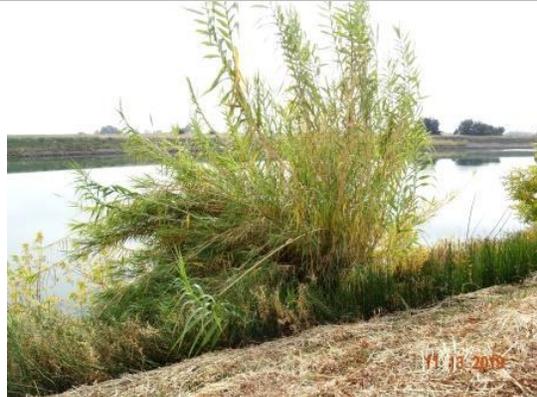
Photo 1 of 1 : FA_2019_RD0150_16_36_20191121_00122.jpg

LM Start	2.38	Rating **	M	Issue No.	36
LM End	2.38	Issue Type +	Ma	Location *	WS
Category	Earthen Levee		GPS Latitude/Longitude		
			Start	End	
Item	Vegetation		38.347477°	38.347477°	
			-121.542680°	-121.542680°	
DWR ID	DWR_RD0150_02_f_2019_36				
Comment Code					
V2 : Remove the wild growth other than native grasses from the levee slopes.					
Inspector Comment					
Remove invasive Arundo growth.

View of Arundo growth. Fall 2019

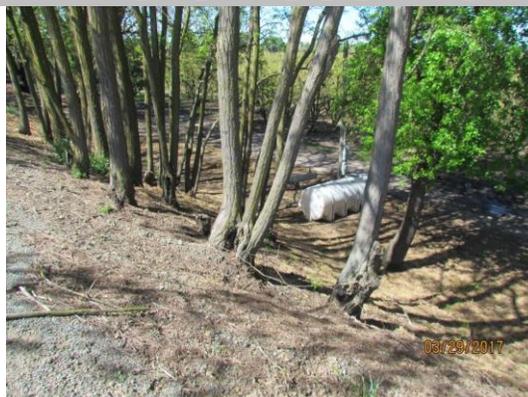
Photo 1 of 1 : FA_2019_RD0150_16_70_20190904_00044.jpg

LM Start	2.72	Rating **	M	Issue No.	70
LM End	2.72	Issue Type +	En	Location *	LS
Category	Earthen Levee			GPS Latitude/Longitude	
				Start	End
Item	Encroachments			38.349777°	38.349777°
				-121.537247°	-121.537247°
DWR ID	DWR_RD0150_02_s_2017_70				
Comment Code					
TA : Tank					
Inspector Comment

A tank was found on the landside toe of the levee. Spring 2017

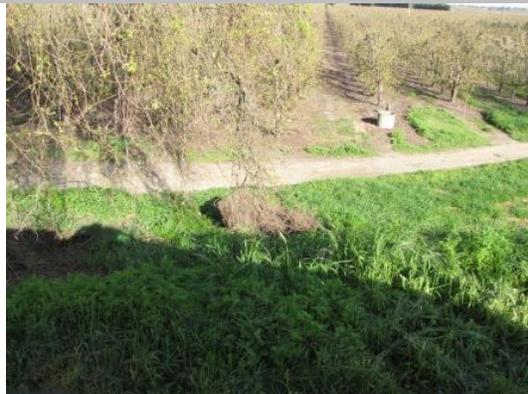
Photo 1 of 1 : FA_2019_RD0150_16_14_20190904_00006.jpg

LM Start	2.75	Rating **	N	Issue No.	14
LM End	2.75	Issue Type +	Ma	Location *	LS
Category	Earthen Levee			GPS Latitude/Longitude	
				Start	End
Item	Trim / Thin Trees			38.350041 °	38.350041 °
				-121.536853 °	-121.536853 °
DWR ID	DWR_RD0150_02_s_2012_14				
Comment Code					
T5 : Tree stumps.					
Inspector Comment

View of a tree stump on the landward slope.

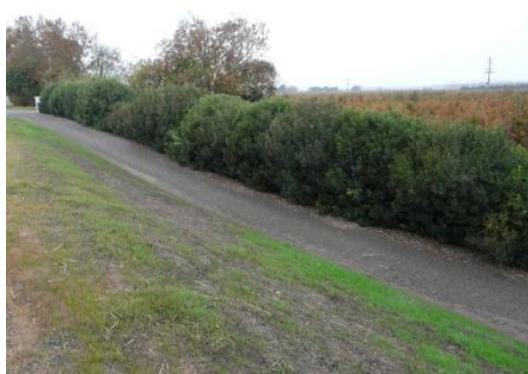
Photo 1 of 1 : FA_2019_RD0150_16_85_20190904_00053.jpg

LM Start	2.97	Rating **	U	Issue No.	85
LM End	3.01	Issue Type +	En	Location *	LS
Category	Earthen Levee			GPS Latitude/Longitude	
				Start	End
Item	Vegetation			38.352372 °	38.352802 °
				-121.534127 °	-121.533638 °
DWR ID	DWR_RD0150_02_s_2012_85				
Comment Code					
V6 : Landscaping					
Inspector Comment

Landscaping providing a screen for a residence on the landside of levee.

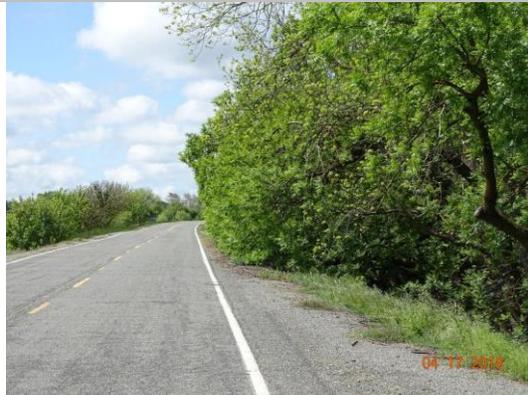
Photo 1 of 1 : FA_2019_RD0150_16_95_20190904_00057.jpg

LM Start	3.08	Rating **	U	Issue No.	95
LM End	3.10	Issue Type +	En	Location *	LS
Category	Earthen Levee			GPS Latitude/Longitude	
				Start	End
Item	Vegetation			38.353541 °	38.353822 °
				-121.532844 °	-121.532574 °
DWR ID	DWR_RD0150_02_s_2018_95				
Comment Code					
V6 : Landscaping					
Inspector Comment					
Trim trees on the landside slope.

Vegetation landside looking southwest. Spring 2018

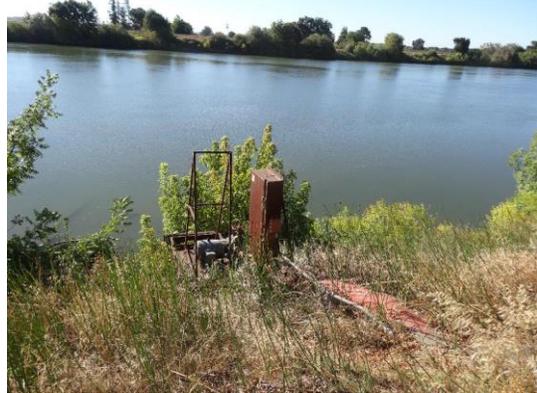
Photo 1 of 3 : UCIP_FA_2019_20736_34917.jpg

Comment Code					
Inspector Comment					
DS_ID:22402 FS_ID:20736 EP_NO: N/A Repair Type: Non-Urgent Crossing Status: Found UCIP Comments: - 10" steel pipe sleeved through 12" steel pipe.- main pipe bifurcates into two pipes on LS slope and connected to standpipe and concrete box.- 2" electric conduit on WS and power pole on LS.- needs filling into gap between 10" and 12" steel pipes on LS. FIELD_STRUCT_DESC: 12-inch steel irrigation discharge pipe through the levee, invert elevation 4 feet below the crown. Pump on a piling structure in the river. Concrete standpipe and concrete distribution box at the landside (LS) toe. (A. Green). [Additional Reference(s): DWR Levee Log, 2005. USACE Sacramento O&M Manual 112, March 1957, (RM 37.30)]. FS Date: 8/30/2013

WS view: pipe, conduit and pump on levee slope.

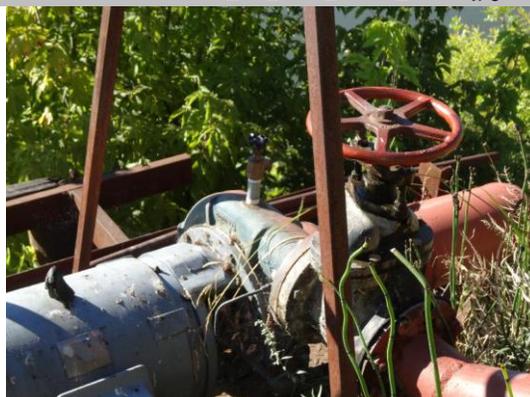
Photo 3 of 3 : UCIP_FA_2019_20736_34915.jpg

Comment Code					
Inspector Comment					
DS_ID:22402 FS_ID:20736 EP_NO: N/A Repair Type: Non-Urgent Crossing Status: Found UCIP Comments: - 10" steel pipe sleeved through 12" steel pipe.- main pipe bifurcates into two pipes on LS slope and connected to standpipe and concrete box.- 2" electric conduit on WS and power pole on LS.- needs filling into gap between 10" and 12" steel pipes on LS. FIELD_STRUCT_DESC: 12-inch steel irrigation discharge pipe through the levee, invert elevation 4 feet below the crown. Pump on a piling structure in the river. Concrete standpipe and concrete distribution box at the landside (LS) toe. (A. Green). [Additional Reference(s): DWR Levee Log, 2005. USACE Sacramento O&M Manual 112, March 1957, (RM 37.30)]. FS Date: 8/30/2013

WS view: pipe and pump on levee slope. Gate valve and air vent on the pipe.

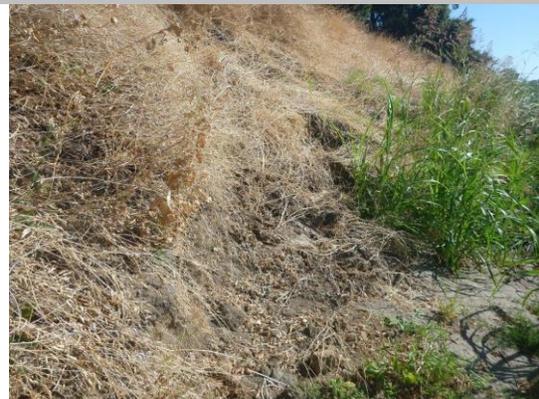
Photo 1 of 3 : LEVAL_FA_2019_287_2143.jpg

LM Start	3.42	Rating **	A/W	Issue No.	47
LM End	3.46	Issue Type +	Ma	Location *	WS
Category	Supplemental			GPS Latitude/Longitude	
				Start	End
Item	2017 Storm Damage			38.357183°	38.357631°
				-121.528547°	-121.527981°
DWR ID	LMA-113

Comment Code					
Inspector Comment					
Levee Evaluation Comments					
Description: The flood damage consists of a waterside erosion approximately 229 feet long on the west (right) bank of the Sacramento River. See attached pages for photos.					
Site ID No: 287					
Site Designation: LMA-113					
Repair Type: Erosion					
Rating: Serious					
Field Date: 7/17/2017					
Notes: Crown is a paved road. Erosion scarps upto 10 ft deep and within 5 ft of crown. Worse conditions on the DS end. Exposed filter fabric. Serious because of depth of erosion into levee, weak soil, and proximity to crown which is a high traffic public road. 2019 Spring DWR Inspection: Erosion was not visible. Slope appears to be intact to at least 5-10' from levee shoulder.

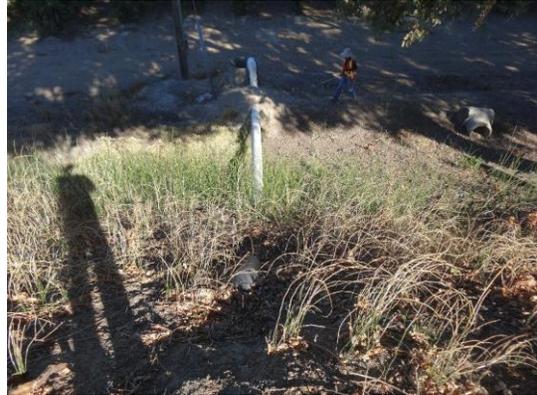
Photo 3 of 3 : UCIP_FA_2019_19846_33725.jpg

Comment Code					
Inspector Comment					
DS_ID:22403 FS_ID:19846 EP_NO: N/A Repair Type: Non-Urgent Crossing Status: Found UCIP Comments: - 8" pvc pipe sleeved into 12" steel pipe.- needs filling/grouting in gas between 8" pvc pipe and 12" steel pipe on WS.- 1.5" electric conduit on WS- 10" steel pipe extended to 8" pvc pipe on landside levee toe. FIELD_STRUCT_DESC: 12-inch steel irrigation discharge pipe through the levee, invert elevation 3 feet below the crown. Pump and gate valve on the waterside (WS) slope. (R. and J. Pylman). [Additional Reference(s): DWR Levee Log, 2005. USACE Sacramento O&M Manual 112, March 1957, (RM 37.56)]. FS Date: 8/30/2013

LS view: exposed pipe on levee slope and standpipe on the toe.

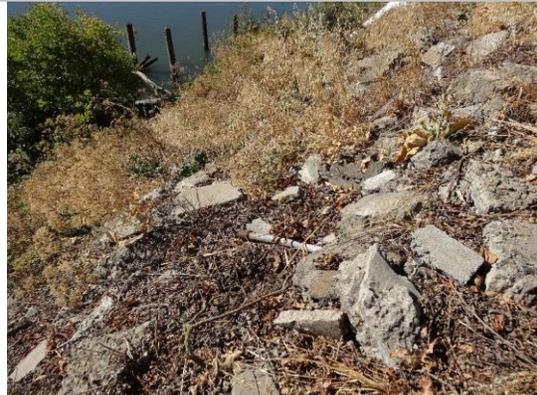
Photo 1 of 3 : UCIP_FA_2019_19848_33734.jpg

LM Start	3.51	Rating **	M	Issue No.	1001
LM End	3.51	Issue Type +	En	Location *	
Category	Supplemental			GPS Latitude/Longitude	
				Start	End
Item	DRAFT DWR UCIP Field Study			38.358131 °	38.358131 °
				-121.527540 °	-121.527540 °
DWR ID	22404				
Comment Code					
Inspector Comment					
DS_ID:22404 FS_ID:19848 EP_NO: N/A Repair Type: Non-Urgent Crossing Status: Found UCIP Comments: - needs proper abandonment. FIELD_STRUCT_DESC: *ABANDONED* 4-inch steel pipe of an unknown purpose on the landside (LS) slope. 1-inch steel conduit on the waterside (WS) slope was found. FS Date: 8/30/2013

WS view: abandoned 1-inch conduit on levee slope.

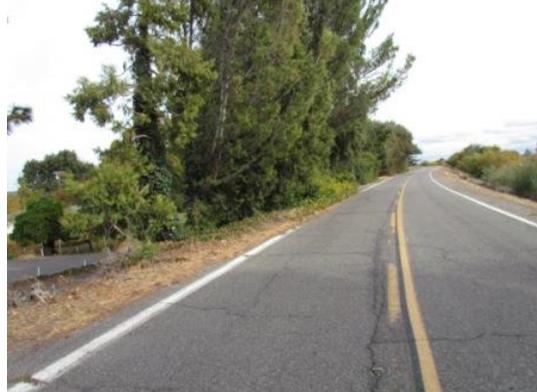
Photo 1 of 1 : FA_2019_RD0150_16_82_20190904_00051.jpg

LM Start	3.54	Rating **	U	Issue No.	82
LM End	3.67	Issue Type +	En	Location *	LS
Category	Earthen Levee			GPS Latitude/Longitude	
				Start	End
Item	Vegetation			38.358530°	38.359749°
				-121.527162°	-121.525245°
DWR ID	DWR_RD0150_02_s_2012_82				
Comment Code					
V6 : Landscaping					
Inspector Comment

Landscaping was blocking the visibility on the landside of the levee looking upstream.

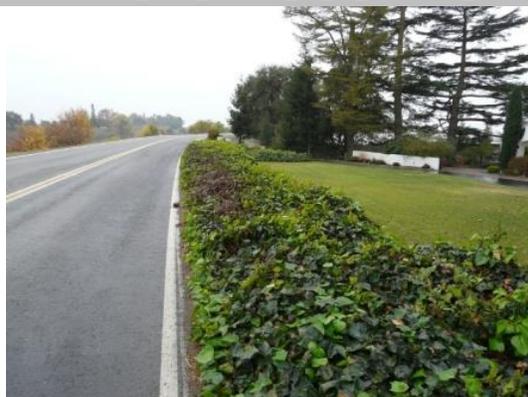
Photo 1 of 1 : FA_2019_RD0150_16_80_20190904_00050.jpg

LM Start	3.84	Rating **	U	Issue No.	80
LM End	3.87	Issue Type +	En	Location *	LS
Category	Earthen Levee		GPS Latitude/Longitude		
			Start	End	
Item	Vegetation		38.361442°	38.361812°	
			-121.523170°	-121.522908°	
DWR ID	DWR_RD0150_02_s_2012_80				
Comment Code					
V6 : Landscaping					
Inspector Comment

Landscaping in front of a residence on landside of levee. The levee in this location is greater than 100' wide.

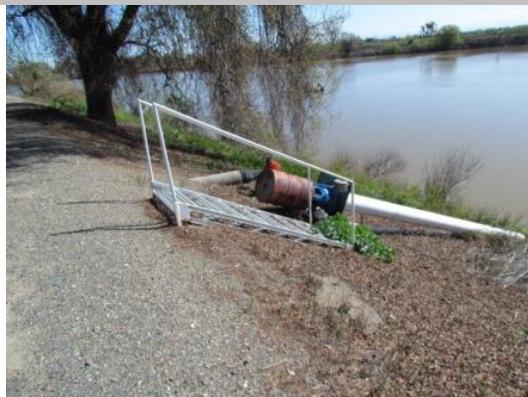
Photo 1 of 1 : FA_2019_RD0150_16_33_20190904_00010.jpg

LM Start	3.88	Rating **	M	Issue No.	33
LM End	3.88	Issue Type +	En	Location *	WS
Category	Earthen Levee		GPS Latitude/Longitude		
			Start	End	
Item	Encroachments		38.361970°	38.361970°	
			-121.522777°	-121.522777°	
DWR ID	DWR_RD0150_02_s_2012_33				
Comment Code					
ST : Stairway					
Inspector Comment

A stairway was found on the waterside slope of the levee.

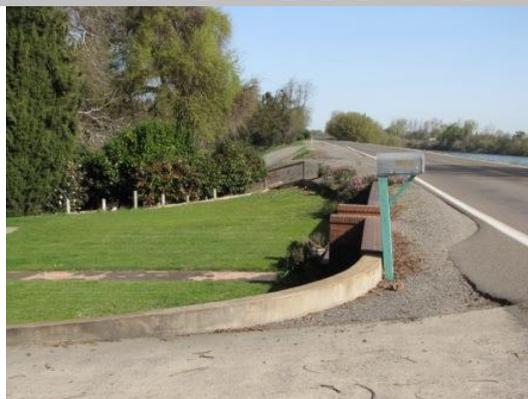
Photo 1 of 1 : FA_2019_RD0150_16_20_20190904_00007.jpg

LM Start	4.09	Rating **	M	Issue No.	20
LM End	4.09	Issue Type +	En	Location *	LS
Category	Earthen Levee		GPS Latitude/Longitude		
			Start	End	
Item	Encroachments		38.364948°	38.364948°	
			-121.522339°	-121.522339°	
DWR ID	DWR_RD0150_02_s_2012_20				
Comment Code					
BU : Building					
Inspector Comment					
A three foot retaining wall is located at the landward shoulder.

View of a retaining wall on the landward slope looking upstream.

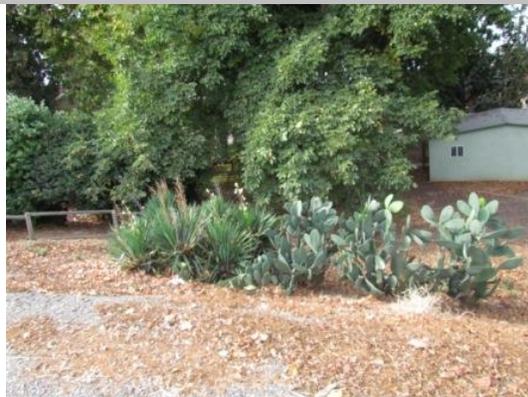
Photo 1 of 1 : FA_2019_RD0150_16_953_20190904_00062.jpg

LM Start	4.11	Rating **	M	Issue No.	953
LM End	4.11	Issue Type +	En	Location *	LS
Category	Earthen Levee		GPS Latitude/Longitude		
			Start	End	
Item	Vegetation		38.365267°	38.365267°	
			-121.522379°	-121.522379°	
DWR ID	DWR_RD0150_02_s_2012_953				
Comment Code					
V6 : Landscaping					
Inspector Comment					
Cactus plants are not permitted on levee slopes.

View of cacti on the landside of the levee looking from the crown.

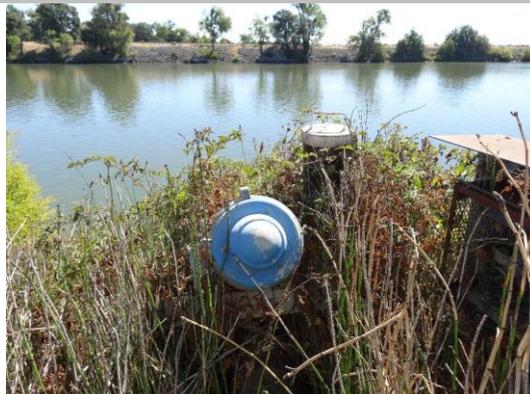
Photo 1 of 3 : UCIP_FA_2019_42702_33782.jpg

Comment Code					
Inspector Comment					
DS_ID:22407 FS_ID:42702 EP_NO: 13505 Repair Type: Non-Urgent Crossing Status: Found UCIP Comments: Appears abandoned and if so should be done so properly.- no pipe and structure found on landside.- siphon breaker in 24" CMP riser on waterside.- control box and electric conduit on waterside slope. FIELD_STRUCT_DESC: 14-inch steel irrigation discharge pipe through the levee, invert elevation 5 feet below the crown. Slant pump on the waterside (WS) slope. Siphon breaker on the WS slope in a corrugated metal pipe (CMP) riser. Control box and electrical conduit on the WS slope. (Plans to replace an existing pipeline with a 14-inch steel pipeline through the levee authorized under Permit No. 13505, 1982 - Gary Pylman). [Additional Reference(s): DWR Levee Log, 2005, 10-inch pipe referenced. USACE Sacramento O&M Manual 112, March 1957, (RM 38.24), 10-inch pipe referenced]. FS Date: 8/30/2013

WS view: slanted pump on levee slope.

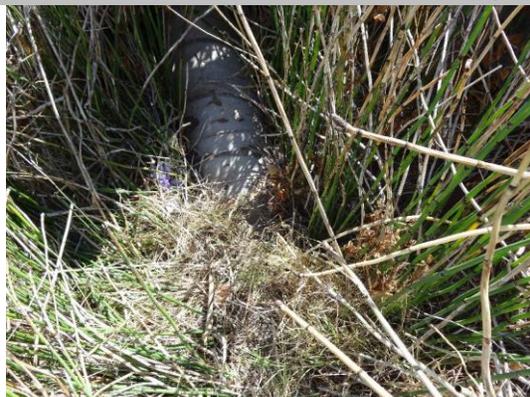
Photo 2 of 3 : UCIP_FA_2019_42702_33781.jpg

WS view: exposed 14-inch steel pipe on levee slope.

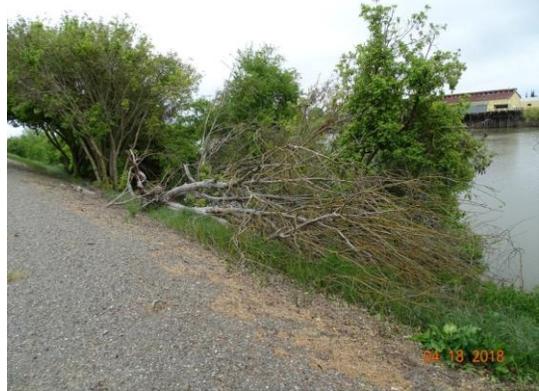
Photo 1 of 1 : FA_2019_RD0150_16_107_20190904_00060.jpg

LM Start	4.27	Rating **	M	Issue No.	107
LM End	4.27	Issue Type +	Ma	Location *	WS
Category	Earthen Levee			GPS Latitude/Longitude	
				Start	End
Item	Encroachments			38.367507°	38.367507°
				-121.522493°	-121.522493°
DWR ID	DWR_RD0150_02_s_2018_107				
Comment Code					
TR : Tree or limb					
Inspector Comment					
Remove fallen tree on the waterside slope.

View of fallen tree on waterside looking northeast. Spring 2018

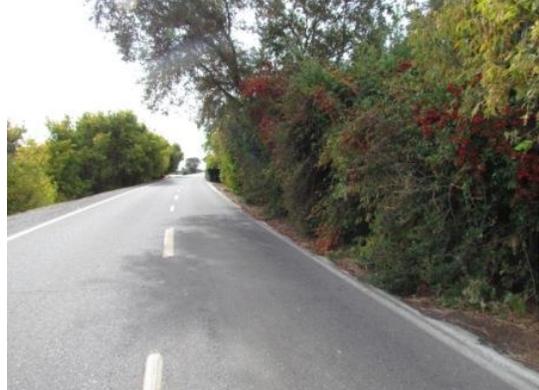
Photo 1 of 1 : FA_2019_RD0150_16_79_20190904_00049.jpg

LM Start	4.30	Rating **	U	Issue No.	79
LM End	4.31	Issue Type +	En	Location *	LS
Category	Earthen Levee			GPS Latitude/Longitude	
				Start	End
Item	Vegetation			38.368036°	38.368200°
				-121.522611°	-121.522667°
DWR ID	DWR_RD0150_02_s_2012_79				
Comment Code					
V6 : Landscaping					
Inspector Comment

Trees are obstructing the views on the landside slope of the levee looking downstream.

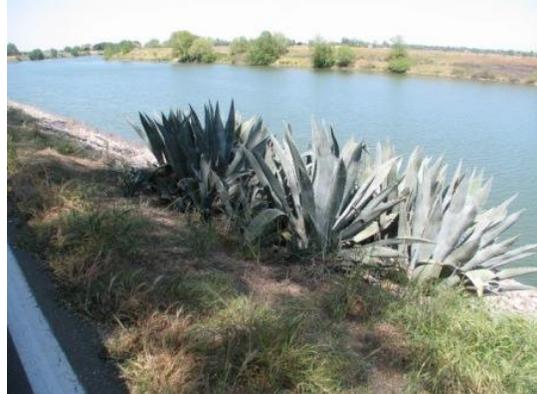
Photo 1 of 1 : FA_2019_RD0150_16_28_20190904_00009.jpg

LM Start	4.69	Rating **	M	Issue No.	28
LM End	4.69	Issue Type +	Ma	Location *	WS
Category	Earthen Levee		GPS Latitude/Longitude		
			Start	End	
Item	Vegetation		38.373485°	38.373485°	
			-121.523963°	-121.523963°	
DWR ID	DWR_RD0150_02_s_2012_28				
Comment Code					
V2 : Remove the wild growth other than native grasses from the levee slopes.					
Inspector Comment					
Remove Century plants from the levee slope.

View of century plants on waterward slope.

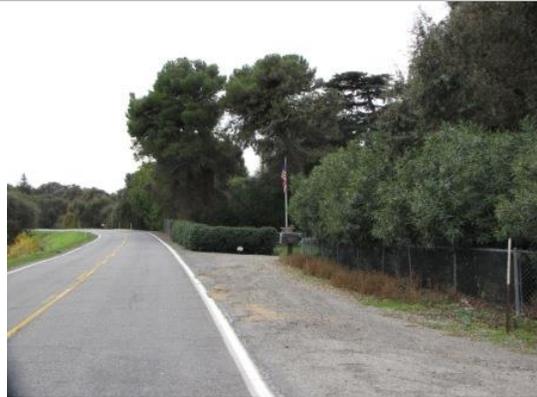
Photo 1 of 1 : FA_2019_RD0150_16_75_20190904_00047.jpg

LM Start	5.10	Rating **	U	Issue No.	75
LM End	5.14	Issue Type +	En	Location *	LS
Category	Earthen Levee		GPS Latitude/Longitude		
			Start	End	
Item	Vegetation		38.379198°	38.379839°	
			-121.525263°	-121.524968°	
DWR ID	DWR_RD0150_02_s_2012_75				
Comment Code					
V6 : Landscaping					
Inspector Comment					
Trees have been trimmed and thinned, but bushes still block visibility at levee shoulder.

View of landscaping along the landward shoulder and slope looking downstream.

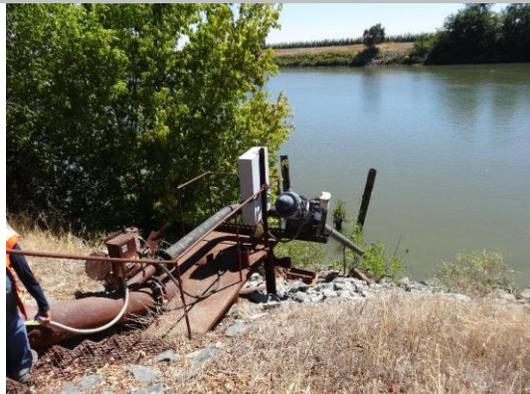
Photo 1 of 3 : UCIP_FA_2019_20740_34941.jpg

LM Start	5.24	Rating **	M	Issue No.	1003
LM End	5.24	Issue Type +	En	Location *	
Category	Supplemental			GPS Latitude/Longitude	
				Start	End
Item	DRAFT DWR UCIP Field Study			38.381079°	38.381079°
				-121.524166°	-121.524166°
DWR ID	22410				
Comment Code					
Inspector Comment					
DS_ID:22410 FS_ID:20740 EP_NO: N/A Repair Type: Non-Urgent Crossing Status: Found UCIP Comments: - 2" electric conduit and gate valve on WS.- abandoned old pump not removed from WS- working during field survey FIELD_STRUCT_DESC: 12-inch steel irrigation discharge pipe and a 2-inch electrical conduit through the levee, invert elevation 3 feet below the crown. Service pole and standpipe at the landside (LS) toe. (C. Sakai). [Additional Reference(s): DWR Levee Log, 2005. USACE Sacramento O&M Manual 112, March 1957, (RM 39.32)]. FS Date: 8/30/2013

WS view: pipe, walkway, slant pump & pump platform on stream bank.

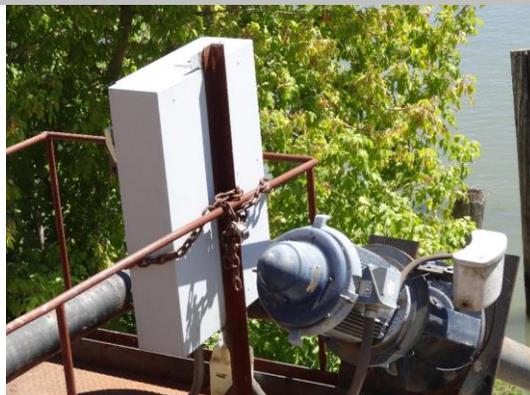
Photo 2 of 3 : UCIP_FA_2019_20740_34940.jpg

WS view: pipe, slant pump & pump platform on stream bank.

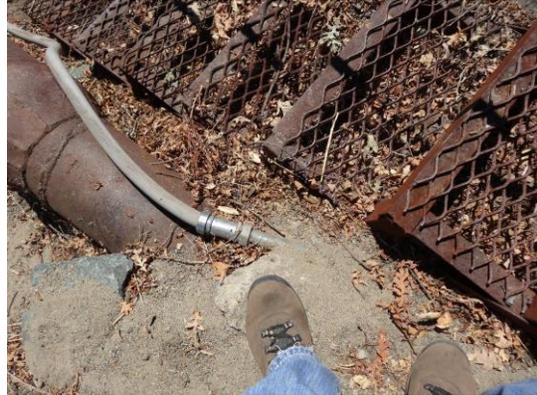
Photo 3 of 3 : UCIP_FA_2019_20740_34939.jpg

LM Start	5.24	Rating **	M	Issue No.	1003 (cont)
LM End	5.24	Issue Type +	En	Location *	
Category	Supplemental			GPS Latitude/Longitude	
				Start	End
Item	DRAFT DWR UCIP Field Study			38.381079°	38.381079°
				-121.524166°	-121.524166°
DWR ID	22410				
Comment Code					
Inspector Comment					
DS_ID:22410 FS_ID:20740 EP_NO: N/A Repair Type: Non-Urgent Crossing Status: Found UCIP Comments: - 2" electric conduit and gate valve on WS.- abandoned old pump not removed from WS- working during field survey FIELD_STRUCT_DESC: 12-inch steel irrigation discharge pipe and a 2-inch electrical conduit through the levee, invert elevation 3 feet below the crown. Service pole and standpipe at the landside (LS) toe. (C. Sakai). [Additional Reference(s): DWR Levee Log, 2005. USACE Sacramento O&M Manual 112, March 1957, (RM 39.32)]. FS Date: 8/30/2013

WS view: steel steps to pump platform, exposed steel pipe, and electric conduit on levee slope.

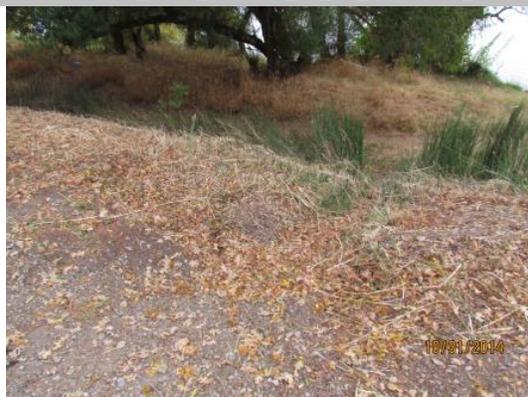
Photo 1 of 1 : FA_2019_RD0150_16_54_20190904_00035.jpg

LM Start	5.33	Rating **	M	Issue No.	54
LM End	5.33	Issue Type +	Ma	Location *	WS
Category	Earthen Levee			GPS Latitude/Longitude	
				Start	End
Item	Slope Stability			38.382072°	38.382072°
				-121.523220°	-121.523220°
DWR ID	DWR_RD0150_02_f_2014_54				
Comment Code					
S2 : Repair the levee slope damaged by foot traffic and prevent access where possible.					
Inspector Comment

View of slope instability on the waterside of the levee looking towards the toe. Fall 2014

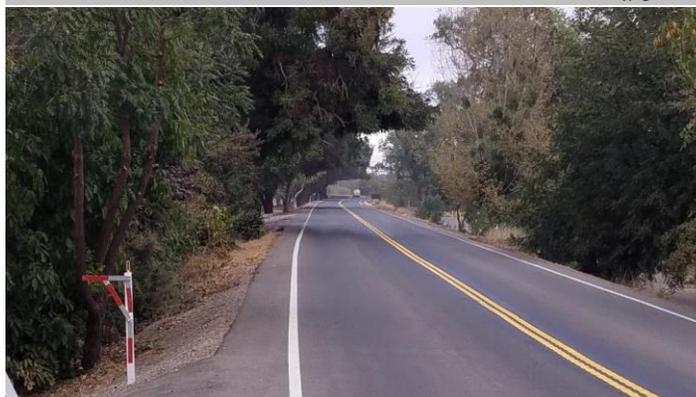
Photo 1 of 1 : FA_2019_RD0150_16_74_20190904_00046.jpg

LM Start	5.40	Rating **	M	Issue No.	74
LM End	5.41	Issue Type +	En	Location *	LS
Category	Earthen Levee			GPS Latitude/Longitude	
				Start	End
Item	Vegetation			38.382780°	38.382880°
				-121.522178°	-121.522008°
DWR ID	DWR_RD0150_02_s_2012_74				
Comment Code					
V6 : Landscaping					
Inspector Comment					
Landowner needs to thin landscaping.

View of dense landscaping on levee slope. Fall 2018

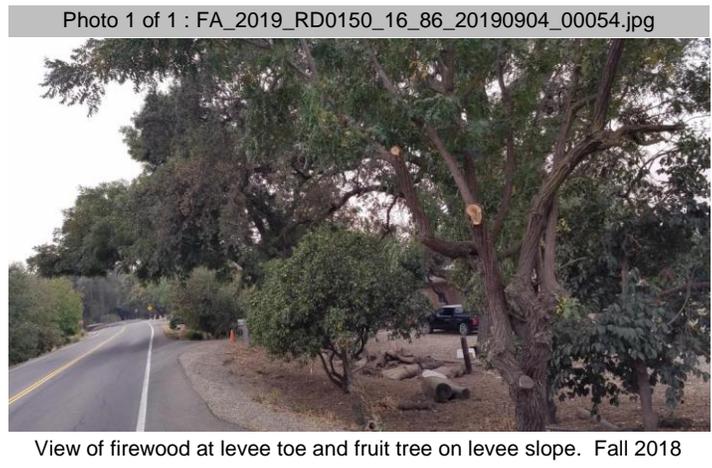
LM Start	5.44	Rating **	U	Issue No.	86
LM End	5.44	Issue Type +	En	Location *	LS
Category	Earthen Levee		GPS Latitude/Longitude		
			Start	End	
Item	Encroachments		38.383127°	38.383127°	
			-121.521603°	-121.521603°	
DWR ID	DWR_RD0150_02_s_2018_86				
Comment Code					
FW : Firewood					
Inspector Comment					
Firewood at the landside toe and fruit tree on the levee slope are not permitted and need to be removed.

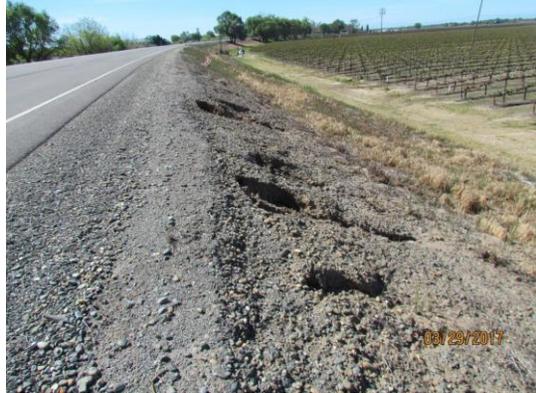
Photo 2 of 2 : FA_2019_RD0150_16_52_20190904_00029.jpg

LM Start	5.90	Rating **	M	Issue No.	52 (cont)
LM End	5.90	Issue Type +	Ma	Location *	LS
Category	Earthen Levee		GPS Latitude/Longitude		
			Start	End	
Item	Erosion / Bank Caving		38.387915°	38.387915°	
			-121.516002°	-121.516002°	
DWR ID	DWR_RD0150_02_f_2016_52				
Comment Code					
E2 : Schedule repair of erosion site prior to the next inspection.					
Inspector Comment					
Repair erosion due to runoff.

View of the erosion on the landside of the levee during spring 2017 inspection.

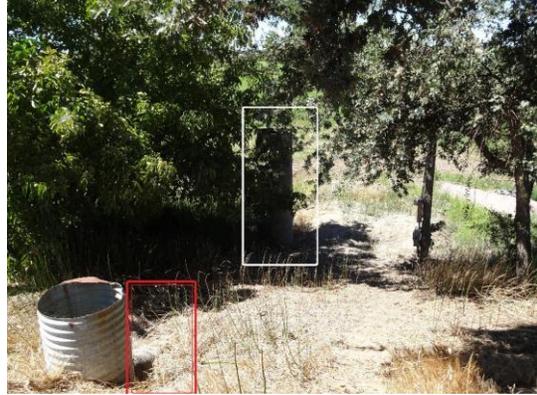
Photo 3 of 3 : UCIP_FA_2019_20748_34965.jpg

Comment Code					
Inspector Comment					
DS_ID:22412 FS_ID:20748 EP_NO: N/A Repair Type: Non-Urgent Crossing Status: Found UCIP Comments: - slope erosion due leaky siphon breaker at CMP riser- leaky pipe and pump- service pole on LS- 2" electric conduit on WS FIELD_STRUCT_DESC: 10-inch steel irrigation discharge pipe and an electrical conduit through the levee, invert elevation 4.8 feet below the crown. Slant pump on the waterside (WS) slope. Siphon breaker in a corrugated metal pipe (CMP) riser on the landside (LS) shoulder. Slope erosion on the LS at the siphon breaker. (Ed Boyles). [Additional Reference(s): DWR Levee Log, 2005. USACE Sacramento O&M Manual 112, March 1957, (RM 40.22)]. FS Date: 8/30/2013

LS view: siphon breaker in CMP riser (left) on levee slope and concrete standpipe at levee toe (right).

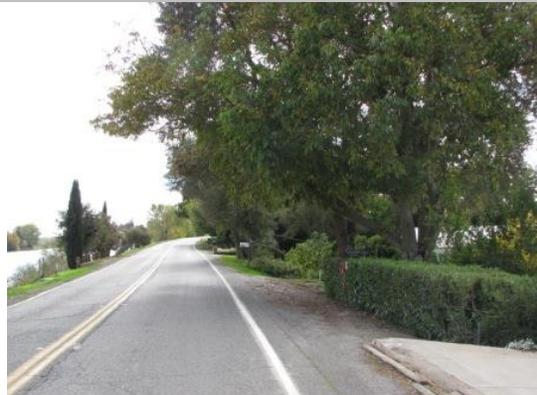
Photo 1 of 1 : FA_2019_RD0150_16_65_20190904_00043.jpg

LM Start	6.39	Rating **	U	Issue No.	65
LM End	6.46	Issue Type +	En	Location *	LS
Category	Earthen Levee			GPS Latitude/Longitude	
				Start	End
Item	Vegetation			38.394935°	38.395931°
				-121.514597°	-121.514604°
DWR ID	DWR_RD0150_02_s_2012_65				
Comment Code					
V6 : Landscaping					
Inspector Comment					
Thin out trees for slope visibility.

View of landscaping along the landside shoulder and slope looking downstream.

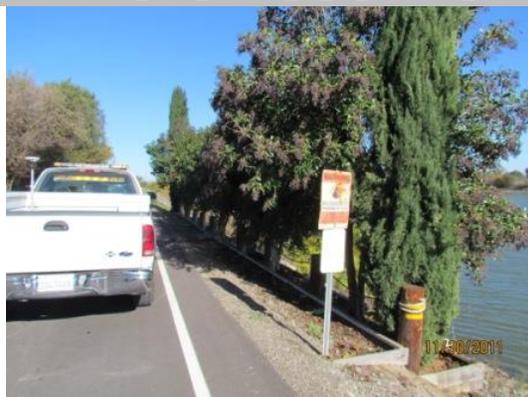
Photo 1 of 1 : FA_2019_RD0150_16_34_20190904_00011.jpg

LM Start	6.42	Rating **	M	Issue No.	34
LM End	6.42	Issue Type +	En	Location *	WS
Category	Earthen Levee			GPS Latitude/Longitude	
				Start	End
Item	Vegetation			38.395340 °	38.395340 °
				-121.514528 °	-121.514528 °
DWR ID	DWR_RD0150_02_s_2012_34				
Comment Code					
V6 : Landscaping					
Inspector Comment

Landscaping was found on the waterside of the levee looking upstream. Fall 2011

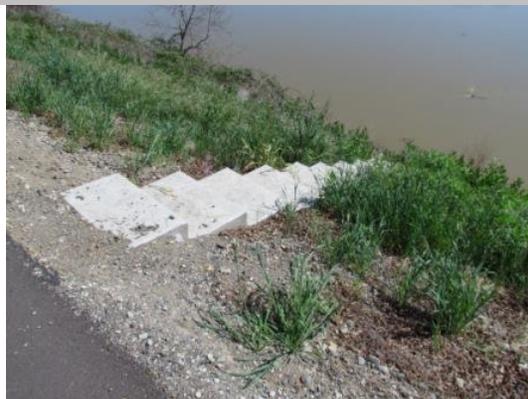
Photo 1 of 1 : FA_2019_RD0150_16_42_20190904_00013.jpg

LM Start	6.48	Rating **	M	Issue No.	42
LM End	6.48	Issue Type +	En	Location *	WS
Category	Earthen Levee			GPS Latitude/Longitude	
				Start	End
Item	Encroachments			38.396235 °	38.396235 °
				-121.514547 °	-121.514547 °
DWR ID	DWR_RD0150_02_s_2012_42				
Comment Code					
ST : Stairway					
Inspector Comment					
An unpermitted stairway is located on the waterside slope.

A stairway was found on the waterside slope of the levee looking upstream.

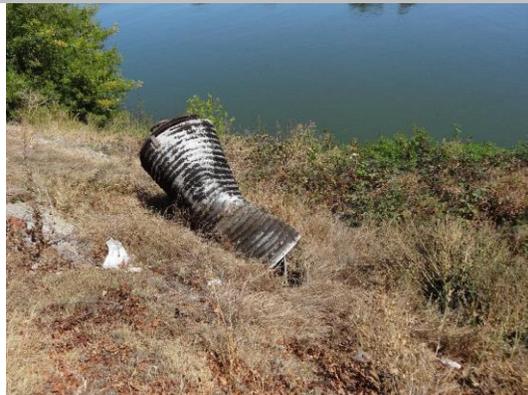
Photo 1 of 3 : UCIP_FA_2019_50669_34985.jpg

Comment Code					
Inspector Comment					
DS_ID:22413 FS_ID:50669 EP_NO: N/A Repair Type: Non-Urgent Crossing Status: Found UCIP Comments: 11/09/2016 Per FPIIB Inspector Pavel Kazi, the CMP riser has been removed and the pipe is now exposed. Pipe still requires proper abandonment. (K. Fazel - UCIP)08/30/2013 Only an abandoned and dismantled CMP riser with gate valve found on WS levee slope. May need proper abandonment. (P. Amatya - DWR) FIELD_STRUCT_DESC: *ABANDONED* 6-inch steel irrigation discharge pipe, 10 feet below the crown. Gate valve on each end, though only one was found on the waterside (WS) in 2013. Pump on the landside (LS), 10 feet from the LS toe, not found in 2013. Riser on the WS slope has been removed as of the 2016 inspection. (C. Godfrey). [Additional Reference(s): DWR Levee Log, 2005. USACE Sacramento O&M Manual 112, March 1957, (RM 40.60), referenced as invert elevation 8.5 feet below the crown]. FS Date: 11/9/2016

WS view: an abandoned and dismantled CMP riser on WS levee slope.

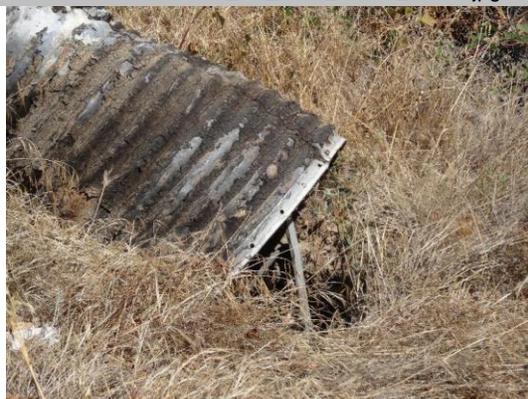
Photo 2 of 3 : UCIP_FA_2019_50669_34984.jpg

WS view: closer view of an abandoned and dismantled CMP riser on WS levee slope.

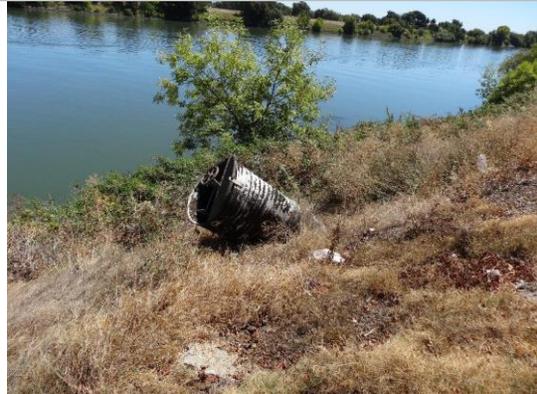
Photo 3 of 3 : UCIP_FA_2019_50669_34983.jpg

Comment Code					
Inspector Comment					
DS_ID:22413 FS_ID:50669 EP_NO: N/A Repair Type: Non-Urgent Crossing Status: Found UCIP Comments: 11/09/2016 Per FPIIB Inspector Pavel Kazi, the CMP riser has been removed and the pipe is now exposed. Pipe still requires proper abandonment. (K. Fazel - UCIP)08/30/2013 Only an abandoned and dismantled CMP riser with gate valve found on WS levee slope. May need proper abandonment. (P. Amatya - DWR) FIELD_STRUCT_DESC: *ABANDONED* 6-inch steel irrigation discharge pipe, 10 feet below the crown. Gate valve on each end, though only one was found on the waterside (WS) in 2013. Pump on the landside (LS), 10 feet from the LS toe, not found in 2013. Riser on the WS slope has been removed as of the 2016 inspection. (C. Godfrey). [Additional Reference(s): DWR Levee Log, 2005. USACE Sacramento O&M Manual 112, March 1957, (RM 40.60), referenced as invert elevation 8.5 feet below the crown]. FS Date: 11/9/2016

WS view: an abandoned and dismantled CMP riser with gate valve handle on WS levee slope.

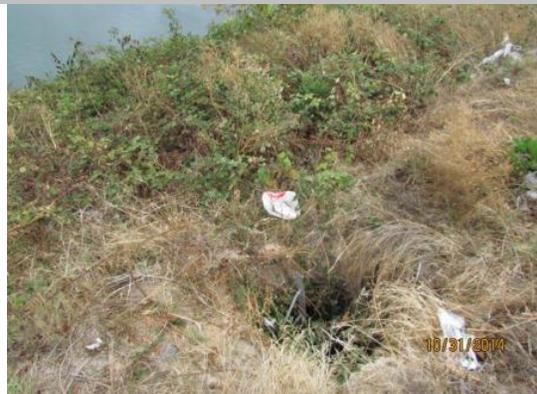
Photo 1 of 1 : FA_2019_RD0150_16_55_20190904_00036.jpg

LM Start	6.50	Rating **	U	Issue No.	55
LM End	6.50	Issue Type +	En	Location *	WS
Category	Earthen Levee			GPS Latitude/Longitude	
				Start	End
Item	Encroachments			38.396518°	38.396518°
				-121.514530°	-121.514530°
DWR ID	DWR_RD0150_02_f_2014_55				
Comment Code					
PI : Pipe					
Inspector Comment					
The pipe gate needs to be covered on the waterside toe of the levee. A large hole remains in the slope.

An open pipe valve was found without a cover on the waterside toe of the levee. Fall 2014

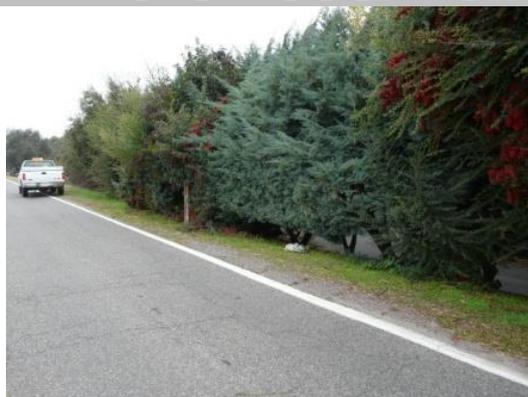
Photo 1 of 1 : FA_2019_RD0150_16_64_20190904_00042.jpg

LM Start	6.57	Rating **	U	Issue No.	64
LM End	6.61	Issue Type +	En	Location *	LS
Category	Earthen Levee		GPS Latitude/Longitude		
			Start	End	
Item	Vegetation		38.397523°	38.398000°	
			-121.514658°	-121.514731°	
DWR ID	DWR_RD0150_02_s_2012_64				
Comment Code					
V6 : Landscaping					
Inspector Comment					
Thin out landscaping for visibility of slope.

Dense landscaping providing a screen for a residence on landside of levee.

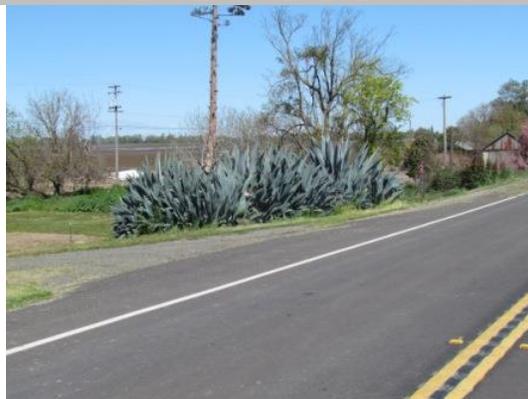
Photo 1 of 1 : FA_2019_RD0150_16_43_20190904_00014.jpg

LM Start	6.65	Rating **	M	Issue No.	43
LM End	6.68	Issue Type +	En	Location *	LS
Category	Earthen Levee		GPS Latitude/Longitude		
			Start	End	
Item	Vegetation		38.398600°	38.399042°	
			-121.514793°	-121.514841°	
DWR ID	DWR_RD0150_02_s_2012_43				
Comment Code					
V6 : Landscaping					
Inspector Comment					
Maintain landscaping, and remove century plant on the landside of the levee.

Century plants were found on the landside of the levee looking upstream.

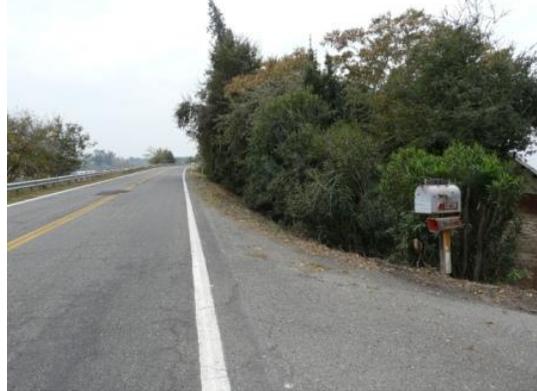
Photo 1 of 1 : FA_2019_RD0150_16_60_20190904_00040.jpg

LM Start	6.76	Rating **	U	Issue No.	60
LM End	7.00	Issue Type +	En	Location *	LS
Category	Earthen Levee		GPS Latitude/Longitude		
			Start	End	
Item	Vegetation		38.400213°	38.403578°	
			-121.514987°	-121.516262°	
DWR ID	DWR_RD0150_02_s_2012_60				
Comment Code					
V6 : Landscaping					
Inspector Comment					
Trim and thin trees/bushes. Remove cactus at LM 6.76, 6.80 and 6.86.

View of dense landscaping providing a screen for a residence on the landside of levee.
