**Flood Control Project Maintenance
Levee Inspections**

Fall 2019 Levee Maintenance Deficiency Summary Report

Reclamation District No. 0150 Merrit Island

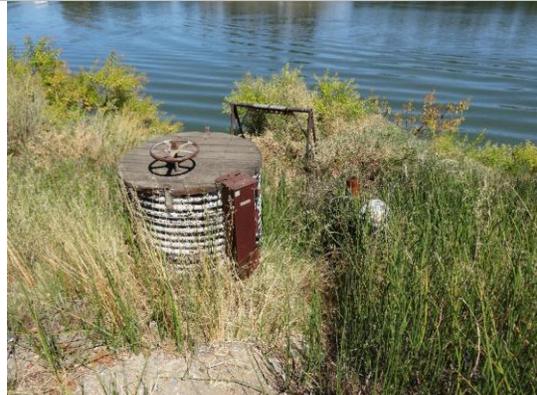
Photo 1 of 3 : UCIP_FA_2019_53333_34162.jpg

Comment Code					
Inspector Comment					
DS_ID:22429 FS_ID:53333 EP_NO: N/A Repair Type: Urgent Crossing Status: Found UCIP Comments: 6/5/2018 Pump in operation at time of inspection. Pipe on WS has significant leak; spilling onto a pile of brush so erosion appears limited, if at all. LS does not appear to have any pipe leaks or levee erosion. Pipe is approximately 85 years and should be internally inspected, and possibly replaced completely, and crossing remains Urgent (DWR UCIP - D. Sanoski). FIELD_STRUCT_DESC: 8-inch concrete encased steel irrigation discharge pipe through the levee, 10 feet below the crown. Pump on a concrete slab and a slide gate in a corrugated metal pipe (CMP) riser on the waterside (WS) slope. Pipe through the levee section is encased in reinforced concrete. Concrete standpipe at the landside (LS) toe. (A. Monice). [Additional Reference(s): DWR Levee Log, 2005. USACE Sacramento O&M Manual 112, March 1957, (RM 41.10), referenced as invert elevation 8.2 feet below the crown]. FS Date: 6/5/2018 1:46:00 PM

WS view: CMP riser with slide gate and pump (right) on levee slope.

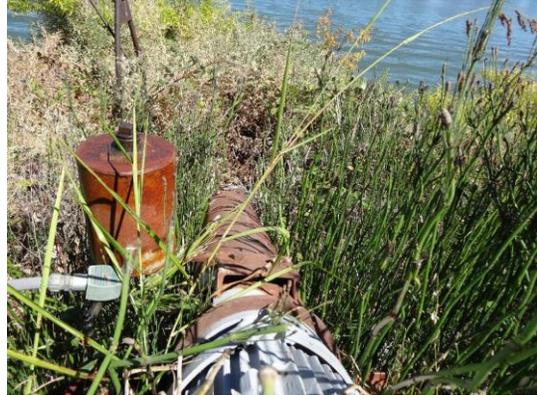
Photo 2 of 3 : UCIP_FA_2019_53333_34161.jpg

Comment Code					
Inspector Comment					
<p>DS_ID:22429 FS_ID:53333 EP_NO: N/A Repair Type: Urgent Crossing Status: Found UCIP Comments: 6/5/2018 Pump in operation at time of inspection. Pipe on WS has significant leak; spilling onto a pile of brush so erosion appears limited, if at all. LS does not appear to have any pipe leaks or levee erosion. Pipe is approximately 85 years and should be internally inspected, and possibly replaced completely, and crossing remains Urgent (DWR UCIP - D. Sanoski). FIELD_STRUCT_DESC: 8-inch concrete encased steel irrigation discharge pipe through the levee, 10 feet below the crown. Pump on a concrete slab and a slide gate in a corrugated metal pipe (CMP) riser on the waterside (WS) slope. Pipe through the levee section is encased in reinforced concrete. Concrete standpipe at the landside (LS) toe. (A. Monice). [Additional Reference(s): DWR Levee Log, 2005. USACE Sacramento O&M Manual 112, March 1957, (RM 41.10), referenced as invert elevation 8.2 feet below the crown]. FS Date: 6/5/2018 1:46:00 PM</p>

WS view: steel intake pipe and pump on levee slope. Dense vegetation on levee slope.

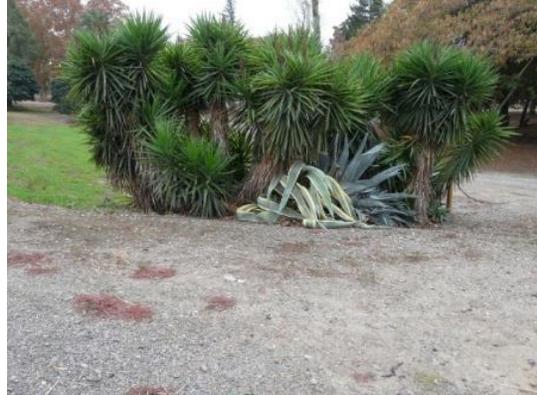
Photo 1 of 1 : FA_2019_RD0150_16_56_20190904_00037.jpg

LM Start	7.79	Rating **	M	Issue No.	56
LM End	7.79	Issue Type +	En	Location *	LS
Category	Earthen Levee			GPS Latitude/Longitude	
				Start	End
Item	Vegetation			38.413705°	38.413705°
				-121.522806°	-121.522806°
DWR ID	DWR_RD0150_02_s_2012_56				
Comment Code					
V6 : Landscaping					
Inspector Comment

Landscaping on landside of levee

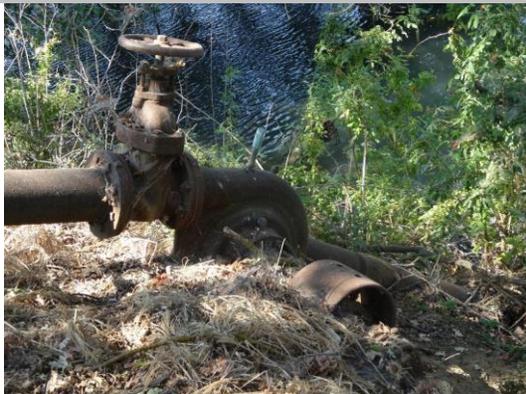
Photo 3 of 3 : UCIP_FA_2019_42694_32003.jpg

LM Start	0.39	Rating **	M	Issue No.	951 (cont)
LM End	0.39	Issue Type +	En	Location *	
Category	Supplemental			GPS Latitude/Longitude	
				Start	End
Item	DRAFT DWR UCIP Field Study			38.337928 °	38.337928 °
				-121.581496 °	-121.581496 °
DWR ID	22453				
Comment Code					
Inspector Comment					
DS_ID:22453 FS_ID:42694 EP_NO: 13612 Repair Type: Non-Urgent Crossing Status: Found UCIP Comments: Abandoned. Proper abandon needs. FIELD_STRUCT_DESC: *ABANDONED* 6-inch steel gravity irrigation pipe through the levee, 3.5 feet below the crown. Pump and gate valve on the waterside (WS) slope. (Runyon). [Additional Reference(s): DWR Levee Log, 2005]. FS Date: 8/20/2013

WS view: abandoned pipe, gate valve, and pump on levee slope.

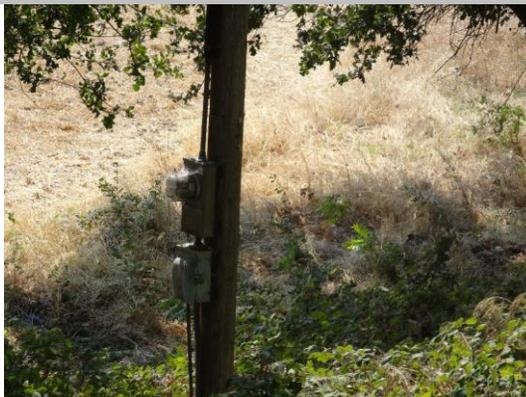
Photo 1 of 3 : UCIP_FA_2019_42693_31979.jpg

LM Start	0.40	Rating **	M	Issue No.	952
LM End	0.40	Issue Type +	En	Location *	
Category	Supplemental			GPS Latitude/Longitude	
				Start	End
Item	DRAFT DWR UCIP Field Study			38.338131 °	38.338131 °
				-121.581434 °	-121.581434 °
DWR ID	22454				
Comment Code					
Inspector Comment					
DS_ID:22454 FS_ID:42693 EP_NO: N/A Repair Type: Non-Urgent Crossing Status: Found UCIP Comments: Seems to be abandoned. Service pole on LS slope. 1" conduit through levee. May need proper abandonment. FIELD_STRUCT_DESC: 6-inch steel irrigation discharge pipe through the levee, 3.5 feet below the crown. Pump and gate valve on the waterside (WS) slope. (Gentner). [Additional Reference(s): DWR Levee Log, 2005]. FS Date: 8/20/2013

LS view: service pole on levee slope.

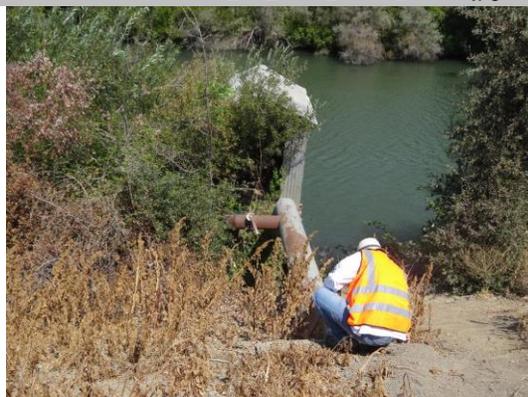
Photo 1 of 3 : UCIP_FA_2019_19112_32044.jpg

LM Start	1.35	Rating **	M	Issue No.	953
LM End	1.35	Issue Type +	En	Location *	
Category	Supplemental			GPS Latitude/Longitude	
				Start	End
Item	DRAFT DWR UCIP Field Study			38.347489°	38.347489°
				-121.573302°	-121.573302°
DWR ID	22433				
Comment Code					
Inspector Comment					
DS_ID:22433 FS_ID:19112 EP_NO: N/A Repair Type: Non-Urgent Crossing Status: Found UCIP Comments: No handrail on wooden walkway. FIELD_STRUCT_DESC: 14-inch steel irrigation discharge pipe through the levee, invert elevation 8 feet below the crown. Pump in a pump house on the waterside (WS) slope. Service pole and steel distribution box on the landside (LS) slope. (A. Pylman). [Additional Reference(s): DWR Levee Log, 2005. USACE Sacramento O&M Manual 112, March 1957, (HLM 1.39)]. FS Date: 8/20/2013

WS view: pipe on levee slope and pump house in channel.

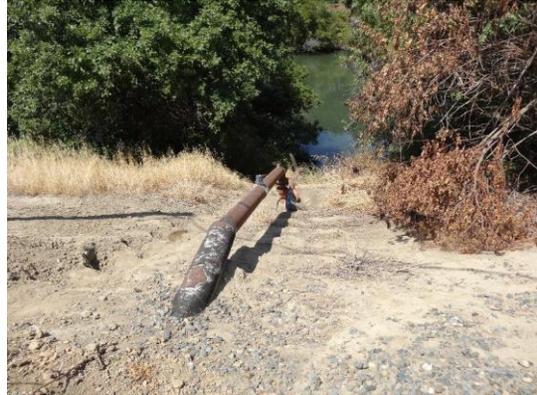
Photo 2 of 3 : UCIP_FA_2019_19137_32107.jpg

LM Start	1.78	Rating **	M	Issue No.	954 (cont)
LM End	1.78	Issue Type +	En	Location *	
Category	Supplemental			GPS Latitude/Longitude	
				Start	End
Item	DRAFT DWR UCIP Field Study			38.353180°	38.353180°
				-121.572907°	-121.572907°
DWR ID	22434				
Comment Code					
Inspector Comment					
DS_ID:22434 FS_ID:19137 EP_NO: N/A Repair Type: Non-Urgent Crossing Status: Found UCIP Comments: Small depression on WS slope due to leak from pump. Pipe opens on LS ditch/depression. FIELD_STRUCT_DESC: 10-inch steel irrigation discharge pipe through the levee, invert elevation 3.4 feet below the crown. Pump, gate valve, and service pole on the waterside (WS) slope. (W. Bogle). [Additional Reference(s): DWR Levee Log, 2005. USACE Sacramento O&M Manual 112, March 1957, (HLM 1.82), 7-inch pipe referenced]. FS Date: 8/20/2013

WS view: exposed pipe on levee slope.

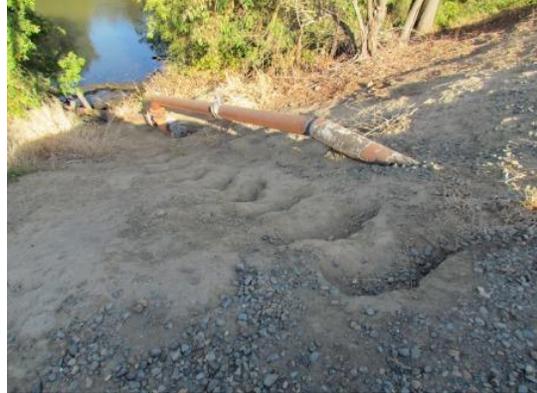
Photo 1 of 1 : FA_2019_RD0150_17_50_20190904_00031.jpg

LM Start	1.78	Rating **	M	Issue No.	50
LM End	1.78	Issue Type +	En	Location *	WS
Category	Earthen Levee		GPS Latitude/Longitude		
			Start	End	
Item	Encroachments		38.353249°	38.353249°	
			-121.572848°	-121.572848°	
DWR ID	DWR_RD0150_03_s_2012_50				
Comment Code					
ST : Stairway					
Inspector Comment					
Stairs are dug next to the pipe.

Steps were dug next to the pipe, and also erosion was found near the vicinity of the pipe on the waterside slope of the levee looking upstream.

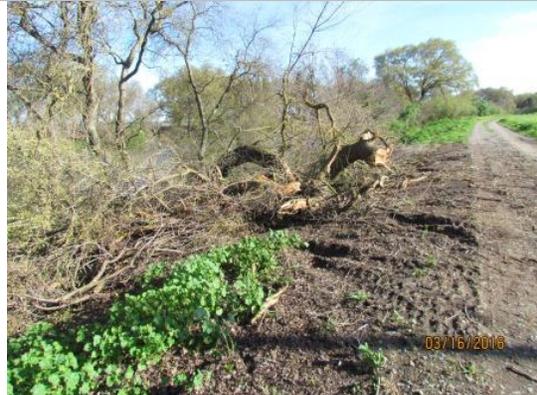
Photo 1 of 1 : FA_2019_RD0150_17_85_20190904_00066.jpg

LM Start	1.83	Rating **	M	Issue No.	85
LM End	1.83	Issue Type +	Ma	Location *	WS
Category	Earthen Levee		GPS Latitude/Longitude		
			Start	End	
Item	Encroachments		38.353761°	38.353761°	
			-121.572390°	-121.572390°	
DWR ID	DWR_RD0150_03_s_2016_85				
Comment Code					
TR : Tree or limb					
Inspector Comment					
The LMA cut part of the fallen tree, but a part remains on the levee slope easement.

View of broken tree trunk on the waterside slope of the levee. Spring 2016

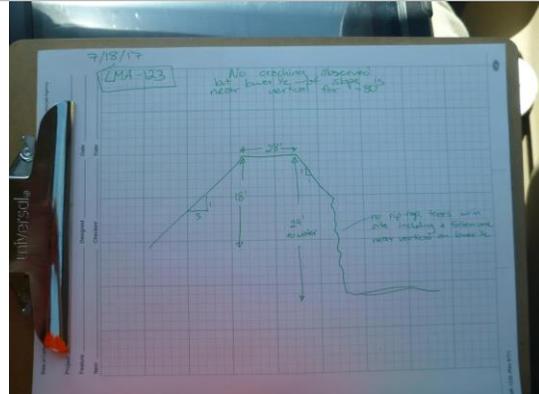
Photo 3 of 3 : LEVAL_FA_2019_297_1933.jpg

LM Start	2.72	Rating **	A/W	Issue No.	42 (cont)
LM End	2.73	Issue Type +	Ma	Location *	WS
Category	Supplemental			GPS Latitude/Longitude	
				Start	End
Item	2017 Storm Damage			38.359256°	38.359461°
				-121.561239°	-121.561275°
DWR ID	LMA-123				
Comment Code					
Inspector Comment					
<p>Levee Evaluation Comments Description: On 11 and 15 January 2017, waterside instability and cracking were observed on the east (left) bank of Elk Slough. The site is approximately 75 feet long and 5 to 10 feet down from the levee crest. See attached pages for photos Site ID No: 297 Site Designation: LMA-123 Repair Type: Stability Rating: Area of Concern Field Date: 7/18/2017 Notes: Crown is a paved road. 20 ft of cracking observed maximum within the site, but lower 1/4 of slope is near vertical. Lower priority because it is not too much worse than the surrounding levees.</p>

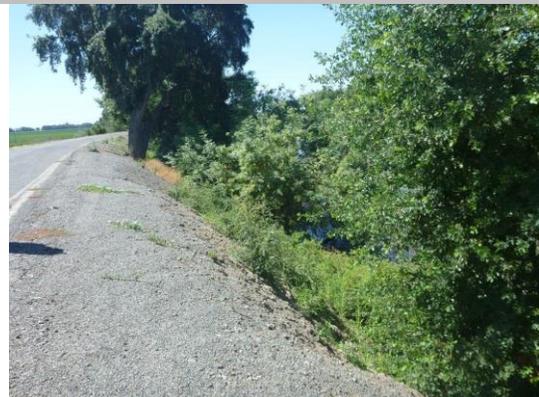
Photo 1 of 3 : LEVAL_FA_2019_298_1924.jpg

LM Start	2.74	Rating **	A/W	Issue No.	45
LM End	2.76	Issue Type +	Ma	Location *	WS
Category	Supplemental			GPS Latitude/Longitude	
				Start	End
Item	2017 Storm Damage			38.359594°	38.359808°
				-121.561308°	-121.561369°
DWR ID	LMA-124				
Comment Code					
Inspector Comment					
<p>Levee Evaluation Comments Description: On 11 and 15 January 2017, waterside instability and cracking were observed on the east (left) bank of Elk Slough. The site is approximately 80 feet long and 5 to 10 feet down from the levee crest. See attached pages for photos. Site ID No: 298 Site Designation: LMA-124 Repair Type: Stability Rating: Area of Concern Field Date: 7/18/2017 Notes: No cracking observed, but there is runoff erosion along the entire WS slope here. Crown is a paved road. Area of concern because erosion was caused by runoff and was less severe than other sites along Elk Slough.</p>

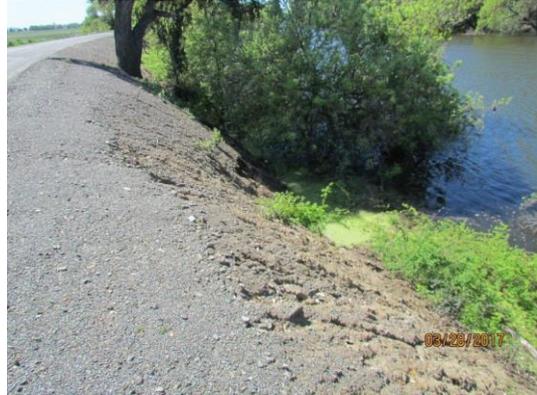
Photo 1 of 1 : FA_2019_RD0150_17_62_20190904_00046.jpg

LM Start	2.75	Rating **	A/W	Issue No.	62
LM End	2.75	Issue Type +	Ma	Location *	WS
Category	Earthen Levee		GPS Latitude/Longitude		
			Start	End	
Item	Erosion / Bank Caving		38.359693°	38.359693°	
			-121.561354°	-121.561354°	
DWR ID	DWR_RD0150_03_s_2017_62				
Comment Code					
E1 : Note and monitor erosion site.					
Inspector Comment					
Erosion is caused from run-off due to rain.

View of erosion on the waterside slope of the levee looking downstream. Spring 2017

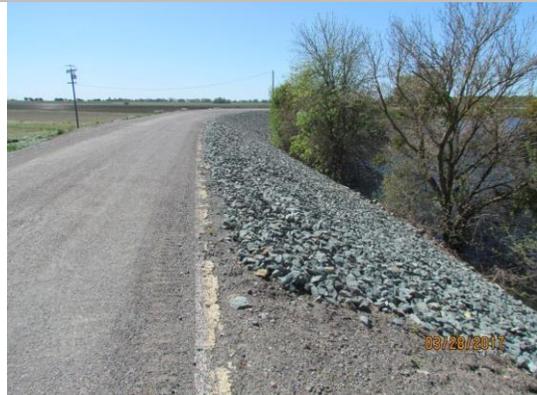
Photo 1 of 1 : FA_2019_RD0150_17_76_20190904_00060.jpg

LM Start	3.37	Rating **	A/W	Issue No.	76
LM End	3.45	Issue Type +	Ma	Location *	WS
Category	Earthen Levee		GPS Latitude/Longitude		
			Start	End	
Item	Riprap Revetments		38.363380 °	38.364325 °	
			-121.555715 °	-121.555330 °	
DWR ID	DWR_RD0150_03_s_2017_76				
Comment Code					
Inspector Comment					
Riprap remains intact.

View of the new riprap on the waterside slope of the levee looking downstream. Spring 2017

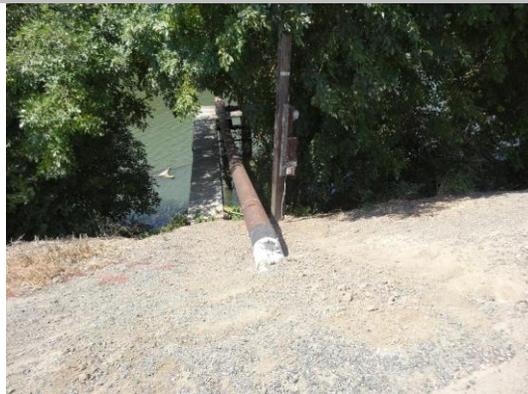
Photo 1 of 3 : UCIP_FA_2019_53334_35013.jpg

Comment Code					
Inspector Comment					
<p>DS_ID:22439 FS_ID:53334 EP_NO: N/A Repair Type: Urgent Crossing Status: Found UCIP Comments: 06/05/2018 Same as last inspection; LS erosion looks the same if not slightly worse, so the crossing remains Urgent (DWR UCIP - D. Sanoski)03/30/2017 Riprap laid around pipe on WS slope. Source of erosion has not been addressed, nor has LS toe been repaired. Update and photo courtesy of Pavel Kazi, FPIIB Inspector, as a part of his Sprint 2017 Inspections. (K. Fazel - UCIP) 11/10/2016 Erosion at LS toe has progressed since last inspection and is now severe. Photo courtesy of Pavel Kazi, FPIIB Inspector, as a part of his Fall 2016 Inspections. Crossing has been upgraded from Non-Urgent to Urgent. (K. Fazel - UCIP)08/20/2013 Leaky concrete standpipe on landside levee toe creating some erosion.- pump was working at the time of inspection. (P. Amatya - DWR) FIELD_STRUCT_DESC: 8-inch steel irrigation discharge pipe through the levee, invert elevation 3.7 feet below the crown. Service pole on the waterside (WS) slope. Pump on a piling structure in the stream. Concrete standpipe at the landside (LS) toe. [Additional Reference(s): DWR Levee Log, 2005. USACE Sacramento O&M Manual 112, March 1957, (RM 3.45)]. FS Date: 6/5/2018 3:29:00 PM</p>

WS view: exposed pipe, walkway, service pole on levee slope and pump support in channel.

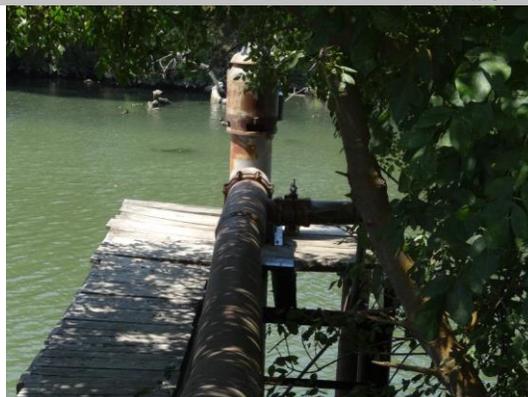
Photo 2 of 3 : UCIP_FA_2019_53334_35012.jpg

WS view: steel pipe & pump, walkway, pump support in the channel.

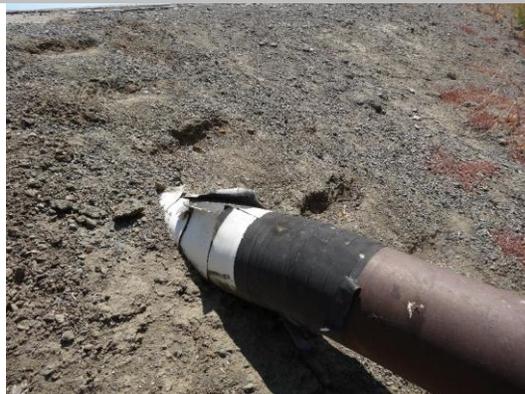
Photo 3 of 3 : UCIP_FA_2019_53334_35011.jpg

Comment Code					
Inspector Comment					
DS_ID:22439 FS_ID:53334 EP_NO: N/A Repair Type: Urgent Crossing Status: Found UCIP Comments: 06/05/2018 Same as last inspection; LS erosion looks the same if not slightly worse, so the crossing remains Urgent (DWR UCIP - D. Sanoski)03/30/2017 Riprap laid around pipe on WS slope. Source of erosion has not been addressed, nor has LS toe been repaired. Update and photo courtesy of Pavel Kazi, FPIIB Inspector, as a part of his Sprint 2017 Inspections. (K. Fazel - UCIP) 11/10/2016 Erosion at LS toe has progressed since last inspection and is now severe. Photo courtesy of Pavel Kazi, FPIIB Inspector, as a part of his Fall 2016 Inspections. Crossing has been upgraded from Non-Urgent to Urgent. (K. Fazel - UCIP)08/20/2013 Leaky concrete standpipe on landside levee toe creating some erosion.- pump was working at the time of inspection. (P. Amatya - DWR) FIELD_STRUCT_DESC: 8-inch steel irrigation discharge pipe through the levee, invert elevation 3.7 feet below the crown. Service pole on the waterside (WS) slope. Pump on a piling structure in the stream. Concrete standpipe at the landside (LS) toe. [Additional Reference(s): DWR Levee Log, 2005. USACE Sacramento O&M Manual 112, March 1957, (RM 3.45)]. FS Date: 6/5/2018 3:29:00 PM

LS view: exposed pipe on levee slope.

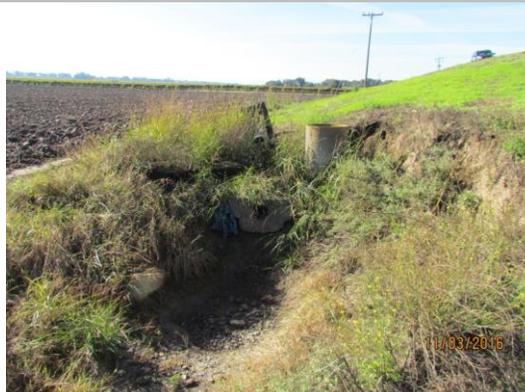
Photo 1 of 3 : FA_2019_RD0150_17_115_20190904_00094.jpg

LM Start	3.39	Rating **	U	Issue No.	115
LM End	3.39	Issue Type +	Ma	Location *	LS
Category	Earthen Levee			GPS Latitude/Longitude	
				Start	End
Item	Erosion / Bank Caving			38.363540 °	38.363540 °
				-121.555554 °	-121.555554 °
DWR ID	DWR_RD0150_03_f_2013_115				
Comment Code					
E2 : Schedule repair of erosion site prior to the next inspection.					
Inspector Comment					
Repair erosion (ditch) found on the landside toe of the levee.

View of the ditch on the landside toe of the levee. Fall 2016

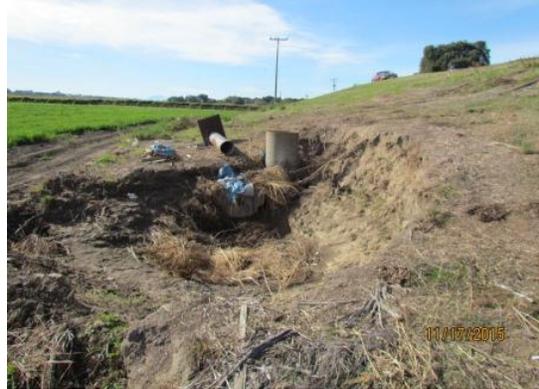
Photo 2 of 3 : FA_2019_RD0150_17_115_20190904_00095.jpg

LM Start	3.39	Rating **	U	Issue No.	115 (cont)
LM End	3.39	Issue Type +	Ma	Location *	LS
Category	Earthen Levee			GPS Latitude/Longitude	
				Start	End
Item	Erosion / Bank Caving			38.363540°	38.363540°
				-121.555554°	-121.555554°
DWR ID	DWR_RD0150_03_f_2013_115				
Comment Code					
E2 : Schedule repair of erosion site prior to the next inspection.					
Inspector Comment					
Repair erosion (ditch) found on the landside toe of the levee.

View of the ditch on the landside toe of the levee during fall 2015 inspection.

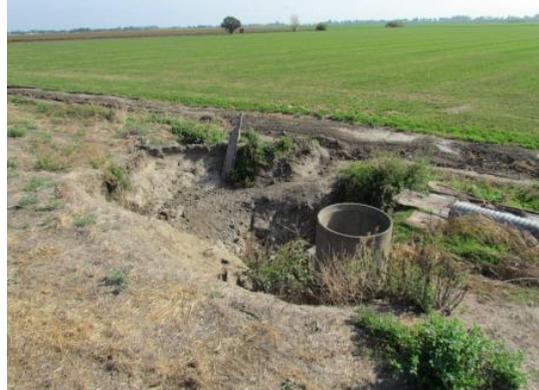
Photo 3 of 3 : FA_2019_RD0150_17_115_20190904_00096.jpg

A drainage ditch with depth of 4 feet and width of 15 feet was found on the landside toe of the levee. The picture was taken from the landside slope looking upstream during the fall 2013 inspection.

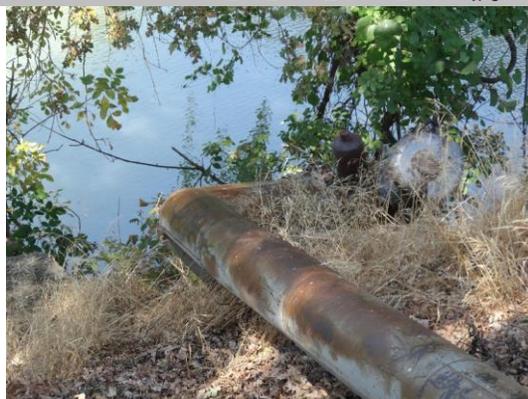
Photo 1 of 3 : UCIP_FA_2019_50202_35018.jpg

Comment Code					
Inspector Comment					
DS_ID:22440 FS_ID:50202 EP_NO: N/A Repair Type: Non-Urgent Crossing Status: Found UCIP Comments: 07/07/2016: Unable to locate evidence of major depression of WS slope. Only slight depression on WS slope above pump. Though this is an up-and-over pipe, no positive closure device found. Inlet in LS standpipe is capped with a board. If no longer in use, needs to be abandoned properly. Siphon breaker/vent on WS needs a cover. Wave-wash run-up along river bank characteristic of much of Elk Slough. Crossing has been downgraded from Urgent to Non-Urgent. (K. Fazel - UCIP)08/20/2013:Levee damage.Gate valve on WS not found. (P. Amatya - DWR) FIELD_STRUCT_DESC: 12-inch steel irrigation discharge pipe through the levee, invert elevation 5.9 feet below the crown. Slant pump on the waterside (WS) slope. Vent/siphon breaker at the apex of the pipe on the WS. Concrete platform lies next to the pump on the WS. Concrete standpipe and service pole with meter at the landside (LS) toe. Property owner is Ken Pylman at (916) 775-1066. [Additional Reference(s): DWR Levee Log, 2005. USACE Sacramento O&M Manual 112, March 1957, (HLM 3.73)]. FS Date: 7/7/2016

WS view: steel pipe and pump on levee slope.

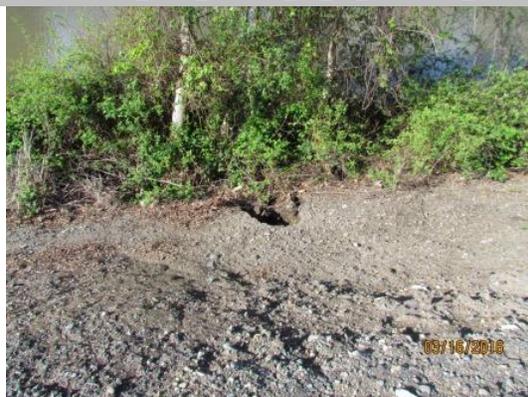
Photo 1 of 1 : FA_2019_RD0150_17_93_20190904_00074.jpg

LM Start	4.02	Rating **	M	Issue No.	93
LM End	4.02	Issue Type +	Ma	Location *	WS
Category	Earthen Levee		GPS Latitude/Longitude		
			Start	End	
Item	Erosion / Bank Caving		38.370125°	38.370125°	
			-121.552030°	-121.552030°	
DWR ID	DWR_RD0150_03_s_2016_93				
Comment Code					
E1 : Note and monitor erosion site.					
Inspector Comment					
There is erosion on the waterside toe of the levee.

Erosion was found on the waterside toe of the levee. Spring 2016

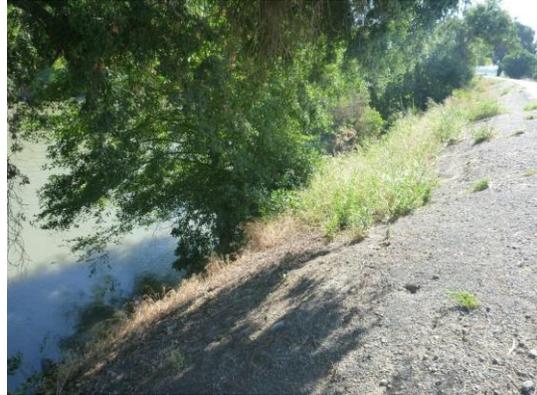
Photo 3 of 3 : LEVAL_FA_2019_304_2078.jpg

Comment Code					
Inspector Comment					
<p>Levee Evaluation Comments Description: Between 11 and 19 January 2017, waterside instability and erosion were observed on the east (left) bank of Elk Slough. The site is approximately 88 feet long, 7 feet below the levee crest, and includes a fallen tree and exposed root ball in the levee slope. See attached pages for photos. Site ID No: 304 Site Designation: LMA-130 Repair Type: Erosion Rating: Serious Field Date: 7/18/2017 Notes: Crown is a paved road. Near vertical on lower 1/2 of slope including a fallen tree with exposed root ball. Serious because sloughing cuts into already over-steepened prism significantly and visible longitudinal cracking near crown.</p>

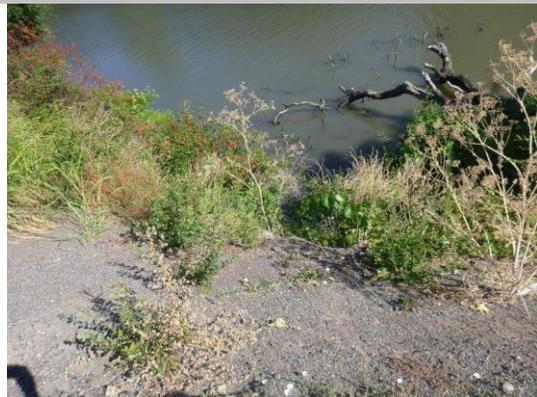
Photo 1 of 2 : LEVAL_FA_2019_305_2066.jpg

LM Start	4.47	Rating **	A/W	Issue No.	108
LM End	4.49	Issue Type +	Ma	Location *	WS
Category	Supplemental			GPS Latitude/Longitude	
				Start	End
Item	2017 Storm Damage			38.374314 °	38.374344 °
				-121.547753 °	-121.547447 °
DWR ID	LMA-131

Comment Code					
Inspector Comment					
<p>Levee Evaluation Comments Description: Between 11 January 2017 and 7 February 2017, instability, cracking, and erosion of the waterside levee slope were observed on the east (left) bank of Elk Slough. The site is approximately 88 feet long. See attached pages for photos. Site ID No: 305 Site Designation: LMA-131 Repair Type: Erosion Rating: Serious Field Date: 7/18/2017 Notes: Crown is a paved road. Near vertical sloughing on the lower 2/3 of the prism. House and ramp/driveway on the LS. Serious because sloughing cuts into already over-steepened prism significantly. 2019 Spring DWR Inspection: Erosion was not visible during the inspection due to high water.</p>

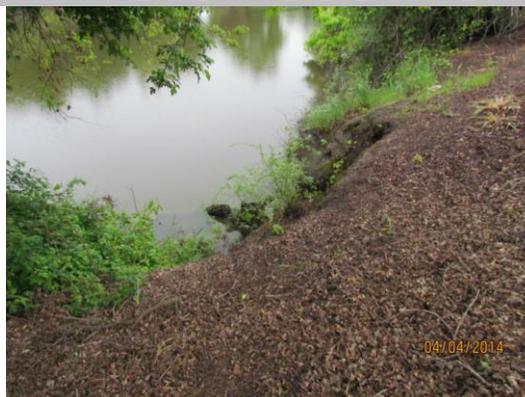
Photo 1 of 1 : FA_2019_RD0150_17_80_20190904_00061.jpg

LM Start	4.49	Rating **	A/W	Issue No.	80
LM End	4.49	Issue Type +	Ma	Location *	WS
Category	Earthen Levee			GPS Latitude/Longitude	
				Start	End
Item	Erosion / Bank Caving			38.374355°	38.374355°
				-121.547436°	-121.547436°
DWR ID	DWR_RD0150_03_s_2014_80				
Comment Code					
E1 : Note and monitor erosion site.					
Inspector Comment

View of an erosion site on the waterside toe of the levee looking upstream. Spring 2014

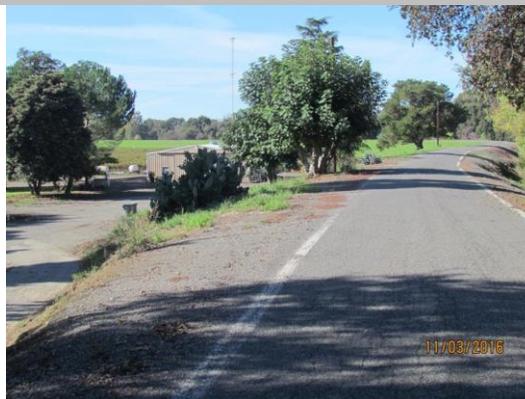
Photo 1 of 1 : FA_2019_RD0150_17_94_20190904_00075.jpg

LM Start	4.49	Rating **	M	Issue No.	94
LM End	4.49	Issue Type +	En	Location *	LS
Category	Earthen Levee			GPS Latitude/Longitude	
				Start	End
Item	Vegetation			38.374367°	38.374367°
				-121.547327°	-121.547327°
DWR ID	DWR_RD0150_03_s_2012_94				
Comment Code					
V6 : Landscaping					
Inspector Comment

View of landscape on the landside shoulder of the levee. Fall 2016

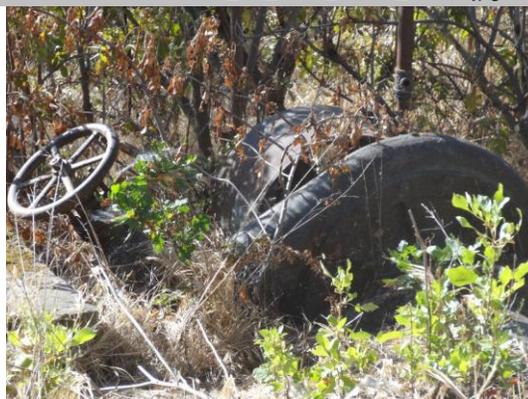
Photo 3 of 3 : UCIP_FA_2019_19283_32563.jpg

LM Start	4.90	Rating **	M	Issue No.	958 (cont)
LM End	4.90	Issue Type +	En	Location *	
Category	Supplemental			GPS Latitude/Longitude	
				Start	End
Item	DRAFT DWR UCIP Field Study			38.377718°	38.377718°
				-121.541413°	-121.541413°
DWR ID	22445				
Comment Code					
Inspector Comment					
DS_ID:22445 FS_ID:19283 EP_NO: N/A Repair Type: Non-Urgent Crossing Status: Found UCIP Comments: - seems abandoned.- may need proper abandonment FIELD_STRUCT_DESC: *ABANDONED* 10-inch steel irrigation discharge pipe through the levee, invert elevation 7.2 feet below the crown. Gate valve on the landside (LS) end. (D. Conner). [Additional Reference(s): DWR Levee Log, 2005. USACE Sacramento O&M Manual 112, March 1957, (HLM 4.99)]. FS Date: 8/23/2013

LS view: abandoned pump and gate valve on levee slope.

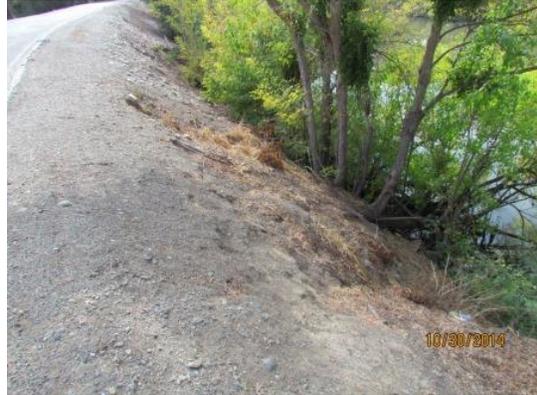
Photo 1 of 1 : FA_2019_RD0150_17_81_20190904_00062.jpg

LM Start	5.05	Rating **	M	Issue No.	81
LM End	5.05	Issue Type +	Ma	Location *	WS
Category	Earthen Levee		GPS Latitude/Longitude		
			Start	End	
Item	Erosion / Bank Caving		38.379608°	38.379608°	
			-121.540082°	-121.540082°	
DWR ID	DWR_RD0150_03_f_2014_81				
Comment Code					
E2 : Schedule repair of erosion site prior to the next inspection.					
Inspector Comment

View of erosion on the waterside of the levee looking downstream. Fall 2014

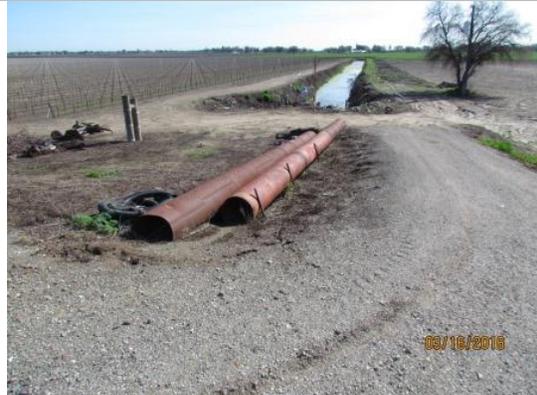
Photo 1 of 1 : FA_2019_RD0150_17_95_20190904_00076.jpg

LM Start	5.05	Rating **	M	Issue No.	95
LM End	5.05	Issue Type +	En	Location *	LS
Category	Earthen Levee		GPS Latitude/Longitude		
			Start	End	
Item	Encroachments		38.379617°	38.379617°	
			-121.540058°	-121.540058°	
DWR ID	DWR_RD0150_03_s_2016_95				
Comment Code					
PI : Pipe					
Inspector Comment					
Abandoned pipe was found on the landside slope of the levee.

View of an abandoned pipe on the landside slope of the levee. Spring 2016

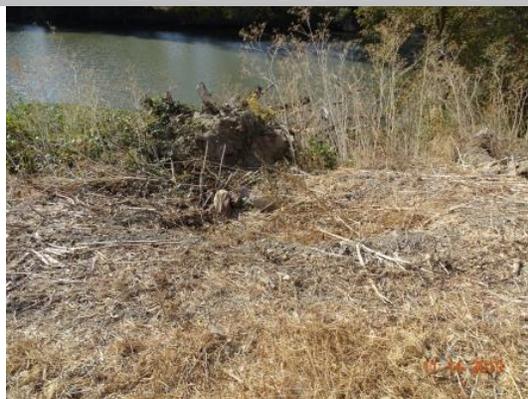
Photo 1 of 1 : FA_2019_RD0150_17_125_20191121_00164.jpg

LM Start	5.19	Rating **	M	Issue No.	125
LM End	5.19	Issue Type +	Ma	Location *	WS
Category	Earthen Levee			GPS Latitude/Longitude	
				Start	End
Item	Encroachments			38.381352°	38.381352°
				-121.540797°	-121.540797°
DWR ID	DWR_RD0150_03_s_2018_125				
Comment Code					
TR : Tree or limb					
Inspector Comment					
Remove fallen tree with exposed rootball.

View of fallen tree with exposed rootball. Fall 2019

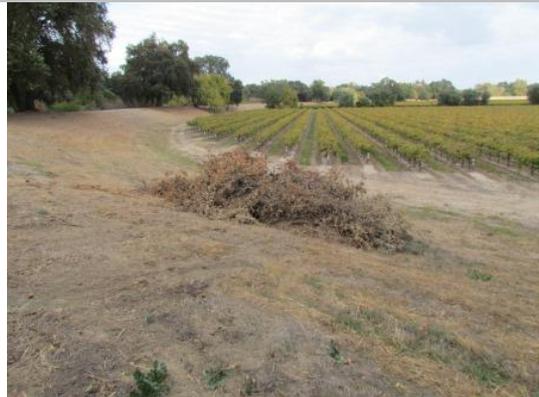
Photo 2 of 2 : FA_2019_RD0150_17_12_20190904_00002.jpg

LM Start	5.50	Rating **	M	Issue No.	12 (cont)
LM End	5.50	Issue Type +	En	Location *	LS

View of pruning pile on the landside toe of the levee looking upstream during the fall 2013 inspection.

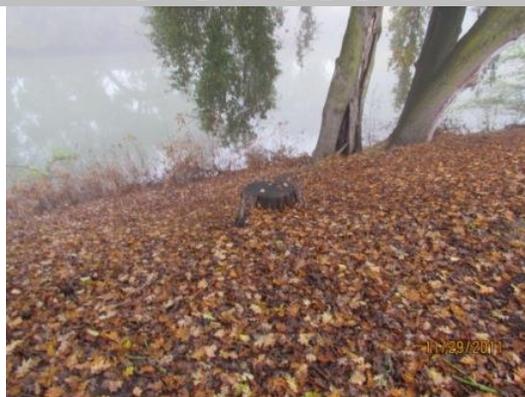
Photo 1 of 1 : FA_2019_RD0150_17_68_20190904_00053.jpg

LM Start	5.56	Rating **	N	Issue No.	68
LM End	5.56	Issue Type +	Ma	Location *	WS
Category	Earthen Levee		GPS Latitude/Longitude		
			Start	End	
Item	Trim / Thin Trees		38.383697°	38.383697°	
			-121.545201°	-121.545201°	
DWR ID	DWR_RD0150_03_f_2019_68				
Comment Code					
T5 : Tree stumps.					
Inspector Comment

Tree stump was found on the waterside of the levee looking upstream. Fall 2011

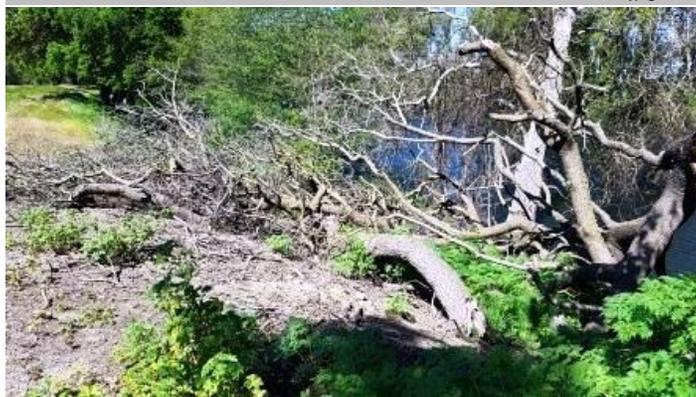
Photo 1 of 2 : FA_2019_RD0150_17_150_20190904_00111.jpg

LM Start	5.64	Rating **	M	Issue No.	150
LM End	5.64	Issue Type +	Ma	Location *	WS
Category	Earthen Levee		GPS Latitude/Longitude		
			Start	End	
Item	Encroachments		38.383825°	38.383825°	
			-121.543683°	-121.543683°	
DWR ID	DWR_RD0150_03_s_2019_150				
Comment Code					
TR : Tree or limb					
Inspector Comment					
Remove tree debris from the levee shoulder and slope.

View of tree debris on waterside slope. Spring 2019

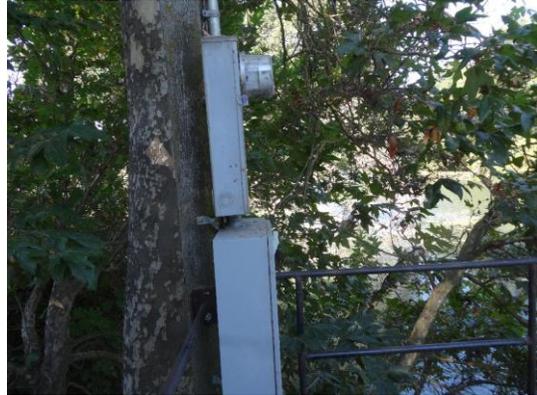
Photo 2 of 3 : UCIP_FA_2019_28265_51973.jpg

Comment Code					
Inspector Comment					
DS_ID:22448 FS_ID:28265 EP_NO: N/A Repair Type: Non-Urgent Crossing Status: Found UCIP Comments: - levee toe cut out at open end of the pipe.- service pole and control box on river bank. FIELD_STRUCT_DESC: 10-inch steel irrigation discharge pipe through the levee, invert elevation 7.8 feet below the crown. Pump and gate valve on a steel platform on the waterside (WS). (Plans for the installation of a vertical unit irrigation pumping plant and a 10-inch, 10-gauge steel discharge pipe through the levee authorized under Permit No. 1167, 1947 - Darrell Connor). [Additional Reference(s): DWR Levee Log, 2005. USACE Sacramento O&M Manual 112, March 1957, (HLM 5.80)]. FS Date: 8/23/2013

WS view: electric control box and power pole.

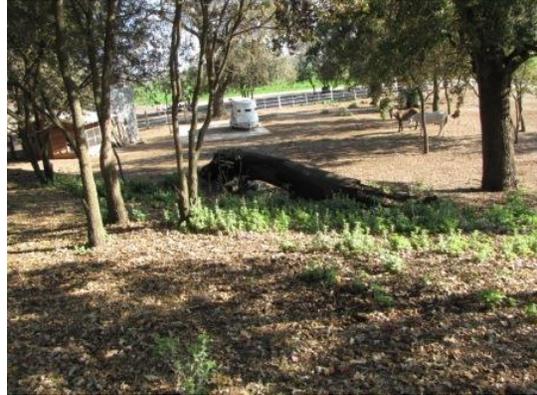
Photo 1 of 1 : FA_2019_RD0150_17_57_20190904_00040.jpg

LM Start	5.82	Rating **	M	Issue No.	57
LM End	5.82	Issue Type +	Ma	Location *	LS
Category	Earthen Levee			GPS Latitude/Longitude	
				Start	End
Item	Encroachments			38.384648 °	38.384648 °
				-121.540669 °	-121.540669 °
DWR ID	DWR_RD0150_03_s_2012_57				
Comment Code					
TR : Tree or limb					
Inspector Comment

View of downed tree on landward slope should be removed.

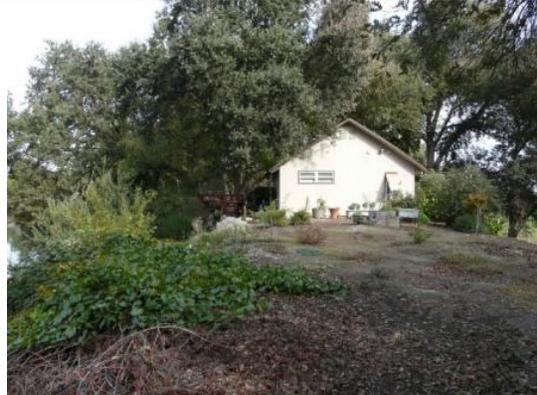
Photo 1 of 1 : FA_2019_RD0150_17_58_20190904_00041.jpg

LM Start	5.83	Rating **	U	Issue No.	58
LM End	5.83	Issue Type +	En	Location *	CR
Category	Earthen Levee			GPS Latitude/Longitude	
				Start	End
Item	Encroachments			38.384803 °	38.384803 °
				-121.540545 °	-121.540545 °
DWR ID	DWR_RD0150_03_s_2012_58				
Comment Code					
BU : Building					
Inspector Comment					
Permit 7517 approved house and graze cattle; 7517-A approved septic tank and 4-inch sewer line.

Building & associated landscaping on levee crown.

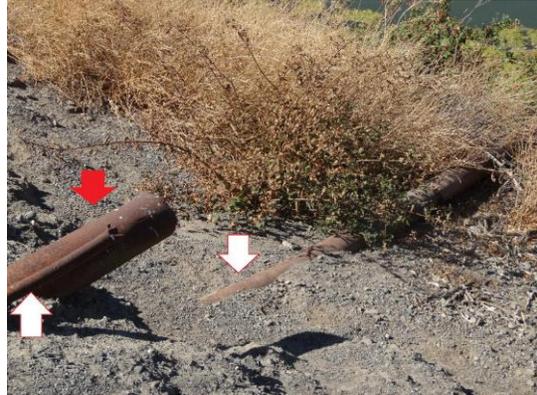
Photo 1 of 3 : UCIP_FA_2019_19403_32942.jpg

Comment Code					
Inspector Comment					
DS_ID:22451 FS_ID:19403 EP_NO: N/A Repair Type: Non-Urgent Crossing Status: Found UCIP Comments: - pipe ends open on both sides of the levee.- abandoned concrete box on WS.- two abandoned steel pipes (6" and 1") also found on WS. - needs proper abandonment FIELD_STRUCT_DESC: *ABANDONED* 6-inch steel irrigation discharge pipe through the levee, invert elevation 2.5 feet below the crown. Pump and gate valve removed prior to October 1962. Steel plate welded to the waterside (WS) end. Power pole and two anchors on the landside (LS) slope. (Warren Bogle). [Additional Reference(s): DWR Levee Log, 2005. USACE Sacramento O&M Manual 112, March 1957, (HLM 6.06)]. FS Date: 8/23/2013

WS view: open ended 6" steel pipe (top-left), 1" steel pipe (bottom), and another 6" steel pipe (right) on levee slope.

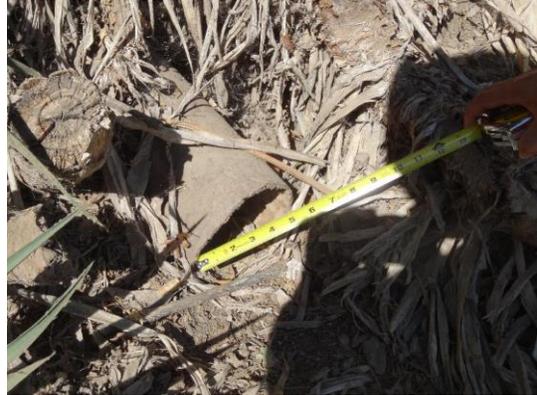
Photo 3 of 3 : UCIP_FA_2019_19403_32943.jpg

Comment Code					
Inspector Comment					
DS_ID:22451 FS_ID:19403 EP_NO: N/A Repair Type: Non-Urgent Crossing Status: Found UCIP Comments: - pipe ends open on both sides of the levee.- abandoned concrete box on WS.- two abandoned steel pipes (6" and 1") also found on WS. - needs proper abandonment FIELD_STRUCT_DESC: *ABANDONED* 6-inch steel irrigation discharge pipe through the levee, invert elevation 2.5 feet below the crown. Pump and gate valve removed prior to October 1962. Steel plate welded to the waterside (WS) end. Power pole and two anchors on the landside (LS) slope. (Warren Bogle). [Additional Reference(s): DWR Levee Log, 2005. USACE Sacramento O&M Manual 112, March 1957, (HLM 6.06)]. FS Date: 8/23/2013

LS view: open end steel pipe on levee toe.

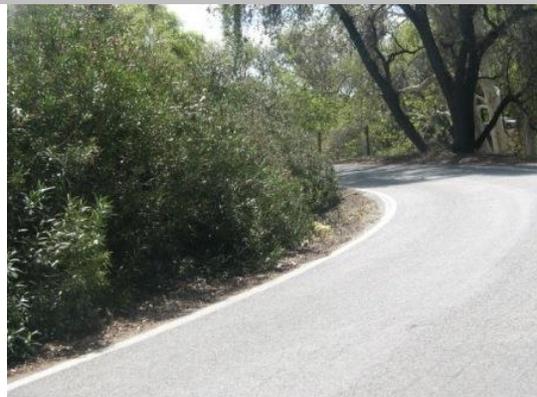
Photo 1 of 1 : FA_2019_RD0150_17_24_20190904_00005.jpg

LM Start	6.13	Rating **	U	Issue No.	24
LM End	6.20	Issue Type +	En	Location *	LS
Category	Earthen Levee		GPS Latitude/Longitude		
			Start	End	
Item	Vegetation		38.388535°	38.389391°	
			-121.541657°	-121.541901°	
DWR ID	DWR_RD0150_03_s_2012_24				
Comment Code					
V6 : Landscaping					
Inspector Comment

Oleander on landward slope blocking view of levee.

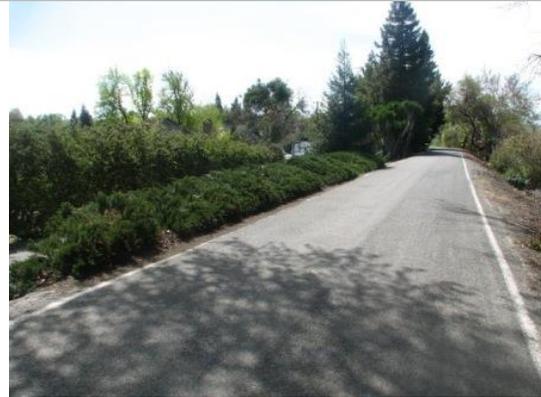
Photo 1 of 1 : FA_2019_RD0150_17_26_20190904_00006.jpg

LM Start	6.25	Rating **	U	Issue No.	26
LM End	6.29	Issue Type +	En	Location *	LS
Category	Earthen Levee			GPS Latitude/Longitude	
				Start	End
Item	Vegetation			38.389858 °	38.390115 °
				-121.541155 °	-121.540657 °
DWR ID	DWR_RD0150_03_s_2012_26				
Comment Code					
V6 : Landscaping					
Inspector Comment

Landscaping on landward slope.

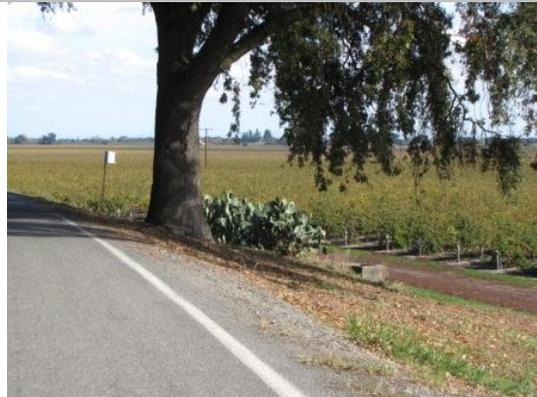
Photo 1 of 1 : FA_2019_RD0150_17_60_20190904_00043.jpg

LM Start	6.45	Rating **	M	Issue No.	60
LM End	6.45	Issue Type +	En	Location *	LS
Category	Earthen Levee			GPS Latitude/Longitude	
				Start	End
Item	Vegetation			38.391616°	38.391616°
				-121.538378°	-121.538378°
DWR ID	DWR_RD0150_03_f_2019_60				
Comment Code					
V6 : Landscaping					
Inspector Comment

View of landscaping along the landward slope.

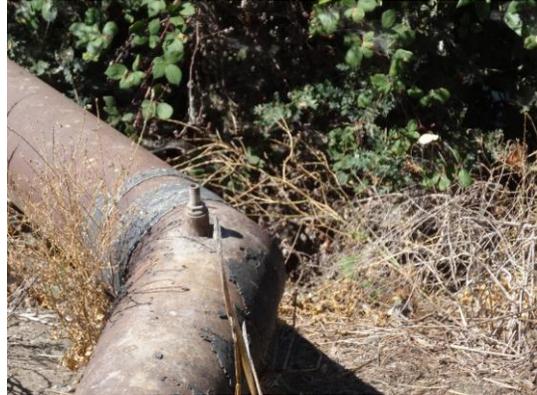
Photo 3 of 3 : UCIP_FA_2019_42692_35080.jpg

LM Start	6.63	Rating **	M	Issue No.	962 (cont)
LM End	6.63	Issue Type +	En	Location *	
Category	Supplemental			GPS Latitude/Longitude	
				Start	End
Item	DRAFT DWR UCIP Field Study			38.394182°	38.394182°
				-121.538609°	-121.538609°
DWR ID	22457				
Comment Code					
Inspector Comment					
DS_ID:22457 FS_ID:42692 EP_NO: 14650 Repair Type: Non-Urgent Crossing Status: Found UCIP Comments: Appears abandoned and if so should be done so properly. FIELD_STRUCT_DESC: 12-inch steel irrigation discharge pipe through the levee, 5 feet below the crown. Diesel powered slant pump on the waterside (WS). Concrete distribution box on the landside (LS) toe. (Plans to install a slant mounted pump on the WS of the levee with a 12-inch discharge pipe through the levee authorized under Permit No. 14650, 1987 - Webber Farms). [Additional Reference(s): DWR Levee Log, 2005]. FS Date: 8/23/2013

WS view: air vent on steel pipe.

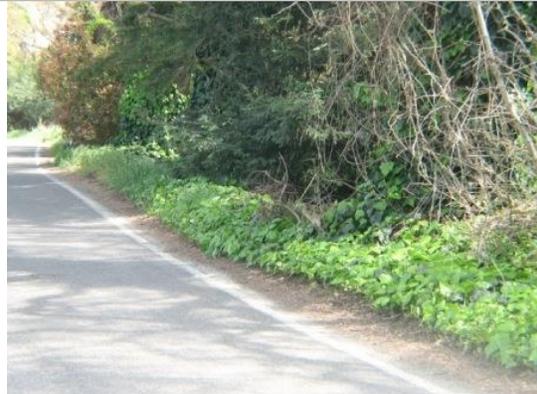
Photo 1 of 1 : FA_2019_RD0150_17_30_20190904_00008.jpg

LM Start	6.75	Rating **	M	Issue No.	30
LM End	6.81	Issue Type +	En	Location *	LS
Category	Earthen Levee		GPS Latitude/Longitude		
			Start	End	
Item	Vegetation		38.395643°	38.395953°	
			-121.537923°	-121.536773°	
DWR ID	DWR_RD0150_03_s_2012_30				
Comment Code					
V6 : Landscaping					
Inspector Comment

Landscaping on landward slope blocking view

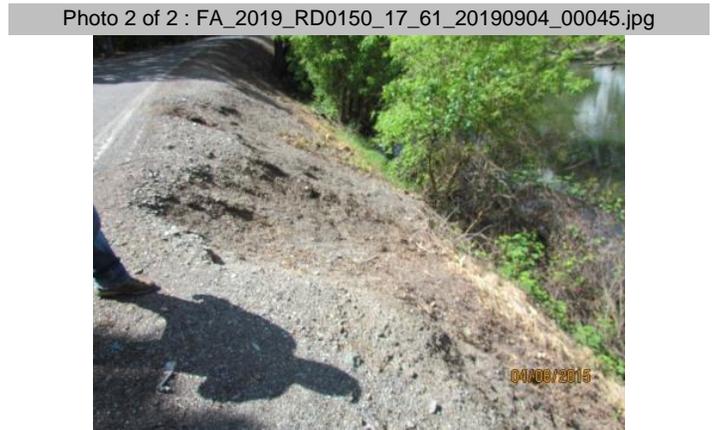
LM Start	6.90	Rating **	M	Issue No.	61
LM End	6.90	Issue Type +	Ma	Location *	WS
Category	Earthen Levee			GPS Latitude/Longitude	
				Start	End
Item	Erosion / Bank Caving			38.396655 °	38.396655 °
				-121.535485 °	-121.535485 °
DWR ID	DWR_RD0150_03_s_2012_61				
Comment Code					
E2 : Schedule repair of erosion site prior to the next inspection.					
Inspector Comment

View of erosion on the waterside of the levee during spring 2015 inspection.

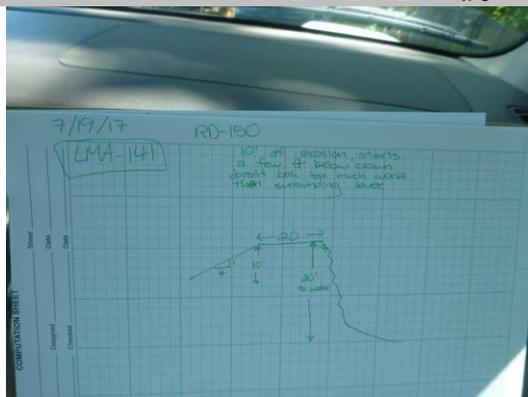
Photo 3 of 3 : LEVAL_FA_2019_314_2324.jpg

LM Start	6.95	Rating **	A/W	Issue No.	121 (cont)
LM End	6.95	Issue Type +	Ma	Location *	WS
Category	Supplemental			GPS Latitude/Longitude	
				Start	End
Item	2017 Storm Damage			38.397197°	38.397225°
				-121.535089°	-121.535092°
DWR ID	LMA-141

Comment Code					
Inspector Comment					
Levee Evaluation Comments					
Description: Erosion was observed on the waterside levee slope on the east (left) bank of Elk Slough. The site is approximately 10 feet long and progresses up to the levee crown. See attached pages for photos. Site ID No:314					
Site Designation: LMA-141					
Repair Type: Erosion					
Rating: Area of Concern					
Field Date: 7/19/2017					
Notes: Area of concern because the site is so small and only looks slightly worse than the surrounding levee slope. Crown is a paved road. Spring 2019 DWR Inspection: Erosion was not visible during this inspection due to high water.

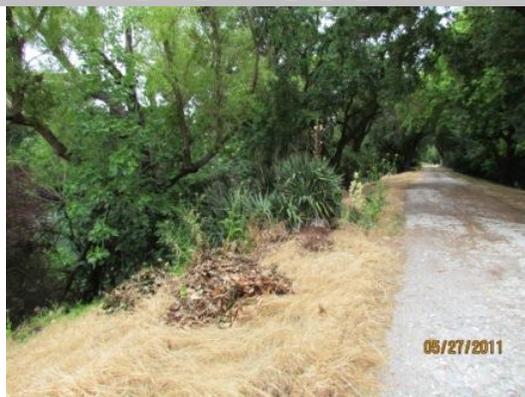
Photo 1 of 1 : FA_2019_RD0150_17_64_20190904_00048.jpg

LM Start	7.27	Rating **	U	Issue No.	64
LM End	7.27	Issue Type +	En	Location *	WS
Category	Earthen Levee		GPS Latitude/Longitude		
			Start	End	
Item	Vegetation		38.401520°	38.401520°	
			-121.536907°	-121.536907°	
DWR ID	DWR_RD0150_03_s_2012_64				
Comment Code					
V6 : Landscaping					
Inspector Comment					
Fan palm trees are not allowed on the levee slope.

Landscaping on the waterside of the levee. The picture was taken from the crown looking upstream. Spring 2011

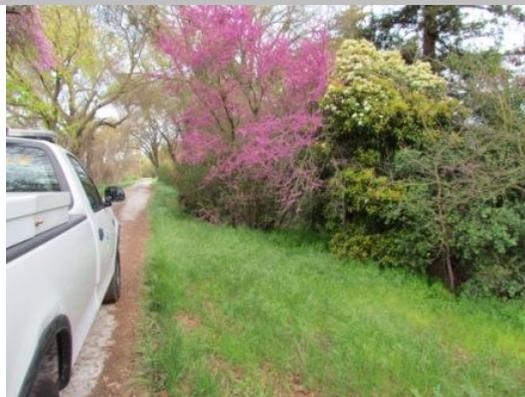
Photo 1 of 2 : FA_2019_RD0150_17_32_20190904_00010.jpg

LM Start	7.29	Rating **	U	Issue No.	32
LM End	7.34	Issue Type +	En	Location *	LS
Category	Earthen Levee		GPS Latitude/Longitude		
			Start	End	
Item	Vegetation		38.401738°	38.402296°	
			-121.537127°	-121.537678°	
DWR ID	DWR_RD0150_03_s_2012_32				
Comment Code					
V6 : Landscaping					
Inspector Comment

Vegetation on the landside of the levee looking upstream. Spring 2012

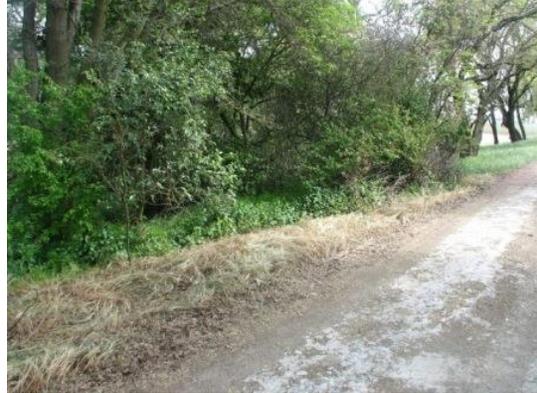
Photo 2 of 2 : FA_2019_RD0150_17_32_20190904_00011.jpg

LM Start	7.29	Rating **	U	Issue No.	32 (cont)
LM End	7.34	Issue Type +	En	Location *	LS
Category	Earthen Levee			GPS Latitude/Longitude	
				Start	End
Item	Vegetation			38.401738 °	38.402296 °
				-121.537127 °	-121.537678 °
DWR ID	DWR_RD0150_03_s_2012_32				
Comment Code					
V6 : Landscaping					
Inspector Comment

Landscaping on landward slope blocking view

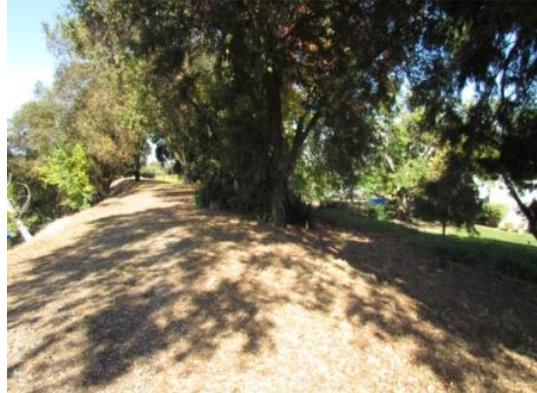
Photo 1 of 1 : FA_2019_RD0150_17_84_20190904_00065.jpg

LM Start	7.39	Rating **	M	Issue No.	84
LM End	7.40	Issue Type +	En	Location *	LS
Category	Earthen Levee			GPS Latitude/Longitude	
				Start	End
Item	Vegetation			38.402910 °	38.403047 °
				-121.538318 °	-121.538433 °
DWR ID	DWR_RD0150_03_s_2012_84				
Comment Code					
V6 : Landscaping					
Inspector Comment					
Pomegranate and citrus trees are planted on the levee slope.

Landscaping was found on the landside shoulder of the levee looking upstream.

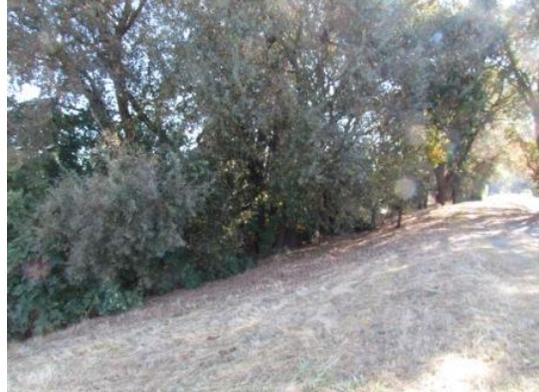
Photo 1 of 1 : FA_2019_RD0150_17_934_20190904_00116.jpg

LM Start	7.44	Rating **	U	Issue No.	934
LM End	7.44	Issue Type +	En	Location *	LS
Category	Earthen Levee		GPS Latitude/Longitude		
			Start	End	
Item	Vegetation		38.403566°	38.403566°	
			-121.538886°	-121.538886°	
DWR ID	DWR_RD0150_03_s_2012_934				
Comment Code					
V6 : Landscaping					
Inspector Comment

Landscaping was blocking the visibility on the landside of the levee looking downstream.

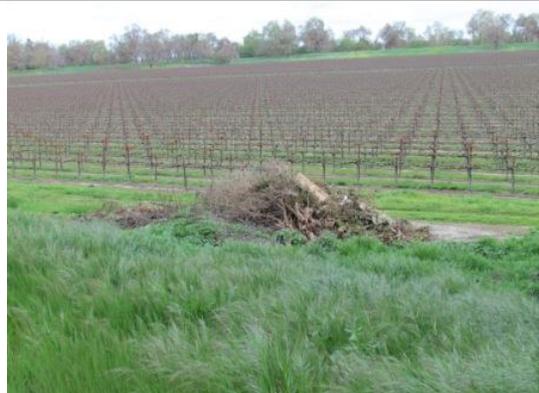
Photo 1 of 2 : FA_2019_RD0150_17_935_20190904_00117.jpg

LM Start	7.47	Rating **	M	Issue No.	935
LM End	7.47	Issue Type +	En	Location *	LS
Category	Earthen Levee		GPS Latitude/Longitude		
			Start	End	
Item	Encroachments		38.403795°	38.403795°	
			-121.539205°	-121.539205°	
DWR ID	DWR_RD0150_03_s_2012_935				
Comment Code					
PR : Prunings					
Inspector Comment

Prunings were found on the landside of the levee looking upstream.

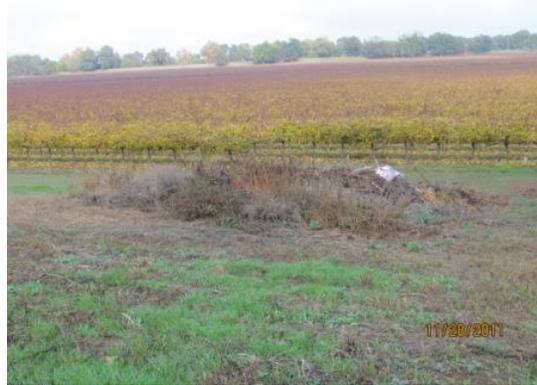
Photo 2 of 2 : FA_2019_RD0150_17_935_20190904_00118.jpg

LM Start	7.47	Rating **	M	Issue No.	935 (cont)
LM End	7.47	Issue Type +	En	Location *	LS
Category	Earthen Levee			GPS Latitude/Longitude	
				Start	End
Item	Encroachments			38.403795°	38.403795°
				-121.539205°	-121.539205°
DWR ID	DWR_RD0150_03_s_2012_935				
Comment Code					
PR : Prunings					
Inspector Comment

Prunings were found on the landside of the levee looking upstream. This picture was taken during fall 2011 inspection.

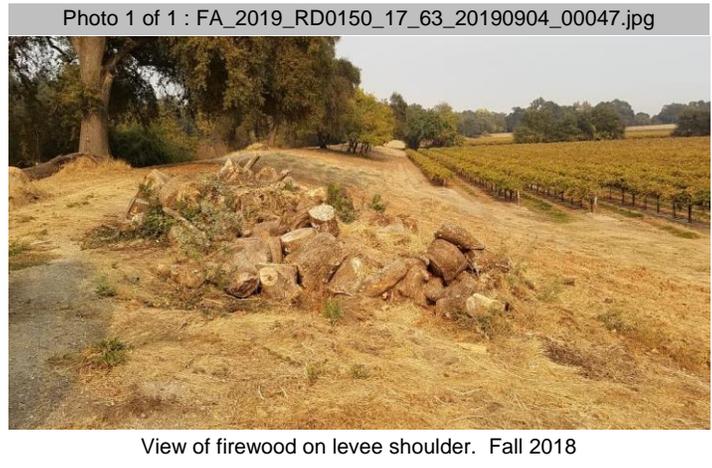
LM Start	7.73	Rating **	U	Issue No.	63
LM End	7.74	Issue Type +	En	Location *	CR
Category	Earthen Levee		GPS Latitude/Longitude		
			Start	End	
Item	Encroachments		38.405961°	38.406060°	
			-121.542968°	-121.543027°	
DWR ID	DWR_RD0150_03_s_2019_63				
Comment Code					
FW : Firewood					
Inspector Comment					
Firewood sits on both sides of the levee crown.

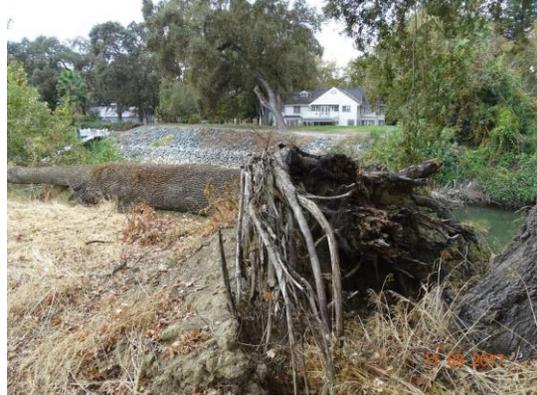
Photo 1 of 1 : FA_2019_RD0150_17_129_20190904_00108.jpg

LM Start	7.75	Rating **	M	Issue No.	129
LM End	7.75	Issue Type +	Ma	Location *	WS
Category	Earthen Levee		GPS Latitude/Longitude		
			Start	End	
Item	Encroachments		38.406298 °	38.406298 °	
			-121.542939 °	-121.542939 °	
DWR ID	DWR_RD0150_03_f_2017_129				
Comment Code					
TR : Tree or limb					
Inspector Comment					
Remove fallen tree from the waterside shoulder of the levee, and fill any large void.

View of a tree stump on the waterside shoulder of the levee. Fall 2017

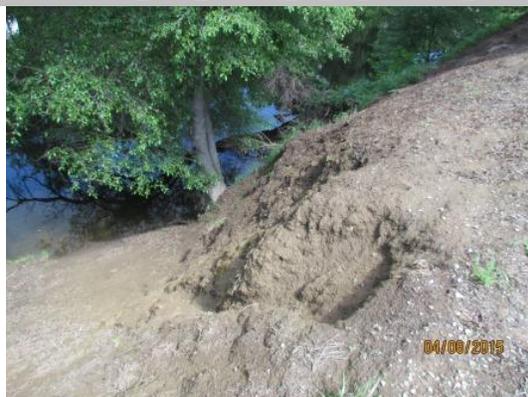
Photo 1 of 2 : FA_2019_RD0150_17_92_20190904_00072.jpg

LM Start	7.99	Rating **	M	Issue No.	92
LM End	8.02	Issue Type +	Ma	Location *	WS
Category	Earthen Levee		GPS Latitude/Longitude		
			Start	End	
Item	Slope Stability		38.409010°	38.409130°	
			-121.540513°	-121.539971°	
DWR ID	DWR_RD0150_03_s_2014_92				
Comment Code					
S1 : Repair slope instability.					
Inspector Comment

View of slope instability on the waterside of the levee looking upstream during spring 2015 inspection.

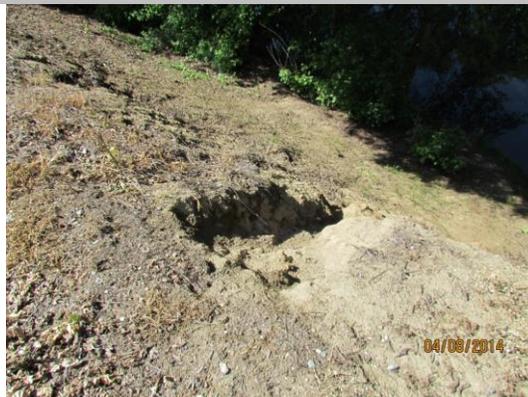
Photo 2 of 2 : FA_2019_RD0150_17_92_20190904_00073.jpg

Slope instability was found on the waterside of the levee looking downstream.

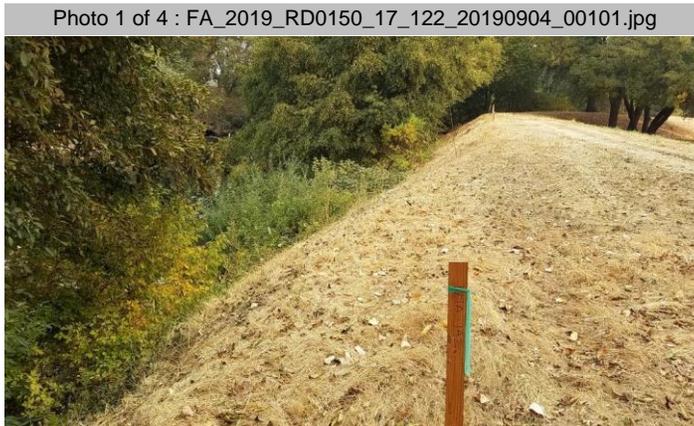
Comment Code					
Inspector Comment					
Levee Evaluation Comments					
Description: Erosion was observed on the waterside levee slope on the east (left) bank of Elk Slough. The site is approximately 10 feet long and progresses up to the levee crown. See attached pages for photos.					
Site ID No:315					
Site Designation:LMA-142					
Repair Type: Erosion					
Rating: Serious					
Field Date:7/17/2017					
Notes: The erosion extends along most of the slope. Nearby WS banks are all very steep (1:1 or less). Serious because the erosion extend along the entire slope, but not into the crown. Fall 2018 DWR					
Inspector: Erosion not visible during this inspection but is marked.

View of waterside slope. Fall 2018
