**Flood Control Project Maintenance
Levee Inspections**

Fall 2019 Levee Maintenance Deficiency Summary Report

Reclamation District No. 0150 Merrit Island

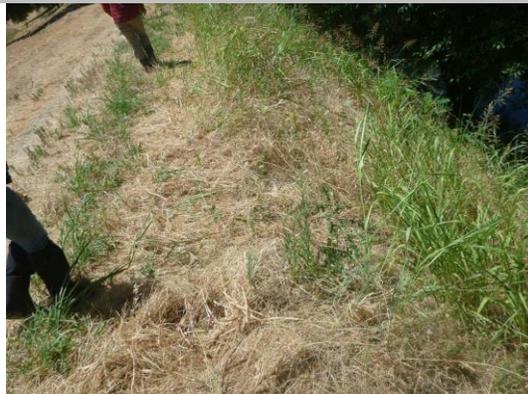
Photo 2 of 4 : LEVAL_FA_2019_315_2183.jpg

Comment Code					
Inspector Comment					
<p>Levee Evaluation Comments Description: Erosion was observed on the waterside levee slope on the east (left) bank of Elk Slough. The site is approximately 10 feet long and progresses up to the levee crown. See attached pages for photos. Site ID No:315 Site Designation:LMA-142 Repair Type: Erosion Rating: Serious Field Date:7/17/2017 Notes: The erosion extends along most of the slope. Nearby WS banks are all very steep (1:1 or less). Serious because the erosion extend along the entire slope, but not into the crown. Fall 2018 DWR Inspector: Erosion not visible during this inspection but is marked.</p>

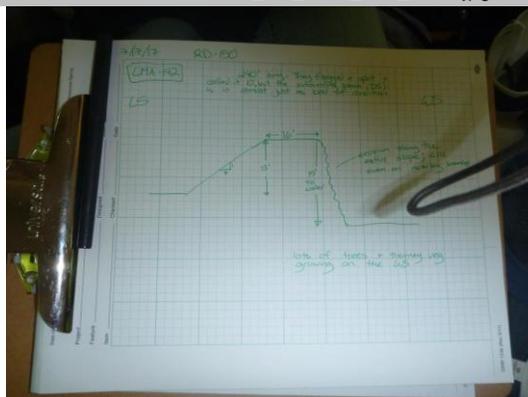
Photo 4 of 4 : LEVAL_FA_2019_315_2187.jpg

Comment Code					
Inspector Comment					
Levee Evaluation Comments					
Description: Erosion was observed on the waterside levee slope on the east (left) bank of Elk Slough. The site is approximately 10 feet long and progresses up to the levee crown. See attached pages for photos. Site ID No:315					
Site Designation:LMA-142					
Repair Type: Erosion					
Rating: Serious					
Field Date:7/17/2017					
Notes: The erosion extends along most of the slope. Nearby WS banks are all very steep (1:1 or less). Serious because the erosion extend along the entire slope, but not into the crown. Fall 2018 DWR Inspector: Erosion not visible during this inspection but is marked.

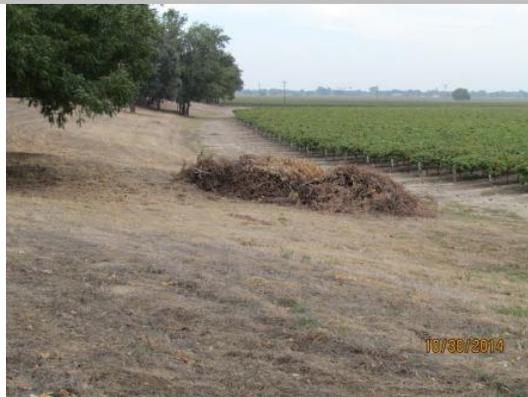
Photo 1 of 1 : FA_2019_RD0150_17_82_20190904_00063.jpg

LM Start	8.05	Rating **	M	Issue No.	82
LM End	8.05	Issue Type +	En	Location *	LS
Category	Earthen Levee		GPS Latitude/Longitude		
			Start	End	
Item	Encroachments		38.409224°	38.409224°	
			-121.539350°	-121.539350°	
DWR ID	DWR_RD0150_03_f_2013_82				
Comment Code					
PR : Prunings					
Inspector Comment

Prunings were found on the landside toe of the levee looking upstream. Fall 2014

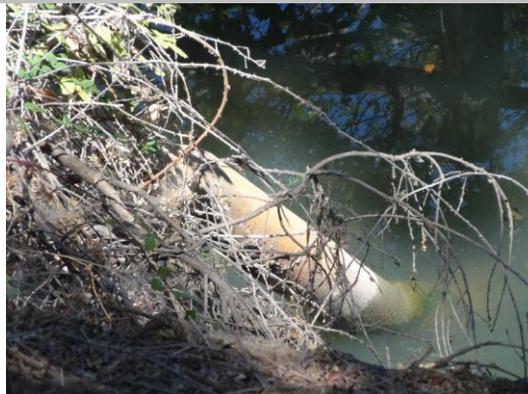
Photo 1 of 3 : UCIP_FA_2019_53335_33627.jpg

Comment Code					
Inspector Comment					
DS_ID:22466 FS_ID:53335 EP_NO: N/A Repair Type: Urgent Crossing Status: Found UCIP Comments: 06/05/2018: Same as last inspection so the crossing remains Urgent due to caved in levee below pipe at gate valve; needs proper abandonment (DWR UCIP - D. Sanoski).07/08/2016: Needs proper abandonment. Levee caved in below pipe at gate valve on WS. Discussed abandonment with Warren Bogle of Colby Ranch. (K. Fazel - UCIP)08/23/2013: Needs proper abandonment (P. Amatya - DWR) FIELD_STRUCT_DESC: *ABANDONED* 10-inch steel irrigation discharge pipe through the levee, invert elevation 13.8 feet below the crown. Gate valve on the waterside (WS) slope. Pilings in the stream, but no pump was found. Service pole with guy wire on the landside (LS) slope. Standpipe on the LS slope. (A. Colby). [Additional Reference(s): DWR Levee Log, 2005. USACE Sacramento O&M Manual 112, March 1957, (HLM 8.34)]. FS Date: 6/5/2018 3:30:00 PM

WS view: pipe visible on levee slope and in the stream.

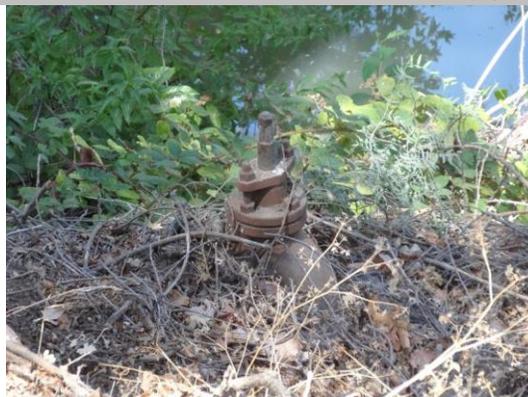
Photo 2 of 3 : UCIP_FA_2019_53335_33626.jpg

LM Start	8.20	Rating **	U	Issue No.	963 (cont)
LM End	8.20	Issue Type +	En	Location *

WS view: abandoned gate valve found on levee slope.

Comment Code					
Inspector Comment					
DS_ID:22466 FS_ID:53335 EP_NO: N/A Repair Type: Urgent Crossing Status: Found UCIP Comments: 06/05/2018: Same as last inspection so the crossing remains Urgent due to caved in levee below pipe at gate valve; needs proper abandonment (DWR UCIP - D. Sanoski).07/08/2016: Needs proper abandonment. Levee caved in below pipe at gate valve on WS. Discussed abandonment with Warren Bogle of Colby Ranch. (K. Fazel - UCIP)08/23/2013: Needs proper abandonment (P. Amatya - DWR) FIELD_STRUCT_DESC: *ABANDONED* 10-inch steel irrigation discharge pipe through the levee, invert elevation 13.8 feet below the crown. Gate valve on the waterside (WS) slope. Pilings in the stream, but no pump was found. Service pole with guy wire on the landside (LS) slope. Standpipe on the LS slope. (A. Colby). [Additional Reference(s): DWR Levee Log, 2005. USACE Sacramento O&M Manual 112, March 1957, (HLM 8.34)]. FS Date: 6/5/2018 3:30:00 PM

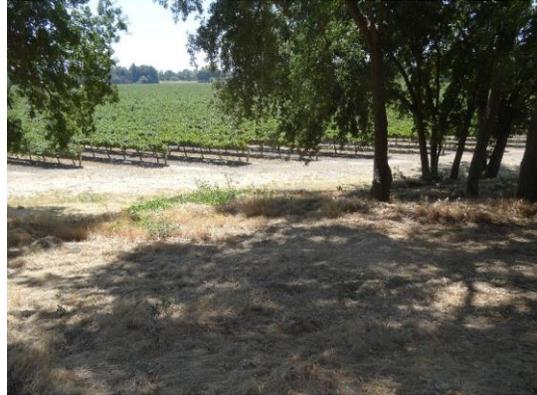
Photo 3 of 3 : UCIP_FA_2019_53335_33625.jpg

LS view: no pipe and structure found on landside.

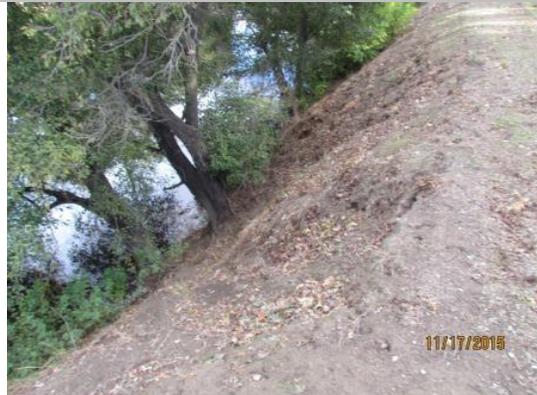
Photo 1 of 1 : FA_2019_RD0150_17_65_20190904_00049.jpg

LM Start	8.26	Rating **	M	Issue No.	65
LM End	8.26	Issue Type +	Ma	Location *	WS
Category	Earthen Levee			GPS Latitude/Longitude	
				Start	End
Item	Erosion / Bank Caving			38.408213 °	38.408213 °
				-121.535911 °	-121.535911 °
DWR ID	DWR_RD0150_03_f_2015_65				
Comment Code					
E2 : Schedule repair of erosion site prior to the next inspection.					
Inspector Comment

View of erosion on the waterside of the levee. Fall 2015

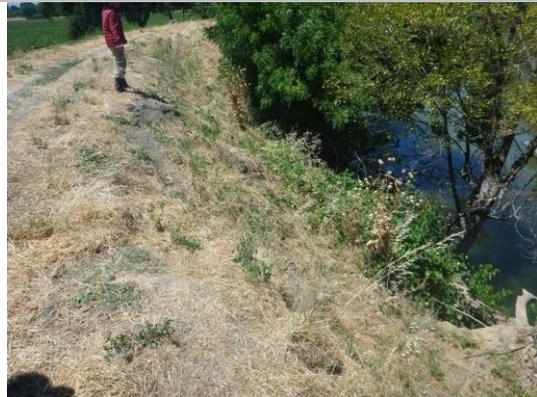
Photo 1 of 3 : LEVAL_FA_2019_316_2180.jpg

LM Start	8.35	Rating **	A/W	Issue No.	123
LM End	8.35	Issue Type +	Ma	Location *	WS
Category	Supplemental		GPS Latitude/Longitude		
			Start	End	
Item	2017 Storm Damage		38.407983 °	38.407992 °	
			-121.534322 °	-121.534289 °	
DWR ID	LMA-143				
Comment Code					
Inspector Comment					
Levee Evaluation Comments					
Description: Erosion was observed on the waterside levee slope on the east (left) bank of Elk Slough. The site is approximately 10 feet long. See attached pages for photos.					
Site ID No:316					
Site Designation:LMA-143					
Repair Type: Erosion					
Rating: Serious					
Field Date:7/17/2017					
Notes: 3 large trees in/adjacent to site including a fallen tree in the middle of the erosion. Erosion on almost the whole slope, but doesn't cut into the crown. Serious because erosion cuts into levee significantly here.

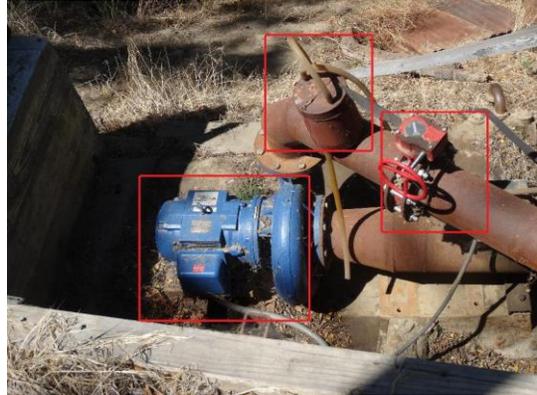
Photo 2 of 3 : UCIP_FA_2019_41648_33641.jpg

Comment Code					
Inspector Comment					
DS_ID:22467 FS_ID:41648 EP_NO: N/A Repair Type: Non-Urgent Crossing Status: Found UCIP Comments: - walkway in poor functional condition- an abandoned 8-inch steel pipe next to 12" pipe. This 8" pipe might have merged with 12" pipe under the levee .- Pipe and pump inside concrete masonry wall. FIELD_STRUCT_DESC: 12-inch steel irrigation discharge pipe through the levee, invert elevation 13 feet below the crown. Pump and gate valve in a pump house on the waterside (WS) slope. Concrete distribution box at the landside (LS) toe. Service pole on the WS shoulder. [Additional Reference(s): DWR Levee Log, 2005. USACE Sacramento O&M Manual 112, March 1957, (HLM 8.51)]. FS Date: 8/23/2013

WS view: pump, gate valve, and airvent on pipe inside concrete masonry box.

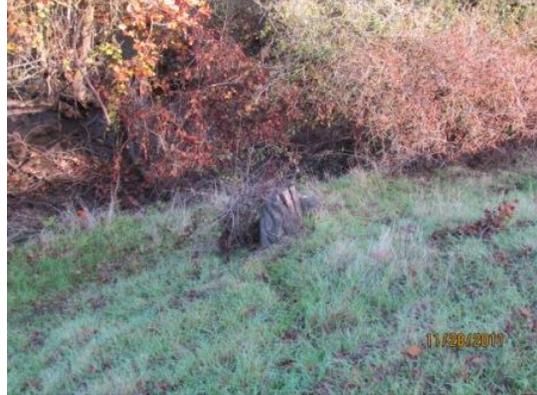
Photo 1 of 1 : FA_2019_RD0150_17_59_20190904_00042.jpg

LM Start	9.21	Rating **	N	Issue No.	59
LM End	9.21	Issue Type +	Ma	Location *	WS
Category	Earthen Levee		GPS Latitude/Longitude		
			Start	End	
Item	Trim / Thin Trees		38.413268°	38.413268°	
			-121.525929°	-121.525929°	
DWR ID	DWR_RD0150_03_s_2012_59				
Comment Code					
T5 : Tree stumps.					
Inspector Comment

A tree stump was found on the waterside of the levee looking upstream. Fall 2011

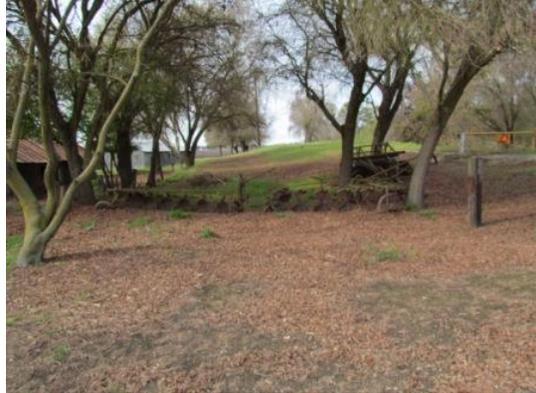
Photo 1 of 1 : FA_2019_RD0150_17_950_20190904_00119.jpg

LM Start	9.39	Rating **	M	Issue No.	950
LM End	9.39	Issue Type +	En	Location *	LS
Category	Earthen Levee			GPS Latitude/Longitude	
				Start	End
Item	Encroachments			38.413560 °	38.413560 °
				-121.522936 °	-121.522936 °
DWR ID	DWR_RD0150_03_s_2012_950				
Comment Code					
EQ : Equipment					
Inspector Comment

Equipment was found on the landside of the levee looking downstream.
