**Flood Control Project Maintenance  
Levee Inspections**

**Maintenance Issue Types Only, Levee Inspection Report By Mile - Fall 2019**

**Reclamation District No. 0150 Merrit Island**

Waterway	Bank	Unit Miles	Inspection Start/End	Inspector
Unit No. 01 Sutter Slough	Left	0.52	11/14/2019 11/14/2019	Luz Dial

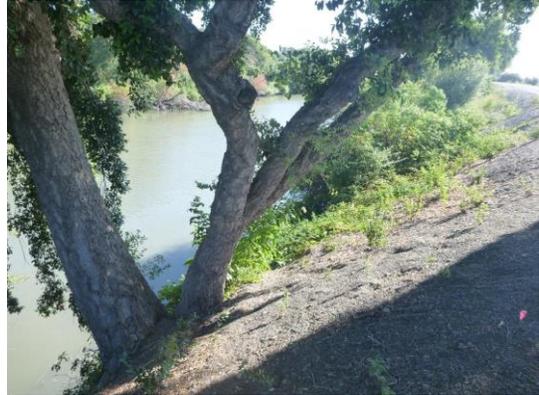
Photo 4 of 4 : LEVAL\_FA\_2019\_294\_2277.jpg

Item	2017 Storm Damage			38.354103°	38.354211°
				-121.564850°	-121.564631°
DWR ID	LMA-120				
Comment Code					
Inspector Comment					
<p>Levee Evaluation Comments                  Description: Instability, cracking, and erosion were observed on the waterside levee slope on the east (left) bank of Elk Slough. The site is approximately 75 feet long. See attached pages for photos.                  Site ID No: 294                  Site Designation: LMA-120                  Repair Type: Erosion                  Rating: Area of Concern                  Field Date: 7/19/2017                  Notes: Area of concern because erosion is not too far into the levee prism and looks similar to the rest of the levee outside of the site. Crown is a paved road.</p>

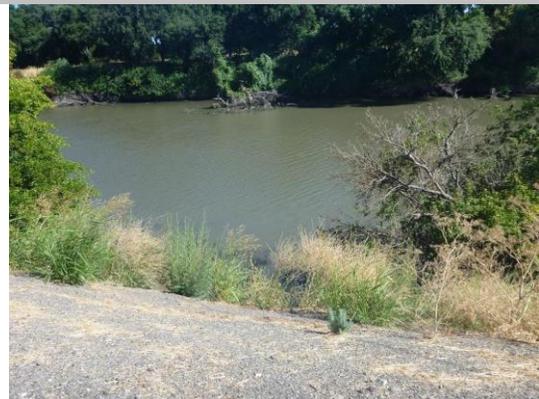
Photo 1 of 3 : LEVAL\_FA\_2019\_304\_2072.jpg

Item	2017 Storm Damage			38.374278°	38.374278°
				-121.549167°	-121.548511°
DWR ID	LMA-130				
Comment Code					
Inspector Comment					
Levee Evaluation Comments					
Description:Between 11 and 19 January 2017, waterside instability and erosion were observed on the east (left) bank of Elk Slough. The site is approximately 88 feet long, 7 feet below the levee crest, and includes a fallen tree and exposed root ball in the levee slope. See attached pages for photos.					
Site ID No:304					
Site Designation:LMA-130					
Repair Type: Erosion					
Rating:Serious					
Field Date:7/18/2017					
Notes: Crown is a paved road. Near vertical on lower 1/2 of slope including a fallen tree with exposed root ball. Serious because sloughing cuts into already over-steepened prism significantly and visible longitudinal cracking near crown.

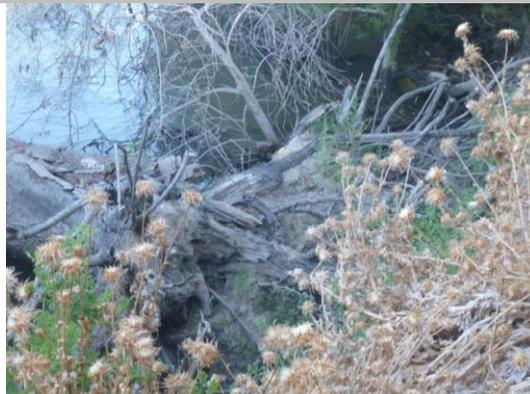
Photo 3 of 3 : LEVAL\_FA\_2019\_309\_2039.jpg

Item	2017 Storm Damage			38.380906 °	38.380928 °
				-121.540344 °	-121.540364 °
DWR ID	LMA-135				
Comment Code					
Inspector Comment					
Levee Evaluation Comments					
Description: On 19 January 2017, two large trees were observed to have fallen into the water exposing the root ball on the waterside levee slope on the east (left) bank of Elk Slough. The site is approximately 10 feet long. See attached pages for photos.					
Site ID No: 309					
Site Designation: LMA-135					
Repair Type: Erosion					
Rating: Area of Concern					
Field Date: 7/18/2017					
Notes: 2 oak trees fell over at the WS toe and took root balls out of the lower slope about 5 ft deep just above the water line. Area of concern because damage is only on the lower slope near the water line. Spring 2019 DWR Inspection: Erosion was not visible due to high water.

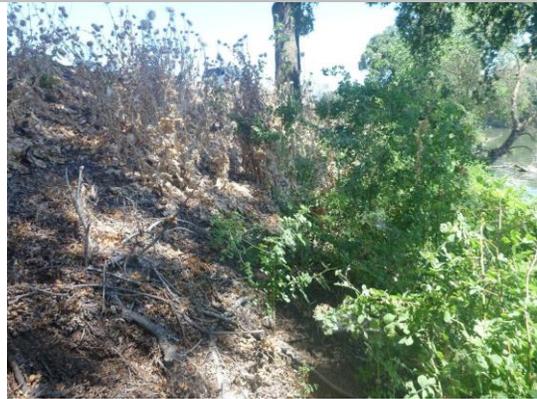
Photo 1 of 3 : LEVAL\_FA\_2019\_310\_2188.jpg

Item	2017 Storm Damage		38.382169°	38.382206°	
			-121.544597°	-121.544731°	
DWR ID	LMA-136				
Comment Code					
Inspector Comment					
Levee Evaluation Comments					
Description:Cracking and erosion were observed on the waterside levee slope on the east (left) bank of Elk Slough. The site is approximately 40 feet long. See attached pages for photos.					
Site ID No:310					
Site Designation:LMA-136					
Repair Type: Erosion					
Rating:Serious					
Field Date:7/17/2017					
Notes: Large oak tree fell over here and took a root ball with it. At least 15 ft wide by 5ft deep soil missing, 5 ft from crown. Longitudinal cracks for 40 ft along crown hinge. Serious because prism is impacted and cracking is visible beyond the damaged area.

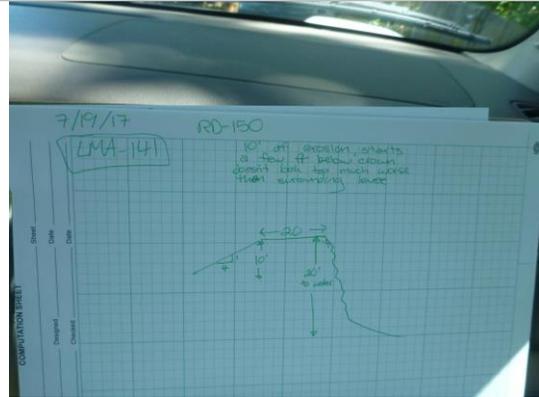
Photo 3 of 3 : LEVAL\_FA\_2019\_314\_2324.jpg

Item	2017 Storm Damage			38.397197°	38.397225°
				-121.535089°	-121.535092°
DWR ID	LMA-141				
Comment Code					
Inspector Comment					
Levee Evaluation Comments					
Description: Erosion was observed on the waterside levee slope on the east (left) bank of Elk Slough. The site is approximately 10 feet long and progresses up to the levee crown. See attached pages for photos. Site ID No:314					
Site Designation:LMA-141					
Repair Type: Erosion					
Rating:Area of Concern					
Field Date:7/19/2017					
Notes: Area of concern because the site is so small and only looks slightly worse than the surrounding levee slope. Crown is a paved road. Spring 2019 DWR Inspection: Erosion was not visible during this inspection due to high water.

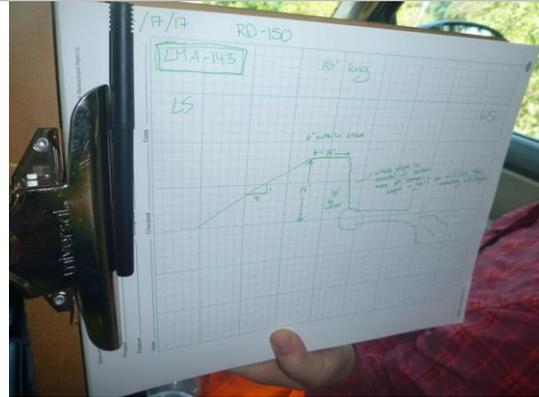
Photo 3 of 3 : LEVAL\_FA\_2019\_316\_2182.jpg

LM Start	<b>8.35</b>	Rating **	A/W	Issue No.	<b>123 (cont)</b>
LM End	<b>8.35</b>	Issue Type +	Ma	Location *	WS
Category	Supplemental			GPS Latitude/Longitude	
				Start	End
Item	2017 Storm Damage			38.407983°	38.407992°
				-121.534322°	-121.534289°
DWR ID	LMA-143				
Comment Code					
Inspector Comment					
Levee Evaluation Comments					
Description: Erosion was observed on the waterside levee slope on the east (left) bank of Elk Slough. The site is approximately 10 feet long. See attached pages for photos.					
Site ID No:316					
Site Designation:LMA-143					
Repair Type: Erosion					
Rating: Serious					
Field Date:7/17/2017					
Notes: 3 large trees in/adjacent to site including a fallen tree in the middle of the erosion. Erosion on almost the whole slope, but doesn't cut into the crown. Serious because erosion cuts into levee significantly here.
