**Flood Control Project Maintenance
Levee Inspections**

Maintenance Issue Types Only, Levee Inspection Report By Mile - Spring 2020

Reclamation District No. 0524 Middle Roberts Island

Waterway	Bank	Unit Miles	Inspection Start/End	Inspector
Unit No. 01 San Joaquin River	Left	6.20	04/30/2020 04/30/2020	Alberto De Leon

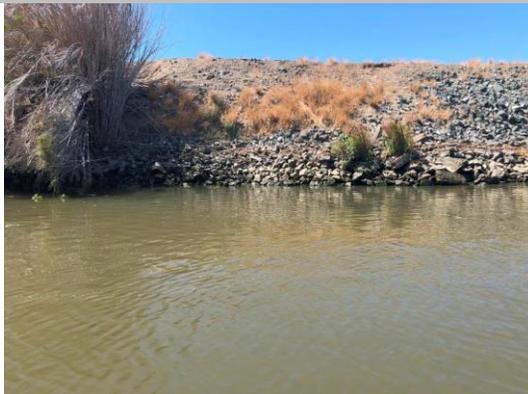
Photo 2 of 2 : SP_2020_RD0524_107_15_20200228_00015.jpg

LM Start	0.63	Rating **	U	Issue No.	15 (cont)
LM End	0.63	Issue Type +	Ma	Location *	WS
Category	Supplemental			GPS Latitude/Longitude	
				Start	End
Item	DWR Erosion Survey			37.938247 °	37.938247 °
				-121.336503 °	-121.336503 °
DWR ID	RD0524U01RM41.26

Front view of the erosion. The erosion is located at the shadow of the vegetation.

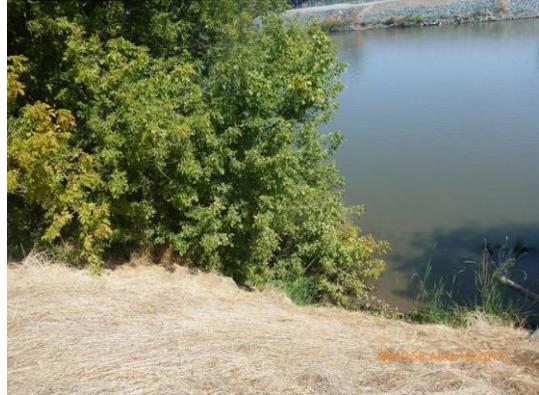
Photo 3 of 3 : LEVAL_SP_2020_537_4104.jpg

LM Start	0.90	Rating **	A/W	Issue No.	193 (cont)
LM End	0.91	Issue Type +	Ma	Location *	
Category	Supplemental			GPS Latitude/Longitude	
				Start	End
Item	2017 Storm Damage			37.935400 °	37.935300 °
				-121.333300 °	-121.333200 °
DWR ID	LMA-443

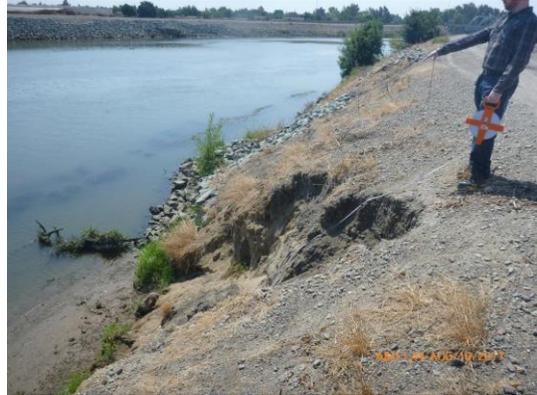
Photo 3 of 3 : LEVAL_SP_2020_534_4126.jpg

LM Start	1.25	Rating **	A/W	Issue No.	222 (cont)
LM End	1.30	Issue Type +	Ma	Location *	WS
Category	Supplemental			GPS Latitude/Longitude	
				Start	End
Item	2017 Storm Damage			37.932600 °	37.931900 °
				-121.328700 °	-121.328400 °
DWR ID	LMA-440

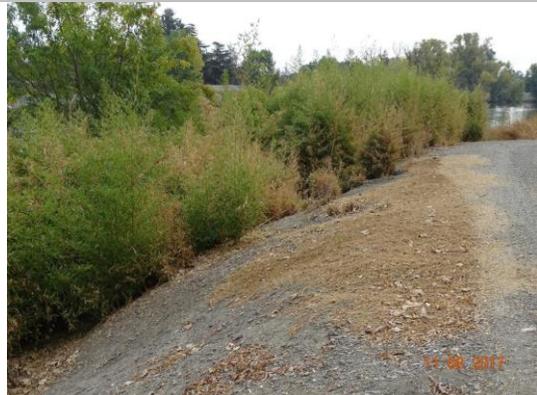
Photo 1 of 1 : SP_2020_RD0524_107_243_20200228_00219.jpg

LM Start	1.70	Rating **	U	Issue No.	243
LM End	1.72	Issue Type +	Ma	Location *	WS
Category	Earthen Levee			GPS Latitude/Longitude	
				Start	End
Item	Vegetation			37.926704 °	37.926471 °
				-121.326462 °	-121.326175 °
DWR ID	DWR_RD0524_01_f_2017_243				
Comment Code					
V2 : Remove the wild growth other than native grasses from the levee slopes.					
Inspector Comment

Looking southeast at the waterside slope.

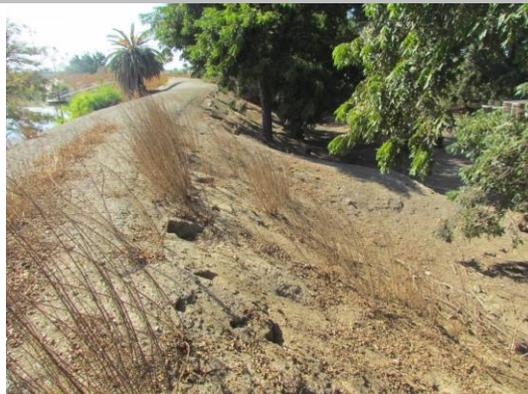
Photo 1 of 1 : SP_2020_RD0524_107_219_20200228_00178.jpg

LM Start	2.77	Rating **	U	Issue No.	219
LM End	2.80	Issue Type +	Ma	Location *	LS
Category	Earthen Levee			GPS Latitude/Longitude	
				Start	End
Item	Animal Control			37.915195 °	37.915052 °
				-121.322930 °	-121.323430 °
DWR ID	DWR_RD0524_01_f_2016_219				
Comment Code					
A1 : Exterminate rodents and backfill and compact or grout burrows.					
Inspector Comment					
Several large rodent holes on landside slope.

Looking south at several rodent holes on landward slope.

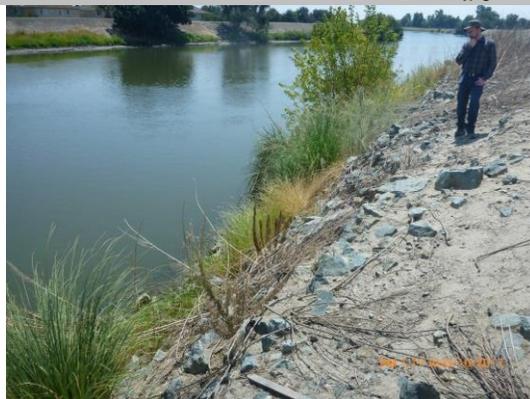
Photo 1 of 1 : LEVAL_SP_2020_529_4188.jpg

LM Start	2.96	Rating **	A/W	Issue No.	228
LM End	3.01	Issue Type +	Ma	Location *	WS
Category	Earthen Levee		GPS Latitude/Longitude		
			Start	End	
Item	Erosion / Bank Caving		37.913023 °	37.912300 °	
			-121.324507 °	-121.324700 °	
DWR ID	LMA-435				
Comment Code					
E1 : Note and monitor erosion site.					
Inspector Comment					
2017 Storm Damage Site, ID No. 529, 465, Slope protection repairs are needed along the waterside slope due to erosion and riprap displacement from high water.

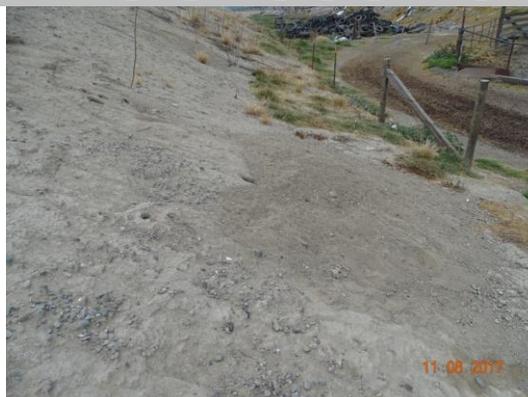
Photo 1 of 1 : SP_2020_RD0524_107_925_20200228_00239.jpg

LM Start	3.10	Rating **	M	Issue No.	925
LM End	3.27	Issue Type +	Ma	Location *	LS
Category	Earthen Levee			GPS Latitude/Longitude	
				Start	End
Item	Animal Control			37.910946 °	37.908602 °
				-121.325147 °	-121.325395 °
DWR ID	DWR_RD0524_01_s_2012_925				
Comment Code					
A1 : Exterminate rodents and backfill and compact or grout burrows.					
Inspector Comment					
Several rodent holes on levee slopes.

Looking southwest at the landside slope.

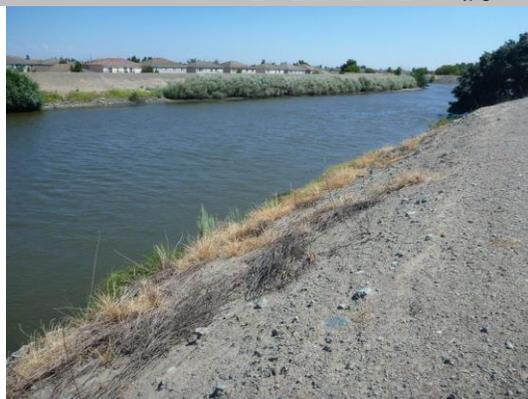
Photo 1 of 1 : LEVAL_SP_2020_466_2229.jpg

LM Start	3.23	Rating **	A/W	Issue No.	229
LM End	3.30	Issue Type +	Ma	Location *	WS
Category	Earthen Levee			GPS Latitude/Longitude	
				Start	End
Item	Erosion / Bank Caving			37.909200 °	37.908200 °
				-121.325300 °	-121.325300 °
DWR ID	LMA-293				
Comment Code					
E1 : Note and monitor erosion site.					
Inspector Comment					
2017 Storm Damage Site ID 466, 528, 527, 467, Slope protection repairs are needed along the waterside slope due to erosion. Notes: Lower priority because damage is only on the lower 1/5 of slope.

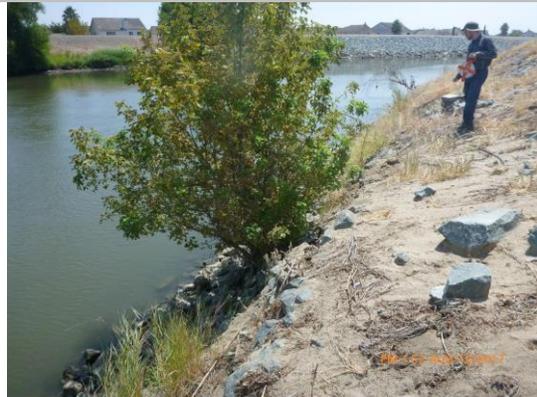
Photo 1 of 1 : LEVAL_SP_2020_526_4201.jpg

LM Start	3.53	Rating **	A/W	Issue No.	233
LM End	3.54	Issue Type +	Ma	Location *	WS
Category	Earthen Levee		GPS Latitude/Longitude		
			Start	End	
Item	Erosion / Bank Caving		37.905300 °	37.905200 °	
			-121.323800 °	-121.323900 °	
DWR ID	LMA-432				
Comment Code					
E1 : Note and monitor erosion site.					
Inspector Comment					
2017 Storm Damage Site, ID No. 526, LMA-432, Slope protection repairs are needed along the waterside slope due to erosion and riprap displacement from high water.

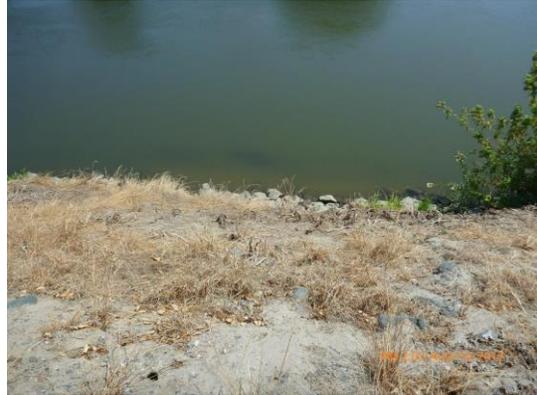
Photo 1 of 1 : LEVAL_SP_2020_525_4205.jpg

LM Start	3.56	Rating **	A/W	Issue No.	234
LM End	3.57	Issue Type +	Ma	Location *	WS
Category	Earthen Levee			GPS Latitude/Longitude	
				Start	End
Item	Erosion / Bank Caving			37.904900 °	37.904800 °
				-121.323900 °	-121.324100 °
DWR ID	LMA-431				
Comment Code					
E1 : Note and monitor erosion site.					
Inspector Comment					
2017 Storm Damage Site, ID No. 525, LMA-431, Slope protection repairs are needed along the waterside slope due to erosion and riprap displacement from high water.

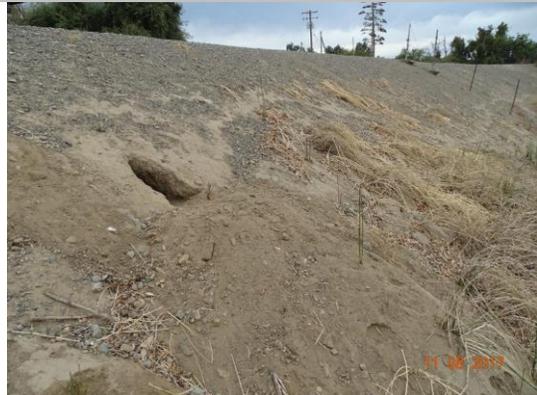
Photo 1 of 1 : SP_2020_RD0524_107_251_20200228_00222.jpg

LM Start	3.67	Rating **	U	Issue No.	251
LM End	3.69	Issue Type +	Ma	Location *	WS
Category	Earthen Levee			GPS Latitude/Longitude	
				Start	End
Item	Animal Control			37.903776 °	37.903513 °
				-121.325323 °	-121.325494 °
DWR ID	DWR_RD0524_01_f_2017_251				
Comment Code					
A3 : No rodents visible, but rodent burrows visible; need to backfill and compact or grout burrows.					
Inspector Comment					
Large rodent holes on waterside slope.

Looking northwest at the waterside slope.

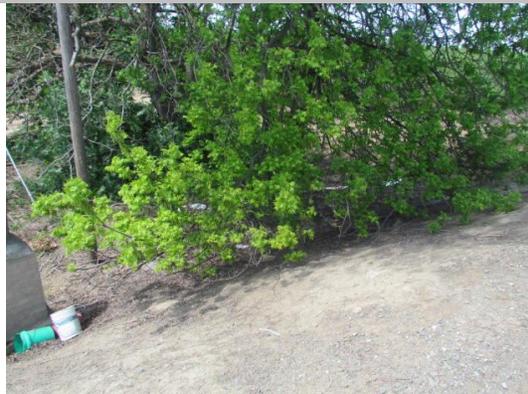
Photo 1 of 1 : SP_2020_RD0524_107_61_20200228_00072.jpg

LM Start	4.04	Rating **	M	Issue No.	61
LM End	4.04	Issue Type +	Ma	Location *	LS
Category	Earthen Levee			GPS Latitude/Longitude	
				Start	End
Item	Trim / Thin Trees			37.898861 °	37.898861 °
				-121.327071 °	-121.327071 °
DWR ID	DWR_RD0524_01_s_2012_61				
Comment Code					
T1 : Trim trees to at least five feet above ground level.					
Inspector Comment

Looking east at untrimmed tree at landward toe.

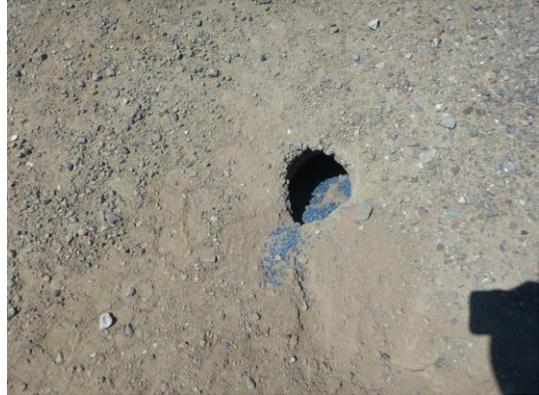
Photo 3 of 3 : LEVAL_SP_2020_468_2221.jpg

LM Start	4.53	Rating **	A/W	Issue No.	235 (cont)
LM End	4.53	Issue Type +	Ma	Location *	WS
Category	Supplemental			GPS Latitude/Longitude	
				Start	End
Item	2017 Storm Damage			37.892230 °	37.892200 °
				-121.327930 °	-121.328000 °
DWR ID	LMA-295

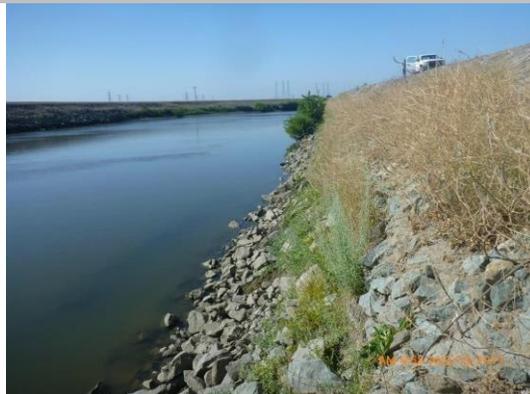
Photo 1 of 1 : LEVAL_SP_2020_523_4217.jpg

LM Start	4.76	Rating **	A/W	Issue No.	236
LM End	4.76	Issue Type +	Ma	Location *	WS
Category	Earthen Levee			GPS Latitude/Longitude	
				Start	End
Item	Erosion / Bank Caving			37.889300 °	37.889300 °
				-121.329800 °	-121.329800 °
DWR ID	DWR_RD0524_01_s_2020_236				
Comment Code					
E1 : Note and monitor erosion site.					
Inspector Comment					
2017 Storm Damage Site, ID No. 523, LMA-429, Slope protection repairs are needed along the waterside slope due to erosion and riprap displacement from high water.

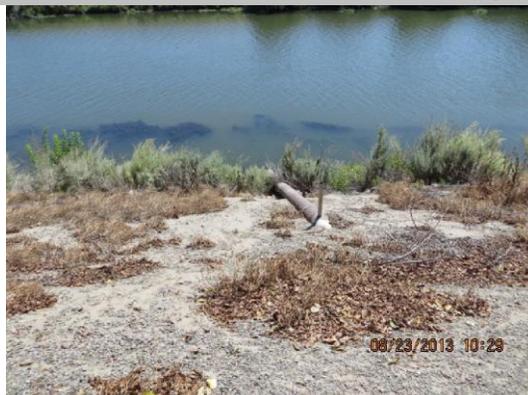
Photo 1 of 3 : UCIP_SP_2020_53358_30689.jpg

LM Start	5.41	Rating **	U	Issue No.	962 (cont)
LM End	5.41	Issue Type +	Ma	Location *

Pipe visible on WS slope.

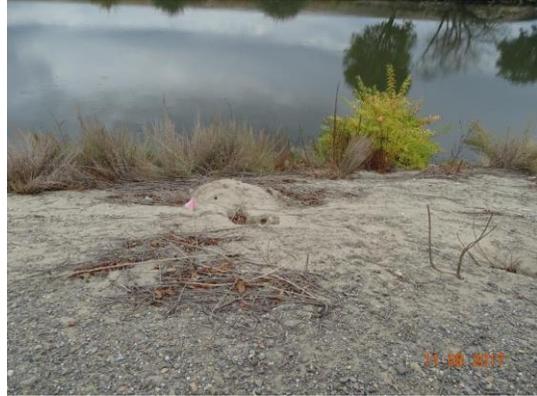
Photo 1 of 1 : SP_2020_RD0524_107_271_20200228_00235.jpg

LM Start	5.76	Rating **	M	Issue No.	271
LM End	5.76	Issue Type +	Ma	Location *	WS
Category	Earthen Levee			GPS Latitude/Longitude	
				Start	End
Item	Animal Control			37.875631 °	37.875631 °
				-121.332907 °	-121.332907 °
DWR ID	DWR_RD0524_01_f_2017_271				
Comment Code					
A3 : No rodents visible, but rodent burrows visible; need to backfill and compact or grout burrows.					
Inspector Comment

Looking east at the waterside slope.

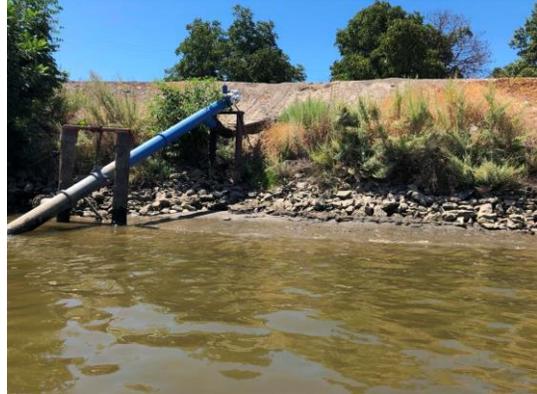
Photo 1 of 1 : SP_2020_RD0524_107_79_20200228_00087.jpg

LM Start	5.87	Rating **	U	Issue No.	79
LM End	5.87	Issue Type +	Ma	Location *	WS
Category	Supplemental		GPS Latitude/Longitude		
			Start	End	
Item	DWR Erosion Survey		37.874185 °	37.874185 °	
			-121.333110 °	-121.333110 °	
DWR ID	RD0524U01RM46.39				
Comment Code					
Inspector Comment					
Site ID: RD0524U01RM46.39 08/13/2019: No significant change observed. 09/13/2017: No significant change observed. 07/25/2016: No significant change observed. 06/24/2015: No significant change observed. 06/19/2014: No significant change observed. 08/13/2013: No significant change observed. 08/07/2012: The erosion is near a water-intake structure. Pipe leakage likely caused the erosion.

Front view of the site.
