**Flood Control Project Maintenance
Levee Inspections**

Fall 2019 Levee Maintenance Deficiency Summary Report

Reclamation District No. 0544 Upper Roberts Island

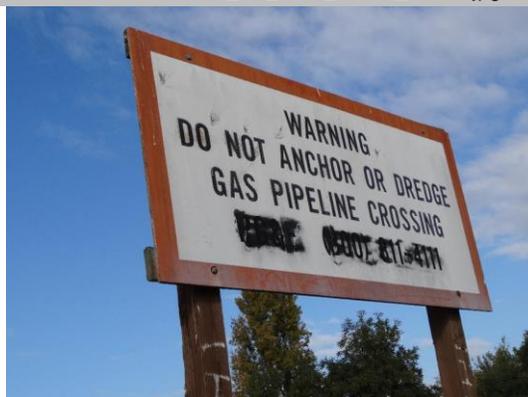
Photo 3 of 3 : UCIP_FA_2019_41906_41711.jpg

Comment Code					
Inspector Comment					
DS_ID:22640 FS_ID:41906 EP_NO: 4116 Repair Type: Non-Urgent Crossing Status: Found UCIP Comments: Need to contact owner to determine status.- a signboard on waterside shoulder and across the river.- no indicators on landside. FIELD_STRUCT_DESC: 8.625-inch steel natural gas pipeline through the levees and under the river, 3.9 feet below the crown. Waterside (WS) slope rock revetted. (Plans for installation of an 8.625-inch gas line under the San Joaquin River and through the levees authorized under Permit No. 4116, 1962 - Pacific Gas and Electric Company [PG&E]). [Additional Reference(s): DWR Levee Log, 2005. USACE San Joaquin O&M Manual 7, April 1964, (HLM 0.01)]. FS Date: 10/29/2013

WS view: closer view of a signboard indicating a gasoline on levee shoulder.

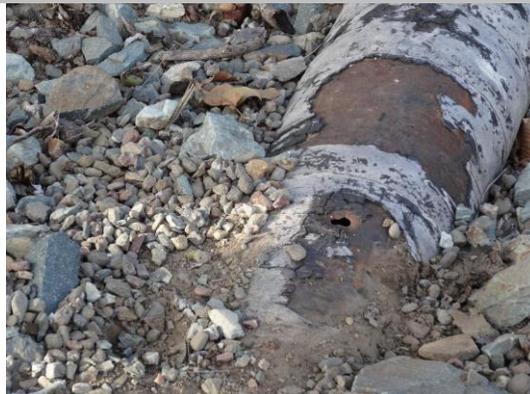
Photo 2 of 3 : UCIP_FA_2019_23851_41727.jpg

LM Start	0.01	Rating **	M	Issue No.	144 (cont)
LM End	0.01	Issue Type +	En	Location *	
Category	Supplemental			GPS Latitude/Longitude	
				Start	End
Item	DRAFT DWR UCIP Field Study			37.870296°	37.870296°
				-121.329826°	-121.329826°
DWR ID	24713				
Comment Code					
Inspector Comment					
DS_ID:24713 FS_ID:23851 EP_NO: N/A Repair Type: Non-Urgent Crossing Status: Found UCIP Comments: Appears abandoned. May need proper abandonment. Pipe exposed on landside slope. FIELD_STRUCT_DESC: *ABANDONED* 12-inch steel pipe of an unknown purpose through the levee, 2 feet below the crown. Appears abandoned. Only visible on the landside (LS) slope. No pipe or other features visible on the waterside (WS). FS Date: 10/29/2013

LS view: a 12-inch steel pipe on levee slope. Holes on the pipe, appears abandoned.

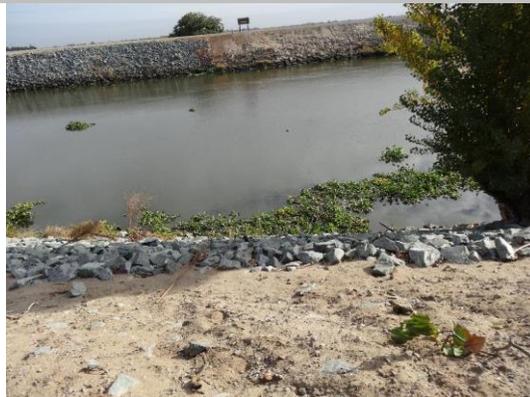
Photo 3 of 3 : UCIP_FA_2019_23851_41726.jpg

WS view: no pipe and appurtenances found on waterside.

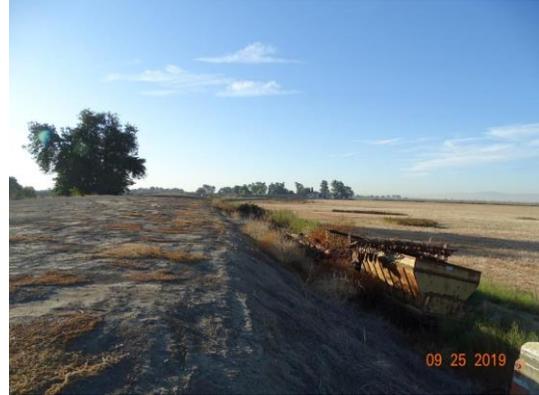
Photo 1 of 1 : FA_2019_RD0544_108_4_20191117_00152.jpg

LM Start	0.06	Rating **	M	Issue No.	4
LM End	0.23	Issue Type +	En	Location *	LS
Category	Earthen Levee		GPS Latitude/Longitude		
			Start	End	
Item	Encroachments		37.869606°	37.867580°	
			-121.329571°	-121.327791°	
DWR ID	DWR_RD0544_01_s_2012_4				
Comment Code					
EQ : Equipment					
Inspector Comment					
Farm equipment and supplies are stored at landside toe.

View of farm equipment on landside toe. Fall 2019

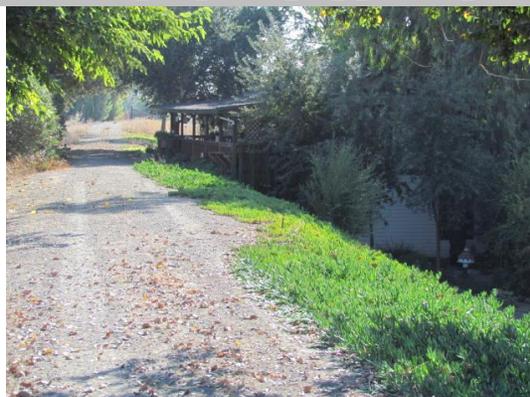
Photo 2 of 2 : FA_2019_RD0544_108_9_20190830_00012.jpg

LM Start	0.66	Rating **	U	Issue No.	9 (cont)
LM End	0.72	Issue Type +	En	Location *	LS
Category	Earthen Levee		GPS Latitude/Longitude		
			Start	End	
Item	Vegetation		37.863790°	37.863432°	
			-121.323027°	-121.322155°	
DWR ID	DWR_RD0544_01_s_2012_9				
Comment Code					
V6 : Landscaping					
Inspector Comment

Looking upstream at landscaping on landward slope.

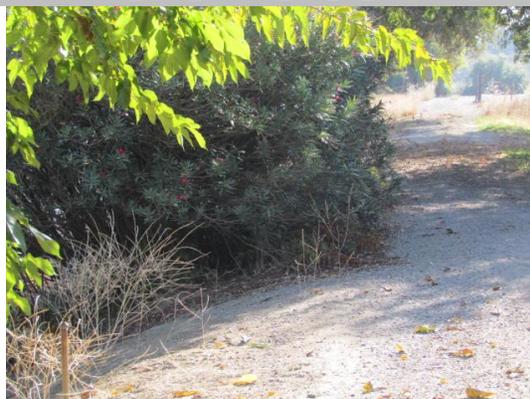
Photo 1 of 1 : FA_2019_RD0544_108_10_20190830_00013.jpg

LM Start	0.70	Rating **	U	Issue No.	10
LM End	0.72	Issue Type +	En	Location *	WS
Category	Earthen Levee		GPS Latitude/Longitude		
			Start	End	
Item	Vegetation		37.863575°	37.863488°	
			-121.322367°	-121.322108°	
DWR ID	DWR_RD0544_01_s_2012_10				
Comment Code					
V6 : Landscaping					
Inspector Comment					
Oleander on waterside slope is blocking visibility.

Dense oleanders on waterward slope, Fall 2015.

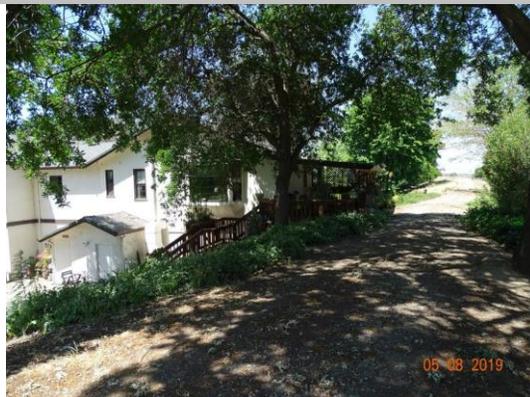
Photo 1 of 1 : FA_2019_RD0544_108_55_20190830_00031.jpg

LM Start	0.70	Rating **	U	Issue No.	55
LM End	0.70	Issue Type +	En	Location *	LS
Category	Earthen Levee		GPS Latitude/Longitude		
			Start	End	
Item	Encroachments		37.863576°	37.863576°	
			-121.322327°	-121.322327°	
DWR ID	DWR_RD0544_01_s_2019_55				
Comment Code					
BU : Building					
Inspector Comment					
There is a residential building on the landside slope.

View of residential building on landside slope. (Spring 2019)

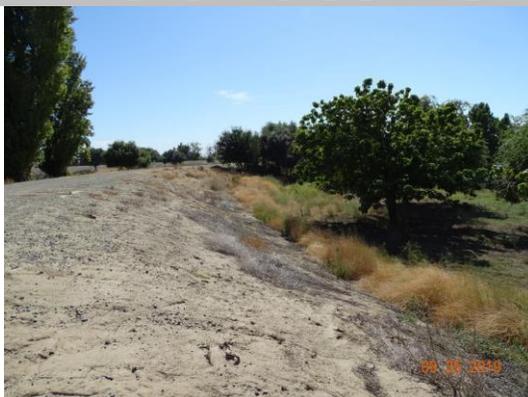
Photo 1 of 1 : FA_2019_RD0544_108_46_20191117_00153.jpg

LM Start	0.75	Rating **	M	Issue No.	46
LM End	0.83	Issue Type +	Ma	Location *	LS
Category	Earthen Levee			GPS Latitude/Longitude	
				Start	End
Item	Vegetation			37.863209°	37.862327°
				-121.321529°	-121.320886°
DWR ID	DWR_RD0544_01_f_2019_46				
Comment Code					
V2 : Remove the wild growth other than native grasses from the levee slopes.					
Inspector Comment

Typical view of vegetation obstructing view of landside toe and easement. Fall 2019

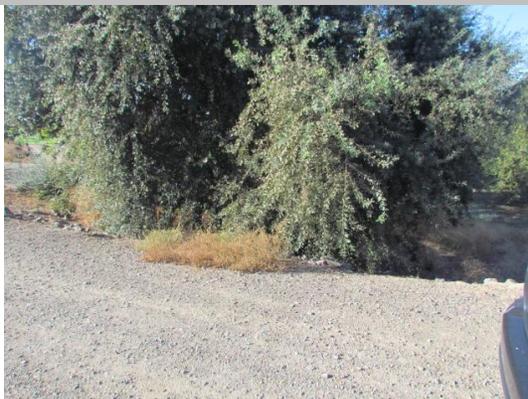
Photo 1 of 1 : FA_2019_RD0544_108_93_20190830_00054.jpg

LM Start	0.81	Rating **	M	Issue No.	93
LM End	0.81	Issue Type +	Ma	Location *	LS
Category	Earthen Levee			GPS Latitude/Longitude	
				Start	End
Item	Trim / Thin Trees			37.862694°	37.862694°
				-121.320887°	-121.320887°
DWR ID	DWR_RD0544_01_f_2014_93				
Comment Code					
T1 : Trim trees to at least five feet above ground level.					
Inspector Comment

Looking west at untrimmed trees on landward slope and toe, Fall 2015.

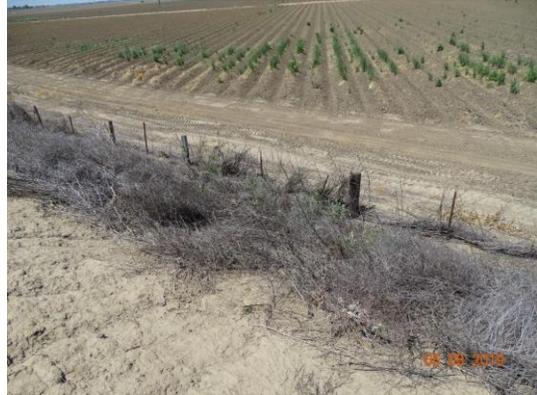
Photo 1 of 1 : FA_2019_RD0544_108_58_20190830_00032.jpg

LM Start	0.83	Rating **	M	Issue No.	58
LM End	1.31	Issue Type +	En	Location *	LS
Category	Earthen Levee		GPS Latitude/Longitude		
			Start	End	
Item	Encroachments		37.862312°	37.857169°	
			-121.320889°	-121.320224°	
DWR ID	DWR_RD0544_01_s_2019_58				
Comment Code					
FE : Fence					
Inspector Comment					
There is a barbed wire fence near the landside toe and within the easement.

View of barbed wire fence near landside toe and within easement. (Spring 2019)

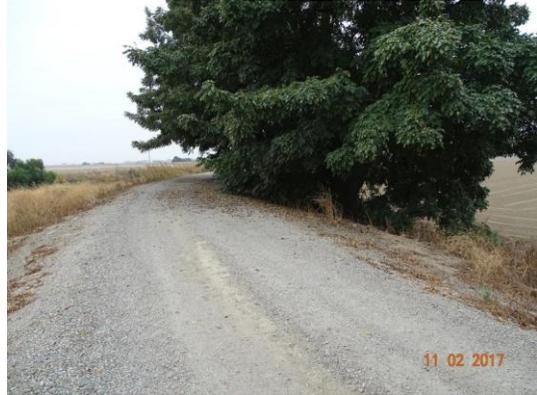
Photo 1 of 2 : FA_2019_RD0544_108_39_20190830_00021.jpg

LM Start	1.12	Rating **	M	Issue No.	39
LM End	1.12	Issue Type +	Ma	Location *	LS
Category	Earthen Levee			GPS Latitude/Longitude	
				Start	End
Item	Trim / Thin Trees			37.859423°	37.859423°
				-121.318328°	-121.318328°
DWR ID	DWR_RD0544_01_s_2012_39				
Comment Code					
T1 : Trim trees to at least five feet above ground level.					
Inspector Comment					
There are untrimmed trees on the landside slope.

Looking southwest at landside slope.

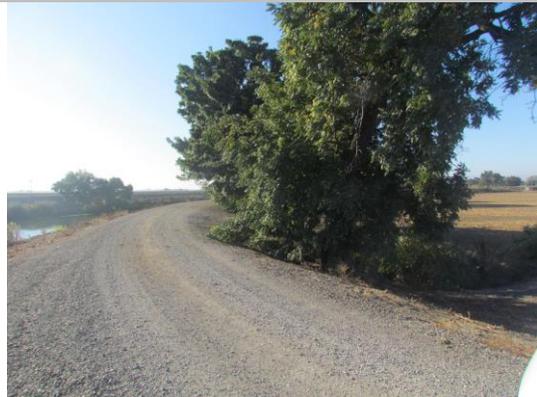
Photo 2 of 2 : FA_2019_RD0544_108_39_20190830_00022.jpg

Looking southwest at untrimmed tree on landward slope.

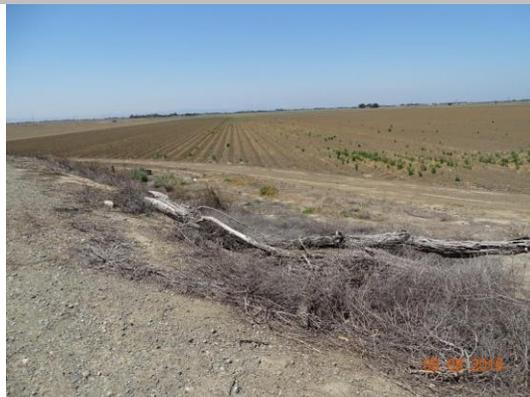
Photo 1 of 1 : FA_2019_RD0544_108_63_20190830_00033.jpg

LM Start	1.32	Rating **	M	Issue No.	63
LM End	1.32	Issue Type +	Ma	Location *	LS
Category	Earthen Levee		GPS Latitude/Longitude		
			Start	End	
Item	Encroachments		37.857093 °	37.857093 °	
			-121.320378 °	-121.320378 °	
DWR ID	DWR_RD0544_01_s_2019_63				
Comment Code					
TR : Tree or limb					
Inspector Comment

View of tree limbs on landside slope. (Spring 2019)

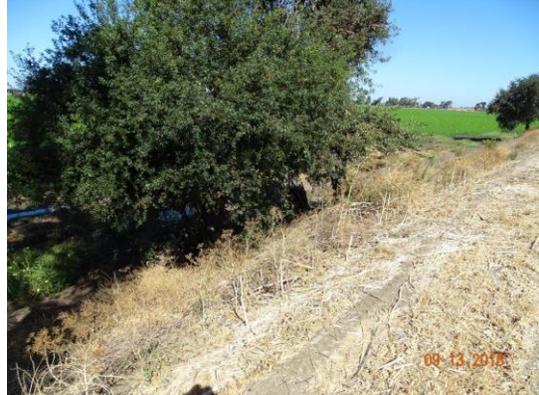
Photo 1 of 1 : FA_2019_RD0544_108_42_20190830_00023.jpg

LM Start	1.44	Rating **	M	Issue No.	42
LM End	1.44	Issue Type +	Ma	Location *	LS
Category	Earthen Levee			GPS Latitude/Longitude	
				Start	End
Item	Trim / Thin Trees			37.855617°	37.855617°
				-121.321157°	-121.321157°
DWR ID	DWR_RD0544_01_f_2018_42				
Comment Code					
T1 : Trim trees to at least five feet above ground level.					
Inspector Comment

Looking at untrimmed tree at landward toe. (Fall 2018)

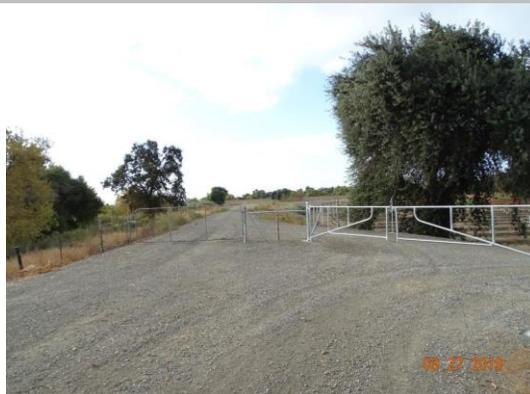
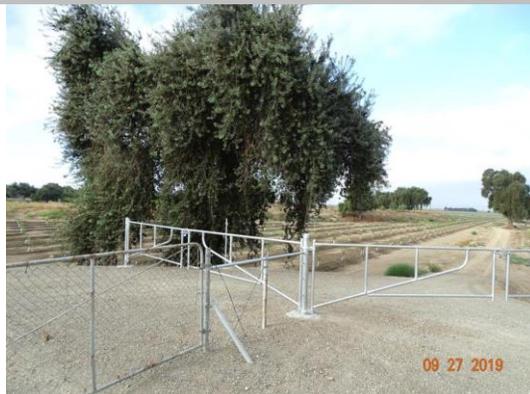
LM Start	1.47	Rating **	U	Issue No.	76
LM End	1.47	Issue Type +	En	Location *	LS
Category	Earthen Levee			GPS Latitude/Longitude	
				Start	End
Item	Encroachments			37.855164°	37.855164°
				-121.321139°	-121.321139°
DWR ID	DWR_RD0544_01_f_2019_76				
Comment Code					
RA : Ramp					
Inspector Comment					
Unpermitted gates on landside shoulder.

View of new gates on landside shoulder. Fall 2019

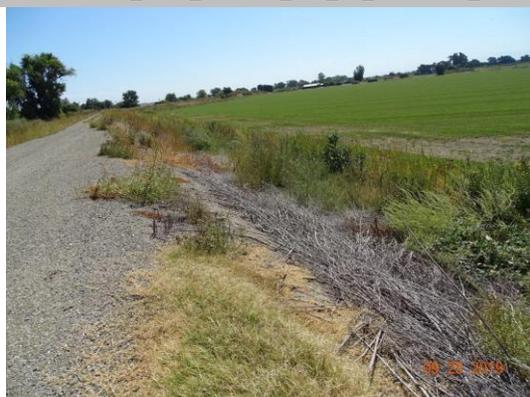
Photo 1 of 1 : FA_2019_RD0544_108_62_20191117_00155.jpg

LM Start	1.48	Rating **	M	Issue No.	62
LM End	6.04	Issue Type +	Ma	Location *	LS
Category	Earthen Levee			GPS Latitude/Longitude	
				Start	End
Item	Vegetation			37.855049°	37.808780°
				-121.321108°	-121.328154°
DWR ID	DWR_RD0544_01_f_2019_62				
Comment Code					
V2 : Remove the wild growth other than native grasses from the levee slopes.					
Inspector Comment					
Visibility of the majority of the landside slope and easement is partially blocked due to tall grass and weeds.

Typical view of vegetation on landside slope and easement. Fall 2019

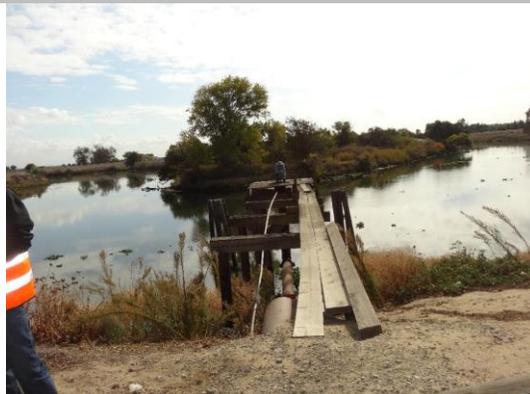
Photo 3 of 3 : UCIP_FA_2019_51351_41784.jpg

Comment Code					
Inspector Comment					
DS_ID:22648 FS_ID:51351 EP_NO: 4114 Repair Type: Non-Urgent Crossing Status: Found UCIP Comments: 12/22/2016: No signs of erosion or depressions found on either levee slope. Slope may have been backfilled but cause of original depression (likely a pipe integrity problem) may not have been addressed. Walkway still in poor structural condition. Downgraded this crossing from Urgent to Non-Urgent. (K. Fazel - UCIP)10/29/2013:- levee depression on both sides of the levee.- 2-inch electric conduit on waterside and service pole on landside.Walkway in poor structural condition. (P. Amatya - DWR) FIELD_STRUCT_DESC: 18-inch steel irrigation discharge pipe through the levee, 2 feet below the crown. Pump mounted on a pile structure pier in the river. Siphon breaker on the apex of the pipe on the landside (LS) slope. Concrete standpipe at the LS toe. 2-inch electrical conduit through the levee. Service pole at the LS toe. (Plans to install a pump, pump structure, and one 20-inch pipeline through the levee authorized under Permit No. 4114, 1962 - Katie M. Feck). [Additional Reference(s): DWR Levee Log, 2005, 14-inch pipe referenced, 4.2 feet below the crown. USACE San Joaquin O&M Manual 7, April 1964, (HLM 1.73), 20-inch pipe, 4.2 feet below the crown, referenced]. FS Date: 12/22/2016

WS view: depression on levee shoulder near walkway. Half of the walkway stripped off.

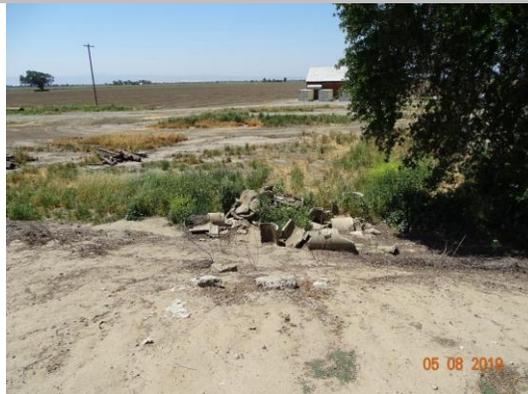
Photo 1 of 2 : FA_2019_RD0544_108_70_20190830_00036.jpg

LM Start	1.83	Rating **	M	Issue No.	70
LM End	1.86	Issue Type +	En	Location *	LS
Category	Earthen Levee			GPS Latitude/Longitude	
				Start	End
Item	Encroachments			37.853006°	37.852683°
				-121.324100°	-121.323972°
DWR ID	DWR_RD0544_01_s_2019_70				
Comment Code					
DE : Debris					
Inspector Comment					
Concrete rubble, firewood, limbs, and branches are located on the landside slope and toe.

View on concrete rubble on landside slope and toe. (Spring 2019)

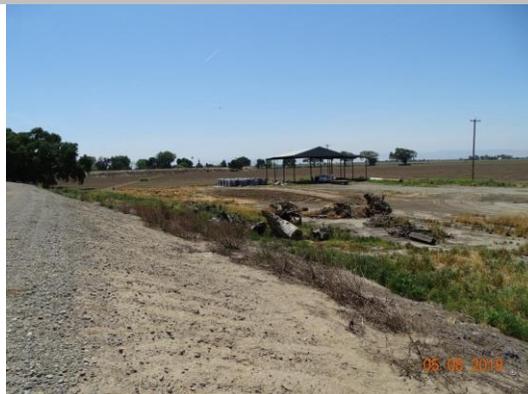
Photo 2 of 2 : FA_2019_RD0544_108_70_20190830_00037.jpg

View of tree limbs and branches on landside slope and toe. (Spring 2019)

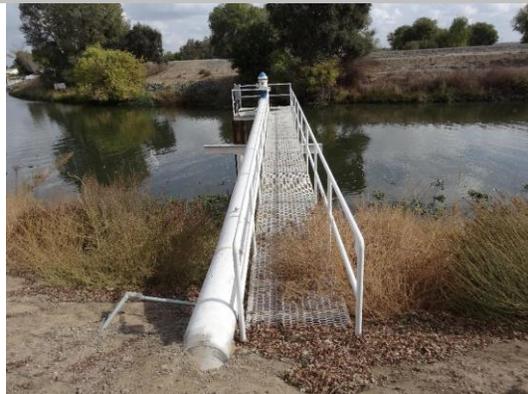
Photo 1 of 3 : UCIP_FA_2019_53362_42007.jpg

Comment Code					
Inspector Comment					
DS_ID:22650 FS_ID:53362 EP_NO: N/A Repair Type: Urgent Crossing Status: Found UCIP Comments: 10/2/2018 Severe erosion on LS slope so crossing remains Urgent (D. Sanoski - DWR UCIP).12/22/2016: Erosion of LS slope along pipe alignment. (K. Fazel - UCIP)10/29/2013:Siphon breaker on the landward slope not found. It has been removed and pipe plugged.Huge levee slope erosion on landside.2-inch electric conduit on waterside, service pole on landside. (P. Amatya - DWR) FIELD_STRUCT_DESC: 14-inch steel irrigation discharge pipe through the levee, 2 feet below the crown. Pump on a pile structure in the river. Steel walkway to the pump. 2-inch electrical conduit through the levee to the waterside (WS). Power pole on the landside (LS). [Additional Reference(s): DWR Levee Log, 2005, pipe referenced as 5 feet below the crown. USACE San Joaquin O&M Manual 7, April 1964, (HLM 2.26), pipe referenced as 5 feet below the crown]. FS Date: 10/2/2018 2:20:00 PM

WS view: steel pipe, walkway to the pump, conduit (bottom left) on levee slope.

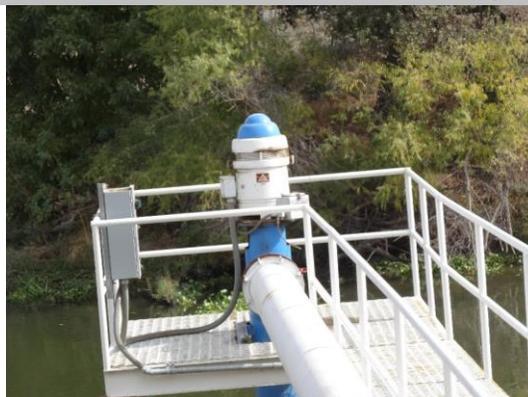
Photo 2 of 3 : UCIP_FA_2019_53362_42006.jpg

WS view: steel pipe, walkway to the pump, and pump on steel pile structure in the stream.

Comment Code					
Inspector Comment					
DS_ID:22650 FS_ID:53362 EP_NO: N/A Repair Type: Urgent Crossing Status: Found UCIP Comments: 10/2/2018 Severe erosion on LS slope so crossing remains Urgent (D. Sanoski - DWR UCIP).12/22/2016: Erosion of LS slope along pipe alignment. (K. Fazel - UCIP)10/29/2013:Siphon breaker on the landward slope not found. It has been removed and pipe plugged.Huge levee slope erosion on landside.2-inch electric conduit on waterside, service pole on landside. (P. Amatya - DWR) FIELD_STRUCT_DESC: 14-inch steel irrigation discharge pipe through the levee, 2 feet below the crown. Pump on a pile structure in the river. Steel walkway to the pump. 2-inch electrical conduit through the levee to the waterside (WS). Power pole on the landside (LS). [Additional Reference(s): DWR Levee Log, 2005, pipe referenced as 5 feet below the crown. USACE San Joaquin O&M Manual 7, April 1964, (HLM 2.26), pipe referenced as 5 feet below the crown]. FS Date: 10/2/2018 2:20:00 PM

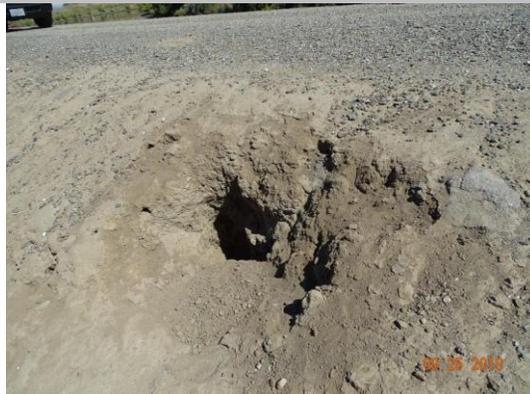
Photo 1 of 2 : FA_2019_RD0544_108_34_20191117_00158.jpg

LM Start	2.27	Rating **	U	Issue No.	34
LM End	2.36	Issue Type +	Ma	Location *	LS
Category	Earthen Levee			GPS Latitude/Longitude	
				Start	End
Item	Animal Control			37.847973°	37.846743°
				-121.324820°	-121.324336°
DWR ID	DWR_RD0544_01_s_2012_34				
Comment Code					
A3 : No rodents visible, but rodent burrows visible; need to backfill and compact or grout burrows.					
Inspector Comment					
There are several rodent holes within this landside reach.

View of large rodent hole on landside slope. Fall 2019

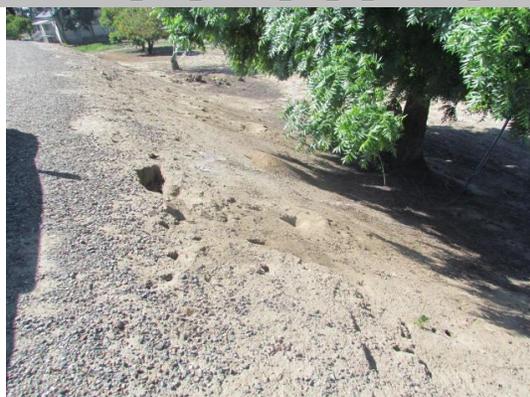
Photo 2 of 2 : FA_2019_RD0544_108_34_20190830_00018.jpg

Looking south at several rodent holes on landward shoulder and slope.

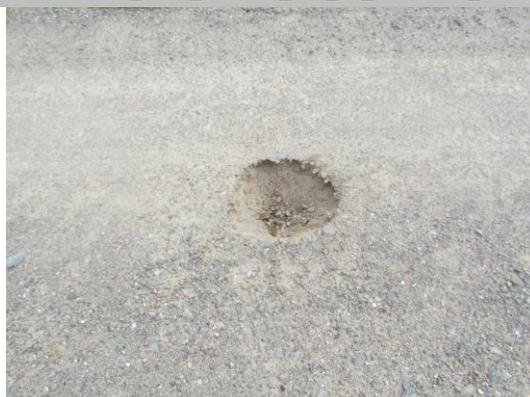
Photo 1 of 1 : FA_2019_RD0544_108_90_20190830_00052.jpg

LM Start	2.30	Rating **	M	Issue No.	90
LM End	2.30	Issue Type +	Ma	Location *	CR
Category	Earthen Levee			GPS Latitude/Longitude	
				Start	End
Item	Crown Surface / Depressions / Rutting			37.847542°	37.847542°
				-121.324732°	-121.324732°
DWR ID	DWR_RD0544_01_s_2019_90				
Comment Code					
C2 : Repair depressions or ruts in the crown or slope.					
Inspector Comment

Looking at pot hole on levee crown.

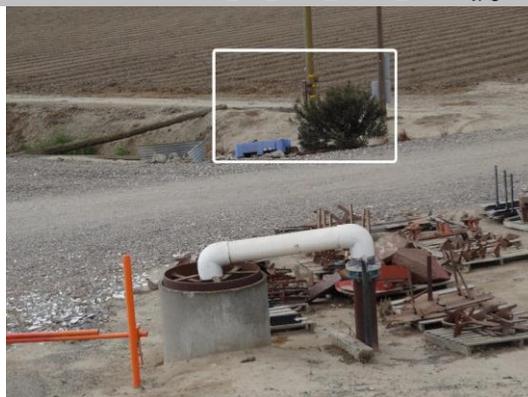
Photo 3 of 3 : UCIP_FA_2019_46671_44834.jpg

LM Start	2.43	Rating **	M	Issue No.	149 (cont)
LM End	2.43	Issue Type +	En	Location *	
Category	Supplemental			GPS Latitude/Longitude	
				Start	End
Item	DRAFT DWR UCIP Field Study			37.845968°	37.845968°
				-121.323357°	-121.323357°
DWR ID	22654				
Comment Code					
Inspector Comment					
DS_ID:22654 FS_ID:46671 EP_NO: N/A Repair Type: Non-Urgent Crossing Status: Found UCIP Comments: - soil around the siphon breaker eroded. FIELD_STRUCT_DESC: 8-inch drainage discharge pipe of an unknown material through the levee, 2 feet below the crown. Siphon breaker on the waterside (WS) slope. Pump on a drainage channel bank on the landside (LS). [Additional Reference(s): DWR Levee Log, 2005]. FS Date: 10/29/2013

LS view: pump on drainage ditch bank about 140 ft from the levee.

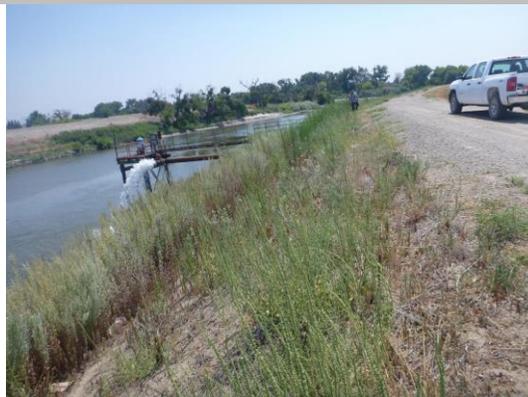
Photo 1 of 3 : LEVAL_FA_2019_567_4552.jpg

LM Start	2.53	Rating **	A/W	Issue No.	129
LM End	2.56	Issue Type +	Ma	Location *	
Category	Supplemental			GPS Latitude/Longitude	
				Start	End
Item	2017 Storm Damage			37.844900°	37.844500°
				-121.322300°	-121.321900°
DWR ID	LMA-473				
Comment Code					
Inspector Comment					
Levee Evaluation Comments Description:Slope protection repairs are needed along the waterside slope due to erosion and riprap displacement from high water. Based upon levee inspections, it was determined the waterside levee slope is eroding, deteriorating, and degrading. The eroded levee sections need to be restored back to design standards to prevent further deterioration and damage. Site ID No:567 Site Designation:LMA-473 Repair Type: Erosion Rating:Area of Concern Field Date:8/10/2017 Notes: large rodent holes observed on landside slope.

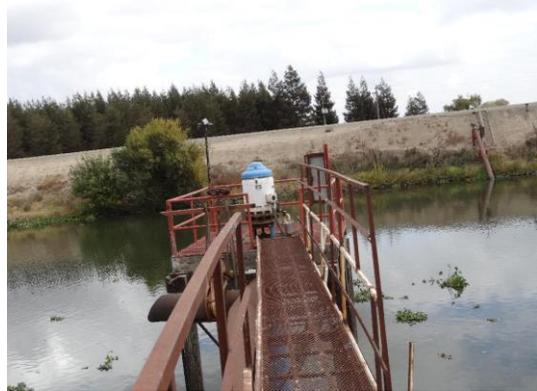
Photo 3 of 3 : UCIP_FA_2019_51361_44837.jpg

Comment Code					
Inspector Comment					
<p>DS_ID:22655 FS_ID:51361 EP_NO: N/A Repair Type: Non-Urgent Crossing Status: Found UCIP Comments: 12/22/2016: Erosion has been backfilled. Slope has been repaired but unclear if the source of the erosion (a possible leak in pipe) was addressed. Crossing has been downgraded from Urgent to Non-Urgent. (K. Fazel - UCIP)10/29/2013:Siphon breaker on the landward shoulder not found.Service pole on landside.Huge erosion on landside and waterside of the levee due to the pipe leakage. (P. Amatya - DWR) FIELD_STRUCT_DESC: 12-inch steel irrigation discharge pipe through the levee, 2 feet below the crown. Pump mounted on a pile structure in the river. Steel walkway to the pump. Air relief valve on the waterside (WS) shoulder. Concrete distribution box at the landside (LS) toe. [Additional Reference(s): DWR Levee Log, 2005. USACE San Joaquin O&M Manual 7, April 1964, (HLM 2.58), 16-inch pipe, 12 feet below the crown, referenced]. FS Date: 12/22/2016</p>

WS view: walkway to pump and pump on pile structure in the stream.

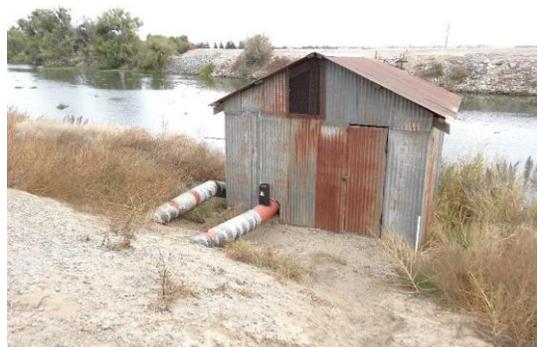
Photo 1 of 3 : UCIP_FA_2019_51365_42207.jpg

Comment Code					
Inspector Comment					
DS_ID:22656					
FS_ID:51365					
EP_NO: N/A					
Repair Type: Non-Urgent					
Crossing Status: Found					
UCIP Comments: 12/22/2016: Giant pit in LS slope has been backfilled, though no permit uncovered for this work. Unclear whether original source of damage (likely a leak in pipe) was addressed. Crossing has been downgraded from Urgent to Non-Urgent. (K. Fazel - UCIP)10/29/2013:- huge levee slope erosion on landside. Walkway to distro box on LS toe in poor structural condition.- 1-inch electric conduit, power pole on landside.- not clear whether this is a irrigation or drainage pipe. (P. Amatya - DWR)					
FIELD_STRUCT_DESC: 1 of 2: 14-inch steel irrigation discharge pipe through the levee, 8 feet below the crown. Slide gate in a 6-foot by 6-foot concrete distribution box at the landside (LS) toe. 1-inch electrical conduit through the levee. Power pole at the LS toe. Pump house on the waterside (WS) slope, but no pump attached as per the 2013 inspection. Flow meter on the WS. [Additional Reference(s): DWR Levee Log, 2005. USACE San Joaquin O&M Manual 7, April 1964, (HLM 3.19)].

WS view: exposed steel pipes, levee slope, and pumphouse for 2nd pipe.

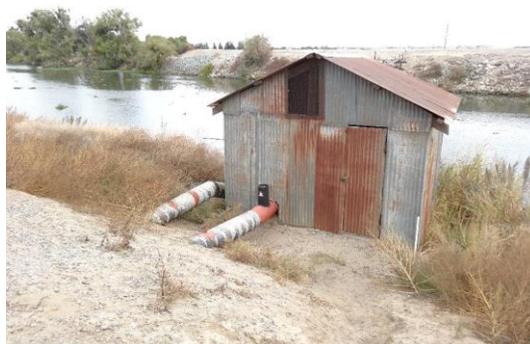
Photo 1 of 3 : UCIP_FA_2019_51366_44845.jpg

Comment Code					
Inspector Comment					
DS_ID:22681 FS_ID:51366 EP_NO: N/A Repair Type: Non-Urgent Crossing Status: Found UCIP Comments: 12/22/2016: Giant pit in LS slope has been backfilled, though no permit uncovered for this work. Unclear whether original source of damage (likely a leak in pipe) was addressed. Crossing has been downgraded from Urgent to Non-Urgent. (K. Fazel - UCIP)10/29/2013:Huge erosion and levee damage on landside slope due to the leaky pipe. Walkway to distro box on LS toe in poor structural condition. (P. Amatya - DWR) FIELD_STRUCT_DESC: 2 of 2: 14-inch steel irrigation discharge pipe through the levee, 8 feet below the crown. Slide gate in a 6-foot by 6-foot concrete distribution box at the landside (LS) toe. 1-inch electrical conduit through the levee. Power pole at the LS toe. Pump house on the waterside (WS) slope, but no pump attached as per the 2013 inspection. Flow meter on the WS. [Additional Reference(s): DWR Levee Log, 2005. USACE San Joaquin O&M Manual 7, April 1964, (HLM 3.19)]. FS Date: 12/22/2016

WS view: exposed steel pipes, levee slope, and pumphouse.

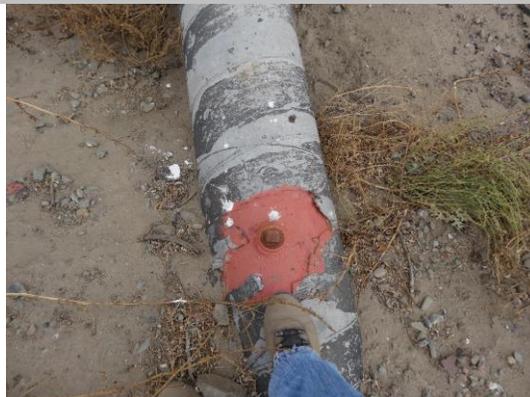
Photo 2 of 3 : UCIP_FA_2019_51366_44844.jpg

WS view: pipe daylights on levee slope. Siphon breaker removed and plugged.

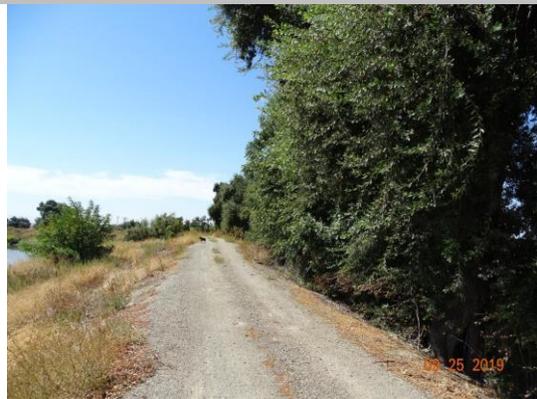
Photo 1 of 2 : FA_2019_RD0544_108_104_20191117_00164.jpg

LM Start	4.64	Rating **	U	Issue No.	104
LM End	4.68	Issue Type +	Ma	Location *	LS
Category	Earthen Levee		GPS Latitude/Longitude		
			Start	End	
Item	Trim / Thin Trees		37.822033 °	37.821826 °	
			-121.319432 °	-121.320071 °	
DWR ID	DWR_RD0544_01_f_2014_104				
Comment Code					
T3 : Trim and thin trees to allow visibility of the ground and room to flood fight.					
Inspector Comment					
Dense untrimmed trees are on the landside slope. Pic updated

View of untrimmed trees on landside slope. Fall 2019

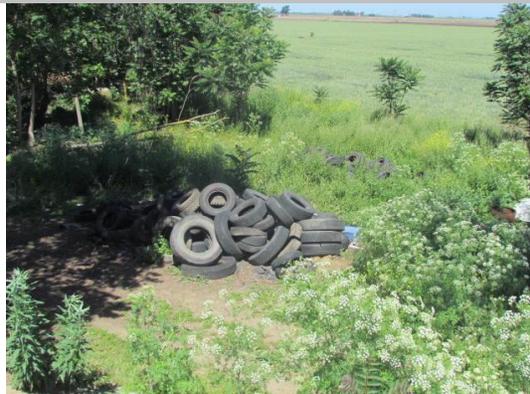
Photo 1 of 1 : FA_2019_RD0544_108_27_20190830_00015.jpg

LM Start	4.68	Rating **	U	Issue No.	27
LM End	4.69	Issue Type +	En	Location *	LS
Category	Earthen Levee			GPS Latitude/Longitude	
				Start	End
Item	Encroachments			37.821847 °	37.821793 °
				-121.320027 °	-121.320188 °
DWR ID	DWR_RD0544_01_s_2012_27				
Comment Code					
GA : Garbage					
Inspector Comment					
Tires are stockpiled on the landside toe.

Looking west at tires stock pile on landward berm.

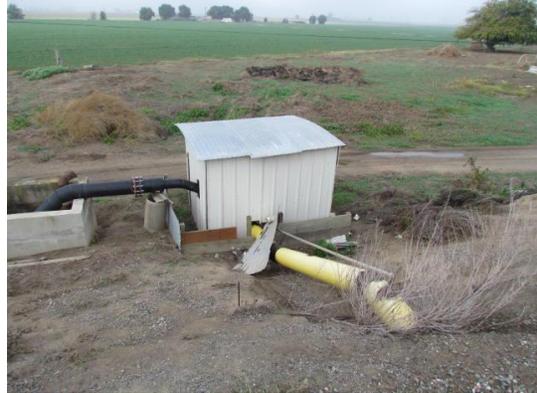
Photo 1 of 1 : FA_2019_RD0544_108_45_20190830_00025.jpg

LM Start	4.75	Rating **	M	Issue No.	45
LM End	4.75	Issue Type +	En	Location *	LS
Category	Earthen Levee		GPS Latitude/Longitude		
			Start	End	
Item	Encroachments		37.821177°	37.821177°	
			-121.321013°	-121.321013°	
DWR ID	DWR_RD0544_01_s_2012_45				
Comment Code					
BU : Building					
Inspector Comment					
An unauthorized pump shed is on the landside toe.

Looking west at a unauthorized pump house on landside toe.

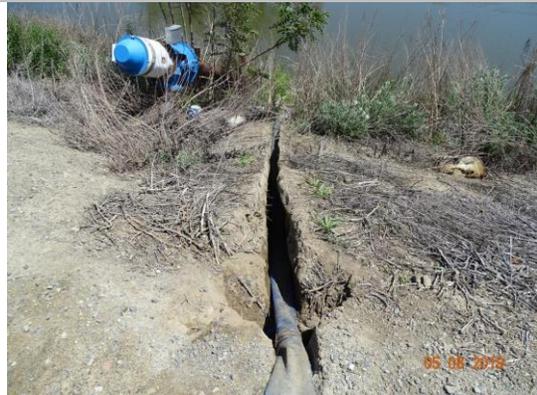
Photo 1 of 3 : FA_2019_RD0544_108_84_20190830_00045.jpg

LM Start	4.75	Rating **	U	Issue No.	84
LM End	4.75	Issue Type +	En	Location *	WS
Category	Earthen Levee		GPS Latitude/Longitude		
			Start	End	
Item	Encroachments		37.821159°	37.821159°	
			-121.320989°	-121.320989°	
DWR ID	DWR_RD0544_01_s_2019_84				
Comment Code					
PI : Pipe					
Inspector Comment					
An unpermitted 6" flexible water line/hose is extending from the landside over the crown to the waterside slope. There is an open trench on the waterside slope, up to 24" deep. A field investigation report will be completed. Follow up with the District and CVFPB.

View of 6 inch water line and open trench on waterside slope. (Spring 2019)

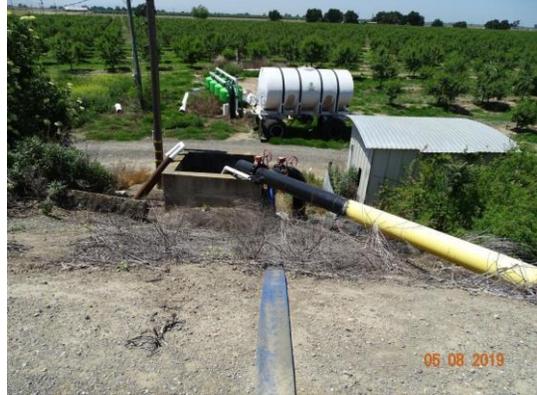
Photo 3 of 3 : FA_2019_RD0544_108_84_20190830_00047.jpg

LM Start	4.75	Rating **	U	Issue No.	84 (cont)
LM End	4.75	Issue Type +	En	Location *	WS
Category	Earthen Levee			GPS Latitude/Longitude	
				Start	End
Item	Encroachments			37.821159 °	37.821159 °
				-121.320989 °	-121.320989 °
DWR ID	DWR_RD0544_01_s_2019_84				
Comment Code					
PI : Pipe					
Inspector Comment					
An unpermitted 6" flexible water line/hose is extending from the landside over the crown to the waterside slope. There is an open trench on the waterside slope, up to 24" deep. A field investigation report will be completed. Follow up with the District and CVFPB.

View of 6 inch water line on landside slope. (Spring 2019)

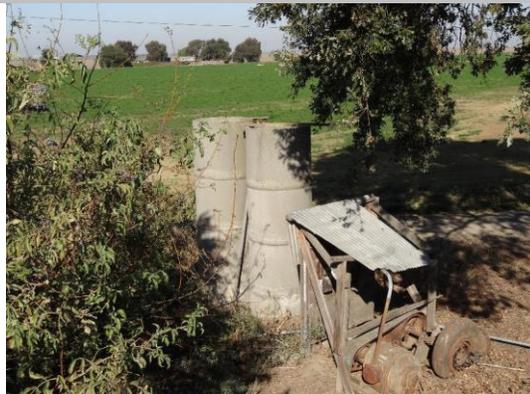
Photo 3 of 3 : UCIP_FA_2019_42962_42875.jpg

Comment Code					
Inspector Comment					
DS_ID:22662 FS_ID:42962 EP_NO: 1738 Repair Type: Non-Urgent Crossing Status: Found UCIP Comments: Appears abandoned and if so should be done so properly. No handle on gatevalve on WS slope. FIELD_STRUCT_DESC: 12-inch steel irrigation discharge pipe through the levee, 6 feet below the crown. Slant pump and gate valve on the waterside (WS) slope. Electrical conduit through the levee and on the landside (LS). Service pole on the LS. Two concrete standpipes on the LS. (Plans for the construction of a pipeline through the levee authorized under Permit No. 1738, 1953 - Barker Corporation). [Additional Reference(s): DWR Levee Log, 2005. USACE San Joaquin O&M Manual 7, April 1964, (HLM 4.82)]. FS Date: 10/31/2013

LS view: two concrete standpipes and abandoned pump on levee slope.

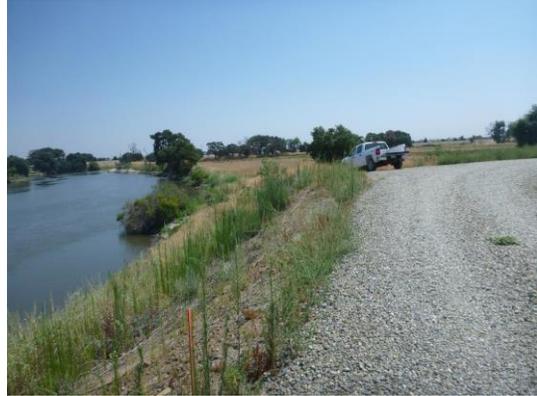
Photo 1 of 3 : LEVAL_FA_2019_559_4887.jpg

LM Start	4.97	Rating **	A/W	Issue No.	139
LM End	4.99	Issue Type +	Ma	Location *	
Category	Supplemental		GPS Latitude/Longitude		
			Start	End	
Item	2017 Storm Damage		37.818600 °	37.818400 °	
			-121.319200 °	-121.319000 °	
DWR ID	LMA-465				
Comment Code					
Inspector Comment					
<p>Levee Evaluation Comments Description:Slope protection repairs are needed along the waterside slope due to erosion and riprap displacement from high water. Based upon levee inspections, it was determined the waterside levee slope is eroding, deteriorating, and degrading. The eroded levee sections need to be restored back to design standards to prevent further deterioration and damage. Site ID No:559 Site Designation:LMA-465 Repair Type: Erosion Rating:Serious Field Date:8/11/2017 Notes:</p>

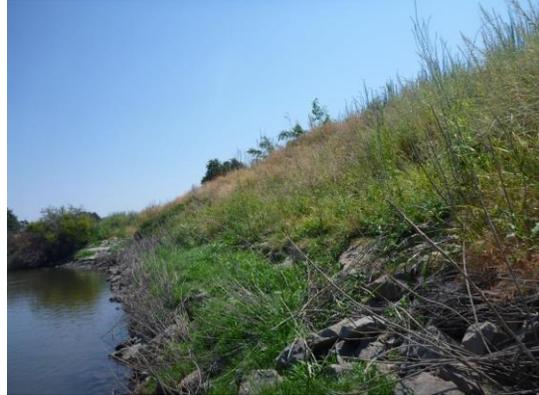
Photo 2 of 3 : LEVAL_FA_2019_559_4892.jpg

LM Start	4.97	Rating **	A/W	Issue No.	139 (cont)
LM End	4.99	Issue Type +	Ma	Location *	
Category	Supplemental		GPS Latitude/Longitude		
			Start	End	
Item	2017 Storm Damage		37.818600 °	37.818400 °	
			-121.319200 °	-121.319000 °	
DWR ID	LMA-465				
Comment Code					
Inspector Comment					
Levee Evaluation Comments					
Description:Slope protection repairs are needed along the waterside slope due to erosion and riprap displacement from high water. Based upon levee inspections, it was determined the waterside levee slope is eroding, deteriorating, and degrading. The eroded levee sections need to be restored back to design standards to prevent further deterioration and damage.					
Site ID No:559					
Site Designation:LMA-465					
Repair Type: Erosion					
Rating:Serious					
Field Date:8/11/2017					
Notes:

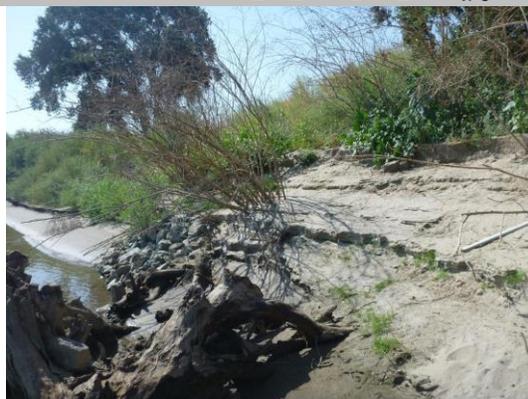
Photo 1 of 3 : LEVAL_FA_2019_558_4900.jpg

LM Start	5.32	Rating **	A/W	Issue No.	140
LM End	5.36	Issue Type +	Ma	Location *	
Category	Supplemental		GPS Latitude/Longitude		
			Start	End	
Item	2017 Storm Damage		37.813900 °	37.813500 °	
			-121.319900 °	-121.319400 °	
DWR ID	LMA-464				
Comment Code					
Inspector Comment					
Levee Evaluation Comments					
Description:Slope protection repairs are needed along the waterside slope due to erosion and riprap displacement from high water. Based upon levee inspections, it was determined the waterside levee slope is eroding, deteriorating, and degrading. The eroded levee sections need to be restored back to design standards to prevent further deterioration and damage.					
Site ID No:558					
Site Designation:LMA-464					
Repair Type: Erosion					
Rating:Serious					
Field Date:8/16/2017					
Notes:

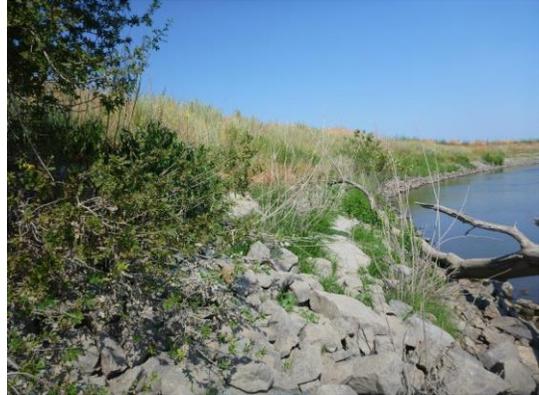
Photo 2 of 3 : LEVAL_FA_2019_558_4904.jpg

LM Start	5.32	Rating **	A/W	Issue No.	140 (cont)
LM End	5.36	Issue Type +	Ma	Location *	
Category	Supplemental		GPS Latitude/Longitude		
			Start	End	
Item	2017 Storm Damage		37.813900°	37.813500°	
			-121.319900°	-121.319400°	
DWR ID	LMA-464				
Comment Code					
Inspector Comment					
<p>Levee Evaluation Comments</p> <p>Description:Slope protection repairs are needed along the waterside slope due to erosion and riprap displacement from high water. Based upon levee inspections, it was determined the waterside levee slope is eroding, deteriorating, and degrading. The eroded levee sections need to be restored back to design standards to prevent further deterioration and damage.</p> <p>Site ID No:558 Site Designation:LMA-464 Repair Type: Erosion Rating:Serious Field Date:8/16/2017 Notes:</p>

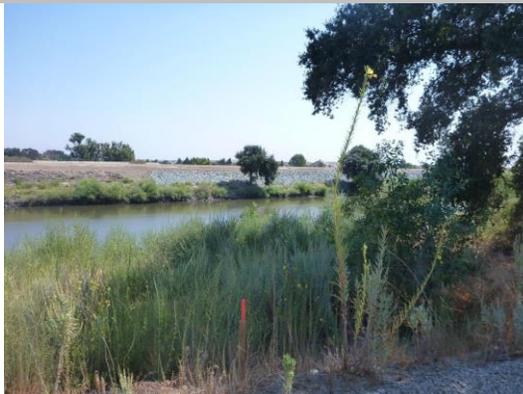
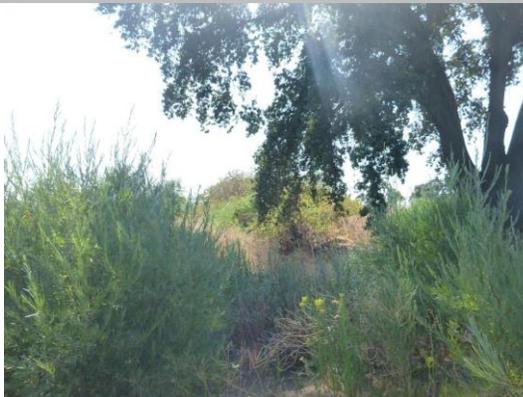
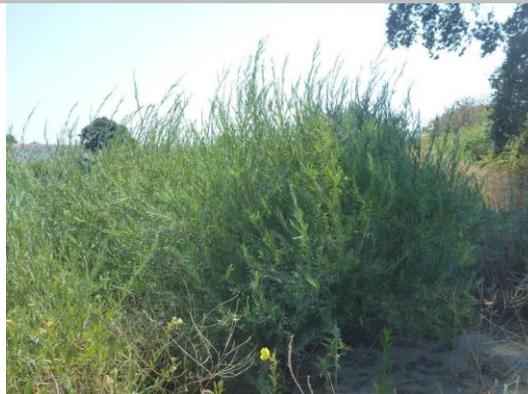
LM Start	5.36	Rating **	A/W	Issue No.	141
LM End	5.37	Issue Type +	Ma	Location *	
Category	Supplemental		GPS Latitude/Longitude		
			Start	End	
Item	2017 Storm Damage		37.813400 °	37.813300 °	
			-121.319300 °	-121.319200 °	
DWR ID	LMA-463				
Comment Code					
Inspector Comment					
<p>Levee Evaluation Comments</p> <p>Description: Slope protection repairs are needed along the waterside slope due to erosion and riprap displacement from high water. Based upon levee inspections, it was determined the waterside levee slope is eroding, deteriorating, and degrading. The eroded levee sections need to be restored back to design standards to prevent further deterioration and damage.</p> <p>Site ID No:557 Site Designation:LMA-463 Repair Type: Erosion Rating:Area of Concern Field Date:8/16/2017 Notes:</p>

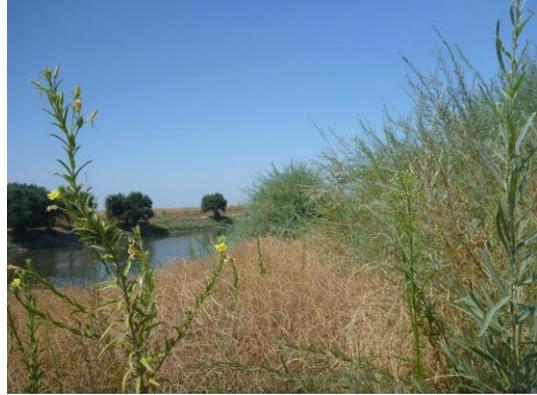
Photo 3 of 3 : LEVAL_FA_2019_556_4522.jpg

LM Start	0.21	Rating **	A/W	Issue No.	37 (cont)
LM End	0.23	Issue Type +	Ma	Location *	
Category	Supplemental			GPS Latitude/Longitude	
				Start	End
Item	2017 Storm Damage			37.808300 °	37.808400 °
				-121.332000 °	-121.332200 °
DWR ID	LMA-462				
Comment Code					
Inspector Comment					
Levee Evaluation Comments Description: Slope protection repairs are needed along the waterside slope due to erosion and riprap displacement from high water. Based upon levee inspections, it was determined the waterside levee slope is eroding, deteriorating, and degrading. The eroded levee sections need to be restored back to design standards to prevent further deterioration and damage. Site ID No: 556 Site Designation: LMA-462 Repair Type: Erosion Rating: Area of Concern Field Date: 8/16/2017 Notes:

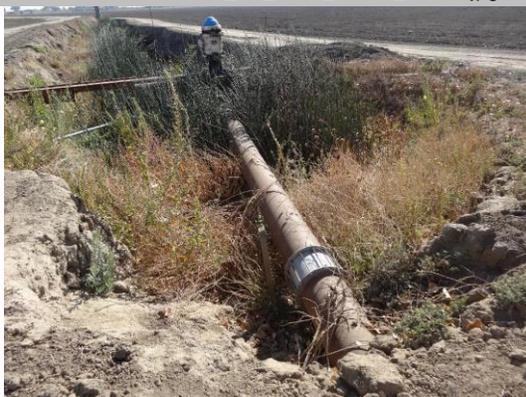
Photo 3 of 3 : UCIP_FA_2019_53366_44880.jpg

Comment Code					
Inspector Comment					
DS_ID:22665 FS_ID:53366 EP_NO: N/A Repair Type: Urgent Crossing Status: Found UCIP Comments: 10/2/2018 Same as last inspection; overgrown vegetation did not allow for visual inspection on LS so remains Urgent due to concern of erosion on WS (D. Sanoski - DWR UCIP).12/22/2016: Same as last inspection. Suspect siphon breaker is leaking due to depression around it. Two giant rodent holes through WS slope at siphon breaker. Siphon breaker is silted in. (K. Fazel - UCIP)10/31/2013:- 8 ft X 7 ft X 4 ft depression around siphon breaker on waterside slope.- no pipe visible on waterside due to dense vegetation.- electric conduit and service pole on landside. (P. Amatya - DWR) FIELD_STRUCT_DESC: 12-inch steel drainage discharge pipe through the levee, 4 feet below the crown. Pump in a drainage ditch off the landside (LS) toe. Siphon breaker on the waterside (WS) slope. [Additional Reference(s): DWR Levee Log, 2005]. FS Date: 10/2/2018 4:06:00 PM

LS view: pump on timber support in drainage ditch. About 150 ft from levee center.

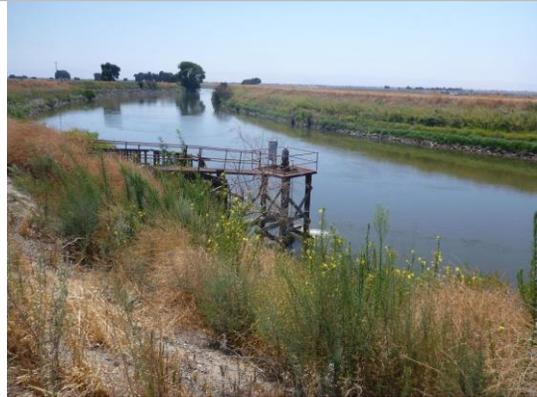
Photo 3 of 3 : LEVAL_FA_2019_552_4813.jpg

LM Start	1.01	Rating **	A/W	Issue No.	82 (cont)
LM End	1.02	Issue Type +	Ma	Location *	
Category	Supplemental			GPS Latitude/Longitude	
				Start	End
Item	2017 Storm Damage			37.818100°	37.818200°
				-121.332800°	-121.332800°
DWR ID	LMA-458				
Comment Code					
Inspector Comment					
Levee Evaluation Comments					
Description: Slope protection repairs are needed along the waterside slope due to erosion and riprap displacement from high water. Based upon levee inspections, it was determined the waterside levee slope is eroding, deteriorating, and degrading. The eroded levee sections need to be restored back to design standards to prevent further deterioration and damage.					
Site ID No: 552					
Site Designation: LMA-458					
Repair Type: Erosion					
Rating: Area of Concern					
Field Date: 8/16/2017					
Notes:

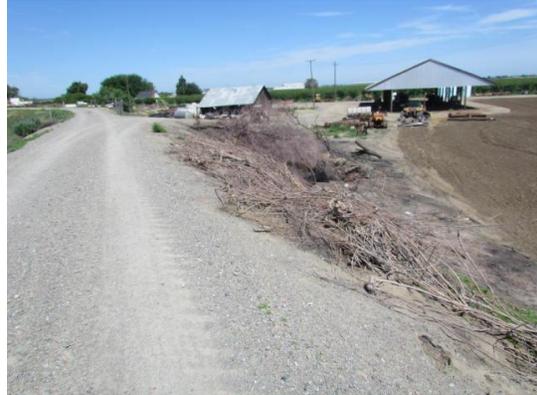
Photo 1 of 1 : FA_2019_RD0544_109_20_20190830_00010.jpg

LM Start	1.12	Rating **	M	Issue No.	20
LM End	1.12	Issue Type +	En	Location *	LS
Category	Earthen Levee			GPS Latitude/Longitude	
				Start	End
Item	Encroachments			37.819530 °	37.819530 °
				-121.333827 °	-121.333827 °
DWR ID	DWR_RD0544_02_s_2012_20				
Comment Code					
PR : Prunings					
Inspector Comment					
Landowner is stock piling prunings on landside slope and toe.

Looking southwest at pruning piles on landward slope.

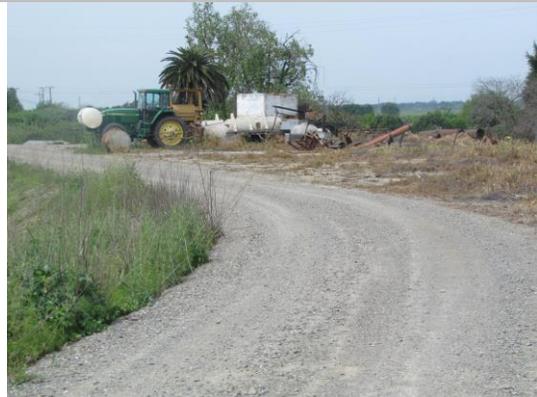
Photo 1 of 2 : FA_2019_RD0544_109_25_20190830_00013.jpg

LM Start	1.13	Rating **	U	Issue No.	25
LM End	1.22	Issue Type +	En	Location *	LS
Category	Earthen Levee			GPS Latitude/Longitude	
				Start	End
Item	Encroachments			37.819560 °	37.820247 °
				-121.333893 °	-121.335337 °
DWR ID	DWR_RD0544_02_s_2012_25				
Comment Code					
EQ : Equipment					
Inspector Comment

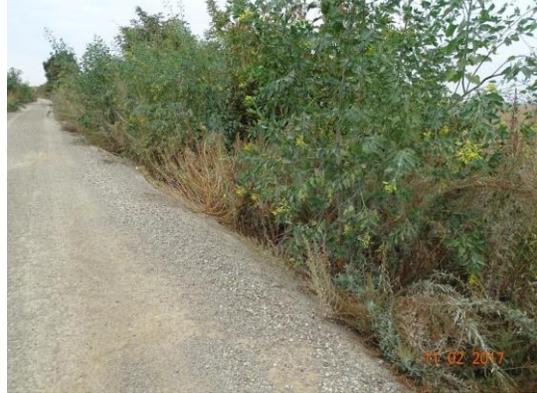
Photo 1 of 1 : FA_2019_RD0544_109_102_20190830_00080.jpg

LM Start	1.29	Rating **	U	Issue No.	102
LM End	1.56	Issue Type +	Ma	Location *	LS
Category	Earthen Levee			GPS Latitude/Longitude	
				Start	End
Item	Vegetation			37.820668 °	37.822239 °
				-121.336491 °	-121.340589 °
DWR ID	DWR_RD0544_02_f_2017_102				
Comment Code					
V2 : Remove the wild growth other than native grasses from the levee slopes.					
Inspector Comment

Looking northwest at the landside slope.

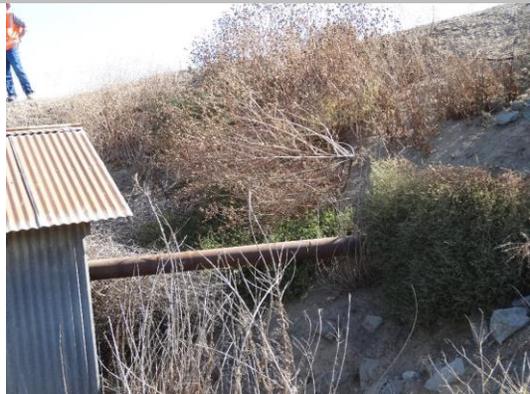
Photo 2 of 3 : UCIP_FA_2019_24907_44894.jpg

LM Start	1.52	Rating **	M	Issue No.	106 (cont)
LM End	1.52	Issue Type +	En	Location *	
Category	Supplemental			GPS Latitude/Longitude	
				Start	End
Item	DRAFT DWR UCIP Field Study			37.822445°	37.822445°
				-121.339910°	-121.339910°
DWR ID	24716				
Comment Code					
Inspector Comment					
DS_ID:24716 FS_ID:24907 EP_NO: N/A Repair Type: Non-Urgent Crossing Status: Found UCIP Comments: No pipe and appurtenances found on waterside. Looks abandoned. FIELD_STRUCT_DESC: *ABANDONED* 8-inch steel drainage discharge pipe through the levee, at an unknown depth. Pump house at the landside (LS) toe. Air vent in a corrugated metal pipe (CMP) riser on the LS shoulder. Outlet on the waterside (WS) not visible. No positive closure device. Appears abandoned. FS Date: 10/31/2013

LS view: pipe daylights on levee slope.

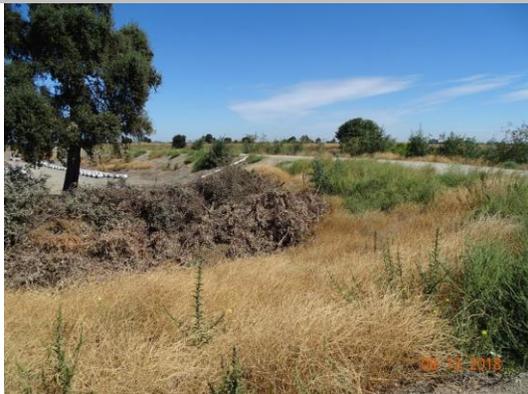
Photo 2 of 2 : FA_2019_RD0544_109_31_20190830_00019.jpg

LM Start	1.90	Rating **	U	Issue No.	31 (cont)
LM End	1.94	Issue Type +	En	Location *	LS
Category	Earthen Levee			GPS Latitude/Longitude	
				Start	End
Item	Encroachments			37.817582°	37.817994°
				-121.342125°	-121.342500°
DWR ID	DWR_RD0544_02_f_2018_31				
Comment Code					
PR : Prunings					
Inspector Comment					
Large pruning pile at landward toe.

Looking northwest at large pruning pile at landward toe. (Fall 2018)

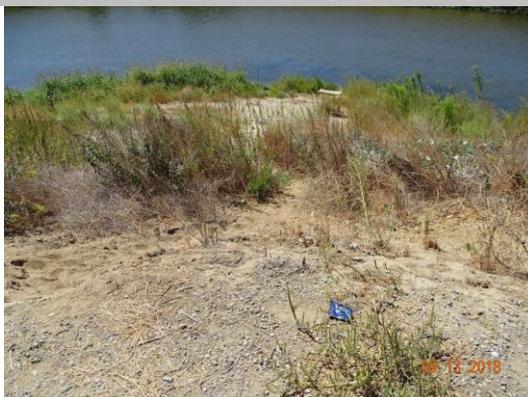
Photo 1 of 1 : FA_2019_RD0544_109_34_20190830_00021.jpg

LM Start	1.91	Rating **	A/W	Issue No.	34
LM End	1.91	Issue Type +	Ma	Location *	WS
Category	Earthen Levee			GPS Latitude/Longitude	
				Start	End
Item	Slope Stability			37.817658°	37.817658°
				-121.342097°	-121.342097°
DWR ID	DWR_RD0544_02_f_2018_34				
Comment Code					
S2 : Repair the levee slope damaged by foot traffic and prevent access where possible.					
Inspector Comment					
Erosion is caused by foot traffic.

Looking east at foot erosion on waterward slope. (Fall 2018)

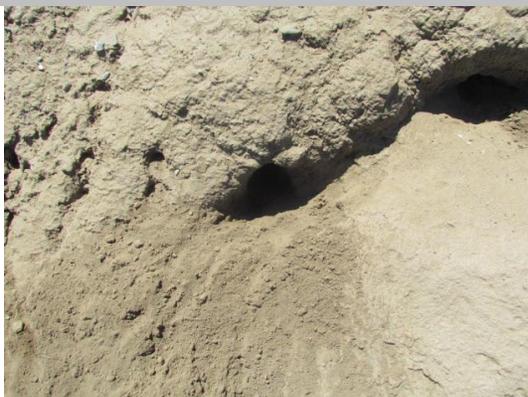
Photo 1 of 1 : FA_2019_RD0544_109_58_20190830_00031.jpg

LM Start	2.02	Rating **	U	Issue No.	58
LM End	2.09	Issue Type +	Ma	Location *	LS
Category	Earthen Levee			GPS Latitude/Longitude	
				Start	End
Item	Animal Control			37.818853°	37.819493°
				-121.343473°	-121.344545°
DWR ID	DWR_RD0544_02_s_2015_58				
Comment Code					
A1 : Exterminate rodents and backfill and compact or grout burrows.					
Inspector Comment					
There are several rodent holes within this reach on the landside slope.

Looking at typical rodent holes on landward slope.

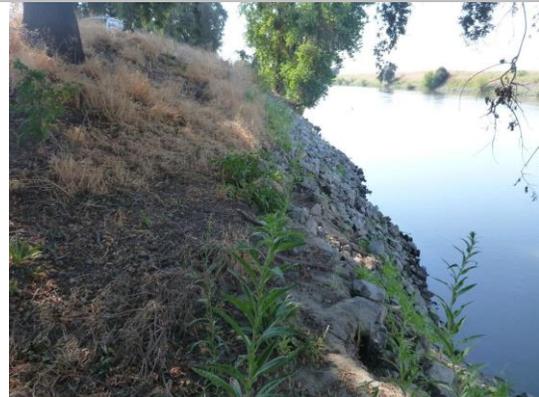
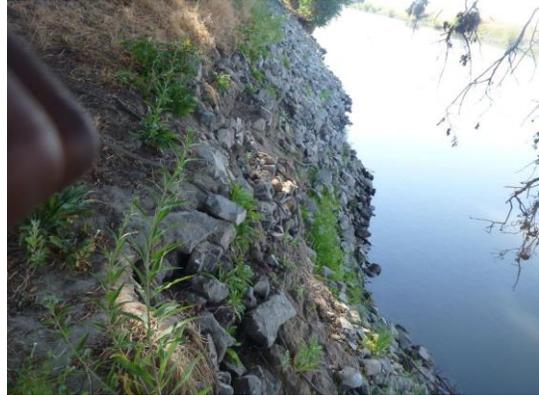
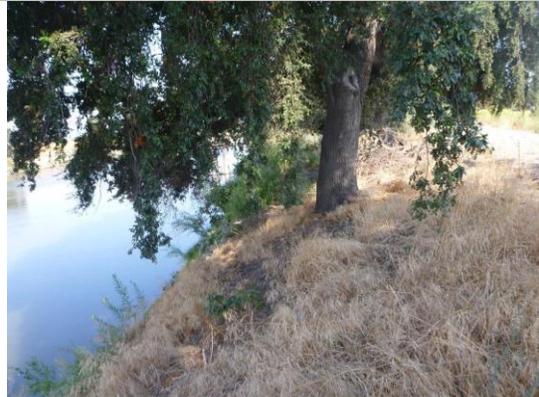
LM Start	2.17	Rating **	A/W	Issue No.	87
LM End	2.18	Issue Type +	Ma	Location *	
Category	Supplemental		GPS Latitude/Longitude		
			Start	End	
Item	2017 Storm Damage		37.820300°	37.820300°	
			-121.345600°	-121.345700°	
DWR ID	LMA-457				
Comment Code					
Inspector Comment					
Levee Evaluation Comments					
Description:Slope protection repairs are needed along the waterside slope due to erosion and riprap displacement from high water. Based upon levee inspections, it was determined the waterside levee slope is eroding, deteriorating, and degrading. The eroded levee sections need to be restored back to design standards to prevent further deterioration and damage.					
Site ID No:551					
Site Designation:LMA-457					
Repair Type: Erosion					
Rating:Serious					
Field Date:8/18/2017					
Notes:

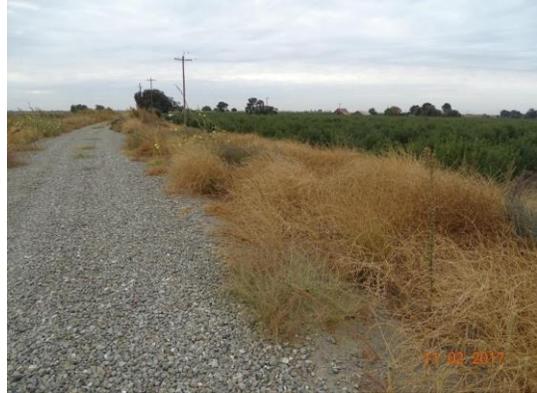
Photo 1 of 1 : FA_2019_RD0544_109_73_20190830_00042.jpg

LM Start	2.41	Rating **	U	Issue No.	73
LM End	2.59	Issue Type +	Ma	Location *	LS
Category	Earthen Levee			GPS Latitude/Longitude	
				Start	End
Item	Vegetation			37.821423°	37.819153°
				-121.348849°	-121.350231°
DWR ID	DWR_RD0544_02_f_2017_73				
Comment Code					
V2 : Remove the wild growth other than native grasses from the levee slopes.					
Inspector Comment

Looking southwest at the landside slope.

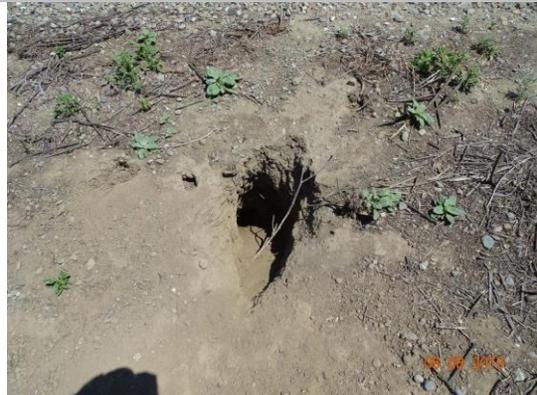
Photo 1 of 2 : FA_2019_RD0544_109_36_20190830_00022.jpg

LM Start	2.43	Rating **	U	Issue No.	36
LM End	2.50	Issue Type +	Ma	Location *	LS
Category	Earthen Levee			GPS Latitude/Longitude	
				Start	End
Item	Animal Control			37.821146°	37.820286°
				-121.348992°	-121.349462°
DWR ID	DWR_RD0544_02_s_2019_36				
Comment Code					
A3 : No rodents visible, but rodent burrows visible; need to backfill and compact or grout burrows.					
Inspector Comment

View of animal burrow on landside slope. (Spring 2019)
