**Flood Control Project Maintenance
Levee Inspections**

Fall 2019 Levee Maintenance Deficiency Summary Report

Reclamation District No. 0544 Upper Roberts Island

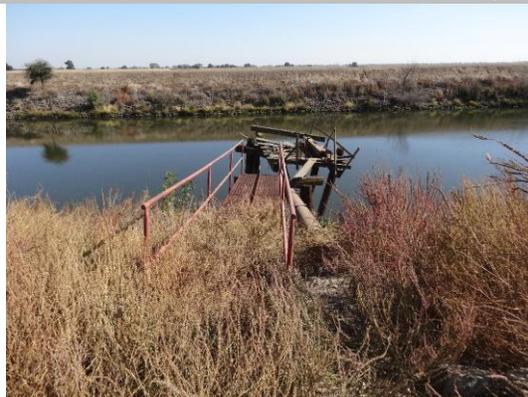
Photo 1 of 3 : UCIP_FA_2019_51381_42972.jpg

Comment Code					
Inspector Comment					
DS_ID:22678 FS_ID:51381 EP_NO: 8625A Repair Type: Non-Urgent Crossing Status: Found UCIP Comments: - abandoned crossing. Needs proper abandonment.- pump removed. Pipe discontinued on landside.- pile structure in dilapalated condion. FIELD_STRUCT_DESC: 16-inch coated steel irrigation discharge pipe through the levee, 7 feet below the crown. Pump mounted on a pile structure in the stream. Siphon breaker on the landside (LS) shoulder. Power pole on the LS slope. (Retention of an existing 16-inch irrigation pipe and pump through the levee authorized under Permit No. 8625-A, 1973 - Irvin Muller). [Additional Reference(s): DWR Levee Log, 2005. USACE San Joaquin O&M Manual 7, April 1964, (HLM 2.65), referenced as 10 feet below the crown]. FS Date: 10/31/2013

WS view: dilapalated walkway and pile structure. Pump removed.

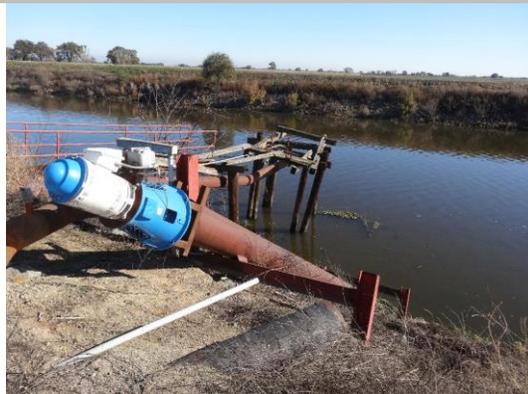
Photo 3 of 3 : UCIP_FA_2019_53173_76632.jpg

Comment Code					
Inspector Comment					
DS_ID:24718 FS_ID:53173 EP_NO: N/A Repair Type: Non-Urgent Crossing Status: Found UCIP Comments: 10/2/2018 Same as last inspection; downgrading to Non-Urgent due to no visual pipe or levee integrity threat (D. Sanoski - DWR UCIP).12/22/2016: Pipe is open on both ends and requires either proper abandonment or flap gate and closure device. Crossing has been upgraded from Non-Urgent to Urgent. (K. Fazel - UCIP)10/31/2013:- needs proper abandonment or closer of pipe end. (P. Amatya - DWR) FIELD_STRUCT_DESC: 14-inch steel pipe of an unknown purpose through the levee, 2 feet below the crown. Pipe open on both ends. 1-inch open conduit also at this location. This crossing was field discovered. FS Date: 10/2/2018 4:13:47 PM

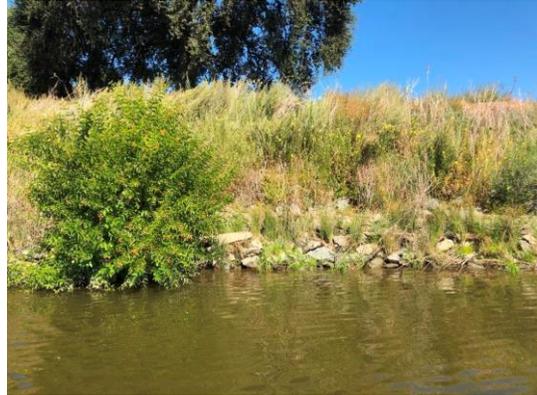
Photo 1 of 2 : SJR2019_RD0544U02RM32.91_1.jpg

Site ID: RD0544U02RM32.91
 08/14/2019: No significant change observed. Dense vegetation was observed at the site.
 09/13/2017: No significant change observed.
 07/25/2016: No significant change observed.
 06/25/2015: No significant change observed.
 07/02/2014: No significant change observed.
 10/11/2013: No significant change observed.
 08/07/2012: Series of pocket erosion sites were discovered at the levee toe during the boat survey. The area is covered with vegetation and riprap, but the riprap has been washed away.

LM Start	2.65	Rating **	M	Issue No.	1 (cont)
LM End	2.67	Issue Type +	Ma	Location *

Front view of the pocket erosion. Note vegetation and riprap at the site.

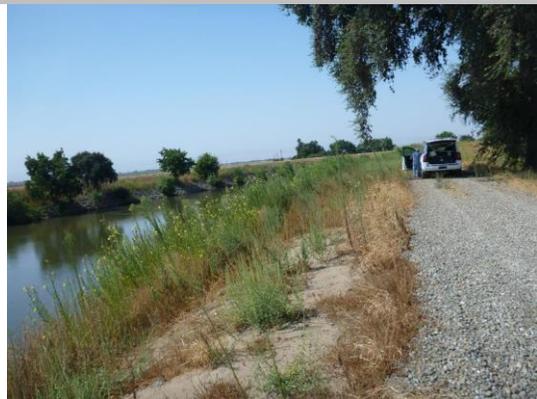
Photo 1 of 3 : LEVAL_FA_2019_548_4661.jpg

LM Start	2.68	Rating **	A/W	Issue No.	90
LM End	2.71	Issue Type +	Ma	Location *	
Category	Supplemental			GPS Latitude/Longitude	
				Start	End
Item	2017 Storm Damage			37.818000°	37.817800°
				-121.351200°	-121.351500°
DWR ID	LMA-454				
Comment Code					
Inspector Comment					
Levee Evaluation Comments					
Description:Slope protection repairs are needed along the waterside slope due to erosion and riprap displacement from high water. Based upon levee inspections, it was determined the waterside levee slope is eroding, deteriorating, and degrading. The eroded levee sections need to be restored back to design standards to prevent further deterioration and damage.					
Site ID No:548					
Site Designation:LMA-454					
Repair Type: Erosion					
Rating:Area of Concern					
Field Date:8/18/2017					
Notes:

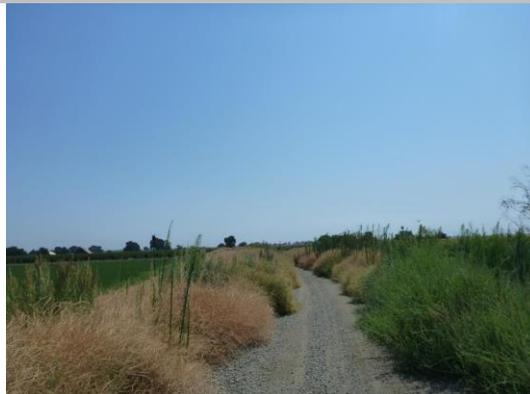
Photo 3 of 3 : LEVAL_FA_2019_546_4698.jpg

LM Start	3.11	Rating **	A/W	Issue No.	92 (cont)
LM End	3.12	Issue Type +	Ma	Location *	
Category	Supplemental			GPS Latitude/Longitude	
				Start	End
Item	2017 Storm Damage			37.817700°	37.817800°
				-121.358600°	-121.358700°
DWR ID	LMA-452				
Comment Code					
Inspector Comment					
Levee Evaluation Comments Description: Slope protection repairs are needed along the waterside slope due to erosion and riprap displacement from high water. Based upon levee inspections, it was determined the waterside levee slope is eroding, deteriorating, and degrading. The eroded levee sections need to be restored back to design standards to prevent further deterioration and damage. Site ID No: 546 Site Designation: LMA-452 Repair Type: Erosion Rating: Area of Concern Field Date: 8/18/2017 Notes: dense vegetations on both sides of the levee made the slopes inaccessible

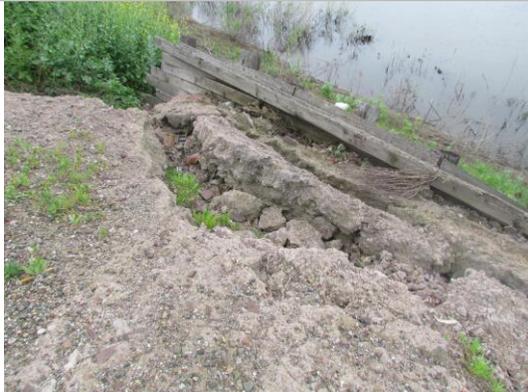
Photo 1 of 1 : FA_2019_RD0544_109_78_20190830_00044.jpg

LM Start	3.25	Rating **	U	Issue No.	78
LM End	3.25	Issue Type +	En	Location *	WS
Category	Earthen Levee			GPS Latitude/Longitude	
				Start	End
Item	Encroachments			37.819347°	37.819347°
				-121.360103°	-121.360103°
DWR ID	DWR_RD0544_02_s_2017_78				
Comment Code					
RW : Retaining Wall					
Inspector Comment					
Waterside slope retaining wall at pump location has slipped.

Looking east at sloughing of earthen pad on waterward shoulder and slope.

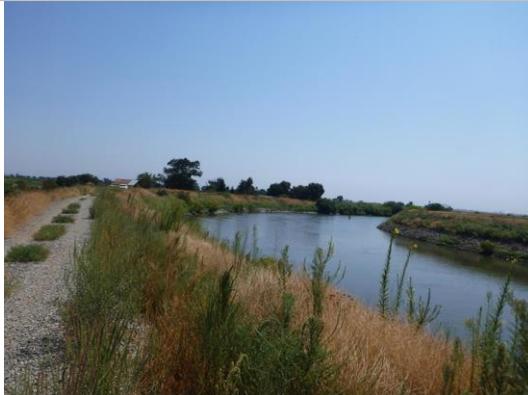
Photo 1 of 3 : LEVAL_FA_2019_545_4707.jpg

LM Start	3.25	Rating **	A/W	Issue No.	93
LM End	3.34	Issue Type +	Ma	Location *	
Category	Supplemental			GPS Latitude/Longitude	
				Start	End
Item	2017 Storm Damage			37.819300°	37.819800°
				-121.360200°	-121.361600°
DWR ID	LMA-451				
Comment Code					
Inspector Comment					
Levee Evaluation Comments					
Description:Slope protection repairs are needed along the waterside slope due to erosion and riprap displacement from high water. Based upon levee inspections, it was determined the waterside levee slope is eroding, deteriorating, and degrading. The eroded levee sections need to be restored back to design standards to prevent further deterioration and damage.					
Site ID No:545					
Site Designation:LMA-451					
Repair Type: Erosion					
Rating:Area of Concern					
Field Date:8/18/2017					
Notes:

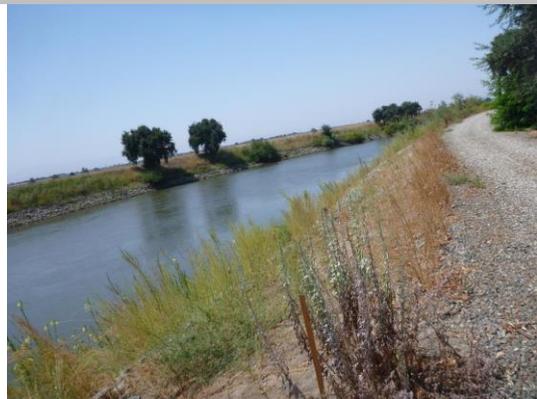
Photo 1 of 3 : LEVAL_FA_2019_543_4790.jpg

LM Start	3.57	Rating **	A/W	Issue No.	95
LM End	3.58	Issue Type +	Ma	Location *	
Category	Supplemental		GPS Latitude/Longitude		
			Start	End	
Item	2017 Storm Damage		37.819400 °	37.819400 °	
			-121.365800 °	-121.365900 °	
DWR ID	LMA-449				
Comment Code					
Inspector Comment					
Levee Evaluation Comments					
Description:Slope protection repairs are needed along the waterside slope due to erosion and riprap displacement from high water. Based upon levee inspections, it was determined the waterside levee slope is eroding, deteriorating, and degrading. The eroded levee sections need to be restored back to design standards to prevent further deterioration and damage.					
Site ID No:543					
Site Designation:LMA-449					
Repair Type: Erosion					
Rating:Area of Concern					
Field Date:8/18/2017					
Notes:

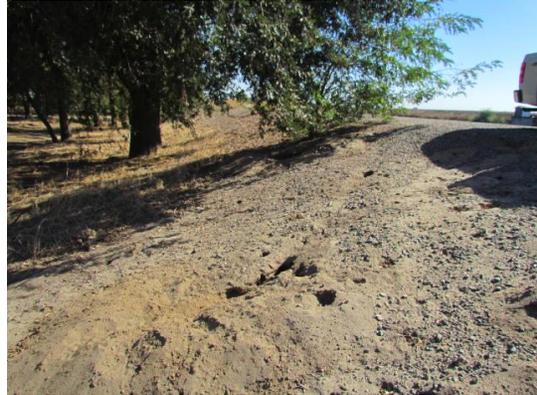
Photo 1 of 2 : FA_2019_RD0544_109_67_20190830_00032.jpg

LM Start	3.58	Rating **	M	Issue No.	67
LM End	3.58	Issue Type +	Ma	Location *	LS
Category	Earthen Levee			GPS Latitude/Longitude	
				Start	End
Item	Animal Control			37.819419°	37.819419°
				-121.365854°	-121.365854°
DWR ID	DWR_RD0544_02_f_2015_67				
Comment Code					
A3 : No rodents visible, but rodent burrows visible; need to backfill and compact or grout burrows.					
Inspector Comment					
Large rodent holes on landward slope.

Looking northeast at typical view of rodent holes on landward slope.
