**Flood Control Project Maintenance
Levee Inspections**

Maintenance Issue Types Only, Levee Inspection Report By Mile - Fall 2019

Reclamation District No. 0544 Upper Roberts Island

Waterway	Bank	Unit Miles	Inspection Start/End	Inspector
Unit No. 01 San Joaquin River	Left	6.05	09/25/2019 09/25/2019	Alberto De Leon

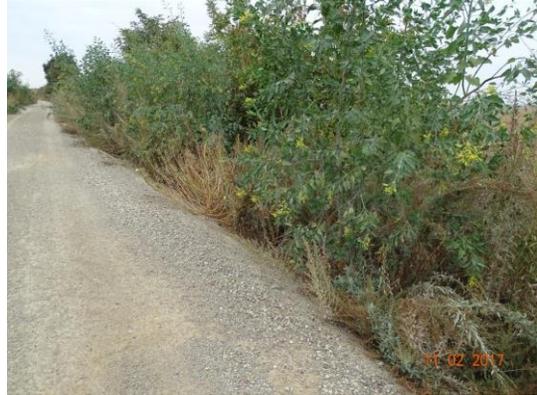
Photo 1 of 1 : FA_2019_RD0544_109_102_20190830_00080.jpg

LM Start	1.29	Rating **	U	Issue No.	102
LM End	1.56	Issue Type +	Ma	Location *	LS
Category	Earthen Levee			GPS Latitude/Longitude	
				Start	End
Item	Vegetation			37.820668 °	37.822239 °
				-121.336491 °	-121.340589 °
DWR ID	DWR_RD0544_02_f_2017_102				
Comment Code					
V2 : Remove the wild growth other than native grasses from the levee slopes.					
Inspector Comment

Looking northwest at the landside slope.

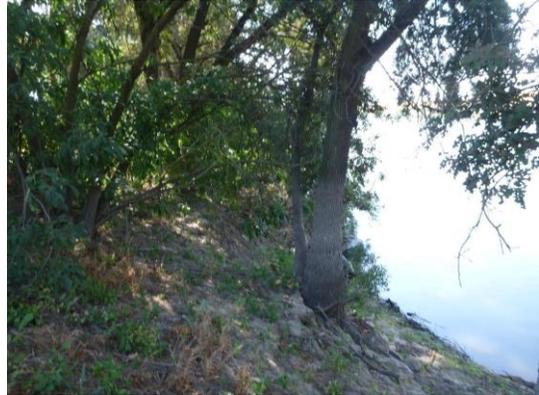
Photo 3 of 3 : LEVAL_FA_2019_549_4654.jpg

LM Start	2.32	Rating **	A/W	Issue No.	89 (cont)
LM End	2.33	Issue Type +	Ma	Location *	
Category	Supplemental			GPS Latitude/Longitude	
				Start	End
Item	2017 Storm Damage			37.821800 °	37.821900 °
				-121.347500 °	-121.347600 °
DWR ID	LMA-455				
Comment Code					
Inspector Comment					
Levee Evaluation Comments					
Description: Slope protection repairs are needed along the waterside slope due to erosion and riprap displacement from high water. Based upon levee inspections, it was determined the waterside levee slope is eroding, deteriorating, and degrading. The eroded levee sections need to be restored back to design standards to prevent further deterioration and damage.					
Site ID No: 549					
Site Designation: LMA-455					
Repair Type: Erosion					
Rating: Area of Concern					
Field Date: 8/18/2017					
Notes:

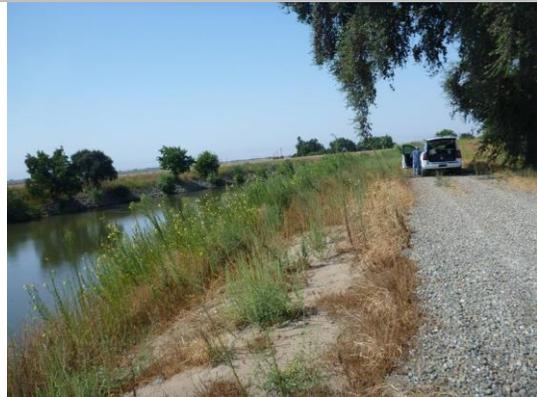
Photo 1 of 3 : LEVAL_FA_2019_548_4661.jpg

LM Start	2.68	Rating **	A/W	Issue No.	90
LM End	2.71	Issue Type +	Ma	Location *	
Category	Supplemental		GPS Latitude/Longitude		
			Start	End	
Item	2017 Storm Damage		37.818000°	37.817800°	
			-121.351200°	-121.351500°	
DWR ID	LMA-454				
Comment Code					
Inspector Comment					
Levee Evaluation Comments					
Description:Slope protection repairs are needed along the waterside slope due to erosion and riprap displacement from high water. Based upon levee inspections, it was determined the waterside levee slope is eroding, deteriorating, and degrading. The eroded levee sections need to be restored back to design standards to prevent further deterioration and damage.					
Site ID No:548					
Site Designation:LMA-454					
Repair Type: Erosion					
Rating:Area of Concern					
Field Date:8/18/2017					
Notes:

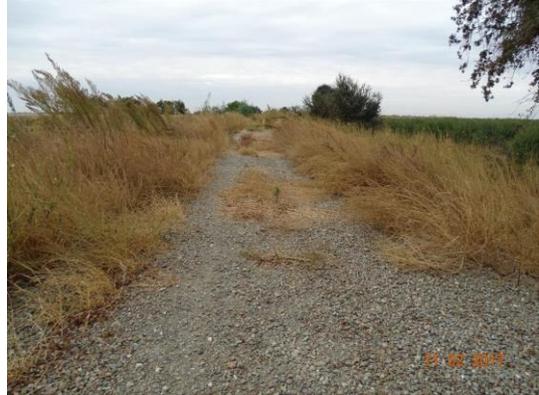
Photo 1 of 2 : FA_2019_RD0544_109_43_20190830_00027.jpg

LM Start	2.71	Rating **	U	Issue No.	43
LM End	3.45	Issue Type +	Ma	Location *	LS
Category	Earthen Levee		GPS Latitude/Longitude		
			Start	End	
Item	Vegetation		37.817747°	37.819583°	
			-121.351578°	-121.363559°	
DWR ID	DWR_RD0544_02_s_2012_43				
Comment Code					
V2 : Remove the wild growth other than native grasses from the levee slopes.					
Inspector Comment

Looking southwest at levee.

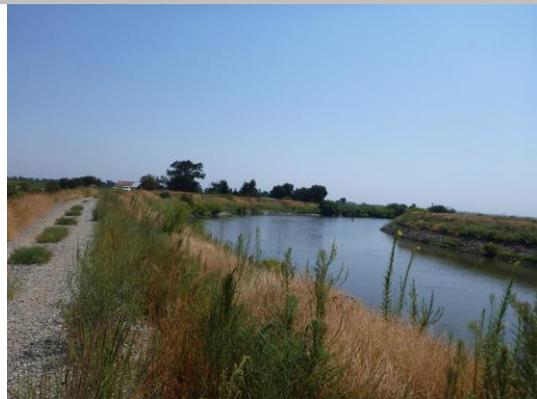
Photo 1 of 3 : LEVAL_FA_2019_545_4707.jpg

LM Start	3.25	Rating **	A/W	Issue No.	93
LM End	3.34	Issue Type +	Ma	Location *	
Category	Supplemental		GPS Latitude/Longitude		
			Start	End	
Item	2017 Storm Damage		37.819300 °	37.819800 °	
			-121.360200 °	-121.361600 °	
DWR ID	LMA-451				
Comment Code					
Inspector Comment					
Levee Evaluation Comments					
Description:Slope protection repairs are needed along the waterside slope due to erosion and riprap displacement from high water. Based upon levee inspections, it was determined the waterside levee slope is eroding, deteriorating, and degrading. The eroded levee sections need to be restored back to design standards to prevent further deterioration and damage.					
Site ID No:545					
Site Designation:LMA-451					
Repair Type: Erosion					
Rating:Area of Concern					
Field Date:8/18/2017					
Notes:

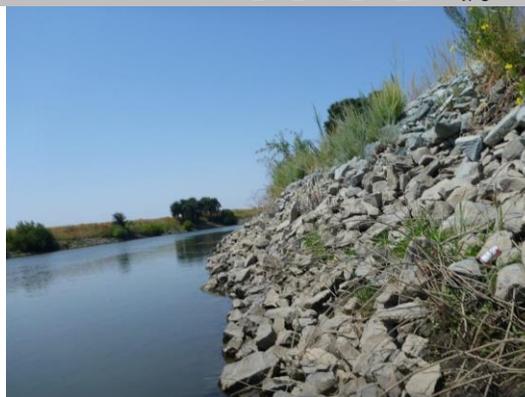
Photo 3 of 3 : LEVAL_FA_2019_543_4799.jpg

LM Start	3.57	Rating **	A/W	Issue No.	95 (cont)
LM End	3.58	Issue Type +	Ma	Location *	
Category	Supplemental			GPS Latitude/Longitude	
				Start	End
Item	2017 Storm Damage			37.819400 °	37.819400 °
				-121.365800 °	-121.365900 °
DWR ID	LMA-449				
Comment Code					
Inspector Comment					
Levee Evaluation Comments					
Description: Slope protection repairs are needed along the waterside slope due to erosion and riprap displacement from high water. Based upon levee inspections, it was determined the waterside levee slope is eroding, deteriorating, and degrading. The eroded levee sections need to be restored back to design standards to prevent further deterioration and damage.					
Site ID No: 543					
Site Designation: LMA-449					
Repair Type: Erosion					
Rating: Area of Concern					
Field Date: 8/18/2017					
Notes:
