**Flood Control Project Maintenance  
Levee Inspections**

**Fall 2019 Levee Maintenance Deficiency Summary Report**

**Sacramento River Basin**

**Reclamation District No. 0551 Pearson**

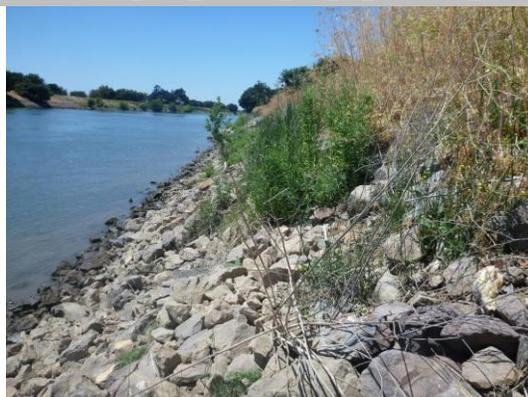
Photo 3 of 3 : FA\_2019\_RD0551\_175\_28\_20190826\_00022.jpg

Item	2017 Storm Damage			38.282778 °	38.282108 °
				-121.549531 °	-121.548386 °
DWR ID	LMA-163				
Comment Code					
Inspector Comment					
<p>Levee Evaluation Comments Description: District Station 231+12 to 235+26, Sec. 16, T. 5 N. R. 4 E., M.D.M. Approximately 414 linear-feet of erosion and subsequent sloughing exists along the waterside slope of the Sacramento River. The erosion commences approximately 3/4 of the way down the slope to the rip rap line. Site ID No:336 Site Designation:LMA-163 Repair Type: Erosion Rating:Area of Concern Field Date:7/13/2017 Notes: We only saw erosion on about 1/2 the length reported by the LMA, but there is another site very close by. Crown is a paved road. Scarps up to 5 ft deep above the rip rap, mostly smaller though so rated this a lower priority site.</p>

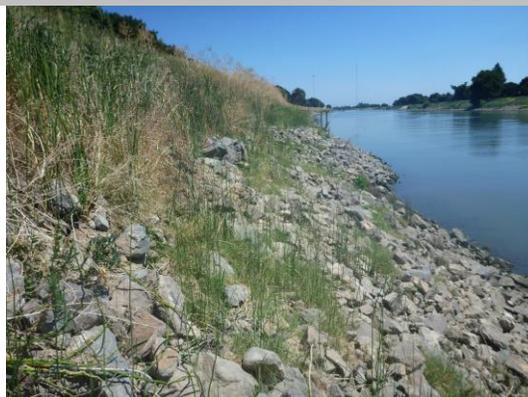
Photo 1 of 3 : FA\_2019\_RD0551\_175\_29\_20190826\_00023.jpg

LM Start	<b>4.49</b>	Rating **	A/W	Issue No.	<b>29</b>
LM End	<b>4.52</b>	Issue Type +	Ma	Location *	WS
Category	Supplemental			GPS Latitude/Longitude	
				Start	End

Item	2017 Storm Damage			38.281994 °	38.281653 °
				-121.548214 °	-121.547700 °
DWR ID	LMA-164				
Comment Code					
Inspector Comment					
<p>Levee Evaluation Comments Description: District Station 235+90 to 237+83, Sec. 16, T. 5 N. R. 4 E., M.D.M. Approximately 193 linear-feet of erosion exists along the waterside slope of the Sacramento River. The erosion commences approximately halfway down the slope and extends to the rip rap. Some existing rip rap has been pulled off in this section. Site ID No:337 Site Designation:LMA-164 Repair Type: Erosion Rating:Area of Concern Field Date:7/13/2017 Notes: Crown is paved road. Veg on slope, not lower bank. Scarps up to 18 in deep above rip rap. Lower priority because erosion is fairly small and rip rap is in good shape through most of the site.</p>

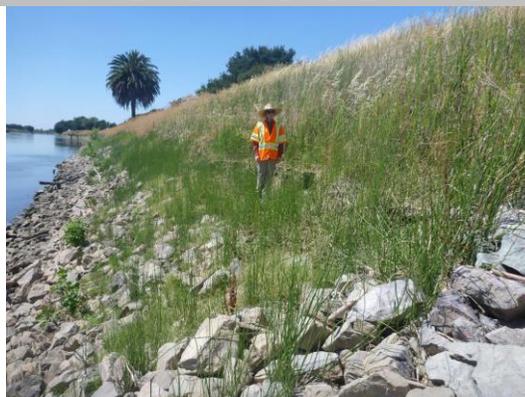
Photo 1 of 3 : FA\_2019\_RD0551\_175\_30\_20190826\_00026.jpg

Item	2017 Storm Damage			38.280236 °	38.279892 °
				-121.545758 °	-121.545314 °
DWR ID	LMA-165				
Comment Code					
Inspector Comment					
Levee Evaluation Comments					
Description: District Station 245+47 to 247+26, Sec. 16, T. 5 N. R. 4 E., M.D.M. Approximately 179 linear-feet of erosion and sloughing exists along the waterside slope of the Sacramento River. The erosion commences approximately halfway down the slope and extends to the rip rap. Some existing rip rap has been pulled off in this section.					
Site ID No: 338					
Site Designation: LMA-165					
Repair Type: Erosion					
Rating: Area of Concern					
Field Date: 7/13/2017					
Notes: Crown is paved road. Scarps up to 7 ft deep, 2 ft typical above the rip rap. Area of concern because the deeper scarp only covered a short distance and was already vegetated so not actively eroding.

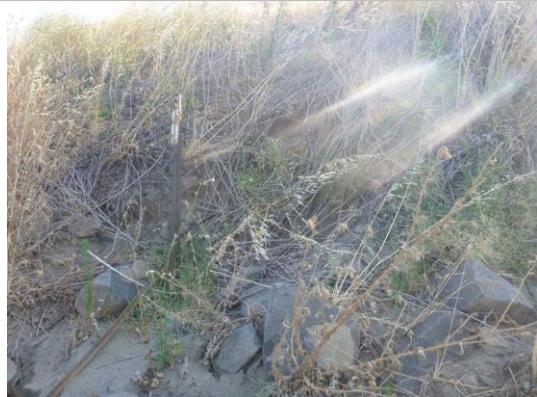
Photo 1 of 3 : FA\_2019\_RD0551\_175\_31\_20190826\_00029.jpg

Item	2017 Storm Damage		38.277589°	38.277256°	
			-121.542575°	-121.542211°	
DWR ID	LMA-166				
Comment Code					
Inspector Comment					
Levee Evaluation Comments					
Description: District Station 258+80 to 260+40, Sec. 16, T. 5 N. R. 4 E., M.D.M. Approximately 160 linear-feet of erosion exists along the waterside slope of the Sacramento River. The erosion commences approximately halfway down the slope from the crown and extends to the rip rap. Some existing rip rap has been pulled off in this section.					
Site ID No: 339					
Site Designation: LMA-166					
Repair Type: Erosion					
Rating: Area of Concern					
Field Date: 7/14/2017					
Notes: crown is a paved road. Scarps of 2.5 ft just above rip rap. Area of concern because erosion is fairly small.

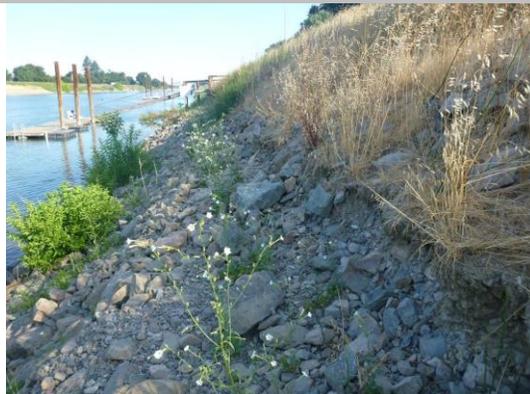
Photo 3 of 3 : FA\_2019\_RD0551\_175\_32\_20190826\_00034.jpg

Item	2017 Storm Damage			38.276072°	38.275761°
				-121.540869°	-121.540497°
DWR ID	LMA-167				
Comment Code					
Inspector Comment					
<p>Levee Evaluation Comments                  Description: District Station 266+16 to 267+71, Sec. 21, T. 5 N. R. 4 E., M.D.M. Approximately 155 linear-feet of erosion and sloughing exists along the waterside slope of the Sacramento River. The erosion commences approximately 3/4 of the way down the slope from the crown and extends into the rip rap. Some existing rip rap has been pulled off in this section.                  Site ID No: 340                  Site Designation: LMA-167                  Repair Type: Erosion                  Rating: Area of Concern                  Field Date: 7/14/2017                  Notes: Crown is a paved road. There is a private boat dock in the middle of the site. Some exposed filter fabric. On the upstream side erosion is above the rip rap and on the downstream side it is within the rip rap. Scarps are 2-3 ft deep. Area of concern because erosion is not very deep into prism.</p>

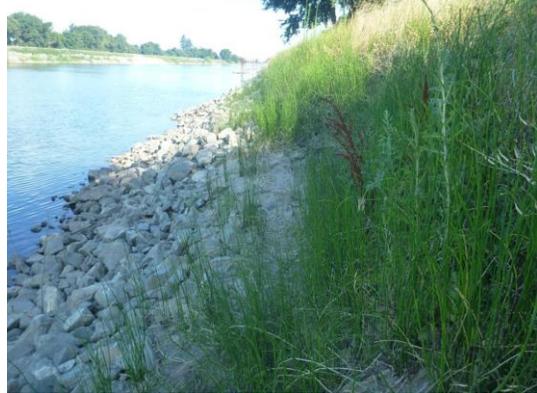
Photo 3 of 3 : FA\_2019\_RD0551\_175\_33\_20190826\_00037.jpg

Item	2017 Storm Damage			38.275442°	38.274997°	
				-121.540094°	-121.539514°	
DWR ID	LMA-168					
Comment Code						
Inspector Comment						
<p><b>Levee Evaluation Comments</b>                      Description: District Station 269+37 to 271+66, Sec. 21, T. 5 N. R. 4 E., M.D.M. Approximately 229 linear-feet of erosion and sloughing exists along the waterside slope of the Sacramento River. The erosion commences approximately 3/4 of the way down the slope from the crown and extends to the rip rap.                      Site ID No: 341                      Site Designation: LMA-168                      Repair Type: Erosion                      Rating: Area of Concern                      Field Date: 7/14/2017                      Notes: crown is a paved road. Scarps up to 4-5 ft, but 18 inches for most of the length. Large tree within site. Area of concern because deeper erosion is only present for a short distance.</p>

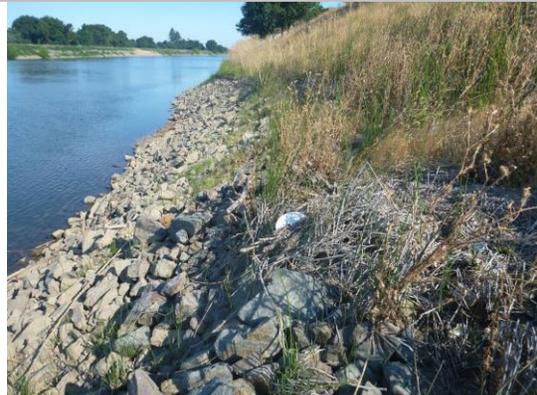
Photo 1 of 3 : FA\_2019\_RD0551\_175\_34\_20190826\_00038.jpg

LM Start	5.20	Rating **	A/W	Issue No.	34	
LM End	5.28	Issue Type +	Ma	Location *	WS	
Category	Supplemental			GPS Latitude/Longitude		
			Start	End		
Item	2017 Storm Damage			38.274592°	38.273800°	
				-121.538958°	-121.537869°	
DWR ID	LMA-169

Comment Code						
Inspector Comment						
<p><b>Levee Evaluation Comments</b>                      Description: District Station 273+82 to 278+08, Sec. 21 and 22, T. 5 N. R. 4 E., M.D.M. Approximately 426 linear-feet of erosion exists along the waterside slope of the Sacramento River. The erosion commences approximately halfway down the slope and extends to the rip rap. Some existing rip rap has been pulled off in this section.                      Site ID No: 342                      Site Designation: LMA-169                      Repair Type: Erosion                      Rating: Serious                      Field Date: 7/14/2017                      Notes: there is a 7 ft scarp that extends for 40-60 ft in very sandy soil, scarps are 2-4 ft the rest of the length. Worst site in this RD so far. Serious because of the length of this deeper scarp and the weak soil here. Crown is a paved road.</p>

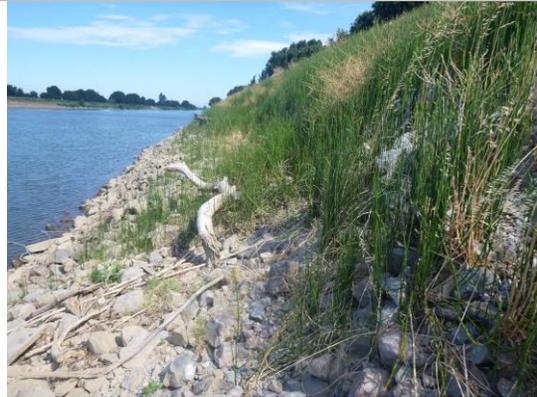
Photo 3 of 3 : FA\_2019\_RD0551\_175\_35\_20190826\_00043.jpg

LM Start	5.38	Rating **	A/W	Issue No.	35 (cont)
LM End	5.42	Issue Type +	Ma	Location *	WS
Category	Supplemental			GPS Latitude/Longitude	
				Start	End
Item	2017 Storm Damage			38.272867°	38.272411°
				-121.536597°	-121.535983°
DWR ID	LMA-170

Comment Code					
Inspector Comment					
<p><b>Levee Evaluation Comments</b>            Description: District Station 283+08 to 285+49, Sec. 22, T. 5 N. R. 4 E., M.D.M. Approximately 241 linear-feet of erosion and sloughing exists along the waterside slope of the Sacramento River. The erosion commences approximately 3/4 of the way down the slope and extends to the rip rap. Some existing rip rap has been pulled off in this section.            Site ID No:343            Site Designation:LMA-170            Repair Type: Erosion            Rating:Area of Concern            Field Date:7/14/2017            Notes: Crown is a paved road. Scarps above rip rap 2-4 ft deep, but not continuous through whole site. Area of concern because erosion is not very deep into prism and is not continuous throughout site.</p>

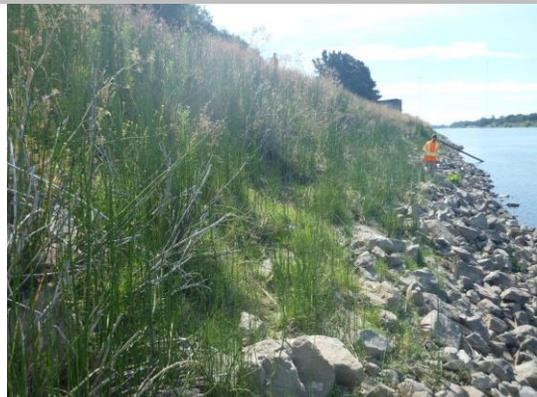
Photo 1 of 3 : FA\_2019\_RD0551\_175\_36\_20190826\_00044.jpg

LM Start	5.52	Rating **	A/W	Issue No.	36
LM End	5.54	Issue Type +	Ma	Location *	WS
Category	Supplemental			GPS Latitude/Longitude	
				Start	End
Item	2017 Storm Damage			38.271406°	38.271208°
				-121.534644°	-121.534381°
DWR ID	LMA-171

Comment Code					
Inspector Comment					
<p><b>Levee Evaluation Comments</b>            Description: District Station 290+80 to 291+85, Sec. 22, T. 5 N. R. 4 E., M.D.M. Approximately 105 linear-feet of erosion and sloughing exists along the waterside slope of the Sacramento River. The erosion commences approximately 3/4 of the way down the slope and extends into the rip rap. Some existing rip rap has been pulled off in this section.            Site ID No:344            Site Designation:LMA-171            Repair Type: Erosion            Rating:Area of Concern            Field Date:7/14/2017            Notes: Crown is a paved road. Erosion scarps 1-4 ft deep just above rip rap. Area of concern because erosion is not very deep into prism.</p>

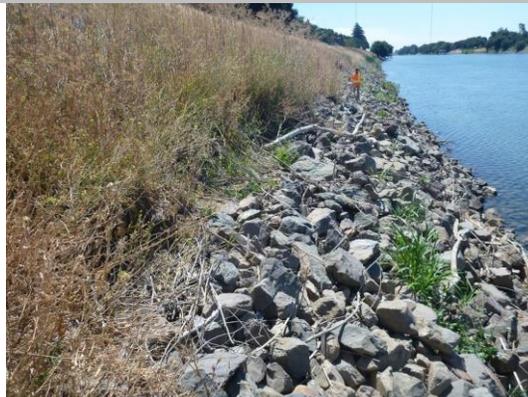
Photo 1 of 3 : FA\_2019\_RD0551\_175\_40\_20190826\_00056.jpg

Item	2017 Storm Damage		38.267286°	38.267094°	
			-121.528886°	-121.528642°	
DWR ID	LMA-176				
Comment Code					
Inspector Comment					
Levee Evaluation Comments					
Description: District Station 313+15 to 314+15, Sec. 22, T. 5 N. R. 4 E., M.D.M. Approximately 100 linear-feet of erosion and sloughing exists along the waterside slope of the Sacramento River. The erosion commences approximately halfway down the slope and extends into the rip rap. Some existing rip rap has been pulled off in this section.					
Site ID No: 349					
Site Designation: LMA-176					
Repair Type: Erosion					
Rating: Area of Concern					
Field Date: 7/14/2017					
Notes: 18 in to 3 ft vertical scarps just above rip rap. Crown is a paved road. Area of concern because erosion is not very deep into prism.

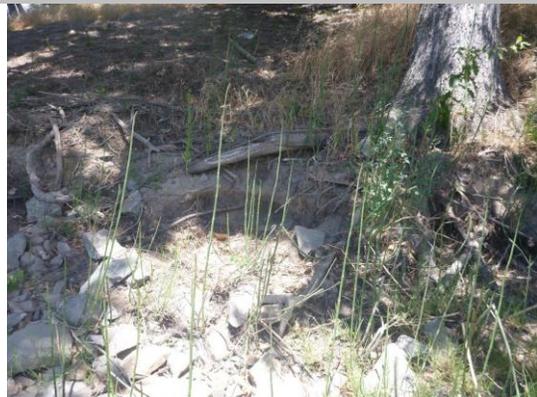
Photo 1 of 3 : FA\_2019\_RD0551\_175\_43\_20190826\_00065.jpg

Item	2017 Storm Damage			38.263906°	38.263756°
				-121.524778°	-121.524575°
DWR ID	LMA-179				
Comment Code					
Inspector Comment					
<p>Levee Evaluation Comments                      Description: District Station 330+19 to 330+99, Sec. 22, T. 5 N. R. 4 E., M.D.M. Approximately 80 linear-feet of erosion/sloughing and minor slippage exists along the waterside slope of the Sacramento River. The erosion/sloughing commences approximately halfway down the slope and extends into the rip rap. Existing rip rap has been pulled off in this section.                      Site ID No: 352                      Site Designation: LMA-179                      Repair Type: Erosion                      Rating: Area of Concern                      Field Date: 7/14/2017                      Notes: Crown is a paved road. Erosion scarps are only 1 ft deep. Area of concern because erosion is not very deep into prism.</p>
