**Flood Control Project Maintenance
Levee Inspections**

Fall 2019 Levee Maintenance Deficiency Summary Report

Reclamation District No. 0563 Tyler Island

Waterway		Bank	Unit Miles
Unit No. 01 Georgiana Slough (Tyler Island)		Left	12.11
	Spring (March - May)	Summer (June - August)	(September - November) Fall Winter (December - February)
Unit Maintenance Rating (Fall Only)			U
Date of Inspection	4/5/2019 - 4/5/2019		11/8/2019 - 11/8/2019
DWR Inspector	David Julian		David Julian
Accompanied By	Steve Mello RD 563		Steve Mello RD 563

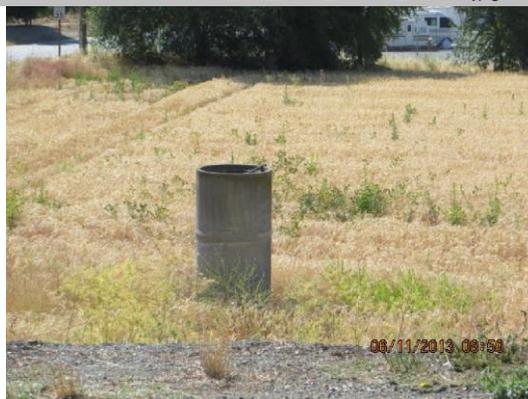
Photo 1 of 3 : UCIP_FA_2019_52739_24503.jpg

Comment Code					
Inspector Comment					
DS_ID:20199 FS_ID:52739 EP_NO: N/A Repair Type: Non-Urgent Crossing Status: Indicator Found UCIP Comments: 07/13/2018 Unable to locate the pipe. Only standpipe found on LS. (O.Yakimov-DWR UCIP)6/11/2013 Need to determine disposition of pipe. Was it abandoned properly? FIELD_STRUCT_DESC: 10-inch steel irrigation pipe through the levee, at an unknown depth. 36-inch concrete standpipe at the landside (LS) toe. Unable to locate pipe, 06/11/2013. [Additional Reference(s): USACE Sacramento O&M Manual 103, June 1954, (Station ""L"" 6+39), listed as a 1-inch pipe and a 36-inch pipe]. FS Date: 7/13/2018 9:06:44 AM

36-inch concrete standpipe on LS toe.

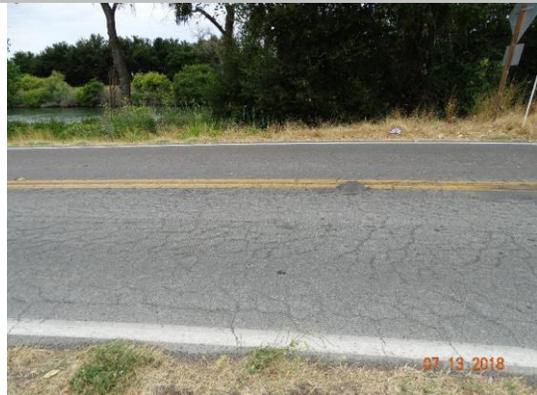
Photo 3 of 3 : UCIP_FA_2019_52739_77711.jpg

LM Start	0.02	Rating **	M	Issue No.	771 (cont)
LM End	0.02	Issue Type +	En	Location *

View of levee crown at the crossing.

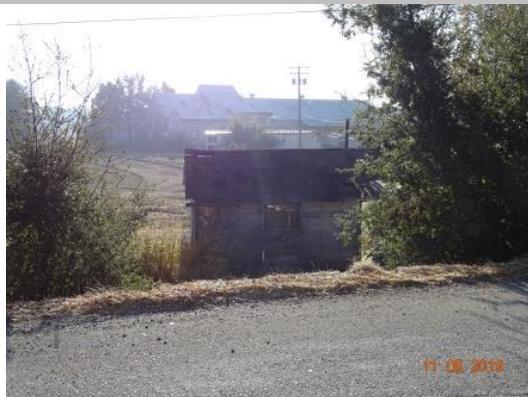
Photo 1 of 1 : FA_2019_RD0563_210_10_20191108_00220.jpg

LM Start	0.15	Rating **	M	Issue No.	10
LM End	0.15	Issue Type +	En	Location *	LS
Category	Earthen Levee		GPS Latitude/Longitude		
			Start	End	
Item	Encroachments		38.233572 °	38.233572 °	
			-121.519083 °	-121.519083 °	
DWR ID	DWR_RD0563_01_f_2013_10				
Comment Code					
BU : Building					
Inspector Comment					
Tool shed at the landside toe

View of building at the landside toe (Fall 2019).

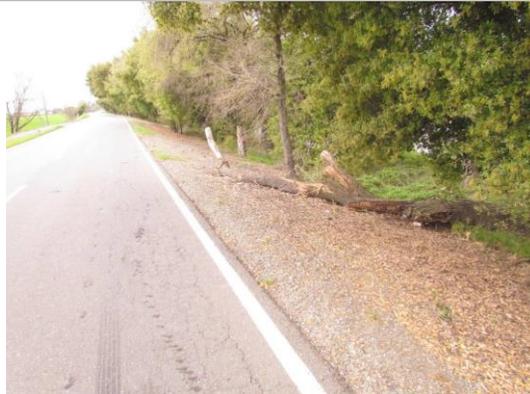
Photo 1 of 2 : FA_2019_RD0563_210_32_20190826_00014.jpg

LM Start	0.17	Rating **	M	Issue No.	32
LM End	0.24	Issue Type +	Ma	Location *	WS
Category	Earthen Levee			GPS Latitude/Longitude	
				Start	End
Item	Encroachments			38.233315°	38.232555°
				-121.519360°	-121.520180°
DWR ID	DWR_RD0563_01_s_2012_32				
Comment Code					
TR : Tree or limb					
Inspector Comment					
A tree has fallen across the waterward slope.

Looking downstream at tree branch on waterward slope. (Spring 2017)

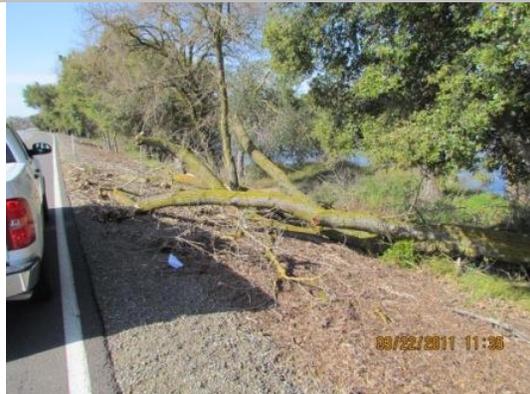
Photo 2 of 2 : FA_2019_RD0563_210_32_20190826_00015.jpg

LM Start	0.17	Rating **	M	Issue No.	32 (cont)
LM End	0.24	Issue Type +	Ma	Location *	WS

Looking downstream at fallen tree limb on waterside slope. (Spring 2016)

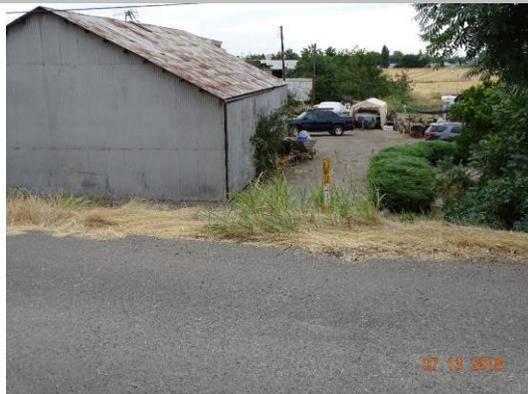
Photo 3 of 3 : UCIP_FA_2019_52740_77712.jpg

LM Start	0.20	Rating **	M	Issue No.	772 (cont)
LM End	0.20	Issue Type +	En	Location *	
Category	Supplemental			GPS Latitude/Longitude	
				Start	End
Item	DRAFT DWR UCIP Field Study			38.233027°	38.233027°
				-121.519631°	-121.519631°
DWR ID	20129				
Comment Code					
Inspector Comment					
DS_ID:20129 FS_ID:52740 EP_NO: 3448 Repair Type: Non-Urgent Crossing Status: Indicator Found UCIP Comments: 07/13/2018 Gas pipeline crossing sign found on LS slope, and monitoring well on levee crown. (O.Yakimov-DWR UCIP)6/11/2013 Sign on waterside slope should be cleared of vegetation. FIELD_STRUCT_DESC: 4.5-inch steel gas line through the levee, 4 feet below the crown and across the channel. Large warning sign on the waterside (WS) slope. (Permit No. 3448, 1960 - Pacific Gas and Electric Company [PG&E]). [Additional Reference(s): DWR Levee Log, 2005]. FS Date: 7/13/2018 9:16:16 AM

Sign on LS slope.

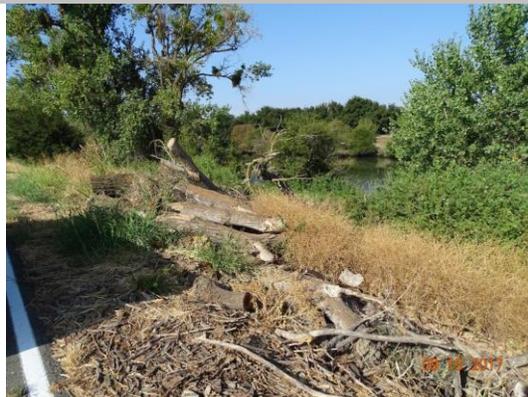
Photo 1 of 1 : FA_2019_RD0563_210_114_20190826_00076.jpg

LM Start	0.40	Rating **	M	Issue No.	114
LM End	0.40	Issue Type +	Ma	Location *	WS
Category	Earthen Levee			GPS Latitude/Longitude	
				Start	End
Item	Encroachments			38.230744°	38.230744°
				-121.522022°	-121.522022°
DWR ID	DWR_RD0563_01_f_2017_114				
Comment Code					
TR : Tree or limb					
Inspector Comment

Looking southwest at the waterside slope.

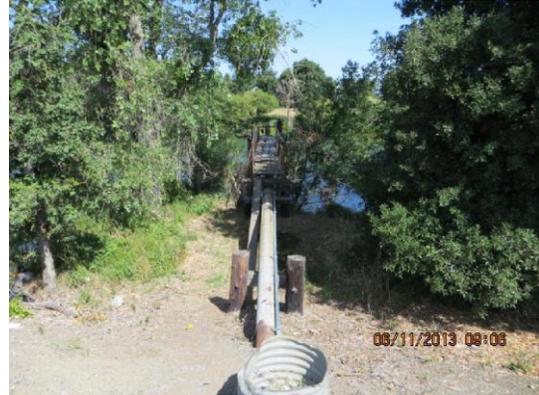
Photo 3 of 3 : UCIP_FA_2019_52741_24509.jpg

Comment Code					
Inspector Comment					
DS_ID:20130 FS_ID:52741 EP_NO: 11218 Repair Type: Non-Urgent Crossing Status: Found UCIP Comments: 07/13/2018 Electrical conduit that is attached to the pipe on WS fell apart at several locations. LS and WS slopes are heavily vegetated. (O.Yakimov-DWR UCIP)06/11/2013 Pipe leaking at various points on WS berm. Failure on berm may indicate potential for failure within the levee. Good candidate for video inspection. (W.Wylie-DWR) FIELD_STRUCT_DESC: 12-inch steel irrigation pipe through the levee, 5 feet below the crown. Walkway to pump on pile structure in stream. Siphon breaker in a 24-inch corrugated metal pipe (CMP) riser on the waterside (WS) shoulder. 1-inch air and vacuum valve and a 15-foot-tall by 36-inch-diameter concrete standpipe at the landside (LS) toe. (Automatic Board Order (ABO) issued as Permit No. 11218, 1975 - Fong Yock Yee). [Additional Reference(s): DWR Levee Log, 2005. USACE Sacramento O&M Manual 103, June 1954, (Station ""L2"" 196+67.8)]. FS Date: 7/13/2018 9:38:39 AM

Pipe and pier on WS.

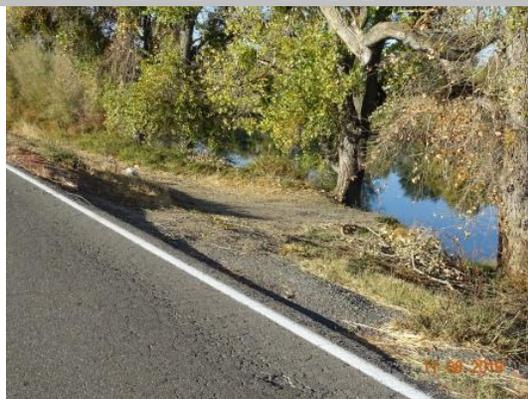
Photo 1 of 1 : FA_2019_RD0563_210_34_20191108_00221.jpg

LM Start	0.53	Rating **	M	Issue No.	34
LM End	0.53	Issue Type +	Ma	Location *	WS
Category	Earthen Levee			GPS Latitude/Longitude	
				Start	End
Item	Slope Stability			38.229232°	38.229232°
				-121.523538°	-121.523538°
DWR ID	DWR_RD0563_01_f_2018_34				
Comment Code					
S3 : Repair the levee slope damaged by vehicle traffic and prevent access where possible.					
Inspector Comment					
Slope damage due to vehicle traffic.

View looking downstream at slope damage from vehicle traffic (Fall 2019).

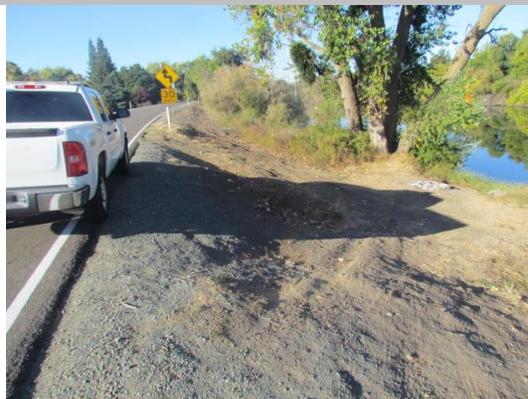
Photo 1 of 2 : FA_2019_RD0563_210_143_20190826_00093.jpg

LM Start	0.56	Rating **	M	Issue No.	143
LM End	0.56	Issue Type +	Ma	Location *	WS
Category	Earthen Levee			GPS Latitude/Longitude	
				Start	End
Item	Slope Stability			38.228930°	38.228930°
				-121.523935°	-121.523935°
DWR ID	DWR_RD0563_01_f_2014_143				
Comment Code					
S3 : Repair the levee slope damaged by vehicle traffic and prevent access where possible.					
Inspector Comment					
Slope damage is due to vehicle traffic.

Looking southeast at slope damage on waterward slope.

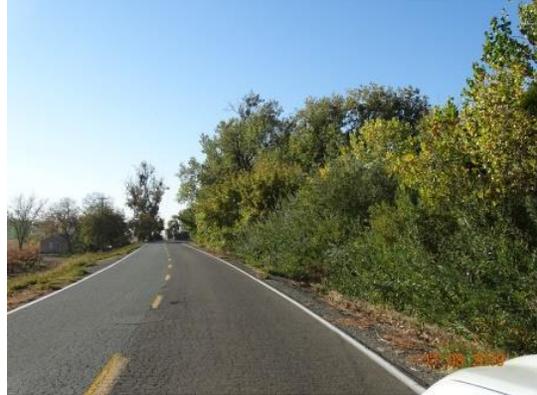
Photo 1 of 1 : FA_2019_RD0563_210_3_20191108_00222.jpg

LM Start	0.73	Rating **	U	Issue No.	3
LM End	0.86	Issue Type +	Ma	Location *	WS
Category	Earthen Levee		GPS Latitude/Longitude		
			Start	End	
Item	Vegetation		38.227169°	38.225597°	
			-121.525892°	-121.526515°	
DWR ID	DWR_RD0563_01_s_2012_3				
Comment Code					
V2 : Remove the wild growth other than native grasses from the levee slopes.					
Inspector Comment

View looking downstream at thick vegetation on the waterside slope (Fall 2019).

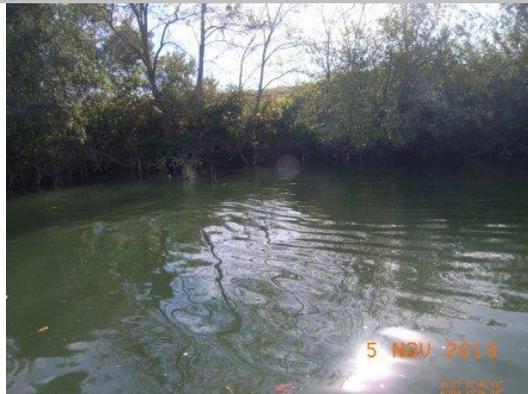
Photo 1 of 1 : FA_2019_RD0563_210_70_20190826_00028.jpg

LM Start	0.92	Rating **	M	Issue No.	70
LM End	1.11	Issue Type +	Ma	Location *	WS
Category	Supplemental		GPS Latitude/Longitude		
			Start	End	
Item	2017 USACE Erosion Survey		38.225660°	38.227157°	
			-121.527556°	-121.530432°	
DWR ID	DWR_RD0563_01_f_2018_70				
Comment Code					
Inspector Comment					
2017 Site ID: GEO 11.0 L Status: Eroding 2017 Field Notes: Increased toe erosion, slumping, boat wake erosion, and revetment failure near downstream end. Site extended upstream. Site History: 2011 - Short sections of eroding bank at the waterline and holes in toe of levee. 2012 - Site extended upstream. 2013 - Erosion pockets filled with an insufficient amounts of revetment. 2016 - Fresh erosion observed.

USACE 2013 Photo #1

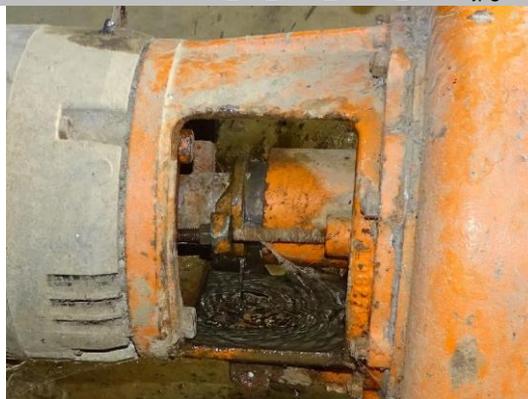
Photo 1 of 3 : UCIP_FA_2019_52744_77722.jpg

Comment Code					
Inspector Comment					
DS_ID:20132 FS_ID:52744 EP_NO: 11210 Repair Type: Non-Urgent Crossing Status: Found UCIP Comments: 07/13/2018 Water pump is running, leak thru pump seal is detected. Pipe on WS has been partially replaced with a new pipe to pumphouse. Remaining part of old pipe needs to be abandoned properly. (O.Yakimov-DWR UCIP)06/11/2013 Pipe does not have sufficient cover at crown. (W.Wylie) FIELD_STRUCT_DESC: 6-inch irrigation pipe of an unknown material through the levee, 3 inches below the crown. Pump and gate valve in pump house on the waterside (WS) slope. Service pole on the landside (LS) slope. (Automatic Board Order (ABO) issued as Permit No. 11210, 1975 - Leland O. Hanson). 1-inch polyvinyl chloride (PVC) electrical conduit through the levee at the same location, at an unknown depth. [Additional Reference(s): DWR Levee Log, 2005. USACE Sacramento O&M Manual 103, June 1954, (Station ""L"" 43+91.9), listed as a 14-inch pipe]. FS Date: 7/13/2018 1:28:34 PM

Water is leaking thru shaft sealing.

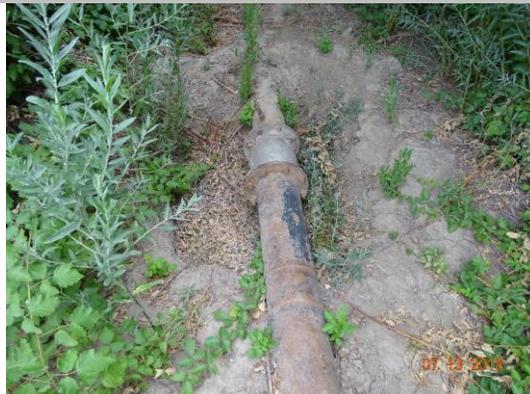
Photo 2 of 3 : UCIP_FA_2019_52744_77723.jpg

Comment Code					
Inspector Comment					
DS_ID:20132 FS_ID:52744 EP_NO: 11210 Repair Type: Non-Urgent Crossing Status: Found UCIP Comments: 07/13/2018 Water pump is running, leak thru pump seal is detected. Pipe on WS has been partially replaced with a new pipe to pumphouse. Remaining part of old pipe needs to be abandoned properly. (O.Yakimov-DWR UCIP)06/11/2013 Pipe does not have sufficient cover at crown. (W.Wylie) FIELD_STRUCT_DESC: 6-inch irrigation pipe of an unknown material through the levee, 3 inches below the crown. Pump and gate valve in pump house on the waterside (WS) slope. Service pole on the landside (LS) slope. (Automatic Board Order (ABO) issued as Permit No. 11210, 1975 - Leland O. Hanson). 1-inch polyvinyl chloride (PVC) electrical conduit through the levee at the same location, at an unknown depth. [Additional Reference(s): DWR Levee Log, 2005. USACE Sacramento O&M Manual 103, June 1954, (Station ""L"" 43+91.9), listed as a 14-inch pipe]. FS Date: 7/13/2018 1:28:34 PM

New pipe and old pipe connection on WS.

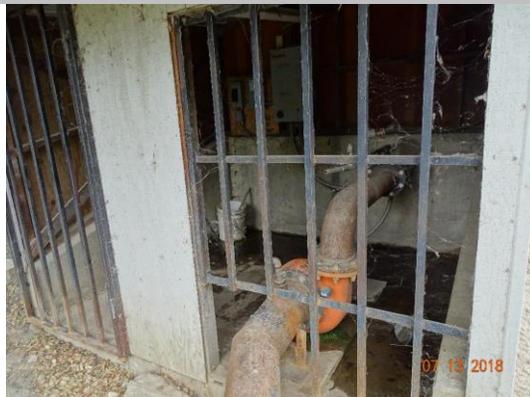
Photo 3 of 3 : UCIP_FA_2019_52744_77725.jpg

LM Start	0.93	Rating **	M	Issue No.	775 (cont)
LM End	0.93	Issue Type +	En	Location *

View of inside of pumphouse.

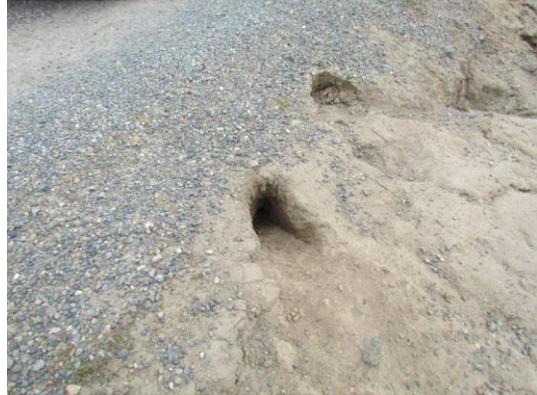
Photo 1 of 2 : FA_2019_RD0563_210_121_20190826_00080.jpg

LM Start	0.95	Rating **	U	Issue No.	121
LM End	0.95	Issue Type +	Ma	Location *	LS
Category	Earthen Levee			GPS Latitude/Longitude	
				Start	End
Item	Animal Control			38.225808°	38.225808°
				-121.528197°	-121.528197°
DWR ID	DWR_RD0563_01_s_2017_121				
Comment Code					
A1 : Exterminate rodents and backfill and compact or grout burrows.					
Inspector Comment					
There are several large rodent holes on the landward slope.

Looking at typical rodent hole at this location.

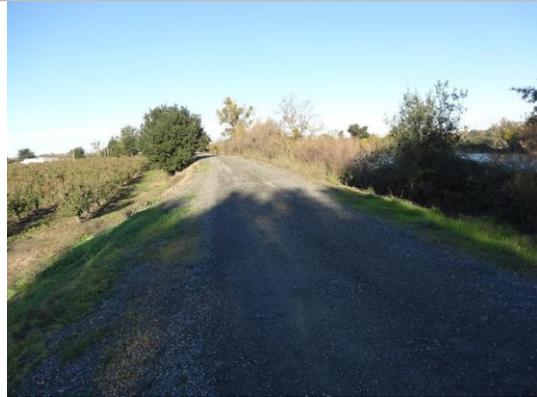
Photo 1 of 3 : UCIP_FA_2019_52745_76827.jpg

Comment Code					
Inspector Comment					
DS_ID:20133 FS_ID:52745 EP_NO: 11210 Repair Type: Non-Urgent Crossing Status: Found UCIP Comments: 07/13/2018 Pipe is open on LS. Same as last inspection. (O.Yakimov-DWR UCIP)12/02/2016 According to LMA representative, Darcy Neuderk, this crossing was installed in 1952 by the USACE and intended to be use for irrigation purposes. However, this crossing has never been used per LMA's knowledge. Crossing has been downgraded from "Urgent" to "Non-Urgent", the flap gate on the WS is functional and prevents any potential flood water from draining to LS. Recommend contacting property owner and working with the CVFPB to address abandoned crossing. (O. Magana - DWR UCIP)06/11/2013 Flap gate rusted in closed position. (W. Wylie - DWR UCIP) FIELD_STRUCT_DESC: 2 of 2: 8-inch steel drainage pipe through the levee, 3 feet below the crown. Flap gate on the waterside (WS). Pipe open on the landside (LS). (8-inch pipe [HLM 0.97] authorized under Automatic Board Order (ABO) issued as Permit No. 11210, 1975 - Leland O. Hanson). [Additional Reference(s): DWR Levee Log, 2005]. FS Date: 7/12/2018 1:40:12 PM

View of levee crown at pipe crossing.

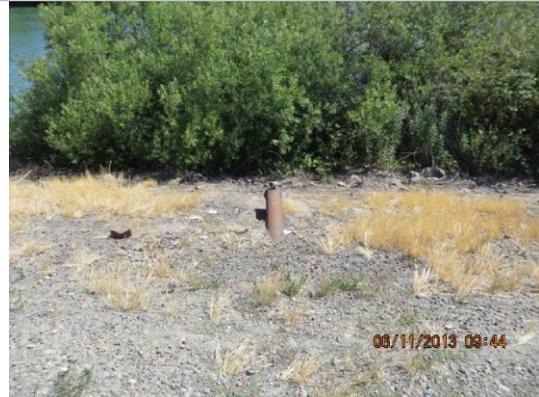
Photo 3 of 3 : UCIP_FA_2019_52745_24524.jpg

Comment Code					
Inspector Comment					
<p>DS_ID:20133 FS_ID:52745 EP_NO: 11210 Repair Type: Non-Urgent Crossing Status: Found UCIP Comments: 07/13/2018 Pipe is open on LS. Same as last inspection. (O.Yakimov-DWR UCIP)12/02/2016 According to LMA representative, Darcy Neuderker, this crossing was installed in 1952 by the USACE and intended to be use for irrigation purposes. However, this crossing has never been used per LMA's knowledge. Crossing has been downgraded from "Urgent" to "Non-Urgent", the flap gate on the WS is functional and prevents any potential flood water from draining to LS. Recommend contacting property owner and working with the CVFPB to address abandoned crossing. (O. Magana - DWR UCIP)06/11/2013 Flap gate rusted in closed position. (W. Wylie - DWR UCIP) FIELD_STRUCT_DESC: 2 of 2: 8-inch steel drainage pipe through the levee, 3 feet below the crown. Flap gate on the waterside (WS). Pipe open on the landside (LS). (8-inch pipe [HLM 0.97] authorized under Automatic Board Order (ABO) issued as Permit No. 11210, 1975 - Leland O. Hanson). [Additional Reference(s): DWR Levee Log, 2005]. FS Date: 7/12/2018 1:40:12 PM</p>

Pipe and flapgate on WS slope.

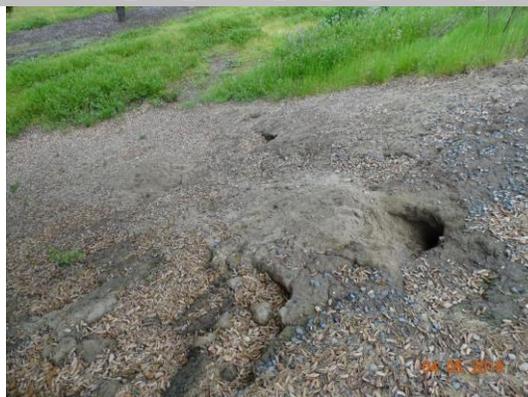
Photo 1 of 1 : FA_2019_RD0563_210_147_20190826_00097.jpg

LM Start	0.99	Rating **	M	Issue No.	147
LM End	0.99	Issue Type +	Ma	Location *	LS
Category	Earthen Levee		GPS Latitude/Longitude		
			Start	End	
Item	Animal Control		38.226138°	38.226138°	
			-121.528745°	-121.528745°	
DWR ID	DWR_RD0563_01_f_2014_147				
Comment Code					
A1 : Exterminate rodents and backfill and compact or grout burrows.					
Inspector Comment

View of squirrel holes with recent rodent activity (Spring 2019).

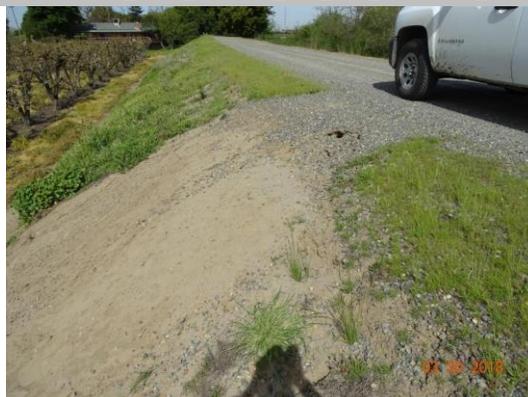
Photo 1 of 1 : FA_2019_RD0563_210_110_20190826_00074.jpg

LM Start	1.03	Rating **	U	Issue No.	110
LM End	1.03	Issue Type +	Ma	Location *	LS
Category	Earthen Levee		GPS Latitude/Longitude		
			Start	End	
Item	Animal Control		38.226422°	38.226422°	
			-121.529410°	-121.529410°	
DWR ID	DWR_RD0563_01_s_2018_110				
Comment Code					
A3 : No rodents visible, but rodent burrows visible; need to backfill and compact or grout burrows.					
Inspector Comment					
A very large rodent burrow has caused the landside shoulder to collapse. The shoulder should be restored.

3/30/2018: Very large rodent burrow causing caving at landside shoulder.

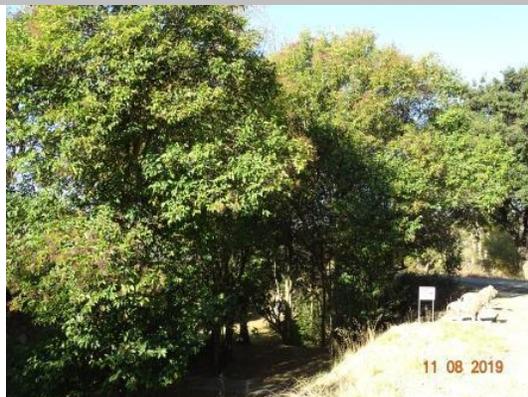
Photo 1 of 1 : FA_2019_RD0563_210_111_20191108_00223.jpg

LM Start	1.09	Rating **	M	Issue No.	111
LM End	1.09	Issue Type +	En	Location *	LS
Category	Earthen Levee		GPS Latitude/Longitude		
			Start	End	
Item	Vegetation		38.226882°	38.226882°	
			-121.530258°	-121.530258°	
DWR ID	DWR_RD0563_01_s_2018_111				
Comment Code					
V6 : Landscaping					
Inspector Comment					
Tree should be trimmed to allow inspection and access to landside slope.

View looking downstream at landscaping trees on the landside slope (Fall 2019).

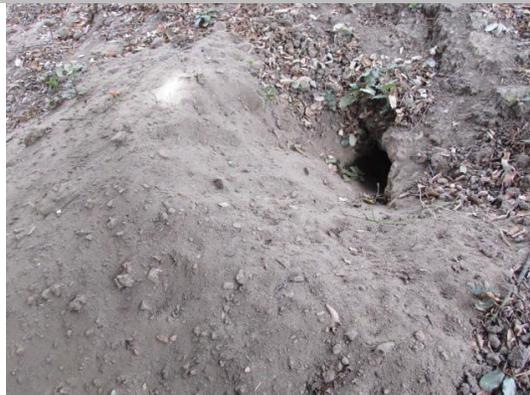
Photo 1 of 1 : FA_2019_RD0563_210_153_20190826_00103.jpg

LM Start	1.15	Rating **	U	Issue No.	153
LM End	1.15	Issue Type +	Ma	Location *	LS
Category	Earthen Levee			GPS Latitude/Longitude	
				Start	End
Item	Animal Control			38.226910°	38.226910°
				-121.531294°	-121.531294°
DWR ID	DWR_RD0563_01_f_2015_153				
Comment Code					
A3 : No rodents visible, but rodent burrows visible; need to backfill and compact or grout burrows.					
Inspector Comment					
Several large to medium rodent holes have been noted at this location.

Looking at typical view of several rodent holes on landward slope.

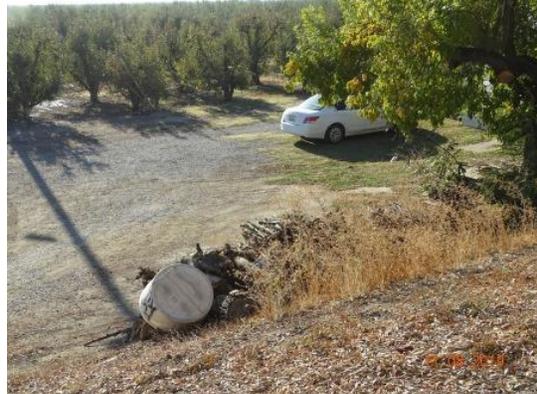
Photo 1 of 1 : FA_2019_RD0563_210_134_20191108_00224.jpg

LM Start	1.21	Rating **	M	Issue No.	134
LM End	1.21	Issue Type +	En	Location *	LS
Category	Earthen Levee			GPS Latitude/Longitude	
				Start	End
Item	Encroachments			38.226462°	38.226462°
				-121.532172°	-121.532172°
DWR ID	DWR_RD0563_01_s_2016_134				
Comment Code					
FW : Firewood					
Inspector Comment					
Landowner is stock piling firewood at the landward toe.

View of firewood at the landside toe (Fall 2019).

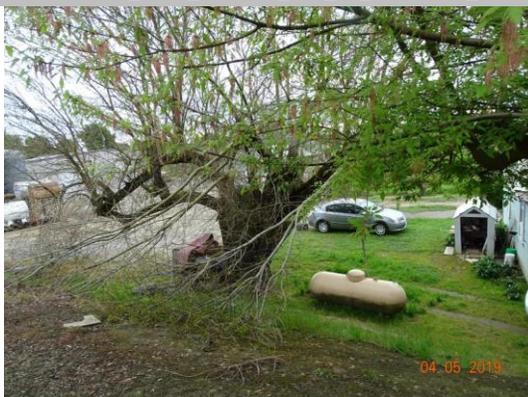
Photo 1 of 1 : FA_2019_RD0563_210_79_20190826_00046.jpg

LM Start	1.22	Rating **	M	Issue No.	79
LM End	1.22	Issue Type +	Ma	Location *	LS
Category	Earthen Levee		GPS Latitude/Longitude		
			Start	End	
Item	Trim / Thin Trees		38.226361°	38.226361°	
			-121.532270°	-121.532270°	
DWR ID	DWR_RD0563_01_s_2019_79				
Comment Code					
T1 : Trim trees to at least five feet above ground level.					
Inspector Comment					
Trim recently downed tree branches on the landside slope.

View looking downslope of recently downed branches on landside slope (Spring 2019).

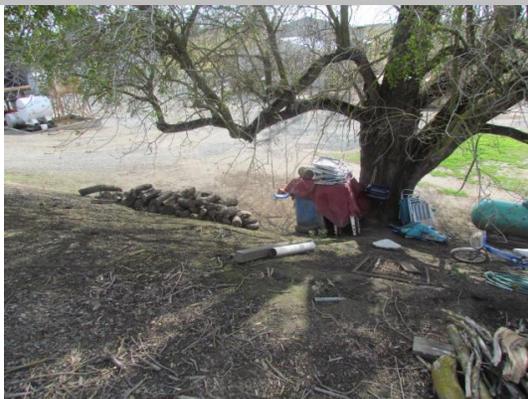
Photo 1 of 2 : FA_2019_RD0563_210_57_20190826_00019.jpg

LM Start	1.22	Rating **	U	Issue No.	57
LM End	1.22	Issue Type +	En	Location *	LS
Category	Earthen Levee		GPS Latitude/Longitude		
			Start	End	
Item	Encroachments		38.226345°	38.226345°	
			-121.532332°	-121.532332°	
DWR ID	DWR_RD0563_01_s_2012_57				
Comment Code					
BU : Building					
Inspector Comment					
Landowner has built a shed extending from the home onto the levee toe. This unpermitted construction should be removed.

Looking east at firewood and other materials stored on landside slope and toe.

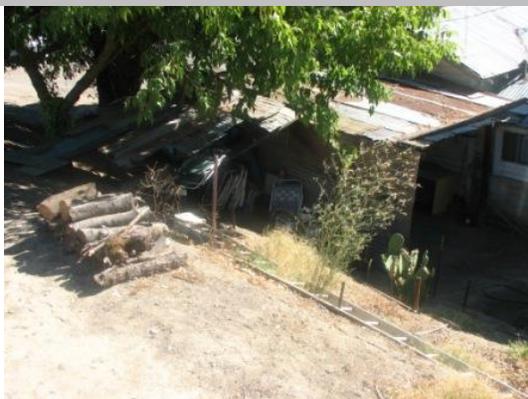
Photo 2 of 2 : FA_2019_RD0563_210_57_20190826_00020.jpg

Looking at a shed at landside toe.

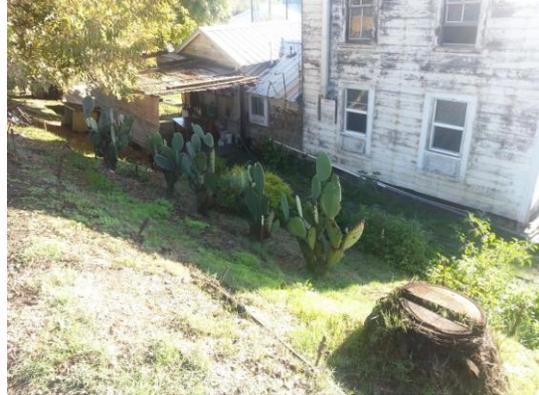
Photo 1 of 2 : FA_2019_RD0563_210_170_20190826_00109.jpg

LM Start	1.22	Rating **	M	Issue No.	170
LM End	1.24	Issue Type +	En	Location *	LS
Category	Earthen Levee		GPS Latitude/Longitude		
			Start	End	
Item	Vegetation		38.226316°	38.226053°	
			-121.532342°	-121.532525°	
DWR ID	DWR_RD0563_01_f_2016_170				
Comment Code					
V6 : Landscaping					
Inspector Comment					
Remove cactus on landward slope.

Looking southeast at cactus on landward slope.

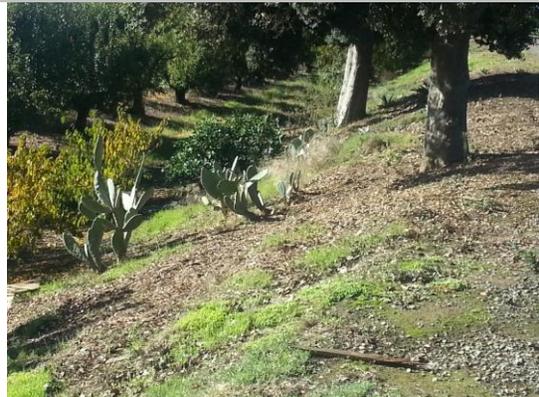
Photo 2 of 2 : FA_2019_RD0563_210_170_20190826_00110.jpg

LM Start	1.22	Rating **	M	Issue No.	170 (cont)
LM End	1.24	Issue Type +	En	Location *	LS

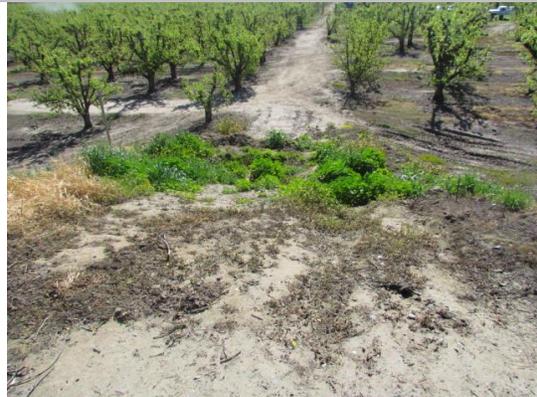
Photo 1 of 3 : FA_2019_RD0563_210_150_20190826_00099.jpg

LM Start	1.35	Rating **	M	Issue No.	150
LM End	1.35	Issue Type +	En	Location *	LS
Category	Earthen Levee		GPS Latitude/Longitude		
			Start	End	
Item	Encroachments		38.224817°	38.224817°	
			-121.533602°	-121.533602°	
DWR ID	DWR_RD0563_01_s_2016_150				
Comment Code					
RA : Ramp					
Inspector Comment					
There is an unauthorized ramp on the landside slope.

Looking southeast at ramp on landward slope.

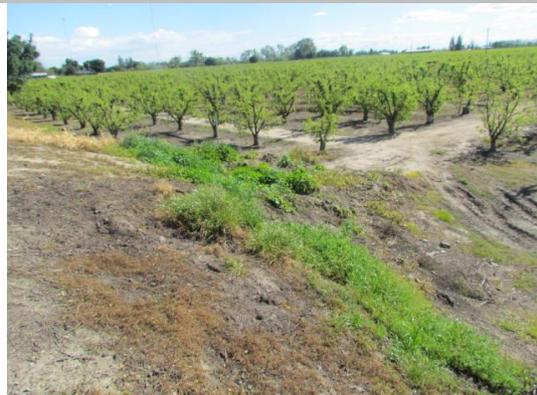
Photo 2 of 3 : FA_2019_RD0563_210_150_20190826_00100.jpg

LM Start	1.35	Rating **	M	Issue No.	150 (cont)
LM End	1.35	Issue Type +	En	Location *	LS

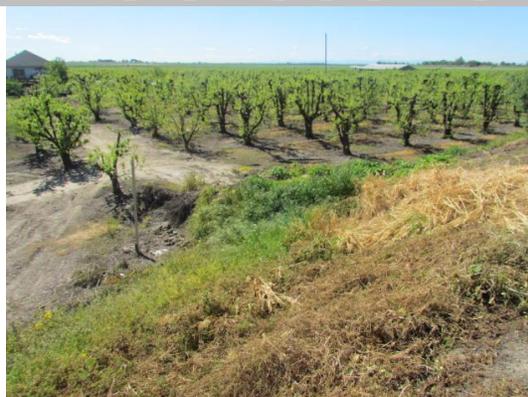
Photo 3 of 3 : FA_2019_RD0563_210_150_20190826_00101.jpg

LM Start	1.35	Rating **	M	Issue No.	150 (cont)
LM End	1.35	Issue Type +	En	Location *	LS
Category	Earthen Levee			GPS Latitude/Longitude	
				Start	End
Item	Encroachments			38.224817°	38.224817°
				-121.533602°	-121.533602°
DWR ID	DWR_RD0563_01_s_2016_150				
Comment Code					
RA : Ramp					
Inspector Comment					
There is an unauthorized ramp on the landside slope.

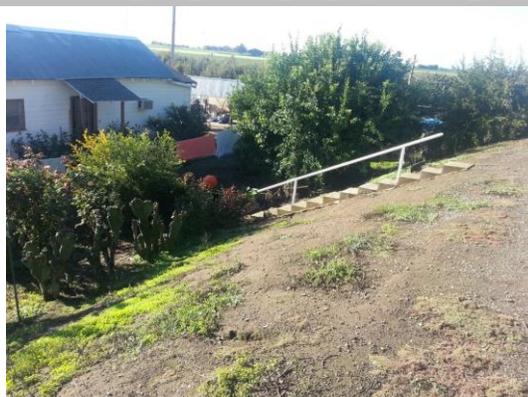
Photo 1 of 1 : FA_2019_RD0563_210_86_20190826_00053.jpg

LM Start	1.39	Rating **	U	Issue No.	86
LM End	1.39	Issue Type +	En	Location *	LS
Category	Earthen Levee			GPS Latitude/Longitude	
				Start	End
Item	Vegetation			38.224351°	38.224351°
				-121.534209°	-121.534209°
DWR ID	DWR_RD0563_01_f_2013_86				
Comment Code					
V6 : Landscaping					
Inspector Comment					
Landowner has fruit trees and other vegetation on landside slope and toe.

Looking southwest at fruit trees and other plantings at landward toe.

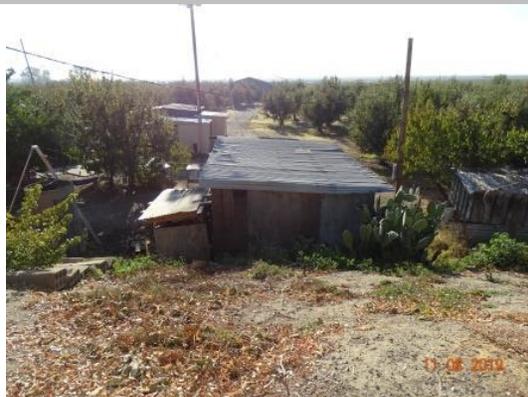
Photo 1 of 1 : FA_2019_RD0563_210_8_20191108_00225.jpg

LM Start	1.40	Rating **	U	Issue No.	8
LM End	1.40	Issue Type +	En	Location *	LS
Category	Earthen Levee			GPS Latitude/Longitude	
				Start	End
Item	Encroachments			38.224315°	38.224315°
				-121.534288°	-121.534288°
DWR ID	DWR_RD0563_01_s_2012_8				
Comment Code					
BU : Building					
Inspector Comment					
Tool shed, animal storage container, and landscaping are on the landside slope and toe.

View of building and landscaping at the landside toe (Fall 2019).

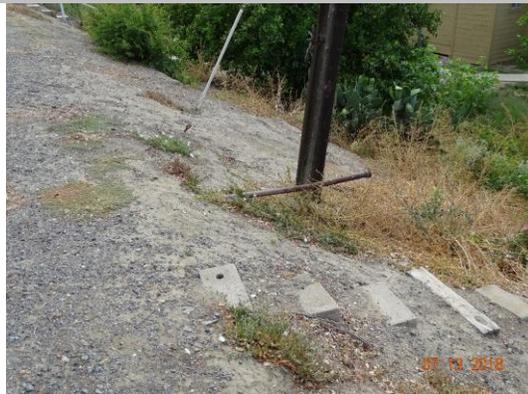
Photo 3 of 3 : UCIP_FA_2019_52747_77727.jpg

LM Start	1.40	Rating **	M	Issue No.	777 (cont)
LM End	1.40	Issue Type +	En	Location *	
Category	Supplemental			GPS Latitude/Longitude	
				Start	End
Item	DRAFT DWR UCIP Field Study			38.224302°	38.224302°
				-121.534287°	-121.534287°
DWR ID	20134				
Comment Code					
Inspector Comment					
DS_ID:20134 FS_ID:52747 EP_NO: N/A Repair Type: Non-Urgent Crossing Status: Found UCIP Comments: 07/13/2018 Same as last inspection. (O.Yakimov-DWR UCIP)06/11/2013 Pipe open on LS and should be removed. FIELD_STRUCT_DESC: *ABANDONED* 2-inch electrical conduit of an unknown material through the levee, 2 feet below the crown. [Additional Reference(s): DWR Levee Log, 2005]. FS Date: 7/13/2018 2:34:56 PM

View of pipe on LS slope.

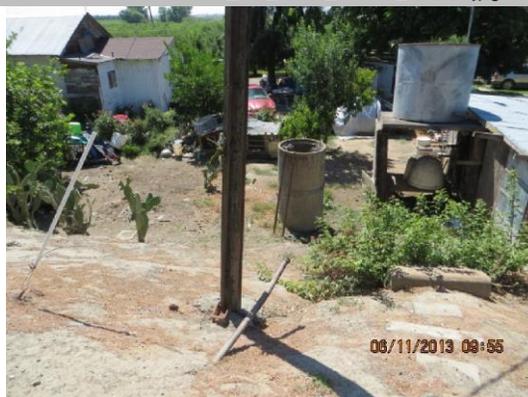
Photo 1 of 3 : UCIP_FA_2019_52748_24530.jpg

Comment Code					
Inspector Comment					
DS_ID:20189 FS_ID:52748 EP_NO: N/A Repair Type: Non-Urgent Crossing Status: Found UCIP Comments: 07/13/2018 Cut-off, abandoned pipe found on riverbank and WS slope next to the irrigation pipe. Old pipe needs to be properly abandoned. (O.Yakimov-DWR UCIP) FIELD_STRUCT_DESC: 8-inch steel irrigation pipe through the levee, 3.1 feet below the crown. 9-foot-tall by 36-inch-diameter concrete standpipe on the landside (LS) toe. 6-foot by 6-foot corrugated metal pump house with pump and butterfly valve on the waterside (WS). 1-inch galvanized iron electrical conduit through the levee at the same location, at an unknown depth. [Additional Reference(s): USACE Sacramento O&M Manual 103, June 1954, (Station ""L2"" 146+62.8)]. FS Date: 7/13/2018 2:47:32 PM

36-inch concrete standpipe on LS toe.

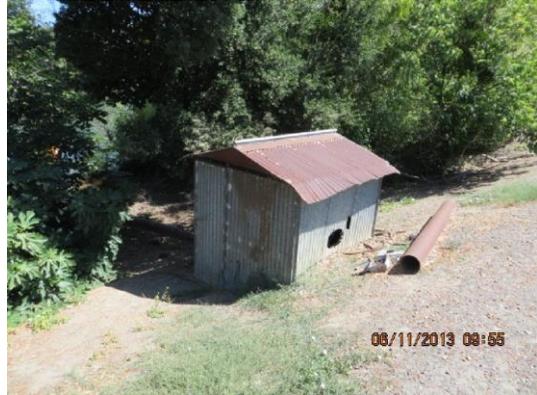
Photo 2 of 3 : UCIP_FA_2019_52748_24529.jpg

Comment Code					
Inspector Comment					
DS_ID:20189 FS_ID:52748 EP_NO: N/A Repair Type: Non-Urgent Crossing Status: Found UCIP Comments: 07/13/2018 Cut-off, abandoned pipe found on riverbank and WS slope next to the irrigation pipe. Old pipe needs to be properly abandoned. (O.Yakimov-DWR UCIP) FIELD_STRUCT_DESC: 8-inch steel irrigation pipe through the levee, 3.1 feet below the crown. 9-foot-tall by 36-inch-diameter concrete standpipe on the landside (LS) toe. 6-foot by 6-foot corrugated metal pump house with pump and butterfly valve on the waterside (WS). 1-inch galvanized iron electrical conduit through the levee at the same location, at an unknown depth. [Additional Reference(s): USACE Sacramento O&M Manual 103, June 1954, (Station ""L2"" 146+62.8)]. FS Date: 7/13/2018 2:47:32 PM

Pumphouse on WS slope.

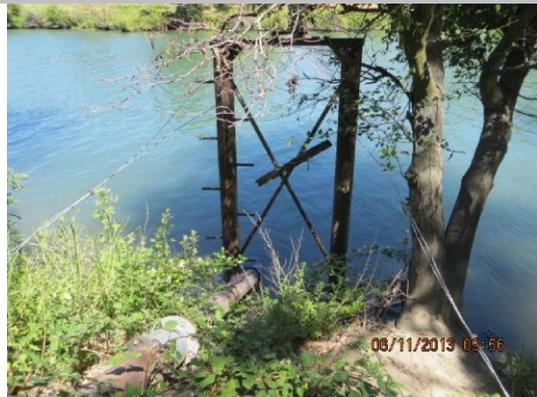
Photo 3 of 3 : UCIP_FA_2019_52748_24528.jpg

Pipe at WS toe.

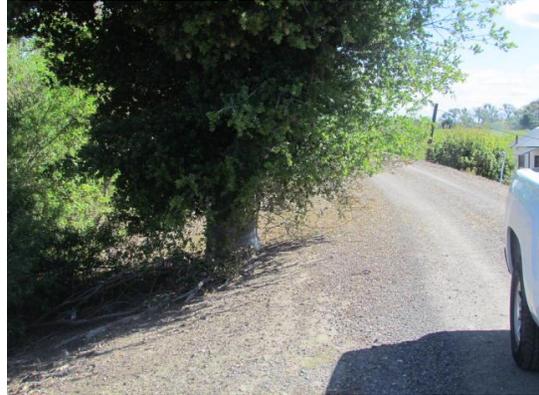
Photo 1 of 1 : FA_2019_RD0563_210_759_20190826_00111.jpg

LM Start	1.42	Rating **	M	Issue No.	759
LM End	1.42	Issue Type +	Ma	Location *	WS
Category	Earthen Levee		GPS Latitude/Longitude		
			Start	End	
Item	Trim / Thin Trees		38.224150°	38.224150°	
			-121.534565°	-121.534565°	
DWR ID	DWR_RD0563_01_s_2015_759				
Comment Code					
T1 : Trim trees to at least five feet above ground level.					
Inspector Comment

Looking northwest at untrimmed trees on waterward slope and toe.

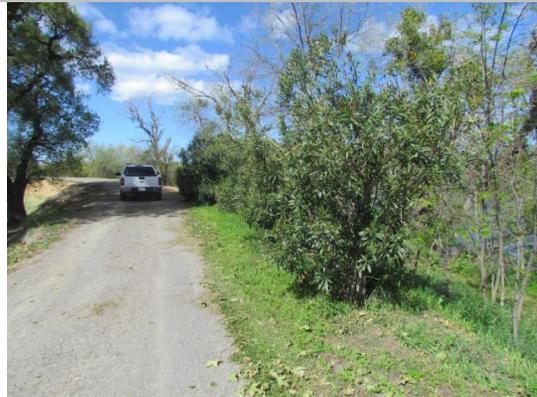
Photo 1 of 2 : FA_2019_RD0563_210_142_20190826_00091.jpg

LM Start	1.86	Rating **	M	Issue No.	142
LM End	1.87	Issue Type +	En	Location *	WS
Category	Earthen Levee			GPS Latitude/Longitude	
				Start	End
Item	Vegetation			38.222743°	38.222720°
				-121.542523°	-121.542741°
DWR ID	DWR_RD0563_01_s_2014_142				
Comment Code					
V6 : Landscaping					
Inspector Comment					
Landowner has planted oleanders on the waterside shoulder.

Looking southwest at oleanders on waterward shoulder.

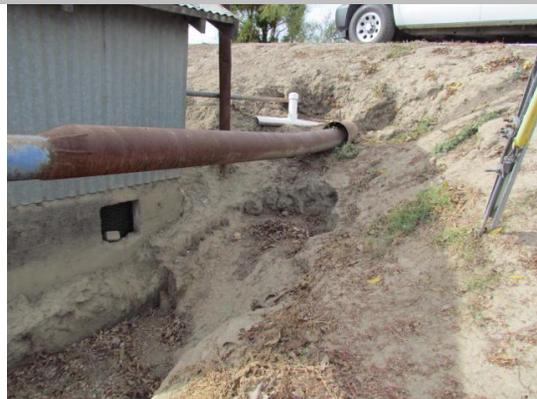
Photo 1 of 2 : FA_2019_RD0563_210_71_20190826_00029.jpg

LM Start	1.95	Rating **	M	Issue No.	71
LM End	1.95	Issue Type +	Ma	Location *	LS
Category	Earthen Levee		GPS Latitude/Longitude		
			Start	End	
Item	Erosion / Bank Caving		38.221826°	38.221826°	
			-121.543467°	-121.543467°	
DWR ID	DWR_RD0563_01_f_2012_71				
Comment Code					
E1 : Note and monitor erosion site.					
Inspector Comment					
There is erosion around the irrigation pump house and pipe on the landside slope.

Looking west at erosion at landside toe and slope next to pump house.

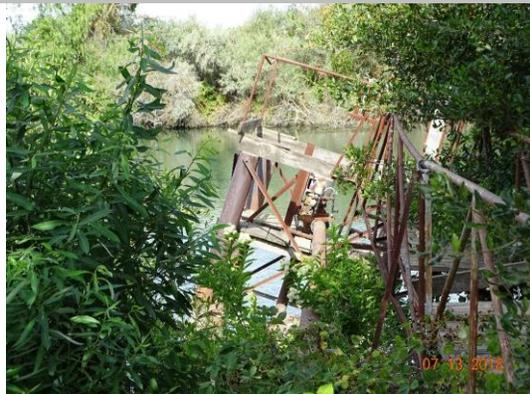
Photo 2 of 3 : UCIP_FA_2019_52751_77735.jpg

Comment Code					
Inspector Comment					
DS_ID:20136 FS_ID:52751 EP_NO: 11204 Repair Type: Non-Urgent Crossing Status: Found UCIP Comments: 07/13/2018 No change from previous inspection. Damaged walkway and tilted pump platform on WS. (O. Yakimov-DWR UCIP)12/02/2016 same as last inspection. Crossing has been downgraded from "Urgent" to "Non-Urgent" no signs of leaks were visible from the surface. Owner will need to coordinate with the CVFPB to comply with Title 23 regarding the sleeved pipe and the non-annular space between the larger and smaller pipe. (O. Magana - DWR UCIP)06/11/2013 Annular space not grouted between 8-inch and 10-inch pipe and the metal walkway is structurally failing. (W. Wylie - DWR UCIP) FIELD_STRUCT_DESC: 8-inch steel irrigation pipe sleeved through a 10-inch pipe (12-inch referenced in permit recordation) through the levee, 4 feet below the crown. 1.5-inch electrical conduit of an unknown material through the levee at the same location, at an unknown depth. Pump on pile structure on the waterside (WS). Timber walkway to pump on the WS. Service pole on the landside (LS) slope. Siphon breaker on the WS slope (12-inch pipe owner name change issued under Permit No. 11204-1, 2015 - Jim Morris. 12-inch pipe [HLM 1.99] authorized under Automatic Board Order (ABO) issued as Permit No. 11204, 1975 - Jim Morris). [Additional Reference(s): DWR Levee Log, 2005. USACE Sacramento O&M Manual 103, June 1954, (Station ""L"" 119+16), listed as a 16-inch pipe]. FS Date: 7/13/2018 8:21:03 AM

Tilted pump platform on WS.

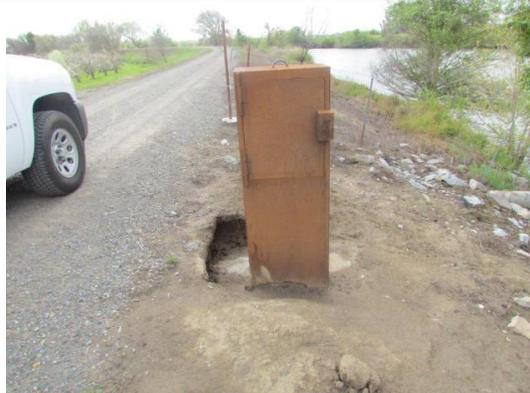
Photo 1 of 1 : FA_2019_RD0563_210_15_20190826_00009.jpg

LM Start	2.18	Rating **	M	Issue No.	15
LM End	2.18	Issue Type +	En	Location *	WS
Category	Earthen Levee			GPS Latitude/Longitude	
				Start	End
Item	Encroachments			38.218575°	38.218575°
				-121.542668°	-121.542668°
DWR ID	DWR_RD0563_01_s_2012_15				
Comment Code					
EQ : Equipment					
Inspector Comment					
Landowner installed a metal box around siphon breaker.

Looking south at siphon box installed on waterside shoulder.

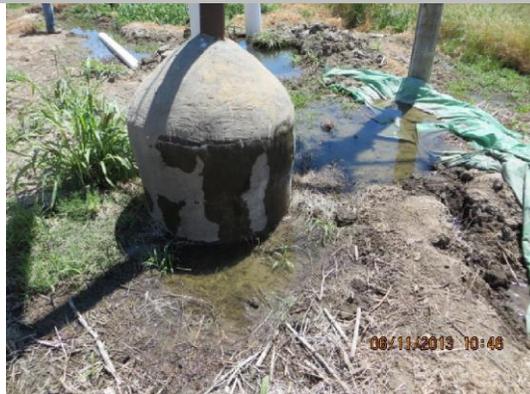
Photo 3 of 3 : UCIP_FA_2019_52732_24539.jpg

Comment Code					
Inspector Comment					
<p>DS_ID:20176 FS_ID:52732 EP_NO: 13311 Repair Type: Urgent Crossing Status: Found UCIP Comments: 07/13/2018 Leak seems to be fixed by the owner by installing steel clamps at pipe join above the standpipe, although could not verify if leak stopped. Site is still vegetated. Crossing remains "Urgent" due to unknown condition of the pipe section through the levee. (O.Yakimov-DWR UCIP)12/02/2016 Dense vegetation around concrete standpipe located on LS toe assume issue recorded back in 2013 is still present due to the dense vegetation around structure. Need to contact owner. Owner will need to coordinate with the CVFPB to address the leaky concrete standpipe and the new metal case installed on WS slope (section of levee still opened). (O. Magana - DWR UCIP)06/11/2013 Concrete standpipe on LS toe is not functioning properly. Leaks springing up in the ground around the standpipe. This may erode the soil at base of levee. (W. Wylie - DWR UCIP) FIELD_STRUCT_DESC: 12-inch steel irrigation pipe through levee, 3 feet below the crown. Slant pump is located on the waterside (WS) toe. 36-inch concrete standpipe and pipe works visible on the landside (LS) toe. Siphon breaker in 24-inch corrugated metal pipe (CMP) riser located on the LS shoulder. Pipe replaced 12-inch pipe from O&M manual/Permit No. 11207. (Permit No. 13311, 1982). (12-inch replaced under Permit No. 13311, 1981 - P. L. Lykins Ranch; 12-inch pipe authorized under Automatic Board Order (ABO) issued as Permit No. 11207, 1975 - Fong) FS Date: 7/13/2018</p>

Leaks around standpipe on LS toe.

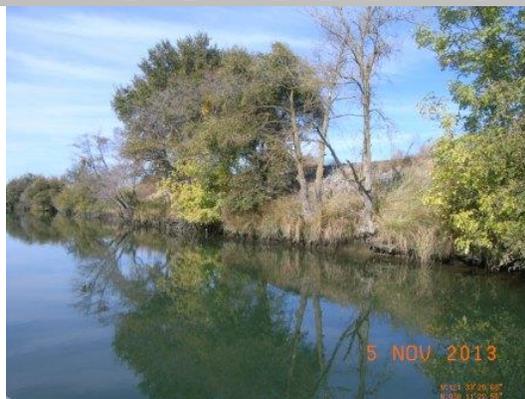
Photo 1 of 1 : FA_2019_RD0563_210_107_20190826_00073.jpg

Comment Code					
Inspector Comment					
2017 Site ID: GEO 9.3 L Status: Critical 2017 Field Notes: Upgraded to critical. Pockets of erosion - subvertical. Areas of failed revetment, old rock is unraveling, and eminent tree popout outs expected. Site History: 1997 - Loss of rock at toe; pockets of upper berm erosion; very narrow berm width; toe rock problem; erosion pockets in rock. 2002 - New brush boxes at toe of the worst spots. 2005 - Upstream 200 ft removed because of the wide berm. 2006 - Some rock repair pockets behind the brush boxes at the upstream end. 2010 - Some new erosion. 2013 - New rock placed on the levee slope. 2016 - Fresh erosion along the toe.

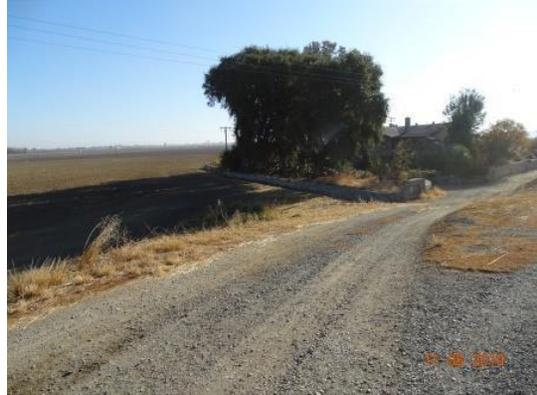
Photo 1 of 1 : FA_2019_RD0563_210_80_20191108_00226.jpg

LM Start	2.57	Rating **	M	Issue No.	80
LM End	2.57	Issue Type +	En	Location *	LS
Category	Earthen Levee		GPS Latitude/Longitude		
			Start	End	
Item	Encroachments		38.214707°	38.214707°	
			-121.538061°	-121.538061°	
DWR ID	DWR_RD0563_01_f_2012_80				
Comment Code					
RA : Ramp					
Inspector Comment					
Landowner installed unauthorized ramp on landside slope. This ramp is not part of permit # 9146.

View looking downstream at unauthorized ramp on the landside slope (Fall 2019).

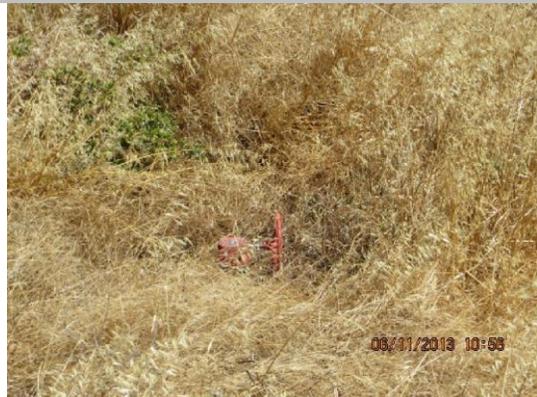
Photo 1 of 3 : UCIP_FA_2019_52753_24545.jpg

Comment Code					
Inspector Comment					
DS_ID:20138 FS_ID:52753 EP_NO: 9146 Repair Type: Non-Urgent Crossing Status: Found UCIP Comments: 07/13/2018 LS levee slope was disturbed to install a closure device and never backfilled. Debris of broken concrete and PVC pipe on LS slope. (O.Yakimov-DWR UCIP) FIELD_STRUCT_DESC: 12-inch steel irrigation pipe through the levee, 1.5 feet below the crown. Slant pump in stream. Gate valve on waterside (WS) slope. Service pole on landside (LS) shoulder. Reinforced concrete standpipe LS of the toe. (Automatic Board Order (ABO) issued as Permit No. 9146, 1973 - Pooie Ying Fong). 1-inch steel electrical conduit at the same location, at an unknown depth. [Additional Reference(s): DWR Levee Log, 2005. USACE Sacramento O&M Manual 103, June 1954, (Station ""L2"" 82+25)]. FS Date: 7/13/2018 9:33:05 AM

Butterfly valve on LS toe.

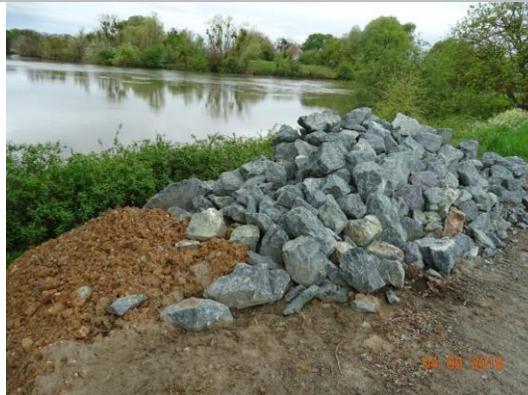
Photo 1 of 1 : FA_2019_RD0563_210_154_20190826_00104.jpg

LM Start	2.80	Rating **	A/W	Issue No.	154
LM End	2.80	Issue Type +	En	Location *	WS
Category	Earthen Levee			GPS Latitude/Longitude	
				Start	End
Item	Encroachments			38.212073°	38.212073°
				-121.535610°	-121.535610°
DWR ID	DWR_RD0563_01_s_2019_154				
Comment Code					
MA : Material					
Inspector Comment					
Rock placed by LMA to deal with beaver hole on waterside berm

View of rock placed by LMA on waterside shoulder (Spring 2019).

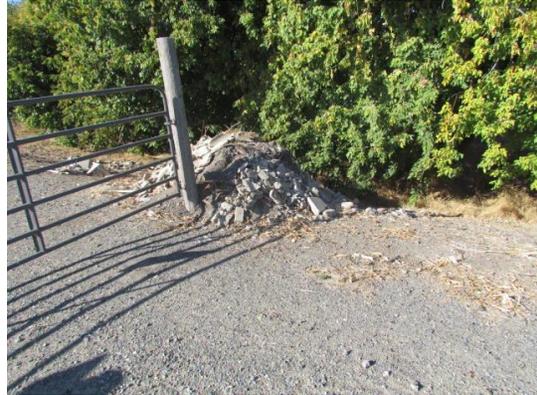
Photo 1 of 2 : FA_2019_RD0563_210_104_20190826_00068.jpg

LM Start	2.89	Rating **	A/W	Issue No.	104
LM End	2.89	Issue Type +	En	Location *	LS
Category	Earthen Levee			GPS Latitude/Longitude	
				Start	End
Item	Encroachments			38.210966°	38.210966°
				-121.534813°	-121.534813°
DWR ID	DWR_RD0563_01_f_2013_104				
Comment Code					
MA : Material					
Inspector Comment					
Landowner stockpiled concrete rubble on landward and waterward slope to stop trespassers

Looking west at concrete rubble on waterward shoulder and slope.

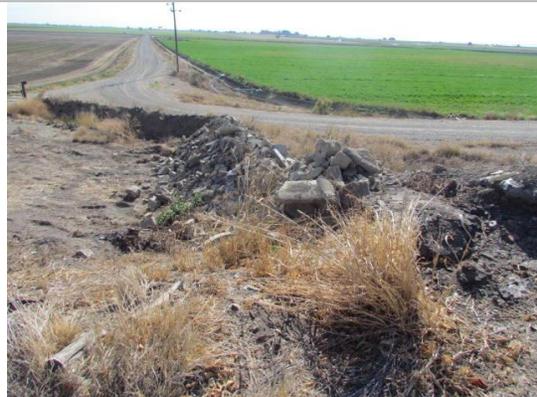
Photo 2 of 2 : FA_2019_RD0563_210_104_20190826_00069.jpg

Looking east at concrete rubble on landward slope.

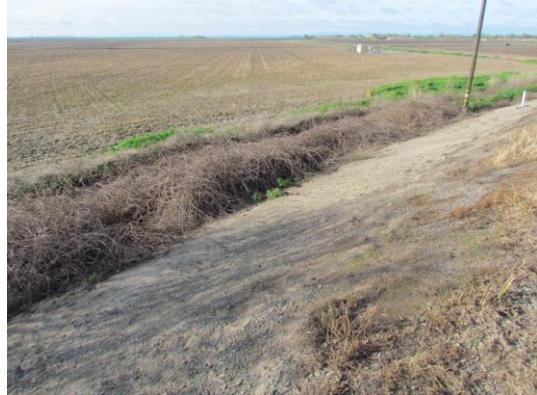
Photo 1 of 2 : FA_2019_RD0563_210_67_20190826_00024.jpg

LM Start	2.93	Rating **	M	Issue No.	67
LM End	2.95	Issue Type +	Ma	Location *	LS
Category	Earthen Levee		GPS Latitude/Longitude		
			Start	End	
Item	Vegetation		38.210472°	38.210358°	
			-121.535175°	-121.535478°	
DWR ID	DWR_RD0563_01_s_2012_67				
Comment Code					
V2 : Remove the wild growth other than native grasses from the levee slopes.					
Inspector Comment					
Dead vines (berry or wildroses) on the landside toe.

Looking east at dead berryvines at landward toe. (Spring 2017)

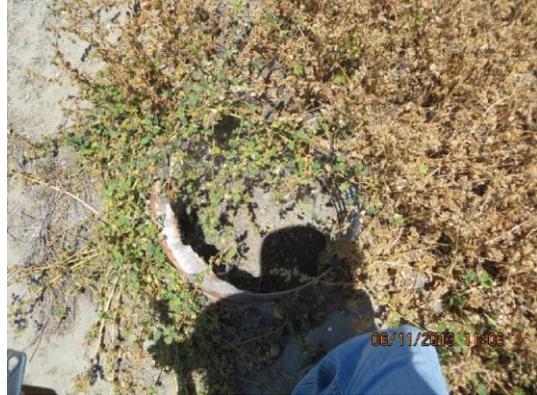
Photo 1 of 3 : UCIP_FA_2019_52754_24548.jpg

Comment Code					
Inspector Comment					
DS_ID:20139 FS_ID:52754 EP_NO: N/A Repair Type: Non-Urgent Crossing Status: Found UCIP Comments: 07/13/2018 Unable to locate siphon breaker and CMP riser on LS due to heavy vegetation. (O.Yakimov-DWR UCIP)06/11/2013 Abandoned and should be done so properly. Need to verify disposition of pipe. FIELD_STRUCT_DESC: *ABANDONED* 6-inch steel pipe of an unknown purpose through the levee, 4 feet below the crown. Siphon breaker in a 24-inch corrugated metal pipe (CMP) riser on the landside (LS) shoulder. Open on both ends. [Additional Reference(s): DWR Levee Log, 2005. USACE Sacramento O&M Manual 103, June 1954, (Station ""L2"" 62+79) 1-inch air valve, brass cock and cover]. FS Date: 7/13/2018 9:42:58 AM

24-inch CMP standpipe on LS slope.

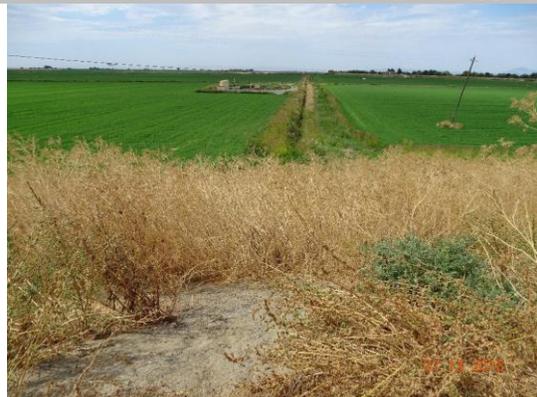
Photo 2 of 3 : UCIP_FA_2019_52754_77743.jpg

Vegetation on LS.

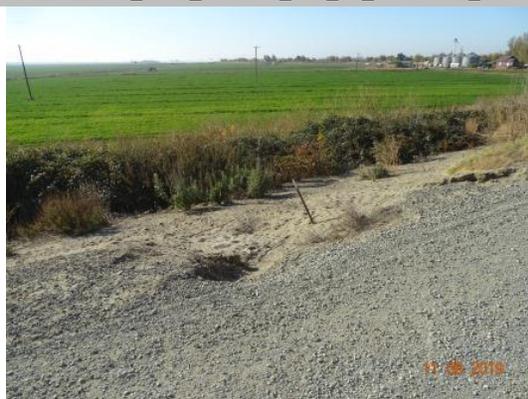
Photo 1 of 3 : FA_2019_RD0563_210_78_20191108_00228.jpg

LM Start	3.06	Rating **	U	Issue No.	78
LM End	3.06	Issue Type +	Ma	Location *	LS
Category	Earthen Levee			GPS Latitude/Longitude	
				Start	End
Item	Slope Stability			38.210240°	38.210240°
				-121.537517°	-121.537517°
DWR ID	DWR_RD0563_01_s_2012_78				
Comment Code					
S1 : Repair slope instability.					
Inspector Comment					
Slope damage on landside shoulder and slope has been in place for several inspection cycles. Proper drainage should be provided to prevent further erosion, and erosion should be repaired.

View looking downslope at erosion in the landside slope (Fall 2019).

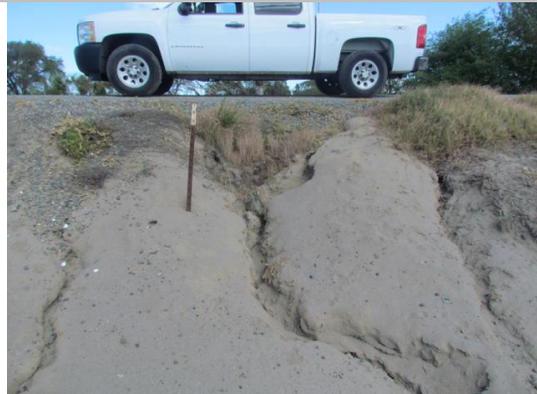
Photo 3 of 3 : FA_2019_RD0563_210_78_20190826_00043.jpg

Looking west at rain runoff erosion on landward slope. (Spring 2016)

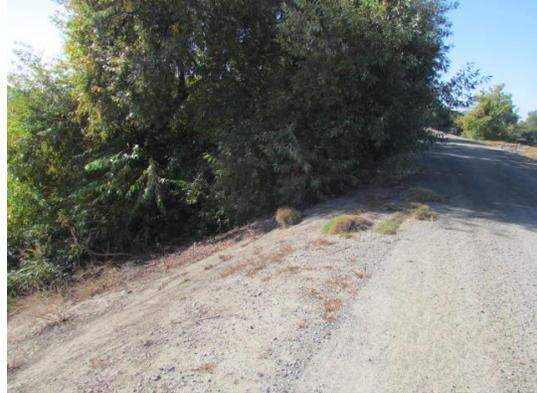
Photo 1 of 2 : FA_2019_RD0563_210_68_20190826_00026.jpg

LM Start	3.21	Rating **	M	Issue No.	68
LM End	3.21	Issue Type +	Ma	Location *	LS
Category	Earthen Levee		GPS Latitude/Longitude		
			Start	End	
Item	Trim / Thin Trees		38.209217°	38.209217°	
			-121.539823°	-121.539823°	
DWR ID	DWR_RD0563_01_s_2012_68				
Comment Code					
T2 : Thin trees to allow visibility of the ground and room to flood fight.					
Inspector Comment

Looking south at dense trees on landward slope.

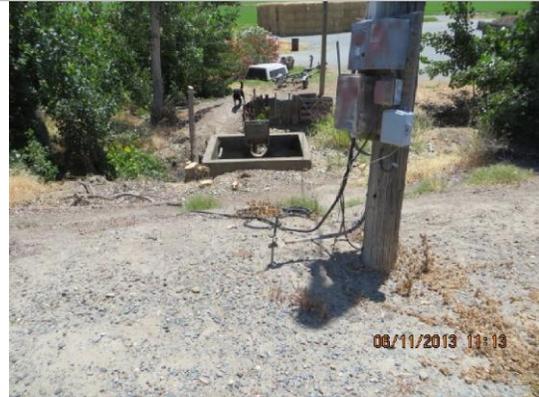
Photo 1 of 3 : UCIP_FA_2019_52755_24550.jpg

Comment Code					
Inspector Comment					
DS_ID:20140 FS_ID:52755 EP_NO: 12708 Repair Type: Non-Urgent Crossing Status: Found UCIP Comments: 07/13/2018 Pump is running, leak detected on intake pipe hanging down the pumping platform toward the slough. (O.Yakimov-DWR UCIP)06/11/2013 Pipe heavily corroded. Good candidate for viewo inspection. FIELD_STRUCT_DESC: 1 of 2: 14-inch coated steel irrigation pipe through the levee, 3 feet below the crown. Slant pump and gate valve on the waterside (WS). 9-foot by 7-foot reinforced concrete distribution box on the landside (LS) toe. Service pole on the LS shoulder. (Permit No. 12708, 1979 - George C. Wilson, replaced 8-inch pipe under Permit No. 11211, 1975 - Erma E. Locke). [Additional Reference(s): DWR Levee Log, 2005. USACE Sacramento O&M Manual 103, June 1954]. FS Date: 7/13/2018 10:26:03 AM

Distribution box and JP on LS.

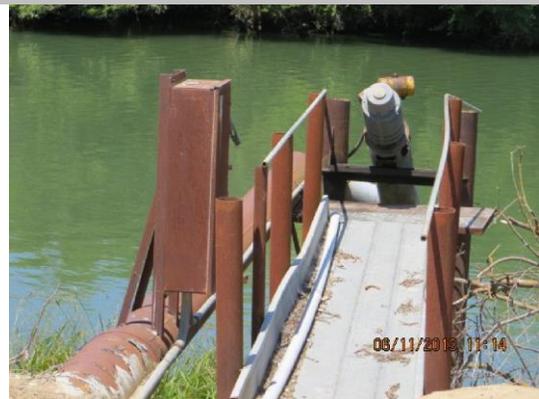
Photo 2 of 3 : UCIP_FA_2019_52755_24549.jpg

Pump and walkway on WS.

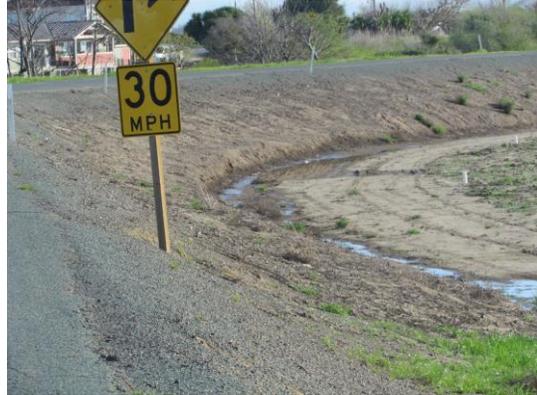
Photo 2 of 4 : FA_2019_RD0563_210_125_20190826_00085.jpg

LM Start	3.90	Rating **	M	Issue No.	125 (cont)
LM End	4.24	Issue Type +	En	Location *	LS
Category	Earthen Levee			GPS Latitude/Longitude	
				Start	End
Item	Encroachments			38.200627°	38.197060°
				-121.542282°	-121.546190°
DWR ID	DWR_RD0563_01_s_2017_125				
Comment Code					
AT : Agricultural tilling					
Inspector Comment					
There is a six to twelve inch cut along the landside toe.

Looking west at cut along farm's service road at landward toe and berm.

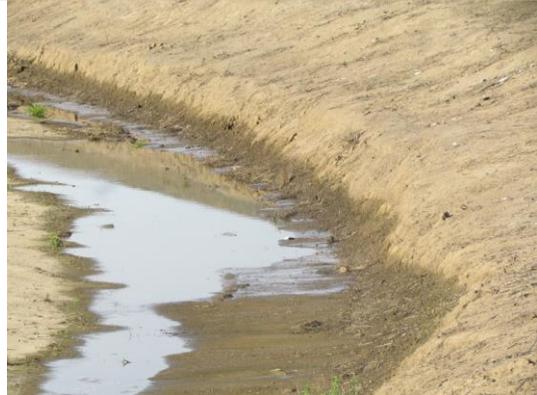
Photo 3 of 4 : FA_2019_RD0563_210_125_20190826_00086.jpg

Looking south at cut along farm's service road at landward toe.
