**Flood Control Project Maintenance
Levee Inspections**

Fall 2019 Levee Maintenance Deficiency Summary Report

Reclamation District No. 0563 Tyler Island

Waterway		Bank	Unit Miles
Unit No. 01 Georgiana Slough (Tyler Island)		Left	12.11
	Spring (March - May)	Summer (June - August)	(September - November) Fall Winter (December - February)
Unit Maintenance Rating (Fall Only)			U
Date of Inspection	4/5/2019 - 4/5/2019		11/8/2019 - 11/8/2019
DWR Inspector	David Julian		David Julian
Accompanied By	Steve Mello RD 563		Steve Mello RD 563

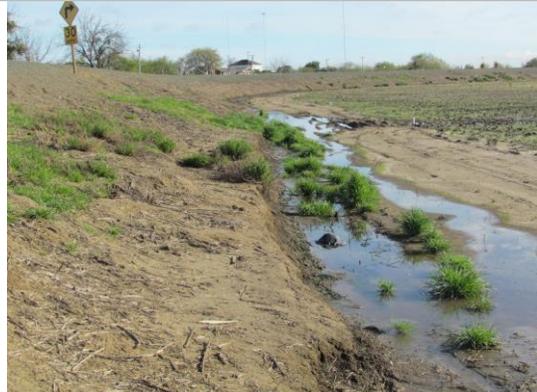
Photo 4 of 4 : FA_2019_RD0563_210_125_20190826_00087.jpg

Looking northwest at cut along farm's service road at landward toe.

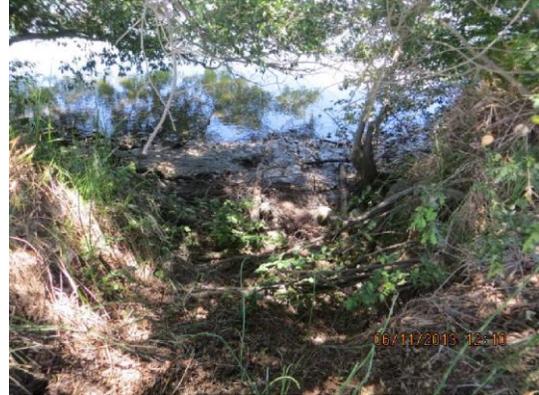
Photo 3 of 3 : UCIP_FA_2019_52758_27388.jpg

Comment Code					
Inspector Comment					
DS_ID:23971 FS_ID:52758 EP_NO: N/A Repair Type: Non-Urgent Crossing Status: Found UCIP Comments: 07/13/2018 Cut-off abandoned, and silted pipe is visible at WS toe. Need a confirmation that pipe through levee was removed. (O.Yakimov-DWR UCIP)06/11/2013 Need to determine disposition of pipe. Likely that this pipe was removed from levee section as evidenced by the cut in pavement on crown. (W.Wylie) FIELD_STRUCT_DESC: 4.5-inch gas line of an unknown material through the levee, at an unknown depth. Cut in pavement and pipe visible on the waterside (WS) toe. (Permit No. 15539 - Pacific Gas and Electric Company [PG&E] [date not indicated in permit]). FS Date: 7/13/2018

Pipe visible on WS toe.

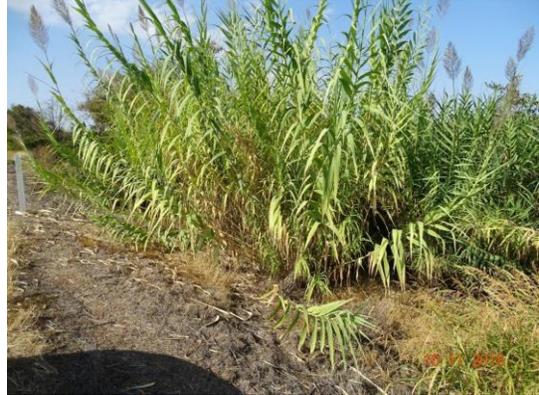
Photo 1 of 1 : FA_2019_RD0563_210_146_20190826_00096.jpg

LM Start	4.52	Rating **	M	Issue No.	146
LM End	4.52	Issue Type +	Ma	Location *	WS
Category	Earthen Levee		GPS Latitude/Longitude		
			Start	End	
Item	Vegetation		38.194090°	38.194090°	
			-121.549568°	-121.549568°	
DWR ID	DWR_RD0563_01_f_2018_146				
Comment Code					
V2 : Remove the wild growth other than native grasses from the levee slopes.					
Inspector Comment					
Remove arundo.

View of arundo on waterside slope (October 2018).

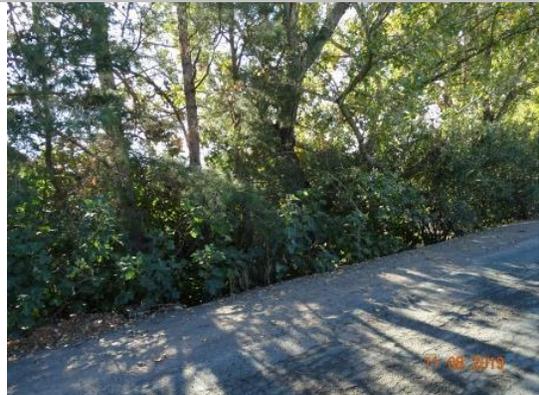
Photo 1 of 1 : FA_2019_RD0563_210_88_20191108_00229.jpg

LM Start	4.63	Rating **	M	Issue No.	88
LM End	4.64	Issue Type +	En	Location *	LS
Category	Earthen Levee		GPS Latitude/Longitude		
			Start	End	
Item	Vegetation		38.193078°	38.192980°	
			-121.551047°	-121.551263°	
DWR ID	DWR_RD0563_01_s_2012_88				
Comment Code					
V6 : Landscaping					
Inspector Comment					
Fig tree and pine trees block view of landside slope.

View of landscaping on the landside slope (Fall 2019).

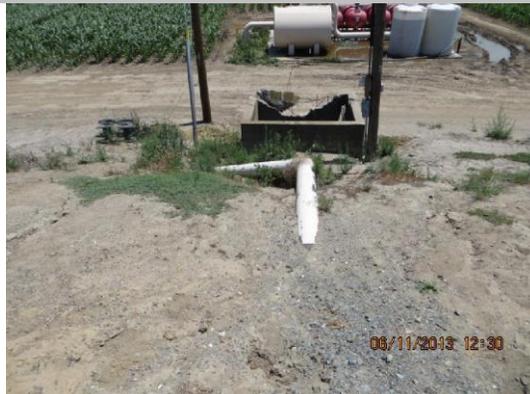
Photo 1 of 3 : UCIP_FA_2019_52761_24590.jpg

Comment Code					
Inspector Comment					
DS_ID:20145 FS_ID:52761 EP_NO: 11205 Repair Type: Non-Urgent Crossing Status: Found UCIP Comments: 07/13/2018 Water pump is running, no leak detected. (O.Yakimov-DWR UCIP)06/11/2013 Some settlement over pipe on WS shoulder and there is some animal burrow tunnels over the pipe on the LS shoulder. (W.Wylie) FIELD_STRUCT_DESC: 10-inch steel irrigation pipe through the levee, 3.8 feet below the crown. Siphon breaker on the landside (LS) shoulder. Slant pump off the waterside (WS) toe. Booster and filter station off the LS toe. Abandoned concrete distribution box at the LS toe. 1-inch galvanized iron electrical conduit through the levee at the same location, at an unknown depth. (Automatic Board Order (ABO) issued as Permit No. 11205, 1975 - Joshua Eppinger Jr.). [Additional Reference(s): DWR Levee Log, 2005. USACE Sacramento O&M Manual 103, June 1954, (Station ""L"" 390+74.5)]. FS Date: 7/13/2018

Pipe, distribution box, JP, electrical conduit, and booster/filter system on LS.

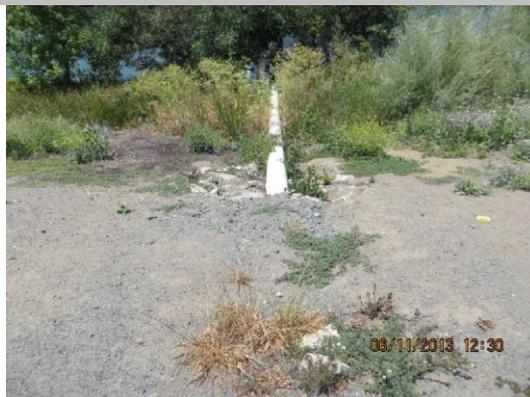
Photo 2 of 3 : UCIP_FA_2019_52761_24589.jpg

Pipe on WS slope.

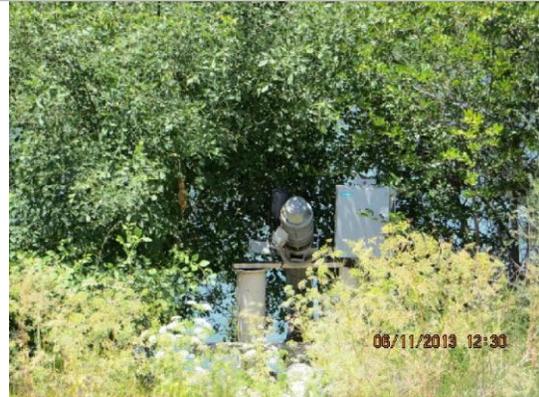
Photo 3 of 3 : UCIP_FA_2019_52761_24588.jpg

Comment Code					
Inspector Comment					
DS_ID:20145 FS_ID:52761 EP_NO: 11205 Repair Type: Non-Urgent Crossing Status: Found UCIP Comments: 07/13/2018 Water pump is running, no leak detected. (O.Yakimov-DWR UCIP)06/11/2013 Some settlement over pipe on WS shoulder and there is some animal burrow tunnels over the pipe on the LS shoulder. (W.Wylie) FIELD_STRUCT_DESC: 10-inch steel irrigation pipe through the levee, 3.8 feet below the crown. Siphon breaker on the landside (LS) shoulder. Slant pump off the waterside (WS) toe. Booster and filter station off the LS toe. Abandoned concrete distribution box at the LS toe. 1-inch galvanized iron electrical conduit through the levee at the same location, at an unknown depth. (Automatic Board Order (ABO) issued as Permit No. 11205, 1975 - Joshua Eppinger Jr.). [Additional Reference(s): DWR Levee Log, 2005. USACE Sacramento O&M Manual 103, June 1954, (Station ""L"" 390+74.5)]. FS Date: 7/13/2018

Slant pump off WS toe.

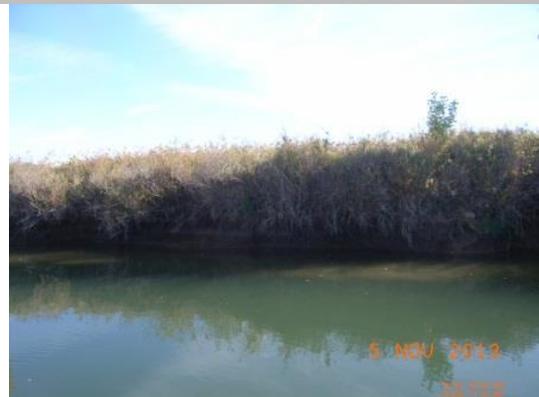
Photo 1 of 1 : FA_2019_RD0563_210_92_20190826_00060.jpg

LM Start	4.98	Rating **	M	Issue No.	92
LM End	5.04	Issue Type +	Ma	Location *	WS
Category	Supplemental			GPS Latitude/Longitude	
				Start	End
Item	2017 USACE Erosion Survey			38.190073 °	38.189524 °
				-121.556307 °	-121.557227 °
DWR ID	DWR_RD0563_01_f_2018_92				
Comment Code					
Inspector Comment					
2017 Site ID: GEO 7.2 L Status: Eroding 2017 Field Notes: New erosion at toe. Site History: 2009 - Small scallops of erosion into the levee toe behind brush boxes. 2011 - Minor new erosion. 2012 - Site extended upstream to account for addition erosion pockets. 2016 - Fresh erosion observed.

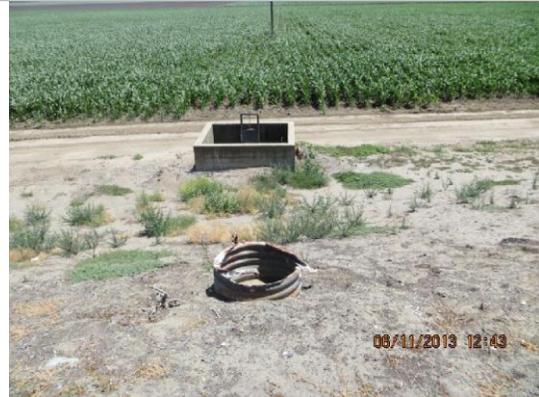
Photo 1 of 3 : UCIP_FA_2019_52763_24595.jpg

Comment Code					
Inspector Comment					
DS_ID:20146 FS_ID:52763 EP_NO: 11205 Repair Type: Non-Urgent Crossing Status: Found UCIP Comments: 06/11/2013 Need to verify wether or not pipe has been abandoned. (W.Wylie) FIELD_STRUCT_DESC: 8-inch steel irrigation pipe through the levee, 3.7 feet below the crown. Pump and gate valve on the waterside (WS) end. Siphon breaker on the landside (LS) shoulder. (Automatic Board Order (ABO) issued as Permit No. 11205, 1975 - Joshua Eppinger Jr.). [Additional Reference(s): DWR Levee Log, 2005. USACE Sacramento O&M Manual 103, June 1954, (Station ""L"" 368+38) 1-inch air valve, brass cock and cover, reinforced concrete spillbox]. FS Date: 7/13/2018

Distribution box and 24-inch CMP riser on LS slope.

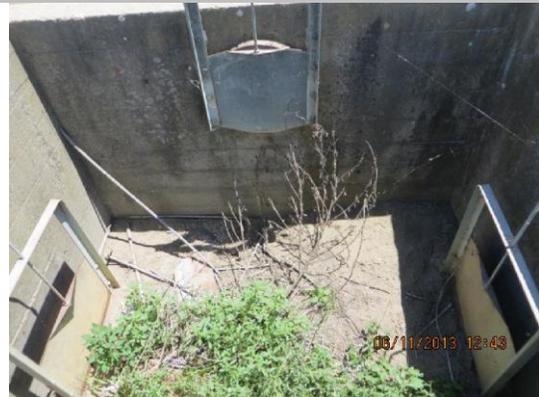
Photo 2 of 3 : UCIP_FA_2019_52763_24594.jpg

Inside distribution box at LS toe.

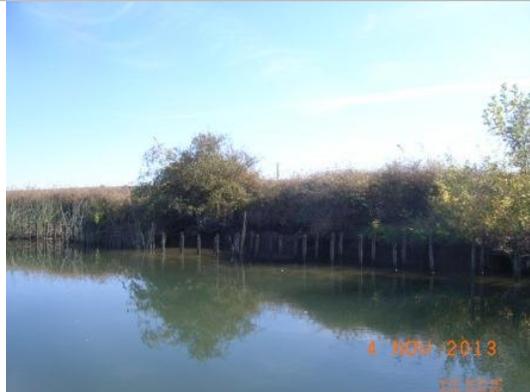
Photo 1 of 1 : FA_2019_RD0563_210_91_20190826_00059.jpg

Comment Code					
Inspector Comment					
2017 Site ID: GEO 6.3 L Status: Critical 2017 Field Notes: Upgraded to CRITICAL. Combined with 6.8. Vertical sections from mid slope to toe, vertical face from levee hinge at some locations. Wave/tide erosion at toe, evidence of beavers. Site History: 1997 - Deep pockets of erosion and narrow berm. Reach is characterized by lots of pockets into the existing berm and/or levee slope. 1999 - Some pockets filled with rock riprap. 2000 - Exposed fabric. 2001 - Staked, low fascine walls at bankline. 2002 - New spot of rock at upstream end. Some new brush boxes. 2005 - Some stone sliding off the underlying geotextile fabric. Some new brush bundles in the brush boxes; some with missing bundles. Some boxes too low relative to high tide. 2009 - Minimal new erosion, site length extended. 2010 - New erosion on downstream end, site extended downstream. 2011 - Sites 6.1, 6.4 and 6.6 were combined. New erosion pockets, site extended to include the erosion in between the old sites. 2012 - Rock has been placed in portions of the bank since last year. 2016 - Site 5.8 was merged with this site due to new erosion connecting the sites.

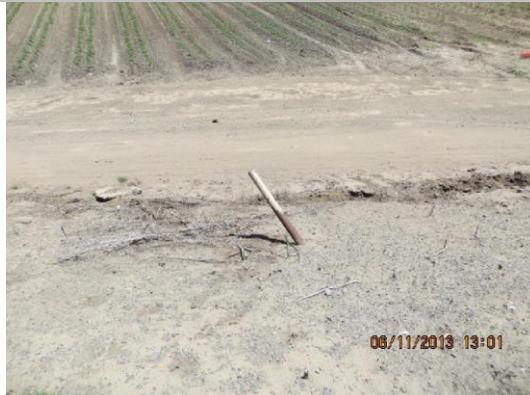
Photo 1 of 2 : UCIP_FA_2019_16289_27439.jpg

LM Start	5.87	Rating **	M	Issue No.	788
LM End	5.87	Issue Type +	En	Location *	
Category	Supplemental			GPS Latitude/Longitude	
				Start	End
Item	DRAFT DWR UCIP Field Study			38.182398°	38.182398°
				-121.569078°	-121.569078°
DWR ID	20148				
Comment Code					
Inspector Comment					
DS_ID:20148 FS_ID:16289 EP_NO: 1826 Repair Type: Non-Urgent Crossing Status: Found UCIP Comments: Pipe abandoned and should be done so properly. FIELD_STRUCT_DESC: *ABANDONED* 2-inch discharge pipe of an unknown material through the levee, 2.7 feet below the crown. (Permit No. 1826, 1953 - Brazos Oil and Gas Company). [Additional Reference(s): DWR Levee Log, 2005]. FS Date: 6/11/2013

Pipe visible on LS slope.

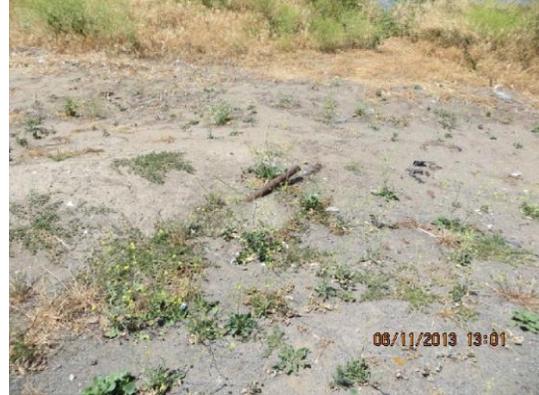
Photo 2 of 2 : UCIP_FA_2019_16289_27438.jpg

LM Start	5.87	Rating **	M	Issue No.	788 (cont)
LM End	5.87	Issue Type +	En	Location *	
Category	Supplemental			GPS Latitude/Longitude	
				Start	End
Item	DRAFT DWR UCIP Field Study			38.182398°	38.182398°
				-121.569078°	-121.569078°
DWR ID	20148				
Comment Code					
Inspector Comment					
DS_ID:20148 FS_ID:16289 EP_NO: 1826 Repair Type: Non-Urgent Crossing Status: Found UCIP Comments: Pipe abandoned and should be done so properly. FIELD_STRUCT_DESC: *ABANDONED* 2-inch discharge pipe of an unknown material through the levee, 2.7 feet below the crown. (Permit No. 1826, 1953 - Brazos Oil and Gas Company). [Additional Reference(s): DWR Levee Log, 2005]. FS Date: 6/11/2013

Pipe visible on WS shoulder.

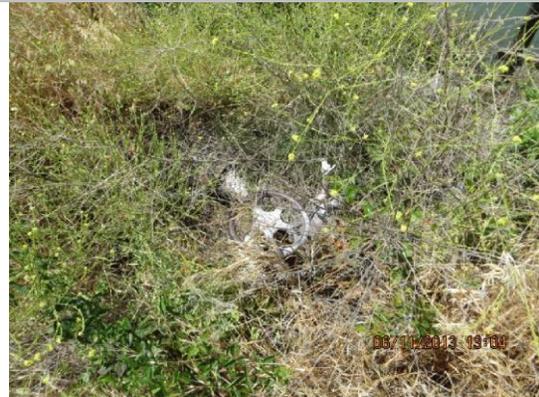
Photo 1 of 3 : UCIP_FA_2019_14949_24603.jpg

Comment Code					
Inspector Comment					
DS_ID:20175 FS_ID:14949 EP_NO: 11206 Repair Type: Non-Urgent Crossing Status: Found UCIP Comments: Pipe appears abandoned and should be done so properly. FIELD_STRUCT_DESC: 1 of 2: 8-inch steel irrigation pipe through the levee, 3.7 feet below the crown. Pump and gate valve on the waterside (WS). Siphon breaker on the landside (LS) shoulder. 7-foot by 9-foot concrete distribution box at the LS toe. (Automatic Board Order (ABO) issued as Permit No. 11206, 1975 - Daniel Faustman). [Additional Reference(s): DWR Levee Log, 2005. USACE Sacramento O&M Manual 103, June 1954, (Station ""L"" 331+00.5)]. FS Date: 6/11/2013

Slide gate at pump on WS slope

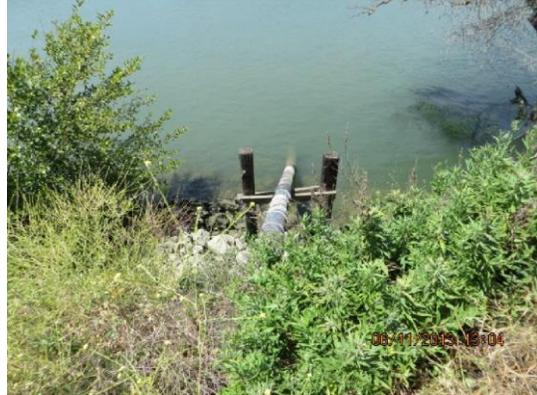
Photo 2 of 3 : UCIP_FA_2019_14949_24602.jpg

Comment Code					
Inspector Comment					
DS_ID:20175 FS_ID:14949 EP_NO: 11206 Repair Type: Non-Urgent Crossing Status: Found UCIP Comments: Pipe appears abandoned and should be done so properly. FIELD_STRUCT_DESC: 1 of 2: 8-inch steel irrigation pipe through the levee, 3.7 feet below the crown. Pump and gate valve on the waterside (WS). Siphon breaker on the landside (LS) shoulder. 7-foot by 9-foot concrete distribution box at the LS toe. (Automatic Board Order (ABO) issued as Permit No. 11206, 1975 - Daniel Faustman). [Additional Reference(s): DWR Levee Log, 2005. USACE Sacramento O&M Manual 103, June 1954, (Station ""L"" 331+00.5)]. FS Date: 6/11/2013

Pipe at WS toe.

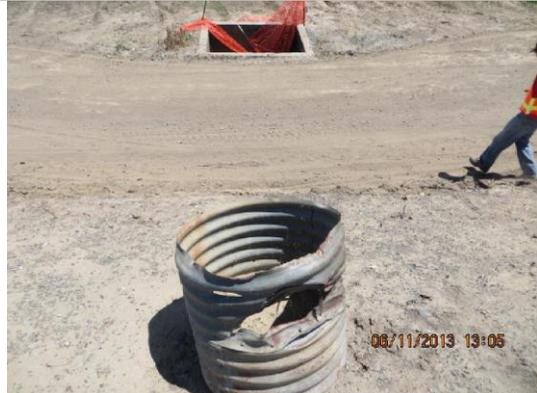
Photo 3 of 3 : UCIP_FA_2019_14949_24601.jpg

Siphon breaker in 24-inch CMP riser on LS shoulder.

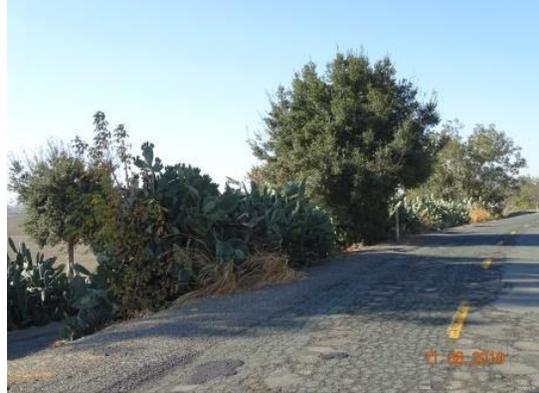
Photo 1 of 1 : FA_2019_RD0563_210_22_20191108_00230.jpg

LM Start	5.92	Rating **	U	Issue No.	22
LM End	5.96	Issue Type +	En	Location *	LS
Category	Earthen Levee		GPS Latitude/Longitude		
			Start	End	
Item	Vegetation		38.181965°	38.181763°	
			-121.569913°	-121.570447°	
DWR ID	DWR_RD0563_01_s_2012_22				
Comment Code					
V6 : Landscaping					
Inspector Comment					
Large cactus on landside slope.

View looking downstream at cactus on the landside slope (Fall 2019).

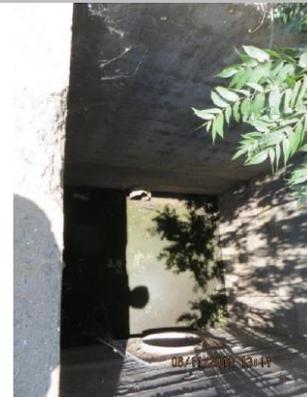
Photo 2 of 3 : UCIP_FA_2019_14950_24606.jpg

Comment Code					
Inspector Comment					
DS_ID:20149 FS_ID:14950 EP_NO: 11206 Repair Type: Non-Urgent Crossing Status: Found UCIP Comments: Need to install a CMP riser on LS shoulder to protect the vent/filler pipe. FIELD_STRUCT_DESC: 2 of 2: 10-inch steel irrigation siphon through the levee, 4.8 feet below the crown. Vent/filler pipe on the landside (LS) shoulder. 7-foot by 9-foot concrete distribution box on the LS toe. (Automatic Board Order (ABO) issued as Permit No. 11206, 1975 - Daniel Faustman). [Additional Reference(s): DWR Levee Log, 2005. USACE Sacramento O&M Manual 103, June 1954, (Station ""L"" 324+07.5) 2-inch air and primer valve, reinforced concrete spillbox]. FS Date: 6/11/2013

Outlet pipe in distribution box on LS toe.

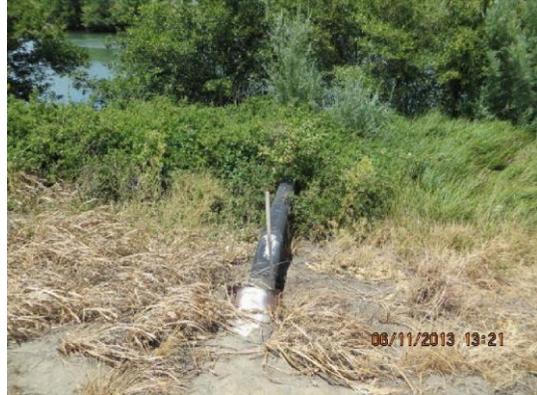
Photo 1 of 3 : UCIP_FA_2019_14963_24622.jpg

Comment Code					
Inspector Comment					
DS_ID:20150 FS_ID:14963 EP_NO: 11200 Repair Type: Non-Urgent Crossing Status: Found UCIP Comments: No permit identified for 10-inch irrigation pipe that is sleeved through the 18-inch. FIELD_STRUCT_DESC: 18-inch steel irrigation pipe through the levee, 5.2 feet below the crown. 10-inch steel irrigation siphon sleeved through the 18-inch pipe. Siphon breaker in a 24-inch corrugated metal pipe (CMP) riser on the landside (LS) shoulder. Air vent on pipe on the LS slope. Slide gate at booster/filter plant off the LS toe. (Automatic Board Order (ABO) issued as Permit No. 11200, 1975 - Cora R. and Furth Brandt). [Additional Reference(s): DWR Levee Log, 2005. USACE Sacramento O&M Manual 103, June 1954, (Station ""L"" 321+03) pipe is plugged]. FS Date: 6/11/2013

10-inch pipe sleeved through 18-inch conduit.

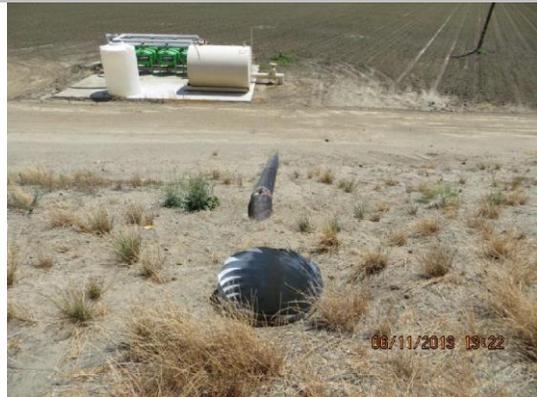
Photo 2 of 3 : UCIP_FA_2019_14963_24621.jpg

Siphon breaker in 24-inch CMP riser on LS shoulder.

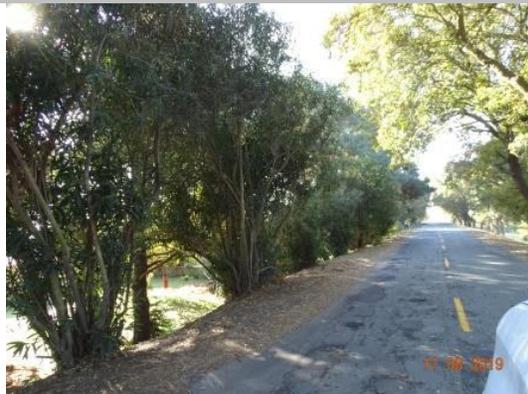
Photo 1 of 1 : FA_2019_RD0563_210_25_20191108_00231.jpg

LM Start	6.47	Rating **	M	Issue No.	25
LM End	6.56	Issue Type +	En	Location *	LS
Category	Earthen Levee		GPS Latitude/Longitude		
			Start	End	
Item	Vegetation		38.179053°	38.177873°	
			-121.578468°	-121.578920°	
DWR ID	DWR_RD0563_01_s_2012_25				
Comment Code					
V6 : Landscaping					
Inspector Comment					
Oleanders have been trimmed and thinned to allow inspection and access. They should be maintained in their current condition. Thick groundcover of ivy should be thinned or removed.

View looking downstream at landscaping on the landside slope (Fall 2019).

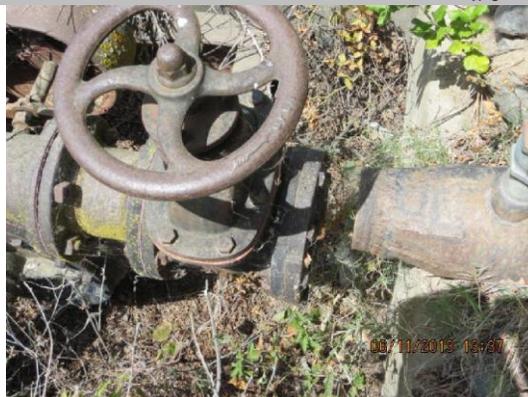
Photo 1 of 3 : UCIP_FA_2019_14966_24628.jpg

LM Start	6.57	Rating **	M	Issue No.	792
LM End	6.57	Issue Type +	En	Location *	
Category	Supplemental		GPS Latitude/Longitude		
			Start	End	
Item	DRAFT DWR UCIP Field Study		38.177779°	38.177779°	
			-121.578995°	-121.578995°	
DWR ID	20152				
Comment Code					
Inspector Comment					
DS_ID:20152 FS_ID:14966 EP_NO: 11201 Repair Type: Non-Urgent Crossing Status: Found UCIP Comments: Appears abandoned and should be done so properly. FIELD_STRUCT_DESC: 3 of 3: 8-inch steel irrigation pipe through the levee, 4.7 feet below the crown. Pump and gate valve on the waterside (WS) berm. 4-foot-diameter concrete standpipe on the landside (LS) toe. Y-ramp on the WS slope. (Automatic Board Order (ABO) issued as Permit No. 11201, 1975 - Joseph Brun). [Additional Reference(s): DWR Levee Log, 2005. USACE Sacramento O&M Manual 103, June 1954, (Station ""L"" 294+25.1)]. FS Date: 6/11/2013

No connection to pump on WS shoulder.

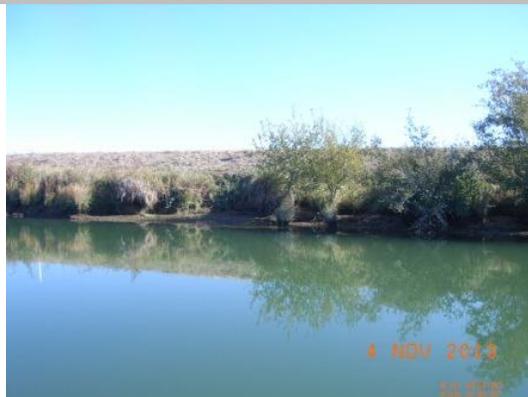
Photo 1 of 1 : FA_2019_RD0563_210_89_20190826_00055.jpg

Comment Code					
Inspector Comment					
2017 Site ID: GEO 5.3 L Status: Eroding 2017 Field Notes: Site extended upstream, increased toe erosion from boat wake/tide action, RD has placed rock on levee slope in places. Site History: 1997 - Pocket erosion into the toe of the levee. 2000 - Scallops in banks with small colored flags, biotech rolls present. 2001 - Staked, low fascine walls at bankline. 2003 - Still have visibly bad spots, especially at the upstream end. 2005 - Some new brush bundles in the brush boxes; some with missing bundles. Some boxes too low relative to high tide. 2010 - Site extended upstream. 2011 - Minor new erosion. 2016 - Fresh erosion observed.

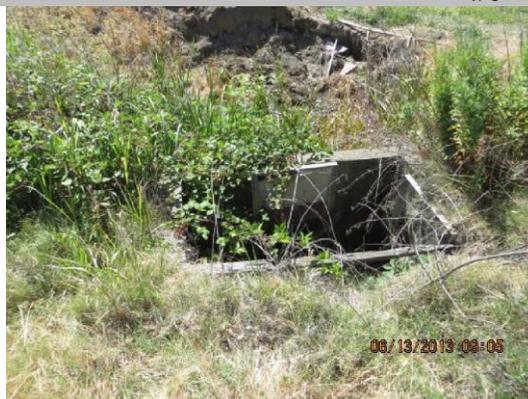
Photo 1 of 3 : UCIP_FA_2019_40790_24633.jpg

Comment Code					
Inspector Comment					
DS_ID:20153 FS_ID:40790 EP_NO: 11202 Repair Type: Non-Urgent Crossing Status: Found UCIP Comments: Pipe appears abandoned and if so should be done so properly. FIELD_STRUCT_DESC: 12-inch steel irrigation pipe through the levee, 4.5 feet below the crown. Vent/filler pipe in a 24-inch corrugated metal pipe (CMP) riser on the landside (LS) shoulder, and a 7-foot by 9-foot concrete distribution box on the LS toe. (Automatic Board Order (ABO) issued as Permit No. 11202, 1975 - Peter L. and Marian M. Campi). [Additional Reference(s): DWR Levee Log, 2005. USACE Sacramento O&M Manual 103, June 1954, (Station ""L"" 289+22.9)]. FS Date: 6/11/2013

7'X9' concrete distribution box on LS toe.

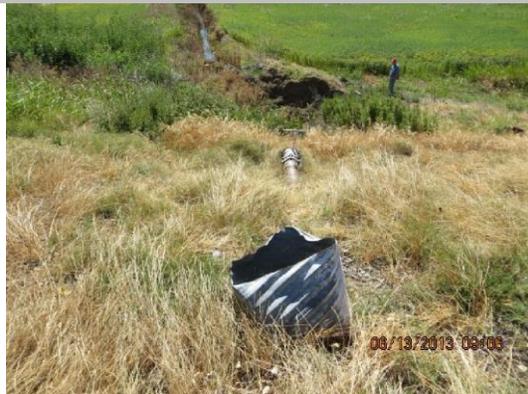
Photo 2 of 3 : UCIP_FA_2019_40790_24632.jpg

Comment Code					
Inspector Comment					
DS_ID:20153 FS_ID:40790 EP_NO: 11202 Repair Type: Non-Urgent Crossing Status: Found UCIP Comments: Pipe appears abandoned and if so should be done so properly. FIELD_STRUCT_DESC: 12-inch steel irrigation pipe through the levee, 4.5 feet below the crown. Vent/filler pipe in a 24-inch corrugated metal pipe (CMP) riser on the landside (LS) shoulder, and a 7-foot by 9-foot concrete distribution box on the LS toe. (Automatic Board Order (ABO) issued as Permit No. 11202, 1975 - Peter L. and Marian M. Campi). [Additional Reference(s): DWR Levee Log, 2005. USACE Sacramento O&M Manual 103, June 1954, (Station ""L"" 289+22.9)]. FS Date: 6/11/2013

24-inch CMP standpipe with vent/filler pipe on LS shoulder.

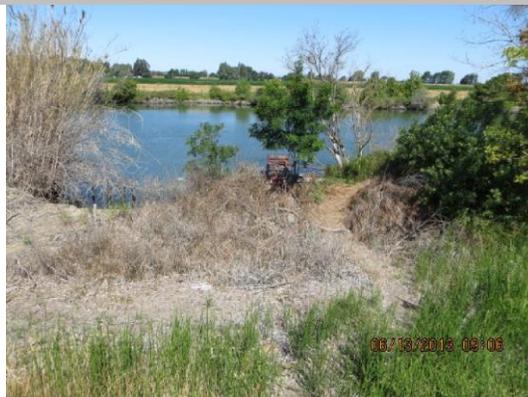
Photo 3 of 3 : UCIP_FA_2019_40790_24631.jpg

Steel walkway support for pipe on WS toe.

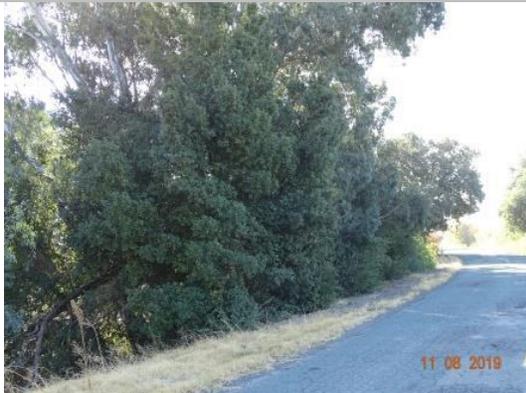
Photo 1 of 1 : FA_2019_RD0563_210_145_20191108_00232.jpg

LM Start	6.75	Rating **	U	Issue No.	145
LM End	6.79	Issue Type +	En	Location *	LS
Category	Earthen Levee			GPS Latitude/Longitude	
				Start	End
Item	Vegetation			38.175219°	38.174743°
				-121.580053°	-121.580016°
DWR ID	DWR_RD0563_01_s_2014_145				
Comment Code					
V6 : Landscaping					
Inspector Comment					
Untrimmed trees blocking view of landside toe.

View looking downstream at untrimmed trees on the landside slope (Fall 2019).

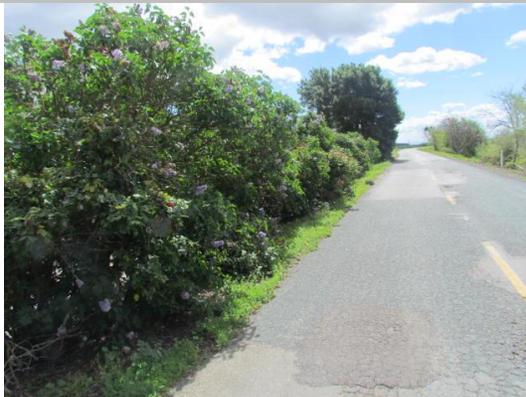
Photo 1 of 1 : FA_2019_RD0563_210_75_20190826_00036.jpg

LM Start	6.80	Rating **	U	Issue No.	75
LM End	6.83	Issue Type +	En	Location *	LS
Category	Earthen Levee			GPS Latitude/Longitude	
				Start	End
Item	Vegetation			38.174598°	38.174125°
				-121.579972°	-121.579892°
DWR ID	DWR_RD0563_01_s_2013_75				
Comment Code					
V6 : Landscaping					
Inspector Comment					
There is dense landscaping on the landside shoulder, slope, and toe.

Looking south at dense landscaping on landward shoulder and slope. (Spring 2016)

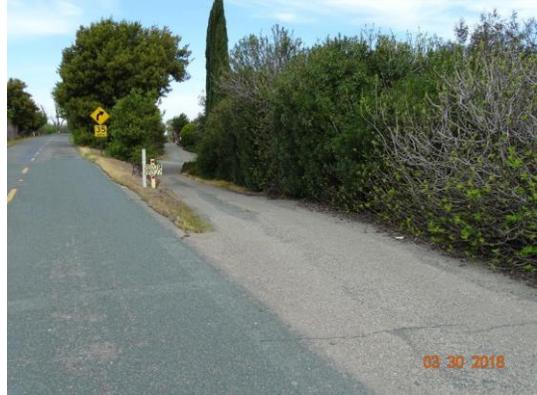
Photo 1 of 1 : FA_2019_RD0563_210_119_20190826_00079.jpg

LM Start	6.84	Rating **	U	Issue No.	119
LM End	6.87	Issue Type +	En	Location *	LS
Category	Earthen Levee			GPS Latitude/Longitude	
				Start	End
Item	Vegetation			38.173912 °	38.173523 °
				-121.579838 °	-121.579737 °
DWR ID	DWR_RD0563_01_s_2018_119				
Comment Code					
V6 : Landscaping					
Inspector Comment					
Thick landscaping prohibits inspection and access.

Thick landside landscaping preventing inspection and access.

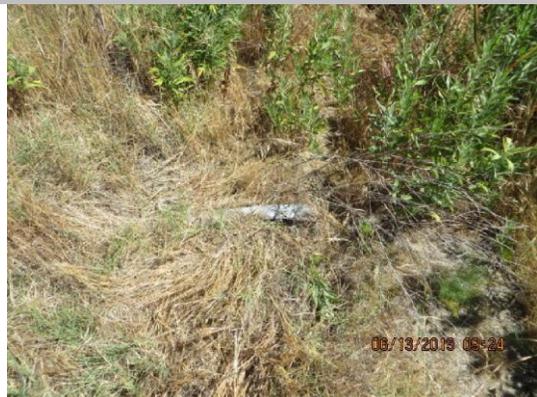
Photo 1 of 3 : UCIP_FA_2019_14968_24637.jpg

Comment Code					
Inspector Comment					
DS_ID:20154 FS_ID:14968 EP_NO: 11214 Repair Type: Non-Urgent Crossing Status: Indicator Found UCIP Comments: Verify type of abandonment. Wide berm on LS toe with some evidence of steel slide gate in soil at berm. FIELD_STRUCT_DESC: 1 of 2: 8-inch steel irrigation pipe through the levee, 3.7 feet below the crown. Siphon breaker on the waterside (WS) slope. (Automatic Board Order (ABO) issued as Permit No. 11214, 1975 - River Island Land Company). [Additional Reference(s): DWR Levee Log, 2005. USACE Sacramento O&M Manual 103, June 1954, (Station ""L"" 269+36) 1-inch air and primer valve, reinforced concrete spillbox]. FS Date: 6/13/2013

Steel parts on LS toe may indicate location of distribution box.

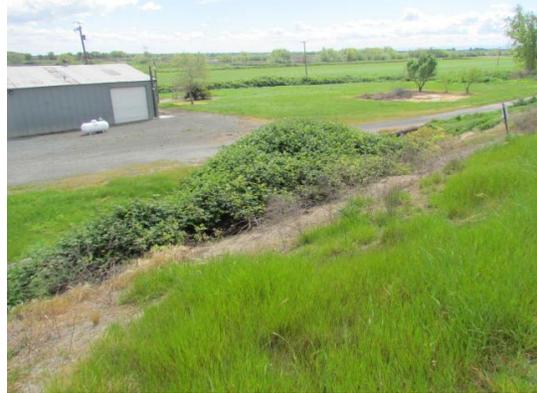
Photo 1 of 1 : FA_2019_RD0563_210_151_20190826_00102.jpg

LM Start	7.07	Rating **	U	Issue No.	151
LM End	7.07	Issue Type +	Ma	Location *	LS
Category	Earthen Levee			GPS Latitude/Longitude	
				Start	End
Item	Vegetation			38.170693°	38.170693°
				-121.579968°	-121.579968°
DWR ID	DWR_RD0563_01_f_2014_151				
Comment Code					
V2 : Remove the wild growth other than native grasses from the levee slopes.					
Inspector Comment					
Dense berry vines at landside toe.

Looking southeast at dense vegetation at landward toe.

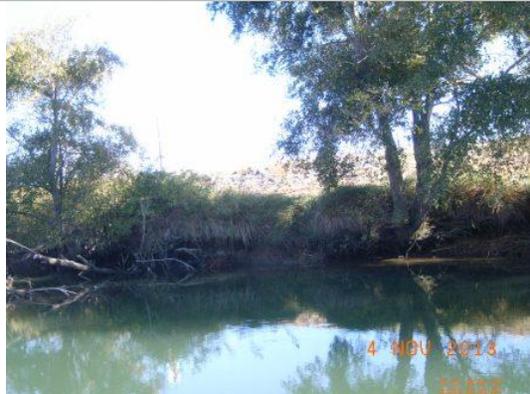
Photo 1 of 1 : FA_2019_RD0563_210_85_20190826_00052.jpg

LM Start	7.53	Rating **	U	Issue No.	85
LM End	7.80	Issue Type +	Ma	Location *	WS
Category	Supplemental			GPS Latitude/Longitude	
				Start	End
Item	2017 USACE Erosion Survey			38.164462°	38.160888°
				-121.583092°	-121.584807°
DWR ID	DWR_RD0563_01_f_2018_85				
Comment Code					
Inspector Comment					
2017 Site ID: GEO 4.5 L Status: Critical 2017 Field Notes: Numerous areas of bank erosion, with vertical sections up to the levee hinge. Site History: 1997 - Pocket erosion at upstream end and into the levee toe under the Alder trees. 2003 - New brush boxes with wattles on bank. 2004 - No brush boxes. 2005 - Site extended from the downstream side of the bridge. Whole bank is vertical. 2010 - Some minor new erosion. 2011 - Site upgraded to CRITICAL. New erosion pockets throughout the site. Sites 4.5, and 4.6 were combined. 2016 - Fresh erosion observed.

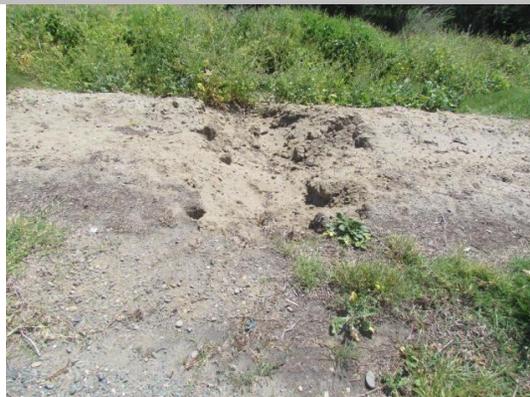
Photo 1 of 1 : FA_2019_RD0563_210_97_20190826_00064.jpg

LM Start	7.62	Rating **	A/W	Issue No.	97
LM End	7.62	Issue Type +	Ma	Location *	LS
Category	Earthen Levee			GPS Latitude/Longitude	
				Start	End
Item	Erosion / Bank Caving			38.163240°	38.163240°
				-121.583328°	-121.583328°
DWR ID	DWR_RD0563_01_s_2013_97				
Comment Code					
E1 : Note and monitor erosion site.					
Inspector Comment					
Minor erosion on landside shoulder and slope should be monitored.

Looking east at slope erosion on landward shoulder and slope.

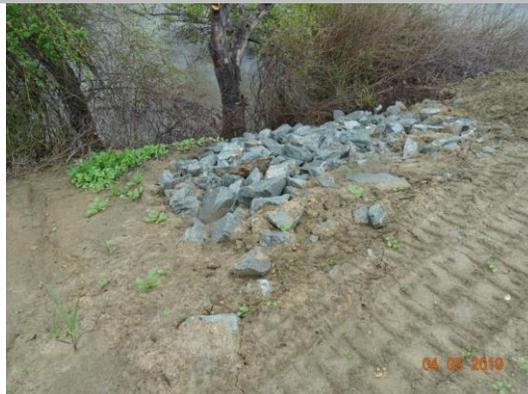
Photo 1 of 1 : FA_2019_RD0563_210_158_20190826_00106.jpg

LM Start	7.71	Rating **	A/W	Issue No.	158
LM End	7.71	Issue Type +	Ma	Location *	WS
Category	Earthen Levee		GPS Latitude/Longitude		
			Start	End	
Item	Slope Stability		38.162056°	38.162056°	
			-121.584043°	-121.584043°	
DWR ID	DWR_RD0563_01_s_2019_158				
Comment Code					
S1 : Repair slope instability.					
Inspector Comment					
The beaver hole was repaired by the LMA.

View of waterside slope repaired by LMA. A beaver hole was discovered on the waterside slope (Spring 2019).

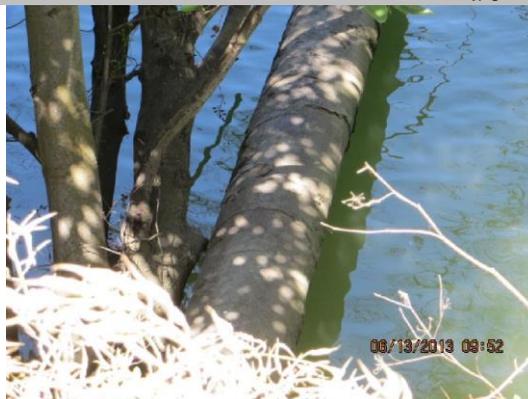
Photo 1 of 2 : UCIP_FA_2019_16304_27464.jpg

LM Start	7.72	Rating **	M	Issue No.	796
LM End	7.72	Issue Type +	En	Location *	
Category	Supplemental		GPS Latitude/Longitude		
			Start	End	
Item	DRAFT DWR UCIP Field Study		38.161873°	38.161873°	
			-121.584109°	-121.584109°	
DWR ID	20185				
Comment Code					
Inspector Comment					
DS_ID:20185 FS_ID:16304 EP_NO: N/A Repair Type: Non-Urgent Crossing Status: Found UCIP Comments: Slight depression in crown along pipe alignment may be indication of pipe internal failure. Good candidate for video inspection. FIELD_STRUCT_DESC: 14-inch steel irrigation pipe through the levee, 5.1 feet below the crown. [Additional Reference(s): USACE Sacramento O&M Manual 103, June 1954, (Station ""L"" 233+50.5)]. FS Date: 6/13/2013

Pipe visible on WS toe.

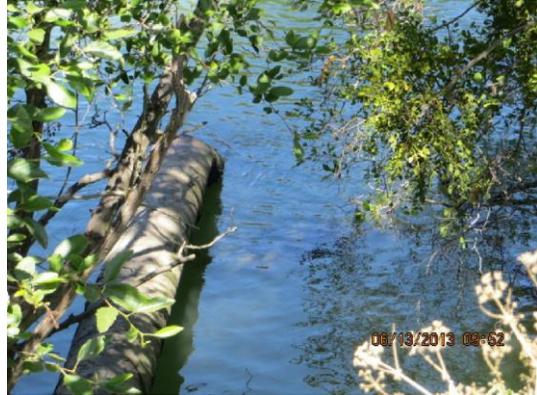
Photo 2 of 2 : UCIP_FA_2019_16304_27463.jpg

LM Start	7.72	Rating **	M	Issue No.	796 (cont)
LM End	7.72	Issue Type +	En	Location *	
Category	Supplemental			GPS Latitude/Longitude	
				Start	End
Item	DRAFT DWR UCIP Field Study			38.161873°	38.161873°
				-121.584109°	-121.584109°
DWR ID	20185				
Comment Code					
Inspector Comment					
DS_ID:20185 FS_ID:16304 EP_NO: N/A Repair Type: Non-Urgent Crossing Status: Found UCIP Comments: Slight depression in crown along pipe alignment may be indication of pipe internal failure. Good candidate for video inspection. FIELD_STRUCT_DESC: 14-inch steel irrigation pipe through the levee, 5.1 feet below the crown. [Additional Reference(s): USACE Sacramento O&M Manual 103, June 1954, (Station ""L"" 233+50.5)]. FS Date: 6/13/2013

Pipe visible on WS toe.

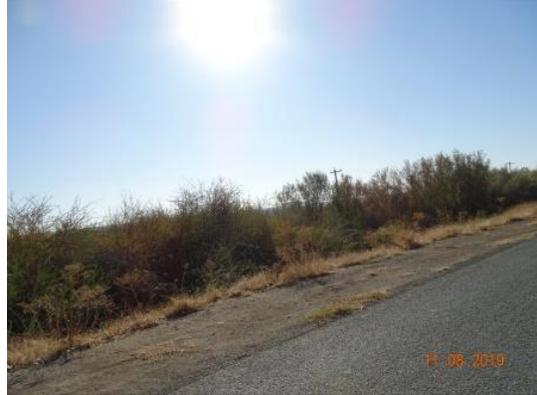
Photo 1 of 1 : FA_2019_RD0563_210_90_20191108_00233.jpg

LM Start	7.80	Rating **	U	Issue No.	90
LM End	7.94	Issue Type +	Ma	Location *	LS
Category	Earthen Levee			GPS Latitude/Longitude	
				Start	End
Item	Vegetation			38.160800°	38.158922°
				-121.584598°	-121.585433°
DWR ID	DWR_RD0563_01_s_2012_90				
Comment Code					
V2 : Remove the wild growth other than native grasses from the levee slopes.					
Inspector Comment					
Berry vines and willows on the landside toe.

View of thick vegetation at the landside toe (Fall 2019).

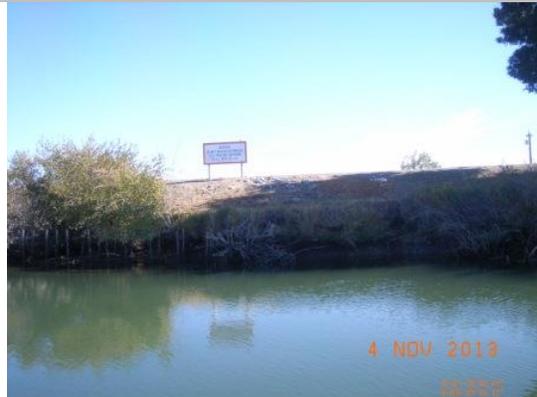
Photo 1 of 1 : FA_2019_RD0563_210_84_20190826_00051.jpg

Comment Code					
Inspector Comment					
2017 Site ID: GEO 4.3 L Status: Eroding 2017 Field Notes: The worst sections have been filled with quarry stone , but still areas of concern. Site History: 1997 - Pockets of erosion into the levee toe. 1999 - Minor rock riprap and willow bundles place in a couple of spots. 2001 - Staked, low fascine walls at bankline. 2003 - Small unprotected pockets still eroding. 2004 - Numerous brush boxes, some falling apart, some with new bundles. 2005 - Some new brush boxes installed; some boxes are empty. Levee slope and banks still look bad with pocket scallops into the levee slopes. 2011 - Erosion continues and the number of pockets is increasing. 2013 - Some of the downstream end was repaired by the RD. 2016 - Fresh erosion observed.

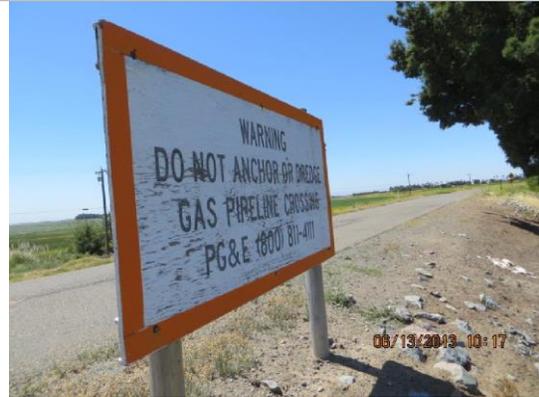
Photo 1 of 2 : UCIP_FA_2019_16263_27401.jpg

LM Start	7.92	Rating **	M	Issue No.	797
LM End	7.92	Issue Type +	En	Location *	
Category	Supplemental		GPS Latitude/Longitude		
			Start	End	
Item	DRAFT DWR UCIP Field Study		38.159207°	38.159207°	
			-121.585304°	-121.585304°	
DWR ID	23973				
Comment Code					
Inspector Comment					
DS_ID:23973 FS_ID:16263 EP_NO: N/A Repair Type: Non-Urgent Crossing Status: Indicator Found UCIP Comments: Need to determine disposition of all gas lines in this immediate area. FIELD_STRUCT_DESC: Gas line of an unknown size or material through the levee, at an unknown depth. Gas line marker on the WS shoulder. FS Date: 6/13/2013

Sign on WS shoulder.

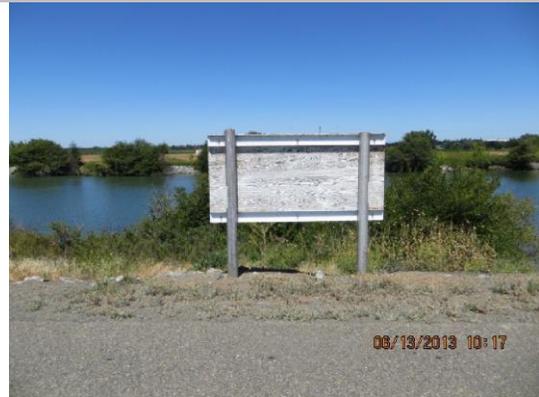
Photo 2 of 2 : UCIP_FA_2019_16263_27400.jpg

Sign on WS shoulder.

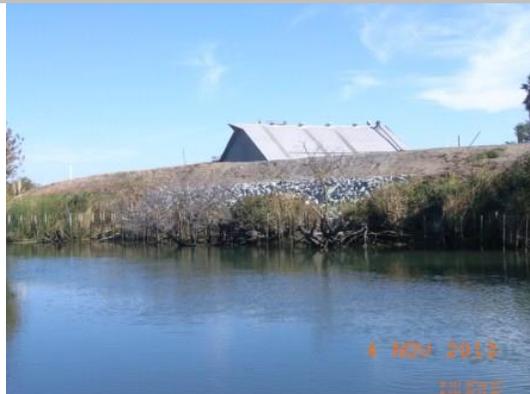
Photo 1 of 1 : FA_2019_RD0563_210_83_20190826_00050.jpg

Comment Code					
Inspector Comment					
2017 Site ID: GEO 3.8 L Status: Eroding 2017 Field Notes: Fresh toe erosion, significant undercutting and slumping. Site History: 1997 - Pockets of erosion into the levee at the water line. Alders are being undercut and rotating out into the channel. Damaged rock at upstream end. 2000 - New minor erosion. 2001 - Staked low fascine walls at bankline. 2002 - New "Brush Boxes" along the bank toe. 2003 - New erosion pockets in the middle of the site. 2005 - Some new bundles in the brush boxes. 2011 - Site upgraded to CRITICAL. Significant new erosion. Sites 3.6, 3.7, 3.71, and 4.0 were combined. 2012 - Rock has been placed in some of the erosion pockets since last year, however site remains critical. 2013 - Site no longer critical. The worst pockets were filled with rock by the local RD.

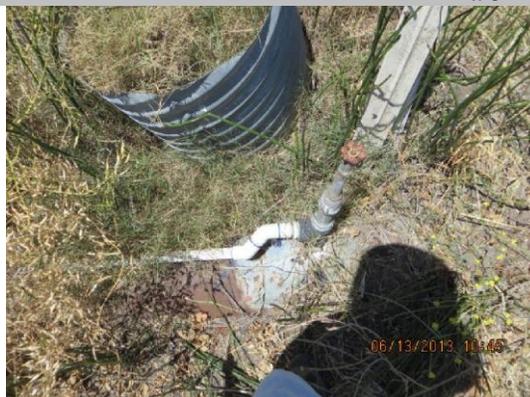
Photo 1 of 3 : UCIP_FA_2019_14988_24670.jpg

Comment Code					
Inspector Comment					
DS_ID:20160 FS_ID:14988 EP_NO: 9145 Repair Type: Non-Urgent Crossing Status: Found UCIP Comments: Good candidate for video inspection. Erosion in levee adjacent to pipe. FIELD_STRUCT_DESC: 2 of 2: 16-inch steel irrigation pipe through the levee, 3 feet below the crown. 14-inch steel irrigation siphon sleeved through the 16-inch pipe with annular space grouted. Air vent/filler pipe on the landside (LS) shoulder with a slide gate in a 48-inch steel standpipe on the LS toe. (Automatic Board Order (ABO) issued as Permit No. 9145, 1973 - care of John Lewallen). [Additional Reference(s): DWR Levee Log, 2005. USACE Sacramento O&M Manual 103, June 1954, (Station ""L"" 212+44.5)]. FS Date: 6/13/2013

air vent/filler pipe on LS shoulder.

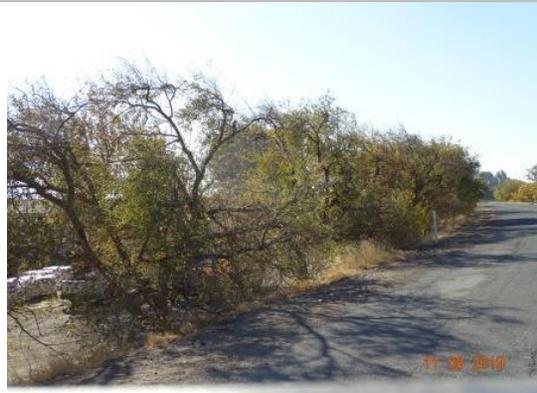
Photo 1 of 1 : FA_2019_RD0563_210_31_20191108_00234.jpg

LM Start	8.38	Rating **	M	Issue No.	31
LM End	8.41	Issue Type +	En	Location *	LS
Category	Earthen Levee			GPS Latitude/Longitude	
				Start	End
Item	Vegetation			38.155974 °	38.155543 °
				-121.591452 °	-121.591595 °
DWR ID	DWR_RD0563_01_s_2012_31				
Comment Code					
V6 : Landscaping					
Inspector Comment

View of landscaping trees on the landside slope (Fall 2019).

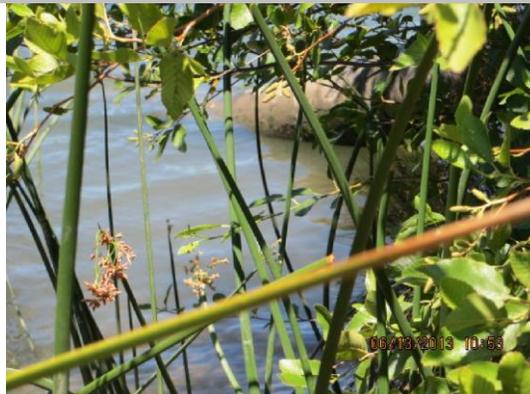
Photo 1 of 3 : UCIP_FA_2019_14990_24677.jpg

Comment Code					
Inspector Comment					
DS_ID:20161 FS_ID:14990 EP_NO: 11217 Repair Type: Non-Urgent Crossing Status: Found UCIP Comments: Pipe appears abandoned and should be done so properly. FIELD_STRUCT_DESC: 1 of 11: 12-inch steel irrigation siphon pipe through the levee, 3.6 feet below the crown. Vent/filler pipe on the landside (LS) shoulder, and a slide gate in a 7-foot by 9-foot concrete distribution box on the LS toe. (Automatic Board Order (ABO) issued as Permit No. 11217, 1975 - Owen E. Wilkenson). [Additional Reference(s): DWR Levee Log, 2005. USACE Sacramento O&M Manual 103, June 1954, (Station ""L"" 193+23.5)]. FS Date: 6/13/2013

Pipe visibel behind trees on WS toe.

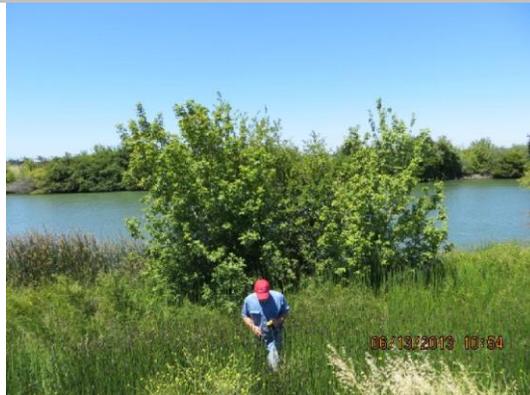
Photo 2 of 3 : UCIP_FA_2019_14990_24676.jpg

Pipe visibel behind trees on WS toe.

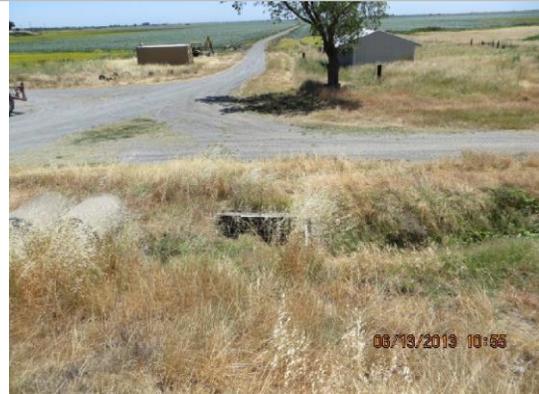
Photo 3 of 3 : UCIP_FA_2019_14990_24675.jpg

Comment Code					
Inspector Comment					
DS_ID:20161 FS_ID:14990 EP_NO: 11217 Repair Type: Non-Urgent Crossing Status: Found UCIP Comments: Pipe appears abandoned and should be done so properly. FIELD_STRUCT_DESC: 1 of 11: 12-inch steel irrigation siphon pipe through the levee, 3.6 feet below the crown. Vent/filler pipe on the landside (LS) shoulder, and a slide gate in a 7-foot by 9-foot concrete distribution box on the LS toe. (Automatic Board Order (ABO) issued as Permit No. 11217, 1975 - Owen E. Wilkenson). [Additional Reference(s): DWR Levee Log, 2005. USACE Sacramento O&M Manual 103, June 1954, (Station ""L"" 193+23.5)]. FS Date: 6/13/2013

7'X9' concrete distribution box on LS toe.

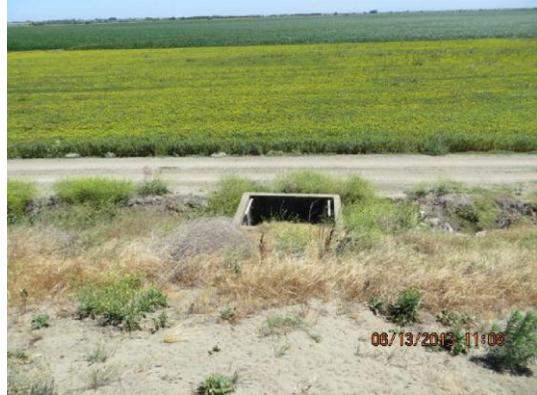
Photo 2 of 3 : UCIP_FA_2019_16292_27452.jpg

Comment Code					
Inspector Comment					
DS_ID:20163 FS_ID:16292 EP_NO: 11217 Repair Type: Non-Urgent Crossing Status: Found UCIP Comments: Appears abandoned and should be done so properly. Slide gate broken. FIELD_STRUCT_DESC: 3 of 11: 14-inch steel irrigation pipe through the levee, 4.2 feet below the crown. Vent/filler pipe on the landside (LS) shoulder. Slide gate in 7-foot by 9-foot concrete distribution box on the LS toe. (Automatic Board Order (ABO) issued as Permit No. 11217, 1975 - Owen E. Wilkenson). [Additional Reference(s): DWR Levee Log, 2005. USACE Sacramento O&M Manual 103, June 1954, (Station ""L"" 171+57.5)]. FS Date: 6/13/2013

Concrete distribution box at LS toe.

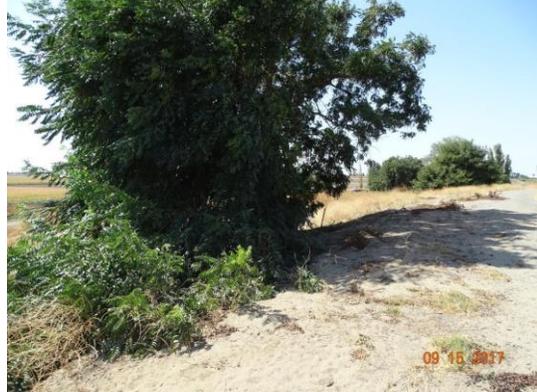
Photo 1 of 2 : FA_2019_RD0563_210_768_20190826_00113.jpg

LM Start	9.25	Rating **	M	Issue No.	768
LM End	9.25	Issue Type +	Ma	Location *	LS
Category	Earthen Levee			GPS Latitude/Longitude	
				Start	End
Item	Trim / Thin Trees			38.145897°	38.145897°
				-121.588203°	-121.588203°
DWR ID	DWR_RD0563_01_s_2015_768				
Comment Code					
T1 : Trim trees to at least five feet above ground level.					
Inspector Comment

Looking south at the landside slope.

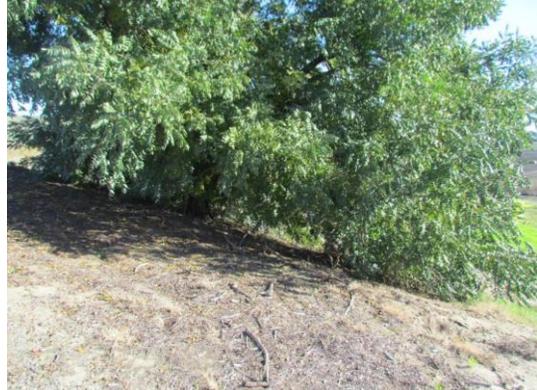
Photo 2 of 2 : FA_2019_RD0563_210_768_20190826_00114.jpg

Looking at untrimmed tree on landward slope.

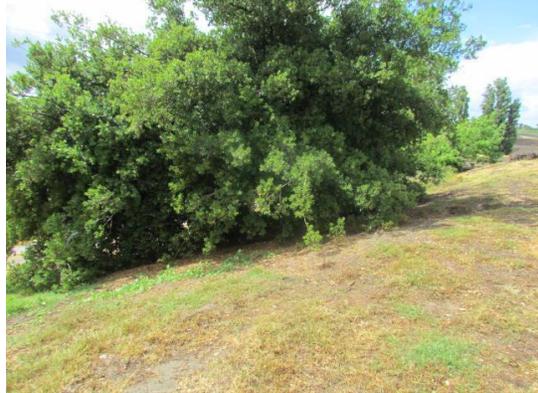
Photo 1 of 1 : FA_2019_RD0563_210_98_20190826_00065.jpg

LM Start	9.28	Rating **	U	Issue No.	98
LM End	9.28	Issue Type +	Ma	Location *	LS
Category	Earthen Levee		GPS Latitude/Longitude		
			Start	End	
Item	Trim / Thin Trees		38.145825°	38.145825°	
			-121.588807°	-121.588807°	
DWR ID	DWR_RD0563_01_s_2013_98				
Comment Code					
T1 : Trim trees to at least five feet above ground level.					
Inspector Comment

Looking southeast at untrimmed trees on landward slope.

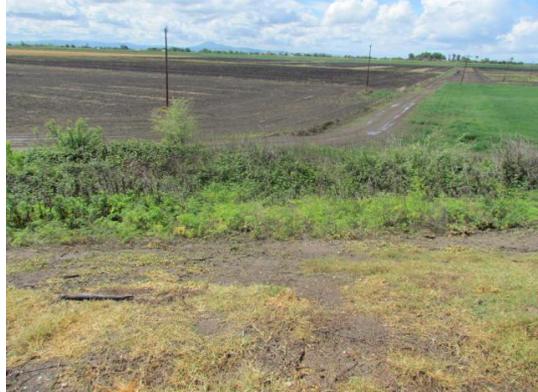
Photo 1 of 1 : FA_2019_RD0563_210_769_20190826_00115.jpg

LM Start	9.36	Rating **	M	Issue No.	769
LM End	9.43	Issue Type +	Ma	Location *	LS
Category	Earthen Levee		GPS Latitude/Longitude		
			Start	End	
Item	Vegetation		38.146276°	38.147034°	
			-121.590189°	-121.590907°	
DWR ID	DWR_RD0563_01_s_2015_769				
Comment Code					
V2 : Remove the wild growth other than native grasses from the levee slopes.					
Inspector Comment

Looking east at dense vegetation at landward toe. (Spring 2015)

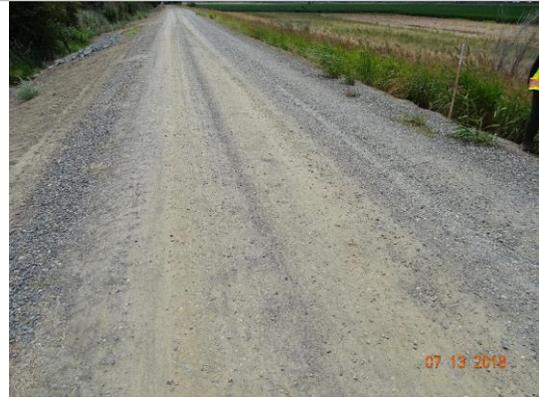
Photo 1 of 2 : UCIP_FA_2019_52765_77766.jpg

Comment Code					
Inspector Comment					
DS_ID:20166 FS_ID:52765 EP_NO: 11217 Repair Type: Non-Urgent Crossing Status: Found UCIP Comments: 06/13/2018 Appears abandoned as stand pipe is partially filled with soil. Abandon properly. No pictures taken. (W.Wylie) FIELD_STRUCT_DESC: 10-inch steel irrigation pipe through the levee, 3.8 feet below the crown. Vent/filler pipe on the landside (LS) shoulder. 4-foot-diameter concrete standpipe on the LS toe. (Automatic Board Order (ABO) issued as Permit No. 11217, 1975 - Owen E. Wilkenson). [Additional Reference(s): DWR Levee Log, 2005. USACE Sacramento O&M Manual 103, June 1954, (Station ""L"" 136+45.1)]. FS Date: 7/13/2018

View of levee crown at the crossing.

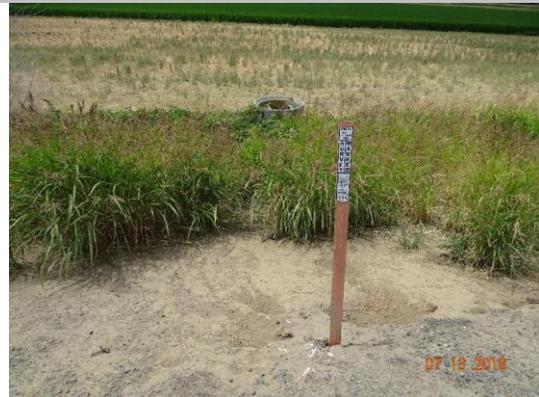
Photo 2 of 2 : UCIP_FA_2019_52765_77767.jpg

View of standpipe on IS.

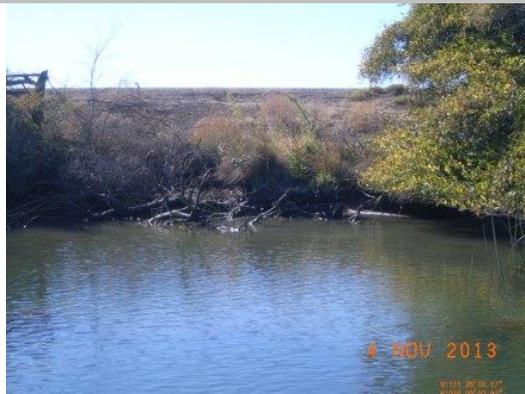
Photo 1 of 1 : FA_2019_RD0563_210_82_20190826_00049.jpg

LM Start	9.73	Rating **	A/W	Issue No.	82
LM End	9.90	Issue Type +	Ma	Location *	WS
Category	Supplemental		GPS Latitude/Longitude		
			Start	End	
Item	2017 USACE Erosion Survey		38.150820°	38.150647°	
			-121.593650°	-121.596858°	
DWR ID	DWR_RD0563_01_f_2018_82				
Comment Code					
Inspector Comment					
2017 Site ID: GEO 2.5 L Status: Eroding 2017 Field Notes: Head scarp observed. Site History: 1997 - Erosion pockets into the toe of the levee. 2001 - Staked low fascine walls at the bankline. 2004 - Numerous "Brush Boxes." 2005 - Some new bundles in the brush boxes. 2012 - Site extended downstream to account for new bank sloughing. 2013 - Some rock added to the upstream end by the local RD.

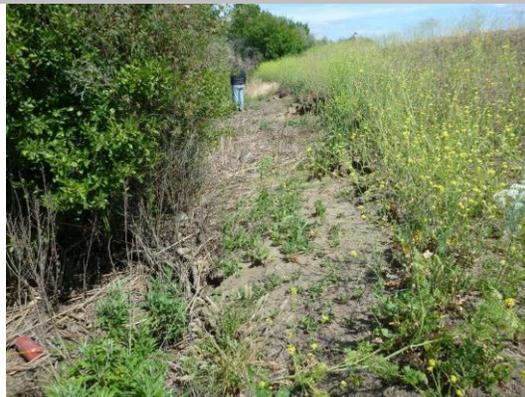
Photo 1 of 3 : LEVAL_FA_2019_70_662.jpg

LM Start	9.73	Rating **	A/W	Issue No.	105
LM End	9.78	Issue Type +	Ma	Location *	
Category	Supplemental		GPS Latitude/Longitude		
			Start	End	
Item	2017 Storm Damage		38.150820°	38.151196°	
			-121.593650°	-121.594780°	
DWR ID	DWR_RD0563_01_s_2012_49				
Comment Code					
Inspector Comment					
Levee Evaluation Comments Description: Site ID No:70 Site Designation:DWR_RD0563_01_s_2012_49 Repair Type: Erosion Rating:Serious Field Date:6/9/2017 Notes:

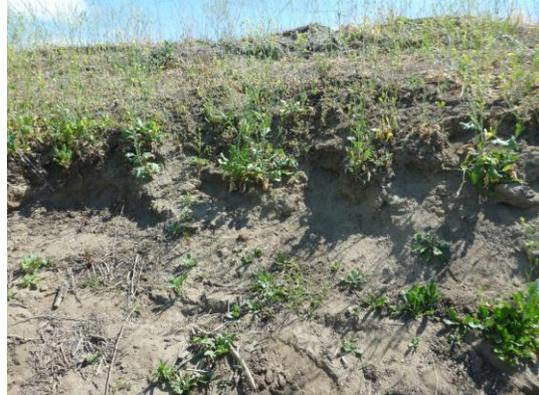
Photo 2 of 3 : LEVAL_FA_2019_70_667.jpg

LM Start	9.73	Rating **	A/W	Issue No.	105 (cont)
LM End	9.78	Issue Type +	Ma	Location *	
Category	Supplemental			GPS Latitude/Longitude	
				Start	End
Item	2017 Storm Damage			38.150820°	38.151196°
				-121.593650°	-121.594780°
DWR ID	DWR_RD0563_01_s_2012_49				
Comment Code					
Inspector Comment					
Levee Evaluation Comments					
Description:					
Site ID No:70					
Site Designation:DWR_RD0563_01_s_2012_49					
Repair Type: Erosion					
Rating:Serious					
Field Date:6/9/2017					
Notes:

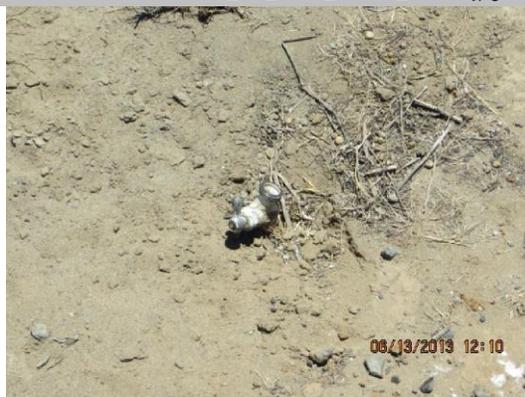
Photo 3 of 3 : UCIP_FA_2019_52766_24686.jpg

Comment Code					
Inspector Comment					
DS_ID:20167 FS_ID:52766 EP_NO: 11217 Repair Type: Non-Urgent Crossing Status: Found UCIP Comments: 07/13/2018 Fall hazard: 5-foot-diameter steel standpipe on LS needs to be covered. (O.Yakimov-DWR UCIP) FIELD_STRUCT_DESC: 14-inch steel irrigation siphon pipe through the levee, 4.3 feet below the crown. Vent/filler pipe on the landside (LS) shoulder, and a slide gate in a 5-foot-diameter steel standpipe at the LS toe. (Automatic Board Order (ABO) issued as Permit No. 11217, 1975 - Owen E. Wilkenson). [Additional Reference(s): DWR Levee Log, 2005. USACE Sacramento O&M Manual 103, June 1954, (Station "L" 119+16) (16-inch pipe listed)]. FS Date: 7/13/2018

Vent/filler pipe on LS shoulder.

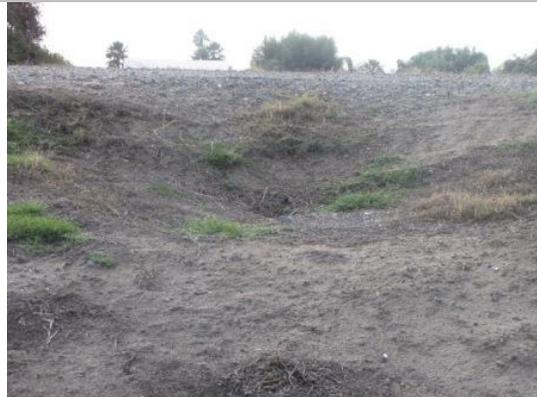
Photo 3 of 4 : FA_2019_RD0563_210_76_20190826_00039.jpg

LM Start	10.59	Rating **	M	Issue No.	76 (cont)
LM End	10.59	Issue Type +	Ma	Location *	LS
Category	Earthen Levee			GPS Latitude/Longitude	
				Start	End
Item	Slope Stability			38.141940°	38.141940°
				-121.598033°	-121.598033°
DWR ID	DWR_RD0563_01_s_2012_76				
Comment Code					
S1 : Repair slope instability.					
Inspector Comment					
There is a deep depression on the landside shoulder and slope; possible pipe collapse.

Looking west at depression on landside shoulder and slope from landside toe.
