**Flood Control Project Maintenance
Levee Inspections**

Fall 2019 Levee Maintenance Deficiency Summary Report

Reclamation District No. 0563 Tyler Island

Waterway		Bank	Unit Miles
Unit No. 01 Georgiana Slough (Tyler Island)		Left	12.11
	Spring (March - May)	Summer (June - August)	(September - November) Fall Winter (December - February)
Unit Maintenance Rating (Fall Only)			U
Date of Inspection	4/5/2019 - 4/5/2019		11/8/2019 - 11/8/2019
DWR Inspector	David Julian		David Julian
Accompanied By	Steve Mello RD 563		Steve Mello RD 563

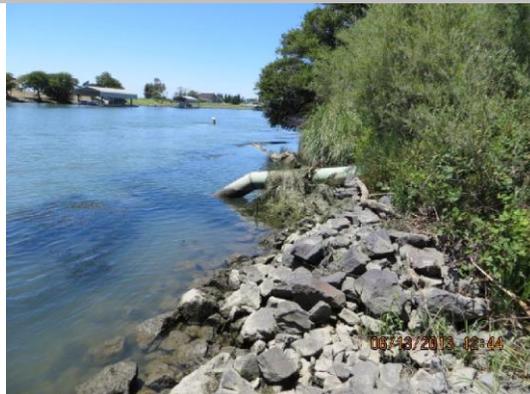
Photo 3 of 3 : UCIP_FA_2019_52767_24689.jpg

Comment Code					
Inspector Comment					
DS_ID:20170 FS_ID:52767 EP_NO: 11217 Repair Type: Non-Urgent Crossing Status: Found UCIP Comments: 06/13/2013 Pipe does not have appropriate clearance at Levee crown. (W.Wylie) FIELD_STRUCT_DESC: 16-inch steel irrigation siphon pipe through the levee, 1 foot below the crown. Air vent/filler pipe on the landside (LS) shoulder. Slide gate in a 5-foot-diameter steel standpipe on the LS toe. (Automatic Board Order (ABO) issued as Permit No. 11217, 1975 - Owen E. Wilkenson). [Additional Reference(s): DWR Levee Log, 2005. USACE Sacramento O&M Manual 103, June 1954, (Station ""L"" 60+34) (14-inch pipe listed)]. FS Date: 7/13/2018

Pipe visible on WS toe.

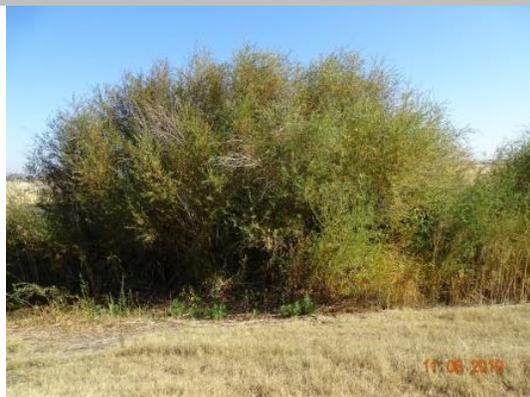
Photo 1 of 1 : FA_2019_RD0563_210_120_20191108_00236.jpg

LM Start	11.18	Rating **	U	Issue No.	120
LM End	11.18	Issue Type +	Ma	Location *	LS
Category	Earthen Levee			GPS Latitude/Longitude	
				Start	End
Item	Trim / Thin Trees			38.134890°	38.134890°
				-121.592188°	-121.592188°
DWR ID	DWR_RD0563_01_f_2019_120				
Comment Code					
T2 : Thin trees to allow visibility of the ground and room to flood fight.					
Inspector Comment

View of thick tree on the landside slope (Fall 2019).

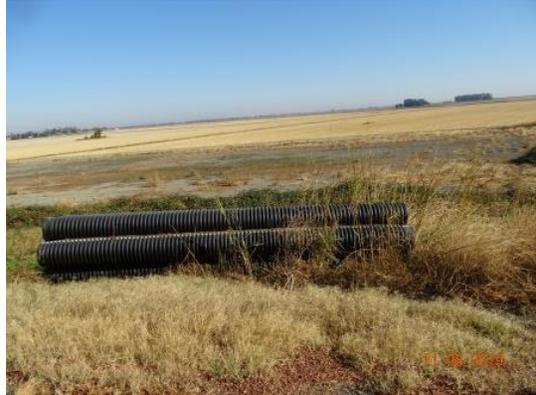
Photo 1 of 1 : FA_2019_RD0563_210_118_20191108_00237.jpg

LM Start	11.25	Rating **	M	Issue No.	118
LM End	11.25	Issue Type +	En	Location *	LS
Category	Earthen Levee		GPS Latitude/Longitude		
			Start	End	
Item	Encroachments		38.134149°	38.134149°	
			-121.591281°	-121.591281°	
DWR ID	DWR_RD0563_01_f_2019_118				
Comment Code					
EQ : Equipment					
Inspector Comment					
Pipe bundles stored on landside slope.

View of bundle of plastic pipes on the landside slope (Fall 2019).

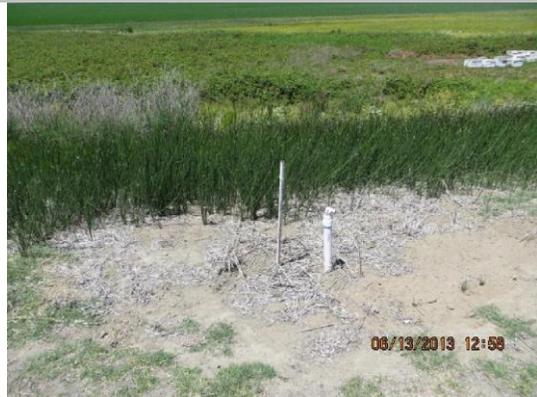
Photo 1 of 3 : UCIP_FA_2019_52769_24705.jpg

Comment Code					
Inspector Comment					
DS_ID:20174 FS_ID:52769 EP_NO: 11217 Repair Type: Non-Urgent Crossing Status: Found UCIP Comments: 06/13/2013 Pipe appears abandoned and should be done so properly. (W.Wylie) FIELD_STRUCT_DESC: 12-inch steel irrigation siphon pipe through the levee, 4.5 feet below the crown. Air vent on the landside (LS) shoulder, and slide gate in a 7-foot by 9-foot concrete distribution box at the LS toe. (Automatic Board Order (ABO) issued as Permit No. 11217, 1975 - Owen E. Wilkenson). [Additional Reference(s): DWR Levee Log, 1980. USACE Sacramento O&M Manual 103, June 1954, (Station ""L"" 19+23.5)]. FS Date: 7/13/2018

Vent and distribution box visible on LS.

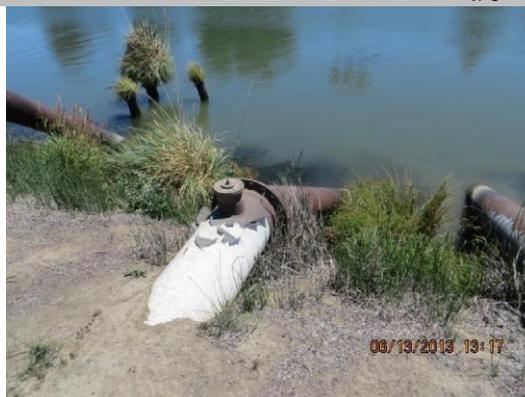
Photo 3 of 3 : UCIP_FA_2019_52771_24729.jpg

LM Start	12.00	Rating **	A/W	Issue No.	806 (cont)
LM End	12.00	Issue Type +	Ma	Location *	
Category	Supplemental			GPS Latitude/Longitude	
				Start	End
Item	DRAFT DWR UCIP LMA Responsibility			38.130726°	38.130726°
				-121.579646°	-121.579646°
DWR ID	20172				
Comment Code					
Inspector Comment					
DS_ID:20172 FS_ID:52771 EP_NO: 11213 Repair Type: No Action Needed Crossing Status: Found UCIP Comments: FIELD_STRUCT_DESC: 20-inch steel drainage pipe through the levee, 1 foot below the crown. Pump on the landside (LS). Siphon breaker on the waterside (WS) shoulder. (18-inch pipe [HLM 12.28] at a depth of 4-feet authorized under Automatic Board Order (ABO) issued as Permit No. 11213, 1975 - Reclamation District No. 563). [Additional Reference(s): DWR Levee Log, 2005. USACE Sacramento O&M Manual 103, June 1954, (Station ""L"" 6+48.9)]. FS Date: 7/13/2018

Pipe and siphon breaker on WS shoulder.

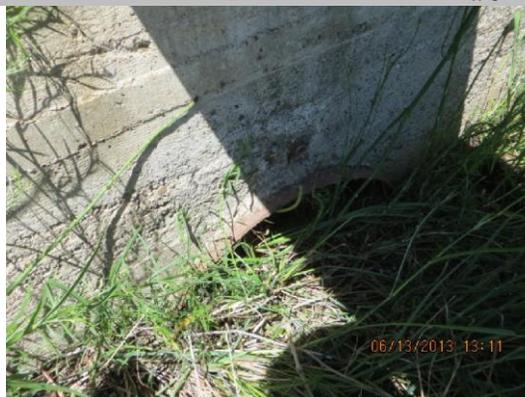
Photo 1 of 2 : UCIP_FA_2019_15028_24736.jpg

LM Start	12.00	Rating **	M	Issue No.	807
LM End	12.00	Issue Type +	En	Location *	
Category	Supplemental			GPS Latitude/Longitude	
				Start	End
Item	DRAFT DWR UCIP Field Study			38.130730°	38.130730°
				-121.579616°	-121.579616°
DWR ID	20182				
Comment Code					
Inspector Comment					
DS_ID:20182 FS_ID:15028 EP_NO: N/A Repair Type: Non-Urgent Crossing Status: Found UCIP Comments: Verify pipe is properly abandoned. FIELD_STRUCT_DESC: *REMOVED* 1 of 2: 36-inch steel drainage pipe through the levee, 4 feet below the crown. Shutoff valve at pump. Pipe visible on the waterside (WS) at headwall. (Replaced by a 30-inch pipe under Permit No. 2635, 1957 - Reclamation District No. 563). [Additional Reference(s): USACE Sacramento O&M Manual 103, June 1954, (Station ""L"" 6+39)]. FS Date: 6/13/2013

Pipe at concrete headwall on WS slope.

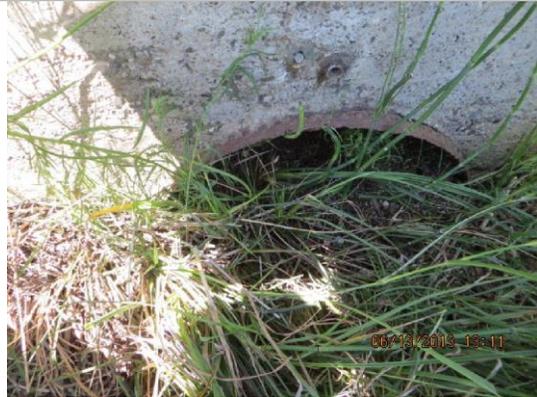
Photo 2 of 2 : UCIP_FA_2019_15028_24735.jpg

LM Start	12.00	Rating **	M	Issue No.	807 (cont)
LM End	12.00	Issue Type +	En	Location *	
Category	Supplemental			GPS Latitude/Longitude	
				Start	End
Item	DRAFT DWR UCIP Field Study			38.130730°	38.130730°
				-121.579616°	-121.579616°
DWR ID	20182				
Comment Code					
Inspector Comment					
DS_ID:20182 FS_ID:15028 EP_NO: N/A Repair Type: Non-Urgent Crossing Status: Found UCIP Comments: Verify pipe is properly abandoned. FIELD_STRUCT_DESC: *REMOVED* 1 of 2: 36-inch steel drainage pipe through the levee, 4 feet below the crown. Shutoff valve at pump. Pipe visible on the waterside (WS) at headwall. (Replaced by a 30-inch pipe under Permit No. 2635, 1957 - Reclamation District No. 563). [Additional Reference(s): USACE Sacramento O&M Manual 103, June 1954, (Station "'L"' 6+39)]. FS Date: 6/13/2013

Pipe at concrete headwall on WS slope.

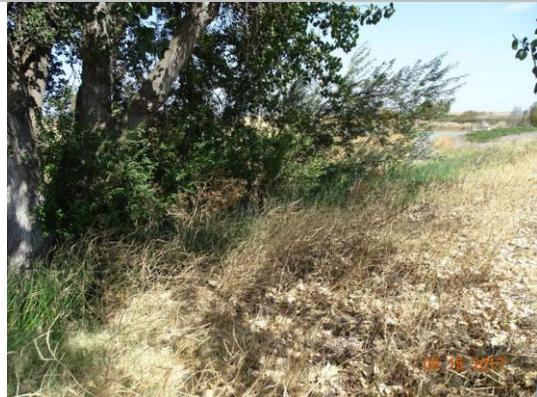
Photo 1 of 2 : FA_2019_RD0563_210_47_20190826_00017.jpg

LM Start	12.04	Rating **	M	Issue No.	47
LM End	12.04	Issue Type +	Ma	Location *	LS
Category	Earthen Levee			GPS Latitude/Longitude	
				Start	End
Item	Trim / Thin Trees			38.130758°	38.130758°
				-121.579027°	-121.579027°
DWR ID	DWR_RD0563_01_s_2012_47				
Comment Code					
T1 : Trim trees to at least five feet above ground level.					
Inspector Comment					
Trim tree on landside slope.

Looking northeast at the landside slope.

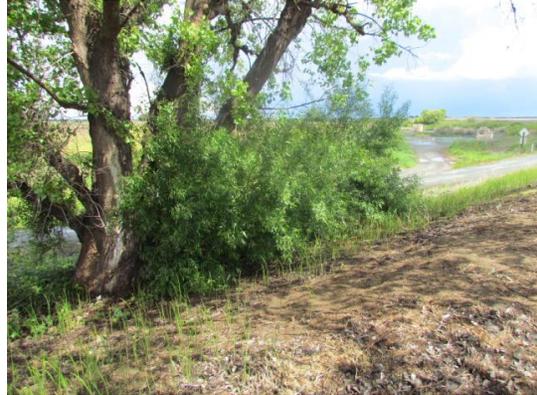
Photo 2 of 2 : FA_2019_RD0563_210_47_20190826_00018.jpg

LM Start	12.04	Rating **	M	Issue No.	47 (cont)
LM End	12.04	Issue Type +	Ma	Location *	LS
Category	Earthen Levee			GPS Latitude/Longitude	
				Start	End
Item	Trim / Thin Trees			38.130758°	38.130758°
				-121.579027°	-121.579027°
DWR ID	DWR_RD0563_01_s_2012_47				
Comment Code					
T1 : Trim trees to at least five feet above ground level.					
Inspector Comment					
Trim tree on landside slope.

Looking northeast at untrimmed tree at landward slope. (Spring 2015)
