**Flood Control Project Maintenance  
Levee Inspections**

**Maintenance Issue Types Only, Levee Inspection Report By Mile - Fall 2019**

**Reclamation District No. 0563 Tyler Island**

Waterway	Bank	Unit Miles	Inspection Start/End	Inspector
Unit No. 01 Georgiana Slough (Tyler Island)	Left	12.11	11/08/2019 11/08/2019	David Julian

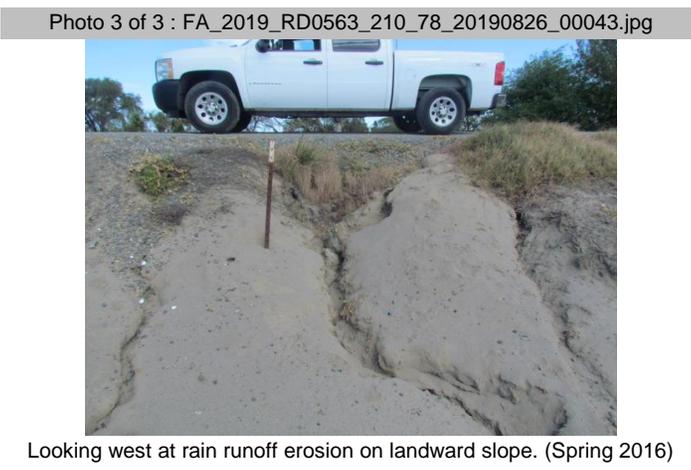
LM Start	<b>3.06</b>	Rating **	U	Issue No.	<b>78 (cont)</b>
LM End	<b>3.06</b>	Issue Type +	Ma	Location *	LS
Category	Earthen Levee			GPS Latitude/Longitude	
				Start	End
Item	Slope Stability			38.210240°	38.210240°
				-121.537517°	-121.537517°
DWR ID	DWR_RD0563_01_s_2012_78				
Comment Code					
S1 : Repair slope instability.					
Inspector Comment					
Slope damage on landside shoulder and slope has been in place for several inspection cycles. Proper drainage should be provided to prevent further erosion, and erosion should be repaired.

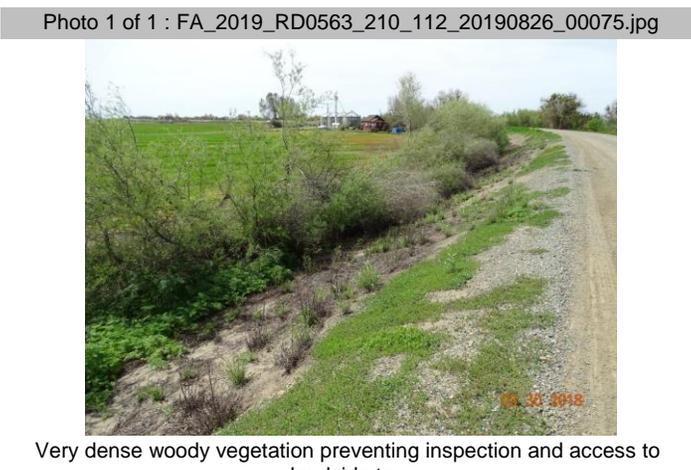
LM Start	<b>3.11</b>	Rating **	U	Issue No.	<b>112</b>
LM End	<b>3.21</b>	Issue Type +	Ma	Location *	LS
Category	Earthen Levee			GPS Latitude/Longitude	
				Start	End
Item	Vegetation			38.210018°	38.209201°
				-121.538353°	-121.539871°
DWR ID	DWR_RD0563_01_s_2018_112				
Comment Code					
V7 : Trees / Woody Vegetation					
Inspector Comment					
Dense woody vegetation (up to 6" in diameter) along lower slope and toe prevents inspection and access. Needs to be removed.

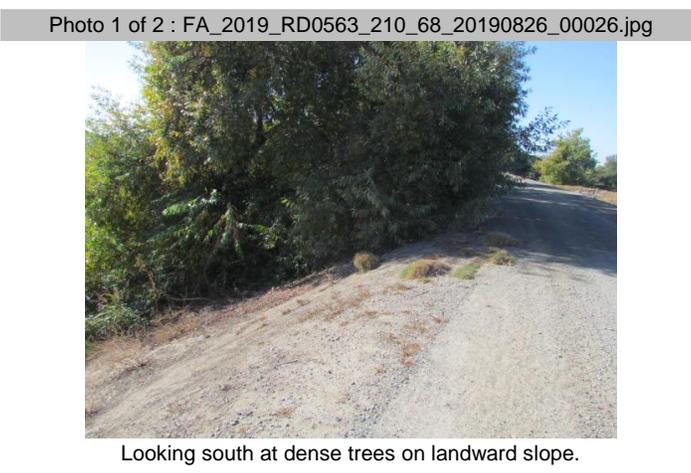
LM Start	<b>3.21</b>	Rating **	M	Issue No.	<b>68</b>
LM End	<b>3.21</b>	Issue Type +	Ma	Location *	LS
Category	Earthen Levee			GPS Latitude/Longitude	
				Start	End
Item	Trim / Thin Trees			38.209217°	38.209217°
				-121.539823°	-121.539823°
DWR ID	DWR_RD0563_01_s_2012_68				
Comment Code					
T2 : Thin trees to allow visibility of the ground and room to flood fight.					
Inspector Comment

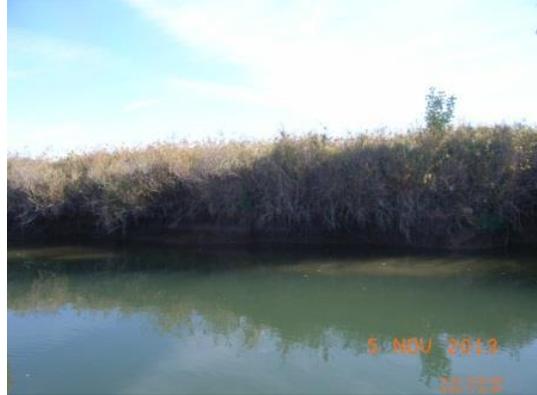
Photo 1 of 1 : FA\_2019\_RD0563\_210\_92\_20190826\_00060.jpg

LM Start	<b>4.98</b>	Rating **	M	Issue No.	<b>92</b>
LM End	<b>5.04</b>	Issue Type +	Ma	Location *	WS
Category	Supplemental		GPS Latitude/Longitude		
			Start	End	
Item	2017 USACE Erosion Survey		38.190073 °	38.189524 °	
			-121.556307 °	-121.557227 °	
DWR ID	DWR_RD0563_01_f_2018_92				
Comment Code					
Inspector Comment					
2017 Site ID: GEO 7.2 L Status: Eroding 2017 Field Notes: New erosion at toe. Site History: 2009 - Small scallops of erosion into the levee toe behind brush boxes. 2011 - Minor new erosion. 2012 - Site extended upstream to account for addition erosion pockets. 2016 - Fresh erosion observed.

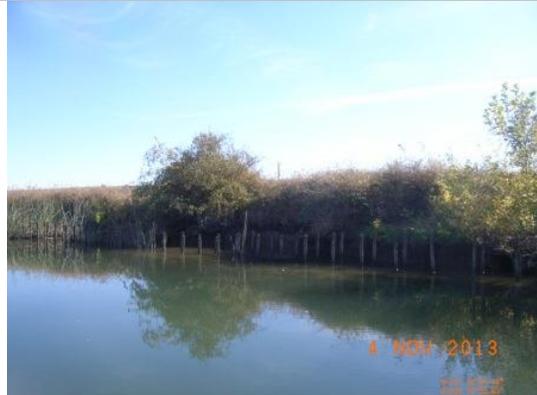
Photo 1 of 1 : FA\_2019\_RD0563\_210\_91\_20190826\_00059.jpg

Item	2017 USACE Erosion Survey		38.186013 °	38.185968 °	
			-121.561512 °	-121.561667 °	
DWR ID	DWR_RD0563_01_f_2018_91				
Comment Code					
Inspector Comment					
2017 Site ID: GEO 6.3 L Status: Critical 2017 Field Notes: Upgraded to CRITICAL. Combined with 6.8. Vertical sections from mid slope to toe, vertical face from levee hinge at some locations. Wave/tide erosion at toe, evidence of beavers. Site History: 1997 - Deep pockets of erosion and narrow berm. Reach is characterized by lots of pockets into the existing berm and/or levee slope. 1999 - Some pockets filled with rock riprap. 2000 - Exposed fabric. 2001 - Staked, low fascine walls at bankline. 2002 - New spot of rock at upstream end. Some new brush boxes. 2005 - Some stone sliding off the underlying geotextile fabric. Some new brush bundles in the brush boxes; some with missing bundles. Some boxes too low relative to high tide. 2009 - Minimal new erosion, site length extended. 2010 - New erosion on downstream end, site extended downstream. 2011 - Sites 6.1, 6.4 and 6.6 were combined. New erosion pockets, site extended to include the erosion in between the old sites. 2012 - Rock has been placed in portions of the bank since last year. 2016 - Site 5.8 was merged with this site due to new erosion connecting the sites.

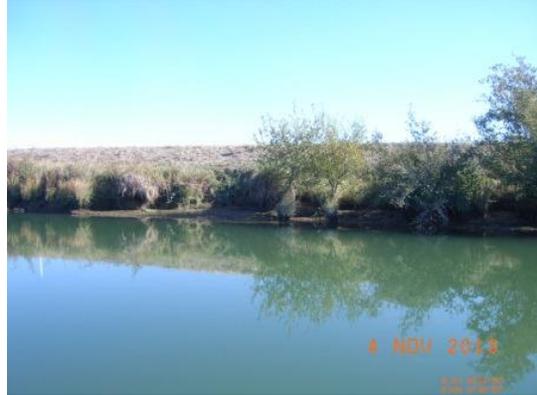
Photo 1 of 1 : FA\_2019\_RD0563\_210\_89\_20190826\_00055.jpg

Item	2017 USACE Erosion Survey			38.177202°	38.167959°
				-121.579439°	-121.581616°
DWR ID	DWR_RD0563_01_f_2018_89				
Comment Code					
Inspector Comment					
2017 Site ID: GEO 5.3 L Status: Eroding 2017 Field Notes: Site extended upstream, increased toe erosion from boat wake/tide action, RD has placed rock on levee slope in places. Site History: 1997 - Pocket erosion into the toe of the levee. 2000 - Scallops in banks with small colored flags, biotech rolls present. 2001 - Staked, low fascine walls at bankline. 2003 - Still have visibly bad spots, especially at the upstream end. 2005 - Some new brush bundles in the brush boxes; some with missing bundles. Some boxes too low relative to high tide. 2010 - Site extended upstream. 2011 - Minor new erosion. 2016 - Fresh erosion observed.

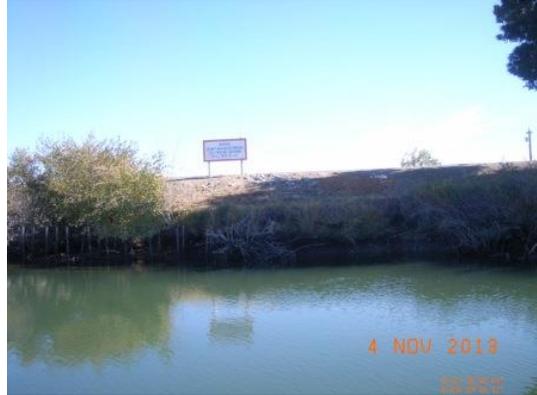
Photo 1 of 1 : FA\_2019\_RD0563\_210\_84\_20190826\_00051.jpg

Item	2017 USACE Erosion Survey		38.160261°	38.157625°	
			-121.585056°	-121.586543°	
DWR ID	DWR_RD0563_01_f_2018_84				
Comment Code					
Inspector Comment					
2017 Site ID: GEO 4.3 L Status: Eroding 2017 Field Notes: The worst sections have been filled with quarry stone , but still areas of concern. Site History: 1997 - Pockets of erosion into the levee toe. 1999 - Minor rock riprap and willow bundles place in a couple of spots. 2001 - Staked, low fascine walls at bankline. 2003 - Small unprotected pockets still eroding. 2004 - Numerous brush boxes, some falling apart, some with new bundles. 2005 - Some new brush boxes installed; some boxes are empty. Levee slope and banks still look bad with pocket scallops into the levee slopes. 2011 - Erosion continues and the number of pockets is increasing. 2013 - Some of the downstream end was repaired by the RD. 2016 - Fresh erosion observed.

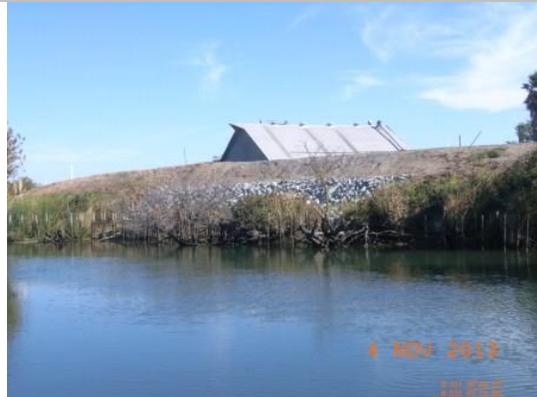
Photo 1 of 1 : FA\_2019\_RD0563\_210\_83\_20190826\_00050.jpg

Item	2017 USACE Erosion Survey		38.156987°	38.152919°	
			-121.587427°	-121.591129°	
DWR ID	DWR_RD0563_01_f_2018_83				
Comment Code					
Inspector Comment					
2017 Site ID: GEO 3.8 L Status: Eroding 2017 Field Notes: Fresh toe erosion, significant undercutting and slumping. Site History: 1997 - Pockets of erosion into the levee at the water line. Alders are being undercut and rotating out into the channel. Damaged rock at upstream end. 2000 - New minor erosion. 2001 - Staked low fascine walls at bankline. 2002 - New "Brush Boxes" along the bank toe. 2003 - New erosion pockets in the middle of the site. 2005 - Some new bundles in the brush boxes. 2011 - Site upgraded to CRITICAL. Significant new erosion. Sites 3.6, 3.7, 3.71, and 4.0 were combined. 2012 - Rock has been placed in some of the erosion pockets since last year, however site remains critical. 2013 - Site no longer critical. The worst pockets were filled with rock by the local RD.

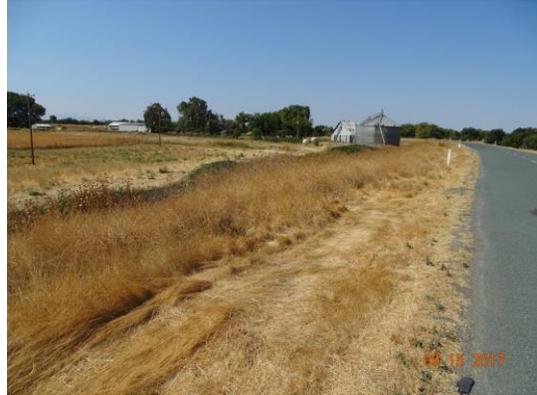
Photo 1 of 1 : FA\_2019\_RD0563\_210\_767\_20190826\_00112.jpg

LM Start	<b>8.18</b>	Rating **	U	Issue No.	<b>767</b>
LM End	<b>8.22</b>	Issue Type +	Ma	Location *	LS
Category	Earthen Levee			GPS Latitude/Longitude	
				Start	End
Item	Vegetation			38.156878°	38.156945°
				-121.588505°	-121.589258°
DWR ID	DWR_RD0563_01_s_2015_767				
Comment Code					
V2 : Remove the wild growth other than native grasses from the levee slopes.					
Inspector Comment					
Dead dense vegetation blocking landside toe.

Looking south at the landside slope.

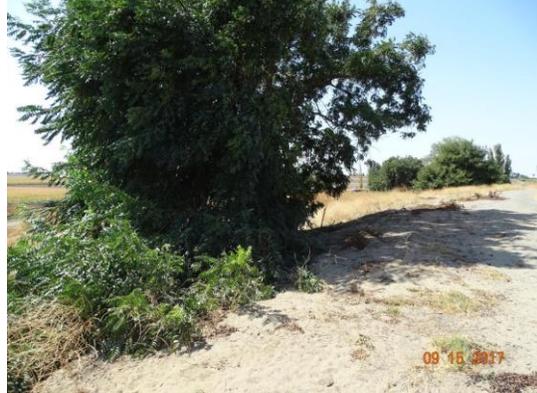
Photo 1 of 2 : FA\_2019\_RD0563\_210\_768\_20190826\_00113.jpg

LM Start	<b>9.25</b>	Rating **	M	Issue No.	<b>768</b>
LM End	<b>9.25</b>	Issue Type +	Ma	Location *	LS
Category	Earthen Levee			GPS Latitude/Longitude	
				Start	End
Item	Trim / Thin Trees			38.145897°	38.145897°
				-121.588203°	-121.588203°
DWR ID	DWR_RD0563_01_s_2015_768				
Comment Code					
T1 : Trim trees to at least five feet above ground level.					
Inspector Comment

Looking south at the landside slope.

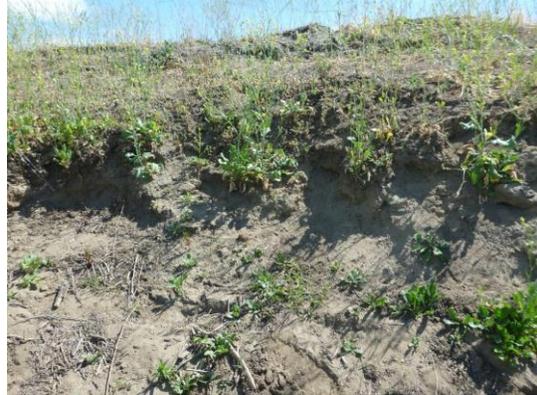
Photo 2 of 3 : LEVAL\_FA\_2019\_70\_667.jpg

LM Start	<b>9.73</b>	Rating **	A/W	Issue No.	<b>105 (cont)</b>
LM End	<b>9.78</b>	Issue Type +	Ma	Location *	
Category	Supplemental			GPS Latitude/Longitude	
				Start	End
Item	2017 Storm Damage			38.150820°	38.151196°
				-121.593650°	-121.594780°
DWR ID	DWR_RD0563_01_s_2012_49				
Comment Code					
Inspector Comment					
Levee Evaluation Comments					
Description:					
Site ID No:70					
Site Designation:DWR_RD0563_01_s_2012_49					
Repair Type: Erosion					
Rating:Serious					
Field Date:6/9/2017					
Notes:

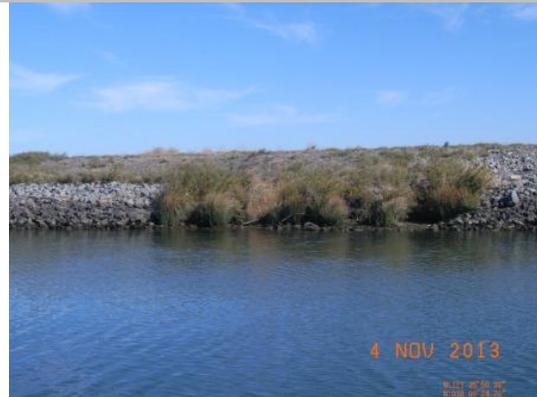
Photo 1 of 1 : FA\_2019\_RD0563\_210\_65\_20190826\_00023.jpg

LM Start	<b>10.45</b>	Rating **	M	Issue No.	<b>65</b>
LM End	<b>10.74</b>	Issue Type +	Ma	Location *	WS
Category	Supplemental			GPS Latitude/Longitude	
				Start	End
Item	2017 USACE Erosion Survey			38.143519°	38.139918°
				-121.599677°	-121.596986°
DWR ID	DWR_RD0563_01_f_2018_65				
Comment Code					
Inspector Comment					
2017 Site ID: GEO 1.7 L Status: Eroding 2017 Field Notes: New rock placed in erosion pockets , site has improved with work done by RD, but still some erosion pockets and toe erosion. Slump failure with headscarp at downstream end. Site History: 1997 - Old damaged rock riprap along the toe. 1999 - Downstream end (400 ft) repaired with rock. 2002 - New rock/concrete rubble section on the downstream end. 2004 - Small pocket repairs at the downstream end. 2005 - Some new bundles in the brush boxes. 2012 - Some rock has been placed in last year.

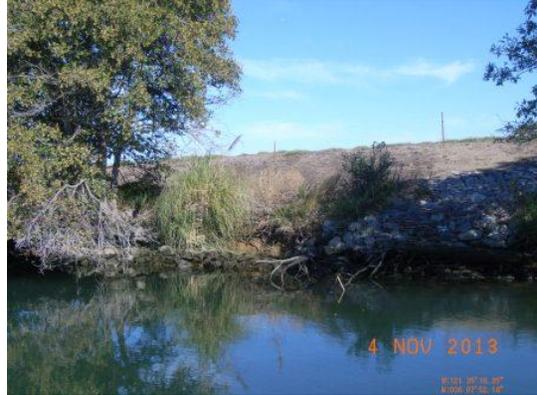
Photo 1 of 1 : FA\_2019\_RD0563\_210\_63\_20190826\_00021.jpg

Item	2017 USACE Erosion Survey		38.130544 °	38.129968 °	
			-121.587607 °	-121.585981 °	
DWR ID	DWR_RD0563_01_f_2018_63				
Comment Code					
Inspector Comment					
2017 Site ID: GEO 0.3 L Status: Eroding 2017 Field Notes: Site shortened. New rock placed on levee slope in erosion pockets. Site History: 1997 - Erosion pockets into the levee toe. 1999 - Some small pockets fixed with rock riprap. 2002 - New "brush boxes" along the bank toe. 2005 - Brush boxes are empty. Some pockets are filled with new stone. 2006 - Some new rock at the downstream end (~100 ft long). Several small pockets of new rock in scallops. Brush boxes in poor to fair condition. 2010 - Site looks a little worse, some toe rock but still has erosion scars at lower to mid slope. 2011 - Site upgraded to CRITICAL. Significant new erosion. Erosion scallops are vertical and almost the height of the levee. 2012 - Rock has been placed in some of the erosion scallops and therefore the site is no longer critical. 2013 - Site shortened site. The downstream half of site was repaired by RD. Pipe no longer in site limits.

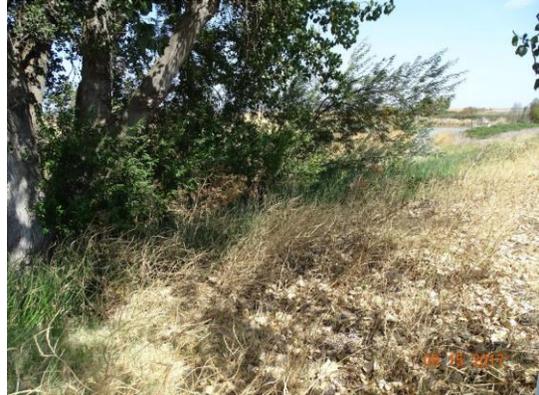
Photo 1 of 2 : FA\_2019\_RD0563\_210\_47\_20190826\_00017.jpg

LM Start	<b>12.04</b>	Rating **	M	Issue No.	<b>47</b>
LM End	<b>12.04</b>	Issue Type +	Ma	Location *	LS
Category	Earthen Levee		GPS Latitude/Longitude		
			Start	End	
Item	Trim / Thin Trees		38.130758°	38.130758°	
			-121.579027°	-121.579027°	
DWR ID	DWR_RD0563_01_s_2012_47				
Comment Code					
T1 : Trim trees to at least five feet above ground level.					
Inspector Comment					
Trim tree on landside slope.

Looking northeast at the landside slope.
