**Flood Control Project Maintenance
Levee Inspections**

Fall 2019 Levee Maintenance Deficiency Summary Report

Sacramento River Basin

Reclamation District No. 0900 West Sacramento

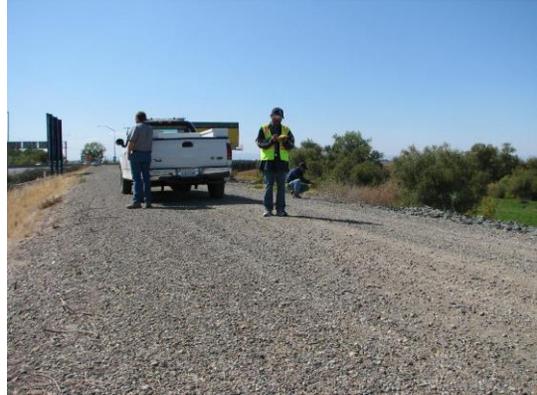
Photo 1 of 3 : UCIP_FA_2019_41825_72725.jpg

Comment Code					
Inspector Comment					
DS_ID:17862 FS_ID:41825 EP_NO: 2444 Repair Type: Non-Urgent Crossing Status: Indicator Found UCIP Comments: Records show 3 gas lines in general area--unable to confirm alignment and status of crossing. Markers visible in general area are for Kinder Morgan and not the owner listed on permit. Need to contact owner to clarify if crossing is still present and if so determine status of crossing. Need date of last inspection and confirmation that crossing is still in operable condition. FIELD_STRUCT_DESC: 16-inch high pressure steel gas line through the levee, 3.0 feet below the levee crown. (16-inch pipe authorized under Permit No. 2444, 1956 - Pacific Gas and Electric Company [PG&E]) [Additional Reference(s): DWR Levee Log, 2003] FS Date: 10/5/2009

View of levee crown near marker.

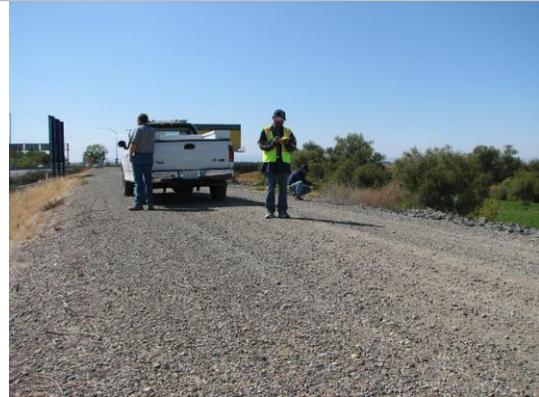
Photo 1 of 3 : UCIP_FA_2019_41826_72722.jpg

Comment Code					
Inspector Comment					
DS_ID:17874 FS_ID:41826 EP_NO: 17739 Repair Type: Non-Urgent Crossing Status: Indicator Found UCIP Comments: Records show 3 gas lines in general area--unable to confirm alignment and status of crossing. Markers visible in general area are for Kinder Morgan and not the owner listed on permit. Need to contact owner to clarify if crossing is still present and if so determine status of crossing. Need date of last inspection and confirmation that crossing is still in operable condition. FIELD_STRUCT_DESC: 20-inch petroleum pipeline across and under (bored) Willow Slough and its west levee, across (trenched) the Yolo bypass, and across and under (bored) toe drain and east levee. (20-inch pipe authorized under Permit No. 17739, 2004 - Paragon Partners Ltd.; name change authorized under Permit No. 17739-Rev, 2004 - SFPP, L.P., a Delaware Limited Partnership c/o Paragon Partners Ltd) FS Date: 10/5/2009

View of levee crown near marker.

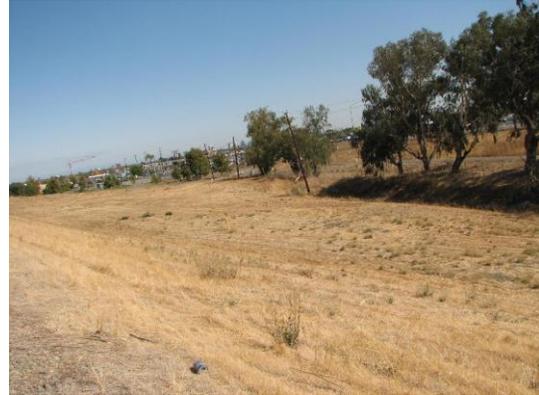
Photo 3 of 3 : UCIP_FA_2019_41826_72720.jpg

Comment Code					
Inspector Comment					
DS_ID:17874 FS_ID:41826 EP_NO: 17739 Repair Type: Non-Urgent Crossing Status: Indicator Found UCIP Comments: Records show 3 gas lines in general area--unable to confirm alignment and status of crossing. Markers visible in general area are for Kinder Morgan and not the owner listed on permit. Need to contact owner to clarify if crossing is still present and if so determine status of crossing. Need date of last inspection and confirmation that crossing is still in operable condition. FIELD_STRUCT_DESC: 20-inch petroleum pipeline across and under (bored) Willow Slough and its west levee, across (trenched) the Yolo bypass, and across and under (bored) toe drain and east levee. (20-inch pipe authorized under Permit No. 17739, 2004 - Paragon Partners Ltd.; name change authorized under Permit No. 17739-Rev, 2004 - SFPP, L.P., a Delaware Limited Partnership c/o Paragon Partners Ltd) FS Date: 10/5/2009

View of additional marker visible on landward side.

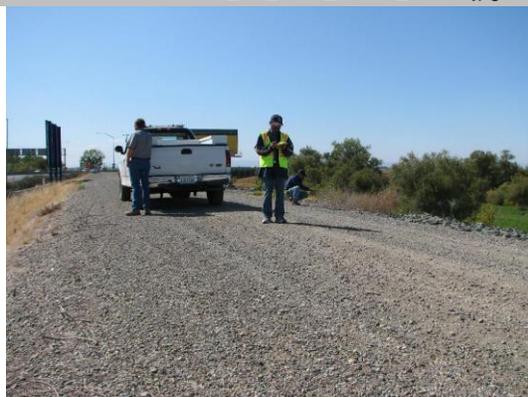
Photo 1 of 3 : UCIP_FA_2019_41824_72728.jpg

Comment Code					
Inspector Comment					
DS_ID:17861 FS_ID:41824 EP_NO: 11539 Repair Type: Non-Urgent Crossing Status: Indicator Found UCIP Comments: Records show 3 gas lines in general area--unable to confirm alignment and status of crossing. Markers visible in general area are for Kinder Morgan and not the owner listed on permit. Need to contact owner to clarify if crossing is still present and if so determine status of crossing. Need date of last inspection and confirmation that crossing is still in operable condition. FIELD_STRUCT_DESC: 16-inch steel gas line through the levee, 3.5 feet below the levee crown. (16-inch pipe authorized under Permit No. 11539, 1977 - Pacific Gas and Electric Company [PG&E]). [Additional Reference(s): DWR Levee Log, 2003] FS Date: 10/5/2009

View of levee crown near marker visible on landward shoulder.

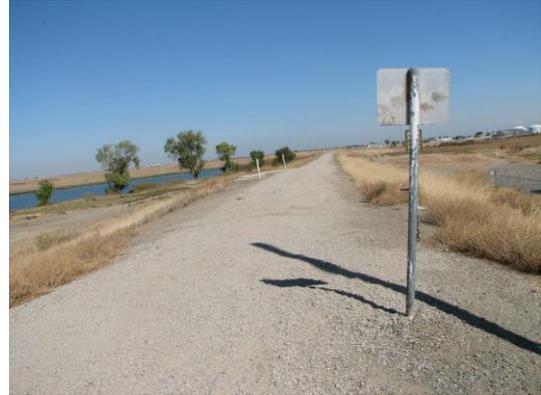
Photo 1 of 3 : UCIP_FA_2019_37770_68626.jpg

LM Start	3.23	Rating **	M	Issue No.	70
LM End	3.23	Issue Type +	En	Location *	
Category	Supplemental			GPS Latitude/Longitude	
				Start	End
Item	DRAFT DWR UCIP Field Study			38.541353°	38.541353°
				-121.582202°	-121.582202°
DWR ID	17885				
Comment Code					
Inspector Comment					
DS_ID:17885 FS_ID:37770 EP_NO: 17070 Repair Type: Non-Urgent Crossing Status: Found UCIP Comments: Dense vegetation limits the inspector's visibility to identify signs of pipe failure (leaks) along the slope. Recommend removing vegetation along pipe alignment to conduct proper inspection of structure. FIELD_STRUCT_DESC: [Southport Business Park Storm Water Pump Station] 1 of 5. 30-inch steel drainage pipe through the levee, 2 feet below the levee crown. (12-inch pipe and four 30-inch pipes authorized under Permit No. 17070, 2000 - Reclamation District No. 900) FS Date: 10/5/2009

View of levee crown at crossing.

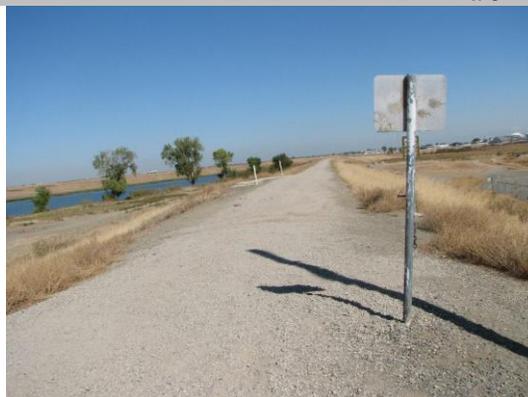
Photo 1 of 3 : UCIP_FA_2019_37766_68620.jpg

LM Start	3.23	Rating **	M	Issue No.	71
LM End	3.23	Issue Type +	En	Location *	
Category	Supplemental			GPS Latitude/Longitude	
				Start	End
Item	DRAFT DWR UCIP Field Study			38.541330°	38.541330°
				-121.582201°	-121.582201°
DWR ID	17876				
Comment Code					
Inspector Comment					
DS_ID:17876 FS_ID:37766 EP_NO: 17070 Repair Type: Non-Urgent Crossing Status: Found UCIP Comments: Dense vegetation limits the inspector's visibility to identify signs of pipe failure (leaks) along the slope. Recommend removing vegetation along pipe alignment to conduct proper inspection of structure. FIELD_STRUCT_DESC: [Southport Business Park Storm Water Pump Station] 2 of 5. 30-inch steel drainage pipe through the levee, 2 feet below the levee crown. (12-inch pipe and four 30-inch pipes authorized under Permit No. 17070, 2000 - Reclamation District No. 900) FS Date: 10/5/2009

View of levee crown at crossing.

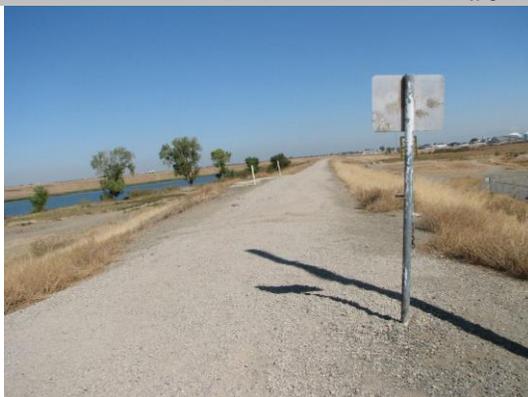
Photo 1 of 3 : UCIP_FA_2019_37780_68662.jpg

LM Start	3.24	Rating **	M	Issue No.	73
LM End	3.24	Issue Type +	En	Location *	
Category	Supplemental			GPS Latitude/Longitude	
				Start	End
Item	DRAFT DWR UCIP Field Study			38.541290 °	38.541290 °
				-121.582201 °	-121.582201 °
DWR ID	17887				
Comment Code					
Inspector Comment					
DS_ID:17887 FS_ID:37780 EP_NO: 17070 Repair Type: Non-Urgent Crossing Status: Found UCIP Comments: Dense vegetation limits the inspector's visibility to identify signs of pipe failure (leaks) along the slope. Recommend removing vegetation along pipe alignment to conduct proper inspection of structure. FIELD_STRUCT_DESC: [Southport Business Park Storm Water Pump Station] 4 of 5. 30-inch steel drainage pipe through the levee, 2 feet below the levee crown. (12-inch pipe and four 30-inch pipes authorized under Permit No. 17070, 2000 - Reclamation District No. 900) FS Date: 10/5/2009

View of levee crown at crossing.

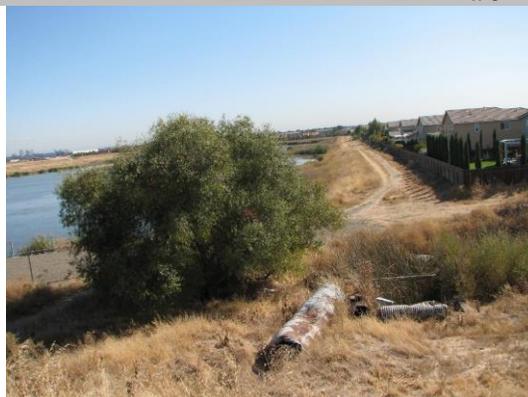
Photo 1 of 3 : UCIP_FA_2019_37785_68693.jpg

Comment Code					
Inspector Comment					
DS_ID:17856 FS_ID:37785 EP_NO: 2721A Repair Type: Non-Urgent Crossing Status: Found UCIP Comments: Need to contact owner--crossing appears to no longer be in use. Abandoned pipe sections visible on landward side and damage to pump station on waterward side. FIELD_STRUCT_DESC: [Drainage Pump Station] 36-inch corrugated metal irrigation pipe through the levee, 3.0 feet below the levee crown. Pump house and siphon breaker are located on the on the waterside (WS). (two 30-inch pipes at location 1, HLM 1.05, (drainage pump) and 36-inch pipe at location 2, HLM 3.68, (irrigation pump) authorized under Permit No. 2721A - Reclamation District No. 900 [RD0900]). [Additional Reference(s): DWR Levee Log, 2003] FS Date: 10/5/2009

View of pipe sections visible on landward side.

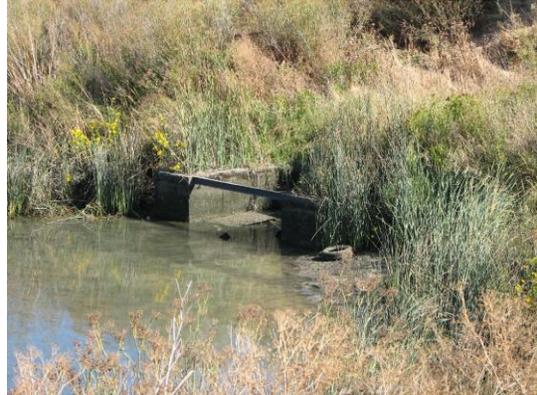
Photo 2 of 3 : UCIP_FA_2019_37785_68692.jpg

Comment Code					
Inspector Comment					
DS_ID:17856 FS_ID:37785 EP_NO: 2721A Repair Type: Non-Urgent Crossing Status: Found UCIP Comments: Need to contact owner--crossing appears to no longer be in use. Abandoned pipe sections visible on landward side and damage to pump station on waterward side. FIELD_STRUCT_DESC: [Drainage Pump Station] 36-inch corrugated metal irrigation pipe through the levee, 3.0 feet below the levee crown. Pump house and siphon breaker are located on the on the waterside (WS). (two 30-inch pipes at location 1, HLM 1.05, (drainage pump) and 36-inch pipe at location 2, HLM 3.68, (irrigation pump) authorized under Permit No. 2721A - Reclamation District No. 900 [RD0900]). [Additional Reference(s): DWR Levee Log, 2003] FS Date: 10/5/2009

Concrete outlet visible on waterward side.

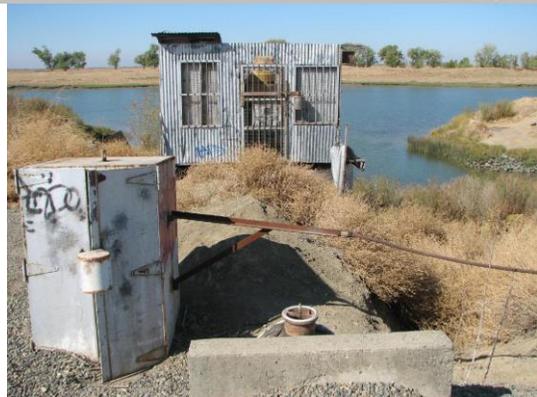
Photo 3 of 3 : UCIP_FA_2019_37785_68691.jpg

View of pump house visible on waterward side.
