**Flood Control Project Maintenance
Levee Inspections**

Fall 2019 Levee Maintenance Deficiency Summary Report

**Flood Control Project Maintenance
Levee Inspections**
LMA District Cover Sheet
Fall 2019 Levee Inspection Results

Reclamation District No. 0999 Netherlands

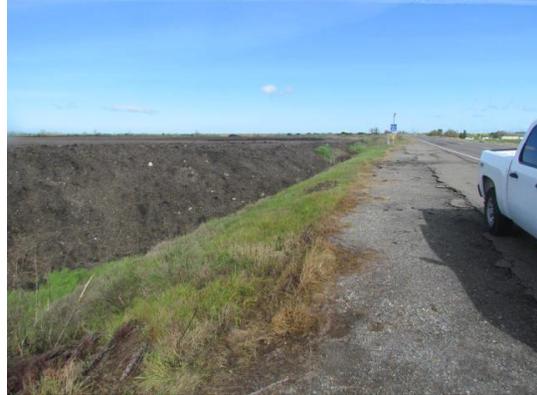
Photo 1 of 3 : FA_2019_RD0999_232_1_20190904_00001.jpg

LM Start	0.12	Rating **	U	Issue No.	1
LM End	0.39	Issue Type +	En	Location *	WS
Category	Earthen Levee		GPS Latitude/Longitude		
			Start	End	
Item	Encroachments		38.503346°	38.499389°	
			-121.582116°	-121.581933°	
DWR ID	DWR_RD0999_01_s_2012_1				
Comment Code					
MA : Material					
Inspector Comment					
Landfill has been in place for several years. Instruct landowner to apply for a CVFPB permit to authorize hauled material on the waterward berm.

Looking north at fill on waterward berm. Spring 2016

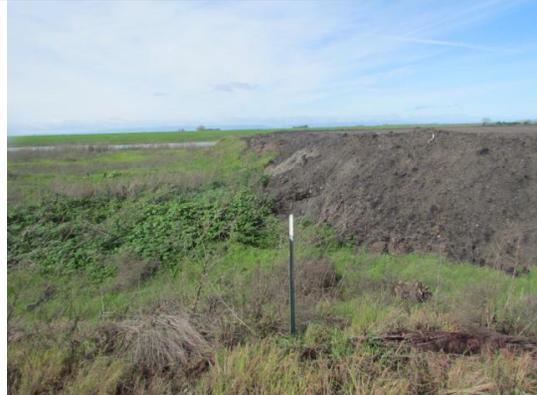
Photo 2 of 3 : FA_2019_RD0999_232_1_20190904_00002.jpg

Looking west at fill on waterward berm. Spring 2016

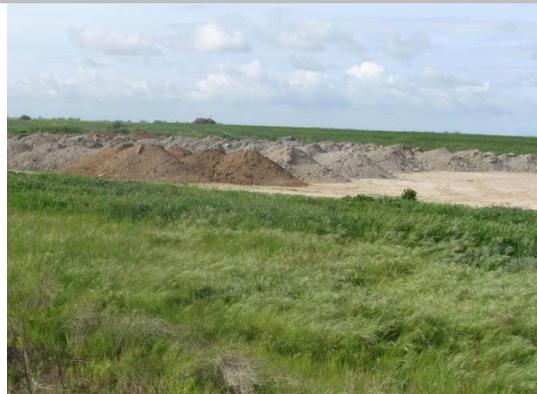
Photo 3 of 3 : FA_2019_RD0999_232_1_20190904_00003.jpg

Looking west at material on waterward berm.

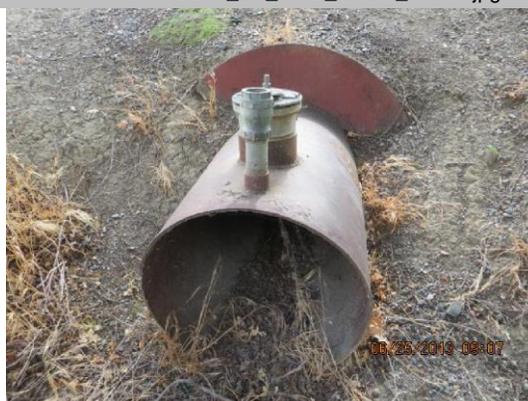
Photo 1 of 3 : UCIP_FA_2019_53368_25191.jpg

Comment Code					
Inspector Comment					
DS_ID:22743 FS_ID:53368 EP_NO: N/A Repair Type: Non-Urgent Crossing Status: Found UCIP Comments: 07/26/2018 Same as last inspection. Pipe open on WS, but no visual signs of pipe or levee integrity issues so downgrading crossing to Non-Urgent (D. Sanoski - DWR UCIP).07/07/2016 Condition largely unchanged from previous inspection. Pipe open on the WS, waterward of the siphon breaker. Dense vegetation and steep slope limited inspection of WS outlet into Ship Channel. (T. Hatch/UCIP) 06/25/2013 Pipe abandoned and open on WS slope. Pipe should be abandoned properly. (W. Wylie/UCIP) FIELD_STRUCT_DESC: *ABANDONED* 30-inch steel drainage pipe through the levee, 6.5 feet below the crown. Pump on a platform in the canal off the landside (LS) toe, not found. Flap gate on the waterside (WS), not found. Siphon breaker and an air vent on the WS shoulder. 1-inch galvanized iron filler pipe visible on the WS shoulder along same alignment. [Additional Reference(s): DWR Levee Log, 1992. USACE Sacramento O&M Manual 113 (Revised), October 1966, (HLM 1.73)]. FS Date: 7/26/2018 10:10:00 AM

Pipe open on WS slope

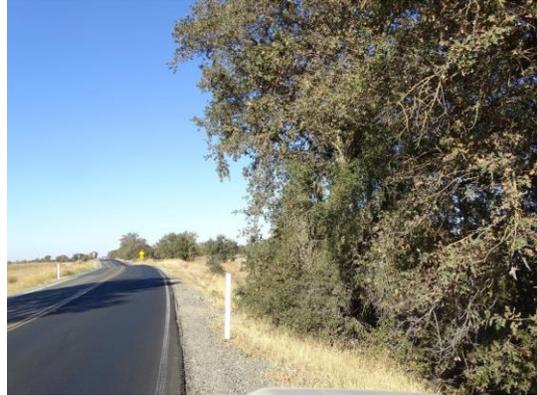
Photo 1 of 3 : FA_2019_RD0999_232_30_20190930_00076.jpg

LM Start	1.79	Rating **	M	Issue No.	30
LM End	2.13	Issue Type +	Ma	Location *	LS
Category	Earthen Levee			GPS Latitude/Longitude	
				Start	End
Item	Trim / Thin Trees			38.479165°	38.474200°
				-121.580640°	-121.580480°
DWR ID	DWR_RD0999_01_s_2012_30				
Comment Code					
T1 : Trim trees to at least five feet above ground level.					
Inspector Comment					
LMA claimed that RD765 is responsible for maintenance for landside section approximately between LM 1.79-2.25, but DWR forwarded the LMA their boundary map located in the USACE Unit 113 O&M Manual.

View of untrimmed trees on landside slope. LMA claims that RD 765 is responsible for maintenance. Fall 2018

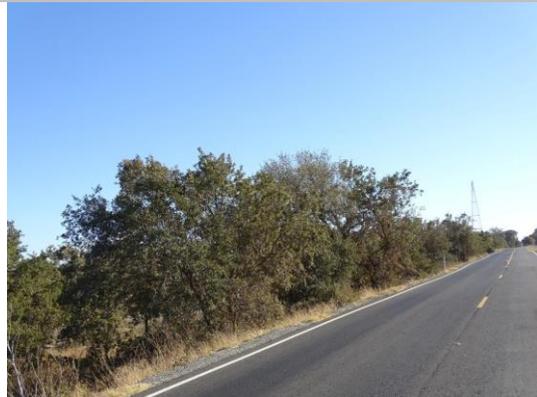
Photo 2 of 3 : FA_2019_RD0999_232_30_20190904_00012.jpg

View of untrimmed trees on landside slope. LMA claims that RD 765 is responsible for maintenance. Fall 2018

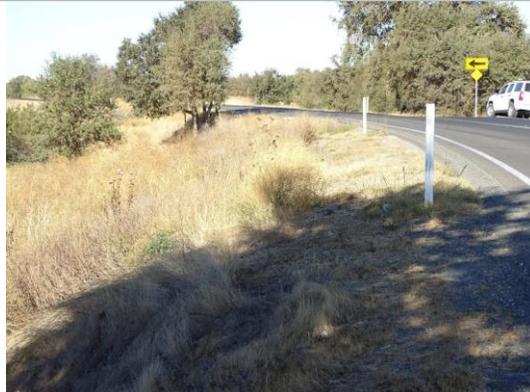
Photo 1 of 2 : FA_2019_RD0999_232_32_20190904_00017.jpg

LM Start	2.17	Rating **	M	Issue No.	32
LM End	2.17	Issue Type +	Ma	Location *	WS
Category	Earthen Levee		GPS Latitude/Longitude		
			Start	End	
Item	Vegetation		38.473650 °	38.473650 °	
			-121.580756 °	-121.580756 °	
DWR ID	DWR_RD0999_01_f_2017_32				
Comment Code					
V2 : Remove the wild growth other than native grasses from the levee slopes.					
Inspector Comment					
Trim wild growth on levee slope, and monitor Arundo in area.

View of tall weeds on levee slope. Fall 2018

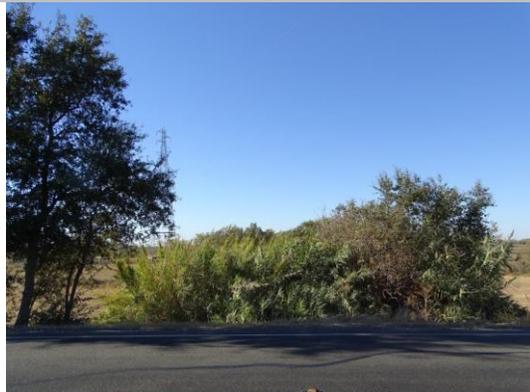
Photo 2 of 2 : FA_2019_RD0999_232_32_20190904_00018.jpg

View of Arundo further down levee slope. Fall 2018

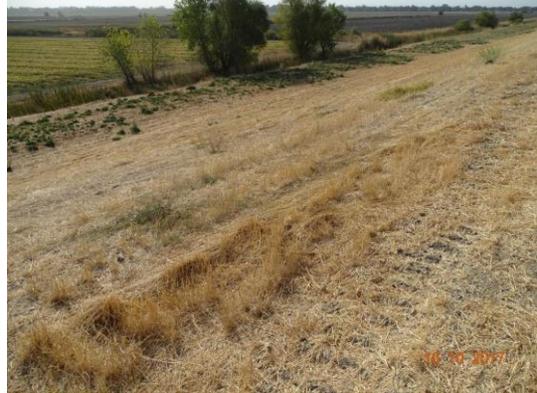
Photo 1 of 3 : FA_2019_RD0999_232_51_20190904_00033.jpg

LM Start	3.22	Rating **	M	Issue No.	51
LM End	3.22	Issue Type +	Ma	Location *	LS
Category	Earthen Levee		GPS Latitude/Longitude		
			Start	End	
Item	Slope Stability		38.459399°	38.459399°	
			-121.587523°	-121.587523°	
DWR ID	DWR_RD0999_01_s_2013_51				
Comment Code					
S1 : Repair slope instability.					
Inspector Comment					
Repair depression on landward shoulder and slope approximately 40' x 20'. Earthen material appears to be sliding toward levee toe.

View of landside slope looking south. Fall 2017

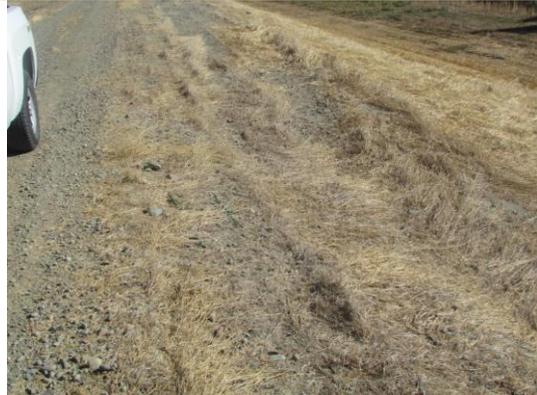
Photo 2 of 3 : FA_2019_RD0999_232_51_20190904_00034.jpg

Looking northeast at depression on landward slope. Fall 2016

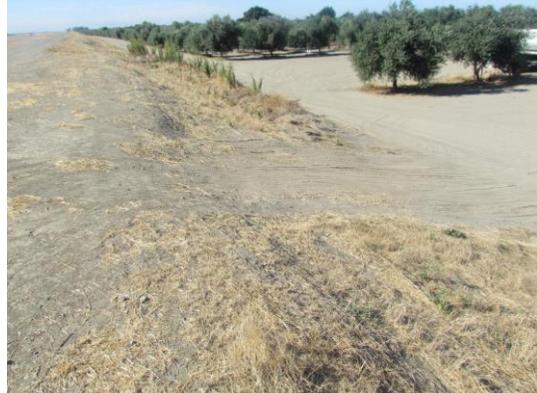
Photo 1 of 1 : FA_2019_RD0999_232_27_20190904_00010.jpg

LM Start	4.31	Rating **	M	Issue No.	27
LM End	4.31	Issue Type +	Ma	Location *	WS
Category	Earthen Levee		GPS Latitude/Longitude		
			Start	End	
Item	Slope Stability		38.444560°	38.444560°	
			-121.594440°	-121.594440°	
DWR ID	DWR_RD0999_01_f_2012_27				
Comment Code					
S3 : Repair the levee slope damaged by vehicle traffic and prevent access where possible.					
Inspector Comment					
Instruct farmer to stop driving equipment and trucks on slope.

Looking at slope damage cause by vehicle traffic on waterward slope. (Fall 2016)

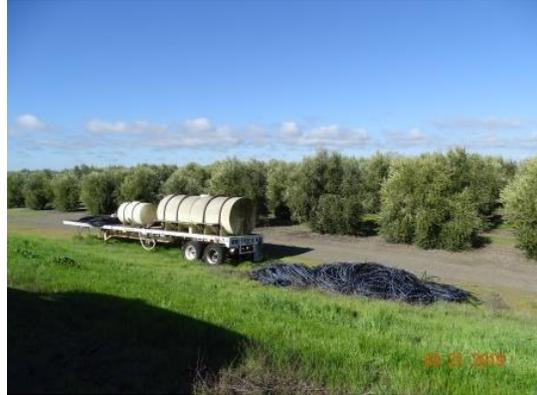
Photo 1 of 1 : FA_2019_RD0999_232_42_20190904_00025.jpg

LM Start	5.13	Rating **	M	Issue No.	42
LM End	5.13	Issue Type +	En	Location *	WS
Category	Earthen Levee		GPS Latitude/Longitude		
			Start	End	
Item	Encroachments		38.433425°	38.433425°	
			-121.599627°	-121.599627°	
DWR ID	DWR_RD0999_01_s_2019_42				
Comment Code					
EQ : Equipment					
Inspector Comment					
Instruct landowner to move farming equipment to at least 10' away from the levee toe.

View of farming equipment and materials at waterside toe. Spring 2019

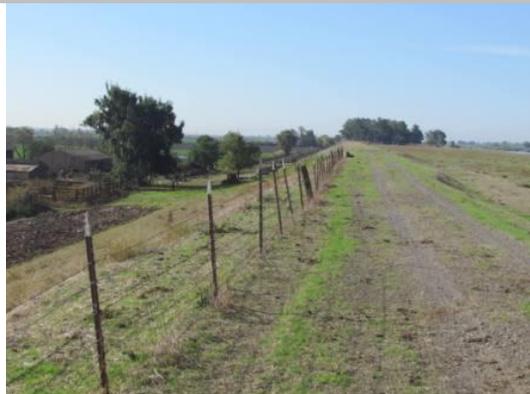
Photo 1 of 2 : FA_2019_RD0999_232_918_20190904_00040.jpg

LM Start	9.12	Rating **	M	Issue No.	918
LM End	9.25	Issue Type +	En	Location *	LS
Category	Earthen Levee		GPS Latitude/Longitude		
			Start	End	
Item	Encroachments		38.379019°	38.377261°	
			-121.624777°	-121.625619°	
DWR ID	DWR_RD0999_01_s_2012_918				
Comment Code					
FE : Fence					
Inspector Comment					
Instruct landowner to apply for a CVFPB permit for fence along the landward shoulder.

Looking south at fence along landside shoulder.

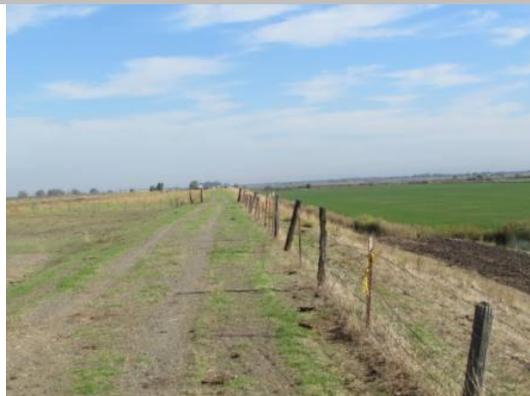
Photo 2 of 2 : FA_2019_RD0999_232_918_20190904_00041.jpg

Looking north at fence along landside shoulder.

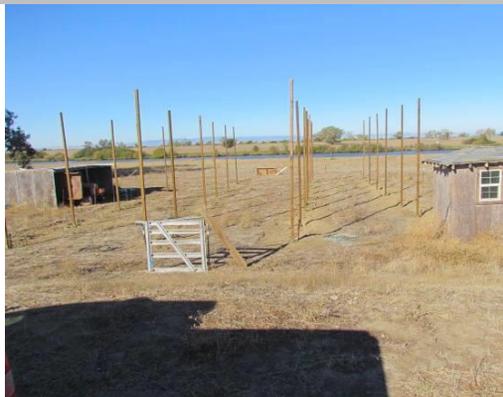
Photo 1 of 1 : FA_2019_RD0999_232_56_20190904_00036.jpg

LM Start	9.64	Rating **	M	Issue No.	56
LM End	9.64	Issue Type +	En	Location *	WS
Category	Earthen Levee		GPS Latitude/Longitude		
			Start	End	
Item	Encroachments		38.372002°	38.372002°	
			-121.628052°	-121.628052°	
DWR ID	DWR_RD0999_01_f_2015_56				
Comment Code					
CR : Crops					
Inspector Comment					
Instruct landowner to apply for a CVFPB permit for authorization of crop plantings and pole and tool shed installations on waterside berm.

Looking west at crops, poles, and tool sheds on waterward berm.

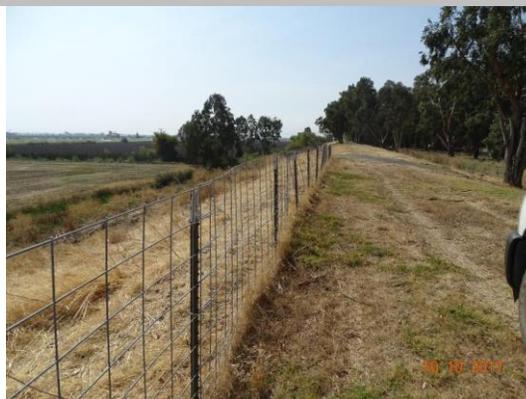
Photo 1 of 1 : FA_2019_RD0999_232_34_20190904_00020.jpg

LM Start	9.65	Rating **	M	Issue No.	34
LM End	9.66	Issue Type +	En	Location *	LS
Category	Earthen Levee		GPS Latitude/Longitude		
			Start	End	
Item	Encroachments		38.371885°	38.371652°	
			-121.628087°	-121.628198°	
DWR ID	DWR_RD0999_01_f_2017_34				
Comment Code					
FE : Fence					
Inspector Comment					
Instruct landowner to move the fence outside of the easement or apply for a CVFPB permit to authorize fence.

View of landside slope looking south. Fall 2017

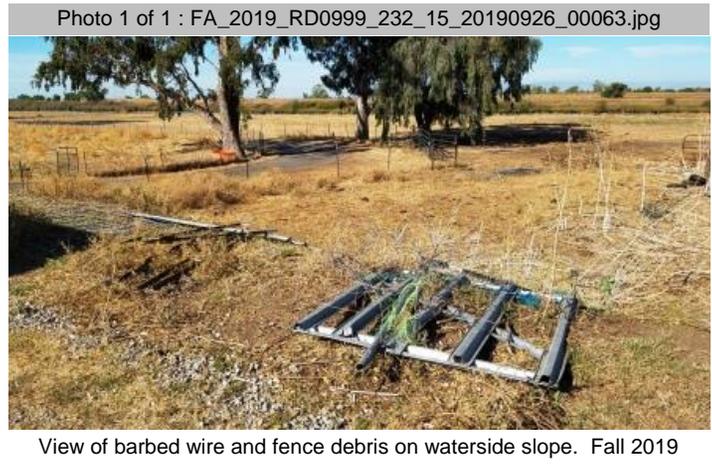
LM Start	9.65	Rating **	M	Issue No.	15
LM End	9.65	Issue Type +	En	Location *	WS
Category	Earthen Levee			GPS Latitude/Longitude	
				Start	End
Item	Encroachments			38.371835 °	38.371835 °
				-121.628140 °	-121.628140 °
DWR ID	DWR_RD0999_01_f_2019_15				
Comment Code					
DE : Debris					
Inspector Comment					
Remove barbed wire debris from the waterside slope.

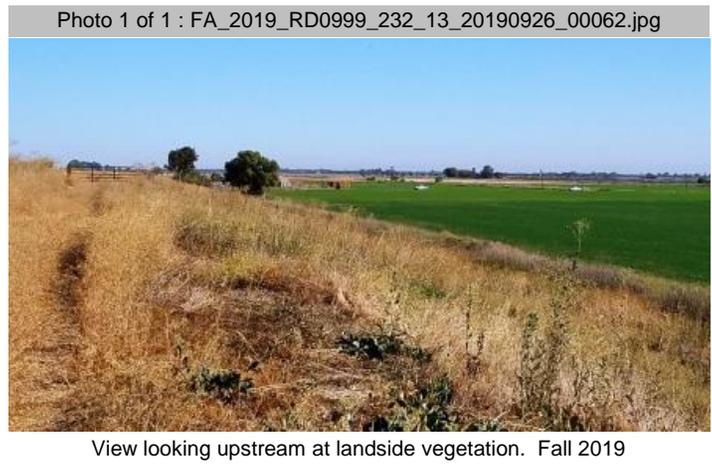
LM Start	9.67	Rating **	M	Issue No.	13
LM End	9.74	Issue Type +	Ma	Location *	LS
Category	Earthen Levee			GPS Latitude/Longitude	
				Start	End
Item	Vegetation			38.371553 °	38.370563 °
				-121.628265 °	-121.628743 °
DWR ID	DWR_RD0999_01_f_2019_13				
Comment Code					
V1 : Control annual grass and weeds on the levee slopes and easements.					
Inspector Comment

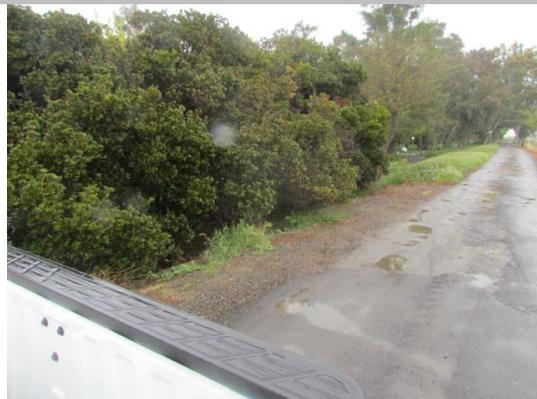
Photo 1 of 1 : FA_2019_RD0999_232_26_20190904_00009.jpg

LM Start	9.87	Rating **	M	Issue No.	26
LM End	9.87	Issue Type +	En	Location *	WS
Category	Earthen Levee			GPS Latitude/Longitude	
				Start	End
Item	Vegetation			38.368898°	38.368898°
				-121.629470°	-121.629470°
DWR ID	DWR_RD0999_01_s_2012_26				
Comment Code					
V6 : Landscaping					
Inspector Comment					
Trees should be trimmed up to 5' above the ground for visibility.

Looking northwest at dense trees on waterside slope.

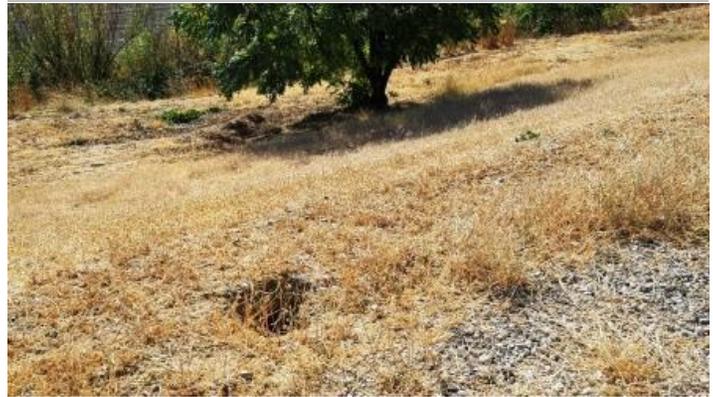
Photo 1 of 1 : FA_2019_RD0999_232_35_20190926_00065.jpg

LM Start	11.16	Rating **	M	Issue No.	35
LM End	11.16	Issue Type +	Ma	Location *	LS
Category	Earthen Levee		GPS Latitude/Longitude		
			Start	End	
Item	Animal Control		38.351308°	38.351308°	
			-121.637642°	-121.637642°	
DWR ID	DWR_RD0999_01_f_2018_35				
Comment Code					
A3 : No rodents visible, but rodent burrows visible; need to backfill and compact or grout burrows.					
Inspector Comment					
Backfill the animal burrow.

View of animal hole on the landside slope. Fall 2019

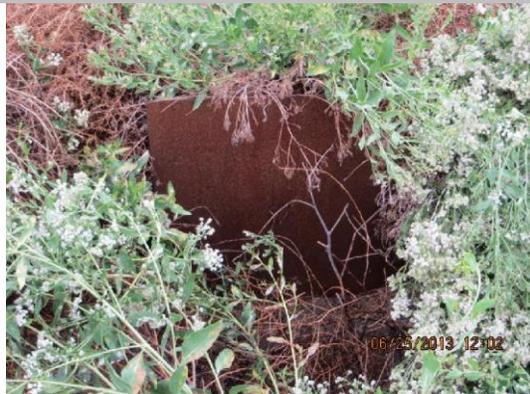
Photo 3 of 3 : UCIP_FA_2019_53369_25418.jpg

Comment Code					
Inspector Comment					
<p>DS_ID:22752 FS_ID:53369 EP_NO: 11735 Repair Type: Urgent Crossing Status: Found UCIP Comments: 07/26/2018 Appears abandoned. WS pipe has a welded metal plate to end and LS pipe end is open. Keeping as Urgent because of levee integrity concern on WS where the levee prism has a large cut into it at the pipe discharge location (D. Sanoski - DWR UCIP).07/07/2016 - Appears abandoned. Pipe is visible in exposed cut on the WS slope of the levee. Riser on LS shoulder damaged from vandalism. welded plate on WS. No pump found on the platform in the drainage ditch. (T. Hatch/UCIP)06/25/2013 - Appears abandoned. Pipe exposed in cut on on WS slope and open at LS toe. No pump or appurtances. (W. Wylie/UCIP) FIELD_STRUCT_DESC: *ABANDONED* 24-inch steel drainage pipe through the levee, 7 feet below the crown. Pump in a drainage ditch on the landside (LS) with a sheet pile headwall, not found. Flap gate on the waterside (WS), not found. Siphon breaker in a riser on the LS slope. (Replaced an existing 24-inch steel pipe under Permit No. 11735, 1978 - Reclamation District No. 999). [Additional Reference(s): DWR Levee Log, 1992. USACE Sacramento O&M Manual 113 (Revised), October 1966, (HLM 12.29)]. FS Date: 7/26/2018 10:16:00 AM</p>

Steel plate welded over pipe on WS end at WS slope.

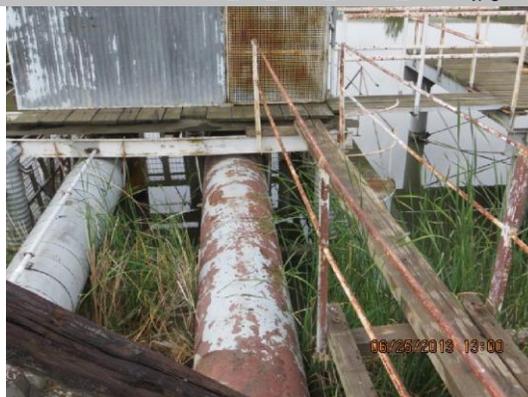
Photo 3 of 3 : UCIP_FA_2019_15365_25225.jpg

LM Start	15.24	Rating **	A/W	Issue No.	925 (cont)
LM End	15.24	Issue Type +	Ma	Location *	
Category	Supplemental			GPS Latitude/Longitude	
				Start	End
Item	DRAFT DWR UCIP LMA Responsibility			38.292973°	38.292973°
				-121.644977°	-121.644977°
DWR ID	22756				
Comment Code					
Inspector Comment					
DS_ID:22756 FS_ID:15365 EP_NO: N/A Repair Type: No Action Needed Crossing Status: Found UCIP Comments: FIELD_STRUCT_DESC: 30-inch steel drainage pipe through the levee, 7 feet below the crown. Flap gate on the waterside (WS) end. Pump in pump house on the landside (LS) toe. Siphon breaker in a corrugated metal pipe (CMP) riser on the WS shoulder. [Additional Reference(s): DWR Levee Log, 1992. USACE Sacramento O&M Manual 113 (Revised), October 1966, (HLM 15.25) (36-inch pipe listed)]. FS Date: 6/25/2013

Closeup of pipe at pumphouse on LS toe.

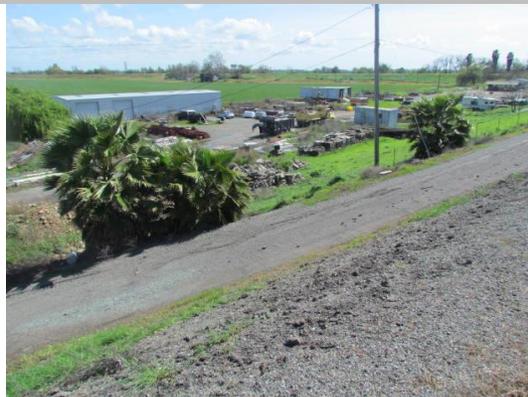
Photo 1 of 2 : FA_2019_RD0999_232_44_20190904_00027.jpg

LM Start	15.26	Rating **	U	Issue No.	44
LM End	15.43	Issue Type +	En	Location *	WS
Category	Earthen Levee			GPS Latitude/Longitude	
				Start	End
Item	Vegetation			38.292702°	38.290241°
				-121.644967°	-121.644716°
DWR ID	DWR_RD0999_01_s_2016_44				
Comment Code					
V6 : Landscaping					
Inspector Comment					
Instruct landowner to apply for a CVFPB permit to authorize palm trees planted on the landward slope and toe.

Looking east at palm trees on landward slope next to ramp.

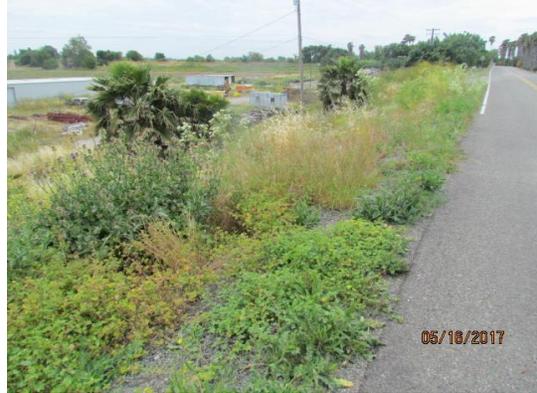
Photo 2 of 2 : FA_2019_RD0999_232_44_20190904_00028.jpg

LM Start	15.26	Rating **	U	Issue No.	44 (cont)
LM End	15.43	Issue Type +	En	Location *	WS
Category	Earthen Levee			GPS Latitude/Longitude	
				Start	End
Item	Vegetation			38.292702°	38.290241°
				-121.644967°	-121.644716°
DWR ID	DWR_RD0999_01_s_2016_44				
Comment Code					
V6 : Landscaping					
Inspector Comment					
Instruct landowner to apply for a CVFPB permit to authorize palm trees planted on the landward slope and toe.

View looking downstream at palm trees on the landward levee easement. Spring 2017

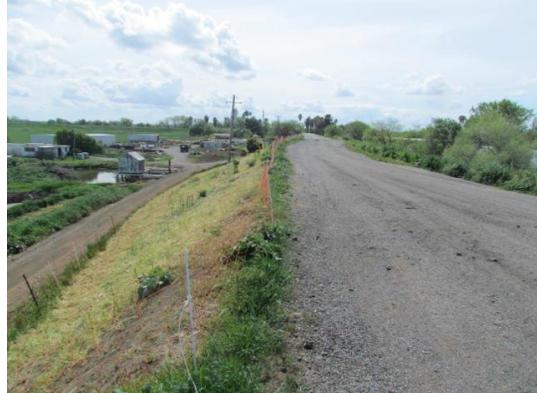
Photo 1 of 3 : FA_2019_RD0999_232_39_20190904_00022.jpg

LM Start	15.27	Rating **	M	Issue No.	39
LM End	15.41	Issue Type +	En	Location *	LS
Category	Earthen Levee			GPS Latitude/Longitude	
				Start	End
Item	Encroachments			38.292578°	38.290525°
				-121.644972°	-121.644902°
DWR ID	DWR_RD0999_01_s_2012_39				
Comment Code					
FE : Fence					
Inspector Comment					
Instruct landowner to move the fence outside of the levee easement or apply for a CVFPB permit to authorize the fence along the landside slope.

Looking east at fencing on landward shoulder and slope. (Spring 2015)

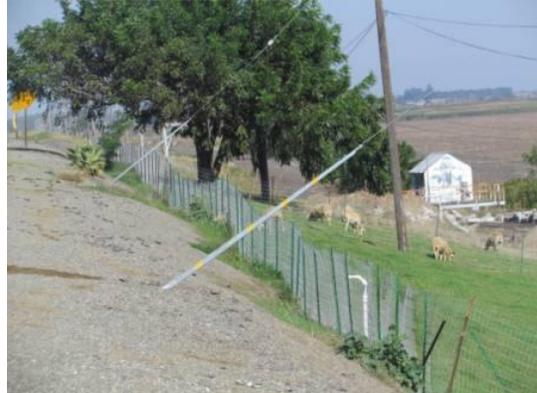
Photo 2 of 3 : FA_2019_RD0999_232_39_20190904_00023.jpg

Looking north at fence along landside slope.

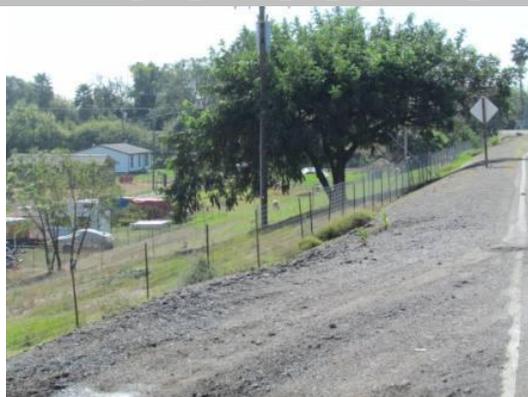
Photo 3 of 3 : FA_2019_RD0999_232_39_20190904_00024.jpg

LM Start	15.27	Rating **	M	Issue No.	39 (cont)
LM End	15.41	Issue Type +	En	Location *	LS
Category	Earthen Levee			GPS Latitude/Longitude	
				Start	End
Item	Encroachments			38.292578 °	38.290525 °
				-121.644972 °	-121.644902 °
DWR ID	DWR_RD0999_01_s_2012_39				
Comment Code					
FE : Fence					
Inspector Comment					
Instruct landowner to move the fence outside of the levee easement or apply for a CVFPB permit to authorize the fence along the landside slope.

Looking south at fence along landside slope.

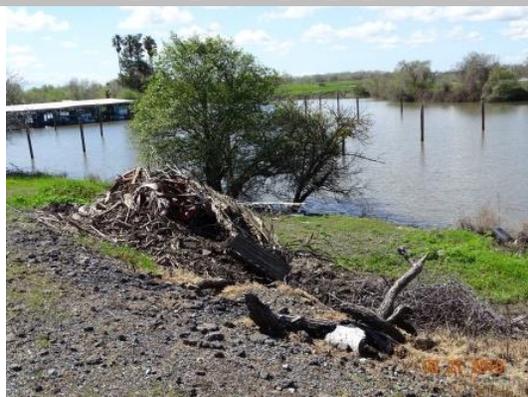
Photo 1 of 2 : FA_2019_RD0999_232_45_20190904_00029.jpg

LM Start	15.27	Rating **	M	Issue No.	45
LM End	15.28	Issue Type +	En	Location *	WS
Category	Earthen Levee			GPS Latitude/Longitude	
				Start	End
Item	Encroachments			38.292463 °	38.292360 °
				-121.645027 °	-121.644968 °
DWR ID	DWR_RD0999_01_s_2017_45				
Comment Code					
PR : Prunings					
Inspector Comment					
Remove prunings and utility poles from the waterside slope.

View of prunings left on waterside slope. Spring 2019

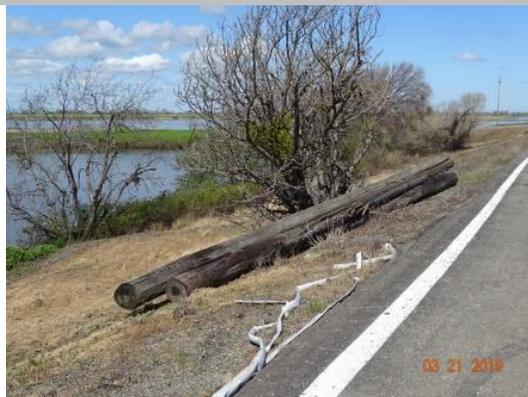
Photo 2 of 2 : FA_2019_RD0999_232_45_20190904_00030.jpg

View of utility poles left on waterside slope. Spring 2019

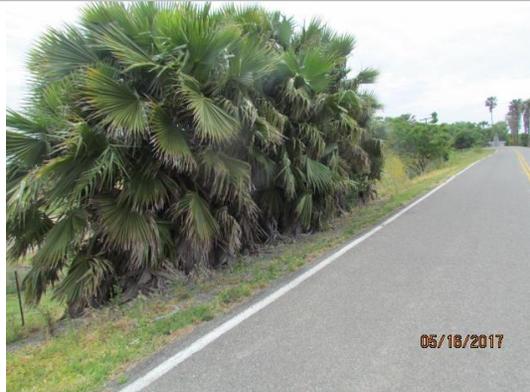
Photo 1 of 1 : FA_2019_RD0999_232_50_20190904_00032.jpg

LM Start	15.33	Rating **	U	Issue No.	50
LM End	15.33	Issue Type +	En	Location *	LS
Category	Earthen Levee		GPS Latitude/Longitude		
			Start	End	
Item	Encroachments		38.291663°	38.291663°	
			-121.644962°	-121.644962°	
DWR ID	DWR_RD0999_01_f_2012_50				
Comment Code					
TR : Tree or limb					
Inspector Comment					
Instruct landowner to apply for a CVFPB permit to authorize palm trees planted on the landside shoulder.

Looking east at palm trees (Spring 2017)

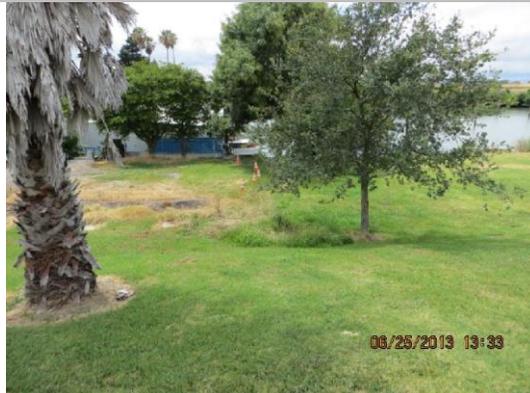
Photo 1 of 3 : UCIP_FA_2019_16330_27512.jpg

LM Start	15.36	Rating **	M	Issue No.	926
LM End	15.36	Issue Type +	En	Location *	
Category	Supplemental		GPS Latitude/Longitude		
			Start	End	
Item	DRAFT DWR UCIP Field Study		38.291192°	38.291192°	
			-121.644987°	-121.644987°	
DWR ID	23970				
Comment Code					
Inspector Comment					
DS_ID:23970 FS_ID:16330 EP_NO: N/A Repair Type: Non-Urgent Crossing Status: Found UCIP Comments: No permit identified for this crossing. FIELD_STRUCT_DESC: 4-inch polyvinyl chloride (PVC) water line through the levee, 2 feet below the crown. Pump off the waterside (WS) toe visible at the water's edge. FS Date: 6/25/2013

Pipe visible at WS toe in grass.

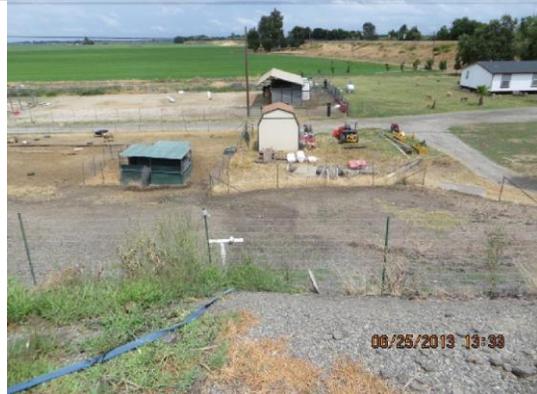
Photo 3 of 3 : UCIP_FA_2019_16330_27510.jpg

Pipe visible on LS toe.

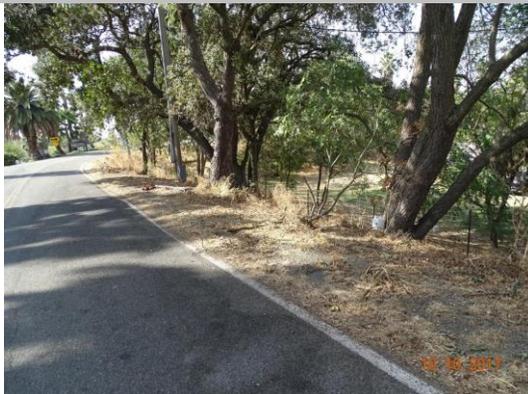
Photo 1 of 3 : FA_2019_RD0999_233_17_20190904_00013.jpg

LM Start	0.01	Rating **	M	Issue No.	17
LM End	0.06	Issue Type +	En	Location *	LS
Category	Earthen Levee			GPS Latitude/Longitude	
				Start	End
Item	Encroachments			38.290355°	38.290472°
				-121.644713°	-121.643888°
DWR ID	DWR_RD0999_02_s_2012_17				
Comment Code					
FE : Fence					
Inspector Comment					
Landowner has installed a fence along the landside slope for sheep to maintain the levee slope. Landowner should apply for a permit to keep the fence.

View of landside slope looking northwest. Fall 2017

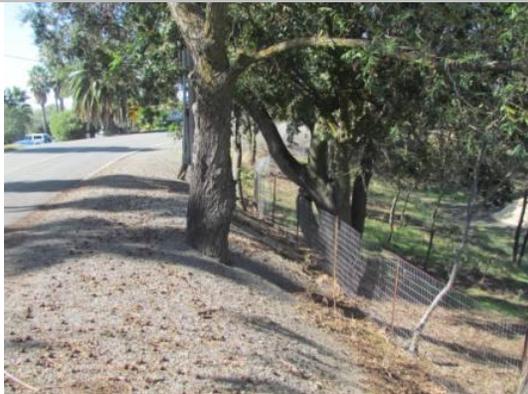
Photo 2 of 3 : FA_2019_RD0999_233_17_20190904_00014.jpg

Looking west at fence along landside slope.

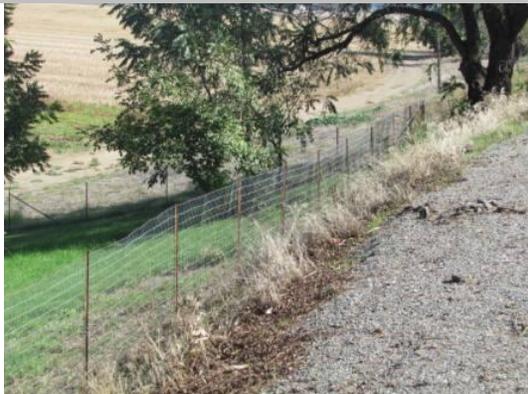
Photo 3 of 3 : FA_2019_RD0999_233_17_20190904_00015.jpg

Looking northeast at fence along landside shoulder.

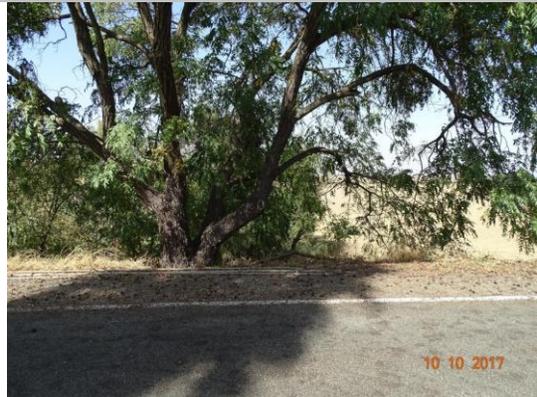
Photo 1 of 1 : FA_2019_RD0999_233_21_20190904_00018.jpg

LM Start	0.06	Rating **	M	Issue No.	21
LM End	0.06	Issue Type +	Ma	Location *	LS
Category	Earthen Levee			GPS Latitude/Longitude	
				Start	End
Item	Trim / Thin Trees			38.290434 °	38.290434 °
				-121.643873 °	-121.643873 °
DWR ID	DWR_RD0999_02_f_2017_21				
Comment Code					
T1 : Trim trees to at least five feet above ground level.					
Inspector Comment

View of trees on landside slope looking north. Fall 2017

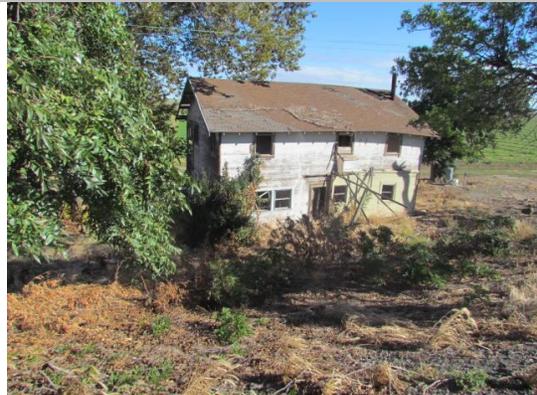
Photo 1 of 1 : FA_2019_RD0999_233_24_20190904_00019.jpg

LM Start	0.18	Rating **	U	Issue No.	24
LM End	0.18	Issue Type +	En	Location *	LS
Category	Earthen Levee			GPS Latitude/Longitude	
				Start	End
Item	Encroachments			38.290871 °	38.290871 °
				-121.641755 °	-121.641755 °
DWR ID	DWR_RD0999_02_f_2013_24				
Comment Code					
BU : Building					
Inspector Comment					
The abandoned building on landward toe and berm does not appear to be authorized.

Looking northward at abandoned building on landward berm.

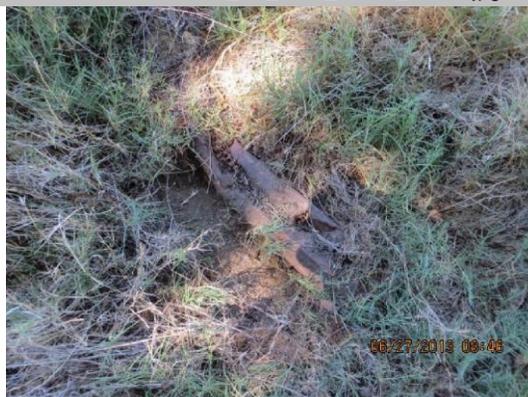
Photo 3 of 3 : UCIP_FA_2019_15384_25240.jpg

LM Start	0.79	Rating **	M	Issue No.	38 (cont)
LM End	0.79	Issue Type +	En	Location *	
Category	Supplemental			GPS Latitude/Longitude	
				Start	End
Item	DRAFT DWR UCIP Field Study			38.292562°	38.292562°
				-121.631331°	-121.631331°
DWR ID	22772				
Comment Code					
Inspector Comment					
DS_ID:22772 FS_ID:15384 EP_NO: N/A Repair Type: Non-Urgent Crossing Status: Found UCIP Comments: Pipe open on both ends. Pumphouse has been removed. Needs to be abandoned properly. FIELD_STRUCT_DESC: *ABANDONED* 8-inch steel irrigation pipe through the levee, 4.5 feet below the crown. Abandoned pump house on the waterside (WS) slope. [Additional Reference(s): DWR Levee Log, 1992. USACE Sacramento O&M Manual 113 (Revised), October 1966, (HLM 0.78)]. FS Date: 6/27/2013

Damaged pipe on LS slope.

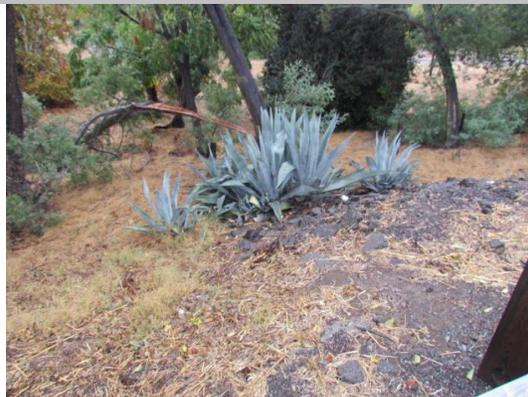
Photo 1 of 2 : FA_2019_RD0999_233_14_20190904_00011.jpg

LM Start	0.82	Rating **	M	Issue No.	14
LM End	0.82	Issue Type +	Ma	Location *	LS
Category	Earthen Levee			GPS Latitude/Longitude	
				Start	End
Item	Vegetation			38.292439°	38.292439°
				-121.630781°	-121.630781°
DWR ID	DWR_RD0999_02_f_2012_14				
Comment Code					
V2 : Remove the wild growth other than native grasses from the levee slopes.					
Inspector Comment					
Remove the Century plant on the landside slope.

Looking north at century plant at landward toe. Fall 2015.

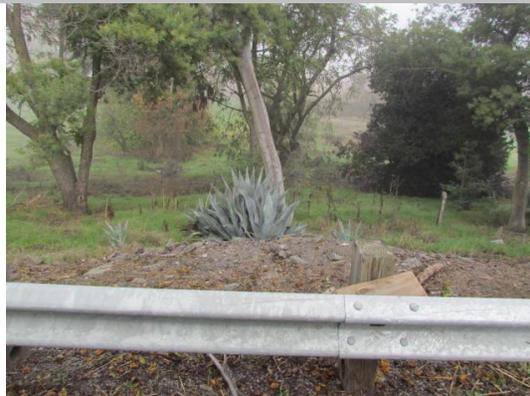
Photo 2 of 2 : FA_2019_RD0999_233_14_20190904_00012.jpg

LM Start	0.82	Rating **	M	Issue No.	14 (cont)
LM End	0.82	Issue Type +	Ma	Location *	LS
Category	Earthen Levee			GPS Latitude/Longitude	
				Start	End
Item	Vegetation			38.292439°	38.292439°
				-121.630781°	-121.630781°
DWR ID	DWR_RD0999_02_f_2012_14				
Comment Code					
V2 : Remove the wild growth other than native grasses from the levee slopes.					
Inspector Comment					
Remove the Century plant on the landside slope.

Looking north at century plant at landside toe.

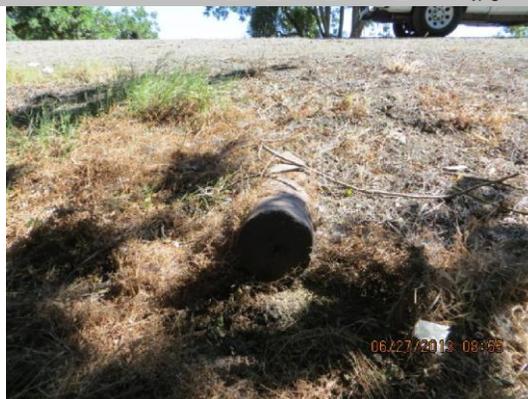
Photo 1 of 3 : UCIP_FA_2019_15385_25246.jpg

LM Start	0.93	Rating **	M	Issue No.	39
LM End	0.93	Issue Type +	En	Location *	
Category	Supplemental			GPS Latitude/Longitude	
				Start	End
Item	DRAFT DWR UCIP Field Study			38.291739°	38.291739°
				-121.628873°	-121.628873°
DWR ID	22773				
Comment Code					
Inspector Comment					
DS_ID:22773 FS_ID:15385 EP_NO: N/A Repair Type: Non-Urgent Crossing Status: Found UCIP Comments: Pipe should be abandoned properly. FIELD_STRUCT_DESC: *ABANDONED* 10-inch steel irrigation pipe through the levee, 4.9 feet below the crown. Capped on both ends. [Additional Reference(s): DWR Levee Log, 1992. USACE Sacramento O&M Manual 113 (Revised), October 1966, (HLM 0.93)]. FS Date: 6/27/2013

Pipe with welded steel plate over end visible on WS

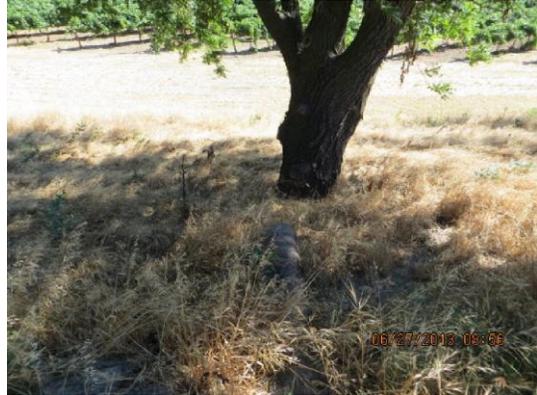
Photo 2 of 3 : UCIP_FA_2019_15385_25245.jpg

LM Start	0.93	Rating **	M	Issue No.	39 (cont)
LM End	0.93	Issue Type +	En	Location *	
Category	Supplemental			GPS Latitude/Longitude	
				Start	End
Item	DRAFT DWR UCIP Field Study			38.291739°	38.291739°
				-121.628873°	-121.628873°
DWR ID	22773				
Comment Code					
Inspector Comment					
DS_ID:22773 FS_ID:15385 EP_NO: N/A Repair Type: Non-Urgent Crossing Status: Found UCIP Comments: Pipe should be abandoned properly. FIELD_STRUCT_DESC: *ABANDONED* 10-inch steel irrigation pipe through the levee, 4.9 feet below the crown. Capped on both ends. [Additional Reference(s): DWR Levee Log, 1992. USACE Sacramento O&M Manual 113 (Revised), October 1966, (HLM 0.93)]. FS Date: 6/27/2013

Pipe with welded steel plate over end visible on LS

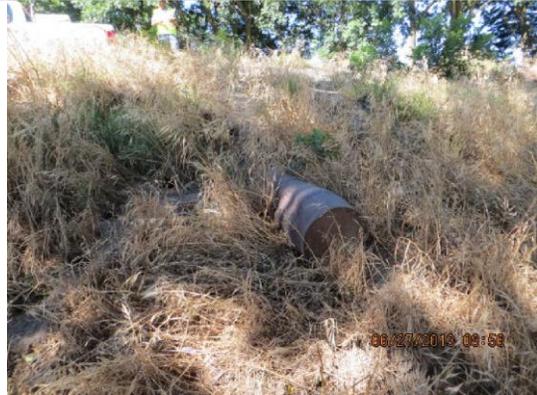
Photo 3 of 3 : UCIP_FA_2019_15385_25244.jpg

LM Start	0.93	Rating **	M	Issue No.	39 (cont)
LM End	0.93	Issue Type +	En	Location *

Pipe with welded steel plate over end

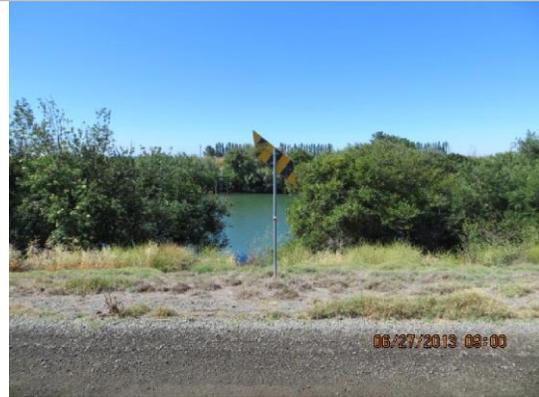
Photo 3 of 3 : UCIP_FA_2019_16331_27514.jpg

LM Start	1.02	Rating **	M	Issue No.	40 (cont)
LM End	1.02	Issue Type +	En	Location *	
Category	Supplemental			GPS Latitude/Longitude	
				Start	End
Item	DRAFT DWR UCIP Field Study			38.291252°	38.291252°
				-121.627398°	-121.627398°
DWR ID	23961				
Comment Code					
Inspector Comment					
DS_ID:23961 FS_ID:16331 EP_NO: N/A Repair Type: Non-Urgent Crossing Status: Found UCIP Comments: Need to determine permit for this crossing. FIELD_STRUCT_DESC: Gas line through the levee at an unknown depth. Markers on both shoulders. FS Date: 6/27/2013

Gasline marker on WS shoulder.

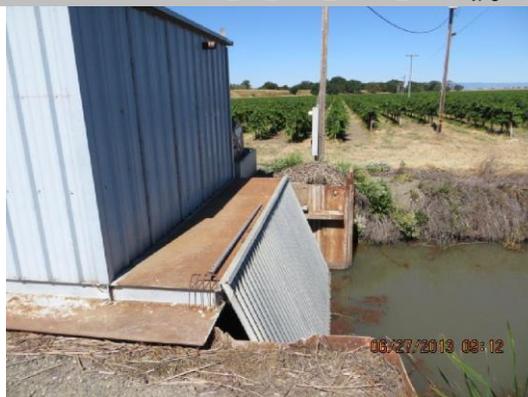
Photo 3 of 3 : UCIP_FA_2019_16333_27521.jpg

LM Start	1.25	Rating **	M	Issue No.	41 (cont)
LM End	1.25	Issue Type +	En	Location *	
Category	Supplemental			GPS Latitude/Longitude	
				Start	End
Item	DRAFT DWR UCIP Field Study			38.291379°	38.291379°
				-121.623285°	-121.623285°
DWR ID	23962				
Comment Code					
Inspector Comment					
DS_ID:23962 FS_ID:16333 EP_NO: N/A Repair Type: Non-Urgent Crossing Status: Found UCIP Comments: Need to determine permit for this crossing. FIELD_STRUCT_DESC: 16-inch coated steel drainage pipe through the levee, 3 feet below the crown. Pump in a pump house on the landside (LS) toe. Siphon breaker in a 24-inch steel riser on the waterside (WS). (Permit No. 17064, 1999 - Reclamation District No. 999). FS Date: 6/27/2013

Trash rack on Pumphouse off LS toe.

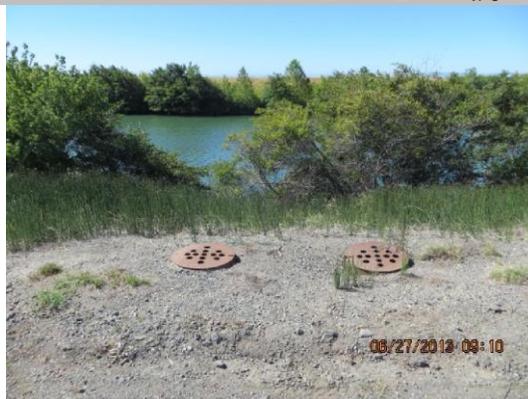
Photo 1 of 3 : UCIP_FA_2019_16334_27527.jpg

LM Start	1.25	Rating **	M	Issue No.	42
LM End	1.25	Issue Type +	En	Location *	
Category	Supplemental			GPS Latitude/Longitude	
				Start	End
Item	DRAFT DWR UCIP Field Study			38.291381°	38.291381°
				-121.623268°	-121.623268°
DWR ID	23963				
Comment Code					
Inspector Comment					
DS_ID:23963 FS_ID:16334 EP_NO: N/A Repair Type: Non-Urgent Crossing Status: Found UCIP Comments: Need to determine permit No. for this crossing. FIELD_STRUCT_DESC: 30-inch coated steel drainage pipe through the levee, 2.5 feet below the crown. Pump in a pump house on the landside (LS) toe. Siphon breaker in a 24-inch steel riser on the waterside (WS). (Permit No. 17064, 1999 - Reclamation District No. 999). FS Date: 6/27/2013

Siphon breaker on WS shoulder.

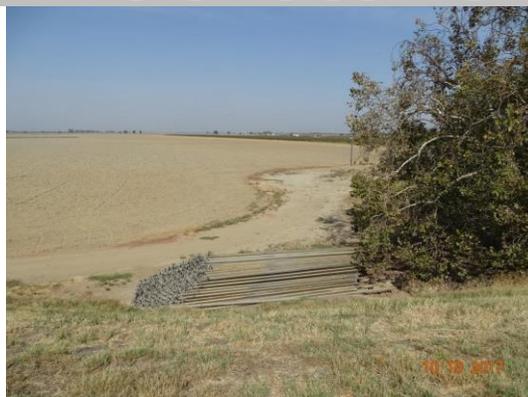
Photo 1 of 1 : FA_2019_RD0999_233_27_20190904_00020.jpg

LM Start	1.66	Rating **	M	Issue No.	27
LM End	1.66	Issue Type +	En	Location *	LS
Category	Earthen Levee		GPS Latitude/Longitude		
			Start	End	
Item	Encroachments		38.290377°	38.290377°	
			-121.615867°	-121.615867°	
DWR ID	DWR_RD0999_02_f_2017_27				
Comment Code					
PI : Pipe					
Inspector Comment					
Landowner needs to move pipes to at least 10' away from the levee toe.

View of equipment on landside slope looking north. Fall 2017

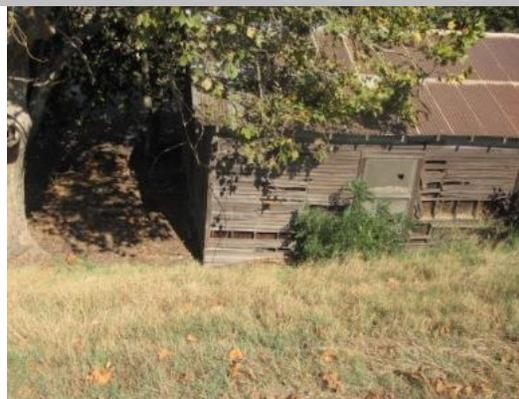
Photo 1 of 2 : FA_2019_RD0999_233_3_20190904_00003.jpg

LM Start	1.67	Rating **	U	Issue No.	3
LM End	1.68	Issue Type +	En	Location *	LS
Category	Earthen Levee		GPS Latitude/Longitude		
			Start	End	
Item	Encroachments		38.290287°	38.290217°	
			-121.615668°	-121.615460°	
DWR ID	DWR_RD0999_02_s_2012_3				
Comment Code					
BU : Building					
Inspector Comment					
Landowner needs to move the old storage shed to at least 10' away from the landside toe.

Looking north at building at landside toe.

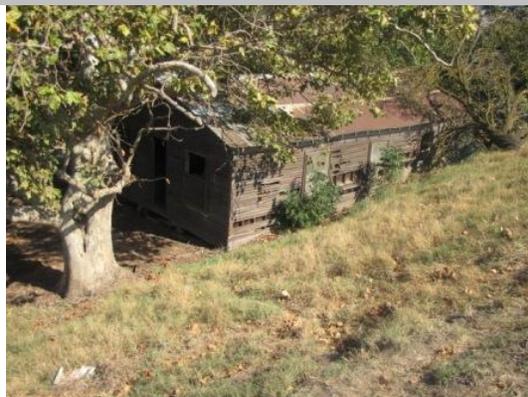
Photo 2 of 2 : FA_2019_RD0999_233_3_20190904_00004.jpg

LM Start	1.67	Rating **	U	Issue No.	3 (cont)
LM End	1.68	Issue Type +	En	Location *	LS

Looking northeast at building at landside toe.

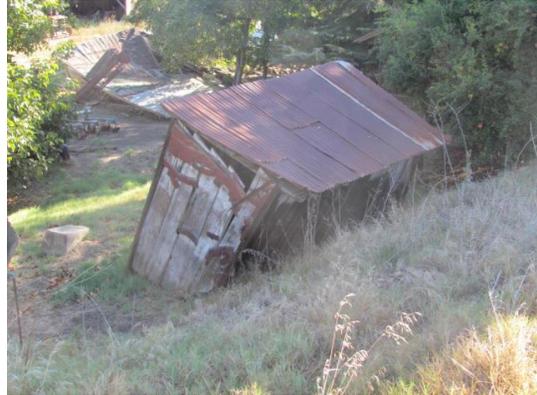
Photo 1 of 1 : FA_2019_RD0999_233_28_20190904_00021.jpg

LM Start	1.68	Rating **	U	Issue No.	28
LM End	1.68	Issue Type +	En	Location *	LS
Category	Earthen Levee			GPS Latitude/Longitude	
				Start	End
Item	Encroachments			38.290260°	38.290260°
				-121.615473°	-121.615473°
DWR ID	DWR_RD0999_02_f_2013_28				
Comment Code					
BU : Building					
Inspector Comment					
The old pump house on the landside toe does not appear to be authorized.

Looking northeast at abandoned pump house on landward toe.

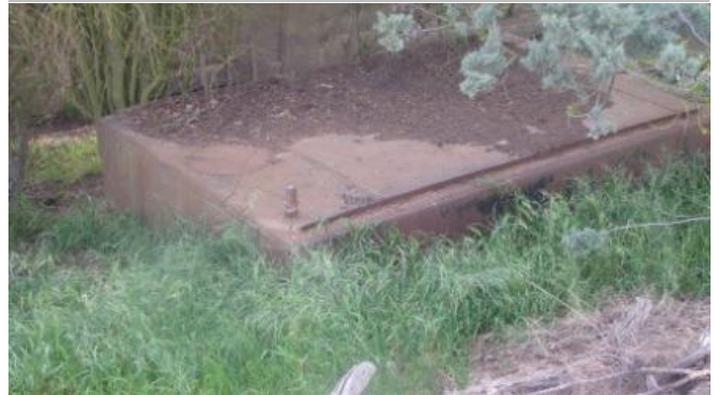
Photo 1 of 1 : FA_2019_RD0999_233_10_20190904_00008.jpg

LM Start	1.69	Rating **	U	Issue No.	10
LM End	1.69	Issue Type +	En	Location *	LS
Category	Earthen Levee			GPS Latitude/Longitude	
				Start	End
Item	Encroachments			38.290195°	38.290195°
				-121.615268°	-121.615268°
DWR ID	DWR_RD0999_02_s_2012_10				
Comment Code					
TA : Tank					
Inspector Comment					
The landowner needs to move the tank to at least 10' away from the levee toe.

Looking north at a tank on the landside slope and toe.

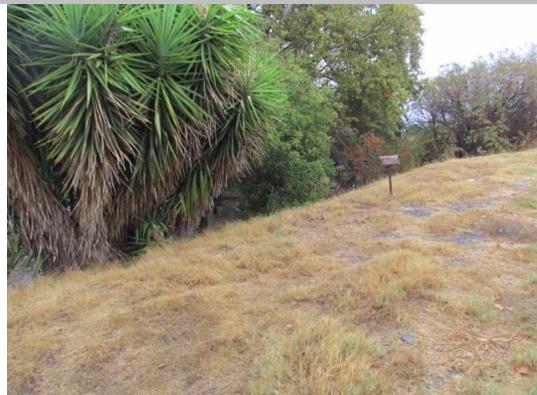
Photo 1 of 2 : FA_2019_RD0999_233_11_20190904_00009.jpg

LM Start	1.70	Rating **	U	Issue No.	11
LM End	1.70	Issue Type +	En	Location *	LS
Category	Earthen Levee			GPS Latitude/Longitude	
				Start	End
Item	Vegetation			38.290171°	38.290171°
				-121.615260°	-121.615260°
DWR ID	DWR_RD0999_02_s_2012_11				
Comment Code					
V6 : Landscaping					
Inspector Comment					
Remove fruit tree and palm tree from the levee easement.

Looking at dense trees on landward slope.

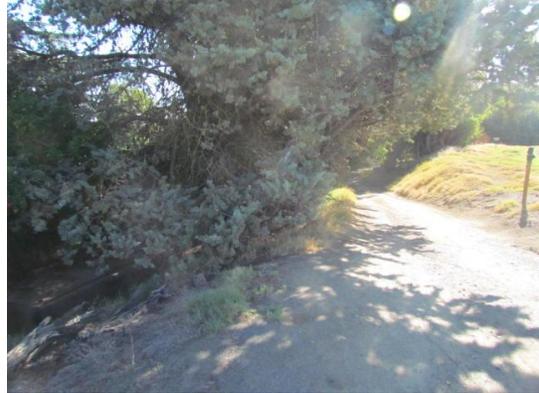
Photo 2 of 2 : FA_2019_RD0999_233_11_20190904_00010.jpg

LM Start	1.70	Rating **	U	Issue No.	11 (cont)
LM End	1.70	Issue Type +	En	Location *	LS
Category	Earthen Levee		GPS Latitude/Longitude		
			Start	End	
Item	Vegetation		38.290171°	38.290171°	
			-121.615260°	-121.615260°	
DWR ID	DWR_RD0999_02_s_2012_11				
Comment Code					
V6 : Landscaping					
Inspector Comment					
Remove fruit tree and palm tree from the levee easement.

Looking southwest at dense trees on landward slope.

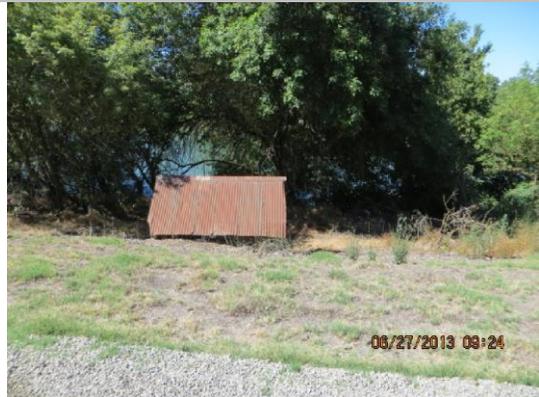
Photo 1 of 3 : UCIP_FA_2019_15386_25249.jpg

LM Start	1.72	Rating **	M	Issue No.	43
LM End	1.72	Issue Type +	En	Location *	
Category	Supplemental		GPS Latitude/Longitude		
			Start	End	
Item	DRAFT DWR UCIP Field Study		38.289967°	38.289967°	
			-121.614873°	-121.614873°	
DWR ID	22774				
Comment Code					
Inspector Comment					
DS_ID:22774 FS_ID:15386 EP_NO: N/A Repair Type: Non-Urgent Crossing Status: Found UCIP Comments: Pipe abandoned and should be done so properly. FIELD_STRUCT_DESC: *ABANDONED* 10-inch steel drainage pipe through the levee, 8.3 feet below the crown. 6-foot by 11-foot corrugated metal pump house and gate valve on the waterside (WS) slope. 36-inch concrete standpipe on the landside (LS) toe. [Additional Reference(s): DWR Levee Log, 1992. USACE Sacramento O&M Manual 113 (Revised), October 1966, (HLM 1.72)]. FS Date: 6/27/2013

Pumphouse on WS slope.

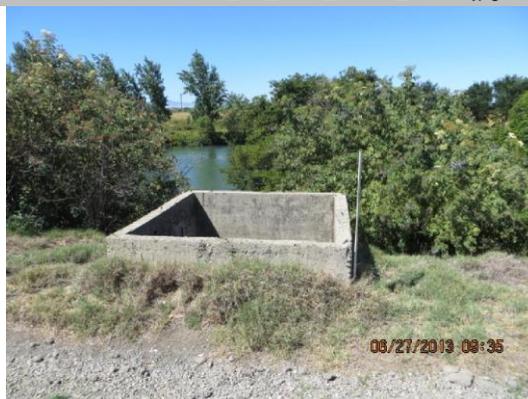
Photo 1 of 2 : UCIP_FA_2019_41069_25251.jpg

LM Start	1.78	Rating **	M	Issue No.	44
LM End	1.78	Issue Type +	En	Location *	
Category	Supplemental		GPS Latitude/Longitude		
			Start	End	
Item	DRAFT DWR UCIP Field Study		38.289357°	38.289357°	
			-121.614089°	-121.614089°	
DWR ID	22775				
Comment Code					
Inspector Comment					
DS_ID:22775 FS_ID:41069 EP_NO: N/A Repair Type: Non-Urgent Crossing Status: Indicator Found UCIP Comments: Appears abandoned. FIELD_STRUCT_DESC: 8-inch steel irrigation pipe through the levee, 4 feet below the crown. Used during irrigation season with a portable pump. 7-foot by 7-foot concrete pump house sump on the waterside (WS) shoulder with pump mount. [Additional Reference(s): DWR Levee Log, 1992. USACE Sacramento O&M Manual 113 (Revised), October 1966, (HLM 1.78)]. FS Date: 6/27/2013

7'X7' concrete pumphouse sump on WS shoulder.

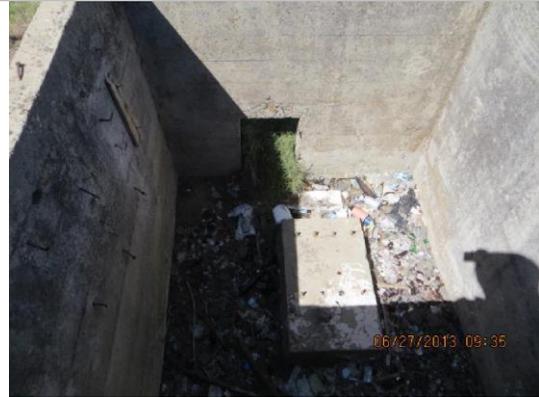
Photo 2 of 2 : UCIP_FA_2019_41069_25250.jpg

LM Start	1.78	Rating **	M	Issue No.	44 (cont)
LM End	1.78	Issue Type +	En	Location *	
Category	Supplemental			GPS Latitude/Longitude	
				Start	End
Item	DRAFT DWR UCIP Field Study			38.289357°	38.289357°
				-121.614089°	-121.614089°
DWR ID	22775				
Comment Code					
Inspector Comment					
DS_ID:22775 FS_ID:41069 EP_NO: N/A Repair Type: Non-Urgent Crossing Status: Indicator Found UCIP Comments: Appears abandoned. FIELD_STRUCT_DESC: 8-inch steel irrigation pipe through the levee, 4 feet below the crown. Used during irrigation season with a portable pump. 7-foot by 7-foot concrete pump house sump on the waterside (WS) shoulder with pump mount. [Additional Reference(s): DWR Levee Log, 1992. USACE Sacramento O&M Manual 113 (Revised), October 1966, (HLM 1.78)]. FS Date: 6/27/2013

Pump mount inside foundation at WS slope.

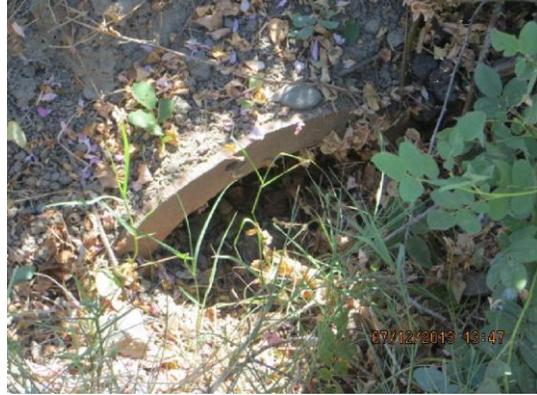
Photo 3 of 3 : UCIP_FA_2019_15703_26123.jpg

LM Start	2.28	Rating **	M	Issue No.	45 (cont)
LM End	2.28	Issue Type +	En	Location *	
Category	Supplemental			GPS Latitude/Longitude	
				Start	End
Item	DRAFT DWR UCIP Field Study			38.286666 °	38.286666 °
				-121.606803 °	-121.606803 °
DWR ID	22770				
Comment Code					
Inspector Comment					
DS_ID:22770 FS_ID:15703 EP_NO: 3855 Repair Type: Non-Urgent Crossing Status: Found UCIP Comments: Pipe not capped on LS and not found on WS. FIELD_STRUCT_DESC: 10-inch steel irrigation pipe through the levee, 4 feet below the crown. Capped during winter months. 6-inch pipe sleeved through the 10-inch pipe during irrigation season. (Permit No. 3855, 1962 - K. Barsoom). [Additional Reference(s): DWR Levee Log, 1992. USACE Sacramento O&M Manual 113 (Revised), October 1966, (HLM 2.31)]. FS Date: 6/27/2013

Pipe partially filled with soil and open on LS.

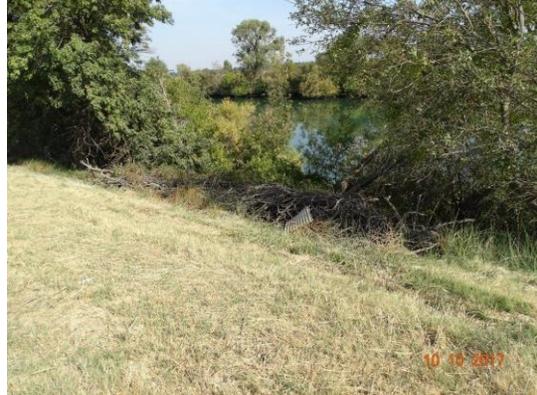
Photo 1 of 1 : FA_2019_RD0999_234_32_20190904_00019.jpg

LM Start	0.04	Rating **	M	Issue No.	32
LM End	0.04	Issue Type +	Ma	Location *	WS
Category	Earthen Levee			GPS Latitude/Longitude	
				Start	End
Item	Encroachments			38.287040°	38.287040°
				-121.605667°	-121.605667°
DWR ID	DWR_RD0999_03_f_2017_32				
Comment Code					
PR : Prunings					
Inspector Comment					
Remove the large pruning pile on waterside slope.

View of waterside slope looking east. Fall 2017

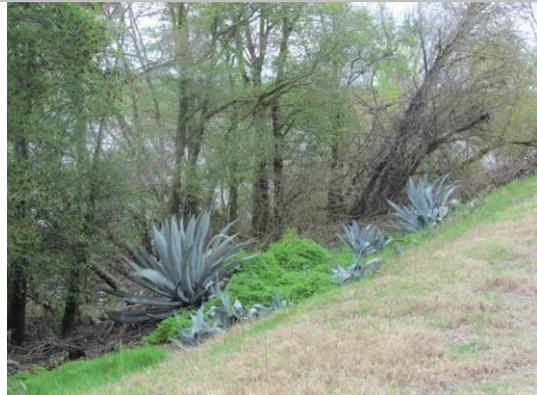
Photo 1 of 1 : FA_2019_RD0999_234_17_20190904_00011.jpg

LM Start	0.06	Rating **	M	Issue No.	17
LM End	0.06	Issue Type +	Ma	Location *	WS
Category	Earthen Levee			GPS Latitude/Longitude	
				Start	End
Item	Vegetation			38.287290°	38.287290°
				-121.605472°	-121.605472°
DWR ID	DWR_RD0999_03_s_2017_17				
Comment Code					
V2 : Remove the wild growth other than native grasses from the levee slopes.					
Inspector Comment					
Remove Century plants that are not allowed on the waterward slope.

Looking east at century plants on waterward slope.

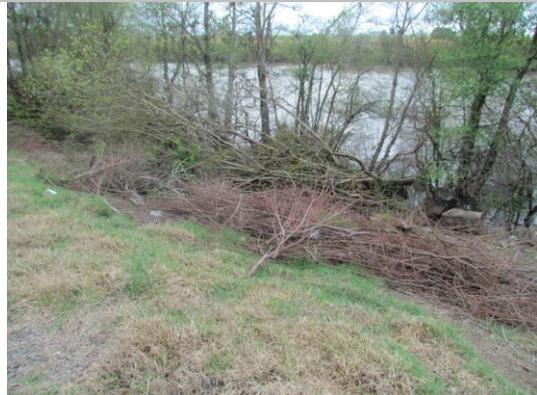
Photo 1 of 1 : FA_2019_RD0999_234_23_20190904_00014.jpg

LM Start	0.09	Rating **	M	Issue No.	23
LM End	0.09	Issue Type +	Ma	Location *	WS
Category	Earthen Levee			GPS Latitude/Longitude	
				Start	End
Item	Encroachments			38.287595°	38.287595°
				-121.605275°	-121.605275°
DWR ID	DWR_RD0999_03_s_2017_23				
Comment Code					
PR : Prunings					
Inspector Comment					
Remove large pruning piles on the waterward slope.

Looking east at large pruning piles on waterward slope.

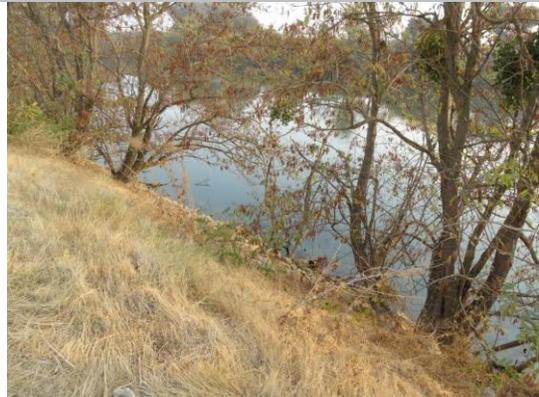
Photo 1 of 2 : FA_2019_RD0999_234_7_20190904_00001.jpg

LM Start	0.22	Rating **	A/W	Issue No.	7
LM End	0.22	Issue Type +	Ob	Location *	LS
Category	Supplemental			GPS Latitude/Longitude	
				Start	End
Item	2017 Storm Damage			38.289394 °	38.289394 °
				-121.604538 °	-121.604538 °
DWR ID	305-01				
Comment Code					
Inspector Comment					
Levee Evaluation Comments Description: Site ID No:114 Site Designation:305-01 Repair Type: Seepage Rating: Field Date: Notes: Fall 2019 DWR Inspection: No evidence of seepage at site.

View of waterside slope with some revetment at the water's edge. Fall 2018
