**Flood Control Project Maintenance
Levee Inspections**

Fall 2019 Levee Maintenance Deficiency Summary Report

**Flood Control Project Maintenance
Levee Inspections**
LMA District Cover Sheet
Fall 2019 Levee Inspection Results

Reclamation District No. 0999 Netherlands

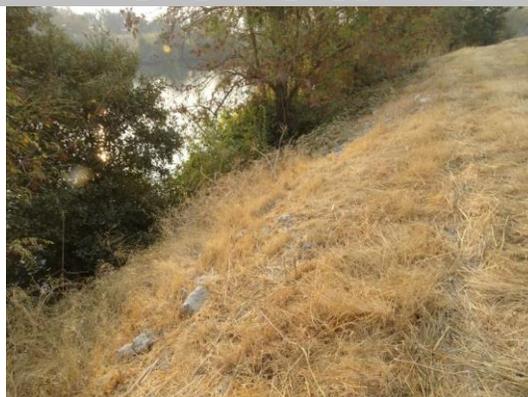
Photo 2 of 2 : FA_2019_RD0999_234_7_20190904_00002.jpg

LM Start	0.22	Rating **	A/W	Issue No.	7 (cont)
LM End	0.22	Issue Type +	Ob	Location *	LS
Category	Supplemental			GPS Latitude/Longitude	
				Start	End
Item	2017 Storm Damage			38.289394 °	38.289394 °
				-121.604538 °	-121.604538 °
DWR ID	305-01				
Comment Code					
Inspector Comment					
Levee Evaluation Comments					
Description:					
Site ID No:114					
Site Designation:305-01					
Repair Type: Seepage					
Rating:					
Field Date:					
Notes: Fall 2019 DWR Inspection: No evidence of seepage at site.

View of waterside slope with some revetment. Fall 2018

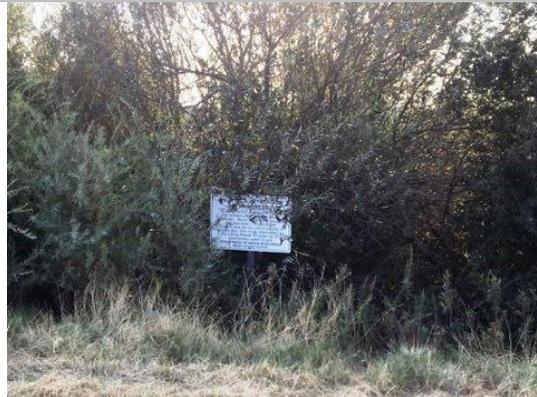
Photo 1 of 2 : FA_2019_RD0999_234_16_20191015_00033.jpg

LM Start	1.14	Rating **	A/W	Issue No.	16
LM End	3.62	Issue Type +	Ob	Location *	WS
Category	Earthen Levee		GPS Latitude/Longitude		
			Start	End	
Item	Vegetation		38.301123°	38.331163°	
			-121.600883°	-121.585780°	
DWR ID	DWR_RD0999_03_f_2019_16				
Comment Code					
V8 : Environmental Requirements.					
Inspector Comment

View of revegetation site signage at LM 1.14. Fall 2019

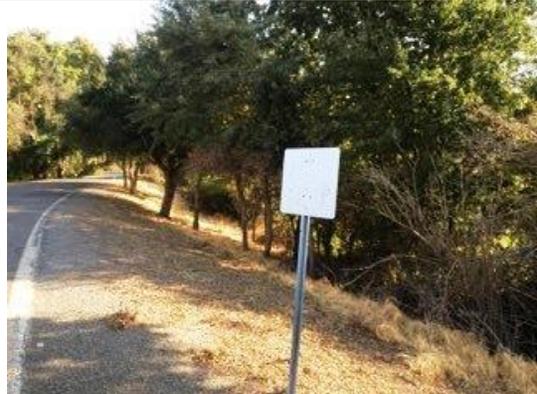
Photo 2 of 2 : FA_2019_RD0999_234_16_20191015_00037.jpg

View of revegetation site signage at LM 3.62. Fall 2019

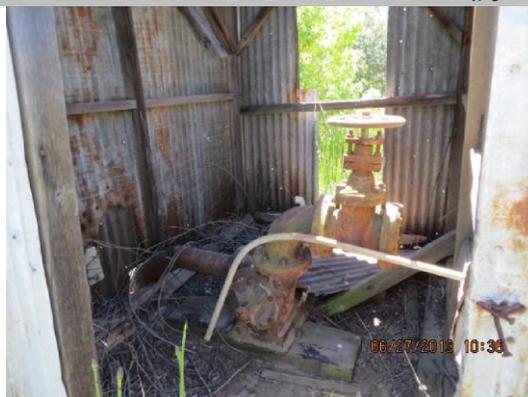
Photo 3 of 3 : UCIP_FA_2019_15392_25259.jpg

LM Start	1.71	Rating **	M	Issue No.	47 (cont)
LM End	1.71	Issue Type +	En	Location *	
Category	Supplemental			GPS Latitude/Longitude	
				Start	End
Item	DRAFT DWR UCIP Field Study			38.308513 °	38.308513 °
				-121.598874 °	-121.598874 °
DWR ID	22779				
Comment Code					
Inspector Comment					
DS_ID:22779 FS_ID:15392 EP_NO: N/A Repair Type: Non-Urgent Crossing Status: Found UCIP Comments: Pipe abandoned and should be verified as being done so properly. FIELD_STRUCT_DESC: *ABANDONED* 5-inch steel irrigation pipe through the levee, 4.4 feet below the crown. Pump and valve in pump house on the waterside (WS) slope. Could not see the landside (LS) end of the pipe, February 1991. 1-inch galvanized iron electrical conduit at the same location. [Additional Reference(s): DWR Levee Log, 1992. USACE Sacramento O&M Manual 113 (Revised), October 1966, (HLM 1.71)]. FS Date: 6/27/2013

gatevalve inside pumphouse with no connection.

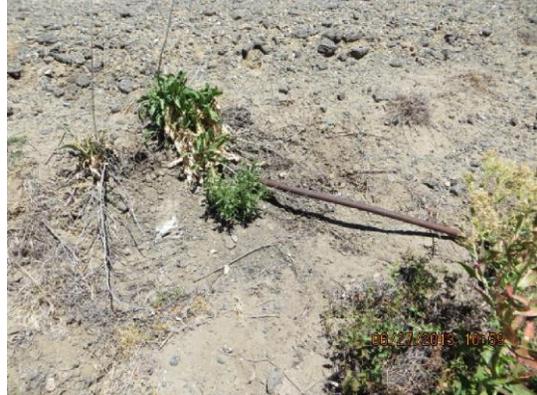
Photo 3 of 3 : UCIP_FA_2019_15393_25262.jpg

LM Start	2.00	Rating **	M	Issue No.	48 (cont)
LM End	2.00	Issue Type +	En	Location *	
Category	Supplemental			GPS Latitude/Longitude	
				Start	End
Item	DRAFT DWR UCIP Field Study			38.311709°	38.311709°
				-121.596713°	-121.596713°
DWR ID	22780				
Comment Code					
Inspector Comment					
DS_ID:22780 FS_ID:15393 EP_NO: N/A Repair Type: Non-Urgent Crossing Status: Found UCIP Comments: Pipe abandoned and should be done so properly. FIELD_STRUCT_DESC: 7-inch steel irrigation pipe through the levee, 4.6 feet below the crown. Pump and gate valve on the waterside (WS) slope. Service pole on the landside (LS) slope. 1-inch galvanized iron electrical conduit at the same location. [Additional Reference(s): DWR Levee Log, 1992. USACE Sacramento O&M Manual 113 (Revised), October 1966, (HLM 2.01)]. FS Date: 6/27/2013

Galvanized iron pipe on WS slope.

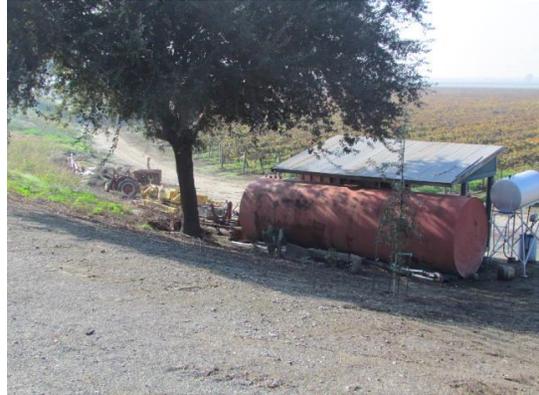
Photo 2 of 3 : FA_2019_RD0999_234_27_20190904_00017.jpg

LM Start	2.54	Rating **	U	Issue No.	27 (cont)
LM End	2.54	Issue Type +	En	Location *	LS
Category	Earthen Levee			GPS Latitude/Longitude	
				Start	End
Item	Encroachments			38.317840°	38.317840°
				-121.590895°	-121.590895°
DWR ID	DWR_RD0999_03_s_2012_27				
Comment Code					
EQ : Equipment					
Inspector Comment					
The diesel tank and farming equipment need to be moved to at least 10' away from the levee toe.

Looking southwest at farm equipment stored at landside toe. (Fall Inspection 2012)

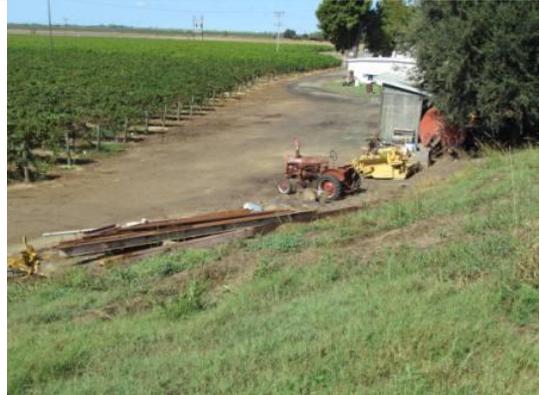
Photo 3 of 3 : FA_2019_RD0999_234_27_20190904_00018.jpg

Looking northwest at equipment at landside toe.

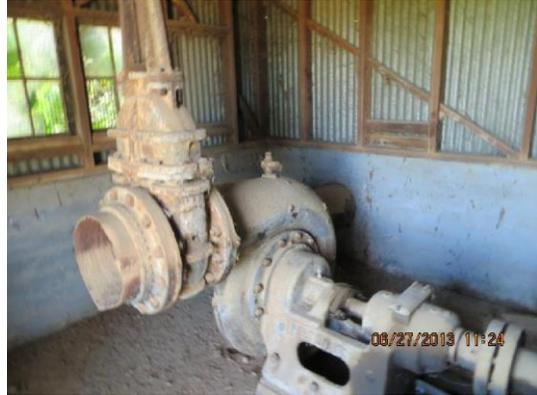
Photo 2 of 3 : UCIP_FA_2019_15406_25284.jpg

LM Start	2.88	Rating **	M	Issue No.	49 (cont)
LM End	2.88	Issue Type +	En	Location *	
Category	Supplemental			GPS Latitude/Longitude	
				Start	End
Item	DRAFT DWR UCIP Field Study			38.322652°	38.322652°
				-121.590841°	-121.590841°
DWR ID	22782				
Comment Code					
Inspector Comment					
DS_ID:22782 FS_ID:15406 EP_NO: N/A Repair Type: Non-Urgent Crossing Status: Found UCIP Comments: This pipe is abandoned and should be done so properly. FIELD_STRUCT_DESC: *ABANDONED* 16-inch steel drainage pipe through the levee, 9.3 feet below the crown. Pump and gate valve in pump house on the landside (LS) slope. [Additional Reference(s): DWR Levee Log, 1992. USACE Sacramento O&M Manual 113 (Revised), October 1966, (HLM 2.91)]. FS Date: 6/27/2013

Pump and gatevalve inside pumphouse at LS toe.

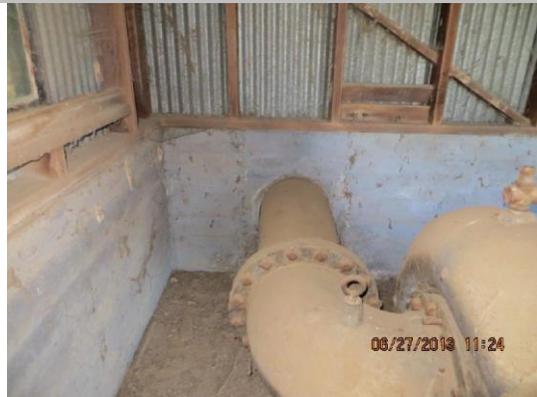
Photo 3 of 3 : UCIP_FA_2019_15406_25283.jpg

Pipe entering levee at LS toe.

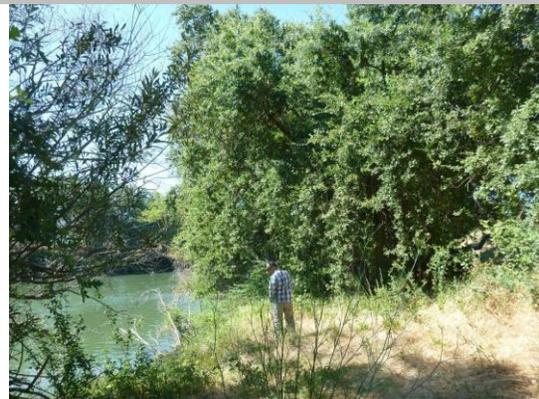
Photo 1 of 3 : LEVAL_FA_2019_356_2492.jpg

LM Start	3.18	Rating **	A/W	Issue No.	15
LM End	3.21	Issue Type +	Ma	Location *	WS
Category	Supplemental		GPS Latitude/Longitude		
			Start	End	
Item	2017 Storm Damage		38.325053°	38.325489°	
			-121.586347°	-121.586100°	
DWR ID	LMA-183				
Comment Code					
Inspector Comment					
Levee Evaluation Comments					
Description: The damage consists of erosion of the lower waterside levee slope and bank approximately 172 feet in length along the west (right) bank of Sutter Slough. See attached pages for photos. Site location T06N R04E Section 3 and 4.					
Site ID No: 356					
Site Designation: LMA-183					
Repair Type: Erosion					
Rating: Area of Concern					
Field Date: 7/27/2017					
Notes: 2018 DWR Inspector: Erosion not visible from levee slope.

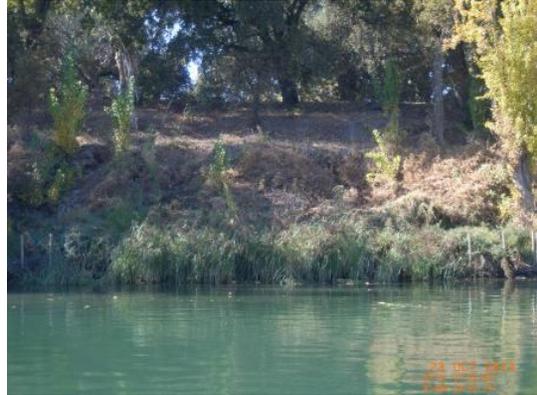
Photo 1 of 1 : FA_2019_RD0999_235_23_20190904_00011.jpg

LM Start	0.02	Rating **	U	Issue No.	23
LM End	0.28	Issue Type +	Ma	Location *	WS
Category	Supplemental			GPS Latitude/Longitude	
				Start	End
Item	2017 USACE Erosion Survey			38.414387°	38.417692°
				-121.522871°	-121.525083°
DWR ID	DWR_RD0999_04_f_2019_23				
Comment Code					
Inspector Comment					
2017 Site ID: SAC 41.9 R Status: Critical 2017 Field Notes: Fresh erosion on entire bank. Upgraded to critical. Site History: 1997 - Structural problem rather than erosional, failed cobble at downstream end. 2005 - New brush boxes at waterline for several hundred feet downstream, No toe or bank protection present. 2006 - Some minor new erosion. Brush boxes not working well; most of the brush has floated out. 2007 - Brush boxes have recently been repaired. 2016 - Minor new slumping.

USACE 2013 Photo #1

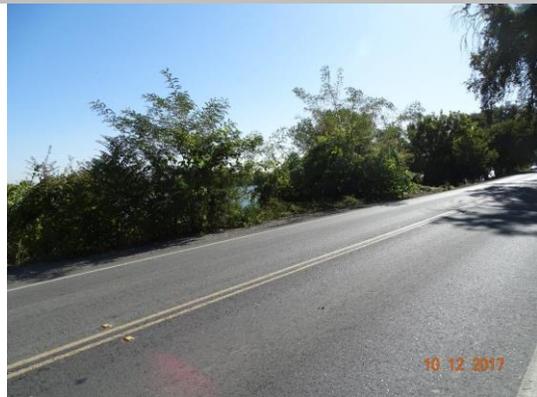
Photo 1 of 1 : FA_2019_RD0999_235_53_20190904_00028.jpg

LM Start	0.04	Rating **	U	Issue No.	53
LM End	0.06	Issue Type +	Ma	Location *	WS
Category	Earthen Levee			GPS Latitude/Longitude	
				Start	End
Item	Vegetation			38.414533°	38.414750°
				-121.523394°	-121.523543°
DWR ID	DWR_RD0999_04_f_2017_53				
Comment Code					
V2 : Remove the wild growth other than native grasses from the levee slopes.					
Inspector Comment					
Remove wild growth vegetation on the waterside slope.

Looking southeast at the waterside slope. Fall 2017

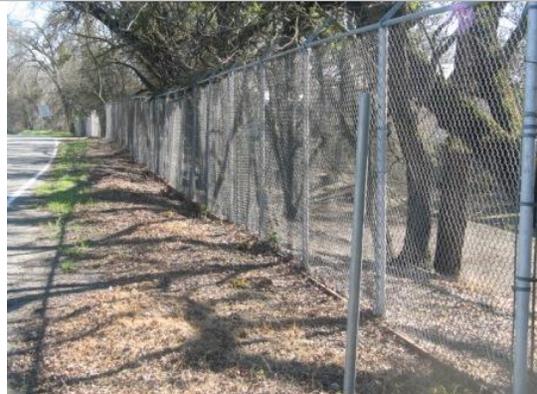
Photo 1 of 1 : FA_2019_RD0999_235_13_20190904_00006.jpg

LM Start	0.05	Rating **	M	Issue No.	13
LM End	0.11	Issue Type +	En	Location *	LS
Category	Earthen Levee		GPS Latitude/Longitude		
			Start	End	
Item	Encroachments		38.414617 °	38.415467 °	
			-121.523499 °	-121.524022 °	
DWR ID	DWR_RD0999_04_s_2012_13				
Comment Code					
FE : Fence					
Inspector Comment

Cyclone fence along landside shoulder at LM 0.05 -0.11

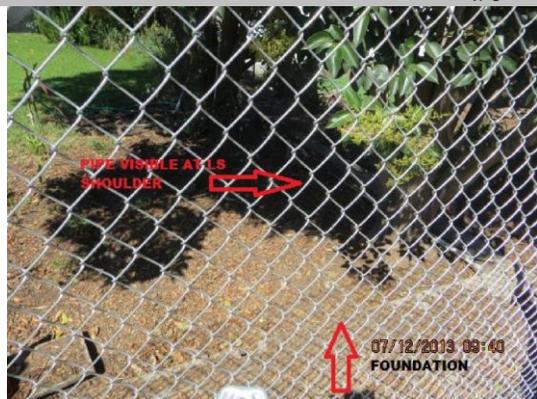
Photo 1 of 3 : UCIP_FA_2019_15709_26140.jpg

Comment Code					
Inspector Comment					
DS_ID:22789 FS_ID:15709 EP_NO: N/A Repair Type: Non-Urgent Crossing Status: Found UCIP Comments: Pipe abandoned and should be done so properly. FIELD_STRUCT_DESC: *ABANDONED* 2-inch steel pipe of unknown purpose through the levee, 4.5 feet below the crown. Concrete blocks for missing pump and pressure system visible on the waterside (WS) slope. 8-inch steel standpipe on the WS toe with remnants of the 2-inch pipe visible at the top. Pipe visible at concrete foundation on the landside (LS) shoulder. [Additional Reference(s): DWR Levee Log, 1992. USACE Sacramento O&M Manual 113 (Revised), October 1966, (HLM 0.02)]. FS Date: 7/12/2013

Pipe visible at concrete foundation on LS shoulder.

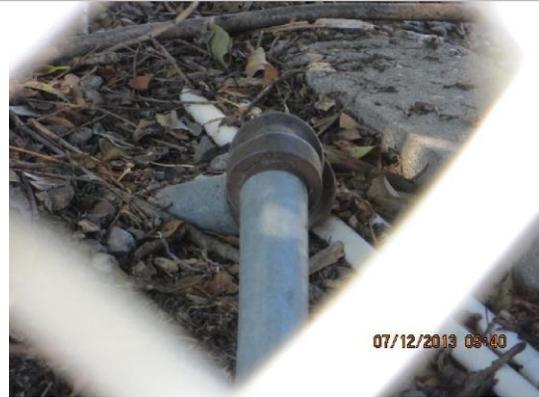
Photo 2 of 3 : UCIP_FA_2019_15709_26139.jpg

Comment Code					
Inspector Comment					
DS_ID:22789 FS_ID:15709 EP_NO: N/A Repair Type: Non-Urgent Crossing Status: Found UCIP Comments: Pipe abandoned and should be done so properly. FIELD_STRUCT_DESC: *ABANDONED* 2-inch steel pipe of unknown purpose through the levee, 4.5 feet below the crown. Concrete blocks for missing pump and pressure system visible on the waterside (WS) slope. 8-inch steel standpipe on the WS toe with remnants of the 2-inch pipe visible at the top. Pipe visible at concrete foundation on the landside (LS) shoulder. [Additional Reference(s): DWR Levee Log, 1992. USACE Sacramento O&M Manual 113 (Revised), October 1966, (HLM 0.02)]. FS Date: 7/12/2013

Pipe visible at concrete foundation on LS shoulder.

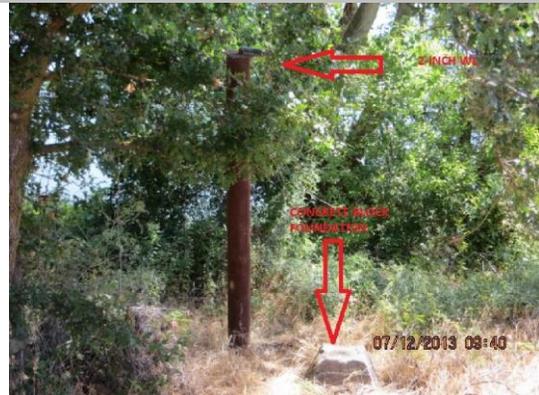
Photo 3 of 3 : UCIP_FA_2019_15709_26138.jpg

Pipe visible at top of steel standpipe. Foundation for pump station visible on WS slope.

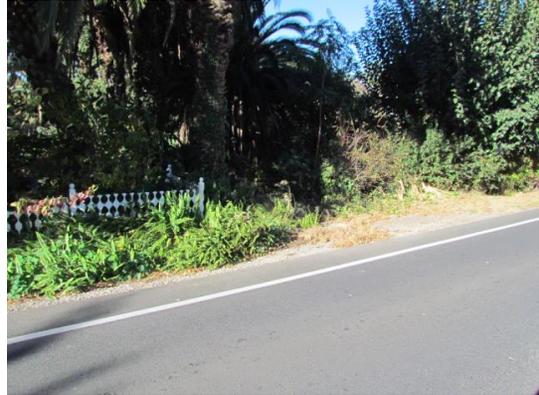
Photo 1 of 2 : FA_2019_RD0999_235_38_20190904_00016.jpg

LM Start	0.16	Rating **	U	Issue No.	38
LM End	0.17	Issue Type +	En	Location *	LS
Category	Earthen Levee			GPS Latitude/Longitude	
				Start	End
Item	Vegetation			38.416090°	38.416167°
				-121.524343°	-121.524391°
DWR ID	DWR_RD0999_04_f_2015_38				
Comment Code					
V6 : Landscaping					
Inspector Comment					
Instruct the landowner to trim and thin dense landscaping on the landside slope and toe.

Looking northwest at dense landscaping on landward slope and toe.

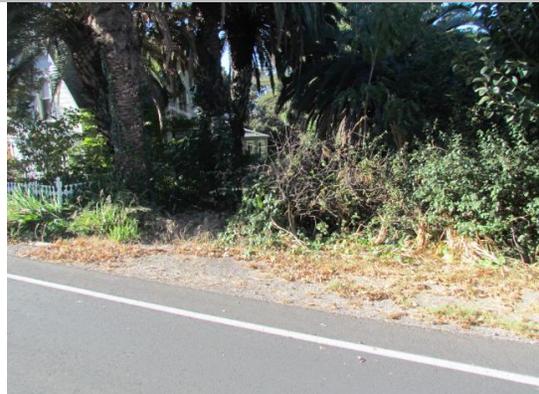
Photo 2 of 2 : FA_2019_RD0999_235_38_20190904_00017.jpg

Looking southwest at dense landscaping on landward slope and toe.

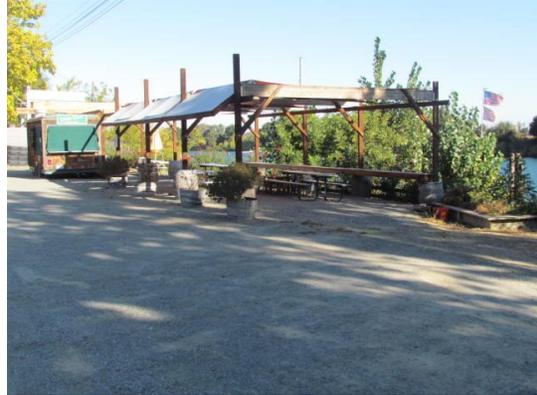
Photo 1 of 1 : FA_2019_RD0999_235_36_20190904_00013.jpg

LM Start	0.29	Rating **	U	Issue No.	36
LM End	0.29	Issue Type +	En	Location *	WS
Category	Earthen Levee		GPS Latitude/Longitude		
			Start	End	
Item	Encroachments		38.417809 °	38.417809 °	
			-121.525488 °	-121.525488 °	
DWR ID	DWR_RD0999_04_f_2014_36				
Comment Code					
BU : Building					
Inspector Comment					
The landowner built a patio structure next to a mobile diner on the waterside shoulder area without a Board permit.

Looking northeast at patio on waterward shoulder.

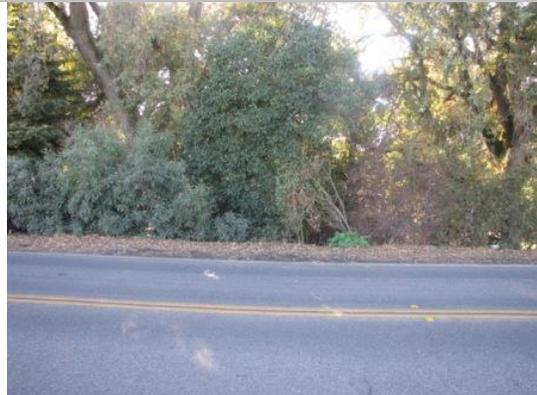
Photo 1 of 2 : FA_2019_RD0999_235_12_20190904_00004.jpg

LM Start	0.31	Rating **	U	Issue No.	12
LM End	0.33	Issue Type +	En	Location *	LS
Category	Earthen Levee		GPS Latitude/Longitude		
			Start	End	
Item	Vegetation		38.417962 °	38.418267 °	
			-121.525709 °	-121.525883 °	
DWR ID	DWR_RD0999_04_s_2012_12				
Comment Code					
V6 : Landscaping					
Inspector Comment

Looking west at dense vegetation on landside slope and toe.

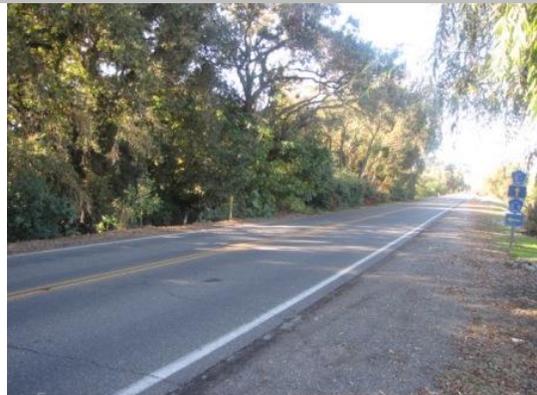
Photo 2 of 2 : FA_2019_RD0999_235_12_20190904_00005.jpg

Looking northwest at dense vegetation on landside shoulder and slope.

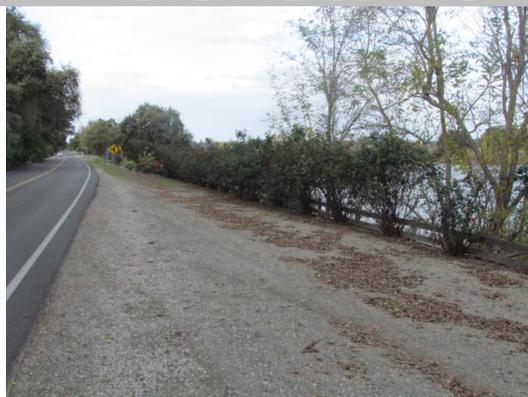
Photo 1 of 1 : FA_2019_RD0999_235_1_20190904_00001.jpg

LM Start	0.36	Rating **	M	Issue No.	1
LM End	0.47	Issue Type +	En	Location *	WS
Category	Earthen Levee			GPS Latitude/Longitude	
				Start	End
Item	Vegetation			38.418593 °	38.420004 °
				-121.526024 °	-121.526962 °
DWR ID	DWR_RD0999_04_s_2012_1				
Comment Code					
V6 : Landscaping					
Inspector Comment					
Landscaping belongs to the Marina, according to LMA, and Permit 3083 does not include plantings.

Looking north at rose bushes on waterside slope.

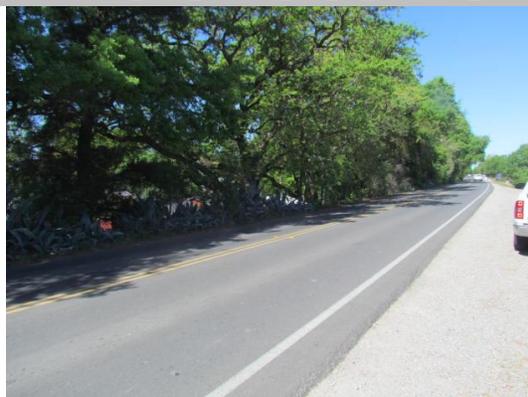
Photo 1 of 2 : FA_2019_RD0999_235_11_20190904_00002.jpg

LM Start	0.38	Rating **	U	Issue No.	11
LM End	0.50	Issue Type +	En	Location *	LS
Category	Earthen Levee			GPS Latitude/Longitude	
				Start	End
Item	Vegetation			38.418871 °	38.420451 °
				-121.526257 °	-121.527386 °
DWR ID	DWR_RD0999_04_s_2012_11				
Comment Code					
V6 : Landscaping					
Inspector Comment					
Trim and thin trees/shrubs, and remove century plants from the levee shoulder.

Looking northwest at dense landscaping on landward slope. (Spring 2015)

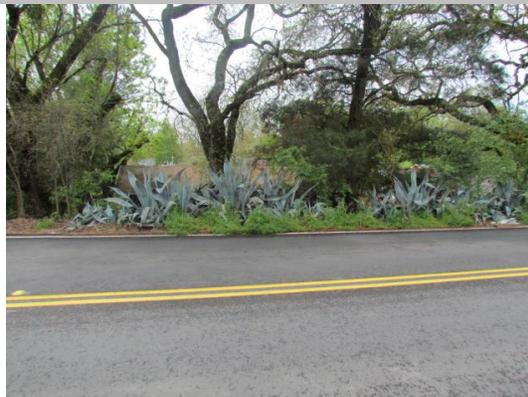
Photo 2 of 2 : FA_2019_RD0999_235_11_20190904_00003.jpg

Looking west at century plants on landside shoulder and slope.

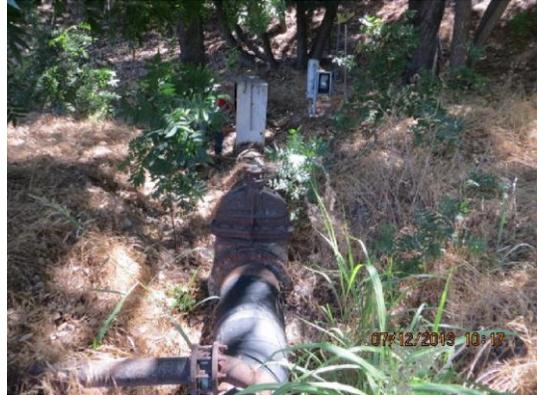
Photo 3 of 3 : UCIP_FA_2019_15712_26148.jpg

LM Start	0.71	Rating **	M	Issue No.	56 (cont)
LM End	0.71	Issue Type +	En	Location *	
Category	Supplemental			GPS Latitude/Longitude	
				Start	End
Item	DRAFT DWR UCIP Field Study			38.423062°	38.423062°
				-121.529241°	-121.529241°
DWR ID	22791				
Comment Code					
Inspector Comment					
DS_ID:22791 FS_ID:15712 EP_NO: 3973 Repair Type: Non-Urgent Crossing Status: Found UCIP Comments: Slide gate broken on LS toe. Appears it may be abandoned. FIELD_STRUCT_DESC: 18-inch steel drainage pipe through the levee, 4.7 feet below the crown. Air vent in an 18-inch steel standpipe on the waterside (WS) shoulder. Gate valve on the landside (LS) toe. (Permit No. 3973, 1962 - American Crystal Sugar Company). [Additional Reference(s): DWR Levee Log, 1992. USACE Sacramento O&M Manual 113 (Revised), October 1966, (HLM 0.71)]. FS Date: 7/12/2013

Gate valve on LS toe.

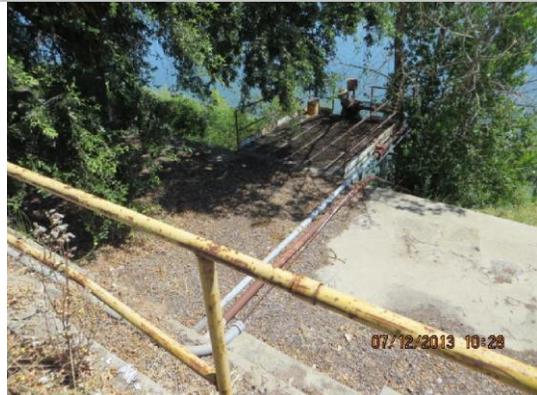
Photo 1 of 3 : UCIP_FA_2019_15725_26181.jpg

LM Start	0.74	Rating **	M	Issue No.	57
LM End	0.74	Issue Type +	En	Location *	
Category	Supplemental			GPS Latitude/Longitude	
				Start	End
Item	DRAFT DWR UCIP Field Study			38.423418°	38.423418°
				-121.529486°	-121.529486°
DWR ID	22796				
Comment Code					
Inspector Comment					
DS_ID:22796 FS_ID:15725 EP_NO: 10514 Repair Type: Non-Urgent Crossing Status: Found UCIP Comments: Pipe appears abandoned and should be done so properly. FIELD_STRUCT_DESC: 1 of 3: 3.5-inch discharge pipe of an unknown material through the levee, 3.8 feet below the crown. Siphon breaker at headwall on the waterside (WS) slope. (Permit No. 10514, 1975 - The Newhall Land and Farming Company). [Additional Reference(s): DWR Levee Log, 1992]. FS Date: 7/12/2013

Discharge pipe at concrete pad then down slope to water.

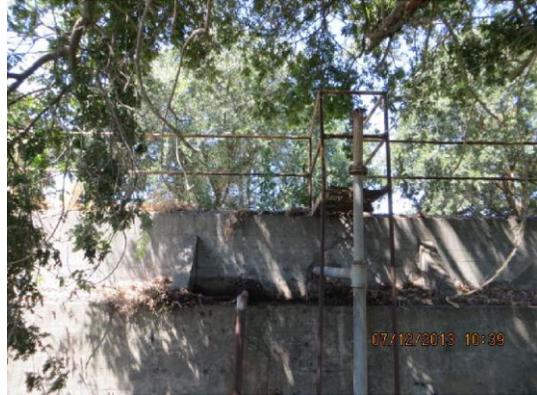
Photo 3 of 3 : UCIP_FA_2019_41556_26158.jpg

LM Start	0.74	Rating **	M	Issue No.	58 (cont)
LM End	0.74	Issue Type +	En	Location *	
Category	Supplemental			GPS Latitude/Longitude	
				Start	End
Item	DRAFT DWR UCIP Field Study			38.423429 °	38.423429 °
				-121.529491 °	-121.529491 °
DWR ID	22794				
Comment Code					
Inspector Comment					
DS_ID:22794 FS_ID:41556 EP_NO: N/A Repair Type: Non-Urgent Crossing Status: Found UCIP Comments: Good candidate for video inspection. FIELD_STRUCT_DESC: 10-inch steel conduit of an unknown purpose through the levee, 3.8 feet below the crown. 4.5-inch galvanized iron pipe sleeved through the 10-inch conduit with annular space grouted. [Additional Reference(s): DWR Levee Log, 1992. USACE Sacramento O&M Manual 113 (Revised), October 1966, (HLM 0.73)]. FS Date: 7/12/2013

4.5-inch pipe at headwall on WS slope.

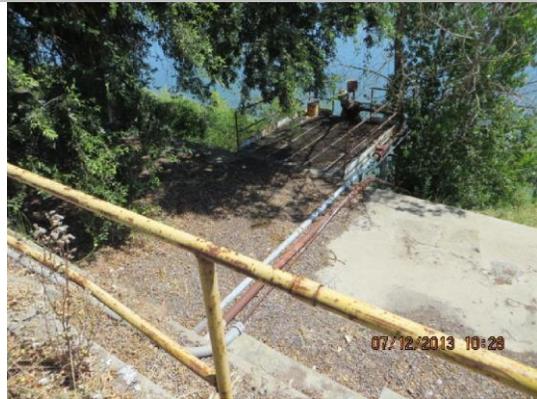
Photo 1 of 2 : UCIP_FA_2019_41535_26167.jpg

LM Start	0.74	Rating **	M	Issue No.	59
LM End	0.74	Issue Type +	En	Location *	
Category	Supplemental			GPS Latitude/Longitude	
				Start	End
Item	DRAFT DWR UCIP Field Study			38.423418 °	38.423418 °
				-121.529486 °	-121.529486 °
DWR ID	22795				
Comment Code					
Inspector Comment					
DS_ID:22795 FS_ID:41535 EP_NO: N/A Repair Type: Non-Urgent Crossing Status: Found UCIP Comments: Pipes appear abandoned and should be checked usage or abandoned properly. FIELD_STRUCT_DESC: 3.5-inch galvanized iron electrical conduit through the levee, 3.8 feet below the crown. Concrete headwall and pad on the waterside (WS) slope. Pipe open on the WS. [Additional Reference(s): DWR Levee Log, 1992. USACE Sacramento O&M Manual 113 (revision), October 1966, (HLM 0.73), listed as two 10-inch pipes]. FS Date: 7/12/2013

Electrical conduit shown at bottom of picture (pipe with 90-degree bend).

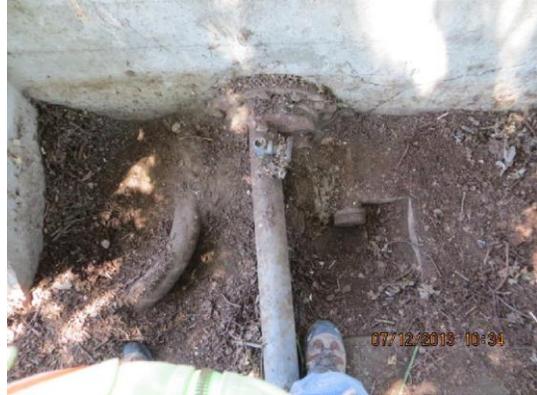
Photo 2 of 2 : UCIP_FA_2019_41535_26166.jpg

LM Start	0.74	Rating **	M	Issue No.	59 (cont)
LM End	0.74	Issue Type +	En	Location *	
Category	Supplemental			GPS Latitude/Longitude	
				Start	End
Item	DRAFT DWR UCIP Field Study			38.423418°	38.423418°
				-121.529486°	-121.529486°
DWR ID	22795				
Comment Code					
Inspector Comment					
DS_ID:22795 FS_ID:41535 EP_NO: N/A Repair Type: Non-Urgent Crossing Status: Found UCIP Comments: Pipes appear abandoned and should be checked usage or abandoned properly. FIELD_STRUCT_DESC: 3.5-inch galvanized iron electrical conduit through the levee, 3.8 feet below the crown. Concrete headwall and pad on the waterside (WS) slope. Pipe open on the WS. [Additional Reference(s): DWR Levee Log, 1992. USACE Sacramento O&M Manual 113 (revision), October 1966, (HLM 0.73), listed as two 10-inch pipes]. FS Date: 7/12/2013

3.5-inch electrical conduit shown at left of 10-inch pipe.

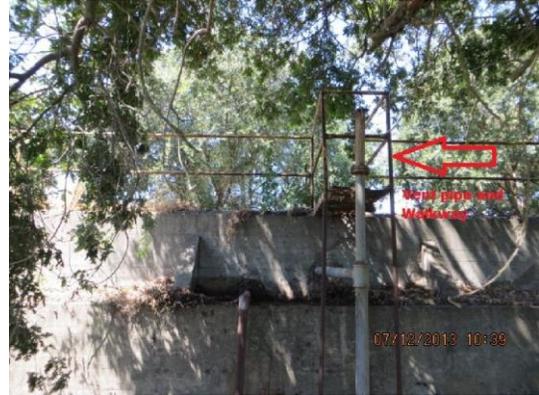
Photo 2 of 3 : UCIP_FA_2019_41070_26173.jpg

LM Start	0.74	Rating **	M	Issue No.	60 (cont)
LM End	0.74	Issue Type +	En	Location *	
Category	Supplemental			GPS Latitude/Longitude	
				Start	End
Item	DRAFT DWR UCIP Field Study			38.423429°	38.423429°
				-121.529491°	-121.529491°
DWR ID	22811				
Comment Code					
Inspector Comment					
DS_ID:22811 FS_ID:41070 EP_NO: 10514 Repair Type: Non-Urgent Crossing Status: Found UCIP Comments: Need to determine disposition of pipe and if abandoned, it should be done so properly. FIELD_STRUCT_DESC: 2 of 3: 4.5-inch galvanized iron irrigation pipe through the levee, 3 feet below the crown. Slant pump, steel walkway, and steel vent pipe on the waterside (WS) slope. Shutoff valve off the landside (LS) toe. (Permit No. 10514, 1975 - The Newhall Land and Farming Company). [Additional Reference(s): DWR Levee Log, 1992]. FS Date: 7/12/2013

Pipe, walkway, and vent on WS shoulder.

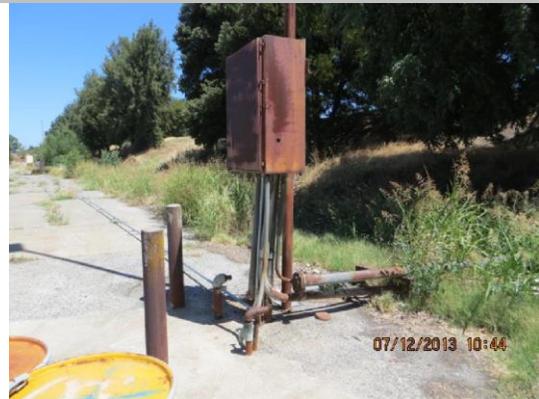
Photo 3 of 3 : UCIP_FA_2019_41070_26175.jpg

Pipe with cap or gate valve on end off LS toe.

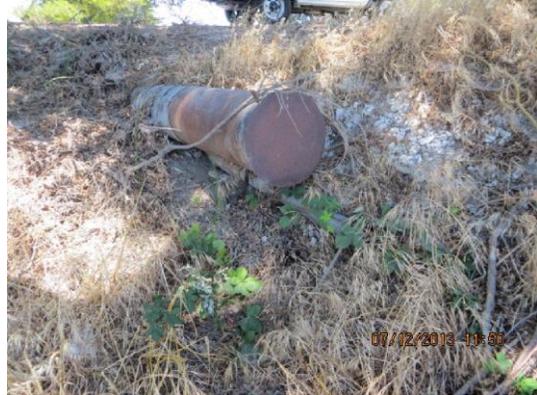
Photo 1 of 2 : UCIP_FA_2019_16389_27669.jpg

LM Start	0.82	Rating **	M	Issue No.	61
LM End	0.82	Issue Type +	En	Location *	
Category	Supplemental			GPS Latitude/Longitude	
				Start	End
Item	DRAFT DWR UCIP Field Study			38.424399°	38.424399°
				-121.530178°	-121.530178°
DWR ID	22797				
Comment Code					
Inspector Comment					
DS_ID:22797 FS_ID:16389 EP_NO: 1624 Repair Type: Non-Urgent Crossing Status: Found UCIP Comments: Pipe abandoned and should be done so properly. FIELD_STRUCT_DESC: 16-inch steel irrigation pipe through the levee, 3 feet below the crown. Pump and pile structure removed from the waterside (WS) toe. Steel plate welded over the WS end. (Permit No. 1624, 1951 - American Crystal Sugar Company. Replaces an existing facility north of this location). [Additional Reference(s): DWR Levee Log, 1992. USACE Sacramento O&M Manual 113 (Revised), October 1966, (HLM 0.81)]. FS Date: 7/12/2013

Pipe with steel plate welded over WS end.

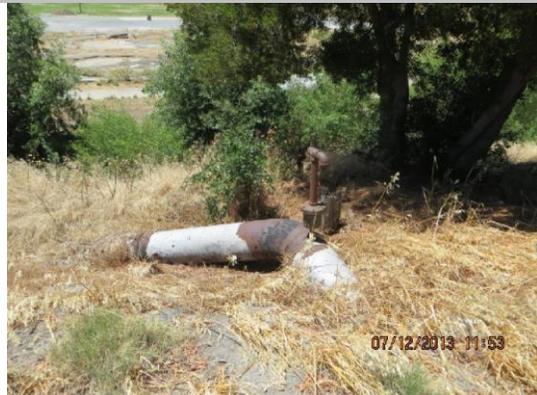
Photo 2 of 2 : UCIP_FA_2019_16389_27668.jpg

Pipe and vent/siphon breaker on LS slope.

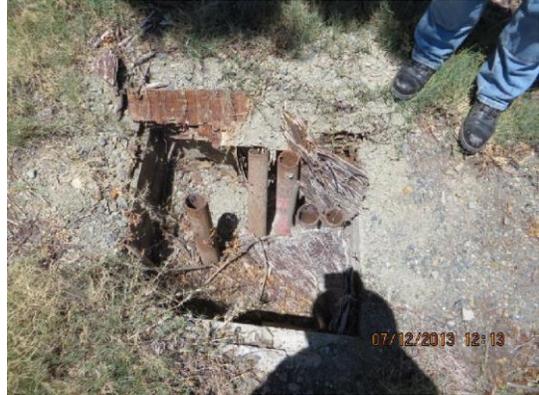
Photo 1 of 3 : UCIP_FA_2019_16385_27655.jpg

LM Start	0.90	Rating **	M	Issue No.	62
LM End	0.90	Issue Type +	En	Location *	
Category	Supplemental			GPS Latitude/Longitude	
				Start	End
Item	DRAFT DWR UCIP Field Study			38.425514 °	38.425514 °
				-121.530970 °	-121.530970 °
DWR ID	22809				
Comment Code					
Inspector Comment					
DS_ID:22809 FS_ID:16385 EP_NO: N/A Repair Type: Non-Urgent Crossing Status: Found UCIP Comments: Pipe abandoned and should be done so properly. FIELD_STRUCT_DESC: *ABANDONED* 5 of 6: 3.5-inch pipe of an unknown material or purpose through the levee, 2.5 feet below the crown. Pipe visible in a concrete well on the landside (LS) shoulder. [Additional Reference(s): DWR Levee Log, 1992]. FS Date: 7/12/2013

Pipe in concrete vault on LS shoulder.

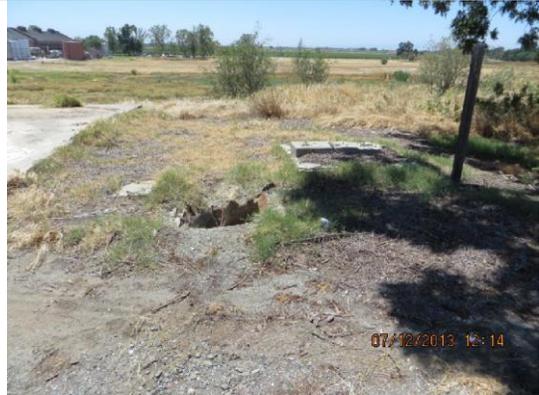
Photo 2 of 3 : UCIP_FA_2019_16385_27654.jpg

Pipe in concrete vault on LS shoulder.

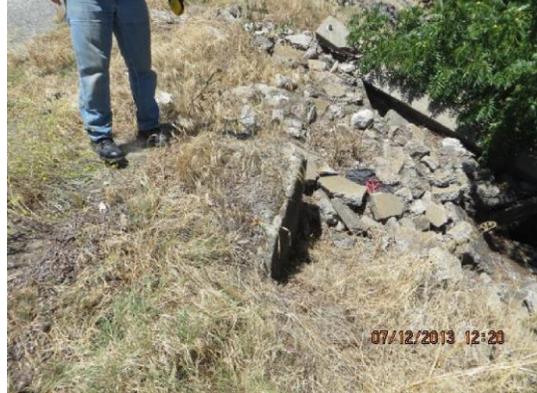
Photo 3 of 3 : UCIP_FA_2019_16385_27653.jpg

LM Start	0.90	Rating **	M	Issue No.	62 (cont)
LM End	0.90	Issue Type +	En	Location *	
Category	Supplemental			GPS Latitude/Longitude	
				Start	End
Item	DRAFT DWR UCIP Field Study			38.425514 °	38.425514 °
				-121.530970 °	-121.530970 °
DWR ID	22809				
Comment Code					
Inspector Comment					
DS_ID:22809 FS_ID:16385 EP_NO: N/A Repair Type: Non-Urgent Crossing Status: Found UCIP Comments: Pipe abandoned and should be done so properly. FIELD_STRUCT_DESC: *ABANDONED* 5 of 6: 3.5-inch pipe of an unknown material or purpose through the levee, 2.5 feet below the crown. Pipe visible in a concrete well on the landside (LS) shoulder. [Additional Reference(s): DWR Levee Log, 1992]. FS Date: 7/12/2013

Pipe assumed to be in concrete vault on WS shoulder.

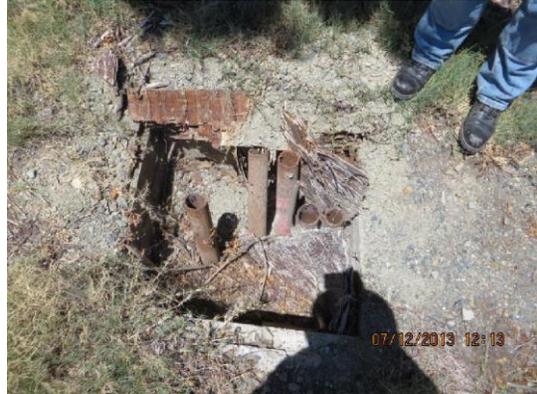
Photo 1 of 3 : UCIP_FA_2019_16386_27661.jpg

LM Start	0.90	Rating **	M	Issue No.	63
LM End	0.90	Issue Type +	En	Location *	
Category	Supplemental			GPS Latitude/Longitude	
				Start	End
Item	DRAFT DWR UCIP Field Study			38.425514 °	38.425514 °
				-121.530970 °	-121.530970 °
DWR ID	22810				
Comment Code					
Inspector Comment					
DS_ID:22810 FS_ID:16386 EP_NO: N/A Repair Type: Non-Urgent Crossing Status: Found UCIP Comments: Pipe abandoned and should be done so properly. FIELD_STRUCT_DESC: *ABANDONED* 6 of 6: 3.5-inch pipe of an unknown material or purpose through the levee, 2.5 feet below the crown. Pipe visible in a concrete well on the landside (LS) shoulder. [Additional Reference(s): DWR Levee Log, 1992]. FS Date: 7/12/2013

Pipes visible in concrete well on LS shoulder.

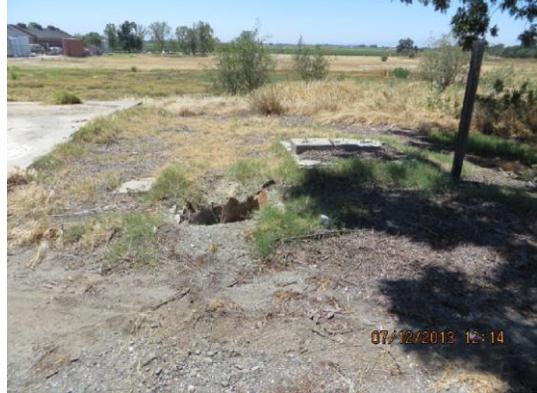
Photo 2 of 3 : UCIP_FA_2019_16386_27660.jpg

LM Start	0.90	Rating **	M	Issue No.	63 (cont)
LM End	0.90	Issue Type +	En	Location *	
Category	Supplemental			GPS Latitude/Longitude	
				Start	End
Item	DRAFT DWR UCIP Field Study			38.425514 °	38.425514 °
				-121.530970 °	-121.530970 °
DWR ID	22810				
Comment Code					
Inspector Comment					
DS_ID:22810 FS_ID:16386 EP_NO: N/A Repair Type: Non-Urgent Crossing Status: Found UCIP Comments: Pipe abandoned and should be done so properly. FIELD_STRUCT_DESC: *ABANDONED* 6 of 6: 3.5-inch pipe of an unknown material or purpose through the levee, 2.5 feet below the crown. Pipe visible in a concrete well on the landside (LS) shoulder. [Additional Reference(s): DWR Levee Log, 1992]. FS Date: 7/12/2013

Pipes visible in concrete well on LS shoulder.

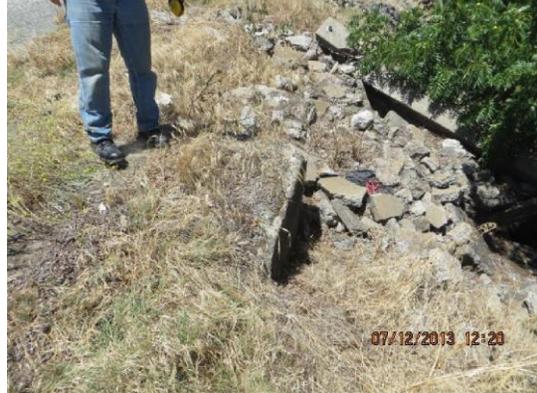
Photo 3 of 3 : UCIP_FA_2019_16386_27659.jpg

Assumed pipes are visible in concrete well on WS shoulder. Soil covers lid on concrete well.

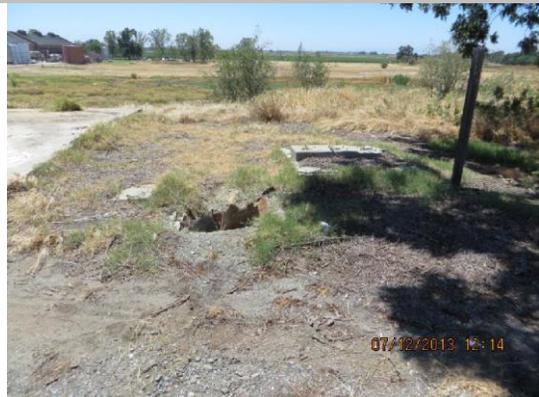
Photo 2 of 3 : UCIP_FA_2019_15728_26188.jpg

Pipes visible in concrete well on LS shoulder.

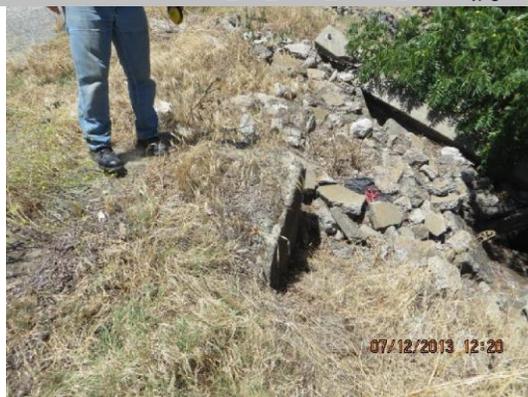
Photo 3 of 3 : UCIP_FA_2019_15728_26187.jpg

LM Start	0.91	Rating **	M	Issue No.	64 (cont)
LM End	0.91	Issue Type +	En	Location *	
Category	Supplemental			GPS Latitude/Longitude	
				Start	End
Item	DRAFT DWR UCIP Field Study			38.425514 °	38.425514 °
				-121.530970 °	-121.530970 °
DWR ID	22806				
Comment Code					
Inspector Comment					
DS_ID:22806 FS_ID:15728 EP_NO: N/A Repair Type: Non-Urgent Crossing Status: Found UCIP Comments: Pipe abandoned and should be done so properly. FIELD_STRUCT_DESC: *ABANDONED* 2 of 6: 3.5-inch pipe of an unknown material or purpose through the levee, 2.5 feet below the crown. Pipe visible in a concrete well on the landside (LS) shoulder and likely in a covered concrete well on the waterside (WS) shoulder. [Additional Reference(s): DWR Levee Log, 1992]. FS Date: 7/12/2013

Assumed pipes are in concrete well on WS shoulder at same location.

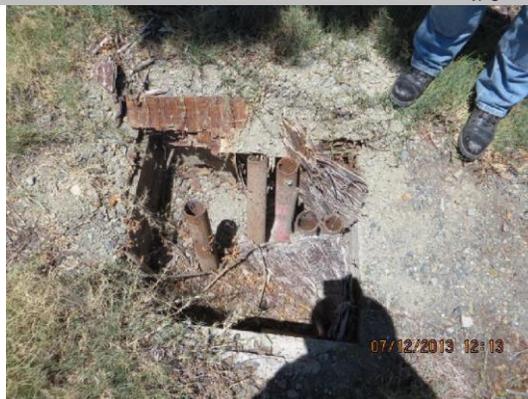
Photo 1 of 3 : UCIP_FA_2019_15727_26186.jpg

LM Start	0.91	Rating **	M	Issue No.	65
LM End	0.91	Issue Type +	En	Location *	
Category	Supplemental			GPS Latitude/Longitude	
				Start	End
Item	DRAFT DWR UCIP Field Study			38.425514 °	38.425514 °
				-121.530970 °	-121.530970 °
DWR ID	22799				
Comment Code					
Inspector Comment					
DS_ID:22799 FS_ID:15727 EP_NO: N/A Repair Type: Non-Urgent Crossing Status: Found UCIP Comments: Pipes abandoned and should be done so properly. FIELD_STRUCT_DESC: *ABANDONED* 1 of 6: 3.5-inch pipe of an unknown material or purpose through the levee, 2.5 feet below the crown. Pipe visible in a concrete well on the landside (LS) shoulder. Concrete well on the waterside (WS) shoulder is visible, but access is covered with soil. [Additional Reference(s): DWR Levee Log, 1992]. FS Date: 7/12/2013

Pipes in concrete well on LS shoulder.

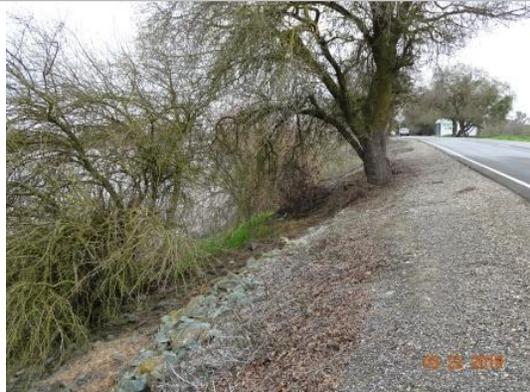
Photo 1 of 1 : FA_2019_RD0999_235_25_20190904_00012.jpg

LM Start	0.96	Rating **	M	Issue No.	25
LM End	0.99	Issue Type +	Ma	Location *	WS
Category	Earthen Levee			GPS Latitude/Longitude	
				Start	End
Item	Trim / Thin Trees			38.426310°	38.426627°
				-121.531460°	-121.531577°
DWR ID	DWR_RD0999_04_s_2019_25				
Comment Code					
T1 : Trim trees to at least five feet above ground level.					
Inspector Comment

View looking downstream at low-hanging tree branches on levee slope. Spring 2019

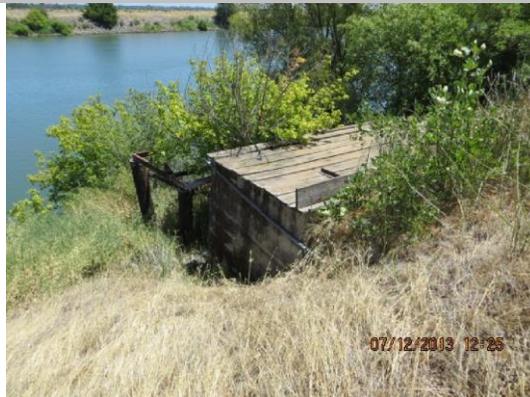
Photo 1 of 3 : UCIP_FA_2019_16387_27664.jpg

LM Start	1.00	Rating **	M	Issue No.	68
LM End	1.00	Issue Type +	En	Location *	
Category	Supplemental			GPS Latitude/Longitude	
				Start	End
Item	DRAFT DWR UCIP Field Study			38.426709°	38.426709°
				-121.531725°	-121.531725°
DWR ID	22800

Comment Code					
Inspector Comment					
DS_ID:22800 FS_ID:16387 EP_NO: N/A Repair Type: Non-Urgent Crossing Status: Found UCIP Comments: Pipe appears abandoned and should be done so properly. FIELD_STRUCT_DESC: 24-inch steel irrigation pipe through the levee, 13 feet below the crown. Pipe measures 16 inches in diameter on the waterside (WS) and 24 inches in diameter on the landside (LS) toe. Gate valve in a 9-foot by 18-foot concrete well on the WS slope. Slant pump missing from the WS slope. Concrete distribution house/box at the LS toe. 1.5-inch galvanized iron electrical conduit at the same location. [Additional Reference(s): DWR Levee Log, 1992. USACE Sacramento O&M Manual 113 (Revised), October 1966, (HLM 0.99)]. FS Date: 7/12/2013

Slide gate in 9'X18' concrete box on WS slope.

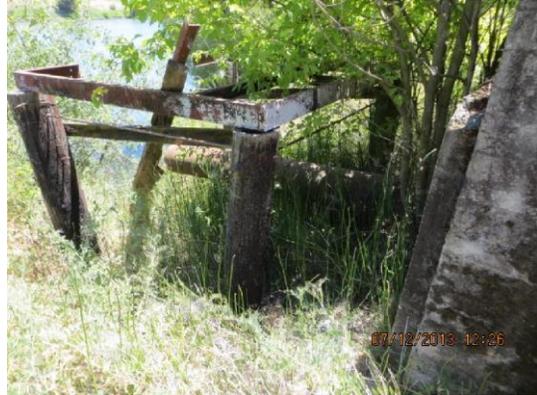
Photo 2 of 3 : UCIP_FA_2019_16387_27663.jpg

Comment Code					
Inspector Comment					
DS_ID:22800 FS_ID:16387 EP_NO: N/A Repair Type: Non-Urgent Crossing Status: Found UCIP Comments: Pipe appears abandoned and should be done so properly. FIELD_STRUCT_DESC: 24-inch steel irrigation pipe through the levee, 13 feet below the crown. Pipe measures 16 inches in diameter on the waterside (WS) and 24 inches in diameter on the landside (LS) toe. Gate valve in a 9-foot by 18-foot concrete well on the WS slope. Slant pump missing from the WS slope. Concrete distribution house/box at the LS toe. 1.5-inch galvanized iron electrical conduit at the same location. [Additional Reference(s): DWR Levee Log, 1992. USACE Sacramento O&M Manual 113 (Revised), October 1966, (HLM 0.99)]. FS Date: 7/12/2013

Slant pump missing from pier on WS slope.

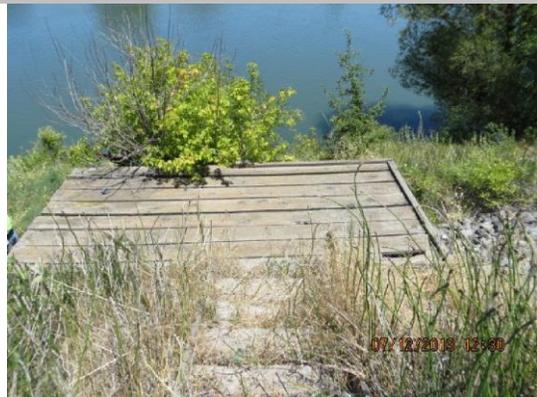
Photo 3 of 3 : UCIP_FA_2019_16387_27662.jpg

9'X18' concrete box with gatevalve on WS slope.

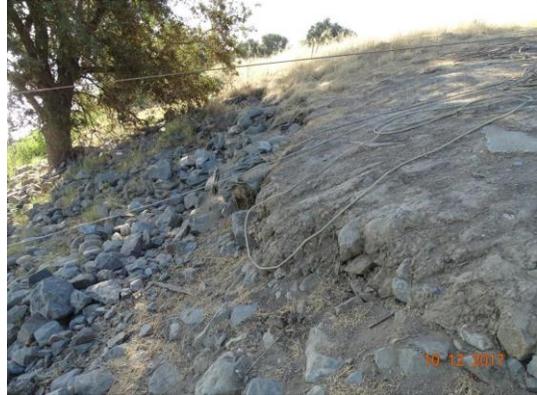
Photo 1 of 3 : FA_2019_RD0999_235_47_20190904_00025.jpg

LM Start	1.10	Rating **	M	Issue No.	47
LM End	1.10	Issue Type +	Ma	Location *	WS
Category	Earthen Levee			GPS Latitude/Longitude	
				Start	End
Item	Erosion / Bank Caving			38.428152°	38.428152°
				-121.532502°	-121.532502°
DWR ID	DWR_RD0999_04_s_2017_47				
Comment Code					
E1 : Note and monitor erosion site.					
Inspector Comment					
Small erosion just above the riprap and runoff erosion exist on the waterside slope.

Looking southeast at the waterside slope.

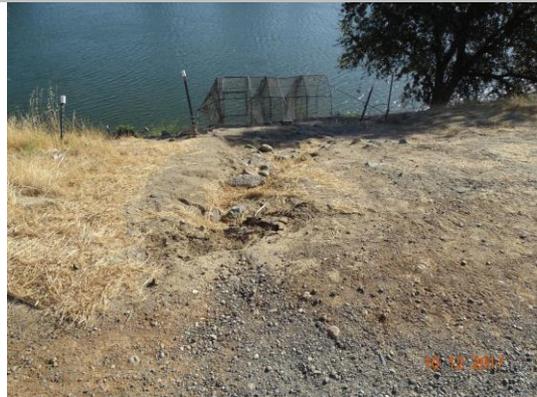
Photo 2 of 3 : FA_2019_RD0999_235_47_20190904_00026.jpg

Looking east at the waterside slope.

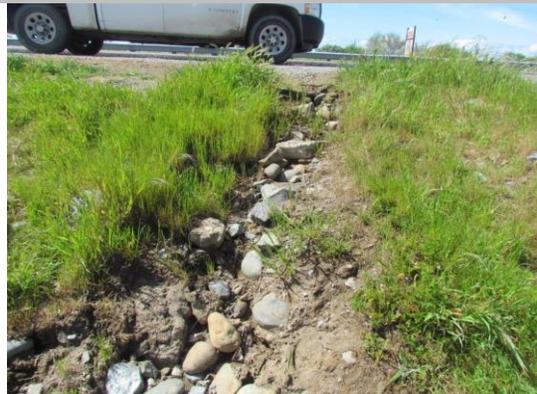
Photo 3 of 3 : FA_2019_RD0999_235_47_20190904_00027.jpg

Looking west at runoff erosion on waterward slope.

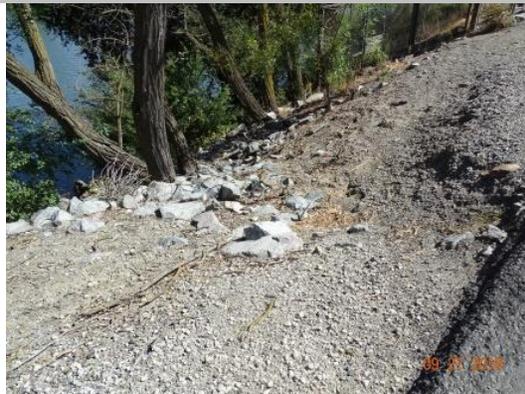
Photo 1 of 2 : FA_2019_RD0999_235_46_20191017_00071.jpg

LM Start	1.18	Rating **	M	Issue No.	46
LM End	1.18	Issue Type +	Ma	Location *	WS
Category	Earthen Levee			GPS Latitude/Longitude	
				Start	End
Item	Erosion / Bank Caving			38.429201 °	38.429201 °
				-121.533012 °	-121.533012 °
DWR ID	DWR_RD0999_04_s_2016_46				
Comment Code					
E2 : Schedule repair of erosion site prior to the next inspection.					
Inspector Comment					
Erosion exists just below the asphalt on the waterside shoulder.

View of erosion on the landside shoulder and slope. Fall 2019

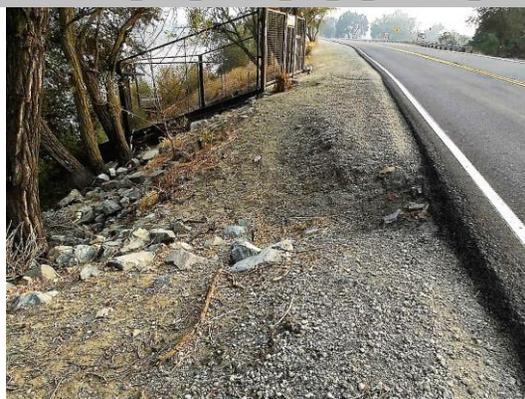
Photo 2 of 2 : FA_2019_RD0999_235_46_20190904_00022.jpg

View of erosion on shoulder and slope. Fall 2018

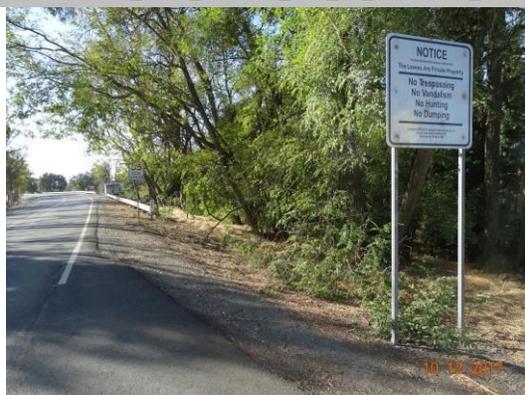
Photo 1 of 2 : FA_2019_RD0999_235_22_20190904_00009.jpg

LM Start	1.20	Rating **	M	Issue No.	22
LM End	1.22	Issue Type +	Ma	Location *	LS
Category	Earthen Levee			GPS Latitude/Longitude	
				Start	End
Item	Trim / Thin Trees			38.429467 °	38.429750 °
				-121.533110 °	-121.533188 °
DWR ID	DWR_RD0999_04_f_2013_22				
Comment Code					
T3 : Trim and thin trees to allow visibility of the ground and room to flood fight.					
Inspector Comment

Looking south at dense trees on landside slope. Fall 2017

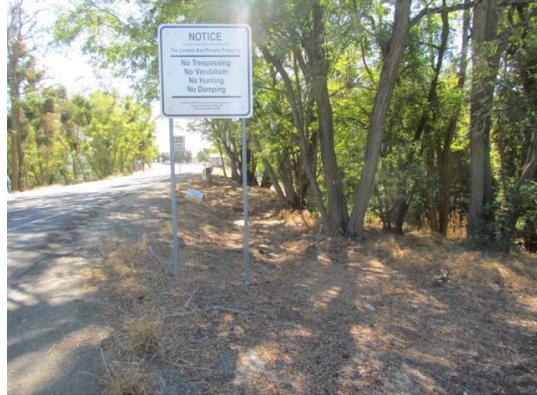
Photo 2 of 2 : FA_2019_RD0999_235_22_20190904_00010.jpg

LM Start	1.20	Rating **	M	Issue No.	22 (cont)
LM End	1.22	Issue Type +	Ma	Location *	LS
Category	Earthen Levee			GPS Latitude/Longitude	
				Start	End
Item	Trim / Thin Trees			38.429467°	38.429750°
				-121.533110°	-121.533188°
DWR ID	DWR_RD0999_04_f_2013_22				
Comment Code					
T3 : Trim and thin trees to allow visibility of the ground and room to flood fight.					
Inspector Comment

Looking south at dense trees on landward slope.

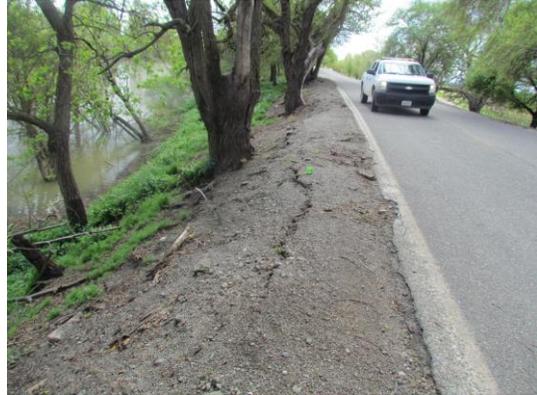
Photo 3 of 3 : FA_2019_RD0999_236_165_20190904_00071.jpg

LM Start	0.11	Rating **	M	Issue No.	165 (cont)
LM End	0.12	Issue Type +	Ma	Location *	WS
Category	Earthen Levee			GPS Latitude/Longitude	
				Start	End
Item	Slope Stability			38.334198°	38.334327°
				-121.584308°	-121.584275°
DWR ID	DWR_RD0999_05_s_2017_165				
Comment Code					
S3 : Repair the levee slope damaged by vehicle traffic and prevent access where possible.					
Inspector Comment					
Repair slope damage.

Looking downstream at crack along waterward shoulder.

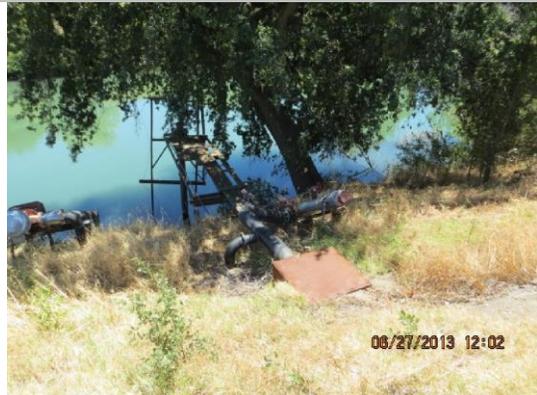
Photo 1 of 3 : UCIP_FA_2019_15411_25295.jpg

Comment Code					
Inspector Comment					
DS_ID:22839 FS_ID:15411 EP_NO: N/A Repair Type: Non-Urgent Crossing Status: Found UCIP Comments: Walkway to pump on pier is falling appart and should be removed. FIELD_STRUCT_DESC: 12-inch steel irrigation pipe through the levee, 11 feet below the crown. 10-inch pipe visible on slopes and at slant pump on the waterside (WS) slope. Pump on structure removed. Additional slant pump on the WS slope ties into pipe. 30-inch steel standpipe on the landside (LS) toe. Butterfly valves located on both sides of the levee. 3-foot by 3-foot steel junction box on the WS shoulder, and a 31-inch by 60-inch steel junction box on the LS shoulder. Service poles on both slopes. [Additional Reference(s): DWR Levee Log, 1992. USACE Sacramento O&M Manual 113 (Revised), October 1966, (HLM 0.23)]. FS Date: 6/27/2013

Pump and steel junction box visible on WS slope.

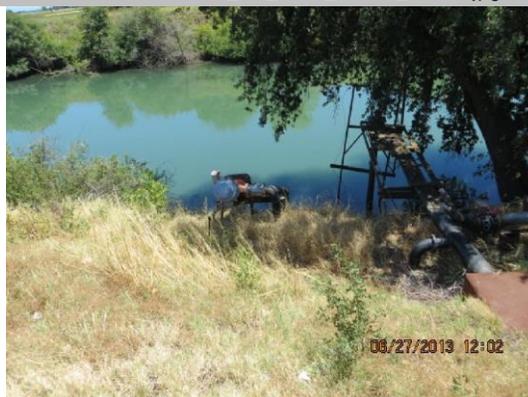
Photo 2 of 3 : UCIP_FA_2019_15411_25294.jpg

Comment Code					
Inspector Comment					
DS_ID:22839 FS_ID:15411 EP_NO: N/A Repair Type: Non-Urgent Crossing Status: Found UCIP Comments: Walkway to pump on pier is falling apart and should be removed. FIELD_STRUCT_DESC: 12-inch steel irrigation pipe through the levee, 11 feet below the crown. 10-inch pipe visible on slopes and at slant pump on the waterside (WS) slope. Pump on structure removed. Additional slant pump on the WS slope ties into pipe. 30-inch steel standpipe on the landside (LS) toe. Butterfly valves located on both sides of the levee. 3-foot by 3-foot steel junction box on the WS shoulder, and a 31-inch by 60-inch steel junction box on the LS shoulder. Service poles on both slopes. [Additional Reference(s): DWR Levee Log, 1992. USACE Sacramento O&M Manual 113 (Revised), October 1966, (HLM 0.23)]. FS Date: 6/27/2013

2nd Pump visible on WS slope.

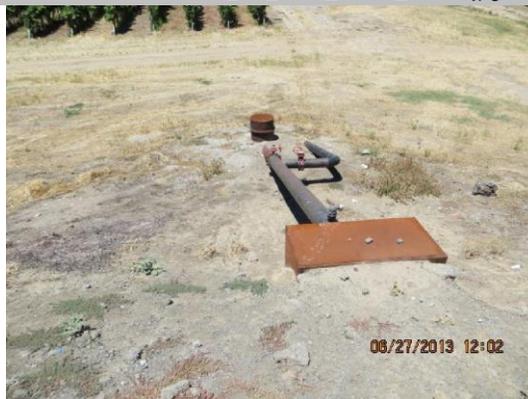
Photo 3 of 3 : UCIP_FA_2019_15411_25293.jpg

Steel junction box, vent, butterfly valve, and standpipe visible on LS slope.

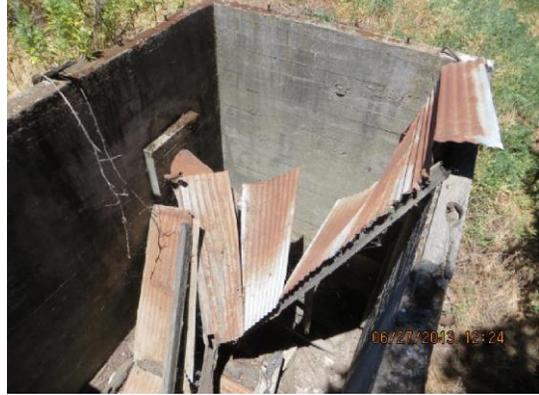
Photo 1 of 3 : UCIP_FA_2019_15414_25308.jpg

LM Start	0.58	Rating **	M	Issue No.	230
LM End	0.58	Issue Type +	En	Location *	
Category	Supplemental			GPS Latitude/Longitude	
				Start	End
Item	DRAFT DWR UCIP Field Study			38.340651 °	38.340651 °
				-121.581861 °	-121.581861 °
DWR ID	22841				
Comment Code					
Inspector Comment					
DS_ID:22841 FS_ID:15414 EP_NO: N/A Repair Type: Non-Urgent Crossing Status: Found UCIP Comments: Pipe abandoned and should be done so properly. FIELD_STRUCT_DESC: *ABANDONED* 16-inch steel irrigation pipe through the levee, 6 feet below the crown. Concrete pump house on the waterside (WS) slope. [Additional Reference(s): DWR Levee Log, 1992. USACE Sacramento O&M Manual 113 (revision), October 1966, (HLM 0.61)]. FS Date: 6/27/2013

Pipe visible inside abandoned pumphouse on WS slope.

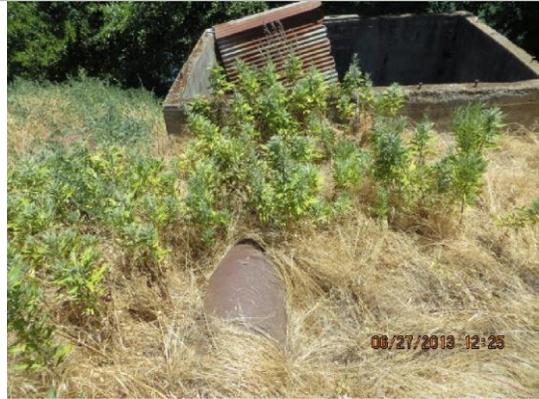
Photo 2 of 3 : UCIP_FA_2019_15414_25307.jpg

Pipe visible on WS slope.

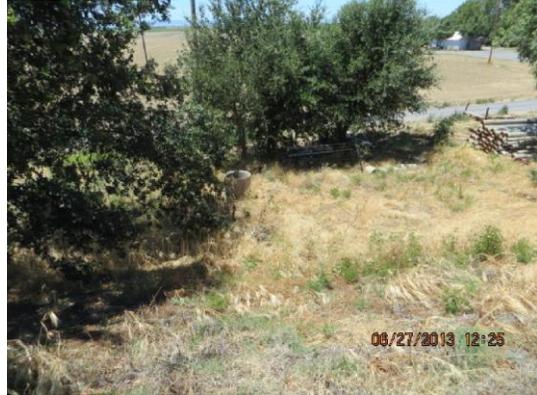
Photo 3 of 3 : UCIP_FA_2019_15414_25306.jpg

LM Start	0.58	Rating **	M	Issue No.	230 (cont)
LM End	0.58	Issue Type +	En	Location *	
Category	Supplemental			GPS Latitude/Longitude	
				Start	End
Item	DRAFT DWR UCIP Field Study			38.340651°	38.340651°
				-121.581861°	-121.581861°
DWR ID	22841				
Comment Code					
Inspector Comment					
DS_ID:22841 FS_ID:15414 EP_NO: N/A Repair Type: Non-Urgent Crossing Status: Found UCIP Comments: Pipe abandoned and should be done so properly. FIELD_STRUCT_DESC: *ABANDONED* 16-inch steel irrigation pipe through the levee, 6 feet below the crown. Concrete pump house on the waterside (WS) slope. [Additional Reference(s): DWR Levee Log, 1992. USACE Sacramento O&M Manual 113 (revision), October 1966, (HLM 0.61)]. FS Date: 6/27/2013

Pipe may be aligned with concrete standpipe at LS toe, but no pipe is visible on LS.

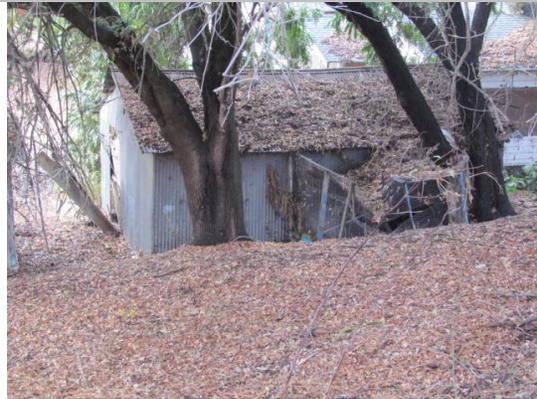
Photo 1 of 1 : FA_2019_RD0999_236_170_20190904_00076.jpg

LM Start	0.70	Rating **	U	Issue No.	170
LM End	0.70	Issue Type +	En	Location *	LS
Category	Earthen Levee			GPS Latitude/Longitude	
				Start	End
Item	Encroachments			38.342288°	38.342288°
				-121.581278°	-121.581278°
DWR ID	DWR_RD0999_05_f_2015_170				
Comment Code					
BU : Building					
Inspector Comment					
The toolshed at the landside toe is without a permit.

Looking at the toolshed at the landward toe.
