**Flood Control Project Maintenance
Levee Inspections**

Fall 2019 Levee Maintenance Deficiency Summary Report

**Flood Control Project Maintenance
Levee Inspections**
LMA District Cover Sheet
Fall 2019 Levee Inspection Results

Reclamation District No. 0999 Netherlands

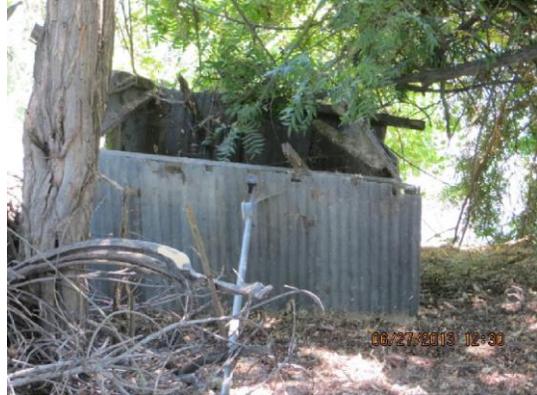
Photo 1 of 2 : UCIP_FA_2019_15450_25386.jpg

LM Start	0.72	Rating **	M	Issue No.	231
LM End	0.72	Issue Type +	En	Location *	
Category	Supplemental			GPS Latitude/Longitude	
				Start	End
Item	DRAFT DWR UCIP Field Study			38.342653°	38.342653°
				-121.581236°	-121.581236°
DWR ID	22842				
Comment Code					
Inspector Comment					
DS_ID:22842 FS_ID:15450 EP_NO: N/A Repair Type: Non-Urgent Crossing Status: Found UCIP Comments: Pipe abandoned and should be done so properly. FIELD_STRUCT_DESC: *ABANDONED* 6-inch steel irrigation pipe through the levee, 11.5 feet below the crown. Pump and gate valve in pump house on the waterside (WS) slope. 1.5-inch galvanized iron electrical conduit at the same location. [Additional Reference(s): DWR Levee Log, 1992. USACE Sacramento O&M Manual 113 (Revised), October 1966, (HLM 0.75)]. FS Date: 6/27/2013

Pumphouse on WS slope with electrical conduit shown.

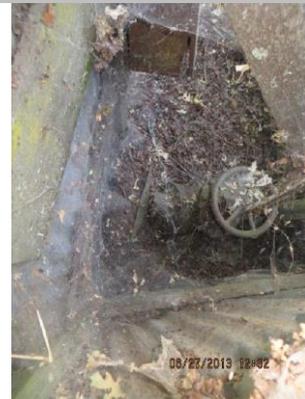
Photo 2 of 2 : UCIP_FA_2019_15450_25385.jpg

Pipe rusted through at gatevalve inside pumphouse.

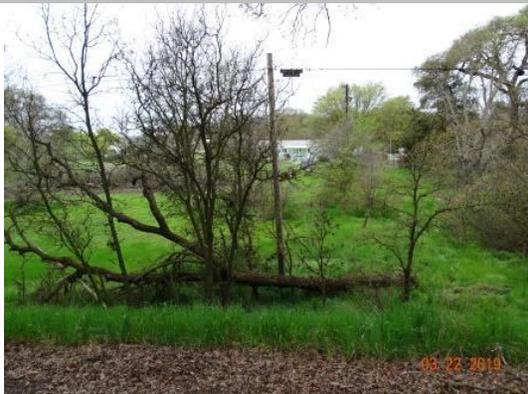
Photo 1 of 1 : FA_2019_RD0999_236_52_20190904_00024.jpg

LM Start	0.76	Rating **	M	Issue No.	52
LM End	0.76	Issue Type +	En	Location *	LS
Category	Earthen Levee		GPS Latitude/Longitude		
			Start	End	
Item	Encroachments		38.343253 °	38.343253 °	
			-121.581318 °	-121.581318 °	
DWR ID	DWR_RD0999_05_s_2019_52				
Comment Code					
TR : Tree or limb					
Inspector Comment					
The landowner needs to remove the fallen tree from the levee easement.

View looking west at fallen tree within levee easement. Spring 2019

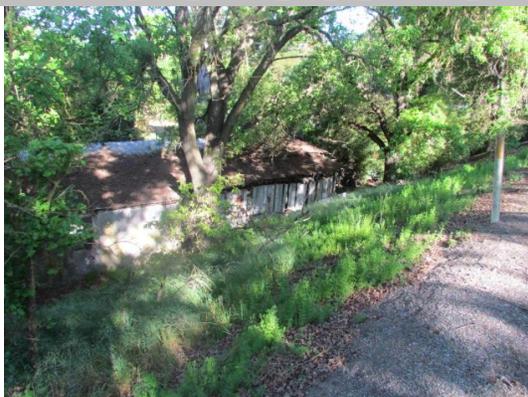
Photo 1 of 2 : FA_2019_RD0999_236_23_20190904_00015.jpg

LM Start	0.77	Rating **	U	Issue No.	23
LM End	0.77	Issue Type +	En	Location *	LS
Category	Earthen Levee		GPS Latitude/Longitude		
			Start	End	
Item	Encroachments		38.343358 °	38.343358 °	
			-121.581295 °	-121.581295 °	
DWR ID	DWR_RD0999_05_f_2012_23				
Comment Code					
BU : Building					
Inspector Comment					
The storage shed at the landside toe does not have a permit.

Looking northwest at abandoned storage shed at landward toe. (Spring 2015)

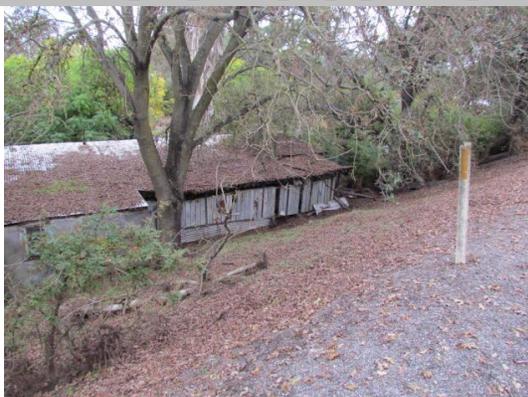
Photo 2 of 2 : FA_2019_RD0999_236_23_20190904_00016.jpg

Looking northwest at storage shed at landside toe and within the 10' easement.

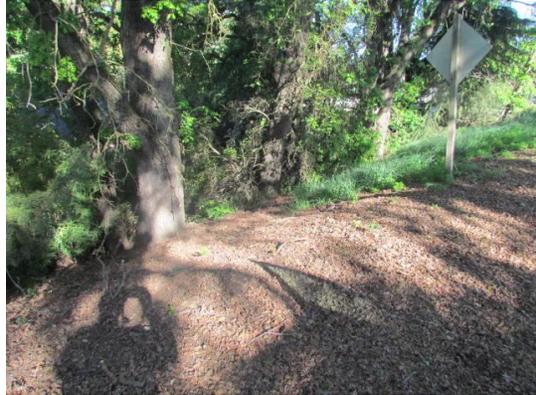
Photo 1 of 2 : FA_2019_RD0999_236_128_20190904_00052.jpg

LM Start	0.78	Rating **	M	Issue No.	128
LM End	0.79	Issue Type +	Ma	Location *	LS
Category	Earthen Levee			GPS Latitude/Longitude	
				Start	End
Item	Trim / Thin Trees			38.343495°	38.343617°
				-121.581282°	-121.581249°
DWR ID	DWR_RD0999_05_s_2012_128				
Comment Code					
T3 : Trim and thin trees to allow visibility of the ground and room to flood fight.					
Inspector Comment

Looking northwest at untrimmed trees on landward slope. (Spring 2015)

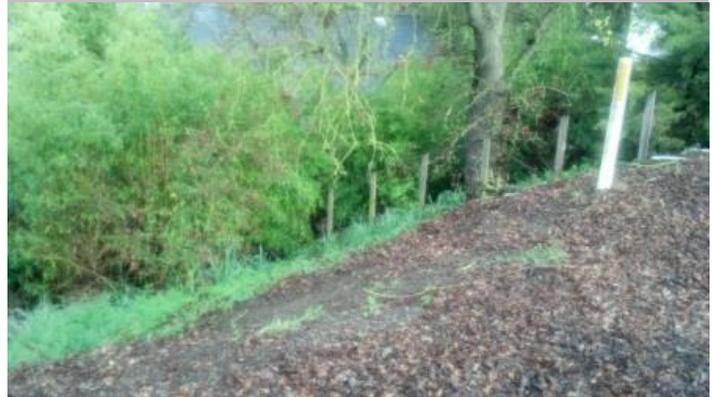
Photo 2 of 2 : FA_2019_RD0999_236_128_20190904_00053.jpg

Looking at dense trees on landside slope and toe.

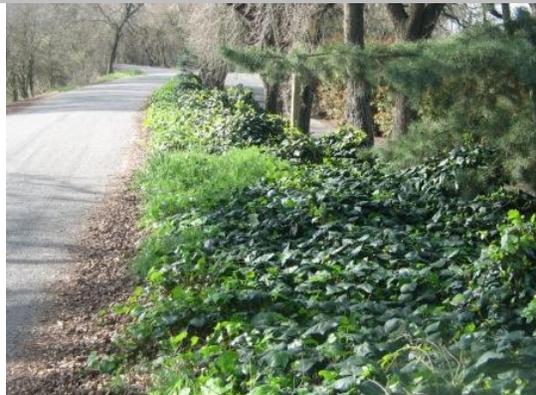
Photo 1 of 2 : FA_2019_RD0999_236_11_20190904_00006.jpg

LM Start	0.80	Rating **	U	Issue No.	11
LM End	0.91	Issue Type +	En	Location *	LS
Category	Earthen Levee			GPS Latitude/Longitude	
				Start	End
Item	Vegetation			38.343825°	38.345383°
				-121.581133°	-121.580717°
DWR ID	DWR_RD0999_05_s_2012_11				
Comment Code					
V6 : Landscaping					
Inspector Comment					
Ivy groundcover is not allowed.

View of landscaping (Ivy) looking upstream.

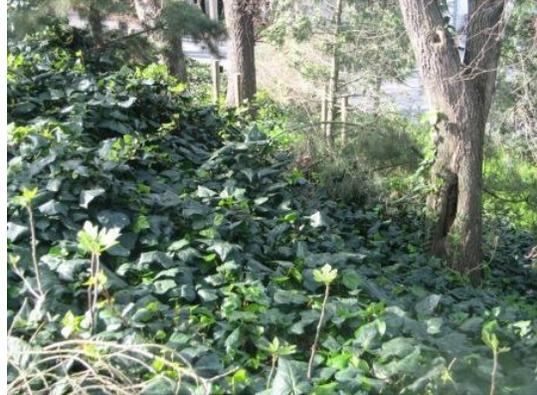
Photo 2 of 2 : FA_2019_RD0999_236_11_20190904_00007.jpg

LM Start	0.80	Rating **	U	Issue No.	11 (cont)
LM End	0.91	Issue Type +	En	Location *	LS
Category	Earthen Levee		GPS Latitude/Longitude		
			Start	End	
Item	Vegetation		38.343825°	38.345383°	
			-121.581133°	-121.580717°	
DWR ID	DWR_RD0999_05_s_2012_11				
Comment Code					
V6 : Landscaping					
Inspector Comment					
Ivy groundcover is not allowed.

View of landscaping (Ivy) blocking view of landside slope.

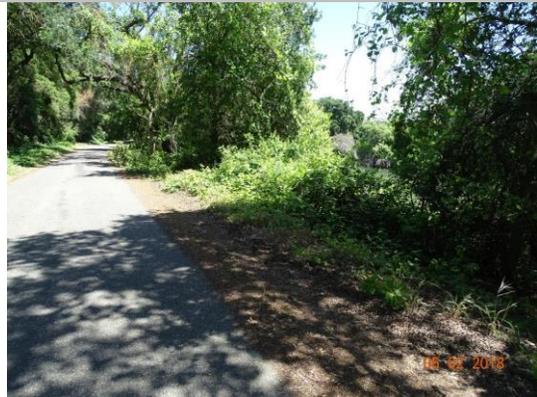
Photo 1 of 1 : FA_2019_RD0999_236_10_20190904_00005.jpg

LM Start	0.84	Rating **	M	Issue No.	10
LM End	0.84	Issue Type +	Ma	Location *	WS
Category	Earthen Levee		GPS Latitude/Longitude		
			Start	End	
Item	Vegetation		38.344294°	38.344294°	
			-121.581054°	-121.581054°	
DWR ID	DWR_RD0999_05_s_2018_10				
Comment Code					
V2 : Remove the wild growth other than native grasses from the levee slopes.					
Inspector Comment					
Clear vegetation from WS slope in vegetation management zone.

Vegetation waterside looking north. Spring 2018

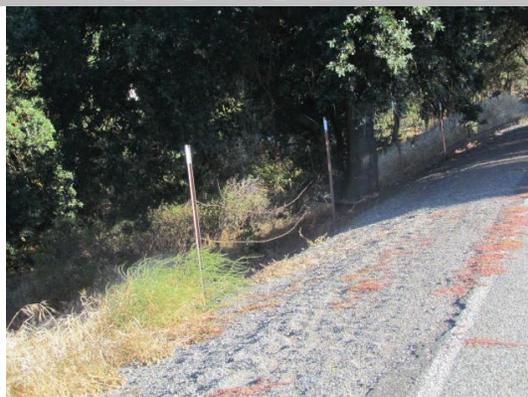
Photo 1 of 1 : FA_2019_RD0999_236_136_20190904_00056.jpg

LM Start	0.96	Rating **	M	Issue No.	136
LM End	1.12	Issue Type +	En	Location *	LS
Category	Earthen Levee			GPS Latitude/Longitude	
				Start	End
Item	Encroachments			38.346016°	38.348053°
				-121.580358°	-121.579007°
DWR ID	DWR_RD0999_05_f_2013_136				
Comment Code					
FE : Fence					
Inspector Comment					
Fencing on the landside slope is unauthorized.

Looking northwest at fence on landward slope.

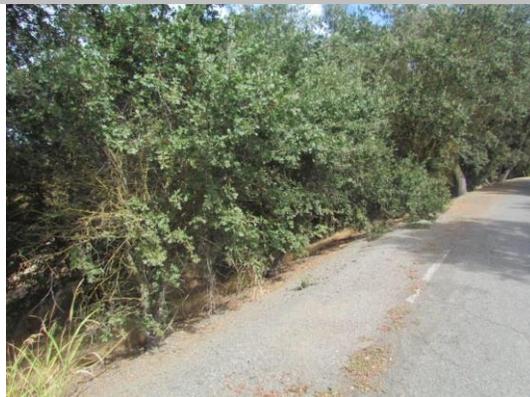
Photo 1 of 1 : FA_2019_RD0999_236_14_20190904_00010.jpg

LM Start	1.07	Rating **	M	Issue No.	14
LM End	1.11	Issue Type +	En	Location *	LS
Category	Earthen Levee		GPS Latitude/Longitude		
			Start	End	
Item	Vegetation		38.347427°	38.347863°	
			-121.579395°	-121.579113°	
DWR ID	DWR_RD0999_05_s_2012_14				
Comment Code					
V6 : Landscaping					
Inspector Comment					
Instruct the landowner to trim and thin trees on the levee easement.

Looking west at untrimmed trees on landward slope and toe.

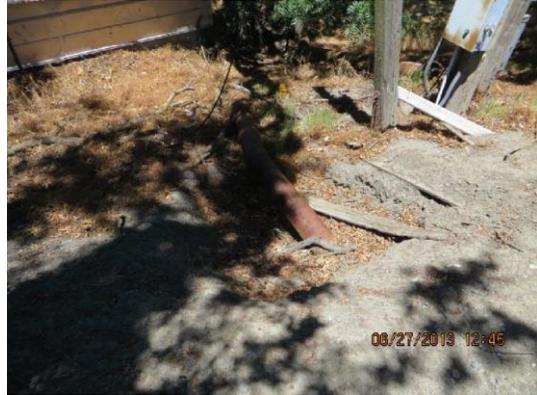
Photo 1 of 2 : UCIP_FA_2019_16336_27532.jpg

LM Start	1.13	Rating **	M	Issue No.	232
LM End	1.13	Issue Type +	En	Location *	
Category	Supplemental			GPS Latitude/Longitude	
				Start	End
Item	DRAFT DWR UCIP Field Study			38.348113°	38.348113°
				-121.578841°	-121.578841°
DWR ID	23964				
Comment Code					
Inspector Comment					
DS_ID:23964 FS_ID:16336 EP_NO: N/A Repair Type: Non-Urgent Crossing Status: Found UCIP Comments: Pipe appears abandoned and should be removed. FIELD_STRUCT_DESC: *ABANDONED* 10-inch steel irrigation pipe through the levee, 6.5 feet below the crown. Pipe extends under metal walkway on the waterside (WS) shoulder. FS Date: 6/27/2013

Pipe visible on LS shoulder.

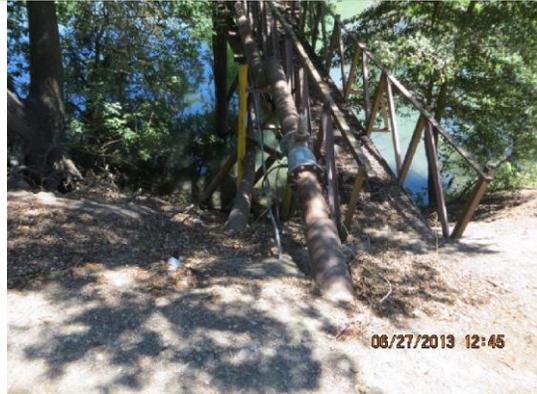
Photo 2 of 2 : UCIP_FA_2019_16336_27531.jpg

Pipe visible beneath 10-inch pipe that is currently in use. No connection.

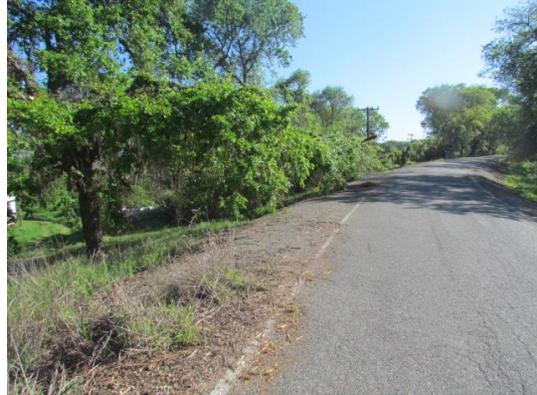
Photo 1 of 1 : FA_2019_RD0999_236_15_20190904_00011.jpg

LM Start	1.15	Rating **	U	Issue No.	15
LM End	1.19	Issue Type +	Ma	Location *	LS
Category	Earthen Levee		GPS Latitude/Longitude		
			Start	End	
Item	Trim / Thin Trees		38.348237°	38.348328°	
			-121.578440°	-121.577735°	
DWR ID	DWR_RD0999_05_s_2012_15				
Comment Code					
T1 : Trim trees to at least five feet above ground level.					
Inspector Comment

Looking north at untrimmed trees on landward slope and toe.

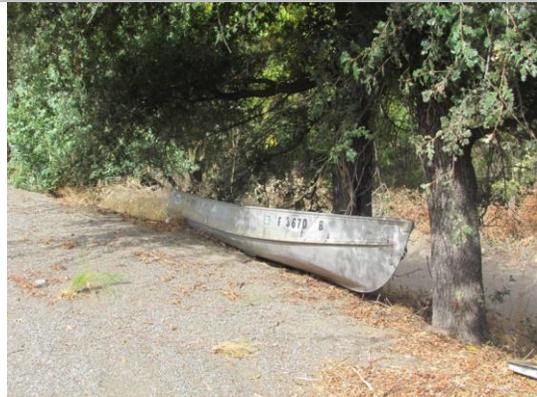
Photo 1 of 1 : FA_2019_RD0999_236_169_20190904_00075.jpg

LM Start	1.18	Rating **	M	Issue No.	169
LM End	1.18	Issue Type +	En	Location *	LS
Category	Earthen Levee		GPS Latitude/Longitude		
			Start	End	
Item	Encroachments		38.348339°	38.348339°	
			-121.577840°	-121.577840°	
DWR ID	DWR_RD0999_05_f_2016_169				
Comment Code					
EQ : Equipment					
Inspector Comment					
Instruct the landowner to move boat off of the landside easement.

Looking southwest at boat on landward slope.

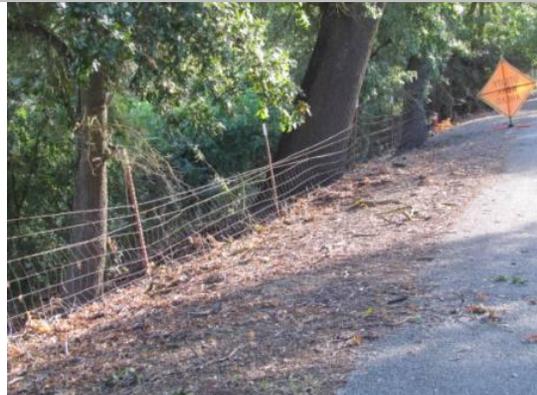
Photo 1 of 1 : FA_2019_RD0999_236_76_20190904_00031.jpg

LM Start	1.20	Rating **	M	Issue No.	76
LM End	1.22	Issue Type +	En	Location *	LS
Category	Earthen Levee		GPS Latitude/Longitude		
			Start	End	
Item	Encroachments		38.348336°	38.348332°	
			-121.577621°	-121.577172°	
DWR ID	DWR_RD0999_05_s_2012_76				
Comment Code					
FE : Fence					
Inspector Comment					
A fence located on the landside shoulder does not appear to be authorized.

Looking north at fence along landside slope.

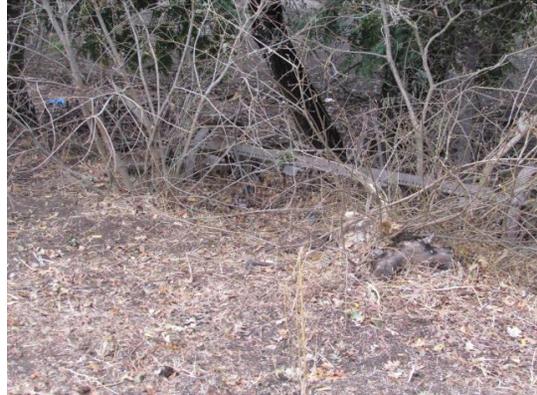
Photo 1 of 1 : FA_2019_RD0999_236_171_20190904_00077.jpg

LM Start	1.25	Rating **	M	Issue No.	171
LM End	1.25	Issue Type +	En	Location *	LS
Category	Earthen Levee			GPS Latitude/Longitude	
				Start	End
Item	Encroachments			38.348319°	38.348319°
				-121.576566°	-121.576566°
DWR ID	DWR_RD0999_05_f_2015_171				
Comment Code					
EQ : Equipment					
Inspector Comment					
Instruct the landowner to move old farm equipment off of the landside easement.

Looking at farm equipment on landward slope.

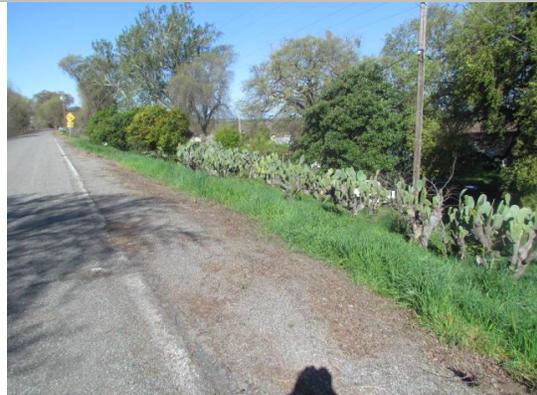
Photo 1 of 4 : FA_2019_RD0999_236_2_20190904_00001.jpg

LM Start	1.28	Rating **	U	Issue No.	2
LM End	1.30	Issue Type +	En	Location *	LS
Category	Earthen Levee			GPS Latitude/Longitude	
				Start	End
Item	Vegetation			38.348279°	38.348287°
				-121.576061°	-121.576562°
DWR ID	DWR_RD0999_05_s_2012_2				
Comment Code					
V6 : Landscaping					
Inspector Comment					
Instruct landowner to remove landscaping, century plant, and cactus from landside slope.

Looking southwest at dense cactus plants on landward slope and toe.

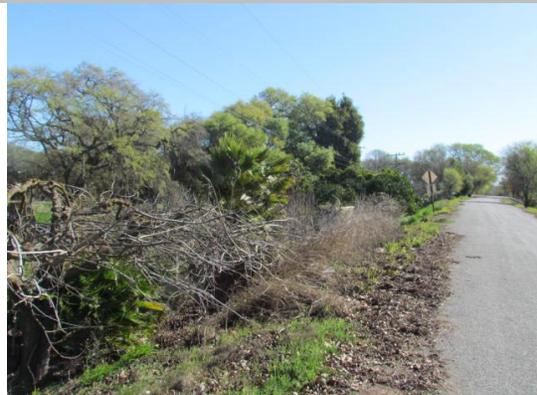
Photo 2 of 4 : FA_2019_RD0999_236_2_20190904_00002.jpg

Looking south at landscaping on landward slope.

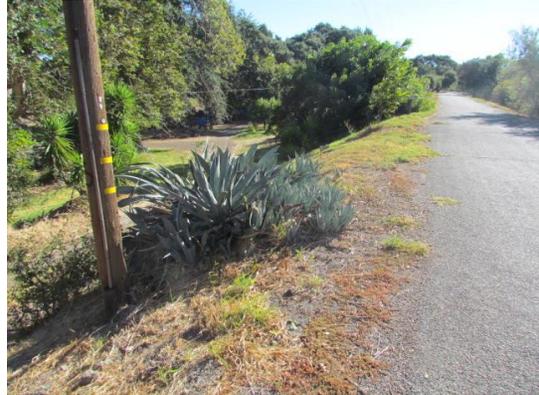
Photo 3 of 4 : FA_2019_RD0999_236_2_20190904_00003.jpg

LM Start	1.28	Rating **	U	Issue No.	2 (cont)
LM End	1.30	Issue Type +	En	Location *	LS
Category	Earthen Levee		GPS Latitude/Longitude		
			Start	End	
Item	Vegetation		38.348279°	38.348287°	
			-121.576061°	-121.575652°	
DWR ID	DWR_RD0999_05_s_2012_2				
Comment Code					
V6 : Landscaping					
Inspector Comment					
Instruct landowner to remove landscaping, century plant, and cactus from landside slope.

Looking northwest at landscaping on landward slope.

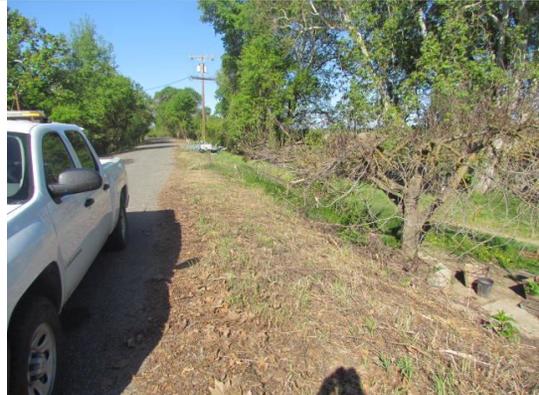
Photo 4 of 4 : FA_2019_RD0999_236_2_20190904_00004.jpg

Looking south at landward slope. (Spring 2015)

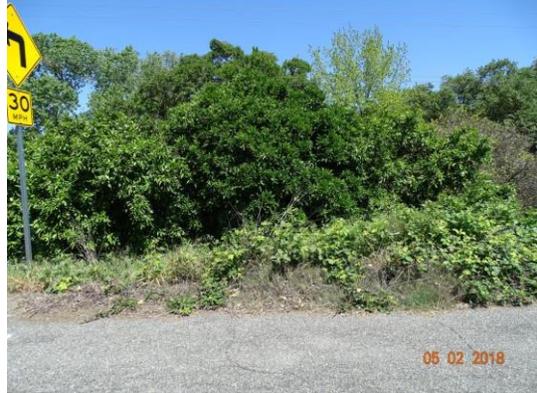
Photo 1 of 1 : FA_2019_RD0999_236_13_20190904_00009.jpg

LM Start	1.31	Rating **	U	Issue No.	13
LM End	1.32	Issue Type +	En	Location *	LS
Category	Earthen Levee			GPS Latitude/Longitude	
				Start	End
Item	Vegetation			38.348250 °	38.348226 °
				-121.575510 °	-121.575399 °
DWR ID	DWR_RD0999_05_s_2018_13				
Comment Code					
V6 : Landscaping					
Inspector Comment					
Instruct the landowner to trim vegetation within the levee easement. Fruit trees at the levee toe do not appear to be authorized.

Vegetation landside looking west. Spring 2018

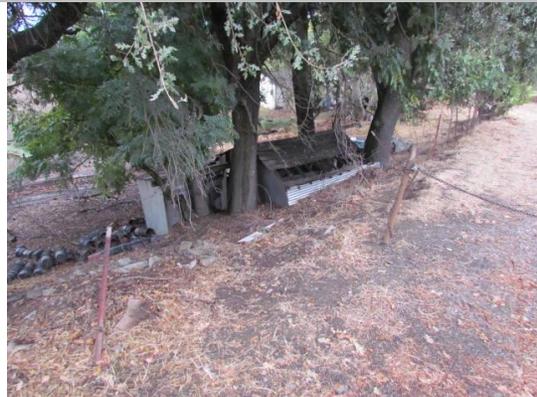
Photo 1 of 3 : FA_2019_RD0999_236_172_20190904_00078.jpg

LM Start	1.31	Rating **	U	Issue No.	172
LM End	1.31	Issue Type +	En	Location *	LS
Category	Earthen Levee			GPS Latitude/Longitude	
				Start	End
Item	Encroachments			38.348248 °	38.348248 °
				-121.575467 °	-121.575467 °
DWR ID	DWR_RD0999_05_f_2015_172				
Comment Code					
BU : Building					
Inspector Comment					
The toolshed located at the landside toe is unauthorized.

Looking southwest at toolshed at landward toe.

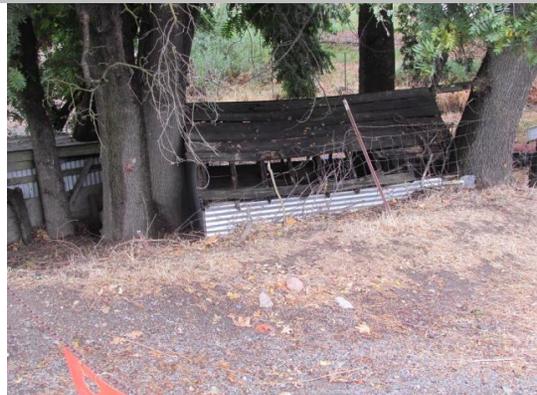
Photo 2 of 3 : FA_2019_RD0999_236_172_20190904_00079.jpg

Looking west at toolshed at landward toe.

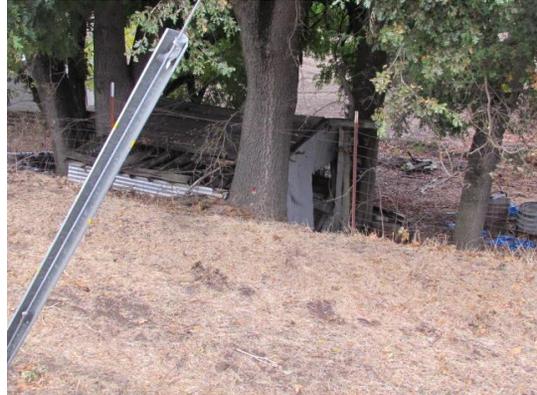
Photo 3 of 3 : FA_2019_RD0999_236_172_20190904_00080.jpg

LM Start	1.31	Rating **	U	Issue No.	172 (cont)
LM End	1.31	Issue Type +	En	Location *	LS
Category	Earthen Levee			GPS Latitude/Longitude	
				Start	End
Item	Encroachments			38.348248°	38.348248°
				-121.575467°	-121.575467°
DWR ID	DWR_RD0999_05_f_2015_172				
Comment Code					
BU : Building					
Inspector Comment					
The toolshed located at the landside toe is unauthorized.

Looking at northwest at toolshed at landward toe.

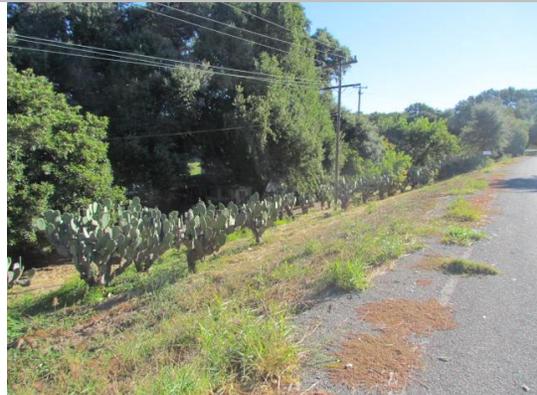
Photo 1 of 1 : FA_2019_RD0999_236_149_20190904_00059.jpg

LM Start	1.33	Rating **	M	Issue No.	149
LM End	1.36	Issue Type +	En	Location *	LS
Category	Earthen Levee			GPS Latitude/Longitude	
				Start	End
Item	Vegetation			38.348223°	38.348191°
				-121.575223°	-121.574667°
DWR ID	DWR_RD0999_05_f_2013_149				
Comment Code					
V6 : Landscaping					
Inspector Comment					
Instruct landowner to remove large cactus plants from the landside slope.

Looking northwest at several cactus plants on landward slope.

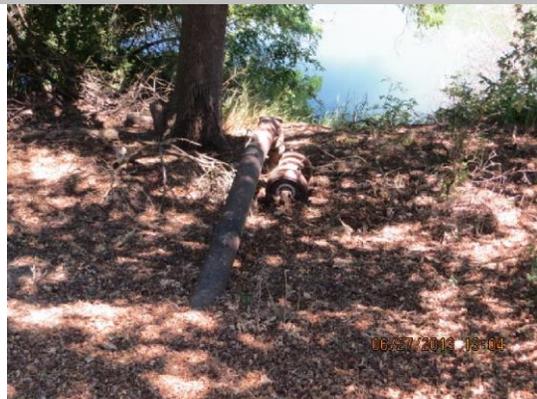
Photo 1 of 2 : UCIP_FA_2019_15421_25323.jpg

LM Start	1.83	Rating **	M	Issue No.	233
LM End	1.83	Issue Type +	En	Location *	
Category	Supplemental			GPS Latitude/Longitude	
				Start	End
Item	DRAFT DWR UCIP Field Study			38.353864°	38.353864°
				-121.573577°	-121.573577°
DWR ID	22847				
Comment Code					
Inspector Comment					
DS_ID:22847 FS_ID:15421 EP_NO: N/A Repair Type: Non-Urgent Crossing Status: Found UCIP Comments: Abandoned and should be done so properly. FIELD_STRUCT_DESC: *ABANDONED* 8-inch steel irrigation pipe through the levee, 4.7 feet below the crown. Pump house on the waterside (WS) slope. Both ends open. [Additional Reference(s): DWR Levee Log, 1992. USACE Sacramento O&M Manual 113 (Revised), October 1966, (HLM 1.89)]. FS Date: 6/27/2013

Pipe and pump remnants on WS slope.

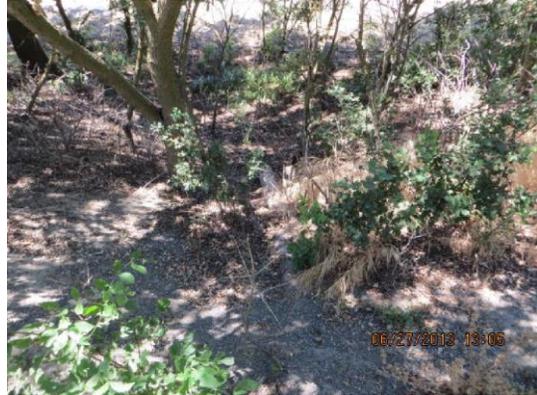
Photo 2 of 2 : UCIP_FA_2019_15421_25322.jpg

LM Start	1.83	Rating **	M	Issue No.	233 (cont)
LM End	1.83	Issue Type +	En	Location *	
Category	Supplemental			GPS Latitude/Longitude	
				Start	End
Item	DRAFT DWR UCIP Field Study			38.353864 °	38.353864 °
				-121.573577 °	-121.573577 °
DWR ID	22847				
Comment Code					
Inspector Comment					
DS_ID:22847 FS_ID:15421 EP_NO: N/A Repair Type: Non-Urgent Crossing Status: Found UCIP Comments: Abandoned and should be done so properly. FIELD_STRUCT_DESC: *ABANDONED* 8-inch steel irrigation pipe through the levee, 4.7 feet below the crown. Pump house on the waterside (WS) slope. Both ends open. [Additional Reference(s): DWR Levee Log, 1992. USACE Sacramento O&M Manual 113 (Revised), October 1966, (HLM 1.89)]. FS Date: 6/27/2013

Pipe visible on LS slope.

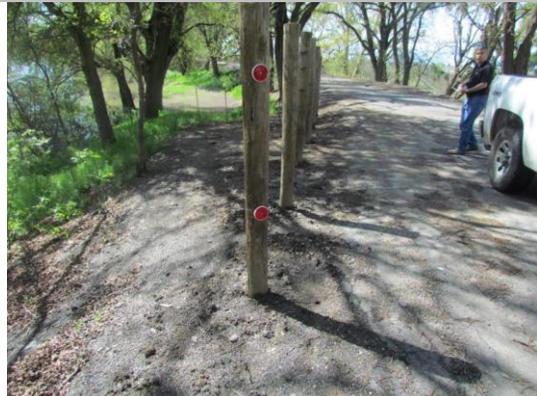
Photo 1 of 3 : FA_2019_RD0999_236_167_20190904_00072.jpg

LM Start	2.00	Rating **	A/W	Issue No.	167
LM End	2.00	Issue Type +	En	Location *	WS
Category	Earthen Levee			GPS Latitude/Longitude	
				Start	End
Item	Encroachments			38.355538 °	38.355538 °
				-121.571398 °	-121.571398 °
DWR ID	DWR_RD0999_05_s_2017_167				
Comment Code					
PO : Pole					
Inspector Comment					
Remove poles 30 to 36 inches deep on the waterside shoulder.

Looking downstream at wooden poles on waterward shoulder.

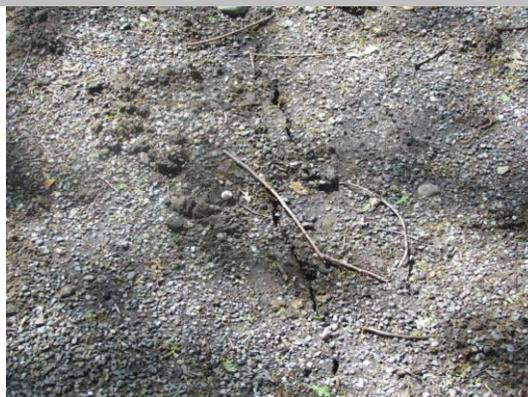
Photo 2 of 3 : FA_2019_RD0999_236_167_20190904_00073.jpg

LM Start	2.00	Rating **	A/W	Issue No.	167 (cont)
LM End	2.00	Issue Type +	En	Location *	WS
Category	Earthen Levee			GPS Latitude/Longitude	
				Start	End
Item	Encroachments			38.355538°	38.355538°
				-121.571398°	-121.571398°
DWR ID	DWR_RD0999_05_s_2017_167				
Comment Code					
PO : Pole					
Inspector Comment					
Remove poles 30 to 36 inches deep on the waterside shoulder.

Looking at crack along waterward caused by poles.

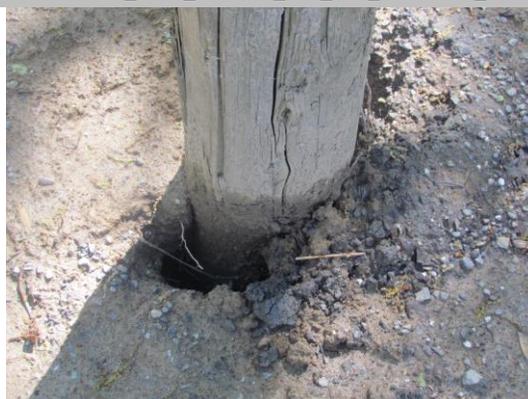
Photo 3 of 3 : FA_2019_RD0999_236_167_20190904_00074.jpg

LM Start	2.00	Rating **	A/W	Issue No.	167 (cont)
LM End	2.00	Issue Type +	En	Location *	WS

Looking at 3-4 ft hole for pole on waterward shoulder.

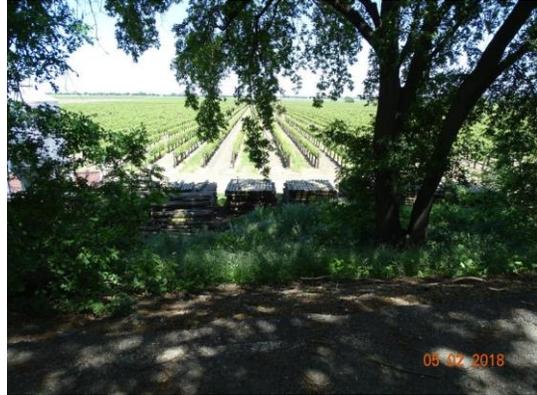
Photo 1 of 1 : FA_2019_RD0999_236_67_20190904_00029.jpg

LM Start	2.05	Rating **	M	Issue No.	67
LM End	2.05	Issue Type +	En	Location *	LS
Category	Earthen Levee		GPS Latitude/Longitude		
			Start	End	
Item	Encroachments		38.355637 °	38.355637 °	
			-121.570442 °	-121.570442 °	
DWR ID	DWR_RD0999_05_s_2018_67				
Comment Code					
EQ : Equipment					
Inspector Comment					
Instruct the landowner to move poles off of the landside toe easement.

Encroachment poles landside looking northwest. Spring 2018

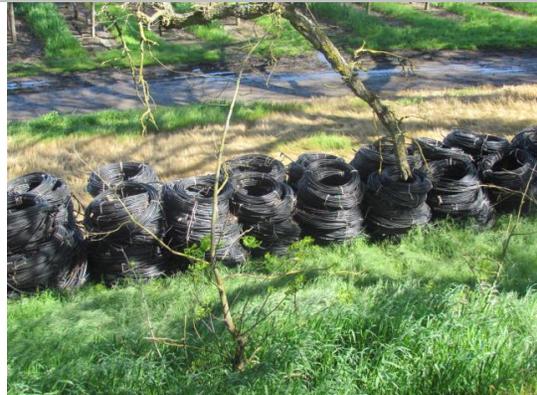
Photo 1 of 1 : FA_2019_RD0999_236_212_20190904_00092.jpg

LM Start	2.09	Rating **	M	Issue No.	212
LM End	2.09	Issue Type +	En	Location *	LS
Category	Earthen Levee		GPS Latitude/Longitude		
			Start	End	
Item	Encroachments		38.355673 °	38.355673 °	
			-121.569794 °	-121.569794 °	
DWR ID	DWR_RD0999_05_s_2016_212				
Comment Code					
EQ : Equipment					
Inspector Comment					
Instruct the farmer to move black sprinkler lines 10-feet off of the landside toe.

Looking south at black sprinkler lines at landward toe.

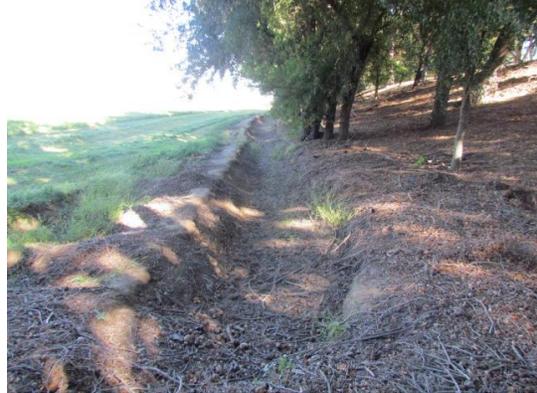
Photo 1 of 1 : FA_2019_RD0999_236_152_20190904_00060.jpg

LM Start	2.86	Rating **	M	Issue No.	152
LM End	3.13	Issue Type +	En	Location *	LS
Category	Earthen Levee			GPS Latitude/Longitude	
				Start	End
Item	Encroachments			38.361047°	38.364478°
				-121.563113°	-121.561752°
DWR ID	DWR_RD0999_05_f_2013_152				
Comment Code					
DT : Ditch					
Inspector Comment					
Irrigation ditch is unauthorized.

Looking north at abandoned irrigation ditch at landward toe.

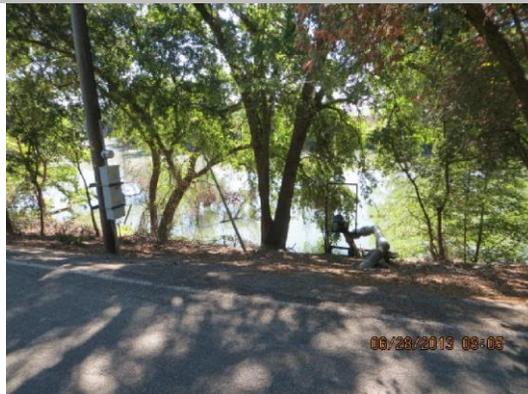
Photo 1 of 3 : UCIP_FA_2019_53370_25332.jpg

Comment Code					
Inspector Comment					
DS_ID:22849 FS_ID:53370 EP_NO: 7378 Repair Type: Non-Urgent Crossing Status: Found UCIP Comments: 07/26/2018 Pump was in operation at time of inspection and no leaks were detected. Erosion on LS toe same as last inspection, so no signs of erosion progression. Recommend monitoring this crossing; downgrading to Non-Urgent from Urgent (D. Sanoski - DWR UCIP).07/07/2016 - LS toe of levee still has erosion around stand pipe and adjacent oak tree. Erosion does not appear to be any worse than during previous inspection. no water in canal on LS toe led to the discovery of two additional appurtenant structures. (T. Hatch/UCIP)06/28/2013 - Pipe outlet is eroding the LS slope of the levee, exposing the roots of an oak and threatening greater damage if allowed to continue. (W. Wylie/UCIP) FIELD_STRUCT_DESC: 10-inch steel irrigation pipe through the levee, 6 feet below the crown. Slant pump and service pole on the waterside (WS) slope. 36-inch concrete standpipe on the landside (LS) toe. (Permit No. 7378, 1971 - Rudolph H. Volz. Replaced an existing 8-inch pipe at the same location). [Additional Reference(s): DWR Levee Log, 1992]. FS Date: 7/26/2018 10:26:00 AM

Slant pump, JP, and meter on WS slope.

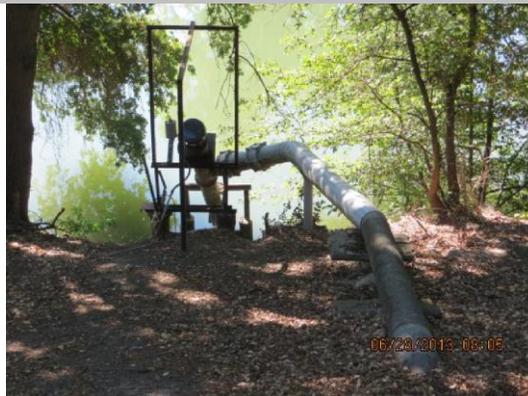
Photo 2 of 3 : UCIP_FA_2019_53370_25331.jpg

LM Start	3.02	Rating **	M	Issue No.	234 (cont)
LM End	3.02	Issue Type +	En	Location *

Slant pump and pipe on WS slope.

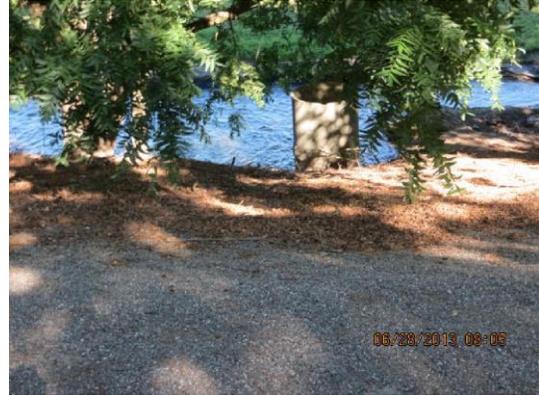
Photo 3 of 3 : UCIP_FA_2019_53370_25330.jpg

Comment Code					
Inspector Comment					
DS_ID:22849 FS_ID:53370 EP_NO: 7378 Repair Type: Non-Urgent Crossing Status: Found UCIP Comments: 07/26/2018 Pump was in operation at time of inspection and no leaks were detected. Erosion on LS toe same as last inspection, so no signs of erosion progression. Recommend monitoring this crossing; downgrading to Non-Urgent from Urgent (D. Sanoski - DWR UCIP).07/07/2016 - LS toe of levee still has erosion around stand pipe and adjacent oak tree. Erosion does not appear to be any worse than during previous inspection. no water in canal on LS toe led to the discovery of two additional appurtenant structures. (T. Hatch/UCIP)06/28/2013 - Pipe outlet is eroding the LS slope of the levee, exposing the roots of an oak and threatening greater damage if allowed to continue. (W. Wylie/UCIP) FIELD_STRUCT_DESC: 10-inch steel irrigation pipe through the levee, 6 feet below the crown. Slant pump and service pole on the waterside (WS) slope. 36-inch concrete standpipe on the landside (LS) toe. (Permit No. 7378, 1971 - Rudolph H. Volz. Replaced an existing 8-inch pipe at the same location). [Additional Reference(s): DWR Levee Log, 1992]. FS Date: 7/26/2018 10:26:00 AM

36-inch concrete standpipe on LS toe.

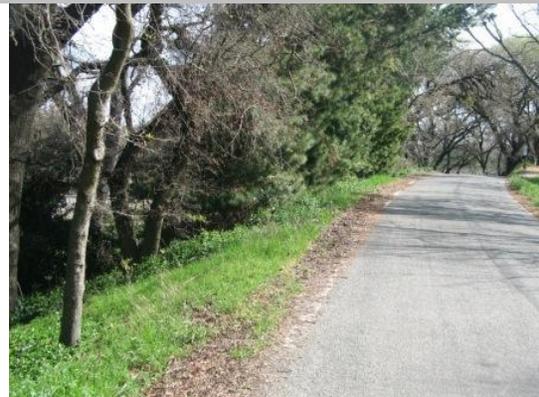
Photo 1 of 1 : FA_2019_RD0999_236_31_20190904_00018.jpg

LM Start	3.13	Rating **	M	Issue No.	31
LM End	3.17	Issue Type +	En	Location *	LS
Category	Earthen Levee			GPS Latitude/Longitude	
				Start	End
Item	Vegetation			38.364500 °	38.364649 °
				-121.561668 °	-121.561025 °
DWR ID	DWR_RD0999_05_s_2012_31				
Comment Code					
V6 : Landscaping					
Inspector Comment

Looking downstream at landscaping blocking view of landside slope.

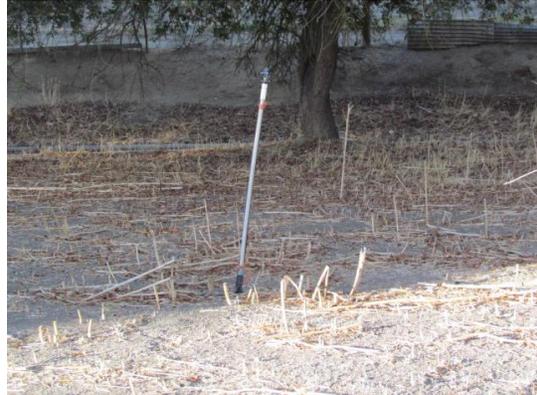
Photo 1 of 1 : FA_2019_RD0999_236_202_20190904_00091.jpg

LM Start	3.58	Rating **	M	Issue No.	202
LM End	3.64	Issue Type +	En	Location *	LS
Category	Earthen Levee			GPS Latitude/Longitude	
				Start	End
Item	Encroachments			38.366100 °	38.367043 °
				-121.556831 °	-121.556772 °
DWR ID	DWR_RD0999_05_f_2014_202				
Comment Code					
LI : Landscape Irrigation					
Inspector Comment					
The sprinkler system on the landside slope needs a permit.

Looking west at one of several sprinklers installed on landward slope.

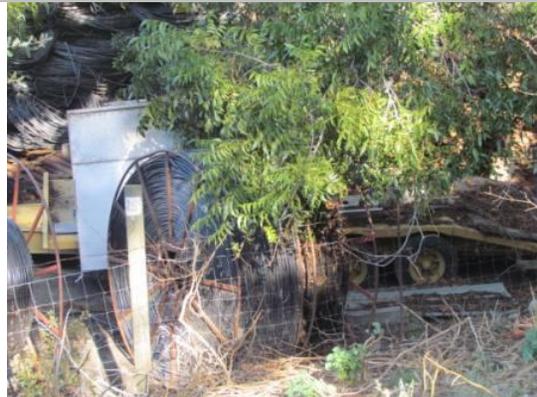
Photo 1 of 2 : FA_2019_RD0999_236_16_20190904_00012.jpg

LM Start	3.64	Rating **	M	Issue No.	16
LM End	3.64	Issue Type +	En	Location *	LS
Category	Earthen Levee			GPS Latitude/Longitude	
				Start	End
Item	Encroachments			38.366958 °	38.366958 °
				-121.556822 °	-121.556822 °
DWR ID	DWR_RD0999_05_s_2012_16				
Comment Code					
EQ : Equipment					
Inspector Comment					
The landowner needs to move equipment stored within the landside toe easement.

Looking northwest at equipment on landside toe.

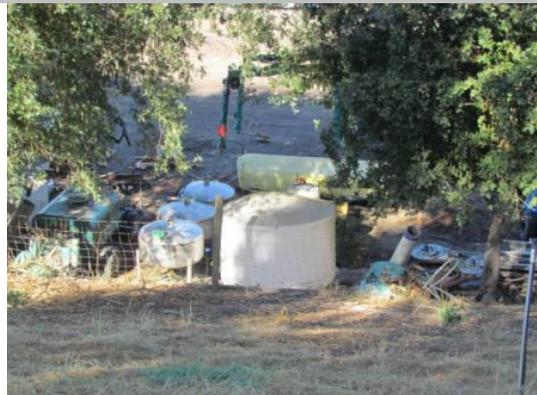
Photo 2 of 2 : FA_2019_RD0999_236_16_20190904_00013.jpg

LM Start	3.64	Rating **	M	Issue No.	16 (cont)
LM End	3.64	Issue Type +	En	Location *	LS

Looking west at equipment at landside toe.

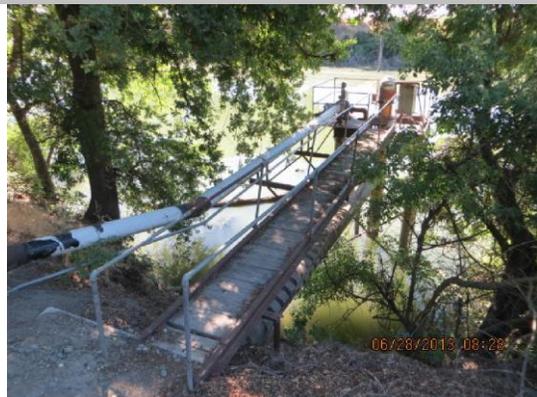
Photo 1 of 3 : UCIP_FA_2019_16337_27535.jpg

LM Start	3.67	Rating **	M	Issue No.	235
LM End	3.67	Issue Type +	En	Location *	
Category	Supplemental			GPS Latitude/Longitude	
				Start	End
Item	DRAFT DWR UCIP Field Study			38.367469 °	38.367469 °
				-121.556509 °	-121.556509 °
DWR ID	23965				
Comment Code					
Inspector Comment					
DS_ID:23965 FS_ID:16337 EP_NO: N/A Repair Type: Non-Urgent Crossing Status: Found UCIP Comments: Need to determine permit No. for this crossing. FIELD_STRUCT_DESC: 9-inch steel irrigation pipe through the levee, 2 feet below the crown. Pump on pier on the waterside (WS) with butterfly valve. Filter plant and siphon breaker on the landside (LS) toe. 1.5-inch galvanized iron electrical conduit at the same location. FS Date: 6/28/2013

Pump on pier at WS.

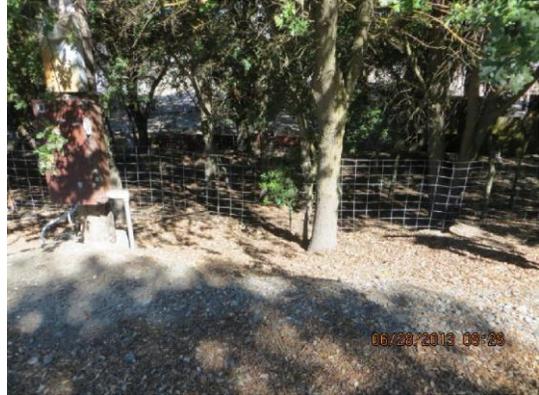
Photo 2 of 3 : UCIP_FA_2019_16337_27534.jpg

LM Start	3.67	Rating **	M	Issue No.	235 (cont)
LM End	3.67	Issue Type +	En	Location *	
Category	Supplemental			GPS Latitude/Longitude	
				Start	End
Item	DRAFT DWR UCIP Field Study			38.367469°	38.367469°
				-121.556509°	-121.556509°
DWR ID	23965				
Comment Code					
Inspector Comment					
DS_ID:23965 FS_ID:16337 EP_NO: N/A Repair Type: Non-Urgent Crossing Status: Found UCIP Comments: Need to determine permit No. for this crossing. FIELD_STRUCT_DESC: 9-inch steel irrigation pipe through the levee, 2 feet below the crown. Pump on pier on the waterside (WS) with butterfly valve. Filter plant and siphon breaker on the landside (LS) toe. 1.5-inch galvanized iron electrical conduit at the same location. FS Date: 6/28/2013

1.5-inch galvanized iron electrical conduit at same location.

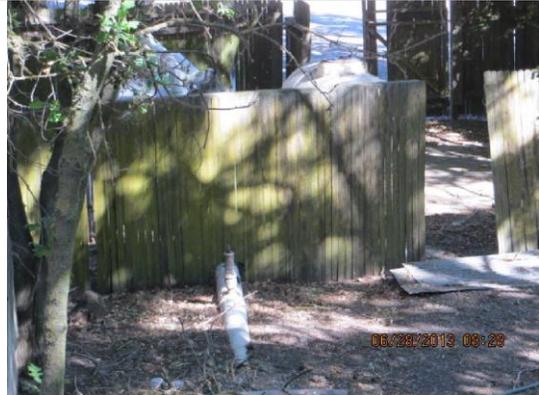
Photo 3 of 3 : UCIP_FA_2019_16337_27533.jpg

LM Start	3.67	Rating **	M	Issue No.	235 (cont)
LM End	3.67	Issue Type +	En	Location *

Siphon breaker and filter plant on LS toe.

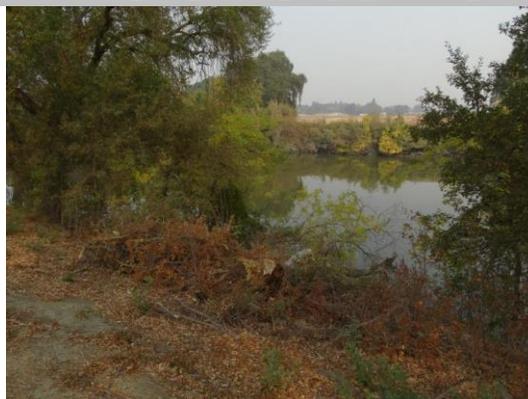
Photo 1 of 1 : FA_2019_RD0999_236_90_20190904_00035.jpg

LM Start	4.01	Rating **	M	Issue No.	90
LM End	4.01	Issue Type +	Ma	Location *	WS
Category	Earthen Levee		GPS Latitude/Longitude		
			Start	End	
Item	Encroachments		38.369813°	38.369813°	
			-121.552985°	-121.552985°	
DWR ID	DWR_RD0999_05_f_2018_90				
Comment Code					
TR : Tree or limb					
Inspector Comment					
Remove tree debris from the levee slope easement.

View of tree debris on levee easement. Fall 2018

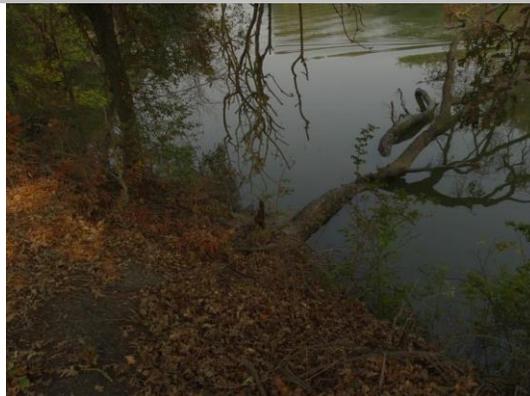
Photo 1 of 1 : FA_2019_RD0999_236_91_20190904_00036.jpg

LM Start	4.08	Rating **	M	Issue No.	91
LM End	4.08	Issue Type +	Ma	Location *	WS
Category	Earthen Levee			GPS Latitude/Longitude	
				Start	End
Item	Erosion / Bank Caving			38.370853 °	38.370853 °
				-121.553605 °	-121.553605 °
DWR ID	DWR_RD0999_05_f_2018_91				
Comment Code					
E2 : Schedule repair of erosion site prior to the next inspection.					
Inspector Comment					
Repair erosion caused by a fallen tree with exposed rootball.

View of tree with rootball exposed. Fall 2018

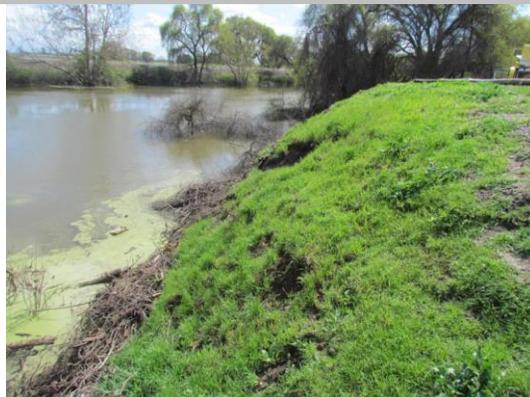
Photo 1 of 1 : FA_2019_RD0999_236_12_20190904_00008.jpg

LM Start	4.25	Rating **	M	Issue No.	12
LM End	4.25	Issue Type +	Ma	Location *	WS
Category	Earthen Levee			GPS Latitude/Longitude	
				Start	End
Item	Slope Stability			38.372872 °	38.372872 °
				-121.552185 °	-121.552185 °
DWR ID	DWR_RD0999_05_s_2017_12				
Comment Code					
S1 : Repair slope instability.					
Inspector Comment					
Sloughing damage needs to be repaired.

Looking downstream at finger erosion on downstream side of slough.

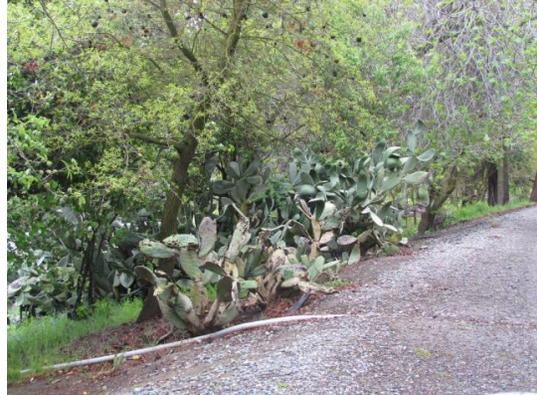
Photo 1 of 1 : FA_2019_RD0999_236_56_20190904_00025.jpg

LM Start	4.36	Rating **	M	Issue No.	56
LM End	4.37	Issue Type +	En	Location *	LS
Category	Earthen Levee		GPS Latitude/Longitude		
			Start	End	
Item	Vegetation		38.374323°	38.374410°	
			-121.551235°	-121.551173°	
DWR ID	DWR_RD0999_05_s_2012_56				
Comment Code					
V6 : Landscaping					
Inspector Comment					
Instruct the landowner to remove cactus and fig tree from the levee easement.

Looking northwest at cactus on landside shoulder and slope. (Spring 2012)

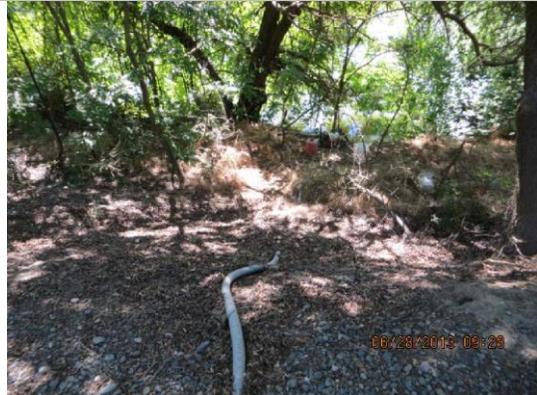
Photo 1 of 2 : UCIP_FA_2019_16338_27538.jpg

LM Start	4.36	Rating **	M	Issue No.	236
LM End	4.36	Issue Type +	En	Location *	
Category	Supplemental		GPS Latitude/Longitude		
			Start	End	
Item	DRAFT DWR UCIP Field Study		38.374376°	38.374376°	
			-121.551201°	-121.551201°	
DWR ID	23966				
Comment Code					
Inspector Comment					
DS_ID:23966 FS_ID:16338 EP_NO: N/A Repair Type: Non-Urgent Crossing Status: Found UCIP Comments: This crossing should be permitted or removed. FIELD_STRUCT_DESC: 2-inch plastic water line through the levee, 6 inches below the crown. Portable pump on the waterside (WS) toe. FS Date: 6/28/2013

Flex pipe through the levee 6-inches below the crown with portable pump on WS toe.

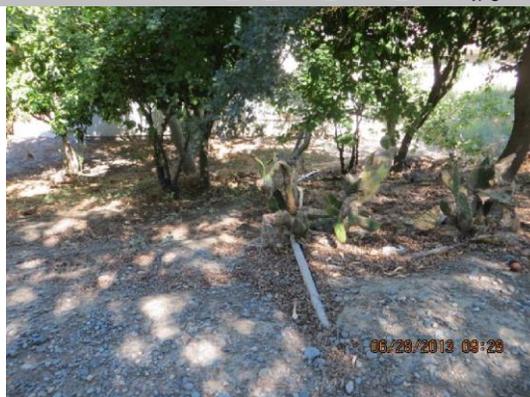
Photo 2 of 2 : UCIP_FA_2019_16338_27537.jpg

LM Start	4.36	Rating **	M	Issue No.	236 (cont)
LM End	4.36	Issue Type +	En	Location *	
Category	Supplemental			GPS Latitude/Longitude	
				Start	End
Item	DRAFT DWR UCIP Field Study			38.374376 °	38.374376 °
				-121.551201 °	-121.551201 °
DWR ID	23966				
Comment Code					
Inspector Comment					
DS_ID:23966 FS_ID:16338 EP_NO: N/A Repair Type: Non-Urgent Crossing Status: Found UCIP Comments: This crossing should be permitted or removed. FIELD_STRUCT_DESC: 2-inch plastic water line through the levee, 6 inches below the crown. Portable pump on the waterside (WS) toe. FS Date: 6/28/2013

Flex pipe visible on LS shoulder.

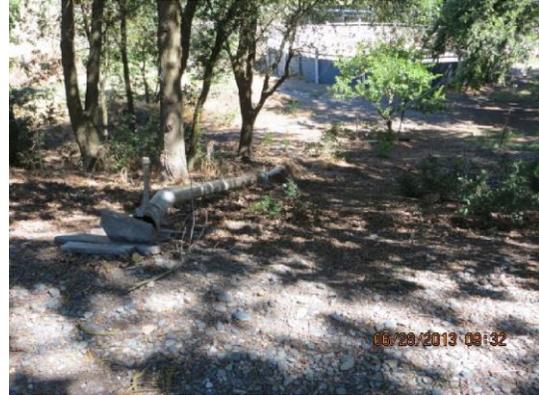
Photo 1 of 3 : UCIP_FA_2019_16403_27686.jpg

LM Start	4.45	Rating **	M	Issue No.	237
LM End	4.45	Issue Type +	En	Location *	
Category	Supplemental			GPS Latitude/Longitude	
				Start	End
Item	DRAFT DWR UCIP Field Study			38.375036°	38.375036°
				-121.549961°	-121.549961°
DWR ID	23967				
Comment Code					
Inspector Comment					
DS_ID:23967 FS_ID:16403 EP_NO: N/A Repair Type: Non-Urgent Crossing Status: Found UCIP Comments: Need to determine Permit No. for this crossing or remove it. FIELD_STRUCT_DESC: 5-inch temporary aluminum irrigation pipe over the top of the levee. Portable pump on the waterside (WS) toe. FS Date: 6/28/2013

Pipe on LS slope.

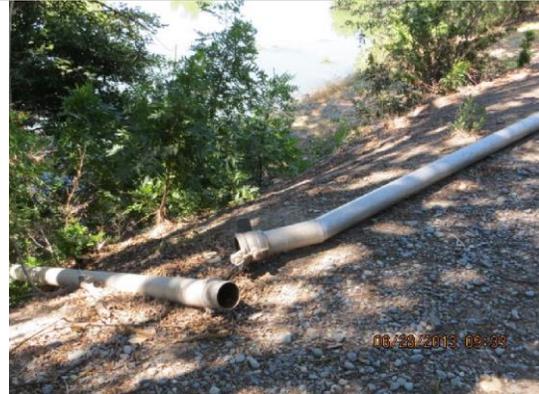
Photo 2 of 3 : UCIP_FA_2019_16403_27685.jpg

Pipe on WS slope.

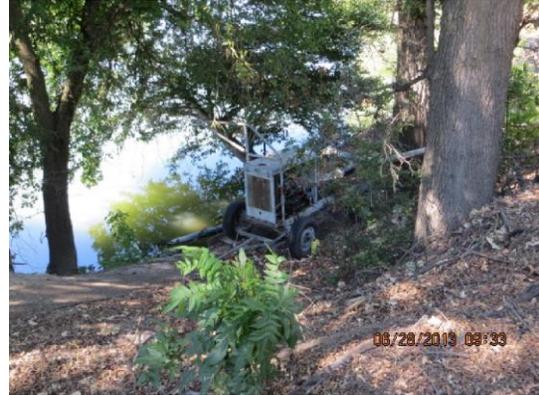
Photo 3 of 3 : UCIP_FA_2019_16403_27687.jpg

LM Start	4.45	Rating **	M	Issue No.	237 (cont)
LM End	4.45	Issue Type +	En	Location *	
Category	Supplemental			GPS Latitude/Longitude	
				Start	End
Item	DRAFT DWR UCIP Field Study			38.375036 °	38.375036 °
				-121.549961 °	-121.549961 °
DWR ID	23967				
Comment Code					
Inspector Comment					
DS_ID:23967 FS_ID:16403 EP_NO: N/A Repair Type: Non-Urgent Crossing Status: Found UCIP Comments: Need to determine Permit No. for this crossing or remove it. FIELD_STRUCT_DESC: 5-inch temporary aluminum irrigation pipe over the top of the levee. Portable pump on the waterside (WS) toe. FS Date: 6/28/2013

Portable pump on WS toe.

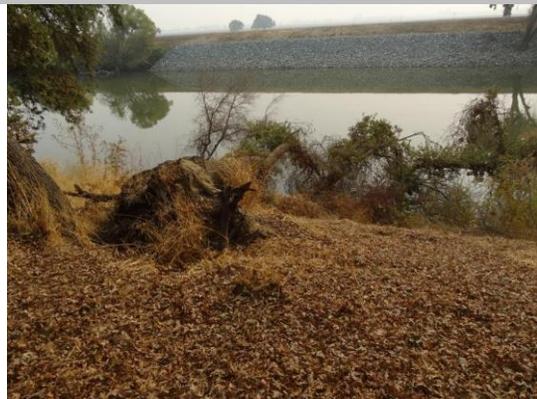
Photo 1 of 1 : FA_2019_RD0999_236_28_20190904_00017.jpg

LM Start	4.62	Rating **	U	Issue No.	28
LM End	4.62	Issue Type +	Ma	Location *	WS
Category	Earthen Levee		GPS Latitude/Longitude		
			Start	End	
Item	Encroachments		38.375308°	38.375308°	
			-121.546828°	-121.546828°	
DWR ID	DWR_RD0999_05_s_2017_28				
Comment Code					
TR : Tree or limb					
Inspector Comment					
Fallen tree on waterside slope and is partly in water. Large hole on waterside slope.

View of dead tree on slope. Fall 2018

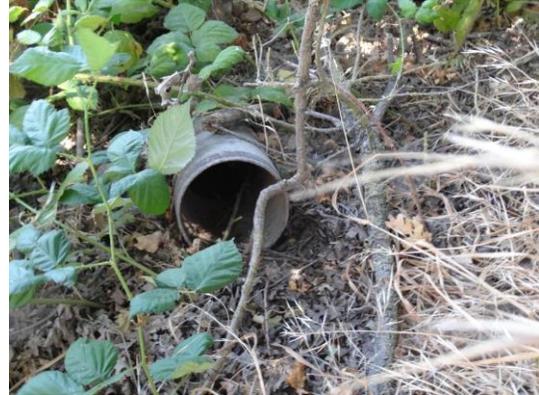
Photo 3 of 3 : UCIP_FA_2019_53371_75319.jpg

Comment Code					
Inspector Comment					
DS_ID:22856 FS_ID:53371 EP_NO: N/A Repair Type: Non-Urgent Crossing Status: Found UCIP Comments: 07/26/2018 Same as last inspection. No outlet on LS and appears abandoned. Downgrading to Non-Urgent due to no visual signs of pipe or levee integrity issues (D. Sanoski - DWR UCIP).07/07/2016 - Pipe open on WS. no pipe or appurtenances visible on LS. pipe on WS slope below open penetration noted. May have previously been connected. (T. Hatch/UCIP)06/28/2013 - Pipe abandoned and should be done so properly. Pipe open on waterside. (W. Wylie/UCIP) FIELD_STRUCT_DESC: *ABANDONED* 7-inch steel irrigation pipe through the levee, 6.5 feet below the crown. [Additional Reference(s): DWR Levee Log, 1992. USACE Sacramento O&M Manual 113 (Revised), October 1966, (HLM 5.31) (8-inch pipe listed)]. FS Date: 7/26/2018 11:15:00 AM

pipe on WS slope of levee below pipe penetrating levee. May have previously been connected.

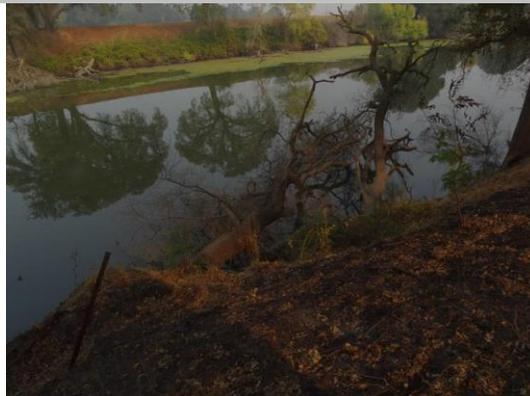
Photo 1 of 2 : FA_2019_RD0999_236_97_20190904_00043.jpg

LM Start	5.35	Rating **	U	Issue No.	97
LM End	5.35	Issue Type +	Ma	Location *	WS
Category	Earthen Levee			GPS Latitude/Longitude	
				Start	End
Item	Erosion / Bank Caving			38.381297°	38.381297°
				-121.545037°	-121.545037°
DWR ID	DWR_RD0999_05_f_2018_97				
Comment Code					
E2 : Schedule repair of erosion site prior to the next inspection.					
Inspector Comment					
Repair levee doe damaged by downed trees.

View of fallen tree and levee scarp. Fall 2018

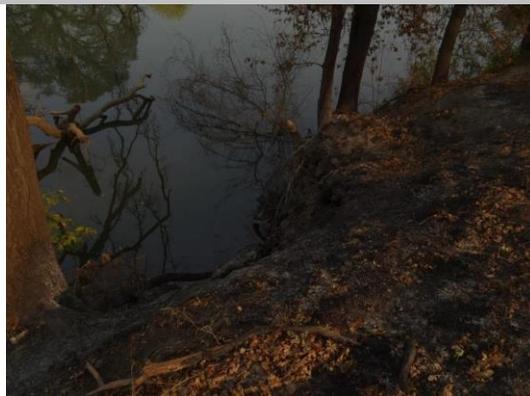
Photo 2 of 2 : FA_2019_RD0999_236_97_20190904_00044.jpg

View of fallen tree and levee scarp. Fall 2018

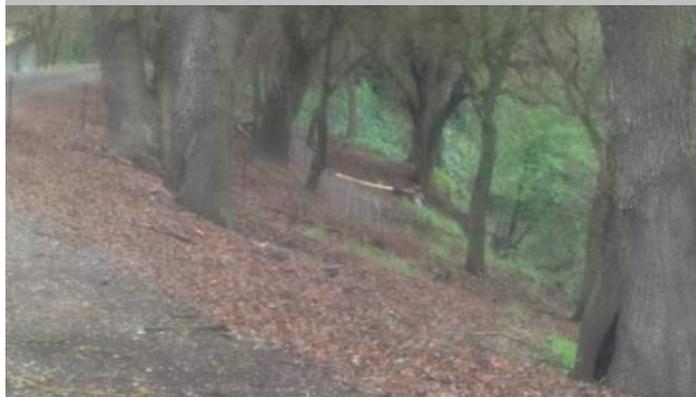
Photo 1 of 1 : FA_2019_RD0999_236_51_20190904_00023.jpg

LM Start	5.38	Rating **	M	Issue No.	51
LM End	5.41	Issue Type +	En	Location *	WS
Category	Earthen Levee			GPS Latitude/Longitude	
				Start	End
Item	Encroachments			38.381490°	38.381774°
				-121.545477°	-121.545964°
DWR ID	DWR_RD0999_05_s_2012_51				
Comment Code					
FE : Fence					
Inspector Comment					
The fence is installed along the waterside slope.

Looking northeast at fence on waterside slope.

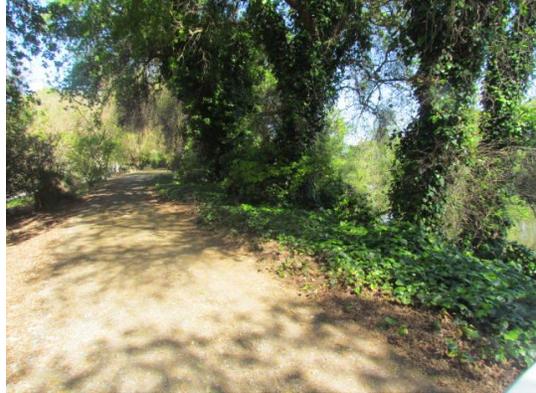
Photo 1 of 2 : FA_2019_RD0999_236_43_20190904_00021.jpg

LM Start	5.42	Rating **	U	Issue No.	43
LM End	5.49	Issue Type +	En	Location *	WS
Category	Earthen Levee			GPS Latitude/Longitude	
				Start	End
Item	Vegetation			38.381815°	38.382720°
				-121.546058°	-121.546748°
DWR ID	DWR_RD0999_05_s_2012_43				
Comment Code					
V6 : Landscaping					
Inspector Comment					
Remove ground cover blocking view of waterside slope.

Looking north at dense groundcover and vegetation on waterward slope. (Spring 2015)

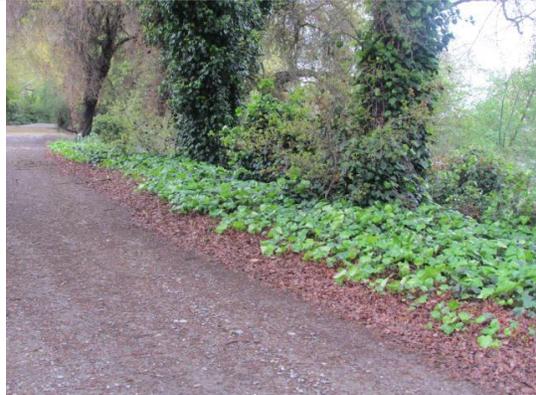
Photo 2 of 2 : FA_2019_RD0999_236_43_20190904_00022.jpg

Looking northeast at dense groundcover and vegetation on waterside slope.

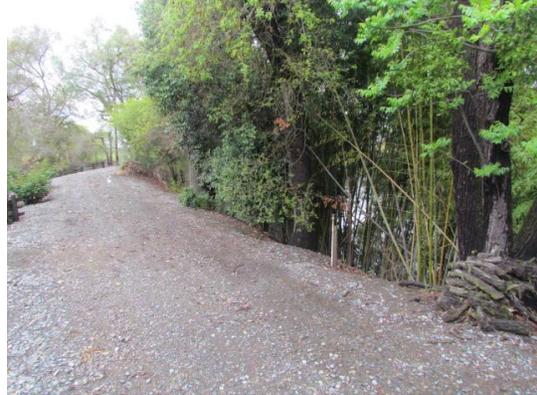
Photo 1 of 1 : FA_2019_RD0999_236_71_20190904_00030.jpg

LM Start	5.50	Rating **	U	Issue No.	71
LM End	5.55	Issue Type +	Ma	Location *	WS
Category	Earthen Levee			GPS Latitude/Longitude	
				Start	End
Item	Vegetation			38.382790 °	38.383548 °
				-121.546754 °	-121.546728 °
DWR ID	DWR_RD0999_05_s_2012_71				
Comment Code					
V2 : Remove the wild growth other than native grasses from the levee slopes.					
Inspector Comment

Looking northeast at dense vegetation on waterside slope.

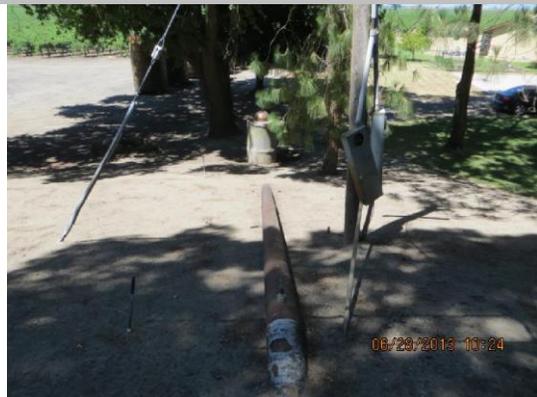
Photo 1 of 3 : UCIP_FA_2019_15446_25366.jpg

Comment Code					
Inspector Comment					
DS_ID:22857 FS_ID:15446 EP_NO: N/A Repair Type: Non-Urgent Crossing Status: Found UCIP Comments: Pipe appears abandoned and should be done so appropriately. FIELD_STRUCT_DESC: 10-inch steel irrigation pipe through the levee, 4 feet below the crown. Pump house and gate valve on the waterside (WS) slope. Vent on the landside (LS) slope, and a 42-inch concrete standpipe on the LS toe. Service pole on the LS slope with a 1.5-inch galvanized iron electrical conduit at the same location. [Additional Reference(s): DWR Levee Log, 1992. USACE Sacramento O&M Manual 113 (Revised), October 1966, (HLM 5.66) (8-inch pipe listed)]. FS Date: 6/28/2013

Pipe visible on LS slope with JP, Meter and electrical conduit, and concrete standpipe,
