**Flood Control Project Maintenance
Levee Inspections**

Fall 2019 Levee Maintenance Deficiency Summary Report

**Flood Control Project Maintenance
Levee Inspections**
LMA District Cover Sheet
Fall 2019 Levee Inspection Results

Reclamation District No. 0999 Netherlands

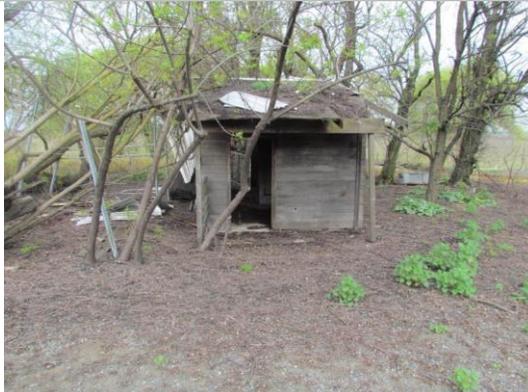
Photo 1 of 2 : FA_2019_RD0999_236_37_20190904_00019.jpg

LM Start	5.57	Rating **	U	Issue No.	37
LM End	5.57	Issue Type +	En	Location *	LS
Category	Earthen Levee			GPS Latitude/Longitude	
				Start	End
Item	Encroachments			38.383780°	38.383780°
				-121.546590°	-121.546590°
DWR ID	DWR_RD0999_05_s_2017_37				
Comment Code					
BU : Building					
Inspector Comment					
The dilapidated horse pen on landside slope and fallen tree need to be removed from the easement.

Looking west at dilapidated horse pen and fallen tree on landward slope.

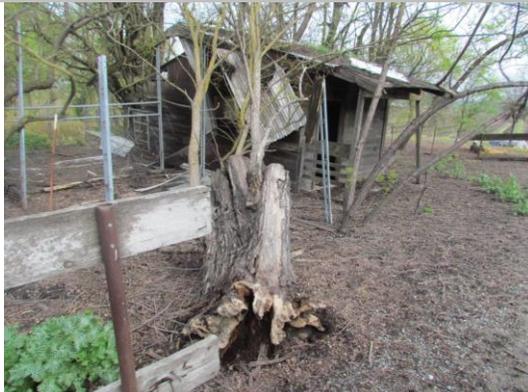
Photo 2 of 2 : FA_2019_RD0999_236_37_20190904_00020.jpg

LM Start	5.57	Rating **	U	Issue No.	37 (cont)
LM End	5.57	Issue Type +	En	Location *	LS

Looking northwest at dilapidated horse pen and fallen tree on landward slope.

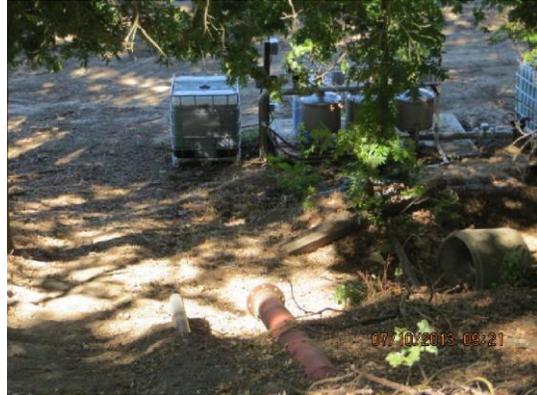
Photo 3 of 3 : UCIP_FA_2019_40791_27553.jpg

LM Start	6.13	Rating **	M	Issue No.	242 (cont)
LM End	6.13	Issue Type +	En	Location *	
Category	Supplemental			GPS Latitude/Longitude	
				Start	End
Item	DRAFT DWR UCIP Field Study			38.388151°	38.388151°
				-121.542624°	-121.542624°
DWR ID	22890				
Comment Code					
Inspector Comment					
DS_ID:22890 FS_ID:40791 EP_NO: N/A Repair Type: Non-Urgent Crossing Status: Found UCIP Comments: No permit identified for crossing. Settlement over pipe alignment on crown. FIELD_STRUCT_DESC: 4-inch steel irrigation pipe through the levee, 1.5 feet below the crown. Pump on the waterside (WS). Filter, booster, and vent on the landside (LS) toe. Joint pole (JP) on the WS shoulder. FS Date: 7/10/2013

Pipe visible on LS slope with filter plant in background.

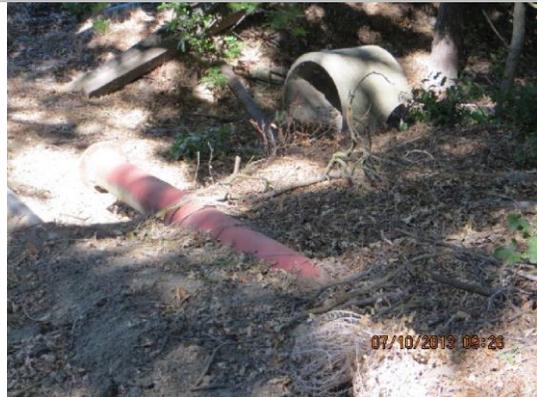
Photo 1 of 3 : UCIP_FA_2019_53372_25859.jpg

LM Start	6.13	Rating **	M	Issue No.	243
LM End	6.13	Issue Type +	En	Location *	
Category	Supplemental			GPS Latitude/Longitude	
				Start	End
Item	DRAFT DWR UCIP Field Study			38.388175°	38.388175°
				-121.542623°	-121.542623°
DWR ID	22859

Comment Code					
Inspector Comment					
DS_ID:22859 FS_ID:53372 EP_NO: N/A Repair Type: Non-Urgent Crossing Status: Found UCIP Comments: 07/26/2018 Appears abandoned with both WS and LS disconnected at endings. No visual signs of pipe or levee integrity issues so downgrading to Non-Urgent (D. Sanoski - DWR UCIP).07/07/2016 - slant pump intake located on WS toe with the opening blocked by cinder blocks. multiple pipes segments laying on WS slope. Otherwise, no change from previous inspection. (T. Hatch/UCIP)07/10/2013 - Pipe appears abandoned and is open on both ends. Pipe should be abandoned properly. (W. Wylie/UCIP) FIELD_STRUCT_DESC: 6-inch steel irrigation pipe through the levee, 6 feet below the crown. Pump and gate valve on the waterside (WS) toe, along with a service pole. 36-inch standpipe at the landside (LS) toe. [Additional Reference(s): DWR Levee Log, 1992. USACE Sacramento O&M Manual 113 (Revised), October 1966, (HLM 6.29) (8-inch pipe listed)]. FS Date: 7/26/2018 12:52:00 PM

6-inch steel pipe on LS slope with evidence of 36-inch standpipe in background.

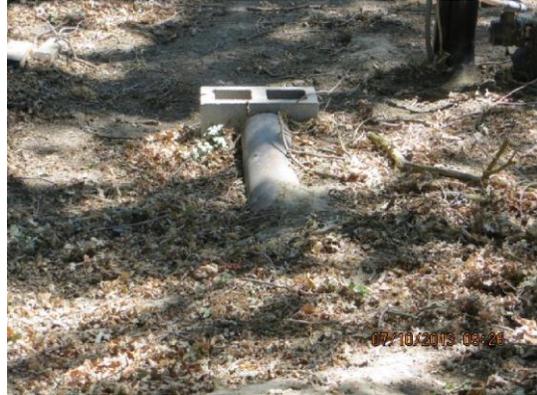
Photo 2 of 3 : UCIP_FA_2019_53372_25858.jpg

Comment Code					
Inspector Comment					
DS_ID:22859 FS_ID:53372 EP_NO: N/A Repair Type: Non-Urgent Crossing Status: Found UCIP Comments: 07/26/2018 Appears abandoned with both WS and LS disconnected at endings. No visual signs of pipe or levee integrity issues so downgrading to Non-Urgent (D. Sanoski - DWR UCIP).07/07/2016 - slant pump intake located on WS toe with the opening blocked by cinder blocks. multiple pipes segments laying on WS slope. Otherwise, no change from previous inspection. (T. Hatch/UCIP)07/10/2013 - Pipe appears abandoned and is open on both ends. Pipe should be abandoned properly. (W. Wylie/UCIP) FIELD_STRUCT_DESC: 6-inch steel irrigation pipe through the levee, 6 feet below the crown. Pump and gate valve on the waterside (WS) toe, along with a service pole. 36-inch standpipe at the landside (LS) toe. [Additional Reference(s): DWR Levee Log, 1992. USACE Sacramento O&M Manual 113 (Revised), October 1966, (HLM 6.29) (8-inch pipe listed)]. FS Date: 7/26/2018 12:52:00 PM

Pipe visible on WS slope.

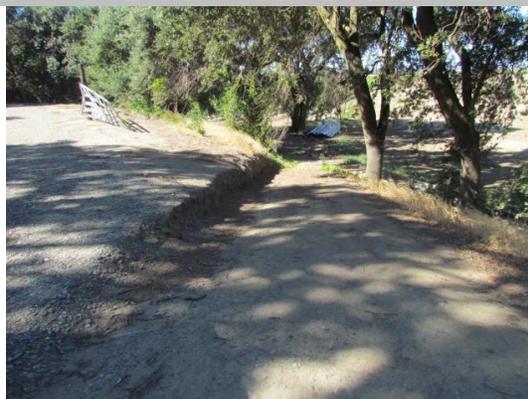
Photo 1 of 1 : FA_2019_RD0999_236_155_20190904_00064.jpg

LM Start	6.26	Rating **	M	Issue No.	155
LM End	6.26	Issue Type +	En	Location *	LS
Category	Earthen Levee			GPS Latitude/Longitude	
				Start	End
Item	Encroachments			38.389946°	38.389946°
				-121.542461°	-121.542461°
DWR ID	DWR_RD0999_05_f_2013_155				
Comment Code					
RA : Ramp					
Inspector Comment					
An unauthorized ramp exists on the landside slope.

Looking southwest at ramp on landward slope.

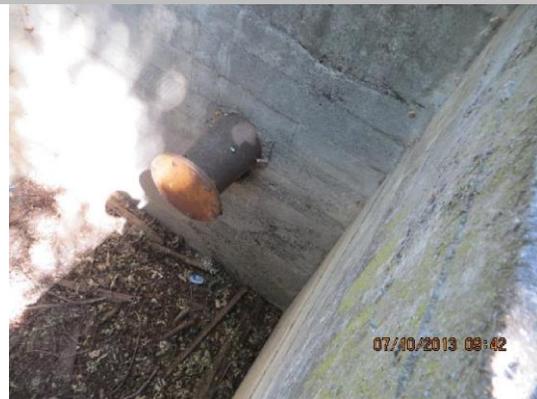
Photo 1 of 2 : UCIP_FA_2019_15604_25875.jpg

LM Start	6.47	Rating **	M	Issue No.	244
LM End	6.47	Issue Type +	En	Location *	
Category	Supplemental			GPS Latitude/Longitude	
				Start	End
Item	DRAFT DWR UCIP Field Study			38.391723°	38.391723°
				-121.539442°	-121.539442°
DWR ID	22860				
Comment Code					
Inspector Comment					
DS_ID:22860 FS_ID:15604 EP_NO: N/A Repair Type: Non-Urgent Crossing Status: Found UCIP Comments: Pipe abandoned and should be done so properly. FIELD_STRUCT_DESC: *ABANDONED* 14-inch steel drainage pipe through the levee, 7.2 feet below the crown. Open 9-foot by 14-foot concrete pump pit on the waterside (WS) slope. Pipe has steel plate bolted over the WS end. [Additional Reference(s): DWR Levee Log, 1992. USACE Sacramento O&M Manual 113 (Revised), October 1966, (HLM 6.61)]. FS Date: 7/10/2013

Pipe with steel plate bolted over opening at concrete pump pit on WS toe.

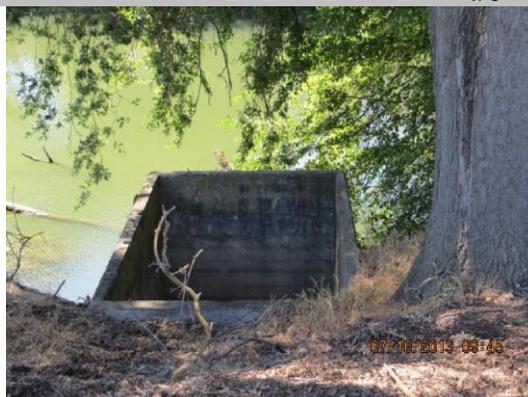
Photo 2 of 2 : UCIP_FA_2019_15604_25874.jpg

LM Start	6.47	Rating **	M	Issue No.	244 (cont)
LM End	6.47	Issue Type +	En	Location *	
Category	Supplemental			GPS Latitude/Longitude	
				Start	End
Item	DRAFT DWR UCIP Field Study			38.391723°	38.391723°
				-121.539442°	-121.539442°
DWR ID	22860				
Comment Code					
Inspector Comment					
DS_ID:22860 FS_ID:15604 EP_NO: N/A Repair Type: Non-Urgent Crossing Status: Found UCIP Comments: Pipe abandoned and should be done so properly. FIELD_STRUCT_DESC: *ABANDONED* 14-inch steel drainage pipe through the levee, 7.2 feet below the crown. Open 9-foot by 14-foot concrete pump pit on the waterside (WS) slope. Pipe has steel plate bolted over the WS end. [Additional Reference(s): DWR Levee Log, 1992. USACE Sacramento O&M Manual 113 (Revised), October 1966, (HLM 6.61)]. FS Date: 7/10/2013

Concrete pump pit on WS slope.

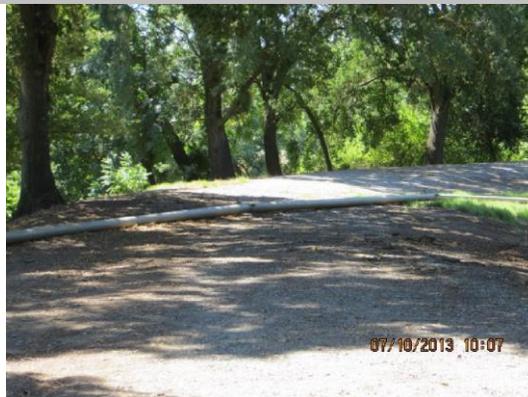
Photo 1 of 2 : UCIP_FA_2019_16342_27544.jpg

LM Start	6.56	Rating **	M	Issue No.	245
LM End	6.56	Issue Type +	En	Location *	
Category	Supplemental			GPS Latitude/Longitude	
				Start	End
Item	DRAFT DWR UCIP Field Study			38.392788°	38.392788°
				-121.539047°	-121.539047°
DWR ID	23988				
Comment Code					
Inspector Comment					
DS_ID:23988 FS_ID:16342 EP_NO: N/A Repair Type: Non-Urgent Crossing Status: Found UCIP Comments: Need to determine Permit No. for this crossing. FIELD_STRUCT_DESC: 8-inch aluminum irrigation pipe over the top of the levee. Pipe blocks crown when in use. Portable pump on the waterside (WS) toe. FS Date: 7/10/2013

Pipe at crossing over crown.

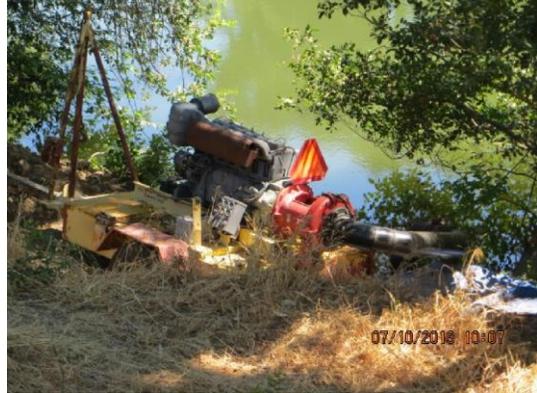
Photo 2 of 2 : UCIP_FA_2019_16342_27543.jpg

LM Start	6.56	Rating **	M	Issue No.	245 (cont)
LM End	6.56	Issue Type +	En	Location *	
Category	Supplemental			GPS Latitude/Longitude	
				Start	End
Item	DRAFT DWR UCIP Field Study			38.392788 °	38.392788 °
				-121.539047 °	-121.539047 °
DWR ID	23988				
Comment Code					
Inspector Comment					
DS_ID:23988 FS_ID:16342 EP_NO: N/A Repair Type: Non-Urgent Crossing Status: Found UCIP Comments: Need to determine Permit No. for this crossing. FIELD_STRUCT_DESC: 8-inch aluminum irrigation pipe over the top of the levee. Pipe blocks crown when in use. Portable pump on the waterside (WS) toe. FS Date: 7/10/2013

Portable pump on WS toe.

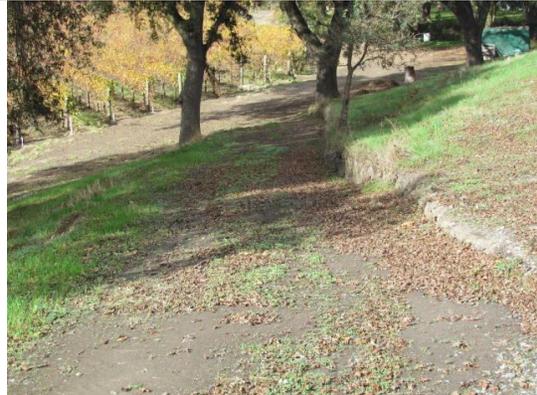
Photo 1 of 1 : FA_2019_RD0999_236_132_20190904_00054.jpg

LM Start	6.61	Rating **	M	Issue No.	132
LM End	6.61	Issue Type +	En	Location *	LS
Category	Earthen Levee			GPS Latitude/Longitude	
				Start	End
Item	Encroachments			38.393578 °	38.393578 °
				-121.539295 °	-121.539295 °
DWR ID	DWR_RD0999_05_f_2012_132				
Comment Code					
RA : Ramp					
Inspector Comment					
The landowner installed a ramp on the landside slope without a permit.

Looking east at unauthorized ramp on landside slope.

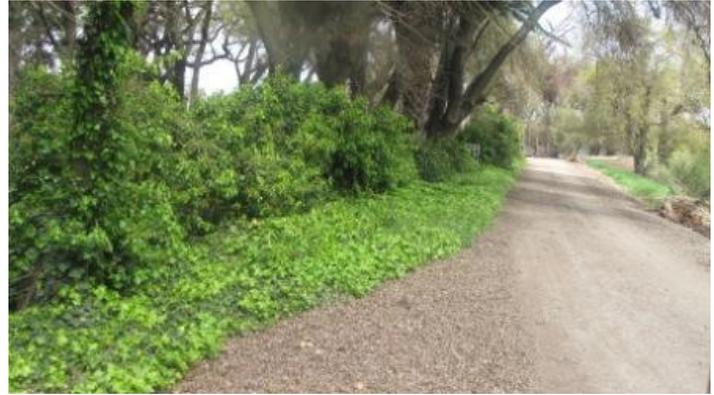
Photo 1 of 2 : FA_2019_RD0999_236_93_20190904_00037.jpg

LM Start	6.68	Rating **	U	Issue No.	93
LM End	6.71	Issue Type +	En	Location *	LS
Category	Earthen Levee			GPS Latitude/Longitude	
				Start	End
Item	Vegetation			38.394512°	38.394991°
				-121.539467°	-121.539333°
DWR ID	DWR_RD0999_05_s_2012_93				
Comment Code					
V6 : Landscaping					
Inspector Comment					
Instruct landowner to trim and thin dense landscaping on the landside slope.

Looking north at overgrown landscape on landside slope and toe.

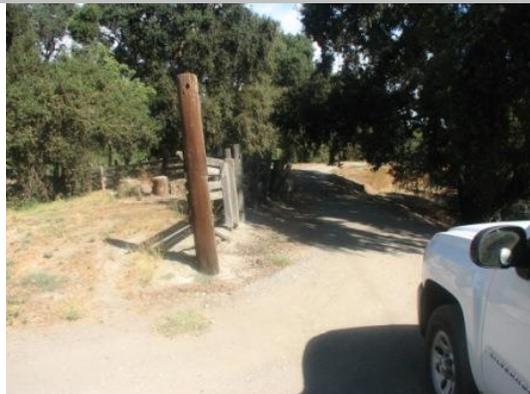
Photo 1 of 4 : FA_2019_RD0999_236_96_20190904_00039.jpg

LM Start	6.73	Rating **	U	Issue No.	96
LM End	6.73	Issue Type +	En	Location *	LS
Category	Earthen Levee			GPS Latitude/Longitude	
				Start	End
Item	Encroachments			38.395234 °	38.395234 °
				-121.539323 °	-121.539323 °
DWR ID	DWR_RD0999_05_s_2012_96				
Comment Code					
MA : Material					
Inspector Comment					
Instruct landowner to remove firewood and other material from the landside shoulder.

Fence, firewood, and material at landside shoulder.

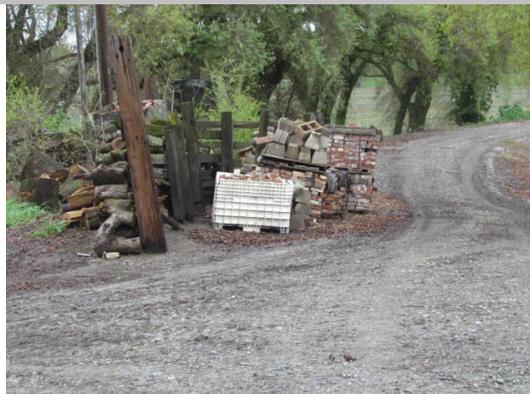
Photo 2 of 4 : FA_2019_RD0999_236_96_20190904_00040.jpg

LM Start	6.73	Rating **	U	Issue No.	96 (cont)
LM End	6.73	Issue Type +	En	Location *	LS

Looking northeast at firewood and other material on landside shoulder. (Spring 2012)

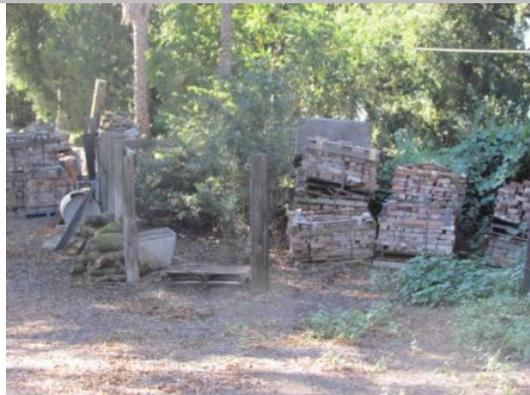
Photo 3 of 4 : FA_2019_RD0999_236_96_20190904_00041.jpg

LM Start	6.73	Rating **	U	Issue No.	96 (cont)
LM End	6.73	Issue Type +	En	Location *	LS

Looking south at firewood and other material on landside shoulder and crown.

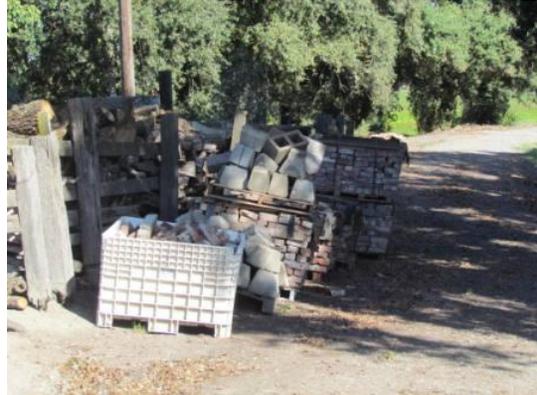
Photo 4 of 4 : FA_2019_RD0999_236_96_20190904_00042.jpg

LM Start	6.73	Rating **	U	Issue No.	96 (cont)
LM End	6.73	Issue Type +	En	Location *	LS
Category	Earthen Levee		GPS Latitude/Longitude		
			Start	End	
Item	Encroachments		38.395234 °	38.395234 °	
			-121.539323 °	-121.539323 °	
DWR ID	DWR_RD0999_05_s_2012_96				
Comment Code					
MA : Material					
Inspector Comment					
Instruct landowner to remove firewood and other material from the landside shoulder.

Looking north at firewood and other material on landside shoulder and crown.

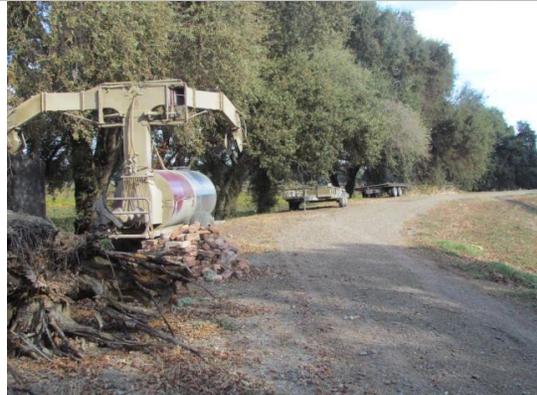
Photo 1 of 3 : FA_2019_RD0999_236_156_20190904_00065.jpg

LM Start	6.75	Rating **	M	Issue No.	156
LM End	6.83	Issue Type +	En	Location *	LS
Category	Earthen Levee		GPS Latitude/Longitude		
			Start	End	
Item	Encroachments		38.395600 °	38.396307 °	
			-121.539232 °	-121.538177 °	
DWR ID	DWR_RD0999_05_f_2013_156				
Comment Code					
EQ : Equipment					
Inspector Comment					
Instruct the landowner to remove farm equipment from the landside shoulder.

Looking north at farm equipment on landward shoulder (Fall 2014)

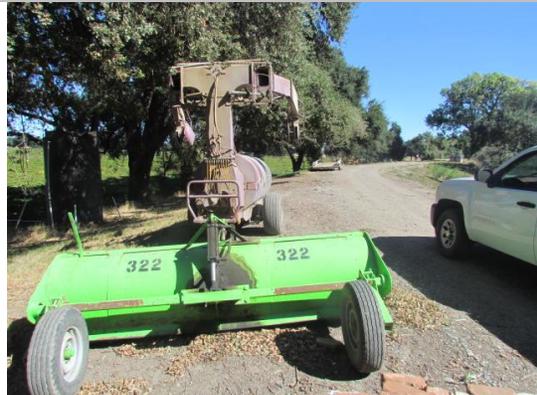
Photo 2 of 3 : FA_2019_RD0999_236_156_20190904_00066.jpg

LM Start	6.75	Rating **	M	Issue No.	156 (cont)
LM End	6.83	Issue Type +	En	Location *	LS

Looking north at farm equipment on landward shoulder.

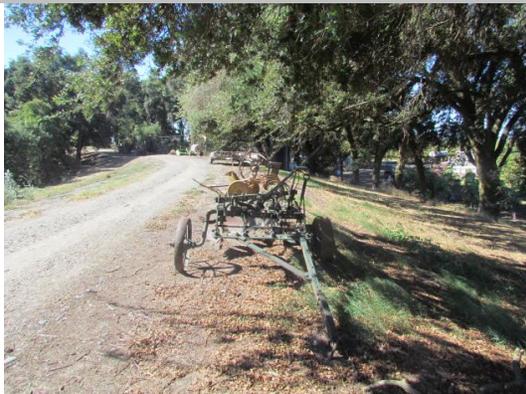
Photo 3 of 3 : FA_2019_RD0999_236_156_20190904_00067.jpg

LM Start	6.75	Rating **	M	Issue No.	156 (cont)
LM End	6.83	Issue Type +	En	Location *	LS
Category	Earthen Levee			GPS Latitude/Longitude	
				Start	End
Item	Encroachments			38.395600 °	38.396307 °
				-121.539232 °	-121.538177 °
DWR ID	DWR_RD0999_05_f_2013_156				
Comment Code					
EQ : Equipment					
Inspector Comment					
Instruct the landowner to remove farm equipment from the landside shoulder.

Looking south at farm equipment on landward shoulder.

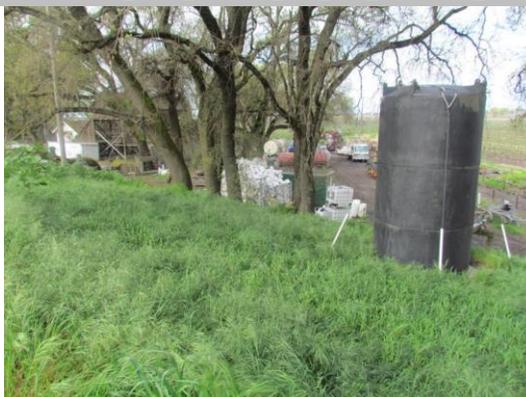
Photo 1 of 1 : FA_2019_RD0999_236_226_20190904_00100.jpg

LM Start	6.76	Rating **	U	Issue No.	226
LM End	6.76	Issue Type +	En	Location *	LS
Category	Earthen Levee			GPS Latitude/Longitude	
				Start	End
Item	Encroachments			38.395668 °	38.395668 °
				-121.539149 °	-121.539149 °
DWR ID	DWR_RD0999_05_s_2017_226				
Comment Code					
TA : Tank					
Inspector Comment					
Instruct the landowner to remove the large water tank from the landside slope and other material from the easement.

Looking west at water tank on landward slope.

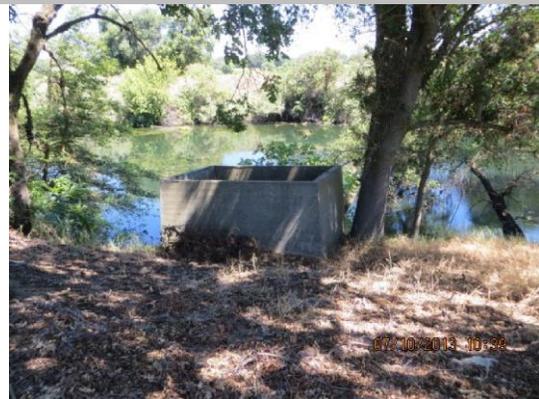
Photo 1 of 3 : UCIP_FA_2019_53373_25938.jpg

Comment Code					
Inspector Comment					
DS_ID:22863 FS_ID:53373 EP_NO: N/A Repair Type: Urgent Crossing Status: Found UCIP Comments: 07/26/2018 Same as last inspection; appears abandoned. Could not find outlet on LS. Erosion around WS concrete box base so crossing remains Urgent (D. Sanoski - DWR UCIP).07/07/2016 - Pipe abandoned and appears to be open inside the concrete box on the WS shoulder. No appurtenances visible from the LS. (T. Hatch/UCIP)07/10/2013 - Pipe abandoned and open on both ends. Concrete pump pit foundation undermined at WS toe. Pipe should be abandoned properly (W. Wylie/UCIP) FIELD_STRUCT_DESC: *ABANDONED* 14-inch (measured) steel irrigation pipe through the levee, 4.8 feet below the crown. 9-foot by 14-foot concrete pump pit on the waterside (WS) slope. Pipe open on the WS inlet to pump pit. [Additional Reference(s): DWR Levee Log, 1992, 16-inch pipe listed. USACE Sacramento O&M Manual 113 (Revised), October 1966, (HLM 7.60), abandoned 16-inch pipe listed]. FS Date: 7/26/2018 1:10:00 PM

Concrete pump pit on WS toe.

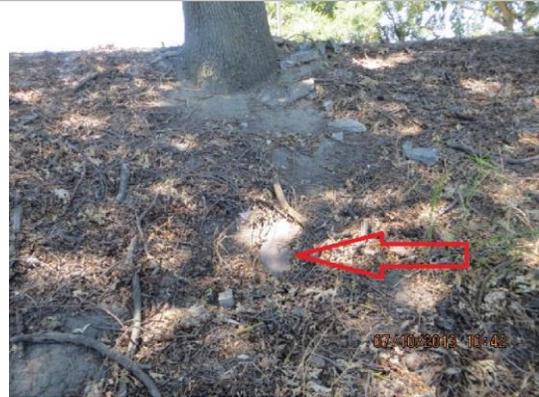
Photo 2 of 3 : UCIP_FA_2019_53373_25937.jpg

Comment Code					
Inspector Comment					
DS_ID:22863 FS_ID:53373 EP_NO: N/A Repair Type: Urgent Crossing Status: Found UCIP Comments: 07/26/2018 Same as last inspection; appears abandoned. Could not find outlet on LS. Erosion around WS concrete box base so crossing remains Urgent (D. Sanoski - DWR UCIP).07/07/2016 - Pipe abandoned and appears to be open inside the concrete box on the WS shoulder. No appurtenances visible from the LS. (T. Hatch/UCIP)07/10/2013 - Pipe abandoned and open on both ends. Concrete pump pit foundation undermined at WS toe. Pipe should be abandoned properly (W. Wylie/UCIP) FIELD_STRUCT_DESC: *ABANDONED* 14-inch (measured) steel irrigation pipe through the levee, 4.8 feet below the crown. 9-foot by 14-foot concrete pump pit on the waterside (WS) slope. Pipe open on the WS inlet to pump pit. [Additional Reference(s): DWR Levee Log, 1992, 16-inch pipe listed. USACE Sacramento O&M Manual 113 (Revised), October 1966, (HLM 7.60), abandoned 16-inch pipe listed]. FS Date: 7/26/2018 1:10:00 PM

Pipe visible on WS slope.

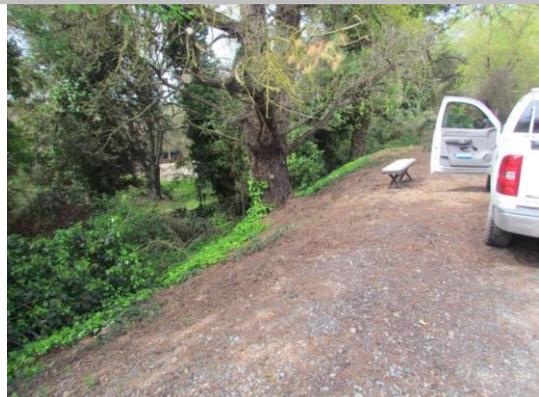
Photo 1 of 2 : FA_2019_RD0999_236_66_20190904_00027.jpg

LM Start	7.54	Rating **	U	Issue No.	66
LM End	7.58	Issue Type +	En	Location *	LS
Category	Earthen Levee		GPS Latitude/Longitude		
			Start	End	
Item	Vegetation		38.403895°	38.404145°	
			-121.541113°	-121.541835°	
DWR ID	DWR_RD0999_05_s_2012_66				
Comment Code					
V6 : Landscaping					
Inspector Comment

Looking east at landscaping at bottom half of levee. (Spring 2017)

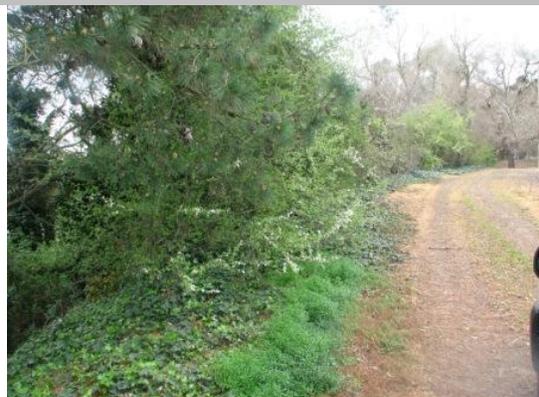
Photo 2 of 2 : FA_2019_RD0999_236_66_20190904_00028.jpg

Landscaping on landside slope blocking view of slope. (Spring 2016)

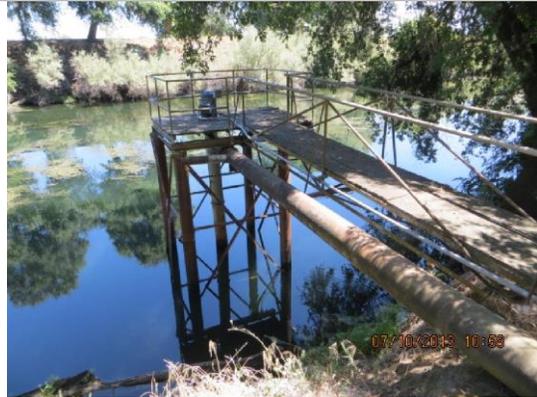
Photo 3 of 3 : UCIP_FA_2019_15624_25967.jpg

LM Start	7.57	Rating **	M	Issue No.	247 (cont)
LM End	7.57	Issue Type +	En	Location *	
Category	Supplemental			GPS Latitude/Longitude	
				Start	End
Item	DRAFT DWR UCIP Field Study			38.403993°	38.403993°
				-121.541626°	-121.541626°
DWR ID	22864				
Comment Code					
Inspector Comment					
DS_ID:22864 FS_ID:15624 EP_NO: N/A Repair Type: Non-Urgent Crossing Status: Found UCIP Comments: Annular space needs to be grouted between the 12 and 14-inch pipes. FIELD_STRUCT_DESC: 12-inch steel irrigation pipe sleeved through the 14-inch pipe through the levee, 7 feet below the crown. Annular space not grouted. 36-inch concrete standpipe on the landside (LS) toe. [Additional Reference(s): DWR Levee Log, 1992. USACE Sacramento O&M Manual 113 (Revised), October 1966, (HLM 7.65), 12-inch pipe listed]. FS Date: 7/10/2013

Pump on metal pier with walkway at WS toe

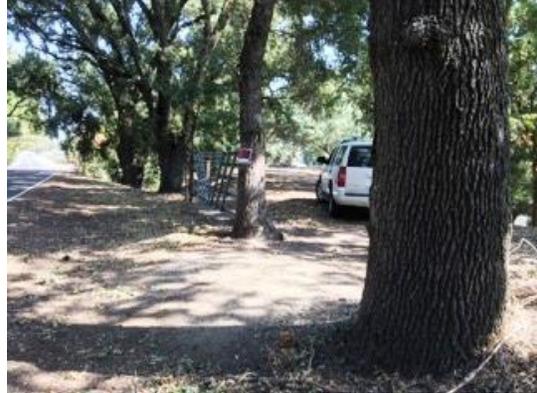
Photo 1 of 1 : FA_2019_RD0999_236_138_20191017_00169.jpg

LM Start	7.59	Rating **	A/W	Issue No.	138
LM End	8.12	Issue Type +	Ma	Location *	CR
Category	Earthen Levee		GPS Latitude/Longitude		
			Start	End	
Item	Vegetation		38.404168 °	38.409867 °	
			-121.541893 °	-121.539667 °	
DWR ID	DWR_RD0999_05_f_2019_138				
Comment Code					
V1 : Control annual grass and weeds on the levee slopes and easements.					
Inspector Comment					
This section contains a house on top of the levee with no access on either side of the crown. Vehicle access resumes at LM 8.13 between two trees next to a private gate.

View of levee access between trees next to a private gate at LM 8.13.

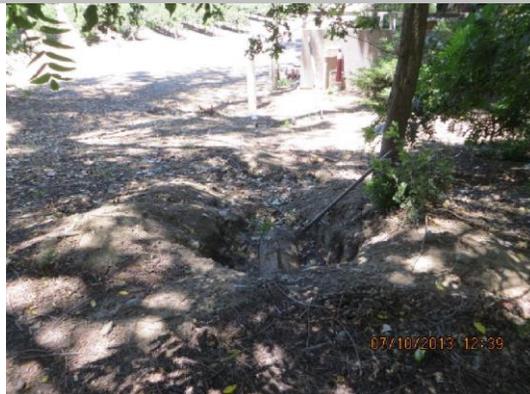
Photo 3 of 3 : UCIP_FA_2019_15683_26100.jpg

Comment Code					
Inspector Comment					
DS_ID:22881 FS_ID:15683 EP_NO: 13463 Repair Type: Non-Urgent Crossing Status: Found UCIP Comments: Pipe exposed in excavation on LS shoulder at what may be a leak. FIELD_STRUCT_DESC: 12-inch steel irrigation pipe through the levee, 2.5 feet below the crown. Pump on pile structure with walkway on the waterside (WS) toe. 12-inch polyvinyl chloride (PVC) standpipe on the landside (LS) toe next to filter plant and shed. 1.5-inch polyvinyl chloride (PVC) electrical conduit at the same location. (12-inch pipe authorized under Permit No. 13463, 1982 - John Plyman, existing 8-inch pipe was grouted in-place). FS Date: 7/10/2013

Pipe visible on LS shoulder with siphon breaker.

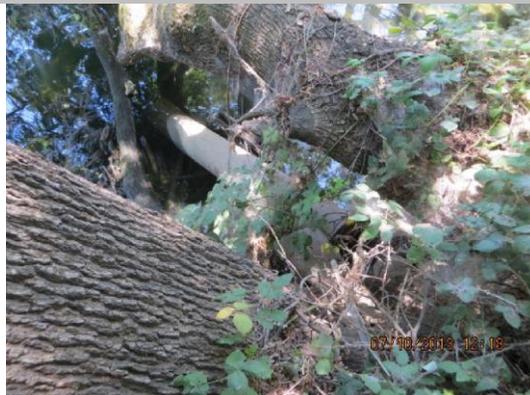
Photo 1 of 3 : UCIP_FA_2019_15663_26082.jpg

LM Start	8.05	Rating **	M	Issue No.	251
LM End	8.05	Issue Type +	En	Location *	
Category	Supplemental			GPS Latitude/Longitude	
				Start	End
Item	DRAFT DWR UCIP Field Study			38.409440 °	38.409440 °
				-121.540928 °	-121.540928 °
DWR ID	22868				
Comment Code					
Inspector Comment					
DS_ID:22868 FS_ID:15663 EP_NO: N/A Repair Type: Non-Urgent Crossing Status: Found UCIP Comments: Pipe abandoned and should be done so properly. FIELD_STRUCT_DESC: *ABANDONED* 14-inch steel irrigation pipe through the levee, 14.4 feet below the crown. Gate valve at pump in concrete pit under pump house on the waterside (WS) slope. [Additional Reference(s): DWR Levee Log, 1992. USACE Sacramento O&M Manual 113 (Revised), October 1966, (HLM 8.13) (10-inch pipe listed)]. FS Date: 7/10/2013

14-inch pipe visible at WS toe below pumphouse.

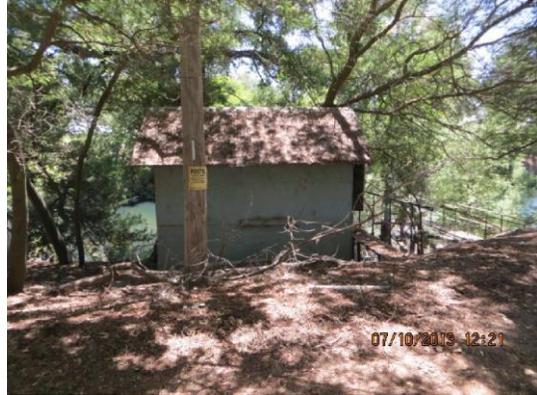
Photo 2 of 3 : UCIP_FA_2019_15663_26081.jpg

LM Start	8.05	Rating **	M	Issue No.	251 (cont)
LM End	8.05	Issue Type +	En	Location *	
Category	Supplemental			GPS Latitude/Longitude	
				Start	End
Item	DRAFT DWR UCIP Field Study			38.409440°	38.409440°
				-121.540928°	-121.540928°
DWR ID	22868				
Comment Code					
Inspector Comment					
DS_ID:22868 FS_ID:15663 EP_NO: N/A Repair Type: Non-Urgent Crossing Status: Found UCIP Comments: Pipe abandoned and should be done so properly. FIELD_STRUCT_DESC: *ABANDONED* 14-inch steel irrigation pipe through the levee, 14.4 feet below the crown. Gate valve at pump in concrete pit under pump house on the waterside (WS) slope. [Additional Reference(s): DWR Levee Log, 1992. USACE Sacramento O&M Manual 113 (Revised), October 1966, (HLM 8.13) (10-inch pipe listed)]. FS Date: 7/10/2013

Concrete pumphouse on WS slope.

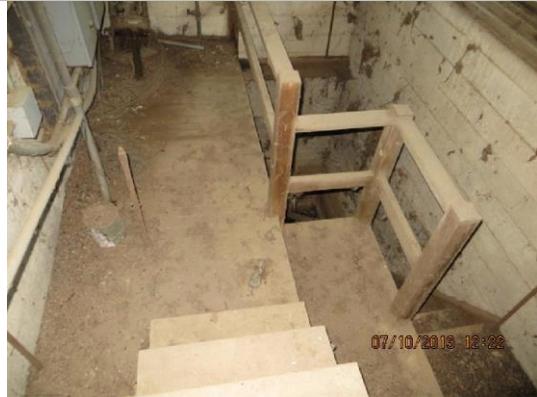
Photo 3 of 3 : UCIP_FA_2019_15663_26080.jpg

Pump and gate valve assumed to be in bottom of concrete well inside pumphouse.

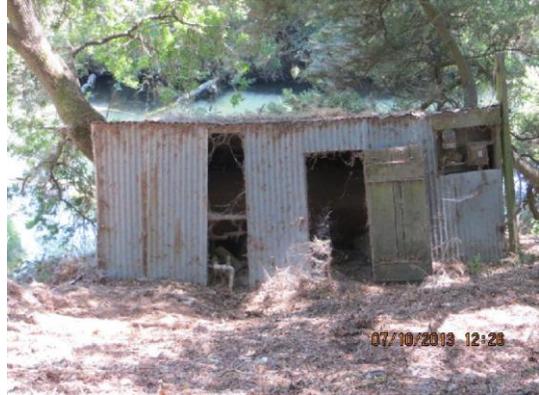
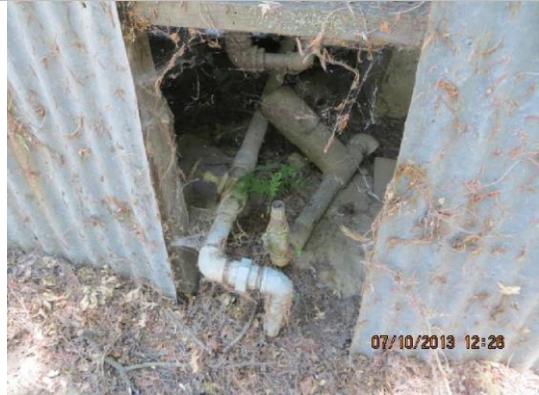
LM Start	8.05	Rating **	M	Issue No.	252
LM End	8.05	Issue Type +	En	Location *	
Category	Supplemental			GPS Latitude/Longitude	
				Start	End
Item	DRAFT DWR UCIP Field Study			38.409488 °	38.409488 °
				-121.540833 °	-121.540833 °
DWR ID	22870				
Comment Code					
Inspector Comment					
DS_ID:22870 FS_ID:15664 EP_NO: N/A Repair Type: Non-Urgent Crossing Status: Found UCIP Comments: Pipe appears abandoned and should be done so properly. FIELD_STRUCT_DESC: 2-inch galvanized iron domestic water line through the levee, 12.5 feet below the crown. Gate valve and domestic pressure system in pump house on the waterside (WS) slope. [Additional Reference(s): DWR Levee Log, 1992. USACE Sacramento O&M Manual 113 (Revised), October 1966, (HLM 8.14)]. FS Date: 7/10/2013

Pipe visible inside pumphouse on WS slope.

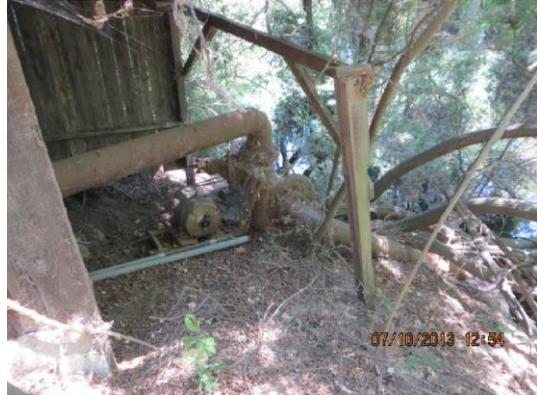
Photo 3 of 3 : UCIP_FA_2019_15685_26104.jpg

Comment Code					
Inspector Comment					
DS_ID:22871 FS_ID:15685 EP_NO: 4851 Repair Type: Non-Urgent Crossing Status: Found UCIP Comments: Pipe appears to be abandoned and should be done so properly. FIELD_STRUCT_DESC: 8-inch steel irrigation pipe through the levee, 6.2 feet below the crown. Gate valve in pump house on the waterside (WS) slope. Service poles on both slopes. (no permit found for the install of original 8-inch pipe; 20-foot section of existing 8-inch pipe was replaced with new 8-inch pipe work authorized under Permit No. 4851, 1965 - J. Plyman). [Additional Reference(s): DWR Levee Log, 1992. USACE Sacramento O&M Manual 113 (Revised), October 1966, (HLM 8.23)]. FS Date: 7/10/2013

Pump and gatevalve in pumphouse on WS toe.

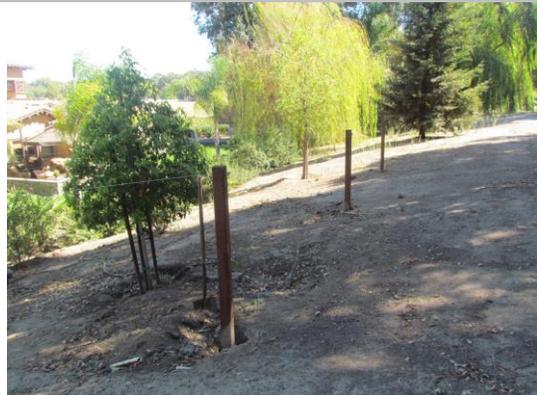
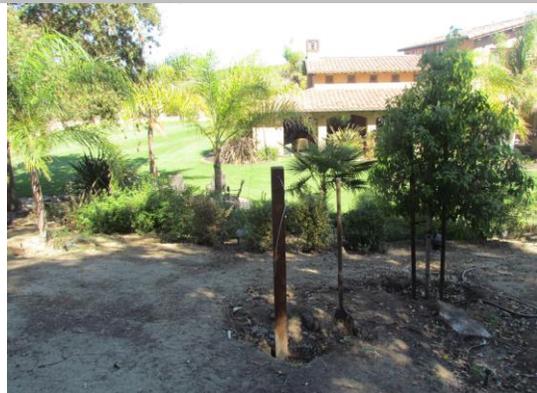
Looking east at wooden poles on landward shoulder.

Looking north at wooden pole on landward shoulder.

LM Start	8.27	Rating **	M	Issue No.	221
LM End	8.27	Issue Type +	En	Location *	LS
Category	Earthen Levee			GPS Latitude/Longitude	
				Start	End
Item	Encroachments			38.409468°	38.409468°
				-121.537066°	-121.537066°
DWR ID	DWR_RD0999_05_f_2016_221				
Comment Code					
PO : Pole					
Inspector Comment					
Instruct landowner to remove wooden poles with lights from the landside slope.

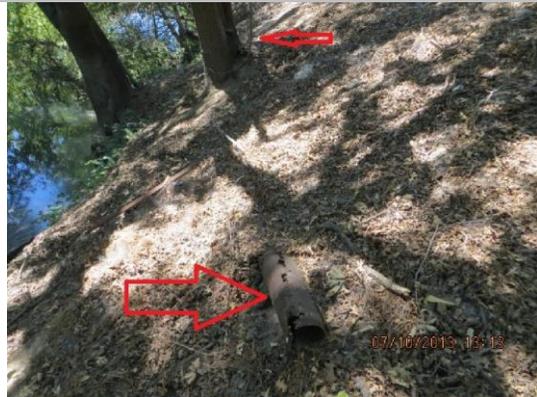
Photo 1 of 3 : UCIP_FA_2019_15686_26109.jpg

LM Start	8.29	Rating **	M	Issue No.	254
LM End	8.29	Issue Type +	En	Location *	
Category	Supplemental		GPS Latitude/Longitude		
			Start	End	
Item	DRAFT DWR UCIP Field Study		38.409264 °	38.409264 °	
			-121.536659 °	-121.536659 °	
DWR ID	22872				
Comment Code					
Inspector Comment					
DS_ID:22872 FS_ID:15686 EP_NO: N/A Repair Type: Non-Urgent Crossing Status: Indicator Found UCIP Comments: Type of pipe abandonment needs to be verified. FIELD_STRUCT_DESC: *ABANDONED* 8-inch steel irrigation pipe through the levee, 11.7 feet below the crown. No control valves. 1.5-inch galvanized iron electrical conduit found on the waterside (WS) slope at oak tree. 8-inch pipe debris visible on the WS slope. [Additional Reference(s): DWR Levee Log, 1992. USACE Sacramento O&M Manual 113 (Revised), October 1966, (HLM 8.43)]. FS Date: 7/10/2013

8-inch pipe debris with 1.5-inch electrical conduit visible in background on WS slope.

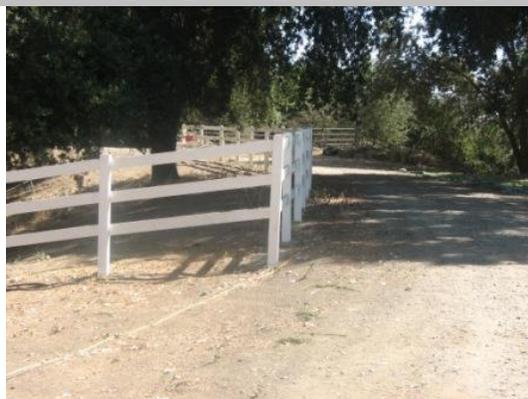
Photo 1 of 1 : FA_2019_RD0999_236_101_20190904_00046.jpg

LM Start	8.39	Rating **	M	Issue No.	101
LM End	8.43	Issue Type +	En	Location *	LS
Category	Earthen Levee		GPS Latitude/Longitude		
			Start	End	
Item	Encroachments		38.408586 °	38.408748 °	
			-121.534992 °	-121.534437 °	
DWR ID	DWR_RD0999_05_s_2012_101				
Comment Code					
FE : Fence					
Inspector Comment					
Fence installed without CVFPB permit in 2008. Fence extends from landside toe to landside shoulder.

Unauthorized fence at landside slope and shoulder.

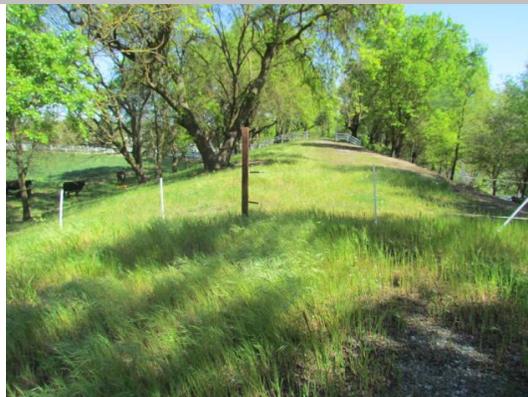
Photo 1 of 1 : FA_2019_RD0999_236_187_20190904_00085.jpg

LM Start	8.50	Rating **	M	Issue No.	187
LM End	8.50	Issue Type +	En	Location *	CR
Category	Earthen Levee		GPS Latitude/Longitude		
			Start	End	
Item	Encroachments		38.409395 °	38.409395 °	
			-121.533593 °	-121.533593 °	
DWR ID	DWR_RD0999_05_s_2015_187				
Comment Code					
FE : Fence					
Inspector Comment					
Landowner installed an electrical fence across levee crown without a permit.

Looking east at new electrical fence across levee crown and landward slope. (Spring 2015)

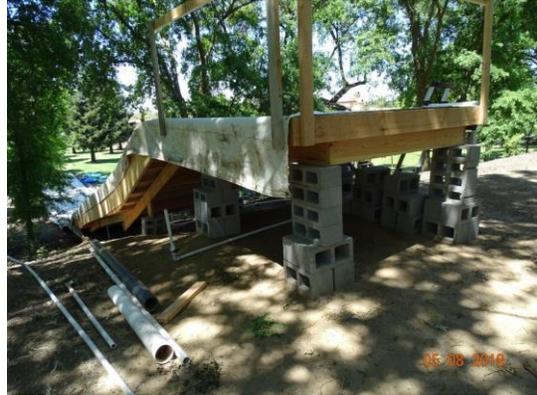
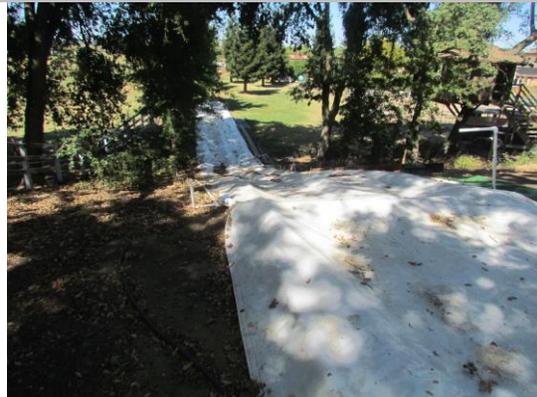
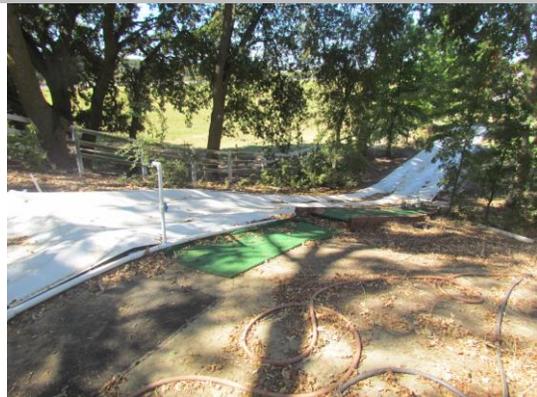
Encroachment waterside landside looking north.

LM Start	8.54	Rating **	U	Issue No.	222
LM End	8.54	Issue Type +	En	Location *	LS
Category	Earthen Levee		GPS Latitude/Longitude		
			Start	End	
Item	Encroachments		38.409931 °	38.409931 °	
			-121.533033 °	-121.533033 °	
DWR ID	DWR_RD0999_05_f_2016_222				
Comment Code					
PL : Pool					
Inspector Comment					
Instruct the landowner to remove slip and slide and pvc pipes on the landside slope.

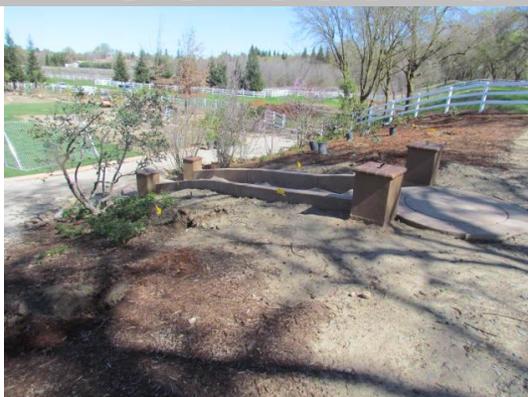
Photo 1 of 2 : FA_2019_RD0999_236_196_20190904_00087.jpg

LM Start	8.58	Rating **	M	Issue No.	196
LM End	8.58	Issue Type +	En	Location *	LS
Category	Earthen Levee		GPS Latitude/Longitude		
			Start	End	
Item	Encroachments		38.410279°	38.410279°	
			-121.532414°	-121.532414°	
DWR ID	DWR_RD0999_05_s_2014_196				
Comment Code					
ST : Stairway					
Inspector Comment					
Landowner installed concrete stairs, sprinkler, and plantings on landside slope without a CVFPB permit.

Looking east at concrete stairs, sprinklers, and plantings on landward slope.

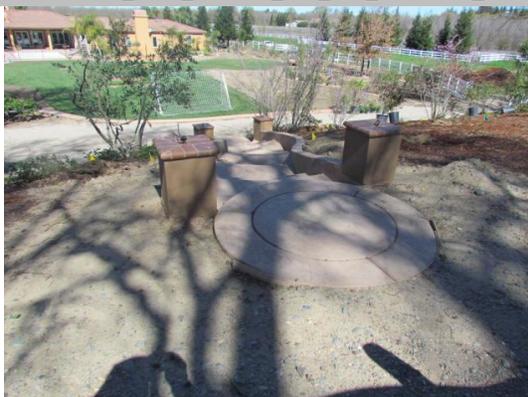
Photo 2 of 2 : FA_2019_RD0999_236_196_20190904_00088.jpg

LM Start	8.58	Rating **	M	Issue No.	196 (cont)
LM End	8.58	Issue Type +	En	Location *	LS

Looking north at concrete stairs on landward slope.

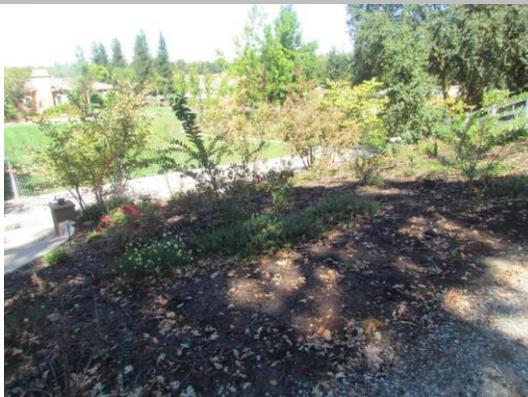
Photo 1 of 1 : FA_2019_RD0999_236_126_20190904_00050.jpg

LM Start	8.59	Rating **	M	Issue No.	126
LM End	8.59	Issue Type +	En	Location *	LS
Category	Earthen Levee		GPS Latitude/Longitude		
			Start	End	
Item	Vegetation		38.410283°	38.410283°	
			-121.532353°	-121.532353°	
DWR ID	DWR_RD0999_05_s_2012_126				
Comment Code					
V6 : Landscaping					
Inspector Comment

Looking northeast at landscaping on landward slope.

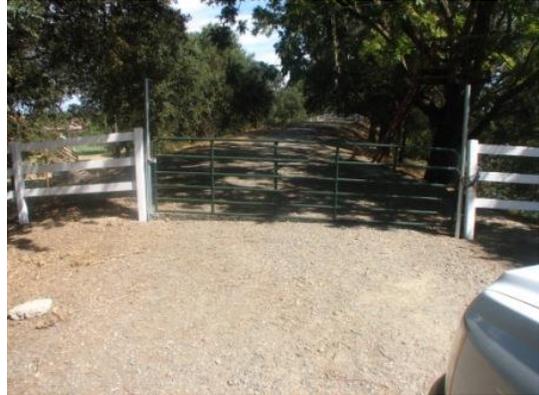
Photo 1 of 2 : FA_2019_RD0999_236_103_20190904_00047.jpg

LM Start	8.59	Rating **	M	Issue No.	103
LM End	8.59	Issue Type +	En	Location *	CR
Category	Earthen Levee		GPS Latitude/Longitude		
			Start	End	
Item	Encroachments		38.410332°	38.410332°	
			-121.532277°	-121.532277°	
DWR ID	DWR_RD0999_05_s_2012_103				
Comment Code					
FE : Fence					
Inspector Comment

View of fence & gate across levee crown, landside & waterside slope.

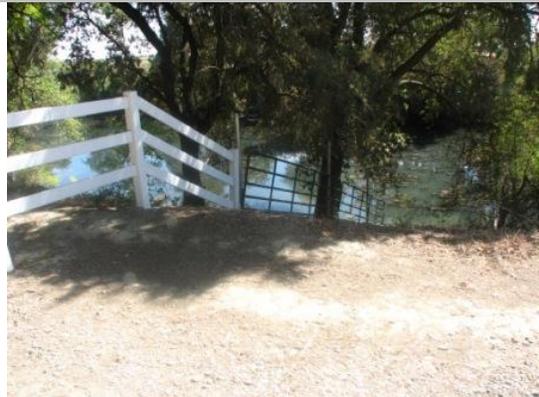
Photo 2 of 2 : FA_2019_RD0999_236_103_20190904_00048.jpg

Unauthorized fence that extends from landside toe to waterside toe.

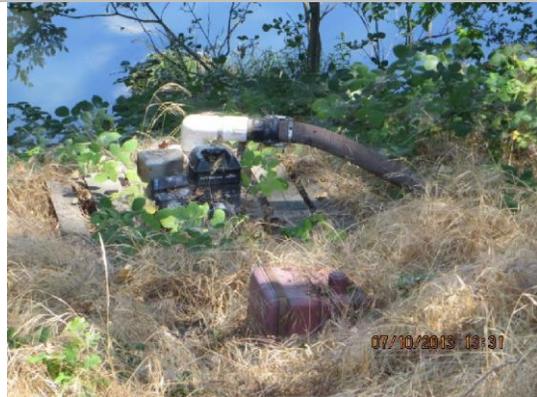
Photo 1 of 2 : UCIP_FA_2019_16345_27558.jpg

LM Start	8.62	Rating **	M	Issue No.	255
LM End	8.62	Issue Type +	En	Location *	
Category	Supplemental			GPS Latitude/Longitude	
				Start	End
Item	DRAFT DWR UCIP Field Study			38.410531 °	38.410531 °
				-121.531785 °	-121.531785 °
DWR ID	23990				
Comment Code					
Inspector Comment					
DS_ID:23990 FS_ID:16345 EP_NO: N/A Repair Type: Non-Urgent Crossing Status: Found UCIP Comments: Need to determine permit No for crossing or remove it. FIELD_STRUCT_DESC: 3-inch plastic irrigation hose over the top of the levee. Small portable pump on the waterside (WS) toe. FS Date: 7/10/2013

Portable pump on WS toe.

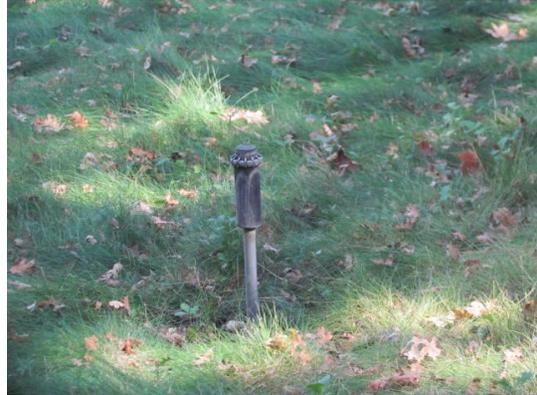
Photo 1 of 1 : FA_2019_RD0999_236_134_20190904_00055.jpg

LM Start	8.73	Rating **	M	Issue No.	134
LM End	8.82	Issue Type +	En	Location *	LS
Category	Earthen Levee			GPS Latitude/Longitude	
				Start	End
Item	Encroachments			38.411577°	38.412619°
				-121.530375°	-121.529691°
DWR ID	DWR_RD0999_05_f_2012_134				
Comment Code					
LI : Landscape Irrigation					
Inspector Comment					
Sprinklers on landside and waterside shoulder need a permit.

Looking at one of several sprinklers on waterward and landward slopes.

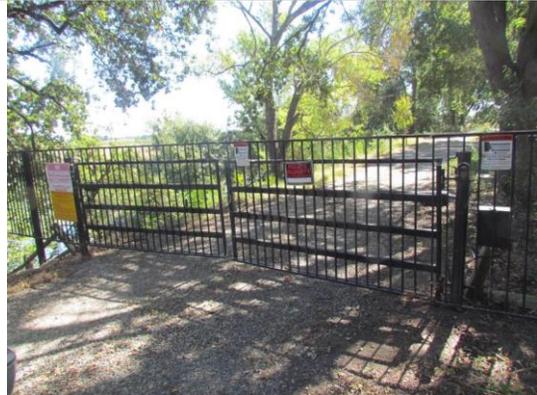
Photo 1 of 2 : FA_2019_RD0999_236_224_20190904_00098.jpg

LM Start	8.82	Rating **	M	Issue No.	224
LM End	8.82	Issue Type +	En	Location *	CR
Category	Earthen Levee			GPS Latitude/Longitude	
				Start	End
Item	Encroachments			38.412718°	38.412718°
				-121.529724°	-121.529724°
DWR ID	DWR_RD0999_05_f_2016_224				
Comment Code					
FE : Fence					
Inspector Comment					
Landowner installed a gate across the levee crown without a permit.

Looking west at code pad on right side of gate.

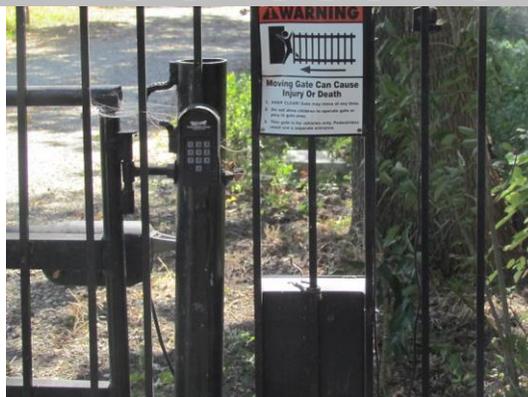
Photo 2 of 2 : FA_2019_RD0999_236_224_20190904_00099.jpg

LM Start	8.82	Rating **	M	Issue No.	224 (cont)
LM End	8.82	Issue Type +	En	Location *	CR
Category	Earthen Levee			GPS Latitude/Longitude	
				Start	End
Item	Encroachments			38.412718 °	38.412718 °
				-121.529724 °	-121.529724 °
DWR ID	DWR_RD0999_05_f_2016_224				
Comment Code					
FE : Fence					
Inspector Comment					
Landowner installed a gate across the levee crown without a permit.

Looking at code pad on right side of gate.

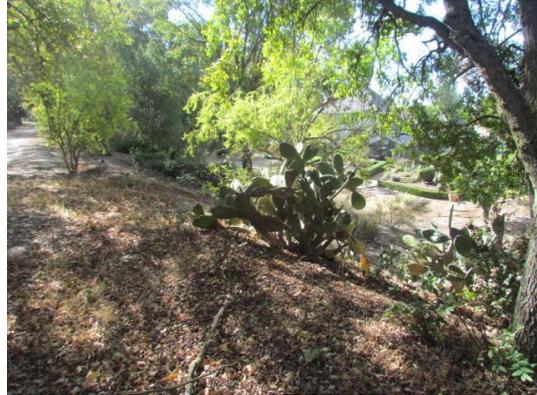
Photo 1 of 1 : FA_2019_RD0999_236_127_20190904_00051.jpg

LM Start	8.90	Rating **	M	Issue No.	127
LM End	8.92	Issue Type +	En	Location *	LS
Category	Earthen Levee		GPS Latitude/Longitude		
			Start	End	
Item	Vegetation		38.413780 °	38.414138 °	
			-121.529727 °	-121.529772 °	
DWR ID	DWR_RD0999_05_s_2012_127				
Comment Code					
V6 : Landscaping					
Inspector Comment					
Instruct the landowner to remove cactus and other plants from landside slope. Pomegranate trees on shoulder are not permitted on levee section. Sprinklers need a permit.

Looking west at cactus and other vegetation on landward slope.

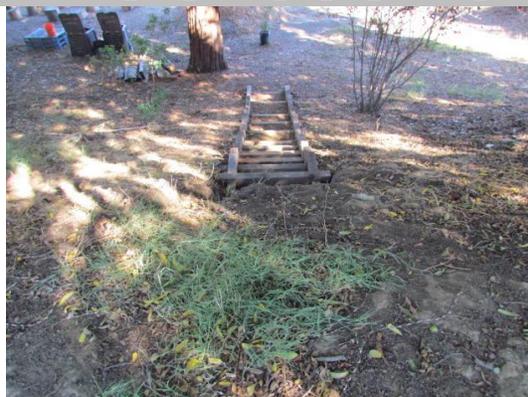
Photo 1 of 1 : FA_2019_RD0999_236_200_20190904_00090.jpg

LM Start	9.14	Rating **	M	Issue No.	200
LM End	9.14	Issue Type +	En	Location *	LS
Category	Earthen Levee			GPS Latitude/Longitude	
				Start	End
Item	Encroachments			38.415787°	38.415787°
				-121.527437°	-121.527437°
DWR ID	DWR_RD0999_05_f_2015_200				
Comment Code					
ST : Stairway					
Inspector Comment					
The landowner installed stairs on the landside slope without a permit.

Looking north at stairs on landward slope.

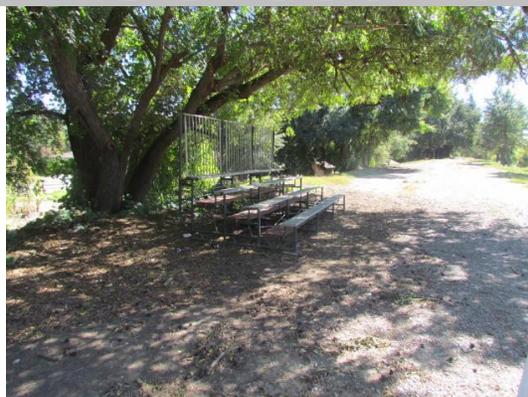
Photo 1 of 1 : FA_2019_RD0999_236_158_20190904_00068.jpg

LM Start	9.15	Rating **	M	Issue No.	158
LM End	9.15	Issue Type +	En	Location *	LS
Category	Earthen Levee			GPS Latitude/Longitude	
				Start	End
Item	Encroachments			38.415709°	38.415709°
				-121.527393°	-121.527393°
DWR ID	DWR_RD0999_05_f_2013_158				
Comment Code					
EQ : Equipment					
Inspector Comment					
Instruct the landowner to remove bleachers from the landside shoulder.

Looking northeast at bleachers stored on landward shoulder.

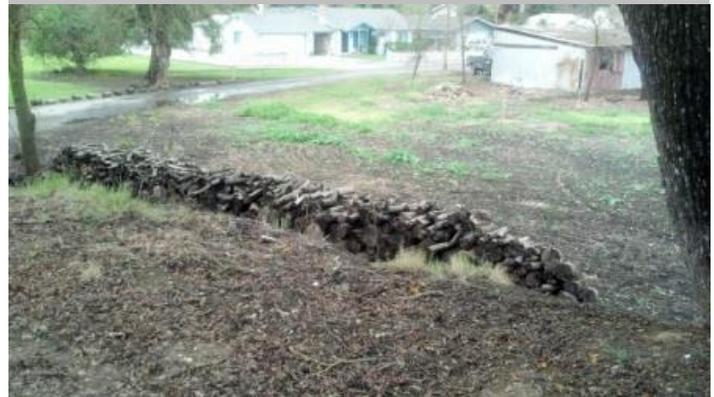
Photo 1 of 2 : FA_2019_RD0999_236_145_20190904_00057.jpg

LM Start	9.44	Rating **	M	Issue No.	145
LM End	9.44	Issue Type +	En	Location *	LS
Category	Earthen Levee		GPS Latitude/Longitude		
			Start	End	
Item	Encroachments		38.413755°	38.413755°	
			-121.523723°	-121.523723°	
DWR ID	DWR_RD0999_05_s_2013_145				
Comment Code					
FW : Firewood					
Inspector Comment					
Instruct landowner to remove firewood stockpile from the levee easement.

Looking north at firewood pile at landside toe.

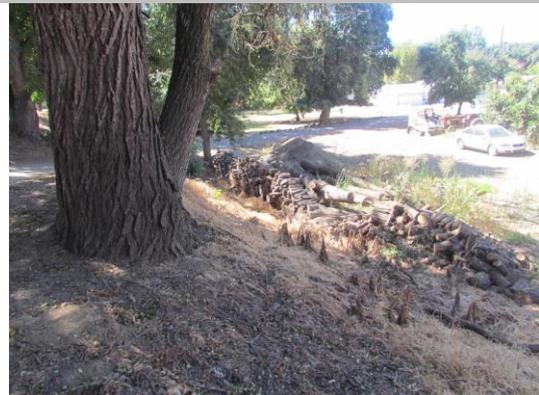
Photo 2 of 2 : FA_2019_RD0999_236_145_20190904_00058.jpg

Looking northwest at firewood at landward toe.
