**Flood Control Project Maintenance
Levee Inspections**
LMA District Cover Sheet
Spring 2020 Levee Inspection Results

Reclamation District No. 1500 Sutter Basin

Spring 2020 Levee Inspection Results

Waterway	Bank	Unit Miles
Unit No. 01 Sacramento River	Left	33.15

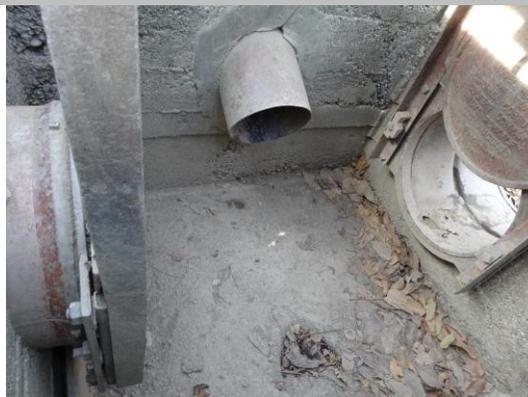
Photo 3 of 3 : UCIP_SP_2020_28183_51843.jpg

LS view: open steel pipe in concrete distribution box on levee toe.

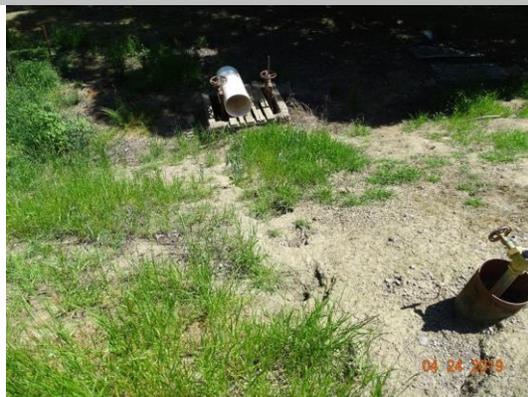
Photo 1 of 1 : SP_2020_RD1500_189_145_20200228_00058.jpg

LM Start	0.31	Rating **	M	Issue No.	145
LM End	0.31	Issue Type +	En	Location *	LS
Category	Earthen Levee			GPS Latitude/Longitude	
				Start	End
Item	Encroachments			38.763230 °	38.763230 °
				-121.679014 °	-121.679014 °
DWR ID	DWR_RD1500_01_f_2018_145				
Comment Code					
ST : Stairway					
Inspector Comment					
Stairs are dug into the landside slope.

View of stairs on the landside slope. Spring 2019.

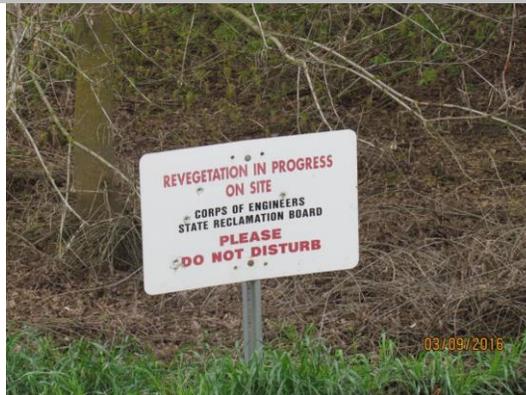
Photo 2 of 2 : SP_2020_RD1500_189_72_20200228_00026.jpg

Sign is located at the toe of the levee on the waterward side. Spring 2016.

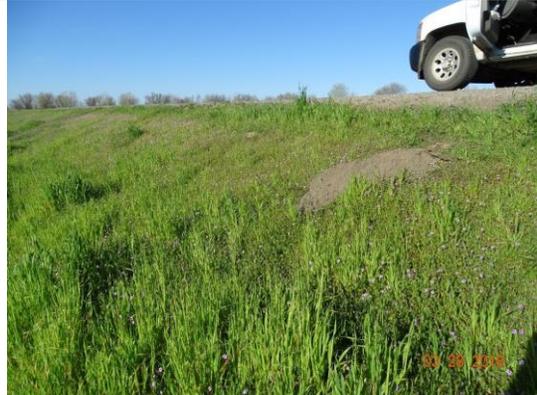
Photo 1 of 2 : SP_2020_RD1500_189_99_20200228_00039.jpg

LM Start	1.25	Rating **	M	Issue No.	99
LM End	1.25	Issue Type +	Ma	Location *	LS
Category	Earthen Levee			GPS Latitude/Longitude	
				Start	End
Item	Animal Control			38.769274 °	38.769274 °
				-121.691700 °	-121.691700 °
DWR ID	DWR_RD1500_01_f_2017_99				
Comment Code					
A3 : No rodents visible, but rodent burrows visible; need to backfill and compact or grout burrows.					
Inspector Comment					
There are multiple rodent holes and mounds on the landside slope.

View of rodent holes. Spring 2018

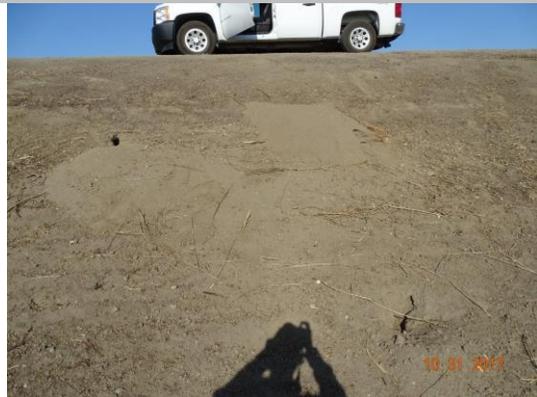
Photo 2 of 2 : SP_2020_RD1500_189_99_20200228_00040.jpg

View of holes and mounds on landside slope. Fall 2017.

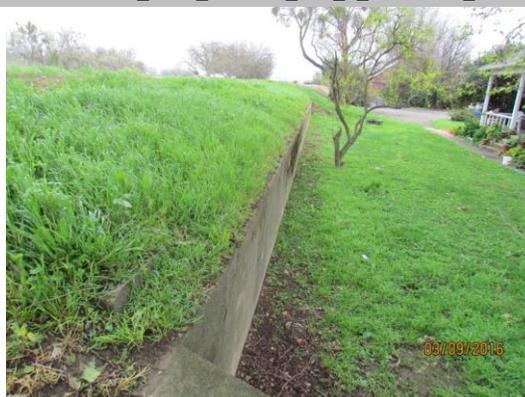
Photo 1 of 1 : SP_2020_RD1500_189_4_20200228_00001.jpg

LM Start	1.33	Rating **	M	Issue No.	4
LM End	1.33	Issue Type +	En	Location *	LS
Category	Earthen Levee			GPS Latitude/Longitude	
				Start	End
Item	Encroachments			38.770023 °	38.770023 °
				-121.690575 °	-121.690575 °
DWR ID	DWR_RD1500_01_s_2012_4				
Comment Code					
RW : Retaining Wall					
Inspector Comment					
A retaining wall was built into the levee.

View of the retaining wall that is in USACE as-builts on the landward side of the levee looking upstream. Wall cuts into levee toe. Spring 2016.

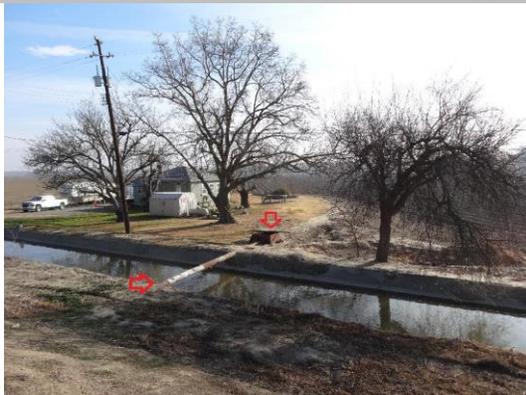
Photo 3 of 3 : UCIP_SP_2020_28204_51873.jpg

LS view: pipe crosses irrigation ditch. Steel distribution box across irrigation ditch.

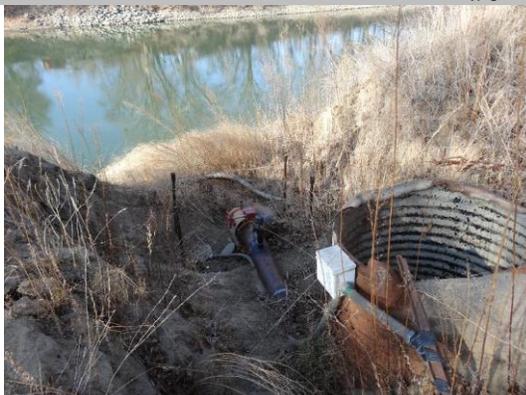
Photo 1 of 3 : UCIP_SP_2020_28263_51965.jpg

DS_ID:20034
 FS_ID:28263
 EP_NO: 16146
 Repair Type: Non-Urgent
 Crossing Status: Found
 UCIP Comments: - pump removed- overhead powerline- pile structure abandoned- levee slope erosion due to leaky siphon breaker on landside.
 FIELD_STRUCT_DESC: *REPLACEMENT CROSSING* 12-inch steel irrigation discharge pipe through the levee, 12 feet below the crown. Pump mounted on the riverbank. Butterfly valve on the waterside (WS). Power pole with one anchor on the WS slope. Pipe discharges into a 5-foot by 5-foot damaged concrete distribution box across the irrigation ditch on the landside (LS). Electrical conduit through the levee. (Cat. I - Furlan). (Abandonment-in-place of an existing pipe and replacement of approximately 70 feet of 12-inch irrigation discharge pipe authorized under Permit No. 16146, 1993 - Antonio Furlan and Joe Schreiner). [Additional Reference(s): DWR Levee Log, 2005. USACE Sacramento O&M Manual 128, March 1960, (HLM 1.96)].

WS view: Pump (removed and plywood plated), pipe, and gate valve in CMP riser on river bank.

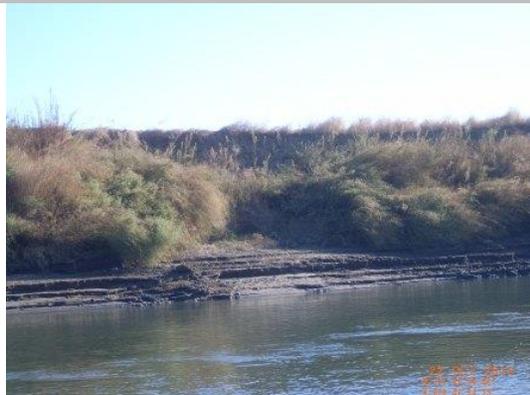
Photo 1 of 1 : SP_2020_RD1500_189_87_20200228_00034.jpg

LM Start	2.30	Rating **	A/W	Issue No.	87
LM End	2.52	Issue Type +	Ma	Location *	WS
Category	Supplemental			GPS Latitude/Longitude	
				Start	End
Item	2017 USACE Erosion Survey			38.781962 °	38.784936 °
				-121.688033 °	-121.690033 °
DWR ID	DWR_RD1500_01_f_2018_87				
Comment Code					
Inspector Comment					
2017 Site ID: SAC 87.1 L Status: Eroding 2017 Field Notes: Large whole bank failure section in middle of site. Site History: 2010 - The upstream end of the repair site at 87.0. Repair did not extend far enough upstream. 2011 - New erosion pockets. 2012 - Minor new erosion at toe. 2013 - Minor new erosion. 2015 - Significant new toe erosion. 2016 - Fresh erosion on riverbank.

USACE 2013 Photo #1

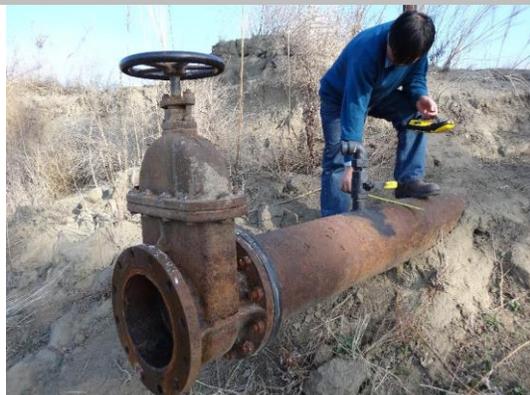
Photo 1 of 3 : UCIP_SP_2020_28264_51971.jpg

Comment Code					
Inspector Comment					
DS_ID:20035 FS_ID:28264 EP_NO: 10029 Repair Type: Non-Urgent Crossing Status: Found UCIP Comments: - pump removed- outlet plugged- looks abandoned. Found abandoned pipe parts on levee slope and berm.- overhead powerline FIELD_STRUCT_DESC: *ABANDONED* 12-inch steel irrigation discharge pipe through the levee, 11 feet below the crown. Two metal cutoff walls installed. Pumps on the riverbank during irrigation season. Gate valve at the waterside (WS) toe. Pipe discharges into a 2.5-foot by 2.5-foot concrete distribution box on the landside (LS) of the irrigation ditch. (Retention of a 12-inch steel irrigation discharge pipe through the levee and pumps on the riverbank during irrigation season authorized under Automatic Board Order (ABO) issued as Permit No. 10029, 1974 - Merle Anderson). [Additional Reference(s): DWR Levee Log, 2005. USACE Sacramento O&M Manual 128, March 1960, (HLM 2.40)]. FS Date: 1/9/2014

WS view: steel pipe, gate valve, and pump (removed) on river bank. Looks abandoned.

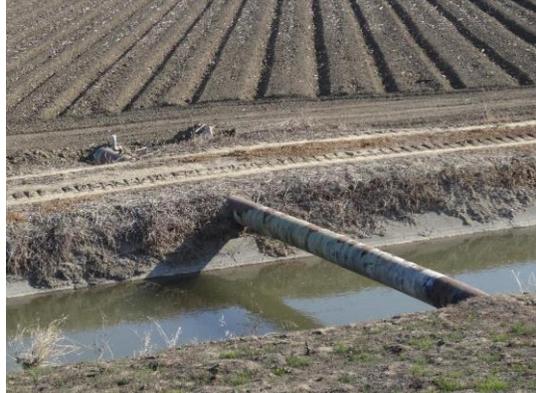
Photo 2 of 3 : UCIP_SP_2020_28264_51970.jpg

LS view: discharge pipe crossing irrigation ditch on landside.

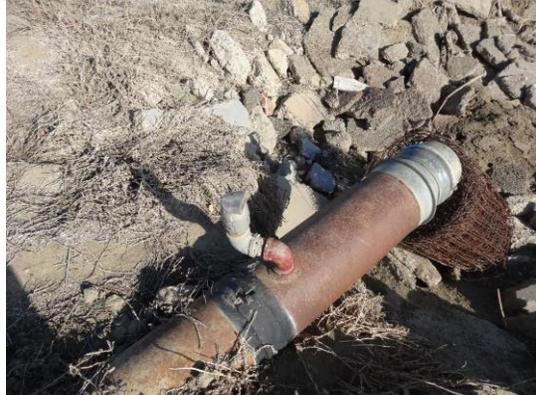
Photo 3 of 3 : UCIP_SP_2020_28264_51969.jpg

LS view: plugged discharge pipe with air vent across irrigation ditch on landside.

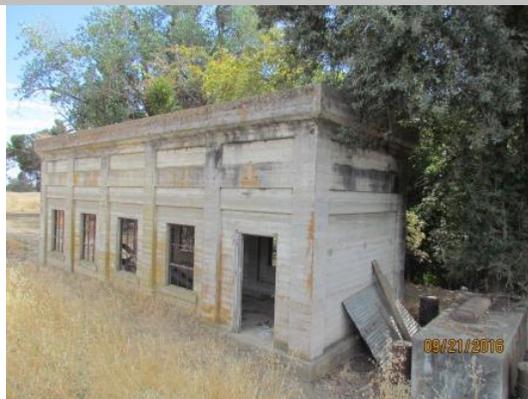
Photo 1 of 1 : SP_2020_RD1500_189_131_20200228_00052.jpg

LM Start	3.69	Rating **	M	Issue No.	131
LM End	3.69	Issue Type +	En	Location *	WS
Category	Earthen Levee		GPS Latitude/Longitude		
			Start	End	
Item	Encroachments		38.797152 °	38.797152 °	
			-121.691238 °	-121.691238 °	
DWR ID	DWR_RD1500_01_f_2016_131				
Comment Code					
BU : Building					
Inspector Comment					
There is an abandoned building at this location.

Abandoned building at waterward toe of the levee. Fall 2016.

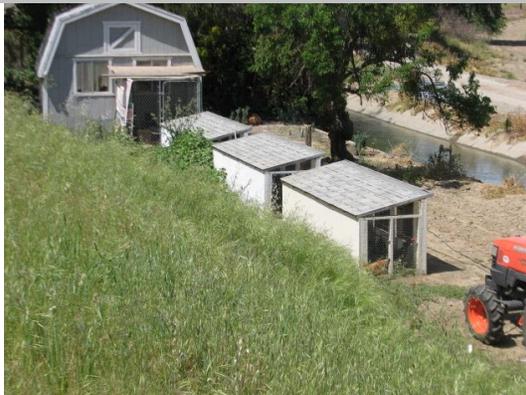
Photo 2 of 2 : SP_2020_RD1500_189_7_20200228_00003.jpg

Chicken coupes have been added along the toe of the levee. Spring 2014

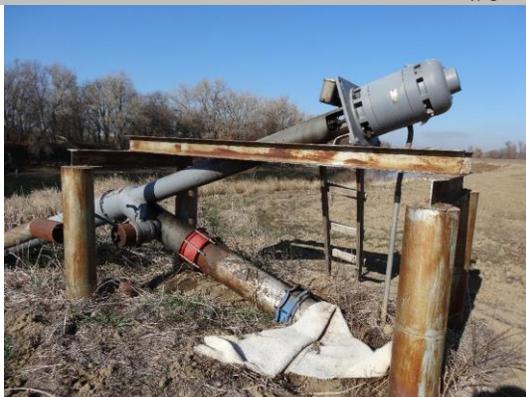
Photo 1 of 3 : UCIP_SP_2020_28272_52012.jpg

WS view: slant pump on steel frame on levee berm.

Comment Code					
Inspector Comment					
DS_ID:20037 FS_ID:28272 EP_NO: 3638 Repair Type: Non-Urgent Crossing Status: Found UCIP Comments: - No protection for pressure breaker. FIELD_STRUCT_DESC: 12-inch steel irrigation discharge pipe through the levee, 2.4 feet below the crown. Slant pump on the berm. Siphon breaker on the landside (LS) slope. Service pole at the LS toe. Pipe discharges into a 36-inch concrete standpipe on the LS. (Installation, maintenance, and operation of an inclined pump and an existing pipe to remain through the levee authorized under Permit No. 3638, 1961 - James F. Waters). [Additional Reference(s): DWR Levee Log, 2005. USACE Sacramento O&M Manual 128, March 1960, (HLM 4.04)]. FS Date: 1/9/2014

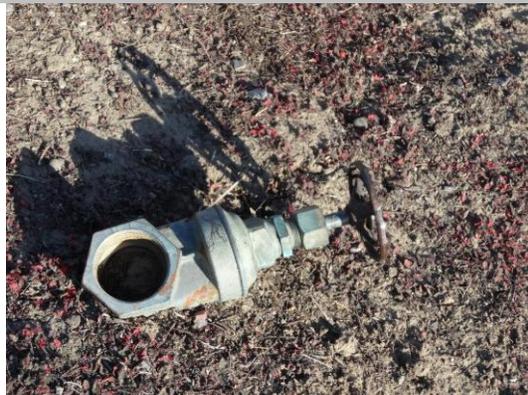
Photo 2 of 3 : UCIP_SP_2020_28272_52011.jpg

LS view: pressure breaker without protection on levee slope.

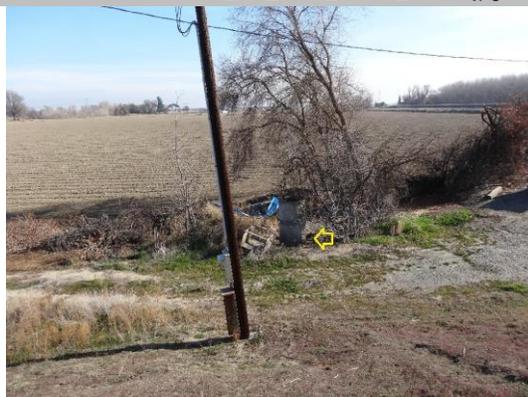
Photo 3 of 3 : UCIP_SP_2020_28272_52013.jpg

LS view: power pole and concrete standpipe on levee toe.

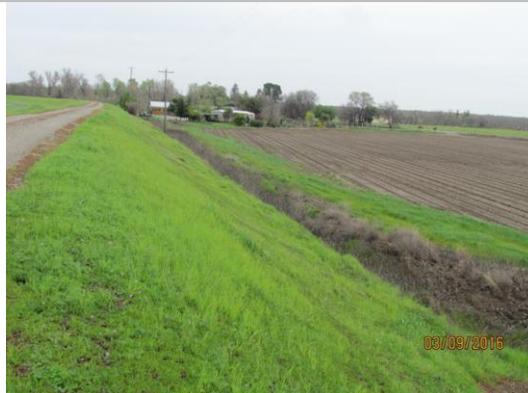
Photo 1 of 1 : SP_2020_RD1500_189_54_20200228_00023.jpg

LM Start	4.02	Rating **	M	Issue No.	54
LM End	4.12	Issue Type +	En	Location *	LS
Category	Earthen Levee			GPS Latitude/Longitude	
				Start	End
Item	Encroachments			38.798526 °	38.800063 °
				-121.696326 °	-121.696622 °
DWR ID	DWR_RD1500_01_s_2012_54				
Comment Code					
DT : Ditch					
Inspector Comment					
A ditch runs along the toe of the levee.

View of the ditch on the landward side of the levee looking upstream. Spring 2016.

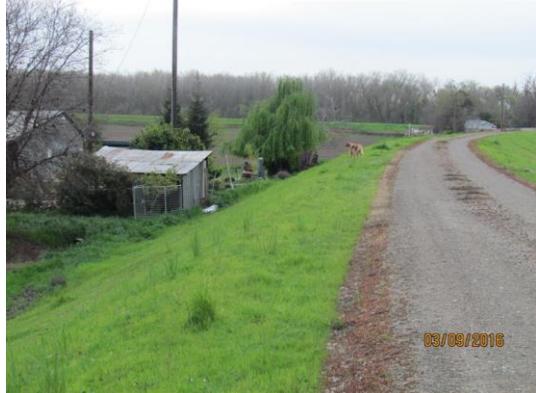
Photo 1 of 1 : SP_2020_RD1500_189_11_20200228_00004.jpg

View of the equipment shed on the landward side of the levee looking downstream. Spring 2016.

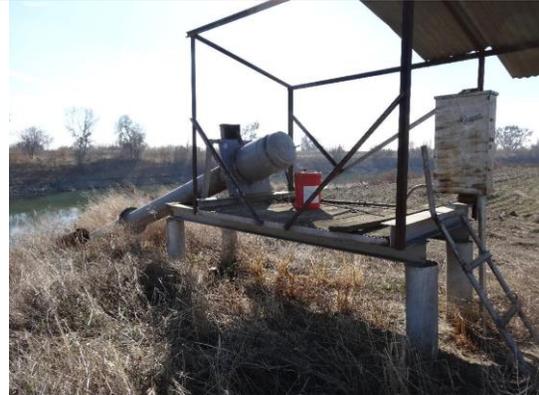
Photo 1 of 3 : UCIP_SP_2020_28912_53181.jpg

Comment Code					
Inspector Comment					
DS_ID:20040 FS_ID:28912 EP_NO: 5031 Repair Type: Non-Urgent Crossing Status: Found UCIP Comments: New butterfly valve in CMP riser on waterside slope. New pipe and pump.Needs cleaning and clearing of siphon breaker in CMP on landside.An abandoned 5x5 foot concrete distribution box on landside. Abandoned pipe found on both sides of the levee. FIELD_STRUCT_DESC: 12-inch steel irrigation discharge pipe through the levee at a slight angle, 4.2 feet below the crown. 2-inch conduit through the levee, 2 feet below the crown. Slant pump on a steel platform on the berm. (Slant pump authorized under Permit No. 5031, 1965 - Gladys Johnston and Helen Dixon). Pipe discharges into an irrigation ditch and an abandoned 5-foot by 5-foot concrete distribution box on the landside. (Pipe originally installed in 1950. 12-inch centrifugal irrigation pump and 14-inch, 12-gage welded steel pipe through the levee authorized under Permit No. 1466, 1950 - Estate of Caroline L. Knox. Pipe reinstalled by USACE in 1958). [Additional Reference(s): DWR Levee Log, 2005. USACE Sacramento O&M Manual 128, March 1960, (HLM 4.71)]. FS Date: 1/9/2014

WS view: slant pump and switch panel in shed on levee berm.

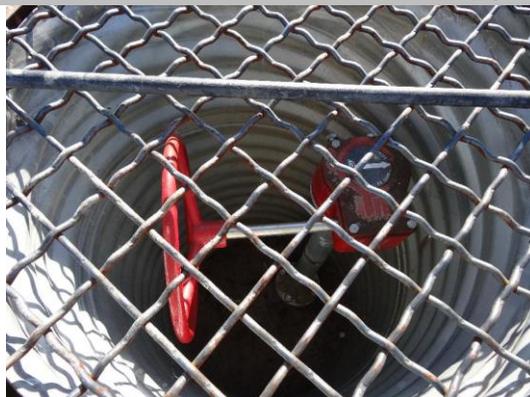
Photo 3 of 3 : UCIP_SP_2020_28912_53179.jpg

WS view: new butterfly valve in CMP on levee shoulder.

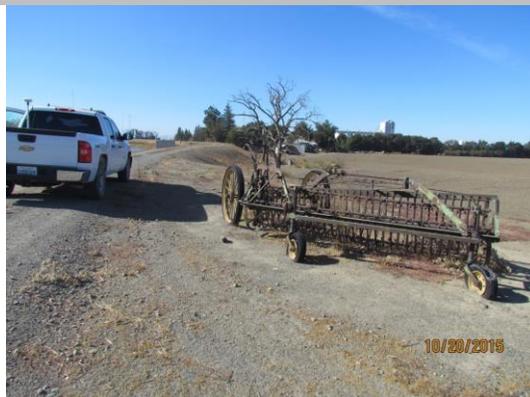
Photo 1 of 1 : SP_2020_RD1500_189_108_20200228_00042.jpg

View of the equipment on the landward side of the levee looking upstream. Fall 2015.

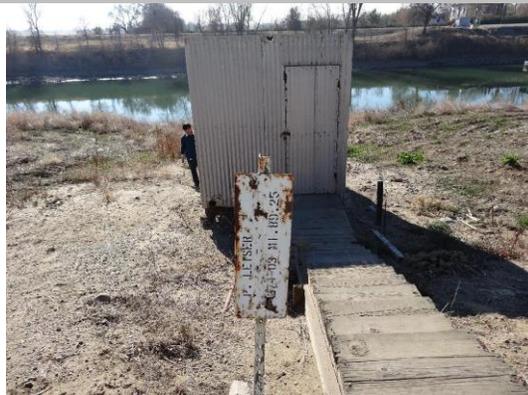
Photo 1 of 3 : UCIP_SP_2020_28913_53184.jpg

Comment Code					
Inspector Comment					
DS_ID:20041 FS_ID:28913 EP_NO: 10056 Repair Type: Non-Urgent Crossing Status: Found UCIP Comments: Depression on landside levee slope around siphon breaker due to leakage. Siphon breaker needs protection. FIELD_STRUCT_DESC: 18-inch steel irrigation discharge pipe through the levee, 4 feet below the crown. 1.5-inch conduit through the levee, 20 feet below the crown. Slant pump in a corrugated metal pump house on the waterside (WS). Wooden steps on the WS slope. Siphon breaker on the landside (LS) slope. 5-foot by 5-foot concrete distribution box at the LS toe. (18-inch steel irrigation discharge pipe and all other elements of this irrigation structure retained under Automatic Board Order (ABO) issued as Permit No. 10056, 1974 - Philip Leiser). [Additional Reference(s): DWR Levee Log, 2005. USACE Sacramento O&M Manual 128, March 1960, (HLM 5.23)]. FS Date: 1/9/2014

WS view: wooden steps to pump house on levee berm.

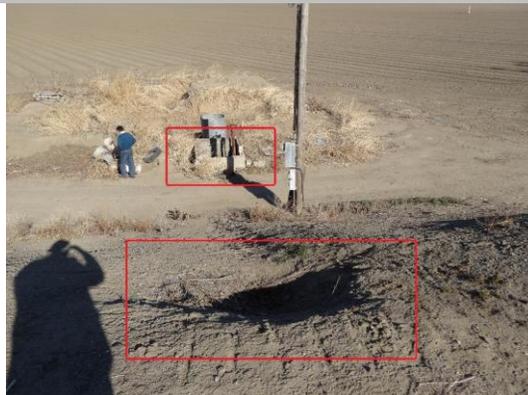
Photo 2 of 3 : UCIP_SP_2020_28913_53183.jpg

LS view: depression on landside levee slope around siphon breaker due to leakage. Concrete distribution box (top) on levee toe.

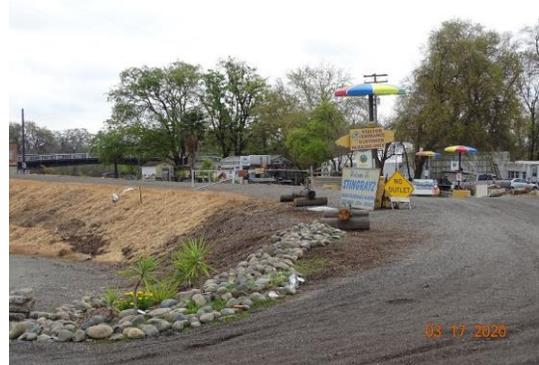
Photo 1 of 1 : SP_2020_RD1500_189_52_20200319_00205.jpg

LM Start	5.61	Rating **	M	Issue No.	52
LM End	5.69	Issue Type +	En	Location *	WS
Category	Earthen Levee		GPS Latitude/Longitude		
			Start	End	
Item	Encroachments		38.803067 °	38.803238 °	
			-121.720270 °	-121.721847 °	
DWR ID	DWR_RD1500_01_s_2012_52				
Comment Code					
EQ : Equipment					
Inspector Comment					
Sting Rayz Beach Boardwalk Marina on the waterside berm should move equipment stored on landside shoulder.

View of the equipment on the landside shoulder. Spring 2020.

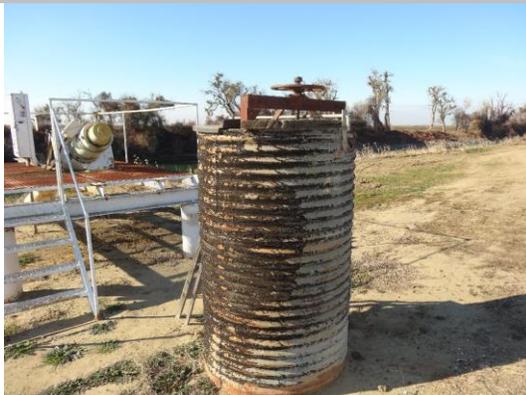
Photo 1 of 2 : UCIP_SP_2020_28286_52059.jpg

Comment Code					
Inspector Comment					
DS_ID:20044 FS_ID:28286 EP_NO: 10074 Repair Type: Non-Urgent Crossing Status: Found UCIP Comments: Not found- 36-inch concrete standpipe on landside. 2-inch conduit through the levee. Pipe description does not match with field observaion. It needs review and more info from LMA. A capped pipe, air vent, and butterfly valve found on landside toe. But, it is not clear whether these belongs to this crossing. FIELD_STRUCT_DESC: 30-inch steel irrigation discharge pipe and electrical conduit through the levee, 13 feet below the crown. Slide gate in a 42-inch corrugated metal pipe (CMP) riser on the berm. Slant pump on steel pump platform on the berm. Installed by USACE in 1959. (30-inch steel irrigation discharge pipe and all other appurtenances retained under Automatic Board Order (ABO) issued as Permit No. 10074, 1974 - T. I. and T. Company). [Additional Reference(s): DWR Levee Log, 2005. USACE Sacramento O&M Manual 128, March 1960, (HLM 6.53)]. FS Date: 1/9/2014

WS view: CMP riser with slide gate and slant pump on steel platform on levee berm.

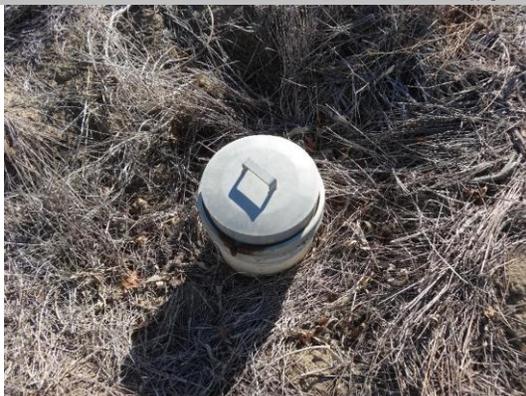
Photo 2 of 2 : UCIP_SP_2020_28286_52058.jpg

LS view: a capped pipe on levee toe. It is not clear whether this pipe is connected to the CMP riser on waterside.

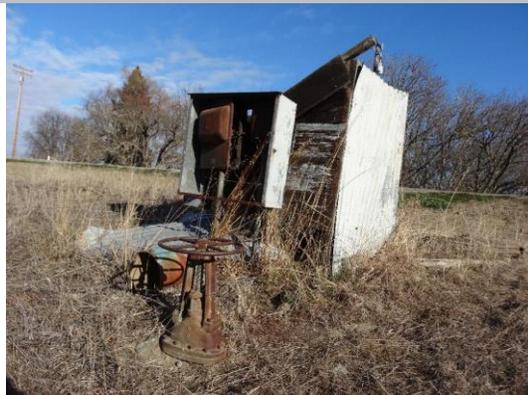
Photo 1 of 3 : UCIP_SP_2020_28923_53202.jpg

Comment Code					
Inspector Comment					
DS_ID:20047 FS_ID:28923 EP_NO: 10048 Repair Type: Non-Urgent Crossing Status: Found UCIP Comments: An abandoned pipe. Highly deteriorated pipe on river bank. Needs proper abandonment. Not found- Siphon breaker at landward levee toe. FIELD_STRUCT_DESC: *ABANDONED* 10-inch steel irrigation discharge pipe and a 1-inch conduit through the levee, 4.5 feet below the crown. Pump in a metal shed on the riverbank. Gate valve on the waterside (WS) end. Service pole and 24-inch concrete standpipe at the landside (LS) toe. Installed by USACE in 1958. (10-inch steel irrigation discharge pipe through the levee and all other appurtenances retained under Automatic Board Order (ABO) issued as Permit No. 10048, 1974 - Virgil J. King) [Additional Reference(s): DWR Levee Log, 2005. USACE Sacramento O&M Manual 128, March 1960, (HLM 7.22)]. FS Date: 1/9/2014

WS view: dilapidated and abandoned CM pump house on berm. Pipe and gate valve also on berm.

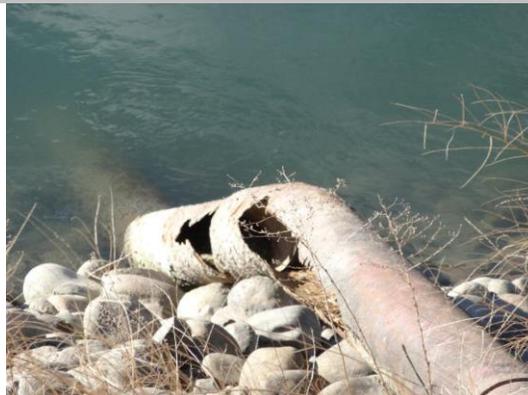
Photo 2 of 3 : UCIP_SP_2020_28923_53201.jpg

WS view: deteriorated and abandoned steel pipe on river bank.

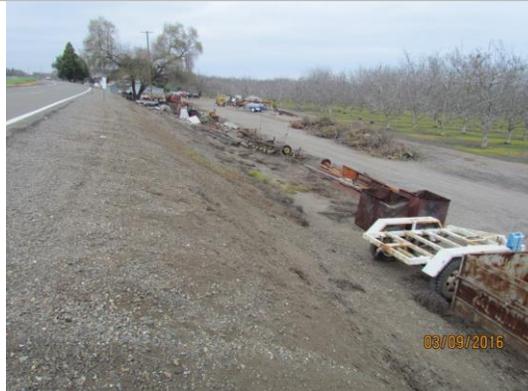
Photo 1 of 1 : SP_2020_RD1500_189_16_20200228_00005.jpg

LM Start	7.47	Rating **	M	Issue No.	16
LM End	7.53	Issue Type +	En	Location *	LS
Category	Earthen Levee		GPS Latitude/Longitude		
			Start	End	
Item	Encroachments		38.828676 °	38.829352 °	
			-121.724168 °	-121.724600 °	
DWR ID	DWR_RD1500_01_f_2017_16				
Comment Code					
EQ : Equipment					
Inspector Comment

View of the equipment along the levee toe on the landward side of the levee looking upstream. Spring 2016.

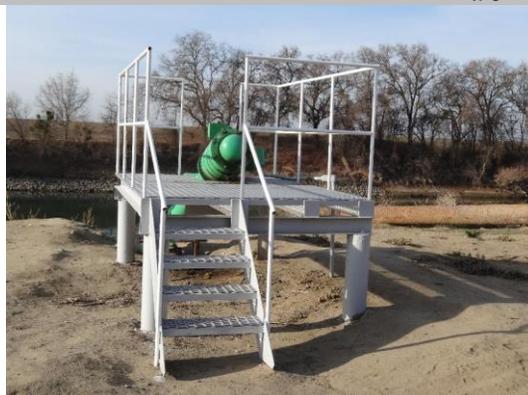
Photo 1 of 3 : UCIP_SP_2020_50199_53204.jpg

WS view: slant pump on steel platform on end of berm.

DS_ID:20049
 FS_ID:50199
 EP_NO: 8147
 Repair Type: Non-Urgent
 Crossing Status: Found
 UCIP Comments: 08/29/2016: New pumps installed at LS toe ditch, could not find permit for this work. No signs of leakage or excessive vegetation growth in alignment with the pipe. Riser silted in; recommend installing a lid. Crossing has been downgraded from Urgent to Non-Urgent. (K. Fazel - UCIP)01/10/2014:Not found- slide gate in 48-inch corrugated metal riser at waterside toe.Repair works under way. Contact LMA for repair works information.Sign of leaky pipe and siphon breaker. This needs detailed investigation. (P. Amatya - DWR) FIELD_STRUCT_DESC: 12-inch steel irrigation discharge pipe through the levee, 4.8 feet below the crown. Slant pump mounted on a steel structure at the riverbank. 4-foot by 4-foot concrete distribution box at the landside (LS) toe with newly installed pumps with shutoff valves. (Replacement of a discharge pipe through the levee with a new 12-inch steel discharge pipe authorized under Permit No. 8147, 1972 - J. A. Driver). [Additional Reference(s): DWR Levee Log, 2005. USACE Sacramento O&M Manual 128, March 1960, (HLM 7.79)].

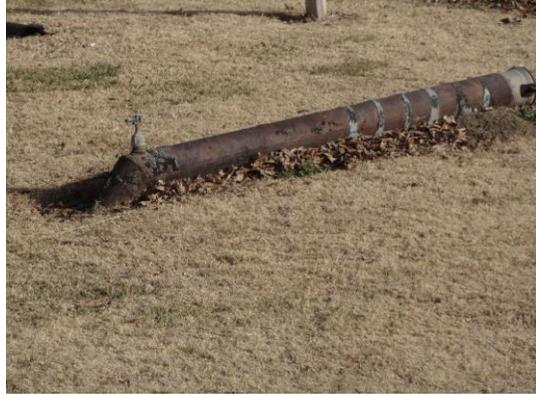
Photo 3 of 3 : UCIP_SP_2020_28323_52123.jpg

LS view: outlet steel pipe across the residential road off the levee toe on field.

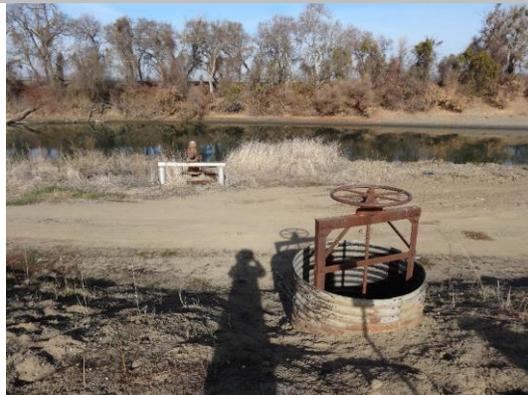
Photo 1 of 3 : UCIP_SP_2020_28324_52131.jpg

Comment Code					
Inspector Comment					
DS_ID:20053 FS_ID:28324 EP_NO: 10064 Repair Type: Non-Urgent Crossing Status: Found UCIP Comments: Looks abandoned as service pole not found. May need proper abandonment. FIELD_STRUCT_DESC: 24-inch by 24-inch concrete box irrigation discharge culvert through the levee, 13 feet below the crown. Two concrete cutoff walls. Pump on a 6-foot-diameter concrete pump well on the berm. Slide gate in a 42-inch corrugated metal pipe (CMP) riser on the waterside (WS) slope. 4.5-foot by 6-foot concrete distribution box at the landside (LS) toe. Installed by Reclamation District No. 1500 in 1920. Improvements made by USACE in 1955. (24-inch by 24-inch concrete box irrigation discharge culvert through the levee and all other appurtenances retained under Automatic Board Order (ABO) issued as Permit No. 10064, 1974 - Paul Donald Nix). [Additional Reference(s): DWR Levee Log, 2005. USACE Sacramento O&M Manual 128, March 1960, (HLM 8.44), 36-inch pipe referenced]. FS Date: 1/10/2014

WS view: slide gate in CMP riser on levee slope. Looks abandoned.

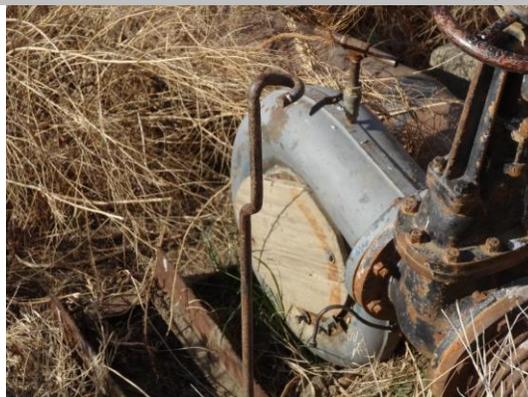
Photo 2 of 3 : UCIP_SP_2020_28343_52144.jpg

WS view: pipe, pump (removed and capped with plywood), and gate valve on river bank.

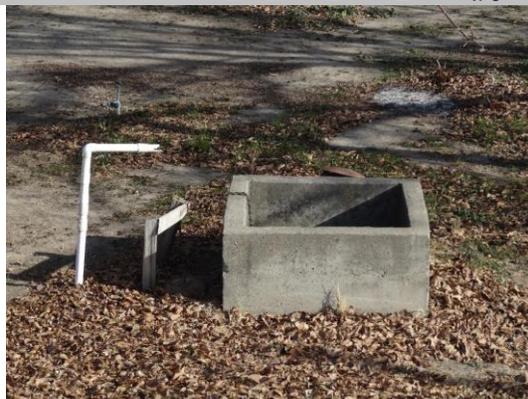
Photo 3 of 3 : UCIP_SP_2020_28343_52143.jpg

LS view: concrete distribution box on landside toe.

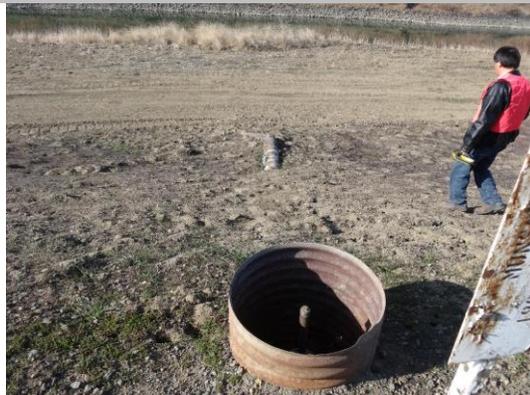
Photo 1 of 3 : UCIP_SP_2020_28363_52167.jpg

Comment Code					
Inspector Comment					
DS_ID:20055 FS_ID:28363 EP_NO: 8503 Repair Type: Non-Urgent Crossing Status: Found UCIP Comments: Looks abandoned. No pump found on WS. New well near landside. May need proper abandonment. Exposed pipe on waterside. Found steel plate closed pipe on landside. FIELD_STRUCT_DESC: *ABANDONED* 12-inch steel irrigation discharge pipe through the levee, 3.8 feet below the crown. Pump on concrete pad with headwall at the riverbank. Siphon breaker in a 24-inch corrugated metal pipe (CMP) riser on the waterside (WS) slope. 1.25-inch conduit through the levee, 3 feet below the crown. Meter pole with switch panel at the landside (LS) toe. Concrete distribution box at the LS toe. (12-inch steel irrigation discharge pipe through the levee and slant pump retained under Permit No. 8503, 1972 - James T. Munson). [Additional Reference(s): DWR Levee Log, 2005. USACE Sacramento O&M Manual 128, March 1960, (HLM 9.04), 10-inch pipe referenced]. FS Date: 1/10/2014

WS view: siphon breaker in CMP riser on levee slope.

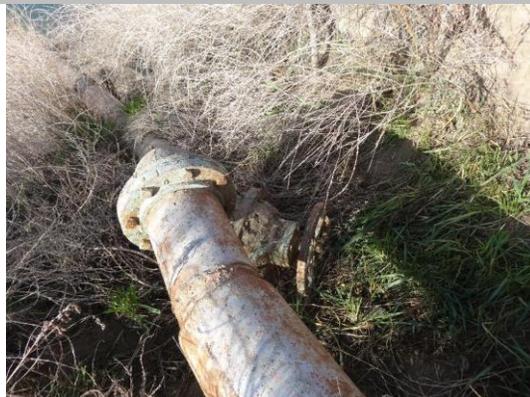
Photo 2 of 3 : UCIP_SP_2020_28363_52166.jpg

WS view: inlet steel pipe with gate valve on river bank.

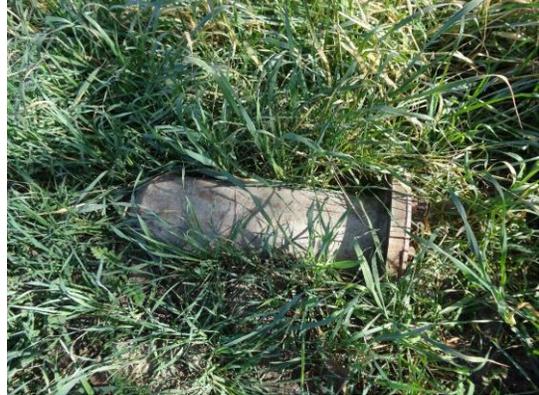
Photo 3 of 3 : UCIP_SP_2020_28363_52165.jpg

LS view: pipe end capped with steel plate on levee toe. Looks abandoned.

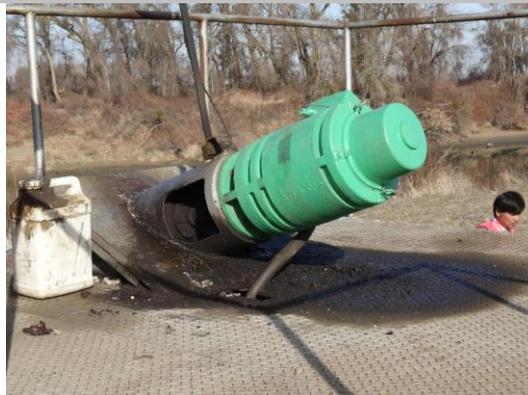
Photo 1 of 3 : UCIP_SP_2020_28364_52174.jpg

Comment Code					
Inspector Comment					
DS_ID:20056 FS_ID:28364 EP_NO: 5598 Repair Type: Non-Urgent Crossing Status: Found UCIP Comments: Not found- Wood headwall 18 ft from landward toe. Not found- Flap gate on landward side.No outlet structure found. Only a capped pipe found, but not sure whether it is connected to the crossing. FIELD_STRUCT_DESC: 12-inch steel irrigation discharge pipe and electrical conduit through the levee, 4.8 feet below the crown. One metal cutoff wall. Slant pump on steel structure on the berm. Siphon breaker in an 8.5-inch steel pipe riser on the landside (LS) shoulder. Meter pole on the LS toe. Wooden headwall with flap gate off the LS toe. Pipe discharges into field. Installed in 1967. (Construction of a pumping plant and installation of a discharge pipe through the levee authorized under Permit No. 5598, 1966 - Arthur C. James Jr. Existing encroachments retained under Permit No. 8505, 1972 - Arthur C. James Jr.). [Additional Reference(s): DWR Levee Log, 2005]. FS Date: 1/10/2014

WS view: slant pump on steel platform on levee berm. Excessive oil leak from the pump.

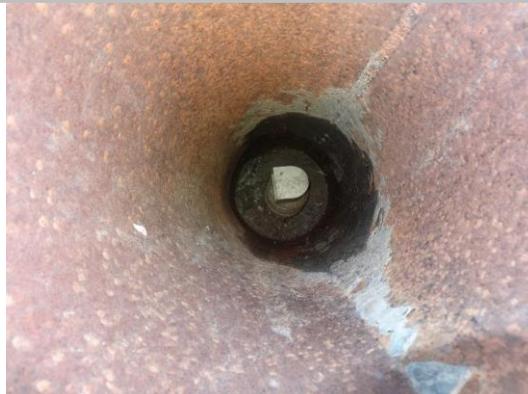
Photo 2 of 3 : UCIP_SP_2020_28364_52175.jpg

LS view: air vent in steel pipe riser on levee slope.

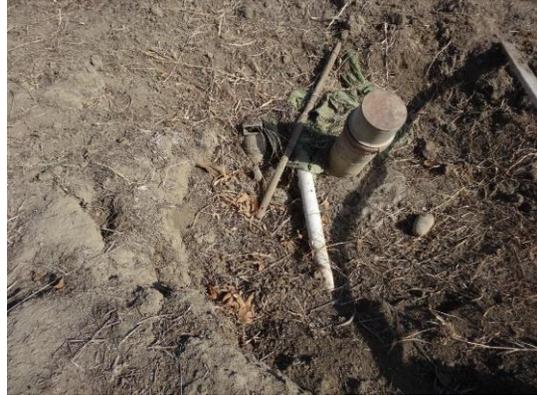
Photo 3 of 3 : UCIP_SP_2020_28364_52173.jpg

LS view: capped outlet pipe on levee toe.

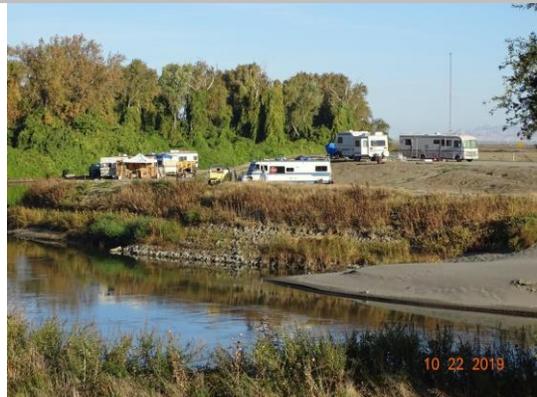
Photo 1 of 2 : SP_2020_RD1500_189_137_20200319_00202.jpg

LM Start	9.26	Rating **	U	Issue No.	137
LM End	9.83	Issue Type +	En	Location *	WS
Category	Earthen Levee			GPS Latitude/Longitude	
				Start	End
Item	Encroachments			38.849020 °	38.853750 °
				-121.725142 °	-121.727530 °
DWR ID	DWR_RD1500_01_s_2020_137				
Comment Code					
UR : Urban					
Inspector Comment					
Large stretch of campers on the waterside berm.

View of the campers on the waterside berm. Fall 2019.

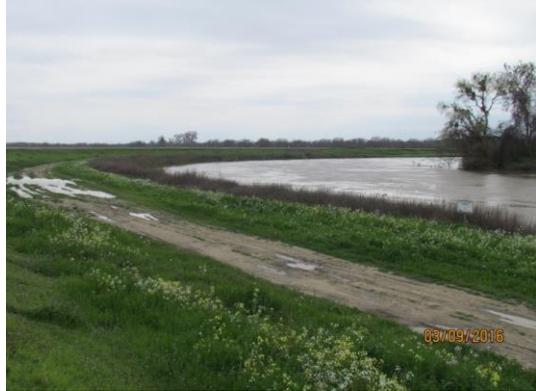
Photo 1 of 2 : SP_2020_RD1500_189_74_20200228_00027.jpg

LM Start	9.40	Rating **	A/W	Issue No.	74
LM End	9.57	Issue Type +	Ob	Location *	WS
Category	Earthen Levee		GPS Latitude/Longitude		
			Start	End	
Item	Vegetation		38.850267 °	38.852564 °	
			-121.723275 °	-121.723179 °	
DWR ID	DWR_RD1500_01_s_2012_74				
Comment Code					
V8 : Environmental Requirements.					
Inspector Comment

View of the revegetation site along the edge of the berm on the waterward side of the levee looking downstream. Spring 2016.

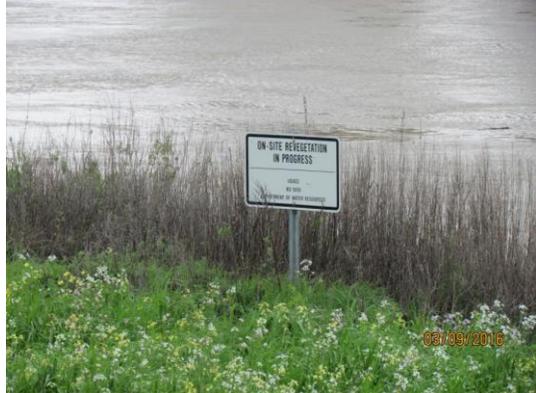
Photo 2 of 2 : SP_2020_RD1500_189_74_20200228_00028.jpg

Sign for the revegetation site by USACE.

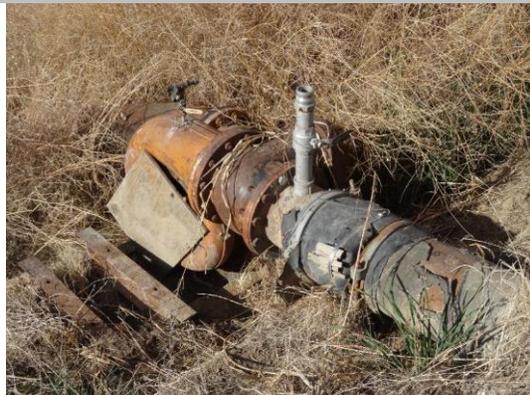
Photo 1 of 3 : UCIP_SP_2020_50069_52188.jpg

Comment Code					
Inspector Comment					
DS_ID:20058 FS_ID:50069 EP_NO: 10068 Repair Type: Non-Urgent Crossing Status: Found UCIP Comments: 01/10/2014Surface erosion along pipe alignment on landside.30-inch concrete pipe in CMP riser on waterside. 30-inch x 24-inch concrete culvert on landside. FIELD_STRUCT_DESC: 24-inch by 30-inch reinforced concrete box irrigation discharge culvert diagonally through the levee, 13 feet below the crown. Two concrete cutoff walls. Slant pump on the riverbank. Slide gate in a 40-inch by 40-inch concrete surge box on the berm. Power pole and switch panel on the waterside (WS) slope. Concrete distribution box at the landside (LS) toe. Installed by Reclamation District No. 1500 in 1920. (24-inch by 30-inch reinforced concrete box irrigation discharge culvert diagonally through the levee, slant pump, and all other appurtenances retained under Automatic Board Order (ABO) issued as Permit No. 10068, 1974 - Cecil Reel). [Additional Reference(s): DWR Levee Log, 2005. USACE Sacramento O&M Manual 128, March 1960, (HLM 10.22)]. FS Date: 1/10/2014

WS view: pipe and pump with appurtenances on river bank. Pump removed and plugged with plywood.

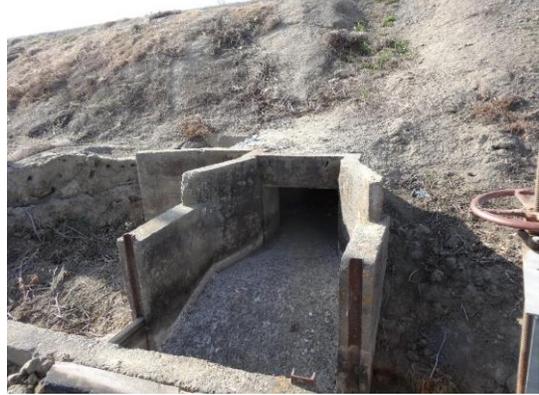
Photo 3 of 3 : UCIP_SP_2020_50069_52192.jpg

LS view: outlet of concrete box culvert on levee toe.

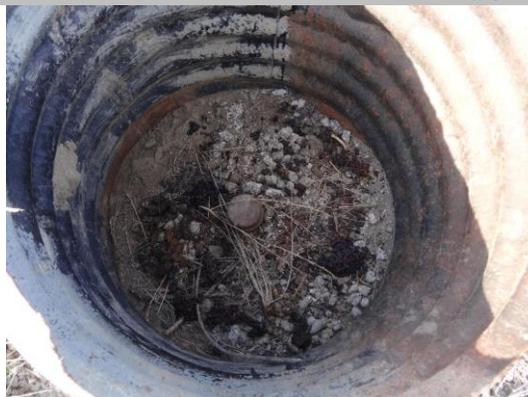
Photo 3 of 3 : UCIP_SP_2020_28925_53208.jpg

LS view: obstructed siphon breaker in CMP riser (bottom) on levee slope.

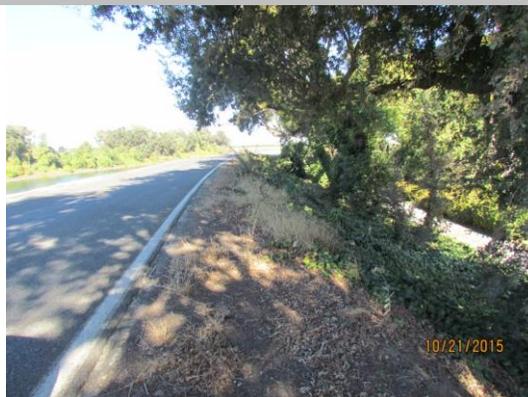
Photo 1 of 1 : SP_2020_RD1500_189_20_20200228_00007.jpg

LM Start	11.30	Rating **	M	Issue No.	20
LM End	11.30	Issue Type +	En	Location *	LS
Category	Earthen Levee			GPS Latitude/Longitude	
				Start	End
Item	Vegetation			38.866383 °	38.866383 °
				-121.745911 °	-121.745911 °
DWR ID	DWR_RD1500_01_s_2020_20				
Comment Code					
V6 : Landscaping					
Inspector Comment					
Permitted landscape needs maintenance. (PN: 10041)

View of the landscaping on the landward side of the levee looking upstream. Fall 2015.

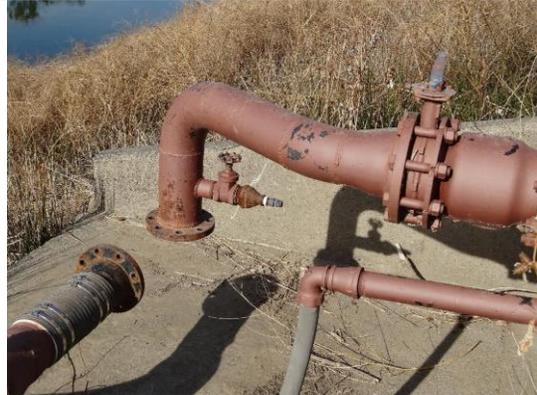
Photo 1 of 3 : UCIP_SP_2020_50198_52220.jpg

Comment Code					
Inspector Comment					
DS_ID:20061 FS_ID:50198 EP_NO: 10041 Repair Type: Non-Urgent Crossing Status: Found UCIP Comments: 08/29/2016 Depressions cited previously are a make-shift staircase and not an indication of a problem with pipe. Pipe partiallay exposed on LS slope which should be backfilled. Crossing has been downgraded from Urgent to Non-Urgent. (K. Fazel - UCIP)01/10/2014 Depressions on both sides of the levee slope. It needs more investigation.Pump removed. (P. Amatya - DWR) FIELD_STRUCT_DESC: 8-inch steel irrigation discharge pipe through the levee, 4 feet below the crown. One corrugated metal cutoff wall. Pump and gate valve on a concrete pump platform on the riverbank. Corrugated metal switch house on the waterside (WS) slope. Meter pole on the WS shoulder. 8-foot by 6-foot, inside dimensions, concrete distribution box on the landside (LS). Overhead power line crosses the levee. Pole at the LS toe. Installed by USACE in 1952. (8-inch steel irrigation discharge pipe through the levee, pump, and all other appurtenances retained under Automatic Board Order (ABO) issued as Permit No. 10041, 1974 - William J. Duffy Jr.) [Additional Reference(s): DWR Levee Log, 2005. USACE Sacramento O&M Manual 128, March 1960, (HLM 11.57)]. FS Date: 8/29/2016

WS view: pipe, pump (removed), headwall, and appurtenances on river bank.

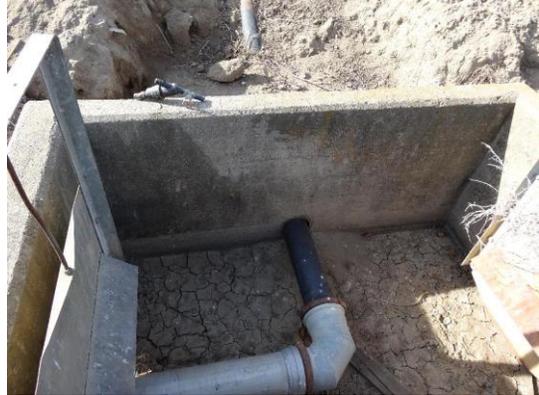
Photo 3 of 3 : UCIP_SP_2020_50198_52221.jpg

LS view: concrete distribution box on levee toe. Exposed pipe and depression (top) visible on levee slope.

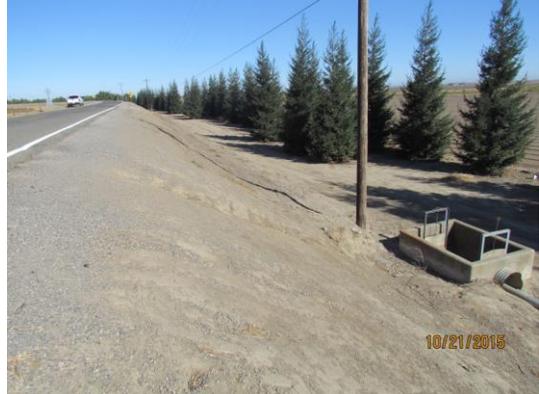
Photo 1 of 3 : SP_2020_RD1500_189_114_20200228_00043.jpg

LM Start	11.45	Rating **	M	Issue No.	114
LM End	11.45	Issue Type +	En	Location *	LS
Category	Earthen Levee			GPS Latitude/Longitude	
				Start	End
Item	Encroachments			38.868577 °	38.868577 °
				-121.746487 °	-121.746487 °
DWR ID	DWR_RD1500_01_f_2015_114				
Comment Code					
ST : Stairway					
Inspector Comment					
Landowner has dug stairs on the landside slope to irrigation equipment.

Perspective view of the concrete box on the landward side of the levee looking upstream. Fall 2015.

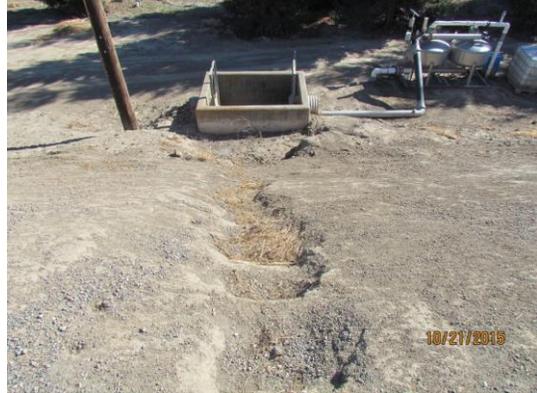
Photo 2 of 3 : SP_2020_RD1500_189_114_20200228_00044.jpg

There is erosion at the levee toe around the concrete box. There are also stairs leading down the slope. Fall 2015.

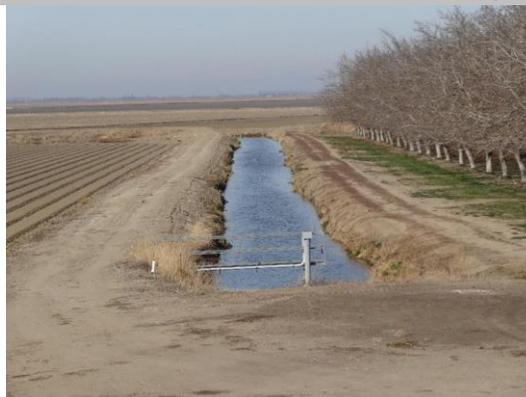
Photo 3 of 3 : UCIP_SP_2020_41744_51344.jpg

LS view: overview of irrigation ditch on toe of levee.

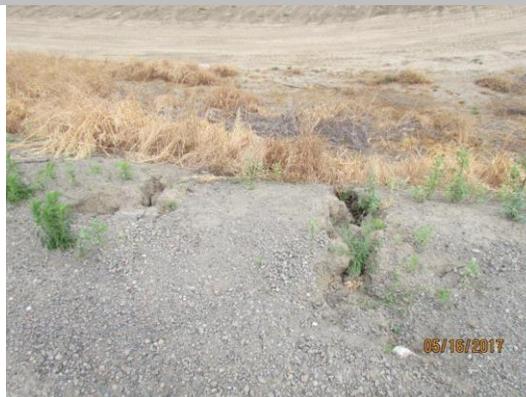
Photo 1 of 1 : SP_2020_RD1500_189_116_20200228_00046.jpg

LM Start	12.01	Rating **	M	Issue No.	116
LM End	12.01	Issue Type +	Ma	Location *	LS
Category	Earthen Levee			GPS Latitude/Longitude	
				Start	End
Item	Erosion / Bank Caving			38.870730 °	38.870730 °
				-121.752908 °	-121.752908 °
DWR ID	DWR_RD1500_01_s_2017_116				
Comment Code					
E2 : Schedule repair of erosion site prior to the next inspection.					
Inspector Comment					
There is runoff erosion on the landside levee slope.

View of erosion on landside slope. Spring 2017.

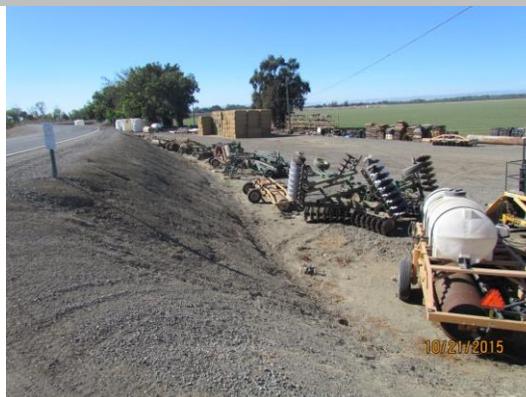
Photo 1 of 1 : SP_2020_RD1500_189_24_20200228_00008.jpg

LM Start	12.42	Rating **	M	Issue No.	24
LM End	12.53	Issue Type +	En	Location *	LS
Category	Earthen Levee			GPS Latitude/Longitude	
				Start	End
Item	Encroachments			38.868834 °	38.867492 °
				-121.760014 °	-121.760903 °
DWR ID	DWR_RD1500_01_s_2012_24				
Comment Code					
EQ : Equipment					
Inspector Comment

View of the equipment on the landward side of the levee looking upstream. Fall 2015.

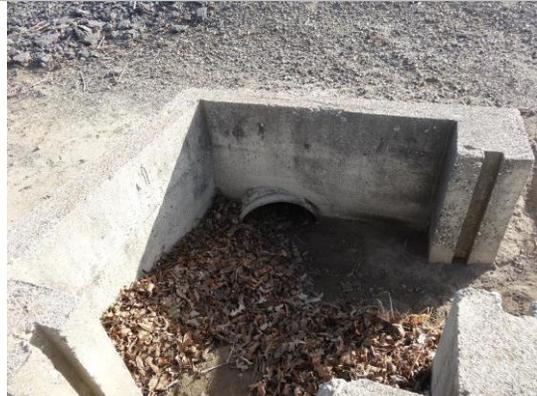
Photo 2 of 3 : UCIP_SP_2020_50197_52424.jpg

Comment Code					
Inspector Comment					
DS_ID:20063 FS_ID:50197 EP_NO: 10061 Repair Type: Non-Urgent Crossing Status: Found UCIP Comments: 08/29/2016 Same as last inspection. (K. FAZel - UCIP)01/10/2014 Needs proper abandonment. (P. Amatya - DWR) FIELD_STRUCT_DESC: *ABANDONED* 18-inch corrugated metal gravity drainage pipe through the levee, 15 feet below the crown. Slide gate in a 4-foot by 4-foot concrete box at the waterside (WS) toe. Concrete box at the landside (LS) toe. Pipe crosses overflow area to the river. Installed by USACE in 1944. (18-inch corrugated metal gravity drainage pipe through the levee and all other appurtenances retained under Automatic Board Order (ABO) issued as Permit No. 10061, 1974 - Roger L. Matteoli). [Additional Reference(s): DWR Levee Log, 2005. USACE Sacramento O&M Manual 128, March 1960, (HLM 12.69)]. FS Date: 8/29/2016

LS view: concrete intake box on levee toe.

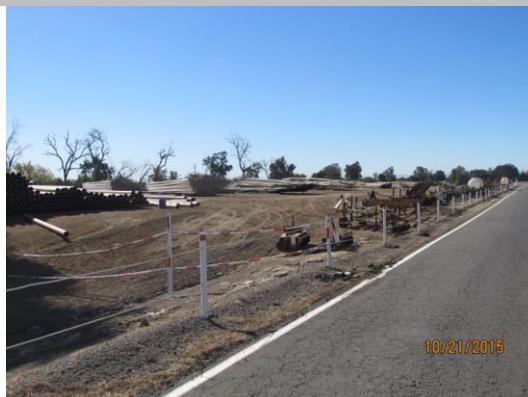
Photo 1 of 1 : SP_2020_RD1500_189_25_20200228_00009.jpg

LM Start	12.78	Rating **	M	Issue No.	25
LM End	12.86	Issue Type +	En	Location *	WS
Category	Earthen Levee			GPS Latitude/Longitude	
				Start	End
Item	Encroachments			38.865429 °	38.864777 °
				-121.764684 °	-121.765857 °
DWR ID	DWR_RD1500_01_s_2012_25				
Comment Code					
EQ : Equipment					
Inspector Comment

View of the equipment on the waterside shoulder of the levee looking upstream. Fall 2015.

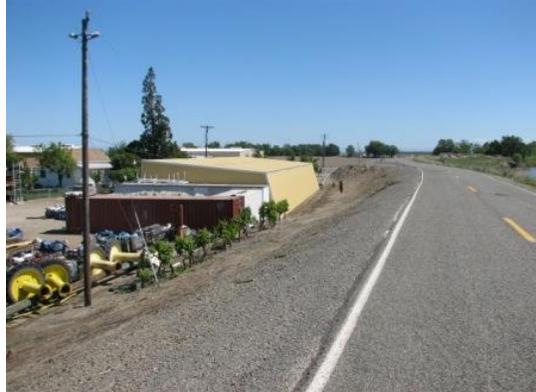
Photo 1 of 1 : SP_2020_RD1500_189_26_20200228_00010.jpg

LM Start	13.01	Rating **	M	Issue No.	26
LM End	13.01	Issue Type +	En	Location *	LS
Category	Earthen Levee			GPS Latitude/Longitude	
				Start	End
Item	Encroachments			38.863438 °	38.863438 °
				-121.768212 °	-121.768212 °
DWR ID	DWR_RD1500_01_s_2019_26				
Comment Code					
BU : Building					
Inspector Comment

The building's backside was built into the toe of the levee.

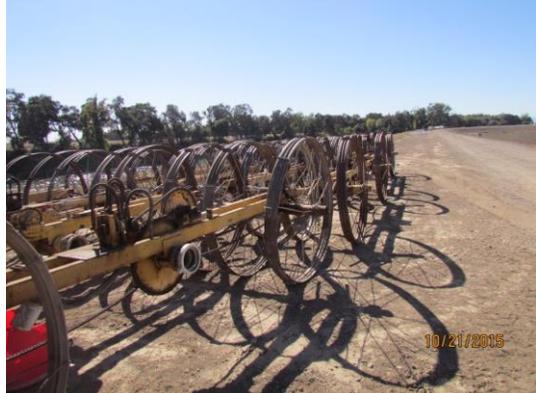
Photo 1 of 1 : SP_2020_RD1500_189_119_20200228_00048.jpg

LM Start	13.78	Rating **	M	Issue No.	119
LM End	13.82	Issue Type +	En	Location *	WS
Category	Earthen Levee			GPS Latitude/Longitude	
				Start	End
Item	Encroachments			38.859679 °	38.859201 °
				-121.780862 °	-121.781276 °
DWR ID	DWR_RD1500_01_f_2015_119				
Comment Code					
EQ : Equipment					
Inspector Comment

View of the equipment on the crown of the levee looking upstream. Fall 2015.

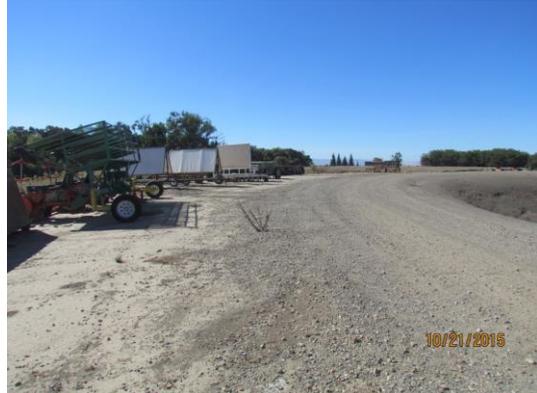
Photo 1 of 1 : SP_2020_RD1500_189_28_20200228_00011.jpg

LM Start	13.96	Rating **	M	Issue No.	28
LM End	13.96	Issue Type +	En	Location *	WS
Category	Earthen Levee		GPS Latitude/Longitude		
			Start	End	
Item	Encroachments		38.857625 °	38.857625 °	
			-121.782832 °	-121.782832 °	
DWR ID	DWR_RD1500_01_s_2012_28				
Comment Code					
EQ : Equipment					
Inspector Comment					
Equipment are on the waterside shoulder but does not obstruct access.

View of the equipment on the crown side of the levee looking upstream. Fall 2015.

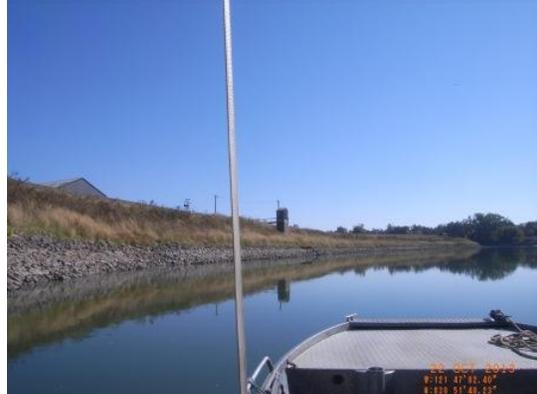
Photo 1 of 1 : SP_2020_RD1500_189_89_20200228_00035.jpg

LM Start	13.98	Rating **	A/W	Issue No.	89
LM End	14.28	Issue Type +	Ma	Location *	WS
Category	Supplemental		GPS Latitude/Longitude		
			Start	End	
Item	2017 USACE Erosion Survey		38.857239 °	38.861899 °	
			-121.783771 °	-121.784057 °	
DWR ID	DWR_RD1500_01_f_2018_89				
Comment Code					
Inspector Comment					
2017 Site ID: SAC 99.0 L Status: Eroding 2017 Field Notes: Rock continues to unravel. Site History: 1997 - Intermittent toe failure of the hand placed riprap; failure of toe materials.

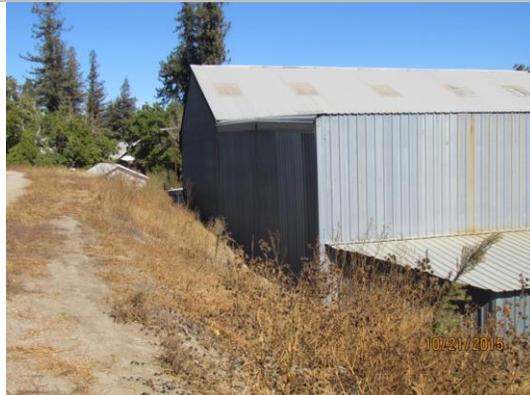
Photo 1 of 1 : SP_2020_RD1500_189_30_20200228_00012.jpg

LM Start	14.19	Rating **	M	Issue No.	30
LM End	14.19	Issue Type +	En	Location *	LS
Category	Earthen Levee			GPS Latitude/Longitude	
				Start	End
Item	Encroachments			38.860624 °	38.860624 °
				-121.783324 °	-121.783324 °
DWR ID	DWR_RD1500_01_s_2012_30				
Comment Code					
BU : Building					
Inspector Comment					
Concrete stemwall into levee embankment.

View of the building on the landward side of the levee looking upstream. Fall 2015.

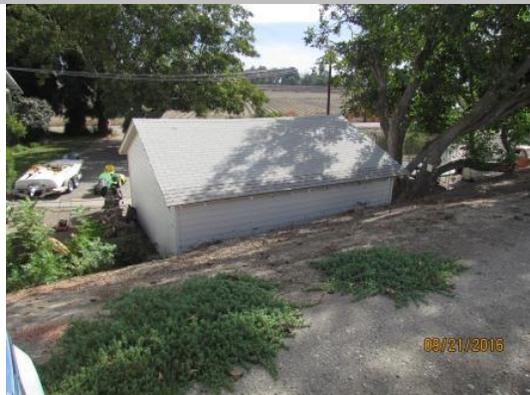
Photo 1 of 1 : SP_2020_RD1500_189_138_20200228_00056.jpg

LM Start	14.21	Rating **	M	Issue No.	138
LM End	14.21	Issue Type +	En	Location *	LS
Category	Earthen Levee			GPS Latitude/Longitude	
				Start	End
Item	Encroachments			38.860951 °	38.860951 °
				-121.783422 °	-121.783422 °
DWR ID	DWR_RD1500_01_f_2016_138				
Comment Code					
BU : Building					
Inspector Comment

View of a building encroaching the levee on landside toe. Fall 2016.

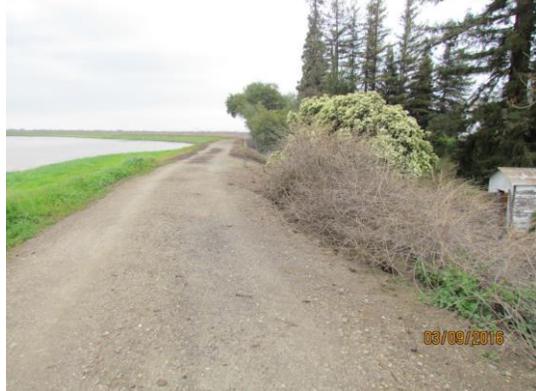
Photo 1 of 1 : SP_2020_RD1500_189_31_20200228_00013.jpg

LM Start	14.24	Rating **	M	Issue No.	31
LM End	14.25	Issue Type +	En	Location *	LS
Category	Earthen Levee		GPS Latitude/Longitude		
			Start	End	
Item	Vegetation		38.861335 °	38.861385 °	
			-121.783605 °	-121.783621 °	
DWR ID	DWR_RD1500_01_s_2012_31				
	Comment Code				
	V6 : Landscaping				
	Inspector Comment

View of the landscaping on the landward side of the levee looking upstream. Spring 2016.

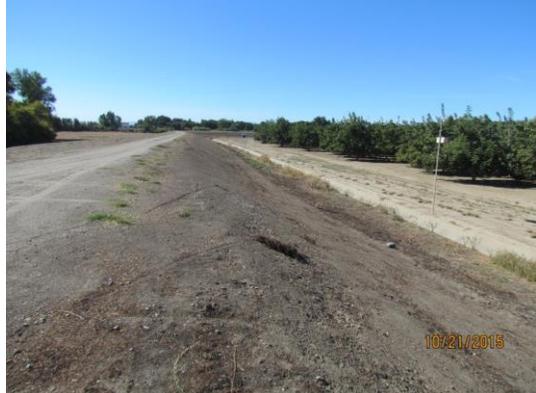
Photo 1 of 1 : SP_2020_RD1500_189_969_20200228_00061.jpg

LM Start	14.71	Rating **	M	Issue No.	969
LM End	15.76	Issue Type +	En	Location *	LS
Category	Earthen Levee		GPS Latitude/Longitude		
			Start	End	
Item	Encroachments		38.865395 °	38.871827 °	
			-121.789402 °	-121.804158 °	
DWR ID	DWR_RD1500_01_s_2012_969				
	Comment Code				
	DT : Ditch				
	Inspector Comment				
	There is a ditch at the levee toe.

View of the ditch on the landward side of the levee looking upstream. Fall 2015.
