**Flood Control Project Maintenance
Levee Inspections**
LMA District Cover Sheet
Spring 2020 Levee Inspection Results

Reclamation District No. 1500 Sutter Basin

Spring 2020 Levee Inspection Results

Waterway	Bank	Unit Miles
Unit No. 01 Sacramento River	Left	33.15

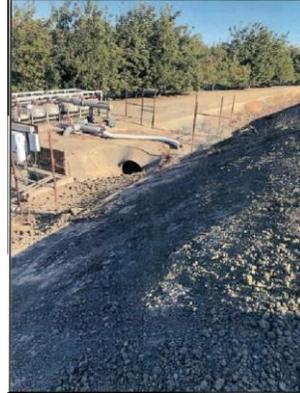
Photo 2 of 3 : UCIP_SP_2020_56135_83383.jpg

Completed landside levee slope. Photo courtesy MBK

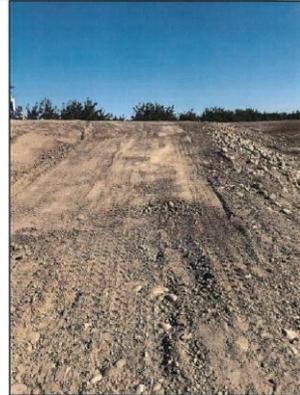
Photo 3 of 3 : UCIP_SP_2020_56135_83384.jpg

Completed waterside ramp and levee slope. Photo courtesy MBK

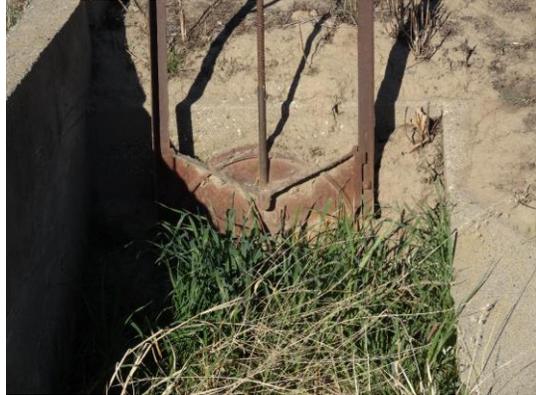
Photo 3 of 3 : UCIP_SP_2020_28489_52477.jpg

LS view: U type concrete headwall with slide gate on levee toe.

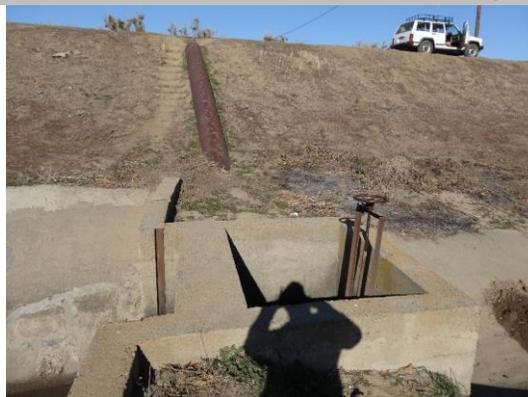
Photo 3 of 3 : UCIP_SP_2020_28490_52483.jpg

LS view: exposed pipe on levee slope, and concrete distribution box on levee toe.

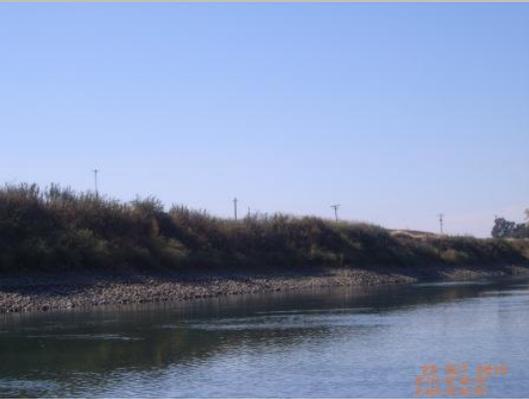
Photo 1 of 1 : SP_2020_RD1500_189_80_20200228_00029.jpg

LM Start	18.38	Rating **	A/W	Issue No.	80
LM End	19.06	Issue Type +	Ma	Location *	WS
Category	Supplemental			GPS Latitude/Longitude	
				Start	End
Item	2017 USACE Erosion Survey			38.901337 °	38.902721 °
				-121.801175 °	-121.790677 °
DWR ID	DWR_RD1500_01_f_2018_80				
Comment Code					
Inspector Comment					
2017 Site ID: SAC 104.0 L Status: Eroding 2017 Field Notes: Bank slope is relatively stable. Site History: 1997 - Pocket failures of cobble revetment toe; scallops of rock loss along the bank; irregular bankline developing. 2001 - Small scallops in the toe of the berm. 2005 - Still multiple erosion pockets in the toe. 2006 - Two new small slumps. 2011 - Old cobble continue to fail causing minor slumping. 2012 - Portions of site appears to be stabilizing. 2016- Cobble revetment continues to fail.

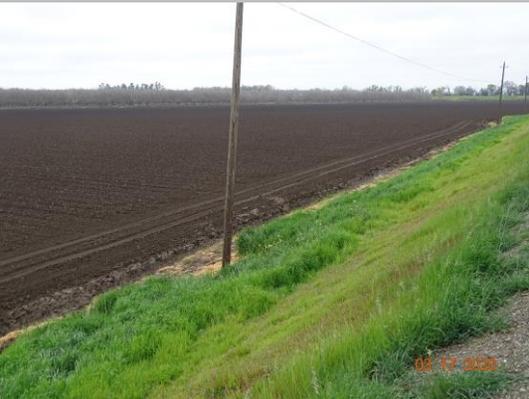
Photo 1 of 1 : SP_2020_RD1500_189_60_20200319_00201.jpg

LM Start	18.40	Rating **	M	Issue No.	60
LM End	18.85	Issue Type +	En	Location *	LS
Category	Earthen Levee			GPS Latitude/Longitude	
				Start	End
Item	Encroachments			38.900986 °	38.900279 °
				-121.800993 °	-121.792889 °
DWR ID	DWR_RD1500_01_s_2020_60				
Comment Code					
DT : Ditch					
Inspector Comment					
Irrigation ditch within the landside easement.

View of the ditch at the landside toe. Spring 2020.

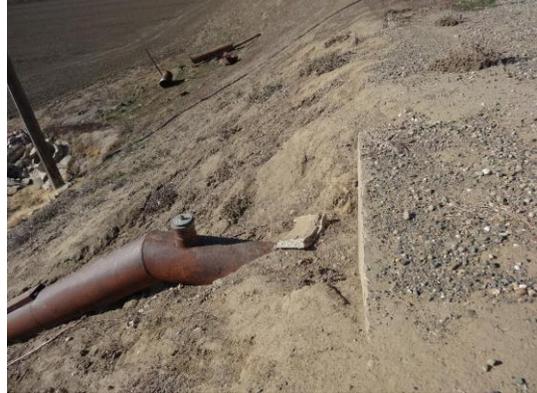
Photo 3 of 3 : UCIP_SP_2020_28505_52515.jpg

LM Start	18.40	Rating **	M	Issue No.	2576 (cont)
LM End	18.40	Issue Type +	En	Location *	
Category	Supplemental			GPS Latitude/Longitude	
				Start	End
Item	DWR UCIP Field Study			38.900885 °	38.900885 °
				-121.800999 °	-121.800999 °
DWR ID	20068

LS view: siphon breaker (left) on exposed steel pipe on levee slope. Concrete pad (right) on levee shoulder.

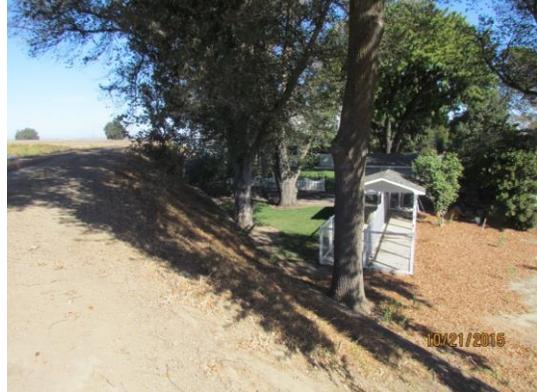
Photo 1 of 1 : SP_2020_RD1500_189_36_20200228_00014.jpg

LM Start	18.98	Rating **	M	Issue No.	36
LM End	18.98	Issue Type +	En	Location *	LS
Category	Earthen Levee			GPS Latitude/Longitude	
				Start	End
Item	Encroachments			38.901570 °	38.901570 °
				-121.791235 °	-121.791235 °
DWR ID	DWR_RD1500_01_s_2012_36				
Comment Code					
BU : Building					
Inspector Comment					
Building and concrete retaining wall are located at the toe of landside levee. The retaining wall is permitted (Permit #10065) but the building is not.

View of the building on the landward side of the levee looking upstream. Fall 2015.

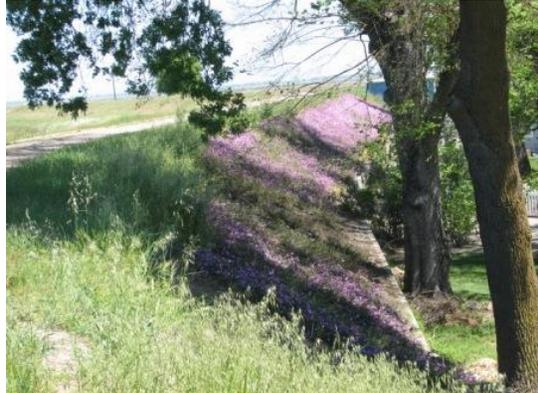
Photo 1 of 2 : SP_2020_RD1500_189_37_20200228_00015.jpg

LM Start	18.98	Rating **	M	Issue No.	37
LM End	19.06	Issue Type +	En	Location *	LS
Category	Earthen Levee		GPS Latitude/Longitude		
			Start	End	
Item	Vegetation		38.901659 °	38.902528 °	
			-121.791264 °	-121.790434 °	
DWR ID	DWR_RD1500_01_s_2012_37				
Comment Code					
V6 : Landscaping					
Inspector Comment					
The groundcover is on the levee slope above the concrete retaining wall. The groundcover is irrigated.

View of the groundcover on the levee slope above the concrete retaining wall.

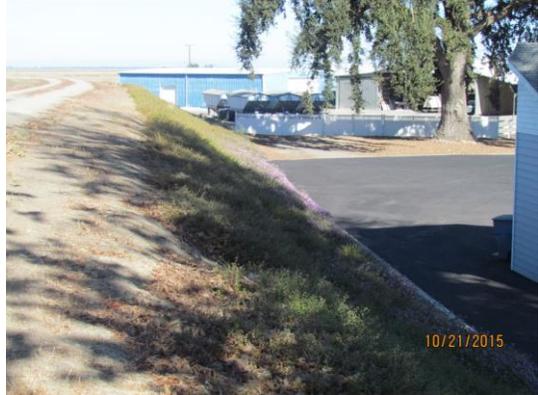
Photo 2 of 2 : SP_2020_RD1500_189_37_20200228_00016.jpg

View of the groundcover on the landward side of the levee looking upstream. Fall 2015.

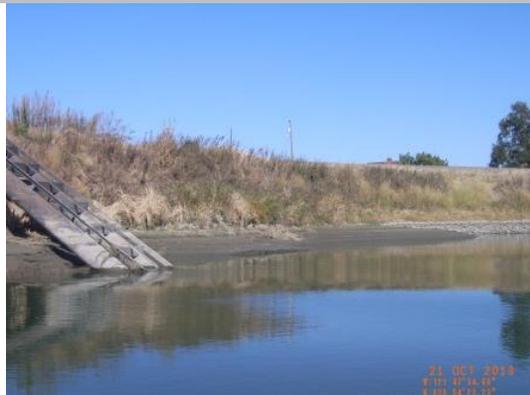
Photo 1 of 1 : SP_2020_RD1500_189_81_20200228_00030.jpg

LM Start	19.16	Rating **	A/W	Issue No.	81
LM End	19.47	Issue Type +	Ma	Location *	WS
Category	Supplemental		GPS Latitude/Longitude		
			Start	End	
Item	2017 USACE Erosion Survey		38.904041 °	38.906697 °	
			-121.790298 °	-121.792796 °	
DWR ID	DWR_RD1500_01_f_2018_81				
Comment Code					
Inspector Comment					
2017 Site ID: SAC 104.5 L Status: Eroding 2017 Field Notes: Site appears stable. Site History: 1997 - Cobbles eroded off the clay materials; not much evidence of erosion on the toe; cobble loss on the toe. 2011 - Some minor new erosion.

USACE 2013 Photo #1

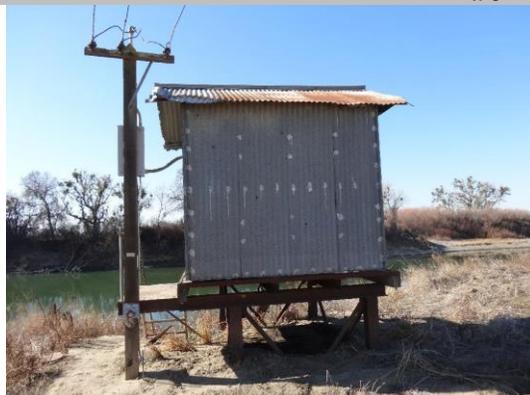
Photo 1 of 3 : UCIP_SP_2020_28506_52523.jpg

Comment Code					
Inspector Comment					
DS_ID:20087 FS_ID:28506 EP_NO: 550 Repair Type: Non-Urgent Crossing Status: Found UCIP Comments: Surface erosion on landside slope. Oil leaks from the pump. FIELD_STRUCT_DESC: 14-inch coated steel irrigation discharge pipe through the levee, 4.8 feet below the crown. Two concrete cutoff walls. Slant pump and gate valve in a corrugated metal pump house on a steel structure on the berm. Water meter installed on the pipe on the waterside (WS) slope. Screw gate at the landside (LS) end. Concrete distribution box on the LS. (Installation of a pump and a 14-inch steel discharge pipe through the levee authorized under Permit No. 550, 1931 - P. J. Hiatt. Replacement of a failing 14-inch pipe with the same size pipe through the levee authorized under Permit No. 17648, 2003 - Van Ruiten Brothers). [Additional Reference(s): DWR Levee Log, 1993. USACE Sacramento O&M Manual 128, March 1960, (HLM 19.44)]. FS Date: 1/14/2014

WS view: slant pump in CM shed on levee berm. Oil leaks from the pump.

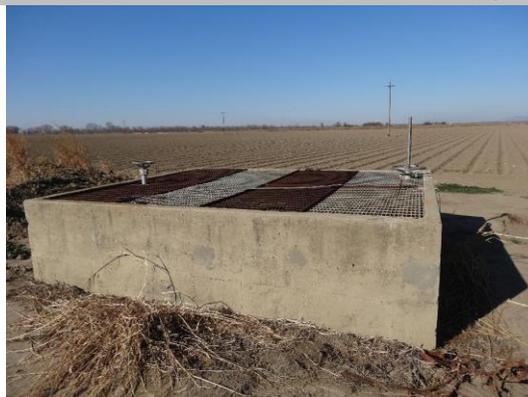
Photo 3 of 3 : UCIP_SP_2020_28524_52549.jpg

LS view: concrete distribution box on levee toe.

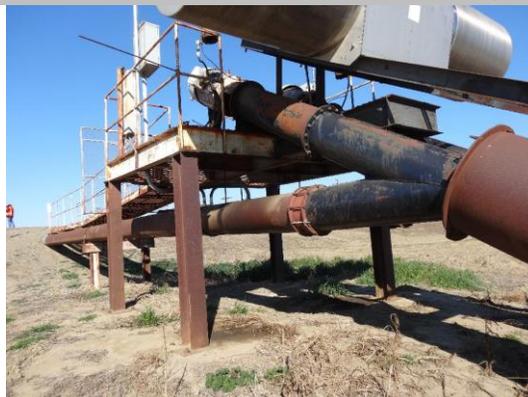
Photo 1 of 3 : UCIP_SP_2020_28927_53216.jpg

WS view: pipe, walkway, slant pump, and steel platform on levee berm.

Comment Code					
Inspector Comment					
DS_ID:20022 FS_ID:28927 EP_NO: 15681 Repair Type: Non-Urgent Crossing Status: Found UCIP Comments: Obstructed siphon breakers on landside. Two 3-inch conduit through the levee. Service box on pump platform. Pumping plant was working during the field visit. FIELD_STRUCT_DESC: 2 of 2: 20-inch steel irrigation discharge pipe, asphalt coated inside and out and wrapped with asphalt saturated felt, through the levee, 1.5 feet below the crown. Cutoff wall at the centerline of the levee. Two slant pumps supported by a steel piling structure on the riverbank. Steel walkway to the pump platform. Siphon breakers in steel pipe risers on the landside (LS) shoulder. Pipe discharges into a concrete discharge box off the LS toe. (Installation of a discharge pipe through the levee and a slant pump on the riverbank authorized under Permit No. 15681, 1991 - Blackfraires Investment). FS Date: 1/14/2014

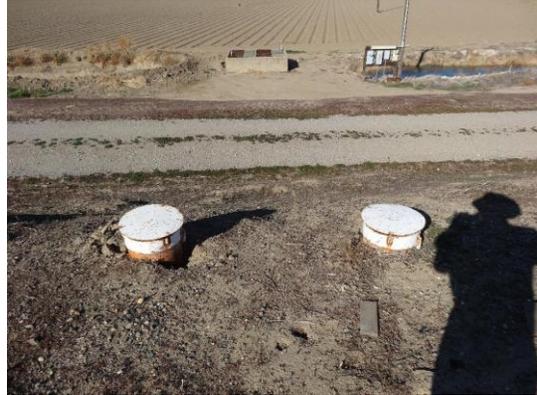
Photo 2 of 3 : UCIP_SP_2020_28927_53215.jpg

LS view: siphon breakers in steel pipe risers (bottom) on levee slope and concrete distribution (top) box on levee toe.

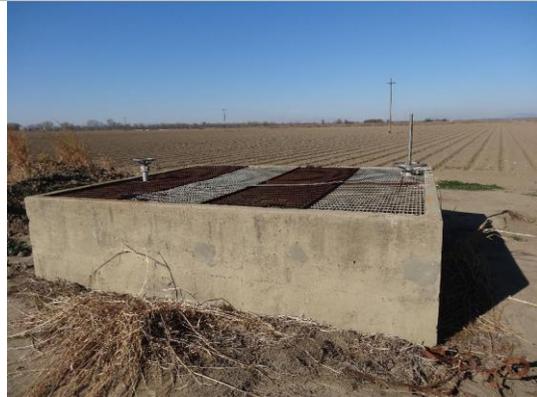
Photo 3 of 3 : UCIP_SP_2020_28927_53214.jpg

LS view: concrete distribution box on levee toe.

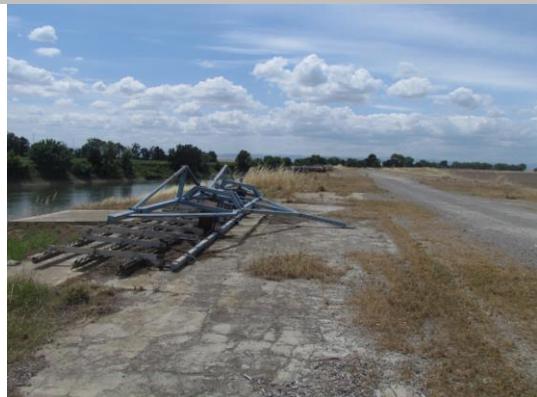
Photo 1 of 1 : SP_2020_RD1500_189_2549_20200228_00064.jpg

LM Start	19.56	Rating **	M	Issue No.	2549
LM End	19.56	Issue Type +	En	Location *	WS
Category	Earthen Levee			GPS Latitude/Longitude	
				Start	End
Item	Encroachments			38.906565 °	38.906565 °
				-121.794472 °	-121.794472 °
DWR ID	DWR_RD1500_01_s_2015_2549				
Comment Code					
EQ : Equipment					
Inspector Comment

View of the equipment on the waterward side of the levee looking upstream. Spring 2015.

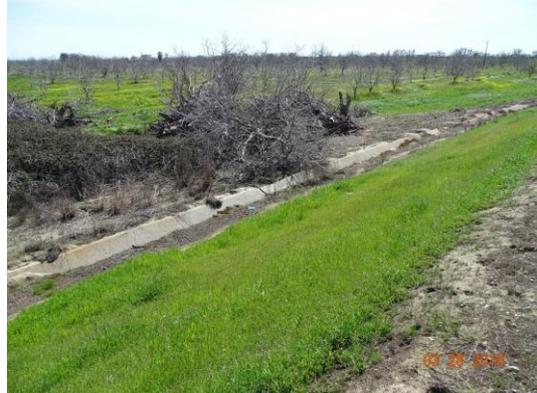
Photo 1 of 1 : SP_2020_RD1500_189_123_20200228_00050.jpg

LM Start	20.97	Rating **	M	Issue No.	123
LM End	21.15	Issue Type +	En	Location *	LS
Category	Earthen Levee			GPS Latitude/Longitude	
				Start	End
Item	Encroachments			38.910885 °	38.913199 °
				-121.804603 °	-121.803256 °
DWR ID	DWR_RD1500_01_s_2018_123				
Comment Code					
DT : Ditch					
Inspector Comment					
Ditch within landside easement.

View of ditch at the landside toe. Spring 2018.

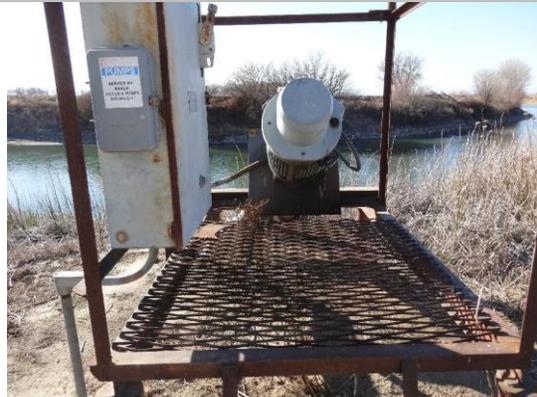
Photo 1 of 3 : UCIP_SP_2020_28527_52568.jpg

Comment Code					
Inspector Comment					
DS_ID:20070 FS_ID:28527 EP_NO: 11959A Repair Type: Non-Urgent Crossing Status: Found UCIP Comments: Siphon breaker (obstructed) in CMP on landside slope. Power pole on landside toe. FIELD_STRUCT_DESC: 10-inch coated and wrapped steel irrigation discharge pipe through the levee, 3 feet below the crown. Corrugated metal cutoff wall. Slant pump on a steel platform at the riverbank. Obstructed siphon breaker in a corrugated metal pipe (CMP) riser on the landside (LS) slope. Pipe discharges into a 6-foot by 6-foot concrete distribution box on the LS. (Replacement of an existing 10-inch steel pipe with a new 10-inch steel pipe through the levee authorized under Permit No. 11959-A, 1977 - George Van Ruiten Jr.). [Additional Reference(s): DWR Levee Log, 2005. USACE Sacramento O&M Manual 128, March 1960, (HLM 21.50)]. FS Date: 1/14/2014

WS view: slant pump on steel platform on levee berm.

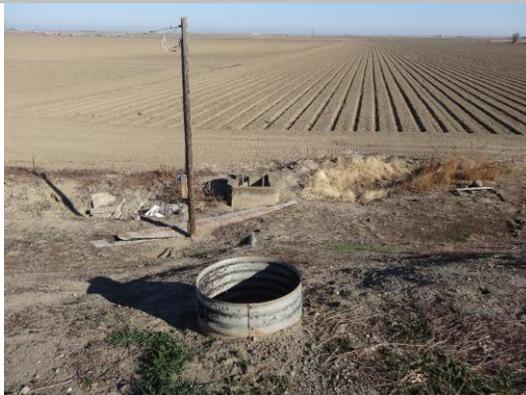
Photo 2 of 3 : UCIP_SP_2020_28527_52567.jpg

LS view: siphon breaker in CMP riser on levee slope (bottom) and concrete distribution box (top) on levee toe.

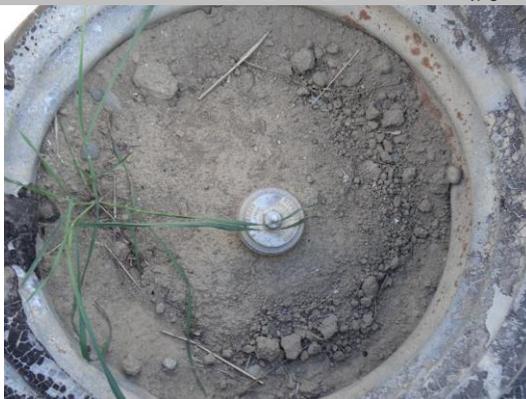
Photo 3 of 3 : UCIP_SP_2020_28527_52566.jpg

LS view: obstructed siphon breaker in CMP riser on levee slope.

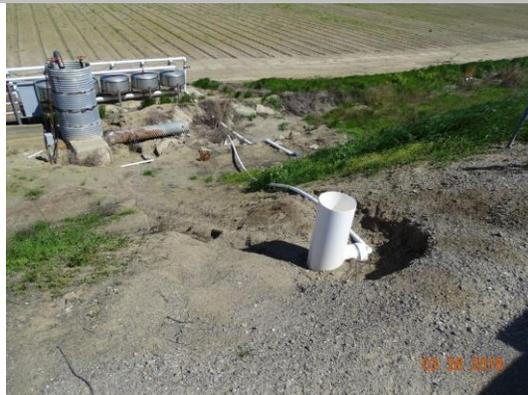
Photo 1 of 1 : SP_2020_RD1500_189_120_20200228_00049.jpg

LM Start	21.58	Rating **	M	Issue No.	120
LM End	21.58	Issue Type +	En	Location *	LS
Category	Earthen Levee		GPS Latitude/Longitude		
			Start	End	
Item	Encroachments		38.916207 °	38.916207 °	
			-121.808893 °	-121.808893 °	
DWR ID	DWR_RD1500_01_s_2018_120				
Comment Code					
PI : Pipe					
Inspector Comment					
There is erosion around landowner's PVC standpipe.

View of erosion around PVC standpipe. Spring 2018.

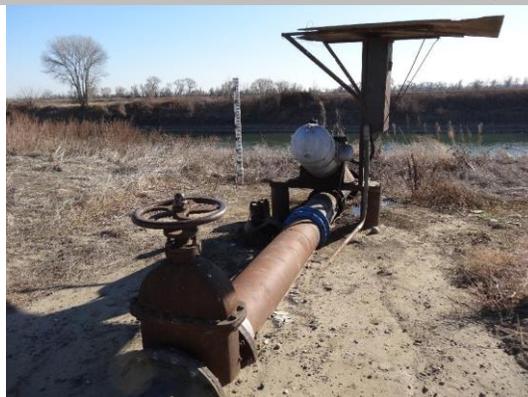
Photo 1 of 3 : UCIP_SP_2020_28528_52576.jpg

Comment Code					
Inspector Comment					
DS_ID:20071 FS_ID:28528 EP_NO: 10063 Repair Type: Non-Urgent Crossing Status: Found UCIP Comments: Water leaks near pump. Obstructed siphon breaker in CMP on landside.Plant was working during field visit. FIELD_STRUCT_DESC: 16-inch steel irrigation discharge pipe through the levee, 6.3 feet below the crown. Corrugated metal cutoff wall. 1.5-inch conduit through the levee, 6.5 feet below the crown. Slant pump and gate valve on riverbank. Siphon breaker in a 24-inch corrugated metal pipe (CMP) riser on the landside (LS) slope. 5-foot by 5-foot concrete distribution box on the LS. CMP standpipe on the LS toe. Power pole and one anchor at the LS toe. (Automatic Board Order (ABO) issued as Permit No. 10063, 1974 - Thomas L. Nelson). [Additional Reference(s): DWR Levee Log, 2005. USACE Sacramento O&M Manual 128, March 1960, (HLM 21.83)]. FS Date: 1/14/2014

WS view: slant pump on steel platform on levee berm. Exposed steel pipe with gate valve also on levee berm.

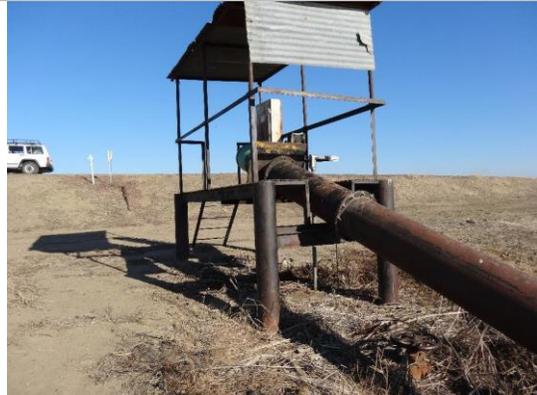
Photo 1 of 3 : UCIP_SP_2020_28583_52627.jpg

Comment Code					
Inspector Comment					
DS_ID:19995 FS_ID:28583 EP_NO: 10851 Repair Type: Non-Urgent Crossing Status: Found UCIP Comments: Exposed conduit on both slopes of the levee. Plant was working during field visit. Water was leaking from pipe joint near pump. Obstructed siphon breaker in CMP. FIELD_STRUCT_DESC: [Pumping Plant No. 2] 14-inch steel irrigation discharge pipe through the levee, 6.2 feet below the crown. Corrugated metal cutoff wall. 2-inch conduit through the levee, 5 feet below the crown. Pump and gate valve on a steel platform at the riverbank. Switch panel on the berm. Siphon breaker in a 24-inch corrugated metal pipe (CMP) riser on the landside (LS) shoulder. Pipe discharges into a 36-inch CMP standpipe at the LS toe. Meter pole at the LS toe. (Installation of three centrifugal pumps authorized under Permit No. 2895, 1958 - George Van Ruiten). [Additional Reference(s): DWR Levee Log, 1993. USACE Sacramento O&M Manual 128, March 1960, (HLM 23.00), 14-inch pipe referenced]. FS Date: 1/14/2014

WS view: slant pump on steel platform on levee berm.

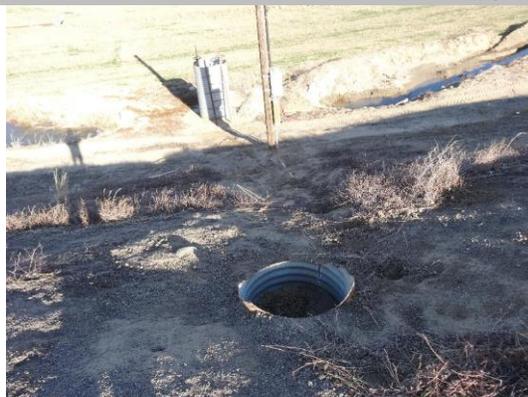
Photo 3 of 3 : UCIP_SP_2020_28583_52625.jpg

LS view: siphon breaker in CMP riser on levee slope (bottom) and CMP stand pipe (top) on levee toe.

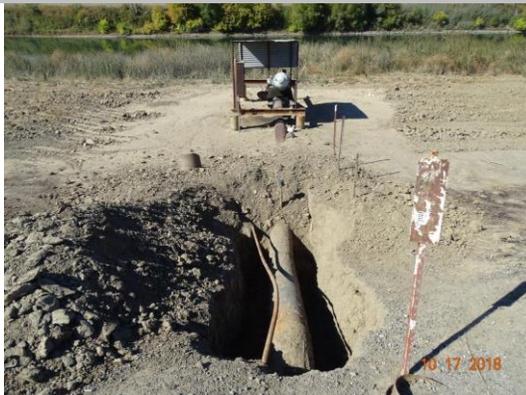
Photo 2 of 3 : UCIP_SP_2020_53023_78167.jpg

DS_ID:20072
 FS_ID:53023
 EP_NO: 2895
 Repair Type: Urgent
 Crossing Status: Found
 UCIP Comments: 10/18/2018 WS levee slope was disturbed to perform pipe maintenance. Unable to locate a permit for this work. Crossing remains "Urgent" due to soil disturbance on WS levee slope. (O.Yakimov - DWR UCIP)Most of the pipe exposed on levee slopes. Leaky pump. Obstructed siphon breaker. Not found- Concrete headwall at landward toe.
 FIELD_STRUCT_DESC: [Pumping Plant No. 1] 14-inch steel irrigation discharge pipe through the levee, 6.5 feet below the crown. Corrugated metal cutoff wall. 1.5-inch conduit through the levee, 4 feet below the crown. Slant pump and control panel on steel structure on the berm. Siphon breaker in a 24-inch corrugated metal pipe (CMP) riser on the landside (LS) shoulder. 36-inch concrete standpipe at the LS toe. Concrete headwall at the LS toe. Meter pole at the LS toe. (Installation of three centrifugal pumps authorized under Permit No. 2895, 1958 - George Van Ruiten). [Additional Reference(s): DWR Levee Log, 2005. USACE Sacramento O&M Manual 128, March 1960, (HLM 23.92), 24-inch pipe referenced].

Levee crown view: WS levee slope was excavated to do pipe maintenance, photo courtesy of Zach Jojola.

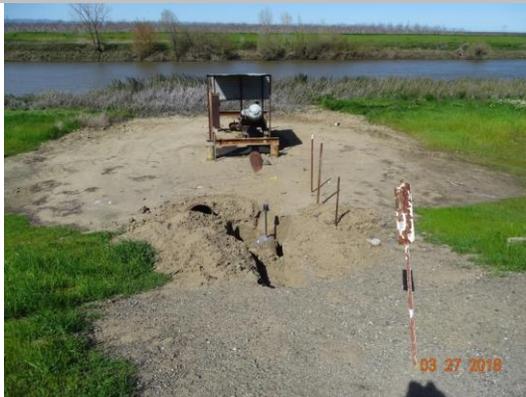
Photo 3 of 3 : UCIP_SP_2020_53023_77546.jpg

WS view: Currently installing a new meter. Still needs backfill. Levee inspector: Zachary Jojola.

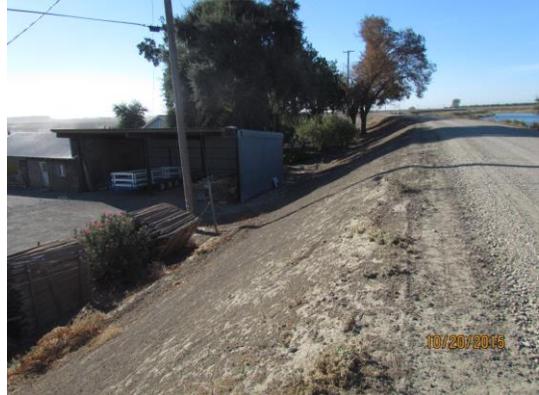
Photo 1 of 1 : SP_2020_RD1500_189_42_20200228_00018.jpg

LM Start	23.77	Rating **	M	Issue No.	42
LM End	23.77	Issue Type +	En	Location *	LS
Category	Earthen Levee			GPS Latitude/Longitude	
				Start	End
Item	Encroachments			38.931838 °	38.931838 °
				-121.834437 °	-121.834437 °
DWR ID	DWR_RD1500_01_s_2012_42				
Comment Code					
EQ : Equipment					
Inspector Comment					
Some equipment is located at the landside toe.

View of the barn and equipment on the landward side of the levee looking downstream. Fall 2015.

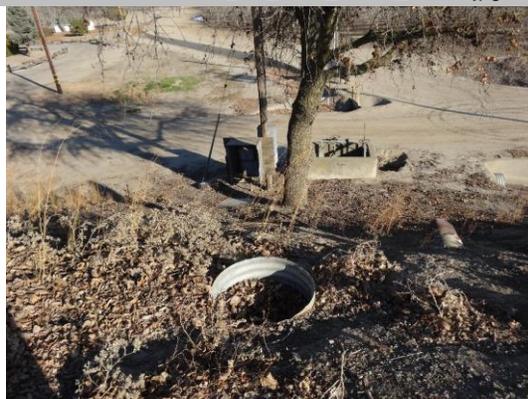
Photo 3 of 3 : UCIP_SP_2020_28603_52665.jpg

LS view: siphon breaker in CMP riser on levee slope (bottom) and concrete distribution box (top) on levee toe.

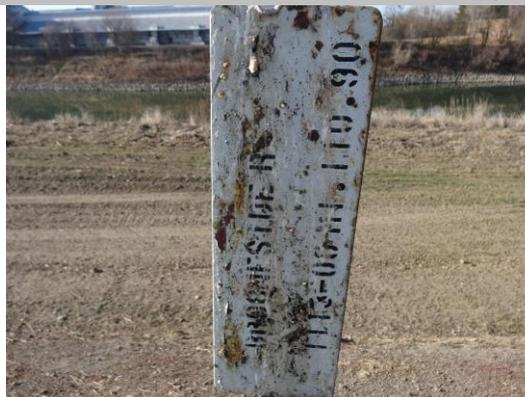
Photo 1 of 2 : UCIP_SP_2020_41728_52673.jpg

Comment Code					
Inspector Comment					
DS_ID:20074 FS_ID:41728 EP_NO: 8765 Repair Type: Non-Urgent Crossing Status: Found UCIP Comments: Burried Concrete headwall on landside toe. Should verify pipe has been properly abandoned. Utility tag plate on waterside shoulder. No pipe found. FIELD_STRUCT_DESC: *ABANDONED* 48-inch by 48-inch reinforced concrete box irrigation discharge culvert through the levee, 10 feet below the crown. (48-inch by 48-inch concrete culvert retained under Permit No. 9175, 1973 - David S. Lewis, DBA Broomieside Farms. To sleeve a 20-inch steel irrigation discharge pipe through the existing concrete culvert from a new slant-type pumping facility authorized under Permit No. 8765, 1973 - David S. Lewis, DBA Broomieside Farms. The 20-inch discharge pipe will be enclosed in a 30-inch, 0.375-inch wall steel pipe.). [Additional Reference(s): DWR Levee Log, 2005. USACE Sacramento O&M Manual 128, March 1960, (HLM 25.80)]. FS Date: 1/15/2014

WS view: utility tag plate on waterside shoulder. No pipe found.

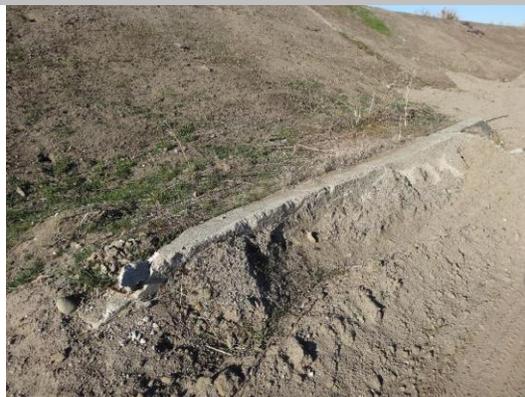
Photo 2 of 2 : UCIP_SP_2020_41728_52672.jpg

LS view: concrete headwall on landside toe. No pipe found.

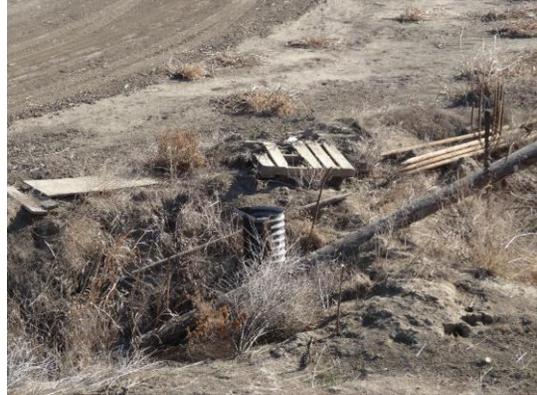
Photo 2 of 2 : UCIP_SP_2020_28629_52708.jpg

Comment Code					
Inspector Comment					
DS_ID:20014 FS_ID:28629 EP_NO: 10057 Repair Type: Non-Urgent Crossing Status: Found UCIP Comments: May need proper abandonment. FIELD_STRUCT_DESC: *ABANDONED* 1 of 2: 24-inch steel irrigation discharge pipe through the levee, 7.1 feet below the crown. Two corrugated metal cutoff walls. Siphon breakers in 24-inch and 30-inch corrugated metal pipe (CMP) risers on the landside (LS) shoulder. 2-inch conduit through the levee. Installed by USACE in 1958. Wooden walkway to two slant pumps on a steel pile structure on berm. Meter pole and switch panel at the LS toe. (Steel discharge pipes, slant pumps, and all other appurtenances retained under Automatic Board Order (ABO) issued as Permit No. 10057, 1974 - David S. Lewis, care of Broomieside Farms, [RM 112.06]. Moved to HLM 26.50 under Permit No. 16165, 1994 - Pelger Mutual Water Company/Murray, Burns, and Kienlen). [Additional Reference(s): DWR Levee Log, 1993. USACE Sacramento O&M Manual 128, March 1960, (HLM 26.84)]. FS Date: 1/15/2014

LS view: abandoned CMP risers on levee toe.

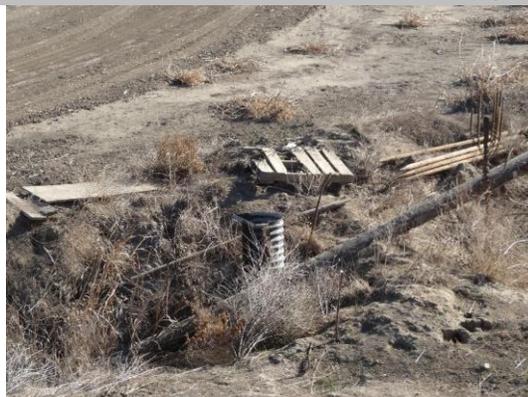
Photo 2 of 2 : UCIP_SP_2020_28628_52704.jpg

DS_ID:20013
 FS_ID:28628
 EP_NO: 10057
 Repair Type: Non-Urgent
 Crossing Status: Found
 UCIP Comments: May need proper abandonment.
 FIELD_STRUCT_DESC: *ABANDONED* 2 of 2: 30-inch steel irrigation discharge pipe through the levee, 7.1 feet below the crown. Two corrugated metal cutoff walls. Siphon breakers in 24-inch and 30-inch corrugated metal pipe (CMP) risers on the landside (LS) shoulder. 2-inch conduit through the levee. Installed by USACE in 1958. Wooden walkway to two slant pumps on a steel pile structure on berm. Meter pole and switch panel at the LS toe. (Steel discharge pipes, slant pumps, and all other appurtenances retained under Automatic Board Order (ABO) issued as Permit No. 10057, 1974 - David S. Lewis, care of Broomieside Farms, [RM 112.06]. Moved to HLM 26.50 under Permit No. 16165, 1994 - Pelger Mutual Water Company/Murray, Burns, and Kienlen). [Additional Reference(s): DWR Levee Log, 1993. USACE Sacramento O&M Manual 128, March 1960, (HLM 26.84)].

LS view: abandoned CMP risers on levee toe.

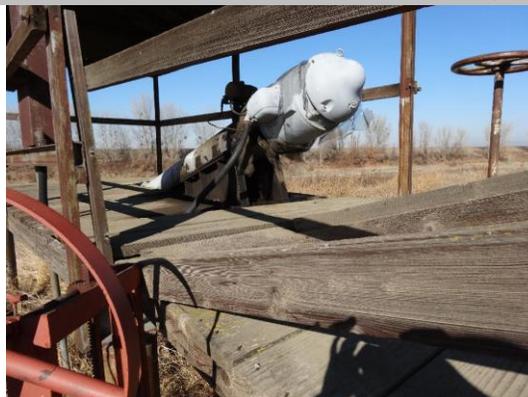
Photo 1 of 3 : UCIP_SP_2020_28631_52720.jpg

DS_ID:20015
 FS_ID:28631
 EP_NO: 10052
 Repair Type: Non-Urgent
 Crossing Status: Found
 UCIP Comments: Obstructed siphon breaker. Leaky pump.
 FIELD_STRUCT_DESC: 18-inch steel irrigation discharge pipe through the levee, 7.1 feet below the crown. Corrugated metal cutoff wall. 2-inch conduit through the levee, 5.5 feet below the crown. Wooden walkway to slant pump and gate valve on wooden pump platform mounted on a steel pile structure on the berm. Siphon breaker in a 24-inch corrugated metal pipe (CMP) riser on the landside (LS) slope. Meter pole at the LS toe. (18-inch steel irrigation discharge pipe through the levee, slant pump, and all other appurtenances retained under Automatic Board Order (ABO) issued as Permit No. 10052, 1974 - Clifton Lamb, [RM 112.29]). [Additional Reference(s): DWR Levee Log, 1993. USACE Sacramento O&M Manual 128, March 1960, (HLM 27.07)].
 FS Date: 1/15/2014

WS view: slant pump and gate valves on wooden platform at levee berm. Wooden walkway to the pump.

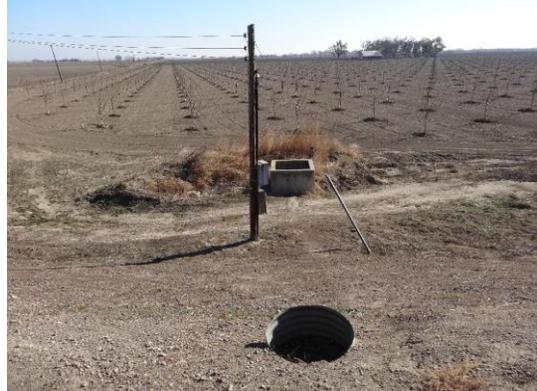
Photo 2 of 3 : UCIP_SP_2020_28631_52719.jpg

LS view: siphon breaker in CMP riser on levee slope (bottom) and concrete distribution box on levee toe.

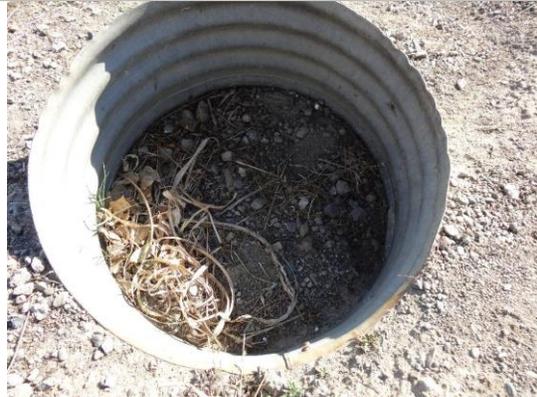
Photo 3 of 3 : UCIP_SP_2020_28631_52721.jpg

LS view: obstructed siphon breaker in CMP riser on levee slope.

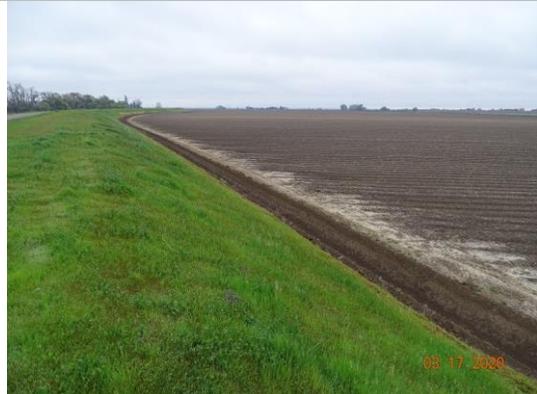
Photo 1 of 1 : SP_2020_RD1500_189_100_20200319_00199.jpg

LM Start	26.99	Rating **	M	Issue No.	100
LM End	27.28	Issue Type +	En	Location *	LS
Category	Earthen Levee			GPS Latitude/Longitude	
				Start	End
Item	Encroachments			38.970939 °	38.972487 °
				-121.831034 °	-121.826108 °
DWR ID	DWR_RD1500_01_s_2020_100				
Comment Code					
DT : Ditch					
Inspector Comment

View of the ditch at the landside toe. Spring 2020.

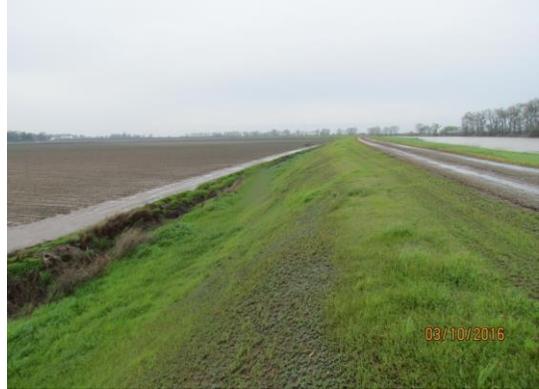
Photo 1 of 1 : SP_2020_RD1500_189_983_20200228_00063.jpg

LM Start	27.31	Rating **	M	Issue No.	983
LM End	27.44	Issue Type +	En	Location *	LS
Category	Earthen Levee		GPS Latitude/Longitude		
			Start	End	
Item	Encroachments		38.972552 °	38.972924 °	
			-121.825574 °	-121.823198 °	
DWR ID	DWR_RD1500_01_s_2015_983				
Comment Code					
DT : Ditch					
Inspector Comment

View of the ditch on the landward side of the levee looking downstream. Spring 2016.

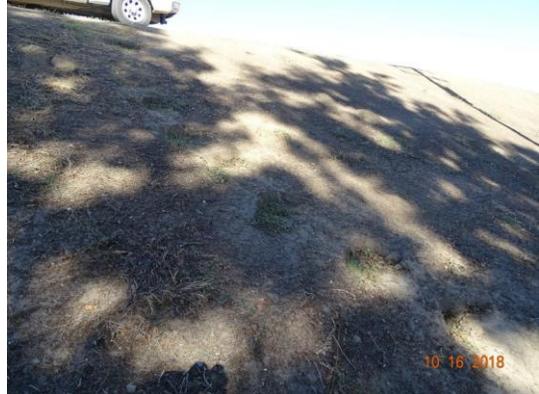
Photo 1 of 1 : SP_2020_RD1500_189_94_20200228_00037.jpg

LM Start	27.61	Rating **	M	Issue No.	94
LM End	27.61	Issue Type +	En	Location *	LS
Category	Earthen Levee		GPS Latitude/Longitude		
			Start	End	
Item	Encroachments		38.974258 °	38.974258 °	
			-121.820587 °	-121.820587 °	
DWR ID	DWR_RD1500_01_f_2018_94				
Comment Code					
ST : Stairway					
Inspector Comment					
Stairs are dug into the landside slope.

View of stairs on the landside slope. Fall 2018.

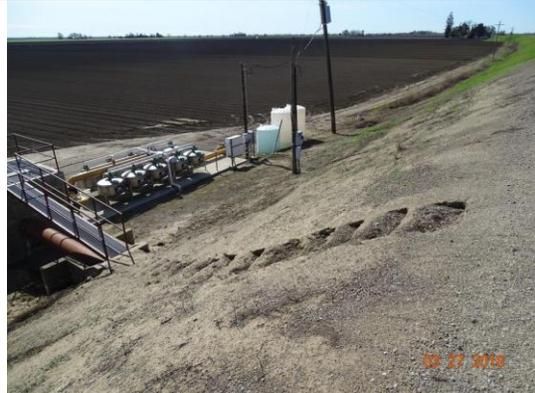
Photo 1 of 1 : SP_2020_RD1500_189_96_20200228_00038.jpg

LM Start	28.16	Rating **	M	Issue No.	96
LM End	28.16	Issue Type +	En	Location *	LS
Category	Earthen Levee		GPS Latitude/Longitude		
			Start	End	
Item	Encroachments		38.982180 °	38.982180 °	
			-121.819979 °	-121.819979 °	
DWR ID	DWR_RD1500_01_s_2018_96				
Comment Code					
ST : Stairway					
Inspector Comment					
Steps are dug out on the landside levee slope.

View of steps on the landside slope. Spring 2018.

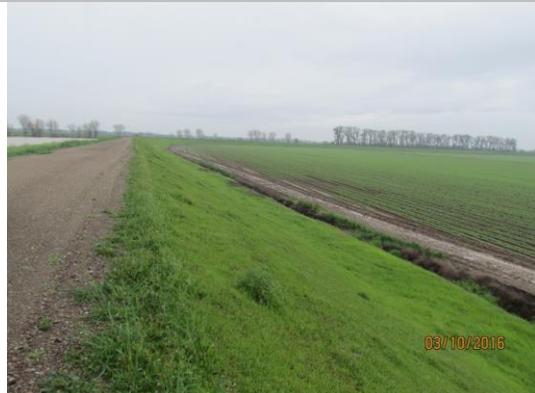
Photo 1 of 1 : SP_2020_RD1500_189_38_20200228_00017.jpg

LM Start	28.23	Rating **	M	Issue No.	38
LM End	29.23	Issue Type +	En	Location *	LS
Category	Earthen Levee		GPS Latitude/Longitude		
			Start	End	
Item	Encroachments		38.983119 °	38.988538 °	
			-121.819923 °	-121.806445 °	
DWR ID	DWR_RD1500_01_s_2012_38				
Comment Code					
DT : Ditch					
Inspector Comment

View of the ditch on the landward side of the levee looking upstream. Spring 2016.

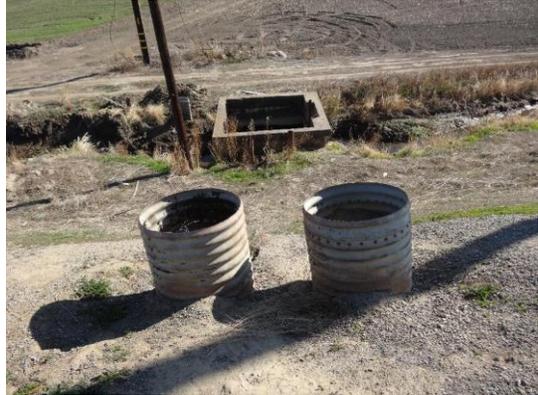
Photo 2 of 3 : UCIP_SP_2020_50201_52854.jpg

LS view: siphon breakers in CMP riser on levee slope and distribution box on levee toe.

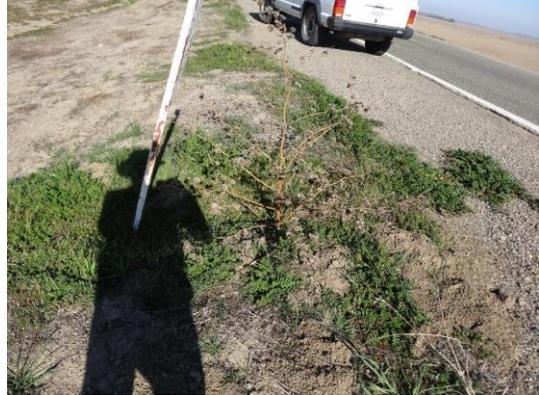
Photo 3 of 3 : UCIP_SP_2020_50193_51825.jpg

WS view: excessive vegetation along pipe alignment on levee slope.

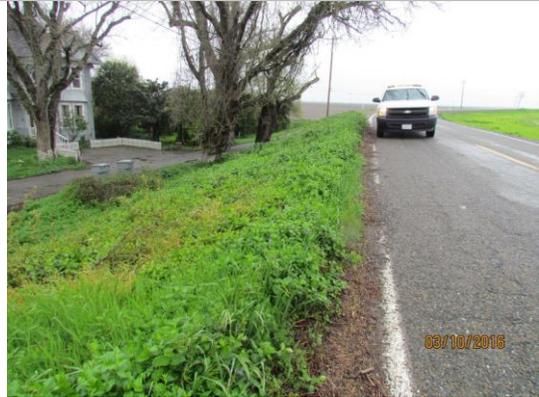
Photo 1 of 1 : SP_2020_RD1500_189_45_20200228_00019.jpg

LM Start	30.22	Rating **	M	Issue No.	45
LM End	30.22	Issue Type +	En	Location *	LS
Category	Earthen Levee			GPS Latitude/Longitude	
				Start	End
Item	Vegetation			38.997027 °	38.997027 °
				-121.794755 °	-121.794755 °
DWR ID	DWR_RD1500_01_s_2012_45				
Comment Code					
V6 : Landscaping					
Inspector Comment

View of the groundcover on the landward side of the levee looking downstream. Spring 2016.

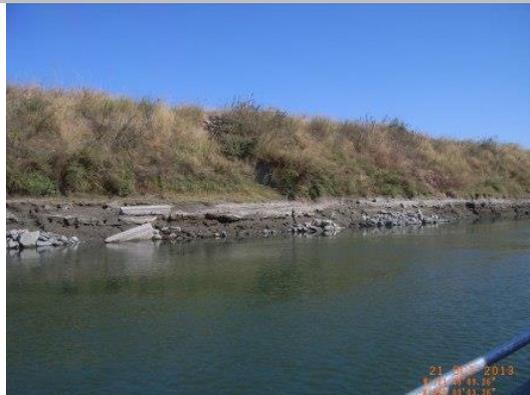
Photo 1 of 1 : SP_2020_RD1500_189_82_20200228_00031.jpg

LM Start	30.60	Rating **	A/W	Issue No.	82
LM End	30.75	Issue Type +	Ma	Location *	WS
Category	Supplemental			GPS Latitude/Longitude	
				Start	End
Item	2017 USACE Erosion Survey			38.999745 °	39.001413 °
				-121.800898 °	-121.802889 °
DWR ID	DWR_RD1500_01_f_2018_82				
Comment Code					
Inspector Comment					
2017 Site ID: SAC 116.0 L Status: Eroding 2017 Field Notes: Minor new erosion throughout the site. Site History: 2000 - Eroding, vertical berm slope over a vertical cohesive toe; slow erosion but getting close to the toe. 2002 - Erosion is getting close to the levee, still eroding with some new small slumps. 2004 - Some minor new erosion. 2006 - Some new erosion, cleaned off older scars and slump faces. 2008 - New, small, partial rotational failure. 2011 - Some new minor erosion. 2016 - Fresh erosion on lower bank.

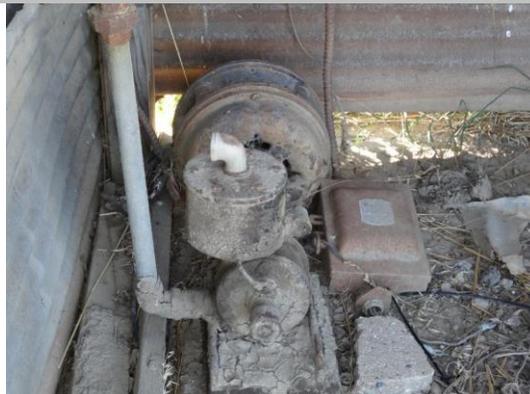
Photo 1 of 3 : UCIP_SP_2020_28144_51812.jpg

Comment Code					
Inspector Comment					
DS_ID:20000 FS_ID:28144 EP_NO: 15916 Repair Type: Non-Urgent Crossing Status: Found UCIP Comments: Surface erosion due to leaky pressure breaker on landside slope. FIELD_STRUCT_DESC: 18-inch steel irrigation discharge pipe through the levee, at an unknown depth. Waterside (WS) pump not mentioned in the Levee Log. Siphon breaker in a 24-inch corrugated metal pipe (CMP) riser on the landside (LS) slope. Pipe discharges into a 6-foot by 8-foot, inside dimensions, concrete distribution box at the LS toe. Installed by USACE in 1951. (12-inch steel irrigation discharge pipe through the levee and all other appurtenances retained under Automatic Board Order (ABO) issued as Permit No. 10034, 1974 - Leslie A. Butler. Replacement of the existing 12-inch discharge pipe with a new 18-inch discharge pipe through the levee authorized under Permit No. 15916, 1992 - Leslie A. Butler). [Additional Reference(s): DWR Levee Log, 1993. USACE Sacramento O&M Manual 128, March 1960, (HLM 31.26)]. FS Date: 1/15/2014

WS view: pump in CM pump house on levee shoulder. Looks abandoned.

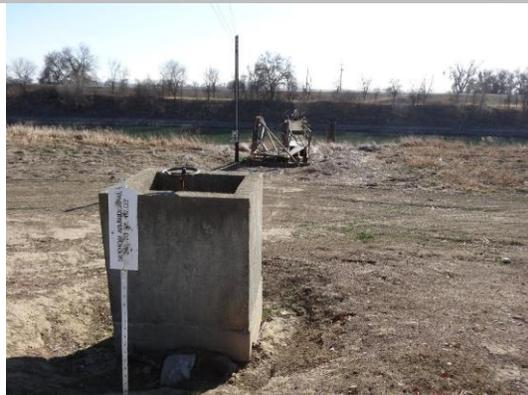
Photo 1 of 3 : UCIP_SP_2020_28143_51805.jpg

Comment Code					
Inspector Comment					
DS_ID:20077 FS_ID:28143 EP_NO: 9657 Repair Type: Non-Urgent Crossing Status: Found UCIP Comments: Looks abandoned. May need proper abandonment. Overhead power line. FIELD_STRUCT_DESC: *ABANDONED* 20-inch steel irrigation discharge pipe through the levee, 15 feet below the crown. Wooden step and walkway to vertical pump on pile structure in the river. Slide gate in a 2.5-foot by 3-foot, inside dimensions, riser. Concrete distribution box on the waterside (WS) slope. Switch panel on the berm. Pipe discharges into a 36-inch, inside diameter, concrete standpipe on the landside (LS). Installed by USACE in 1947. (Replacement of a section of 24-inch irrigation pipe through the levee authorized under Permit No. 9657, 1974 - Clyde M. Bell. 1.5-foot by 2-foot concrete culvert through the levee and all other appurtenances retained under Automatic Board Order (ABO) issued as Permit No. 10030, 1974 - Clyde M. Bell. Replacement of a cracked concrete pipe with a steel pipe at the LS toe authorized under Permit No. 13536, 1982 - Niechen N. V., Alfred Montna, Manager. Replacement of approximately 90 feet of 18-inch pipe in the overflow area of the Sacramento River with new steel pipe authorized under Permit No. 13941, 1984 - Niechen N. V., Alfred Montna, Manager). [Additional Reference(s): DWR Levee Log, 2005. USACE Sacramento O&M Manual 128, March 1960, (HLM 32.02), 2-foot by 2-foot concrete culvert referenced]. FS Date: 1/15/2014

WS view: concrete surge box on levee slope.

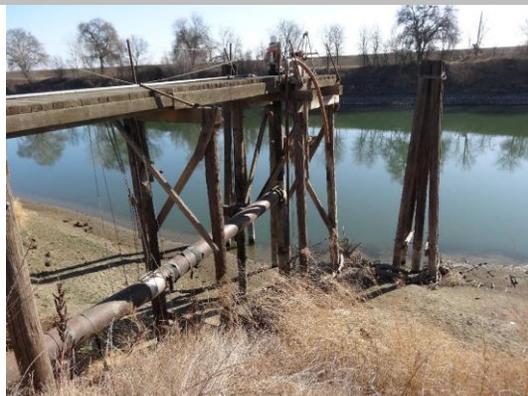
Photo 2 of 3 : UCIP_SP_2020_28143_51804.jpg

WS view: abandoned walkway, pipe, and pump on river bank.

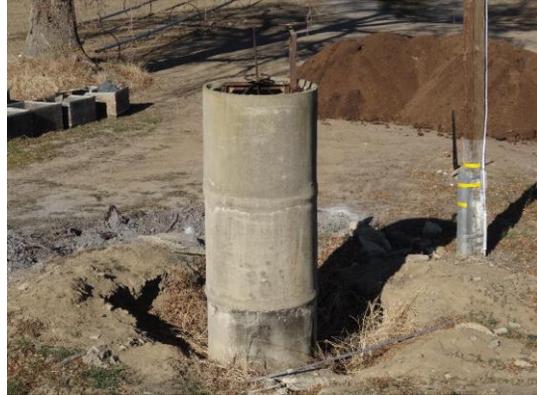
Photo 3 of 3 : UCIP_SP_2020_28143_51803.jpg

LS view: concrete standpipe on levee toe.

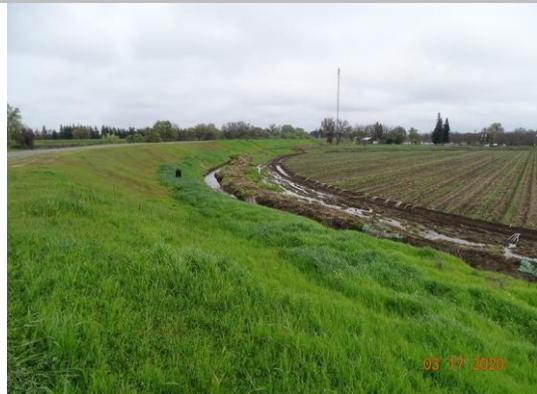
Photo 1 of 1 : SP_2020_RD1500_189_130_20200319_00200.jpg

LM Start	32.25	Rating **	M	Issue No.	130
LM End	32.57	Issue Type +	En	Location *	LS
Category	Earthen Levee			GPS Latitude/Longitude	
				Start	End
Item	Encroachments			39.011526 °	39.015591 °
				-121.825603 °	-121.823461 °
DWR ID	DWR_RD1500_01_s_2020_130				
Comment Code					
DT : Ditch					
Inspector Comment					
Irrigation ditch at the landside toe.

View of the ditch within the landside easement. Spring 2020.

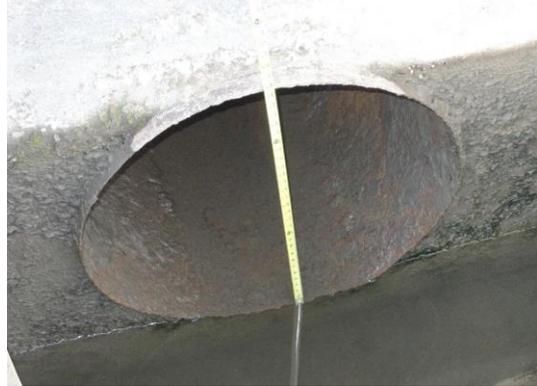
Photo 3 of 3 : UCIP_SP_2020_28943_53220.jpg

LS view: steel pipe in concrete distribution box on levee toe.

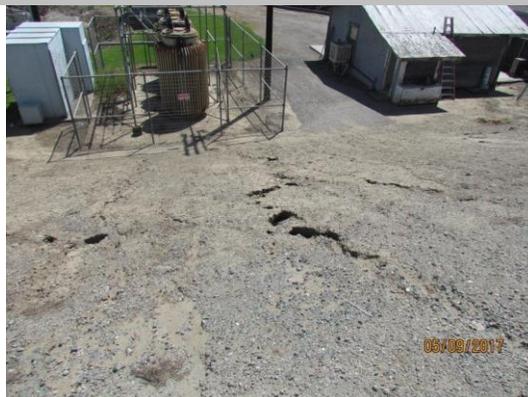
Photo 1 of 1 : SP_2020_RD1500_189_144_20200228_00057.jpg

LM Start	32.98	Rating **	M	Issue No.	144
LM End	32.98	Issue Type +	Ma	Location *	LS
Category	Earthen Levee		GPS Latitude/Longitude		
			Start	End	
Item	Erosion / Bank Caving		39.020782 °	39.020782 °	
			-121.820275 °	-121.820275 °	
DWR ID	DWR_RD1500_01_s_2017_144				
Comment Code					
E2 : Schedule repair of erosion site prior to the next inspection.					
Inspector Comment					
There is runoff erosion on the landside slope.

View of erosion on landside slope. Spring 2017.

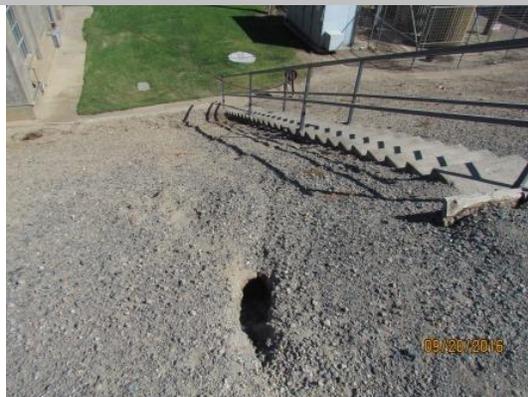
Photo 1 of 1 : SP_2020_RD1500_189_107_20200228_00041.jpg

LM Start	32.98	Rating **	M	Issue No.	107
LM End	32.98	Issue Type +	Ma	Location *	LS
Category	Earthen Levee		GPS Latitude/Longitude		
			Start	End	
Item	Animal Control		39.020874 °	39.020874 °	
			-121.820266 °	-121.820266 °	
DWR ID	DWR_RD1500_01_f_2016_107				
Comment Code					
A3 : No rodents visible, but rodent burrows visible; need to backfill and compact or grout burrows.					
Inspector Comment

View of rodent burrows on landside slope. Fall 2016.

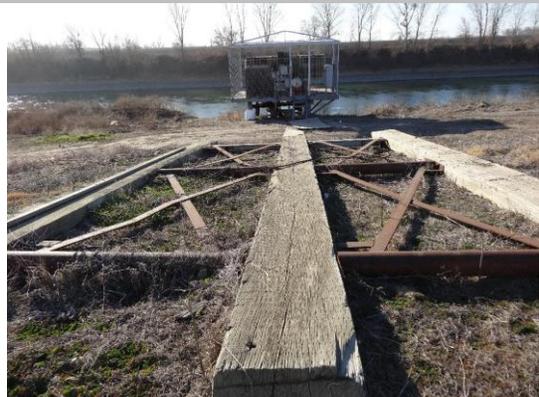
Photo 1 of 3 : UCIP_SP_2020_28952_53249.jpg

DS_ID:24758
 FS_ID:28952
 EP_NO: N/A
 Repair Type: Non-Urgent
 Crossing Status: Found
 UCIP Comments: Not found- slide gate in 54 inch corrugated metal riser on waterside berm. Two 16-inch steel pipes (looks new). Leaky pipe near pump. Plant was working during field visit. Needs more info from LMA. There may be a new permit.
 FIELD_STRUCT_DESC: 2 of 2: 16-inch steel irrigation discharge pipe through the levee, at an unknown depth. Two slant pumps on a steel platform and under the shed. Two air vents on the waterside (WS) levee shoulder. Two pipes with gate valves discharge water into irrigation ditch on the landside (LS). Meter pole on landside toe.
 Previously only a 30-inch steel pipe through the levee and a slide gate in a corrugated metal pipe (CMP) riser on the WS. (Removal of existing structure in river, installation of an incline structure next to the levee with new slant pumps, connected to existing discharge pipe authorized under Permit Nos. 5617, 1967 - Adda Seamans, and 5617-A, 1968 - Oji Brothers Farm, Inc.). [Additional Reference(s): DWR Levee Log, 2005. USACE Sacramento O&M Manual 128, March 1960, (HLM 33.56), 36-inch pipe referenced].

WS view: pump platform and shed on levee berm.

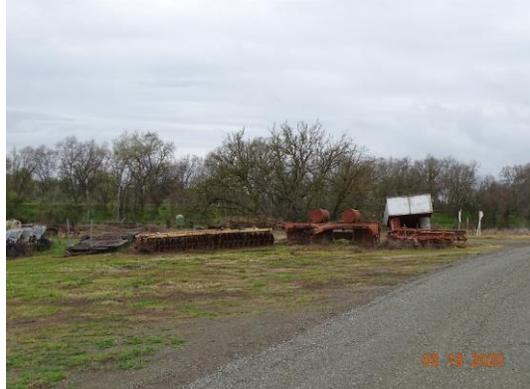
Photo 1 of 1 : SP_2020_RD1500_190_12_20200319_00042.jpg

LM Start	0.00	Rating **	M	Issue No.	12
LM End	0.00	Issue Type +	En	Location *	WS
Category	Earthen Levee		GPS Latitude/Longitude		
			Start	End	
Item	Encroachments		38.761121 °	38.761121 °	
			-121.674592 °	-121.674592 °	
DWR ID	DWR_RD1500_02_s_2012_12				
Comment Code					
EQ : Equipment					
Inspector Comment

View of equipment on the waterside shoulder. Spring 2020.

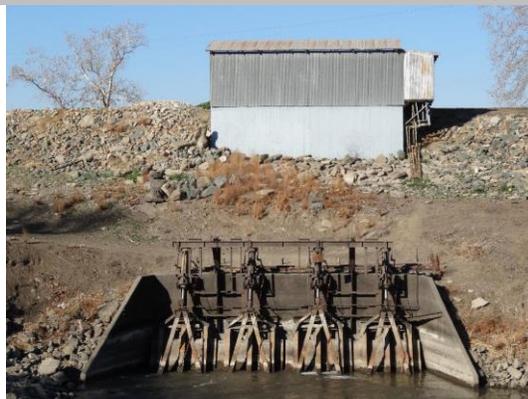
Photo 1 of 3 : UCIP_SP_2020_28886_53098.jpg

Comment Code					
Inspector Comment					
DS_ID:20020 FS_ID:28886 EP_NO: N/A Repair Type: No Action Needed Crossing Status: Found UCIP Comments: Pumping plat was working during the field visit. Hydraulic gates on outfall structure. Motorized slide gates on waterside shoulder. FIELD_STRUCT_DESC: [Reclamation District No. 1500, Pumping Plant No. 3] 1 of 4: 72-inch by 84-inch reinforced concrete box drainage discharge conduit under the levee, 35 feet below the crown. Two concrete cutoff walls. Pumps in concrete pumping plant on the landside (LS). Timber steps on the LS slope. Two service poles and anchors on the LS shoulder. Electrical control gates in a metal and concrete building on the waterside (WS) shoulder. Flap gates on the WS end. Installed by USACE in 1950. (Construction of a four compartment concrete gravity outlet conduit under the levee authorized under Permit No. 1284, 1948 - Reclamation District No. 1500). [Additional Reference(s): DWR Levee Log, 1993. USACE Sacramento O&M Manual 129, June 1954, (Station 1227+00)]. FS Date: 1/21/2014

WS view: CM shed for slide gate on levee shoulder (top) and outfall structure at levee toe (bottom).

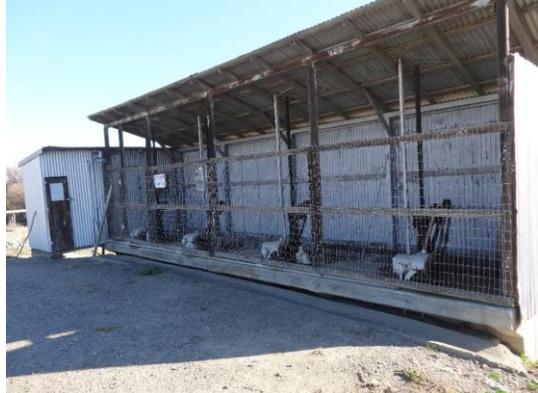
Photo 2 of 3 : UCIP_SP_2020_28886_53096.jpg

WS view: motorized slide gates in CM shed on levee shoulder.

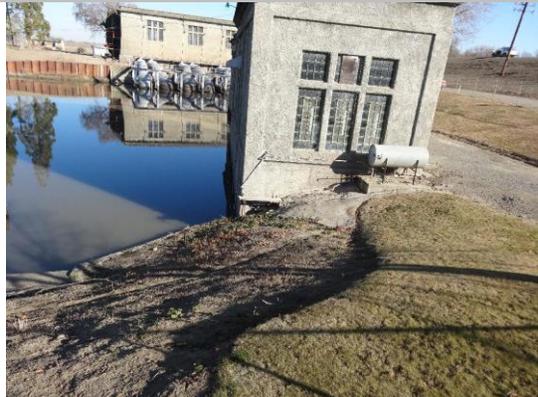
Photo 3 of 3 : UCIP_SP_2020_28886_53097.jpg

LS view: pump house at the end of levee berm.

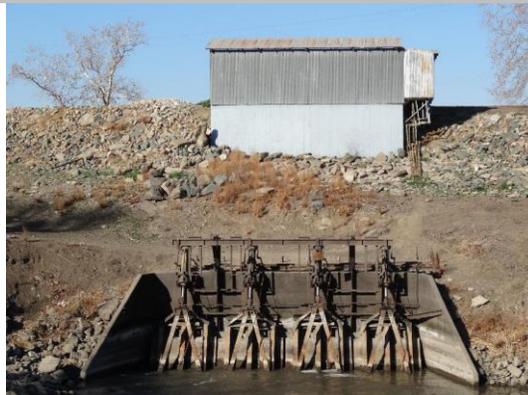
Photo 1 of 3 : UCIP_SP_2020_28883_53085.jpg

Comment Code					
Inspector Comment					
DS_ID:20027 FS_ID:28883 EP_NO: N/A Repair Type: No Action Needed Crossing Status: Found UCIP Comments: Pumping plat was working during the field visit. Hydraulic gates on outfall structure. Motorized slide gates on waterside shoulder. FIELD_STRUCT_DESC: [Reclamation District No. 1500, Pumping Plant No. 3] 2 of 4: 72-inch by 84-inch reinforced concrete box drainage discharge conduit under the levee, 35 feet below the crown. Two concrete cutoff walls. Pumps in concrete pumping plant on the landside (LS). Timber steps on the LS slope. Two service poles and anchors on the LS shoulder. Electrical control gates in a metal and concrete building on the waterside (WS) shoulder. Flap gates on the WS end. Installed by USACE in 1950. (Construction of a four compartment concrete gravity outlet conduit under the levee authorized under Permit No. 1284, 1948 - Reclamation District No. 1500). [Additional Reference(s): DWR Levee Log, 1993. USACE Sacramento O&M Manual 129, June 1954, (Station 1227+00)]. FS Date: 1/21/2014

WS view: CM shed for slide gate on levee shoulder (top) and outfall structure at levee toe (bottom).

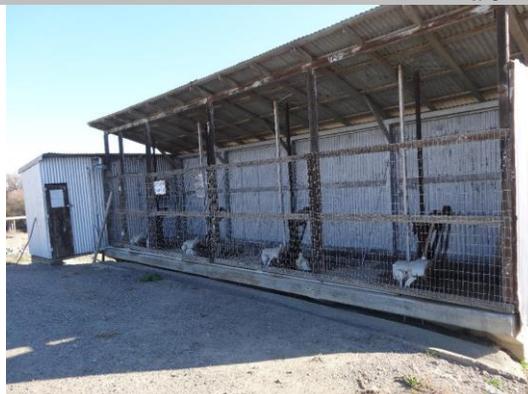
Photo 2 of 3 : UCIP_SP_2020_28883_53083.jpg

WS view: motorized slide gates in CM shed on levee shoulder.

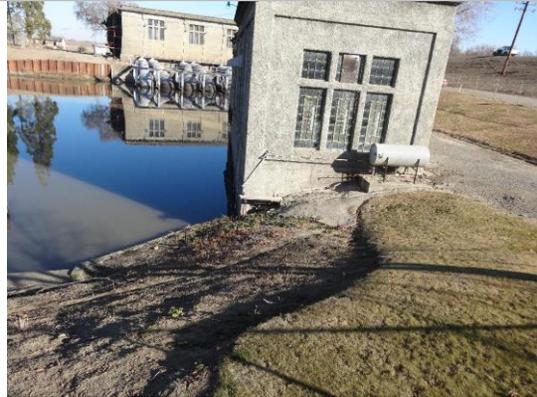
Photo 3 of 3 : UCIP_SP_2020_28883_53084.jpg

LS view: pump house at the end of levee berm.

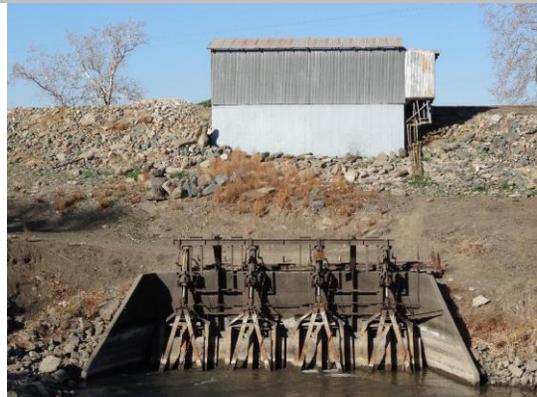
Photo 1 of 3 : UCIP_SP_2020_28884_53089.jpg

DS_ID:20028
 FS_ID:28884
 EP_NO: N/A
 Repair Type: No Action Needed
 Crossing Status: Found
 UCIP Comments: Pumping plat was working during the field visit. Hydraulic gates on outfall structure. Motorized slide gates on waterside shoulder.
 FIELD_STRUCT_DESC: [Reclamation District No. 1500, Pumping Plant No. 3] 3 of 4: 72-inch by 84-inch reinforced concrete box drainage discharge conduit under the levee, 35 feet below the crown. Two concrete cutoff walls. Pumps in concrete pumping plant on the landside (LS). Timber steps on the LS slope. Two service poles and anchors on the LS shoulder. Electrical control gates in a metal and concrete building on the waterside (WS) shoulder. Flap gates on the WS end. Installed by USACE in 1950. (Construction of a four compartment concrete gravity outlet conduit under the levee authorized under Permit No. 1284, 1948 - Reclamation District No. 1500). [Additional Reference(s): DWR Levee Log, 1993. USACE Sacramento O&M Manual 129, June 1954, (Station 1227+00)].

WS view: CM shed for slide gate on levee shoulder (top) and outfall structure at levee toe (bottom).

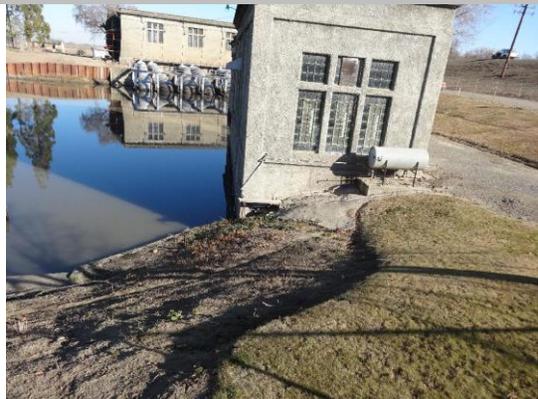
Photo 3 of 3 : UCIP_SP_2020_28884_53099.jpg

LS view: pump house at the end of levee berm.
