**Flood Control Project Maintenance
Levee Inspections**
LMA District Cover Sheet
Spring 2020 Levee Inspection Results

Reclamation District No. 1500 Sutter Basin

Spring 2020 Levee Inspection Results

Waterway	Bank	Unit Miles
Unit No. 01 Sacramento River	Left	33.15

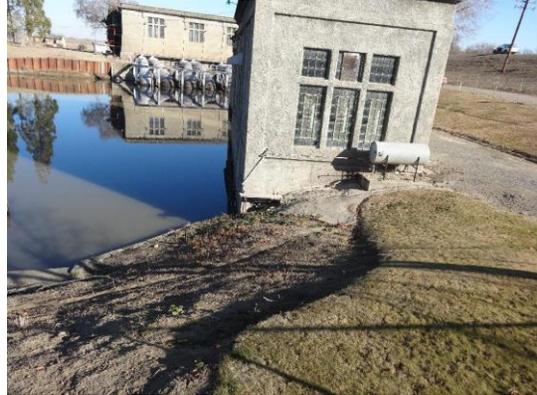
Photo 3 of 3 : UCIP_SP_2020_28885_53093.jpg

LS view: pump house at the end of levee berm.

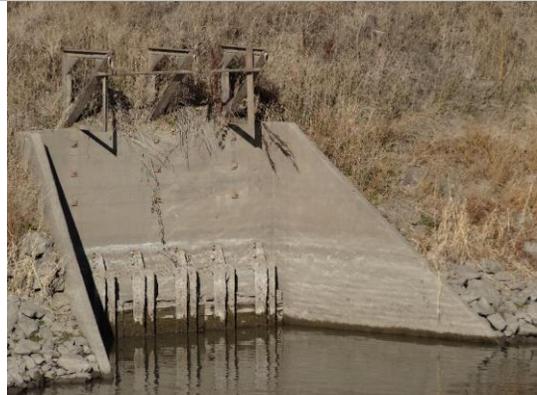
Photo 1 of 3 : UCIP_SP_2020_28954_53260.jpg

WS view: U type concrete headwall and flap gates on levee toe.

Comment Code					
Inspector Comment					
DS_ID:20019 FS_ID:28954 EP_NO: 10088 Repair Type: No Action Needed Crossing Status: Found UCIP Comments: USED Bench Mark on concrete structure at waterside shoulder. FIELD_STRUCT_DESC: [Reclamation District No. 1500, Pumping Plant No. 2] 1 of 3: 48-inch by 48-inch reinforced concrete box drainage discharge conduit under the levee, 37 feet below the crown. Two concrete cutoff walls. Pumps in concrete pumping plant on the landside (LS). Slide gates mounted on a concrete structure on the waterside (WS) slope. Discharges in borrow pit. Flap gates on the WS end. (48-inch by 48-inch reinforced concrete box drainage discharge conduit under the levee and all other appurtenances retained under Automatic Board Order (ABO) issued as Permit No. 10088, 1974 - Reclamation District No. 1500). [Additional Reference(s): DWR Levee Log, 1993. USACE Sacramento O&M Manual 129, June 1954, (Station 1226+00)]. FS Date: 1/21/2014

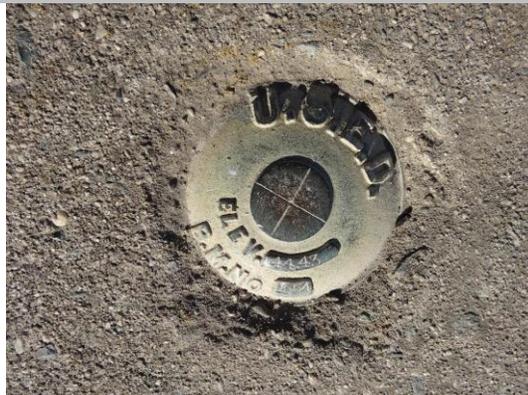
Photo 3 of 3 : UCIP_SP_2020_28955_53264.jpg

WS view: USED Bench Mark on concrete structure at levee shoulder.

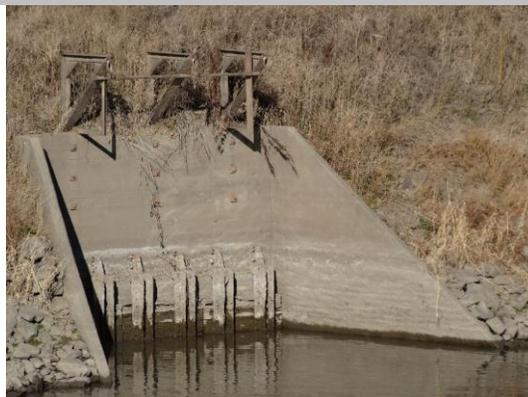
Photo 1 of 3 : UCIP_SP_2020_28956_53269.jpg

WS view: U type concrete headwall and flap gates on levee toe.

Comment Code					
Inspector Comment					
DS_ID:20026 FS_ID:28956 EP_NO: 10088 Repair Type: No Action Needed Crossing Status: Found UCIP Comments: USED Bench Mark on concrete structure at waterside shoulder. FIELD_STRUCT_DESC: [Reclamation District No. 1500, Pumping Plant No. 2] 3 of 3: 48-inch by 48-inch reinforced concrete box drainage discharge conduit under the levee, 37 feet below the crown. Two concrete cutoff walls. Pumps in concrete pumping plant on the landside (LS). Slide gates mounted on a concrete structure on the waterside (WS) slope. Discharges in borrow pit. Flap gates on the WS end. (48-inch by 48-inch reinforced concrete box drainage discharge conduit under the levee and all other appurtenances retained under Automatic Board Order (ABO) issued as Permit No. 10088, 1974 - Reclamation District No. 1500). [Additional Reference(s): DWR Levee Log, 1993. USACE Sacramento O&M Manual 129, June 1954, (Station 1226+00)]. FS Date: 1/21/2014

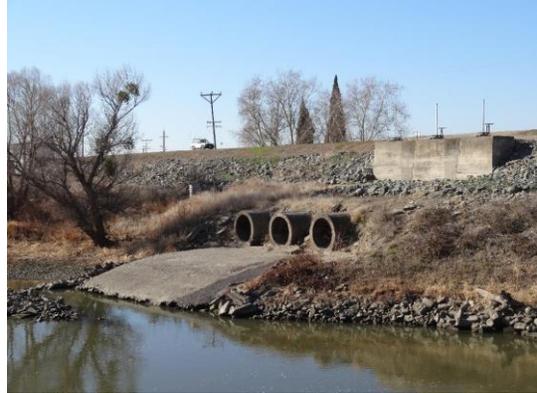
Photo 3 of 3 : UCIP_SP_2020_28891_53135.jpg

WS view: outfall structure on levee toe and concrete box on levee shoulder.

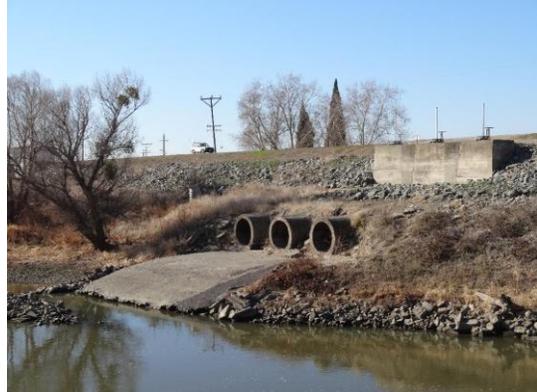
Photo 1 of 3 : UCIP_SP_2020_28892_53147.jpg

WS view: outfall structure on levee toe and concrete box on levee shoulder.

Comment Code					
Inspector Comment					
DS_ID:20092 FS_ID:28892 EP_NO: 10088 Repair Type: No Action Needed Crossing Status: Found UCIP Comments: Pumping plant was working during the field visit. Three 8.5 ft. X 8.5 ft. concrete box on waterside shoulder. FIELD_STRUCT_DESC: [Reclamation District No. 1500, Pumping Plant No. 1] 2 of 3: 84-inch by 84-inch reinforced concrete box drainage discharge conduit under the levee, 24 feet below the crown. Pumps in concrete pumping plant on the landside (LS). Slide gates mounted on a concrete structure on the waterside (WS) slope. Discharges in a concrete spillway and the borrow pit. Ramp on the WS slope. (84-inch by 84-inch reinforced concrete box drainage discharge conduit under the levee and all other appurtenances retained under Automatic Board Order (ABO) issued as Permit No. 10088, 1974 - Reclamation District No. 1500). [Additional Reference(s): DWR Levee Log, 2005. USACE Sacramento O&M Manual 129, June 1954, (Station 1224+75), three 78-inch concrete conduits referenced]. FS Date: 1/21/2014

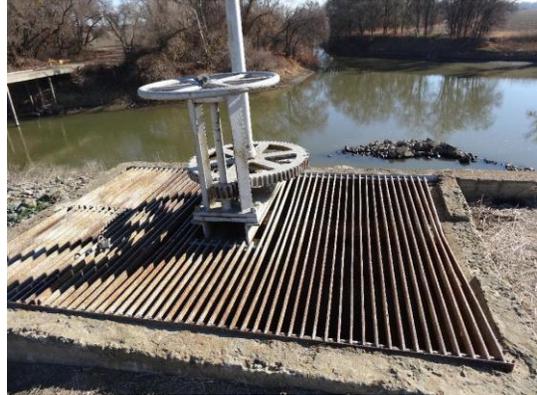
Photo 1 of 3 : UCIP_SP_2020_28893_53157.jpg

Comment Code					
Inspector Comment					
DS_ID:20093 FS_ID:28893 EP_NO: 10088 Repair Type: No Action Needed Crossing Status: Found UCIP Comments: Pumping plant was working during the field visit. Three 8.5 ft. X 8.5 ft. concrete box on waterside shoulder. FIELD_STRUCT_DESC: [Reclamation District No. 1500, Pumping Plant No. 1] 3 of 3: 84-inch by 84-inch reinforced concrete box drainage discharge conduit under the levee, 24 feet below the crown. Pumps in concrete pumping plant on the landside (LS). Slide gates mounted on a concrete structure on the waterside (WS) slope. Discharges in a concrete spillway and the borrow pit. Ramp on the WS slope. (84-inch by 84-inch reinforced concrete box drainage discharge conduit under the levee and all other appurtenances retained under Automatic Board Order (ABO) issued as Permit No. 10088, 1974 - Reclamation District No. 1500). [Additional Reference(s): DWR Levee Log, 2005. USACE Sacramento O&M Manual 129, June 1954, (Station 1224+75), three 78-inch concrete conduits referenced]. FS Date: 1/21/2014

WS view: slide gate in concrete box on levee shoulder.

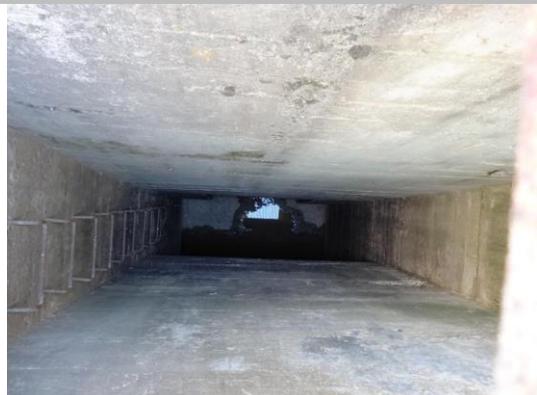
Photo 2 of 3 : UCIP_SP_2020_28893_53156.jpg

WS view: inside view of concrete box on levee shoulder.

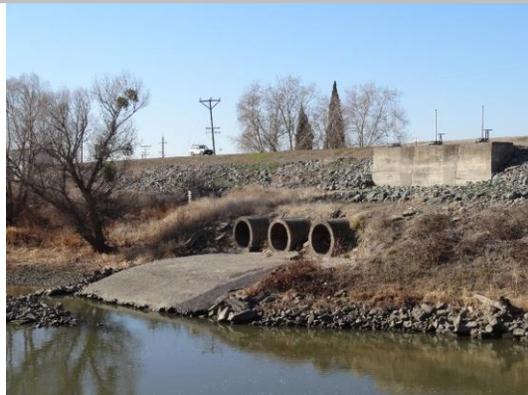
Photo 3 of 3 : UCIP_SP_2020_28893_53155.jpg

WS view: outfall structure on levee toe and concrete box on levee shoulder.

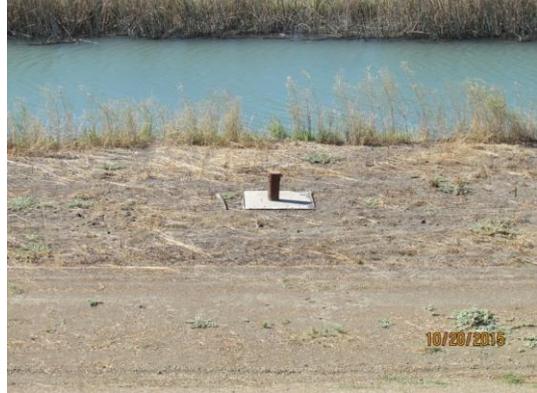
Photo 3 of 3 : SP_2020_RD1500_190_4_20200228_00003.jpg

LM Start	14.13	Rating **	U	Issue No.	4
LM End	14.13	Issue Type +	Ma	Location *	LS
Category	Earthen Levee		GPS Latitude/Longitude		
			Start	End	
Item	Underseepage Relief Wells		38.947628 °	38.947628 °	
			-121.669764 °	-121.669764 °	
DWR ID	DWR_RD1500_02_s_2012_4				
Comment Code					
Inspector Comment					
The concrete pad and the PVC underneath are broken apparently by an attempt to pull out the head of the well.

Another view of damaged well. Fall 2016.

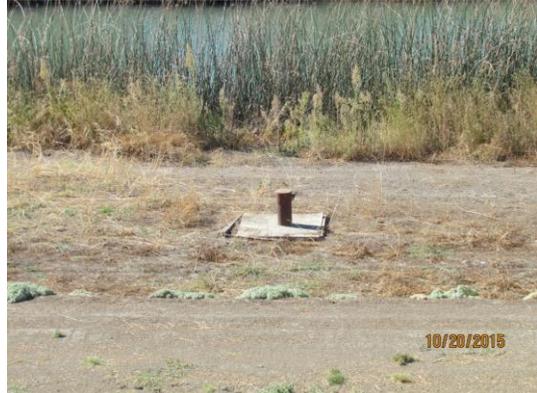
Photo 1 of 1 : SP_2020_RD1500_190_11_20200228_00004.jpg

View of the relief well at historical boil 12. Fall 2015.

LM Start	14.47	Rating **	A/W	Issue No.	11
LM End	14.47	Issue Type +	Ma	Location *	LS
Category	Earthen Levee		GPS Latitude/Longitude		
			Start	End	
Item	Underseepage Relief Wells		38.951413 °	38.951413 °	
			-121.673856 °	-121.673856 °	
DWR ID	DWR_RD1500_02_s_2012_11				
Comment Code					
Inspector Comment

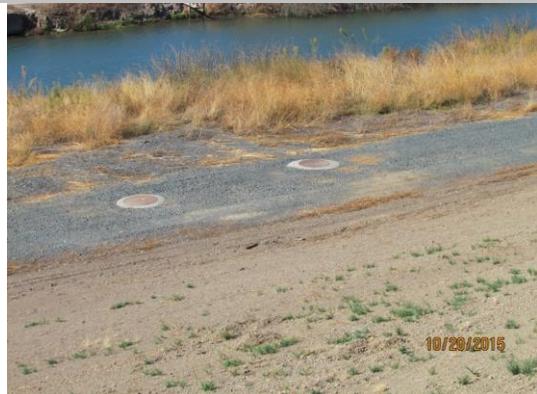
Photo 1 of 2 : SP_2020_RD1500_190_13_20200228_00006.jpg

LM Start	18.17	Rating **	A/W	Issue No.	13
LM End	18.17	Issue Type +	Ma	Location *	LS
Category	Earthen Levee		GPS Latitude/Longitude		
			Start	End	
Item	Underseepage Relief Wells		38.987031 °	38.987031 °	
			-121.725049 °	-121.725049 °	
DWR ID	DWR_RD1500_02_s_2012_13				
Comment Code					
Inspector Comment

View of two of four drains on the landward side of the levee. Fall 2015.

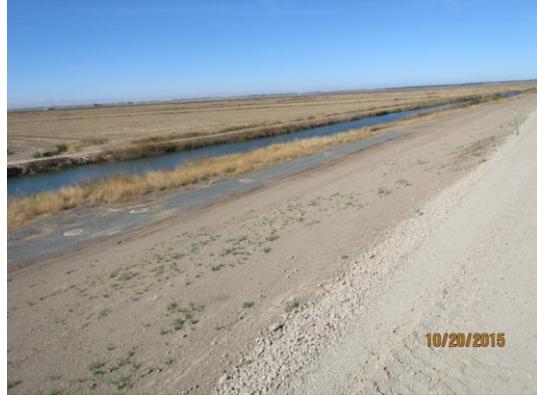
Photo 2 of 2 : SP_2020_RD1500_190_13_20200228_00007.jpg

LM Start	18.17	Rating **	A/W	Issue No.	13 (cont)
LM End	18.17	Issue Type +	Ma	Location *	LS
Category	Earthen Levee		GPS Latitude/Longitude		
			Start	End	
Item	Underseepage Relief Wells		38.987031 °	38.987031 °	
			-121.725049 °	-121.725049 °	
DWR ID	DWR_RD1500_02_s_2012_13

View of the 4 drains at the levee toe on the landward side. Fall 2015.

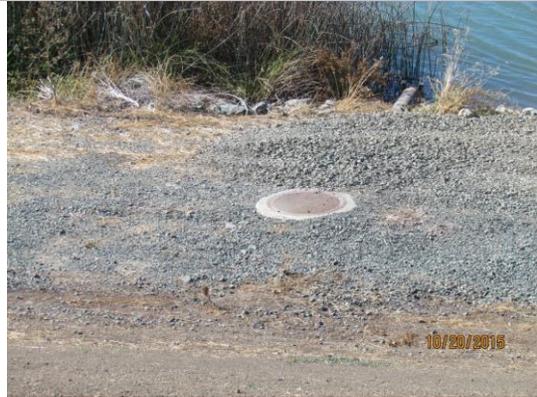
Photo 1 of 1 : SP_2020_RD1500_190_15_20200228_00008.jpg

LM Start	18.43	Rating **	A/W	Issue No.	15
LM End	18.43	Issue Type +	Ma	Location *	LS
Category	Earthen Levee		GPS Latitude/Longitude		
			Start	End	
Item	Underseepage Relief Wells		38.989962 °	38.989962 °	
			-121.727896 °	-121.727896 °	
DWR ID	DWR_RD1500_02_s_2015_15				
Comment Code					
Inspector Comment

View of the toe drainage at the landward toe berm. Fall 2015.
