**Flood Control Project Maintenance  
Levee Inspections**

**Maintenance Issue Types Only, Levee Inspection Report By Mile - Fall 2019**

**Reclamation District No. 1500 Sutter Basin**

Waterway	Bank	Unit Miles	Inspection Start/End	Inspector
Unit No. 01 Sacramento River	Left	33.15	10/30/2019 10/30/2019	Zach Jojola

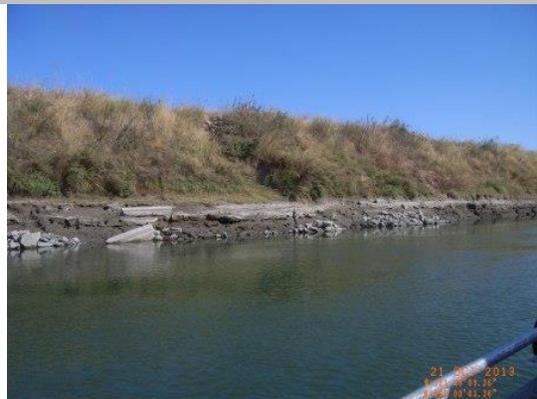
Photo 1 of 1 : FA\_2019\_RD1500\_189\_82\_20190829\_00030.jpg

LM Start	<b>30.60</b>	Rating **	A/W	Issue No.	<b>82</b>
LM End	<b>30.75</b>	Issue Type +	Ma	Location *	WS
Category	Supplemental		GPS Latitude/Longitude		
			Start	End	
Item	2017 USACE Erosion Survey		38.999745°	39.001413°	
			-121.800898°	-121.802889°	
DWR ID	DWR_RD1500_01_f_2018_82				
Comment Code					
Inspector Comment					
2017 Site ID: SAC 116.0 L Status: Eroding 2017 Field Notes: Minor new erosion throughout the site. Site History: 2000 - Eroding, vertical berm slope over a vertical cohesive toe; slow erosion but getting close to the toe. 2002 - Erosion is getting close to the levee, still eroding with some new small slumps. 2004 - Some minor new erosion. 2006 - Some new erosion, cleaned off older scars and slump faces. 2008 - New, small, partial rotational failure. 2011 - Some new minor erosion. 2016 - Fresh erosion on lower bank.

USACE 2013 Photo #1

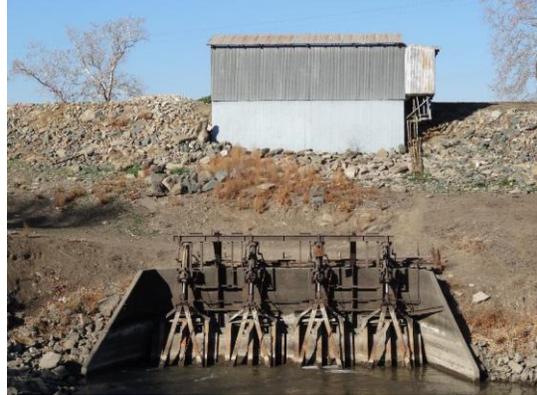
Photo 1 of 3 : UCIP\_FA\_2019\_28886\_53098.jpg

Item	DRAFT DWR UCIP LMA Responsibility		38.783865 °	38.783865 °	
			-121.655170 °	-121.655170 °	
DWR ID	20020				
Comment Code					
Inspector Comment					
DS_ID:20020 FS_ID:28886 EP_NO: N/A Repair Type: No Action Needed Crossing Status: Found UCIP Comments: Pumping plat was working during the field visit. Hydraulic gates on outfall structure. Motorized slide gates on waterside shoulder. FIELD_STRUCT_DESC: [Reclamation District No. 1500, Pumping Plant No. 3] 1 of 4: 72-inch by 84-inch reinforced concrete box drainage discharge conduit under the levee, 35 feet below the crown. Two concrete cutoff walls. Pumps in concrete pumping plant on the landside (LS). Timber steps on the LS slope. Two service poles and anchors on the LS shoulder. Electrical control gates in a metal and concrete building on the waterside (WS) shoulder. Flap gates on the WS end. Installed by USACE in 1950. (Construction of a four compartment concrete gravity outlet conduit under the levee authorized under Permit No. 1284, 1948 - Reclamation District No. 1500). [Additional Reference(s): DWR Levee Log, 1993. USACE Sacramento O&M Manual 129, June 1954, (Station 1227+00)]. FS Date: 1/21/2014

WS view: CM shed for slide gate on levee shoulder (top) and outfall structure at levee toe (bottom).

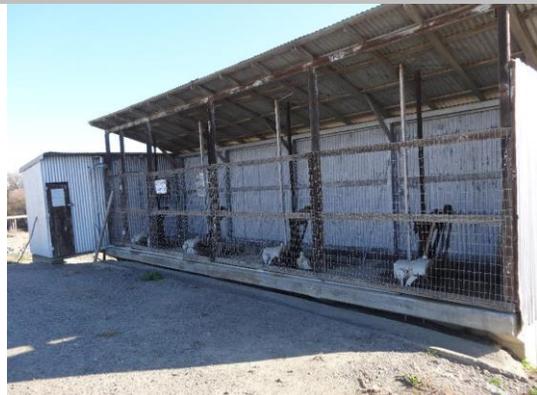
Photo 2 of 3 : UCIP\_FA\_2019\_28886\_53096.jpg

WS view: motorized slide gates in CM shed on levee shoulder.

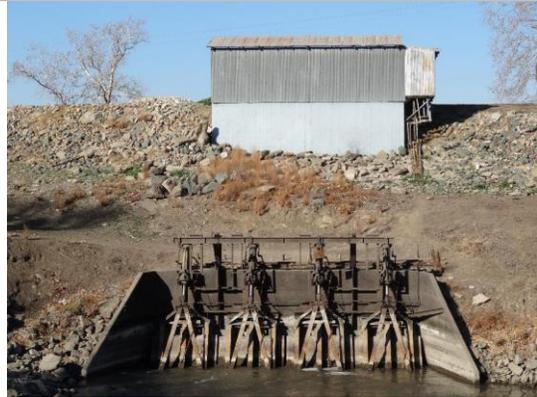
Photo 1 of 3 : UCIP\_FA\_2019\_28883\_53085.jpg

Item	DRAFT DWR UCIP LMA Responsibility		38.783885°	38.783885°	
			-121.655158°	-121.655158°	
DWR ID	20027				
Comment Code					
Inspector Comment					
DS_ID:20027 FS_ID:28883 EP_NO: N/A Repair Type: No Action Needed Crossing Status: Found UCIP Comments: Pumping plat was working during the field visit. Hydraulic gates on outfall structure. Motorized slide gates on waterside shoulder. FIELD_STRUCT_DESC: [Reclamation District No. 1500, Pumping Plant No. 3] 2 of 4: 72-inch by 84-inch reinforced concrete box drainage discharge conduit under the levee, 35 feet below the crown. Two concrete cutoff walls. Pumps in concrete pumping plant on the landside (LS). Timber steps on the LS slope. Two service poles and anchors on the LS shoulder. Electrical control gates in a metal and concrete building on the waterside (WS) shoulder. Flap gates on the WS end. Installed by USACE in 1950. (Construction of a four compartment concrete gravity outlet conduit under the levee authorized under Permit No. 1284, 1948 - Reclamation District No. 1500). [Additional Reference(s): DWR Levee Log, 1993. USACE Sacramento O&M Manual 129, June 1954, (Station 1227+00)]. FS Date: 1/21/2014

WS view: CM shed for slide gate on levee shoulder (top) and outfall structure at levee toe (bottom).

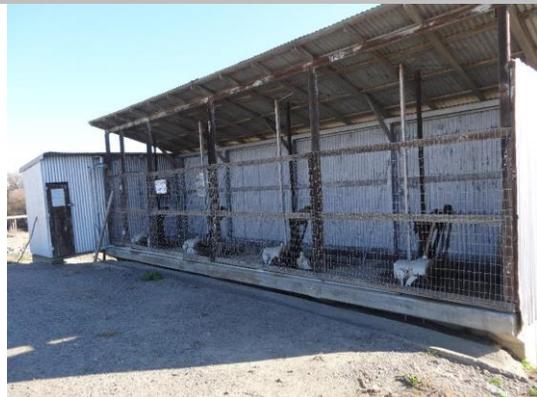
Photo 2 of 3 : UCIP\_FA\_2019\_28883\_53083.jpg

WS view: motorized slide gates in CM shed on levee shoulder.

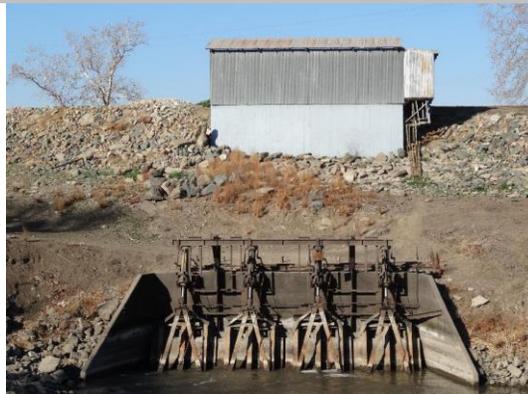
Photo 1 of 3 : UCIP\_FA\_2019\_28884\_53089.jpg

Item	DRAFT DWR UCIP LMA Responsibility		38.783904 °	38.783904 °	
			-121.655149 °	-121.655149 °	
DWR ID	20028				
Comment Code					
Inspector Comment					
DS_ID:20028 FS_ID:28884 EP_NO: N/A Repair Type: No Action Needed Crossing Status: Found UCIP Comments: Pumping plat was working during the field visit. Hydraulic gates on outfall structure. Motorized slide gates on waterside shoulder. FIELD_STRUCT_DESC: [Reclamation District No. 1500, Pumping Plant No. 3] 3 of 4: 72-inch by 84-inch reinforced concrete box drainage discharge conduit under the levee, 35 feet below the crown. Two concrete cutoff walls. Pumps in concrete pumping plant on the landside (LS). Timber steps on the LS slope. Two service poles and anchors on the LS shoulder. Electrical control gates in a metal and concrete building on the waterside (WS) shoulder. Flap gates on the WS end. Installed by USACE in 1950. (Construction of a four compartment concrete gravity outlet conduit under the levee authorized under Permit No. 1284, 1948 - Reclamation District No. 1500). [Additional Reference(s): DWR Levee Log, 1993. USACE Sacramento O&M Manual 129, June 1954, (Station 1227+00)]. FS Date: 1/21/2014

WS view: CM shed for slide gate on levee shoulder (top) and outfall structure at levee toe (bottom).

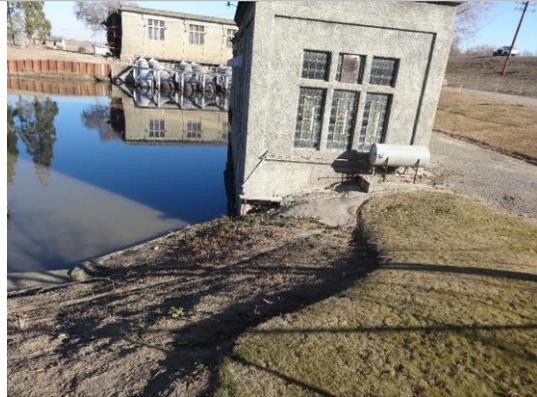
Photo 3 of 3 : UCIP\_FA\_2019\_28884\_53099.jpg

LS view: pump house at the end of levee berm.

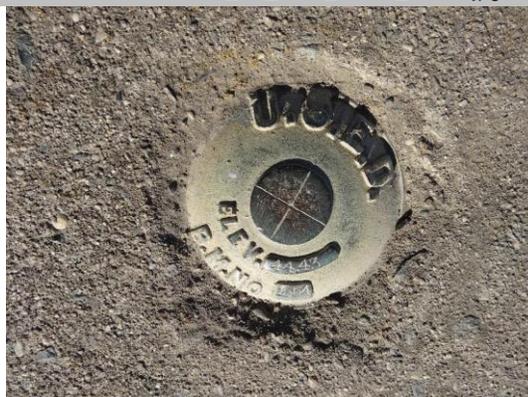
Photo 3 of 3 : UCIP\_FA\_2019\_28954\_53262.jpg

Item	DRAFT DWR UCIP LMA Responsibility			38.784097°	38.784097°
				-121.655073°	-121.655073°
DWR ID	20019				
Comment Code					
Inspector Comment					
DS_ID:20019 FS_ID:28954 EP_NO: 10088 Repair Type: No Action Needed Crossing Status: Found UCIP Comments: USED Bench Mark on concrete structure at waterside shoulder. FIELD_STRUCT_DESC: [Reclamation District No. 1500, Pumping Plant No. 2] 1 of 3: 48-inch by 48-inch reinforced concrete box drainage discharge conduit under the levee, 37 feet below the crown. Two concrete cutoff walls. Pumps in concrete pumping plant on the landside (LS). Slide gates mounted on a concrete structure on the waterside (WS) slope. Discharges in borrow pit. Flap gates on the WS end. (48-inch by 48-inch reinforced concrete box drainage discharge conduit under the levee and all other appurtenances retained under Automatic Board Order (ABO) issued as Permit No. 10088, 1974 - Reclamation District No. 1500). [Additional Reference(s): DWR Levee Log, 1993. USACE Sacramento O&M Manual 129, June 1954, (Station 1226+00)]. FS Date: 1/21/2014

WS view: USED Bench Mark on concrete structure on levee shoulder.

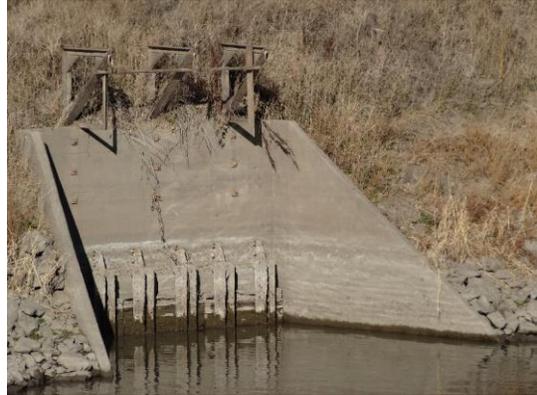
Photo 1 of 3 : UCIP\_FA\_2019\_28955\_53265.jpg

Item	DRAFT DWR UCIP LMA Responsibility		38.784111°	38.784111°	
			-121.655067°	-121.655067°	
DWR ID	20025				
Comment Code					
Inspector Comment					
DS_ID:20025 FS_ID:28955 EP_NO: 10088 Repair Type: No Action Needed Crossing Status: Found UCIP Comments: USED Bench Mark on concrete structure at levee shoulder. FIELD_STRUCT_DESC: [Reclamation District No. 1500, Pumping Plant No. 2] 2 of 3: 48-inch by 48-inch reinforced concrete box drainage discharge conduit under the levee, 37 feet below the crown. Two concrete cutoff walls. Pumps in concrete pumping plant on the landside (LS). Slide gates mounted on a concrete structure on the waterside (WS) slope. Discharges in borrow pit. Flap gates on the WS end. (48-inch by 48-inch reinforced concrete box drainage discharge conduit under the levee and all other appurtenances retained under Automatic Board Order (ABO) issued as Permit No. 10088, 1974 - Reclamation District No. 1500). [Additional Reference(s): DWR Levee Log, 1993. USACE Sacramento O&M Manual 129, June 1954, (Station 1226+00)]. FS Date: 1/21/2014

WS view: U type concrete headwall and flap gates on levee toe.

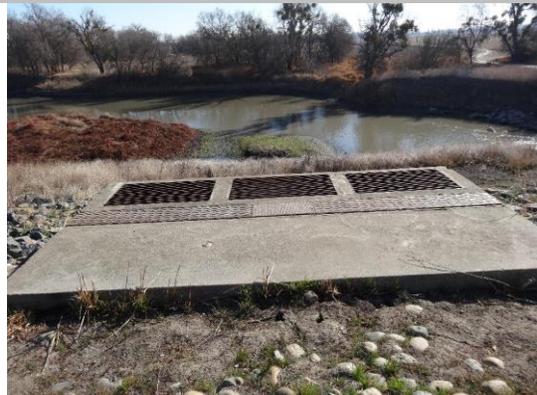
Photo 2 of 3 : UCIP\_FA\_2019\_28955\_53263.jpg

WS view: concrete surge structure on waterside shoulder.

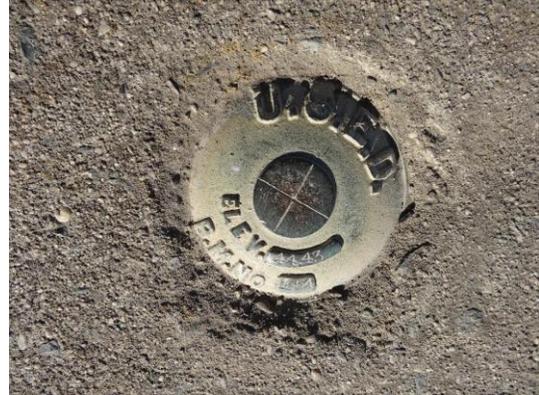
Photo 3 of 3 : UCIP\_FA\_2019\_28955\_53264.jpg

WS view: USED Bench Mark on concrete structure at levee shoulder.

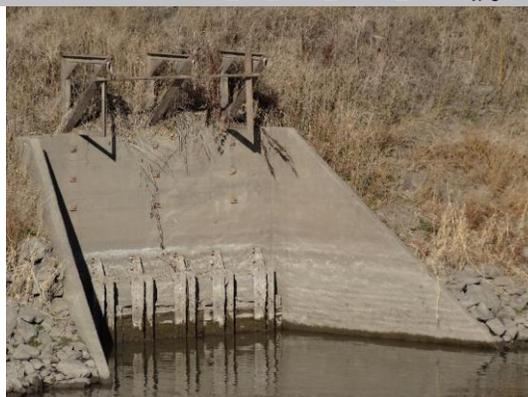
Photo 1 of 3 : UCIP\_FA\_2019\_28956\_53269.jpg

Item	DRAFT DWR UCIP LMA Responsibility		38.784127°	38.784127°	
			-121.655057°	-121.655057°	
DWR ID	20026				
Comment Code					
Inspector Comment					
DS_ID:20026 FS_ID:28956 EP_NO: 10088 Repair Type: No Action Needed Crossing Status: Found UCIP Comments: USED Bench Mark on concrete structure at waterside shoulder. FIELD_STRUCT_DESC: [Reclamation District No. 1500, Pumping Plant No. 2] 3 of 3: 48-inch by 48-inch reinforced concrete box drainage discharge conduit under the levee, 37 feet below the crown. Two concrete cutoff walls. Pumps in concrete pumping plant on the landside (LS). Slide gates mounted on a concrete structure on the waterside (WS) slope. Discharges in borrow pit. Flap gates on the WS end. (48-inch by 48-inch reinforced concrete box drainage discharge conduit under the levee and all other appurtenances retained under Automatic Board Order (ABO) issued as Permit No. 10088, 1974 - Reclamation District No. 1500). [Additional Reference(s): DWR Levee Log, 1993. USACE Sacramento O&M Manual 129, June 1954, (Station 1226+00)]. FS Date: 1/21/2014

WS view: U type concrete headwall and flap gates on levee toe.

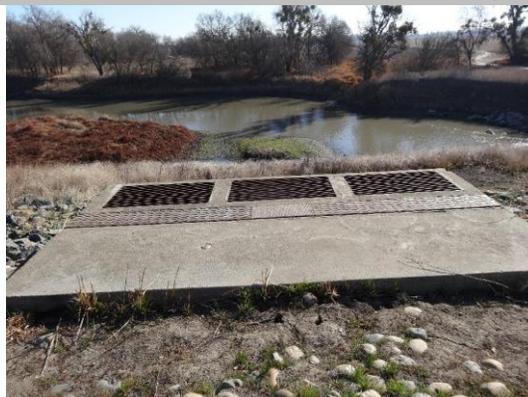
Photo 2 of 3 : UCIP\_FA\_2019\_28956\_53268.jpg

WS view: U type concrete headwall and flap gates on levee toe.

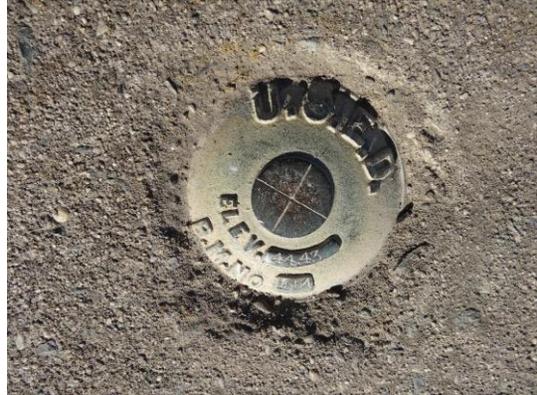
Photo 3 of 3 : UCIP\_FA\_2019\_28956\_53267.jpg

WS view: USED Bench Mark on concrete structure at levee shoulder.

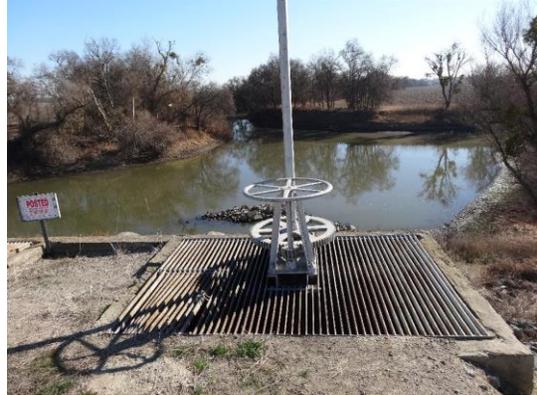
Photo 1 of 3 : UCIP\_FA\_2019\_28891\_53137.jpg

Item	DRAFT DWR UCIP LMA Responsibility			38.784783 °	38.784783 °
				-121.654791 °	-121.654791 °
DWR ID	20088				
Comment Code					
Inspector Comment					
DS_ID:20088 FS_ID:28891 EP_NO: 10088 Repair Type: No Action Needed Crossing Status: Found UCIP Comments: Pumping plant was working during the field visit. Three 8.5 ft. X 8.5 ft. concrete box on waterside shoulder. FIELD_STRUCT_DESC: [Reclamation District No. 1500, Pumping Plant No. 1] 1 of 3: 84-inch by 84-inch reinforced concrete box drainage discharge conduit under the levee, 24 feet below the crown. Pumps in concrete pumping plant on the landside (LS). Slide gates mounted on a concrete structure on the waterside (WS) slope. Discharges in a concrete spillway and the borrow pit. Ramp on the WS slope. (84-inch by 84-inch reinforced concrete box drainage discharge conduit under the levee and all other appurtenances retained under Automatic Board Order (ABO) issued as Permit No. 10088, 1974 - Reclamation District No. 1500). [Additional Reference(s): DWR Levee Log, 2005. USACE Sacramento O&M Manual 129, June 1954, (Station 1224+75), three 78-inch concrete conduits referenced]. FS Date: 1/21/2014

WS view: slide gate in concrete box on levee shoulder.

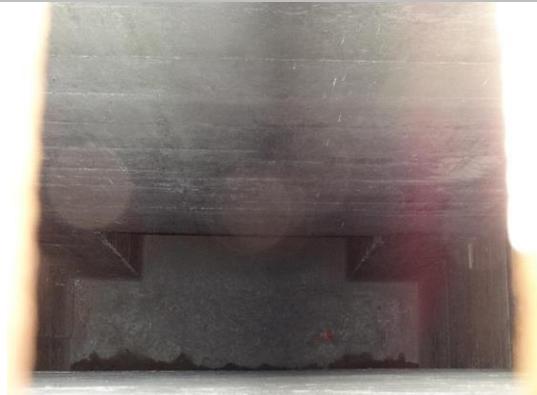
Photo 2 of 3 : UCIP\_FA\_2019\_28891\_53136.jpg

WS view: inside view of concrete box on levee shoulder.

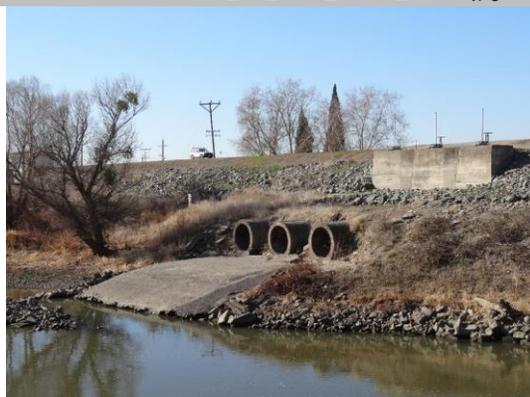
Photo 3 of 3 : UCIP\_FA\_2019\_28891\_53135.jpg

WS view: outfall structure on levee toe and concrete box on levee shoulder.

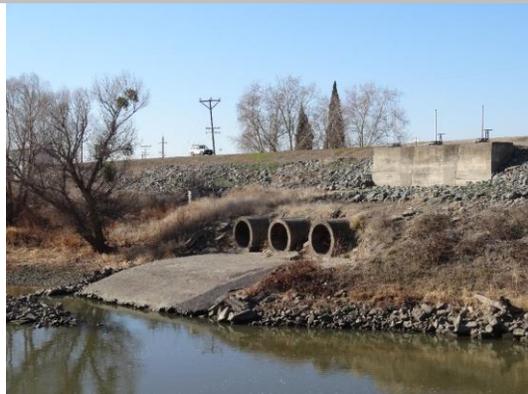
Photo 3 of 3 : UCIP\_FA\_2019\_28893\_53155.jpg

Item	DRAFT DWR UCIP LMA Responsibility		38.784856 °	38.784856 °	
			-121.654762 °	-121.654762 °	
DWR ID	20093				
Comment Code					
Inspector Comment					
DS_ID:20093 FS_ID:28893 EP_NO: 10088 Repair Type: No Action Needed Crossing Status: Found UCIP Comments: Pumping plant was working during the field visit. Three 8.5 ft. X 8.5 ft. concrete box on waterside shoulder. FIELD_STRUCT_DESC: [Reclamation District No. 1500, Pumping Plant No. 1] 3 of 3: 84-inch by 84-inch reinforced concrete box drainage discharge conduit under the levee, 24 feet below the crown. Pumps in concrete pumping plant on the landside (LS). Slide gates mounted on a concrete structure on the waterside (WS) slope. Discharges in a concrete spillway and the borrow pit. Ramp on the WS slope. (84-inch by 84-inch reinforced concrete box drainage discharge conduit under the levee and all other appurtenances retained under Automatic Board Order (ABO) issued as Permit No. 10088, 1974 - Reclamation District No. 1500). [Additional Reference(s): DWR Levee Log, 2005. USACE Sacramento O&M Manual 129, June 1954, (Station 1224+75), three 78-inch concrete conduits referenced]. FS Date: 1/21/2014

WS view: outfall structure on levee toe and concrete box on levee shoulder.
