**Flood Control Project Maintenance
Levee Inspections**
LMA District Cover Sheet
Spring 2020 Levee Inspection Results

Reclamation District No. 1600 Mull

Waterway	Bank	Unit Miles
Unit No. 01 Sacramento River	Right	10.46

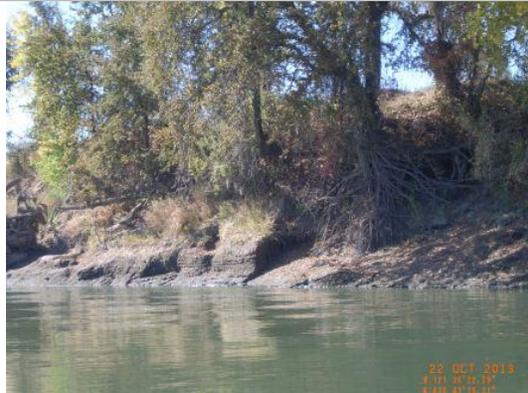
Photo 1 of 1 : SP_2020_RD1600_191_16_20200228_00005.jpg

LM Start	3.58	Rating **	M	Issue No.	16
LM End	3.83	Issue Type +	Ma	Location *	WS
Category	Supplemental			GPS Latitude/Longitude	
				Start	End
Item	2017 USACE Erosion Survey			38.717770 °	38.721351 °
				-121.607423 °	-121.606414 °
DWR ID	DWR_RD1600_01_f_2018_16				
Comment Code					
Inspector Comment					
2017 Site ID: SAC 74.4 R Status: Eroding 2017 Field Notes: Significant erosion at toe in the past year. Fresh tree popout. Site History: 1997 - Steep high bank. 2005 - Some small pockets in the low toe near the waterline. 2006 - Minor slope clearing. 2010 - Minor new erosion. 2011 - Multiple trees have fallen since last year. Some other trees look ready to fall. Significant new erosion since last year. 2012 - Minor new erosion. 2013 - Minor new erosion. 2015 - Minor new toe erosion.

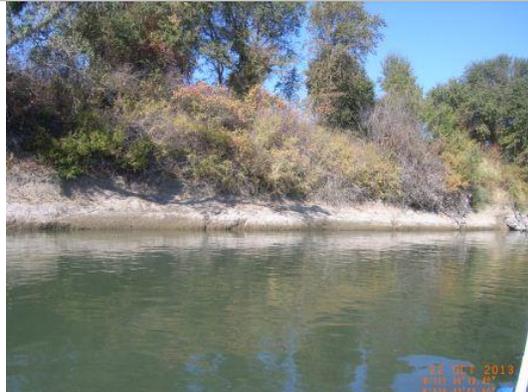
Photo 1 of 1 : SP_2020_RD1600_191_17_20200228_00006.jpg

LM Start	4.34	Rating **	A/W	Issue No.	17
LM End	4.86	Issue Type +	Ma	Location *	WS
Category	Supplemental			GPS Latitude/Longitude	
				Start	End
Item	2017 USACE Erosion Survey			38.728684 °	38.736110 °
				-121.605844 °	-121.604153 °
DWR ID	DWR_RD1600_01_f_2018_17				
Comment Code					
Inspector Comment					
2017 Site ID: SAC 75.3 R Status: Eroding 2017 Field Notes: Fresh erosion along lower bank in sections. Site History: 1997 - Very steep bank. 2005 - Lots of small trees down along the bank at the upstream end. 2006 - Minor new erosion, but slow. 2010 - Almost all of the roots are exposed on the trees, appears ready to fall. 2011 - New erosion and tree popouts. 2012 - Site has become overgrown with vegetation, making it hard to observe. 2015 - Dense vegetation made the site difficult to observe.					
DWR Inspector Comment: Worst spot near LM 4.66. Recommend monitoring.
